Historic Structure Report  
**Wright Brothers Monument  
and Powerhouse**  
*100% FINAL*

# Wright Brothers Monument and Powerhouse

## Historic Structure Report

October 2022

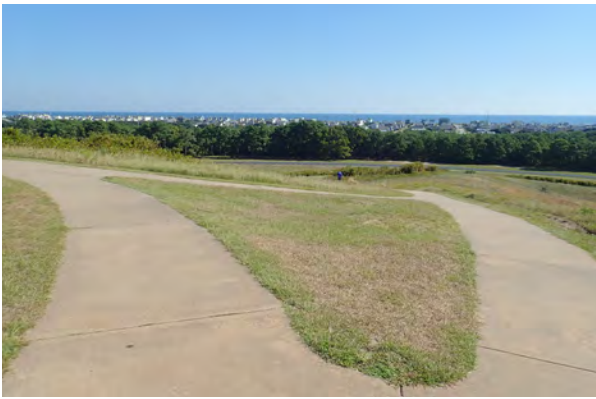
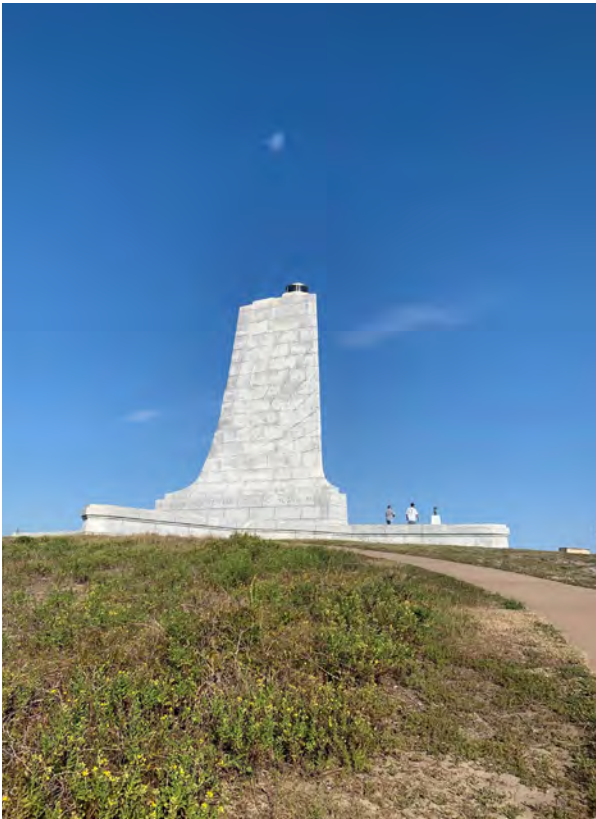
Around the terrace at the exterior there is wearing down of the grass with natural worn footpaths having been utilized by visitors. Surface erosion of the mown grass has occurred by visitor traffic off the paved paths and close-cut mowing. (Figure 3-9 and Figure 3-10).

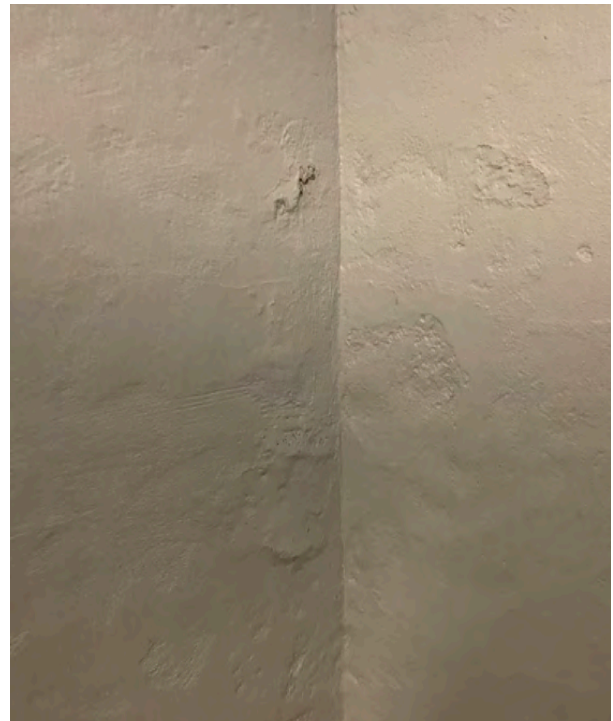
FIGURE 3–13. Interior of the pylon, showing bubbling paint and surface pockets.

Where the concrete structure could be observed, it is in good condition overall. Acute surface pockets were observed in the interior faces of the concrete on the second level. These pockets appear to be due to disintegrating surface material rather than concrete which has been physically forced from the body of the structure (a typical spalling condition). (Figure 3–13). In one location, an area of bubbling paint was probed, revealing similar disintegrated concrete material underneath. No reinforcing or other potential proximate causes for these pockets were observed, leading the team to conclude that the deterioration is likely caused by moisture entrapment underneath painted surfaces.

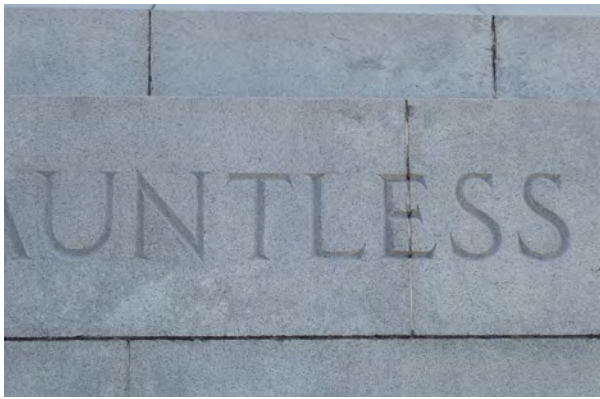
FIGURE 3-14. Close up view of the base courses, showing typical open joints and deterioration.

The exterior of the pylon is in good condition with minimal damage to the granite. Mortar joints are generally weathered on the pylon exterior, with more significant weathering in the flared Course D section. The base plinth also exhibits substantive open or deteriorated joints. (Figure 3-14) Sealant appears to have been installed over the joints in the flared section, where original drawings note that a flashing or waterproof membrane is present. (Figure 3-16) The sealant was applied to the

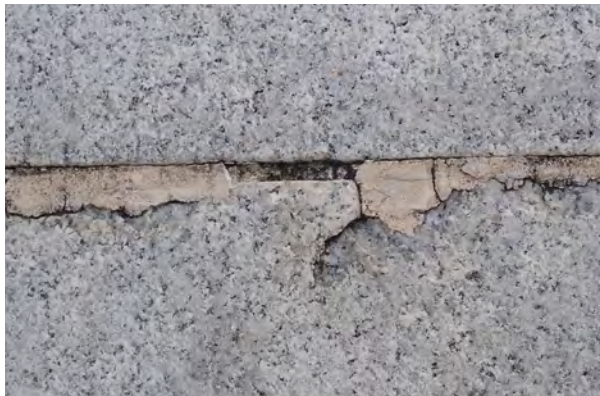
FIGURE 3-15. Close up view of a previous mortar and patch repair.

surface of the existing mortar joints rather than bedded into the joints themselves, and is mostly displaced. Evidence of a prior repointing campaign is present in non-matching, newer-looking mortar joints. (Figure 3-15) Many of these repointed joints, similar to the sealant-treated joints, were not raked properly prior to application of new mortar and consequently the new mortar has not held up.

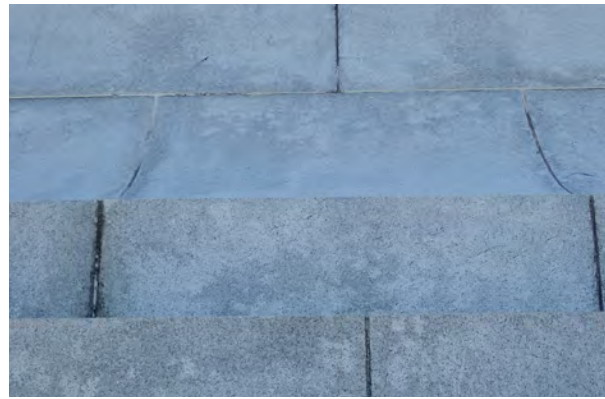
FIGURE 3-16. Close up view of the curved profile stone (Course D), with non matching sealant in joints.

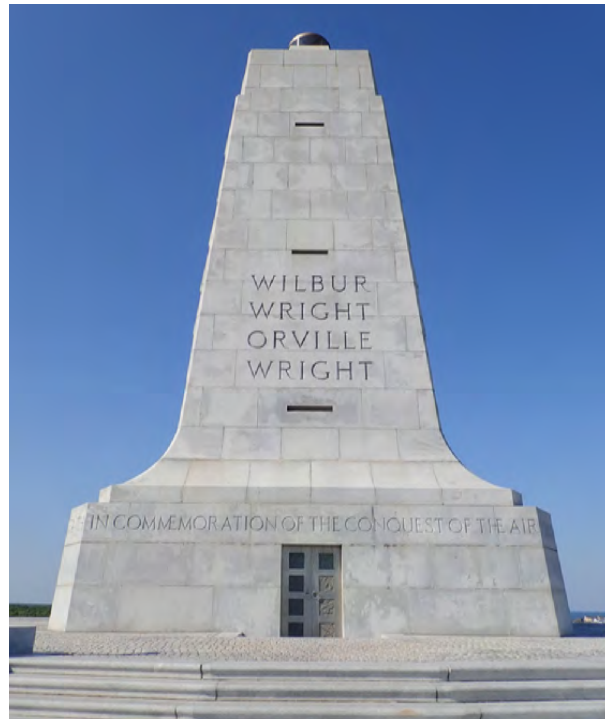
FIGURE 3-17. View of the Monument, south elevation.

The front (south) elevation is in good condition. There are typical areas of open and deteriorated joints, the majority of which are located along the

bottom three courses of stone. Additional open joints occur near the top of the tower as well as around the three louver openings. There are some spalls at various locations on the south elevation face.

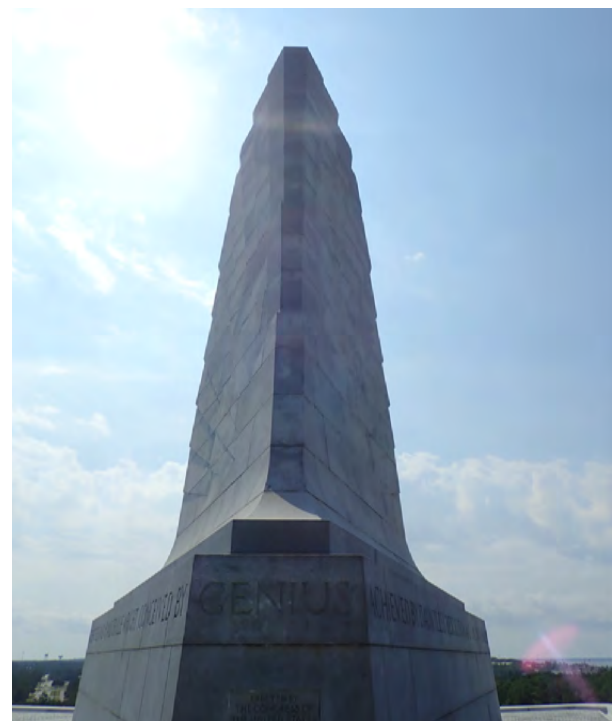
FIGURE 3-20. View of the Monument, north elevation.

The rear (north) elevation (Figure 3-20) is in good condition and has typical conditions as the other three elevations. This elevation is the smallest with areas of open and deteriorated joints at the bottom and the top courses. There also areas of non-matching mortar.

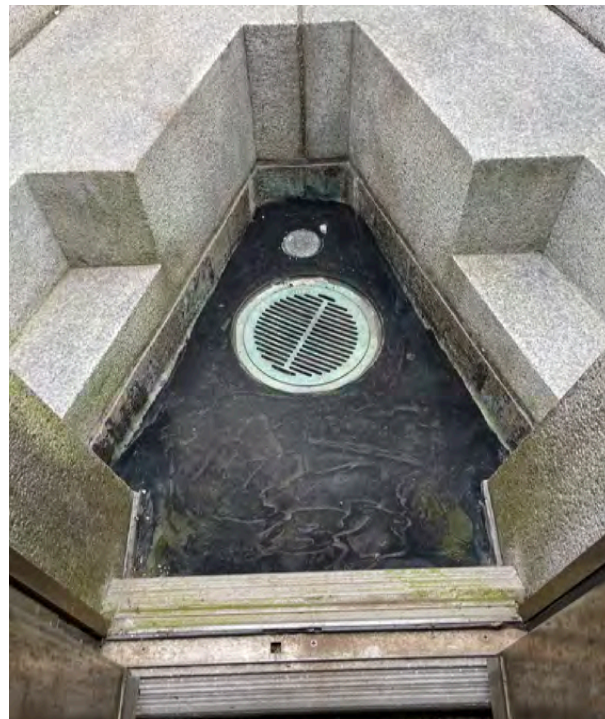
Roofing on the pylon is limited to a small patch of flat area in the base of the observation deck. (Figure 3-21) This roof area appears to have been originally constructed of lead-coated copper and provided with a single roof drain, connected to a 3-inch rain leader that extends down the pylon and discharges through a scupper on the east side of the pedestal retaining wall. The sheet metal assembly is flashed to the granite surrounding the observation deck and set in reglets approximately 3 inches above the roof surface. (Figure 3-22) The roof surface was subsequently covered in a rubberized roof patching material.

FIGURE 3-21. Observation deck level, flat roof with drain and rubber flat roofing.

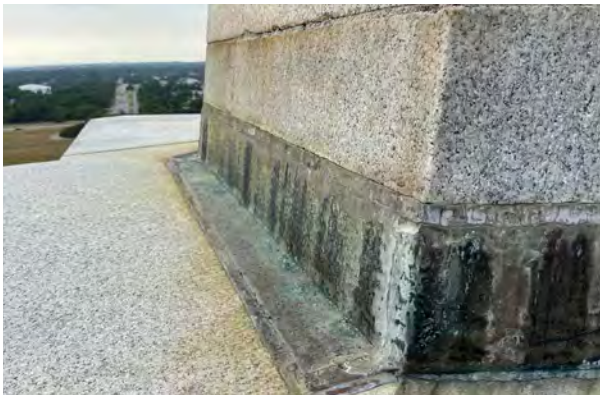
The existing flashings and the patching material appear to be in fair condition. The roof drain body is intact and shows no direct sign of wear, damage or leakage. The rain leader and conductor are discussed in the mechanical system sections below. The granite stones around the observation level have open joints on the exterior and at the interior face.

FIGURE 3-22. Metal flashing around granite cupola base at observation deck level, facing south.

- Clean and reseal or replace metal flashing at base of cupola plinth stone, Stone Course 'X'<sup>24</sup> (Figure 3-22).
- Clean and reseal or replace metal flashing at base of cupola plinth stone, Stone Course 'X'<sup>25</sup> (Figure 3-22).

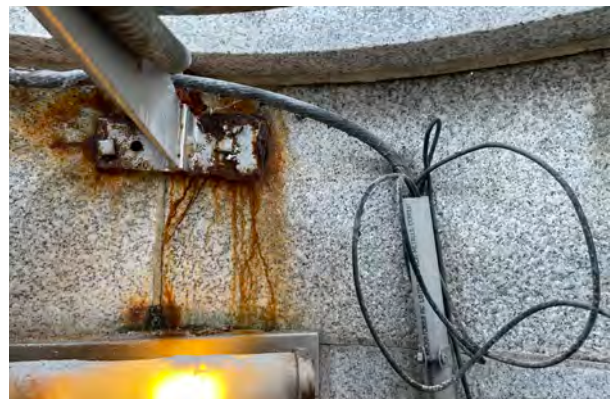
FIGURE 3-24. Beacon attachment and light below, surface staining and rust at metal.

There are previous treatment options present including a clear silicone sealant. (Figure 3–24)

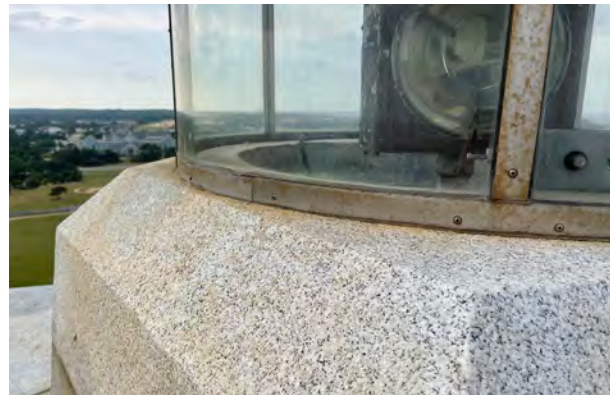
FIGURE 3-25. Exterior of beacon with failed sealant joints and surface rust.

The cupola is in fair condition. A broken pane was noted on the northeast quadrant and the broken portion appears to have been covered with clear tape. Glazing materials are cracked and dry but generally intact. The metal work at the interior shows no sign of water staining or other infiltration. On the exterior there is surface rust and the sealant joints at the base of the cupola are deteriorating and cracking. (Figure 3–25)

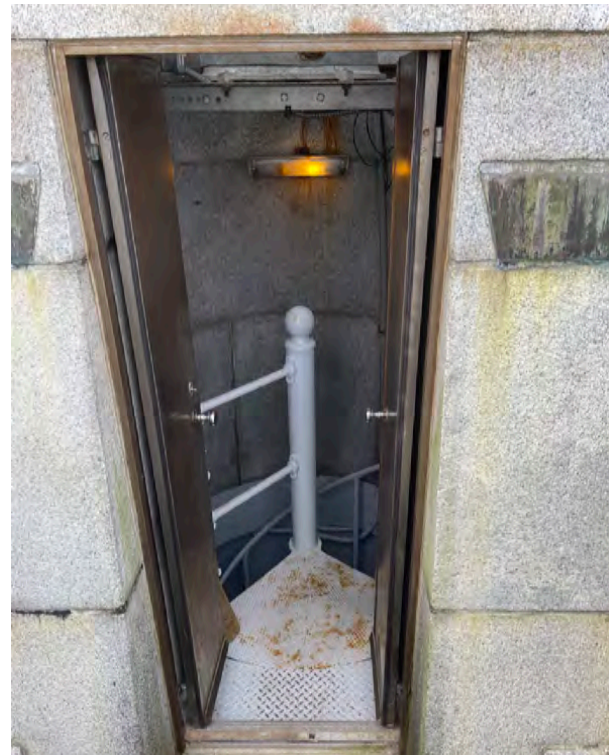
FIGURE 3–28. Metal doors to roof access.

The observation deck doors are also in good condition. The flush bolts appear to be out of alignment and do not extend properly into their mortises, and are difficult to operate. Because of this, the door cannot be properly secured and has been wedged shut with a piece of lumber. Like the entry doors, these doors exhibit minor corrosion.

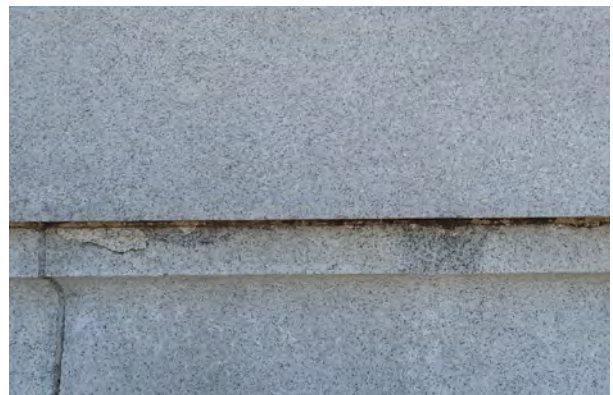
FIGURE 3–32. Typical condition of spalls at underneath of terrace cap.

The pedestal walls are in good condition, with some isolated areas of spall primarily below the drip edge at the exterior face. (Figure 3–32) There are open mortar joints in the copings and some face stones. (Figure 3–31) There is acute displacement of stone units on the easternmost point of the pedestal, exposing the joint filler material used between stones.

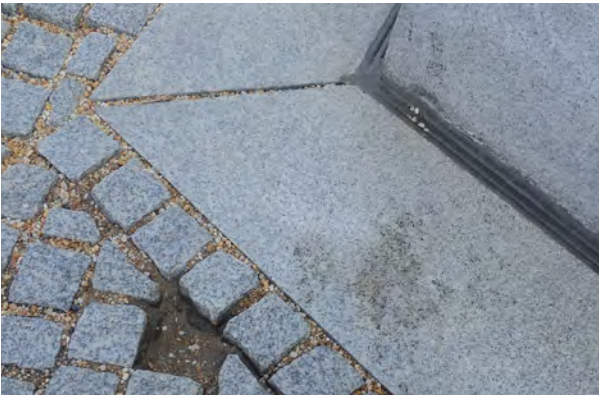
The terrace surface pavers are in good condition; however, they can be easily removed by hand, with one missing during the time of the site visit. The surface as a whole is undulating, indicating settlement in the substrates. This also has resulted in inadequate surface drainage restricting some

FIGURE 3–34. Missing terrace granite paver and broken sealant joint at base of the Monument.

storm water from properly draining to the perimeter gutters. The joint between the wide flat pavers and the base of the tower appears to have no backing and is torn or failed in several locations.

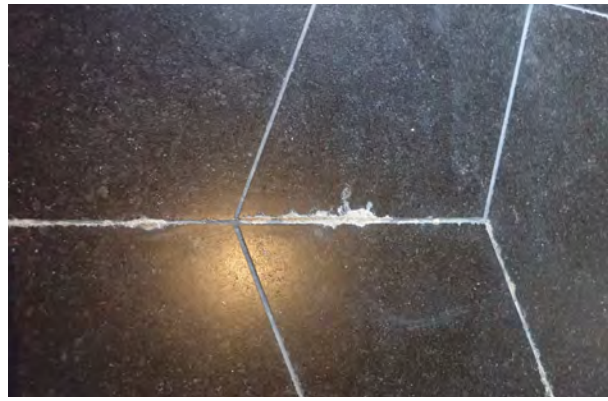
The granite flooring is in fair condition, with minor joint deterioration and staining caused by the water-damaged mortar as noted above. There is a

FIGURE 3-42. Typical joint conditions at Memorial Room floor.

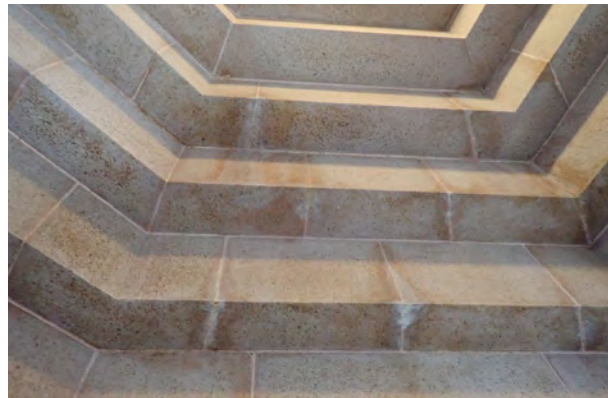
At the memorial room interior, the stone work is in good condition overall, exhibiting minor efflorescence in both the stone and mortar joints. At the corbeled ceiling there is efflorescence coming through the joints, the majority along the lower three courses. (Figure 3-43) There is evidence of substantive water infiltration through the wall joints, creating stalactites and mineral stains on the floor below. Occasional holes in mortar joints were observed, either at locations of removed anchorages or holes drilled in the mortar joints as part of investigations related to the 2017 report.

FIGURE 3-43. Water staining at joints in ceiling.

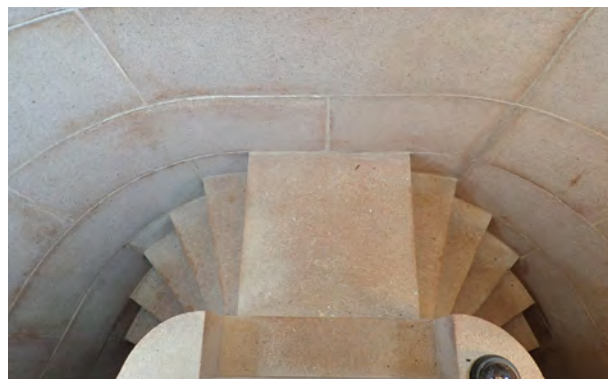
FIGURE 3-45. Landing at double staircase.

The granite staircases are in good condition showing similar signs of damage as the interior walls. There is minor efflorescence in both the stone and mortar joints. (Figure 3-45) There is evidence of substantive water infiltration through the joints, with salt deposit on the wall that is leeching from the stone.

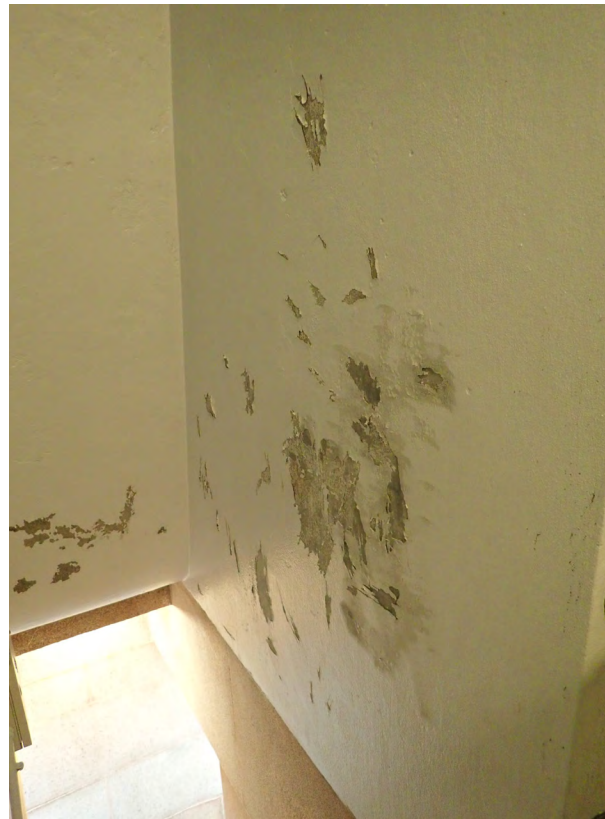
The concrete at Level B is in good condition with some previous surface spalls. In the stairwell area, the paint is peeling and coming off the surface. (Figure 3-50) There is also a small spall at the

FIGURE 3-50. Paint peeling and popping off at stairwell, below access hatch.

| Event | Location | Moisture Type | Observation Source | Notes on Suspected Source | Further Exploration | Image Reference |
|---|---|---|---|---|---|---|
| Bubbling/peeling paint on concrete | Interior, Level B: wall | Seepage | AE Field observation | Condensate line from dehumidification equipment appears to connect into roof storm leader, appears to be leaking into the void behind the wall. | Confirm condensate line routing and tie-in location. | Figure 3-50 |

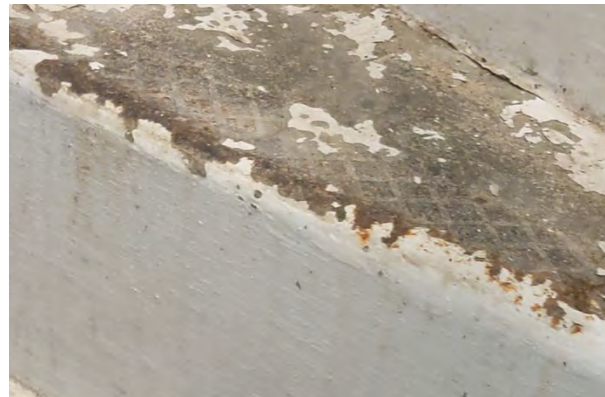
FIGURE 3-51. Surface wear and rust at risers, typical.

The concrete spiral staircase is in good condition. There is paint wear on the risers due to the traffic going up and down the stairs. (Figure 3-51). The metal treads are showing signs of surface rust that is coming through the paint and staining the surface. There are no surface cracks or spalling of the concrete.

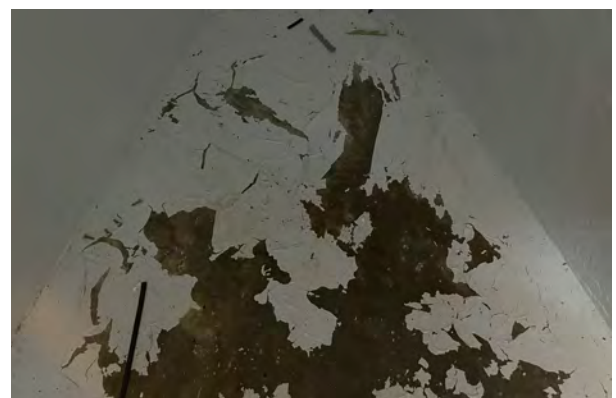
FIGURE 3-54. Peeling and worn paint at intermediate landing in the pylon.

The concrete at Level C is in good condition with areas of worn paint in high traffic locations. The paint is peeling up at the edge of the floor along the rear wall. (Figure 3-54)

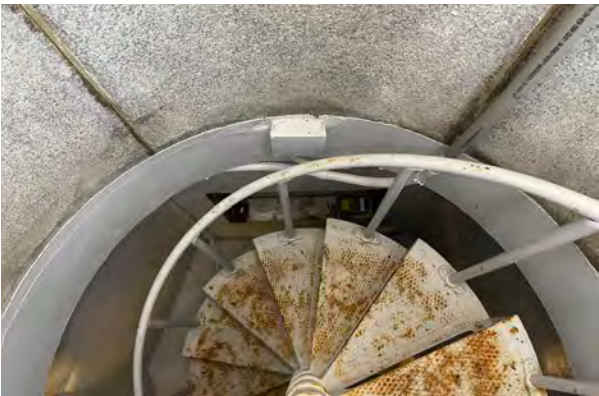
FIGURE 3–57. View from top of cupola, showing metal spiral staircase, interior joints at top cupola stones.

The steel staircase is in fair condition with surface rust at the treads, landings and anchor connections. The metal support pole at the middle also has surface rust. (Figure 3-57)

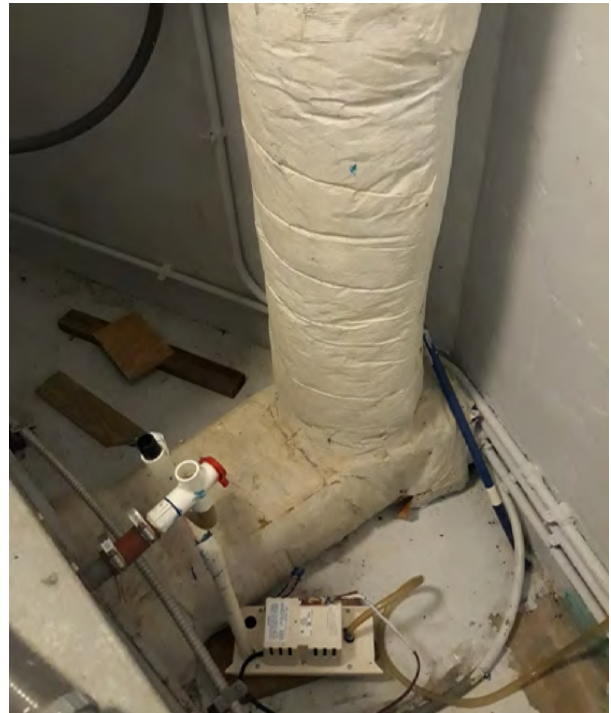
FIGURE 3-59. Dehumidification unit condensate pump and duct work.

The engineer observed that while the supply fan in the dehumidification unit was constantly running, the compressor in the unit did not turn on despite the inside condition of the space being noticeably humid.

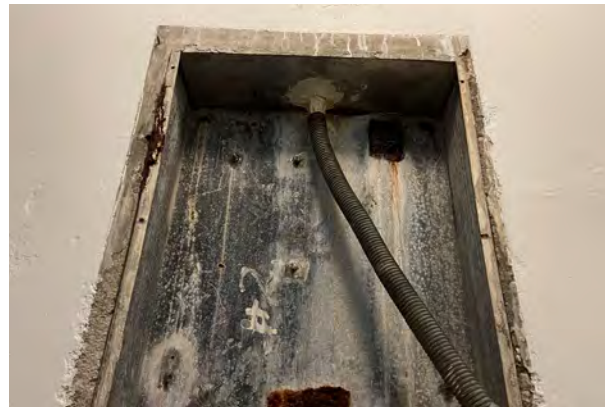
FIGURE 3–63. Electrical box and repairs at Level C.

The panel was installed within the wall opening for the previous electrical panel. The previous panel enclosure is not contributing to the interior of the Monument. An abandoned conduit located at the top of the opening is providing a path for water from above to enter the conduit leak into the opening. This water is being diverted into 5-gallon buckets by way of a flexible hose to prevent the electrical panel from getting wet. (Figure 3-63, Figure 3-64)

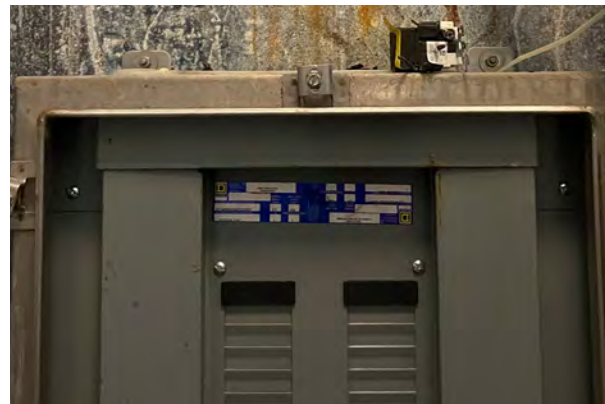
FIGURE 3–65. Panel rust.

The panel that sits in an opening of an earlier panel is showing some signs of rust. (Figure 3-65) The walls of this opening are lined with what appears to be the metal box of an earlier panel and is showing signs of decay. An abandoned conduit located at the top of the opening is providing a path for water from above to enter the conduit leak into the opening. This water is being diverted into 5-gallon buckets by way of a flexible hose to

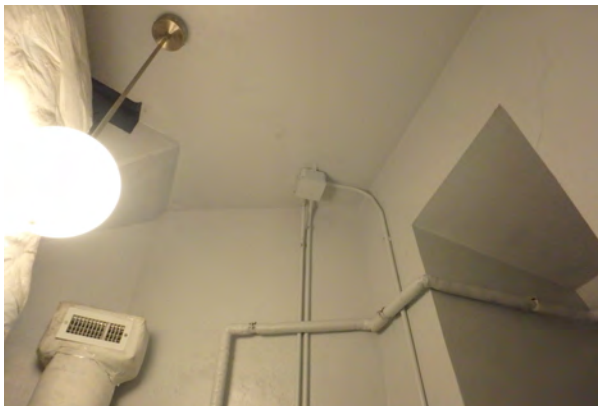
The branch circuits from the third level panel, serving lights and receptacles, are routed within the existing walls to the upper and lower levels through the junction box with the exception of some surface mounted conduit serving new equipment that has been installed to help control the humidity within the pylon. (Figure 3-66) There is also a conductor running from the metal portion of the globe located at the top of the pylon housing the beacon down to the junction box. This is assumed to be a lightning grounding conductor. (Figure 3-67, Figure 3-68, Figure 3-69)

FIGURE 3-66. Branch circuit conduits.

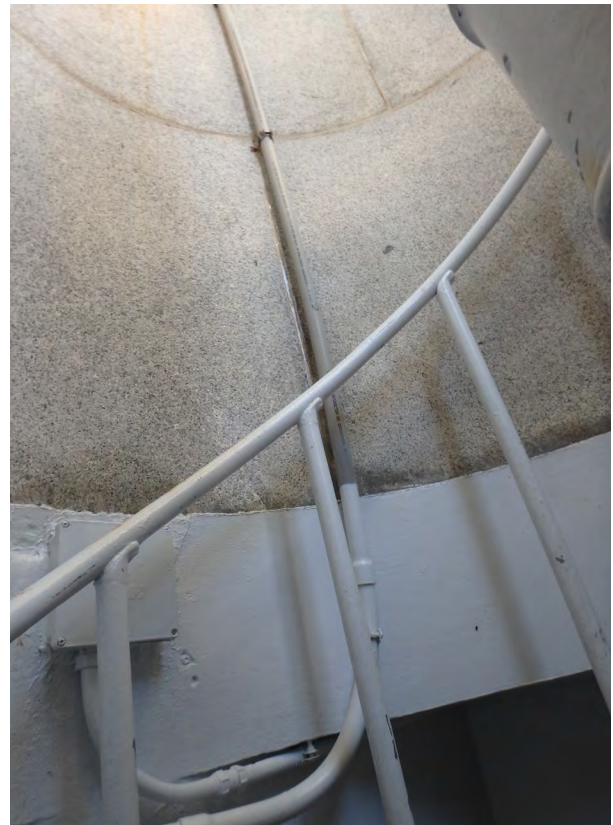
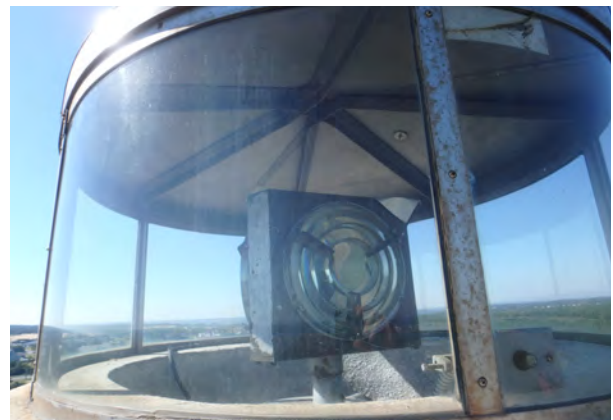
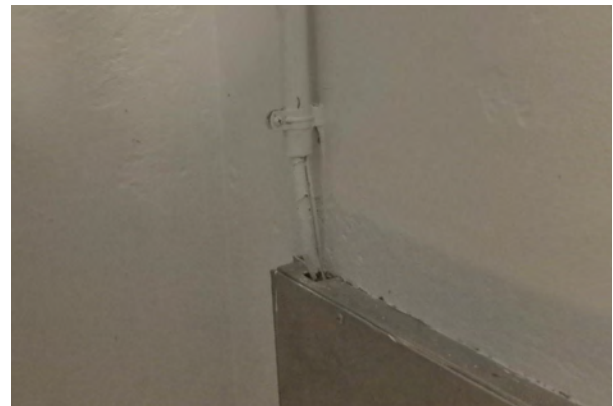
FIGURE 3-67. Lightning grounding conductor.

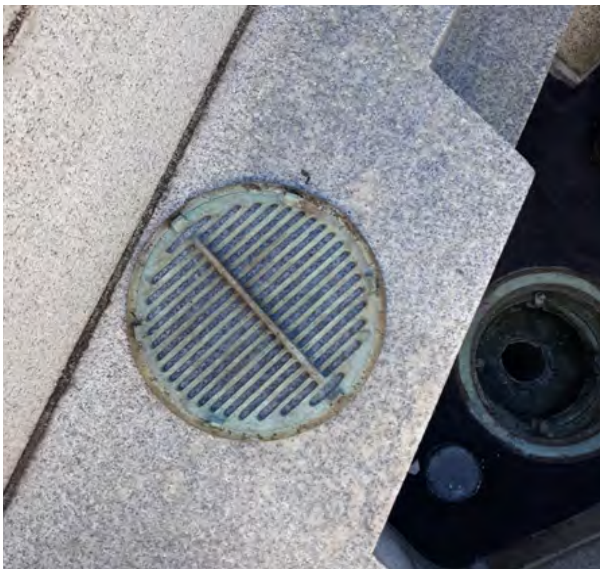
Plumbing systems are limited to area drains on the site terrace and the rain leader serving the observation deck roof. (Figure 3-70) The roof rain conductor is a 3 inch pipe, indicated as brass on original drawings.

FIGURE 3-70. Roof drain and grate at top of pylon.

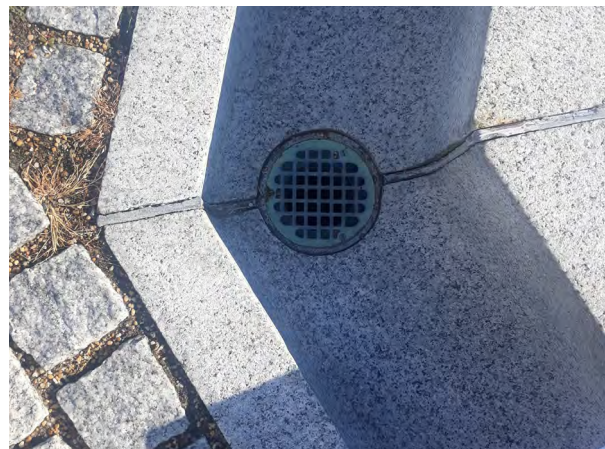
Some of the plumbing outlets at the ground appear to be clogged by landscaping. (Figure 3-72, Figure 3-73) The terrace surface drains along the gutter do not appear to be used with the slope of the surface. (Figure 3-71) There is one storm drain that shows consistent use at the pedestal walls.

FIGURE 3-71. Area drain in drain trench at perimeter of deck.

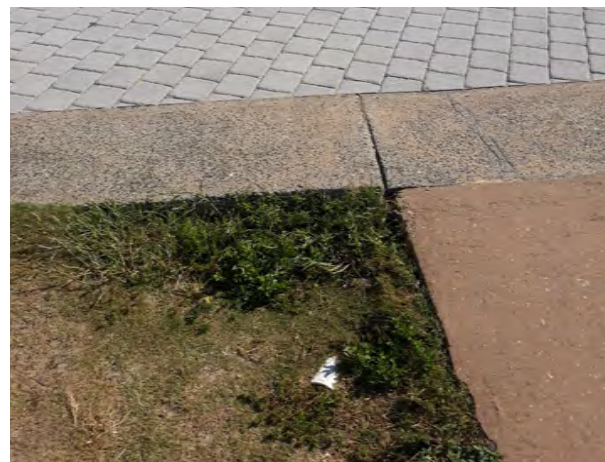
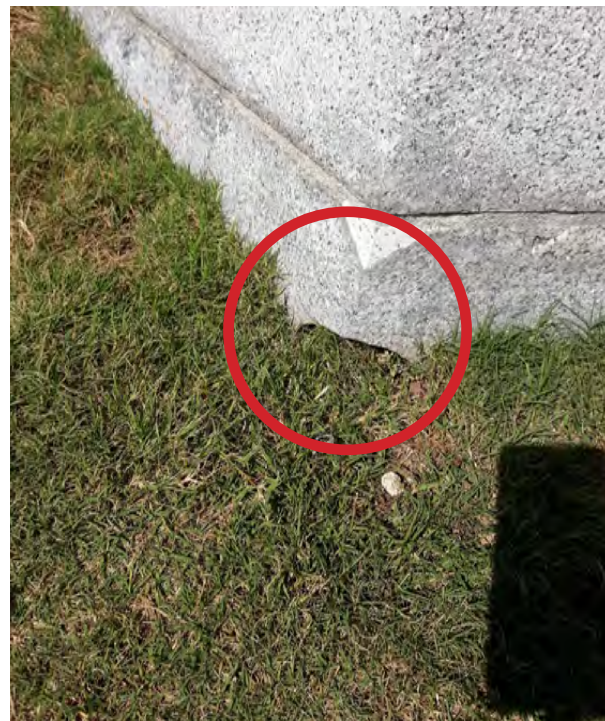
FIGURE 3-72. PVC storm outlet on southwest side.

FIGURE 3-73. Clogged storm outlet at southeast corner.

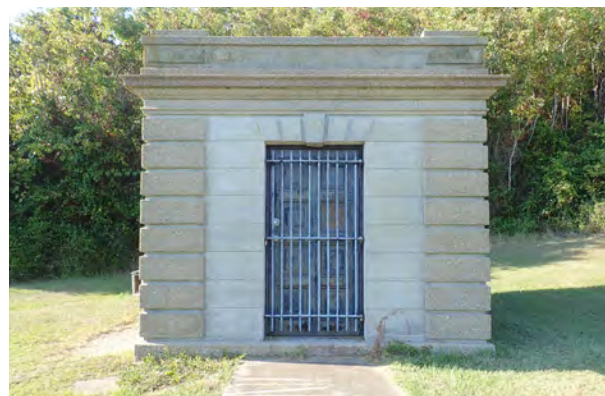
The front (south) elevation is in good condition. There are no visible signs of concrete deterioration

and the joints are in good condition with one open joint at the top of the wall above the door. There is some biological growth at the top of the parapet wall.

FIGURE 3–80. Powerhouse, front (south) elevation.

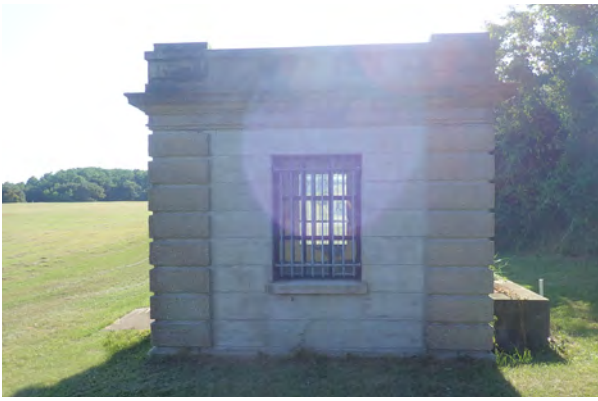
FIGURE 3-81. Powerhouse, side (east) elevation.

The side (east) elevation is in good condition. The concrete is in good condition with some superficial surface cracks near the window. There is biological growth and staining along the top of the parapet. (Figure 3-84)

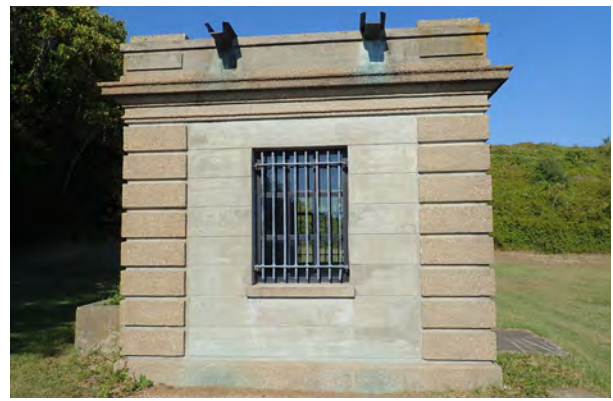
FIGURE 3-83. Powerhouse, side (west) elevation.

The side (west) elevation is in good condition. The concrete is in good condition with some surface cracking near the bottom of the wall and spreading from the window sill. There is ferrous staining from the metal scuppers at the top of the parapet as well

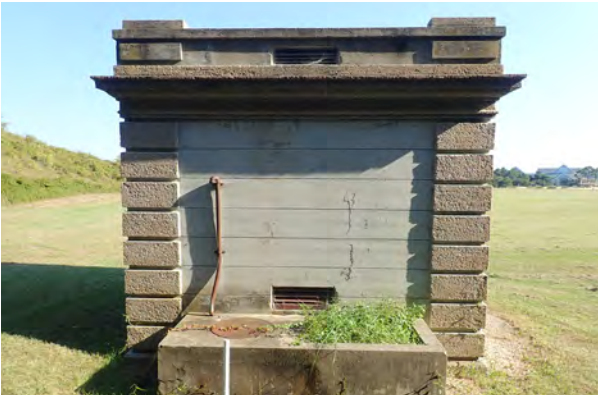
FIGURE 3-82. Powerhouse, rear (north) elevation.

The rear (north) elevation is in good condition. The concrete is in good condition with one surface crack leading from the lower louver opening. There is atmospheric and biological staining along the lower base, below the cornice and at the

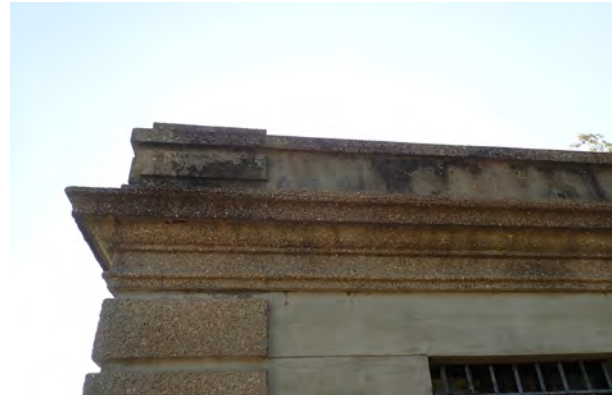
FIGURE 3-84. Powerhouse, close-up of cornice, parapet and quoining.

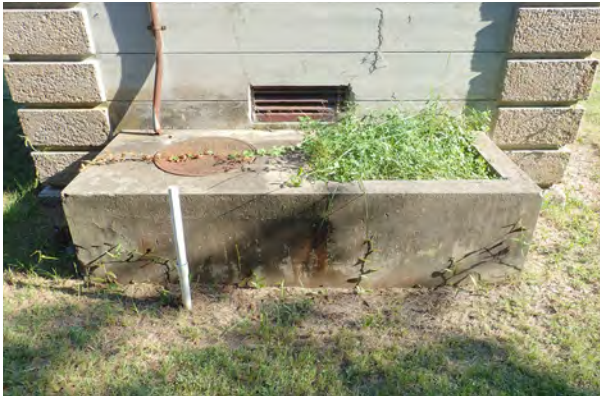
FIGURE 3-85. Powerhouse, rear concrete bump out.

parapet. There is some surface spall and cracks at the concrete bumpout. There is grass growing at the earth filled planter.

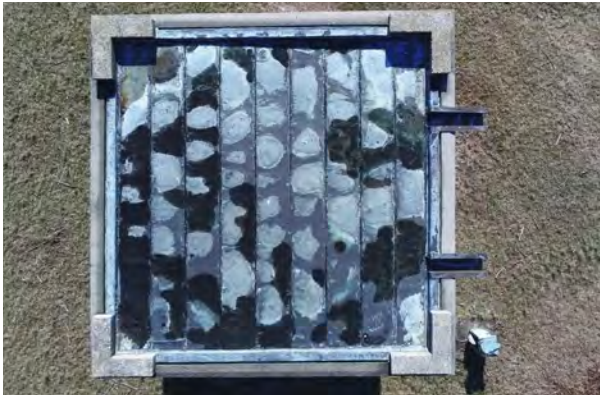
FIGURE 3-86. Powerhouse, view of the roof (NPS).

While there was limited visibility of the roof, it appears to be in fair condition. There is water ponding in the corner locations and staining at areas. The parapet wall is in good condition. The roof and drainage system was repaired and the roof scuppers were replaced in 2000.

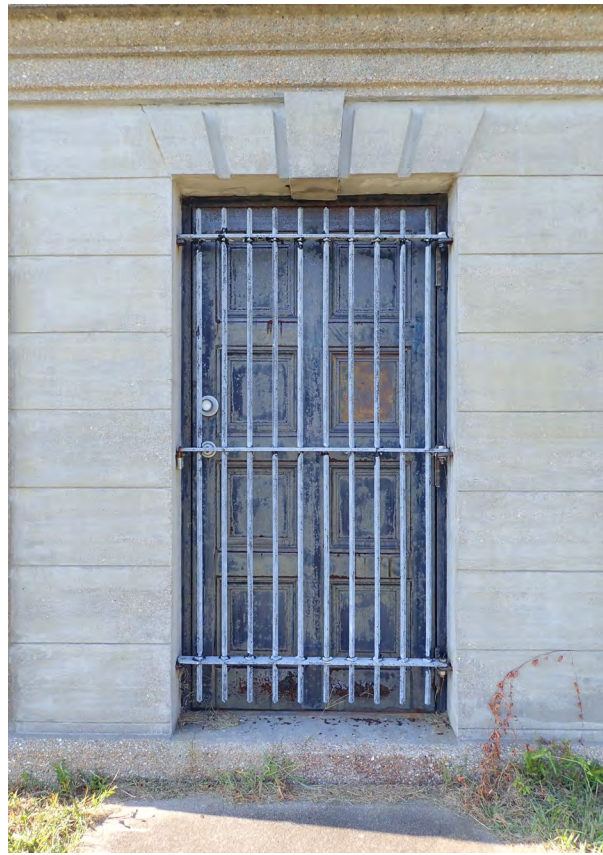
FIGURE 3-87. Powerhouse, view of front entry door.

The entry door is not original and was replaced in 2000. It is in fair condition. There is surface rust along the frame of the door, on multiple of the panels as well as at the base of the door. At the base the metal is deteriorating and sloughing from the surface.

The security bars at the entry door are in fair condition. The metal is in good condition however the black paint has worn off in a majority of the locations. There is some surface rust at the concrete where the security gate hinges are embedded.

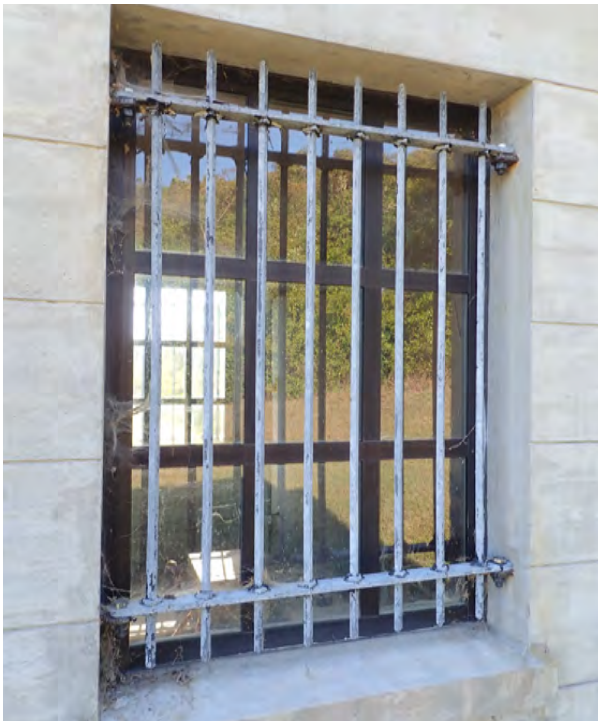
FIGURE 3-88. Powerhouse, view of windows.

The windows are not original and they were replaced in 2000. The windows at the Powerhouse are in good condition. The metal frames and glass panes are in good condition with no breakage or surface rust. The metal security bars show similar signs of wear with the black paint having worn off and some of the bottom bars are bent.

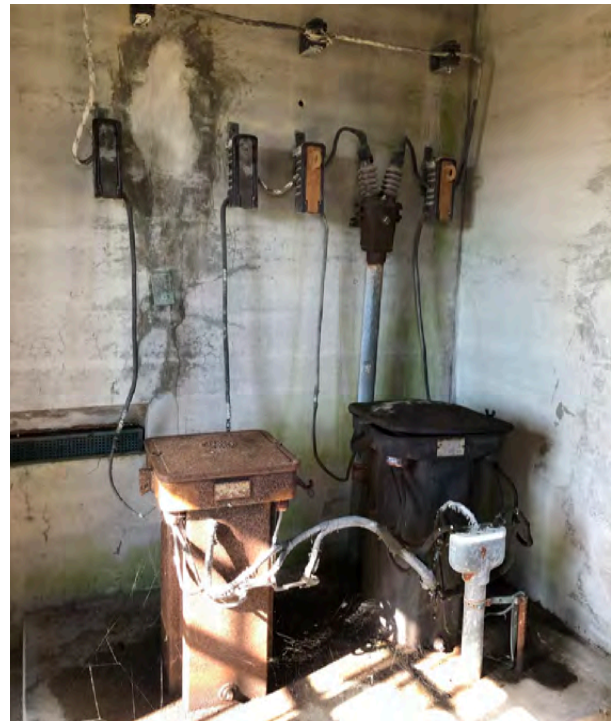
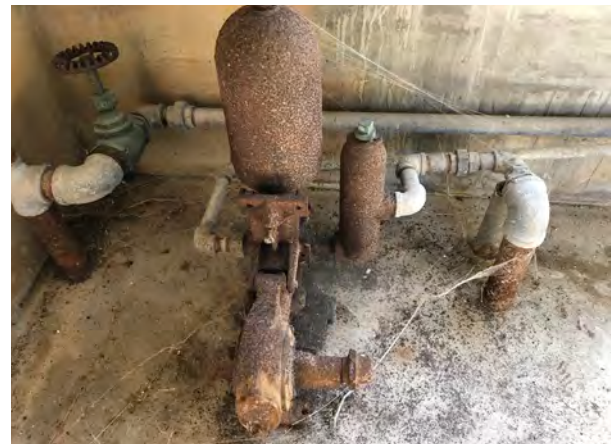
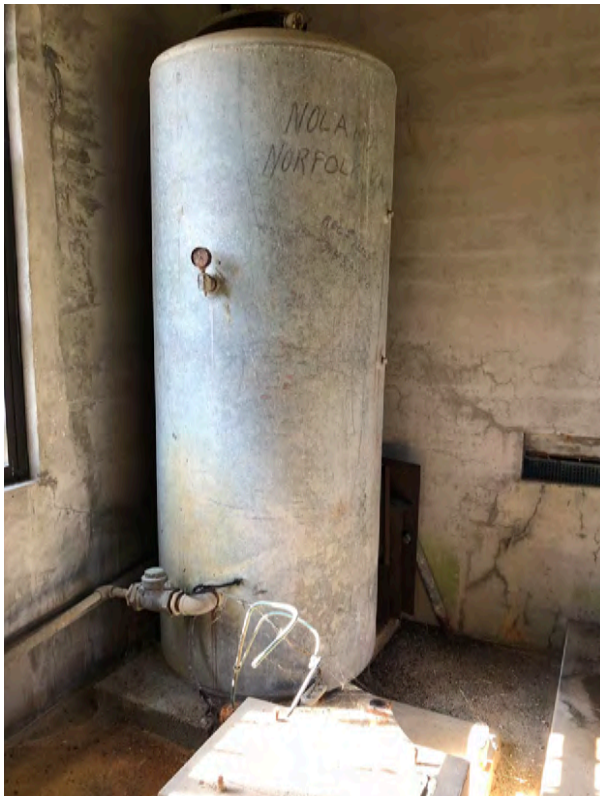
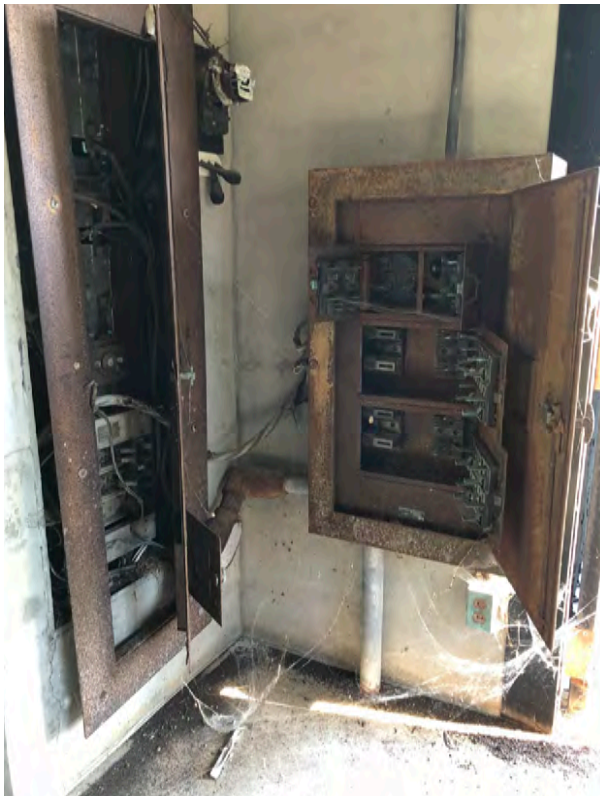
The interior of the Powerhouse was inaccessible; however, visual inspection from recent photos show that it is in fair condition. The concrete walls have biological growth as well as environmental staining along the walls and floor. The exterior cracks are also visible on the interior along the rear (north) elevation. There is water intrusion present at the floor and along the wall.

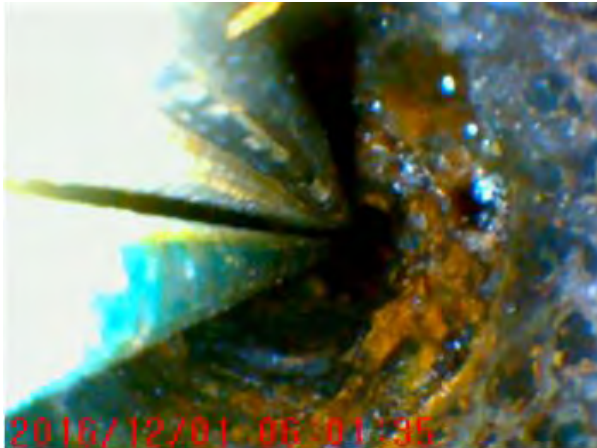
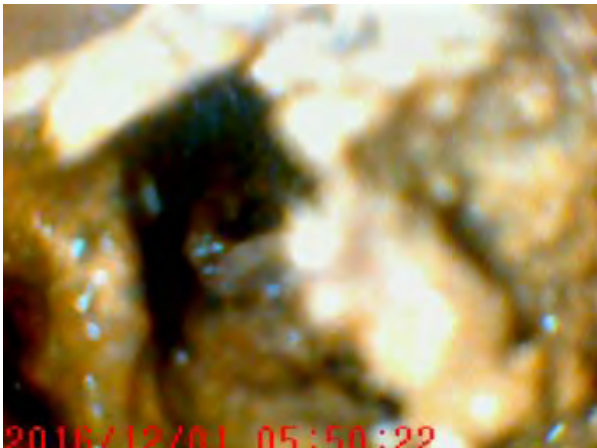
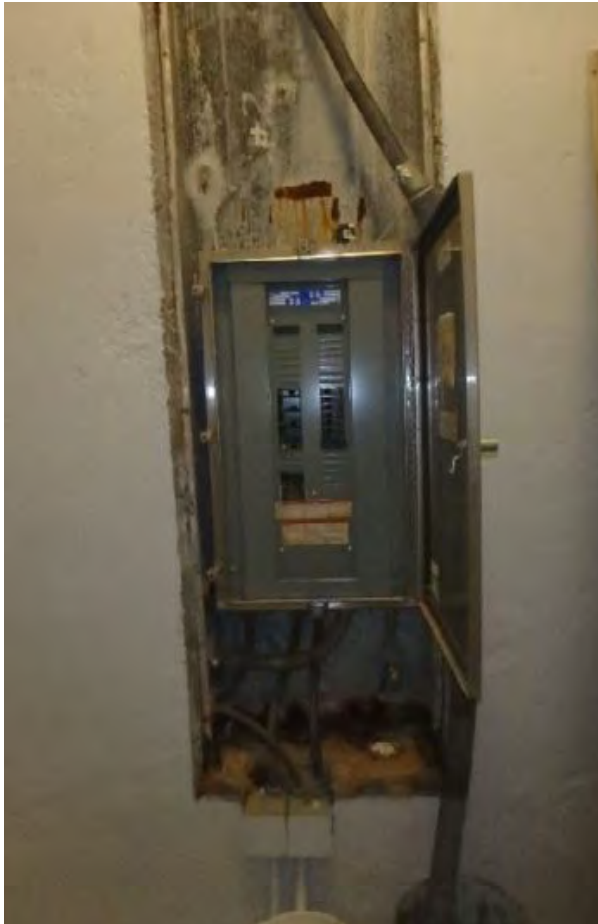
| Event | Location | Moisture Type | Observation Source | Notes on Suspected Source | Further Exploration | Image Reference |
|---|---|---|---|---|---|---|
| Water spilling out of conduit | Ground level and Level C | Bulk water during storm event | Park staff observation, Investigative scoping observation | Observed after rain events, and reported in 2009 post-restoration follow up memo. <sup>3</sup> It is assumed that the volume of water large enough to generate this event is owing to an infiltration condition beyond the capillary action of the veneer stone and mortar. Therefore a possible source may include the observation deck and/or roof leader. Based on the learnings and clarification from the 2017 report the suspected damaged is at 52' - 56' from the drain rim. | Consideration in base scope of PreDesign is to abandon conduits and inject with grout. Alternate treatment aims to address infiltration upstream. | Figure 5-7, Figure 5-8, Figure 5-10 |

FIGURE 5-7. Ground level conduit scope (Atkinson-Noland & Associates, Inc. et al, 2017).

FIGURE 5-8. Level C conduit scope (Atkinson-Noland & Associates, Inc. et al, 2017).

FIGURE 5-10. Conduit drain bucket (QE, 2021).

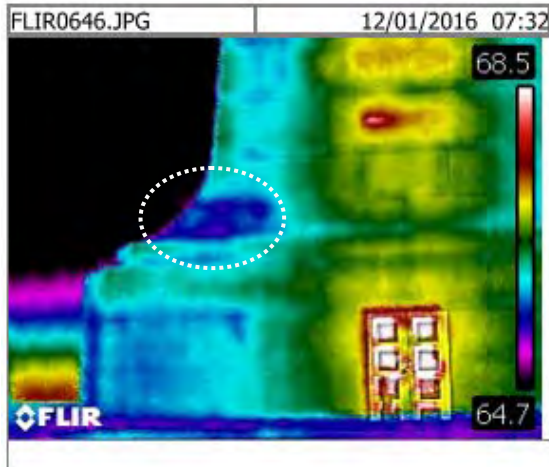
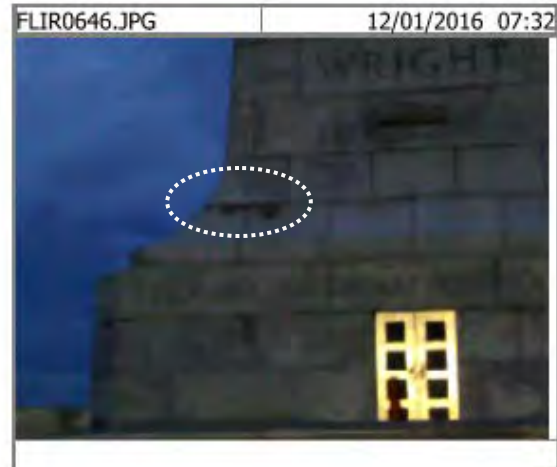
Figure 4. Exterior image taken after a rain event. Bulk water is observed and detected leaking from joints, at a joint where flashing is indicated on original construction details.

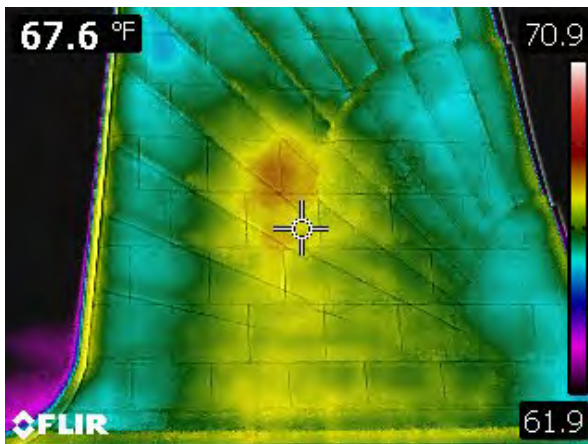
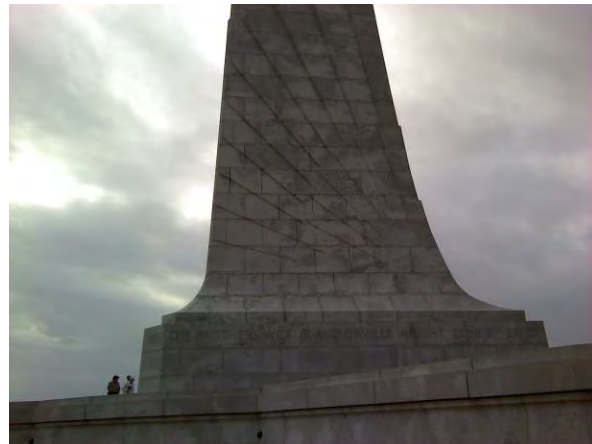
Figure 5. Internal heat penetrating through walls; walls are thinnest at the center portion and correspondingly these areas show the greatest temperatures. See plan drawing in Appendix A for wall thickness. Uneven surface appearance is not evident in infrared image, suggesting color variations are not caused by moisture variations.

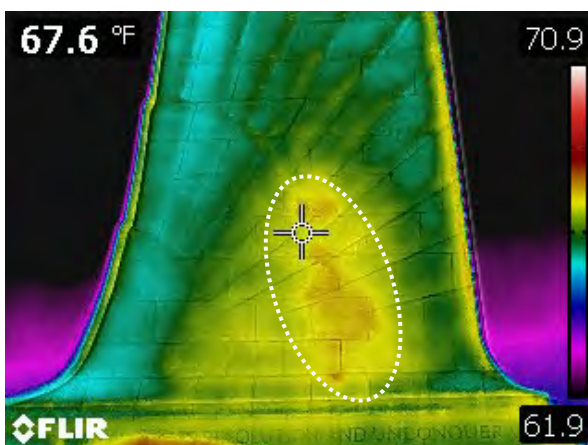
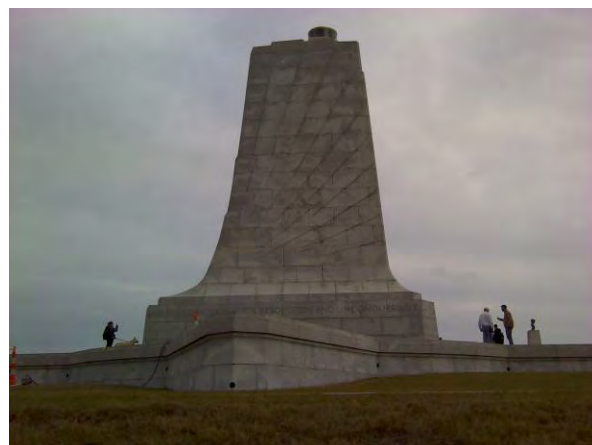
Figure 6. Heating effect apparent. Slight temperature differentials (reddish-orange zones) suggest differential internal construction. Uneven surface appearance is not evident in infrared image.

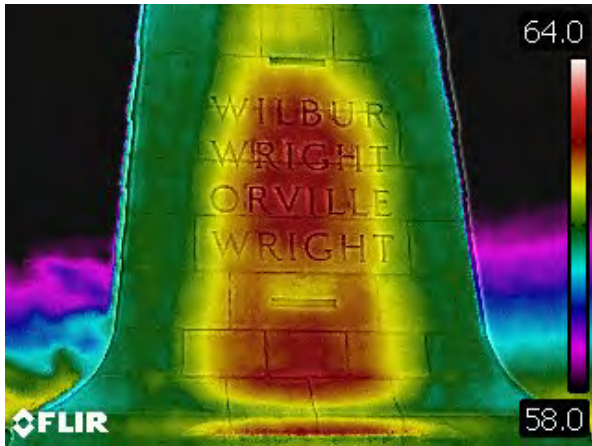
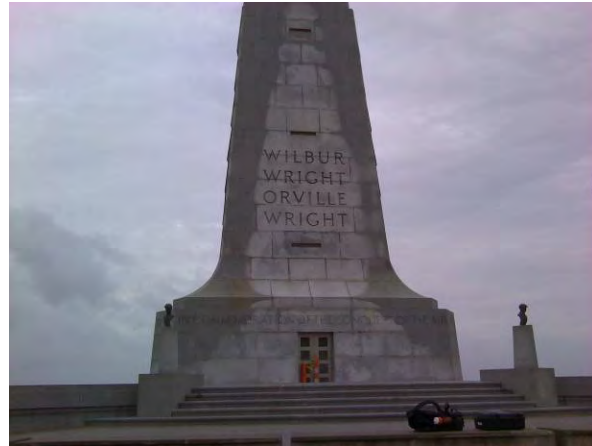
Figure 7. After 2 days of internal heating, temperature differentials are apparent. Higher temperatures at the middle of this elevation increase drying effects; corners are cooled by evaporative effects.
