Historic Structure Report  
**Wright Brothers Monument  
and Powerhouse**  
*100% FINAL*

# Wright Brothers Monument and Powerhouse

## Historic Structure Report

October 2022

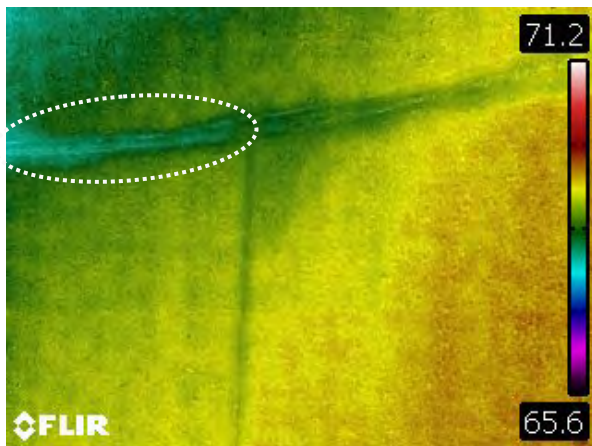
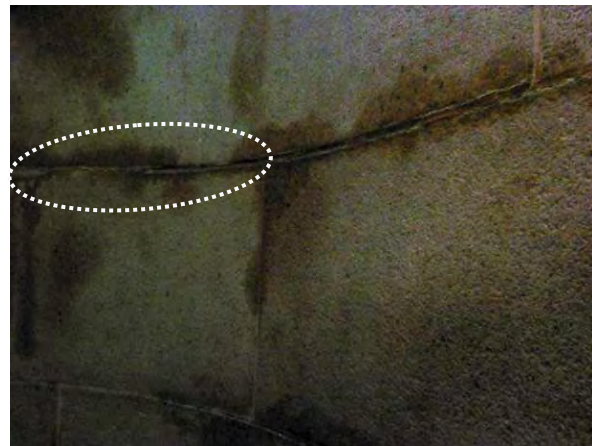
Figure 8. Interior lobby mortar joints. Water leak shows as coolness at mortar joint. Damp zones do not appear cooler indicating no evaporative cooling action.

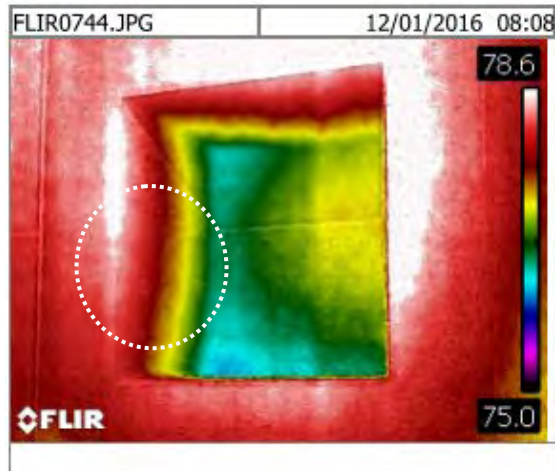
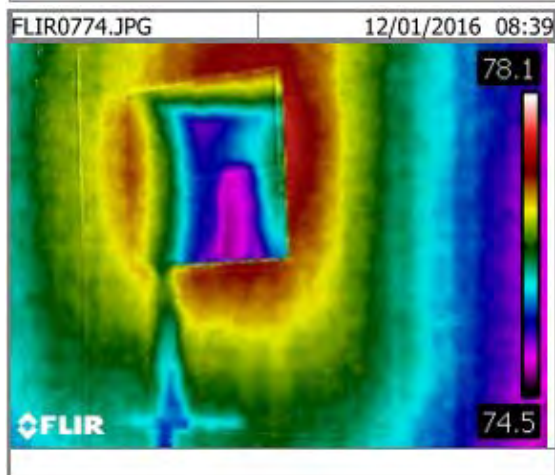
**Figure 10. Blotches on stone does not appear in infrared image (top images); water dribbled down stone face is cooler due to evaporation effects (bottom images).**

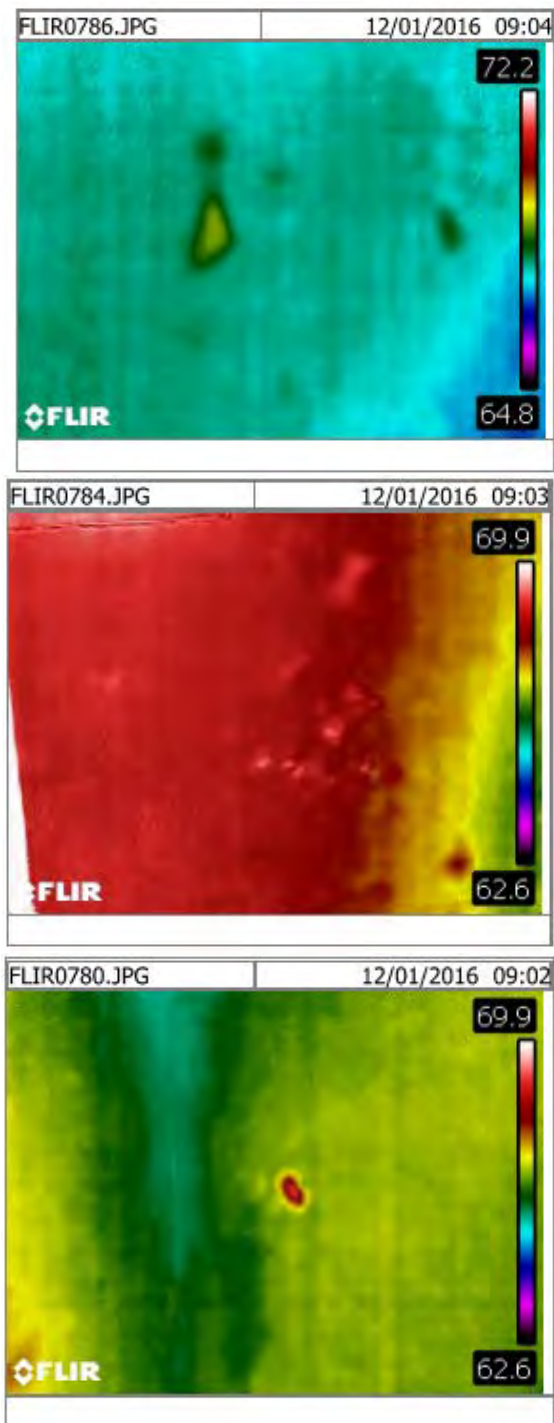
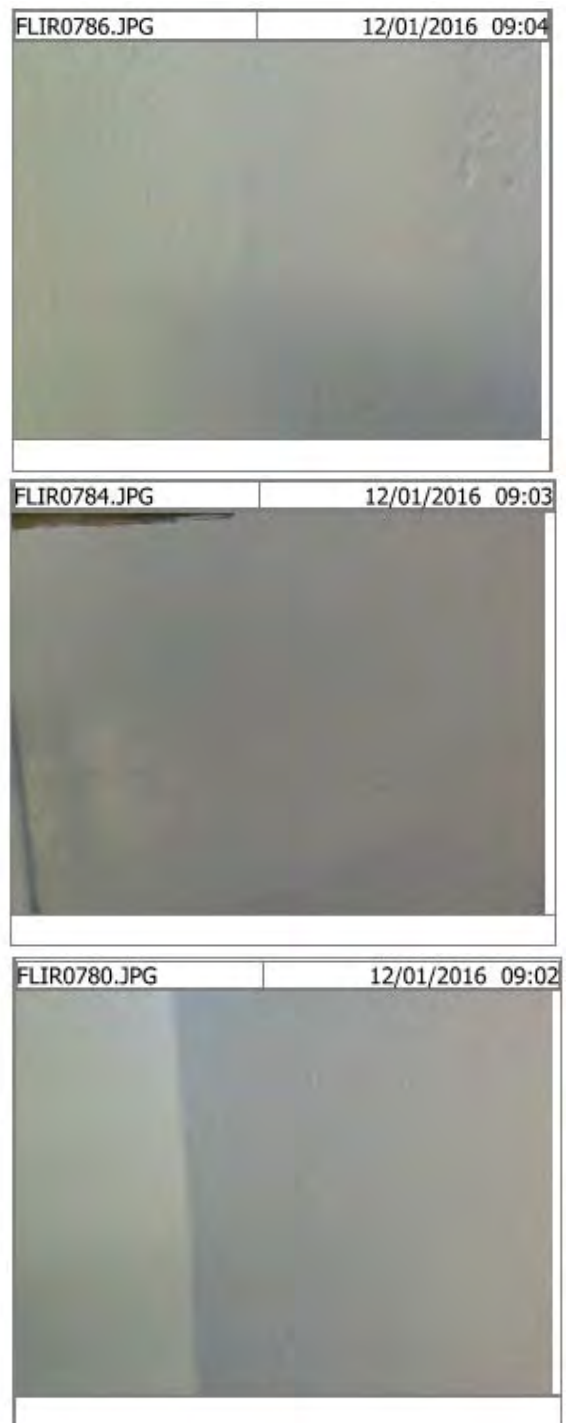
**Figure 11. Image of interior painted concrete surface. Paint blisters are not always visible, but show in the infrared image as warmer zones.**

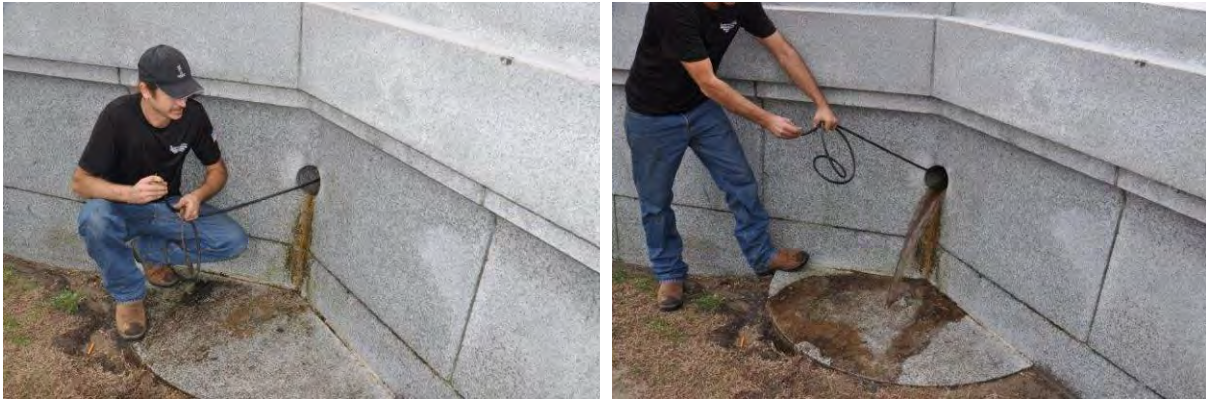
McGee and Sons Plumbing used an inflatable plug to seal the roof drain pipe near its outfall. Water was pumped to the top of the Monument to fill the drain. The water level fell immediately and after 24 hours the inflatable plug was removed. When the drain plug was removed approximately 3 to 5 gallons water flowed from the outlet. This water volume suggests water remained in 7 to 8 feet of the 4-inch inside diameter drain pipe, and that a leak exists approximately 8 feet in from the outlet point under the stone paving. The outfall itself is located 24 feet from the monument.

Figure 12. Plug removal at completion of roof drain water test.

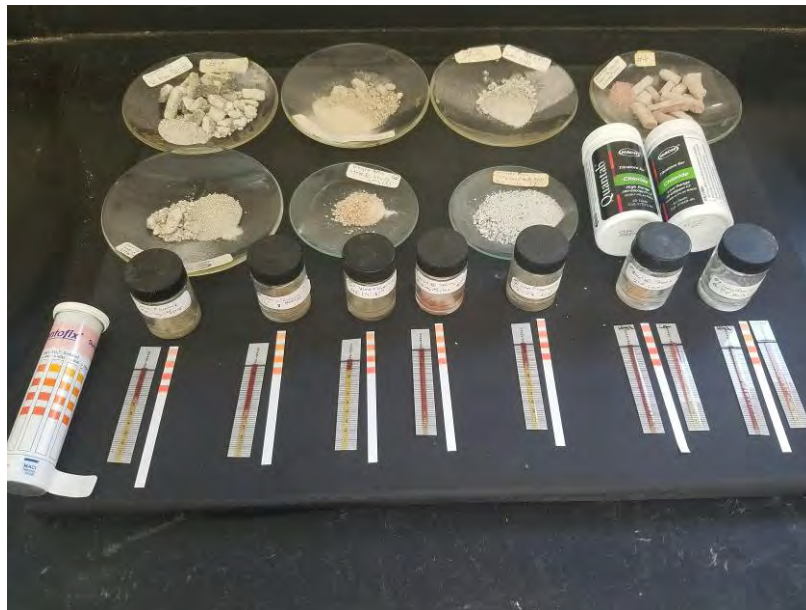
Samples were oven dried, crushed by hand with a mortar/pestle, and tested for chlorides and sulfates. Chlorides were present in all samples. Chloride concentrations were very high in exterior mortar samples, increasing with depth. Interior mortars had lower but still significant chloride contents. Stone scrapings, taken at locations where stone surfaces were sugaring, flaking, and powdering, showed lower but still significant salt content.

Sulfate contents were highly variable, with sulfate levels measured to be between 200 ppm and greater than 800 ppm.

**Figure 15. Mortar and stone samples tested for chlorides and sulfates.**

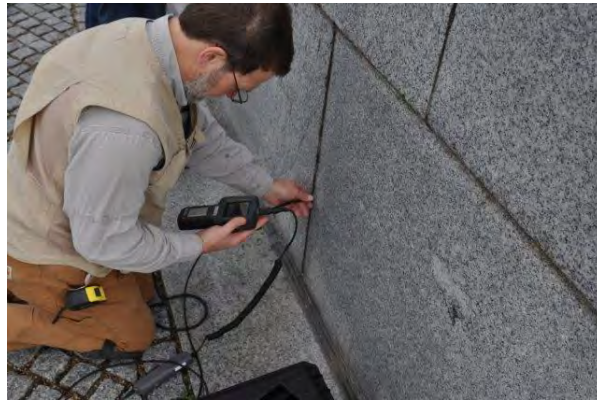
West elevation exterior. Hole drilled in head joint. Videoscope images 5 and 7 and video 6 saved. Joint was observed to be solid to 10 inches deep.

Figure 17. Videoscope evaluation at exterior mortar head joint.

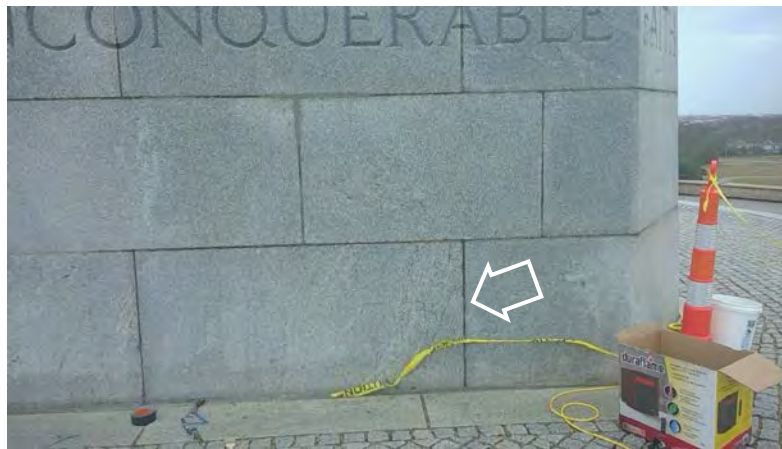
Figure 18. Videoscope evaluation at exterior mortar head joint at location indicated by arrow.

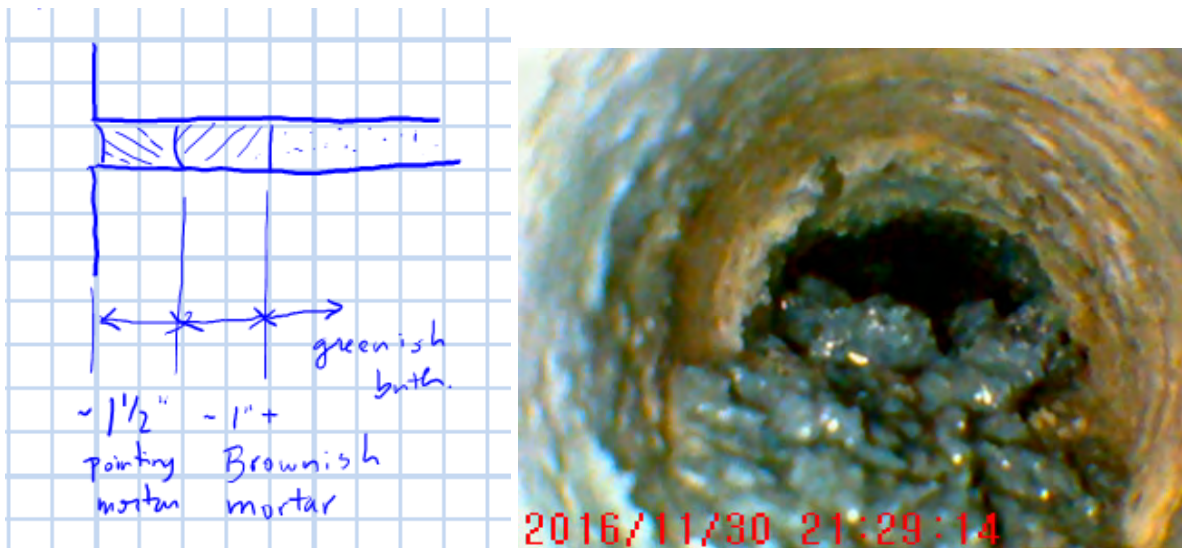
Figure 19. Field notes showing mortar joint composition at exterior wall face. Videoscope image is at transition between pointing mortar and brown joint fill beneath.

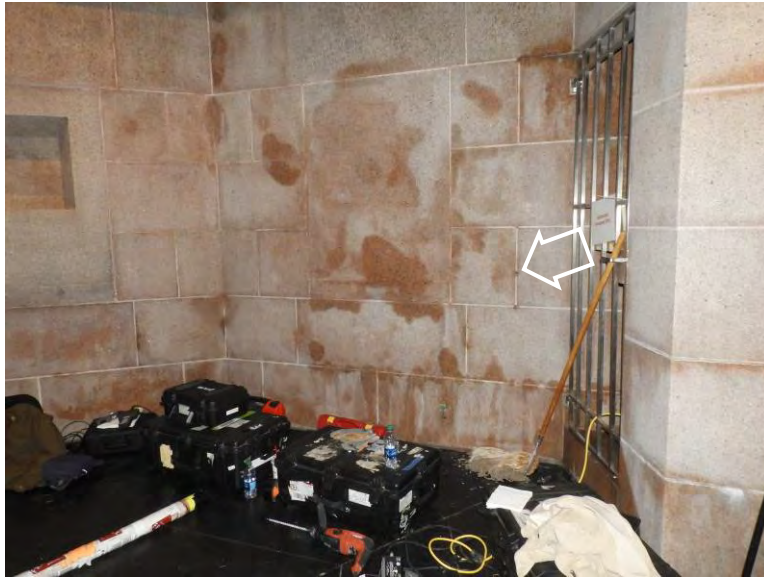
**West wall interior at lobby.** The hole was drilled to a depth of 10 inches. The adjacent stone unit measured 8 inches thick, and hard solid concrete (or granite?) was encountered at a depth of 10 inches. The mortar joint itself was completely solid full depth, with pointing mortar at the outer 3 inches. Mortar at the interior beyond pointing mortar was greenish in color. Photographs 20 and 21 are included below; video 19 and 22 were also saved.

**Figure 20. Videoscope at interior head joint at location indicated by arrow.**

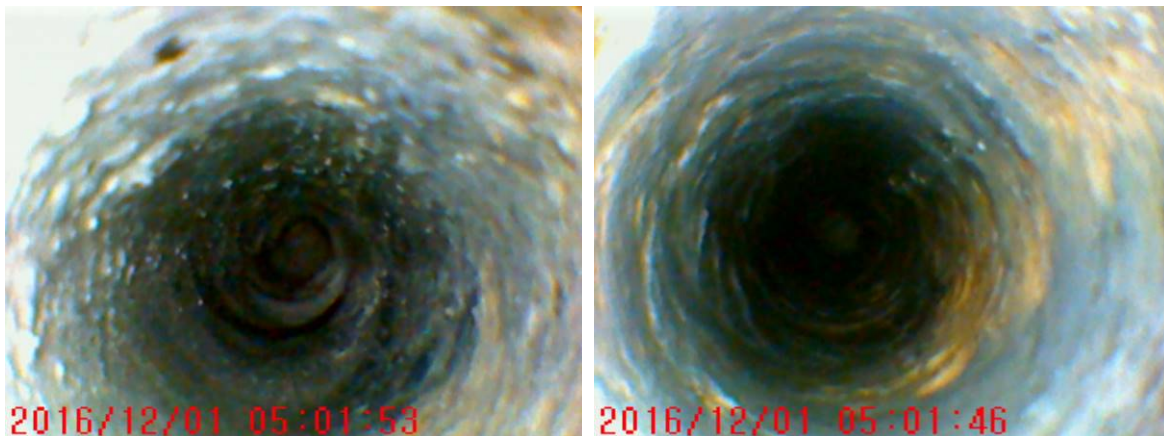
**Figure 21. Videoscope photographs 20 and 21; mortar joints were observed to be solid full-depth. The videoscope scope hole is indicated in the top photograph.**

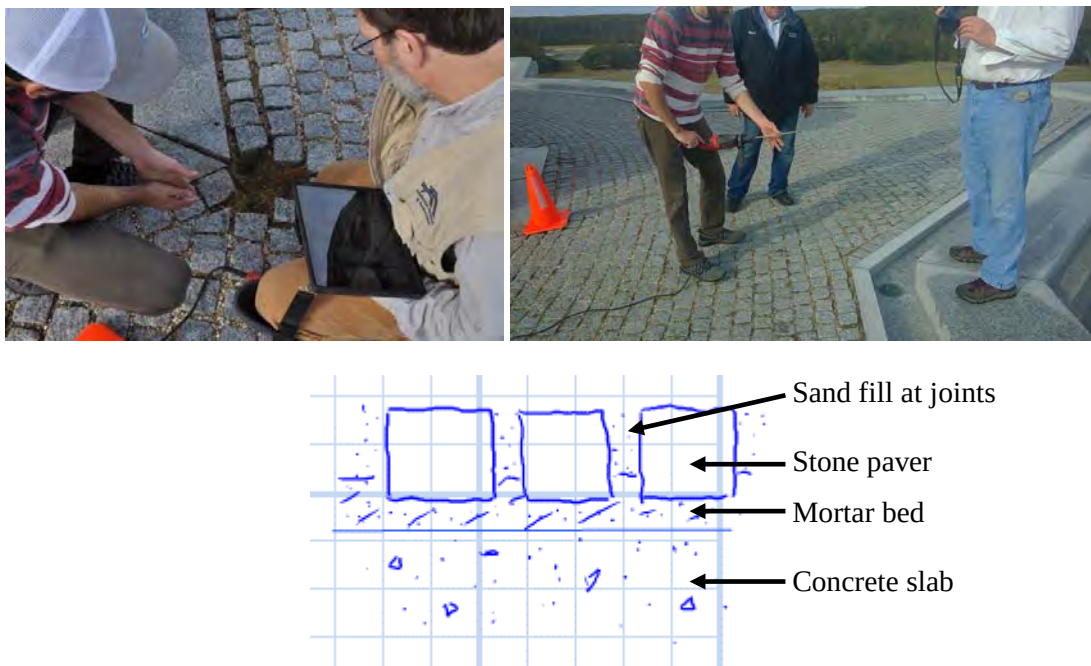
Three granite pavers are missing at the Monument's northeast corner. Existing conditions were evaluated by locally removing sand and drilling beneath the pavers. Granite pavers were measured to be 3 ¼" square to 4" square by 3" deep, over 1" mortar, with concrete slab beneath. Coarse sand fills joints ranging from ½" to 1" wide.

Figure 25. Exterior pavement investigation, northeast monument corner.

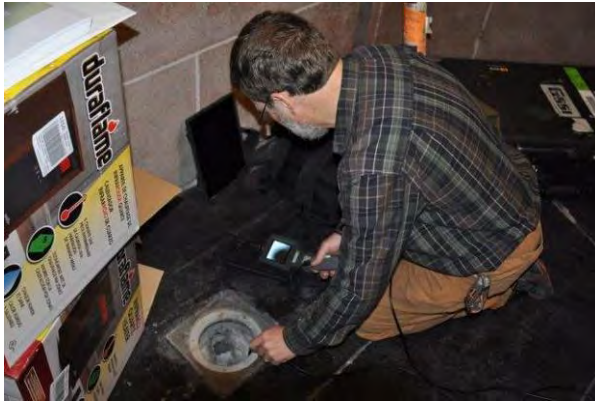
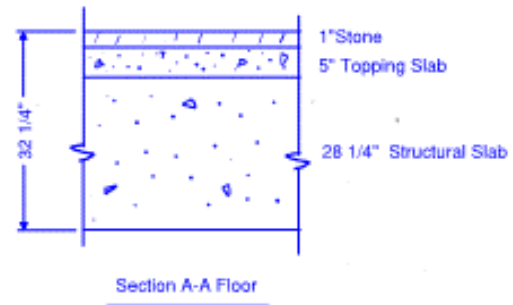
The void space measured 33'-3" from the lobby floor to the top of the monolithic slab at the base of the foundation void. There was standing water approximately ½ to 1 inch deep on the slab at the bottom of the void space. A floor section is provided in the field sketch below; see also field notes in Appendix A.

**Figure 26. Videoscope examination at floor penetration.**

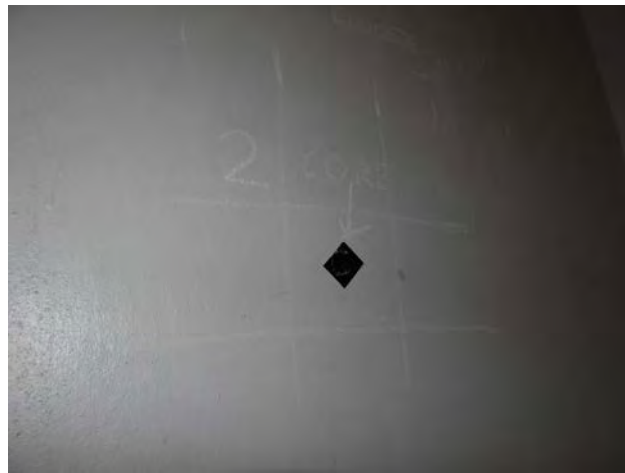
**Figure 30. Potential core locations are marked at the interior with chalk and masking tape.**

Additional investigation is needed to characterize solidity of grout fill between facing stones and the underlying concrete structure. Conditions at the space between stone and concrete would best be investigated by removing 2-inch diameter cores, drilled from the interior, and viewing with a videoscope. A total of 5 potential coring locations were marked while on site. General locations are called out on the drawing in Appendix A and marked on masking tape at each location as shown in Figure 30. Radar scanning was conducted to locate metal reinforcement and potential core locations were marked to miss subsurface reinforcement. Sections of removed cores can be tested for alkali-aggregate reactions and chloride concentrations.

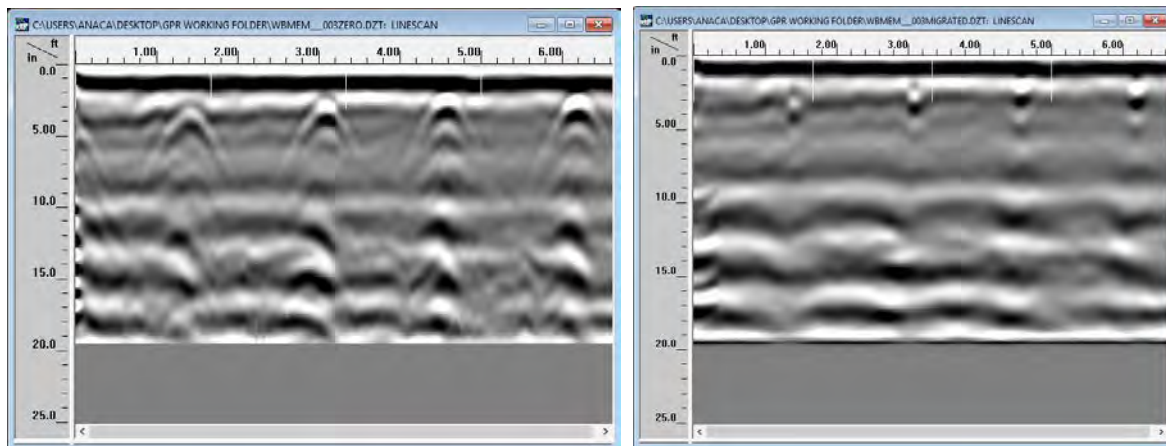
Scan 003, vertical scan, 2<sup>nd</sup> level interior, from floor upwards. Reinforcement at 17 to 19 ½" spacing. Depth varies: 3 to 4 inches.

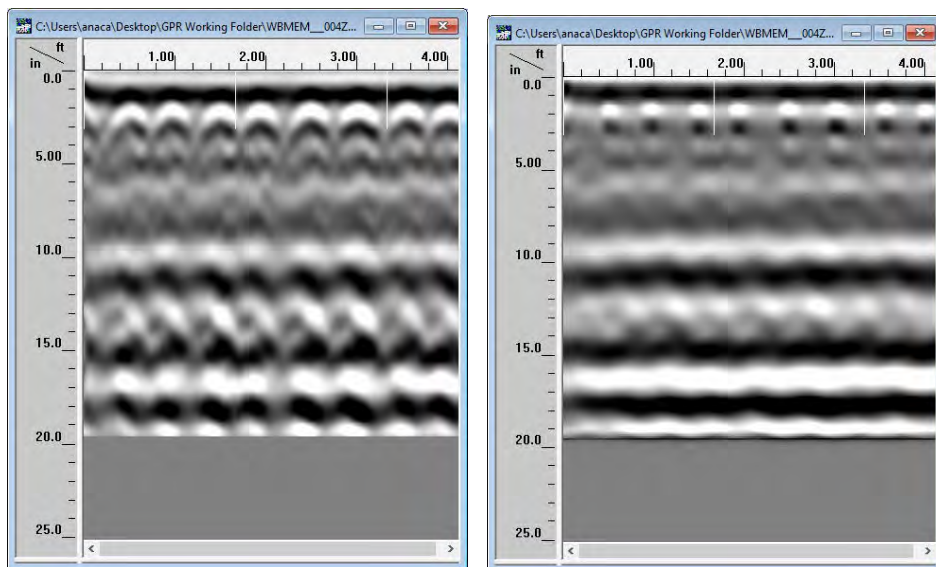
Scan 004: Horiz. @ 4' above 2nd floor. Reinf. @ 5" to 7" spacing. Depth = 1 ¾ "

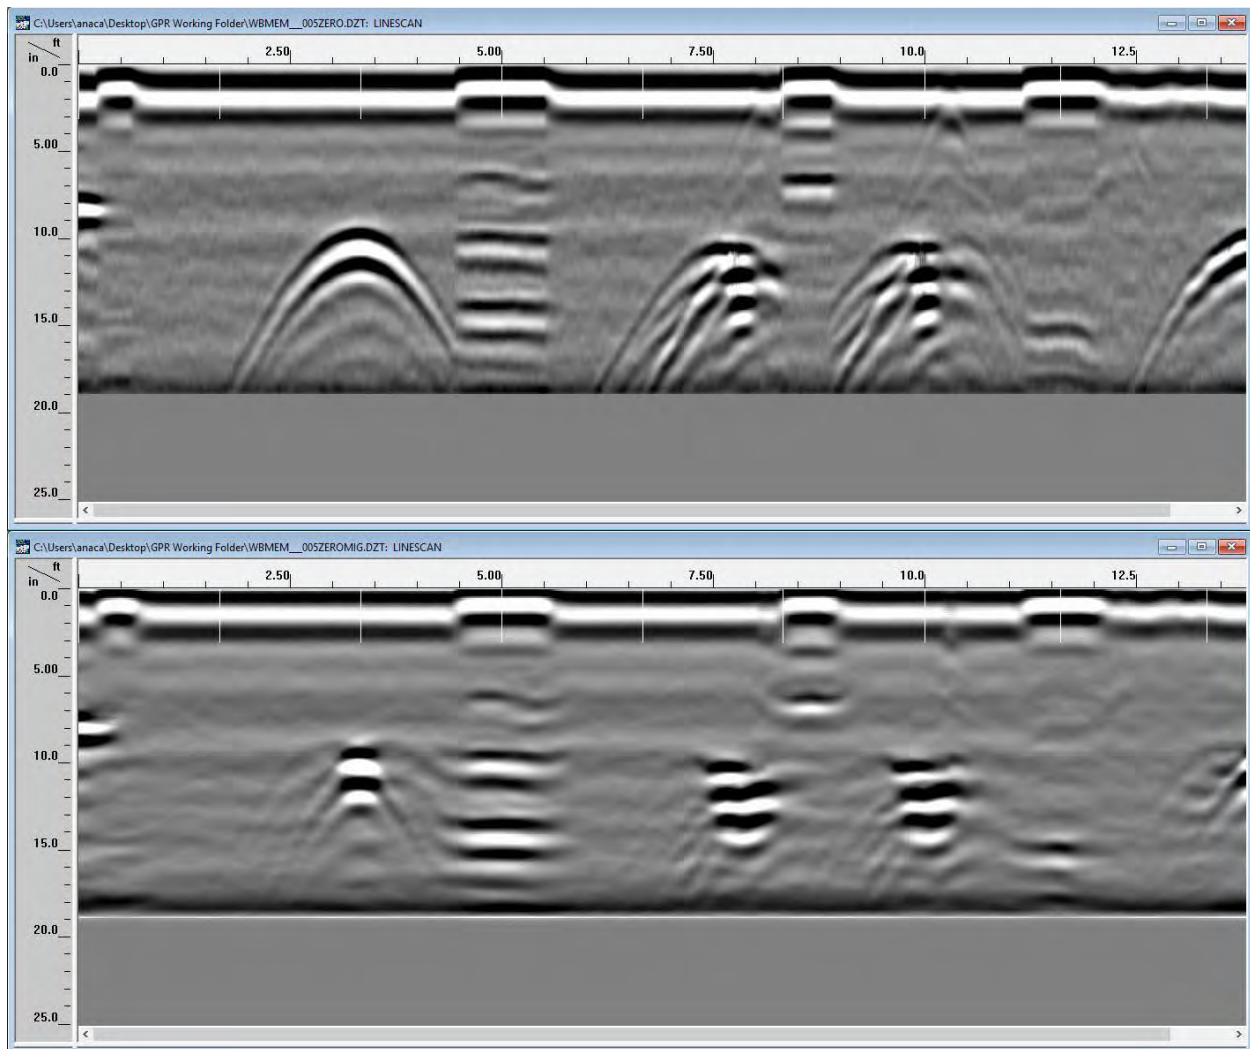
Scan 005: exterior, south elevation at drainpipe to east of entry door, 4 horizontal scans each, separated by wheel spins. Drainpipe detected at approximate 10 inch depth from wall face.

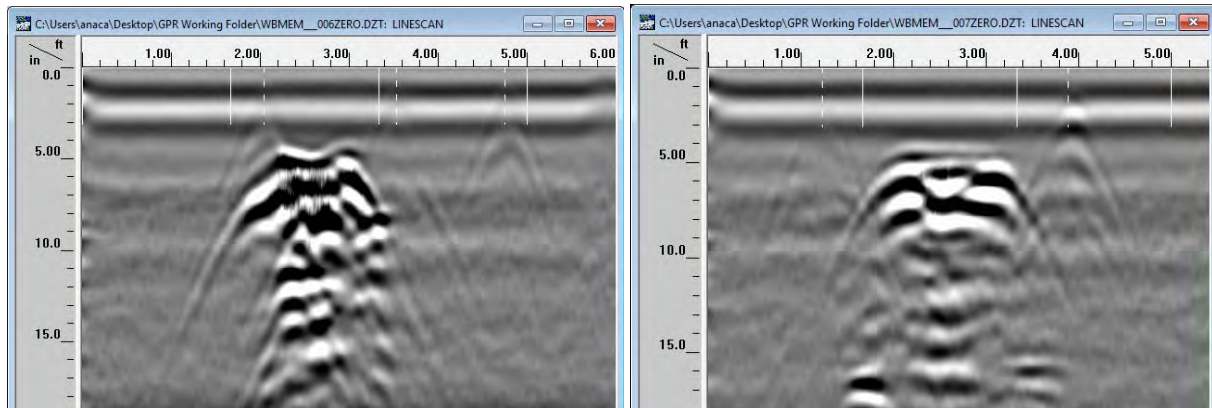
Scans at exterior, north elevation at “cornerstone.” Markers (dashed lines) at mortar joints.

Scan 006: exterior vertical

Scan 007: exterior horizontal

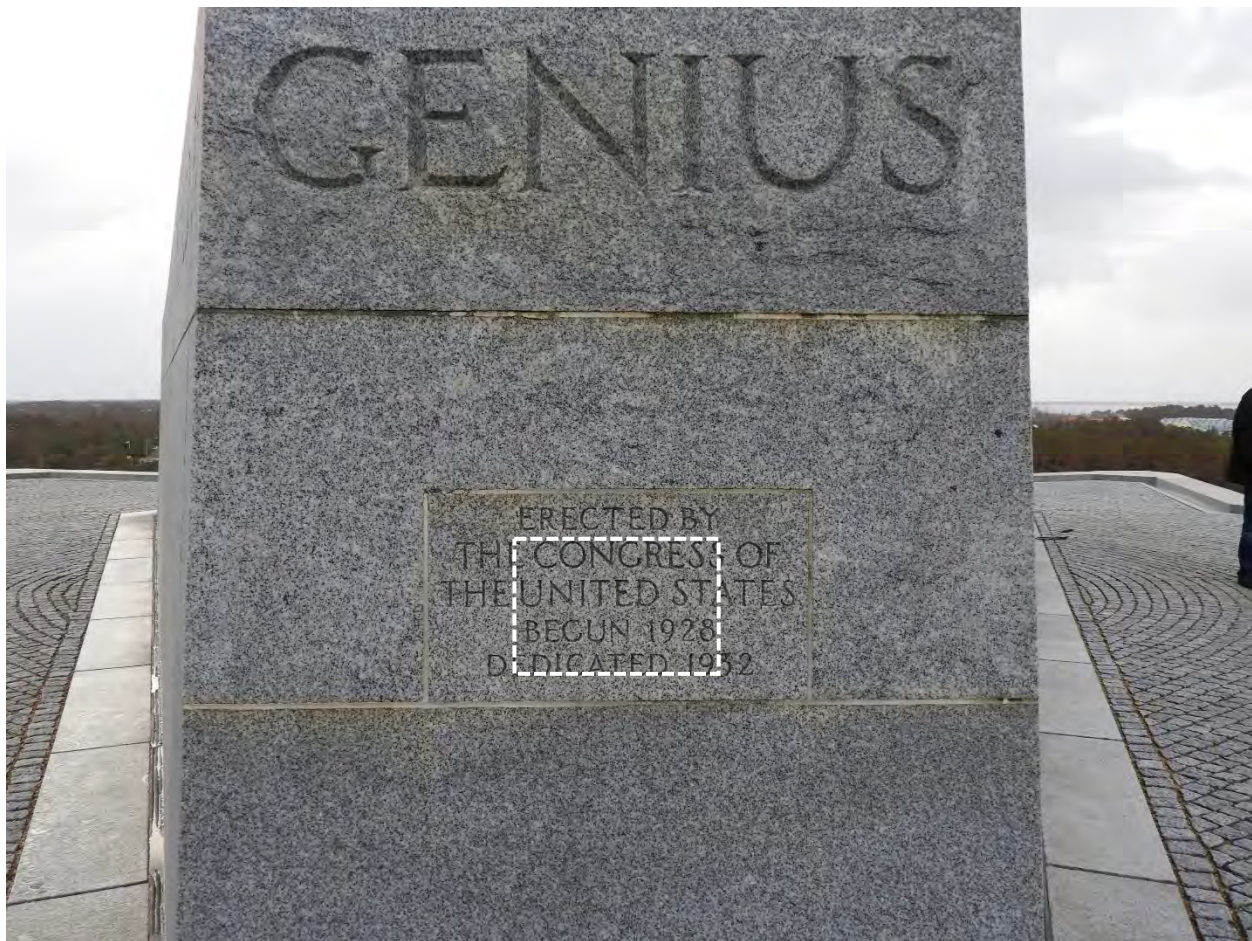
Photograph at “cornerstone” with embedded metal element shown as dashed outline.

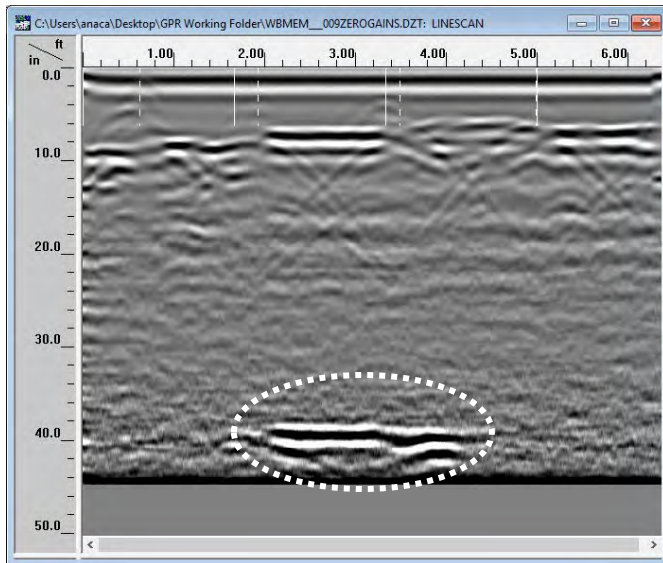
Scan 009: Interior Lobby, vertical, east wall. Stone veneer thickness varies from 8 to 9 inches, with voids behind some stones; backs of stones are somewhat irregular. Strong reflection at 40 inches deep (outlined) suggests a void behind the exterior stone at this location, from 2'-6" to 4'-6" above the interior floor line (above exterior pavement grade).

Void spaces within masonry walls permit moisture to collect and travel within the wall system. Voids in mortar joints and behind stones are best treated by injecting with a fluid grout, specially designed to be compatible with historic materials. Injection can be carried out using low pressure and small-diameter holes drilled into mortar joints. Injection from both the interior and exterior will be required to treat the massive wall sections.

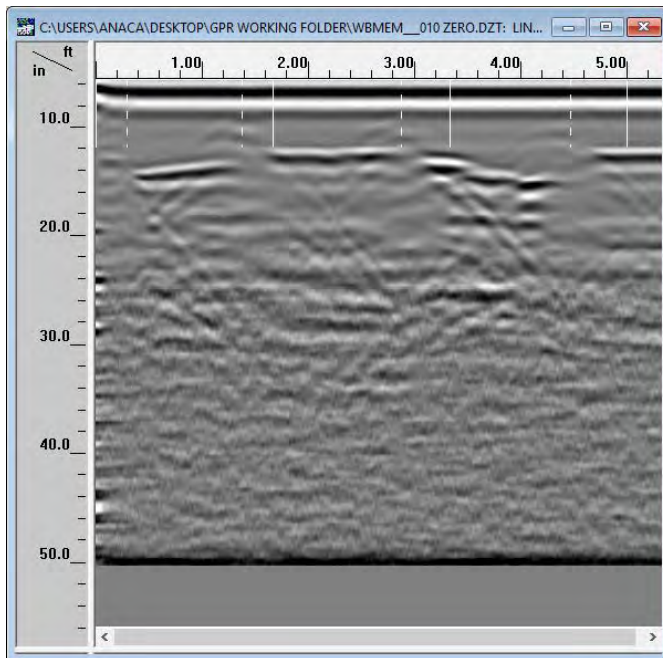
Scan 010: Interior lobby, vertical, east wall. Stone thickness 8 to 10 inches. Reflections at backs of stone suggest moderate voids in grout fill.

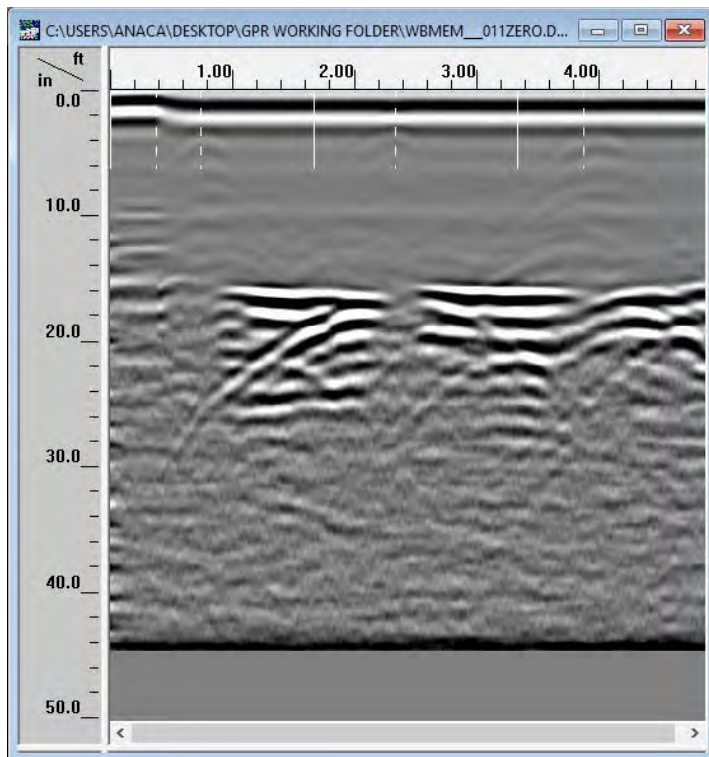
Scan 011: interior lobby, vertical scan, south wall to east of door. Stone much thicker, measuring at 14 to 15 inches thick. Strong reflections suggest significant voids behind stones.

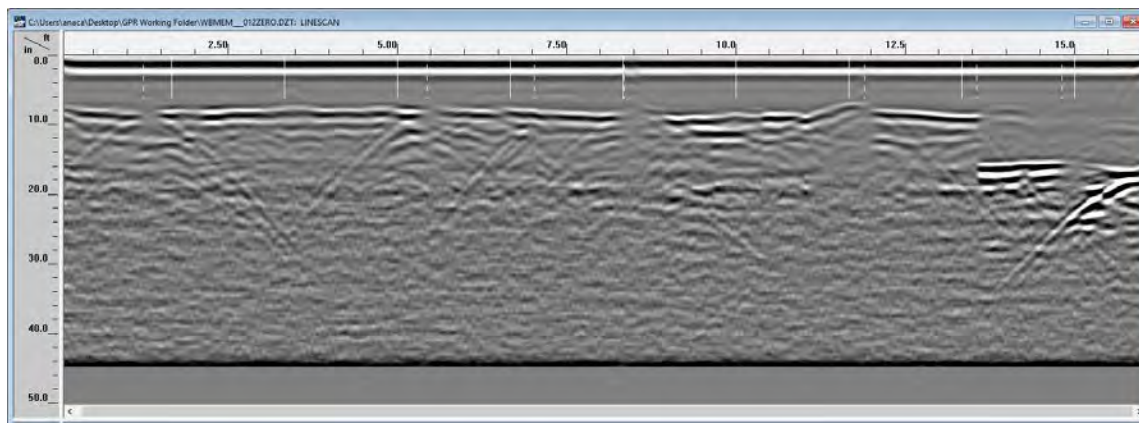
Scan 012: Interior lobby, horizontal, east wall. Stones transition from approx.. 8 inch to 14 inches thick at southeast corner. Reflections at back of stones suggest moderate to significant voids are present behind stones.

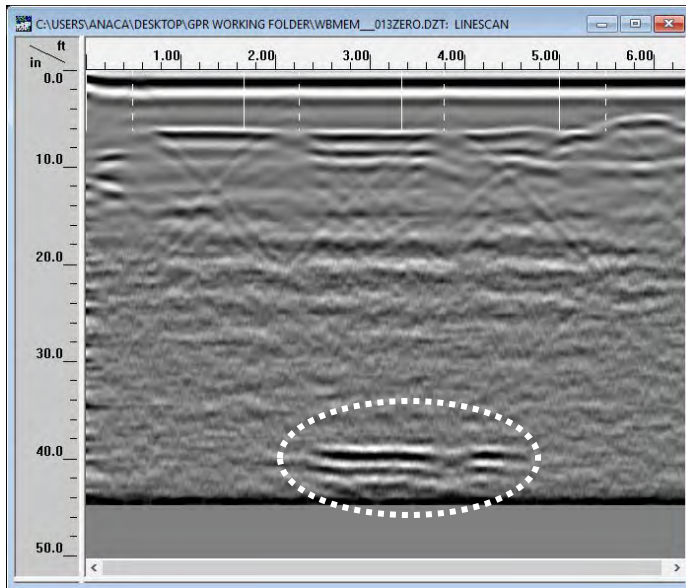
Scan 013: Interior lobby, vertical, west wall. Stone thickness 6 to 7 inches; same isolated void as seen in Scan 009.

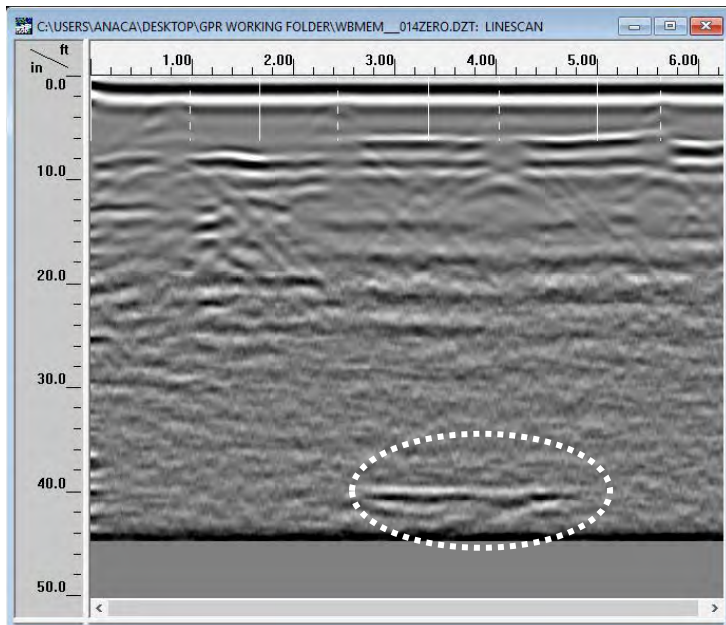
Scan 014: Interior lobby, vertical, west wall. Stone thickness 6 to 7 inches; same isolated void as seen in Scan 009 and 013.

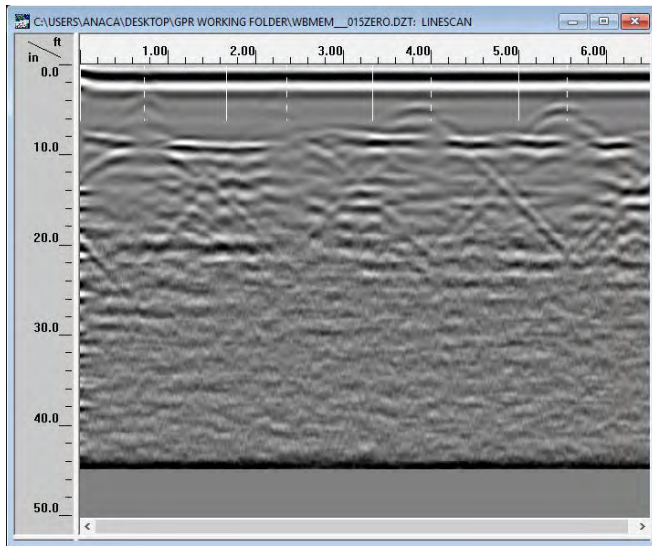
Scan 015: Interior lobby, vertical, south wall to west of door. Stone thickness 7 to 8 inches; significant mortar joint voids.

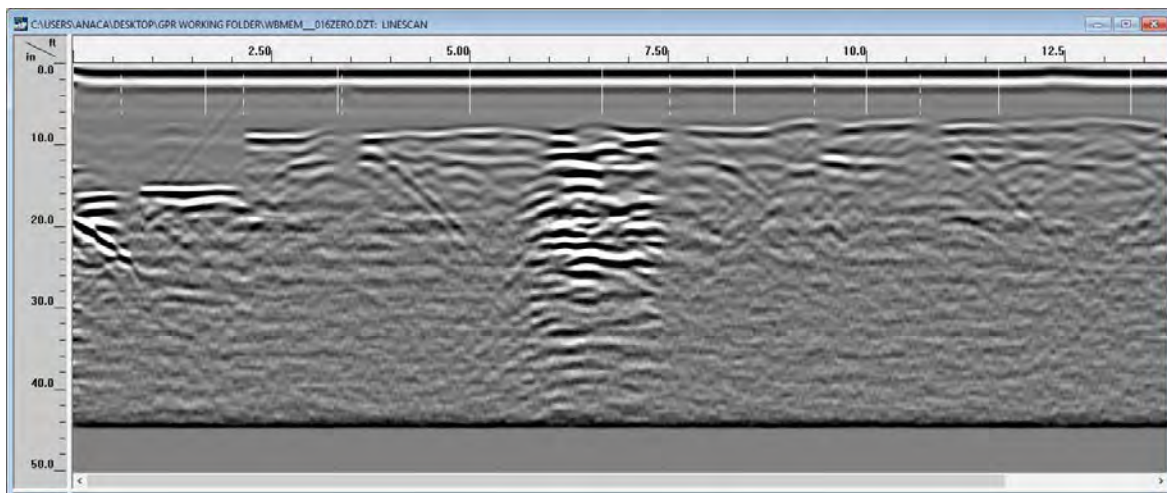
Scan 016: Interior lobby, horiz., west wall/ Stone thickness transitions from 15" to 8" at southwest corner.

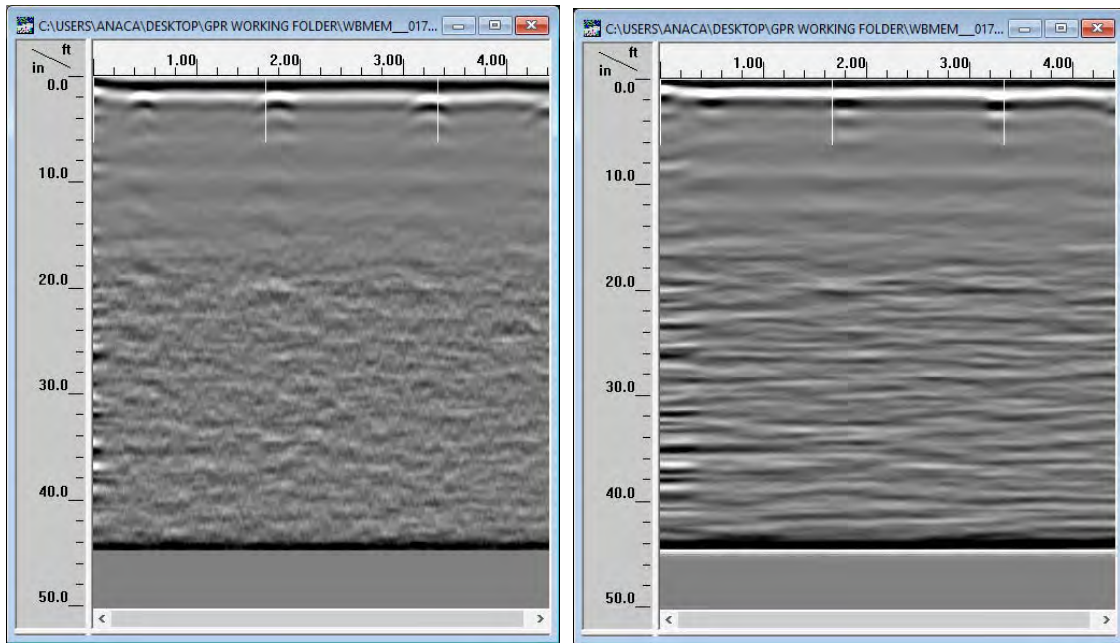
Scan 017: 2nd level concrete from stairs. South wall, vertical. Concrete very wet beyond about 18" depth.

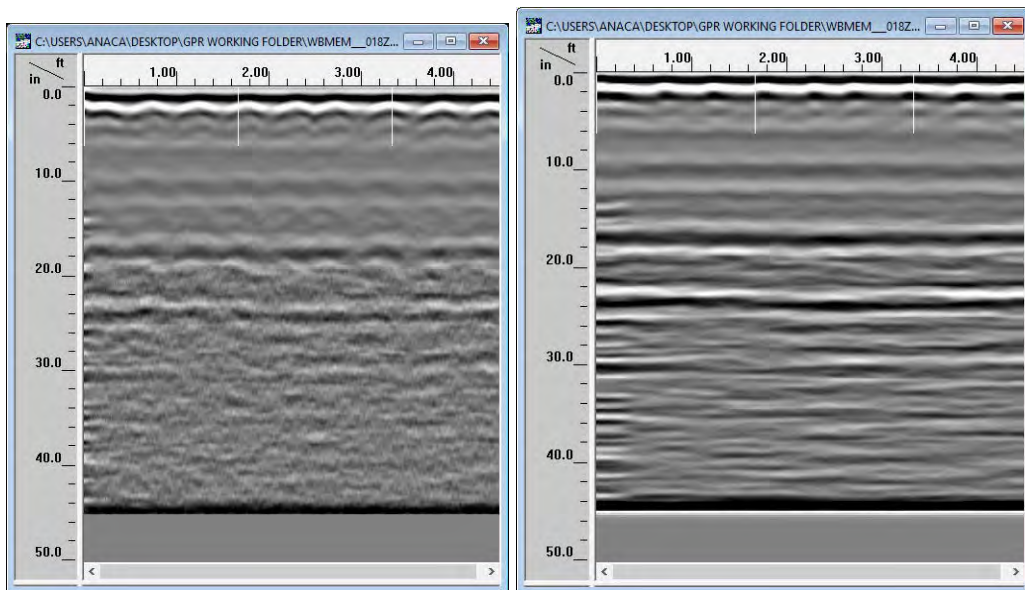
Scan 018: Same as 017, horizontal. Concrete 18" or 24" thick?

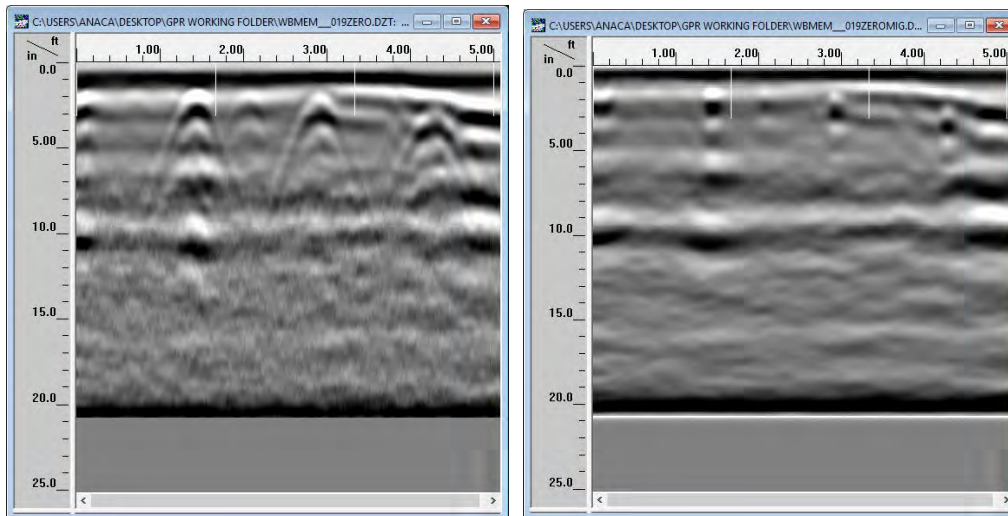
Scan 019: Same as 017, reduced time, rebar at 6" to 17" spacing, depth = 1 3/8" to 2 1/4"

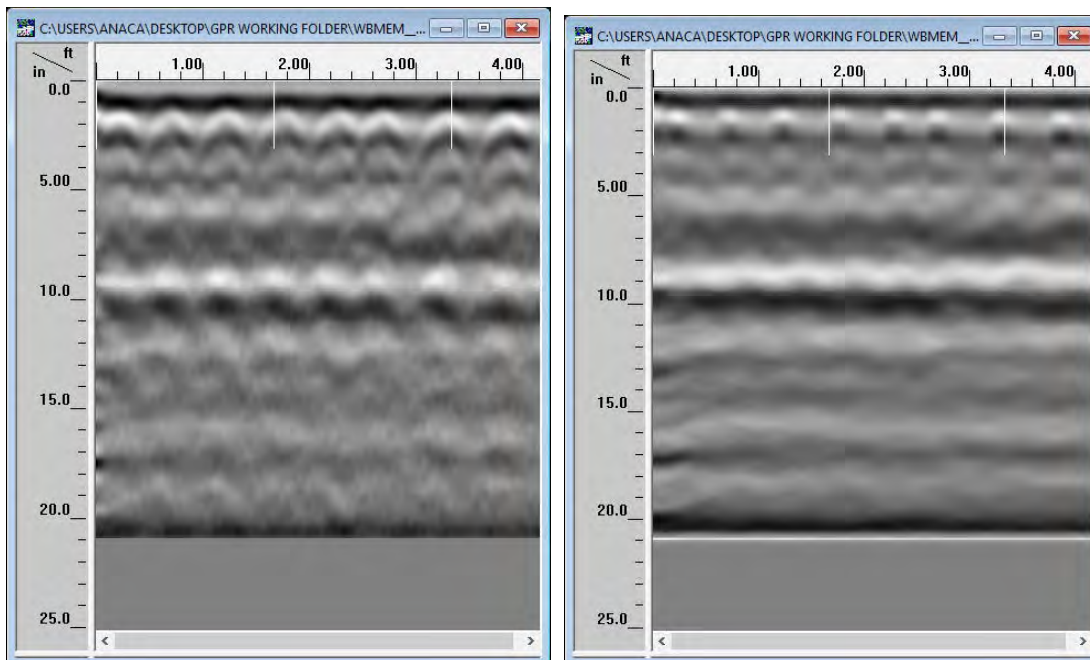
Scan 020: Same as 018, reduced time, rebar at 5" to 8", depth = 1"

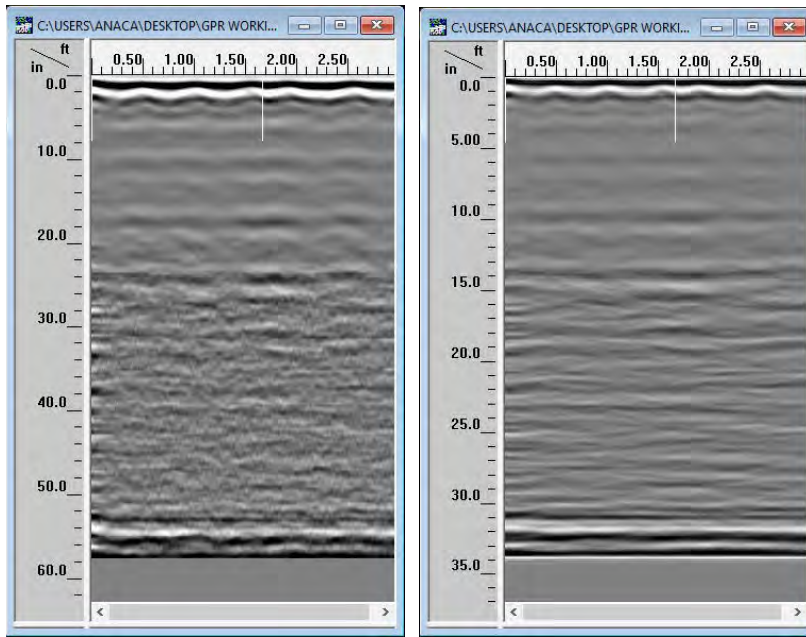
Scan 021: Same as 018, Same as 017, horizontal. Concrete 22" deep?

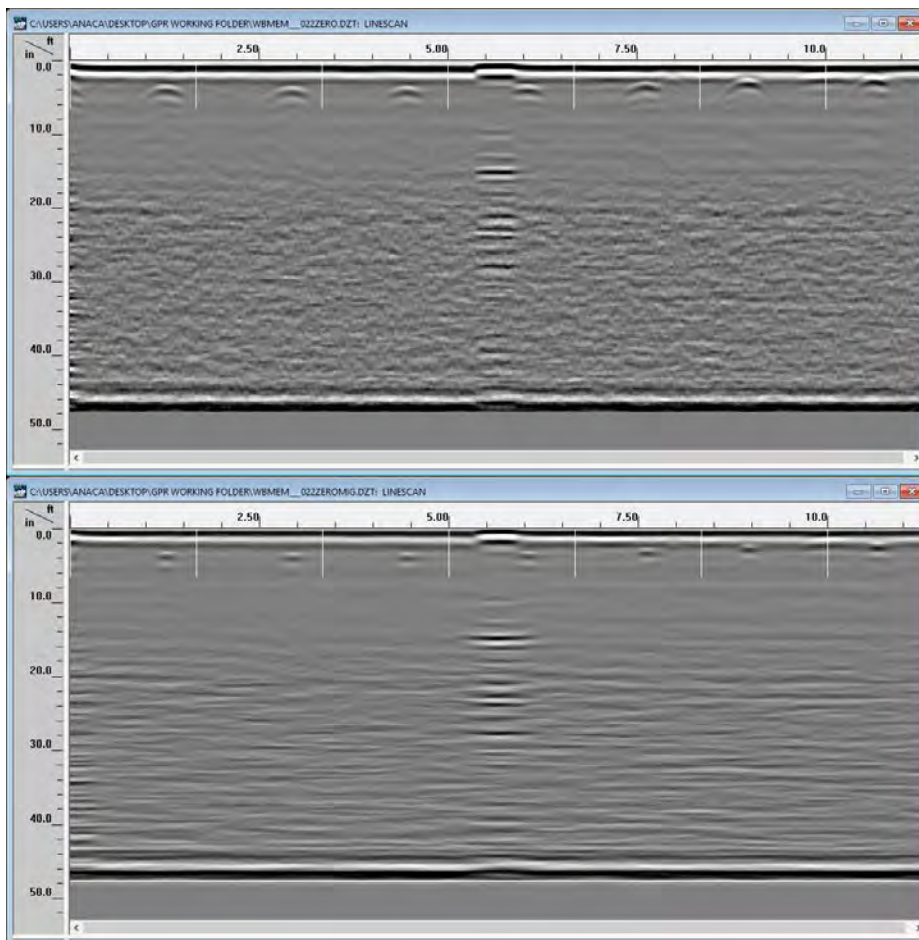
022

Scan 022, 024: 3rd level, vertical. Rebar at 14" to 19" , depth = 3"

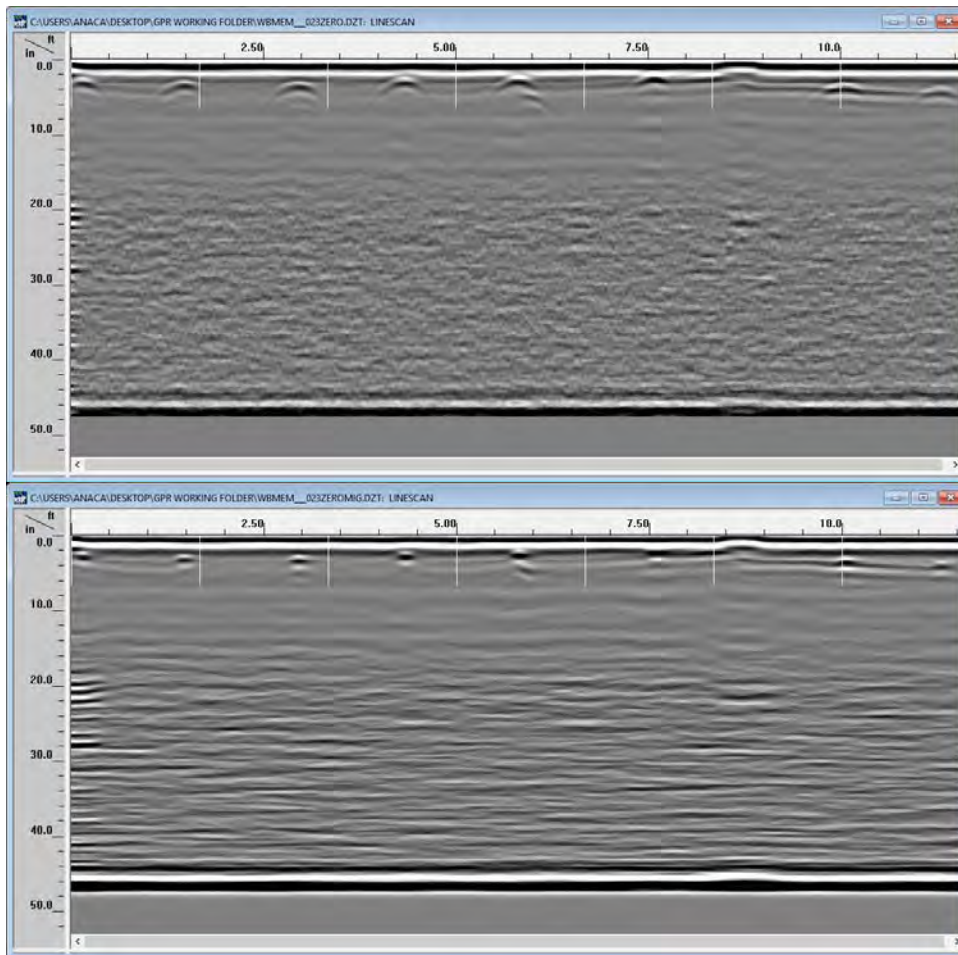
Scan 023: 3rd level concrete, horizontal. Rebar at 16", depth = 1 5/8" to 3"

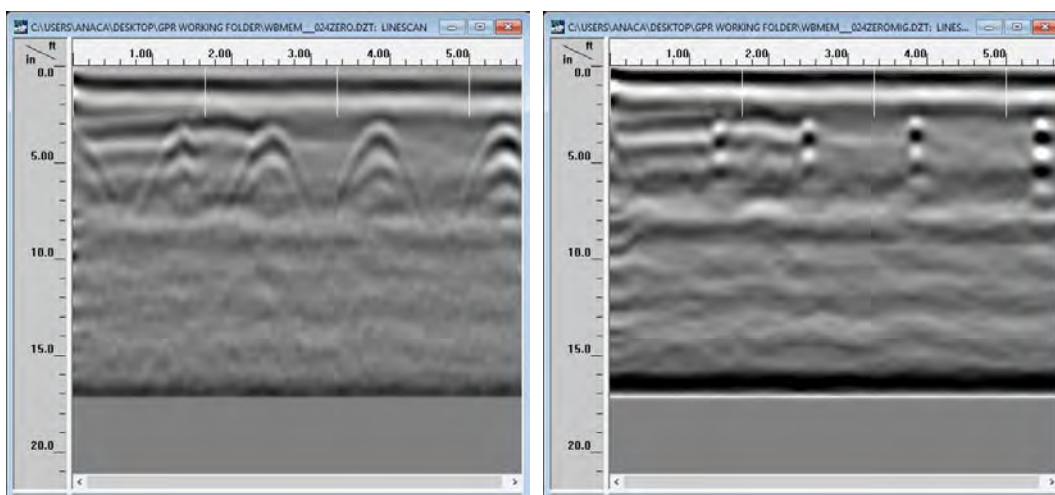
Scan 024: same as 022, 3rd level, vertical. Rebar at 14" to 19" , depth = 3"

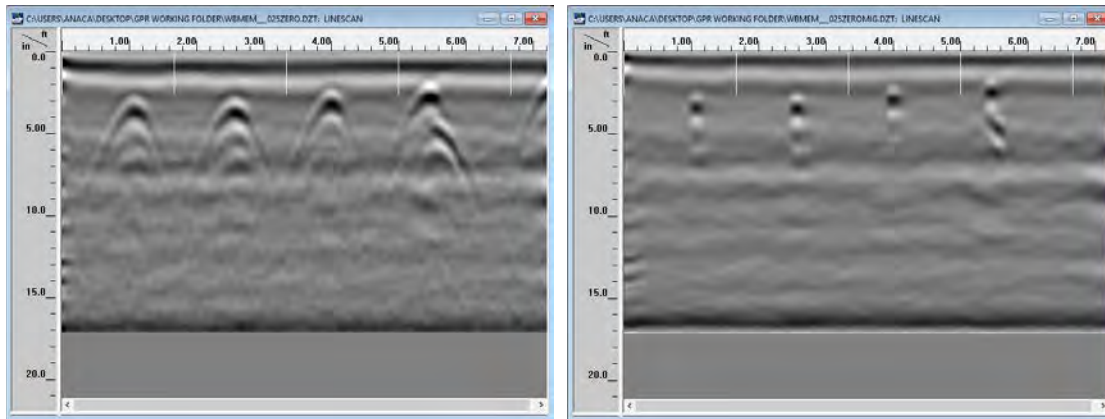
Scan 025: same as 023: 3rd level concrete, horizontal. Rebar at 16", depth = 1 5/8" to 3"
