Historic Structure Report  
**Wright Brothers Monument  
and Powerhouse**  
*100% FINAL*

# Wright Brothers Monument and Powerhouse

## Historic Structure Report

October 2022

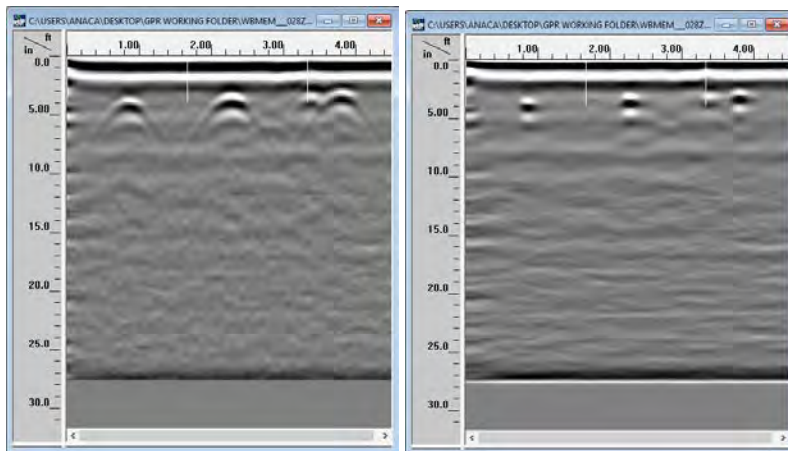
Scan 028: 4th level vertical concrete, west wall, rebar at 16" to 17". One extra bar?

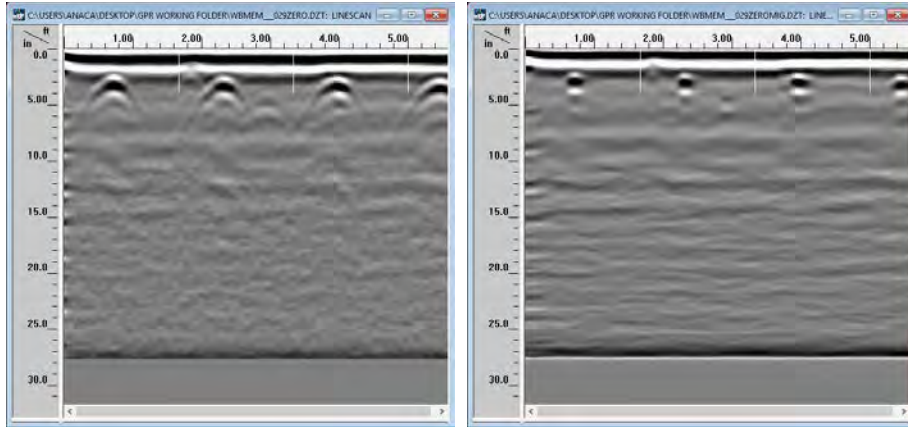
Scan 029: 4th level concrete, horizontal, west wall, rebar at 6" to 18".

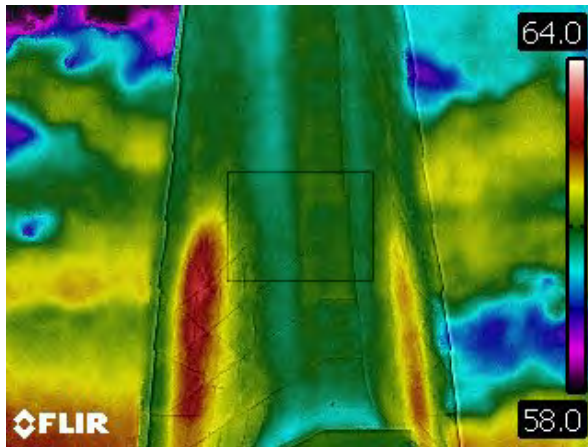
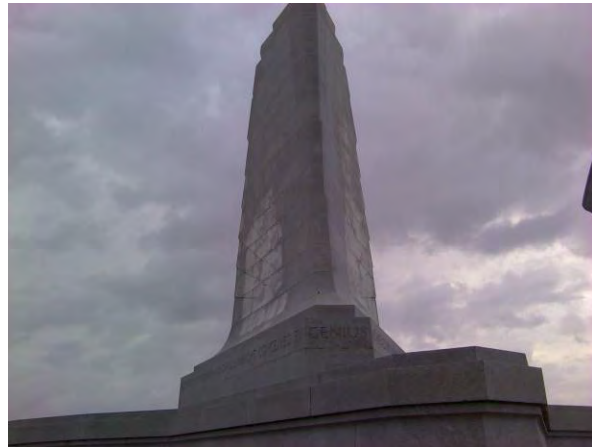
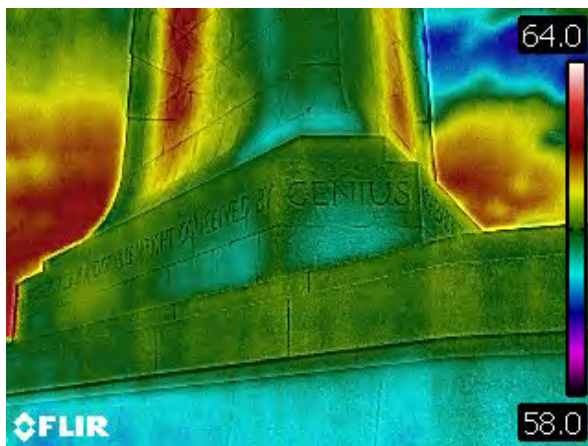
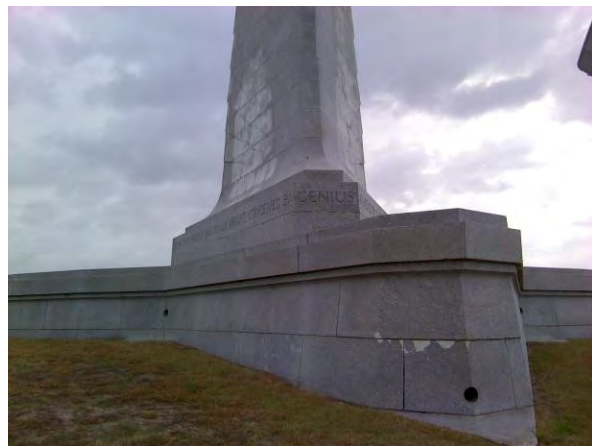
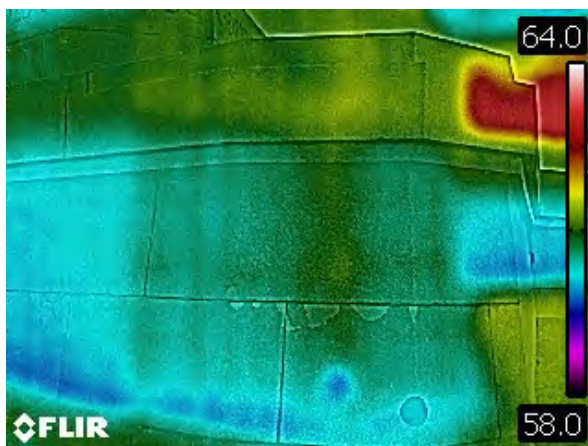
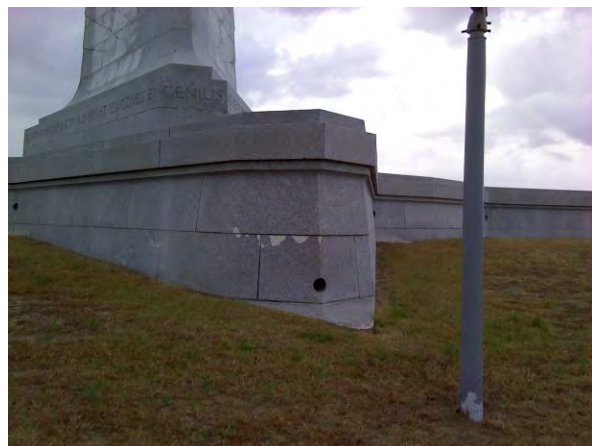
**Infrared Thermography Scan Set 2: Wednesday November 30 between 07:08 and 08:43,  
during roof drain leak test**

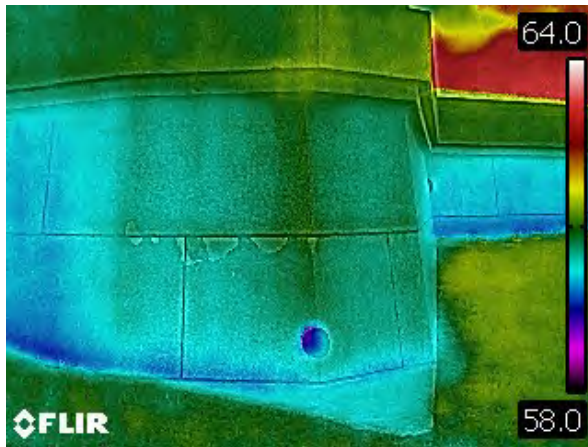
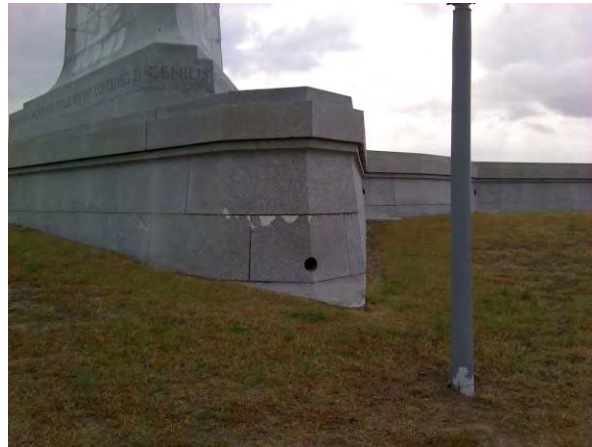
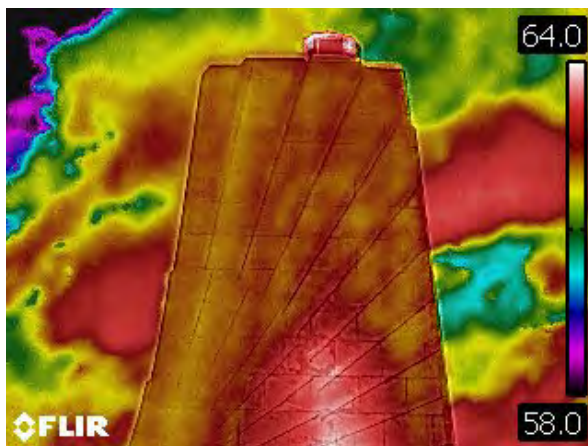
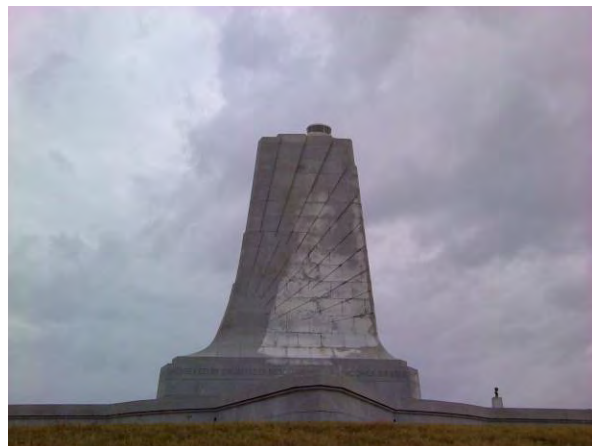
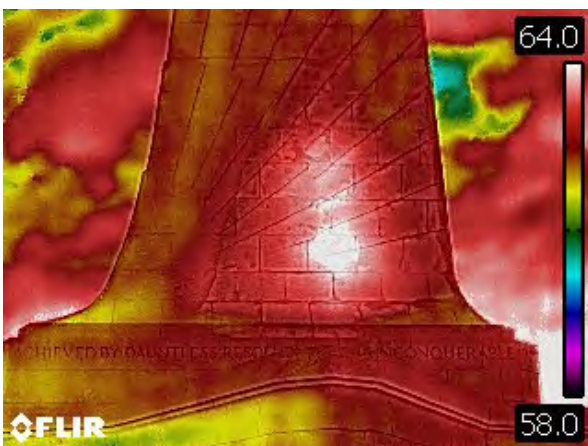
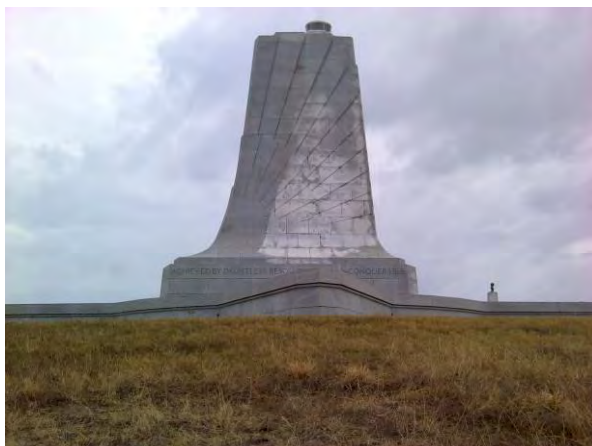
**Infrared Thermography Scan Set 2: Wednesday November 30 between 07:08 and 08:43,  
during roof drain leak test**

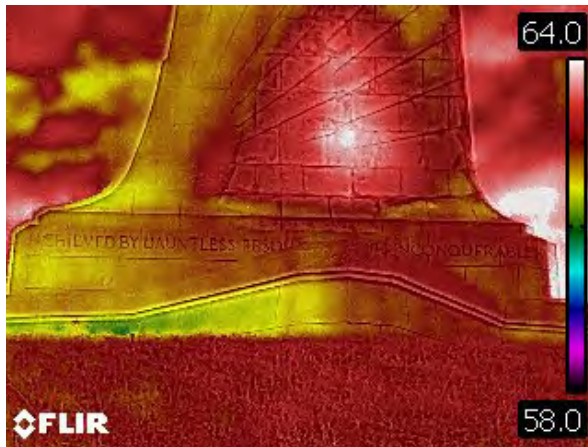
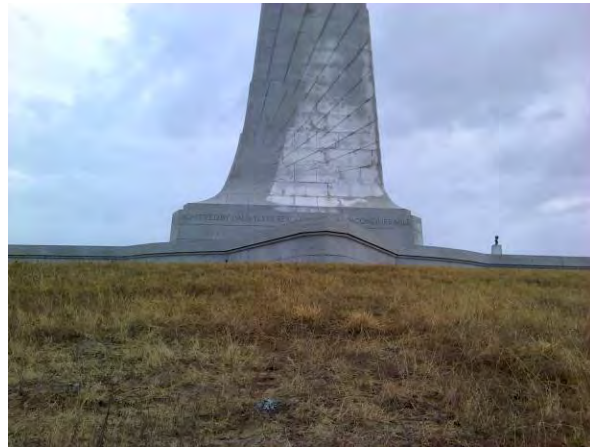
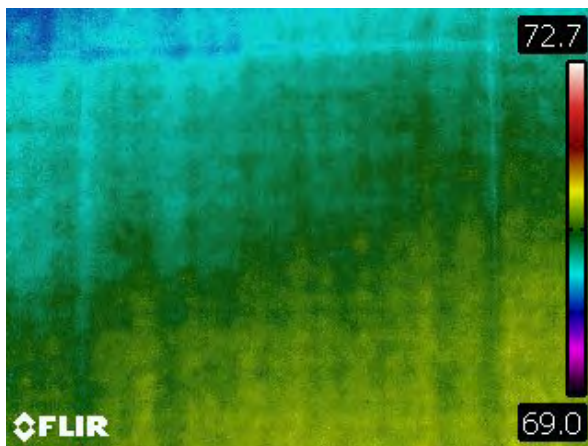
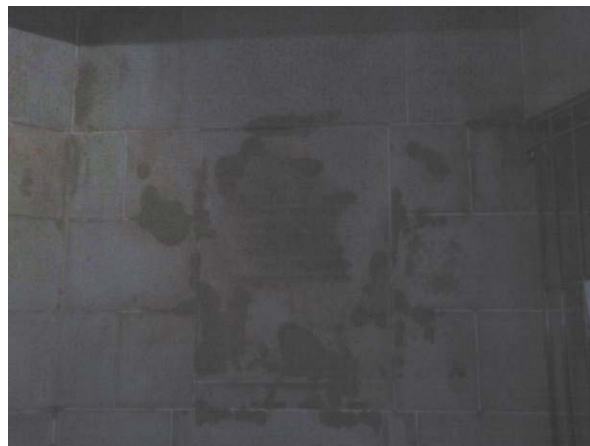
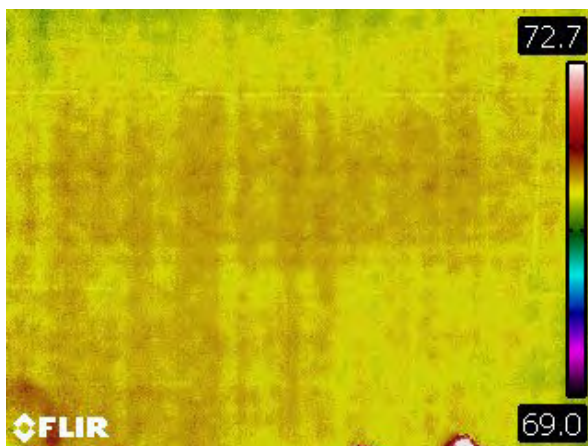
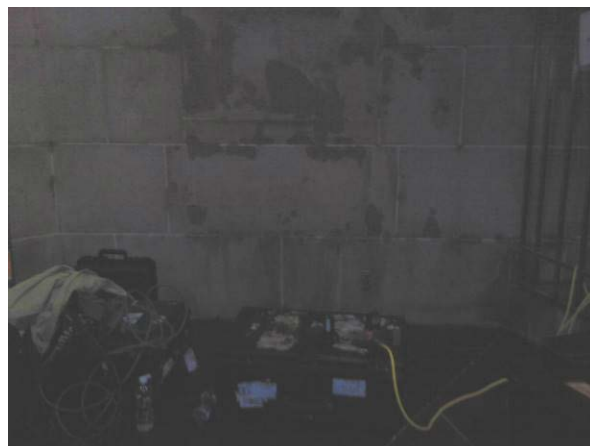
**Infrared Thermography Scan Set 2: Wednesday November 30 between 07:08 and 08:43,  
during roof drain leak test**

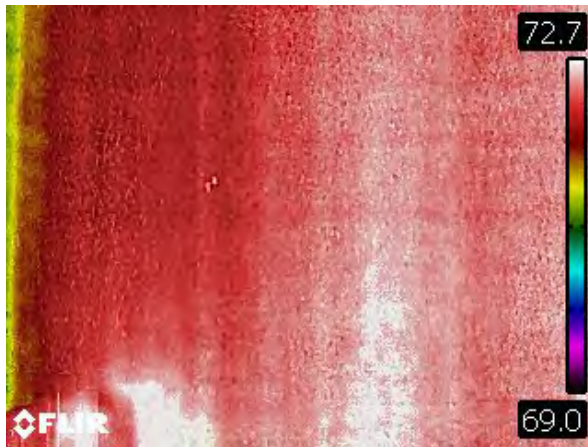
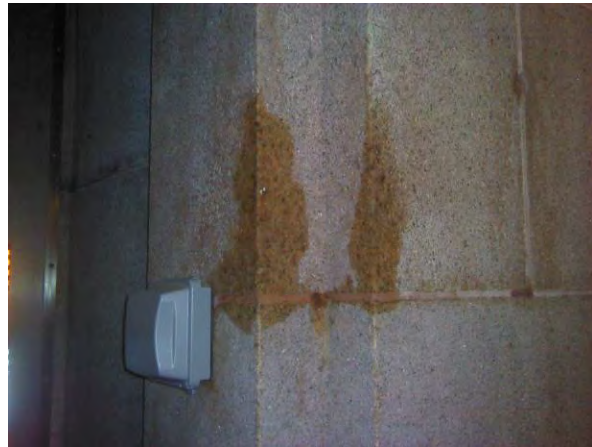
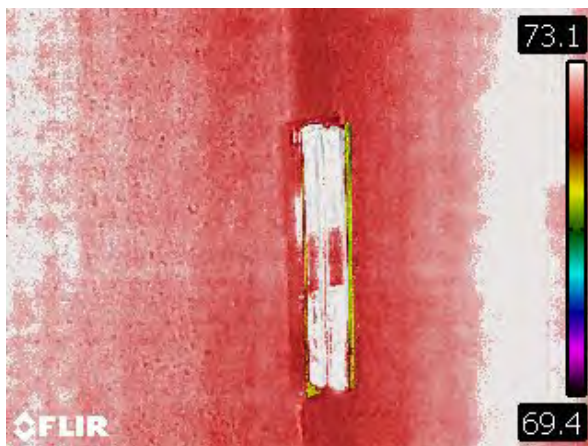
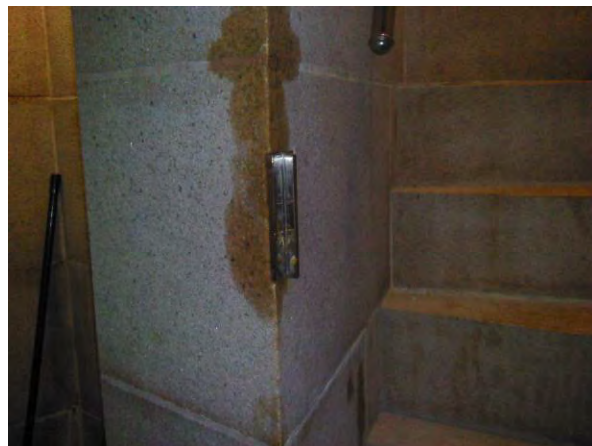
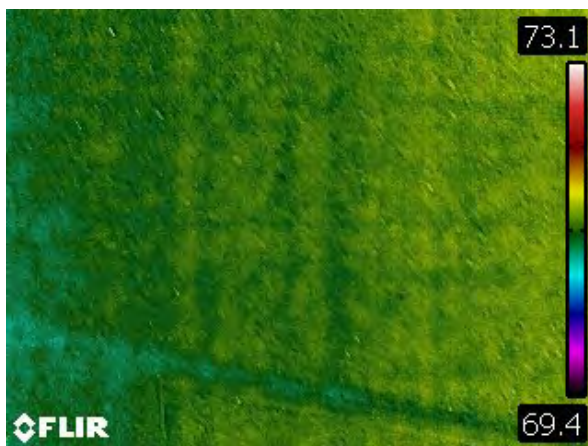
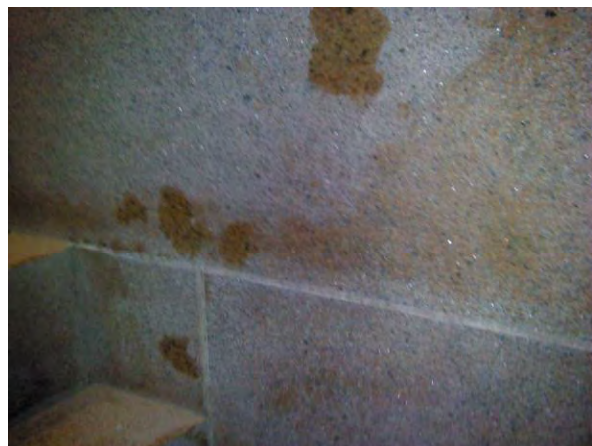
**Infrared Thermography Scan Set 2: Wednesday November 30 between 07:08 and 08:43,  
during roof drain leak test**

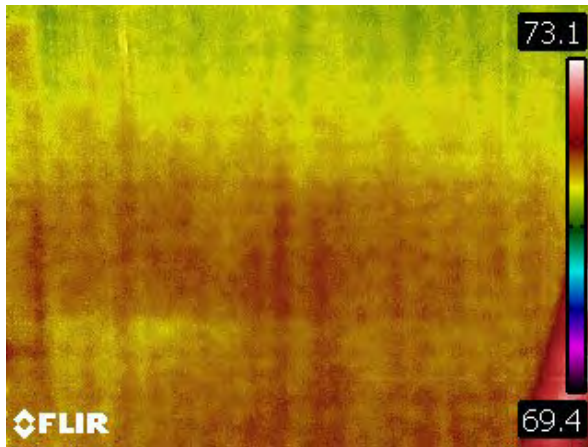
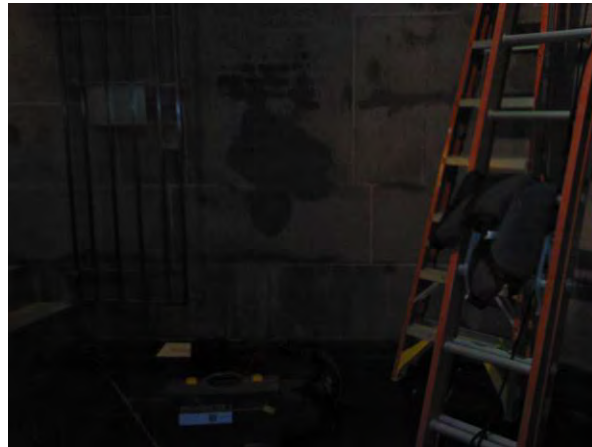
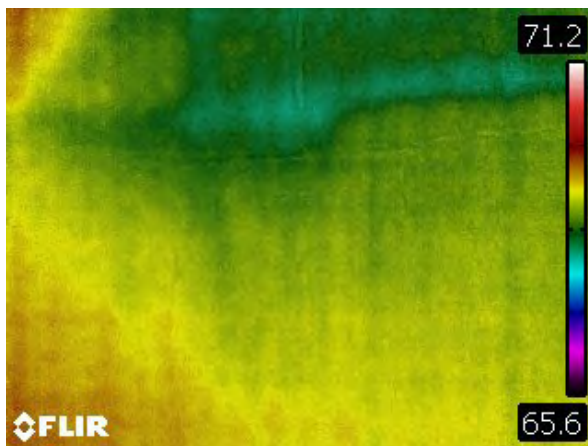
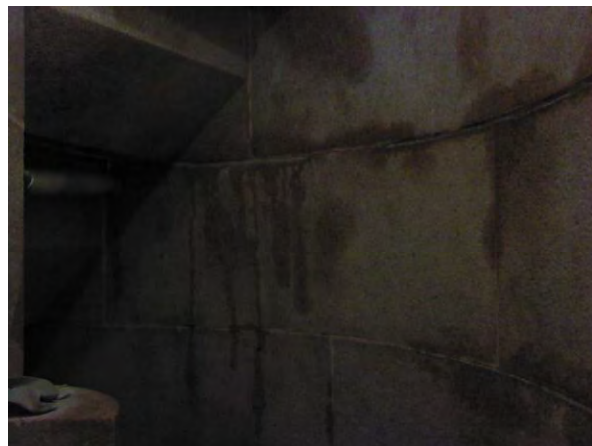
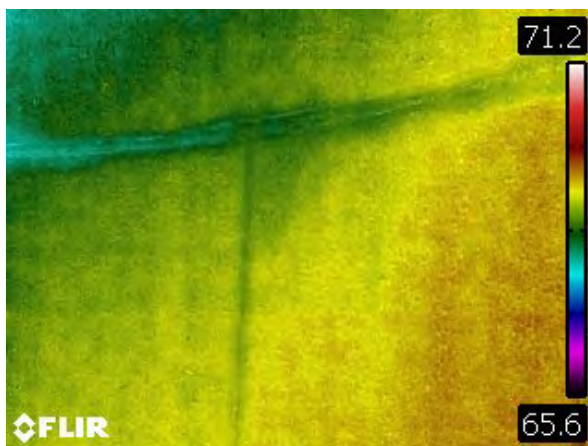
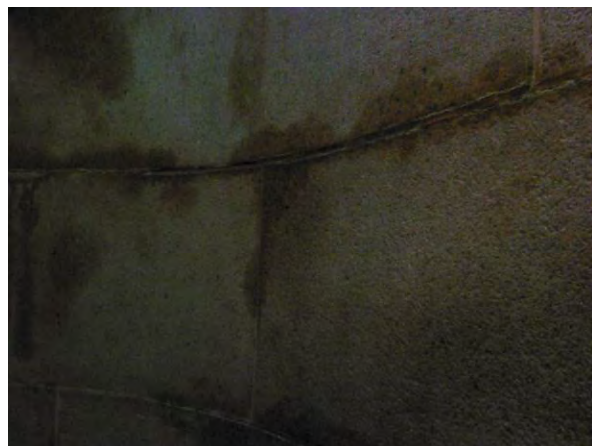
**Infrared Thermography Scan Set 2: Wednesday November 30 between 07:08 and 08:43,  
during roof drain leak test**

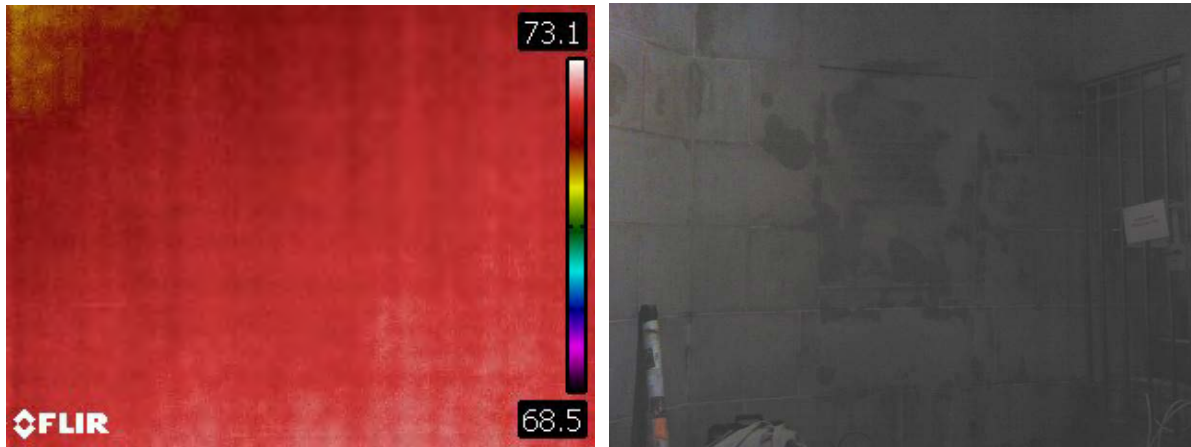
**Infrared Thermography Scan Set 2: Wednesday November 30 between 07:08 and 08:43,  
during roof drain leak test**

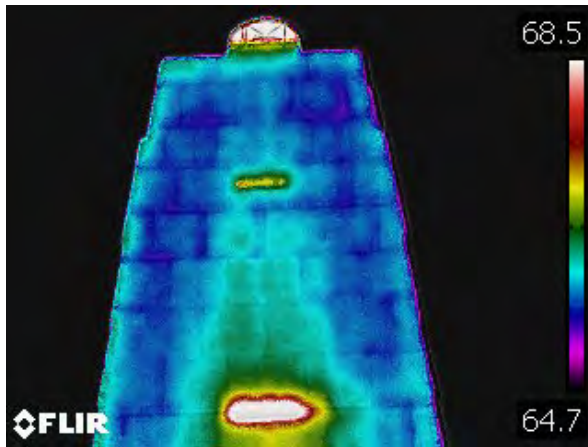
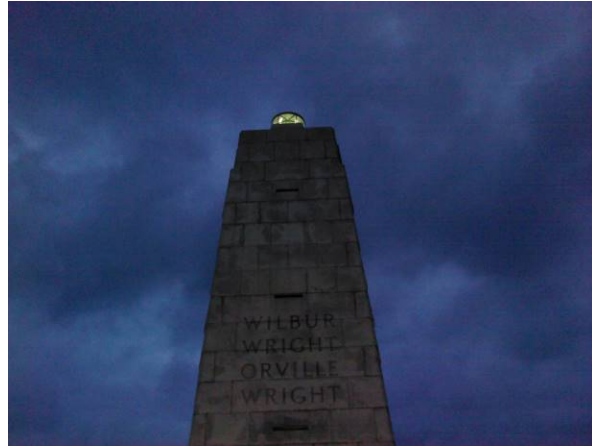
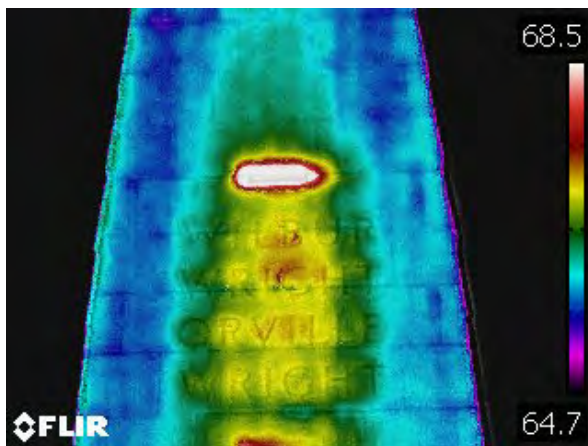
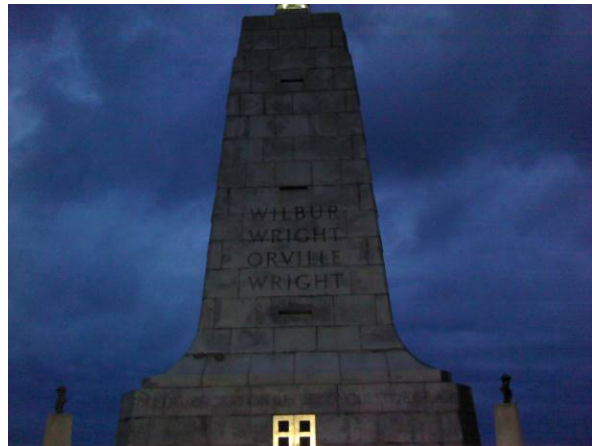
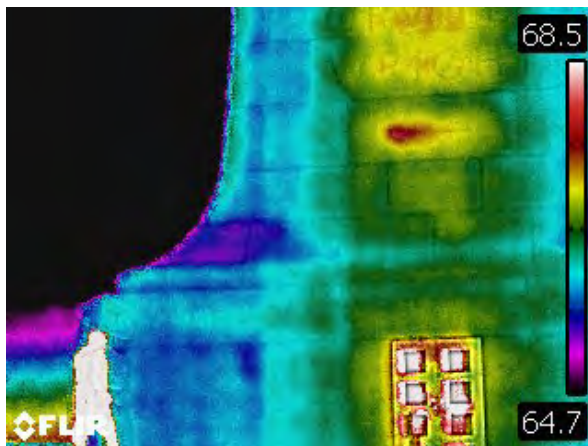
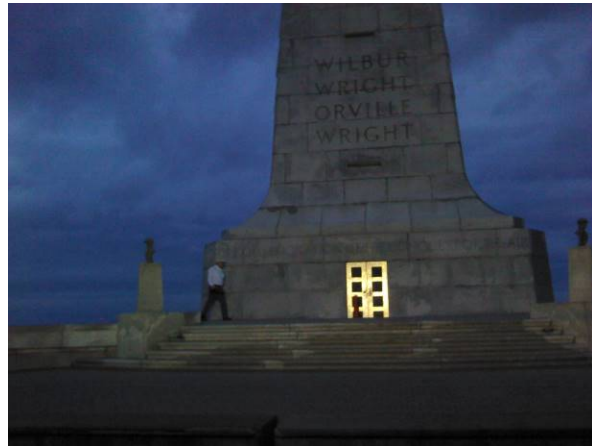
**Infrared Thermography Scan Set 3: Thursday December 1 between 06:31 and 06:55,  
after roof drain leak test**
