Historic Structures Report Fort Yellowstone Power House

Mammoth Hot Springs
Yellowstone National Park, Wyoming

1996

**Historic Structures Report
Fort Yellowstone Power House
Final Document**

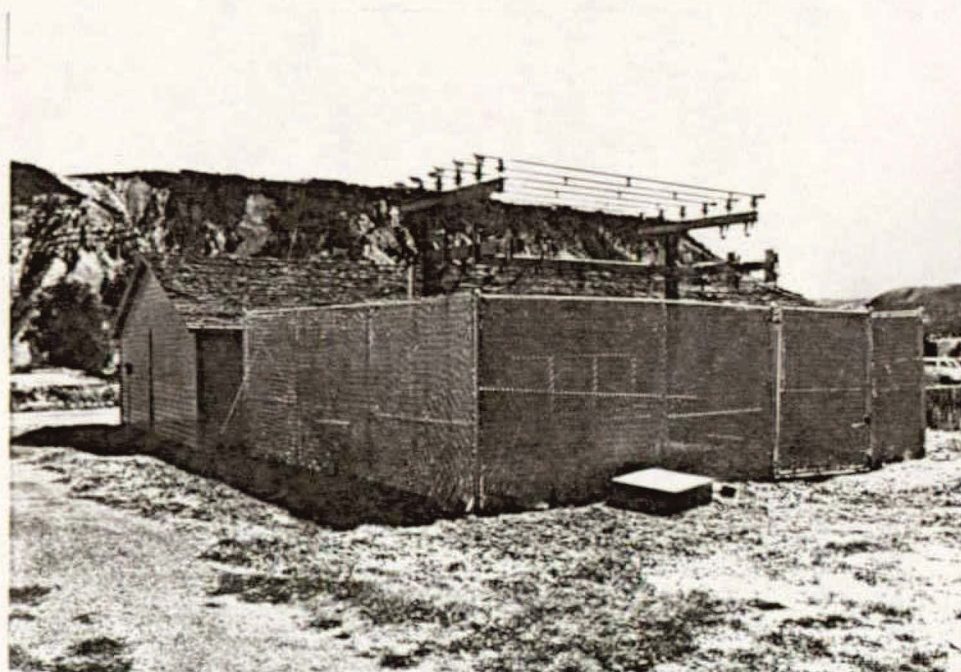
Figure 9. Looking southeast at the abandoned transformer grid on the south side of the power house and west side of the garage. This was abandoned at the same time as the power house.

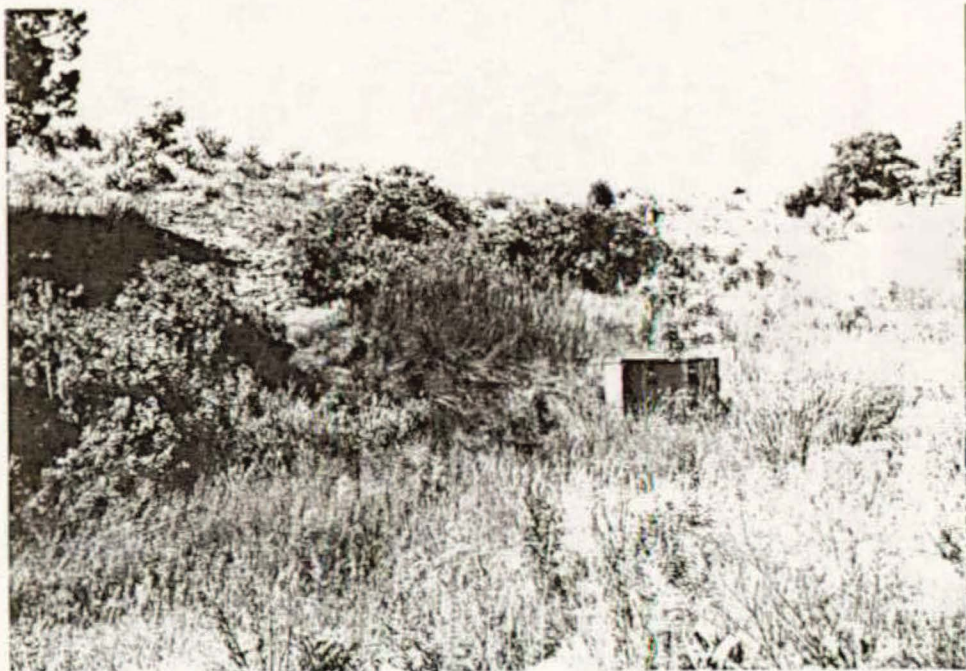
Figure 13. Looking west from the power house at the area where the original penstock is located. The concrete feature is part of the penstock.

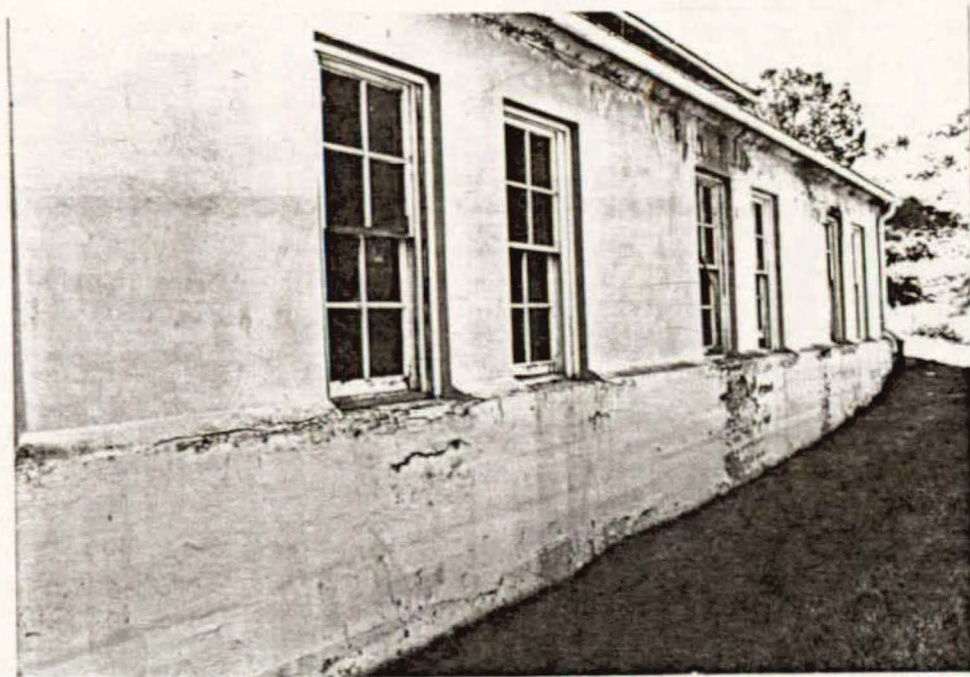
Figure 23.

Looking southwest along the shed roof wing of the power house. Some of the paint has come off the concrete surface and there is some concrete surface deterioration.

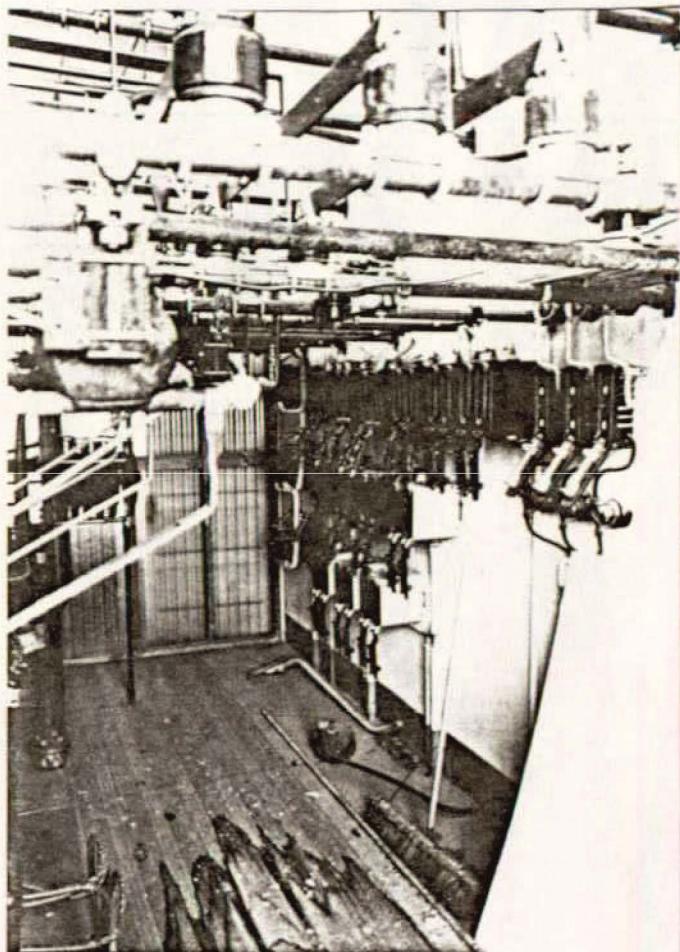
Figure 35.

Looking east at the generator room. The turbines and generators are directly in the center and to the right of the photo amongst the storage boxes.

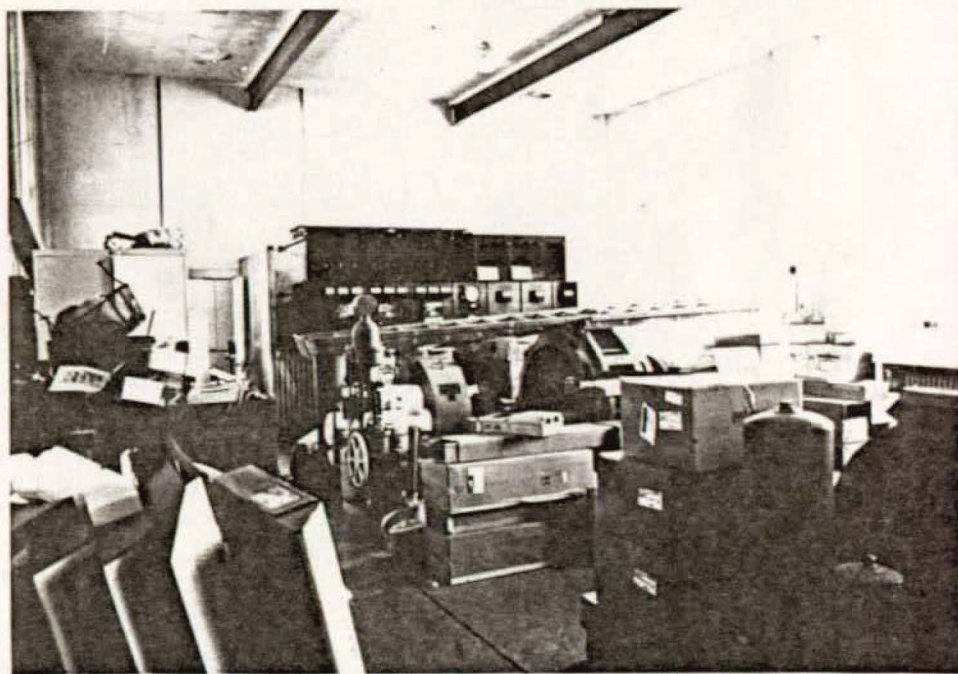
Figure 36. Looking southwest at the generator equipment in the center of the generator room. All of this equipment contributes to the significance of the building.

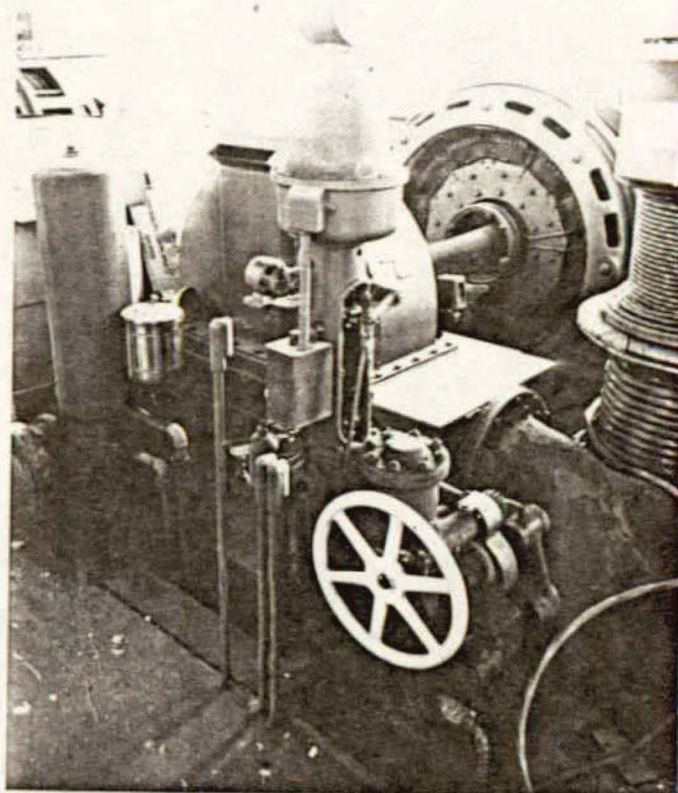
Figure 37. Looking east at the generator room, and original equipment. The room is currently used for storage.

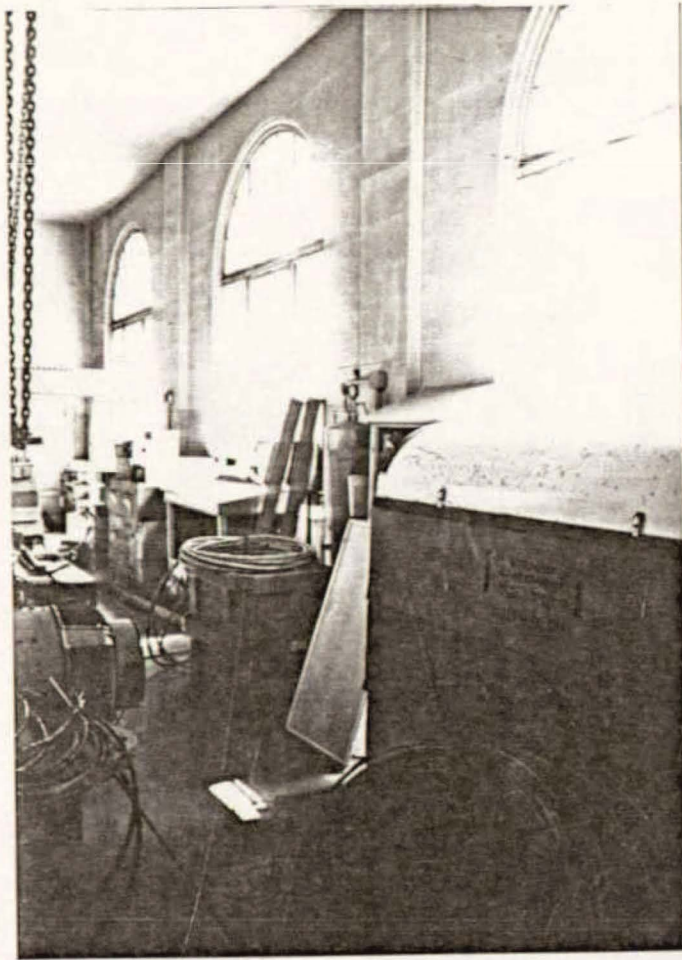
Figure 38. Looking southeast at the large windows on the south side of the building. The interior space and materials are in good condition.
