# ROOSEVELT LODGE HISTORIC STRUCTURES REPORT

**ROOSEVELT LODGE  
YELLOWSTONE NATIONAL PARK  
HISTORIC STRUCTURES REPORT**

**DECEMBER 1993**

**JAMES R. MCDONALD ARCHITECTS  
224 NORTH HIGGINS AVENUE  
P.O. BOX 8163  
MISSOULA, MONTANA 59807**

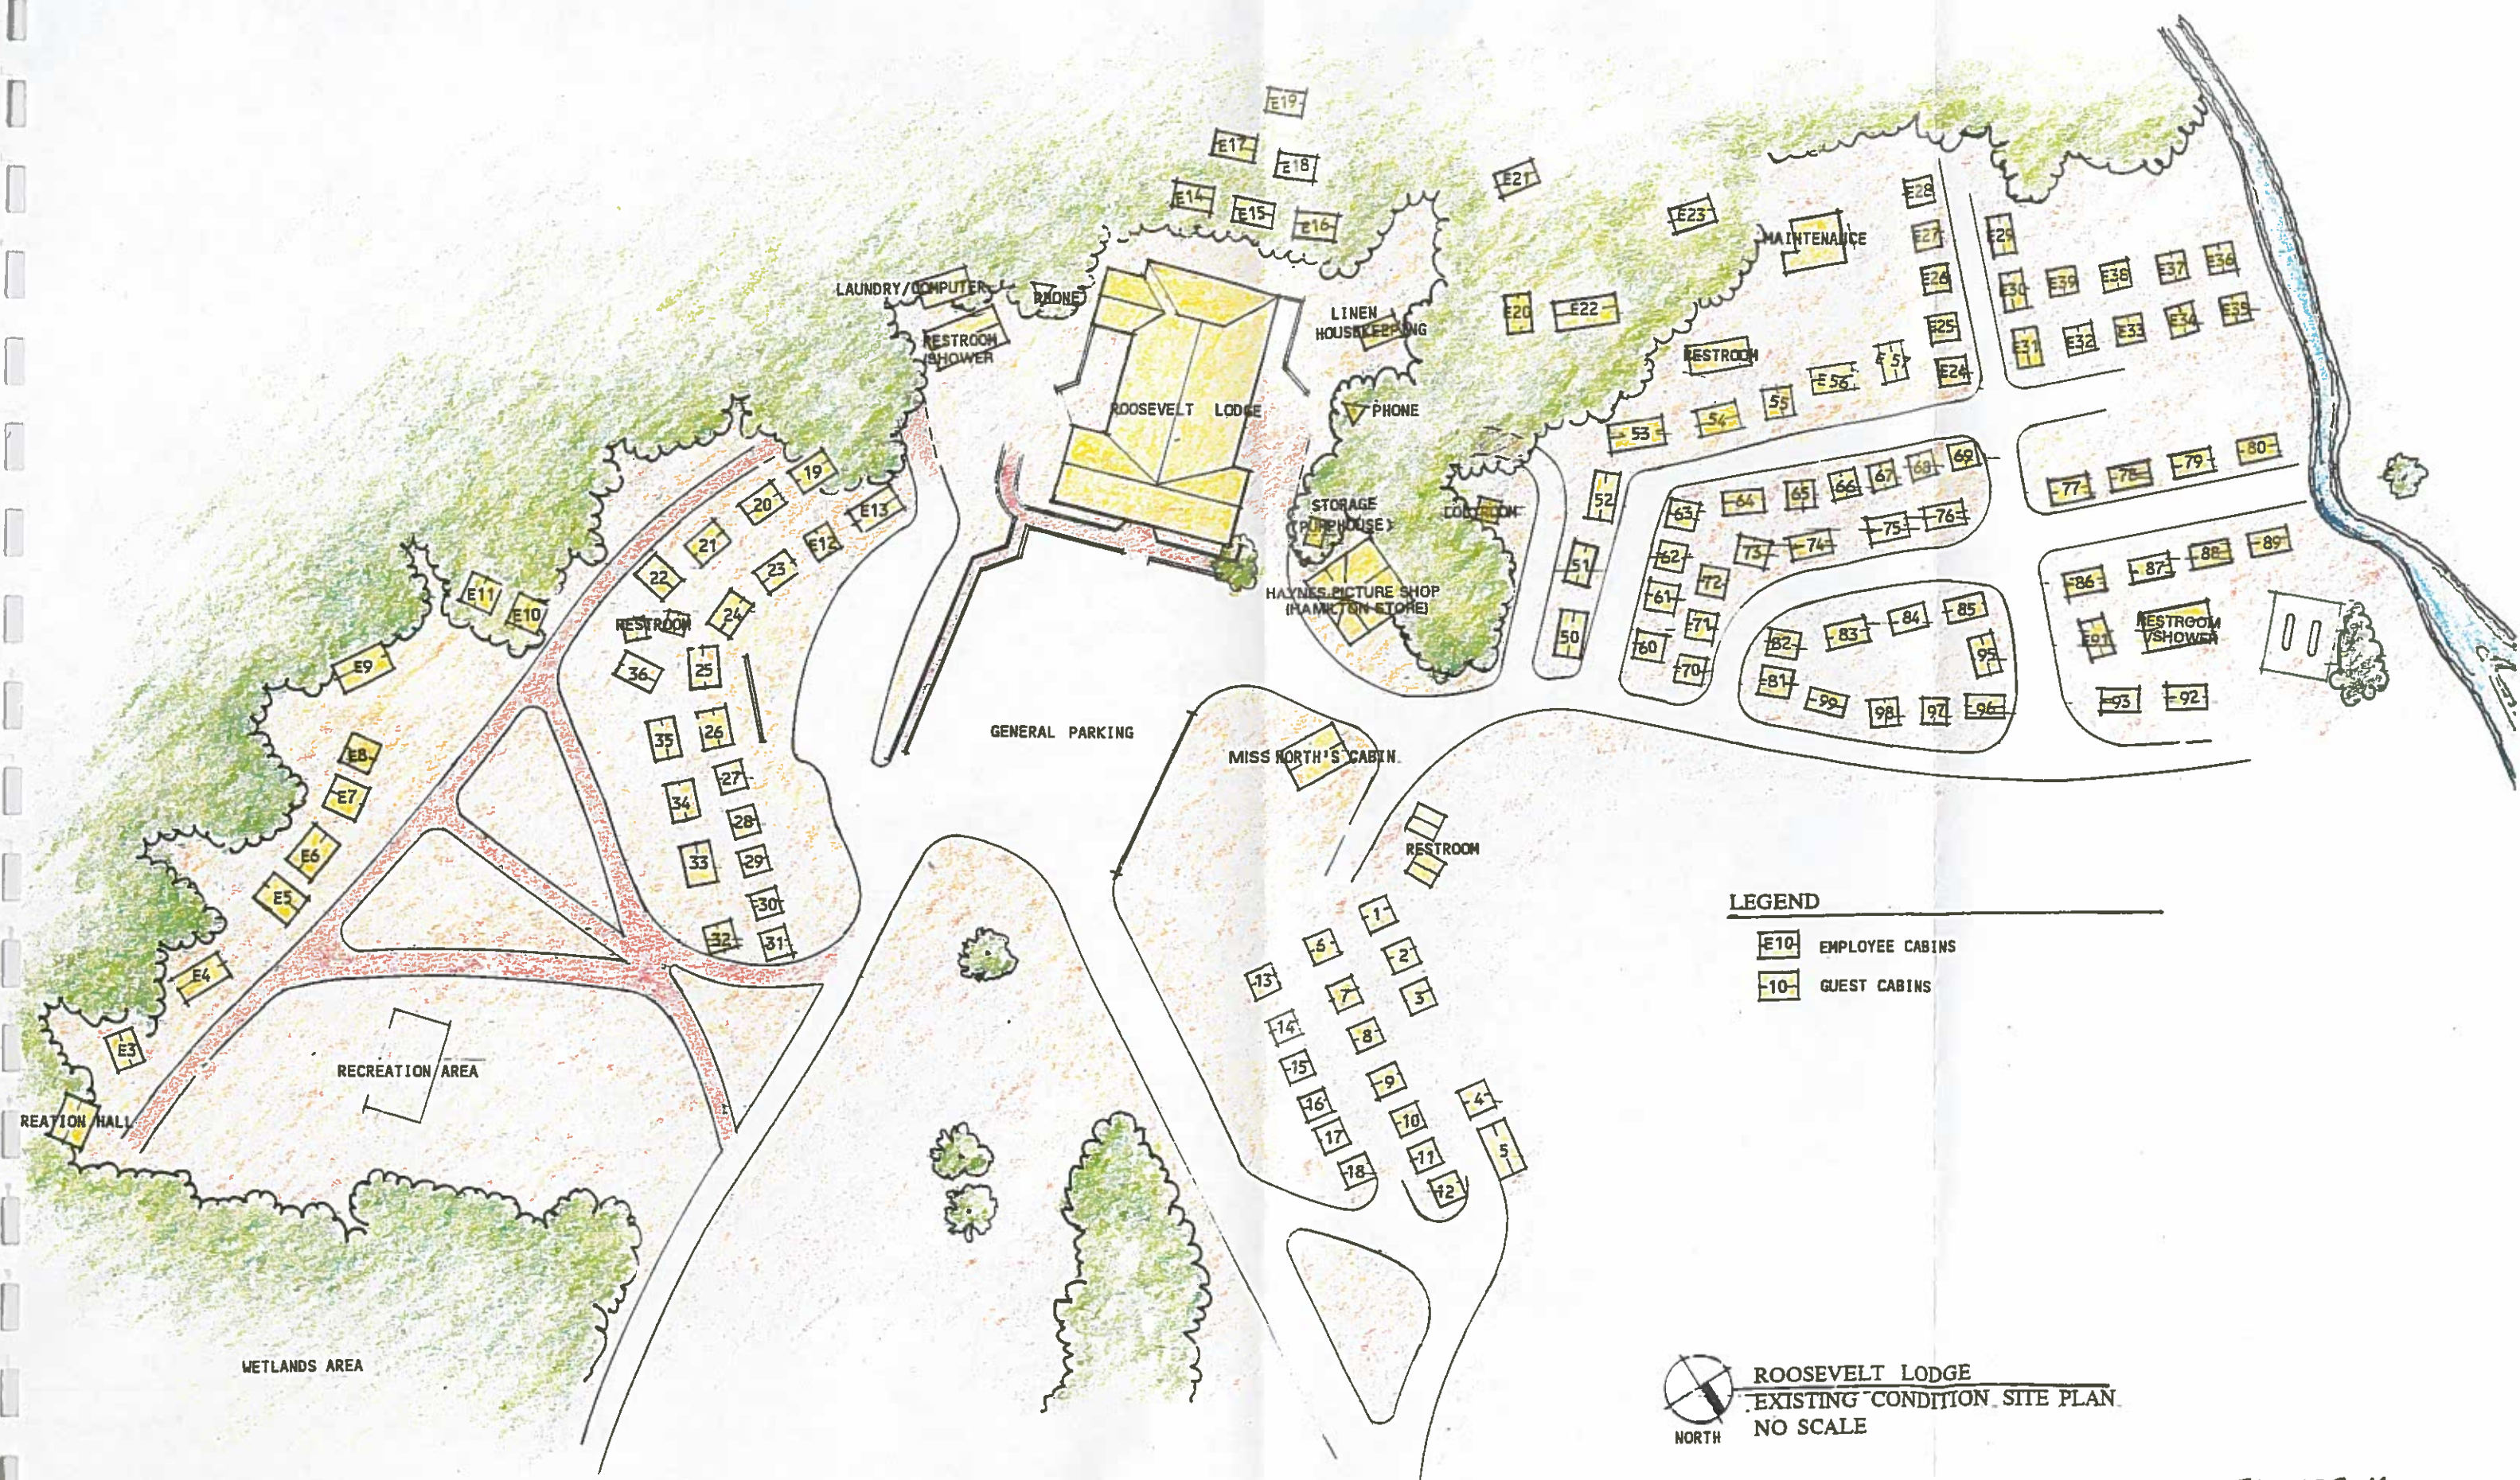
FIGURE 11

The water system and sewage system is a problem in that they do not meet the requirements of the plumbing code. Also, it appears that the cesspool system is failing and needs to be looked at to determine if it should be replaced and what are the best solutions to take care of the increased use of the area.

The following site plan and photos shows some of the problems associated with the site.

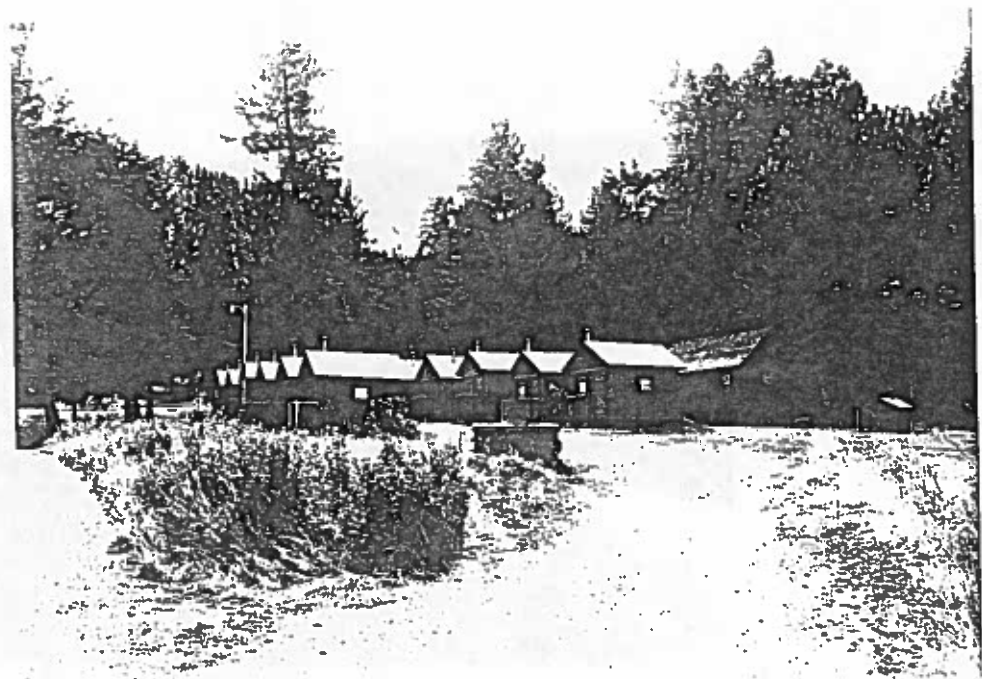
Figure 15: Looking south at the first group of cabins along the road to the Lodge. Note the large dumpster located in front of the cabins.

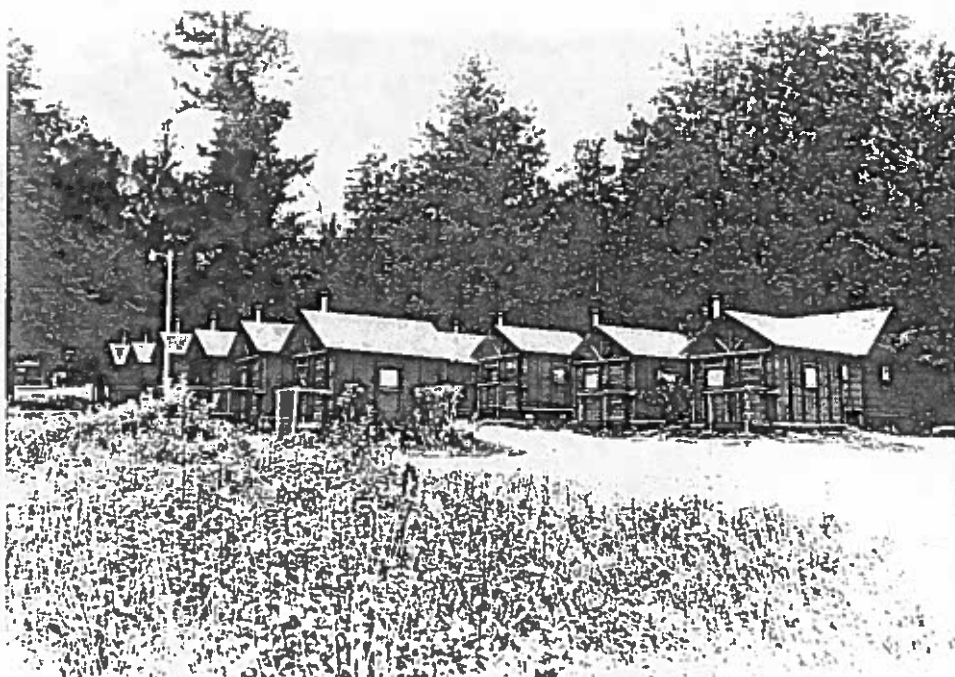
Figure 17: Looking south at the first group of cabins. This historic view has to be maintained and preserved.

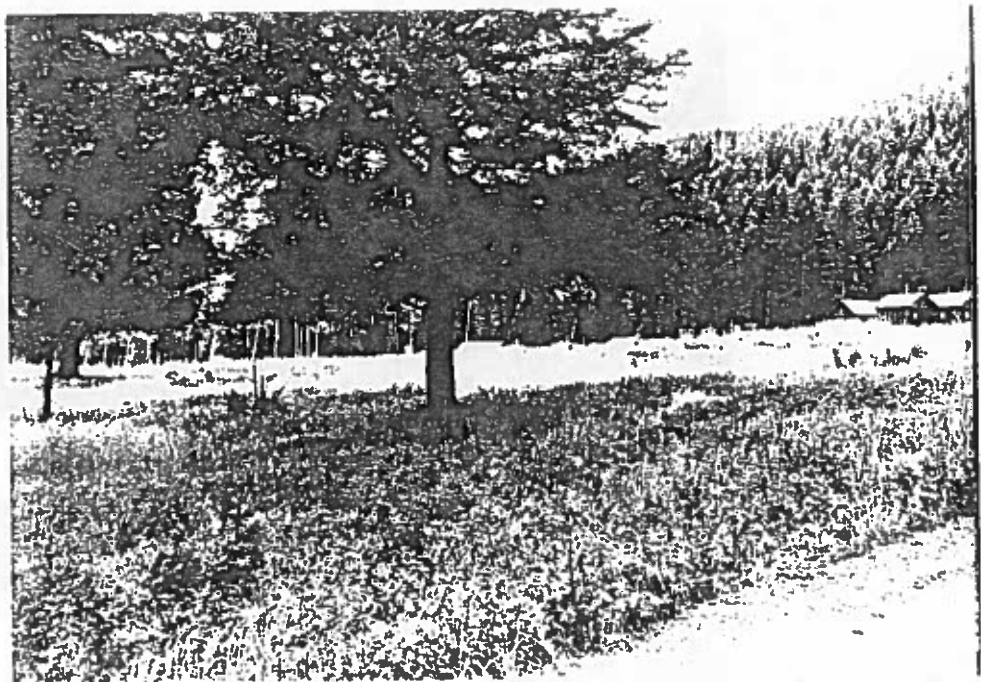
Figure 19: Looking east at the open area on the other side of the road opposite the first group of cabins. Most of this ground area has been disturbed over the years.

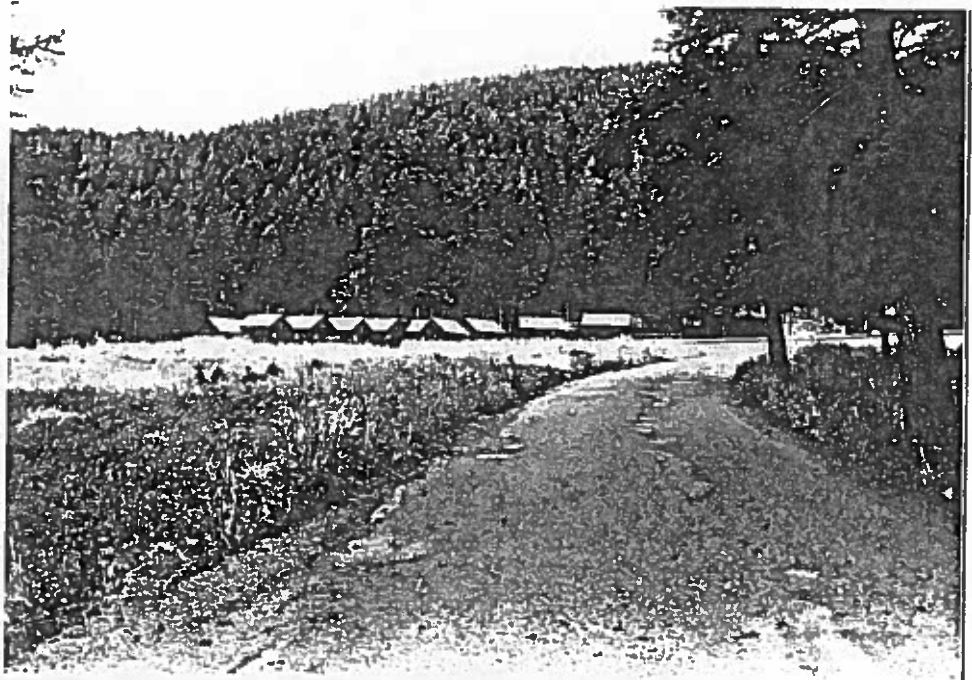
Figure 20: Looking southeast at the second group of cabins to the left of the Lodge. This historic view has to be preserved and maintained.

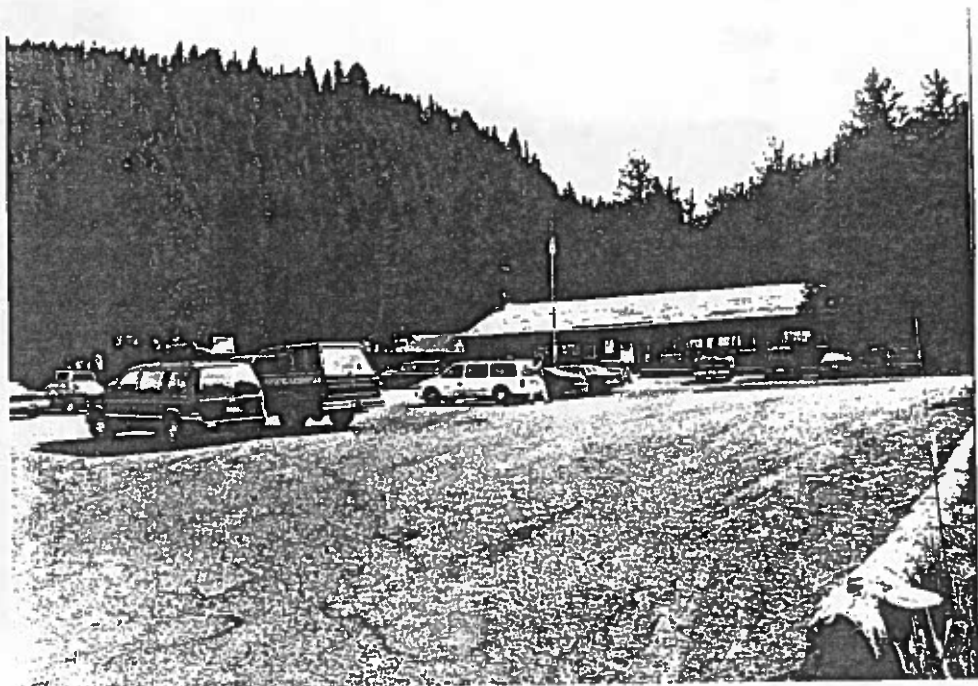
Figure 22: Looking south at the Lodge and parking lot with cars parked in the lot. Most of these cars are small but when the buses and RV's park in the lot the Lodge is completely blocked out.

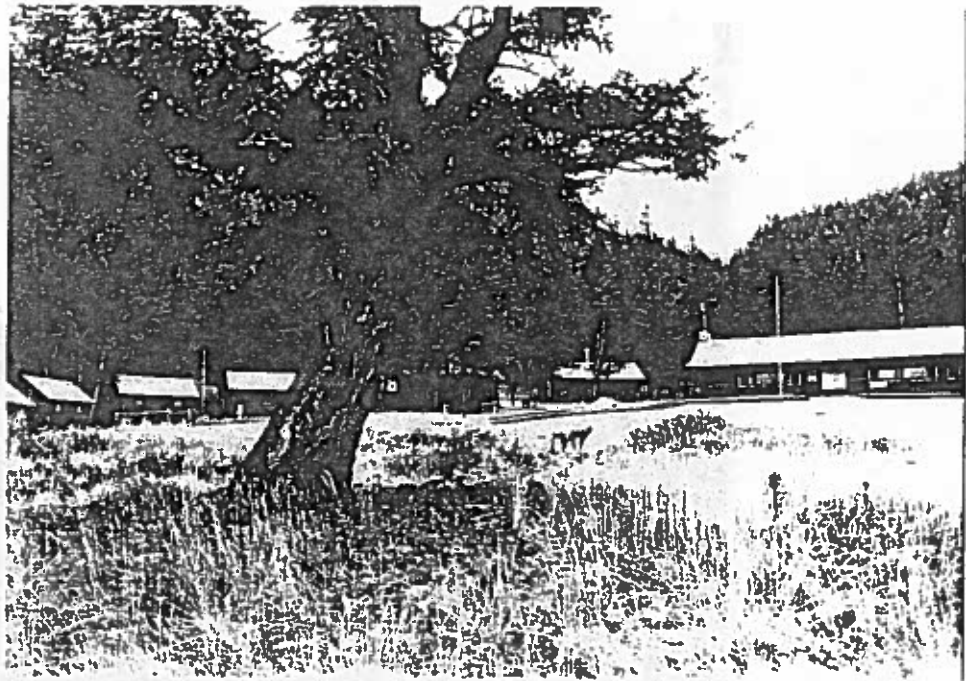
Figure 24: Looking southwest at the original tree next to the original sign in Figure 4. This tree, especially, should be protected.

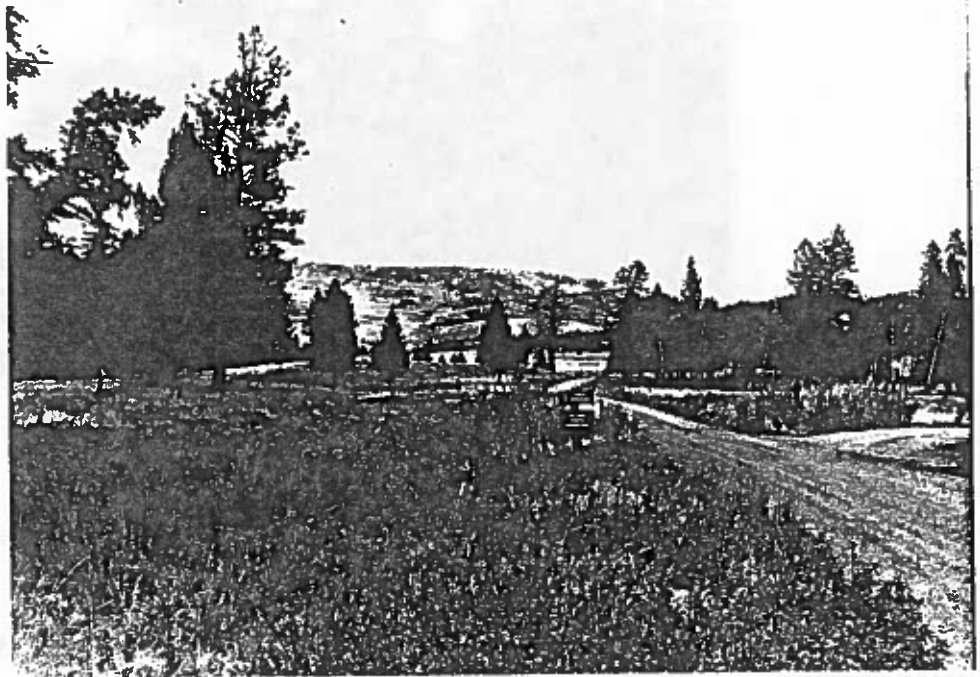
Figure 26: Looking east down the road to the corrals from the parking lot. This area has been disturbed over the years.

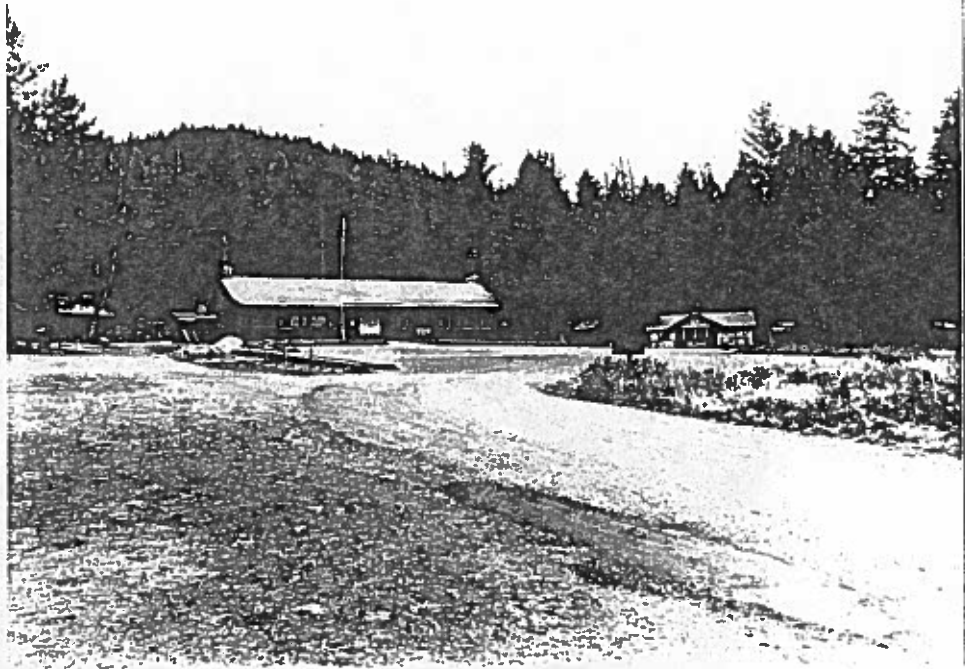
Figure 28: Looking southwest at the Lodge and Hamilton Store from the road to the corrals and the cabin row. The roads and parking have created a large open "no mans land" area.

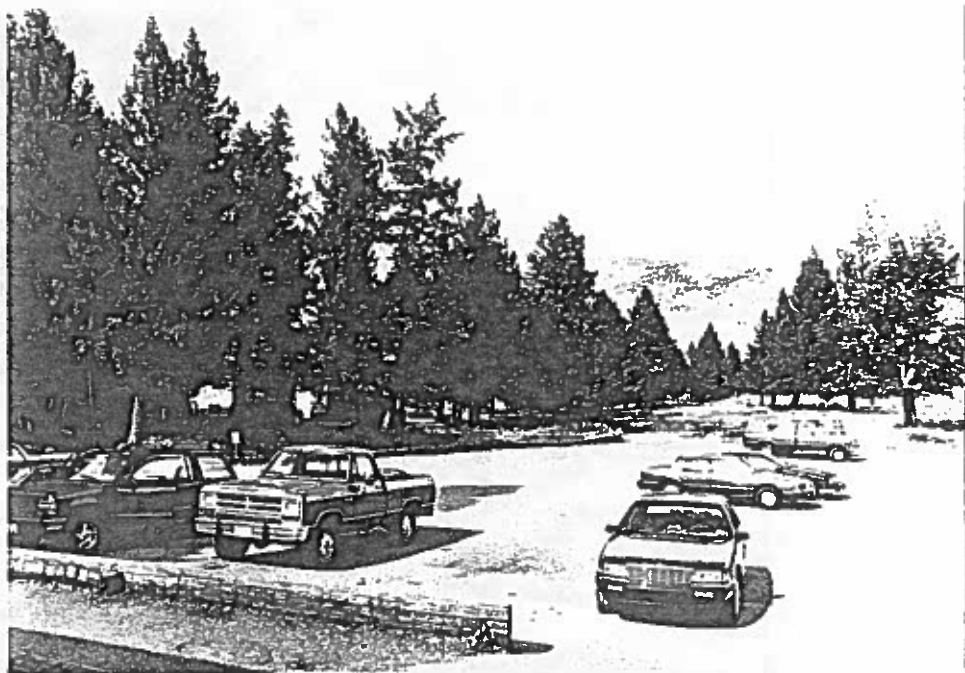
Figure 29: Looking north at the parking lot from the front steps of the Lodge. Note how the cars obscure the view even though there are fewer and smaller cars than would normally park here.

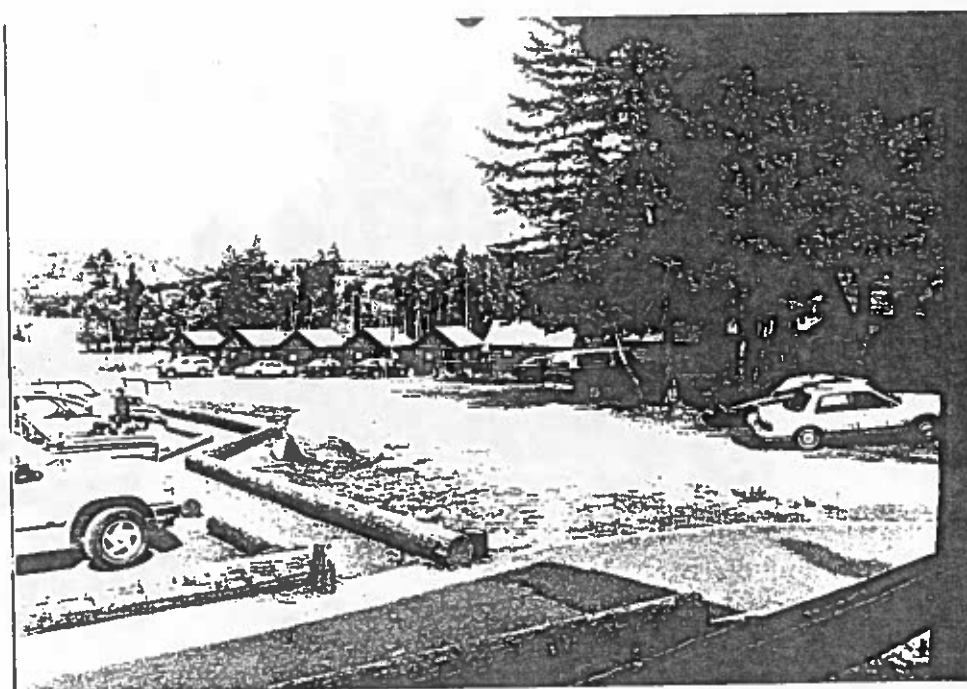
Figure 31: Looking east at the guest cabins with the cars parked in front of them. Note the large log bumpers lining the pedestrian walkway. The large boulder is also out of character. Originally there were trees, meadow grass and wildflowers in this area.

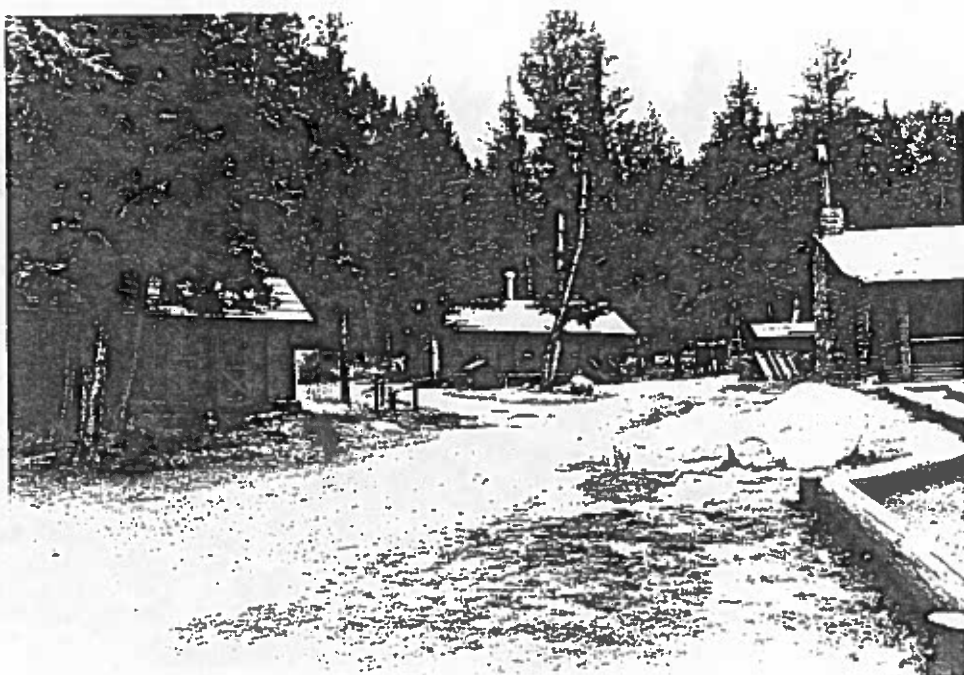
Figure 34: Looking south along the roadway between the cabins and the Lodge. The original meadowgrasses and wildflowers are virtually gone from the front of the Lodge.

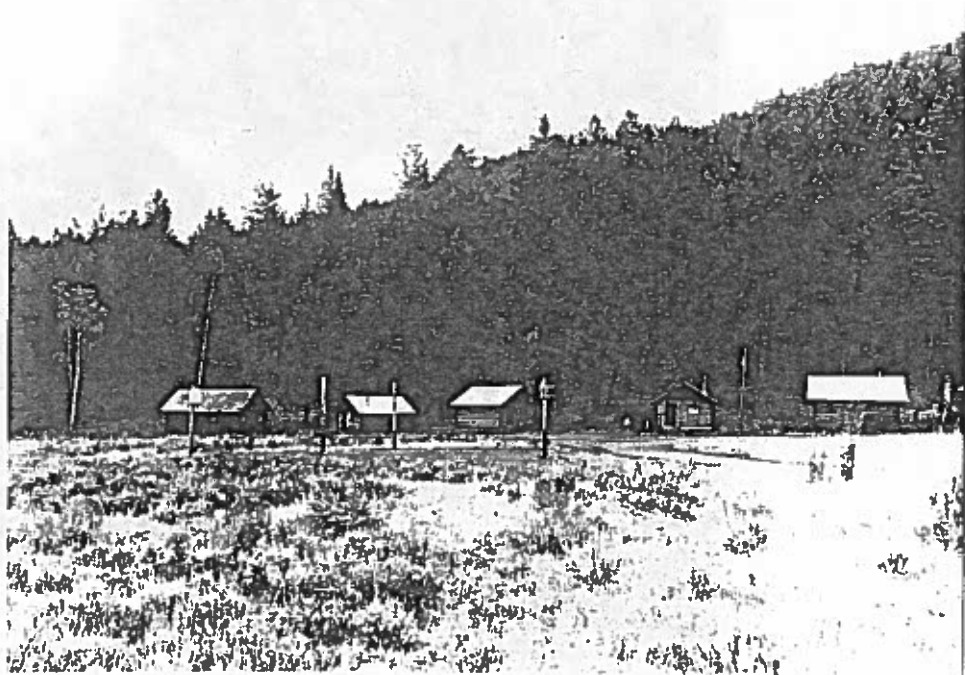
Figure 41: Looking east at the recreation area in front of the employee cabins on the east side of the site. Most of this ground has been disturbed over the years.

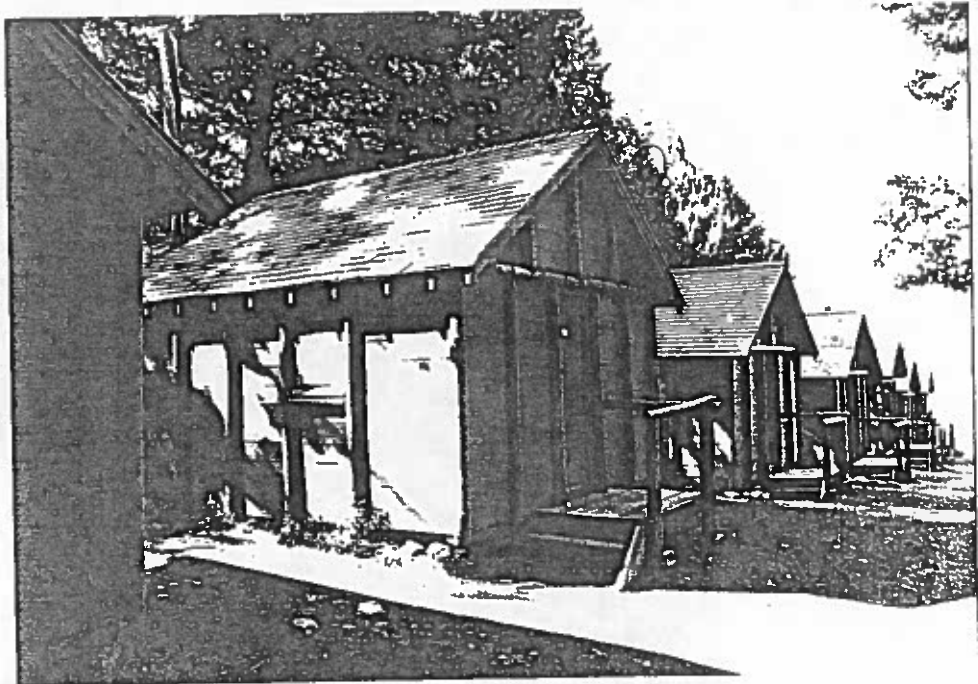
Figure 43: Formal line of log-out cabins on the north side of the site. Most of the grasses are gone from this area due to automobiles and pedestrians walking across this area.

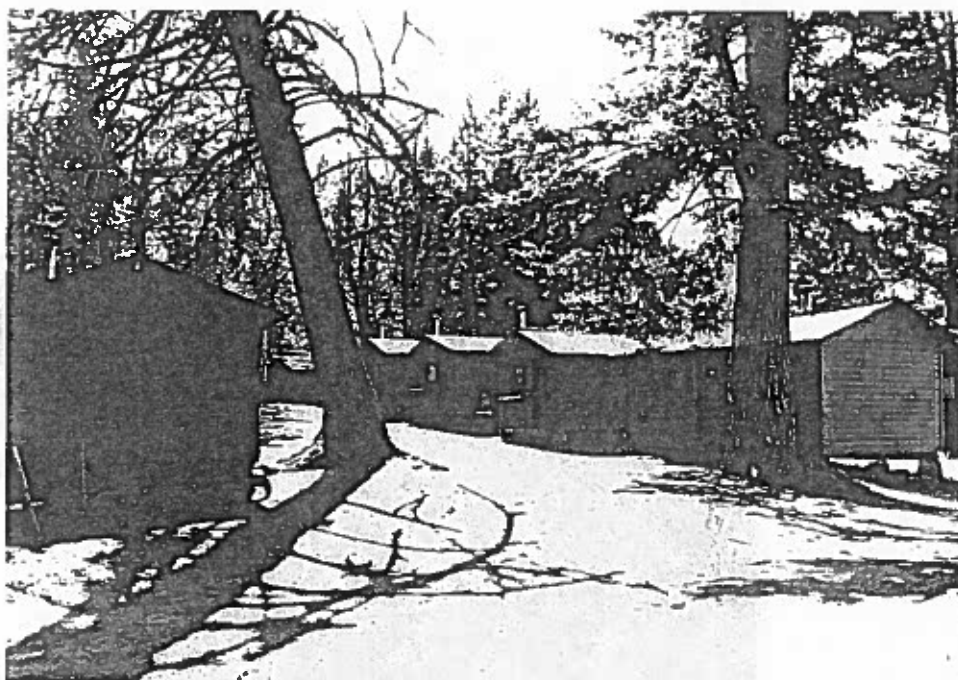
Figure 44: Looking west at the guest cabin area on the west side of the site. This is the first row of cabins you see as you come into this area. The large tree on the left is dying and leaning towards the cabin. There are many dead branches on the lower part of the tree.

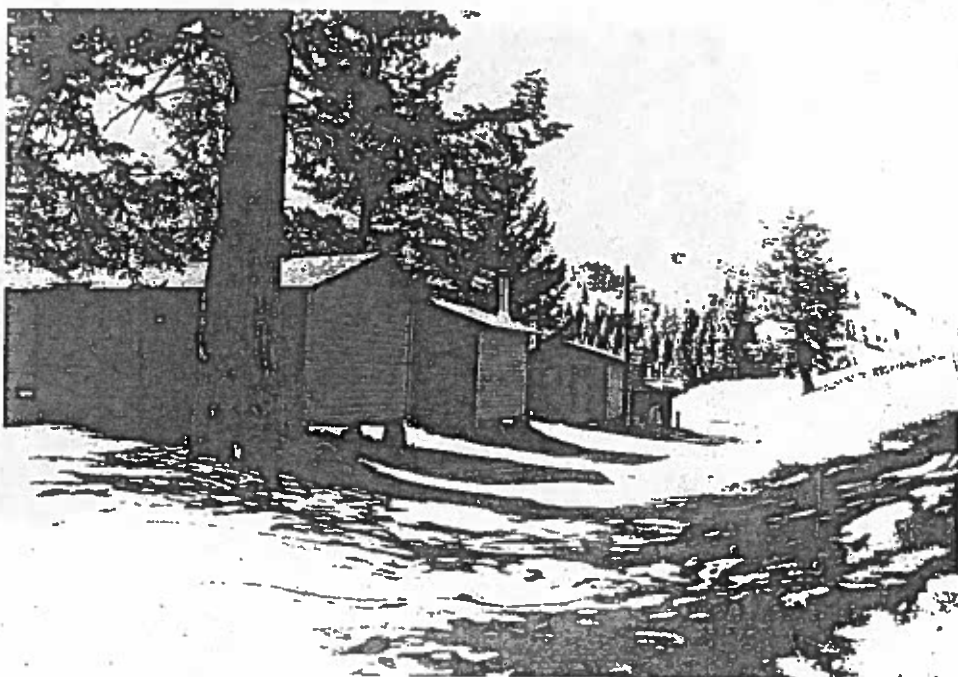
Figure 45: Looking northwest at the guest cabins on the west side of the site. This is the only roadway into the site of the 80 cabins. There is no other vehicular exit from the area.

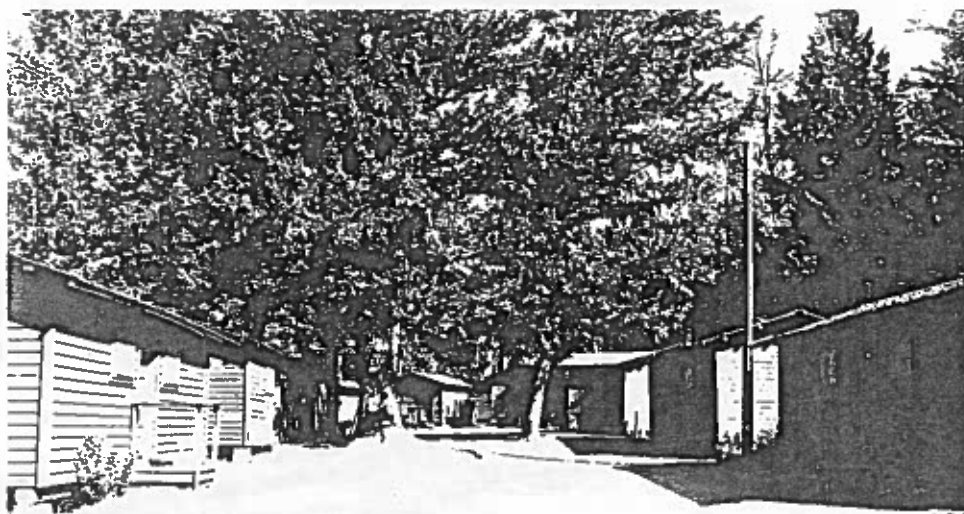
Figure 47: Looking east through the center of a row of guest cabins on the west side. The area between the cabins has become one big roadway.

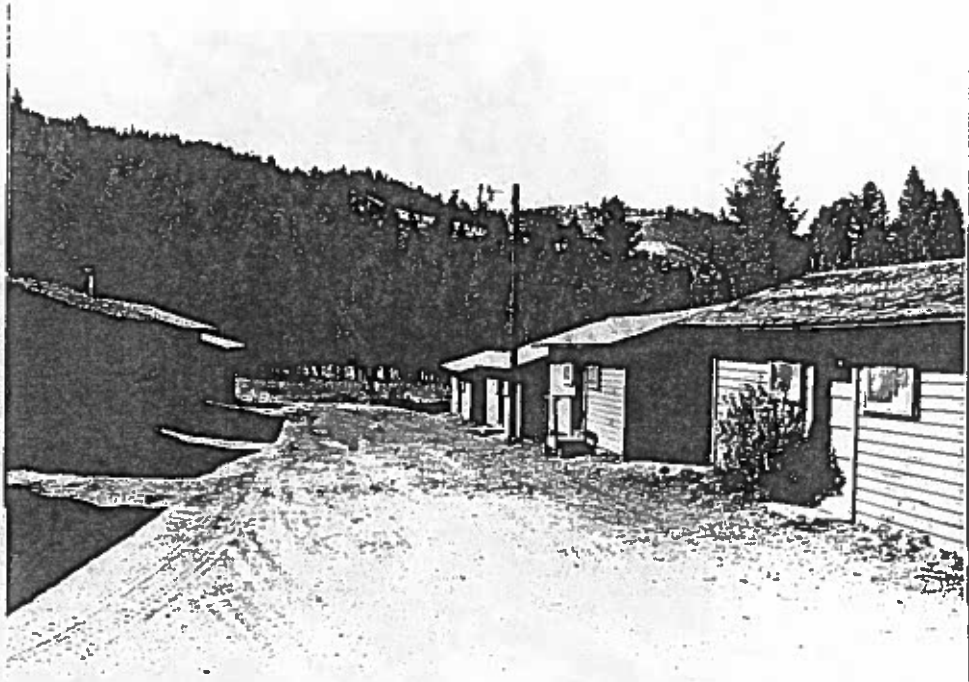
Figure 48: Looking west along a row of cabins on the west side of the site. Lost Creek runs along the end of the row of cabins. Note the large yard light that is not appropriate with the cabins.

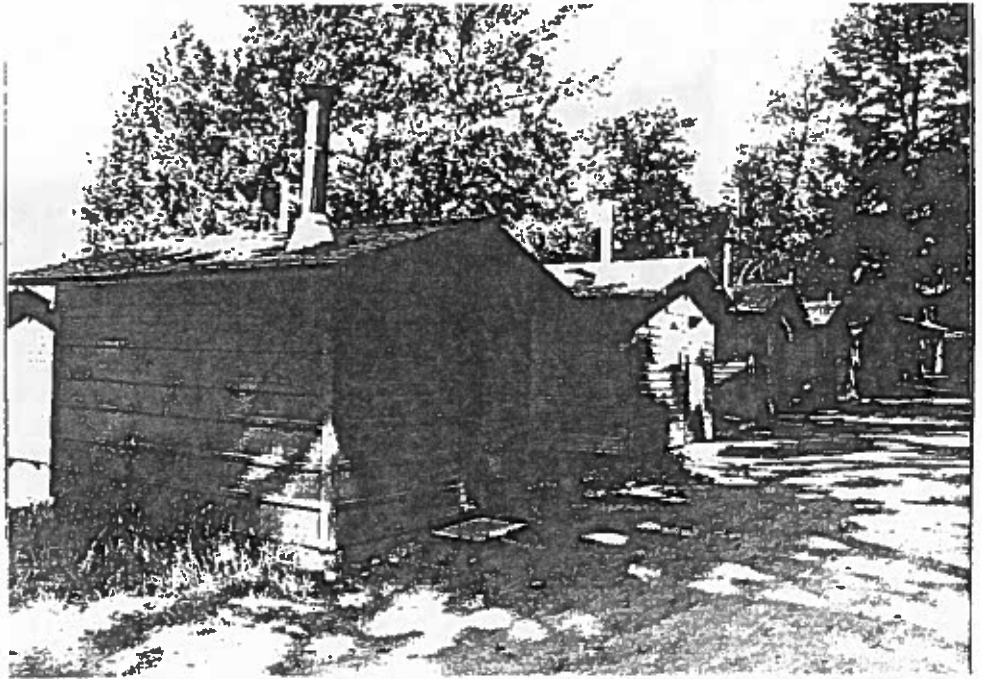
Figure 50: Looking east at a group of guest cabins on the west side of the site. The area around some of the cabins is not graded properly to keep water away from the wood bases.

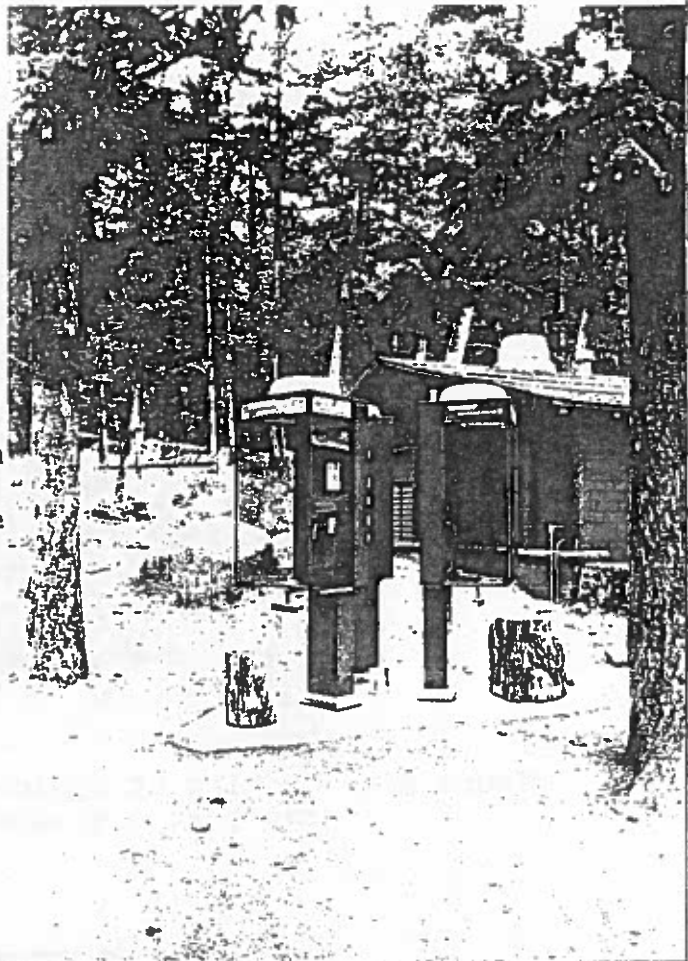
Figure 54: Looking at typical phone booths located on the site. These are not compatible with the site, especially at night when the tops light up.

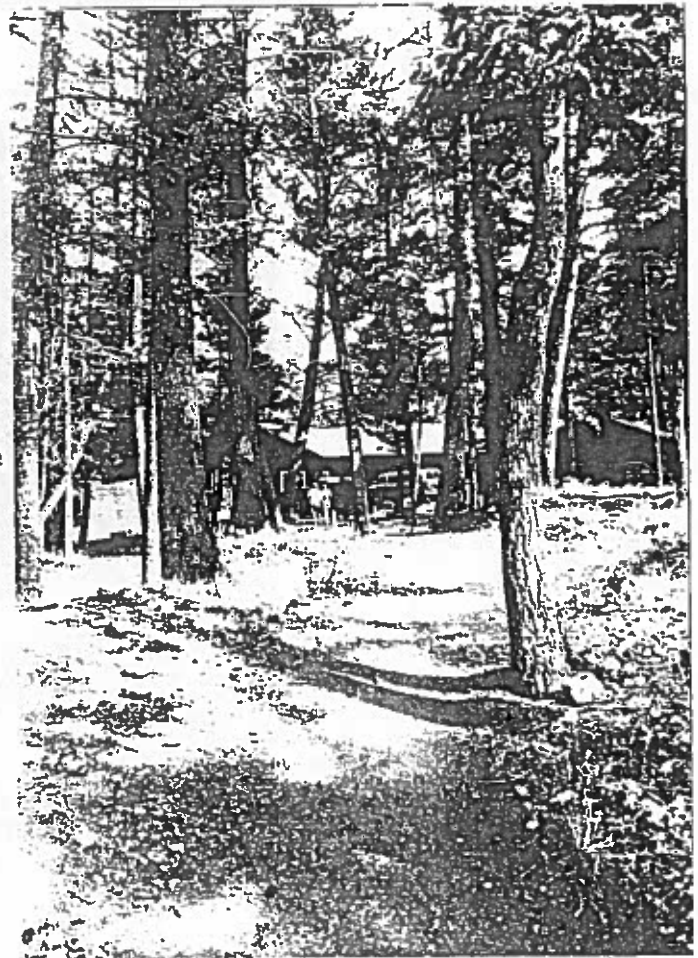
Figure 57: Looking east at the trail from the guest cabins on the west side of the site and the Lodge. Most of the trails are smooth and directional, however there are some areas that have not been maintained.

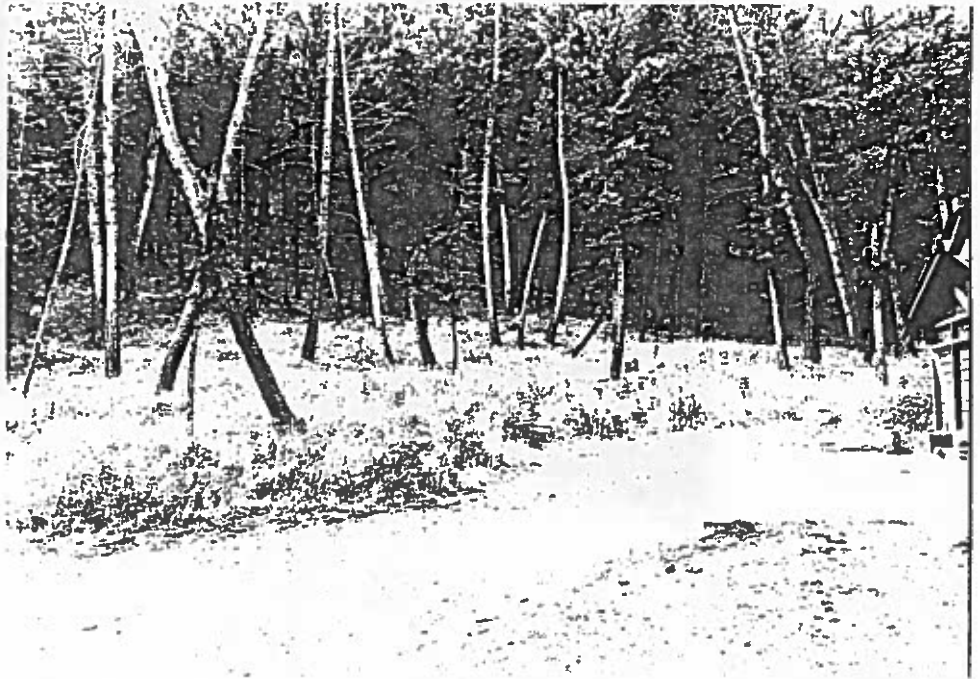
Figure 58: Looking south at an area behind the guest cabins on the east near the laundry. There are a lot of dead and leaning trees in this area.

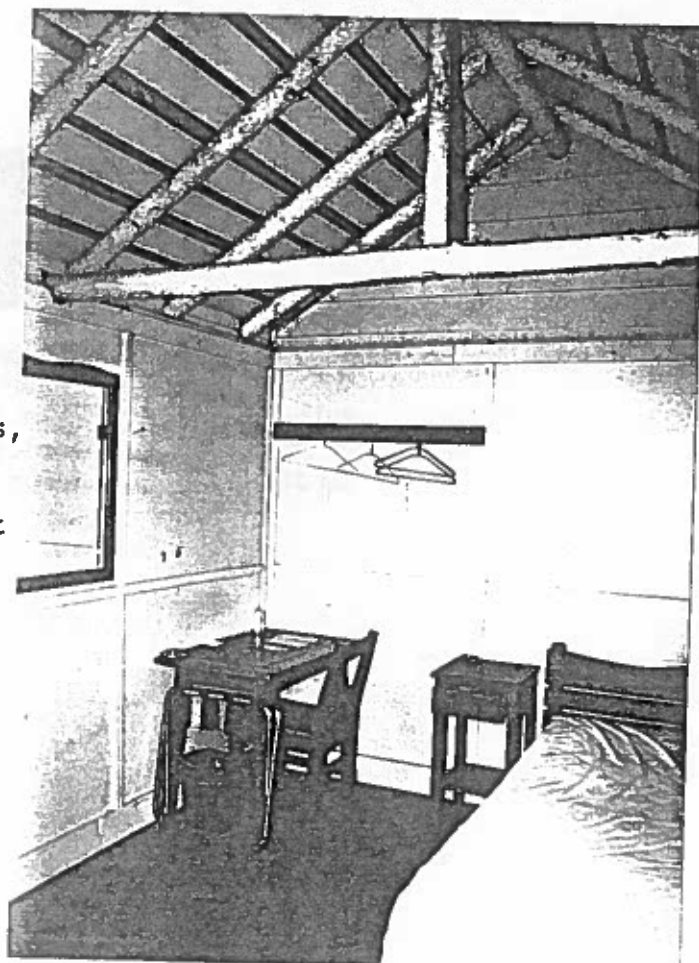
Figure 73: Looking west at the interior of cabin 4. Note the celotex materials on the walls, and the spray painted surfaces throughout. These materials do not retain the historical character of the cabins.

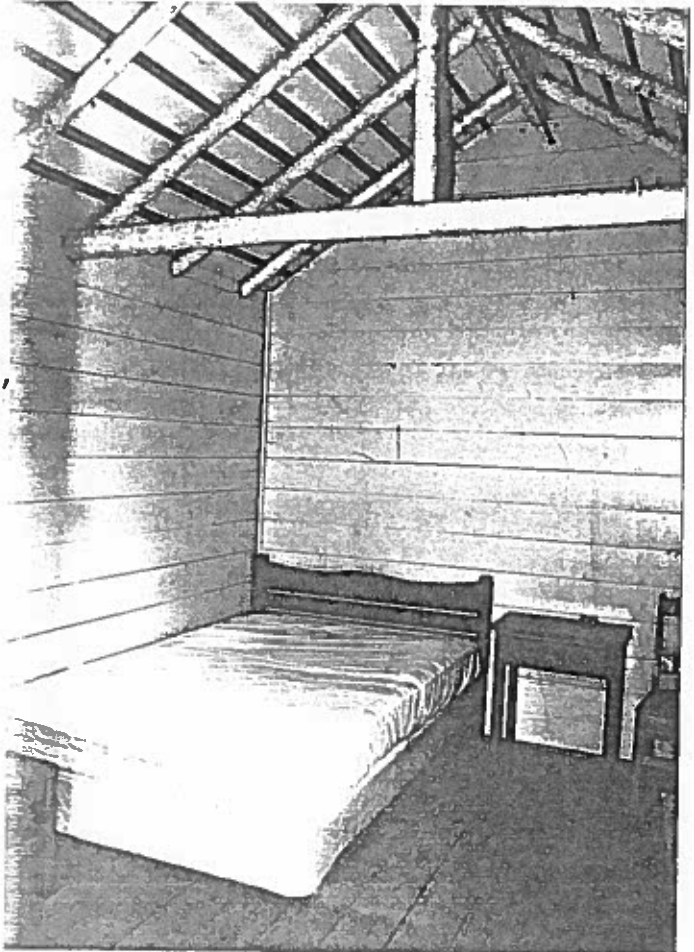
Figure 78: Looking southwest at the interior of cabin 10. Note the spray painted walls, ceiling, and log structure.

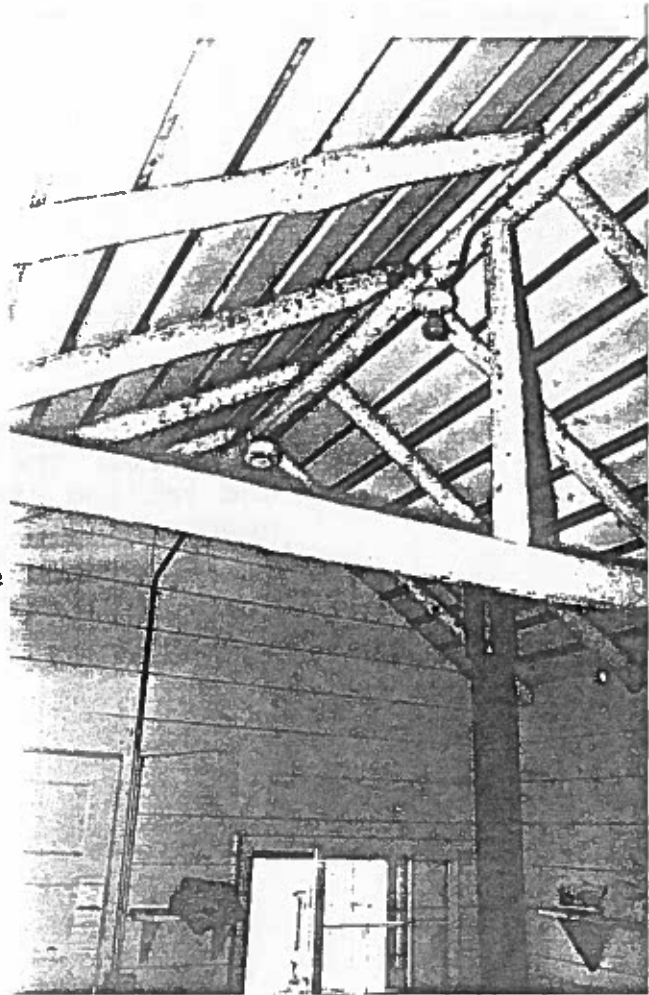
Figure 79: Looking southeast at the ceiling of cabin 10. Note the electrical conduit run across the surface, the smoke detection, and bare bulb light fixture.

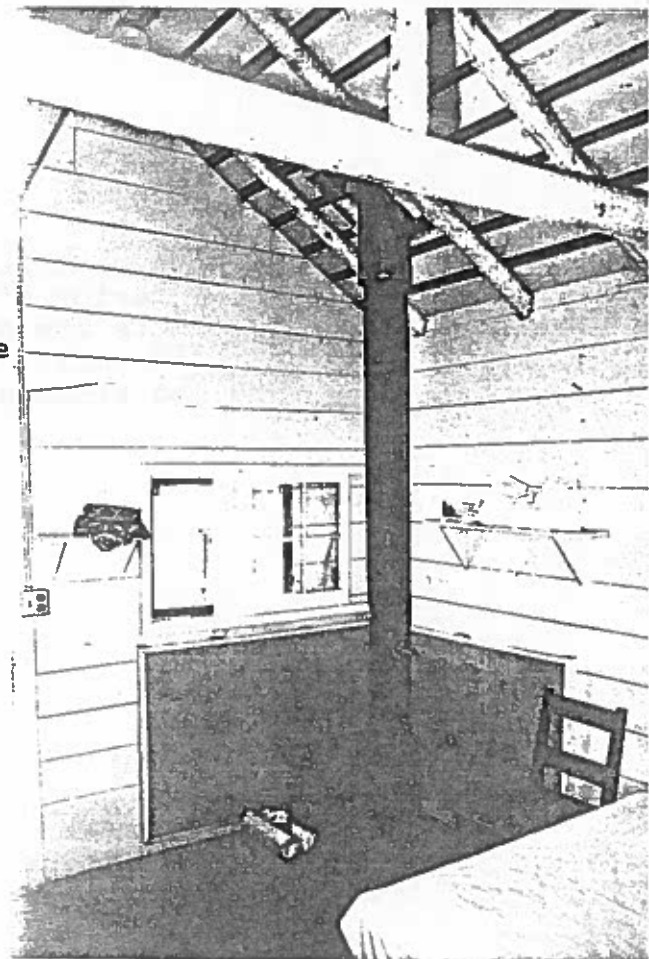
Figure 80: Looking southeast at the interior of cabin 10. Note the woodstove with the asbestos surround.

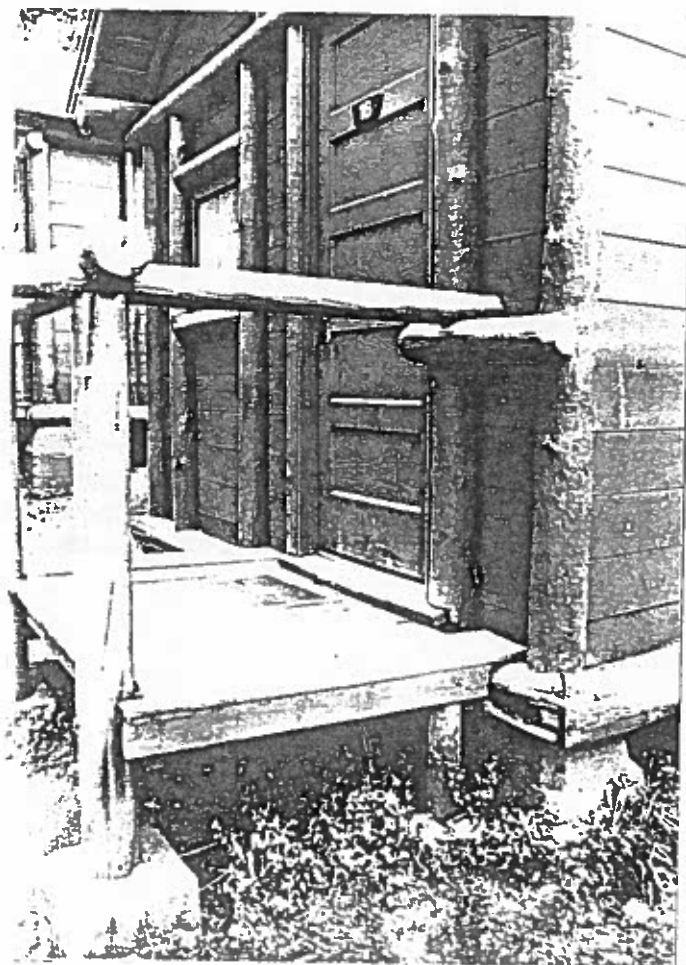
Figure 83: Looking southwest at the base detail on cabin 16. Note the poor condition of the stoop and the rotted sill log.

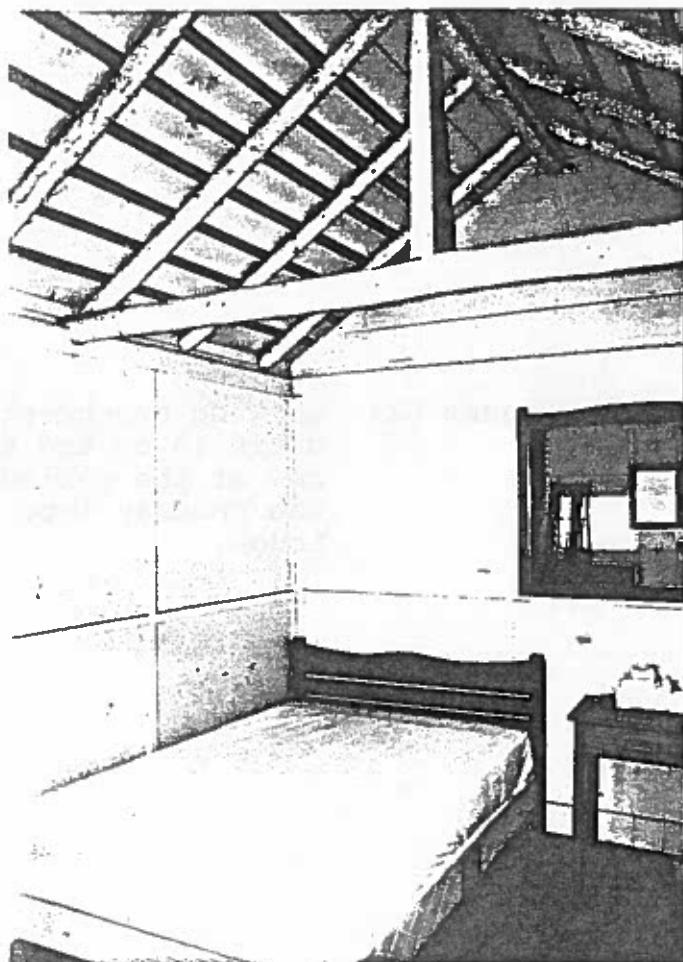
Figure 84: Looking southwest at the interior of cabin 16. Note the celotex wall finish and white interior.
