# ROOSEVELT LODGE HISTORIC STRUCTURES REPORT

**ROOSEVELT LODGE  
YELLOWSTONE NATIONAL PARK  
HISTORIC STRUCTURES REPORT**

**DECEMBER 1993**

**JAMES R. MCDONALD ARCHITECTS  
224 NORTH HIGGINS AVENUE  
P.O. BOX 8163  
MISSOULA, MONTANA 59807**

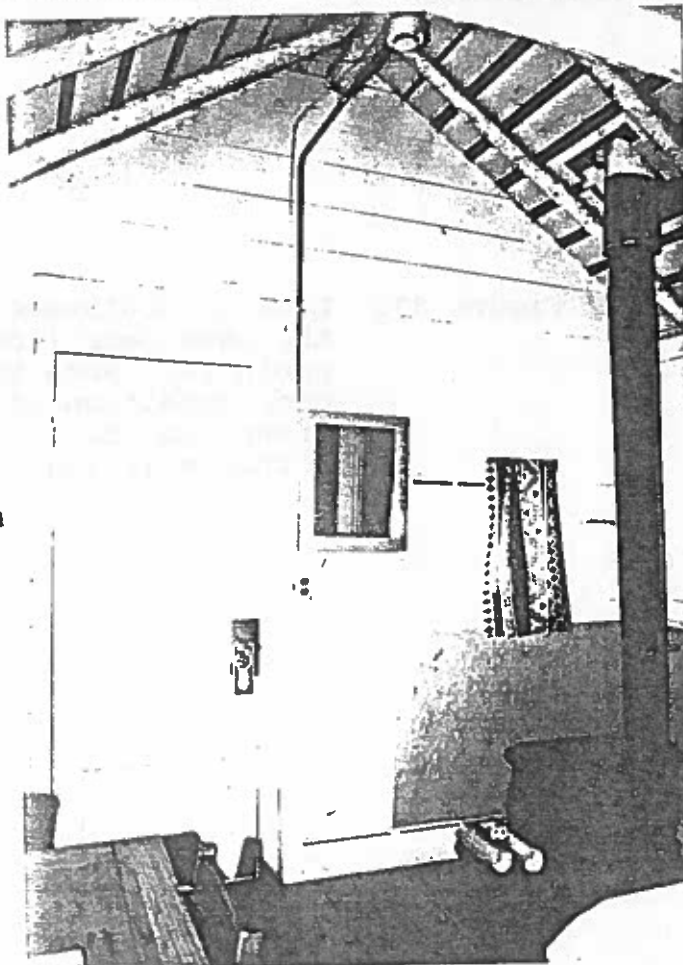
Figure 85: Looking southeast at the interior of cabin 16. Note the electrical conduit run down the walls.

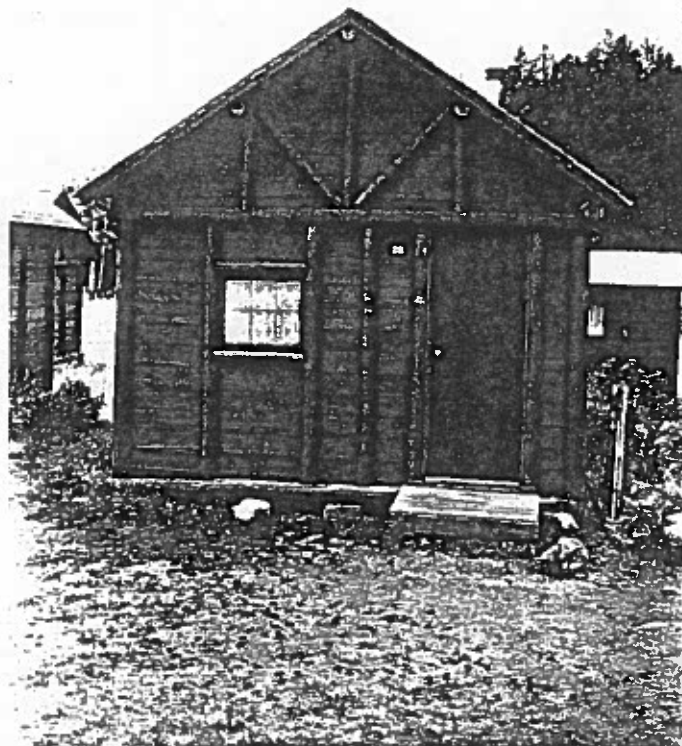
Figure 86: Looking east at cabin 29 a similar "log-out" cabin. The wood flush door is not appropriate.

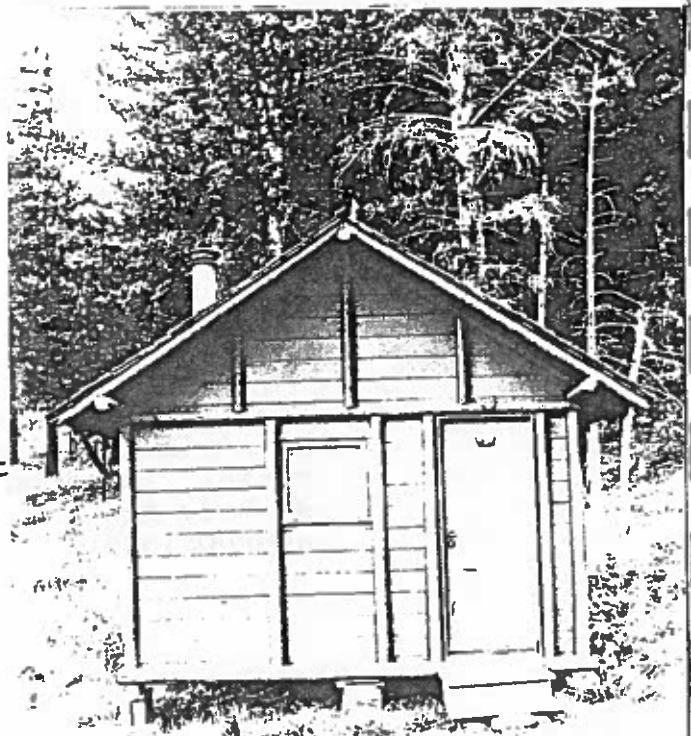
Figure 88: Looking east at cabin E7. Note the different types of blocking for the piers. The stoop is deteriorated; the flush door is not appropriate.

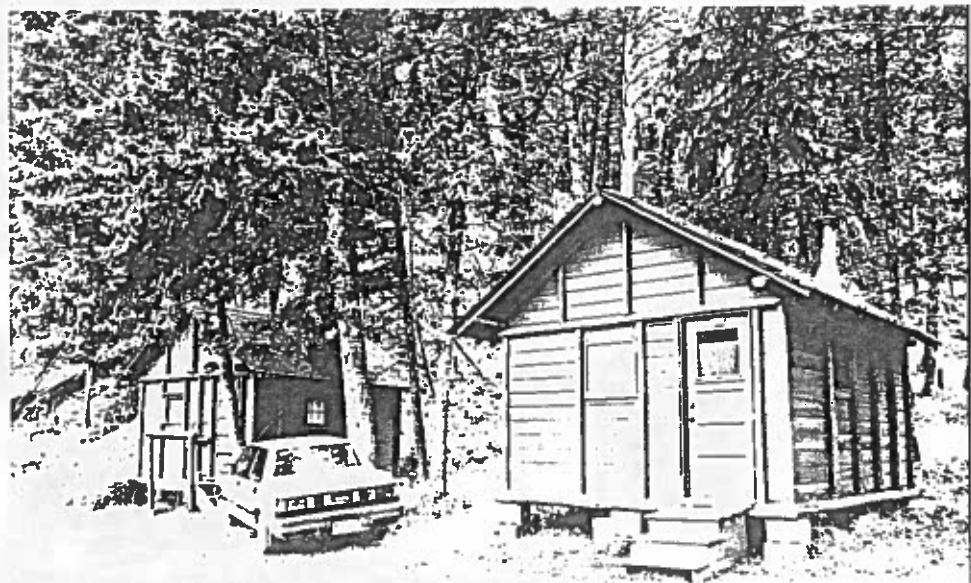
Figure 89: Looking south at "log-out" cabins E10 and E11. Both of the roofs will need replacement in a few years.

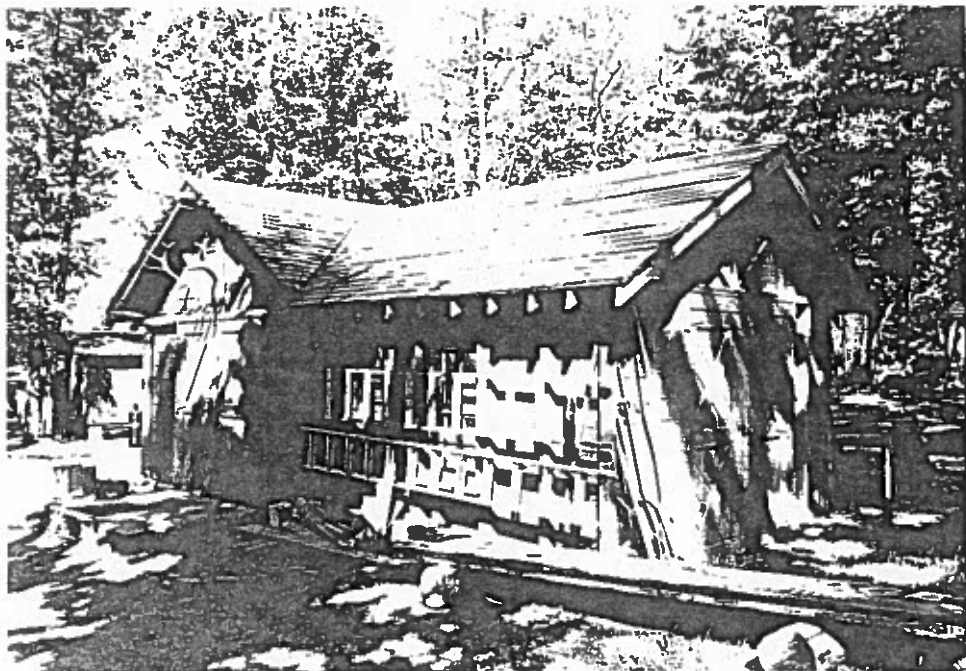
Figure 95: Looking northeast at the maintenance building. Note the clutter of materials and equipment on and around the building.

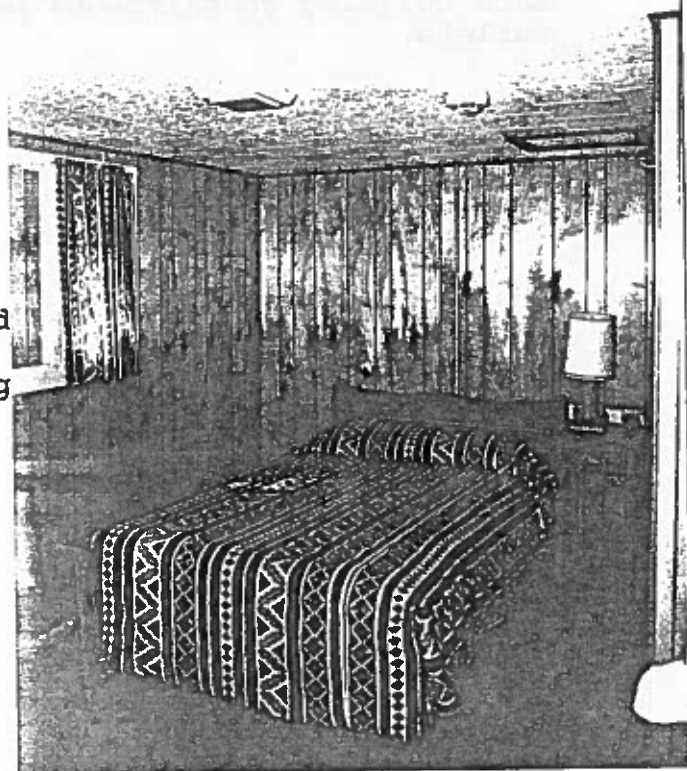
Figure 99: Looking northwest at the interior of cabin 22. Note the dark wood paneling and the acoustical tile ceiling which is not appropriate with the rustic or even western atmosphere of the Lodge.

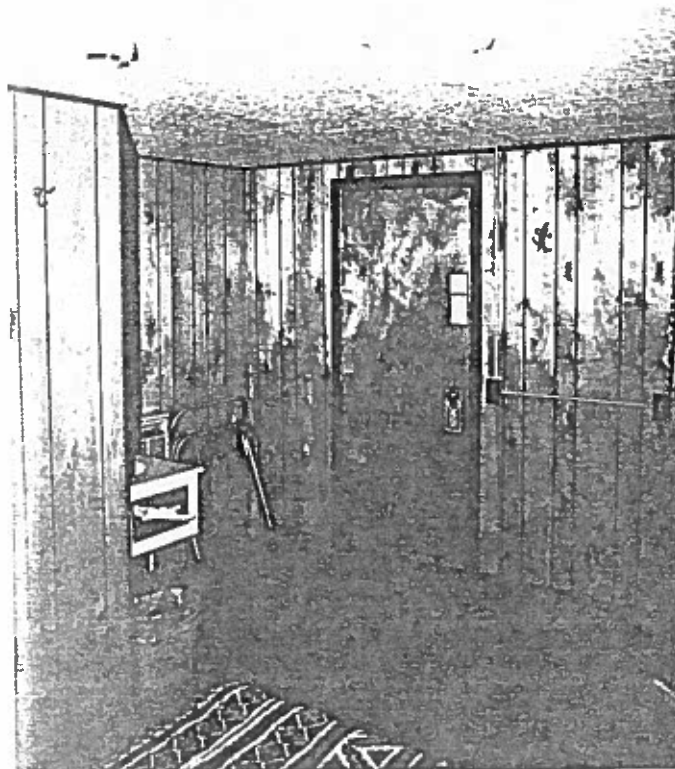
Figure 100: Looking southeast at the interior and the entrance of cabin 22. Note the lighting and darkness of the paneling.

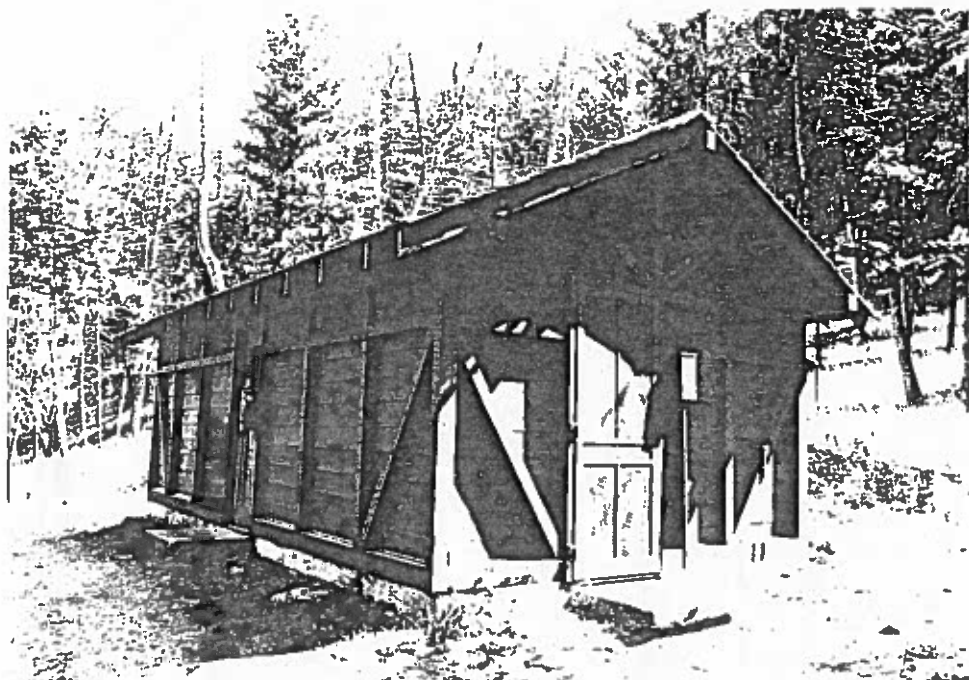
Figure 103: Looking southeast at the laundry/computer building. This building is in good condition. Note the electrical service next to the entrance to the computer room.

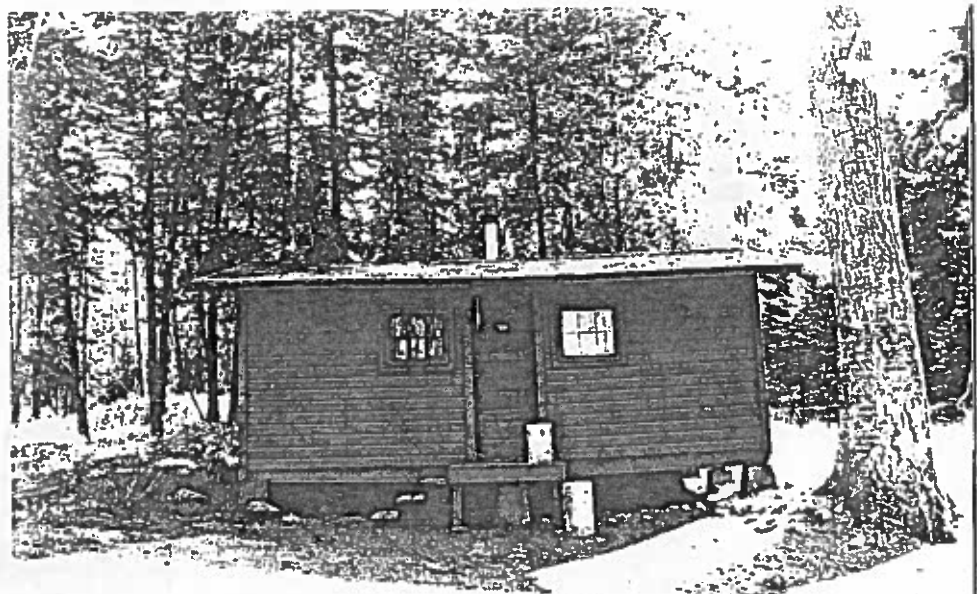
Figure 108: Looking south at cabin E23 an employee cabin in the west end near the maintenance area. This porch needs to have a railing because of its height. The other similar cabins have the same problem.

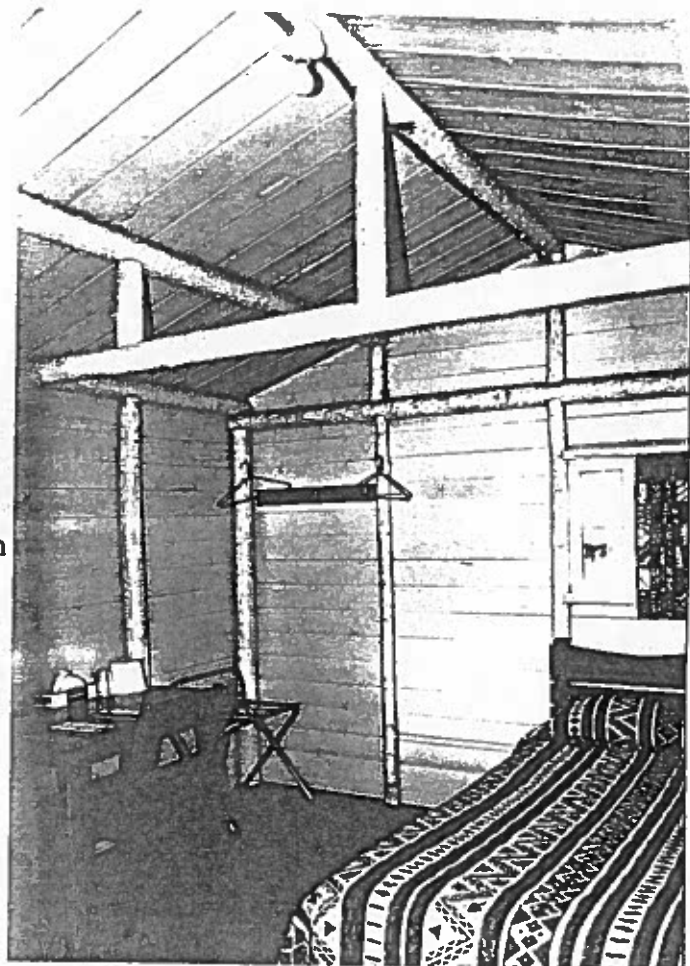
Figure 112: Looking southeast at the interior of cabin 61. Note the electrical conduit run along the logs and down the walls. The floors are carpeted.

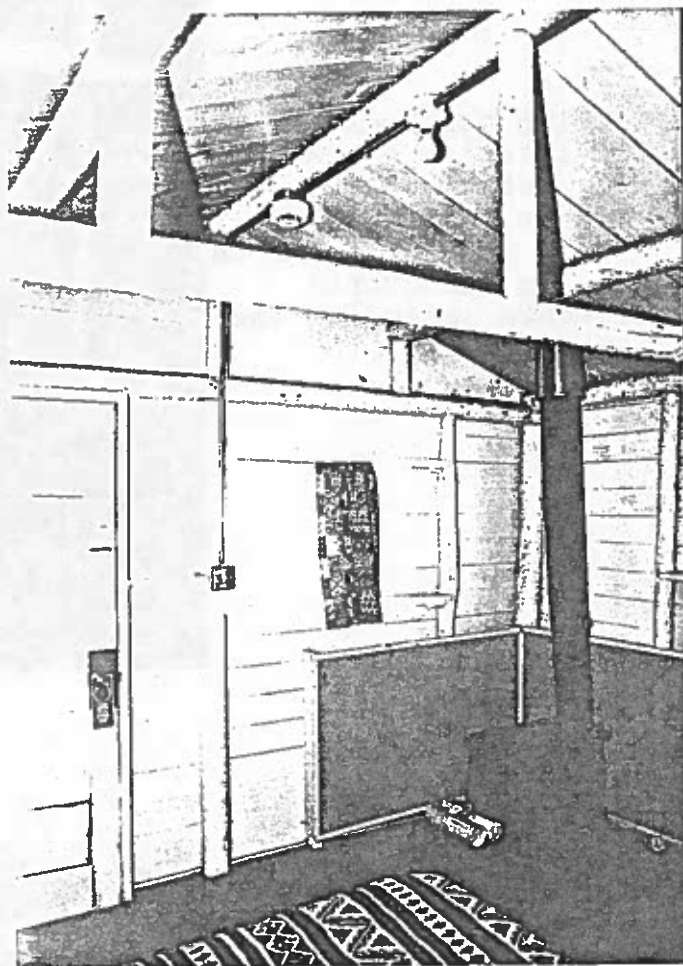
Figure 113: Looking south at the interior of cabin 61. Note the wood stove with the asbestos surround. Note the curtains. The door needs some work as there are some cracks on the inside.

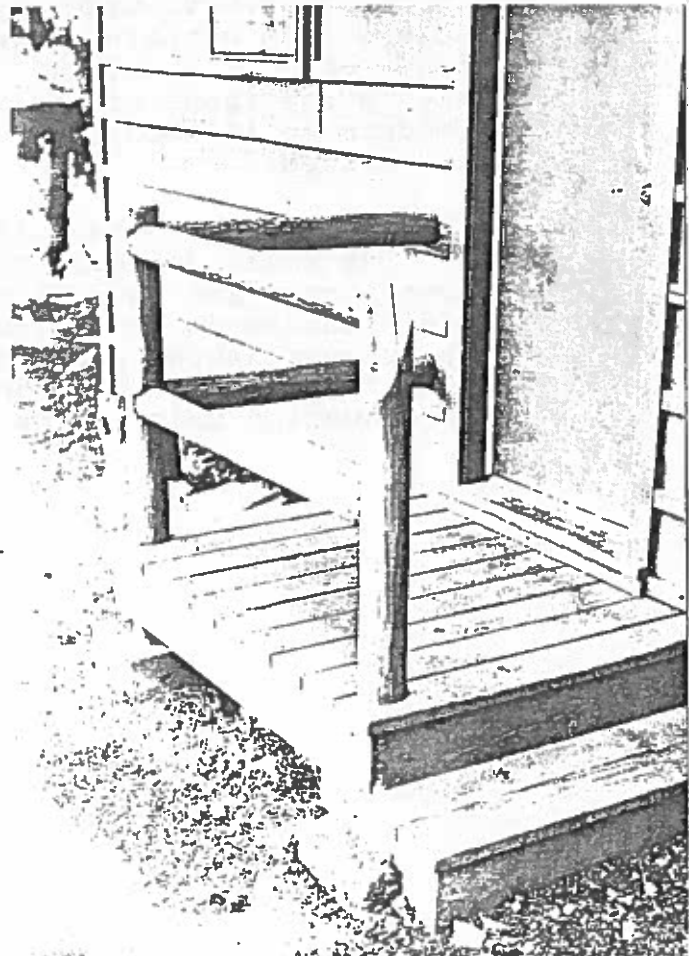
Figure 115: Looking at a typical handrail detail. This is a good model for all cabin stoops.

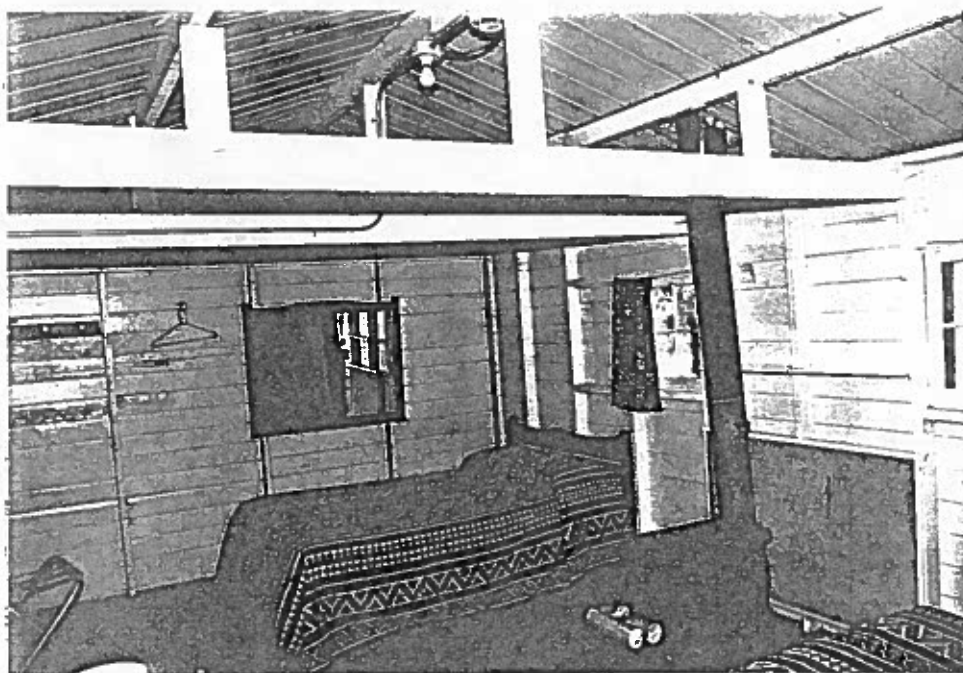
Figure 118: Looking south at the interior of cabin 79. Note the dimensional frame in the interior. Also, note the conduit run along the timber and up on the ceiling.

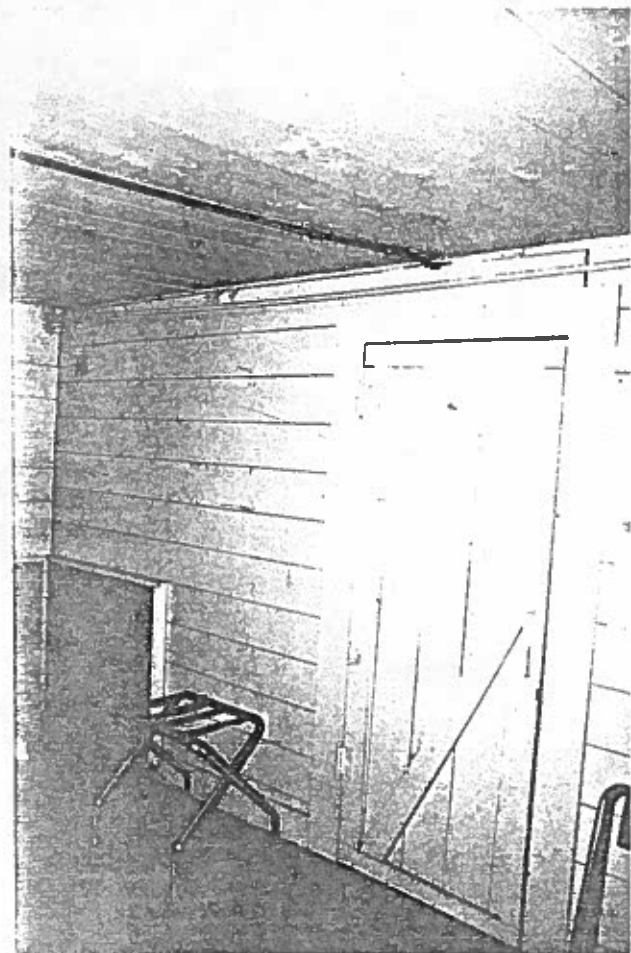
Figure 125: Looking north at the board and batten door on the interior between the two units. Note that everything is painted the sterile white color.

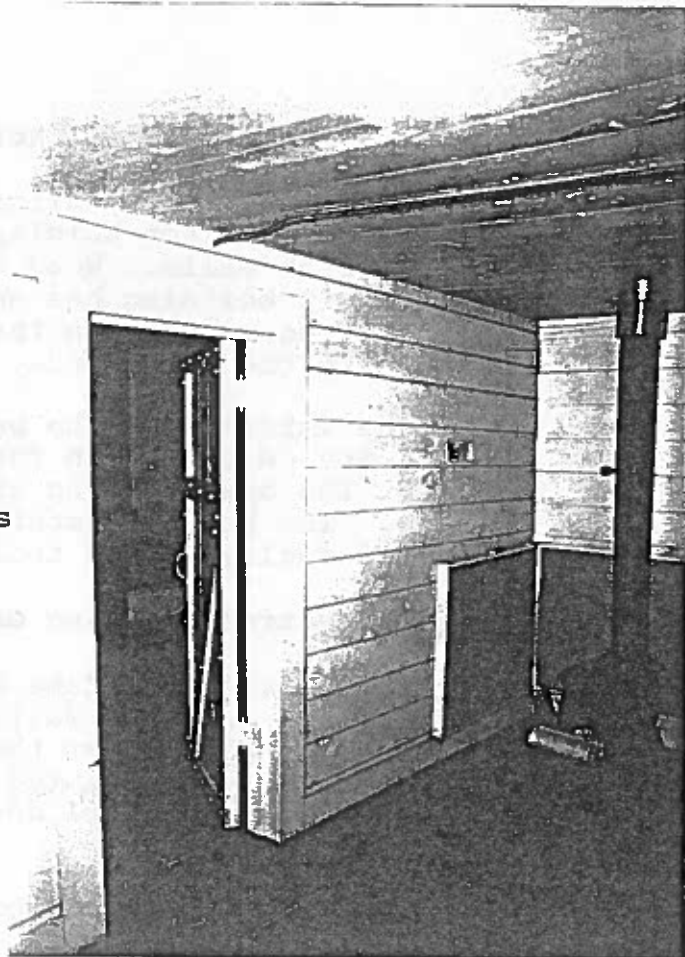
Figure 127: Looking northeast at the interior of cabin 5b. Note the problems with the exposed conduit all around the area. The ranch furniture fits in very well in these cabins.

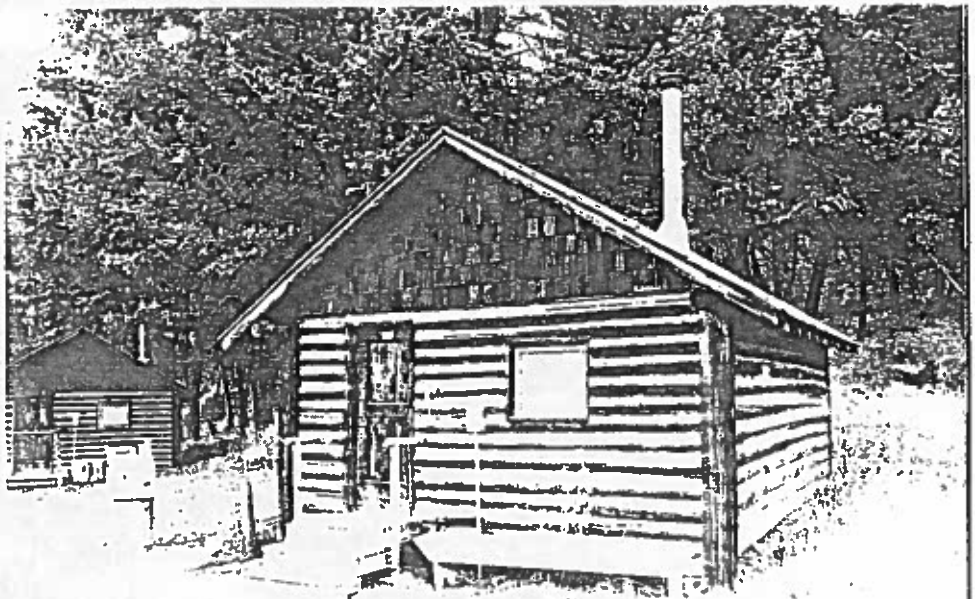
Figure 136: Looking south at cabin E5. Similar problems exist in this cabin as they do in all others. Note the electrical service that runs up the front of the cabin which is typical of all of the log cabins.

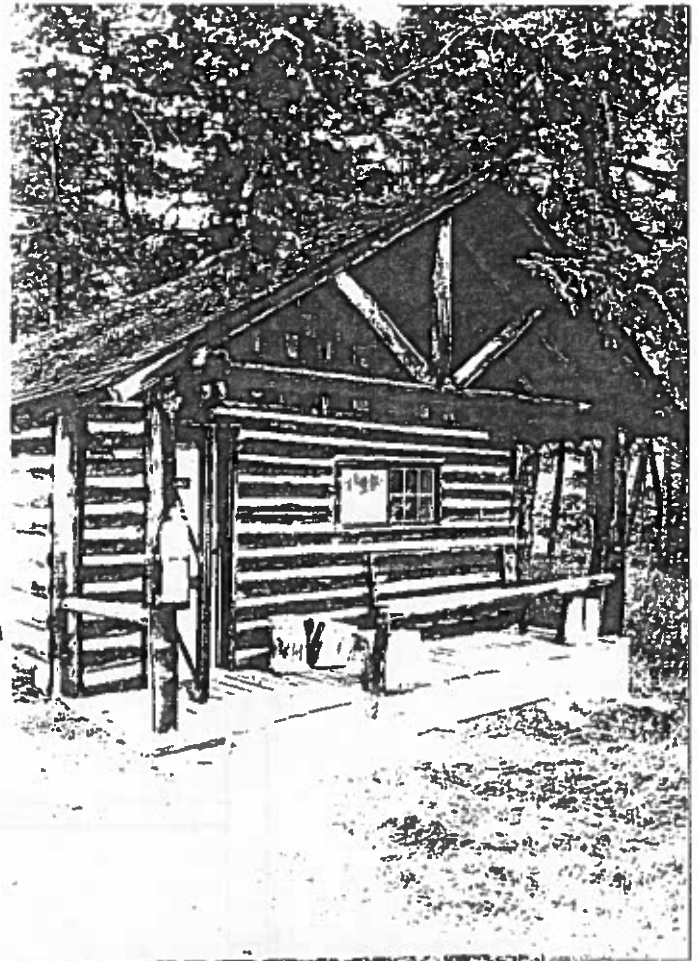
Figure 140: Looking west at the side of Miss North's cabin. Note the large tree leaning up against the roof of the cabin. There is another tree in the back pushing up against the ridge.

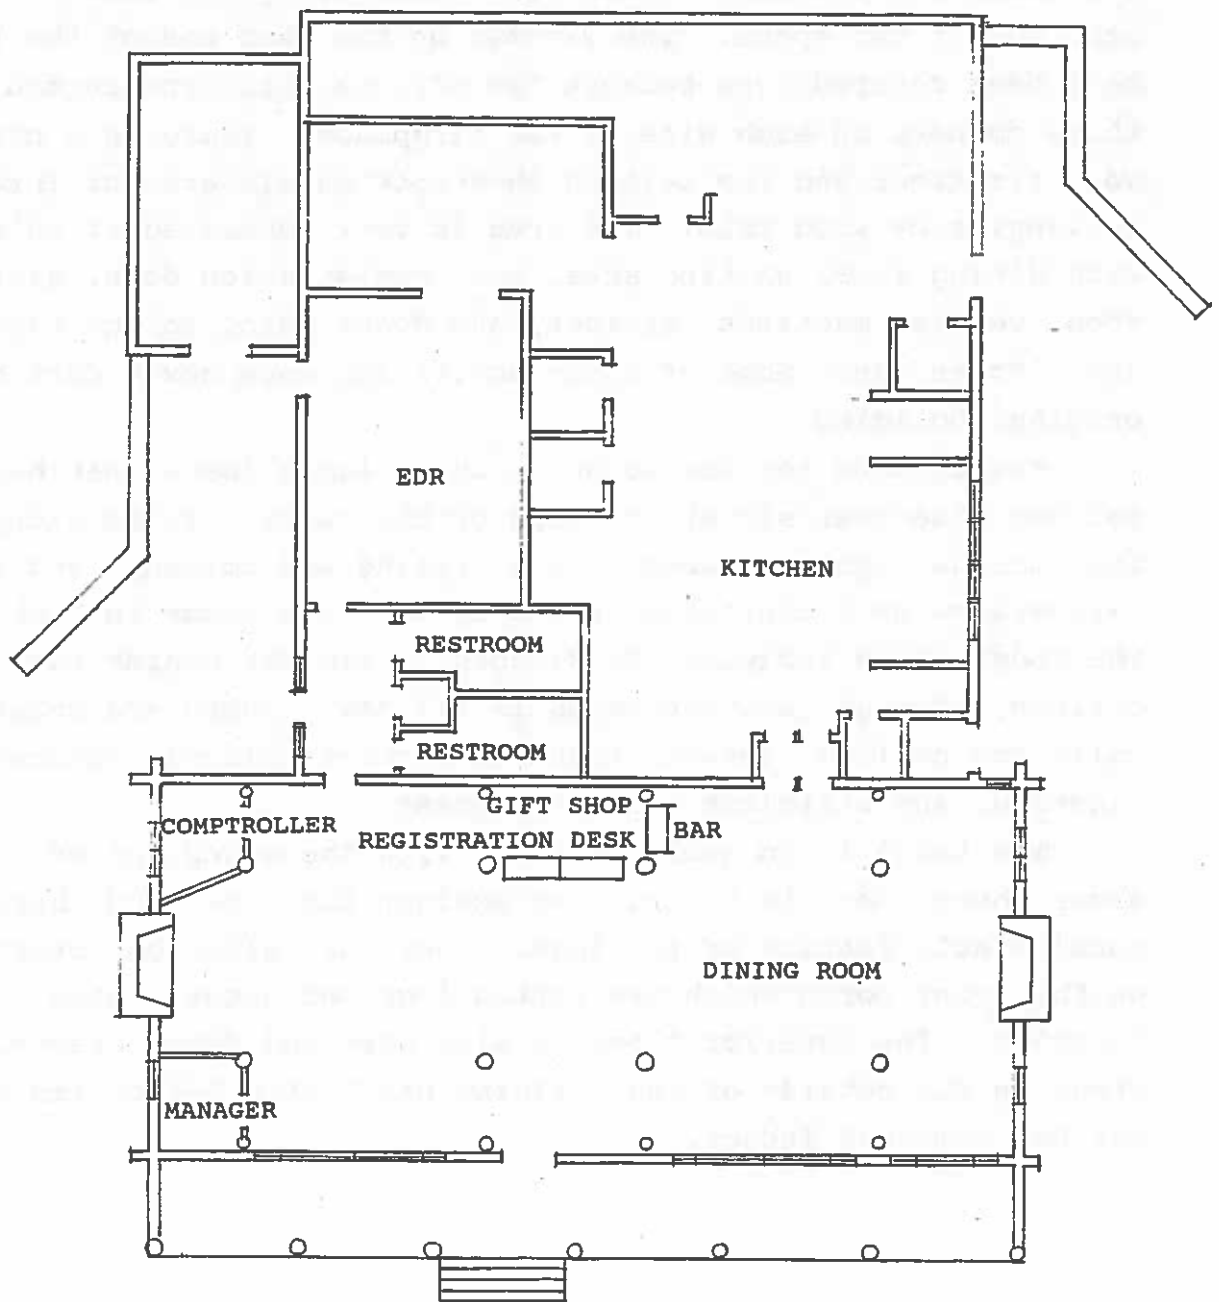
FIGURE 143

The Lodge is in good condition with the exception of the areas where there is concrete up against the logs, and therefore considerable rotting of the logs. There are also some problems on the front porch which has rotted logs and deteriorated flooring. The interior floor is also worn and deteriorated. The stone on the outside of the building has lost a lot of its mortar but has remained intact.

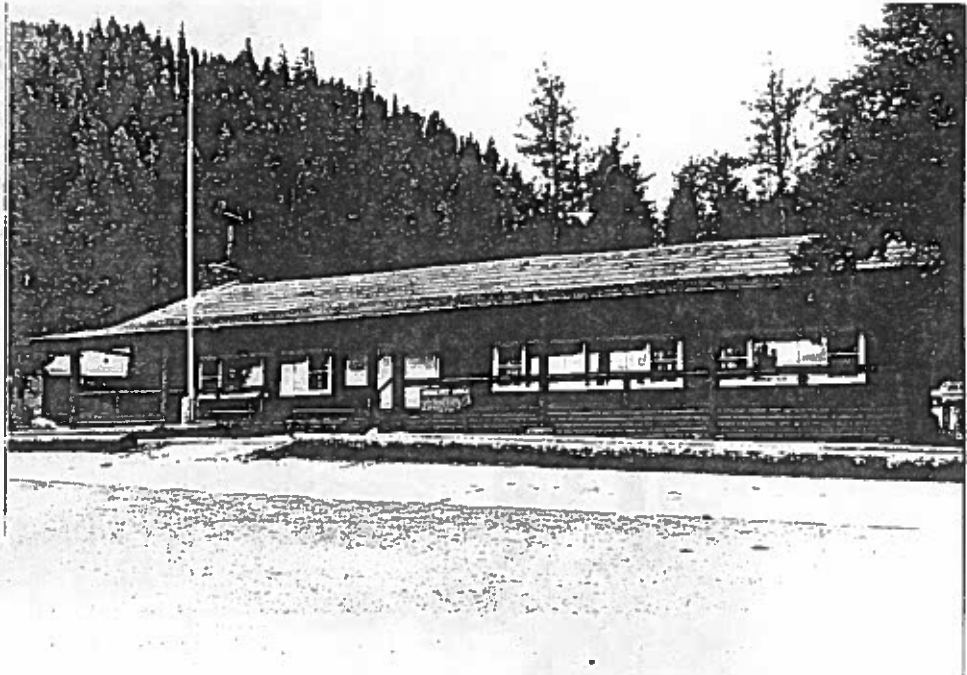
Figure 148: Looking south at the main Lodge building. The flagpole originally sat out further and to the east. The parking goes right up to the front bumper logs next to the walkway.

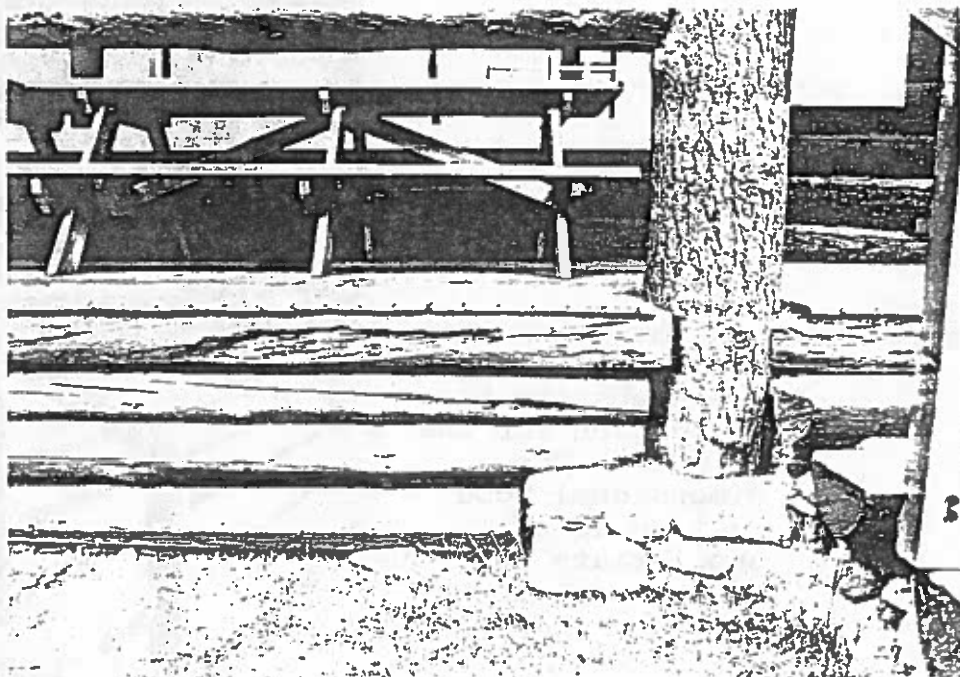
Figure 152: Looking southwest at a detail of the porch on the Lodge. Note the rotted logs as well as the rotted floor boards.

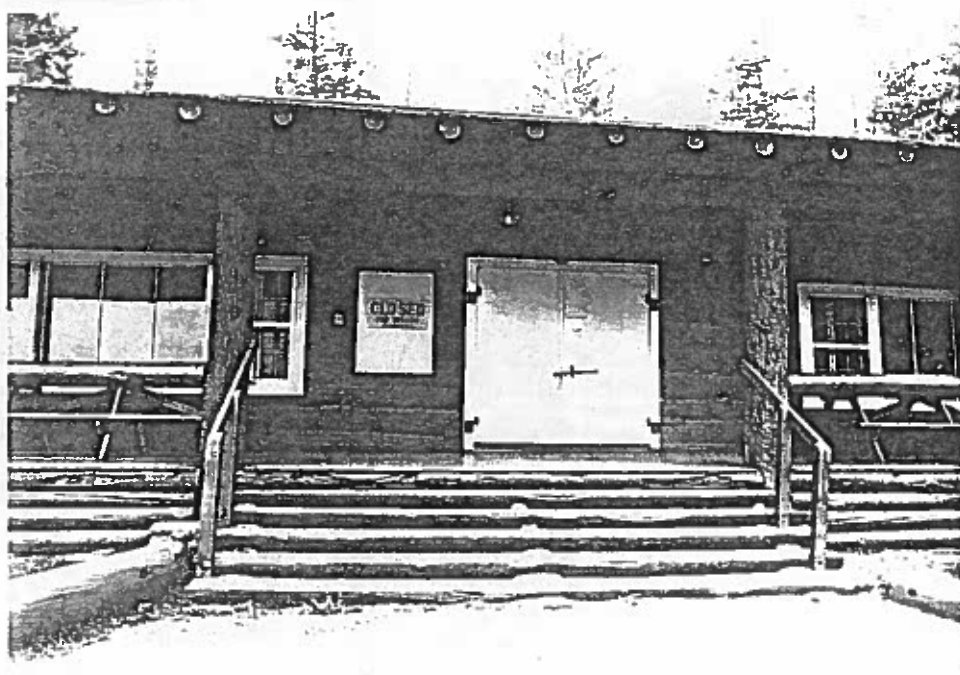
Figure 153: Looking southwest at the entrance steps to the Lodge. They appear to be in good condition.

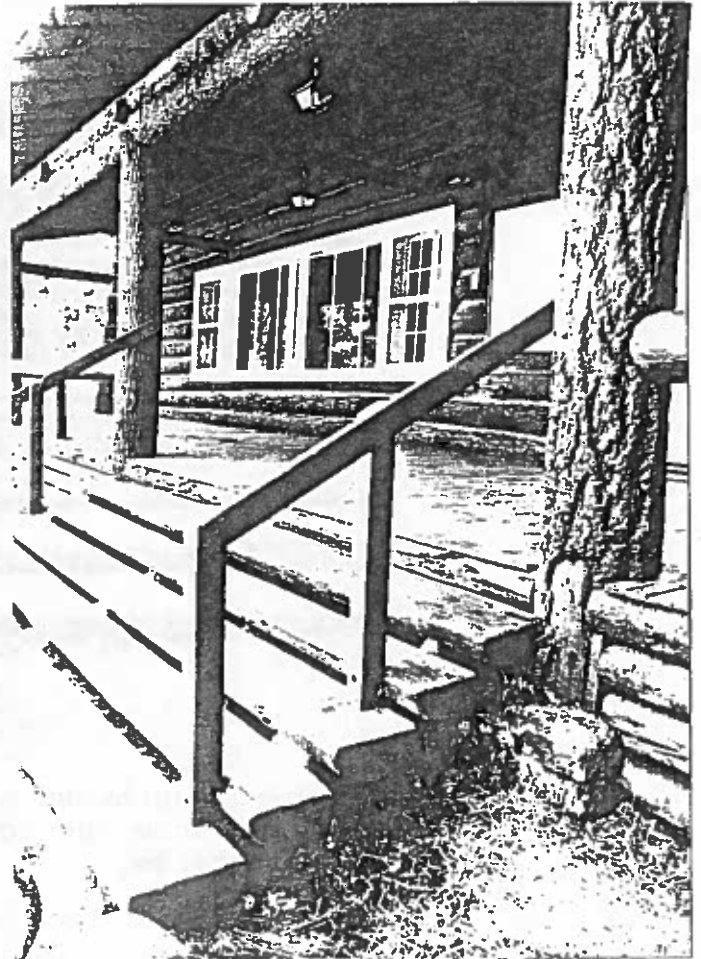
Figure 155: Looking west at the porch on the Lodge. The porch extended out to the east in the original construction.

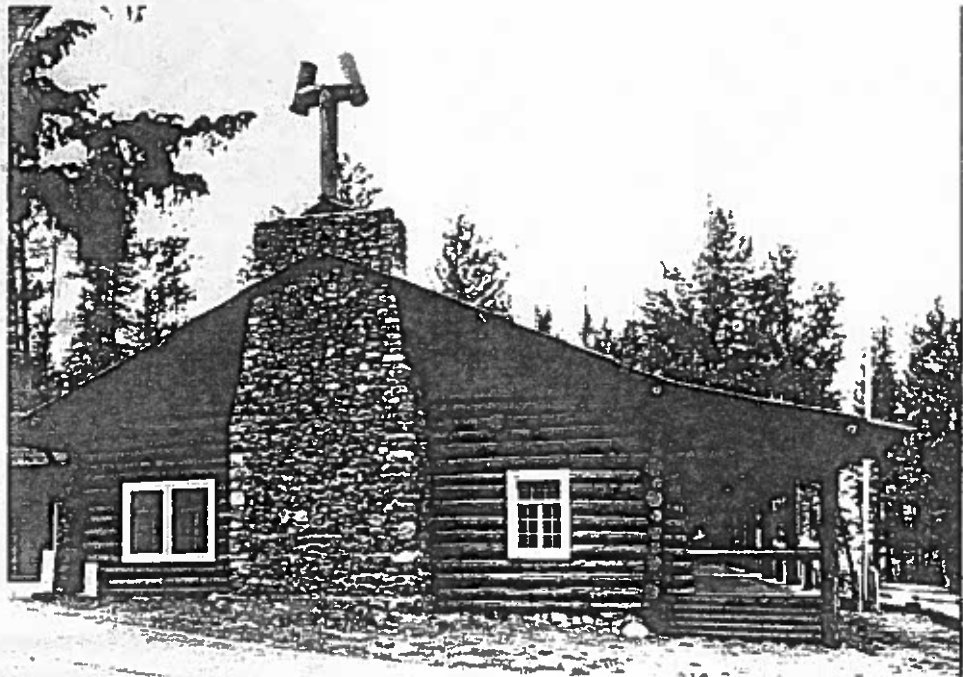
Figure 157: Looking at a typical window on the Lodge. It is in good condition. Note the loose rubble stone filled in between the piers.

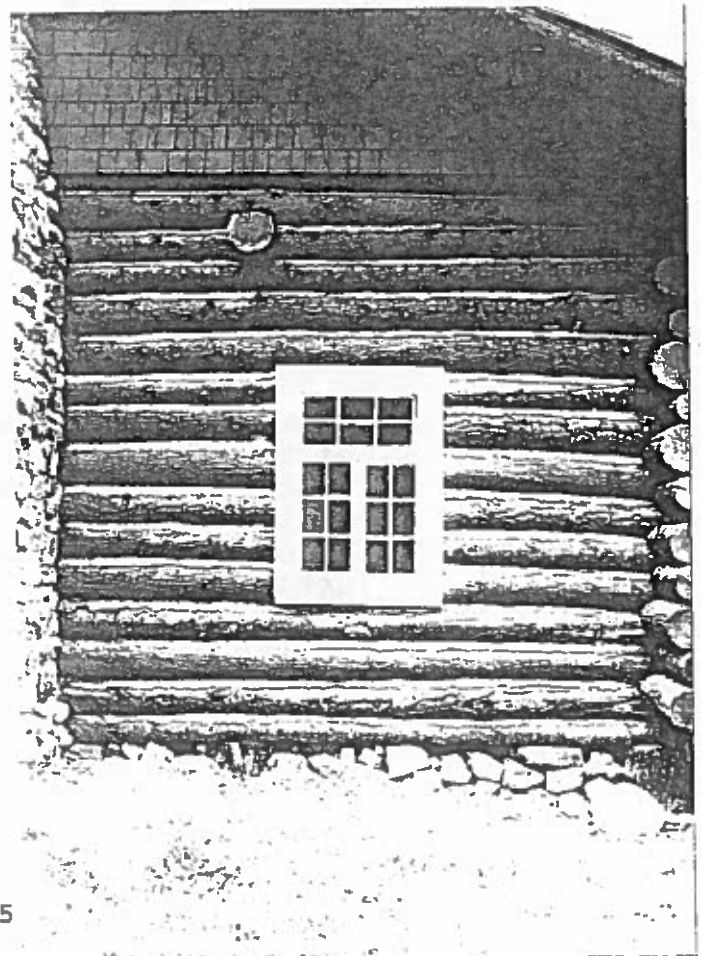
Figure 158: Looking at a typical double window on the Lodge. It is in good condition. Note the telephone box up against the building.

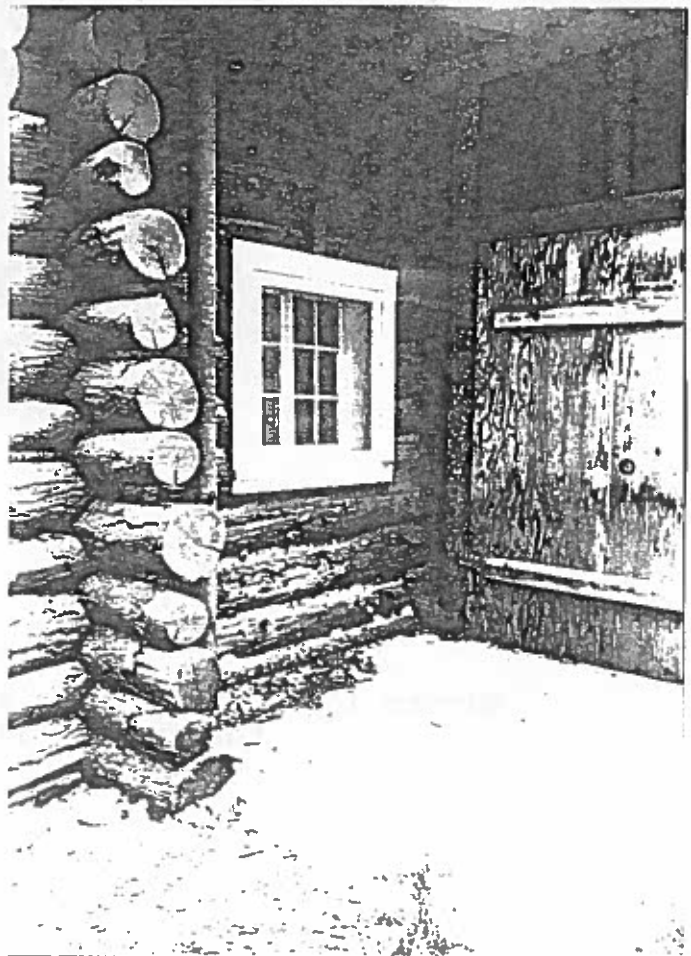
Figure 162: Looking at the west end of the porch. The corners are rotting at the base.

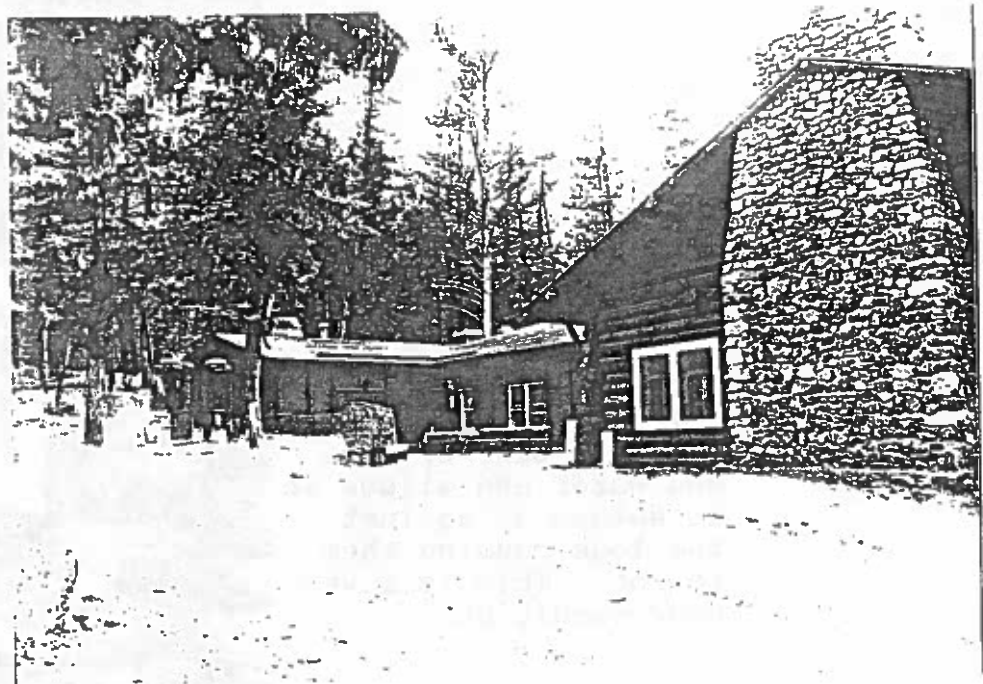
Figure 163: Looking west at the Lodge and the new addition. Note the compatibility of the new and the old.

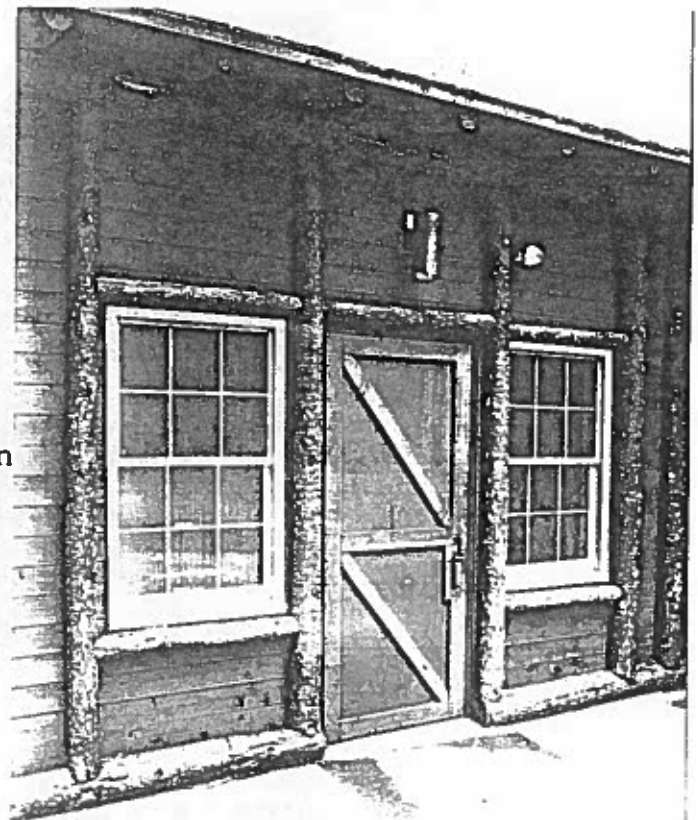
Figure 165: Looking northwest at an entrance door into the new addition to the Lodge. Note where the bark is coming off of the Lodge. The sill log is rotting.

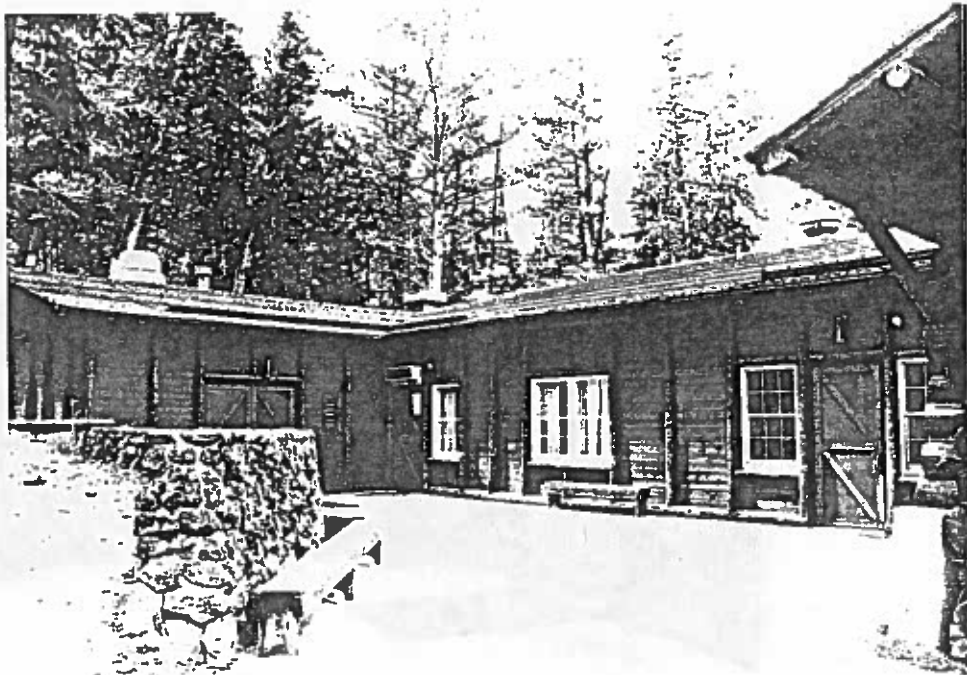
Figure 166: Looking west at the outdoor courtyard for the employees. The building is generally in good condition.

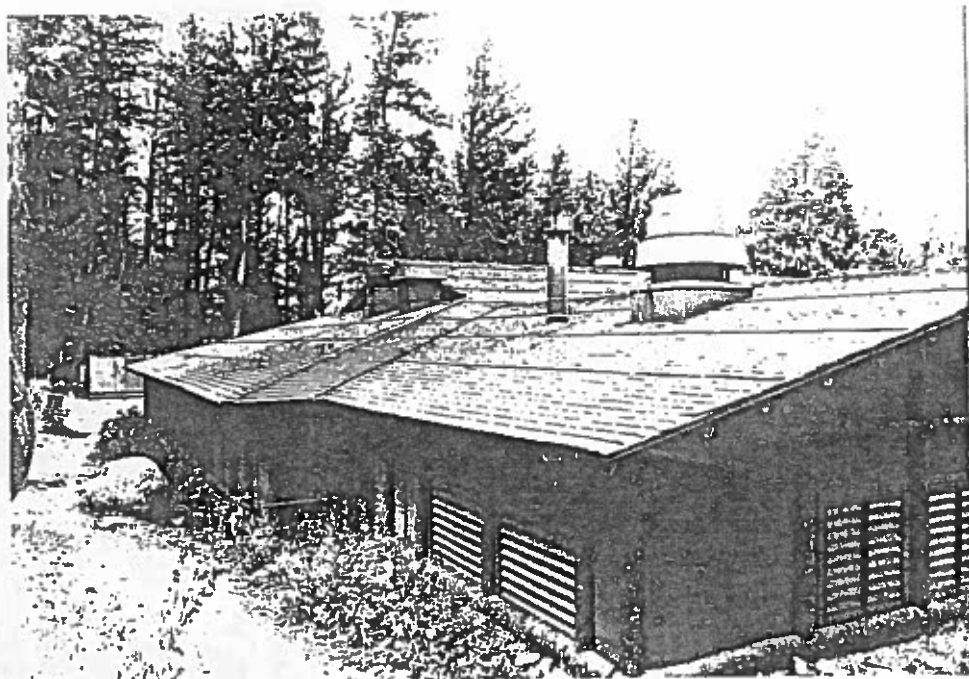
Figure 167: Looking north at the back end of the building and the roof. The roof is in good condition and the logs seem to be in good condition due to the fact that gravel was put around the base of the building to provide good drainage.

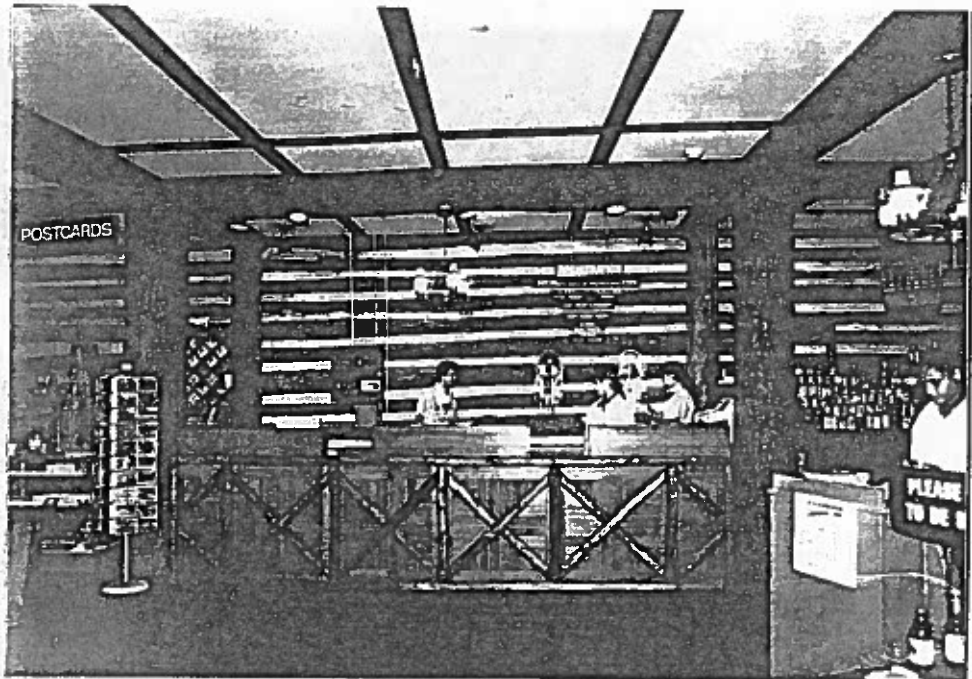
Figure 168: Looking at the main registration desk area on the interior of the Lodge. Note all of the various lighting fixtures and fire alarm panel on the back wall.

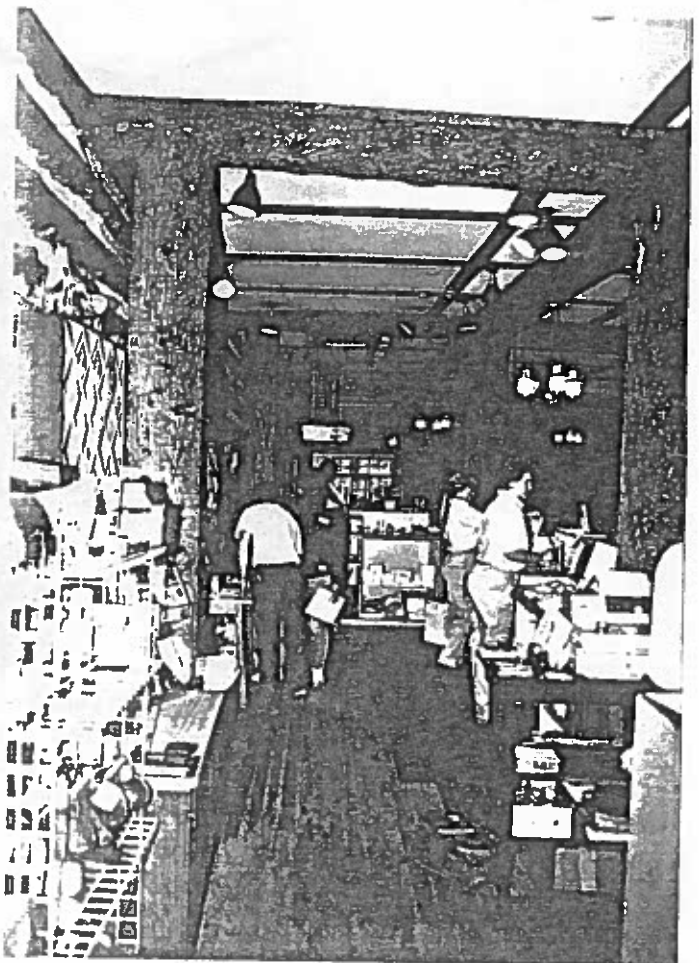
Figure 169: Looking from the gift shop into the registration area. Note the condition of the fir floor.

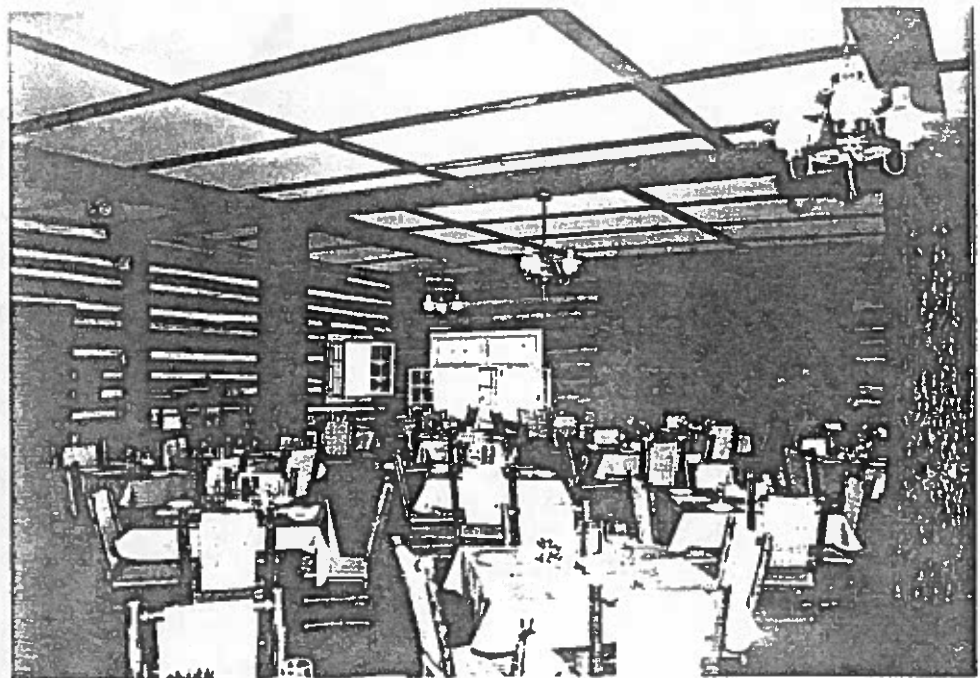
Figure 171: Looking across the dining room from the main entrance to the Lodge. Note the light fixtures and the forced air furnace in the corner. The old hickory furniture, even though not the original, is appropriate for the area.

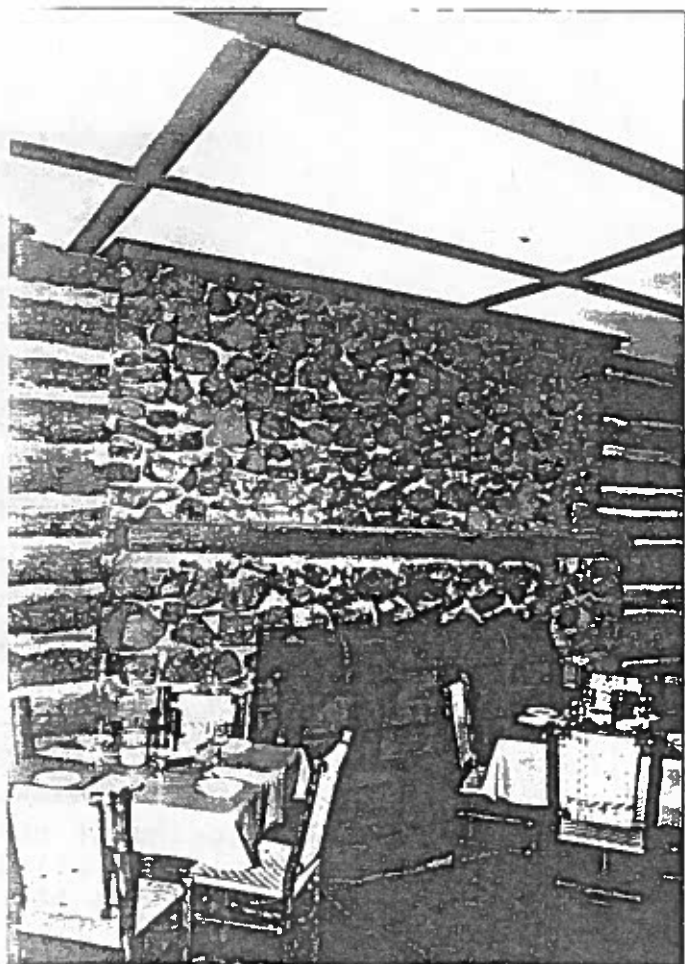
Figure 172: Fireplace on the dining room end of the Lodge. It is not usable because it does not draw properly.
