# ROOSEVELT LODGE HISTORIC STRUCTURES REPORT

**ROOSEVELT LODGE  
YELLOWSTONE NATIONAL PARK  
HISTORIC STRUCTURES REPORT**

**DECEMBER 1993**

**JAMES R. MCDONALD ARCHITECTS  
224 NORTH HIGGINS AVENUE  
P.O. BOX 8163  
MISSOULA, MONTANA 59807**

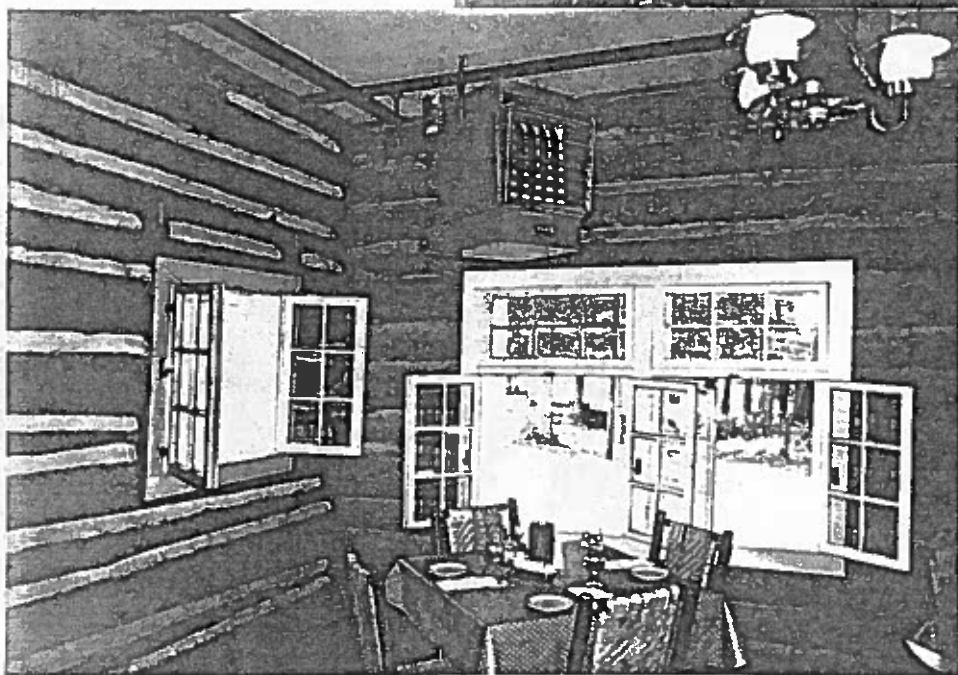
Figure 173: Looking at a corner of the dining room with windows open to see how they operate. The windows are in good condition. Note the forced air heater hung up at the ceiling.

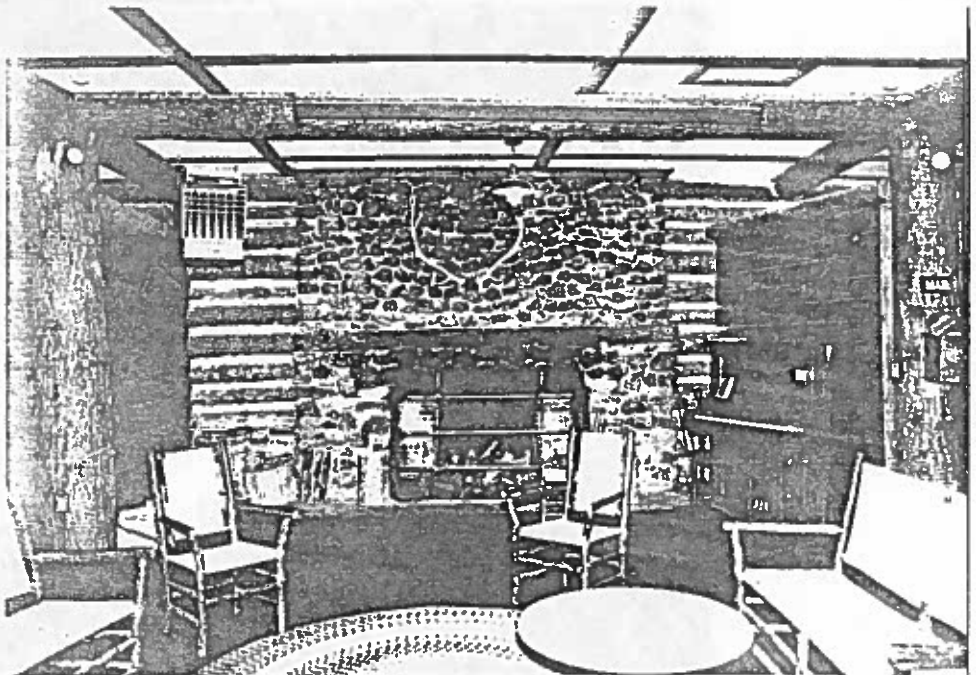
Figure 175: Looking at the fireplace in the waiting area of the Lodge. This fireplace is usable but still has some smoking problems. Note the forced air heater at the ceiling.

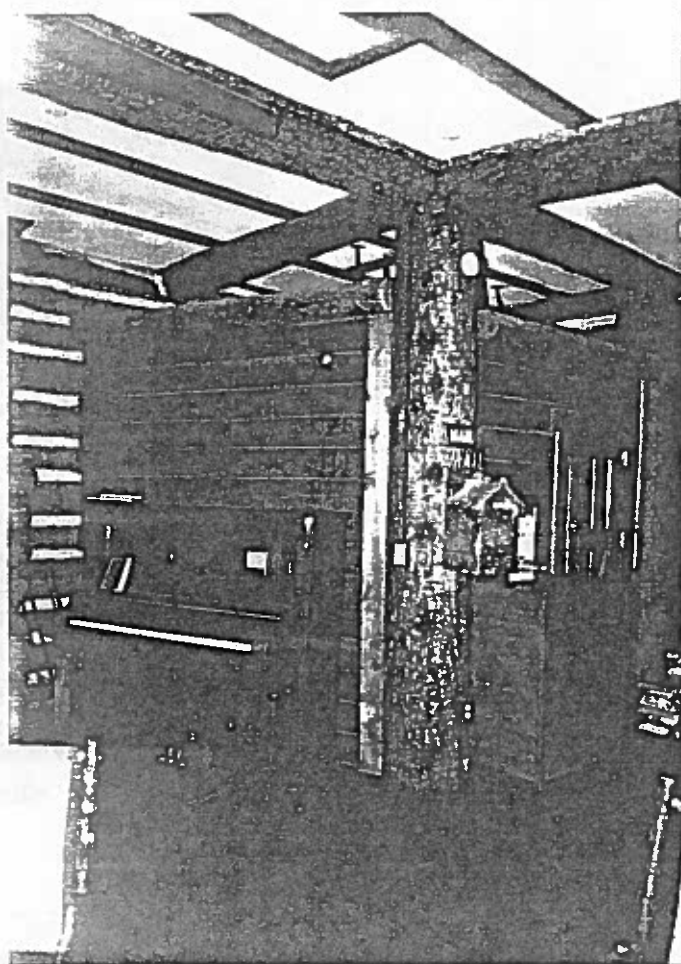
Figure 176: Looking at the comptrollers office in the Lodge. This office blocks out the window in this corner making the waiting area a very dark place.

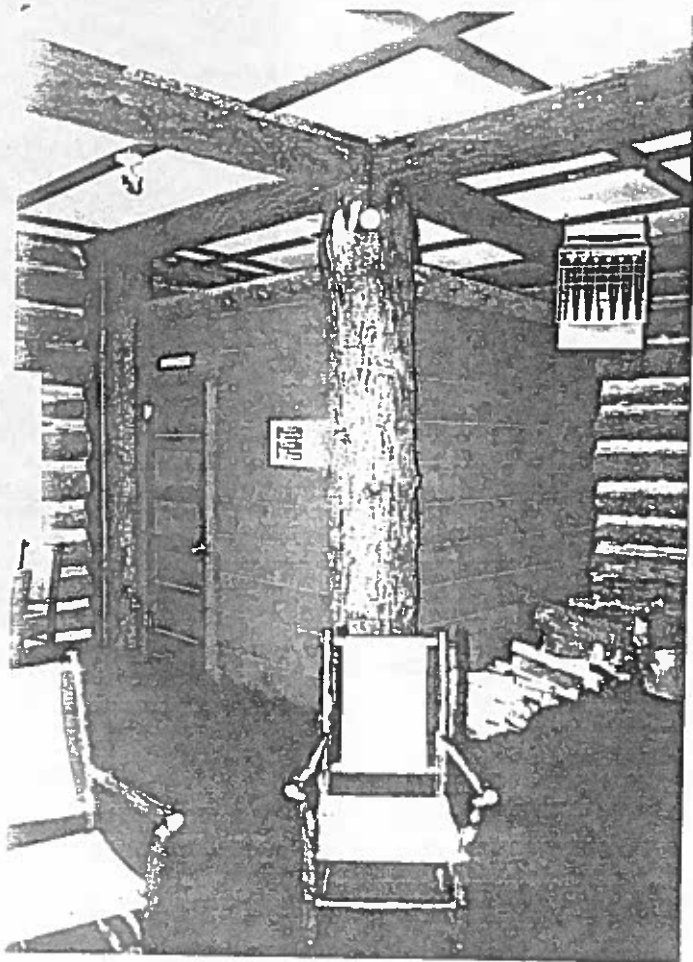
Figure 177: Looking at the managers office which also blocks out sunlight to the waiting area.
