# **Coal Creek Camp**

## **YUKON-CHARLEY RIVERS NATIONAL PRESERVE, ALASKA**

### **HISTORIC STRUCTURE REPORT**

**NPS Task Order #140P2021F0185**  
**April 2022**

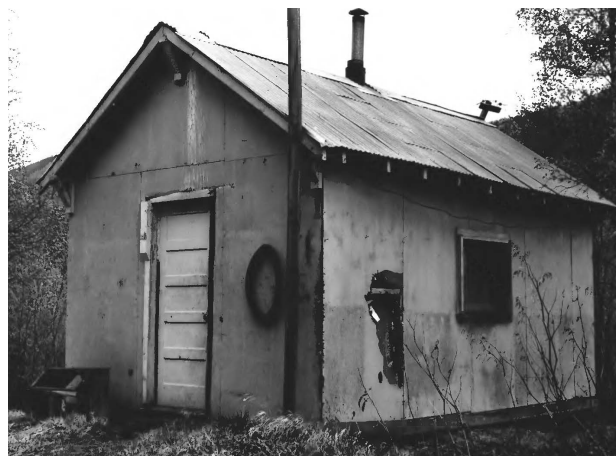
Image 14: Bunkhouse with original beaverboard deteriorating at exterior, 1986, Historic American Building Survey..

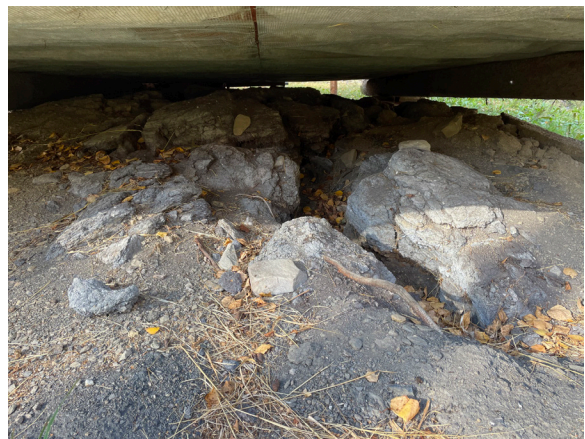
Melting and upheaving permafrost is resulting in structural instability of all buildings, with elevated severity at the bunkhouses with bermed foundations. See Structural Systems section.

*Image 18: Typical permafrost upheaval, located at Bunkhouse 2.*

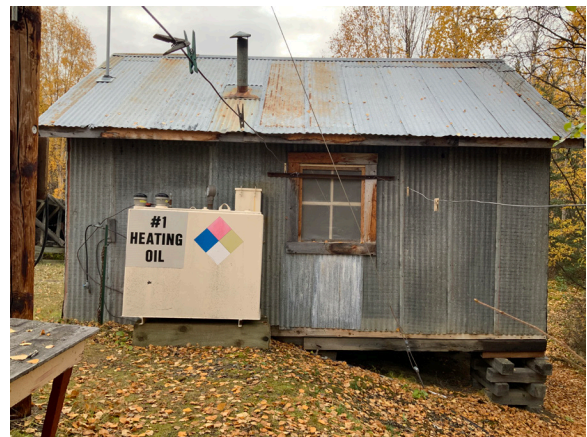
The fuel tank is no longer in use, and the fuel in the tank is gellified. Combined with the age of the tank, there is risk for leaking.

Image 21: Oil tank located at the north elevation of the Laundry Building.

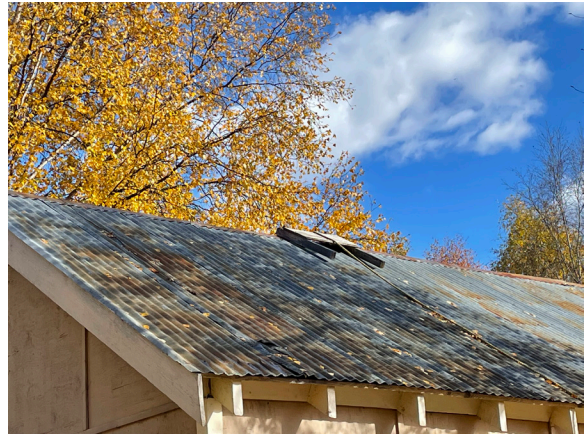
Image 27: Mild corrosion at corrugated metal roofing.

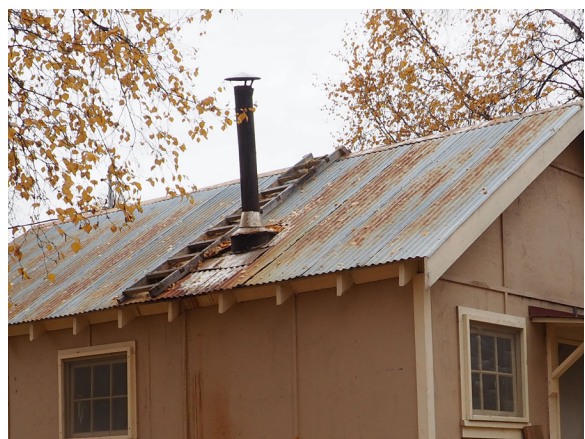
The chimney penetration is an access point for moisture and is leading to elevated moisture levels in nearby wood members and finish deterioration.

The chimney is not braced and does not meet code height requirements of 2' minimum projection above ridge.

Image 29: Chimney is not braced and is leaning.

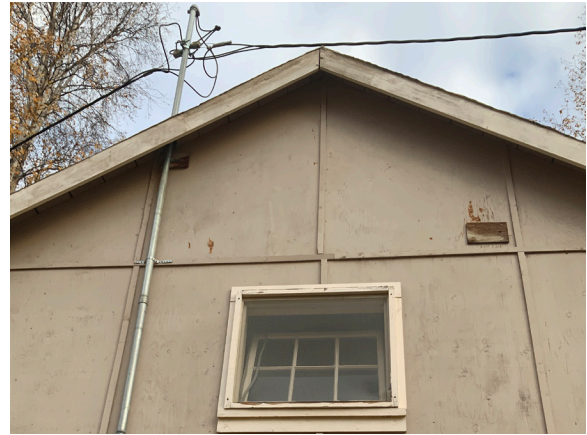
*Image 30: South elevation plywood exterior sheathing with surface wear and patched penetrations.*

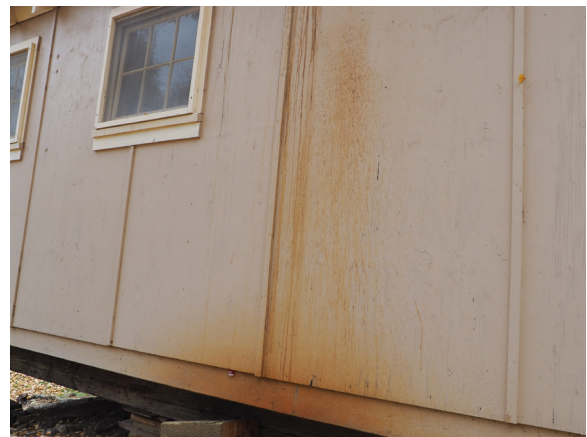
*Image 31: Rust staining at the east elevation below chimney location.*

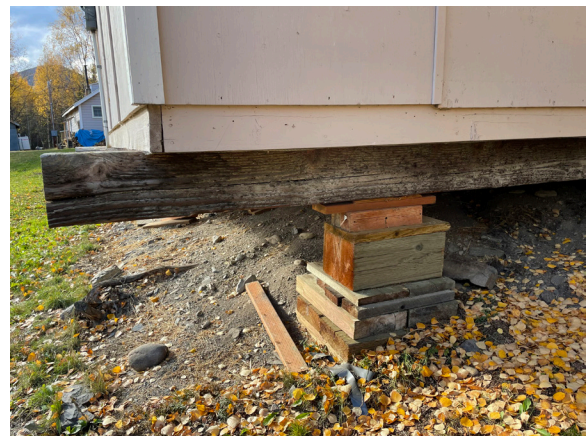
*Image 32: Cribbing supports the southeast corner of the building.*

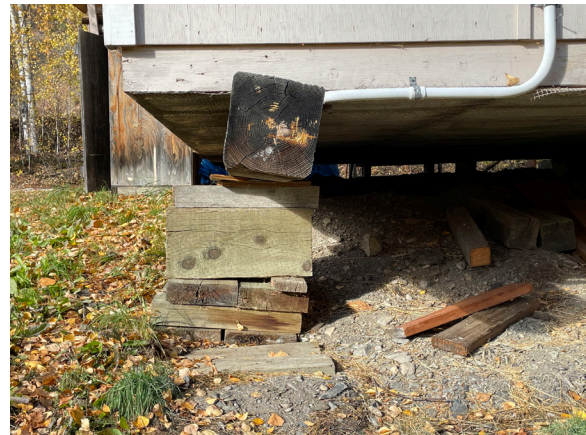
Image 33: Replacement skid is warped and unstable.

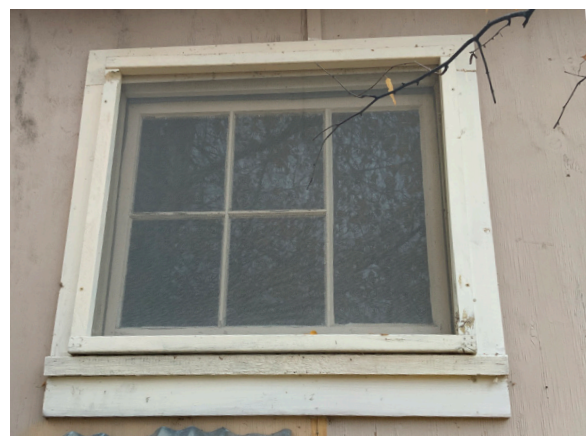
Windows are in fair condition with moderate surface and paint deterioration at the exterior. Windows fit loosely in their frames and are not sealed. Putty glaze is dry and cracked throughout. Window S1 has a cracked pane. Window W1 is missing a muntin.

Image 35: Typical 6-lite hopper window. Window W1 is missing a muntin.

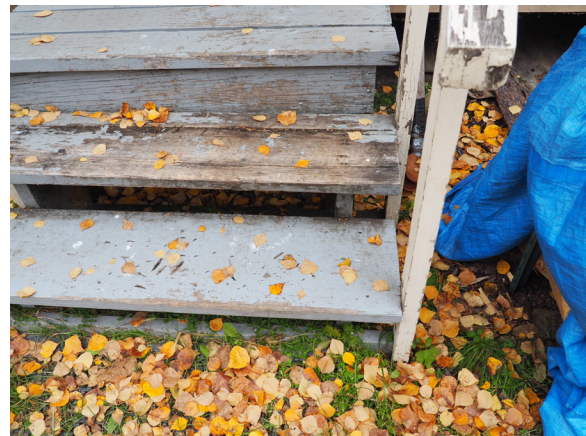
Entry stair and handrails do not meet code for landing requirements, tread or riser dimensions, and handrail heights and profiles. Paint is deteriorated throughout. The lower tread has settled into the grade. Moderate rot is evident at projecting handrails and treads.

*Image 37: North elevation entry stair with moderate rot at stair treads.*

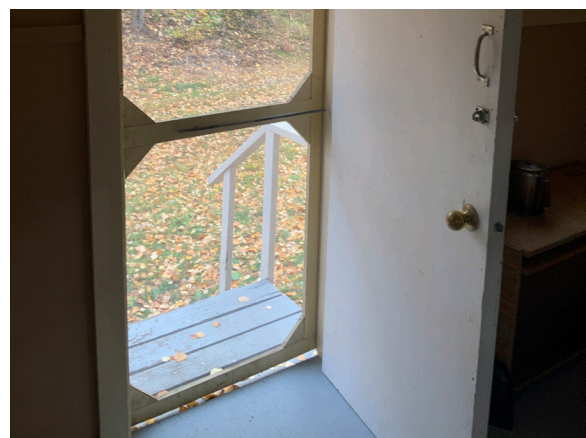
*Image 38: Hollow core entry door and wood frame screen.*

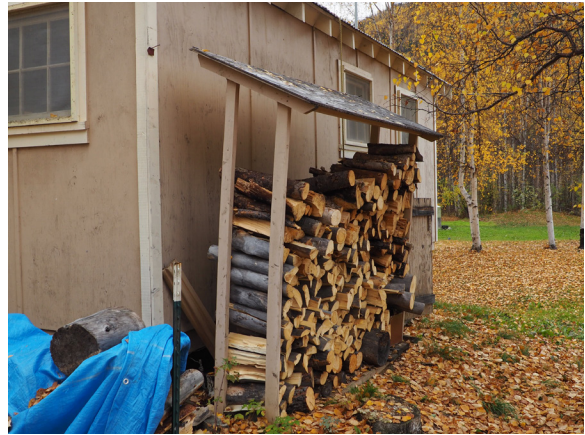
*Image 39: Wood shed at west elevation is leaning away from building and unstable.*

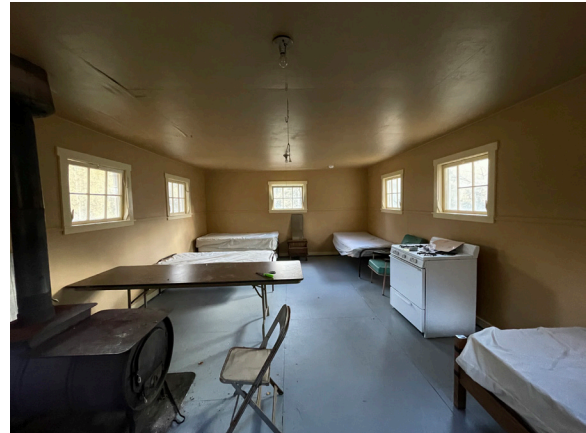
Image 41: Looking south into the one-room interior.

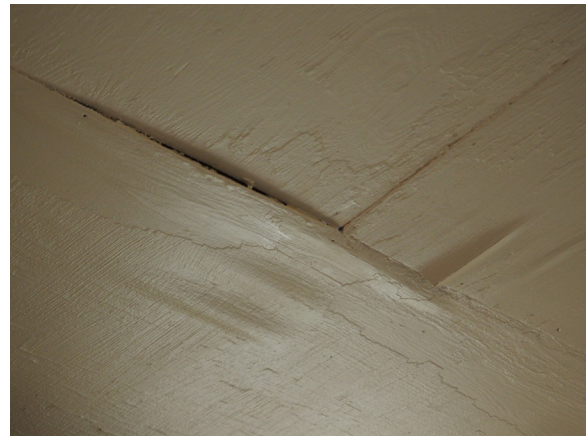
The ceiling surrounding the wood stove chimney is warped and recorded high moisture levels. There is no vapor retarder.

Image 42: Detail of water damage at plywood ceiling.

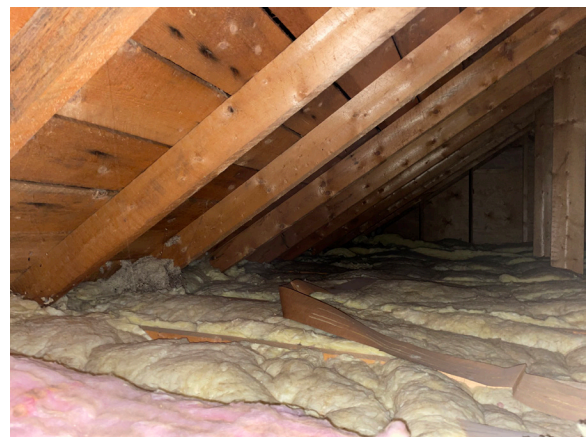
The attic is not ventilated. Batt-fiberglass insulation is damp to the touch.

Image 43: Batt-fiberglass insulation above ceiling in the attic.

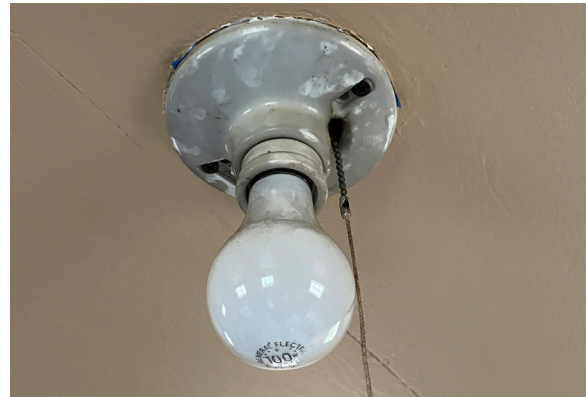
*Image 45: Typical porcelain socket, one of two at ceiling.*

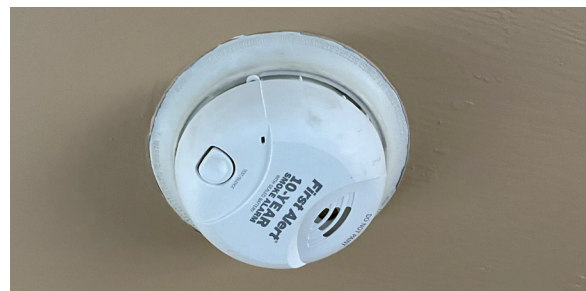
Missing fire extinguisher. Smoke alarm battery was not tested.

*Image 46: Smoke alarm.*

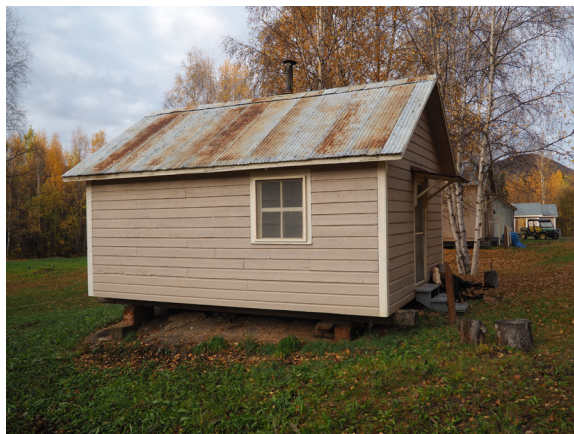
Corrugated metal roofing has moderate surface corrosion throughout.

Image 48: Moderate corrosion of corrugated metal roofing at east elevation.

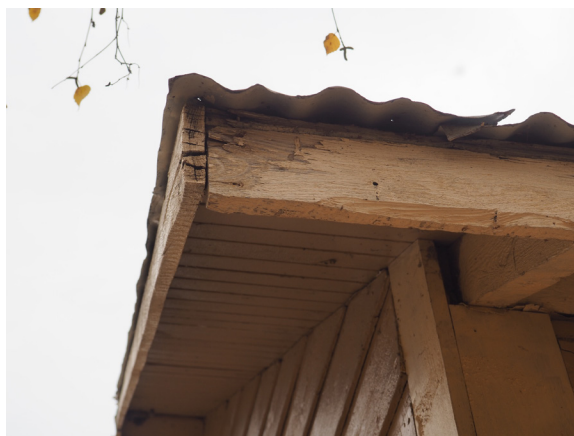
Image 49: Rot and cracking at east fascia board.

Bargeboards exhibit paint and surface deterioration. There is a gap at the ridge of the north elevation bargeboards as well as cracking at the west end. East fascia board exhibits surface rot and cracking.

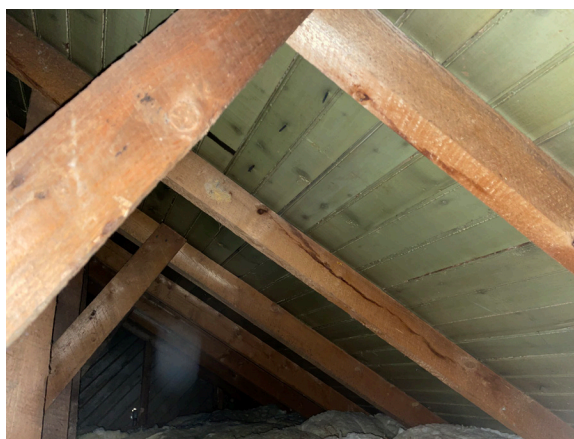
Image 50: Painted beadboard sheathing visible within the attic.

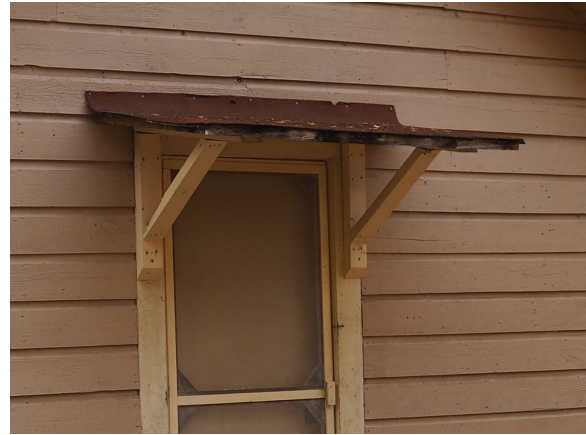
Image 51: North entrance awning with eave trim rot.

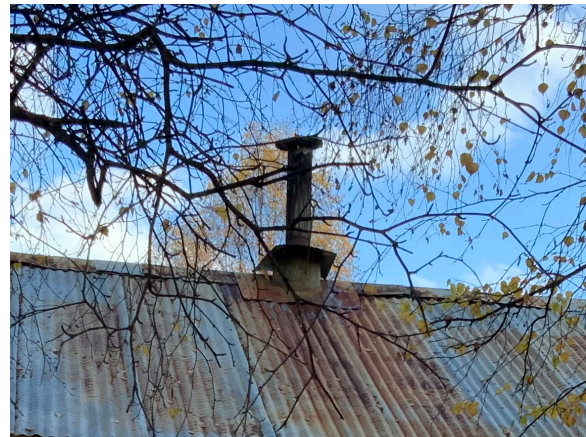
The chimney penetration is an access point for moisture and is leading to elevated moisture levels in nearby wood members and finish deterioration. The chimney is not braced.

Image 52: Chimney projecting from the ridge with chimney cap, storm collar, and severe corrosion.

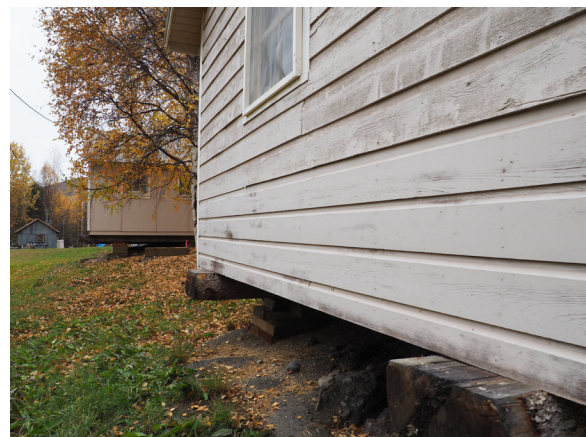
Drop siding is weathered with paint deterioration throughout. The west elevation has rust staining below the wood stove chimney. Cracked boards are located at all elevations. Various holes are located at the south elevation, one patched with a piece of unpainted wood. The bottom three rows of drop siding have been replaced.

Image 53: Paint weathering at exterior drop siding. Lowermost boards have been replaced with new siding.

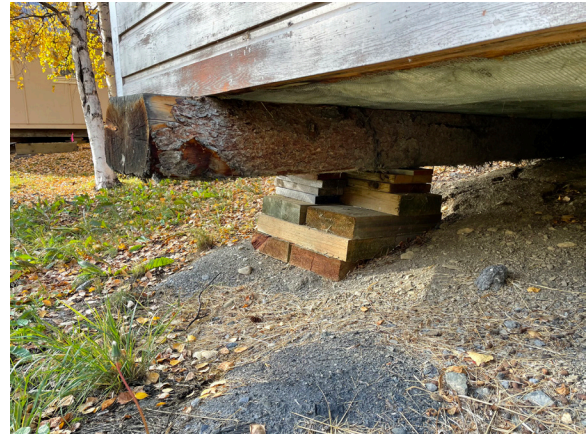
Image 54: Various cribbing supports log skids.

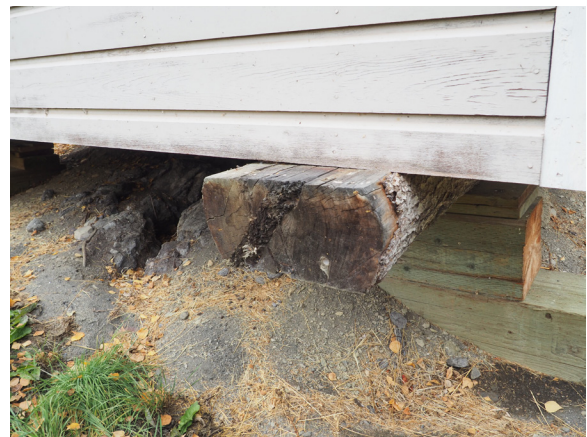
Exposed projecting ends of the log skids have biogrowth but moisture levels less than 10% WME. Melting permafrost at the bermed earth below is resulting in severe settlement and ground upheaval. To level the bunkhouse, the log skids are shimmed with various wood blocking and temporary cribbing at the south end of both elevations.

Image 55: Biogrowth at projecting log skid.

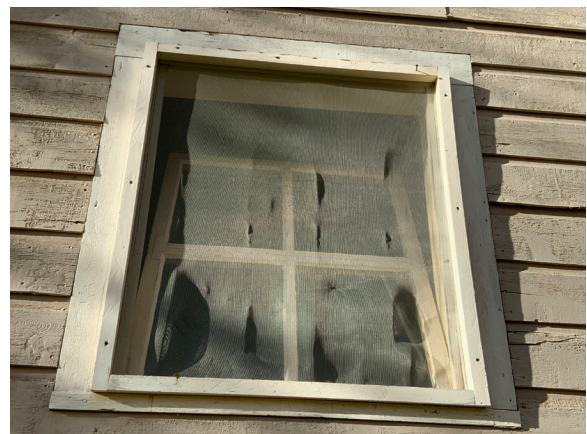
Image 56: Typical warped and torn window screen.

Windows are in fair condition with moderate surface and paint deterioration at the exterior sash and sills. Windows fit loosely in their frames and are not sealed. Putty glaze is dry and cracked throughout. Window S1 has a warped screen.

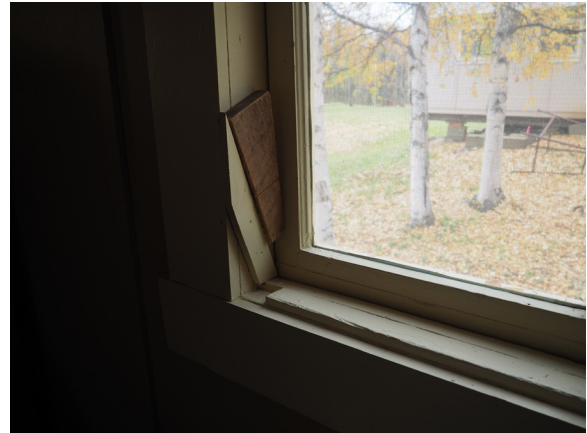
Image 57: Detail of wood stops that hold windows in place.

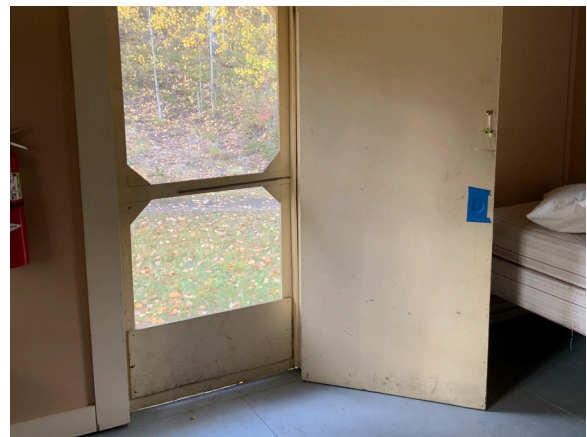
There is moderate surface deterioration at the exterior face of the door. Paint weathering. Original door handle is missing.

Image 58: Entry door with missing handleset.

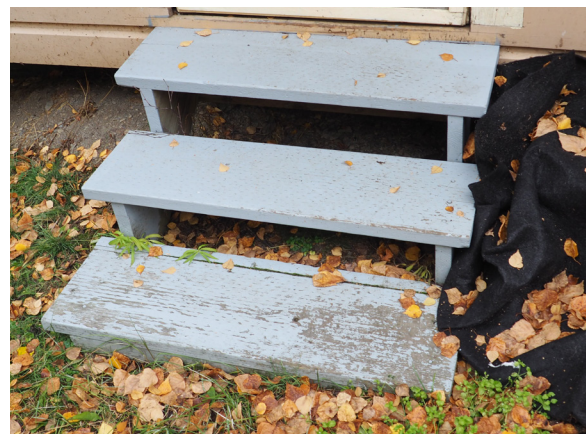
Entry stair does not meet code for landing requirements, tread or riser dimensions, and handrail heights and profiles. Paint is deteriorated throughout. The lower tread has settled into grade. Moderate rot is evident at projecting handrails and treads.

Image 59: Entry stair settling into grade.

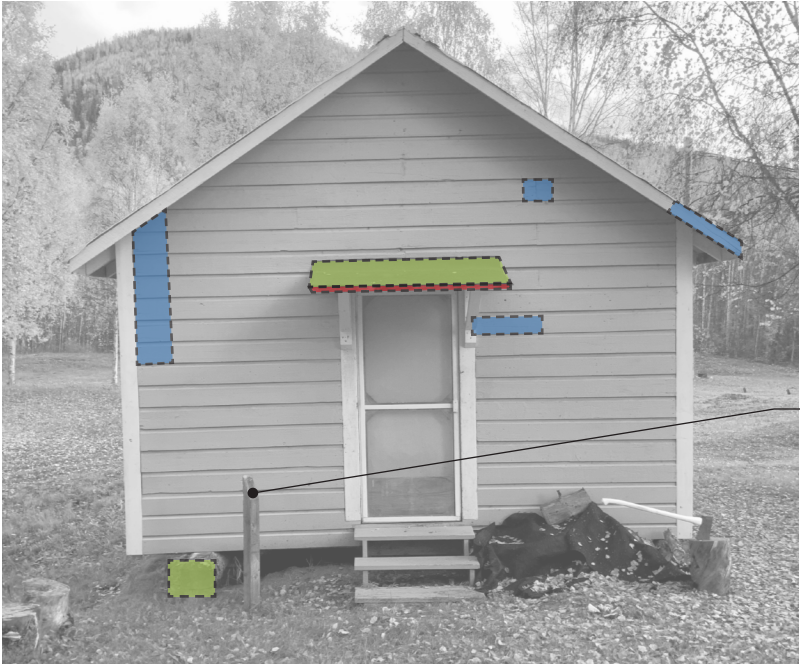
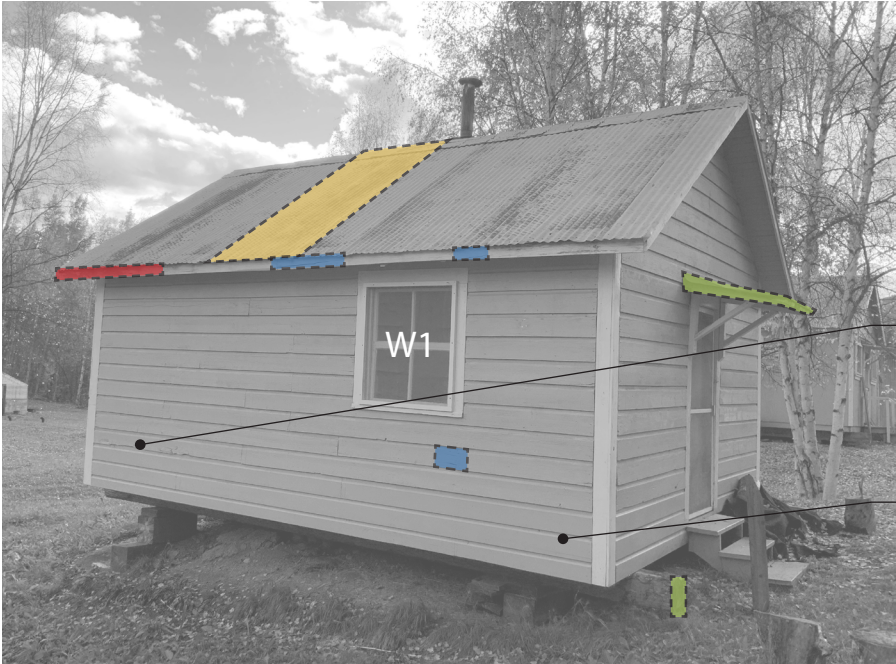
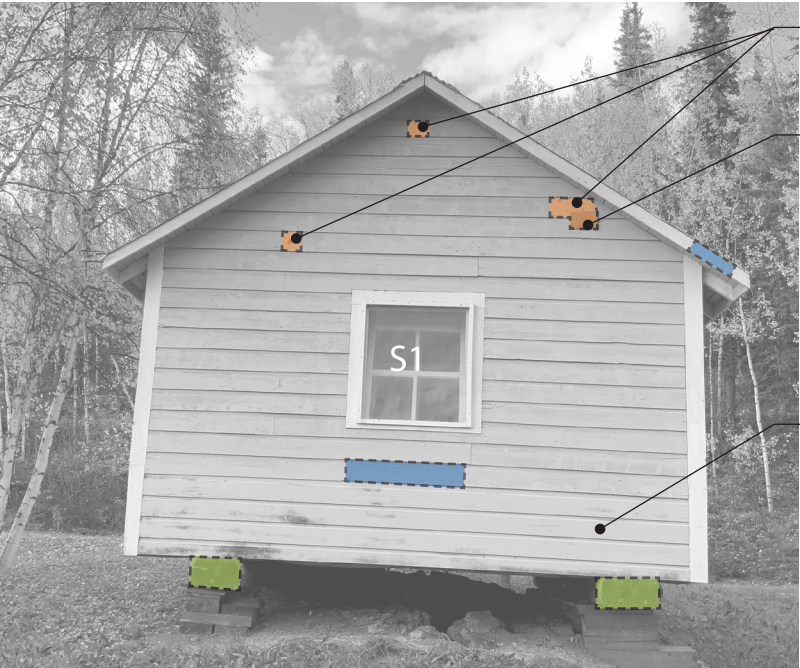
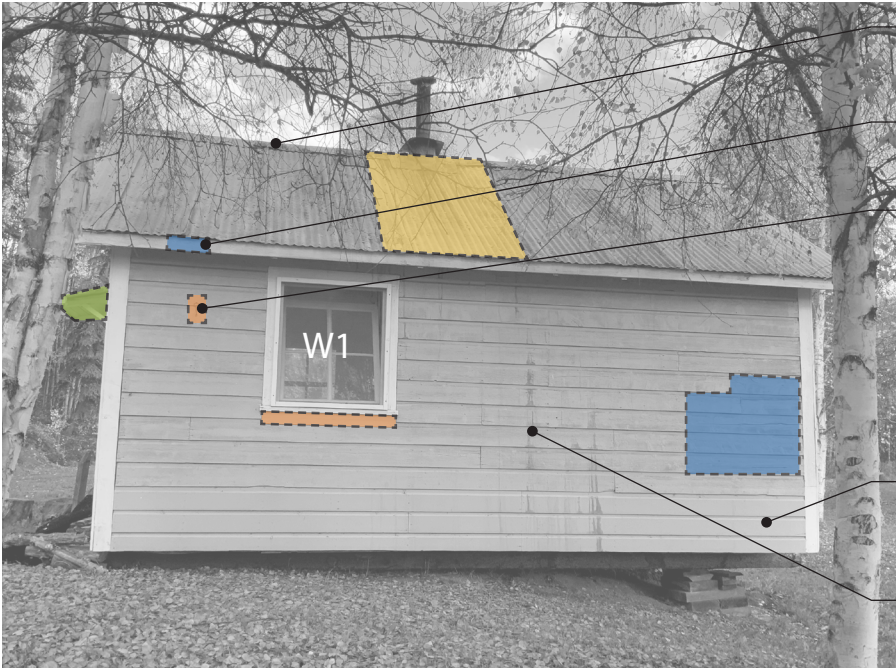
## Exterior Elevation Condition Diagram

Impact damage

Bottom three rows replaced

Water stains

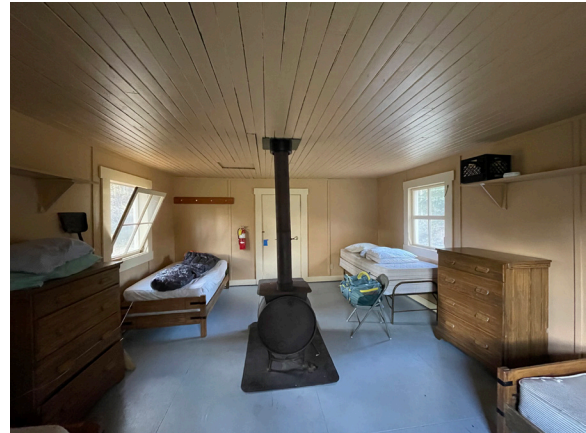
Image 60: Looking south into the one room interior with central wood stove.

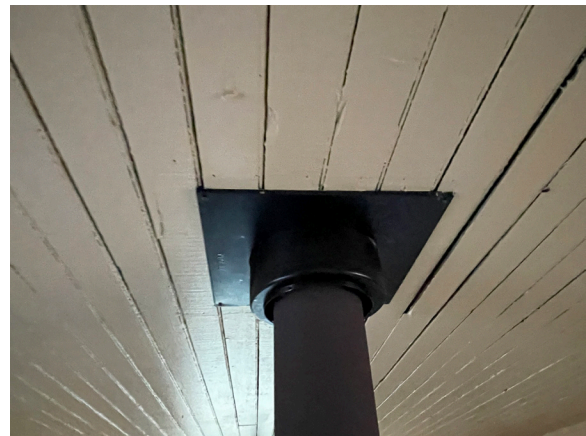
Image 61: Chimney thimble at beadboard ceiling.

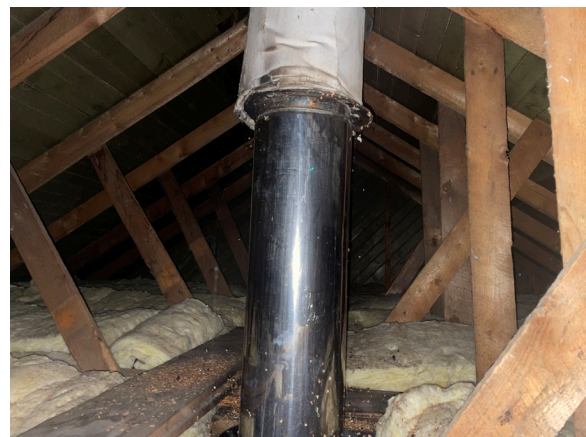
Image 62: Exposed framing and chimney at attic.

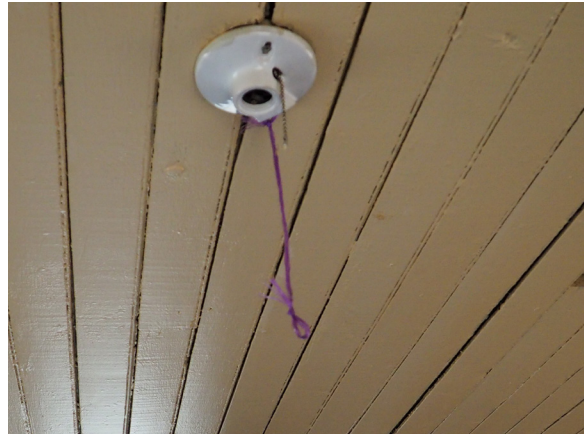
One light bulb is missing. Electricity no longer runs to the building.

*Image 63: Porcelain socket missing light bulb.*

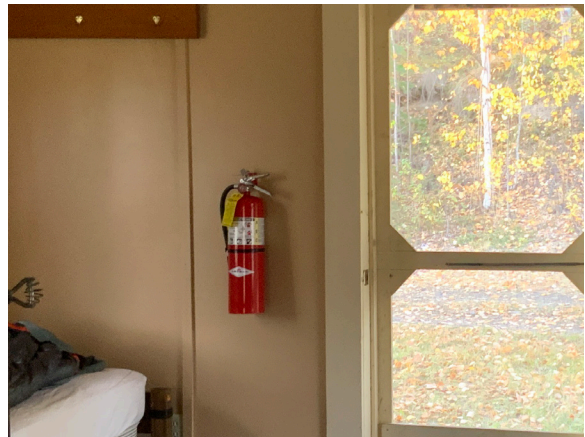
*Image 64: Fire extinguisher mounted at north wall.*

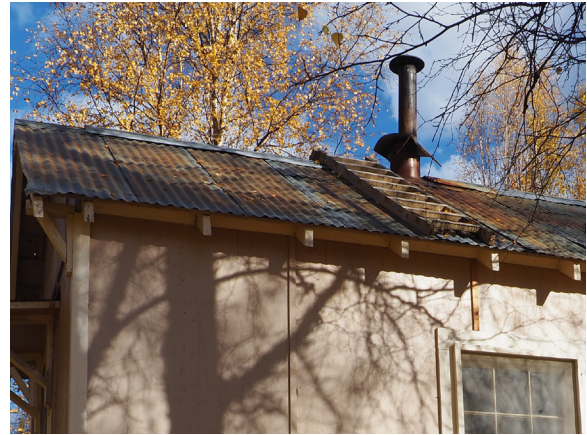
Corrugated metal roofing has mild surface corrosion throughout. The metal is bent at the south elevation, with ridge flashing loose. The addition of galvanized flashing at the south elevation indicates the sheathing has failed beneath. Access ladder is deteriorated and unsafe.

Image 66: Mild corrosion, access ladder, and chimney projecting through ridge.

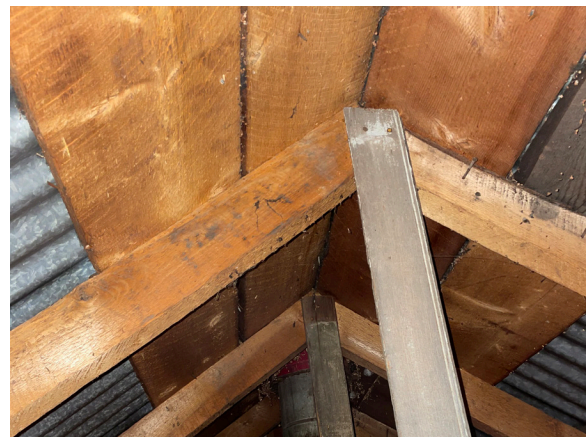
Image 67: View of skip sheathing and king posts in attic.

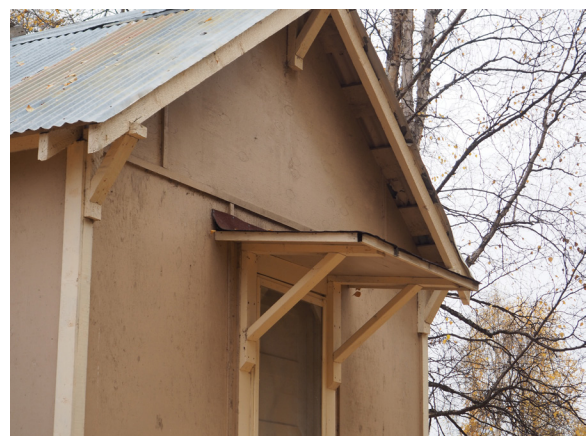
Image 68: North entrance awning.

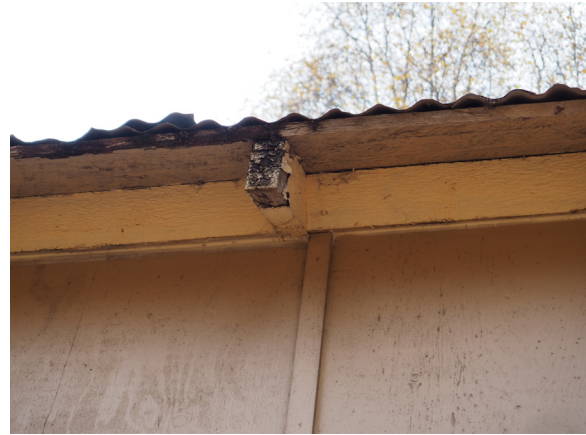
Image 69: Rotting rafter tail at east elevation.

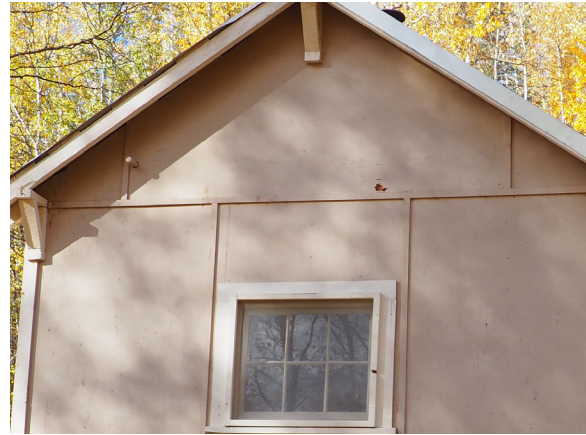
Exterior plywood is weathered with paint deterioration throughout. Moisture readings throughout the plywood indicated elevated moisture levels at or above 14% WME. There is surface damage at the south elevation gable.

Image 72: Surface damage at the south elevation gable.

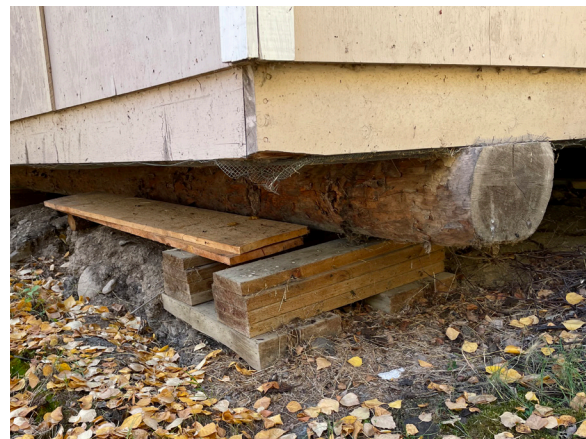
Exposed projecting ends of the log skids are weathered. Melting permafrost at the bermed earth below is resulting in severe settlement and ground upheaval. To level the bunkhouse, the log skids are shimmed with various wood blocking and temporary cribbing at all elevations.

Image 73: Cribbing supports log skids.

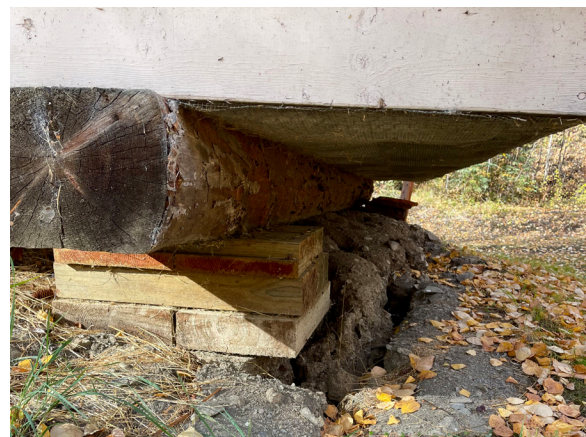
Image 74: Permafrost melting with upheaval.

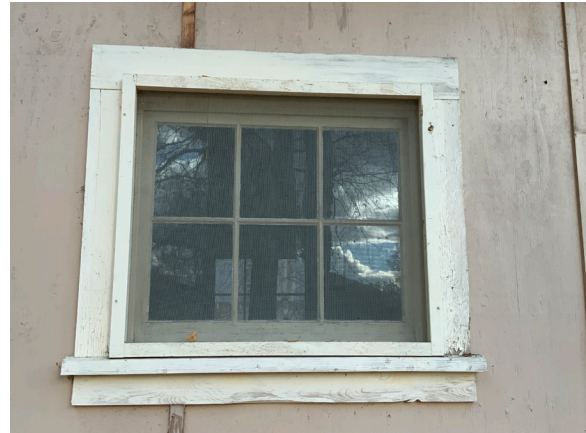
Windows are in fair condition with moderate surface and paint deterioration at the exterior. Windows fit loosely in their frames and are not sealed. Putty glaze is dry and cracked throughout. Window S1 is missing a sash lock and held in place using paper shims. Window E1 has moderate sill deterioration and a torn screen. Window W1 has moderate surface deterioration at the sill.

Image 75: Hopper window with paint deterioration at exterior.

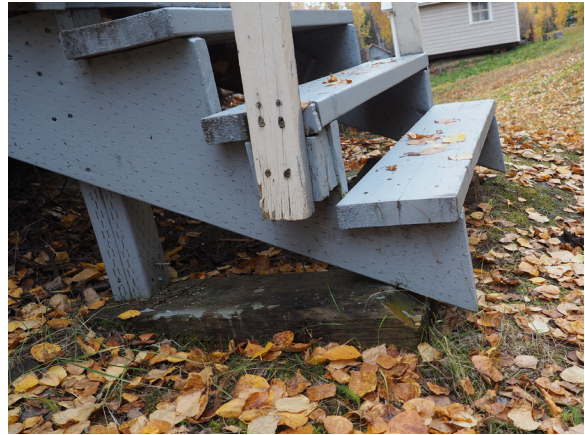
Entry stair and handrails do not meet code for landing requirements, tread or riser dimensions, and handrail heights and profiles. Paint is deteriorated throughout. The stair treads rest on pressure treated lumber to combat building settlement, and stair is unstable. Moderate rot is evident at projecting handrails.

*Image 78: Stringer rests on deteriorated wood sill.*

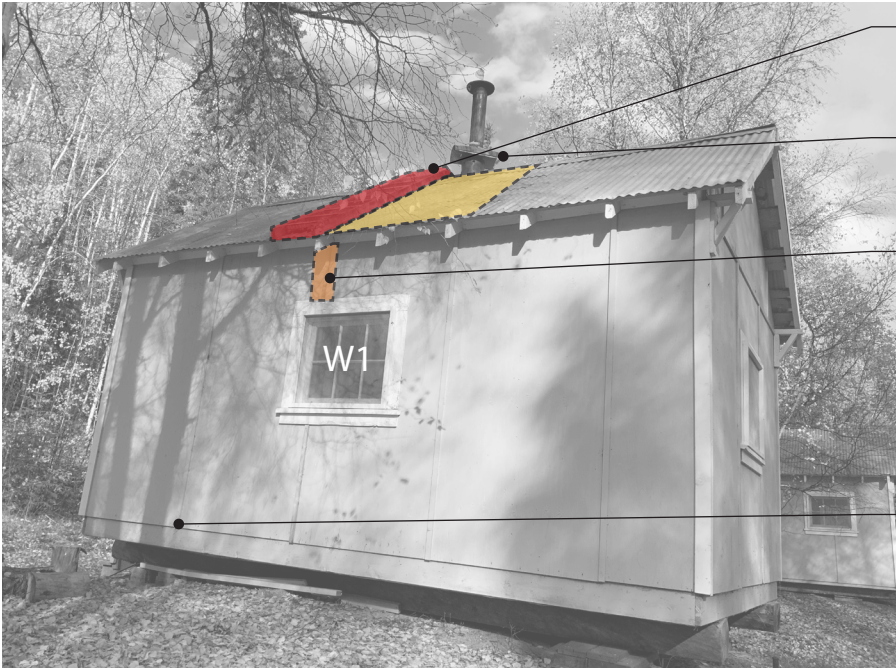
West Elevation

Access ladder

Failing flashing

Missing batten

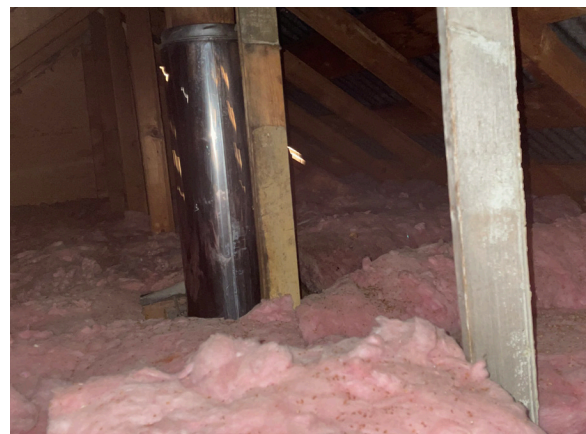
Batt-fiberglass insulation is dislodged from several joist bays. The attic access is difficult due to the vapor retarder and insulation placed loosely over the top of the hatch.

Image 81: Batt-fiberglass insulation in attic.

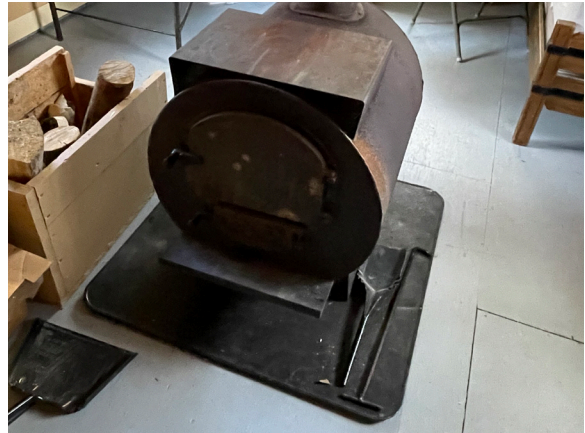
The stove has mild surface corrosion and is in working condition.

*Image 82: Mild corrosion at barrel stove.*

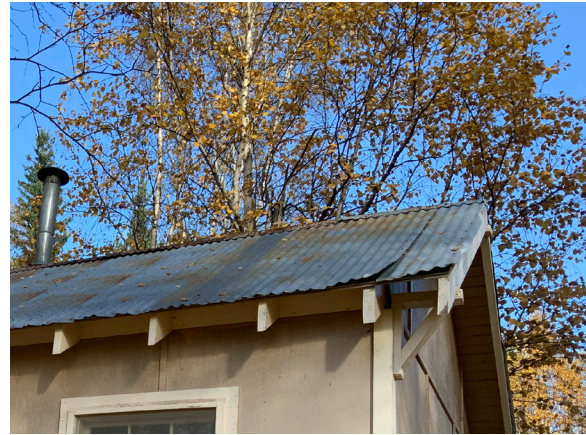
Corrugated metal roofing has mild surface corrosion throughout. The metal is bent and nailed to the bargeboard of the south elevation. The covering is loose at the west elevation. Access ladder is deteriorated and unsafe.

Image 85: Bent and uplifting corrugated metal roofing.

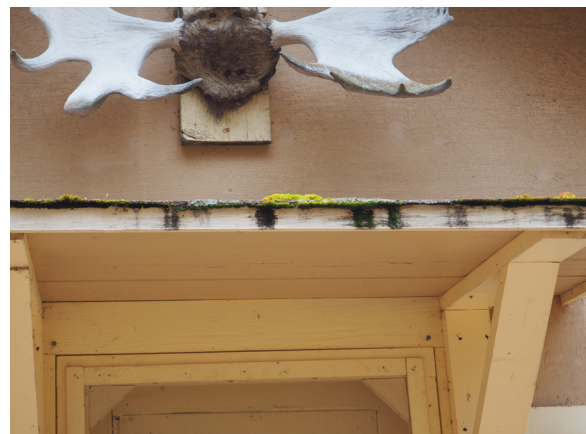
Image 87: Active biogrowth at north entry awning and associated trim rot.

Wood framing has active wood rot with surface deterioration. Mineral-surfaced rolled roofing has biogrowth.

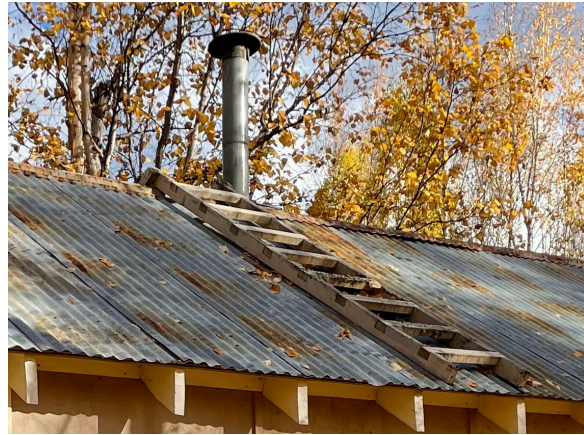
Image 88: Deteriorating roof access ladder.

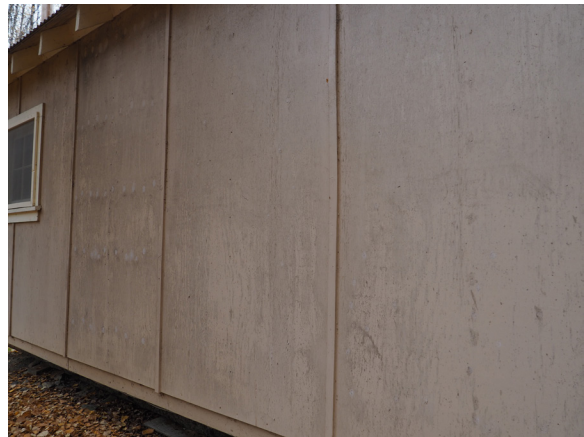
Image 89: Surface wear at exterior plywood.

Exterior plywood is weathered with paint deterioration throughout. Moisture readings throughout the plywood indicated elevated moisture levels at or above 14% WME.

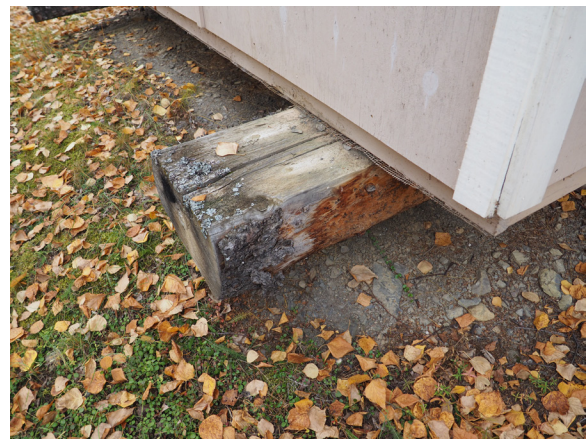
Image 92: Surface rot at projecting log skids.

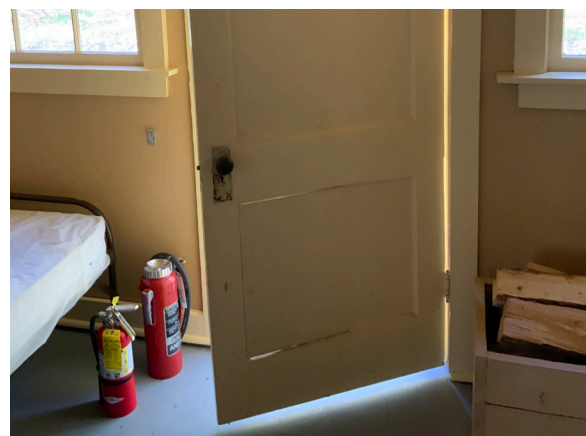
Image 96: Natural light is visible through lowermost panel of exterior door.

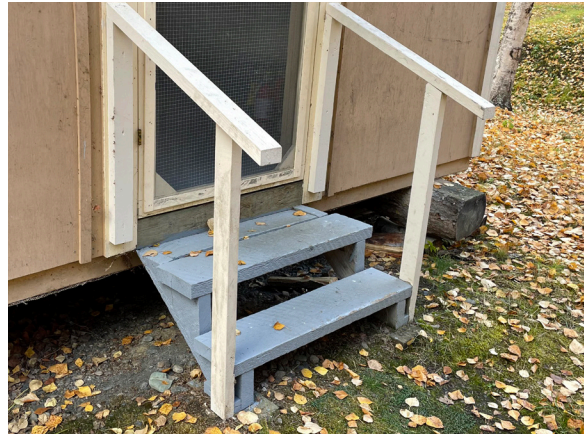
Entry stair and handrails do not meet code for landing requirements, tread or riser dimensions, and handrail heights and profiles. The stair and handrail are in good condition with minor surface wear.

*Image 97: North elevation entry stair.*

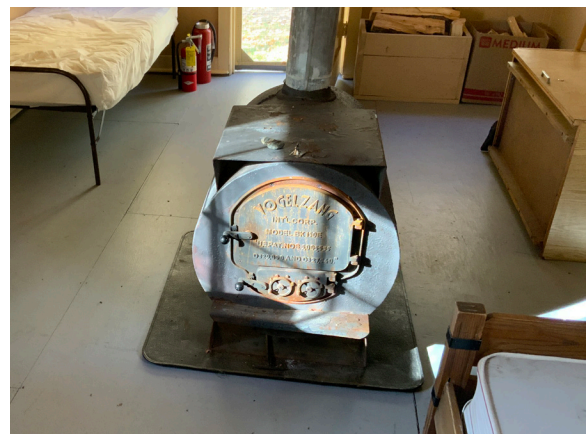
The stove location does not meet clearance requirements from adjacent interior walls. The stove has mild surface corrosion and is in working condition.

Image 100: Mild corrosion at barrel stove.

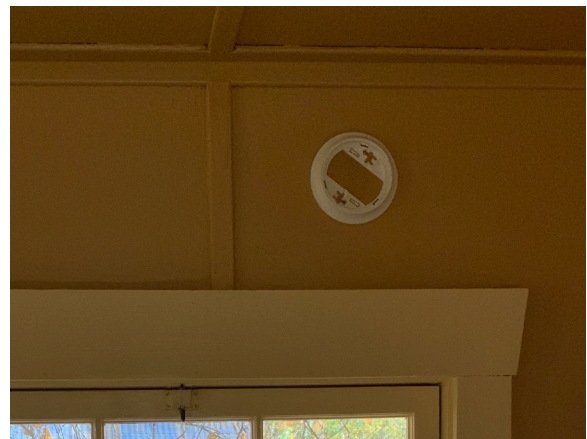
Smoke alarms were removed for seasonal testing at the time of assessment and were not observed..

*Image 102: Smoke detector mount.*

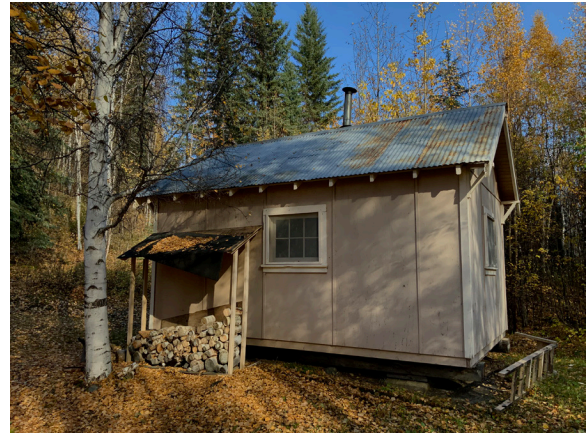
Corrugated metal roofing has mild surface corrosion throughout. Ridge flashing is loose at the south elevation.

Image 104: Mild corrosion at east elevation corrugated metal roofing.

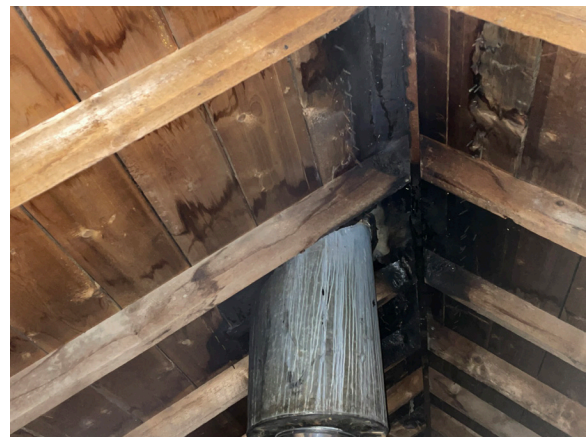
Fire damage was visible at the interior faces of the ridge and sheathing near the wood stove pipe.

Image 105: Fire damage surrounding chimney in attic.

Fire damage was visible at rafters within the attic space.

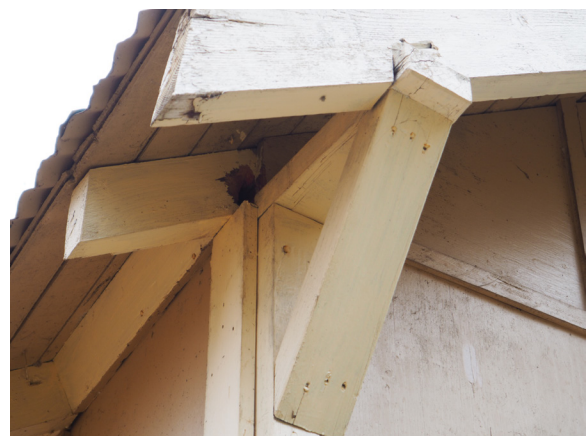
Image 106: Cracked bargeboard at north elevation.

North elevation bargeboard is cracked. South elevation bargeboard end is cracked with moderate rot.

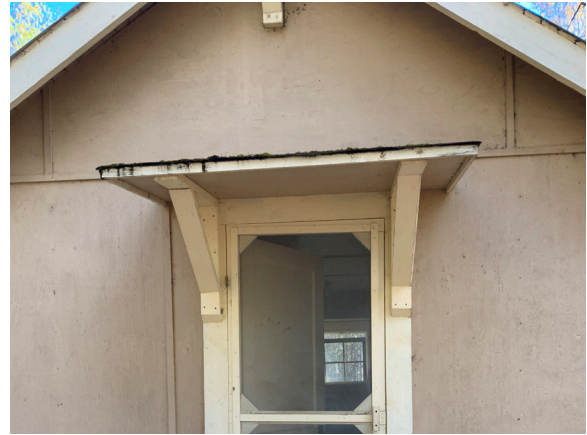
Wood framing has active wood rot with surface deterioration. Mineral-surfaced rolled roofing has biogrowth.

Image 107: North entry awning with active biogrowth and rot.

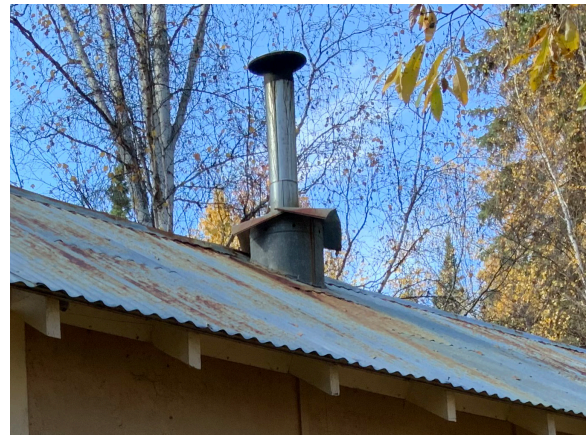
The thimble has become disconnected from the wood stove pipe at the interior. The chimney penetration is an access point for moisture and is leading to elevated moisture levels in nearby wood members and finish deterioration. The chimney is not braced.

Image 108: Projecting chimney with storm collar and cap.

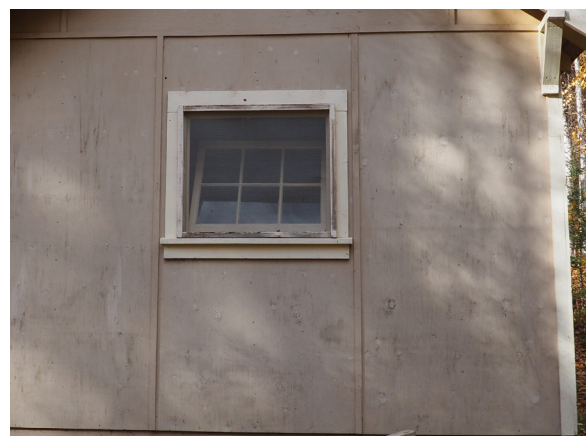
Image 109: Surface wear at exterior plywood sheathing, south elevation.

Exterior plywood is weathered with paint deterioration throughout. Moisture readings at the west elevation indicated elevated moisture levels at or above 14% WME.

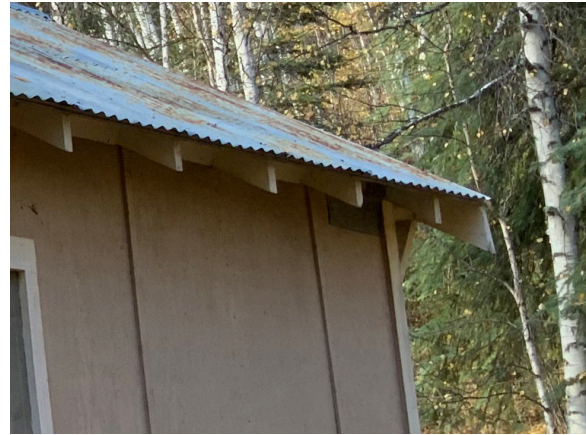
Frieze board is patched with metal sheet at east elevation. Cornerboard at southwest corner is cracked at the base with animal damage near the rafter.

Image 110: Frieze board patched at east elevation.

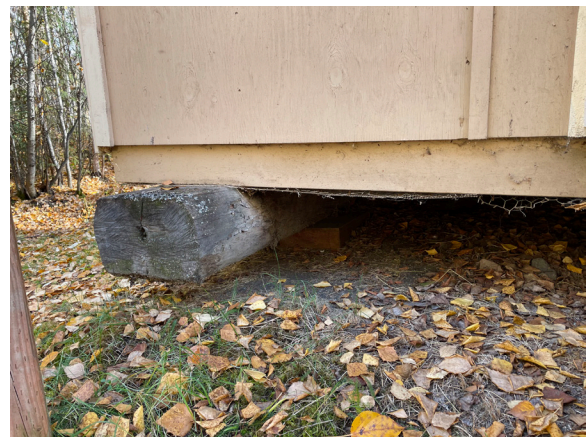
Exposed projecting ends of the log skids are weathered. Melting permafrost at the bermed earth below is resulting in severe settlement and ground upheaval. To level the bunkhouse, the log skids are shimmed with various wood blocking.

Image 111: Weathered projecting log skids.

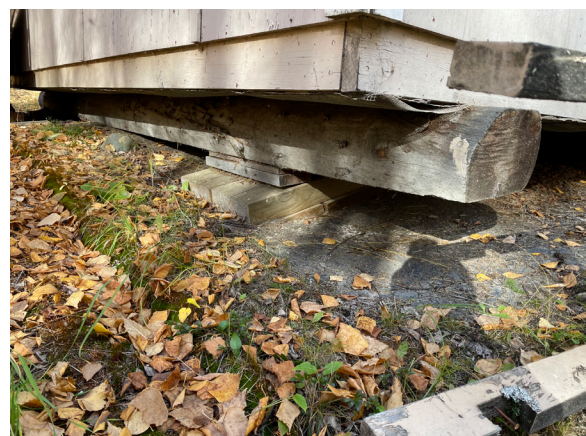
Image 112: Melting permafrost with cribbing supporting log skids.

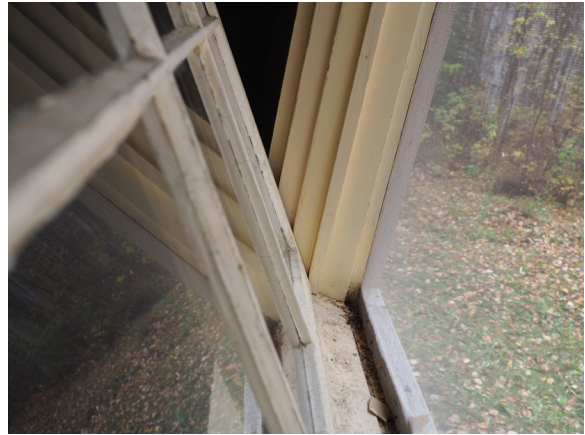
Windows are in fair condition with moderate surface and paint deterioration at the exterior. Windows fit loosely in their frames and are not sealed. Putty glaze is dry and cracked throughout. Window E1 has a cracked pane. Window W1 has surface deterioration at the sill.

Image 113: Detail of hopper window frame, with hopper sash resting in opening.

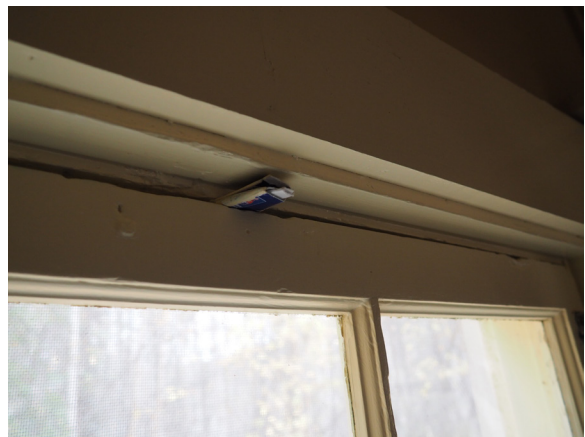
Image 114: Paper shim used to hold window closed.
