# **Coal Creek Camp**

## **YUKON-CHARLEY RIVERS NATIONAL PRESERVE, ALASKA**

### **HISTORIC STRUCTURE REPORT**

**NPS Task Order #140P2021F0185**  
**April 2022**

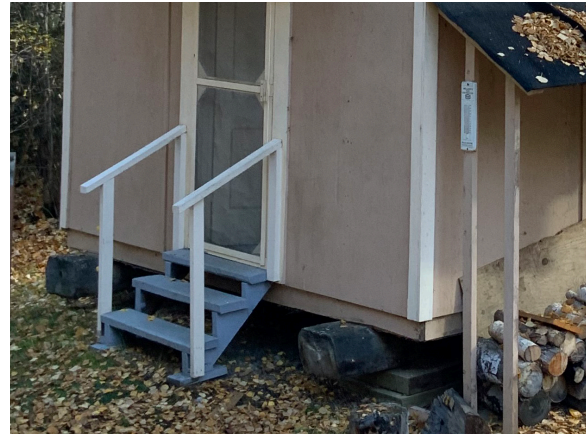
Entry stair and handrails do not meet code for landing requirements, tread or riser dimensions, and handrail heights and profiles. The stair and handrail are in good condition with minor surface wear.

*Image 116: North entry stair.*

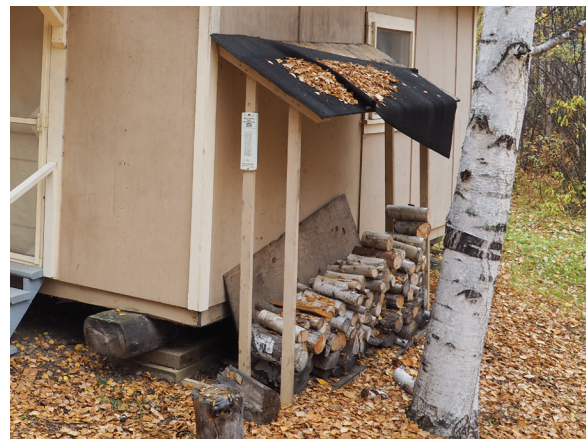
The wood shed is tacked into the west elevation of the building with a nail at the south end. The rolled roofing is failing and falling off. Plywood sheathing exhibits wood rot. The location of the wood shed violates the NPS Eastern Area Fire Management (EAFM) Prescription, which requires firewood to be stored a minimum of 30' from all structures.

*Image 117: Wood shed at west elevation.*

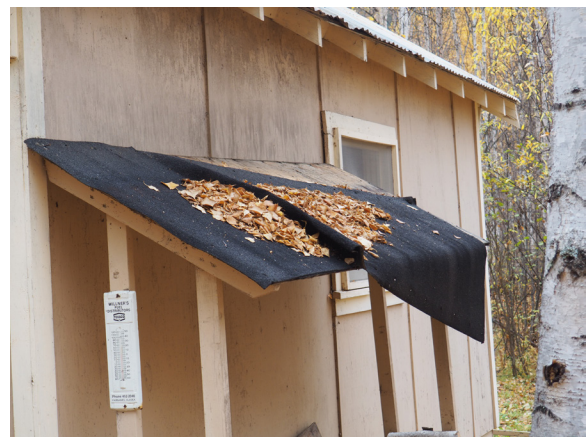
*Image 118: Detail of failing rolled asphalt roof covering at wood shed.*

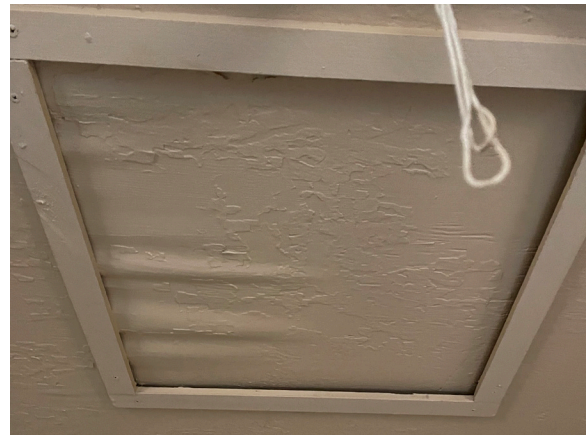
High moisture levels were recorded near the attic hatch at 13.2% WME. Plywood hatch is warped.

Image 120: Water damage at plywood attic access hatch.

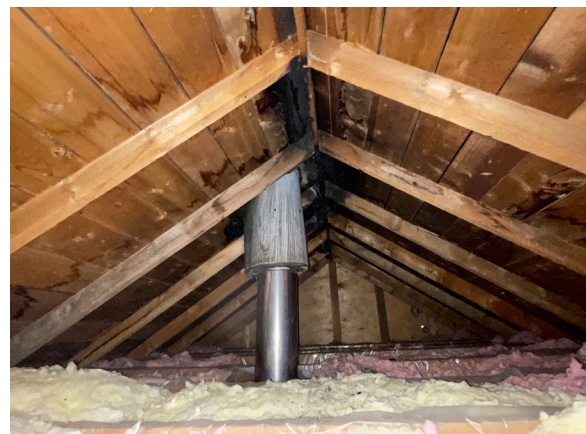
The attic is not ventilated. Batt-fiberglass insulation is damp to the touch. There is evidence of fire damage, see Roof section.

Image 121: Fire damage at roof framing surrounding chimney.

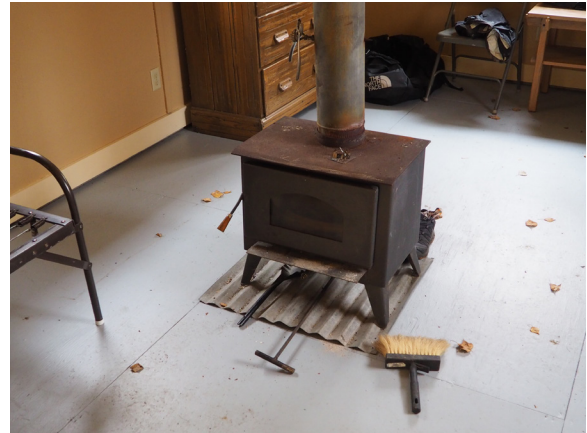
The stove has visible water leaks and surface corrosion. It is in working condition. Corrugated metal radiation shield is inadequate in size and should extend a minimum of 18” beyond stove feet.

*Image 122: Wood stove with inadequate heat shield at floor.*

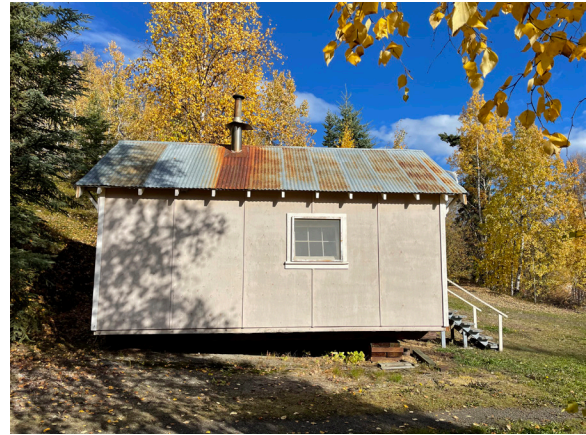
Corrugated metal roofing has mild surface corrosion throughout, with moderate corrosion concentrated around the chimney. A section is loose at the west elevation.

Image 125: Moderate corrosion at corrugated metal roofing surrounding chimney.

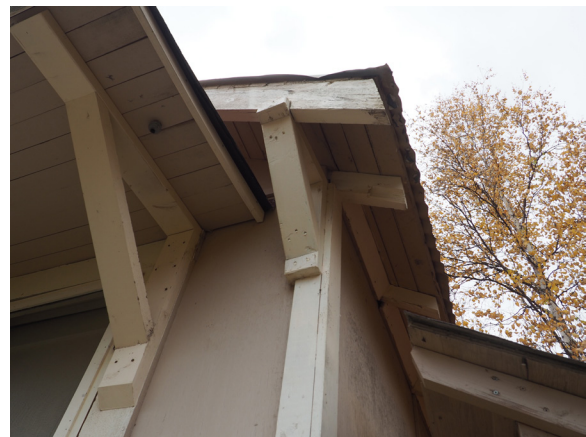
Image 126: Exposed tongue and groove sheathing at underside of primary roof and awning roof.

Tongue and groove sheathing exposed at the south elevation indicated end rot.

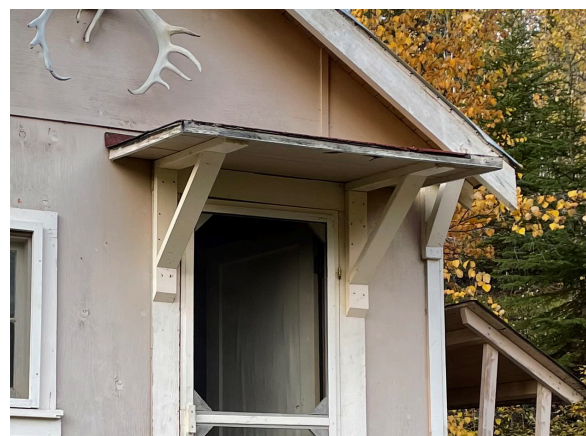
Image 127: South entrance awning.

Wood framing has active wood rot with surface deterioration. Mineral-surfaced rolled roofing has biogrowth.

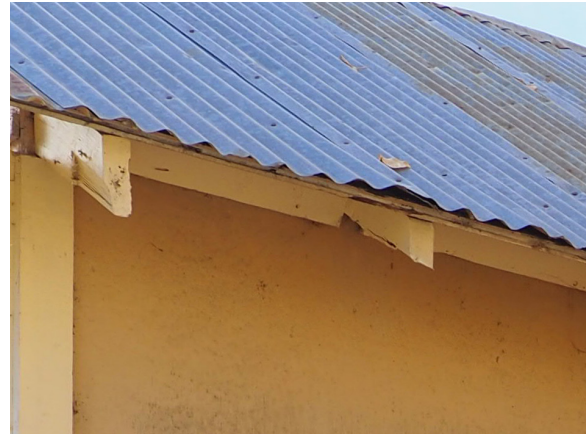
One cracked rafter at east elevation.

Image 128: Fractured rafter tail at east elevation.

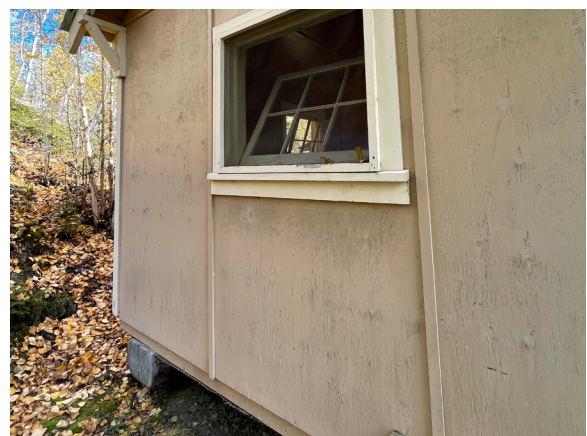
Image 130: Surface weathering at exterior plywood, north elevation.

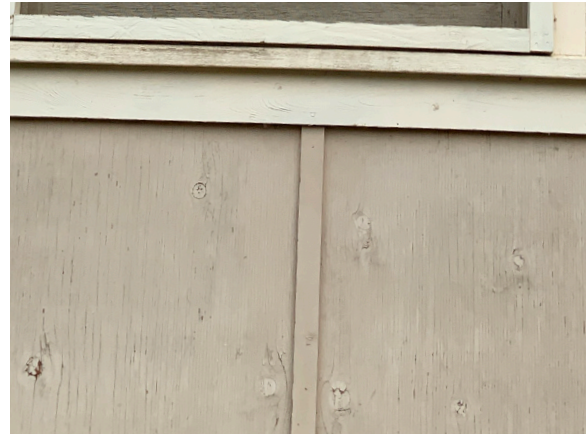
Image 131: Detail of typical paint weather at exterior plywood and trim.

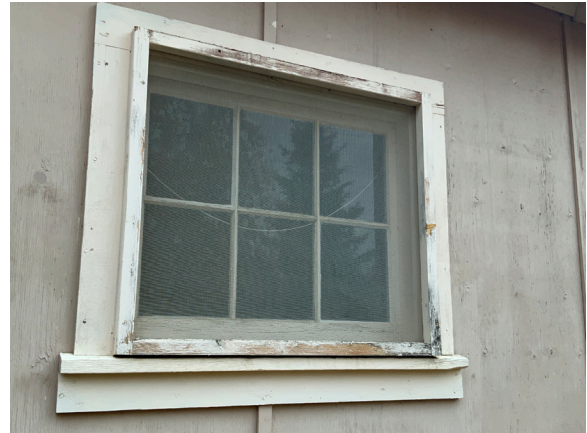
*Image 134: Hopper window with exterior screen and paint weathering.*

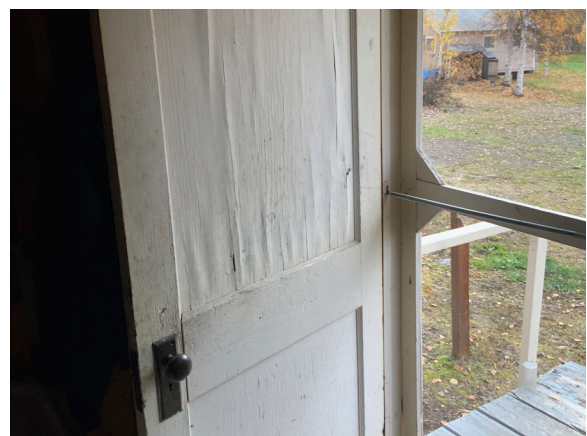
*Image 136: Delamination of exterior door upper panel.*

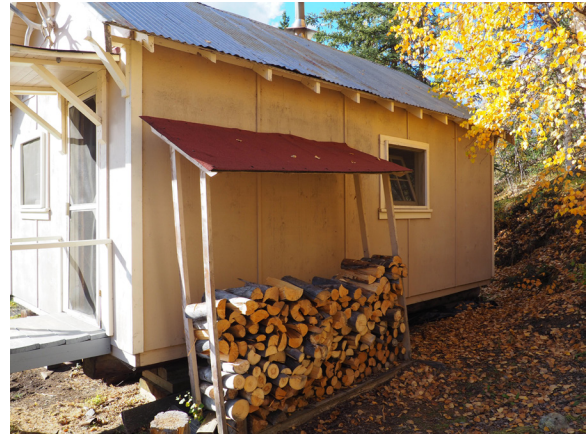
*Image 137: Warped wood shed at east elevation.*

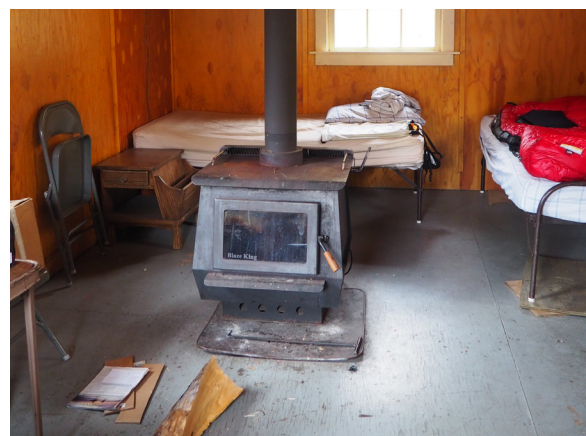
Without electricity for fan circulation, the wood stove produces a lot of smoke. Radiation shield at floor is inadequate and should project a minimum of 18" from stove feet.

Image 140: Wood stove with inadequate heat shield at floor.

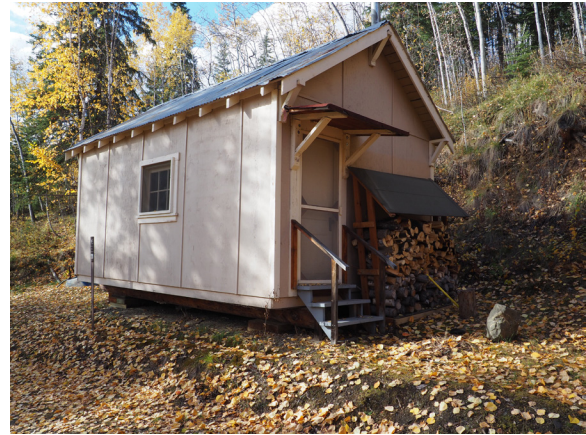
Corrugated metal roofing has mild surface corrosion throughout, with moderate corrosion concentrated around the chimney. A section has been patched at the west gable.

Image 145: Corrugated metal roof with project shed roofs at east entry and wood shed.

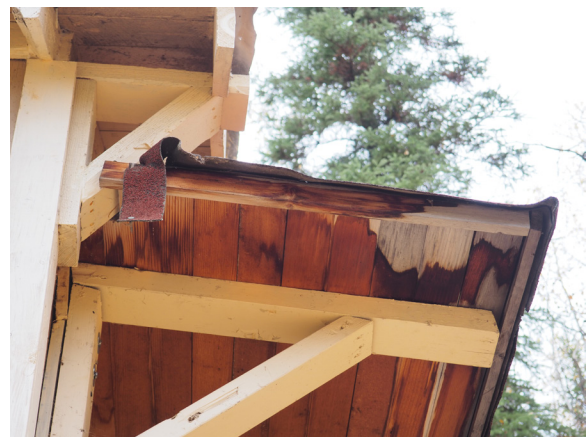
Image 147: Active rot at east elevation entry awning.

Wood framing has active wood rot with surface deterioration. Mineral-surfaced rolled roofing has biogrowth.

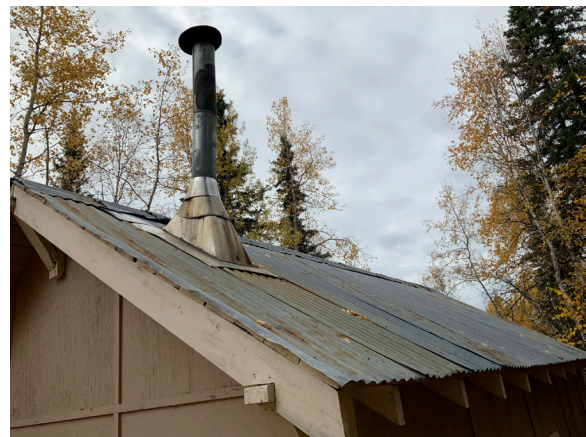
The chimney is not braced. Water leaking is evident.

Image 149: Chimney projecting at north elevation.

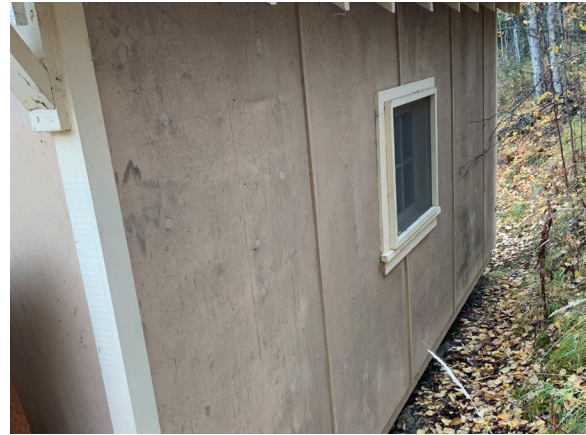
Exterior plywood is weathered with paint deterioration throughout. Moisture readings at all elevations included elevated moisture levels at or above 12% WME. Active rot and potential mold visible at north elevation..

Image 151: Mildew discoloration at north elevation plywood sheathing.

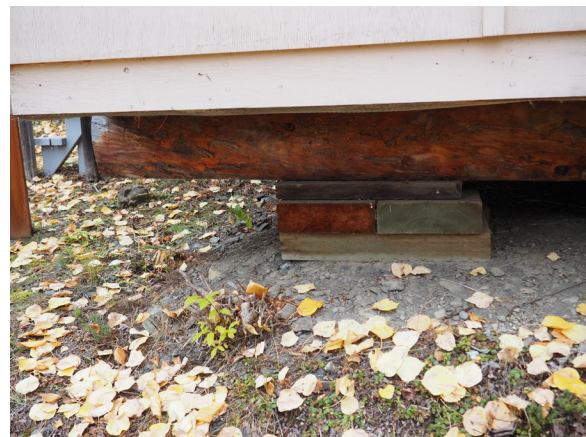
Exposed projecting ends of the log skids are weathered. Melting permafrost at the bermed earth below is resulting in settlement and ground upheaval at the south elevation. To level the bunkhouse, the south skid is shimmed with various wood blocking and cribbing.

Image 152: Cribbing supports log skids at foundation.

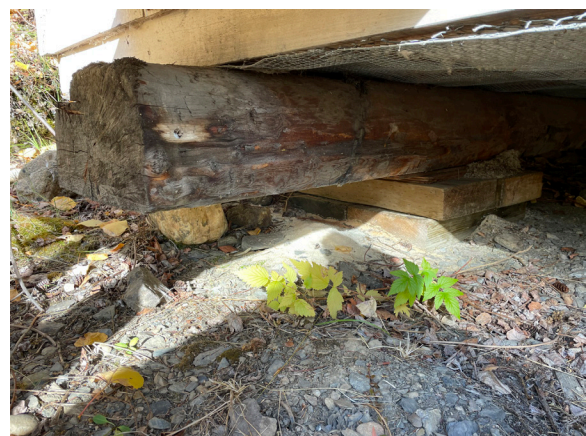
Image 153: Projecting log skids are weathered.

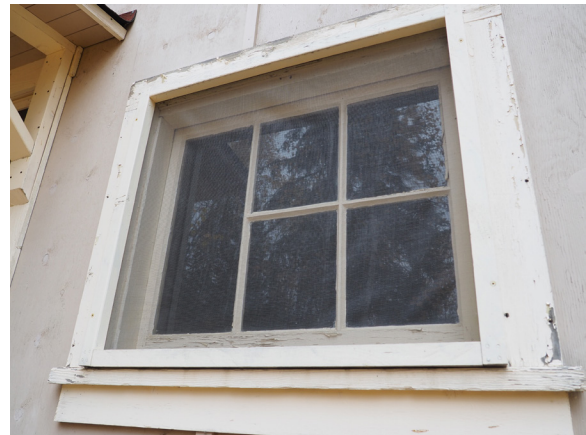
Windows are in fair condition with moderate surface and paint deterioration at the exterior. Windows fit loosely in their frames and are not sealed. Putty glaze is dry and cracked throughout. Window S1 has surface deterioration at the sill and is missing the chain stay. Window W1 is missing a muntin, latch and chain and is nailed closed.

Image 154: Typical hopper window with exterior screen. Window W1 is missing a muntin.

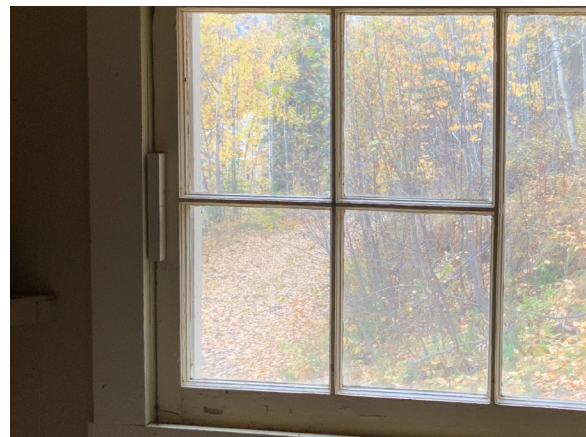
Image 155: Windows are nailed closed using wood blocking.

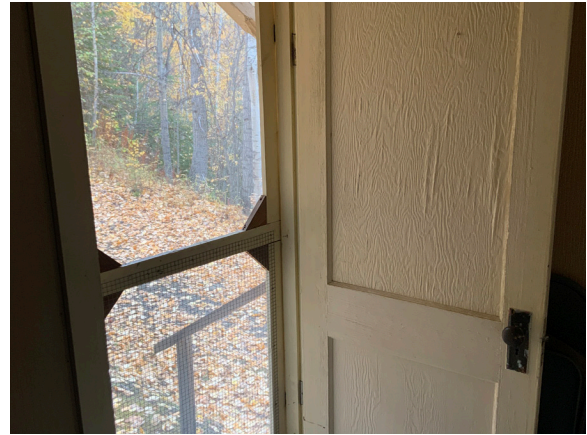
Surface deterioration at both faces of door. Upper panel exterior face is delaminating. Handleset is in working condition. Spring closer is in good operable condition.

*Image 158: East entrance door with exterior delamination at upper panel.*

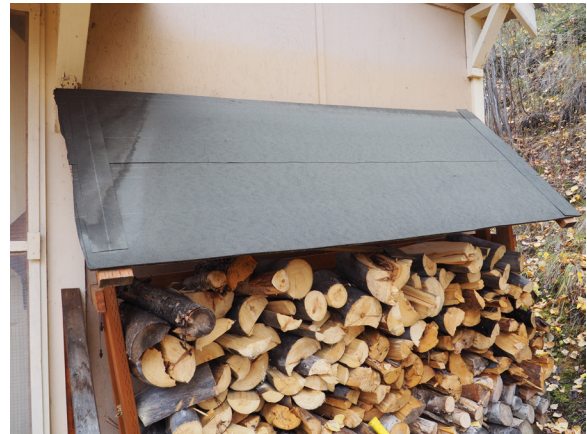
Shed and wood pile is stacked directly against the building. Rolled roofing has biogrowth. The location of the wood shed violates the NPS Eastern Area Fire Management (EAFM) prescription, which requires firewood to be stored a minimum of 30' from all structures.

*Image 159: Wood shed roof with biogrowth.*

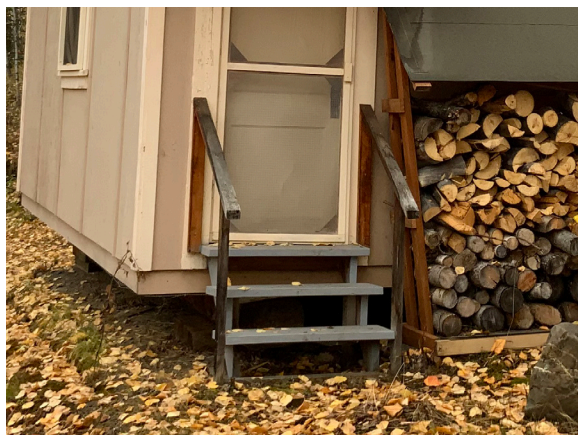
Entry stair and handrails do not meet code for landing requirements, tread or riser dimensions, and handrail heights and profiles. Both stairs are in fair condition with surface wear. Both handrails are in poor condition with severe wood rot.

*Image 157: Severe rot at west entry handrail.*

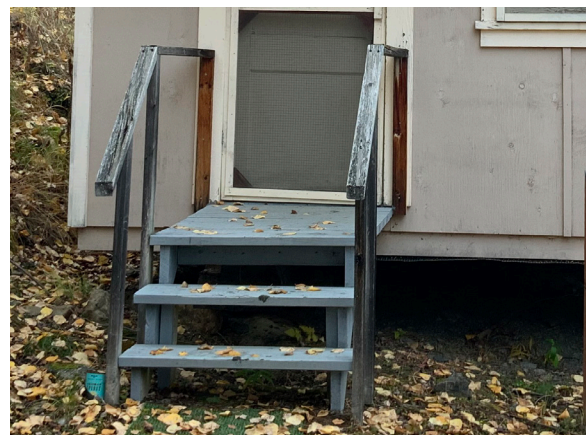
*Image 160: Severe rot at east entry handrail.*

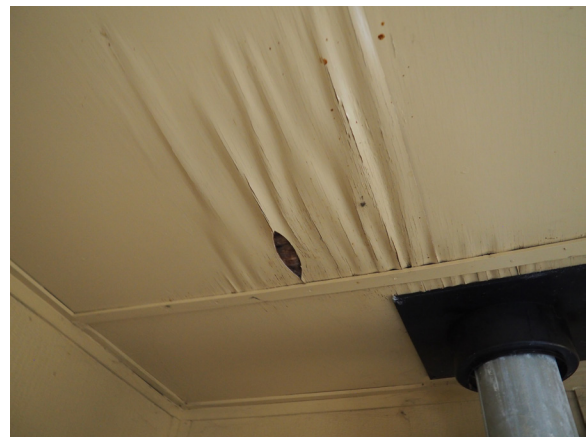
The ceiling surrounding the chimney penetration has severe water damage with 21% WME recordings.

Image 162: Delamination and water damage at plywood ceiling surrounding chimney.

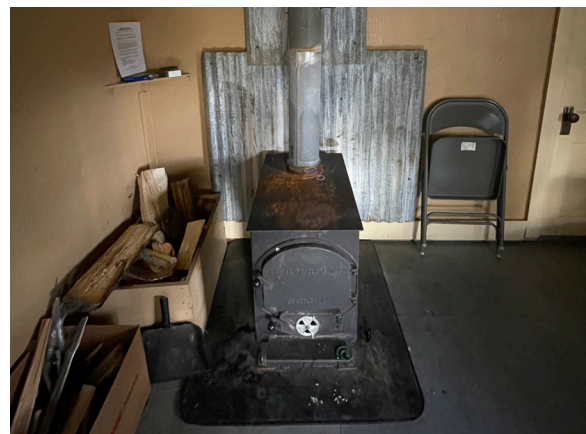
The stove location does not meet clearance requirements from adjacent interior walls. Wood stove pipe is leaking. Stove appears in operating condition.

Image 163: Wood stove with corrugated metal radiation shield.

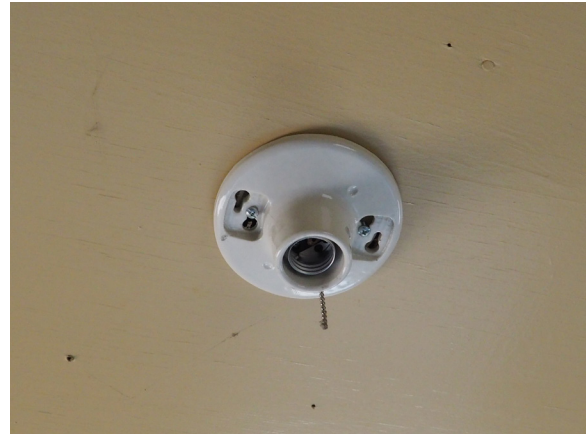
Light bulbs are missing. Electricity no longer runs to the building.

Image 164: Porcelain socket and missing bulb.

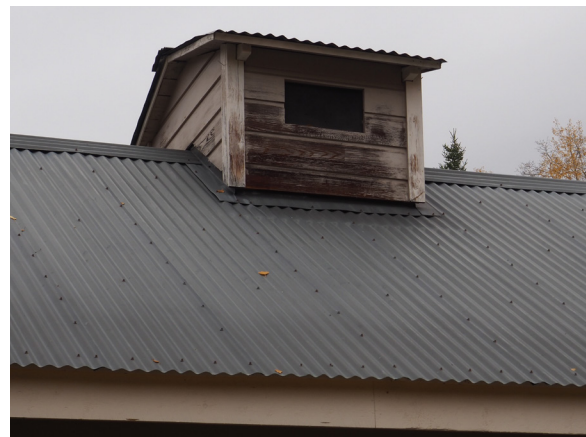
Image 168: Paint weathering at roof cupola.

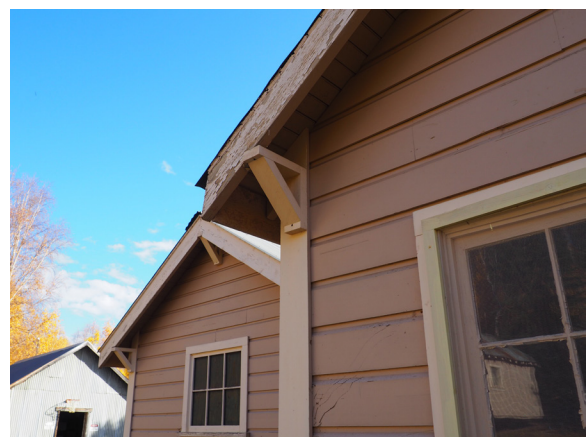
There is surface rot at the west elevation bargeboard return where the bunkroom meets the hall. Paint is weathering at the north elevation bargeboards.

Image 169: Paint weathering at north elevation bargeboards.

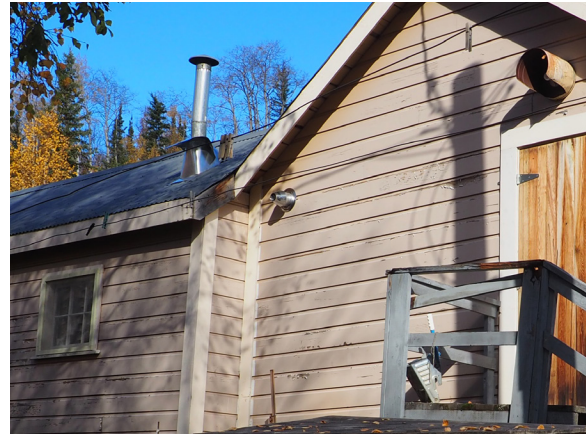
*Image 170: Wood rot at intersecting roofs at the west elevation.*

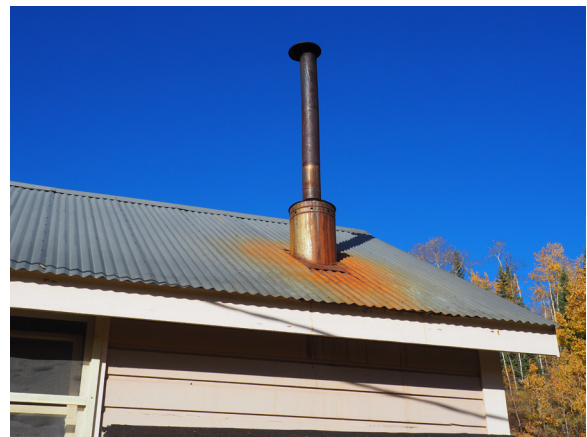
*Image 171: Moderate corrosion surrounding Mess Hall chimney projection. Chimney is not braced.*

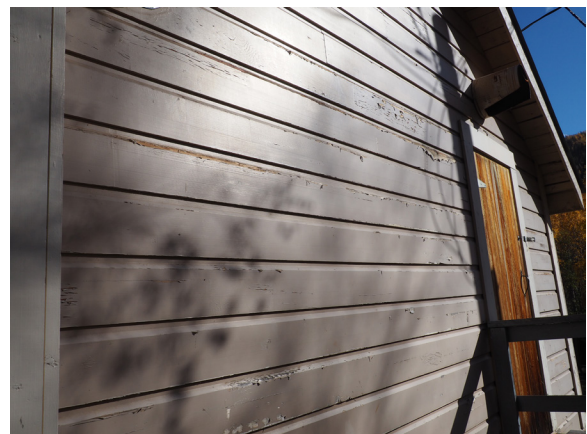
Exterior drop siding is weathered with paint deterioration throughout. Paint is weathered at the west, south, and east elevations. There is insect and bear scratch damage at the north elevation near windows. The pantry wing is settling away from the main building, leaving a gap in the siding. Drop siding at the cupola is weathered at the south elevation.

*Image 172: Detail of exterior drop siding and paint weathering.*

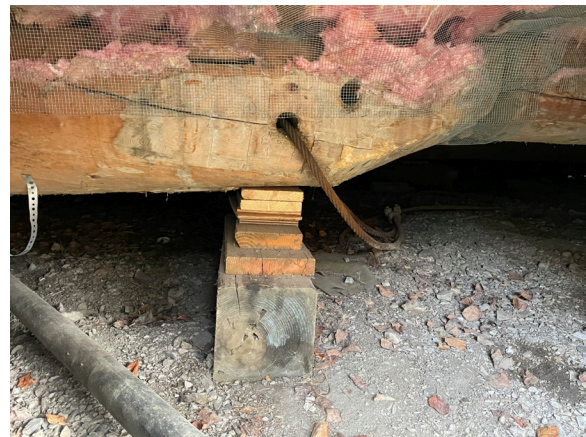
*Image 174: Chamfered log skids at splice, with abandoned tow cable and support cribbing.*

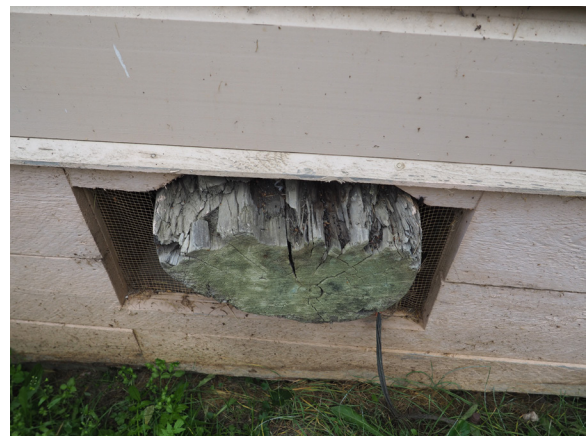
Exposed projecting ends of the log skids are weathered. The log skid projecting at the west elevation hall shows active rot and moisture levels above 12% WME. Melting permafrost at the bermed earth below is resulting in severe settlement and ground upheaval. To level the Mess Hall, the log skids are shimmed with various wood blocking and cribbing.

*Image 175: Active wood rot at projecting log skid at east elevation.*

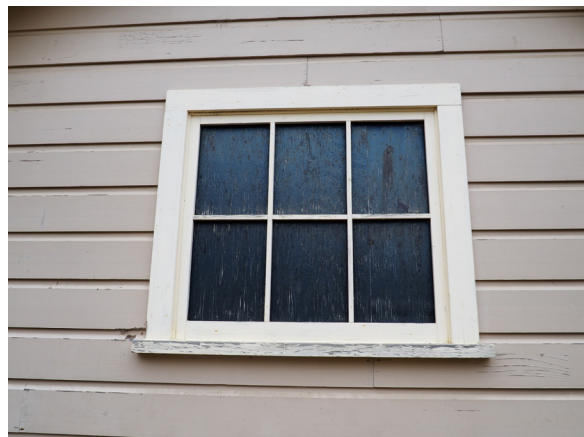
Image 177: Pantry window N1 infilled with plywood for security.

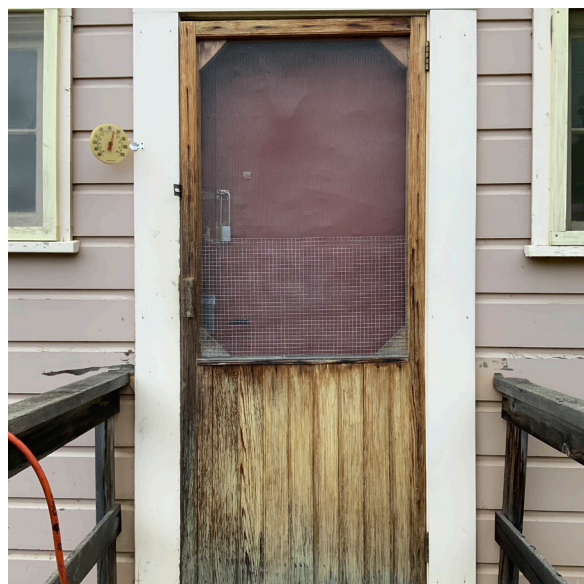
Image 178: Door D2, main entrance.

Wood door has severe surface deterioration. Plywood infill is deteriorating. Exterior screen is weathered, screen is torn and patched. Handleset is loose, sliding bolt used to latch door. Spring closer is in good operable condition.

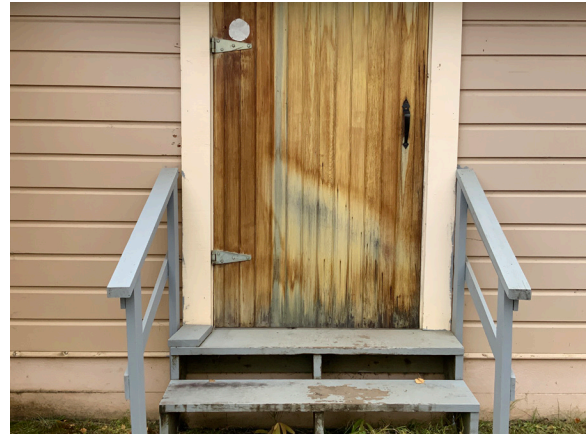
Entries D1 and D4 have surface wear at the treads. Entries D2 and D3 are severely rotted and unstable.

*Image 179: Surface wear at door D1.*

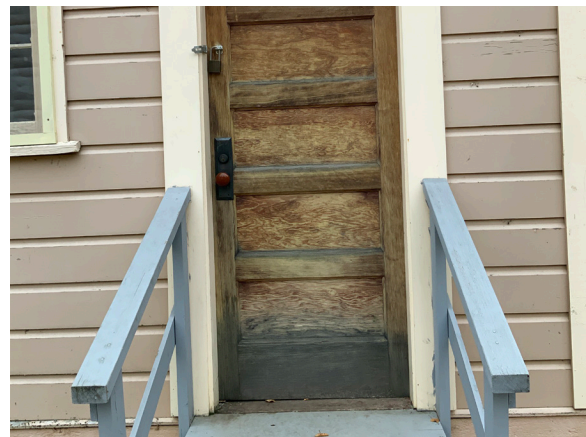
*Image 180: Surface wear at door D4*

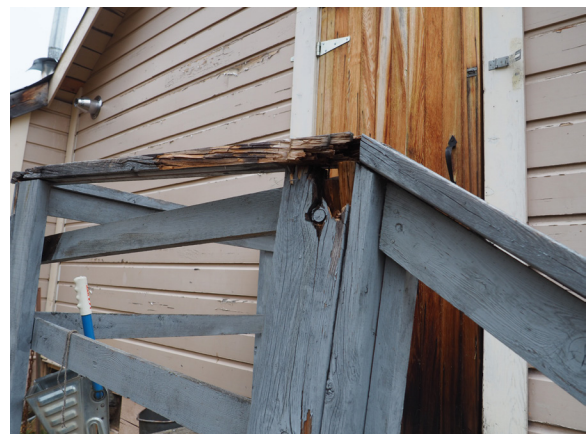
*Image 181: Severe wood rot at west elevation handrail.*

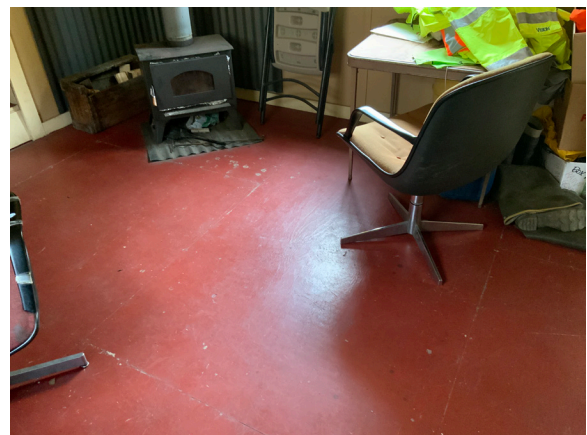
Plywood floors are fair throughout with paint and surface deterioration.

Image 186: Painted plywood flooring in bunkroom.

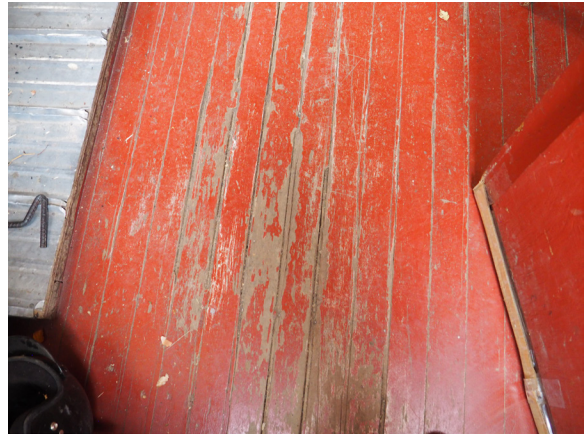
The wood tongue and groove floor is in poor condition with gaps between boards, splintering, and surface wear.

Image 187: Surface wear at wood floor near main entrance in mess hall.

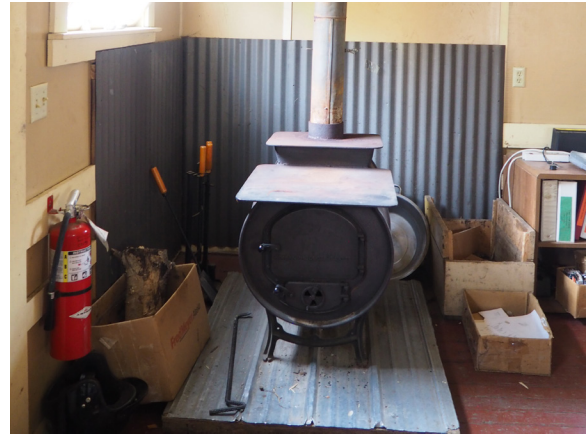
Both stove locations do not meet clearance requirements from adjacent interior walls. Mess hall stove has surface corrosion. No deficiencies noted at bunkroom stove.

Image 190: Mess hall barrel stove with corrugated metal wall shield and v-crimp galvanized steel panel floor shield.

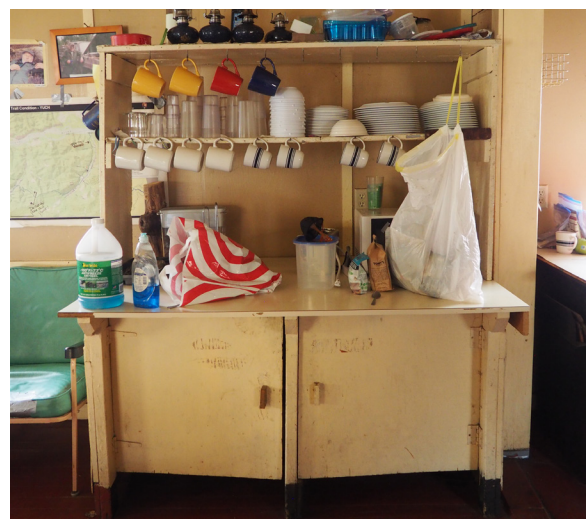
The hutch has surface wear but is in stable condition.

Image 192: Original kitchen hutch, still in use.

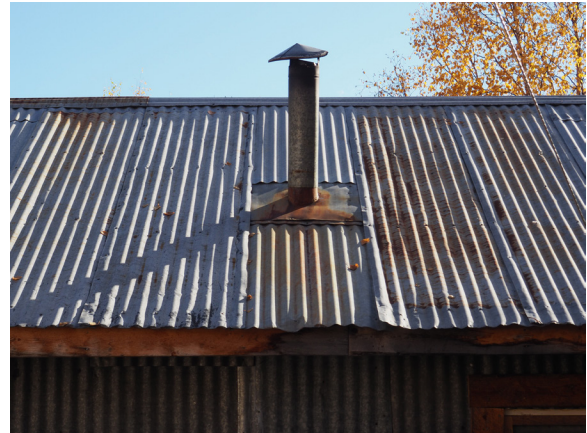
Corrugated metal roofing has mild surface corrosion throughout. A section is loose at the north elevation.

Image 196: Corrugated metal roof with mild corrosion and projecting chimney.

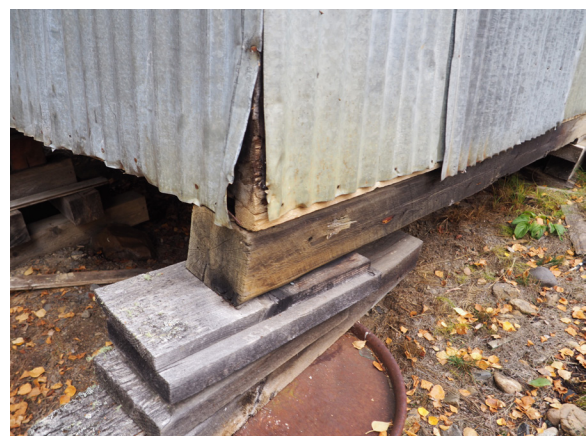
There are holes and penetrations throughout the exterior, which have been patched or double-layered with additional sheathing. The southwest corner is delaminating near the foundation.

Image 198: Bent corrugated metal siding at southwest corner revealing wood framing.

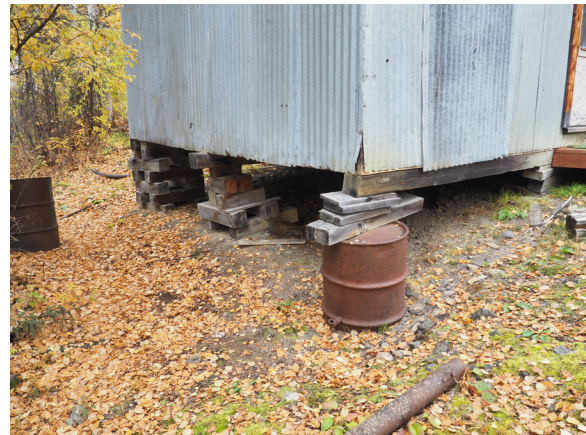
*Image 199: Severe erosion at the west end of the building, with various cribbing and barrels used to support the building.*

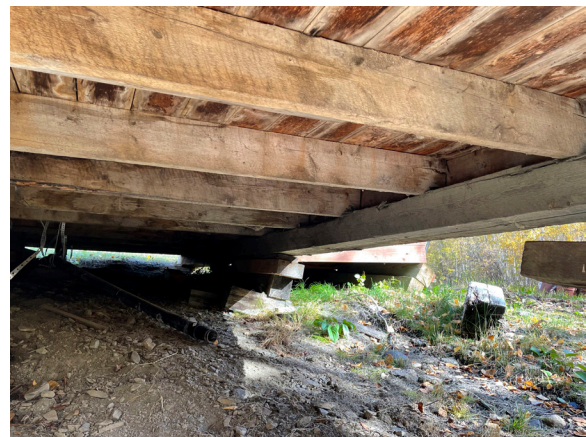
*Image 200: Underside of building with detail of floor framing. Building is not insulated.*

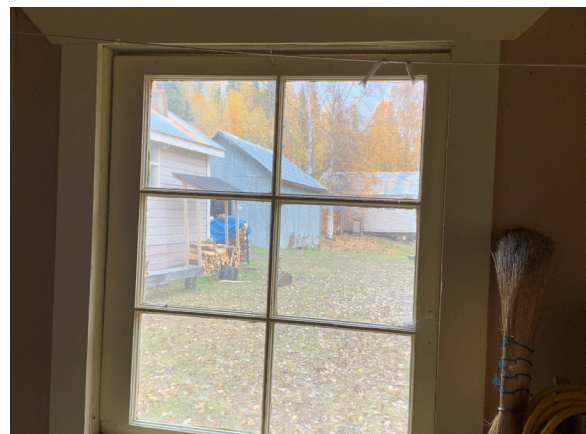
*Image 201: Six-lite window sash, installed sideways.*

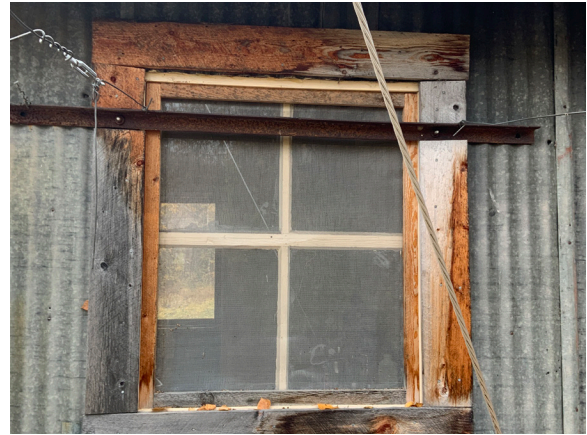
Image 202: North elevation window with metal bar installed across face. Wood trim is weathered.

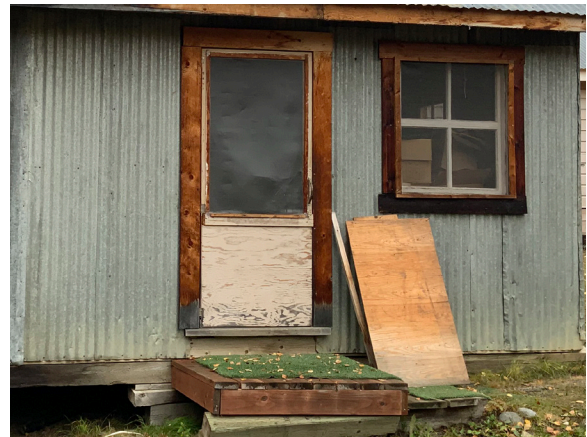
The screen door is severely weathered and warped. Spring closer is in operable condition. Exterior trim is weathered at the base. Interior trim is in good condition.

Image 203: South entry screen door, severely weathered.

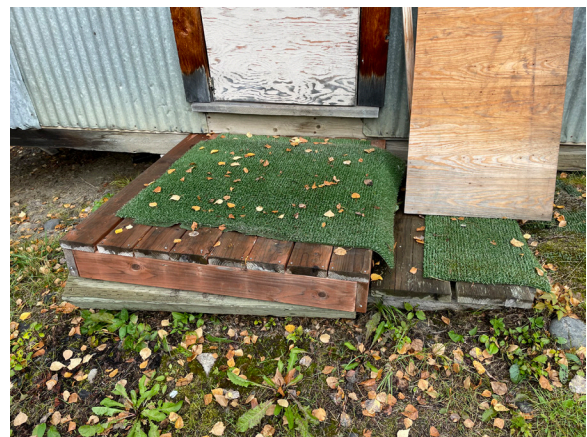
The entry stair and landing does not meet code for landing requirements, tread or riser dimensions. The landing has severe rot and is propped on wood blocking due to erosion below.

Image 204: South entry landing is unstable with wood rot.

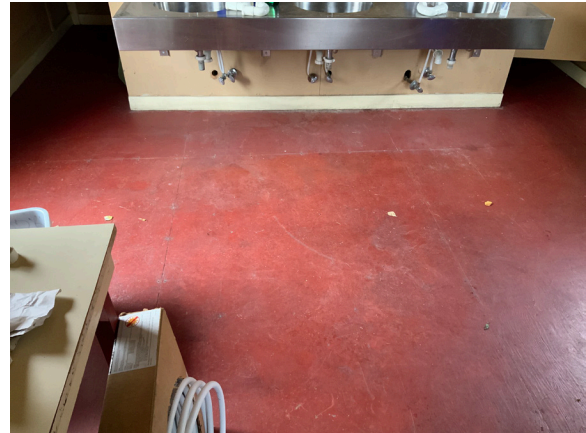
Plywood floors are fair throughout with paint and surface deterioration.

Image 205: Painted plywood interior flooring.

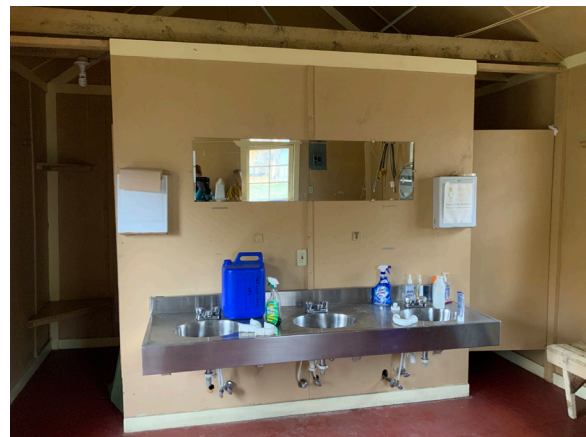
Plywood walls and battens are fair throughout with paint and surface deterioration.

Image 206: Plywood walls with battens. Sinks are wall-mounted on an interior partition separating the laundry room from shower rooms.

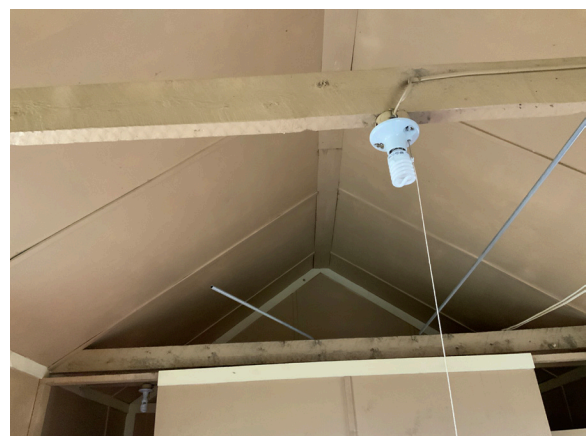
Image 207: Gabled ceiling with exposed joists and porcelain light sockets.

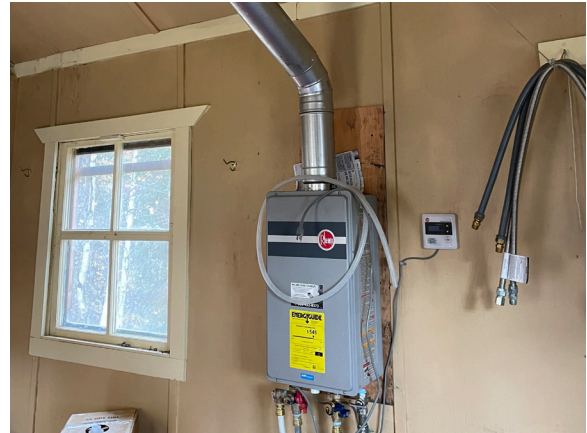
According to NPS, the water heater has not been connected to domestic water supply due to improper connections and equipment.

Image 208: Wall mounted on-demand hot water heater, not in use.

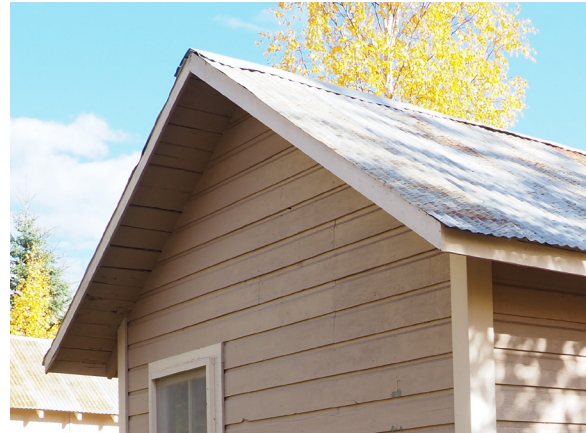
Corrugated metal roofing has mild surface corrosion throughout, with moderate corrosion concentrated around the chimney. A section is loose at the east elevation. The ridge flashing is patched with smooth metal panel at the north gable.

Image 211: Roof ridge flashing replaced with sheet metal at north end.

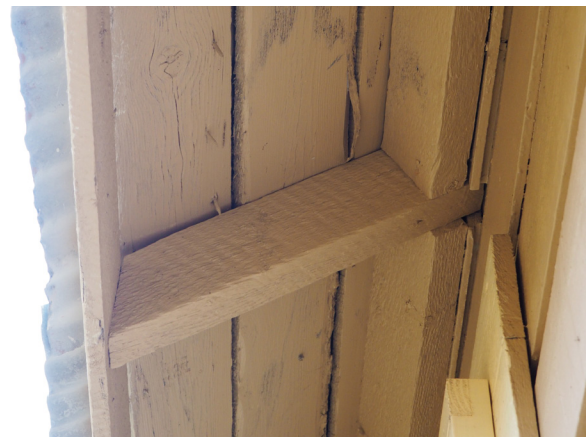
Moderate rot at exposed sheathing at north gable.

Image 212: 1x6 plank sheathing visible at exposed eaves.

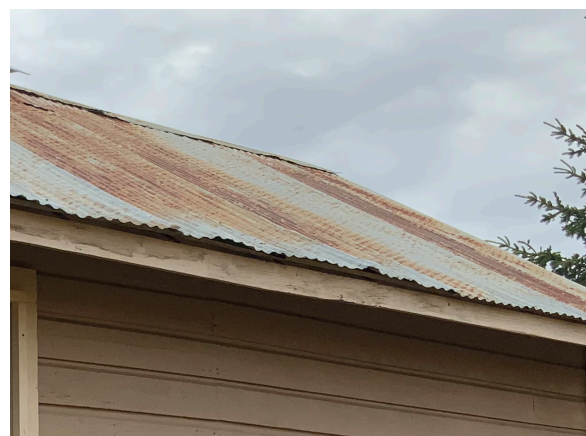
Image 213: Mild to moderate corrosion of corrugated metal roofing.

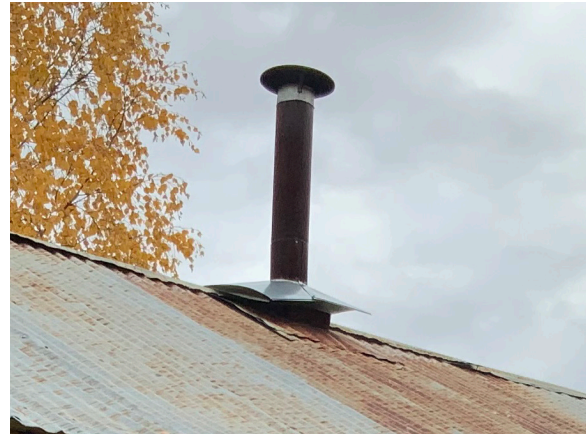
The chimney is not braced. The metal thimble does not extend down the interior ceiling finishes, leaving the ceiling unprotected.

*Image 214: Chimney projects from gable, with storm collar and cap.*

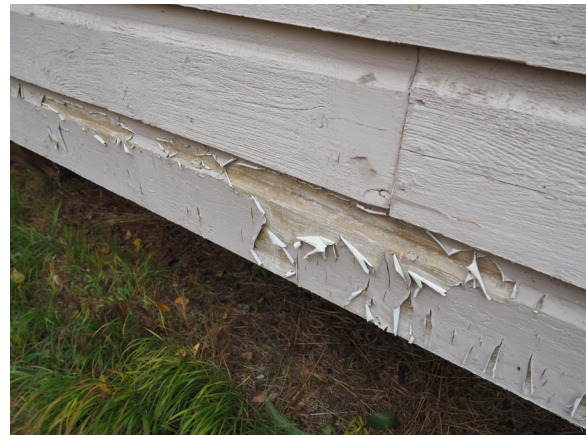
Exterior siding is weathered with paint deterioration throughout.

*Image 215: Typical paint failure at exterior drop siding.*

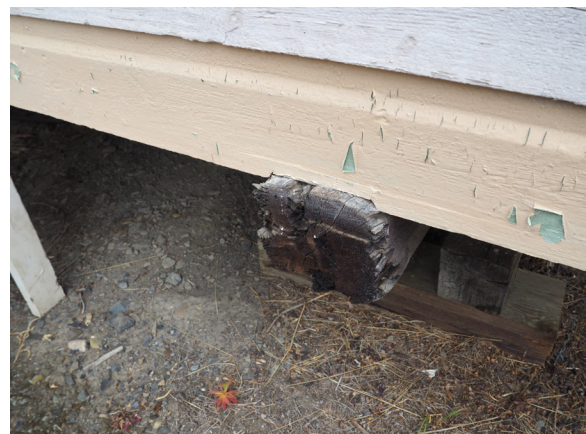
*Image 216: Projecting log skids are weathered.*

Exposed projecting ends of the timber skids are weathered with biogrowth. Melting permafrost at the bermed earth below is resulting in severe settlement to the south elevation. To level the building, the timber skids are shimmed with various wood blocking and cribbing at the south elevation.

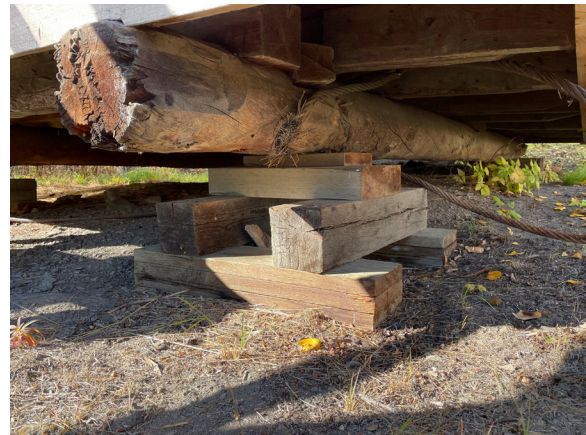
Image 217: Wood cribbing supports log skids.

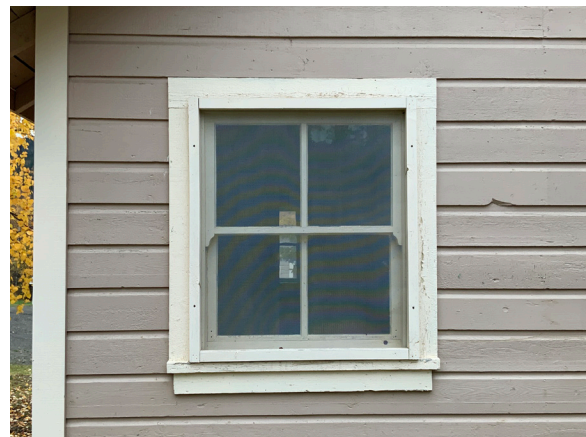
Windows are in fair condition with moderate surface and paint deterioration at the exterior. Windows fit loosely in their frames and are not sealed. Putty glaze is dry and cracked throughout. Window W1 has a warped screen.

Image 218: Typical two-over-two wood double hung window with exterior screen.

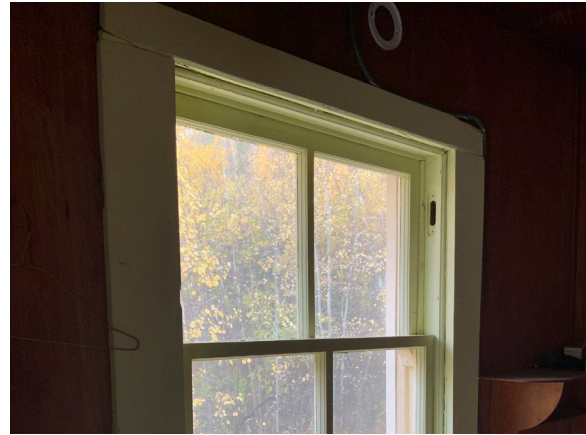
Image 220: Detail of missing double hung sash ropes.

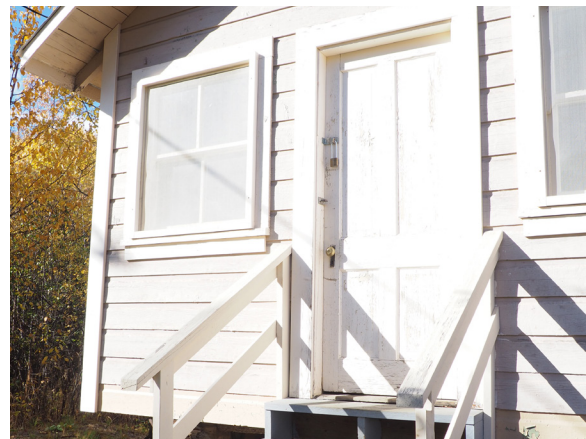
Surface deterioration at both faces of door. Handleset is in working condition.

Image 221: Exterior four-panel wood door.

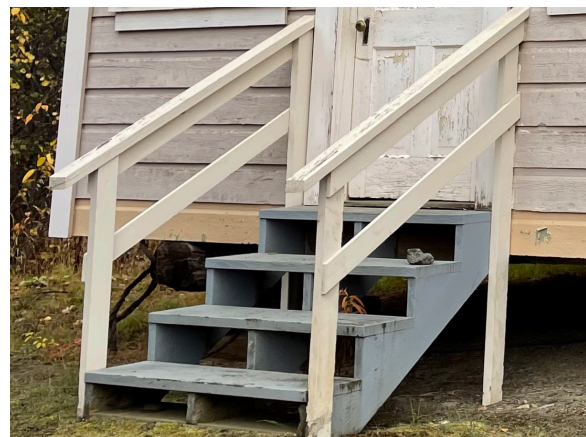
Entry stair and handrails do not meet code for landing requirements, tread or riser dimensions, and handrail heights and profiles. The stair and handrail are in fair condition with surface wear. The handrail recorded 15% WME but no rot was evident.

Image 222: South entry stair.

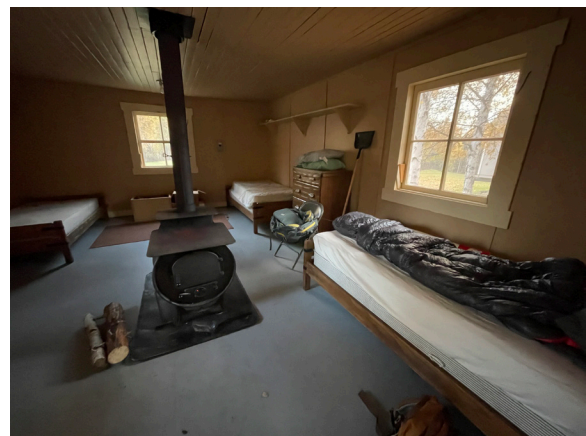
Beadboard is in fair condition with gaps. Plywood is in good condition.

Image 225: Painted beadboard ceiling.

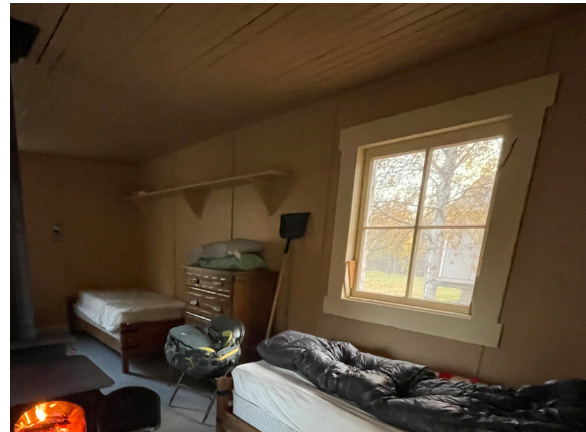
Light bulbs are missing from all locations. Electricity no longer runs to the building.

Image 227: Surface conduit and porcelain socket light, missing bulb.

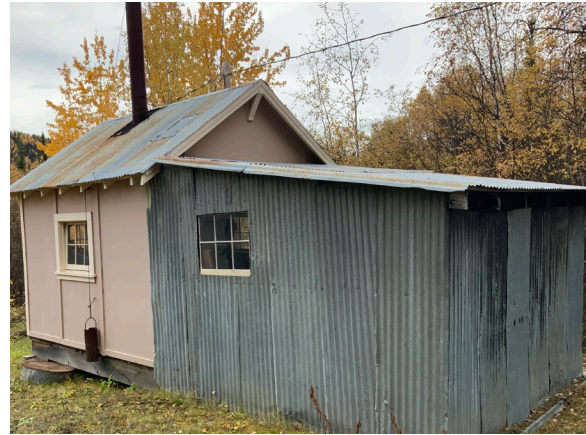
No deficiencies noted at main building. Active rot at north addition.

Image 230: Corrugated metal shed addition projects at the north.

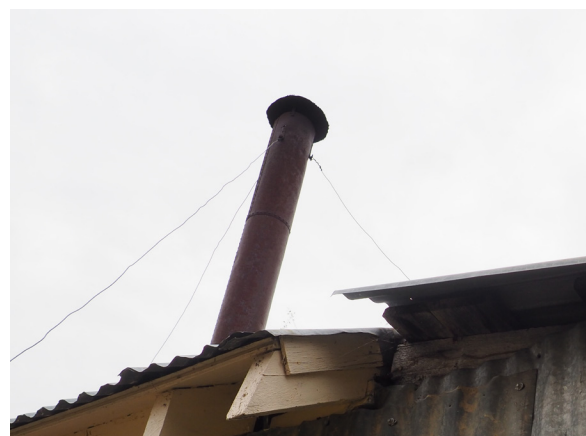
Image 232: Chimney projects from ridge at main building and is braced using cables.

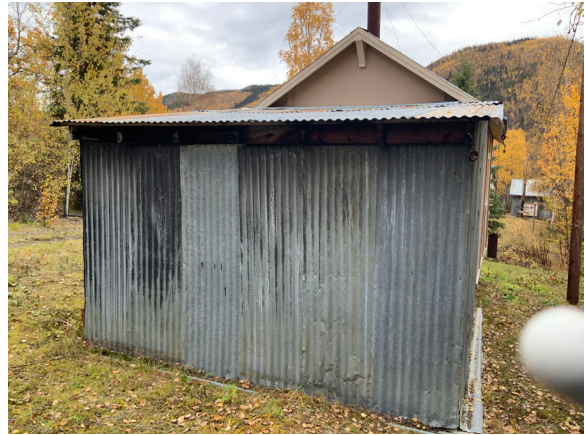
Metal is in fair condition with denting and hole punctures throughout. Holes appear to be patched or repair with added layers of corrugated paneling.

Image 233: Corrugated metal siding is dented throughout.
