# **Coal Creek Camp**

## **YUKON-CHARLEY RIVERS NATIONAL PRESERVE, ALASKA**

### **HISTORIC STRUCTURE REPORT**

**NPS Task Order #140P2021F0185**  
**April 2022**

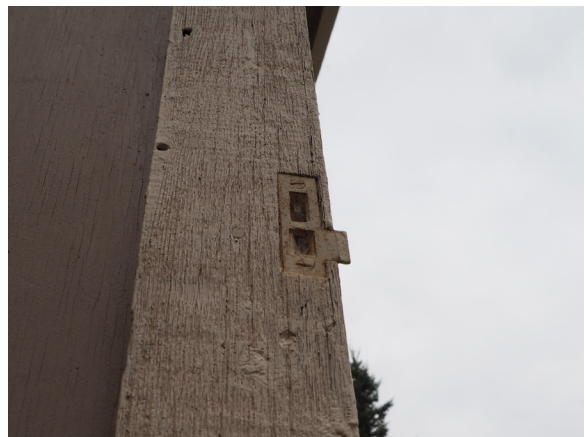
Image 234: Remnants of door hardware at exterior corner board trim, evidence that wood trim was salvaged from another building.

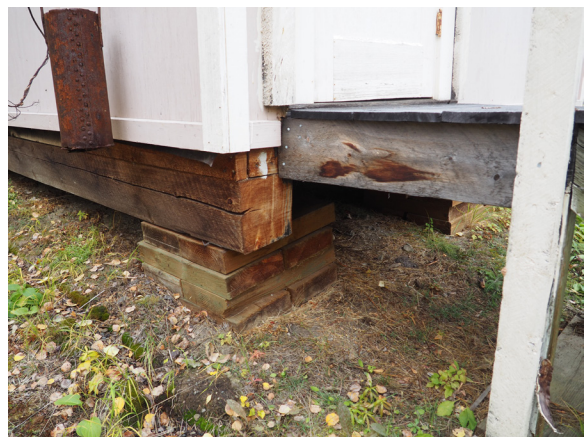
Image 235: Wood skids and cribbing at south elevation, below entry stair.

Exposed projecting ends of the timber skids are weathered and checked with moderate rot. Melting permafrost at the grade below is resulting in severe settlement to the south. To level the office, the skids are shimmed with various wood blocking and cribbing at the south elevation.

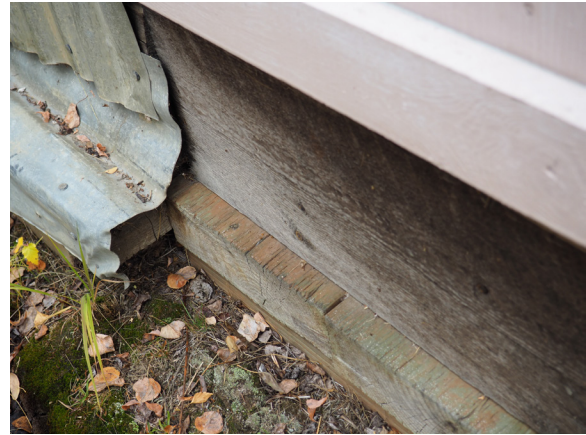
*Image 236: Wood sills are flashed in corrugated metal at the north addition.*

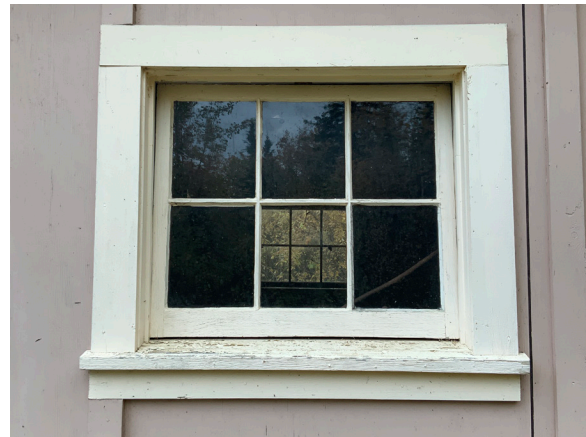
*Image 237: Typical hopper window, no exterior screen.*

Windows are in fair condition with moderate surface and paint deterioration at the exterior. Windows fit loosely in their frames and are not sealed. Putty glaze is dry and cracked throughout.

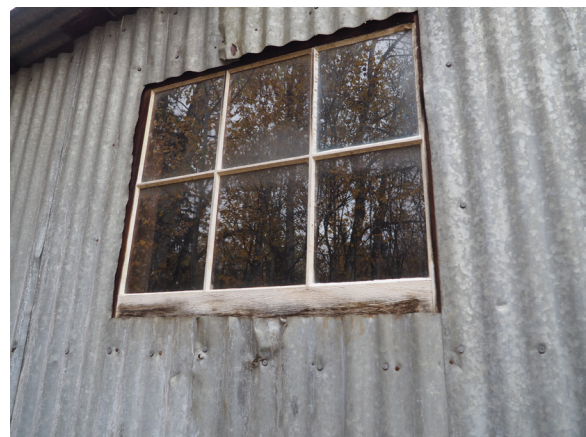
*Image 238: Typical fixed sash at north addition, no trim.*

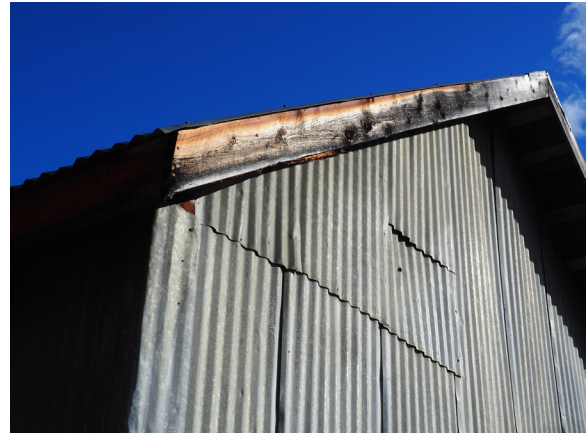
Image 242: Natural finish bargeboards with surface weathering.

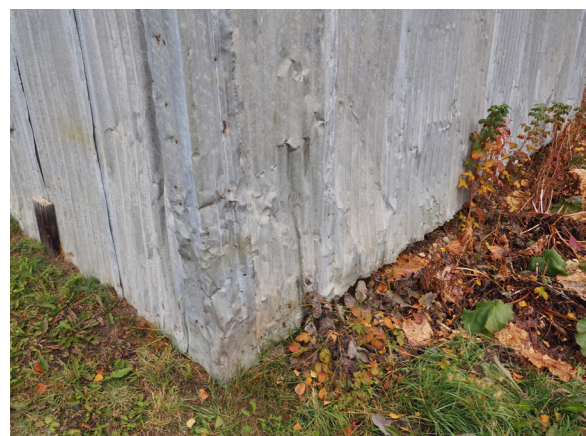
Metal panels are dented throughout, typically near the base of the building. Hole punctures are typical at the north and west elevations.

Image 244: Corrugated metal siding is dented throughout.

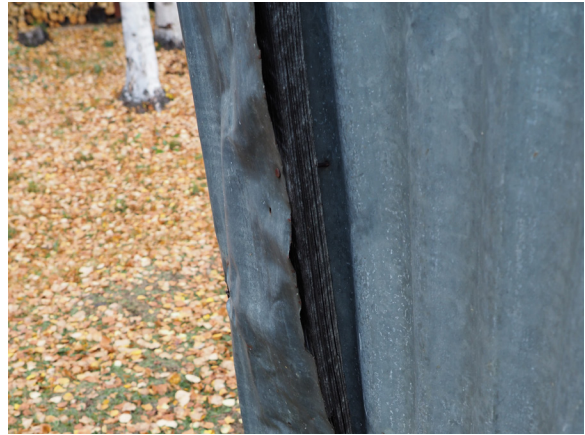
Exposed surfaces of wood nailers at building corners exhibit rot and high moisture levels.

*Image 245: Corners are treated with wood nailers and wrapped corrugated metal.*

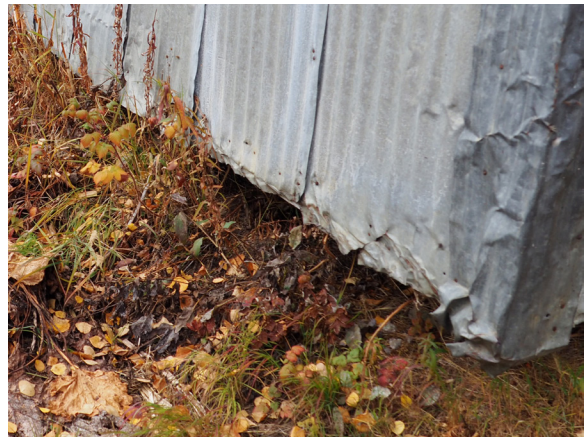
Projecting log skid ends have elevated moisture levels and moderate rot.

*Image 246: Minimal exposed log skids are visible at east elevation.*

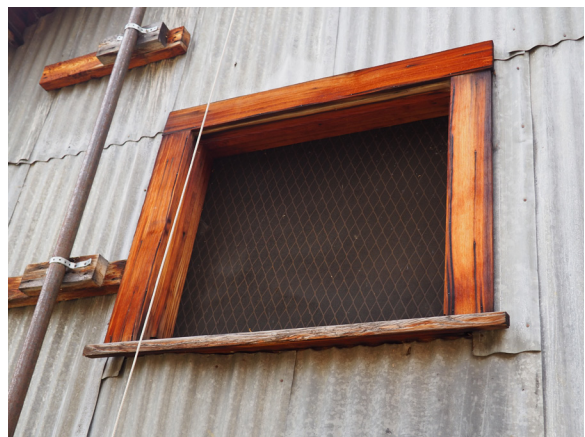
Screen is in good condition with surface deterioration at exterior trim.

*Image 247: Screened window opening at east elevation.*

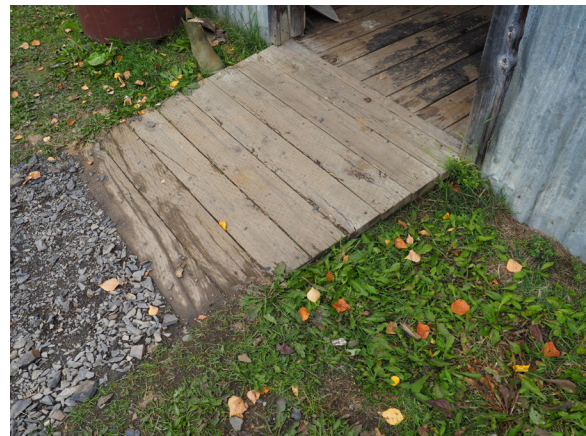
Ramp has settled into the earth but is in good condition.

Image 249: Entry ramp.

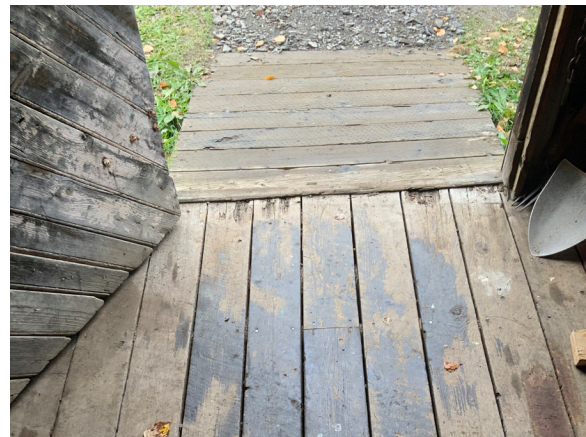
Wood is in fair condition with surface wear and staining.

Image 251: Wood floor has surface wear and staining.

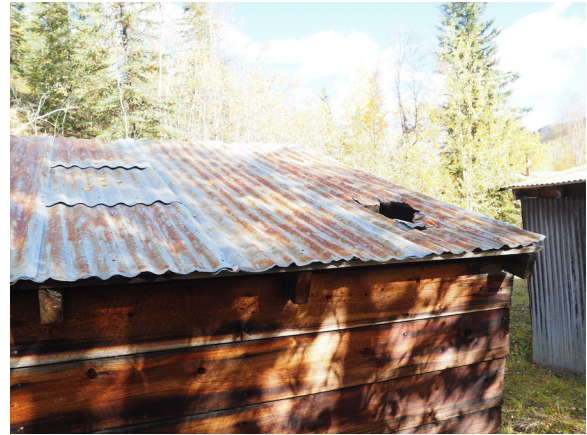
Corrugated metal roofing has moderate corrosion and large hole at the southwest corner, likely from vent pipe no longer extant.

Image 254: Moderate corrosion and abandoned chimney hole at roof.

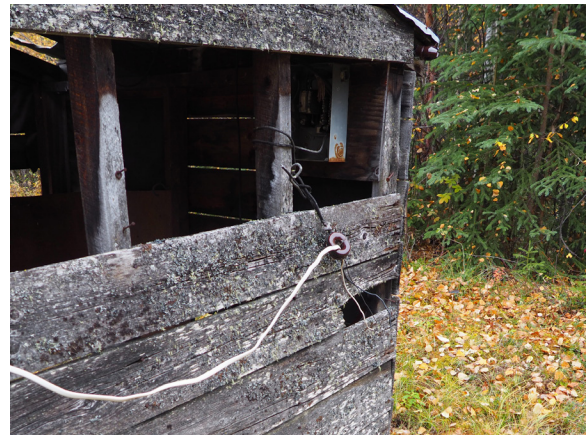
Siding is in poor condition with severe rot and missing members at the north, west, and south elevations.

Image 255: Typical exterior siding with severe wood rot and active biogrowth. Siding is missing throughout.

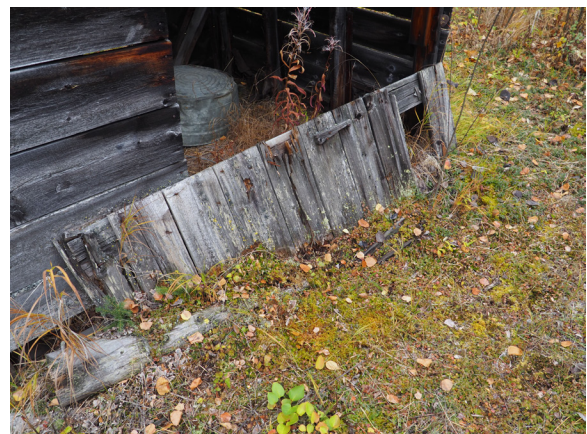
One door slab remains, deteriorated and rotting on the ground.

Image 256: One panel of the original double door is rotting on the ground.

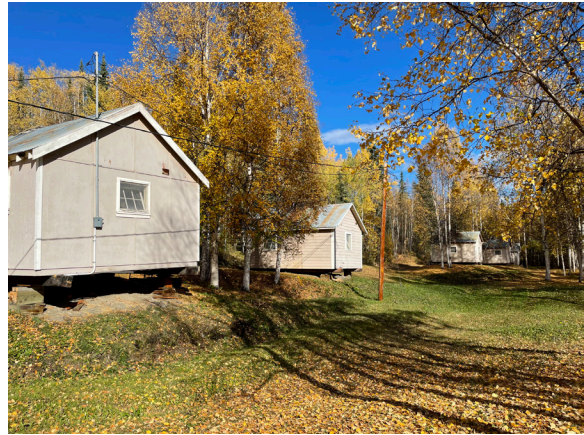
*Image 257: Typical slope south of the bunkhouses showing south sides on cribbing.*

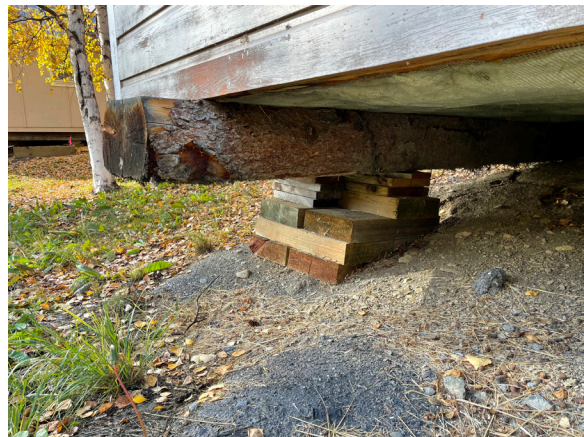
*Image 258: Bunkhouse #2 cribbing composed of dimensional lumber and stacked shims.*

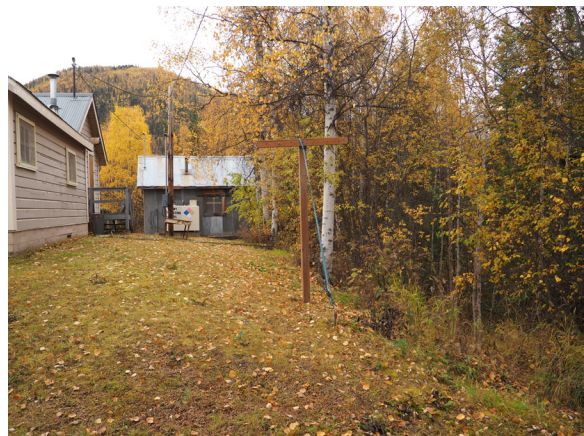
*Image 259: Slope dropping down to the creek behind the Mess Hall (foreground) and Laundry building (distance).*

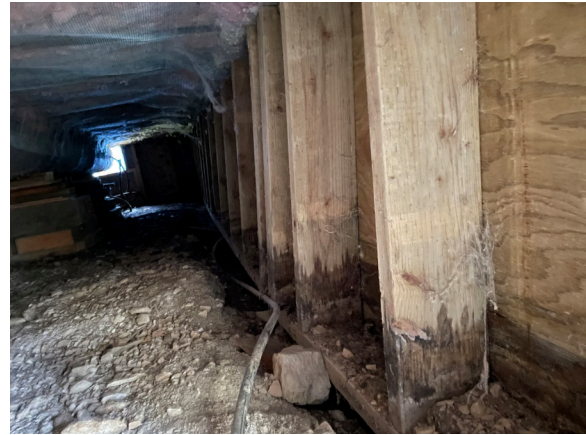
Image 260: Decayed perimeter skirting supported directly on soil.

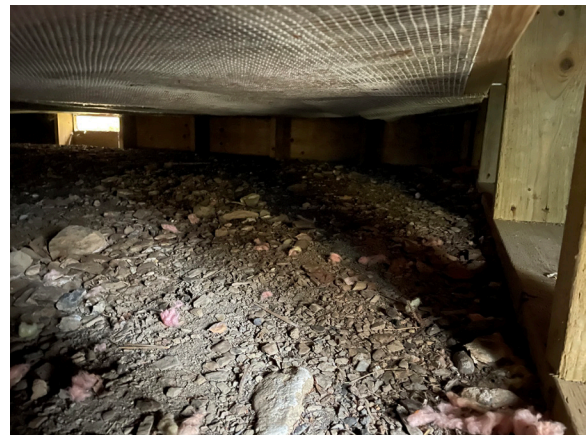
Image 261: Perimeter skirting or cripple wall supported directly on soil.

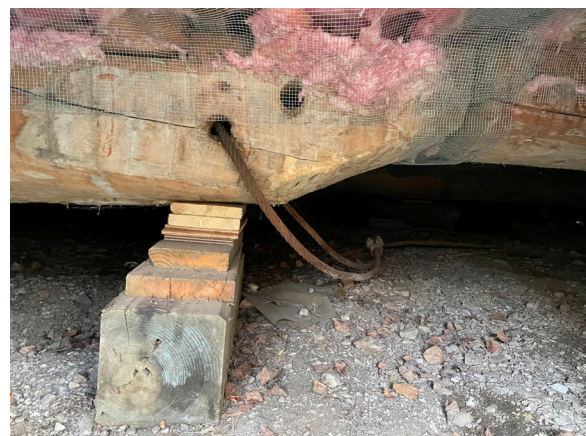
Image 262: Narrow stack of cribbing.

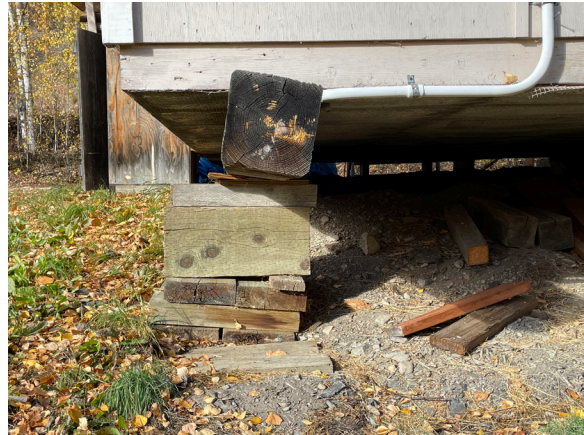
Image 263: Settled timber skid cribbing at Bunkhouse 1.

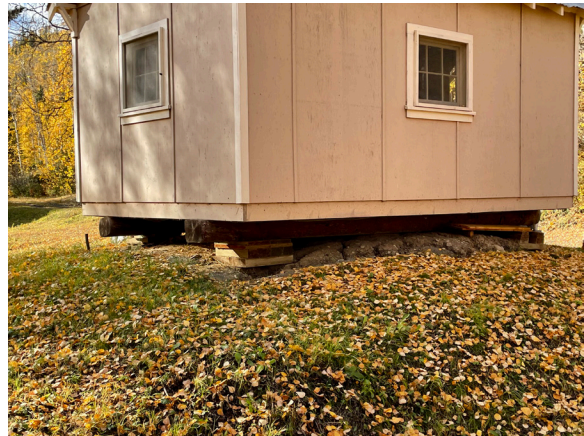
The cribbing on this building has settled and appears to be on disturbed soil. The nature of the soil disturbance is unknown but may be related to frost-heave or other seasonal actions. The cribbing configuration itself otherwise appears good, providing broad, stable support for the sawn log skids.

Image 264: Settled sawn log skid cribbing on disturbed soil at Bunkhouse 3.

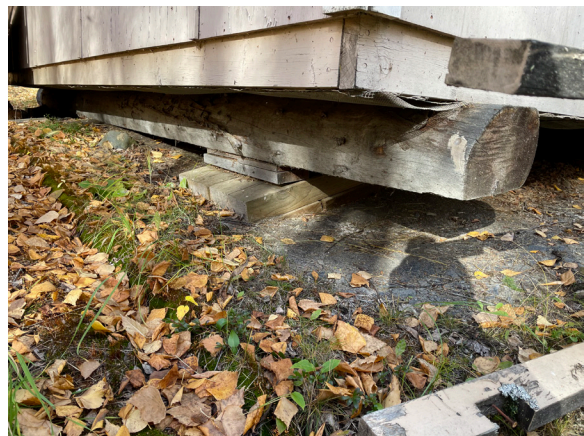
Image 265: Settled sawn log skid cribbing on gravel at Bunkhouse 5.

Most of these deficiencies are minor, however the overall foundation configuration of the buildings represents the greatest source of life-safety and resource loss hazard. The skid buildings supported directly on the ground or on low, stable cribbing would be expected to perform better than buildings on un-even sites and/or tall cribbing.

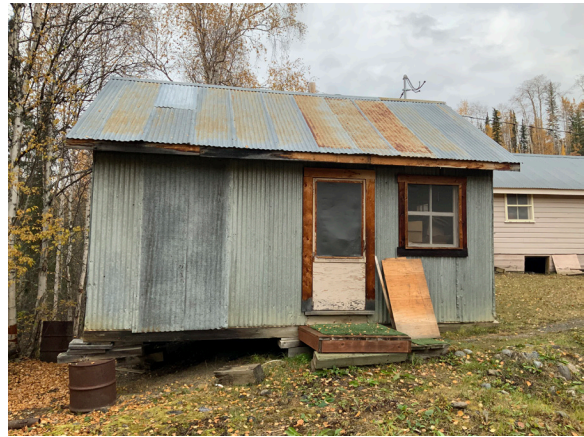
- Lack of ties between diaphragms and walls
- General lack of foundations providing support for overturning uplift or sliding
- Unstable cribbing which could result in toppling and large displacements of the structures

Image 266: Unstable cribbing at Laundry building.

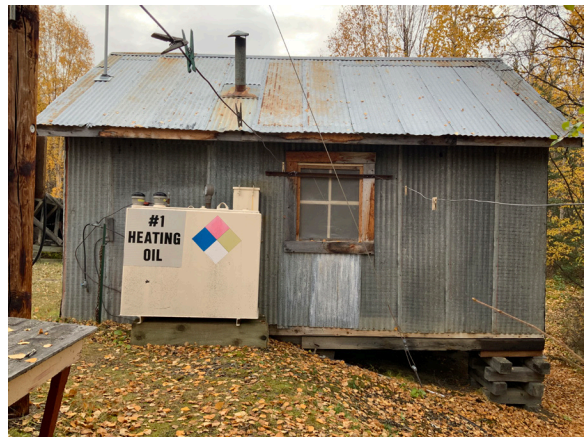
An additional seismic deficiency observed relates to the fuel oil tank adjacent to the Laundry Building. The tank appears to be free-standing on wood timbers. This tank may be prone to overturning in a seismic event and the laundry building is also particularly prone to shifting during a seismic event.

Image 267: Fuel oil tank at Laundry building.

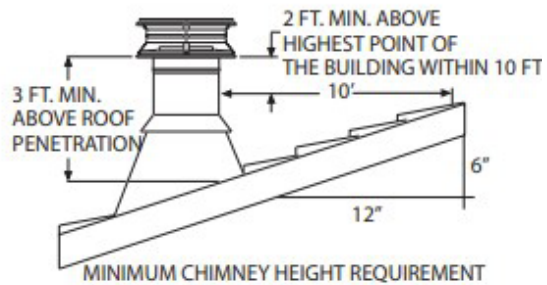
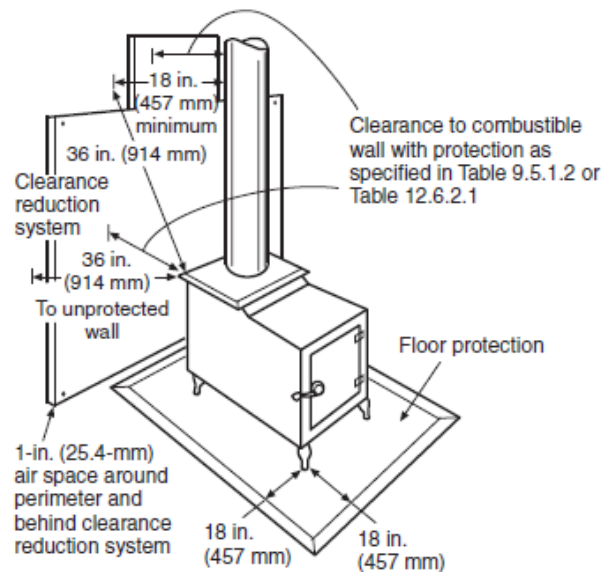
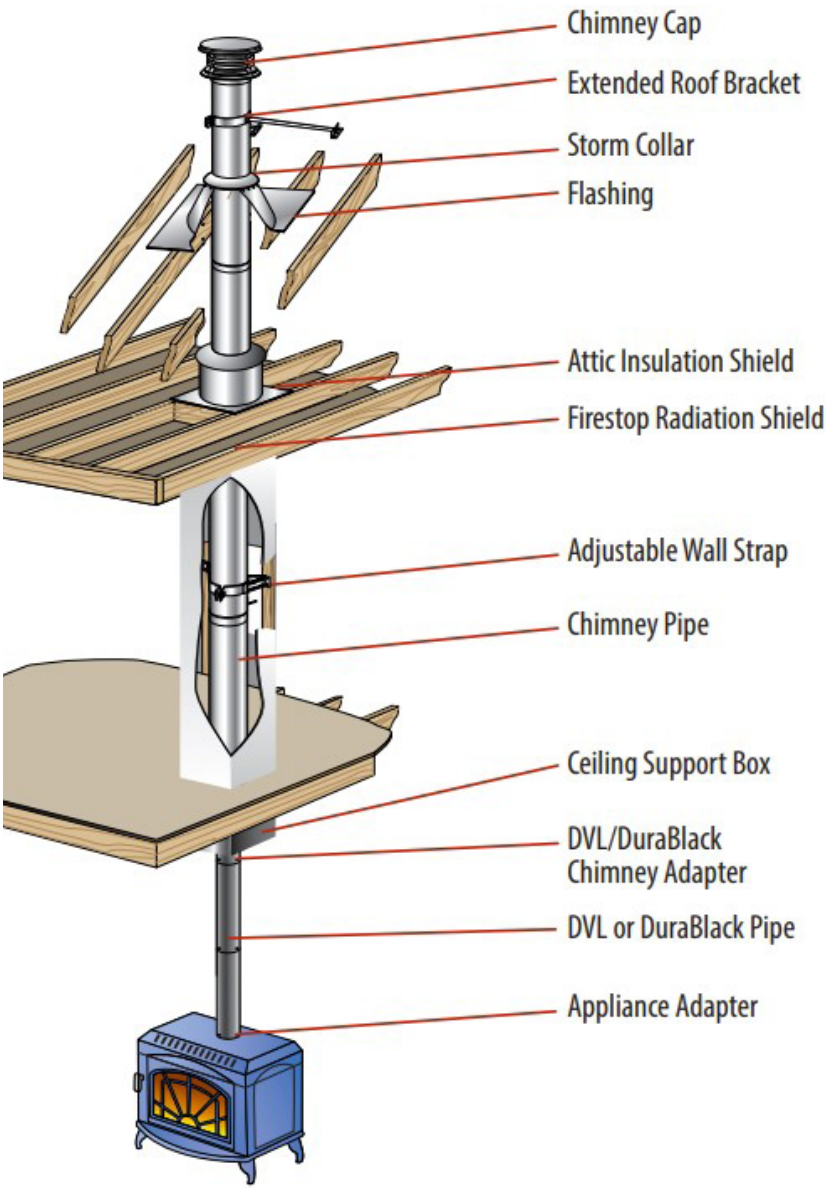
Barrel stoves used inside any kind of structure need to be properly vented and protected against fire. Existing chimneys are predominately scrap piping from dredge operations and are not insulated. The original condition of an extra-large cylindrical thimble that starts just below the ceiling and extends into the attic is likely the only current protection mechanism, providing both a fire stop and insulation shield.

NFPA Standard #211 requires chimney pipes to extend a minimum of 3 feet above the highest point through which the chimney penetrates the roof and a minimum of 2 feet above the highest roof point within 10 feet of the chimney. Adequate protection of the floor and adjacent wall surfaces must be provided with non-combustible materials within 36" of the stove. The chimney collar must have a functional damper where connected to the barrel stove. Where loose or batt-fiberglass insulation exists, an insulation shield is recommended. See Wood Stove and Chimney Components diagrams for illustrations of required chimney components, chimney heights, and stove clearances.

Replacement of chimneys with NFPA-approved insulated chimneys is recommended, such as Duravent DuraTech chimney in black or similar. Include all manufacturer required components, see illustration. In addition, regular inspection and maintenance of barrel stoves should include:

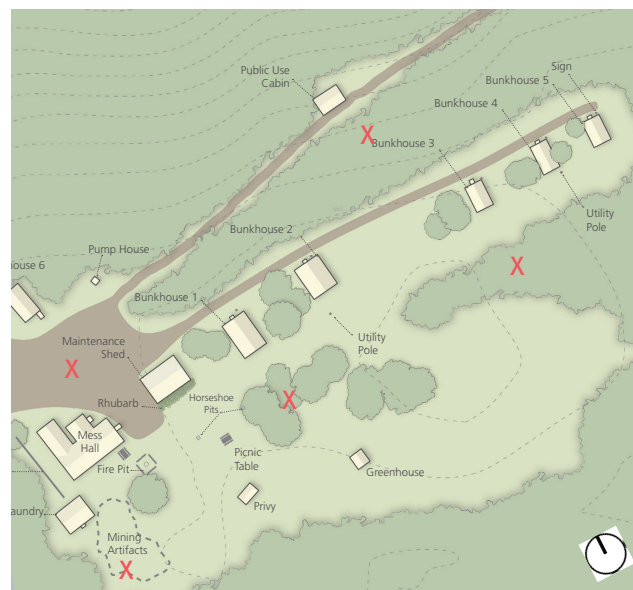
Image 270: 2004 Cultural Landscape Inventory map of Coal Creek Camp, with recommended locations for new wood storage sheds identified by red "x"s.

Per NPS EAFM Remote Cabin Firewise Prescription, all firewood must be stored at a minimum distance of 30' from all structures. Five new wood storage shed locations are recommended in discreet locations across the site to provide firewood within walking distance of all buildings with wood stoves. See recommended locations for new sheds in the diagram below. Actual locations should be confirmed via site measurements.

New wood storage sheds should be simple wood frame structures with shed roofs. The shed roofs should incorporate rolled asphalt roof covering and plywood sheathing to match existing wood sheds. New sheds to use dimensional lumber with exposed structure and cross-bracing for improved stability.

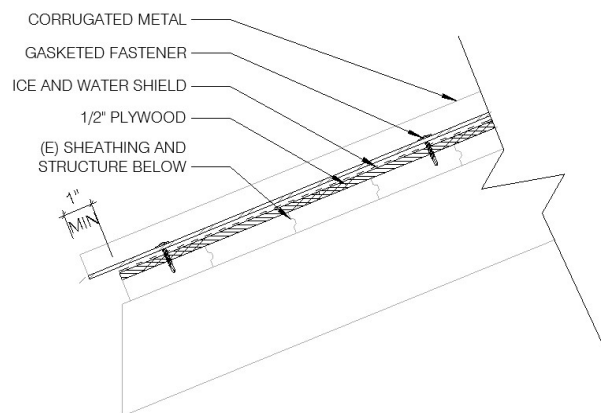
Image 272: Recommended roof covering diagram.

- Remove existing corrugated panels, fasteners, bargeboards, and tar paper (where it exists) down to sheathing or rafters. Salvage panels and bargeboards for reuse.
- Repair sheathing and rafters in-kind where damaged.
- Install 1/2" exterior grade plywood sheathing on top of existing sheathing
- Install ice and water shield on top of plywood sheathing
- Replace moderate or severely corroded panels in-kind, reinstall all other existing panels. Replace all fasteners with neoprene gasketed fasteners.
- Replace chimney flashing.
- Reinstall bargeboards.
- See Assessment of Effect action #1.1 for analysis.

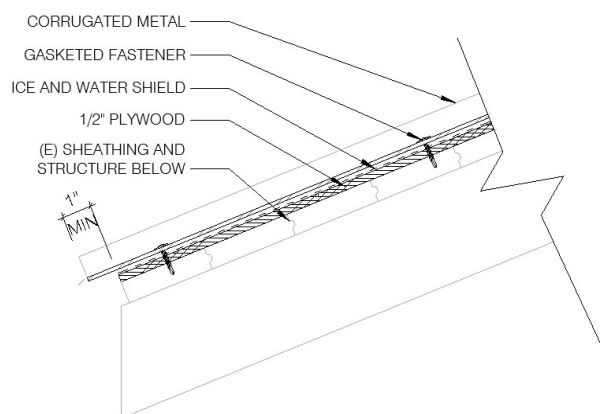
Image 274: Recommended roof covering diagram.

- Remove existing corrugated panels, fasteners, bargeboards, and tar paper (where it exists) down to sheathing or rafters. Salvage panels and bargeboards for reuse.
- Repair sheathing and rafters in-kind where damaged.
- Install 1/2" exterior grade plywood sheathing on top of existing sheathing
- Install ice and water shield on top of plywood sheathing
- Replace moderate or severely corroded panels in-kind, reinstall all other existing panels. Replace all fasteners with neoprene gasketed fasteners.
- Replace chimney flashing.
- Reinstall bargeboards.
- See Assessment of Effect action #1.1 for analysis.

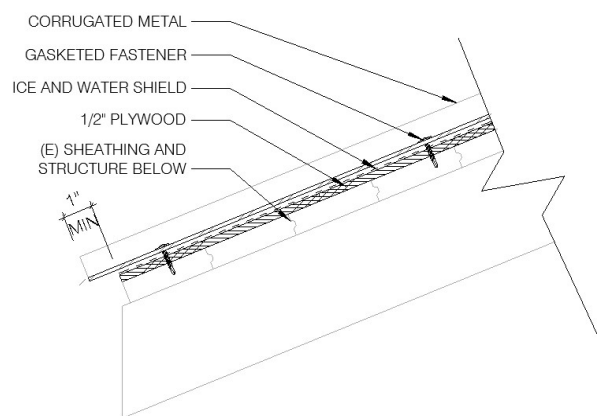
Image 276: Recommended roof covering diagram.

- Remove existing corrugated panels, fasteners, bargeboards, and tar paper (where it exists) down to sheathing or rafters. Salvage panels and bargeboards for reuse.
- Repair sheathing and rafters in-kind where damaged.
- Install 1/2" exterior grade plywood sheathing on top of existing sheathing
- Install ice and water shield on top of plywood sheathing
- Replace moderate or severely corroded panels in-kind, reinstall all other existing panels. Replace all fasteners with neoprene gasketed fasteners.
- Replace chimney flashing.
- Reinstall bargeboards.
- See Assessment of Effect action #1.3 for analysis.

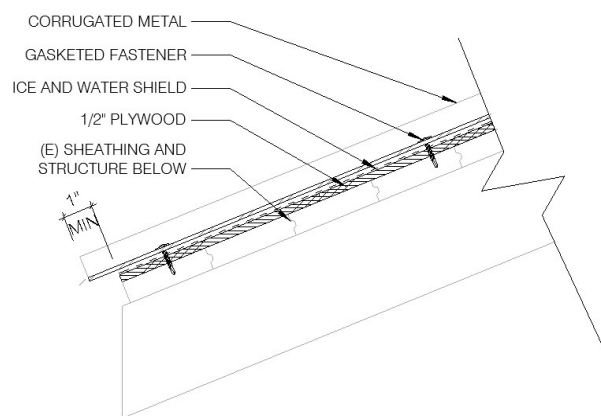
Image 278: Recommended roof covering diagram.

- Remove existing corrugated panels, fasteners, bargeboards, and tar paper (where it exists) down to sheathing or rafters. Salvage panels and bargeboards for reuse.
- Repair sheathing and rafters in-kind where damaged.
- Install 1/2" exterior grade plywood sheathing on top of existing sheathing
- Install ice and water shield on top of plywood sheathing
- Replace moderate or severely corroded panels in-kind, reinstall all other existing panels. Replace all fasteners with neoprene gasketed fasteners.
- Replace chimney flashing.
- Reinstall bargeboards.
- See Assessment of Effect action #1.1 for analysis.

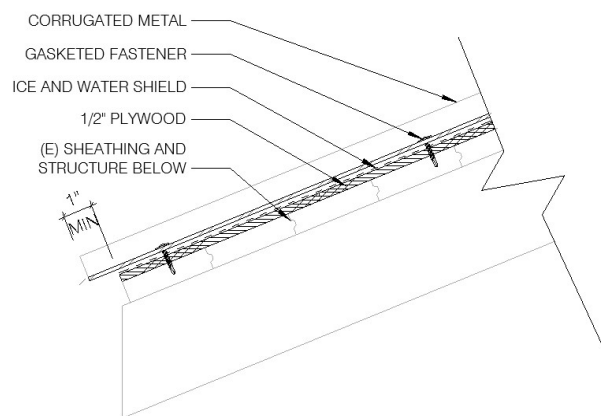
Image 280: Recommended roof covering diagram.

- Remove existing corrugated panels, fasteners, bargeboards, and tar paper (where it exists) down to sheathing or rafters. Salvage panels and bargeboards for reuse.
- Repair sheathing and rafters in-kind where damaged.
- Install 1/2" exterior grade plywood sheathing on top of existing sheathing
- Install ice and water shield on top of plywood sheathing
- Replace moderate or severely corroded panels in-kind, reinstall all other existing panels. Replace all fasteners with neoprene gasketed fasteners.
- Replace chimney flashing.
- Reinstall bargeboards.
- See Assessment of Effect action #1.1 for analysis.

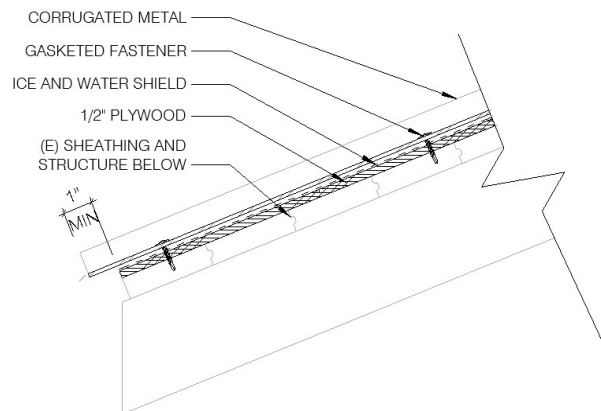
Image 282: Recommended roof covering diagram.

- Remove existing corrugated panels, fasteners, bargeboards, and tar paper (where it exists) down to sheathing or rafters. Salvage panels and bargeboards for reuse.
- Repair sheathing and rafters in-kind where damaged.
- Install 1/2" exterior grade plywood sheathing on top of existing sheathing
- Install ice and water shield on top of plywood sheathing
- Replace moderate or severely corroded panels in-kind, reinstall all other existing panels. Replace all fasteners with neoprene gasketed fasteners.
- Replace chimney flashing.
- Reinstall bargeboards.
- See Assessment of Effect action #1.1 for analysis.

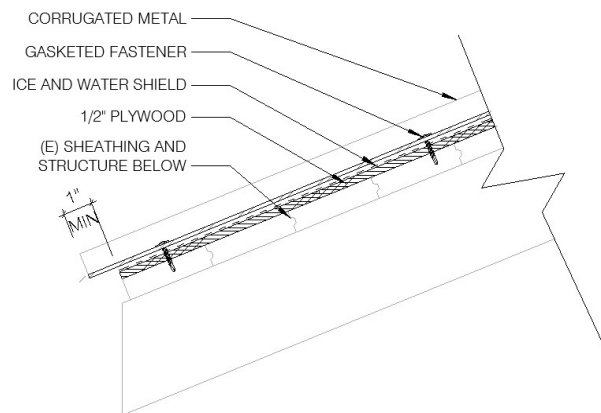
Image 284: Recommended roof covering diagram.

- Remove existing corrugated panels, fasteners, bargeboards, and tar paper (where it exists) down to sheathing or rafters. Salvage panels and bargeboards for reuse.
- Repair sheathing and rafters in-kind where damaged.
- Install 1/2" exterior grade plywood sheathing on top of existing sheathing
- Install ice and water shield on top of plywood sheathing
- Replace moderate or severely corroded panels in-kind, reinstall all other existing panels. Replace all fasteners with neoprene gasketed fasteners.
- Replace chimney flashing.
- Reinstall bargeboards.
- See Assessment of Effect action #211 for analysis.

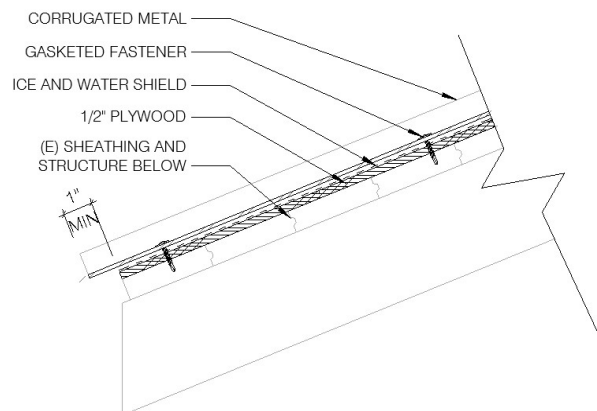
Image 287: Recommended roof covering diagram.

- Remove existing corrugated panels, fasteners, bargeboards, and tar paper (where it exists) down to sheathing or rafters. Salvage panels and bargeboards for reuse.
- Repair sheathing and rafters in-kind where damaged.
- Install 1/2" exterior grade plywood sheathing on top of existing sheathing
- Install ice and water shield on top of plywood sheathing
- Replace moderate or severely corroded panels in-kind, reinstall all other existing panels. Replace all fasteners with neoprene gasketed fasteners.
- Reinstall bargeboards.
- See Assessment of Effect action #1.1 for analysis.

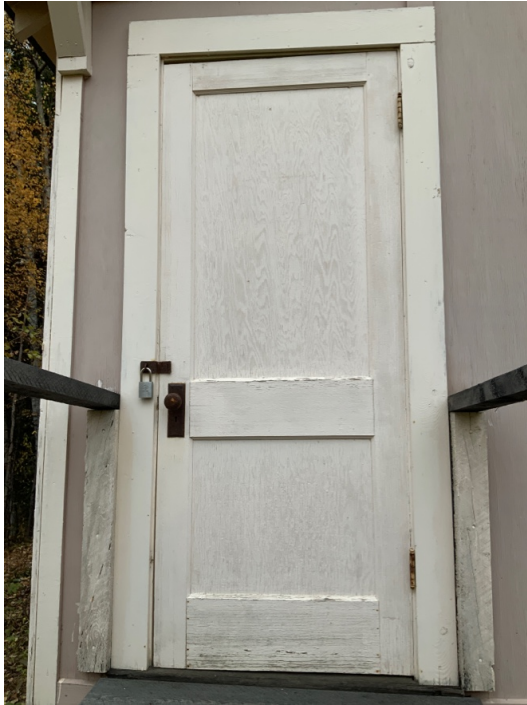
Building: Assay Office

Slab Condition: Surface deterioration

Sill: Moderate deterioration

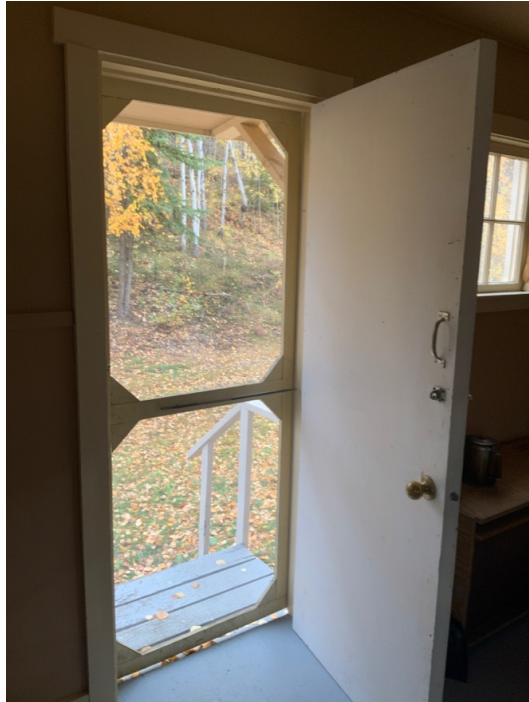
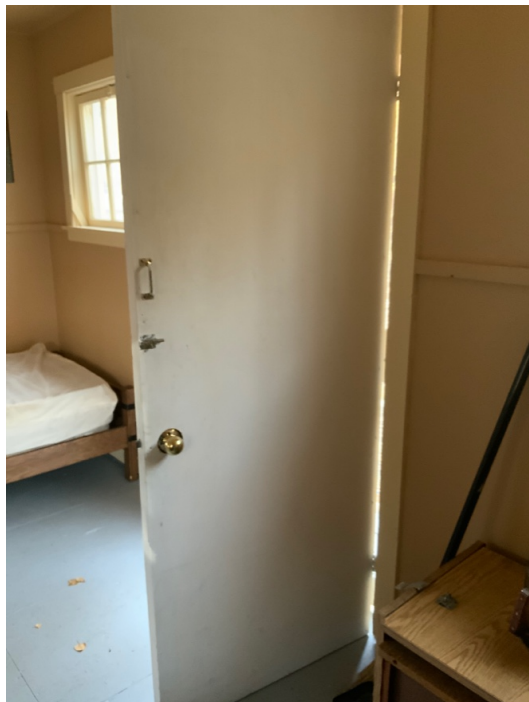
Tag: B1.D1

Slab Condition: Surface deterioration

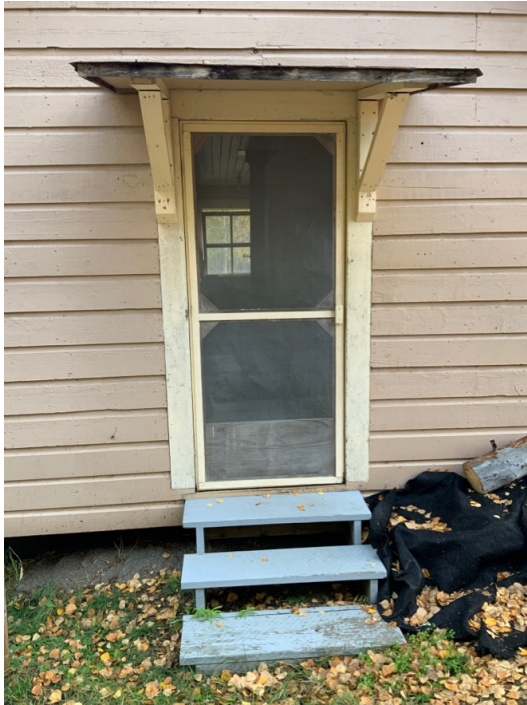
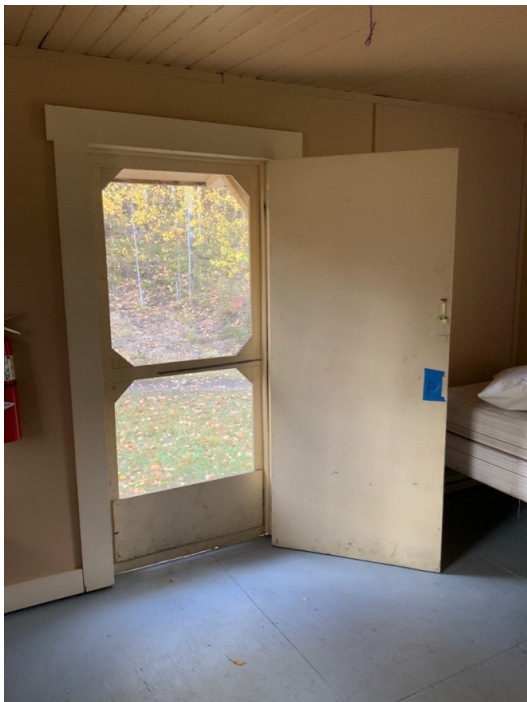
Tag: B2.D1

Slab Condition: Surface deterioration

Jamb: Surface deterioration

Sill: Surface deterioration

Exterior Trim: Surface deterioration

Hardware Condition: Missing

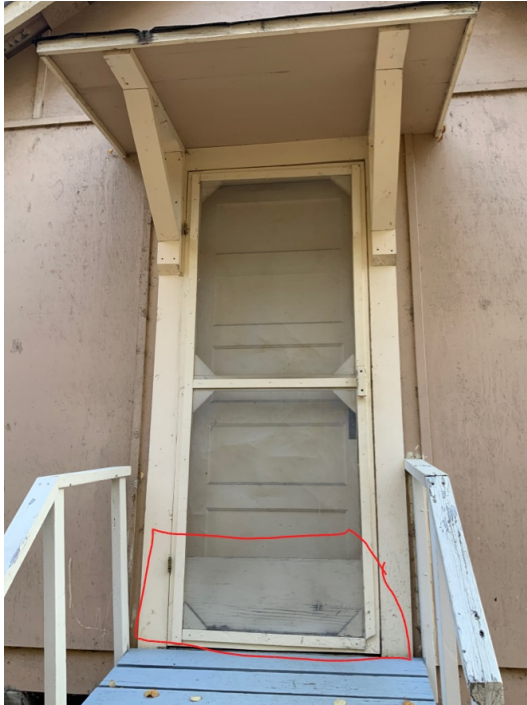
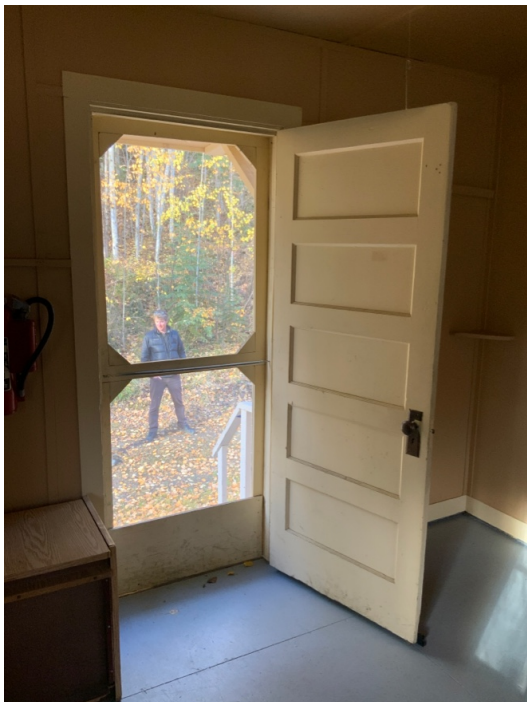
Tag: B3.D1

Slab Condition: Surface deterioration

Sill: Surface deterioration

Interior Trim: Surface deterioration

Hardware Condition: Broken/Inoperable

Strike Plate: Missing

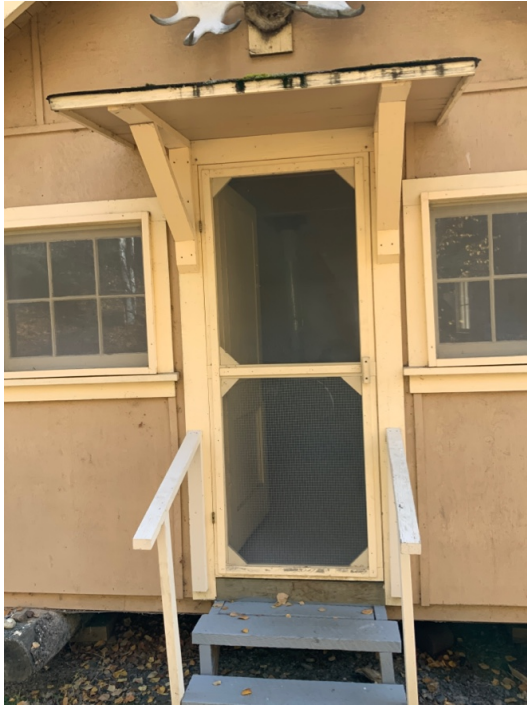
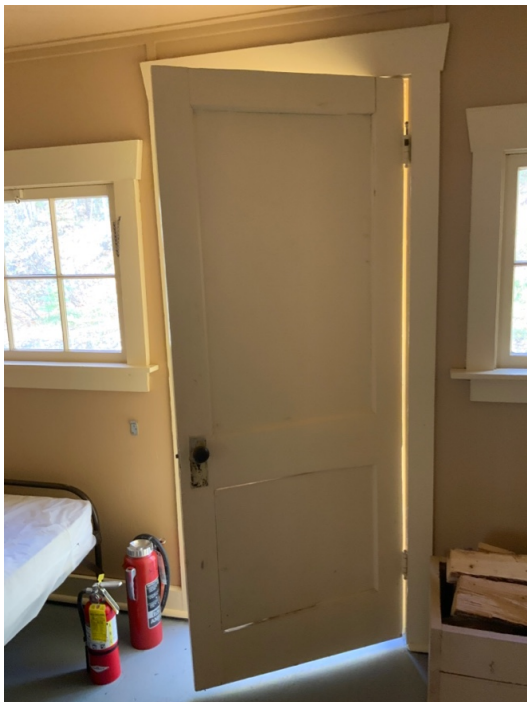
Tag: B4.D1

Slab Condition: Moderate deterioration

Sill: Surface deterioration

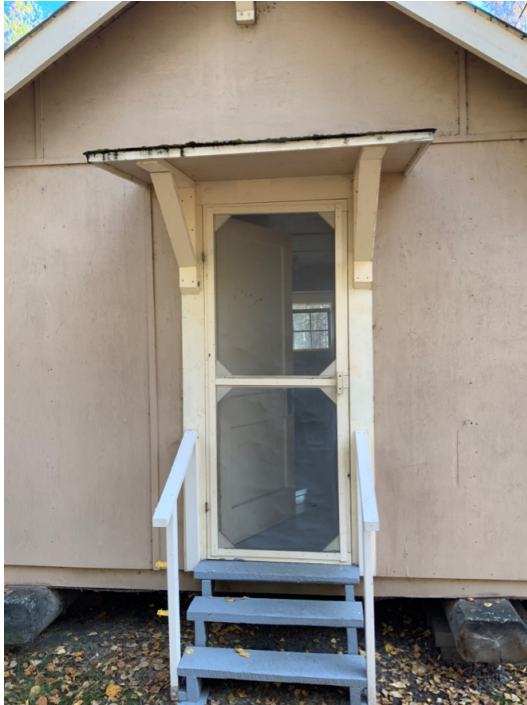
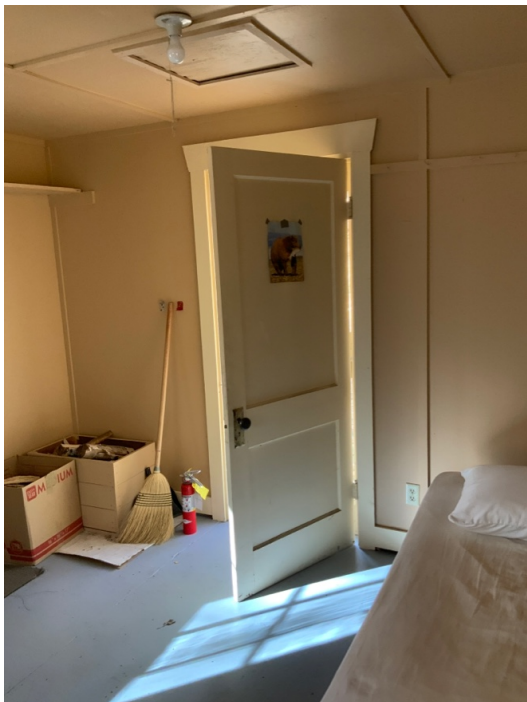
Tag: B5.D1

Slab Condition: Good

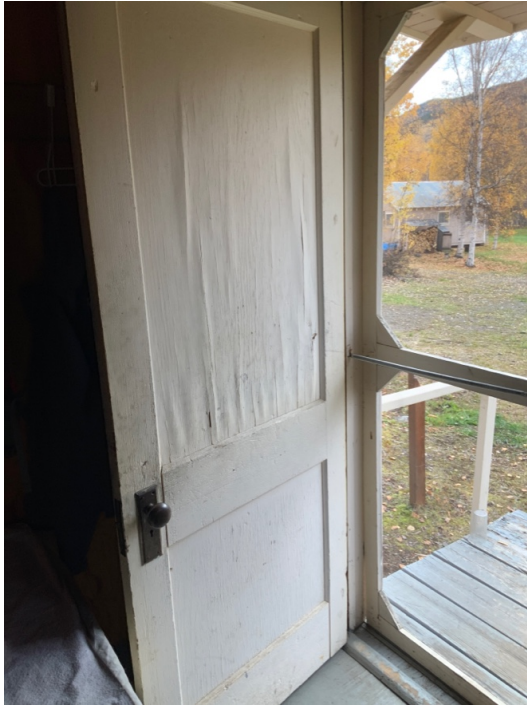
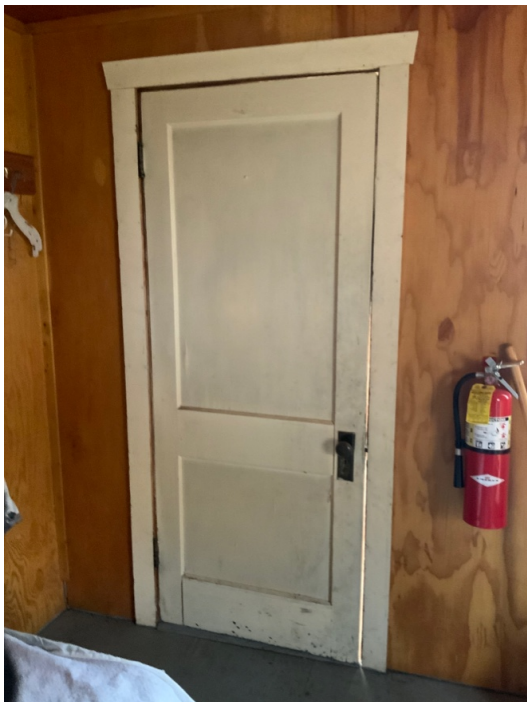
Tag: B6.D1

Slab Condition: Moderate deterioration

Jamb: Surface deterioration

Threshold: Surface deterioration

Interior Trim: Surface deterioration

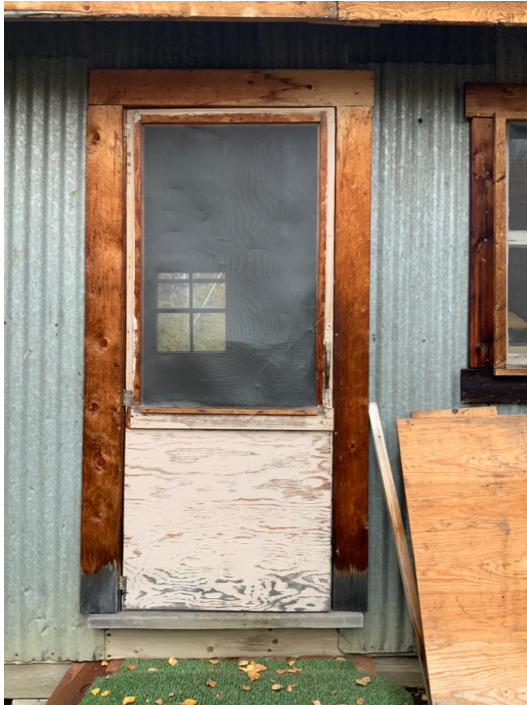
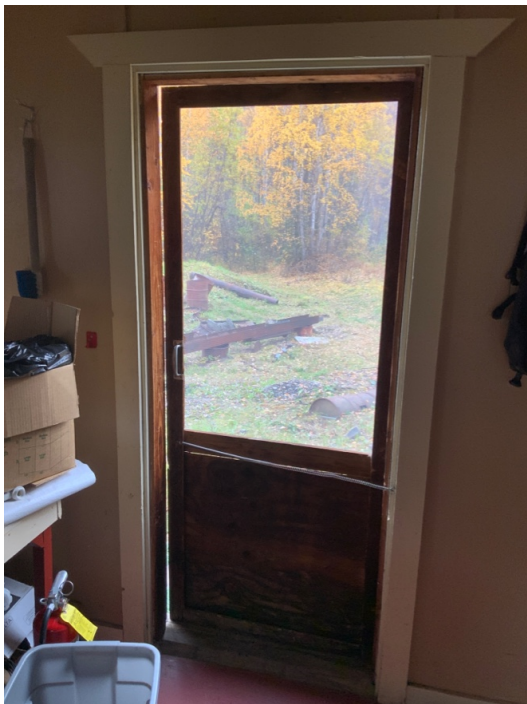
Tag: LA.D1

Slab Condition: Severe deterioration

Jamb: Surface deterioration

Exterior Trim: Surface deterioration

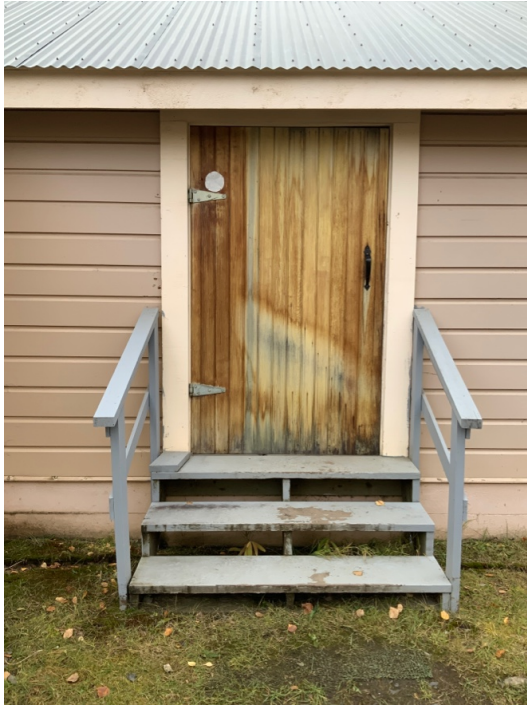
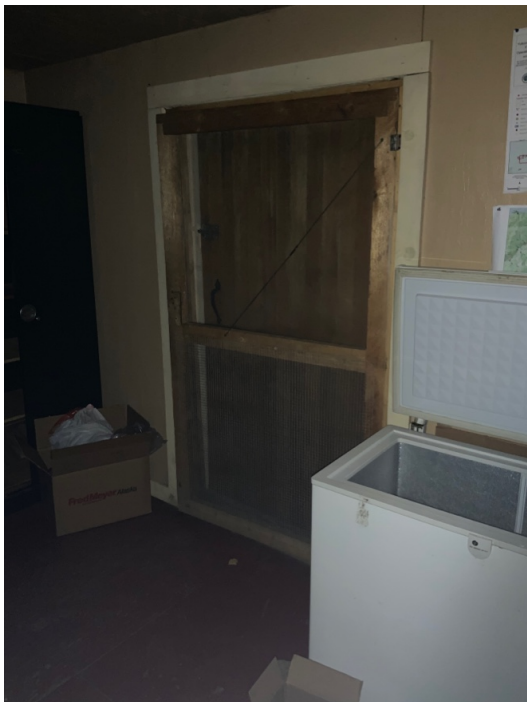
Tag: MH.D1

Slab Condition: Surface deterioration

Threshold: Surface deterioration

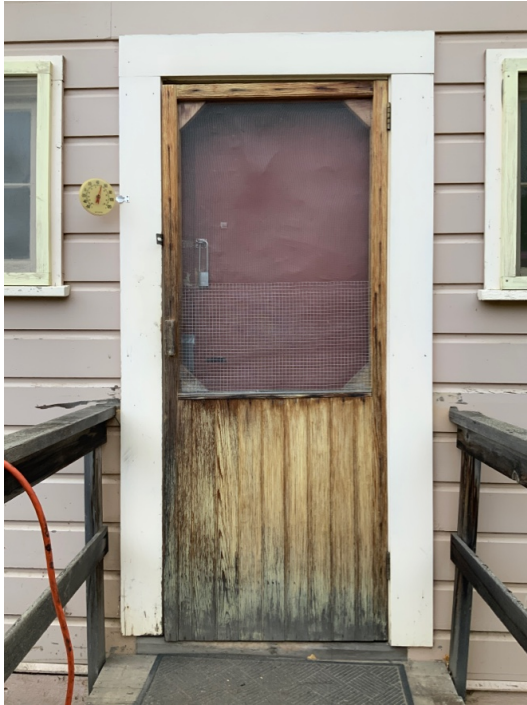
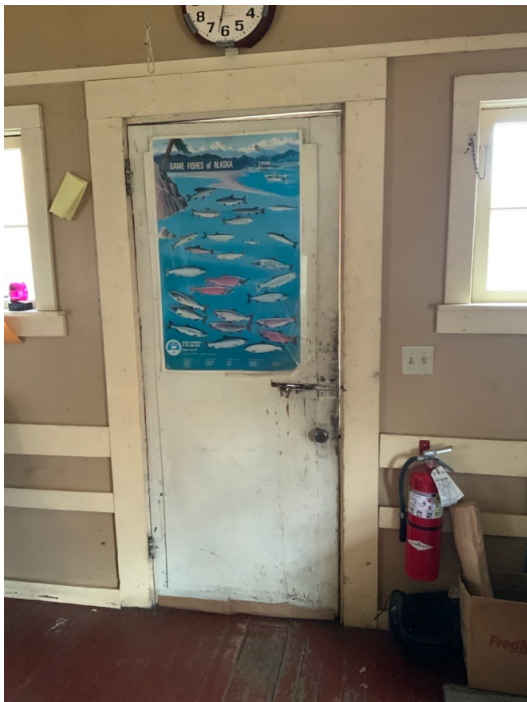
Tag: MH.D2

Slab Condition: Severe deterioration

Jamb: Surface deterioration

Sill: Severe deterioration

Threshold: Severe deterioration

Exterior Trim: Surface deterioration

Interior Trim: Surface deterioration

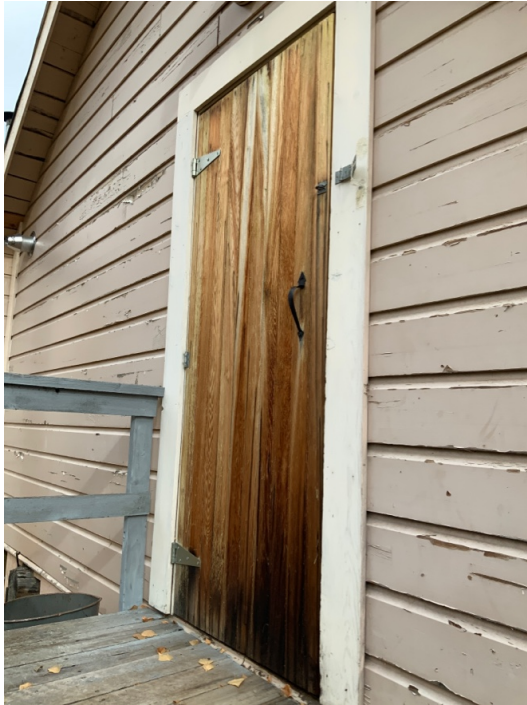
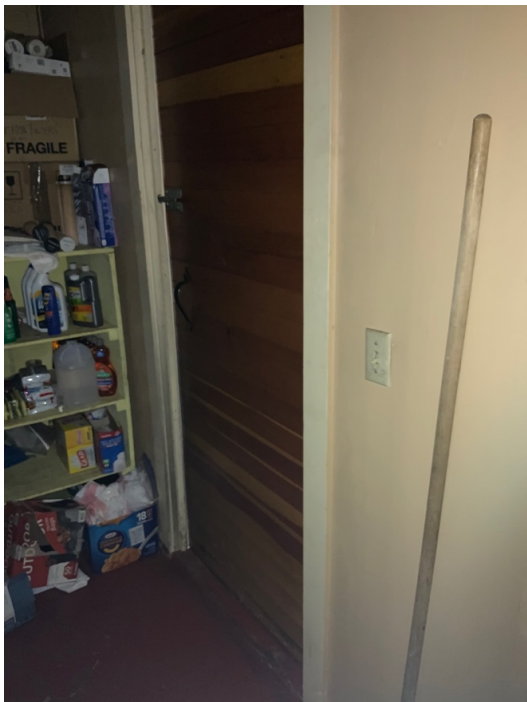
Tag: MH.D3

Slab Condition: Moderate bottom rail

Sill: Moderate deterioration

Exterior Trim: Surface deterioration

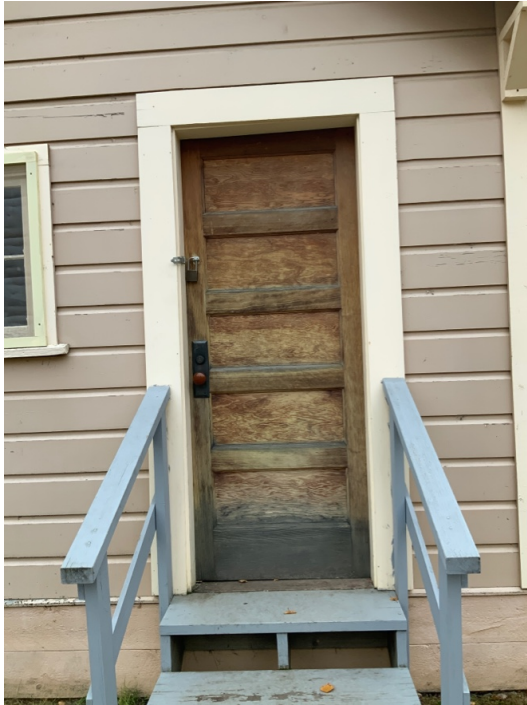
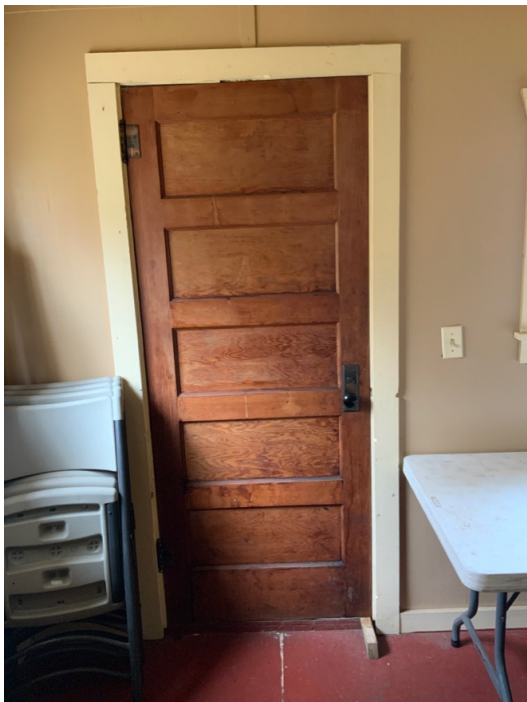
Tag: MH.D4

Slab Condition: Surface deterioration

Sill: Moderate deterioration
