# **Coal Creek Camp**

## **YUKON-CHARLEY RIVERS NATIONAL PRESERVE, ALASKA**

### **HISTORIC STRUCTURE REPORT**

**NPS Task Order #140P2021F0185**  
**April 2022**

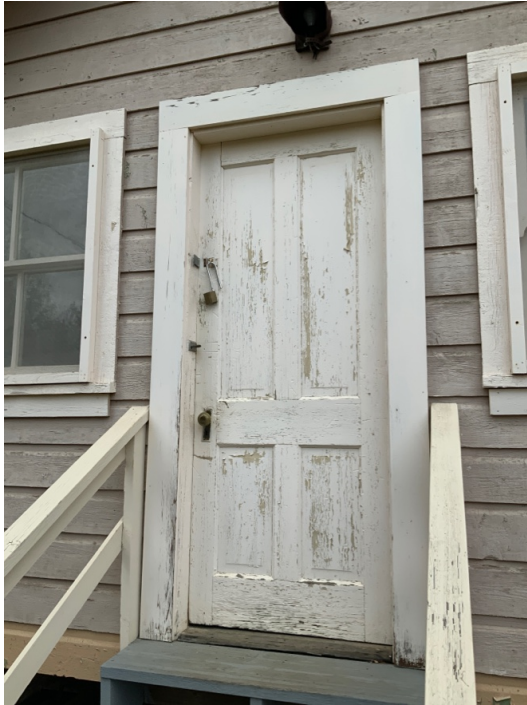
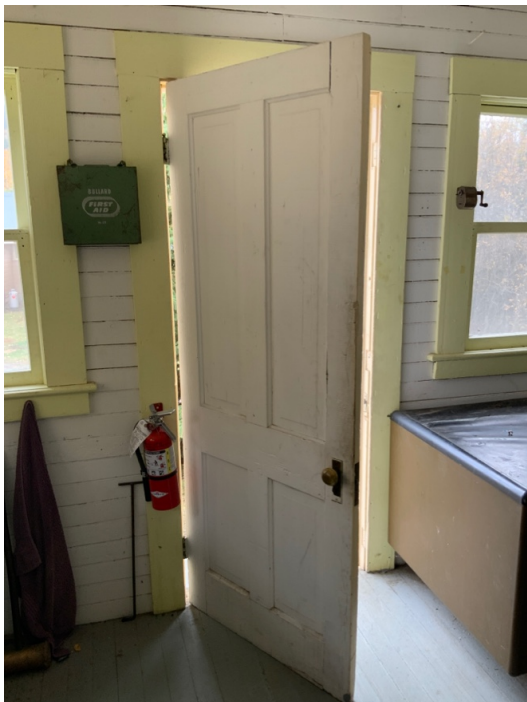
Tag: MO.D1

Slab Condition: Moderate deterioration

Jamb: Moderate deterioration

Sill: Moderate deterioration

Exterior Trim: Surface deterioration

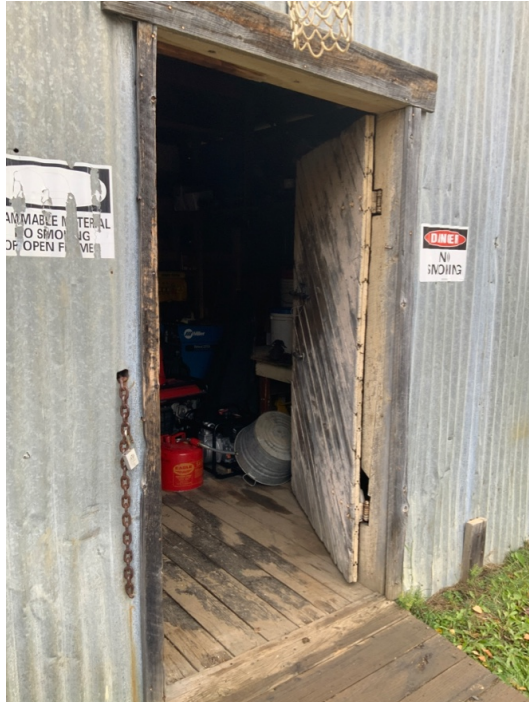
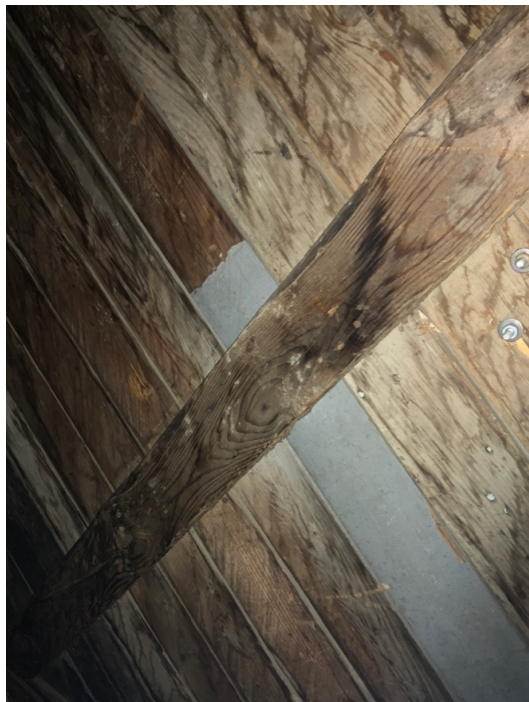
Tag: MS.D1

Slab Condition: Surface deterioration

Jamb: Moderate deterioration

Threshold: Moderate deterioration

Exterior Trim: Moderate deterioration

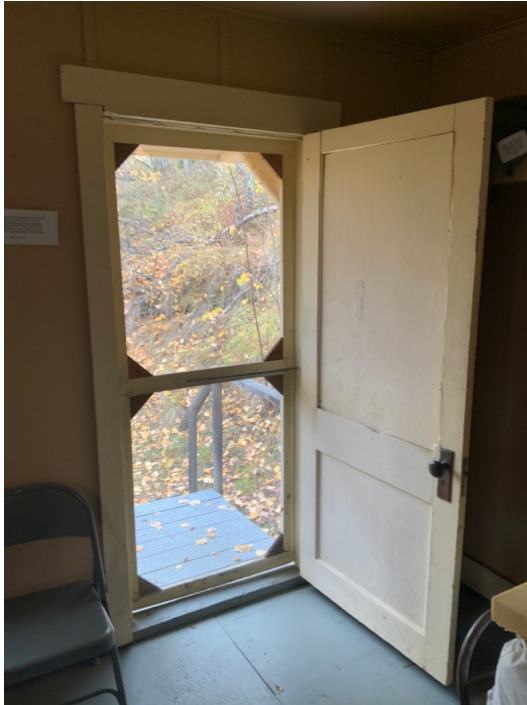
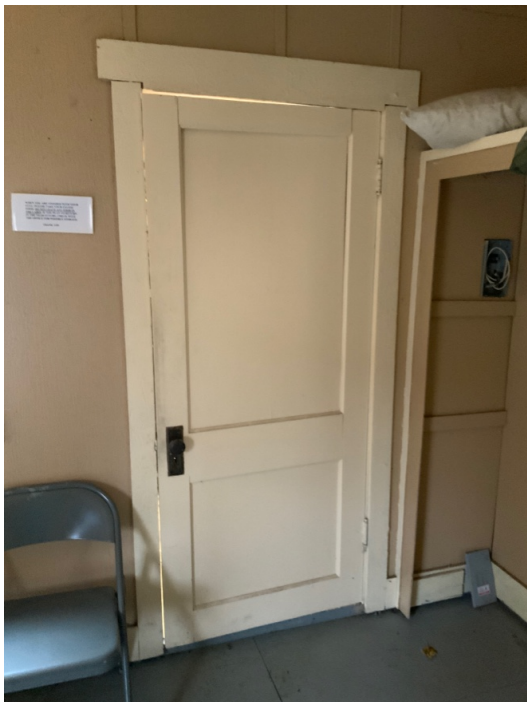
Tag: PC.D1

Slab Condition: Moderate deterioration

Jamb: Surface deterioration

Sill: Surface deterioration

Exterior Trim: Surface deterioration

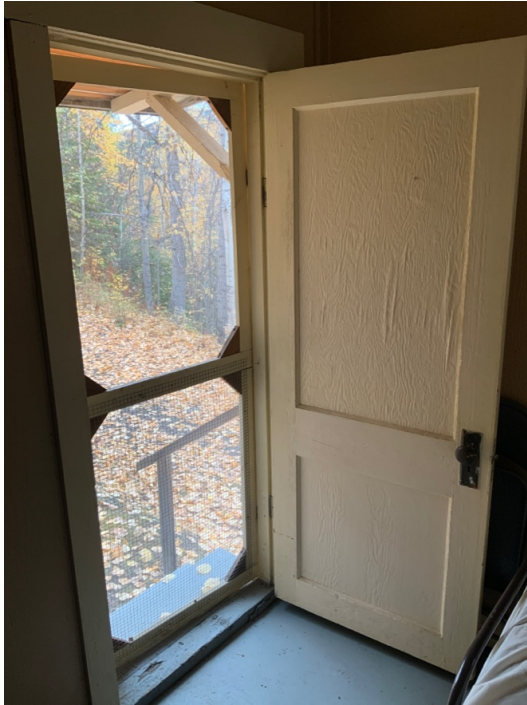
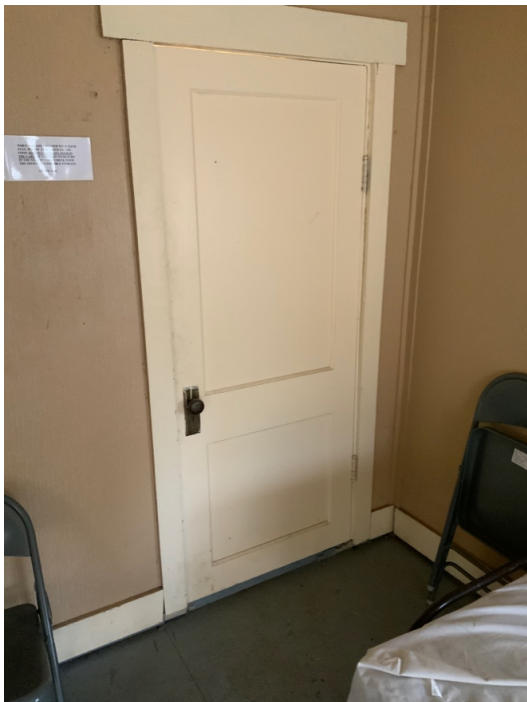
Tag: PC.D2

Slab Condition: Surface deterioration

Sill: Moderate deterioration

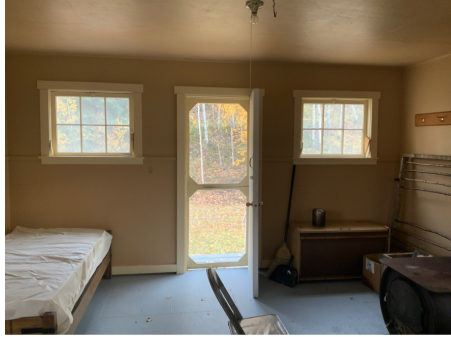
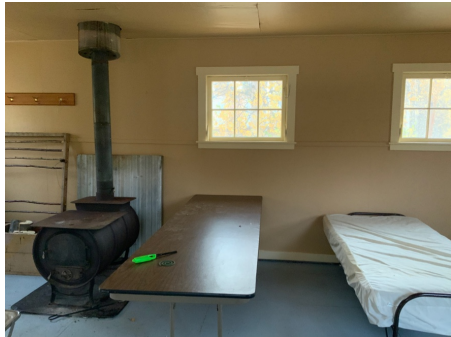
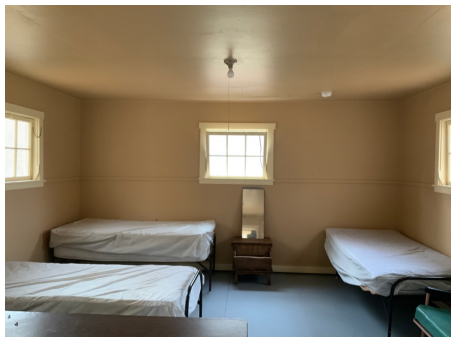
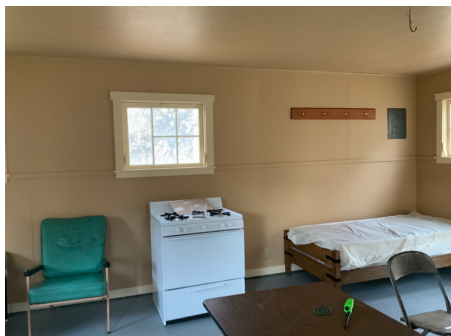
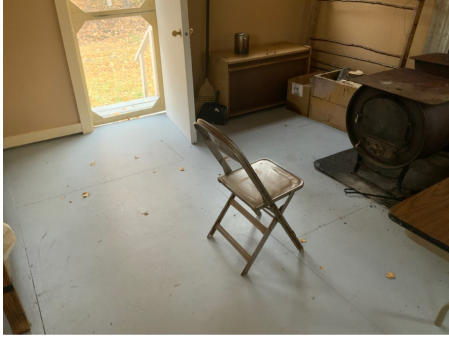
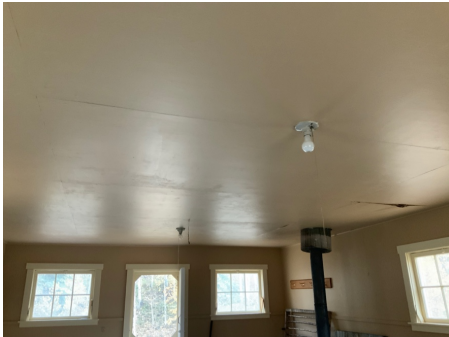
Building: Bunkhouse 1

Ceiling Condition: Poor

Stove condition: Water Leaking

Notes: Severe water damage at stove pipe/ceiling.  
Ceiling 9.1%, walls 11.3%

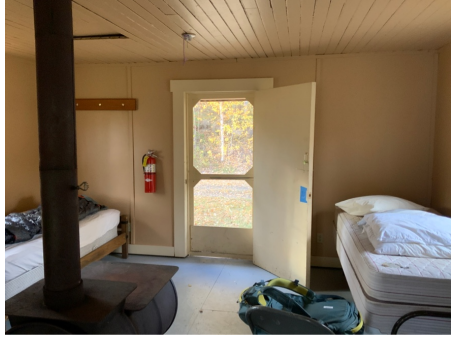
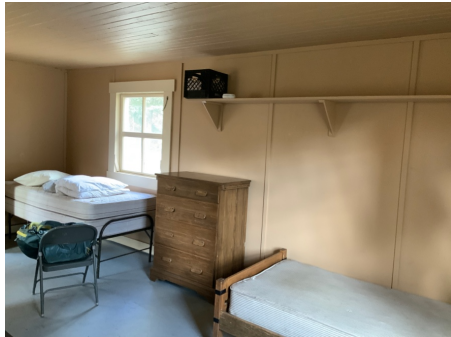
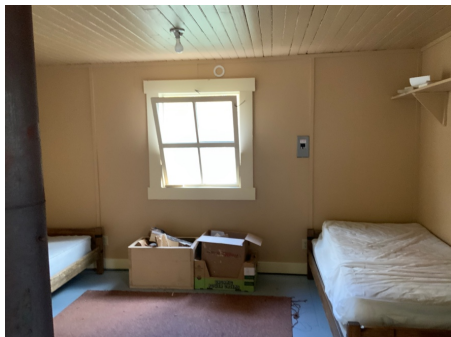
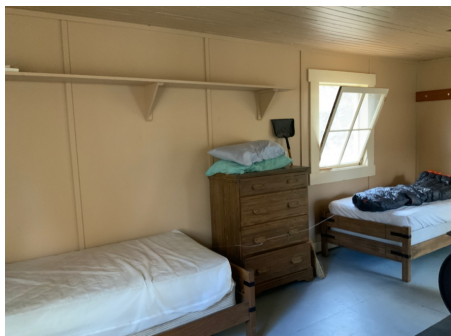
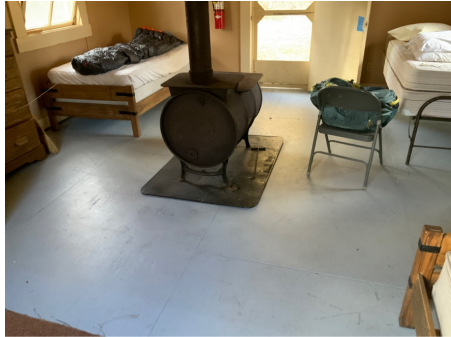
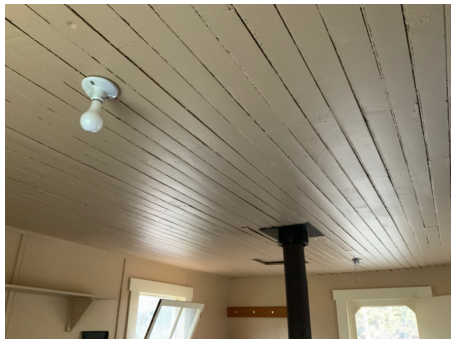
Building: Bunkhouse 2

Flooring Condition: Fair

Ceiling Condition: Fair

Lighting Condition: Missing bulb(s)

Stove condition: Corrosion

Notes: T&G ceiling warped  
10.2% WME at walls

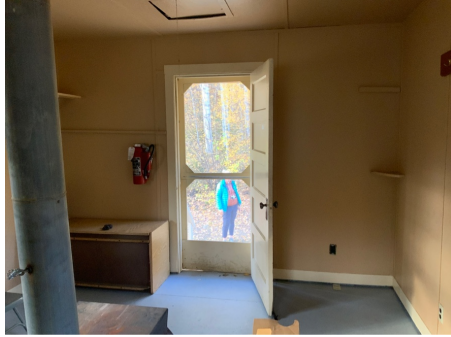
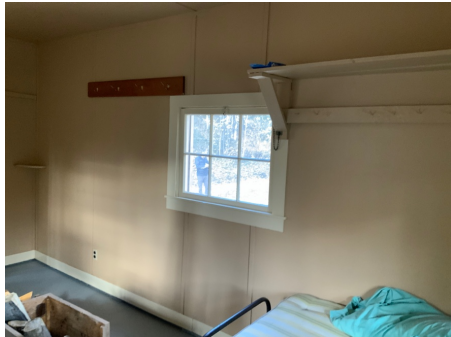
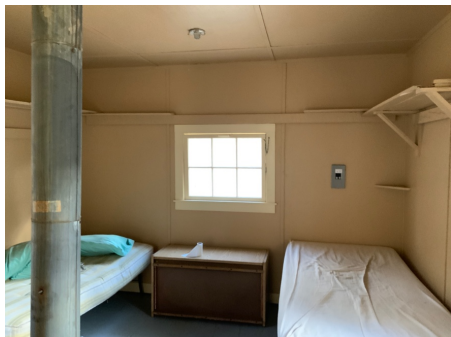
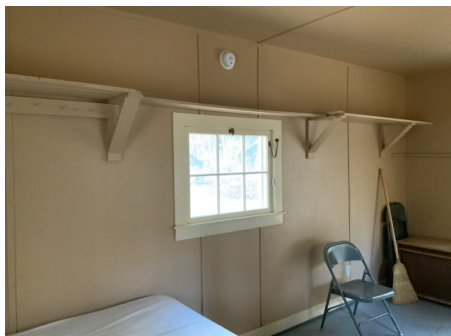
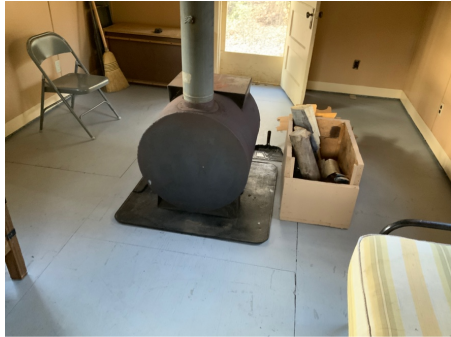
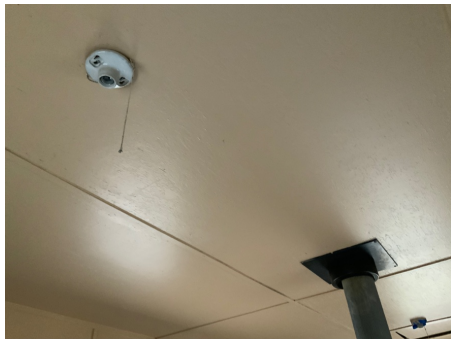
Building: Bunkhouse 3

Lighting Condition: Missing bulb(s)

Stove condition: Corrosion

Notes: 8% WME at walls, good.  
Attic access hatch, moisture  
barrier blocking access

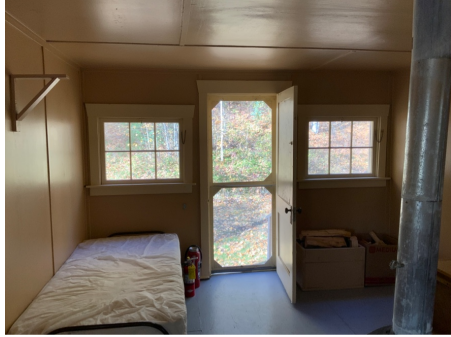
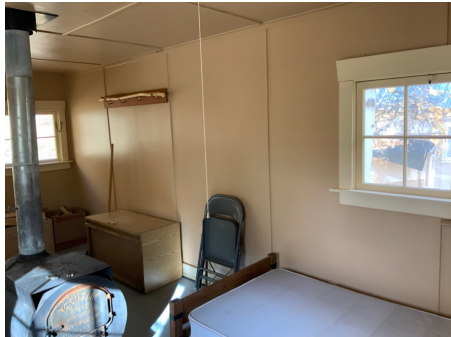
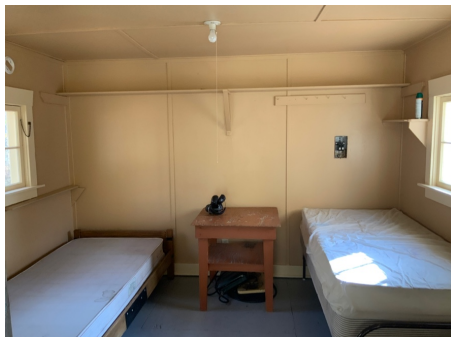
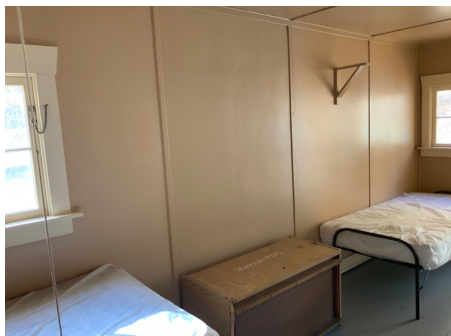
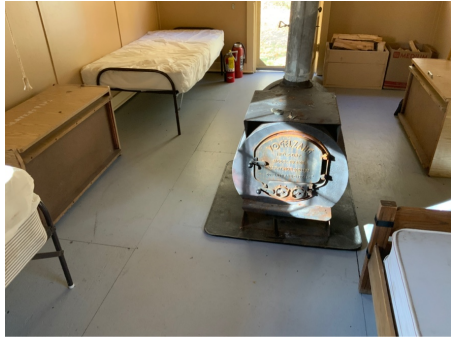
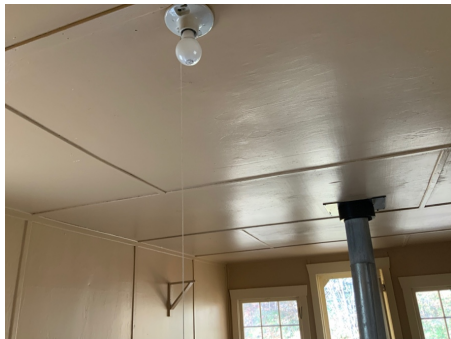
Building: Bunkhouse 4

Ceiling Condition: Fair

Stove condition: Corrosion

Notes: No attic access hatch. WME  
12%+ at ceiling and walls.

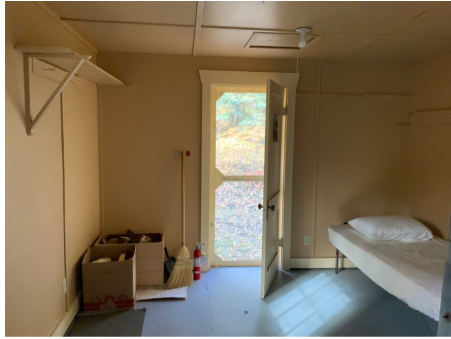
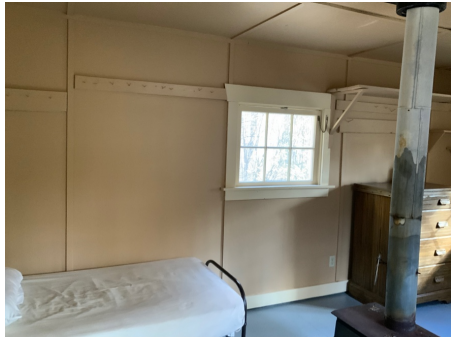
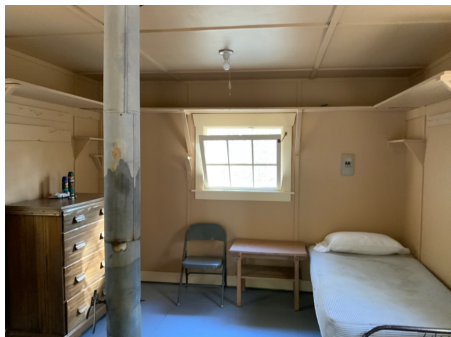
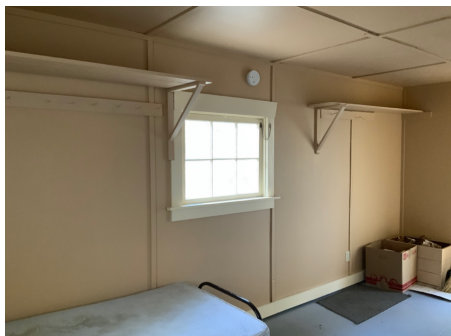
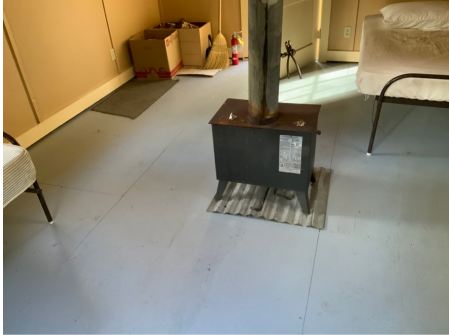
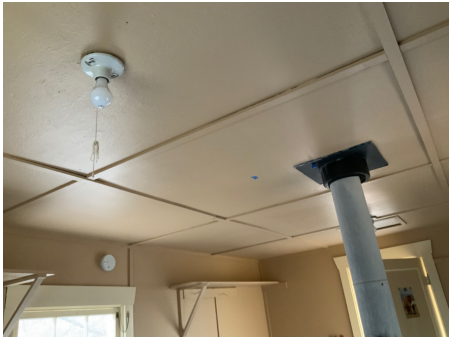
Building: Bunkhouse 5

Ceiling Condition: Fair

Stove condition: Water Leaking

Notes: Attic hatch water damage, warped, active moisture.

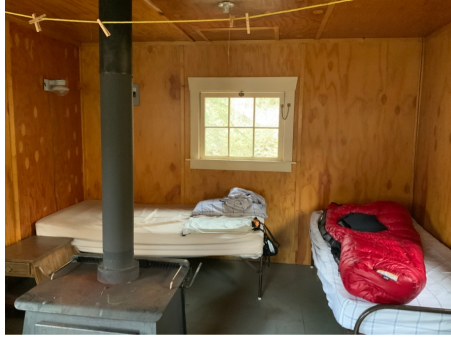
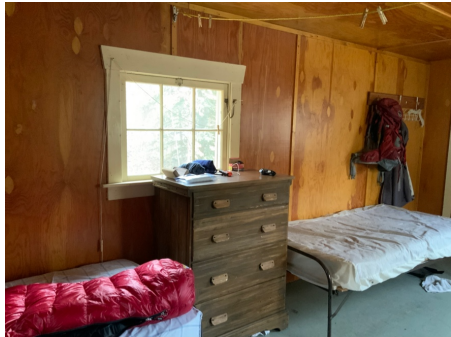
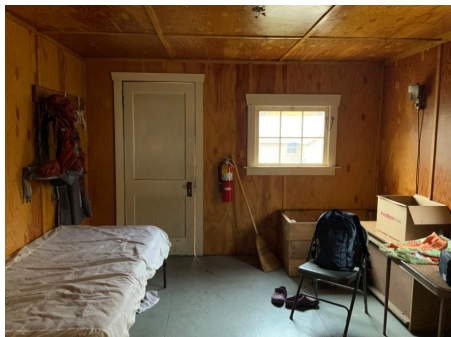
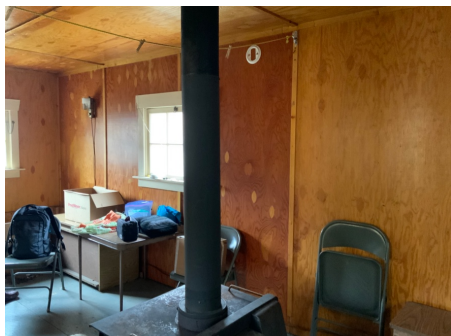
Building: Bunkhouse 6

Flooring Condition: Fair

Lighting Condition: Poor

Notes: Missing (1) socket light,  
(2) additional propane sconces,  
Plywood dry

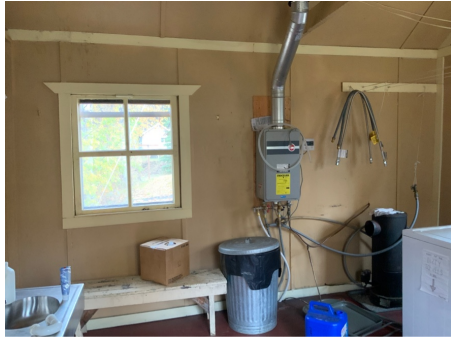
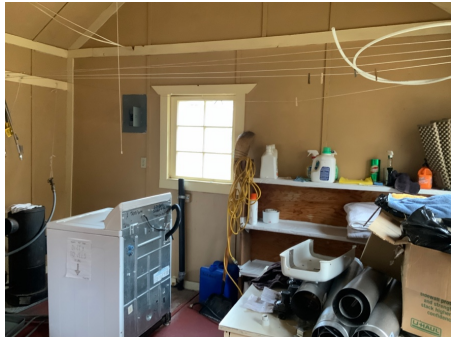
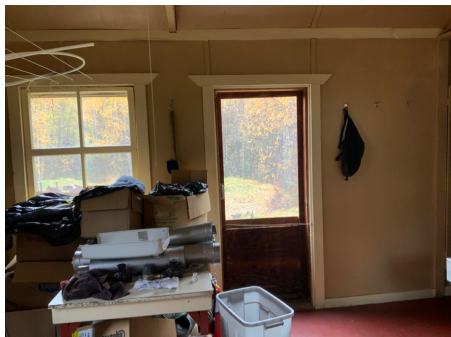
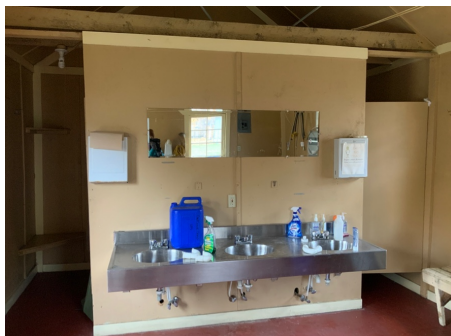
Building: Laundry

Wall Condition : Poor

Notes: 16.3% WME at north wall near water heater

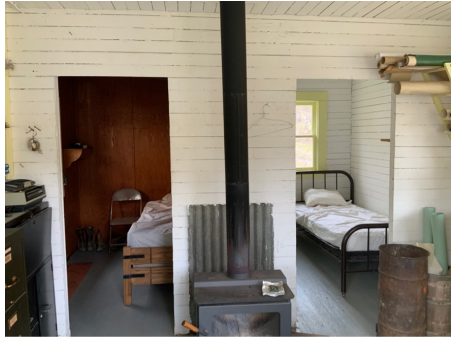
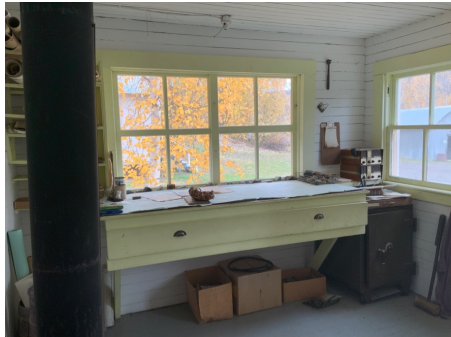
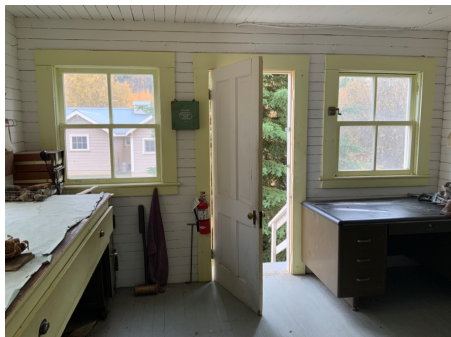
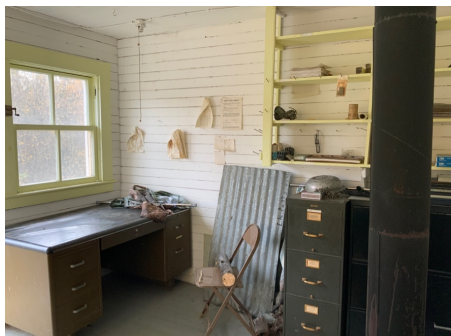
Building: Manager's Office

Flooring Condition: Fair

Wall Condition : Fair

Ceiling Condition: Fair

Lighting Condition: Missing bulb(s)

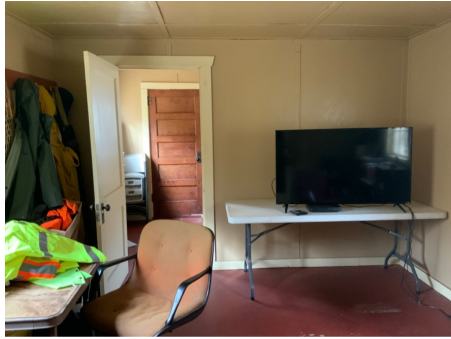
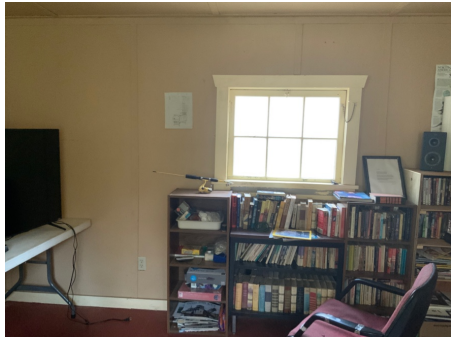
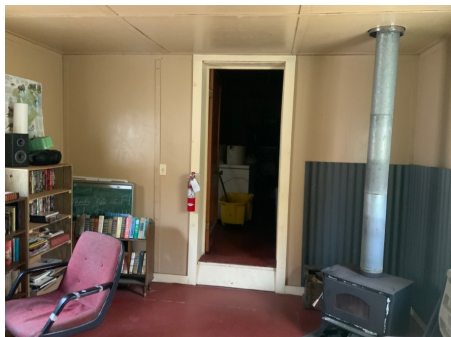
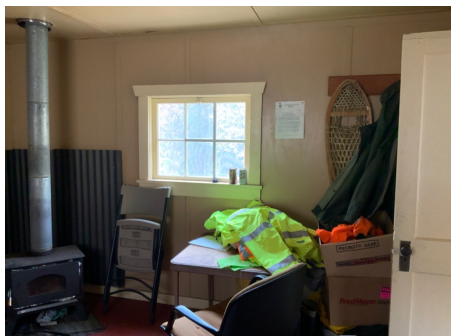
Building: Mess Hall

Flooring Condition: Fair

Base Condition: Fair

Notes: 7.7% WME at walls

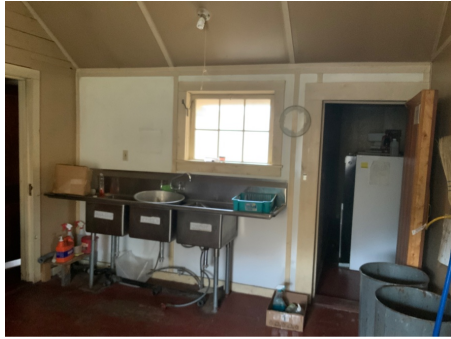
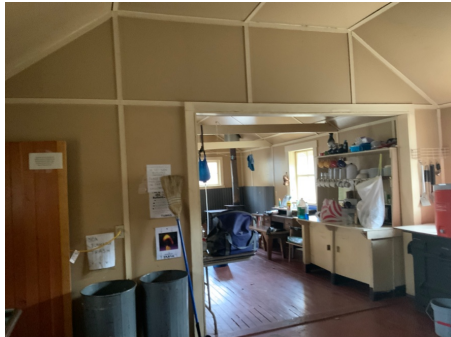
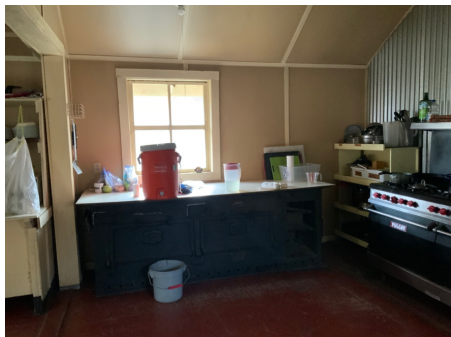
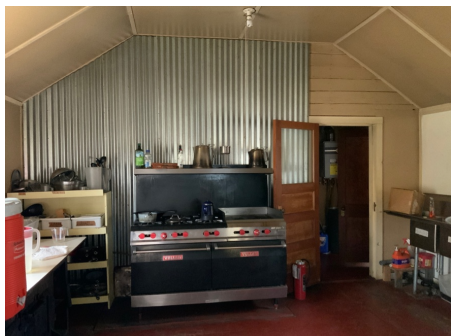
Building: Mess Hall

Flooring Condition: Fair

Base Condition: Fair

Notes: Painted ply, hardboard, and  
corrugated wall  
South wall 8% WME

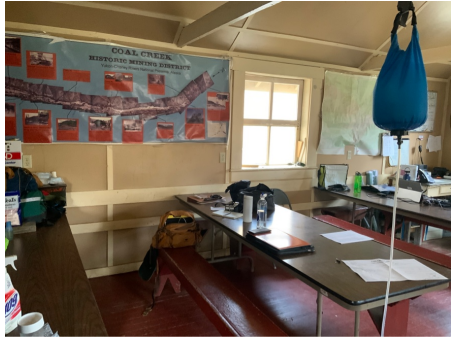
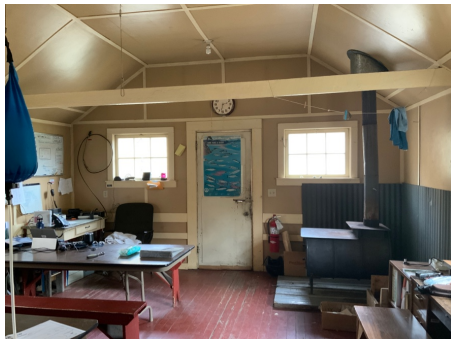
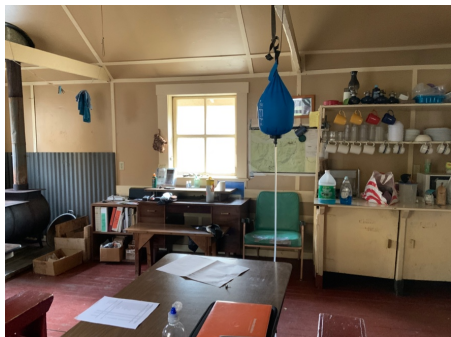
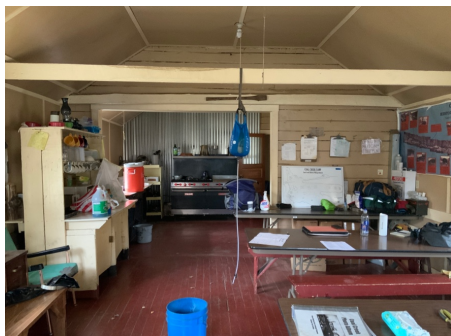
Building: Mess Hall

Flooring Condition: Poor

Base Condition: Fair

Wall Condition : Fair

Stove condition: Corrosion

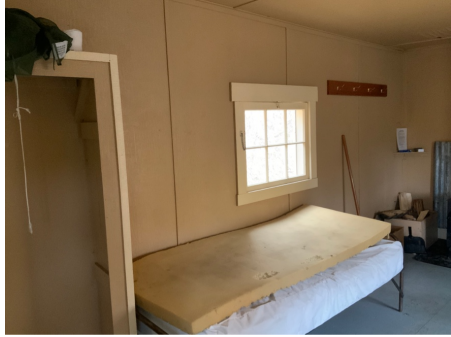
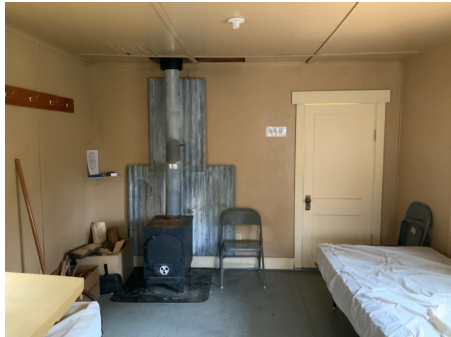
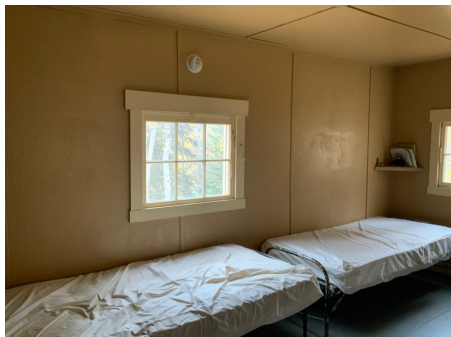
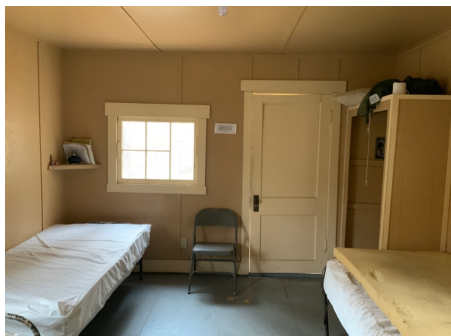
Building: Public Use Cabin

Ceiling Condition: Poor

Lighting Condition: Missing bulb(s)

Stove condition: Water Leaking

Notes: Severe water damage at top pipe ceiling, 21.5% moisture

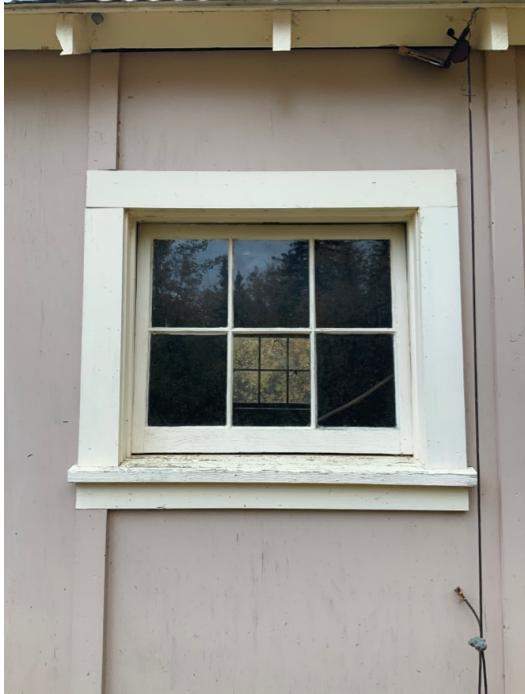
Building: Assay Office

Upper/Fixed Sash: Surface deterioration

Muntins: Surface deterioration

Exterior Sill: Surface deterioration

Putty: Dry/Cracked

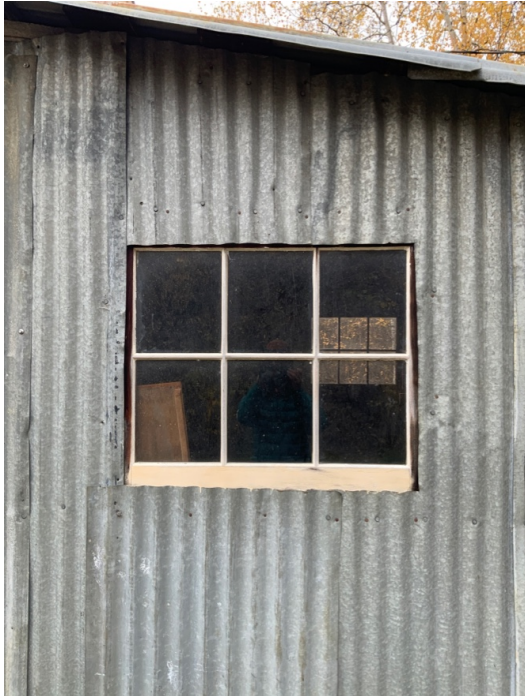
Building: Assay Office

Upper/Fixed Sash: Surface deterioration

Muntins: Surface deterioration

Putty: Dry/Cracked

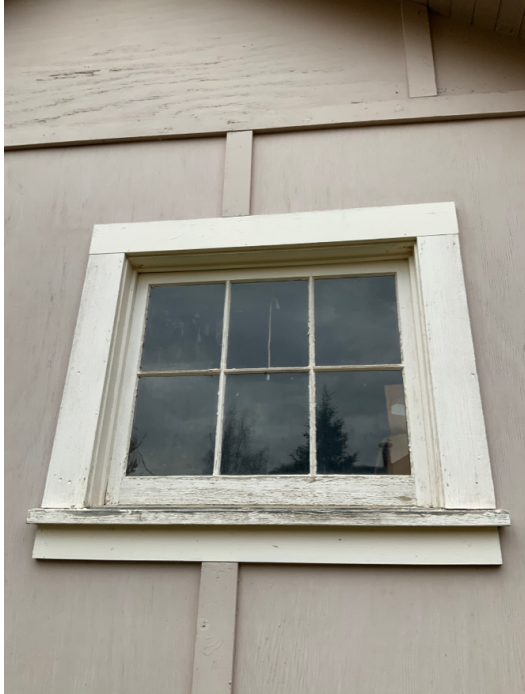
Building: Assay Office

Upper/Fixed Sash: Surface deterioration

Muntins: Surface deterioration

Jamb: Surface deterioration

Exterior Sill: Surface deterioration

Exterior Trim: Surface deterioration

Putty: Dry/Cracked

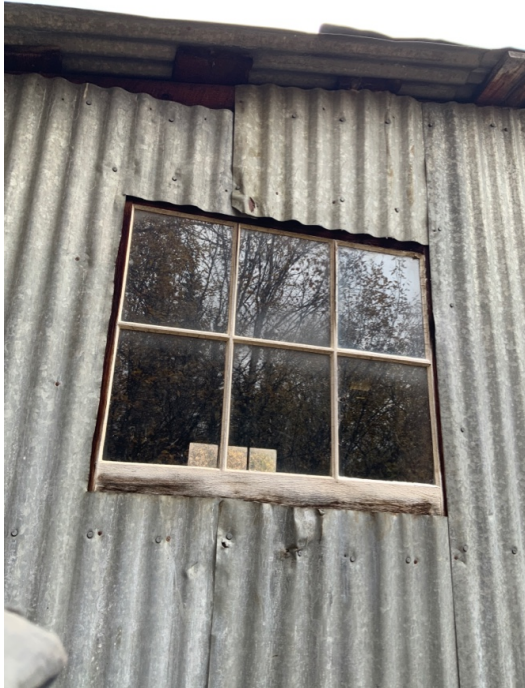
Building: Assay Office

Upper/Fixed Sash: Surface deterioration

Muntins: Surface deterioration

Putty: Dry/Cracked

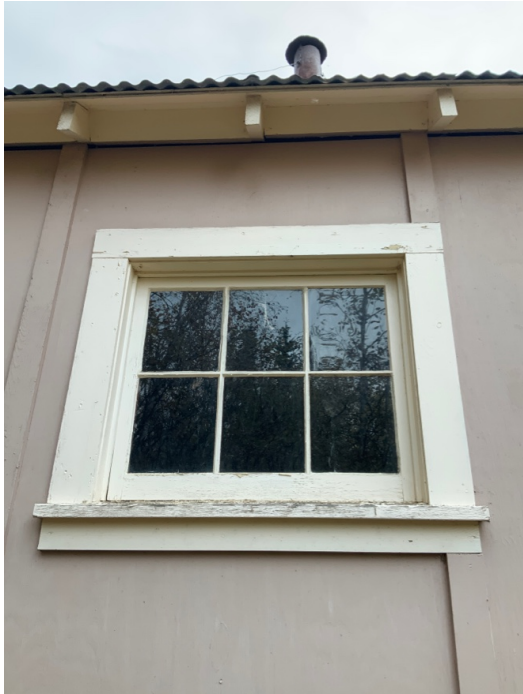
Building: Assay Office

Upper/Fixed Sash: Surface deterioration

Exterior Sill: Surface deterioration

Exterior Trim: Surface deterioration

Putty: Dry/Cracked

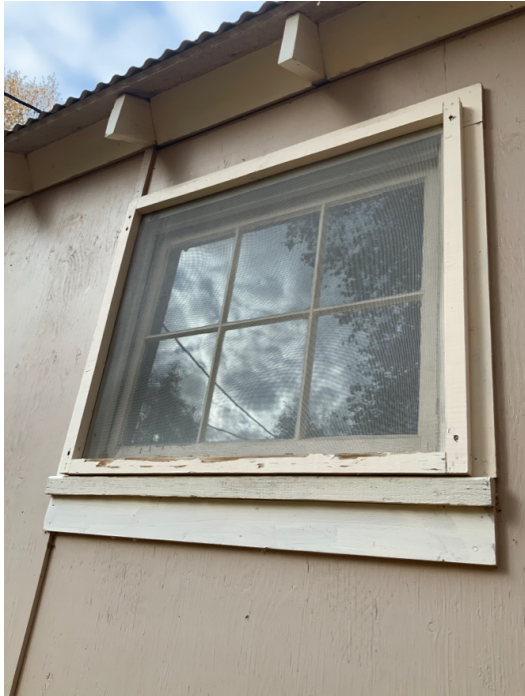
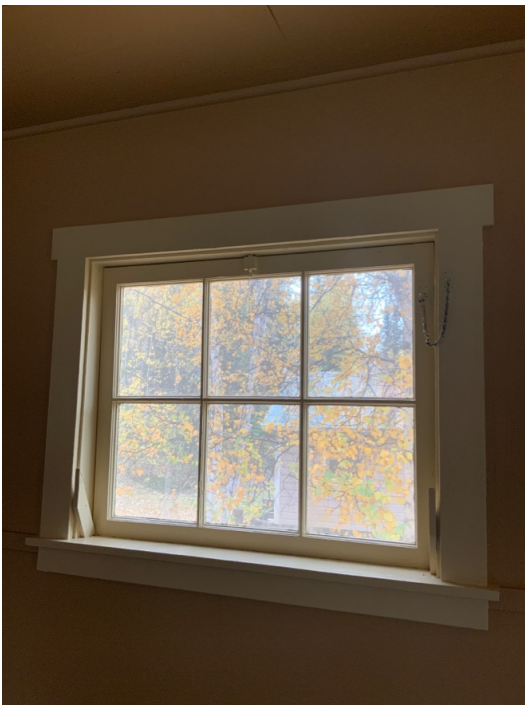
Window: B1.E2

Upper/Fixed Sash: Surface deterioration

Frame: Surface deterioration

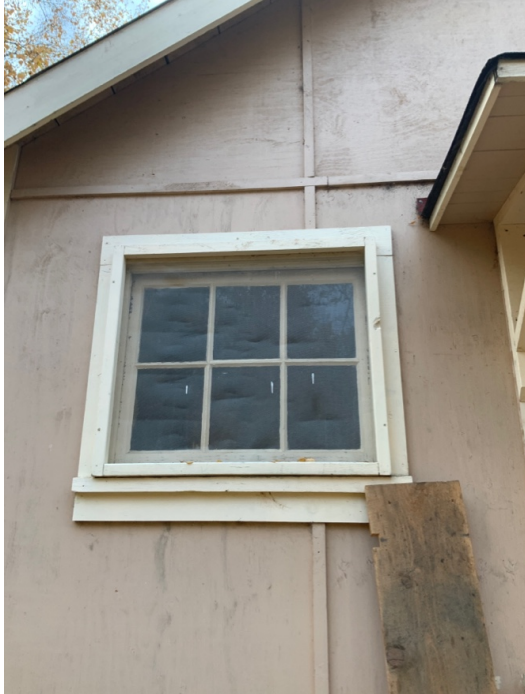
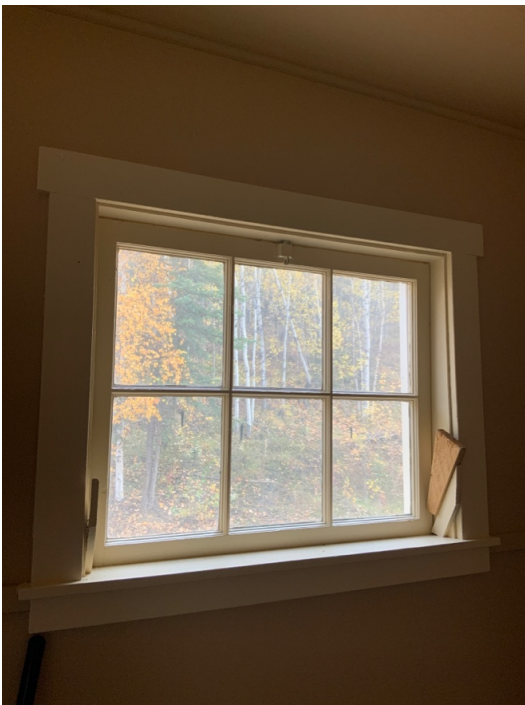
Window: B1.N1

Upper/Fixed Sash: Surface deterioration

Jamb: Surface deterioration

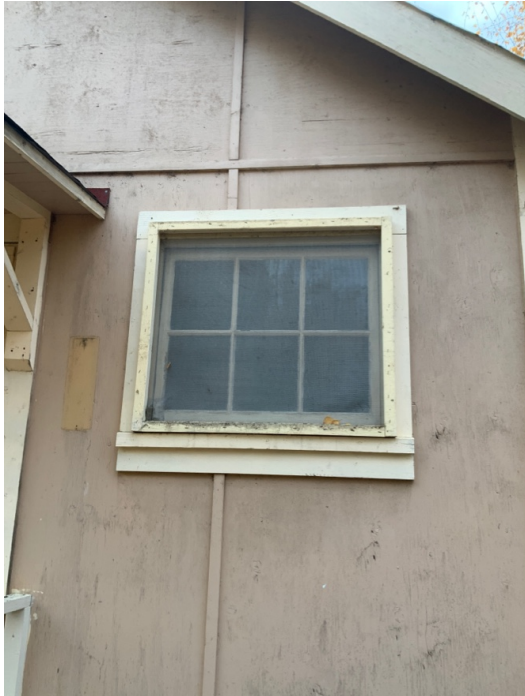
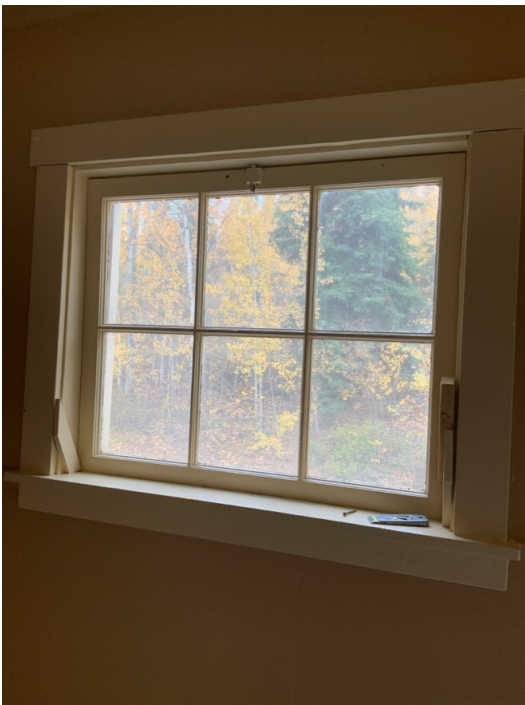
Window: B1.N2

Upper/Fixed Sash: Surface deterioration

Putty: Failed/Missing

Frame: Surface deterioration

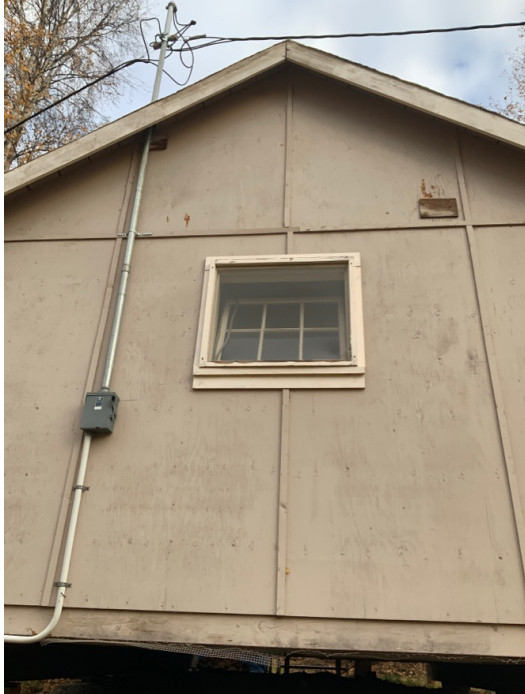
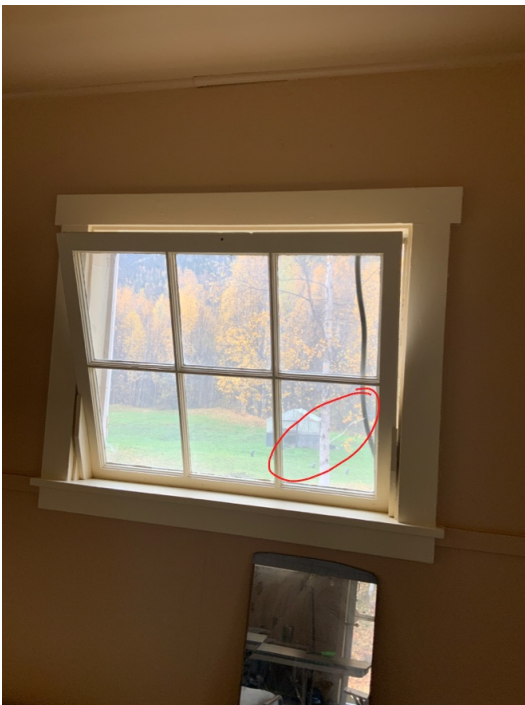
Window: B1.S1

Glazing Condition: Cracked

Frame: Surface deterioration

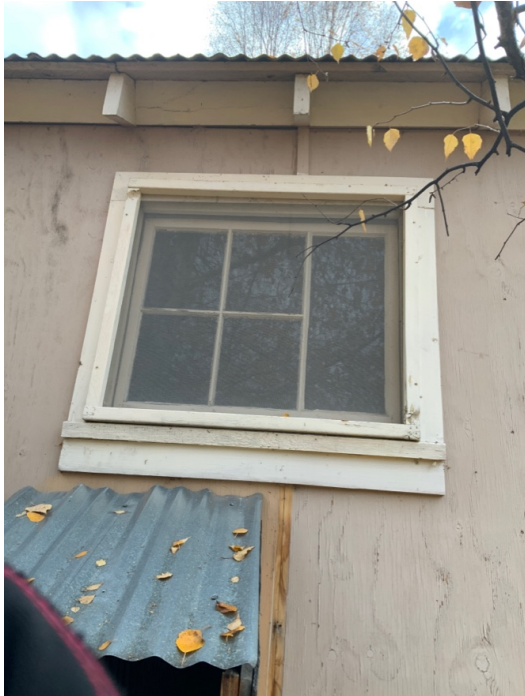
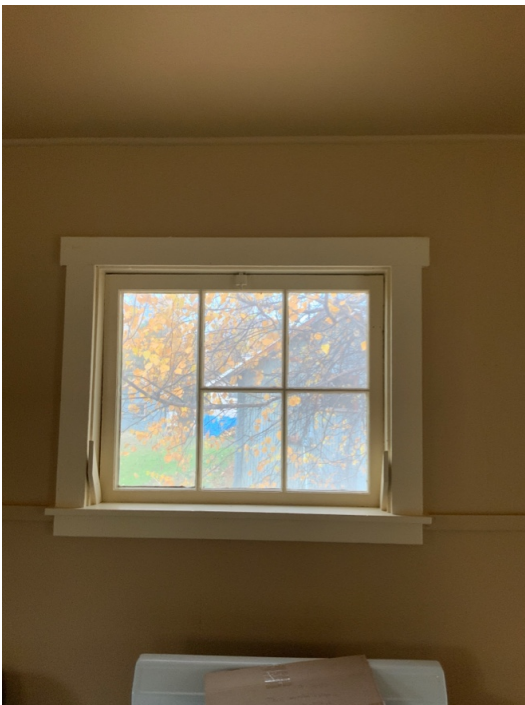
Window: B1.W1

Upper/Fixed Sash: Surface deterioration

Muntins: Missing

Putty: Dry/Cracked

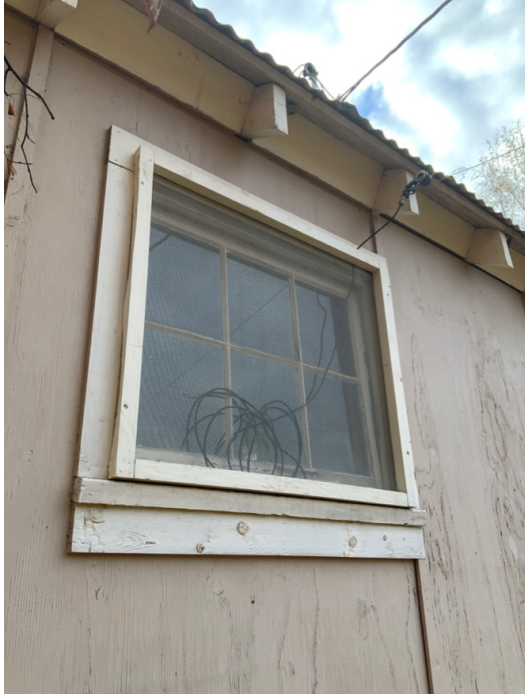
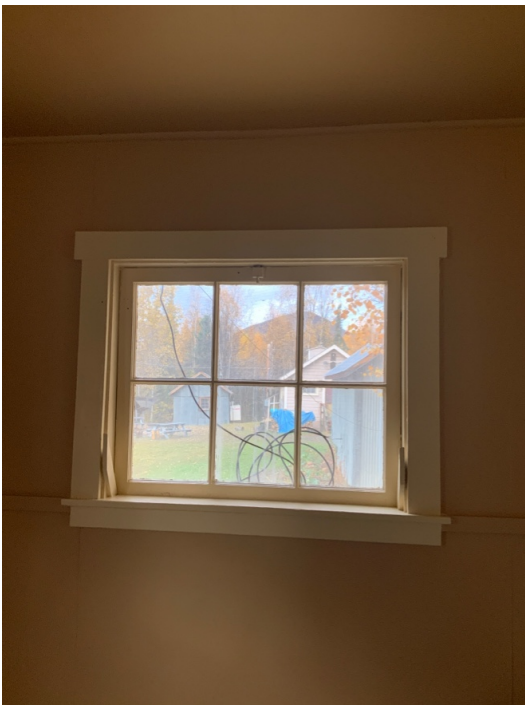
Window: B1.W2

Upper/Fixed Sash: Severe deterioration

Muntins: Surface deterioration

Putty: Dry/Cracked

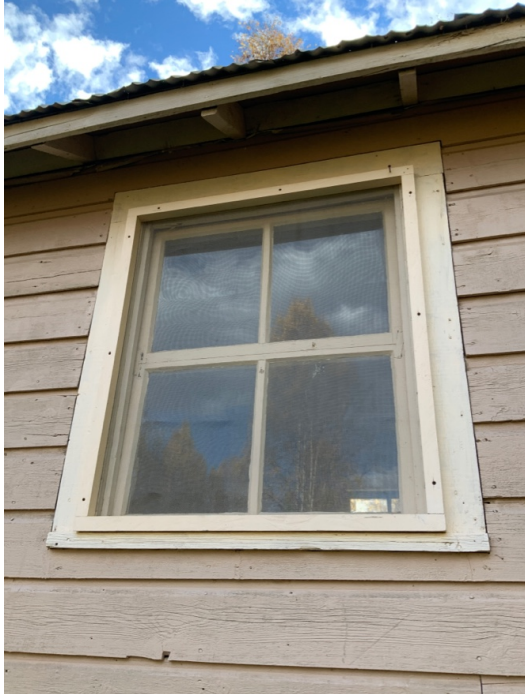
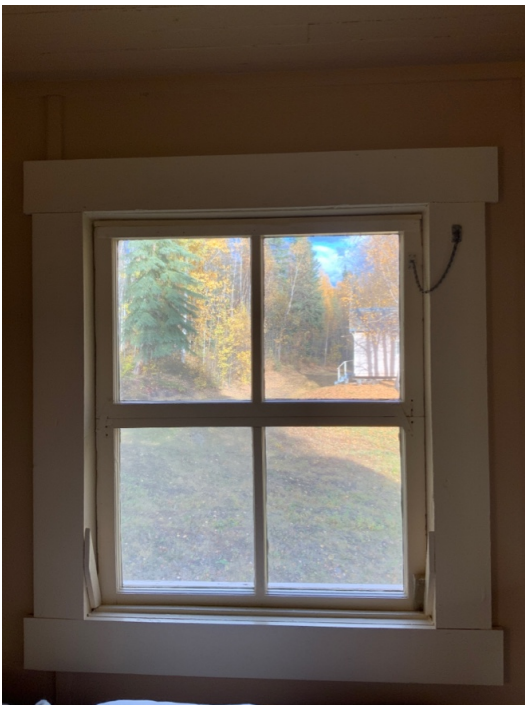
Window: B2.E1

Upper/Fixed Sash: Surface deterioration

Muntins: Surface deterioration

Jamb: Surface deterioration

Exterior Sill: Surface deterioration

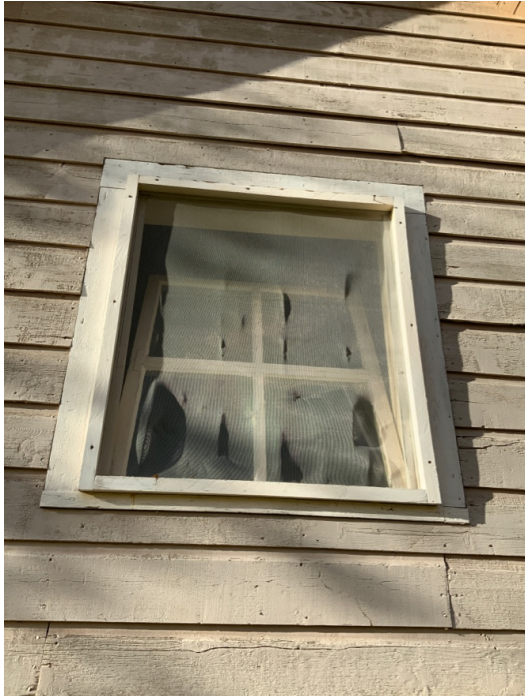
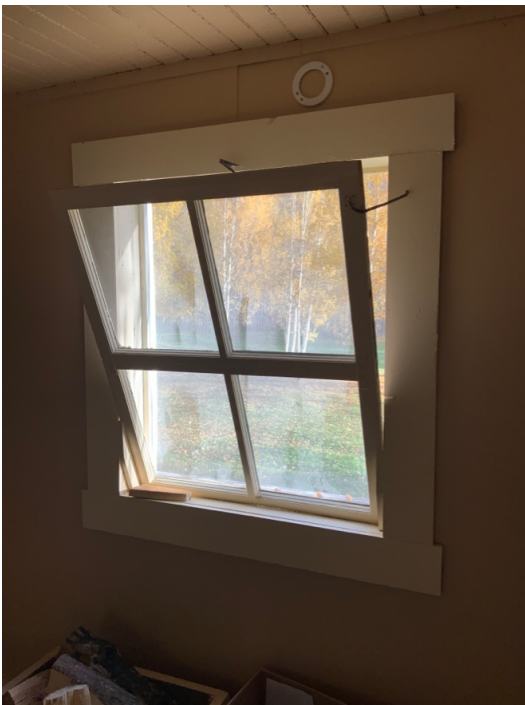
Window: B2.S1

Upper/Fixed Sash: Surface deterioration

Muntins: Surface deterioration

Exterior Sill: Surface deterioration

Putty: Dry/Cracked

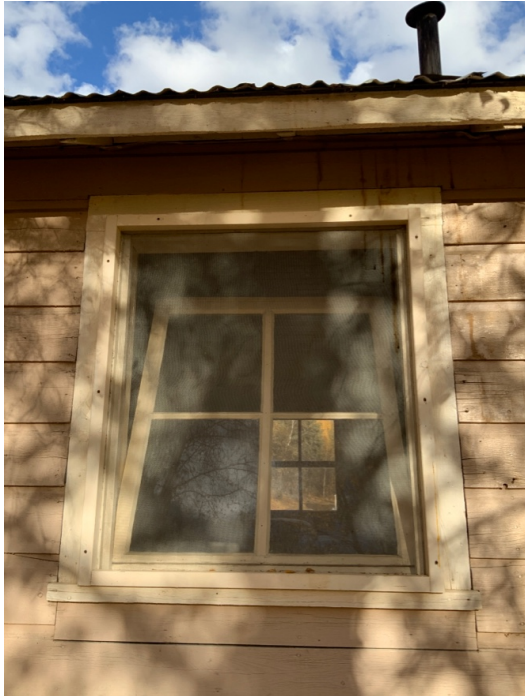
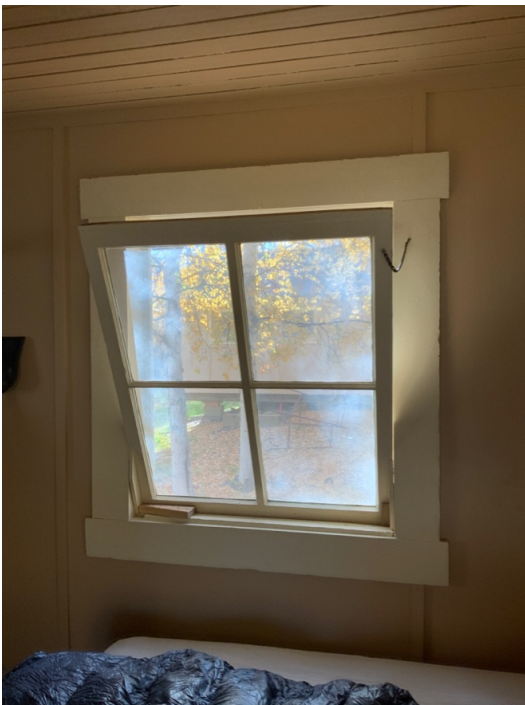
Window: B2.W1

Exterior Sill: Moderate deterioration

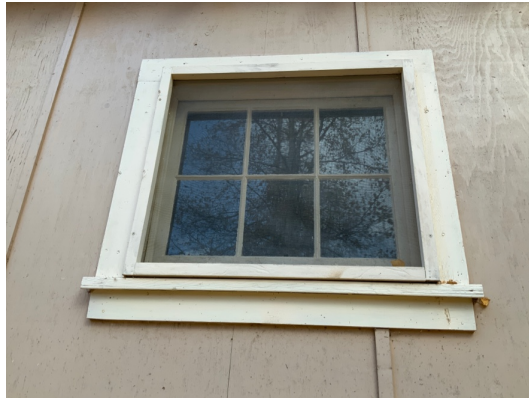
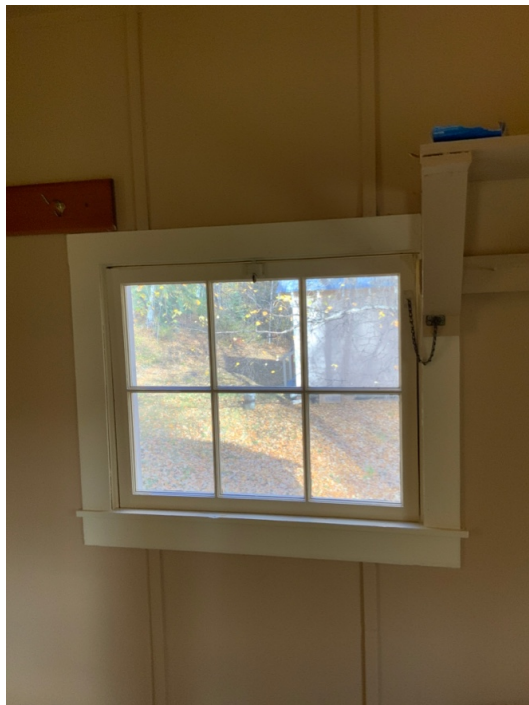
Window: B3.E1

Upper/Fixed Sash: Surface deterioration

Exterior Sill: Moderate deterioration

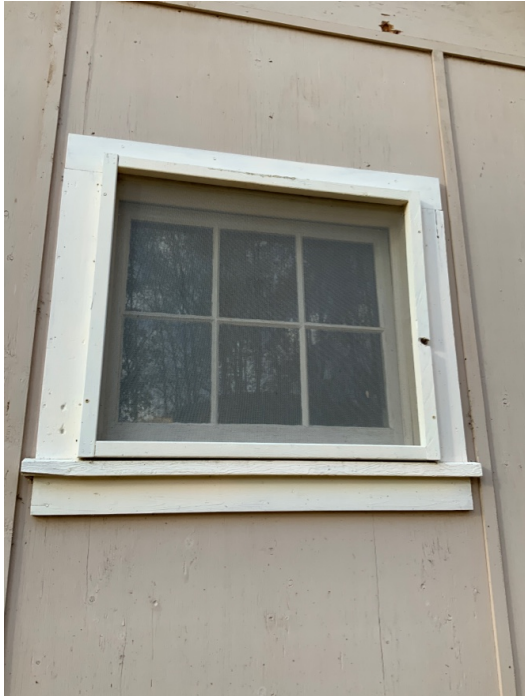
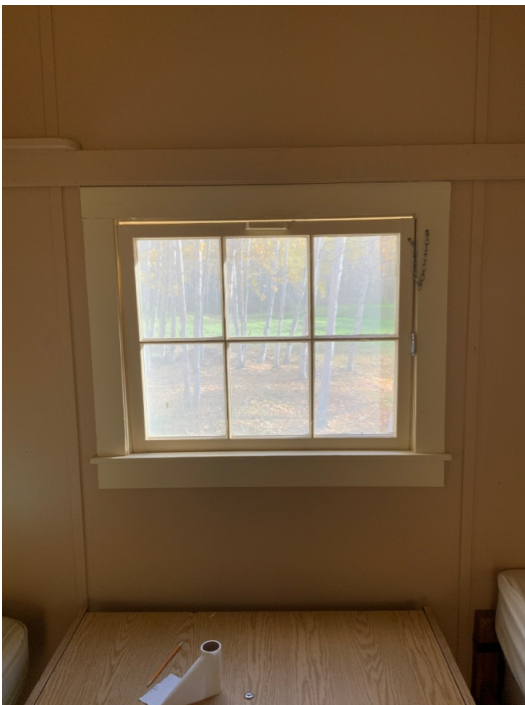
Window: B3.S1

Upper/Fixed Sash: Surface deterioration
