# **Coal Creek Camp**

## **YUKON-CHARLEY RIVERS NATIONAL PRESERVE, ALASKA**

### **HISTORIC STRUCTURE REPORT**

**NPS Task Order #140P2021F0185**  
**April 2022**

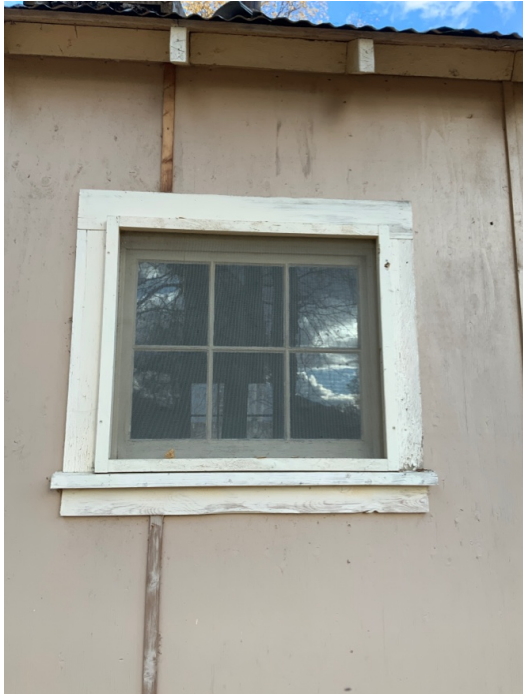
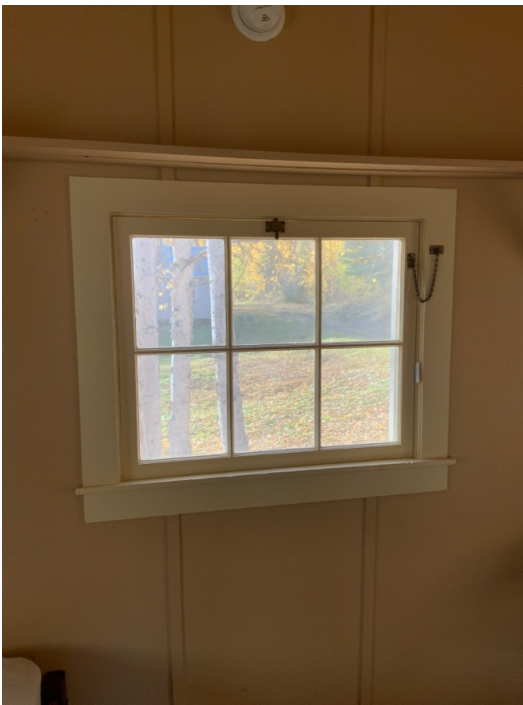
Window: B3.W1

Upper/Fixed Sash: Surface deterioration

Exterior Sill: Surface deterioration

Exterior Trim: Moderate deterioration

Putty: Failed/Missing

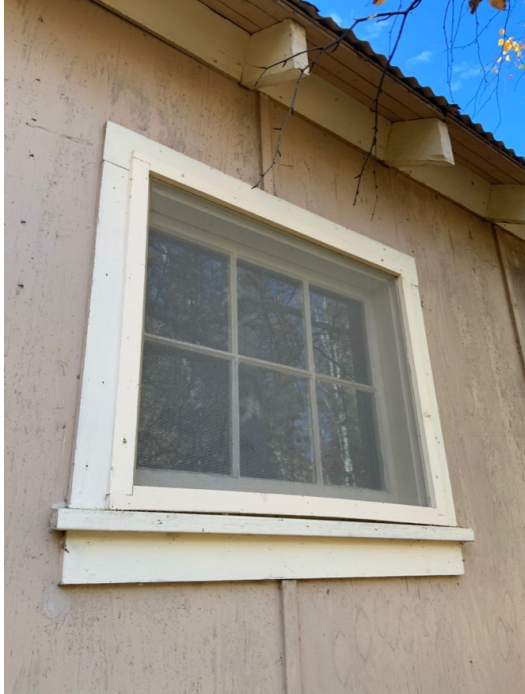
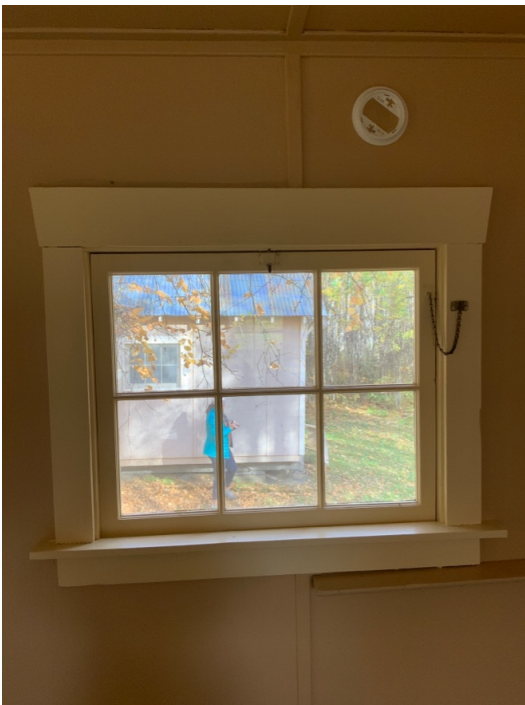
Window: B4.E1

Putty: Dry/Cracked

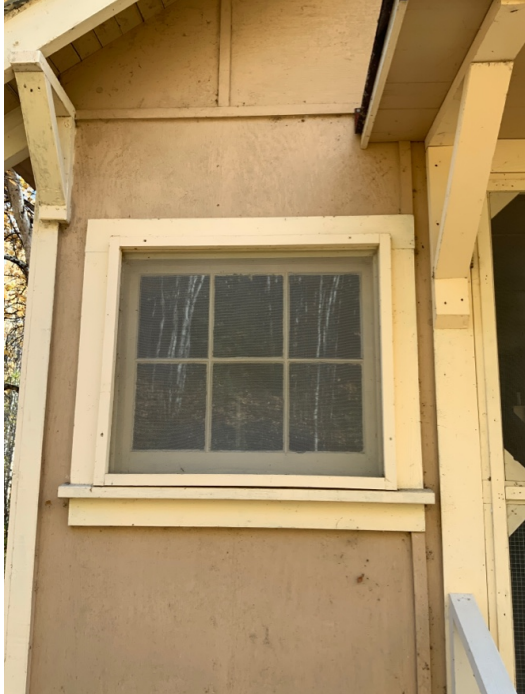
Putty: Failed/Missing

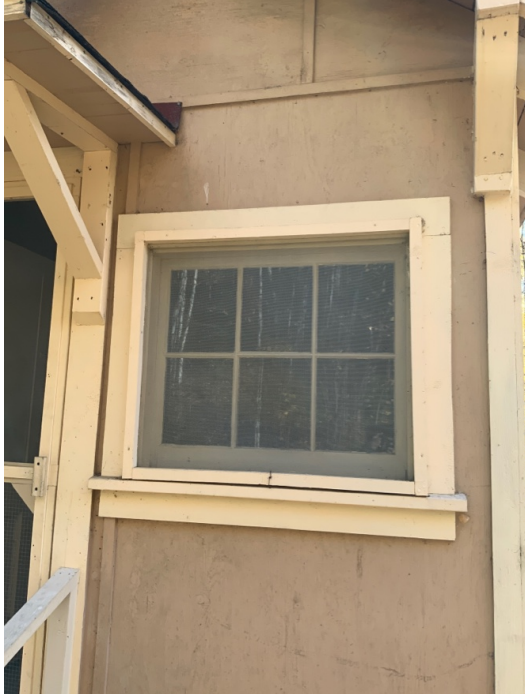
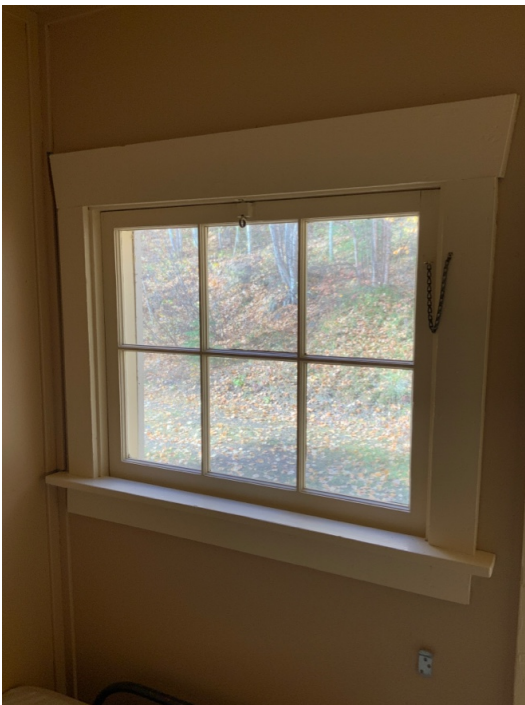
Window: B4.N2

Putty: Failed/Missing

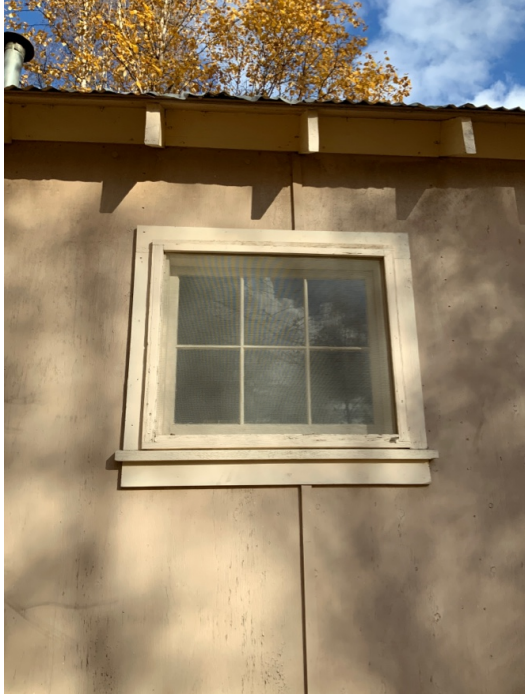
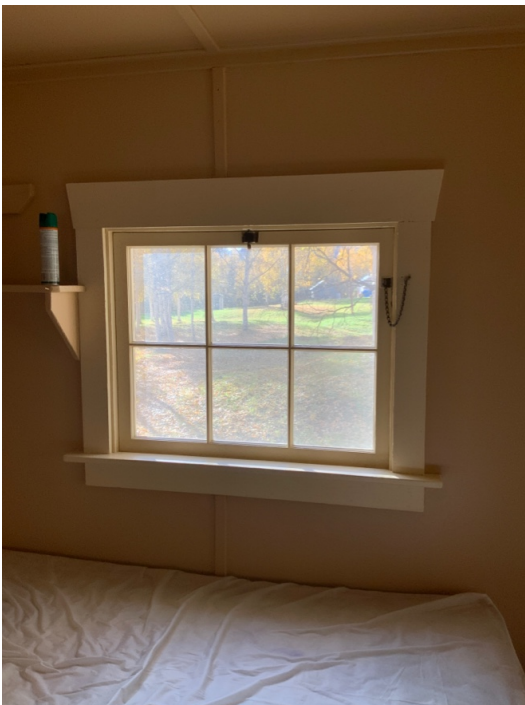
Window: B4.W1

Upper/Fixed Sash: Surface deterioration

Putty: Dry/Cracked

Frame: Moderate deterioration

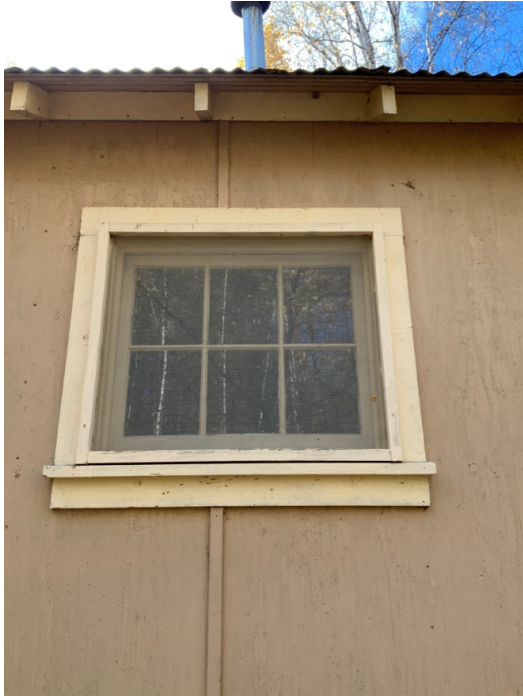
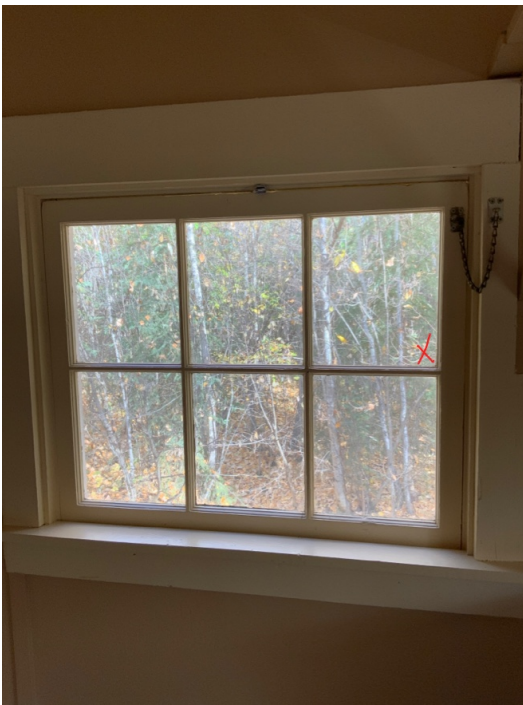
Window: B5.E1

Upper/Fixed Sash: Surface deterioration

Glazing Condition: Cracked

Putty: Failed/Missing

Frame: Surface deterioration

☐ Wood stops☐ Latch ☐ Strike☐ Chain stayNotes: 1 pane cracked  
Chain stay, no latch

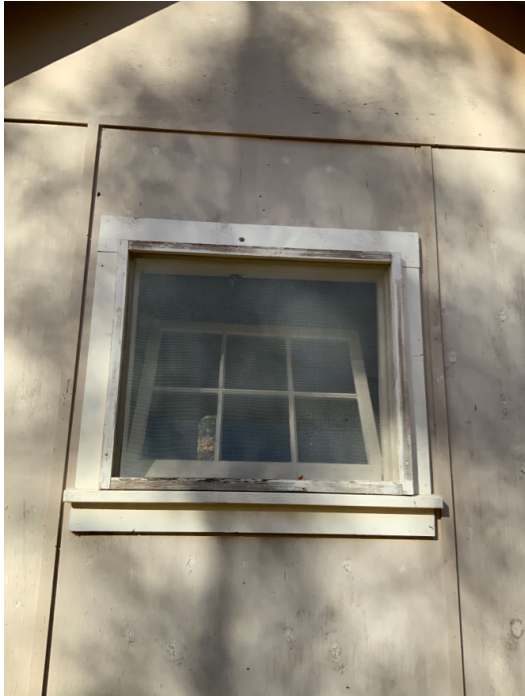
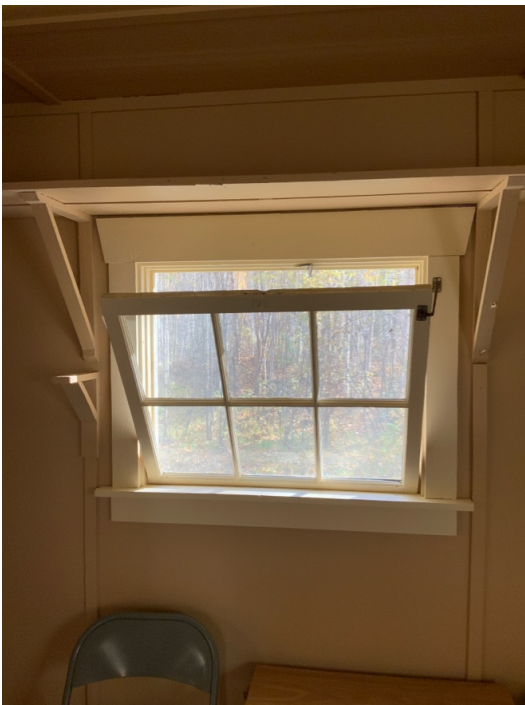
Window: B5.S1

Putty: Dry/Cracked

Frame: Surface deterioration

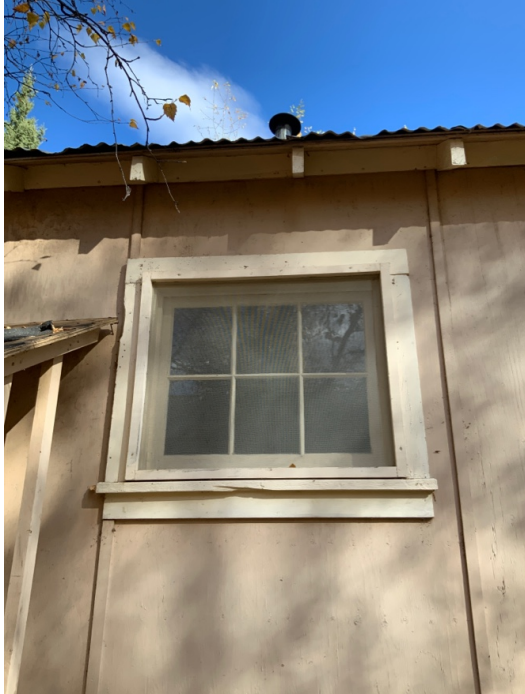
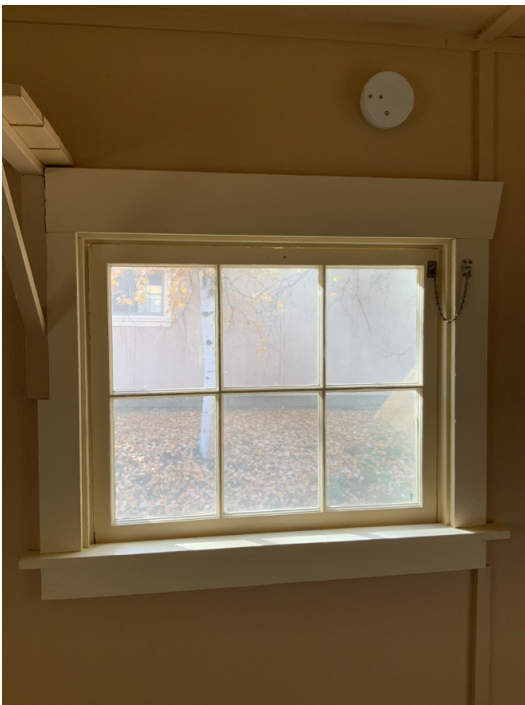
Window: B5.W1

Upper/Fixed Sash: Surface deterioration

Exterior Trim: Surface deterioration

Putty: Dry/Cracked

☐ Wood stops☐ Latch ☐ Strike☐ Chain stayNotes: Sill fractured but good condition  
Chain stay no latch

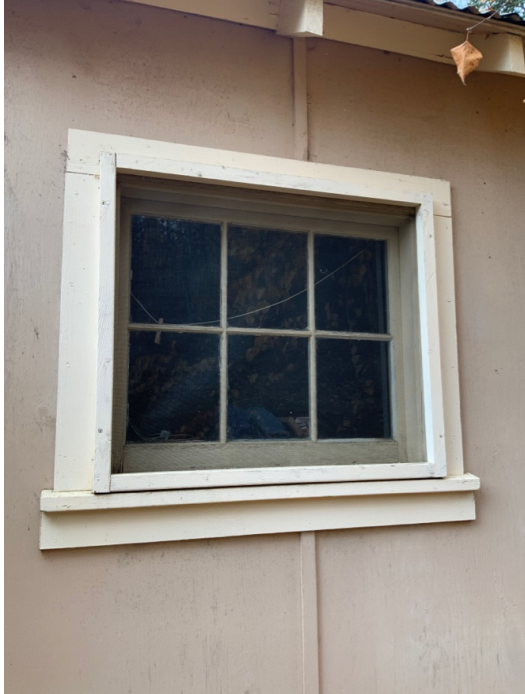
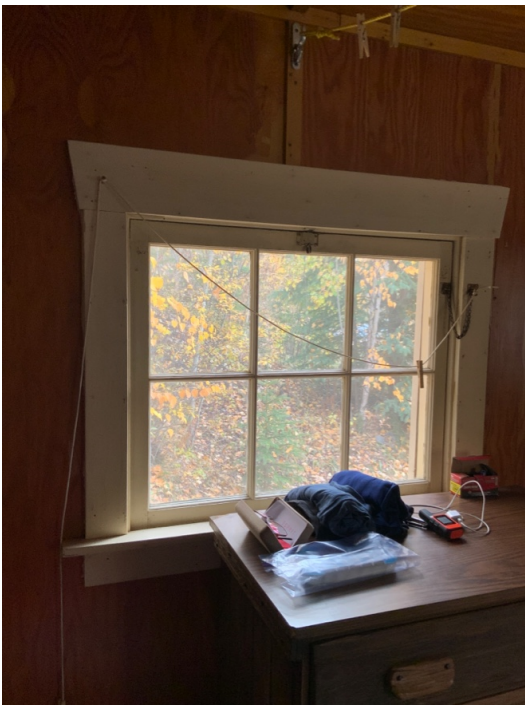
Window: B6.E1

Muntins: Surface deterioration

Exterior Sill: Surface deterioration

Putty: Failed/Missing

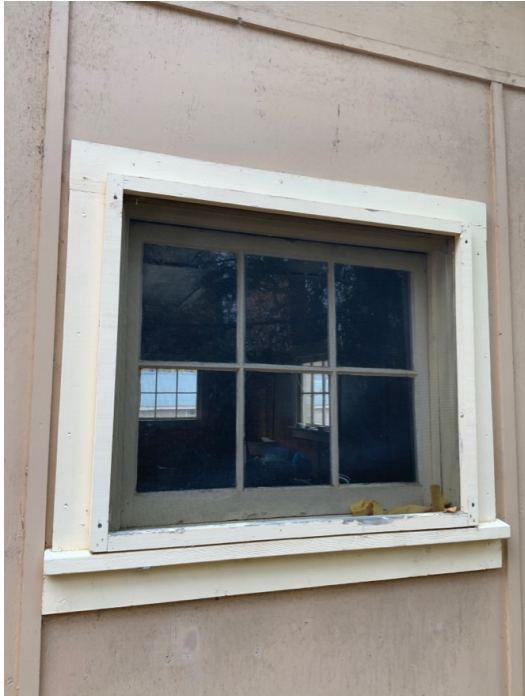
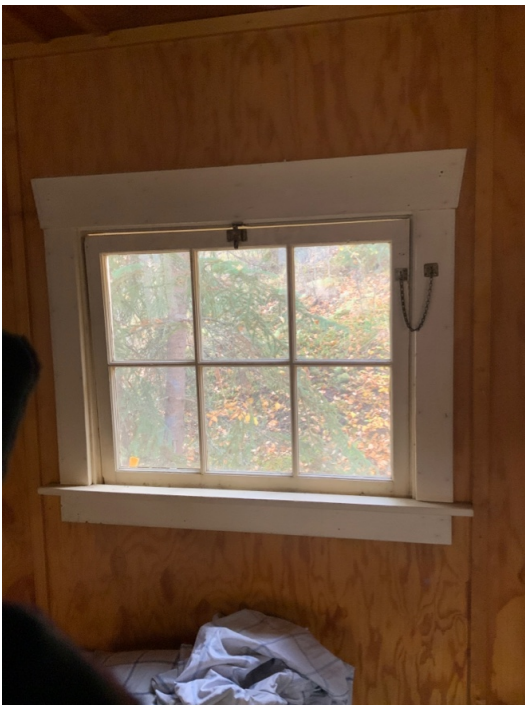
Window: B6.N1

Upper/Fixed Sash: Surface deterioration

Muntins: Surface deterioration

Putty: Dry/Cracked

Frame: Surface deterioration

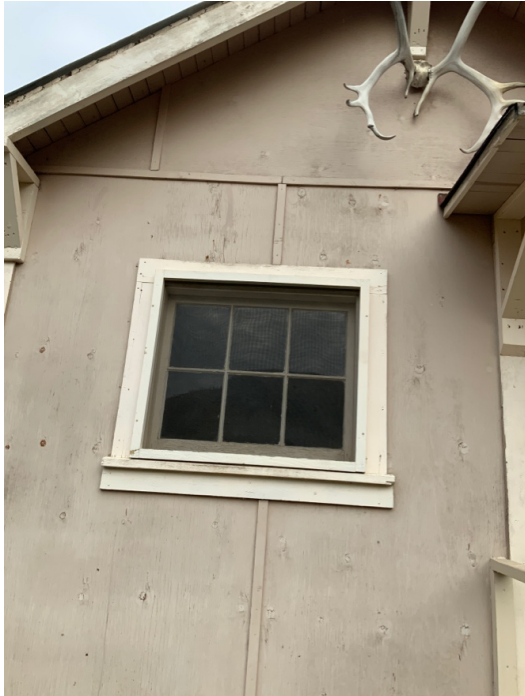
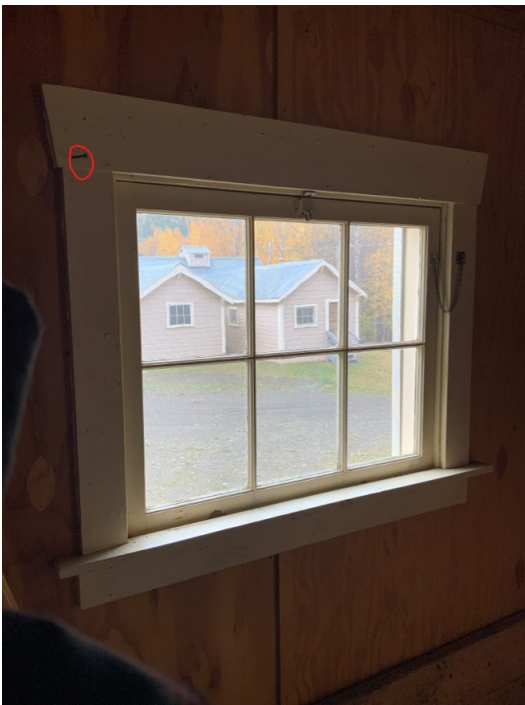
Window: B6.S1

Upper/Fixed Sash: Surface deterioration

Muntins: Surface deterioration

Exterior Sill: Surface deterioration

Exterior Trim: Moderate deterioration

Putty: Dry/Cracked

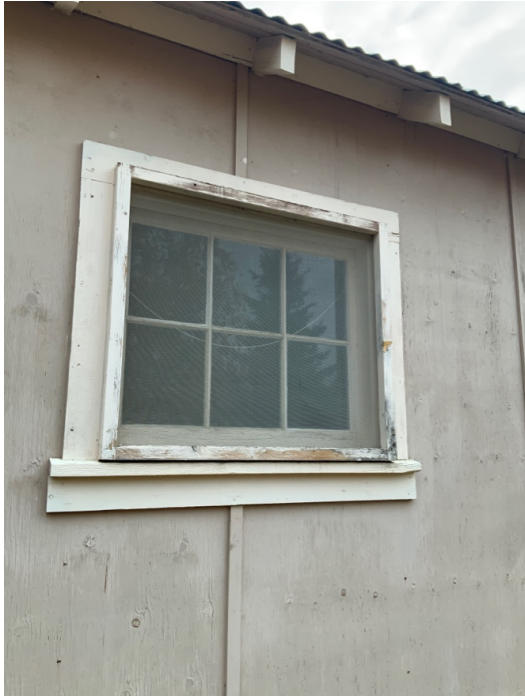
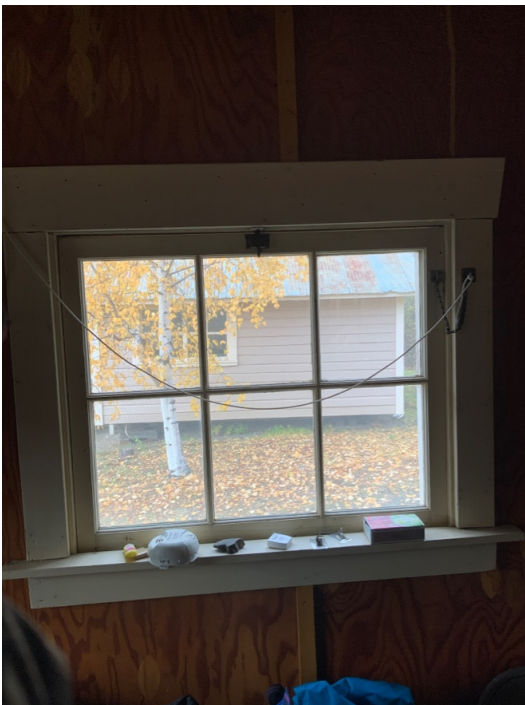
Window: B6.W1

Upper/Fixed Sash: Surface deterioration

Muntins: Surface deterioration

Exterior Sill: Surface deterioration

Exterior Trim: Moderate deterioration

Putty: Dry/Cracked

Frame: Surface deterioration

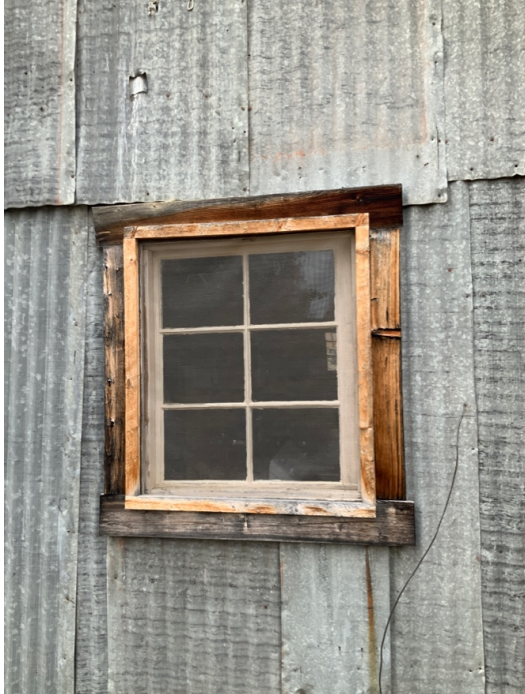
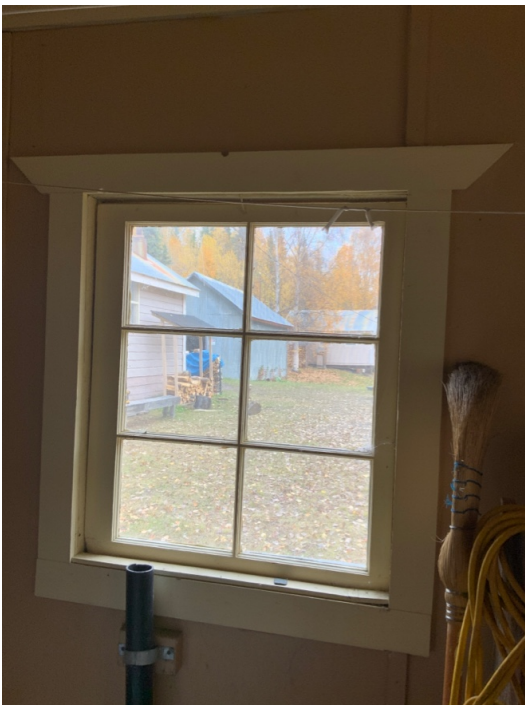
Window: LA.E1

Upper/Fixed Sash: Surface deterioration

Exterior Trim: Surface deterioration

Putty: Dry/Cracked

Frame: Surface deterioration

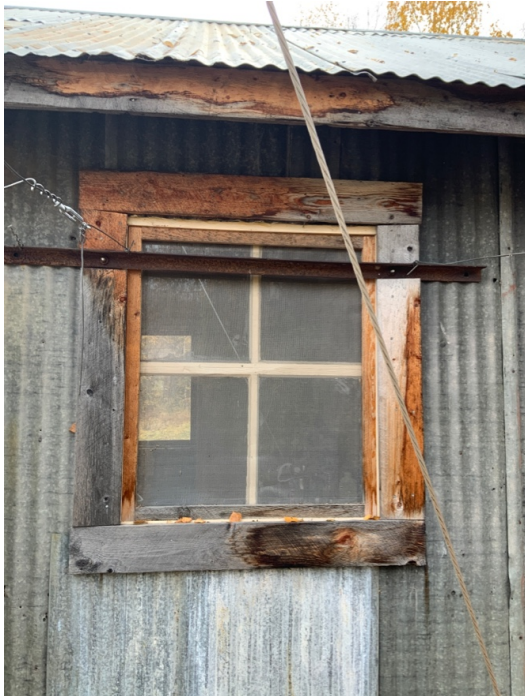
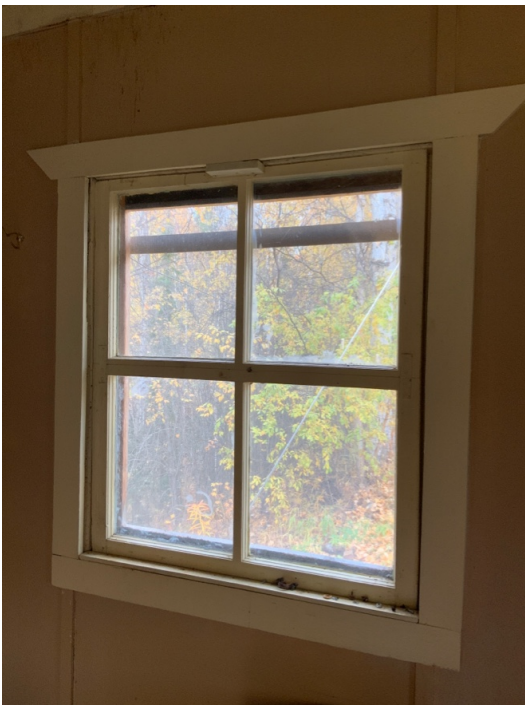
Window: LA.N1

Upper/Fixed Sash: Surface deterioration

Muntins: Surface deterioration

Exterior Trim: Moderate deterioration

Putty: Failed/Missing

Frame: Surface deterioration

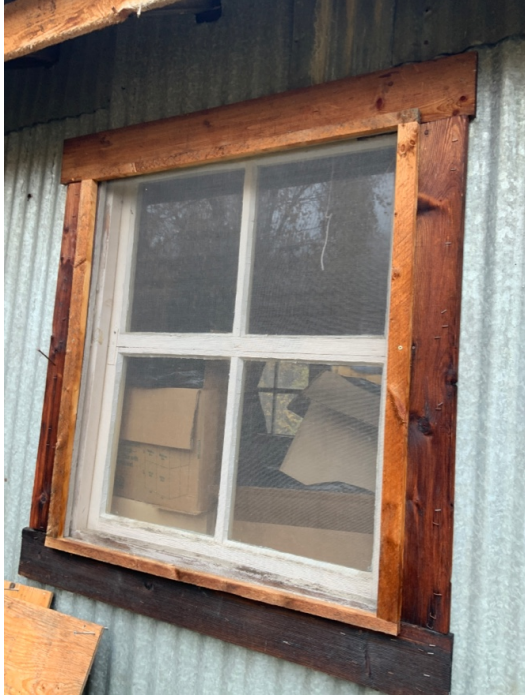
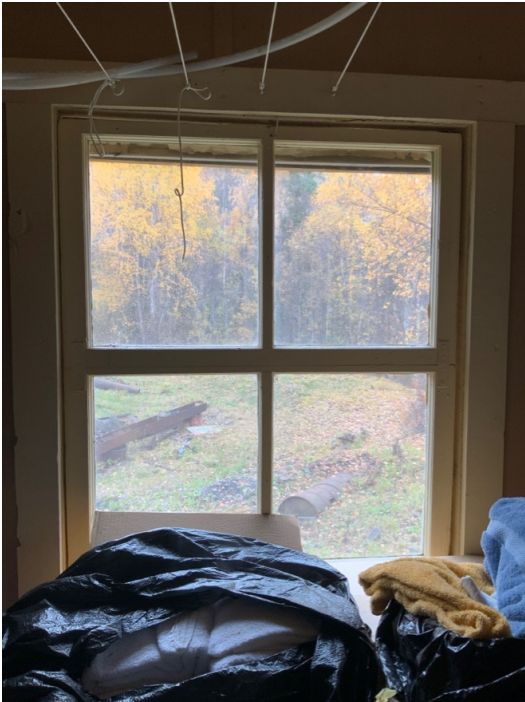
Window: LA.S1

Upper/Fixed Sash: Surface deterioration

Jamb: Surface deterioration

Exterior Sill: Moderate deterioration

Putty: Dry/Cracked

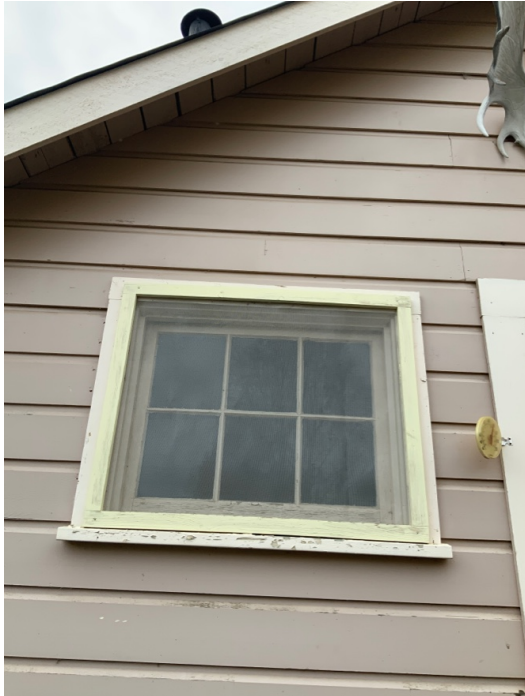
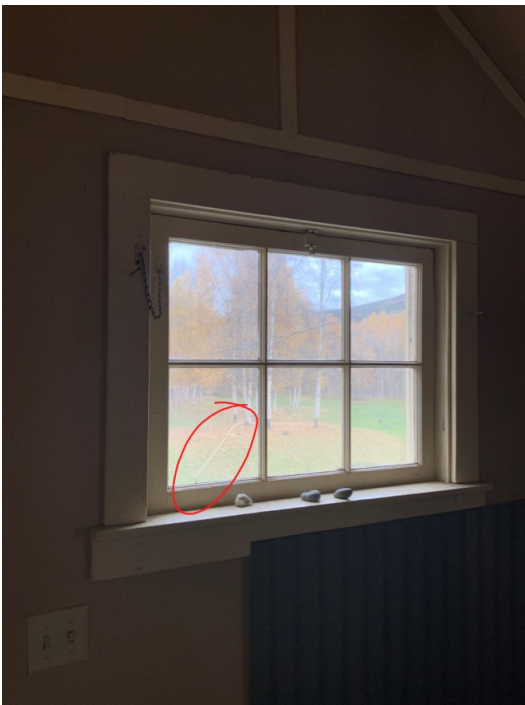
Window: MH.E1

Upper/Fixed Sash: Surface deterioration

Exterior Sill: Surface deterioration

Glazing Condition: Cracked

Putty: Dry/Cracked

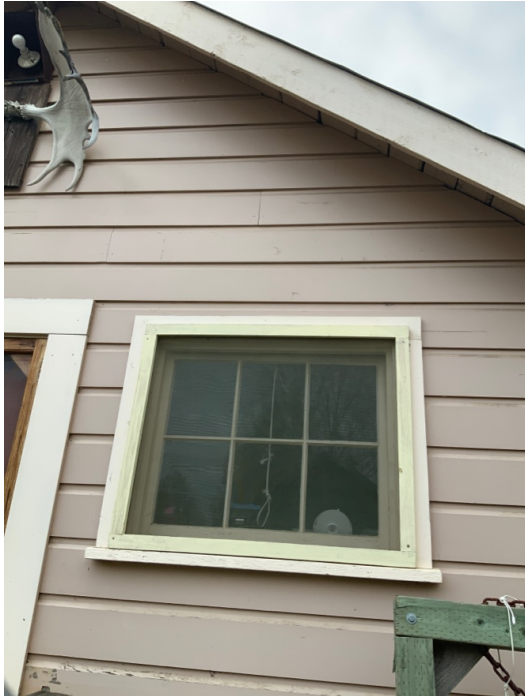
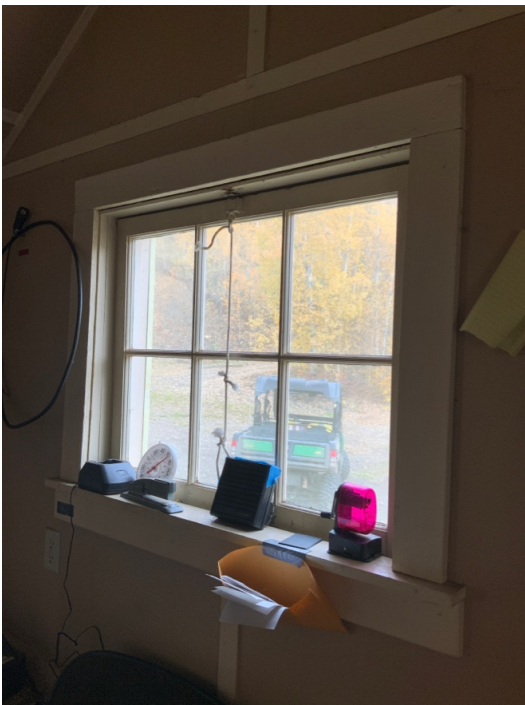
Window: MH.E2

Upper/Fixed Sash: Surface deterioration

Muntins: Surface deterioration

Exterior Sill: Surface deterioration

Putty: Dry/Cracked

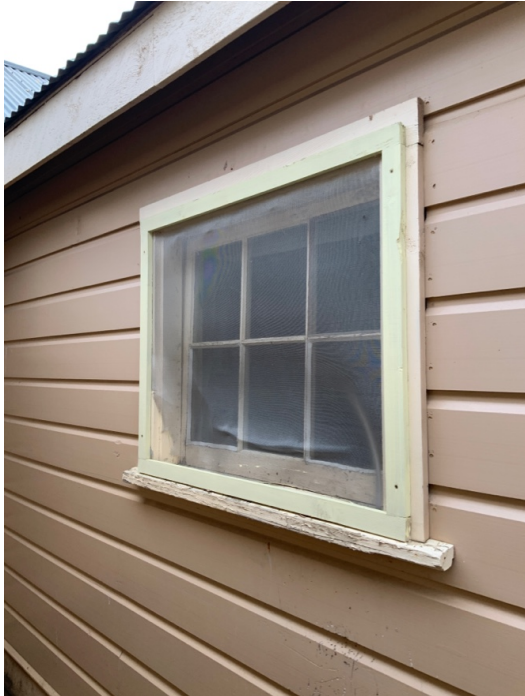
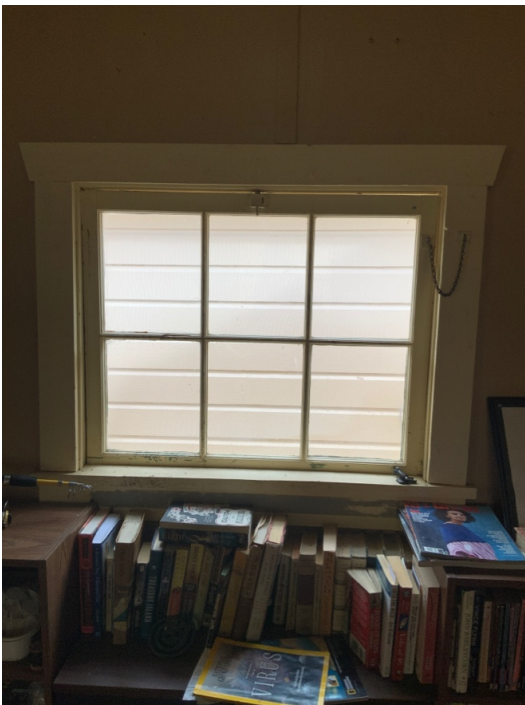
Window: MH.E3

Upper/Fixed Sash: Surface deterioration

Muntins: Surface deterioration

Jamb: Surface deterioration

Exterior Sill: Moderate deterioration

Putty: Failed/Missing

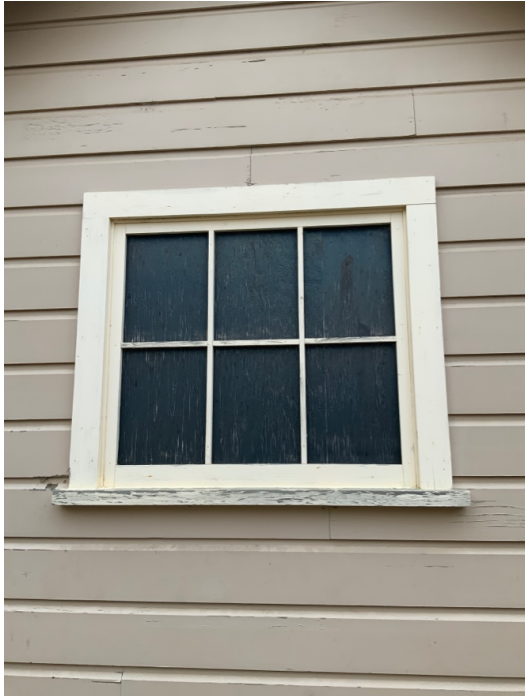
Building: Mess Hall

Exterior Sill: Surface deterioration

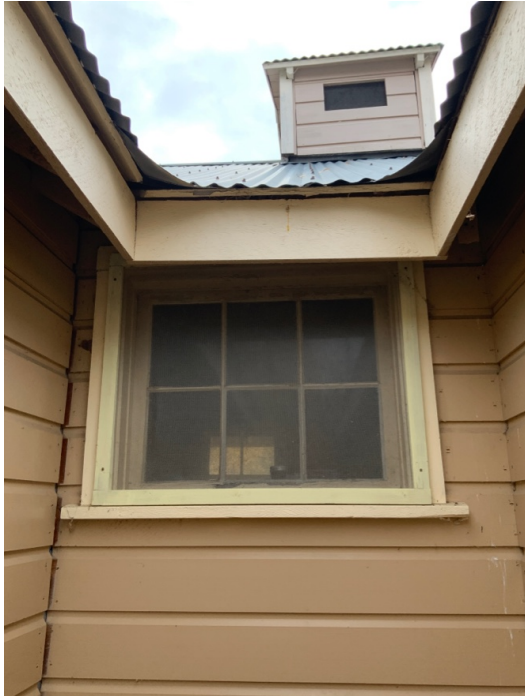
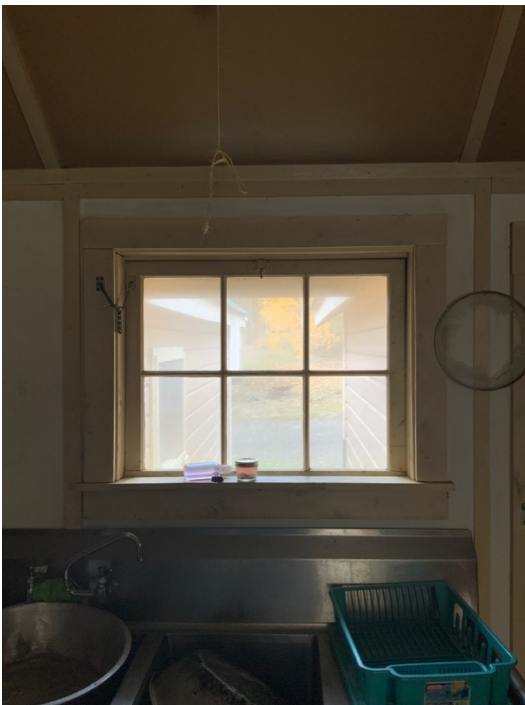
Window: MH.N2

Upper/Fixed Sash: Moderate deterioration

Muntins: Surface deterioration

Putty: Failed/Missing

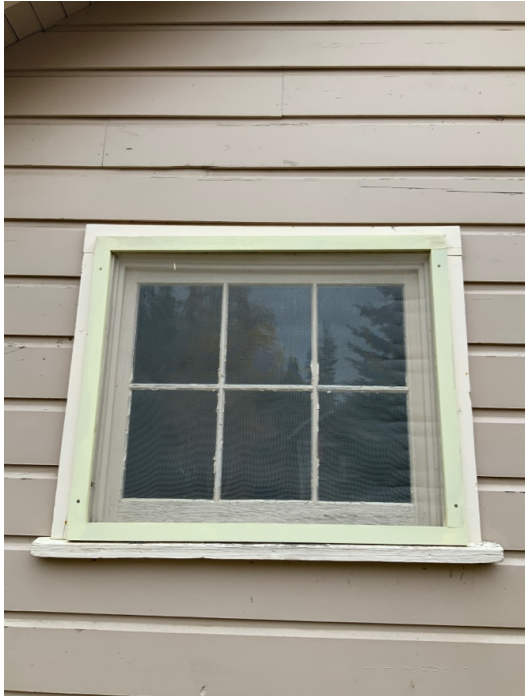
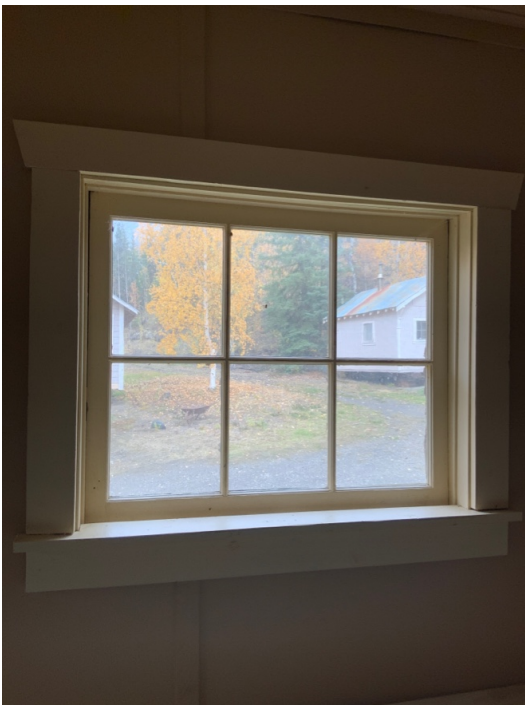
Window: MH.N3

Upper/Fixed Sash: Surface deterioration

Muntins: Surface deterioration

Exterior Sill: Surface deterioration

Putty: Failed/Missing

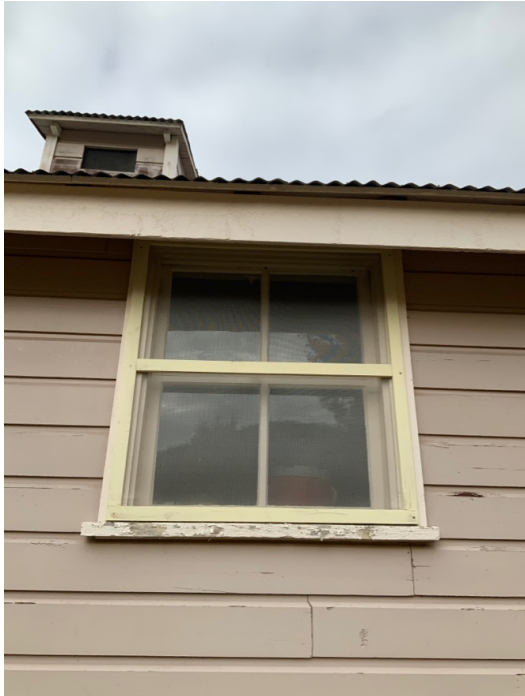
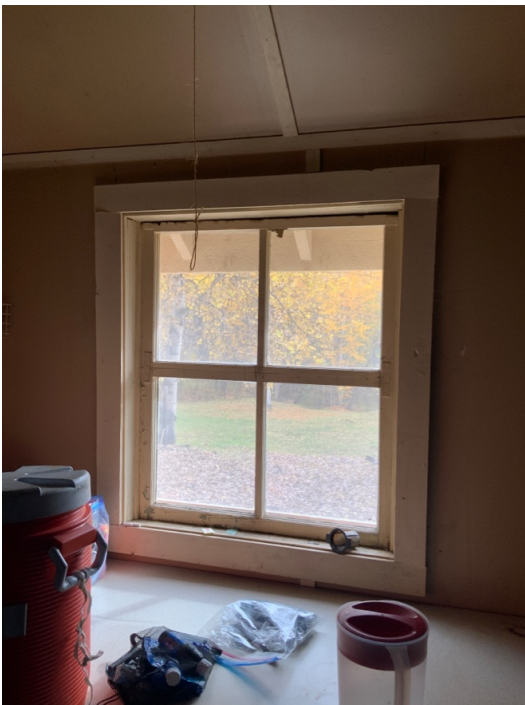
Window: MH.S1

Exterior Sill: Surface deterioration

Putty: Dry/Cracked

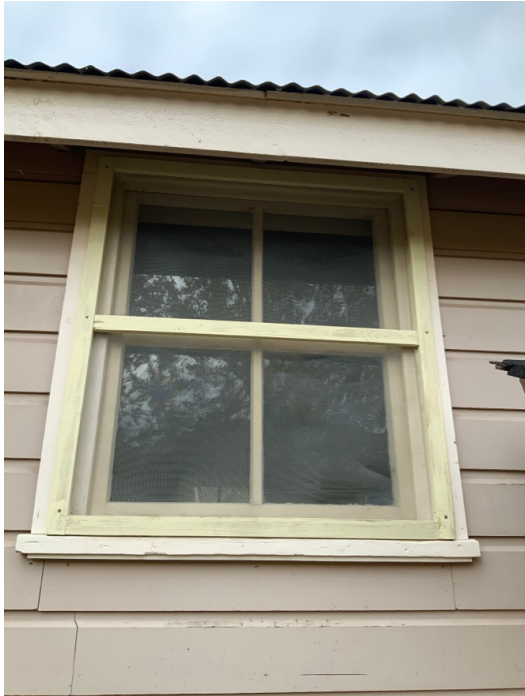
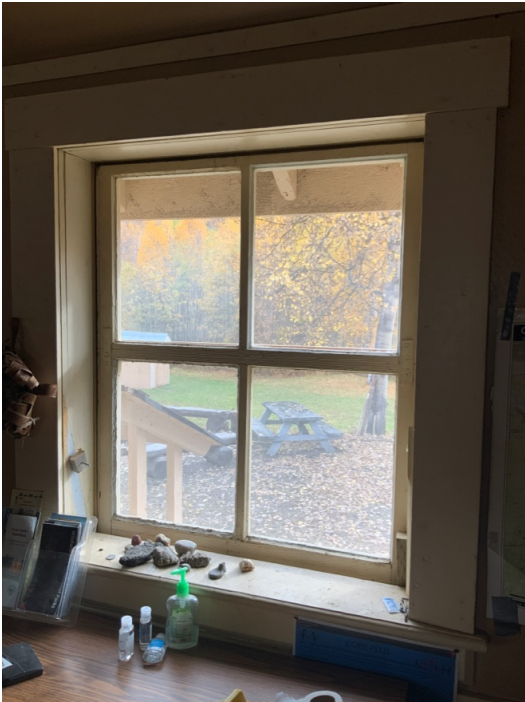
Window: MH.S2

Upper/Fixed Sash: Surface deterioration

Muntins: Surface deterioration

Putty: Failed/Missing

☒ Wood stops☐ Latch ☐ Strike☐ Chain stayNotes: Sash installed backwards  
Left stop missing

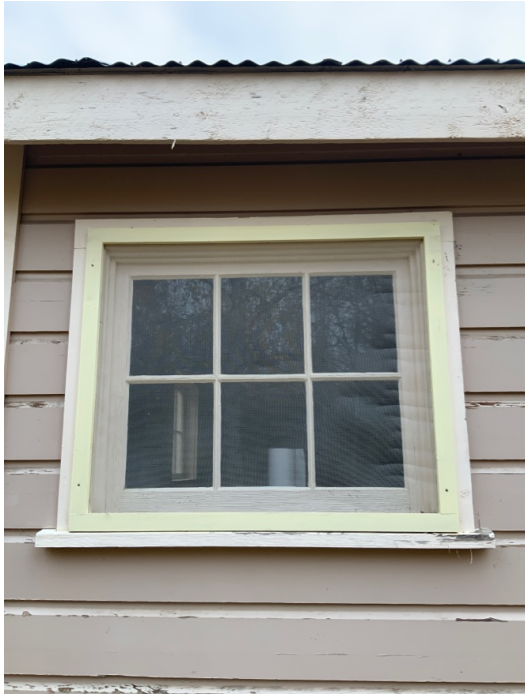
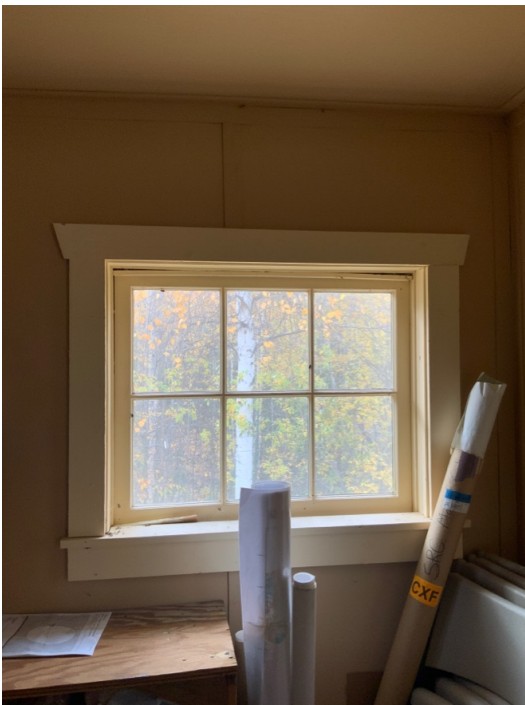
Glazing Condition: Intact

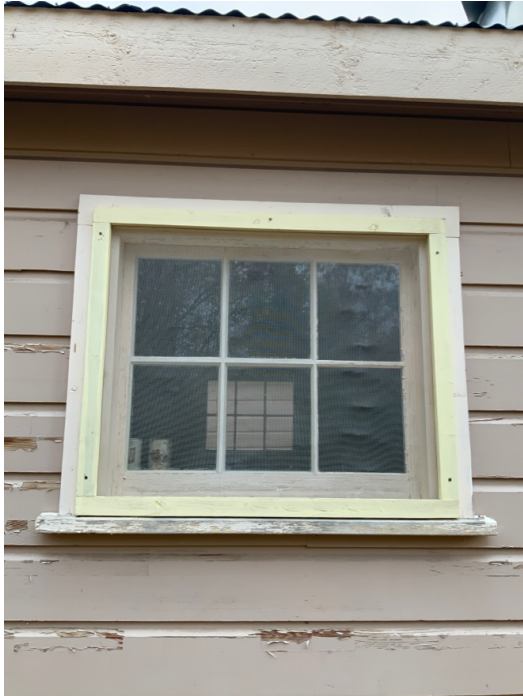
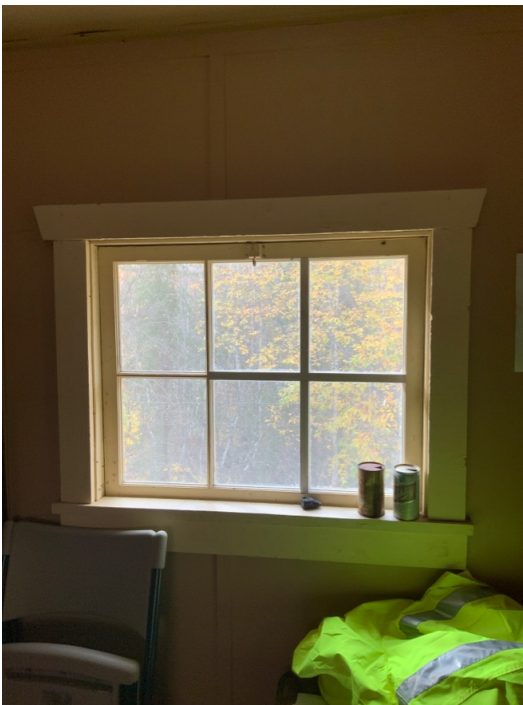
Window: MH.W1

Upper/Fixed Sash: Surface deterioration

Exterior Sill: Surface deterioration

Glazing Condition: Intact

Putty: Dry/Cracked

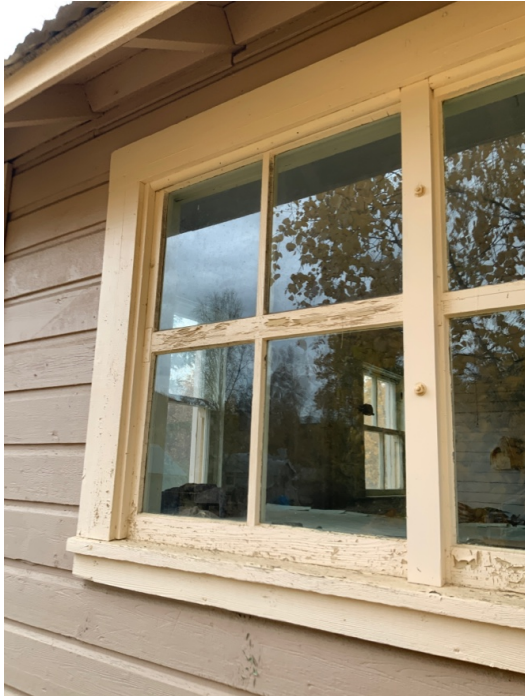
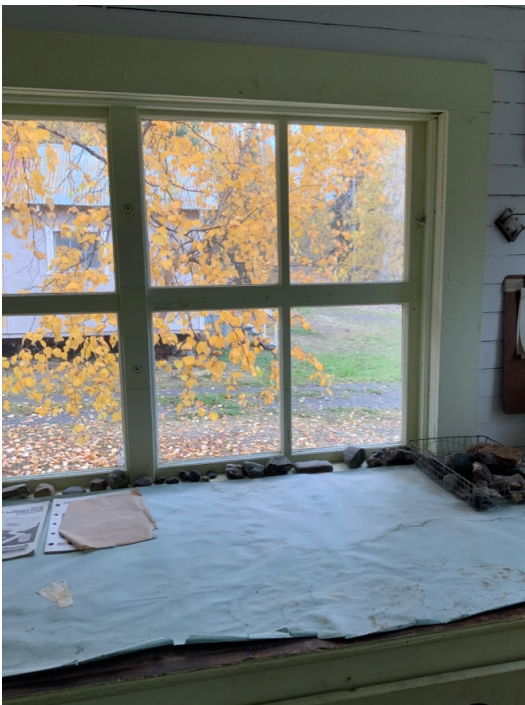
Window: MH.W2

Upper/Fixed Sash: Surface deterioration

Exterior Sill: Surface deterioration

Glazing Condition: Intact

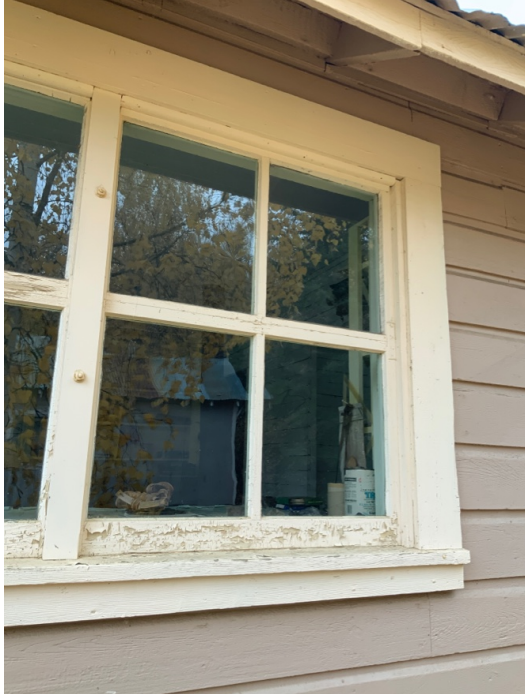
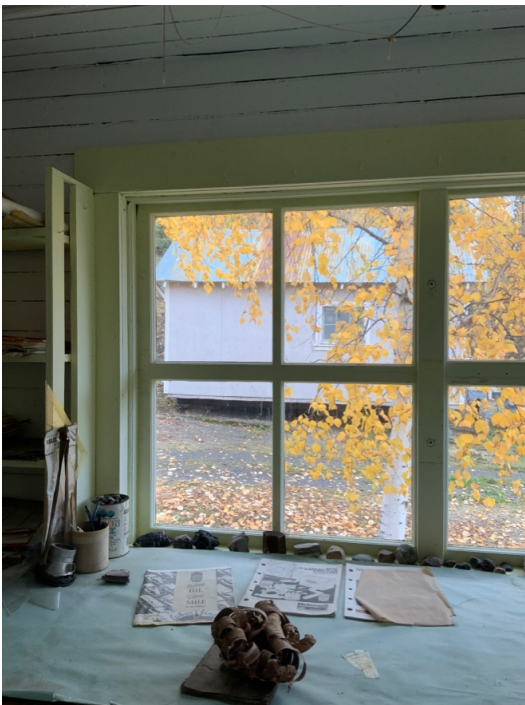
Window: MO.E1

Upper/Fixed Sash: Surface deterioration

Jamb: Surface deterioration

Exterior Sill: Surface deterioration

Exterior Trim: Surface deterioration

Glazing Condition: Intact

Putty: Failed/Missing

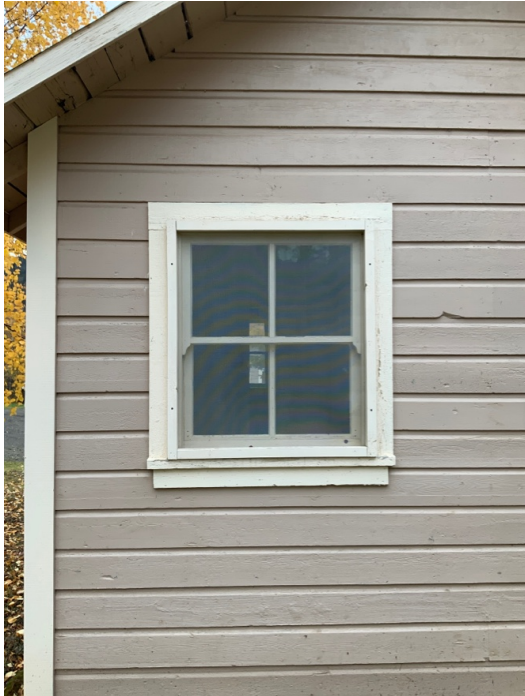
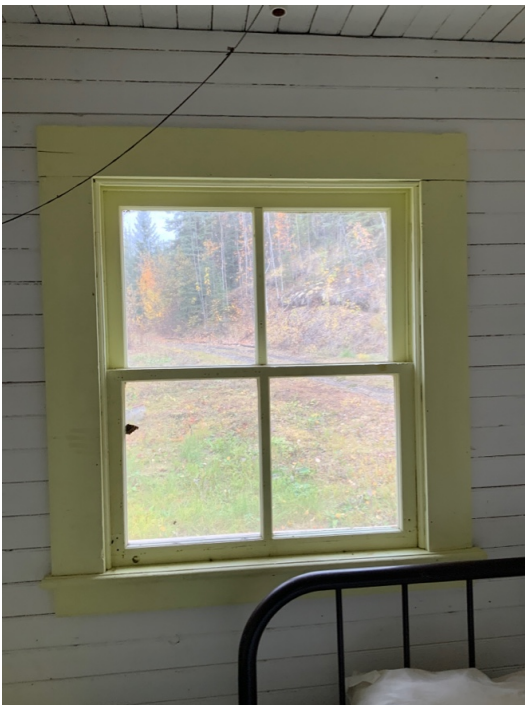
Window: MO.E2

Upper/Fixed Sash: Surface deterioration

Muntins: Surface deterioration

Jamb: Surface deterioration

Exterior Sill: Surface deterioration

Exterior Trim: Surface deterioration

Glazing Condition: Intact

Putty: Dry/Cracked

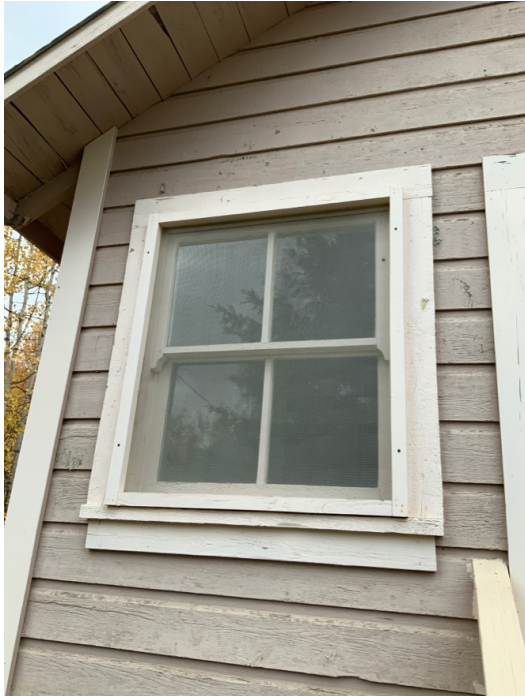
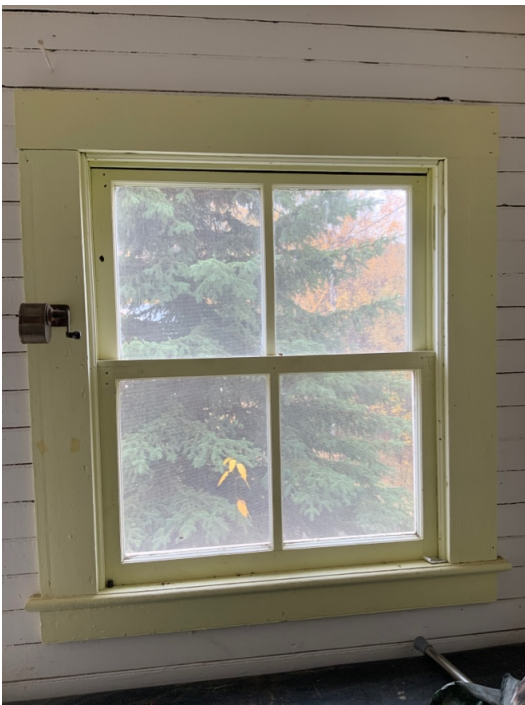
Window: MO.N1

Operable: Ropes and pulleys missing

Upper/Fixed Sash: Surface deterioration

Lower Sash: Surface deterioration

Muntins: Surface deterioration

Exterior Sill: Surface deterioration

Exterior Trim: Surface deterioration

Glazing Condition: Intact

Putty: Dry/Cracked

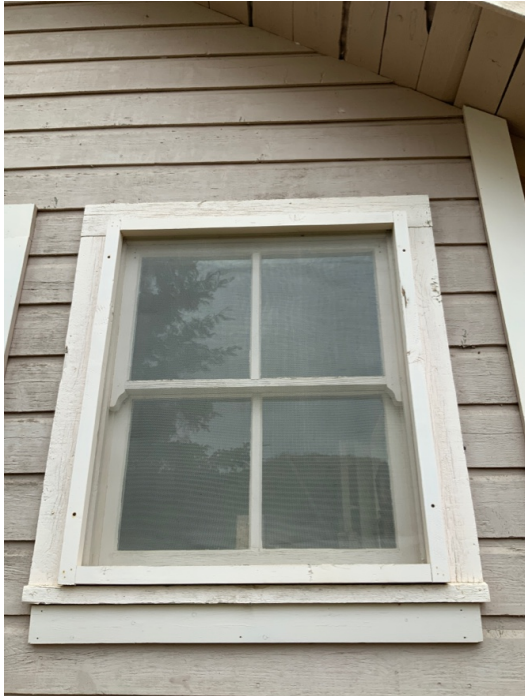
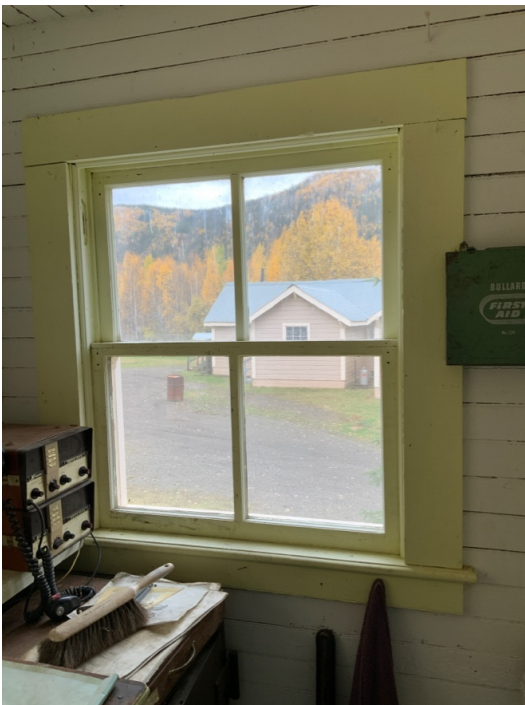
Window: MO.S1

Operable: Ropes and pulleys missing

Lower Sash: Surface deterioration

Exterior Sill: Surface deterioration

Exterior Trim: Surface deterioration

Glazing Condition: Intact

Putty: Dry/Cracked
