# **Coal Creek Camp**

## **YUKON-CHARLEY RIVERS NATIONAL PRESERVE, ALASKA**

### **HISTORIC STRUCTURE REPORT**

**NPS Task Order #140P2021F0185**  
**April 2022**

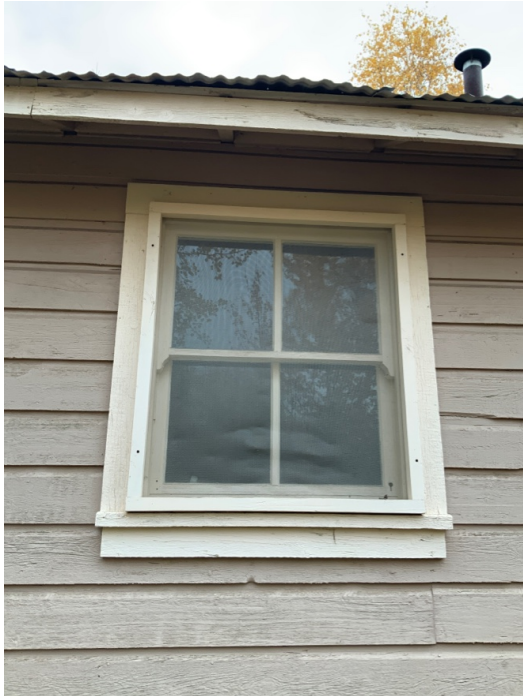
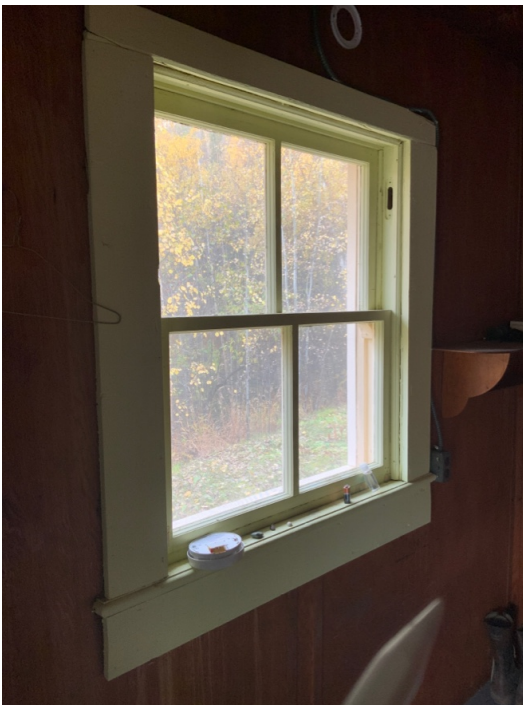
Window: MO.S2

Operable: Ropes and pulleys missing

Upper/Fixed Sash: Surface deterioration

Lower Sash: Surface deterioration

Exterior Sill: Surface deterioration

Exterior Trim: Surface deterioration

Glazing Condition: Intact

Putty: Dry/Cracked

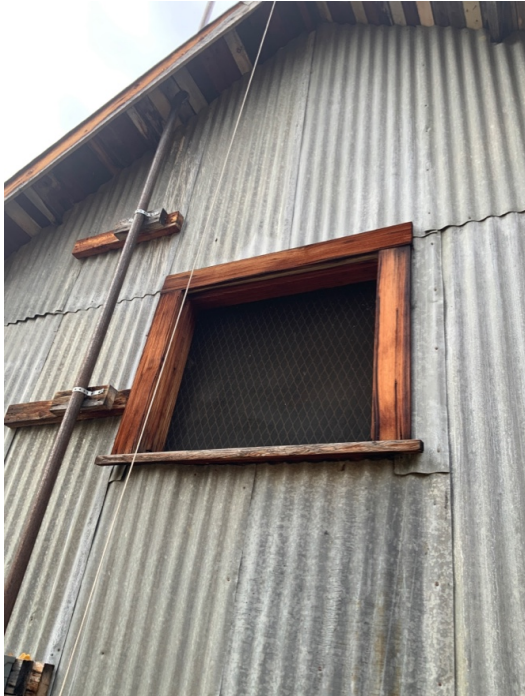
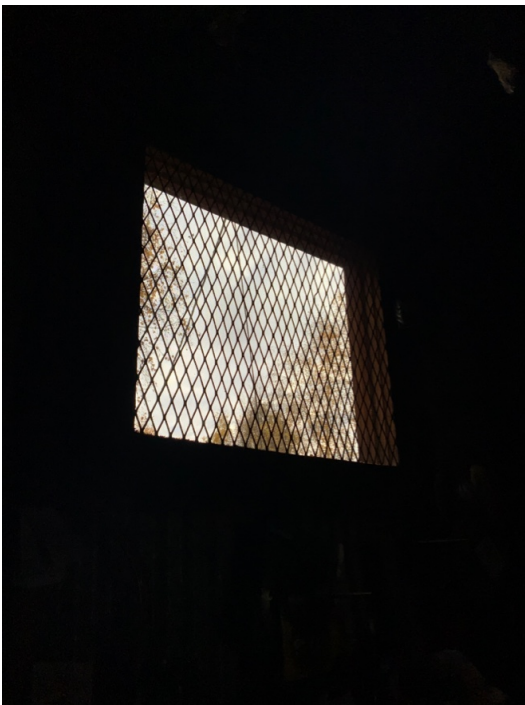
Window: MO.W1

Operable: Ropes and pulleys missing

Upper/Fixed Sash: Surface deterioration

Lower Sash: Surface deterioration

Exterior Sill: Surface deterioration

Exterior Trim: Surface deterioration

Glazing Condition: Intact

Putty: Dry/Cracked

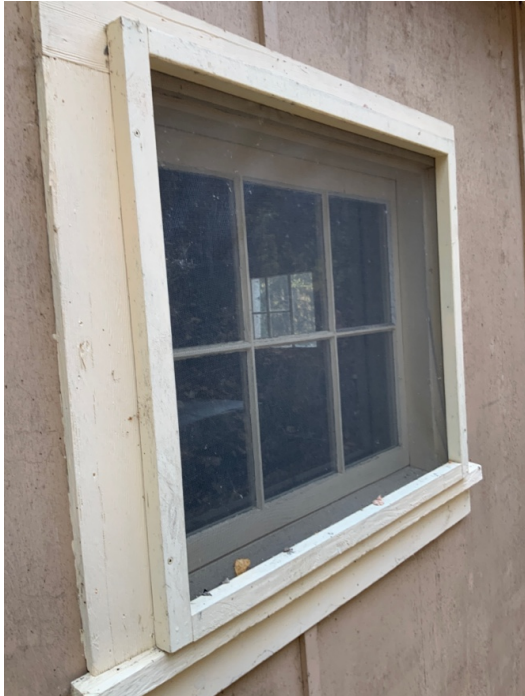
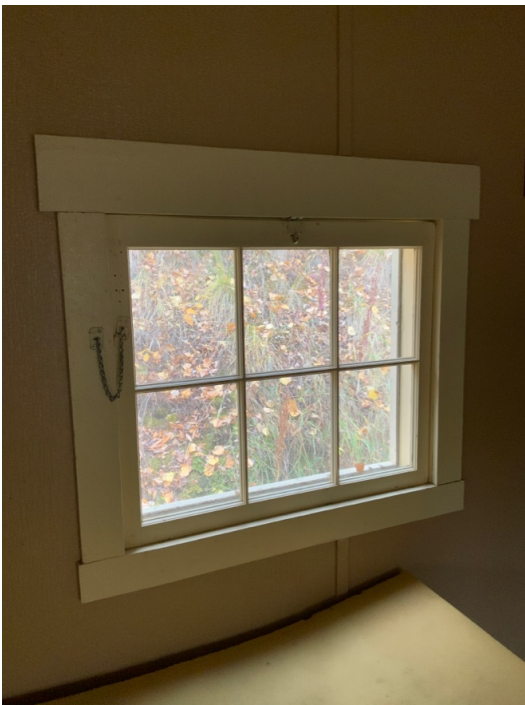
Window: MS.E1

Exterior Sill: Surface deterioration

Glazing Condition: —

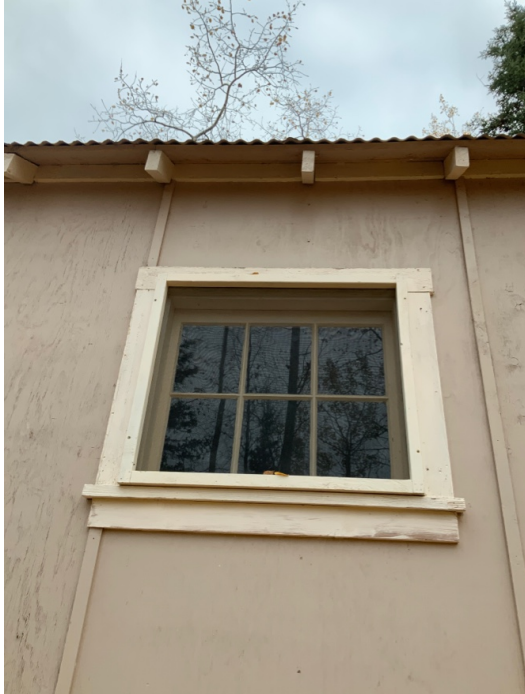
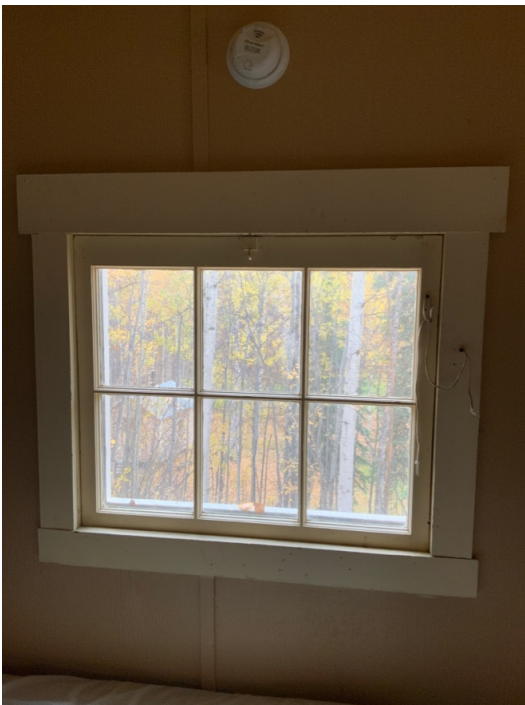
Window: PB.N1

Glazing Condition: Intact

Putty: Dry/Cracked

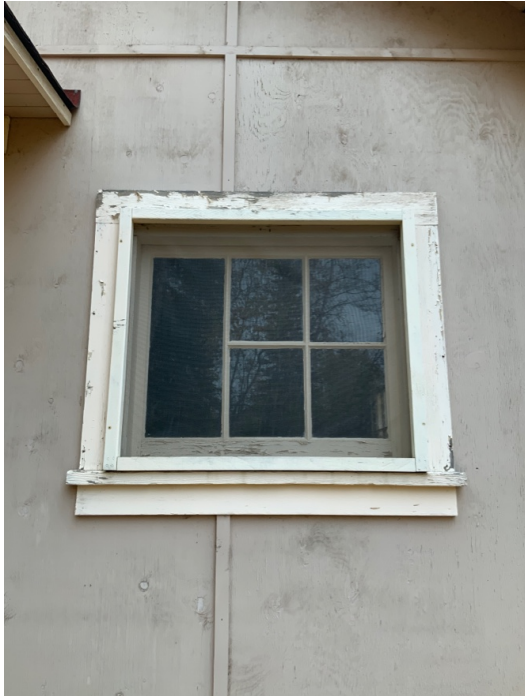
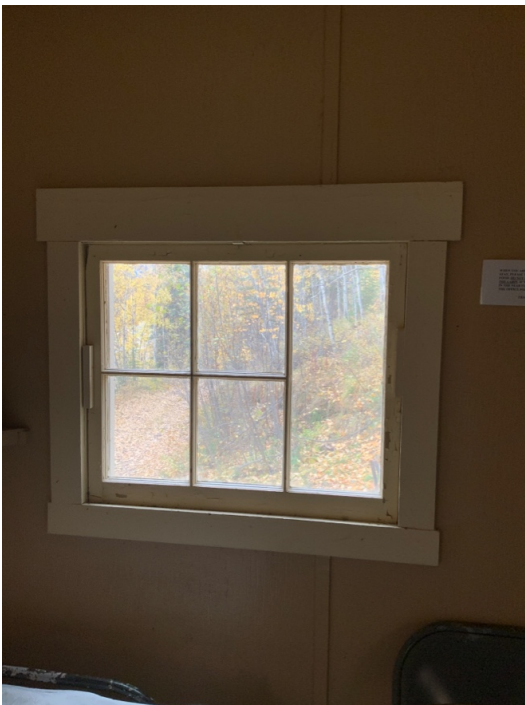
Window: PB.S1

Exterior Sill: Surface deterioration

Glazing Condition: Intact

Putty: Dry/Cracked
