HISTORIC STRUCTURE REPORT

SOUTHWEST REGION HEADQUARTERS BUILDING
SANTA FE, NEW MEXICO

Southwest Cultural Resources Center Professional Paper No. 6
U.S. Department of the Interior
National Park Service
Santa Fe, New Mexico
March 1985

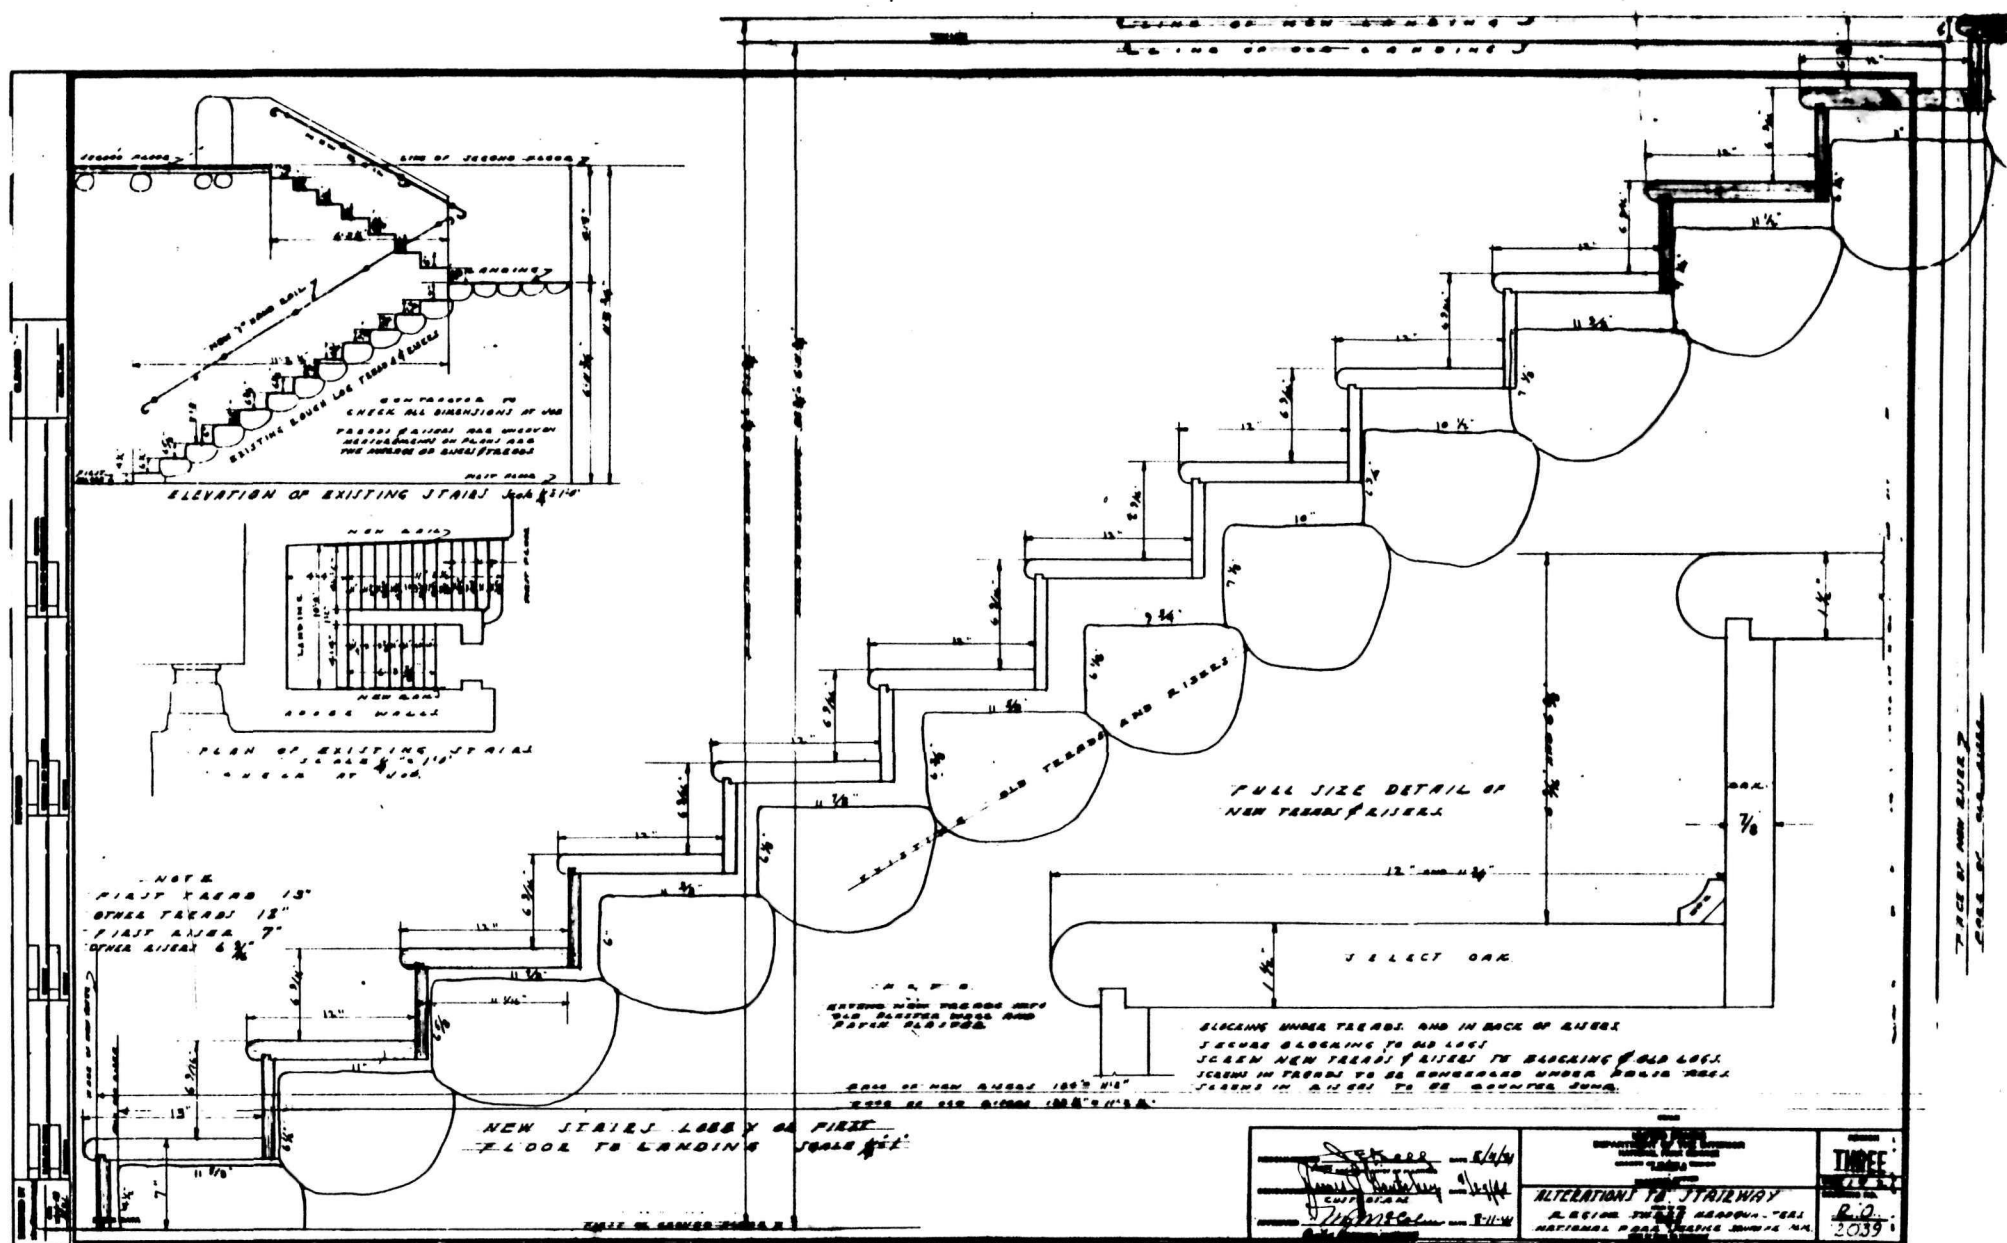
Figure 42.

The building had only been opened a year when employees began to complain about tripping on the log stairs. After careful measuring, it was discovered that the logs were uneven. To rectify the situation, new treads and risers were constructed over the original log stairs. The new treads and risers were constructed of oak and were screwed down to leveling blocks which had previously been attached to the logs. When remodeling neared completion, the plaster walls were patched and the screws concealed under false pegs. The stair exists today as it was remodeled in 1941. All of the new treads measure 12 inches except the first which measures 13 inches, and all of the risers measure 6-7/16 inches except the first which measures 7 inches (Figure 42).

Original log stair to the second level modified in 1941 with new oak treads and risers.

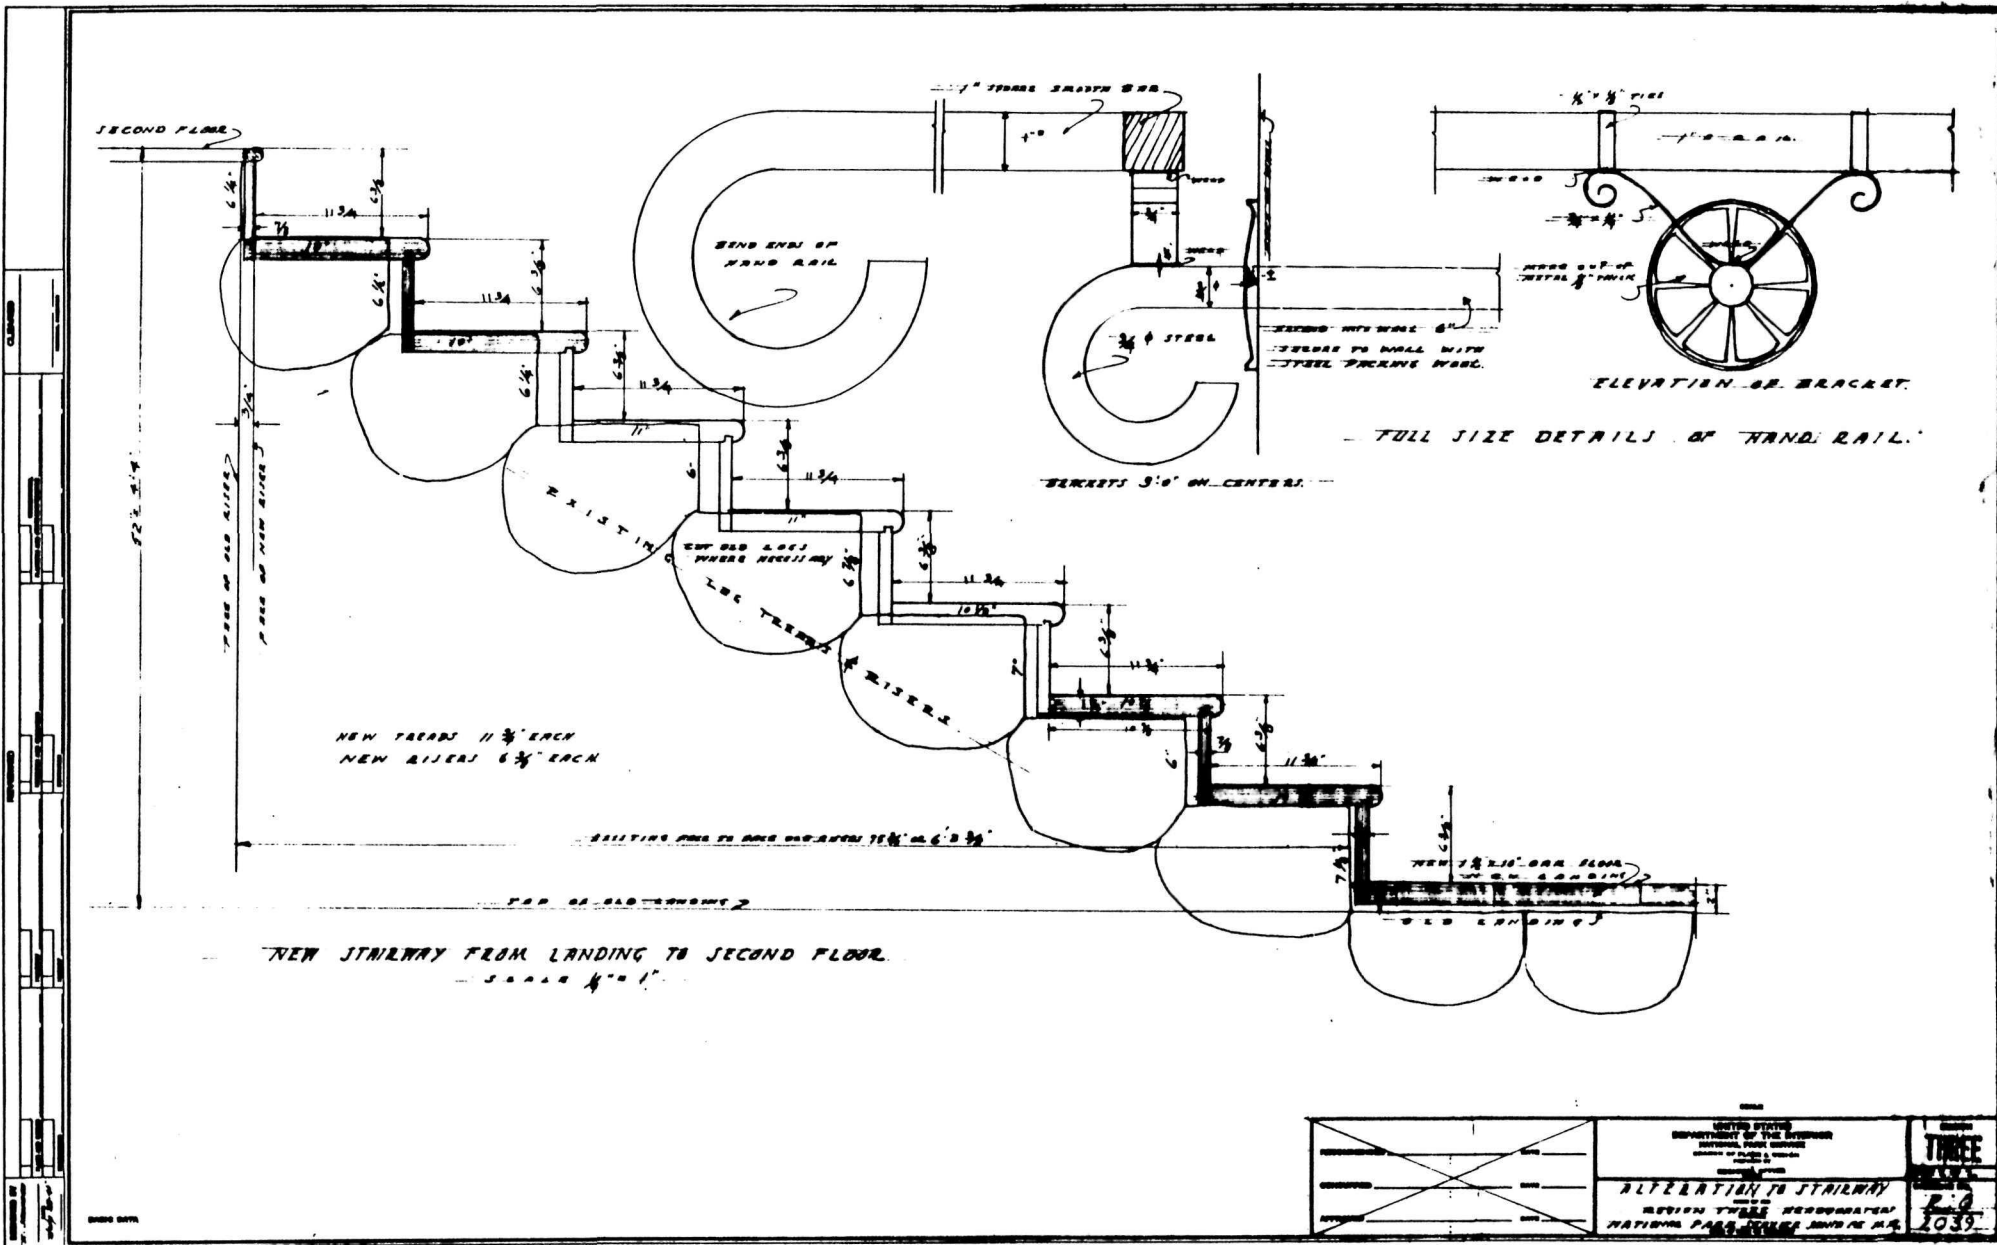
Also shown on stair remodeling drawings were oak dust trim pieces, to be placed on each step, and a new handrail. The rail, to be hand-made in Santa Fe, is shown in Figure 43. The design of the railing called for the ends to be bent in a curve and the rail itself to be a square, smooth bar with decorative metal brackets. As the original (1939) railing is still in place, it is unlikely that this more ornamental rail was ever constructed.

Stairway alteration from landing to second floor and details of a proposed handrail.

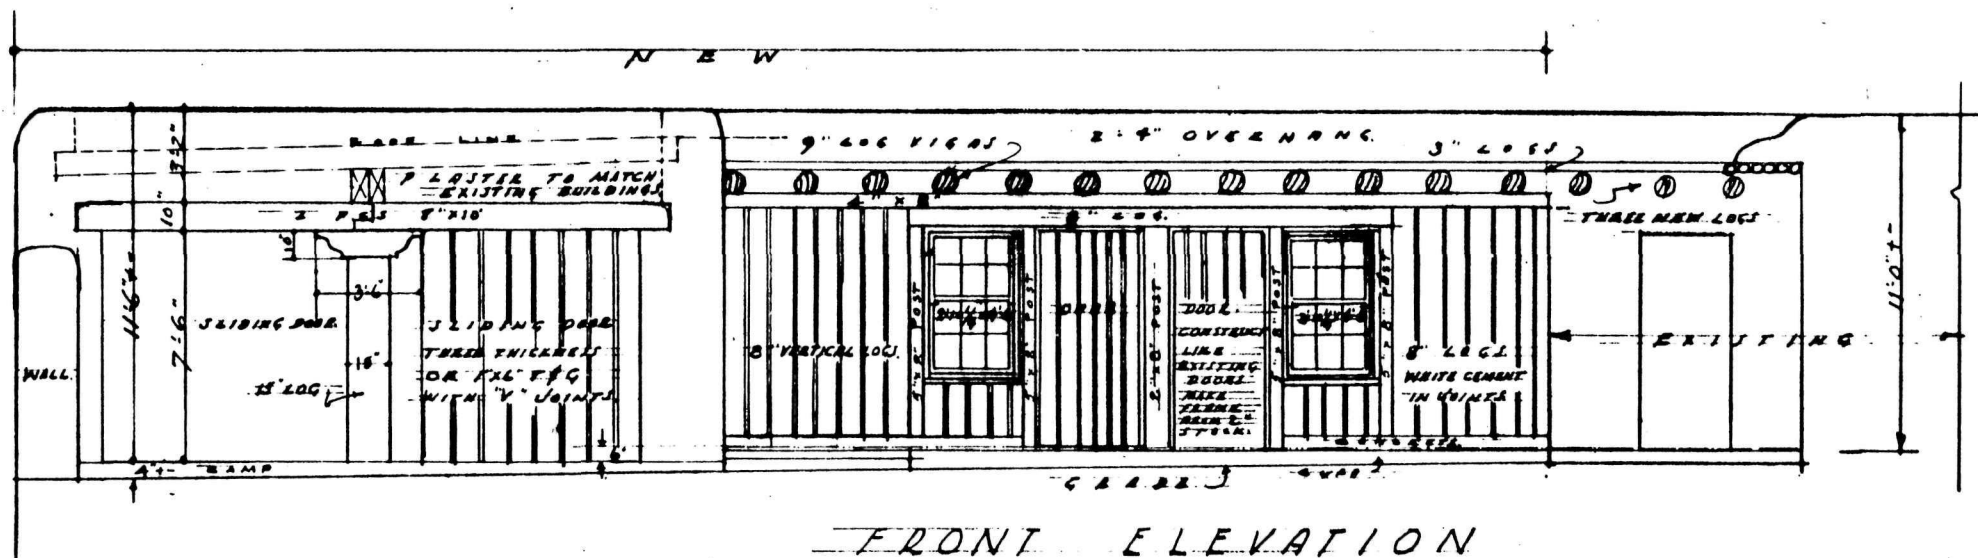
Figure 44.

doors were built of tongue and groove V-joint stock. The north wall of the file rooms was constructed of 8-foot exposed vertical logs, 7 inches in diameter, with a 7-inch viga acting as a lintel above. The addition was finished after the final application of cement chinking between the logs and three coats of cement plaster over the exterior and interior adobe walls (Figures 44 and 45).

The front elevation of the service building was constructed of 7-inch exposed vertical logs with chinking in between. This method of log construction is most common in the small towns to the north of Mountainair, New Mexico.

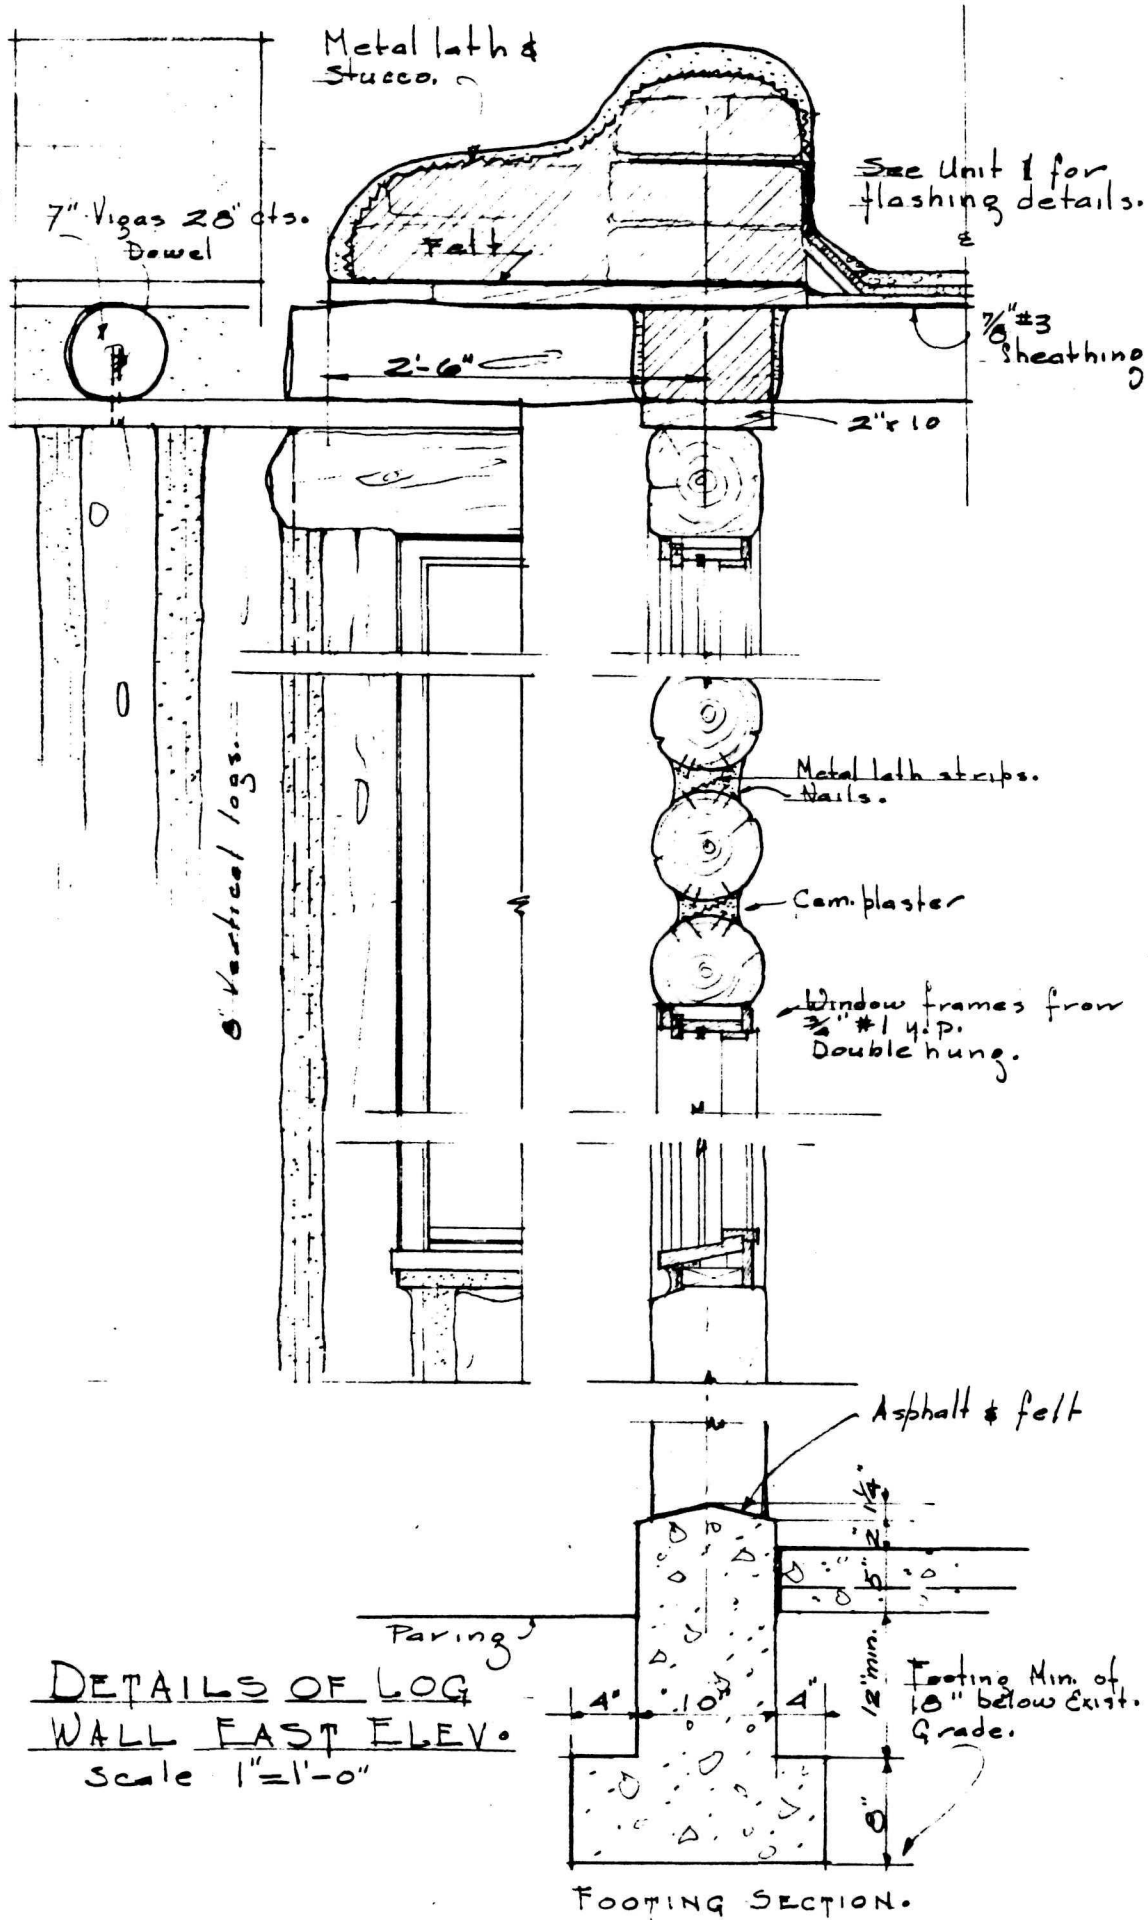
Figure 45.

The service building's east wall was constructed of 8-foot vertical logs, 7 inches in diameter. A 7-inch wide air space was left between logs above

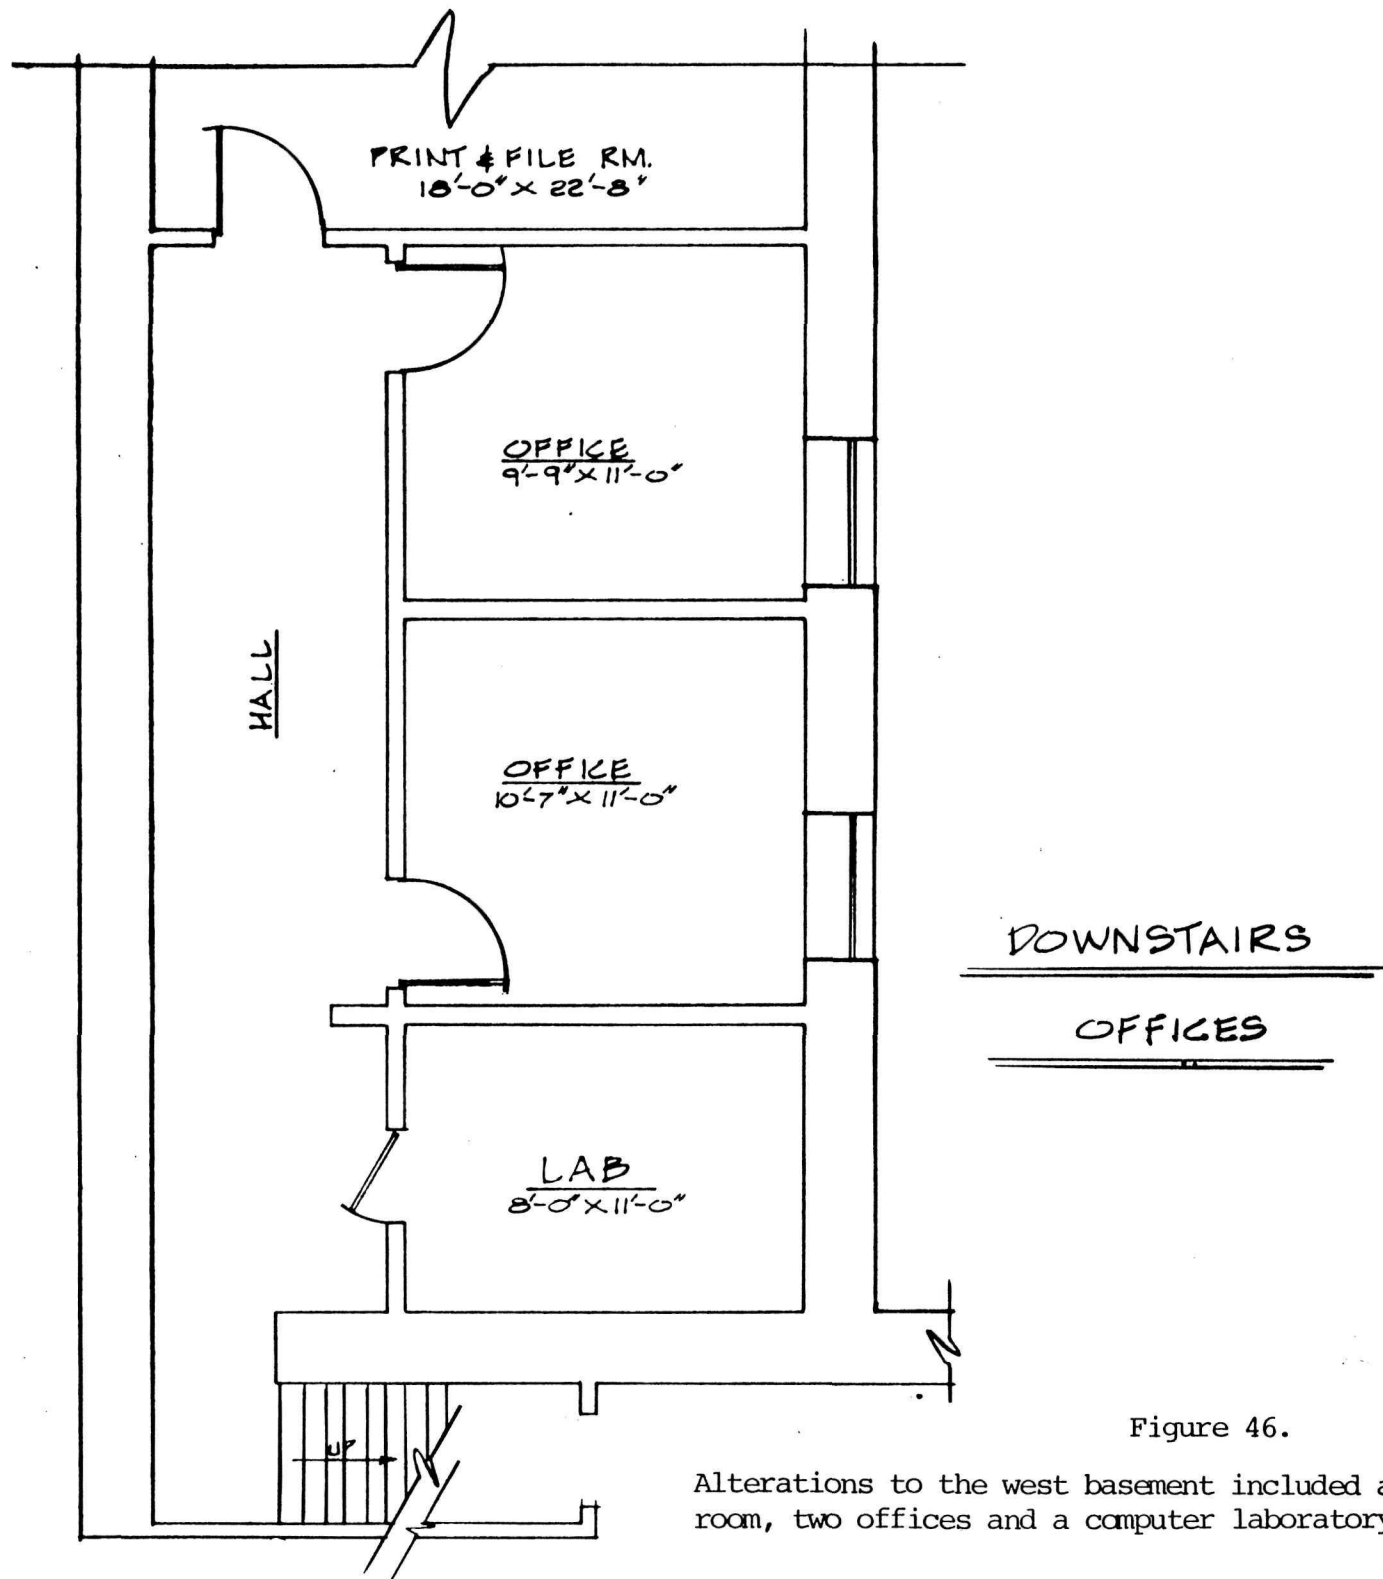
Figure 46.

In June 1956 plans were completed for the remodeling of the file room located in the west basement. After days of refiling plans, the files were organized in a small room in the south end of the basement. With the extra space available, a new office for the Civil Engineer, a spare office and a computer laboratory were built. The basement has not been remodeled since (Figure 46).

Alterations to the west basement included a print and file room, two offices and a computer laboratory.

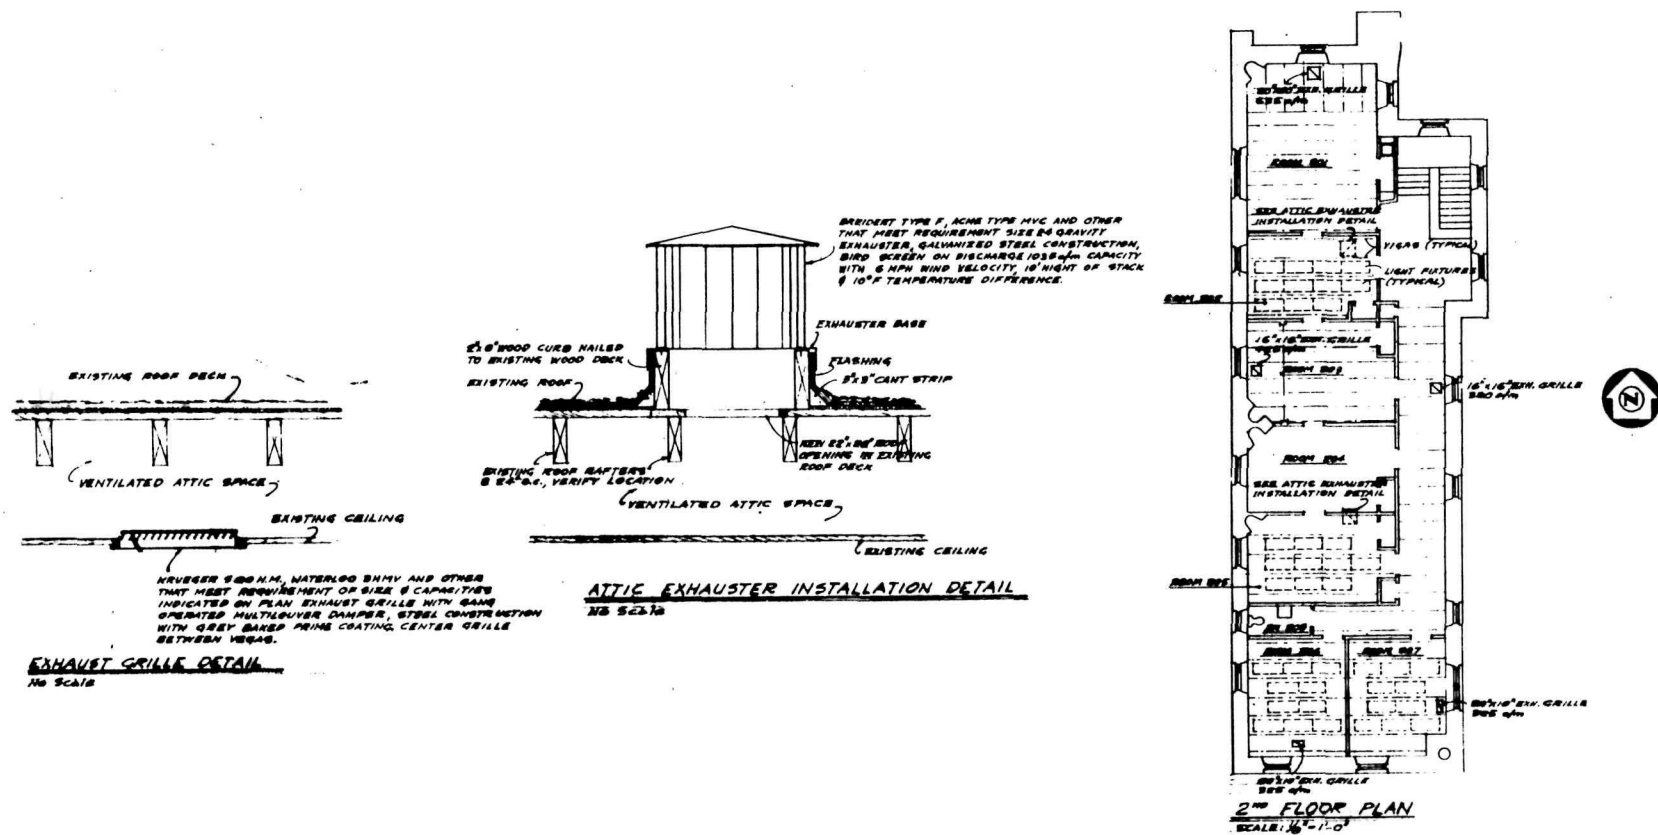
Figure 51.

The building's mechanical system also required some minor additions. Five Krueger S 80 H.M. exhaust grilles and two Breidert Type F size 24 gravity exhausters were placed on the roof of the two-story portion of the building. The exhaust grilles have multi-louvered dampers and were constructed of steel with a grey baked primer coating. The grilles were centered between vigas so that none of the vigas needed to be altered. The attic exhausters, built of galvanized steel, have a 6-mph wind velocity and stand 10 feet high (Figure 51).

Exhaust grills and two main attic exhausters were added to the roof of the building during the 1967 remodeling.

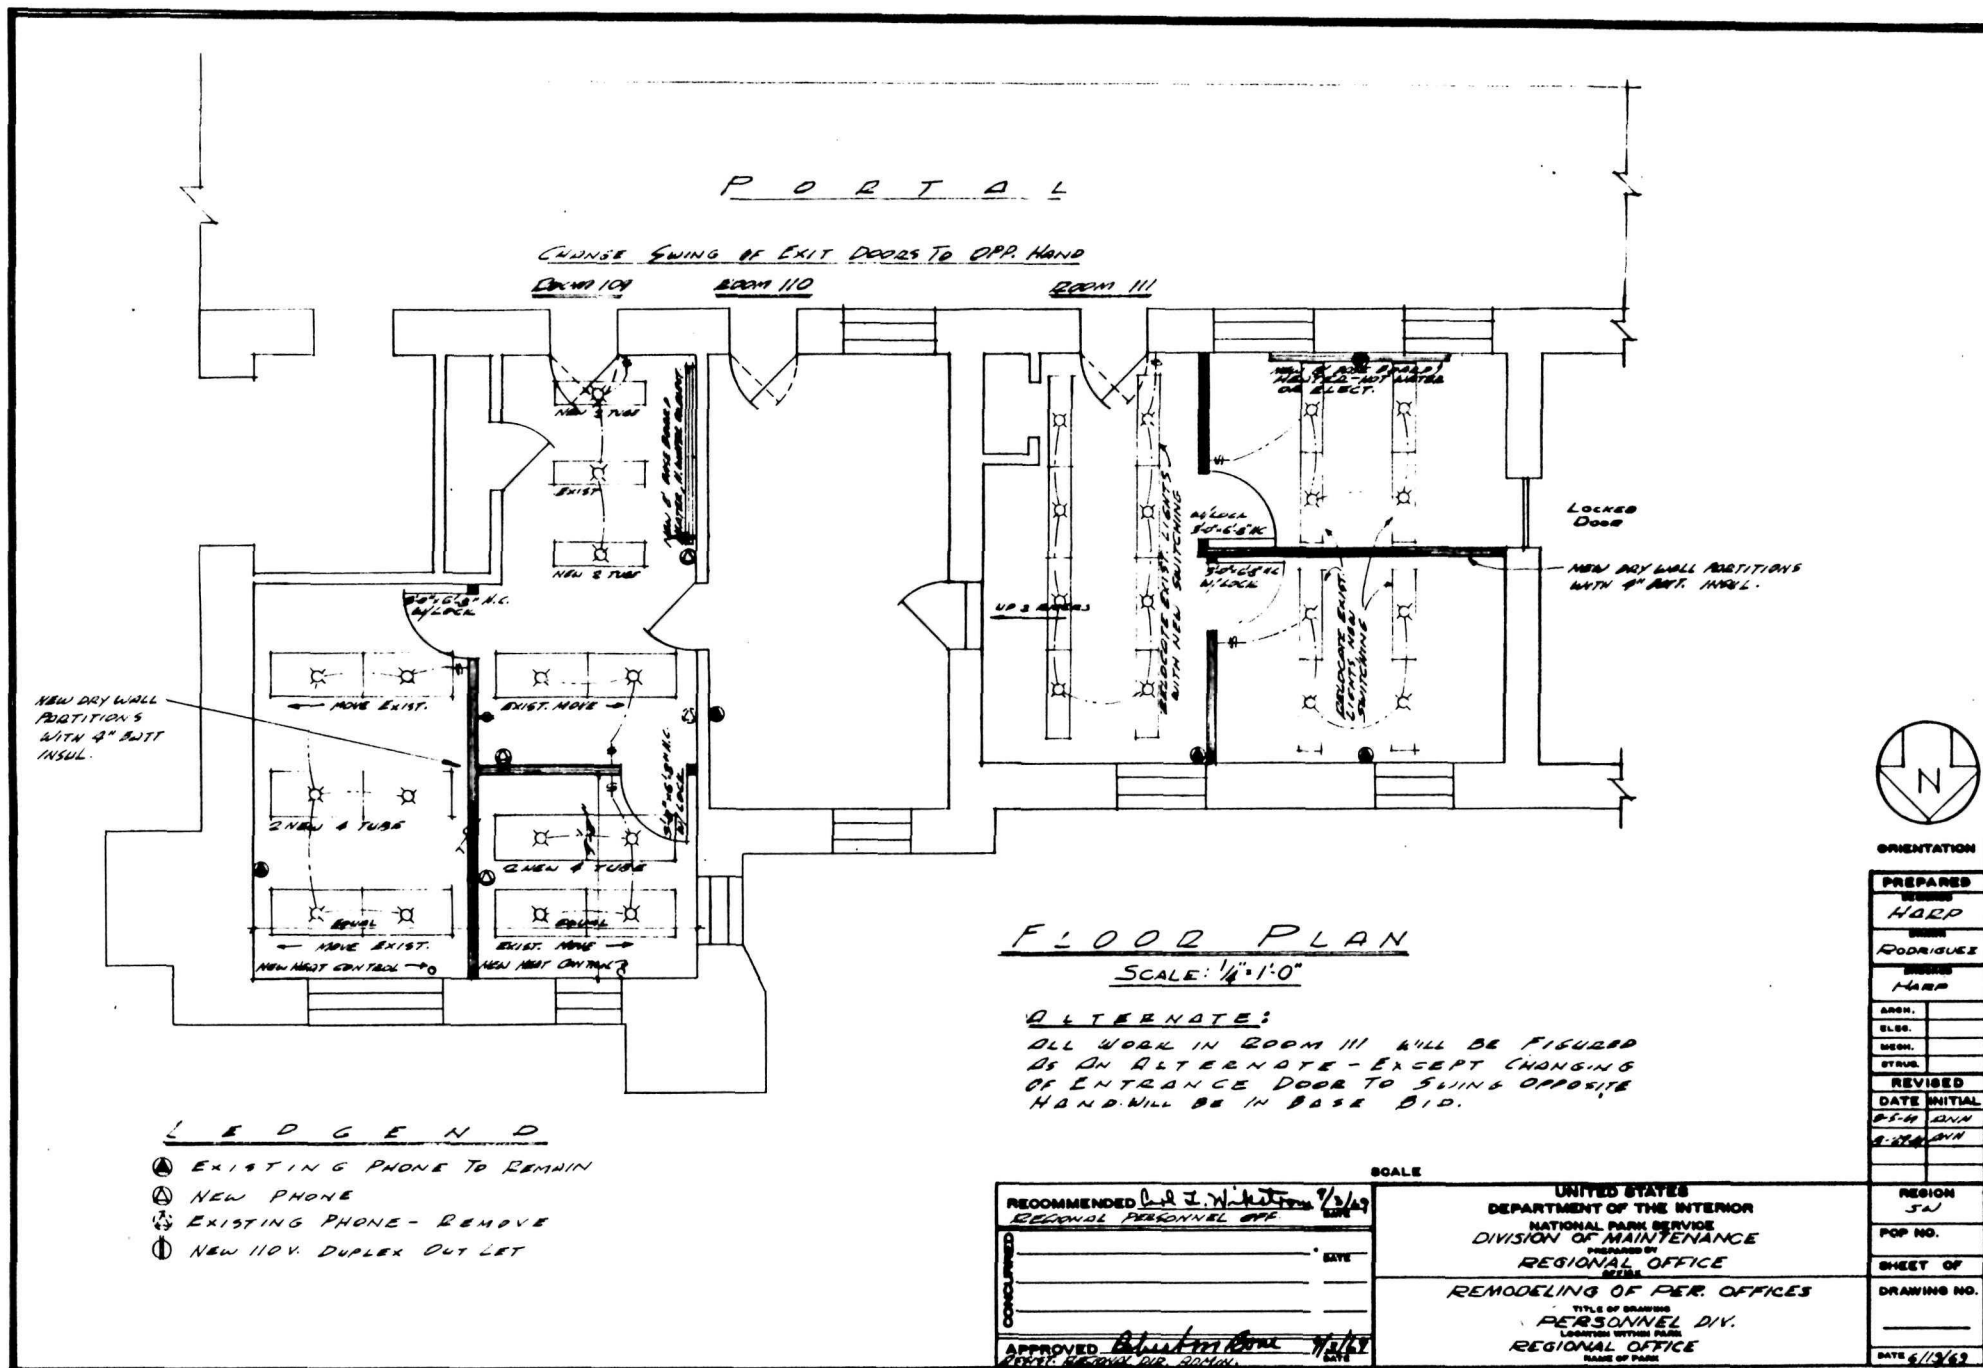
Figure 53.

During the remodeling, Rooms 109, 110 and 111 bordering the large courtyard, required minor changes (Figure 53,). In all three rooms, the door swings were changed to the opposite hand and new drywall partitions with 4 inches of batt insulation were added.

The floor plan of Rooms 109, 110, and 111 showing alterations to door swings and drywall partitions.
