CULTURAL LANDSCAPE REPORT

MARTIN VAN BUREN

NATIONAL HISTORIC SITE

Site History, Existing Conditions, and Analysis

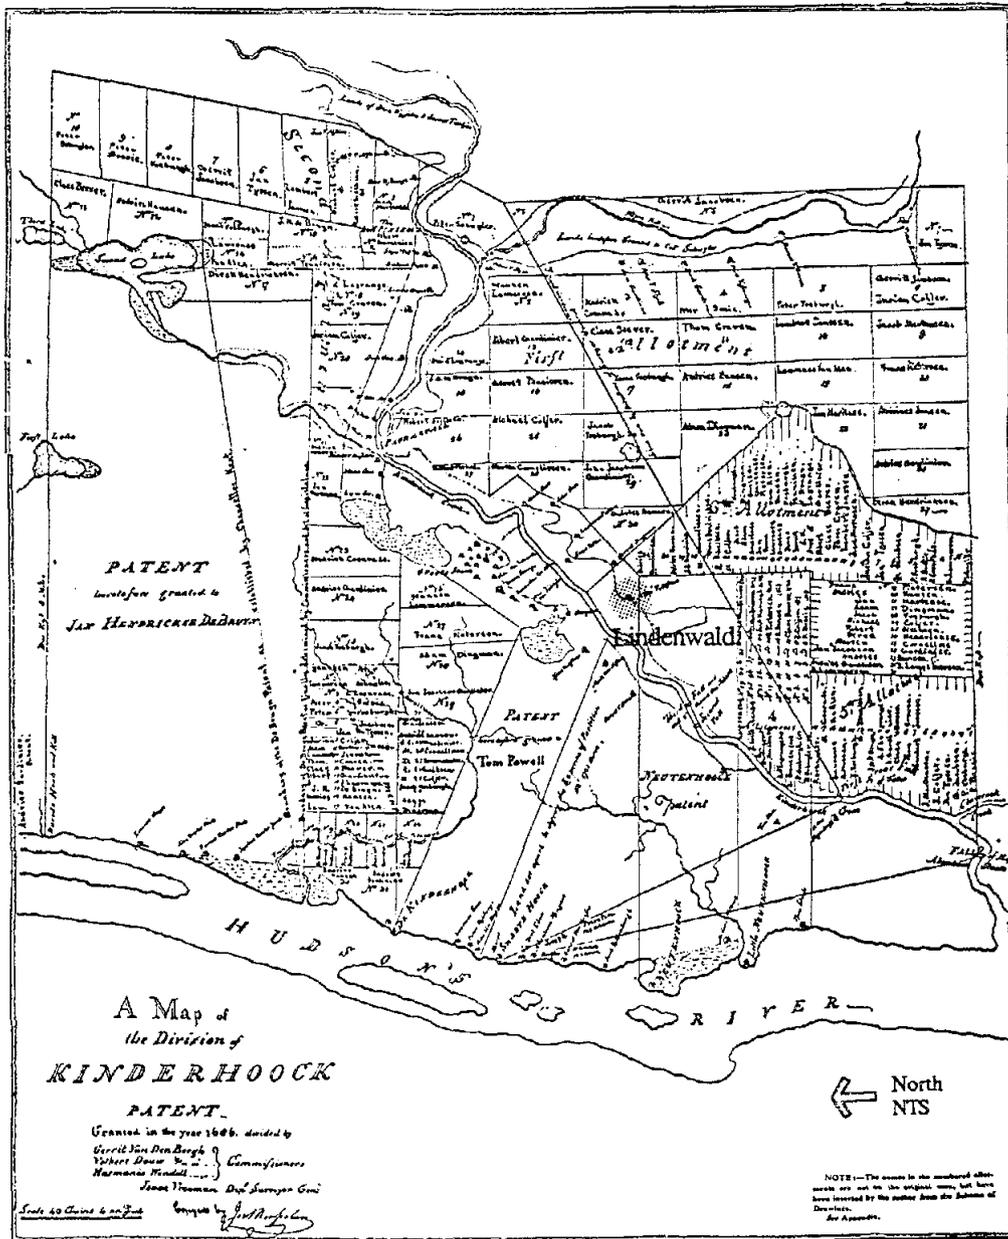
Figure 1.1: Kinderhook Patent Map of 1686, illustrating area patents of 1686 and a 1780 overlay of land allotments of smaller farms (Collier, *A History of Old Kinderhook*, 124).

Figure 1.1 illustrates some of the large farms existing in 1686, prior to the Van Ness Period, along with some of the later, smaller farms overlaid on top of them (the map was updated in 1914).¹⁹ Figure 1.2 illustrates the environmental context of the area surrounding Kleinrood during the Van Ness Period. Period plans, located at the end of the chapter, illustrate the Van Ness Period. Included are a 1" = 50' plan of the house lot (Historic Core: Van Ness Period) and a 1" = 250' plan of the entire farm (Historic Farm: Van Ness Period).²⁰

Before the Van Ness purchase of the property, Post Road traversed the farm along the slope between the terraces and extending adjacent to the stone house. It was later moved, at an undocumented time, to the location along the east side of the property. Figure 1.1 illustrates the original position of Post Road.

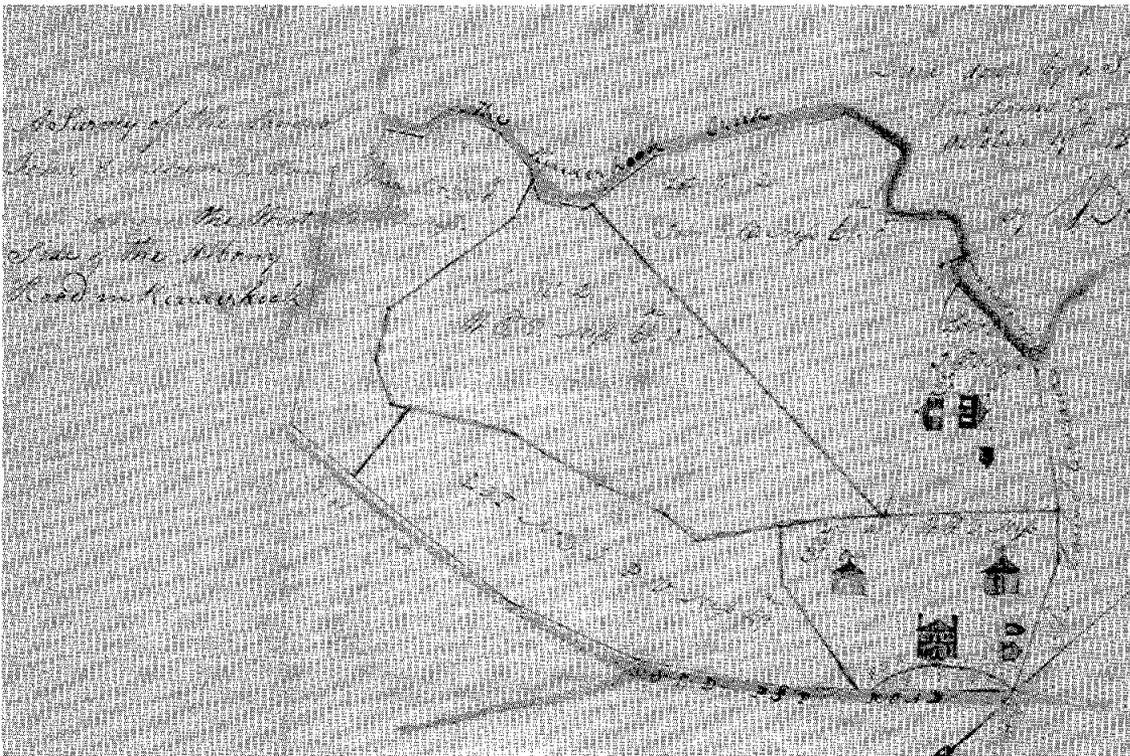
Figure 1.3: 1805 Map: Produced as a result of the will of Peter Van Ness in 1805, this demonstrates the division of Kleinrood between John and William Van Ness (Photographic copy on file, MVB NHS).

Peter Van Ness died in 1804, leaving Kleinrood to his two oldest sons, John and William. A map was produced in 1805 to document the division of the property between John and William (fig. 1.3).²³ This map illustrates the six parcels, three for each son, created by the will. The parcel containing the stone house was left to John and the parcel with the new main house to William. Of the documented 260 acres, each son received 130 acres and a residence (fig. 1.5).²⁴ The lots and their acreage were identified in Peter Van Ness's will and illustrated on the map as follows:

The Kinderhook Creek was a part of the northwest boundary of the property. This corner of the property was the only portion to abut the Creek during this period. The location of the Creek bed changed many times over the years and may have had a different location than is shown in figure 1.3. The portion of the Creek that formed the northwest boundary of Lindenwald did not change.⁵⁷

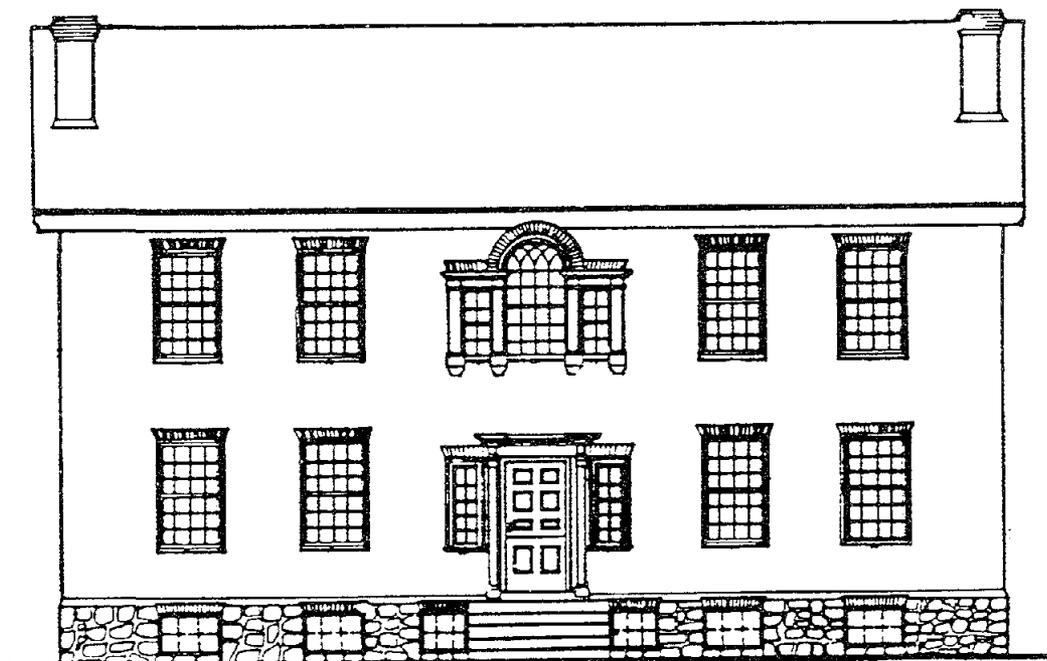
Figure 1.6: 1797 Peter Van Ness house (DSC, National Park Service, n.d.).

Several buildings and structures existed on the property during the Van Ness Period: the stone house, main house, carriage barn, and farm office. Other support buildings and structures existed but cannot be adequately documented.³⁴ The Van Alstynes had constructed at least two houses on the property: the stone house on the second terrace and another house on the first terrace east of the current house lot.³⁵ After purchasing the property, Peter Van Ness resided in the Van Alstyne stone house for approximately twenty years; he moved his family into the new house he built in 1797. The new main house was a simple, Late Georgian/Early Federal brick house (fig. 1.6), much larger and more formal in design than the stone house.³⁶ The new, main house was a rectangular block with two chimneys on each end, four main rooms and a central hall on the first floor, and five rooms around a smaller central hall on the second floor.

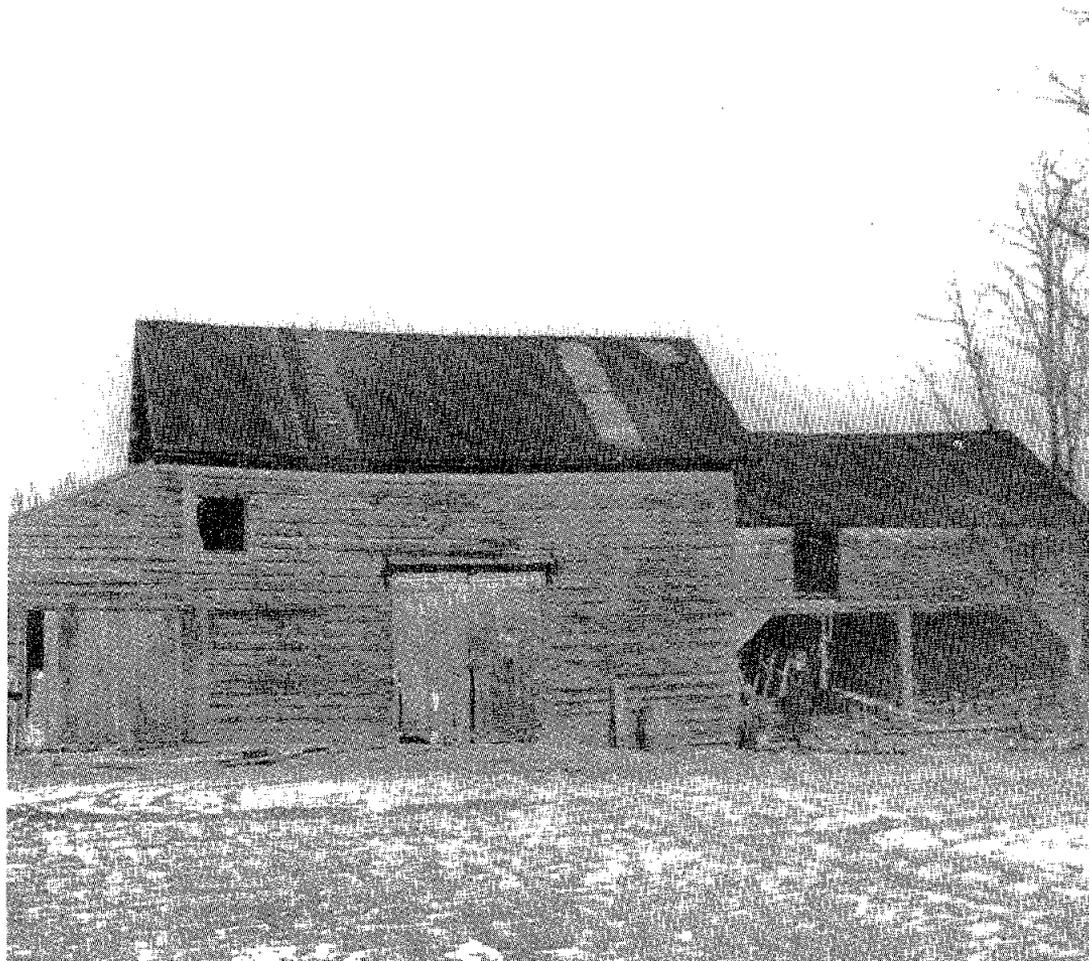
Figure 1.7: Carriage barn, 1937 (Photo # CLR-403. On file, MVB NHS).

The carriage barn (fig. 1.7) was located northwest of the house. The size of the carriage barn was approximately thirty feet wide and sixty-five feet long.³⁷ It was a wood-frame building with clapboard siding and a gable roof.

Several buildings and structures were existing on the property when Van Buren purchased it in 1839. The main house, built by Peter Van Ness in 1797, stood at the center of the house lot facing Post Road. Also on the house lot were the carriage barn, northwest of the main house (fig. 1.7), and the farm office, at the northeast corner of the garden (fig. 1.8).⁵⁹ The use of the farm office, during this period, is unclear, but during later periods it was used for storage. Its location within the garden suggests it was associated with the garden, but the use is unknown. The condition, or existence, of the stone house cannot be documented after the Van Ness Period. Ruins of the building remained into the deProsse Period (1917–1973), but whether the stone house was intact or in ruins during the Van Buren Period is unknown.⁶⁰ The stone house may have been occupied by Van Buren's farm foreman during the first few years of his tenure on the property.

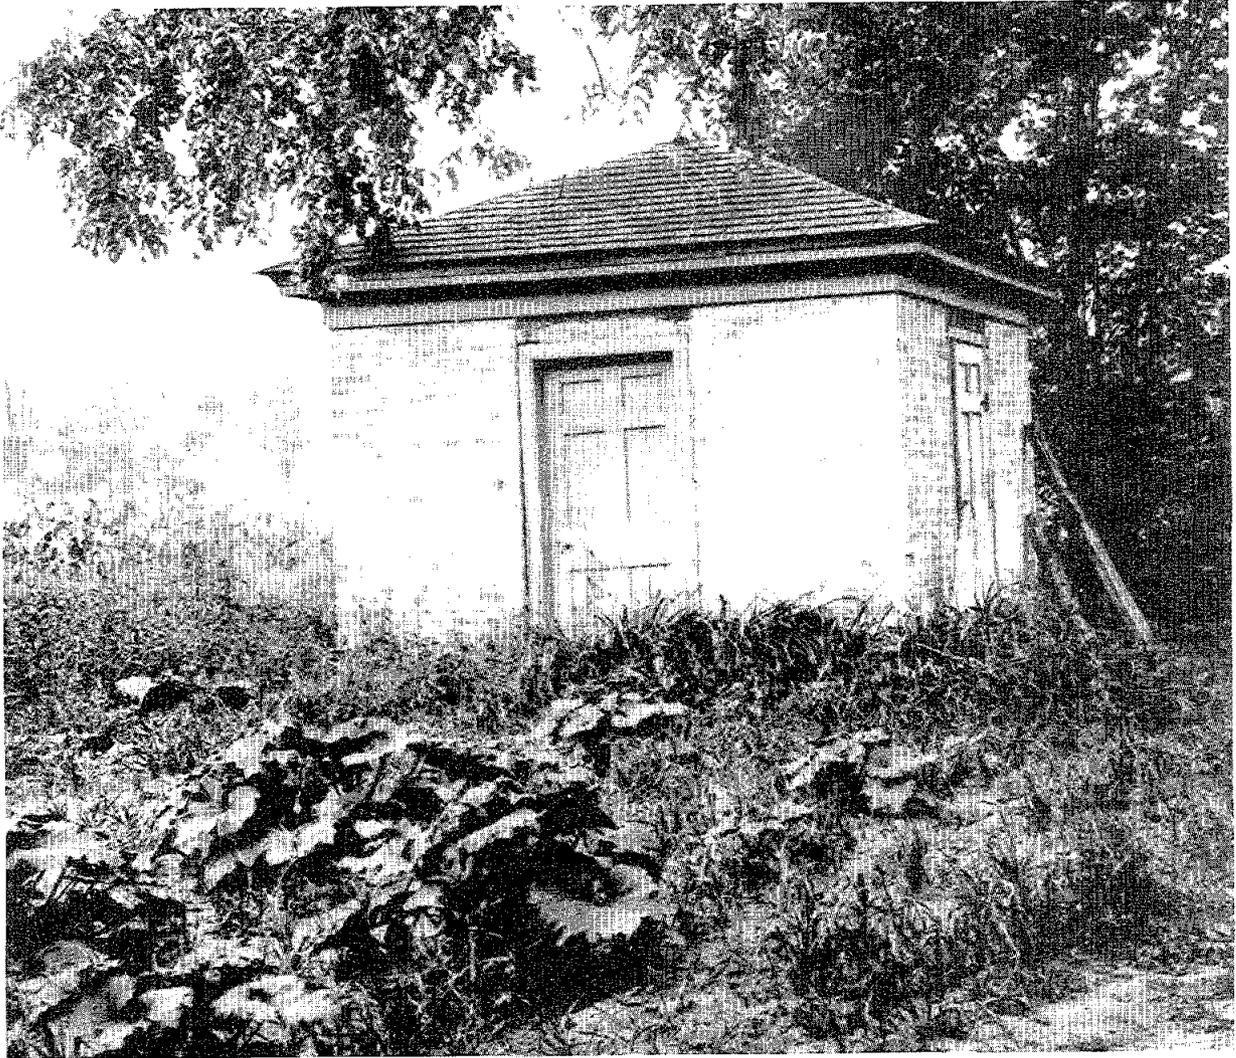
Figure 1.8: Farm office, 1936 (Photo # CLR-401. On file, MVB NHS).

The other building existing on the house lot was the farm office, west of the main house. The farm office was a one-story, eleven-foot, square building (fig. 1.8).³⁸ It was a brick building with a hip roof.

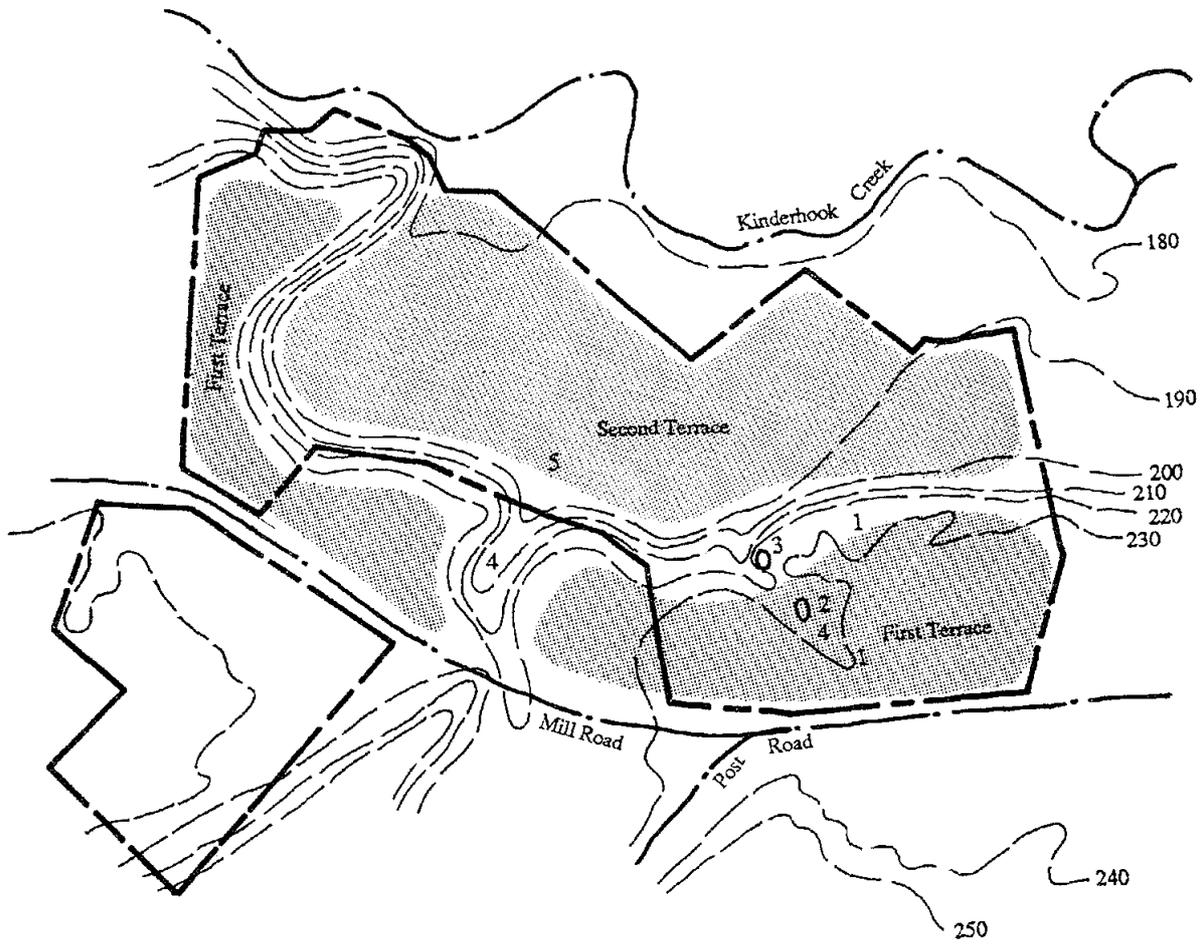
TOPOGRAPHY & HYDROLOGY KEY:

The ravine and water flow that fed the wetland on the second terrace remained. In August of 1847 Van Buren drained the wetland by creating ditches. Van Buren stated ". . . a thousand miles of Ditches, . . ." implying the task was quite large.⁵⁸ The ditches may have drained into Kinderhook Creek. A spring existed on the south end of the house lot which Van Buren used to feed the two artificial ponds he created on the edge of the house lot. Figure 2.3 illustrates the topography and hydrology for the Van Buren Period.

- 1. Spring
- 2. Upper Pond
- 3. Lower Pond
- 4. Ravine
- 5. Wetland

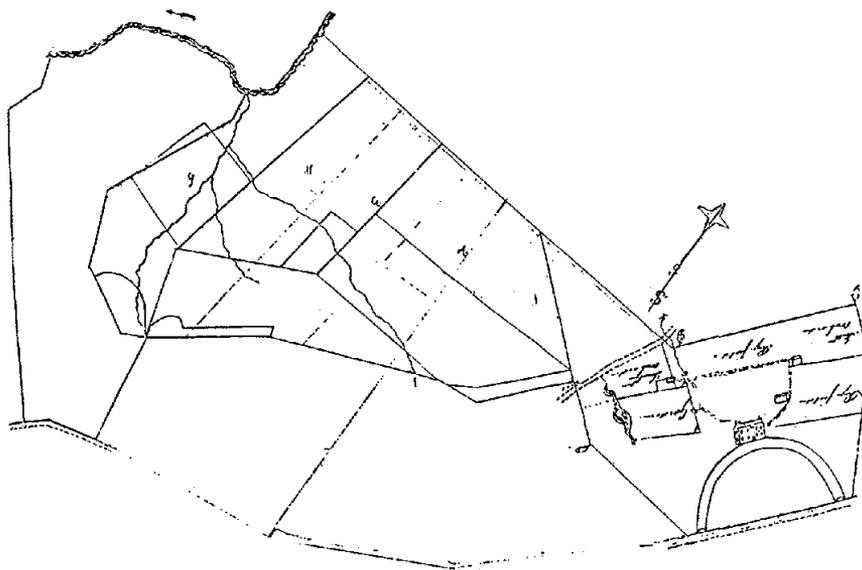
Figure 2.4: c.1841 sketch map of Lindenwald (Martin Van Buren Papers, Syracuse University).

In addition to these existing buildings, Van Buren constructed many new buildings and structures. A few structures were completed in preparation for his taking residence at the property. This immediate construction included a hothouse, stables, and wood houses (presumably for storing wood). The hothouse was constructed within the garden, west of the main house, in 1840. A greenhouse was also in use on the site in 1841. The origin of the greenhouse is uncertain. Although unlikely, it may have existed at the time of purchase. It is more likely that the greenhouse was part of the immediate work included the construction of the hothouse. Figure 2.4, a circa 1841 sketch map of the farm, shows the garden and the structures within it soon after Van Buren's purchase. The farm office can be seen in the east corner of the garden, nearest the main house. Two structures also are shown in the north corner of the garden and may represent the hothouse and greenhouse. It is uncertain what each symbol represents.⁶¹

Although the types of crops grown on the farm can be documented, it is difficult, if not impossible, to locate where each of these was grown. It is probable that the crops were rotated to different locations throughout the twenty-three years Van Buren owned the farm. The only crop locations that can be accurately documented are the two rye fields located next to the orchards circa 1841, as seen in figure 2.4.

Figure 2.4 shows the area behind the main house planted as a rye field, confirming Mr. Gilpin's statement regarding the meadows. Whether or not Van Buren followed this advice is unknown. He constructed the farm cottage within this view one year later. Several years later he constructed the red

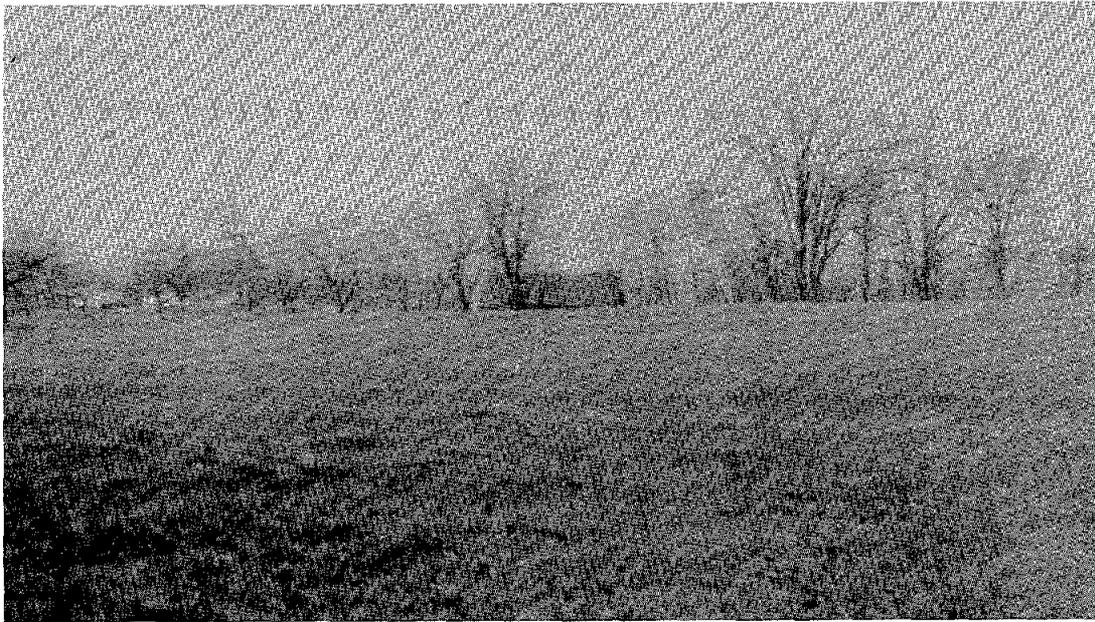
Figure 2.6: Farm cottage and red hillside barn, c.1900 (Photo # CLR-002. On file, MVB NHS).

After Van Buren took residence in 1841, he constructed additional buildings on the property. These included a cottage, for his farm foreman, and two large barns. The construction of the cottage and one of the barns was complete by the summer of 1844. Van Buren wrote: ". . . built me what I call a beautiful cottage (for my foreman) on the brow of the hill and a large hay barn in the meadows. . . ."⁶⁴ The farm cottage was a small, two-story house reflecting the Federal style. It was built behind the main house, on the edge of the first terrace (fig. 2.6). The barn, referred to as the "black hay barn," was constructed on the second terrace at the bank of the Kinderhook Creek (fig. 2.7). The "red hillside barn" constructed in 1849, was built into the side of the slope between the first and second terraces just behind the farm cottage (fig. 2.6).⁶⁵

hillside barn near the farm cottage. The roof of the barn also was within this view (fig. 2.6). This suggests the view was not as valued by Van Buren as it was by Mr. Gilpin. The addition of these structures were in the immediate view across the farm to the creek but did not obstruct the view to the Catskill Mountains. Van Buren may have considered these elements to be modest intrusions of the immediate view.

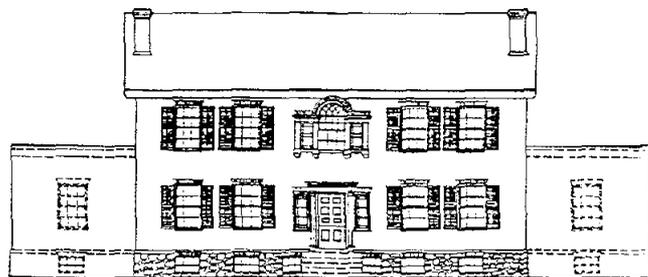
Figure 2.8: Lindenwald main house, pre-1849 (DSC, National Park Service, n.d.).

In 1849, the final two years of major improvements began on the property. These last improvements were to accommodate Smith Thompson and his family as they moved onto Lindenwald. The alterations, designed and supervised by well-known architect Richard Upjohn, began that year and were completed in 1850. The purpose of the alterations was to enlarge the main house, but much more was done. The simple rectangular Van Ness house was increased greatly in size by a large addition along the rear, a south and a west wing, and a four story tower. To accommodate these changes, the stable wings were removed. Along with this tremendous increase in size, the exterior of the main house was transformed from the original Late Georgian/Early Federal style to Italianate. Ornamentation was added to the exterior including a small, finely detailed porch at the front entrance, a large gable and dormers on the front facade, and ornamentation on the overhangs of the roof. The simple Van Ness farm house was transformed into a large and elaborate mansion (fig. 2.8 and 2.9).

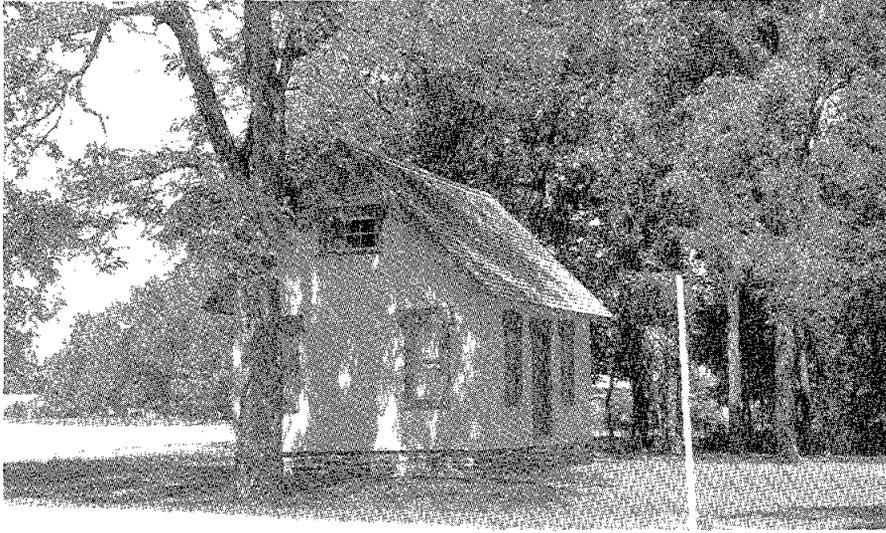
Figure 2.10: South gate house, 1993 (Photo # CLR- 1510. Uschold, SUNY CESF).

In addition to the alterations on the main house, two gate houses were constructed as part of the Upjohn plan, one at each entrance to the drive. The two buildings were sixteen feet by twenty-three feet and were mirror images of one another, except for the dormer in the south side of the north gate house. They were small, one and one-half story board and batten buildings with a wood-shingle, gable roof, field stone foundation, and full basement (fig. 2.10 and 2.11).⁶⁶

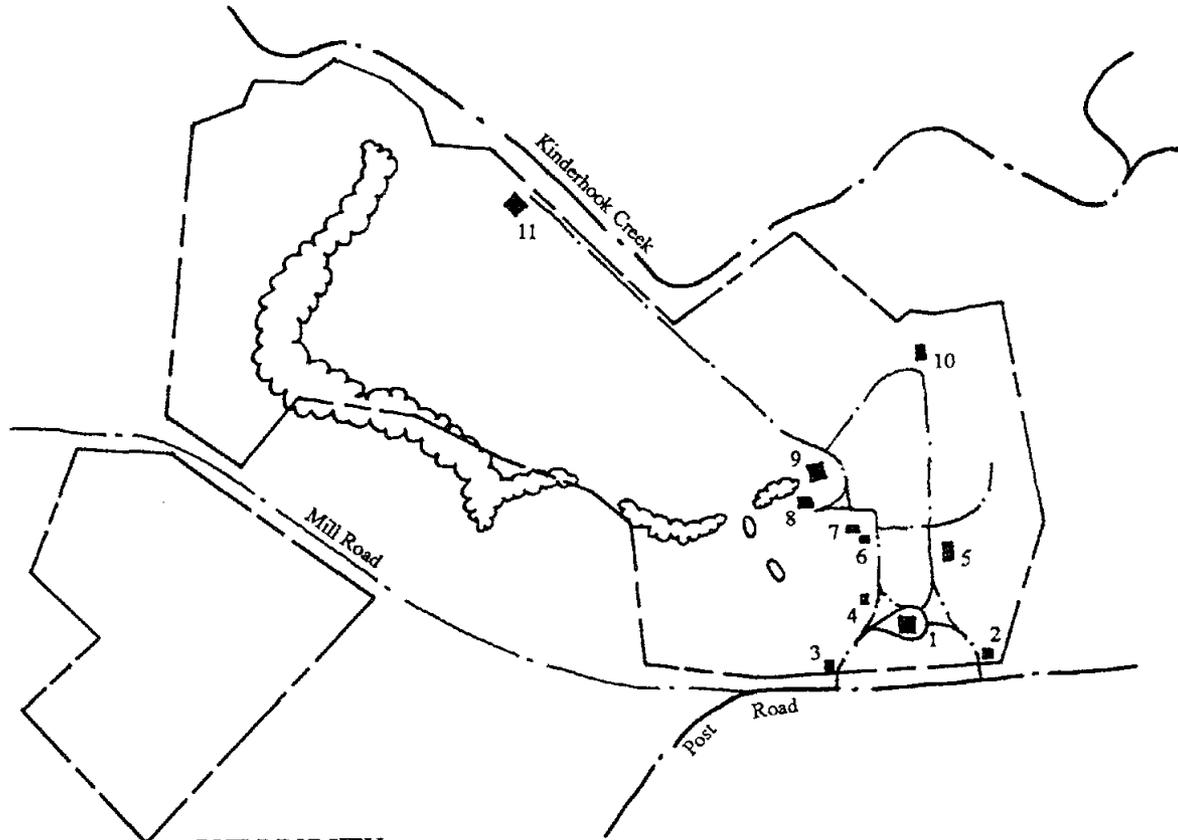
BUILDING KEY:

The buildings and structures of Lindenwald during the Van Buren Period were in a constant state of change. From the modest beginnings of the Van Ness farm, Lindenwald experienced an eleven-year time span characterized by construction and renovation, ending in 1850. At the completion of these improvements, the property had been transformed from a simple country home into a substantial and successful working farm. The buildings and structures on the property at this time remained throughout the period. They included the main house, north gate house, south gate house, farm cottage, carriage barn, farm office, hothouse, greenhouse, red hillside barn, black hay barn, and stone house. Figure 2.12 illustrates the buildings and structures for the Van Buren Period.

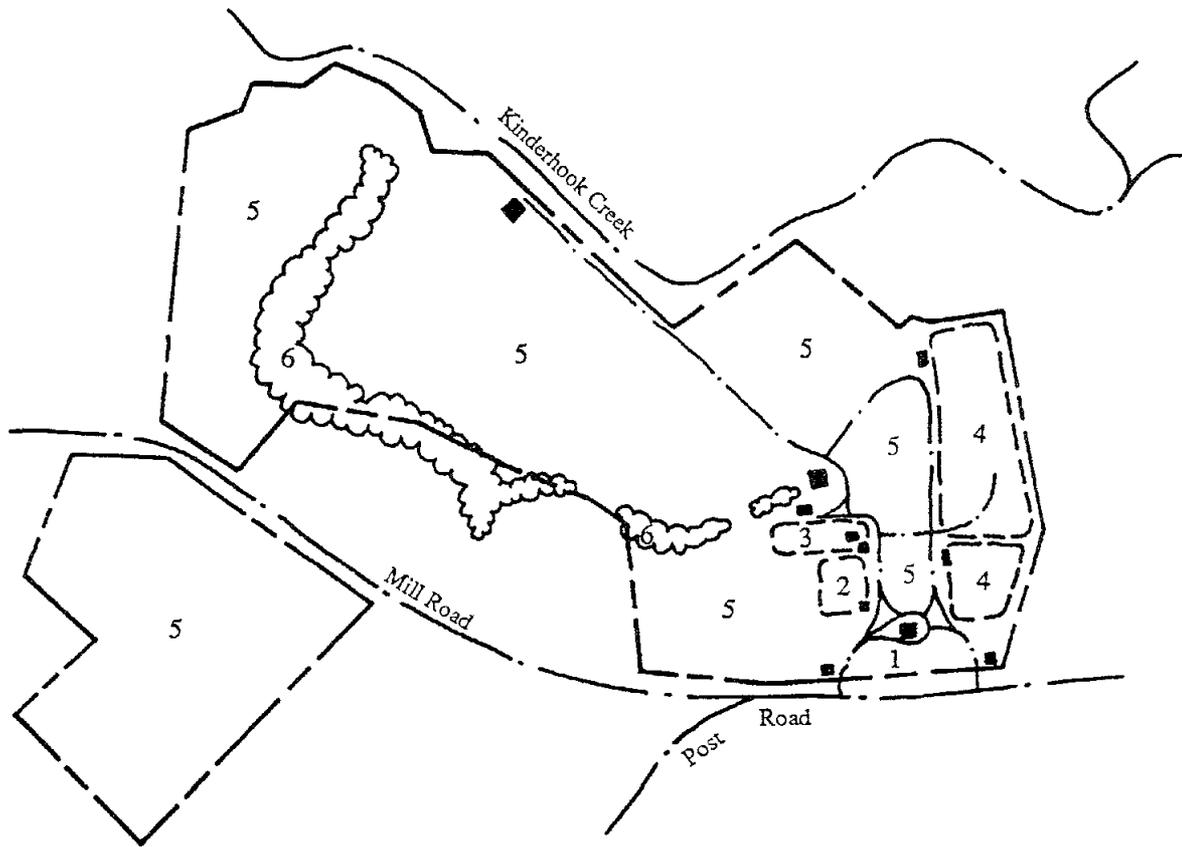
VEGETATION KEY:

- 1. Front Lawn
- 2. Garden
- 3. South Orchard
- 4. North Orchard
- 5. Agricultural Field
- 6. Woodland

Figure 2.14: Vegetation: Van Buren Period (Ussold, 1993. SUNY CESF).

The appearance that only a few crops were being grown in 1841, or even 1843, could be due to Van Buren not yet having acquired all of the property to complete his farm. The 1841 and 1848 lists in no way illustrate a complete inventory of what was being grown at that time; it was clearly just a mention of some of the crops. On the other hand, the inventory of crops recorded in 1850 seems reasonable evidence of Van Buren's intention to create a prosperous and self-sufficient farm. Figure 2.14 illustrates the general pattern of the vegetation for the Van Buren Period.

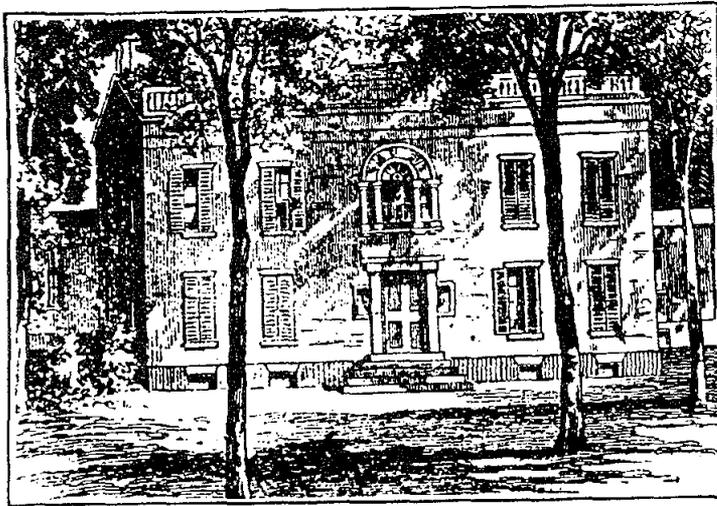
Figure 2.15: c.1843 sketch of main house (Photo # CLR-201, photographic copy of original drawing. On file, MVB NHS).

The circa 1843 sketch of the main house (fig. 2.15), prior to renovation, and the circa 1849 Upjohn rendering (fig. 2.16), post renovation, are not entirely reliable references regarding the landscape. In the past these illustrations have been thought to be valuable sources documenting the vegetation of the property for the Van Buren tenure. Due to the questionable reliability of these two sources, their use in this report has been limited.⁸⁷

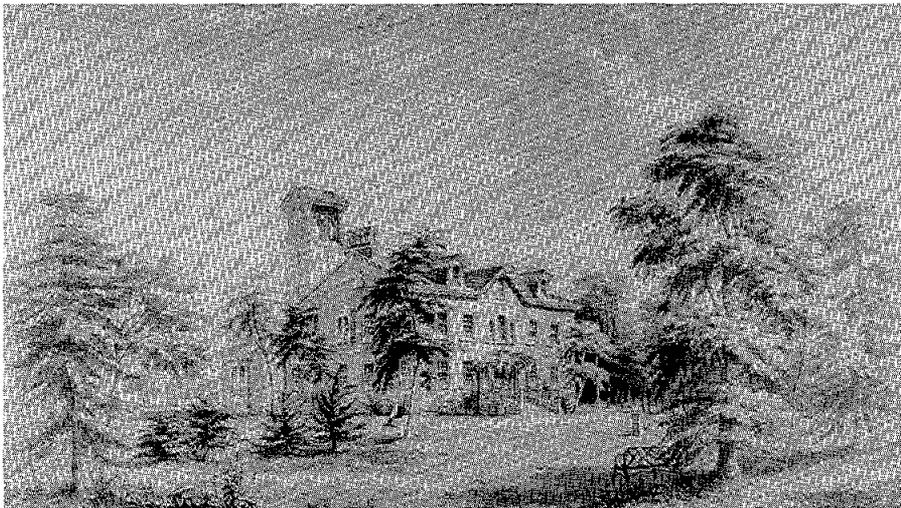
Figure 2.16: c.1849 Upjohn Rendering of Main house (Photo # CLR-202, photographic copy of original painting. On file, MVB NHS).

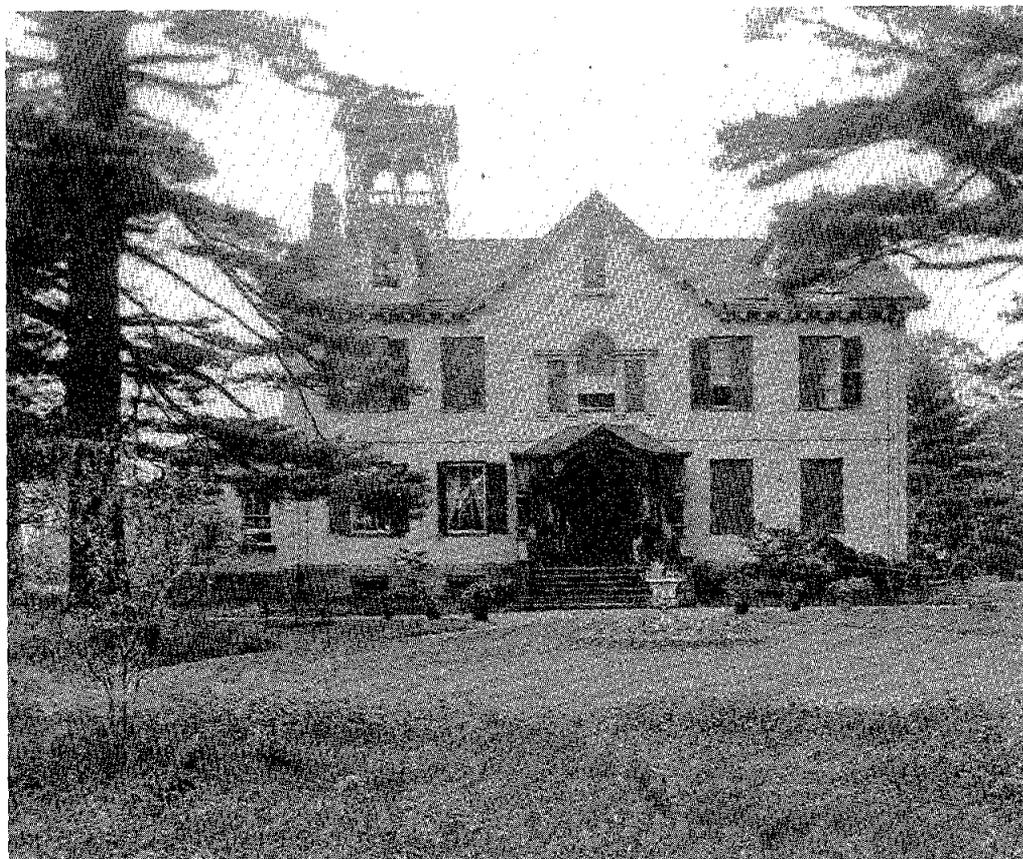
Figure 2.17: Front garden at entrance to main house, c.1913 (Photo # CLR-302. On file, MVB NHS).

Within the house lot, several smaller spaces existed. The front lawn, a major feature of Lindenwald's formal image, was a large space defined by the entry drive and Post Road and enclosed by the locust allee and front pine row. The lawn had scattered trees within it but still maintained an expansive and open character. The locust allee, lining the entry drive, formed a corridor space that lead to the front of the main house. The trees in the allee were spaced so that they created a vertical and overhead enclosure for the drive. The vertical enclosure was created by the trunks of the trees and did not fully enclose the drive. A full overhead enclosure for the drive was created by the canopies of the trees. The front garden was a smaller, more detailed space, within the front lawn. It was located at the front entrance of the main house, defined by a circular pedestrian path, and enclosed by three Eastern White Pines. The pines were large and the branches created an overhead canopy over most of the garden. Within the pedestrian path, the lawn was finely manicured, as opposed to the higher lawn surrounding it (fig. 2.17).⁸⁸

Along the outside edge of the small space at the entrance to the main house, a circular pedestrian path existed. This path was approximately two foot wide and extended around the outside edge of the lawn within the space (fig. 2.17).

From the photographs of this period, other furnishings and objects now are evident, including an urn, flower pots, lawn furniture, a trellis, and fences. Within the front garden, an urn was located in the center of the small planting bed. Several flower pots flanked the entrance to this walk. Three pots were located to either side of the entrance, descending in size as they moved away from the entrance. At the south end of the circular walk, outside of the path, was a large tub somewhat buried in the ground. It appears to have been a planter but no plants are seen in it (fig 2.17).

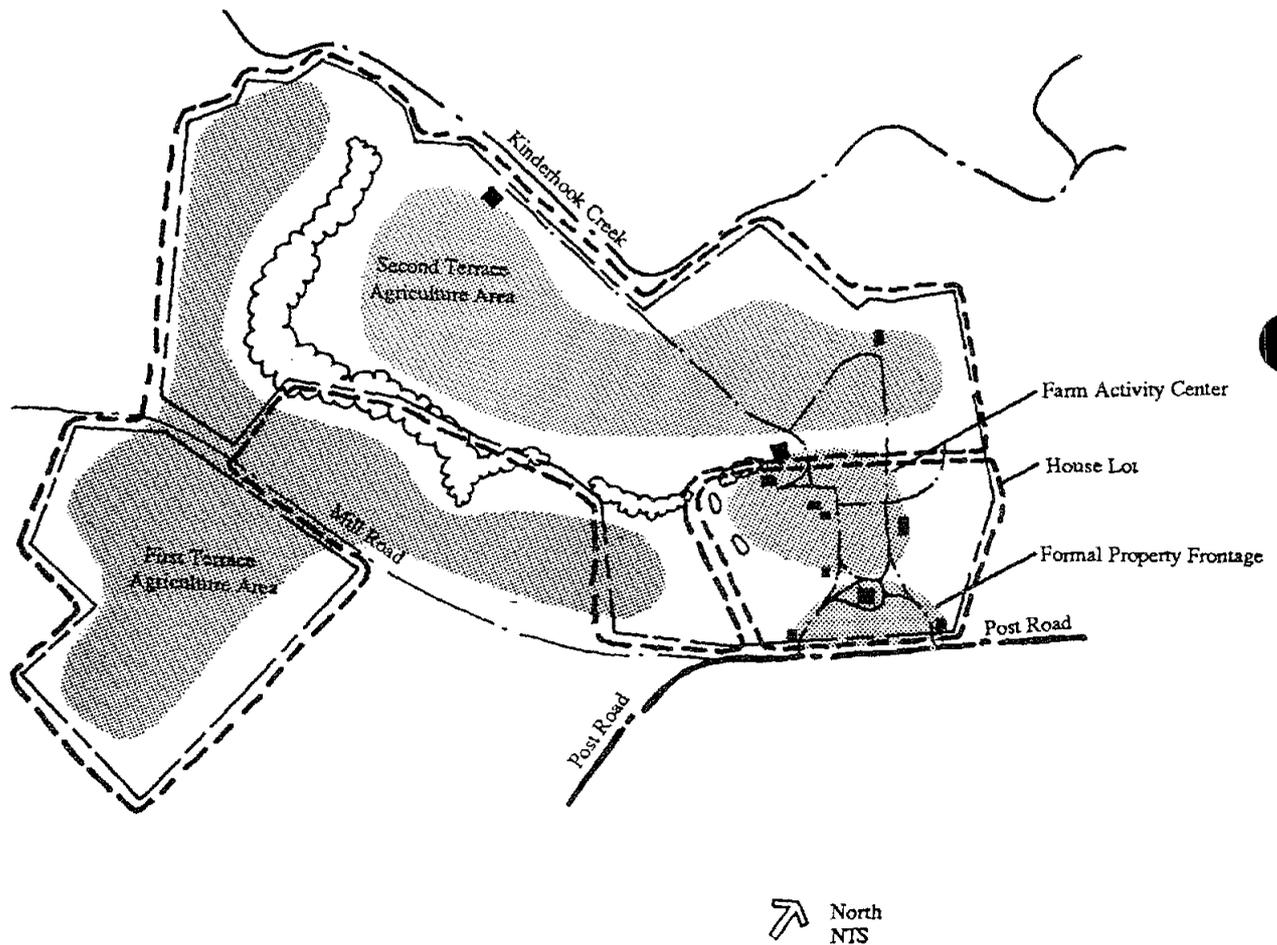
Figure 2.18: Spatial Organization: Van Buren Period (Uschold, 1993. SUNY CESF).

From Post Road, the view of the main house was partially screened by the grove of pines. The grove was located along the road, directly in front of the main house. The view from the main house to the road is undocumented. Figure 2.18 illustrates the spatial organization of the Van Buren Period.

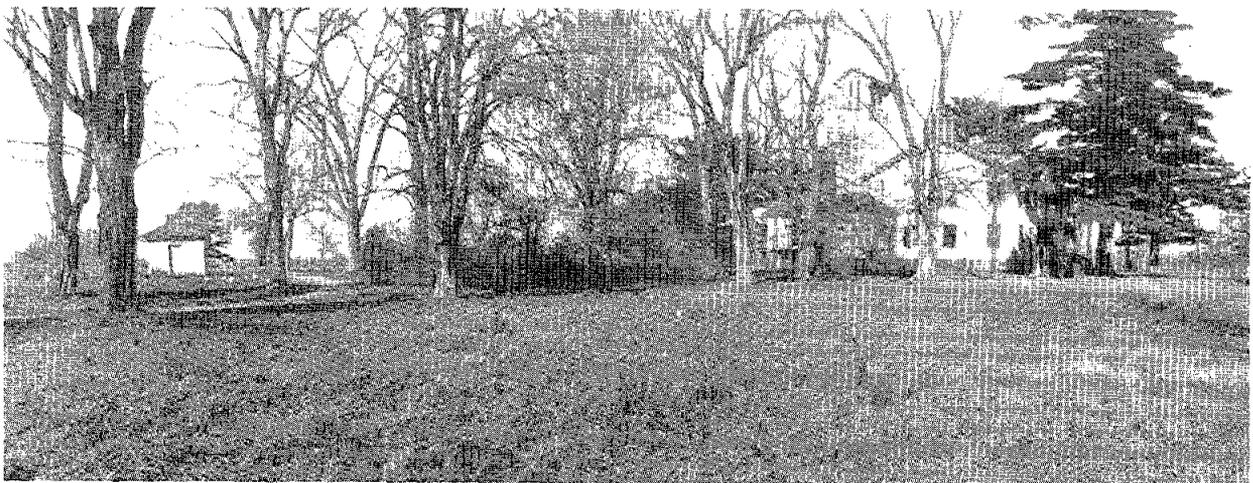
Figure 2.19: South entrance drive and road to farm cottage, c.1913 (Photo # CLR-301. On file, MVB NHS).

Several roads and paths accessed different areas of the property. The most prominent circulation feature was the semicircular entry drive (fig. 2.19). The construction of the gate houses enhanced the significance of the entry drive. The extension off of the entry drive circled the rear of the main house, and appears to have been added during the Van Buren Period. Its arrangement around the Upjohn renovations of the main house supports this assumption. No evidence suggests it existed during the Van Ness Period.

Two roads extended from the entry drive to rear areas of the farm. One road extended from the south portion of the entry drive to the farm cottage and then to the stone house on the second terrace. This road passed directly adjacent to the farm office (fig. 2.19). Another portion of this road extended from the main house, formed a triangular area between this road and the drive and continued to the farm cottage. The rear portion of this road, as it reached the farm cottage, can only be documented in a general location. A second road extended from the north corner of the main house and led to the stone house. This extension passed the southwest facade of the carriage barn, providing access to the barn from the main house. From the carriage barn, it extended to the stone house where it turned and continued on the second terrace, joining the extension from the farm cottage. The exact path of the leg extending from the carriage barn to the stone house cannot be confirmed from the available information, though its general location is known.⁹⁰

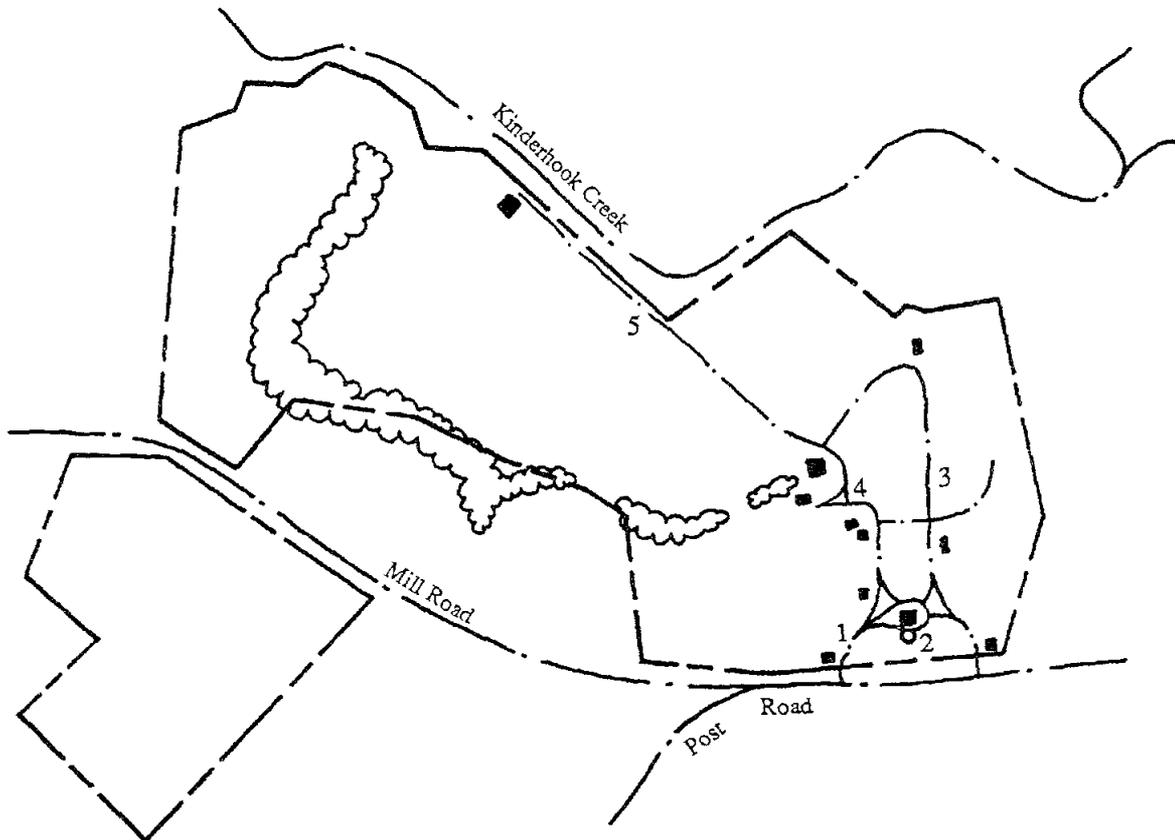
CIRCULATION KEY:

1. Entry Drive
2. Front Garden Path
3. Road to Carriage Barn and Stone House
4. Road to Farm Cottage and Red Hillside Barn
5. Road to Black Hay Barn

Figure 2.20: Circulation: Van Buren Period (Uschold, 1993. SUNY CESF).

No documentation was found regarding the construction materials of the roads and paths. Photographs from later years suggest they were compacted soil.⁹¹ In addition to these roads, there may have been other access paths to reach the fields, but they are undocumented at this time. Figure 2.20 illustrates the circulation for the Van Buren Period.

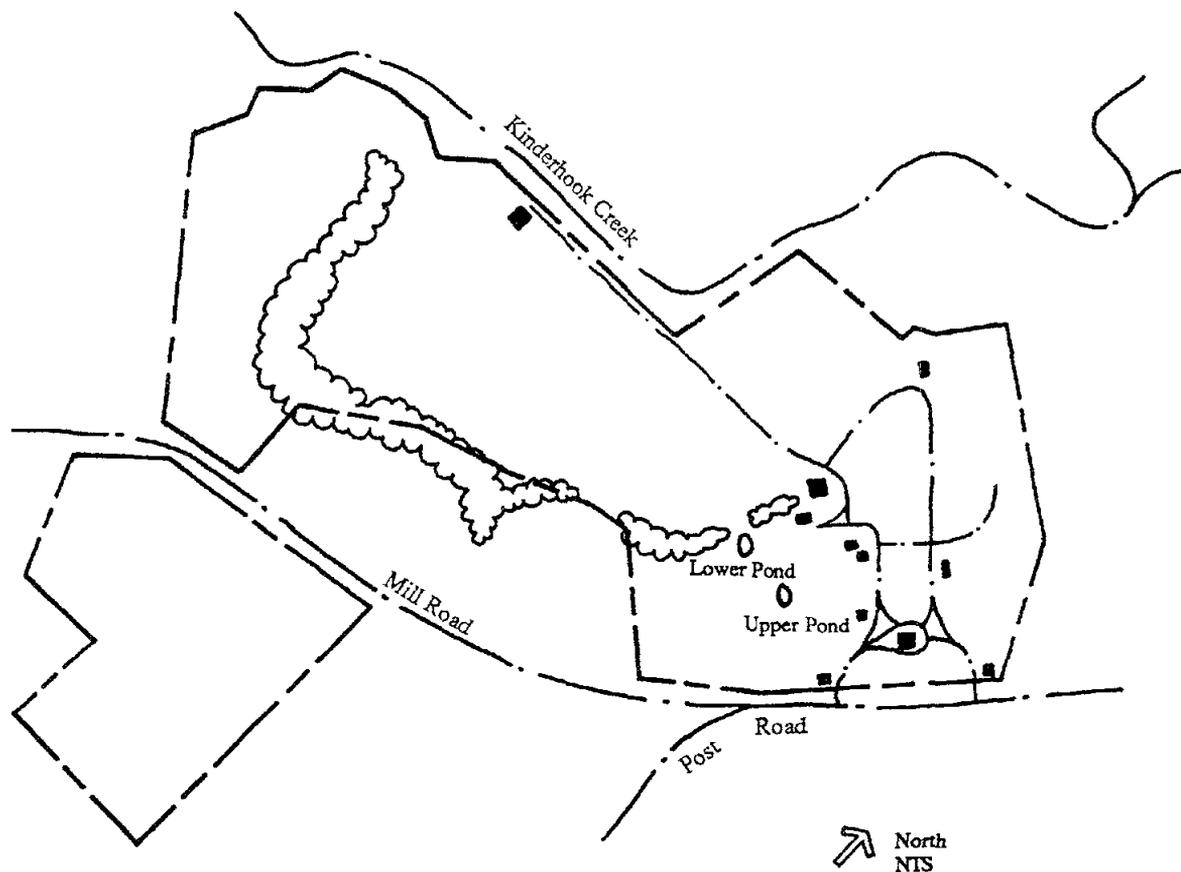
Figure 2.21: Water Features: Van Buren Period (Uschold, 1993. SUNY CESF).

The Van Buren Period is the only time in the history of the property during which any designed water features were constructed within the core. In 1840, Van Buren hired a contractor to, among other things, create fish ponds from the spring by the garden.⁹² Two fish ponds were created by damming the ravine leading from the natural spring located on the south end of the house lot. The upper pond was held by a stone dam at its west end. Van Buren later stocked these ponds with several kinds of fish including trout, pickerel, and perch. The first, or upper, pond was along the southwest border of the garden (fig. 2.4). An 1845 news article in the *Albany Cultivator* states: ". . . two artificial ponds located in the garden. . ."⁹³ While the exact location of the upper pond is documented, the exact location of the lower pond is less clear; it was located somewhere southeast of the farm cottage on the edge of the first terrace slope.⁹⁴ The exact origin of the spring that fed the ponds also is unclear. Figure 2.21 illustrates the water features for the Van Buren Period.

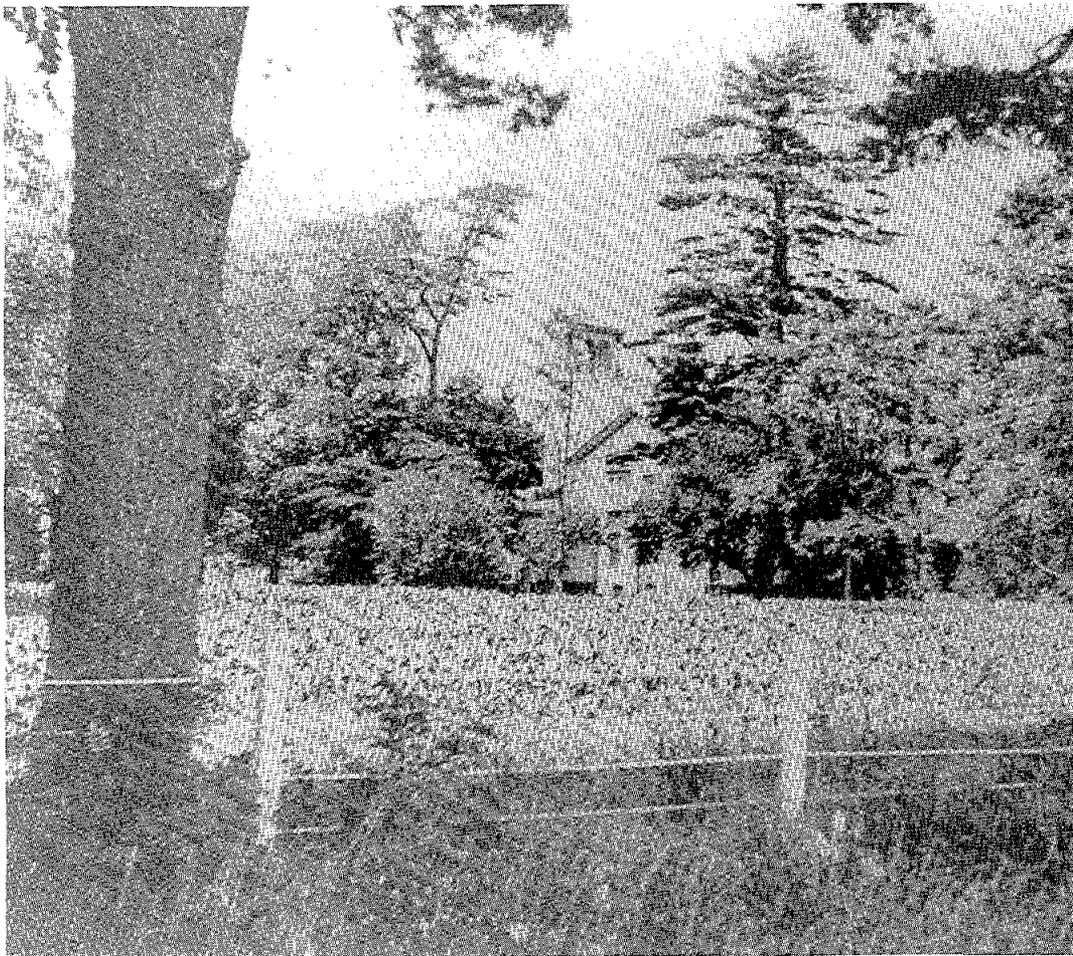
Figure 3.1: Agriculture use (corn field) of front lawn, c.1905 (Photo # CLR-303. On file, MVB NHS).

The Wagoners were known as thrifty and successful farmers in the Kinderhook area.¹⁰⁰ Together, the two brothers operated the property as working farm. In addition to their reputation as prosperous farmers, a circa 1905 photograph (fig. 3.1) illustrates crops growing on the south portion of the front lawn, suggesting very intense farming for the property. Period photographs indicate the farm was well-maintained during the Wagoner occupancy. The main house appears to have been in excellent condition and the lawn area directly in front of the main house finely manicured (fig. 3.2).

Very few other changes in the vegetation are documented for this period. The north and south orchards existed throughout the Wagoner Period. The property continued to be intensely farmed. In a circa 1905 photograph, corn was planted on the south portion of the front lawn (fig. 3.1). The specific years or length of time this lasted is uncertain but is likely to only have been a few years at the beginning of the Wagoner tenure.
