CULTURAL LANDSCAPE REPORT

MARTIN VAN BUREN

NATIONAL HISTORIC SITE

Site History, Existing Conditions, and Analysis

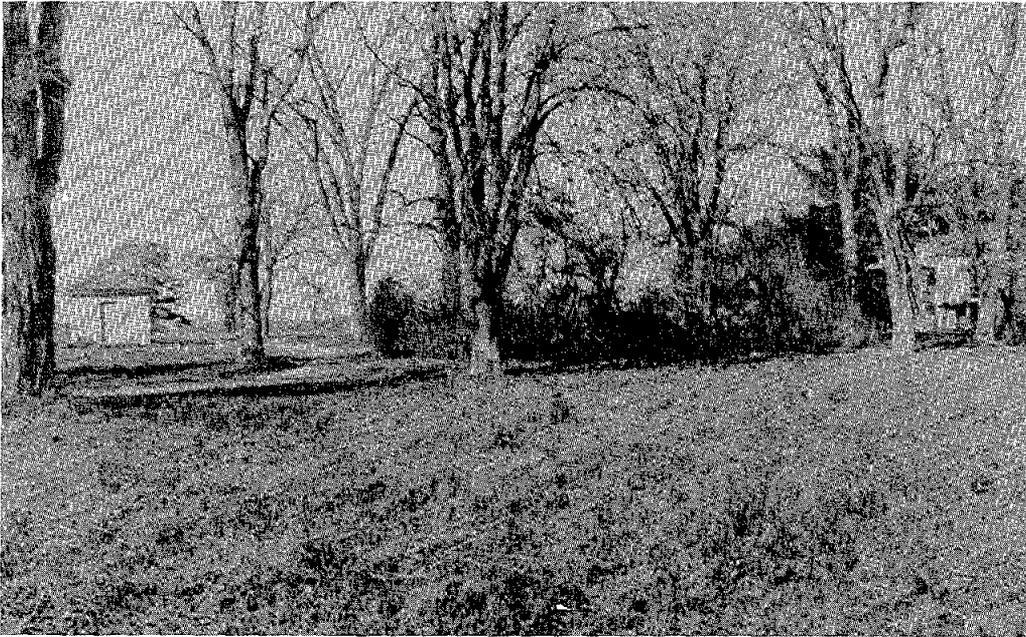
Figure 3.8: Entry drive, road to farm cottage, and garden fence, c.1913 (Photo # CLR-301.5. On file, MVB NHS).

The roads extending to the support and farm buildings and structures during the Van Buren Period remained throughout the Wagoner Period. They included the roads from the main house to the farm cottage and from the main house to the carriage barn and to the stone house site (fig. 2.17 and 3.8). Also existing was the road from the stone house site to the farm cottage and red hillside barn.¹⁰⁸

Two wood posts, three to four feet tall, and used for tethering horses, stood along the entry drive. Approximately thirty feet from the front corners of the main house, one was located at each side of the approach to the main house (fig 3.11). Two fences are documented for this period. A post and wire fence stood along the Post Road boundary of the property. This fence was approximately four feet tall and appears to have been painted white. It was located between the front pine row and Post Road along the front boundary of the house lot (fig 3.1). At the two entries this fence had wood gates across the drive. They were composed of two hinged gates swinging inward and met in the center. The gates were apparently made of wood and had a more ornamental character than the fence they joined (fig 3.12). Another fence stood along the northeast and northwest boundaries of the garden. This wood picket fence was approximately four feet tall and seems to have been painted a light color (fig 3.2 and 3.8).

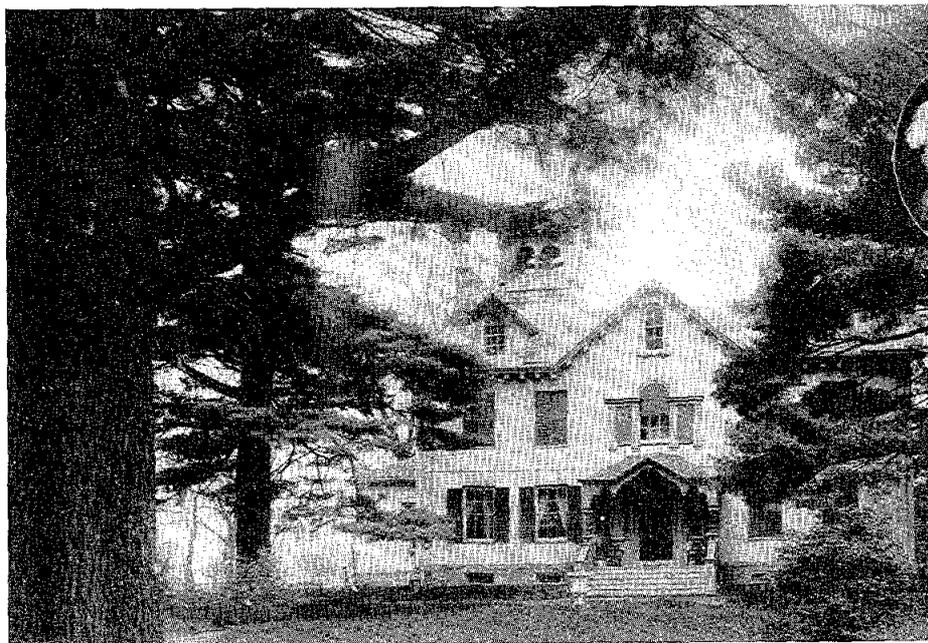
Figure 3.9: Front view of main house, showing curved trellis, c.1895 (Photo # CLR-312. On file, MVB NHS).

A trellis was located approximately ten feet from the front south corner of the main house. Two different trellises existed here during the Wagoner Period. In the early years a wood trellis approximately seven feet tall with a curved form, was in place. It appeared to have been painted a light color (fig 3.9). At the end of the Wagoner Period a less sturdy, rectangular-shaped, wood trellis was in the same location. It was approximately six feet tall and also appears to have been painted a light color (fig 3.10). Near the trellis, on the opposite side of the entry drive, was a lawn swing. The swing appears to have been stationary with two posts approximately ten feet tall with a cross member that held the swing. The entire swing appears to have been constructed of wood and does not appear to have been painted (fig 3.10). This swing is not in the earliest photos of the Wagoner Period, suggesting it was introduced later in this period.

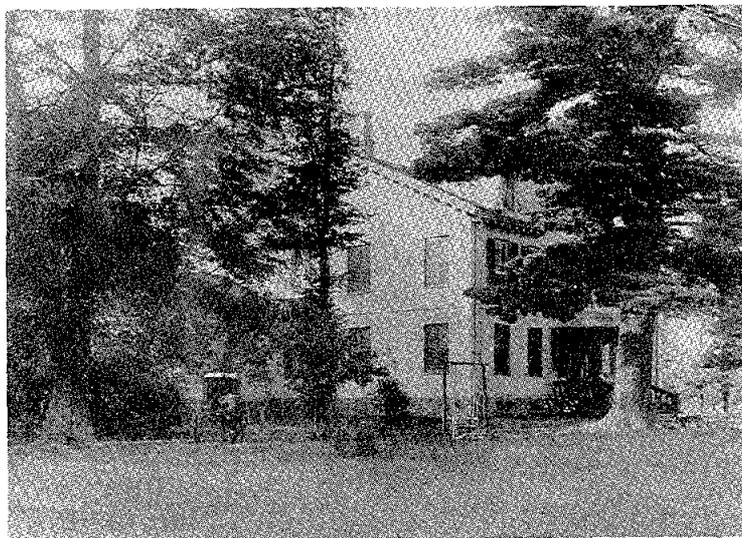
Figure 3.10: View of main house, showing rectangular trellis and lawn swing, c.1913 (Photo # CLR-308. On file, MVB NHS).

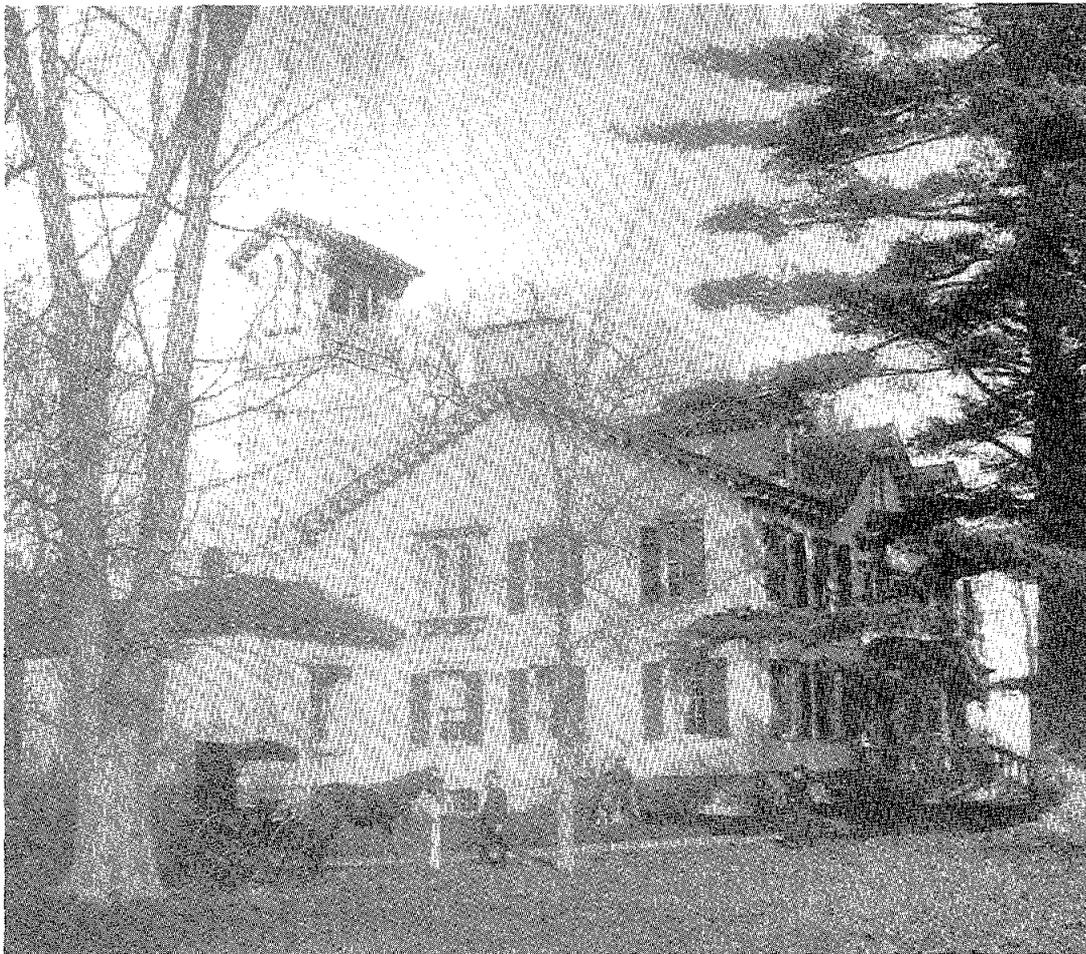
Figure 3.11: View of main house, showing hitching posts, c.1900 (Photo # CLR-311. On file, MVB NHS).

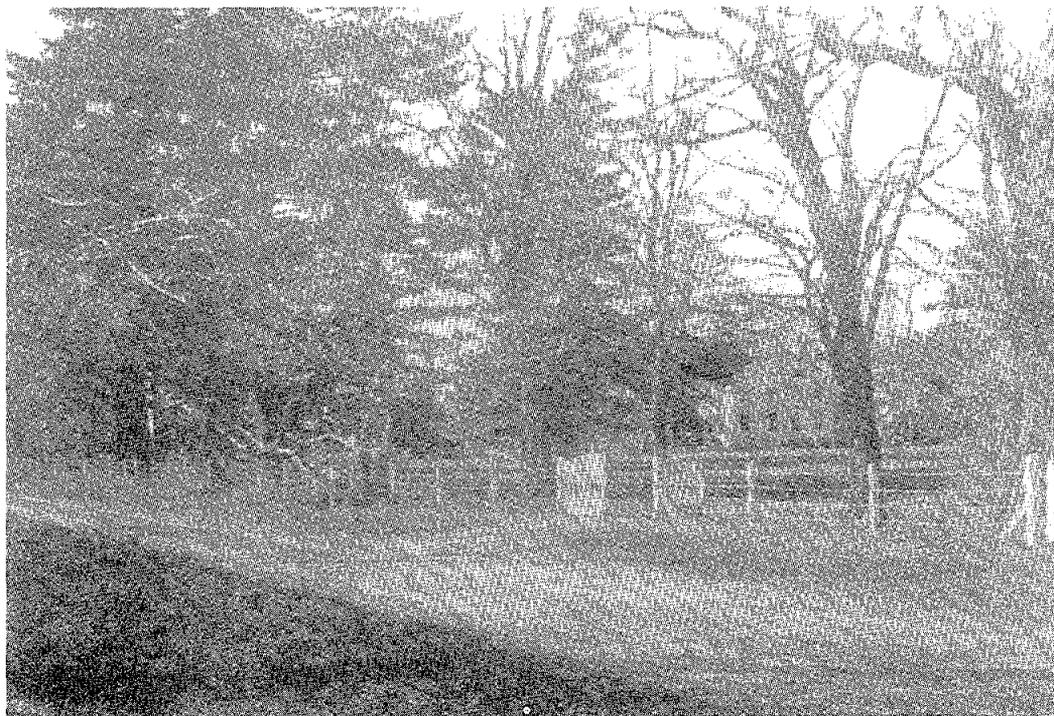
Figure 3.12: View along Post Road, showing front fence and gates to entry drive, c.1895 (Photo # CLR-315. On file, MVB NHS).

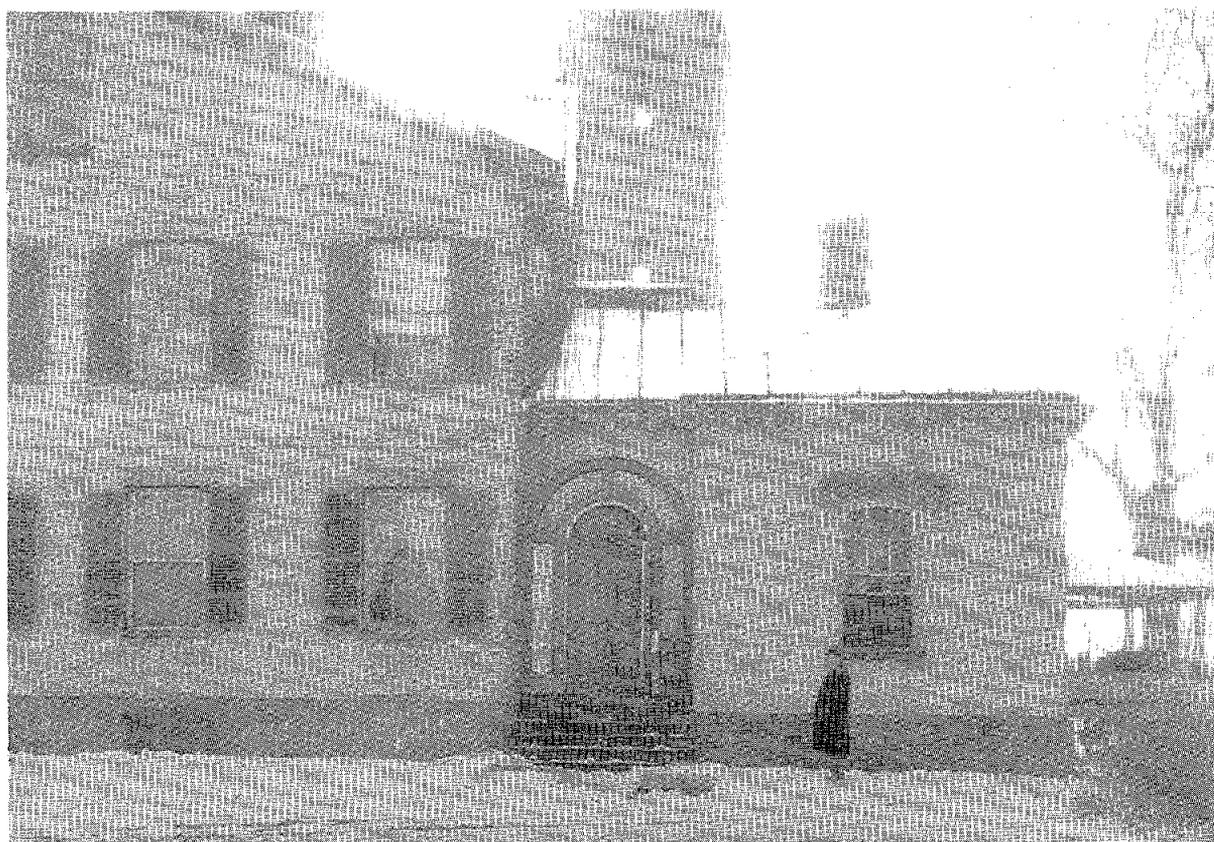
Figure 4.3: Rear porch on main house, 1937 (Photo # CLR-450. On file, MVB NHS).

The main house underwent many changes during the deProsse Period, both on the interior and exterior. On the exterior, a large ornamental front porch, small rear porch, and much ornamentation were added. The porch added to the rear wrapped around the corner of the west wing (fig. 4.3). The exact date of this addition is unknown, but it occurred between 1917 and 1936 and was later enlarged during the deProsse Period (fig. 4.4).

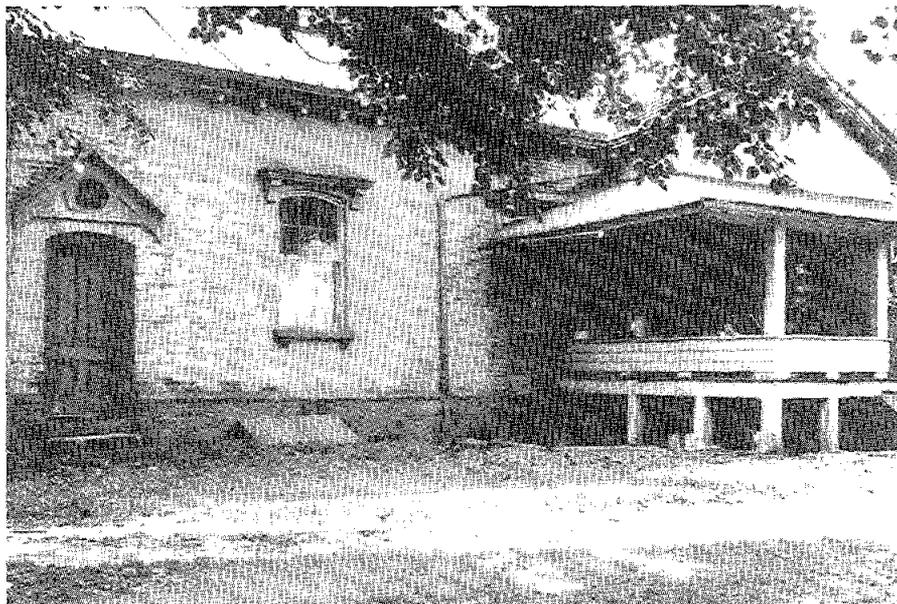
Figure 4.4: Enlarged rear porch on main house, 1936 (Photo # CLR-463. On file, MVB NHS).

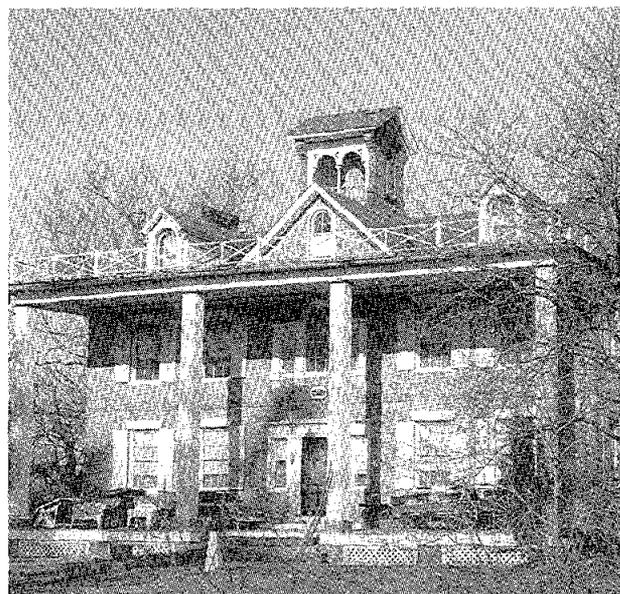
Figure 4.5: Campbell front porch on main house, 1974 (Photo # CLR-530. On file, MVB NHS).

At the end of the deProsse ownership, the front porch was severely deteriorated and had to be removed. When Campbell purchased the property, he added a large porch covering the entire front facade of the main house. Campbell also added ornamentation to the exterior of the main house, around many of the windows and on the roof overhang, disguising the previously Italianate characteristics (fig. 4.5).

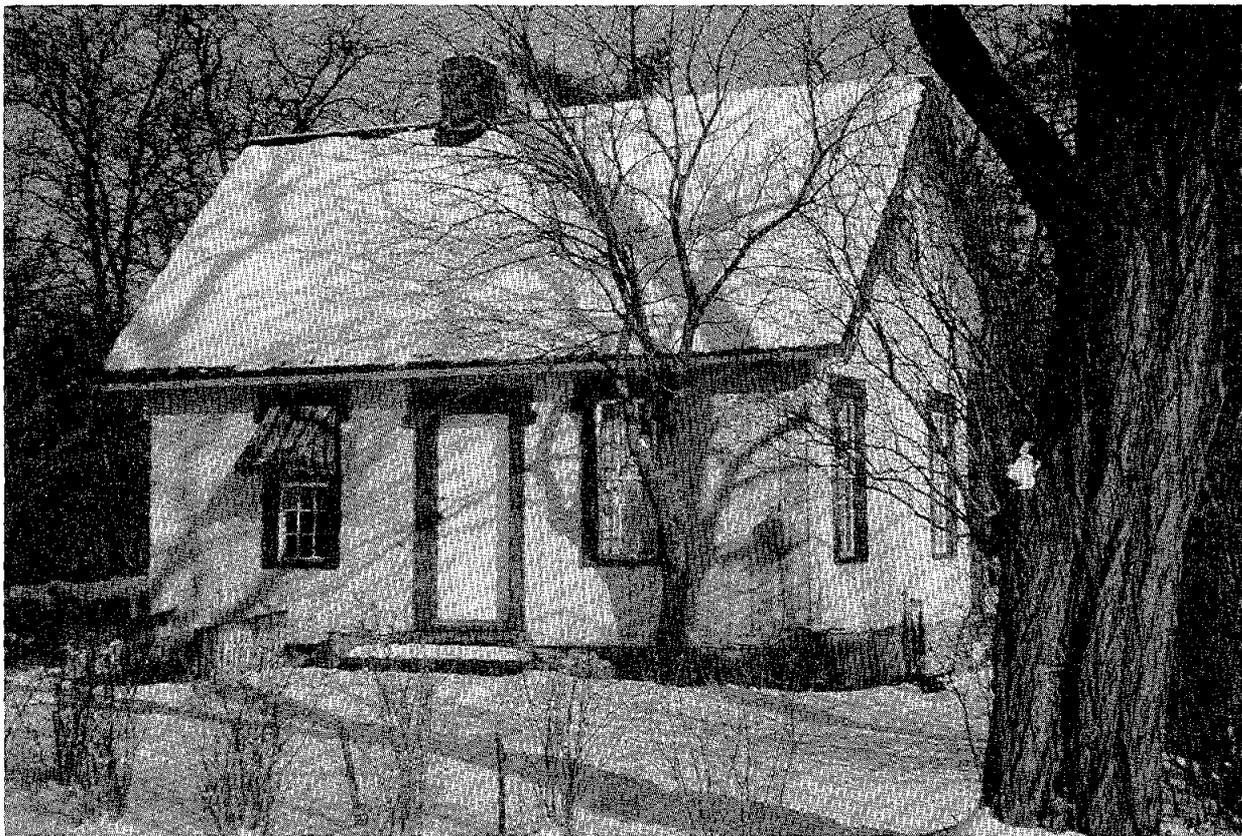
Figure 4.6: South gate house, 1950 (Photo # CLR-434. On file, MVB NHS).

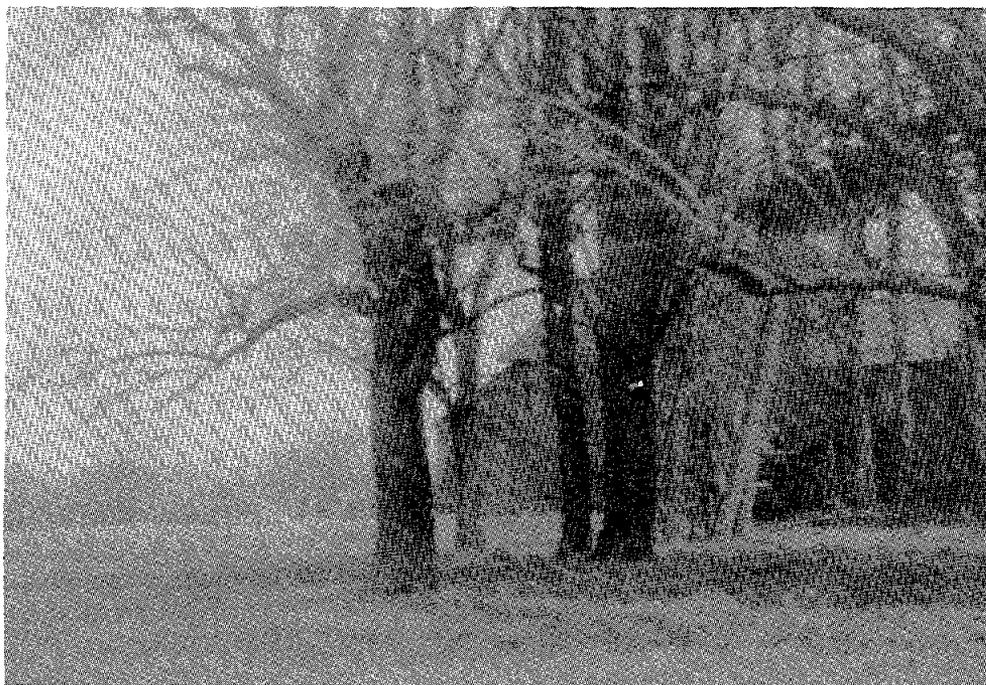
The carriage barn (fig. 1.7 and 4.8) was northwest of the house and approximately thirty feet wide and sixty-five feet long. It was positioned perpendicular to the house, its long axis running northwest/southeast. The building had a main section approximately thirty feet square. Appendages at both ends made the entire length approximately sixty-five feet. The main section or bay of the barn was divided into two areas. The west portion was for carriage storage and the east portion contained animal stalls. The west portion had a sliding door on both the south and north walls for carriage access, and the carriages were stored in the area along the west wall. The east portion was comprised of stalls along both the north and south walls. The south wall had wood tie stalls for securing horses while the north wall had box stalls for storing horses and other animals. It is unknown whether the barn was one large continuous space or whether it was divided into an east and west section as it appears in figure 1.7. The building contained a loft that extended its entire length. Figure 1.7 illustrates the different roof height of the two sections and it would seem the height of the loft in each section was also different. The east section had a lower roof and may have had a lower loft to accommodate this height. The exterior of the barn was covered with six inch wood lap siding and the roof was covered with wood shingles. The carriage barn was over one hundred years old at the start of this period and was deteriorating. As a result, it was dismantled in approximately 1937. All of the debris from the building was removed from the site at that time (see Appendix F for floor plan).¹¹⁹

Figure 4.8: Carriage barn, n.d. (1890-1936) (Photo # CLR-001. On file, MVB NHS).

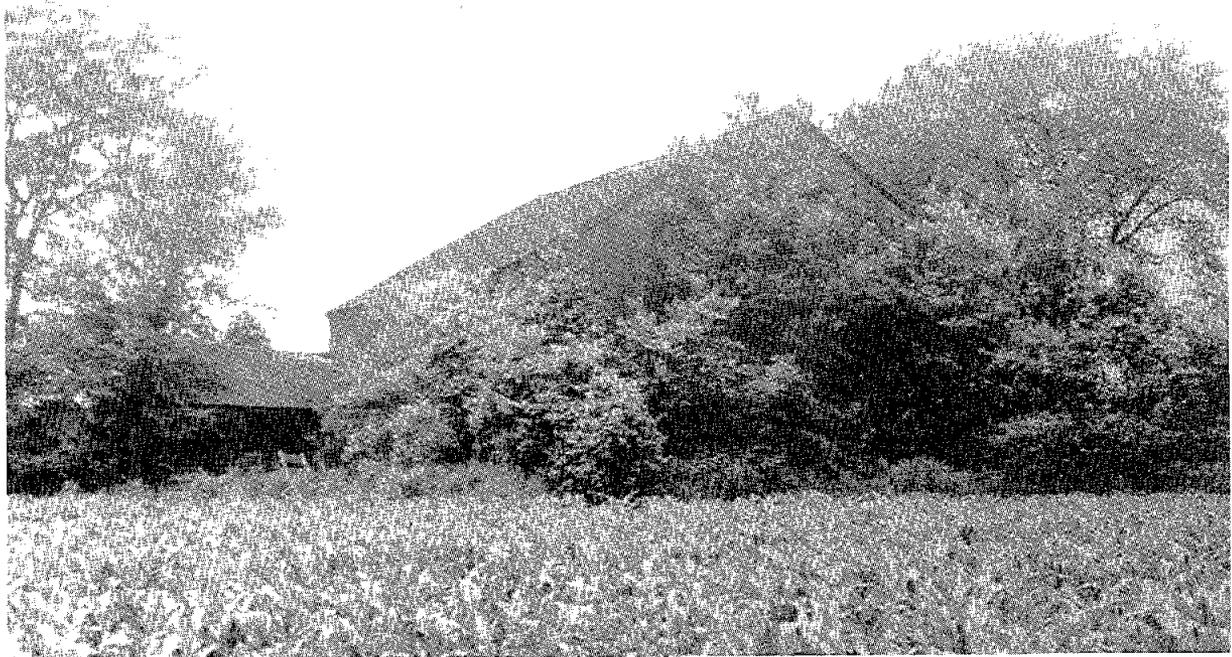
Figure 4.9: Black hay barn, c.1940 (Photo # CLR-408. On file, MVB NHS).

During the deProsse ownership, the farm office, which appears in good condition in a 1936 photograph (fig. 1.8), was used as a storage building and also as a smoke house. It is often referred to as the smoke house today, but was only used as such for one year during the deProsse ownership. The farm office, as it is more commonly known, was a one story, eleven foot square building with a stone foundation, brick walls, and hip roof. It had a wood floor laid directly on the ground and doors on three sides, all but the northwest. The building was removed sometime between 1957 and 1973, during the Campbell ownership, leaving only the foundation.¹²⁰ The red hillside barn (fig. 2.6) was the main building of a small barnyard complex. The barn, constructed into the slope behind the farm cottage, was a large, two level building approximately fifty feet by seventy-five feet and approximately fifty feet tall to the roof peak. The rear of the barn faced the slope and had a raised ramp, or bridge, running from the top of the slope, at the level of the first terrace, directly into the second level of the barn. The barn was divided into many areas for use as animal or produce storage and work space. It was demolished around 1948 and the debris was removed from the property (see Appendix F for floor plan).¹²¹ The black hay barn (fig. 2.7 and 4.9) was a one-level building approximately seventy-five feet square and forty feet high to the roof peak. The west end had an extension approximately twenty-five feet square containing a hay press. The black hay barn was rented by locals for the production of alcohol for two years just before it was sold to Meyer as part of the farmland in 1946. To clear space for more crops, Meyer burned the dilapidated barn in 1948 (see Appendix F for floor plan).¹²²

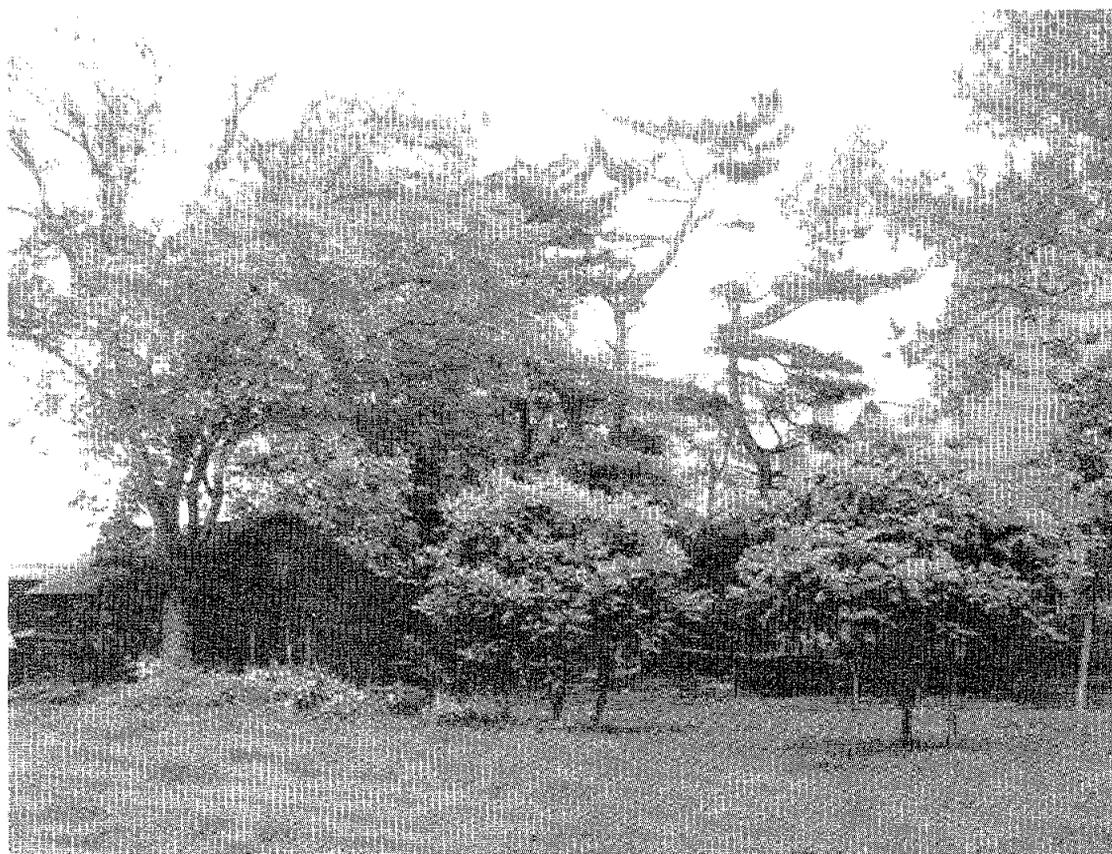
Figure 4.10: Shed complex behind main house, c.1945 (Photo # CLR-419. On file, MVB NHS).

The small complex of buildings directly behind the main house consisted of the wood shed, Wagoner garage, two privies, and a few small structures (fig. 4.10). The wood shed (fig. 4.11) and Wagoner garage (fig. 3.6) were connected to each other by a tool shed and pig pen. On the opposite end of the garage, another shed, similar to the tool shed, was used to store left over slate for the roof of the main house. It was called the slate shed and had been previously used as an ice house during the early part of the period. Behind the wood shed was a three hole privy. Another two hole privy was located in front of the wood shed (see Appendix F). During the beginning of the Campbell ownership, the wood shed, two privies, and pig pen were removed. The Wagoner garage, tool shed and slate shed attached to it were the only part of this complex left standing. These removals were made by Campbell to construct a new garage behind the main house (fig. 4.12). The Campbell garage was a one-story, cinder block building with an asphalt shingled, gable roof. It had four bays for cars and was twenty-five feet by fifty feet.¹²³

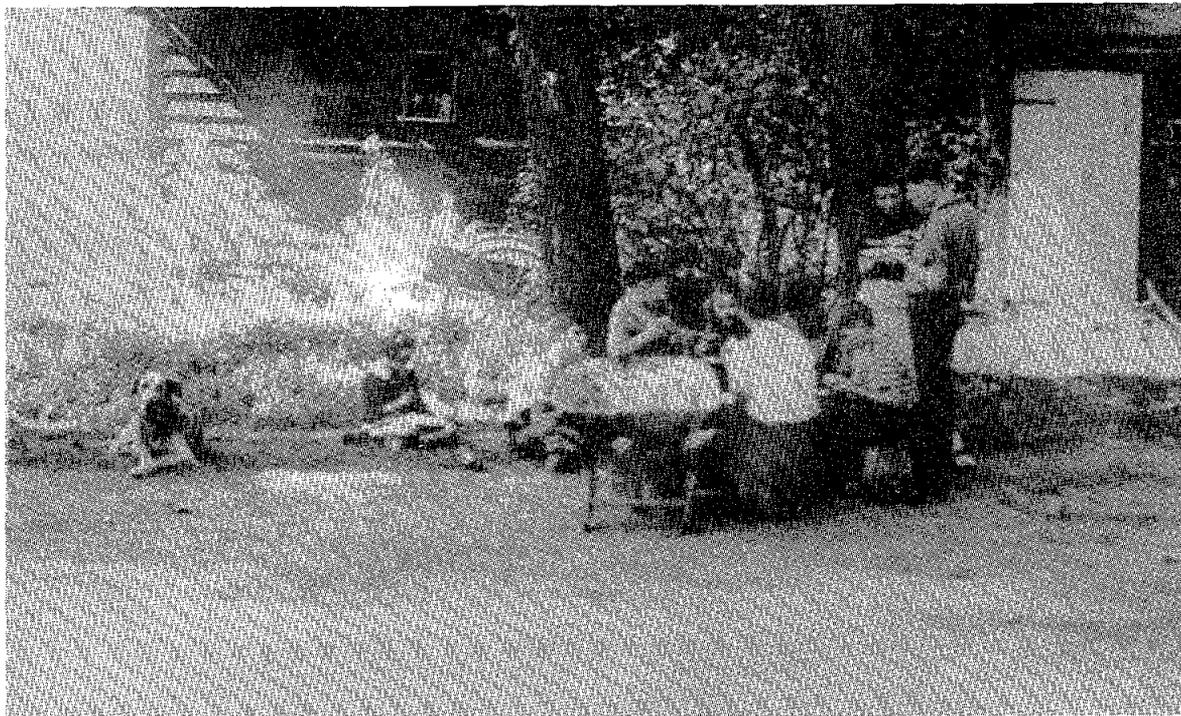
Figure 4.11: Wood shed behind main house, c.1940 (Photo # CLR-411. On file, MVB NHS).

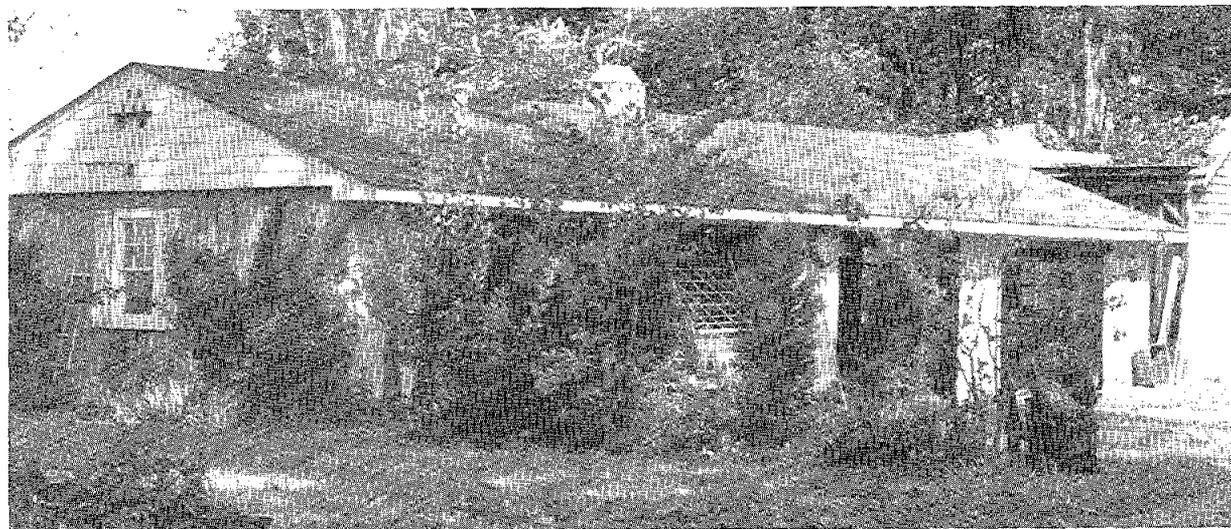
Figure 4.12: Campbell garage, behind main house, c.1969 (Photo # CLR-418. On file, MVB NHS).

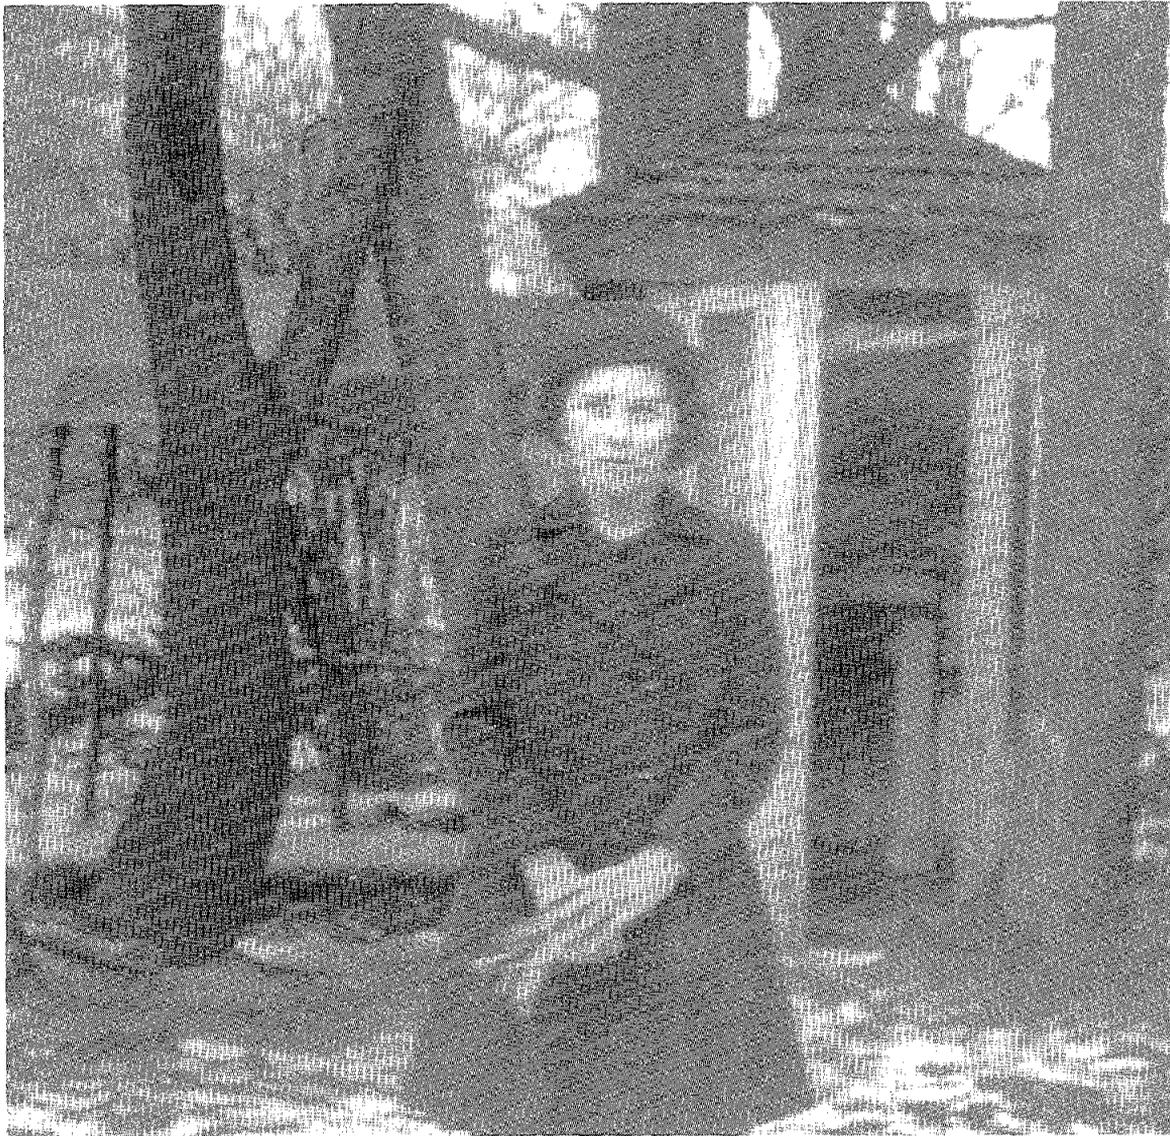
Figure 4.13: Well house converted into play house, c.1935 (Photo # CLR-427. On file, MVB NHS).

The well house, located on top of the well behind the main house during the Wagoner Period, was moved to the northeast corner of the Wagoner garage during the 1930s (fig. 4.13 and 4.14). Located in a grove of trees, it was converted to a play house for the deProsse children. It had either fallen down or been removed by the end of the deProsse Period, probably during the Campbell ownership.¹²⁴

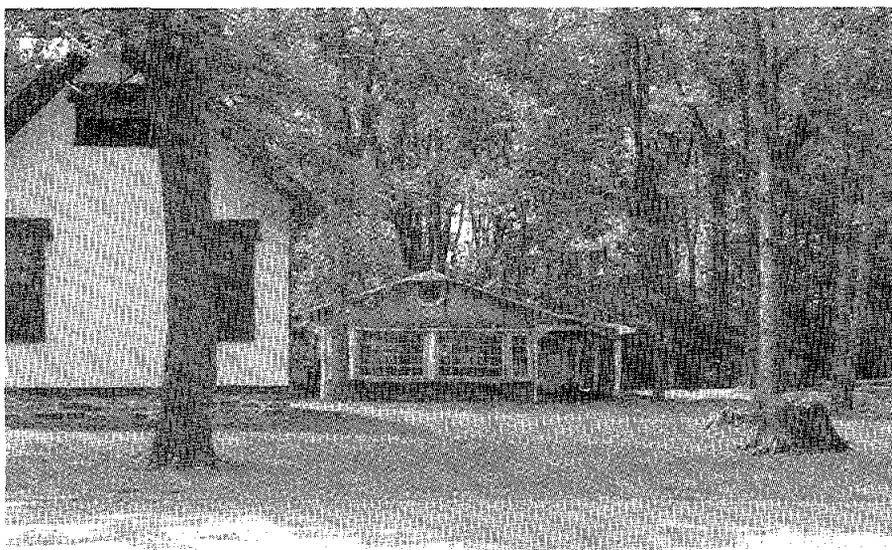
Figure 4.15: Campbell antique shop, 1981 (Photo # CLR-537. On file, MVB NHS).

During the 1960s, Campbell constructed a small shop on the property from which he sold antiques. The shop was located adjacent to the south gate house and was approximately twenty feet square with covered porches on the north and south sides (fig. 4.15).

The Campbell garage was renovated for use as the maintenance shop for the Park in 1978. Three bays are used for work and storage space and the fourth is office space. This garage also has been painted yellow (fig. 5.10). The Wagoner garage collapsed in 1974 and the debris was removed from the property (fig. 5.11). Campbell's antique shop was removed from the property in 1981 due to its visually intrusive character and location (fig. 4.15).¹³⁸

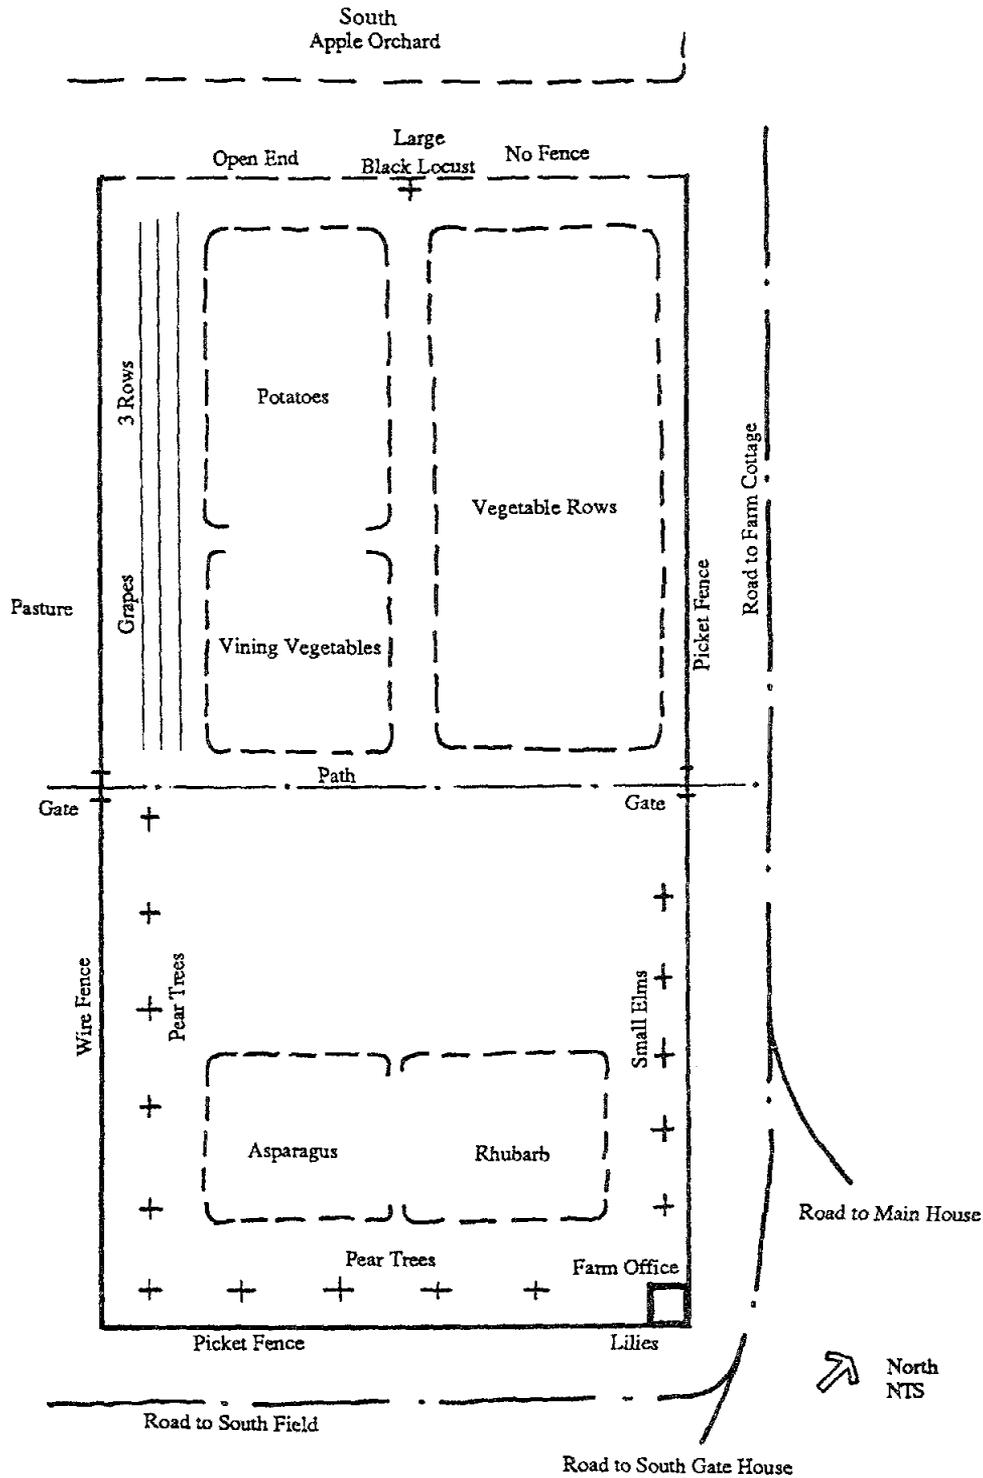
Figure 4.23: Detail of Lindenwald garden, c.1940 (William deProsse, 1993. Re-drawn by Uschold, 1993).

Many details of the garden can be documented from this period. The garden undoubtedly underwent changes, but many elements of Van Buren's garden remained. The location of the garden was the same, though some question remains about its size. Van Buren's garden was thought to extend to the fish pond. The deProsse Period garden was only about one-half that size: approximately 300 feet by 150 feet. The area between the garden and the fish pond was pasture during this period. The layout of the garden, with the grape rows and old pear trees bordering it on the south side suggest this order may have always been the case. Contents of the garden at this time included: trees, vegetables, fruits, and perennials. There were many trees within the garden, including locusts, elms, and approximately ten or twelve pear trees. The garden was surrounded by a fence on three sides and the south orchard on the fourth. The north and east sides had a wood picket fence and the south side a wire fence (fig. 4.23).¹²⁹ The entire garden area, including the portion on the final 12.8 acre parcel, was plowed under and cultivated by Meyer during the 1950s, before Campbell purchased the property. After this time, a small vegetable garden was planted next to the wood shed.¹³⁰

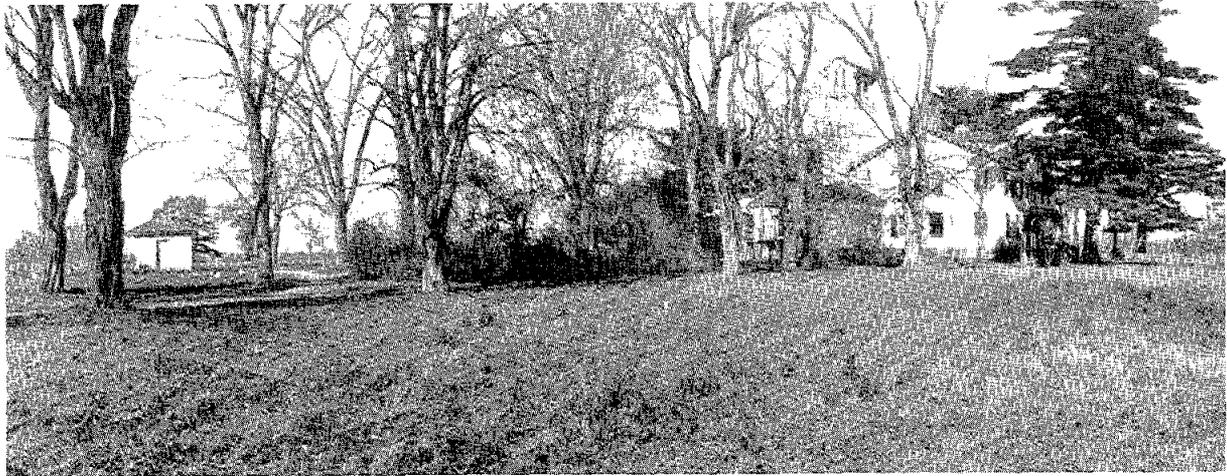
Figure 4.26: Picket fence surrounding garden, c.1913 (Photo # CLR-301. On file, MVB NHS).

At the start of the deProsse Period, the garden had fences enclosing three of its sides. The north and east sides had an elaborate picket fence made of wood and painted white. The fence had posts approximately every six feet that were approximately five inches square. The pickets were spaced approximately one and one-half inches apart. The pickets had flat, onion dome shaped tops and the support posts had fully round tops of the same shape matching those of the front Victorian porch (fig. 4.26 and 4.27).¹³³

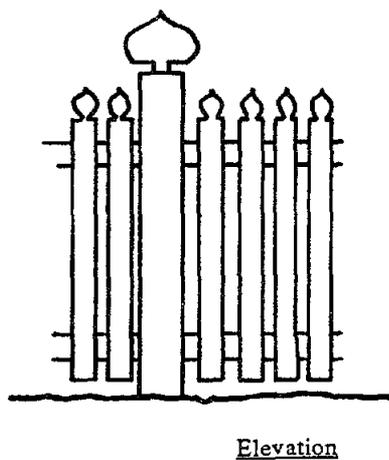
5" Square Support Posts
Pickets Spaced 1 1/2"
Fence Height Approximately 4'-0"
Onion Domes Reflect Style of Victorian
Front Porch Balustrade

Figure 4.27: Detail of picket fence surrounding garden (William deProsse, 1993. Re-drawn by Uschold, 1993).

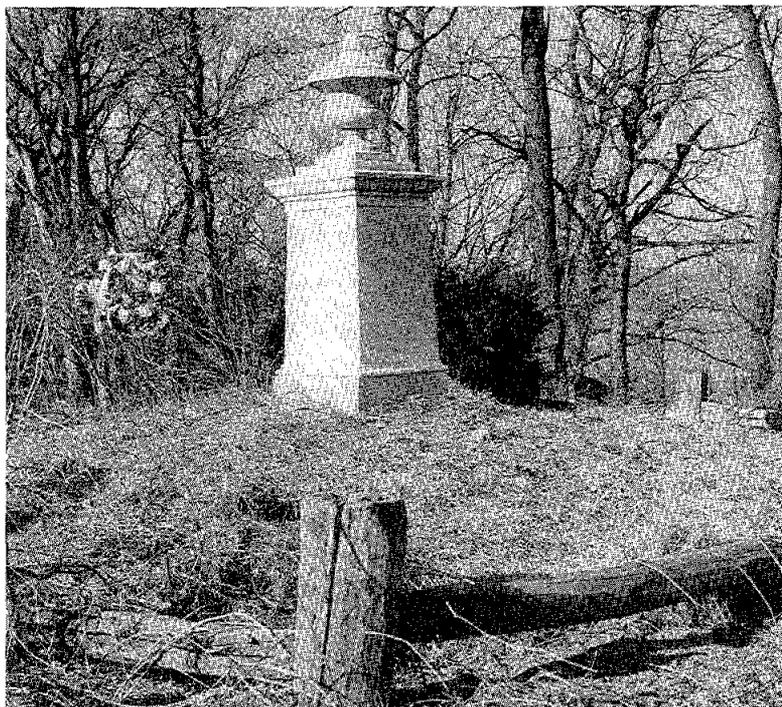
Figure 4.29: Fence around Van Ness grave, behind main house, c.1960 (Photo # CLR-010. On file, MVB NHS).

Several sections of fence were also added to the property during the Campbell ownership (fig. 4.28). The south and east sides of the Lilac grove south of the main house were fenced and both ends of the entry drive had gates. These fences were approximately four feet high, constructed of wood timbers, and painted white. The gates across the entry drives were white, wood gates of a simpler design than the gates recorded there previously. A fence also existed around the Peter Van Ness grave, behind the main house. This fence was constructed of large wood timbers and stood approximately one or two feet high. It surrounded a square area about twenty feet by twenty feet around the grave (fig. 4.29).

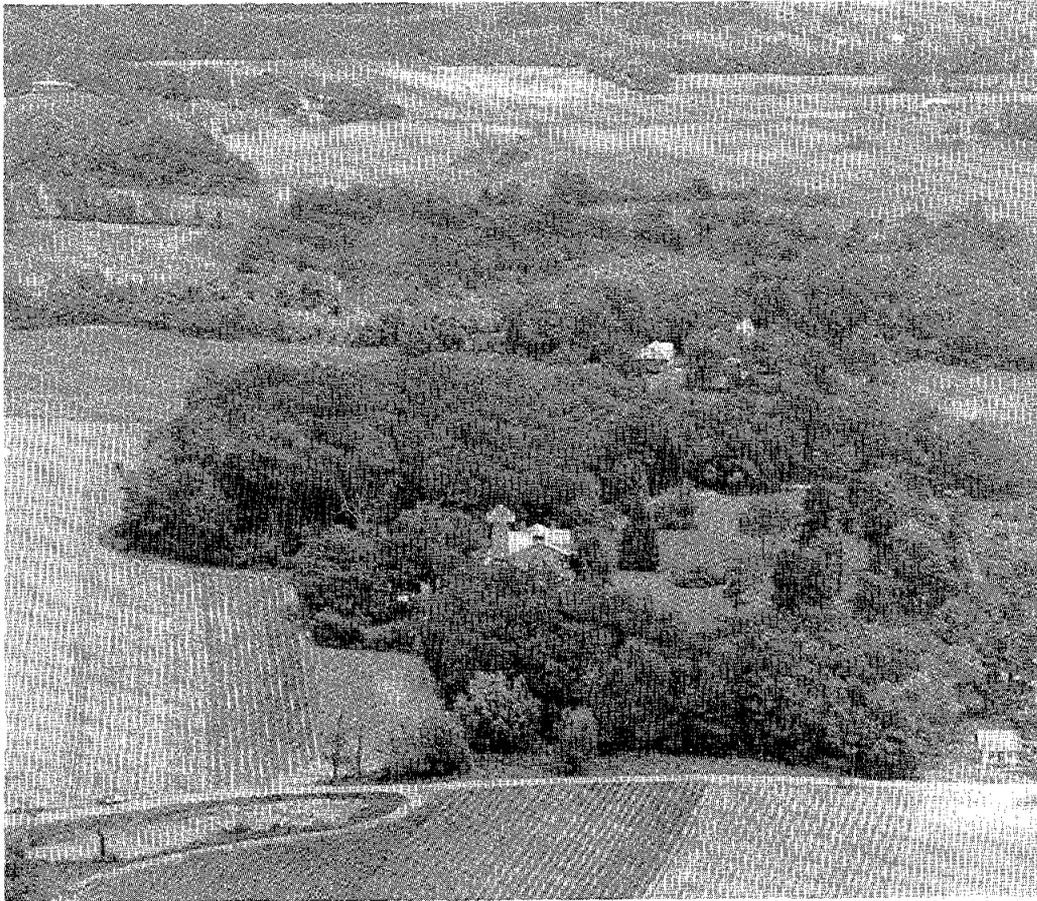
Figure 5.1: Martin Van Buren National Historic Site, aerial view from south, present park setting, 1978 (Photo # CLR-550. On file, MVB NHS).

The property boundaries have changed significantly but the visual setting of the current site has retained its overall character of the previous periods. All of the land adjacent to Lindenwald has remained in agriculture or, at least, undeveloped, maintaining the rural character (fig. 5.1 & 5.2).

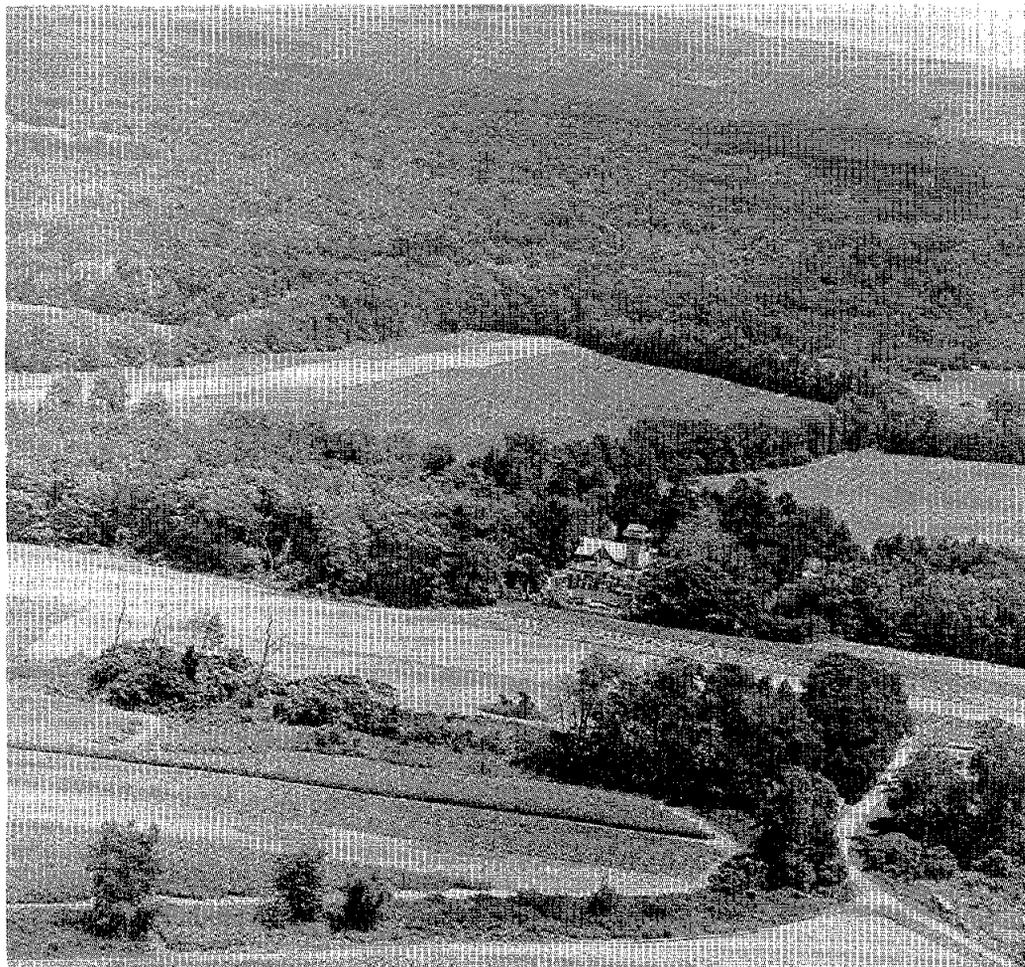
Figure 5.2: Martin Van Buren National Historic Site, aerial view from west, present park setting, 1978 (Photo # CLR-551. On file, MVB NHS).

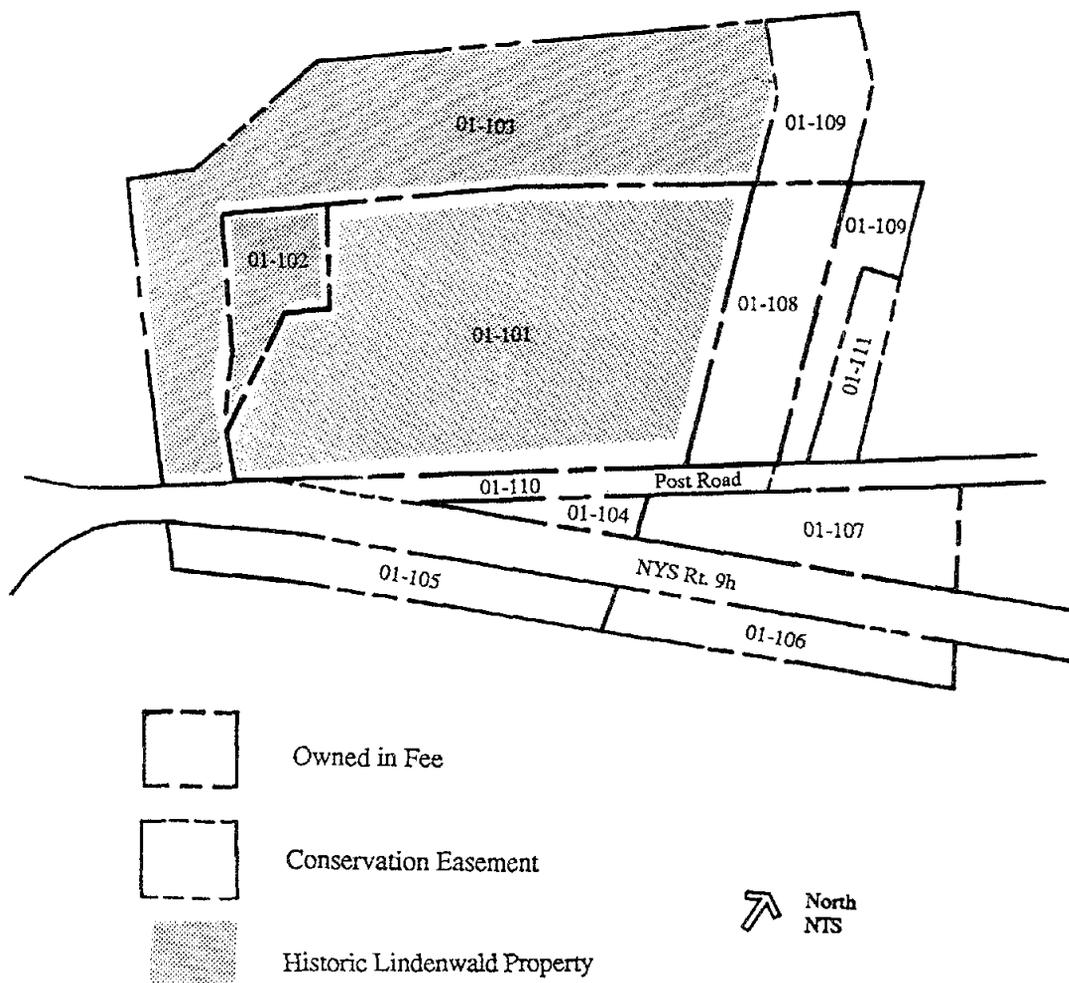
Figure 5.4: Martin Van Buren National Historic Site parcels (Uschold, 1993. SUNY CESF).

Parcels 01-101 and 01-102 make up the 14.3-acre historic core of the property owned in fee. Parcel 01-103 is an easement covering historic property adjacent to the core. Parcels 01-104, 01-107, and 01-108 are non-historic parcels, owned in fee that were acquired to accommodate a proposed visitor facility. Parcels 01-105, 01-106, 01-109, and 01-111 are easements covering non-historic property acquired as buffers surrounding the Park. Parcel 01-110 contains the portion of Post Road that extends in front of the Park. This 1.8-acre parcel is not owned by the Park at this time. It is owned by the Town of Kinderhook, which has stated it would donate the parcel to the Park (fig. 5.3 & 5.4).¹³⁶
