CULTURAL LANDSCAPE REPORT

MARTIN VAN BUREN

NATIONAL HISTORIC SITE

Site History, Existing Conditions, and Analysis

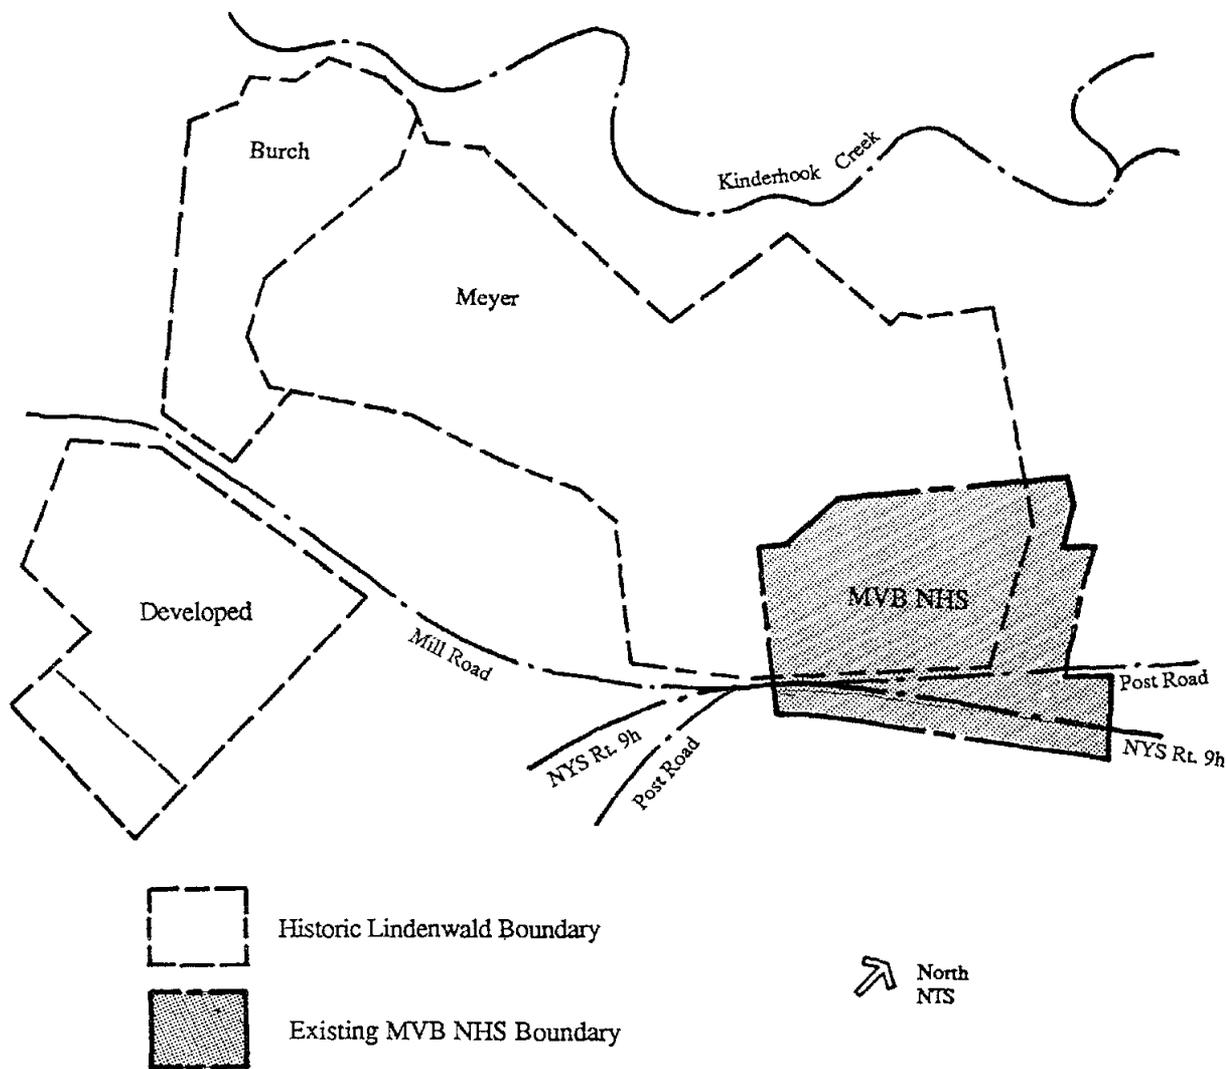
Figure 5.5: Setting: Martin Van Buren National Historic Site (Uschold, 1993. SUNY CESF).

As mentioned above, the majority of the original Lindenwald farmland currently is owned by a local farmer, Ray Meyer, and is still in agricultural use. While many alterations to the farmland have taken place, the property still provides the visual setting of agricultural use. The National Park Service purchased 1.5 acres in fee from Meyer, bringing their historic core holding to 14.3 acres. This purchase left Meyer's Lindenwald farmland holdings at 128 acres. Another 38 acres at the south end of the original Lindenwald farm are owned by a local farmer and are still in agriculture use. Of the forty-three-acre parcel of Lindenwald farmland across Mill Road, thirty-seven acres has been subdivided into several individual lots and developed as residential properties. The other six acres, adjacent to the subdivision, remain within the deProsse family (fig. 5.5).

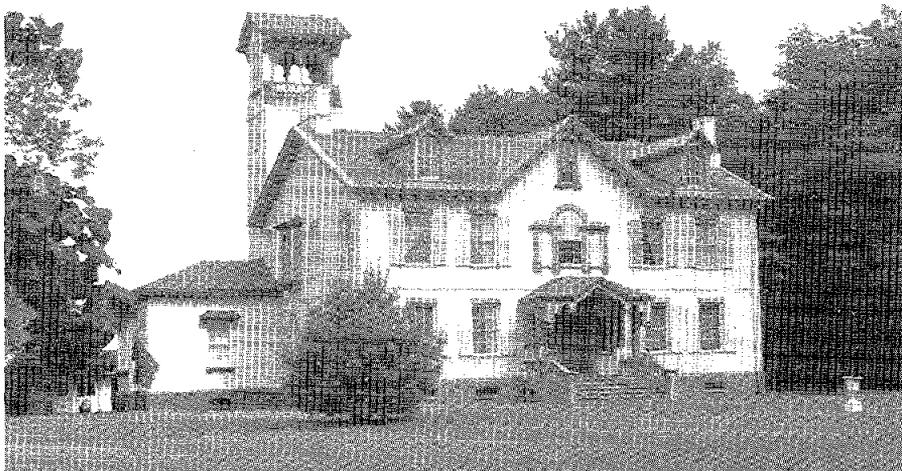
Figure 5.6: Lindenwald, main house, 1993 (Photo # CLR-1411. Uschold, SUNY CESF).

The main house, in a dilapidated state at acquisition, underwent extensive restoration efforts. The non-historic front and rear porches were removed and the historic front porch was replaced. The interior was completed in 1987 and the exterior in 1991, returning the house to its 1850s appearance. The house is now painted yellow with brown trim (fig. 5.6).

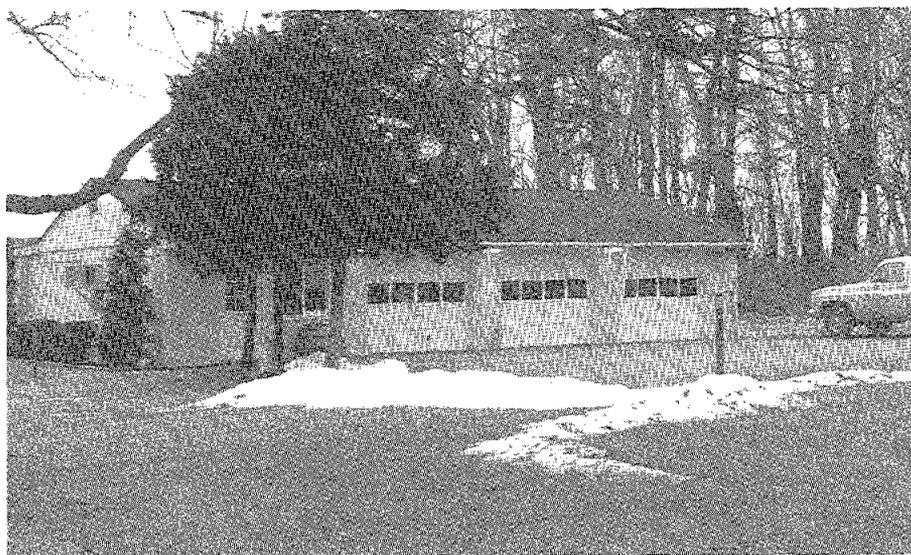
Figure 5.10: Campbell garage: maintenance garage, 1993 (Photo # CLR-1116. Uschold, SUNY CESF).

The Campbell garage was renovated for use as the maintenance shop for the Park in 1978. Three bays are used for work and storage space and the fourth is office space. This garage also has been painted yellow (fig. 5.10). The Wagoner garage collapsed in 1974 and the debris was removed from the property (fig. 5.11). Campbell's antique shop was removed from the property in 1981 due to its visually intrusive character and location (fig. 4.15).¹³⁸

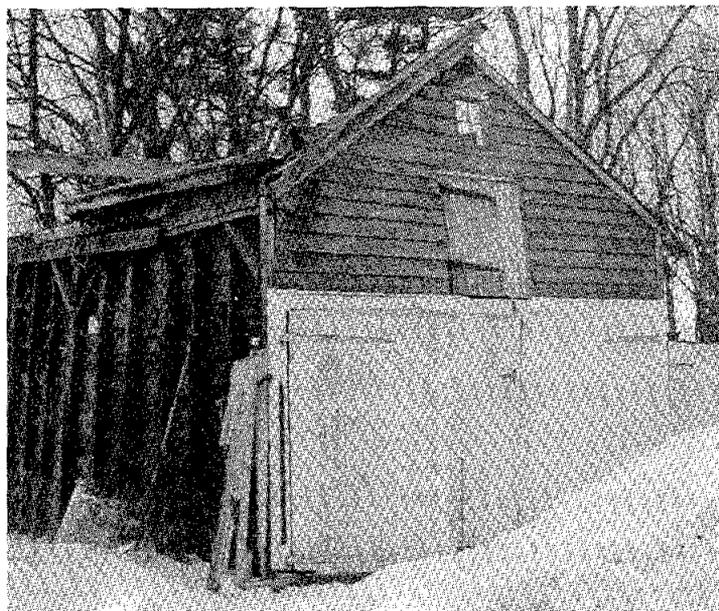
Figure 5.11: Wagoner garage, 1974 (Photo # CLR-501. On file, MVB NHS).

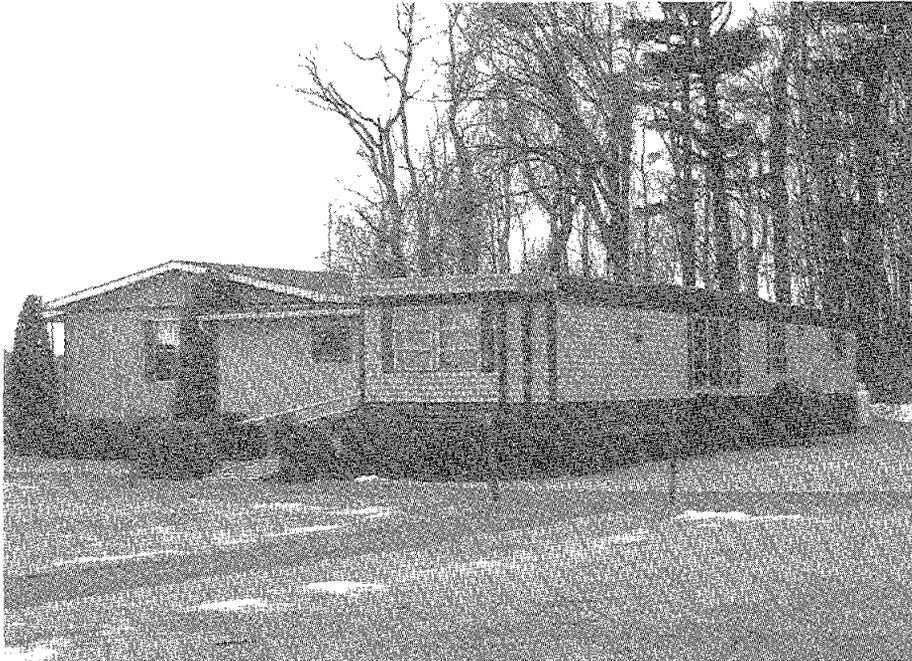
Figure 5.12: Mobile homes: administrative and curatorial offices, 1993 (Photo # CLR-1118. Uschold, SUNY CESF).

In 1977, a mobile home was added for use as Park offices. It was replaced in 1980 by a twelve by fifty-six foot mobile home. This mobile home was supplemented in 1983 by a twenty-four by forty foot, double wide mobile home and a vestibule was constructed between the new and old mobile homes (fig. 5.12). Located behind the main house, the twelve foot wide mobile home now houses the curatorial offices and the newer one houses the administrative offices. Another building, known as the pole barn, located next to the offices, is used for curatorial storage and the maintenance office. The pole barn was constructed in 1983–84 as a temporary structure to house curatorial items (fig. 5.13).¹³⁹

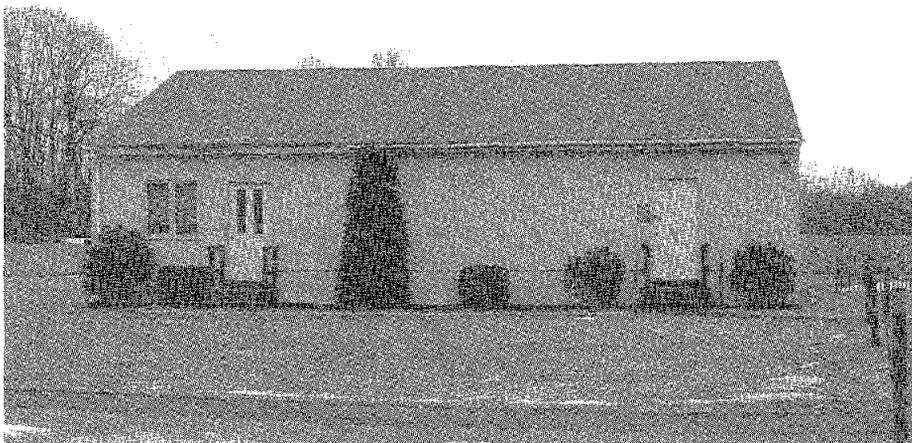
Figure 5.13.: Pole barn: curatorial storage and maintenance office, 1993 (Photo # CLR-1117. Uschold, SUNY CESF).

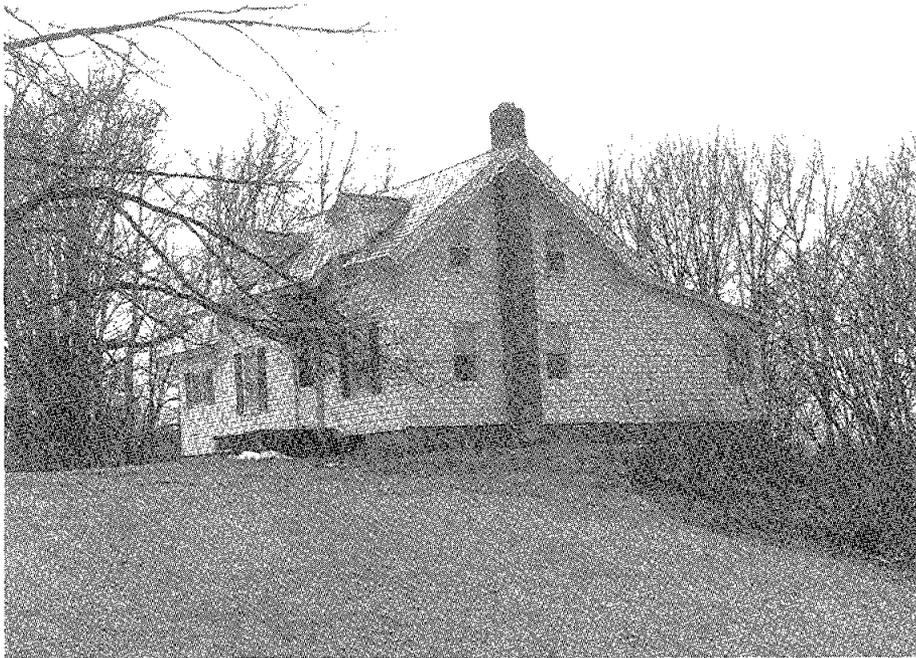
Figure 5.14: Farm cottage, 1993 (Photo # CLR-1112. Uschold, SUNY CESF).

The farmland, now owned by Meyer, had an extensive complex of buildings at the beginning of the period and more buildings have been added to it during this period. The farm cottage is extant, although it has been greatly altered. It has undergone a number of renovation and modernization efforts. Additions have been built on the west and north sides of the building. It is now being used as a residence (fig. 5.14). The farm complex also contains a ranch house built in 1985. In addition, there are three silos, one large barn, seven garages and sheds, one hothouse, and one greenhouse (fig. 5.15 & 5.16).

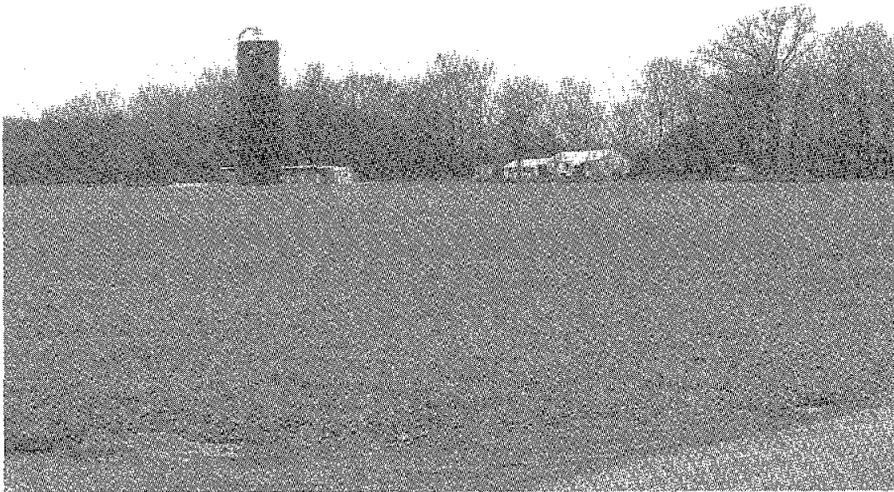
Figure 5.15: Meyer farm complex and 1985 ranch house, 1993 (Photo # CLR-1313. Uschold, SUNY CESF).

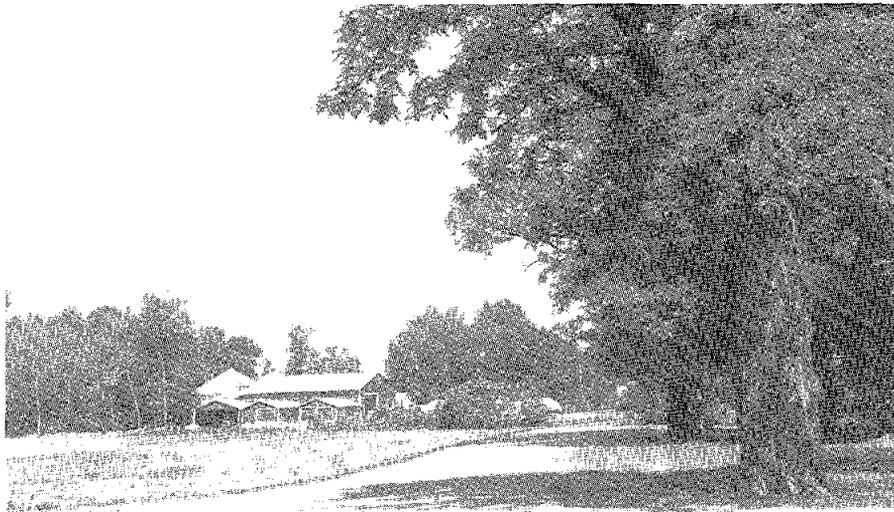
Figure 5.16: Meyer farm complex, 1993 (Photo # CLR-1509. Uschold, SUNY CESF).

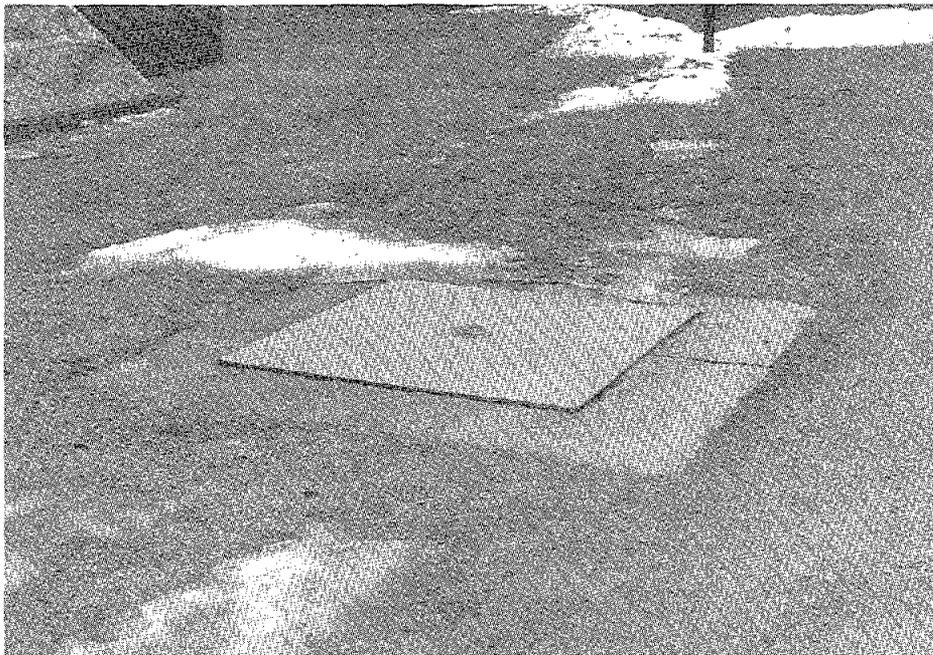
Figure 5.17: Historic well for main house, 1993 (Photo # CLR-1115. Uschold, SUNY CESF).

Water is provided to the Park by an underground well located behind the main house. This well was installed by the Park in 1978. The well provides the amount of water needed at the Park, however it is not dependable for drinking water. The historic well that served the main house still exists at the rear of the house (fig. 5.17). A steel cover has been placed over the well for protection. The sewage from the Park buildings is handled by a 1000-gallon septic tank which was placed underground in front of the pole barn. The septic system which served the main house and was implemented during the deProsse Period, was removed as non-historic in 1984. Four leach tanks were added, located around the main house, and are used for disposal of the storm water run-off from the gutters of the house. These leach tanks are dry wells constructed of concrete. On the north side of the front lawn, a 10,000-gallon water tank was placed underground. It has no connections to the Park's other water supply and was added for the sole purpose of fire protection.

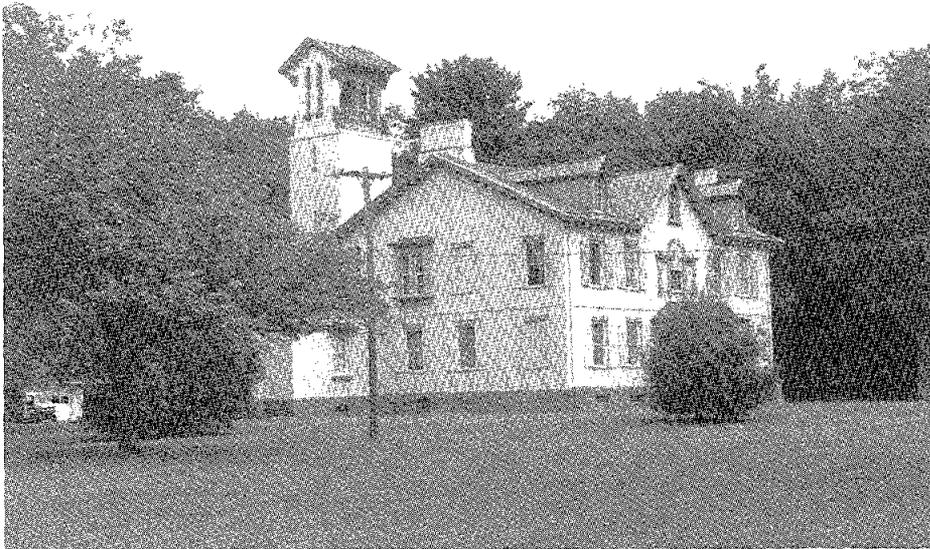
Figure 5.18: Electric service pole for Meyer farm complex, 1993 (Photo # CLR-1415. Uschold, SUNY CESF).

The electric service to the property was re-routed and improved in 1984. Electric service now enters the property via an underground line on the north end of the front lawn. The line runs directly from Post Road and goes straight to a transformer, located in the north wood lot near the main house. From there it goes underground to the main house, continuing to the garage, mobile homes, and pole barn. The south gate house receives its electric service directly from the line running along Post Road. An overhead line runs from the Post Road line to the gate house. From the gate house, this overhead line continues to a pole at the edge of the south wood lot. This extension is no longer in service and stops at the electric pole at the edge of the south wood lot.¹⁴⁰ The overhead electric line that previously served the main house still exists, passing directly across the front lawn. It continues to serve the farm complex behind the Park (fig. 5.18).

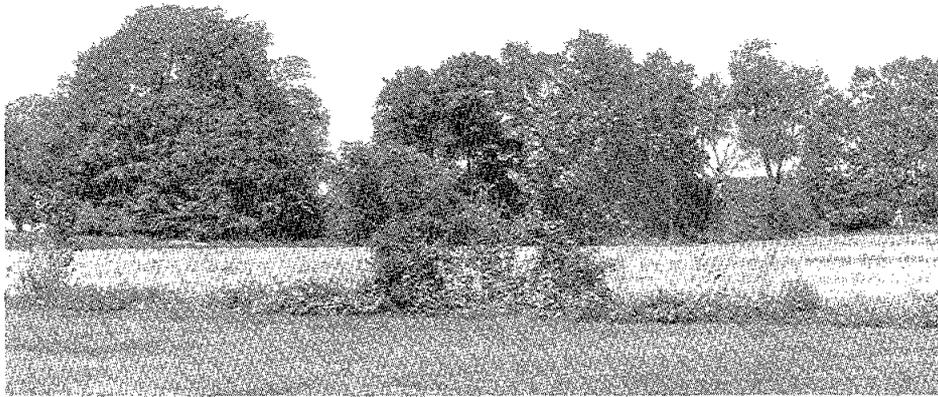
Figure 5.27: View toward farm cottage & Van Ness grave from main house, 1993 (Photo # CLR-1517. Uschold, SUNY CESF).

The view from the rear of the property, to the Catskill Mountains, remains but has been confined to the north corner of the house lot. Vegetation along the transition slope has grown to block this view except from this extreme location. Vegetation on the farm and in the valley behind the Park block much of the immediate view of the valley, but the view to the Mountains is partially intact. Several buildings have been added to the farm complex behind the Park, but, while visible, they do not block any views. The view from the rear of the main house to the farm cottage and the Van Ness grave remains (fig. 5.27 & 5.28).

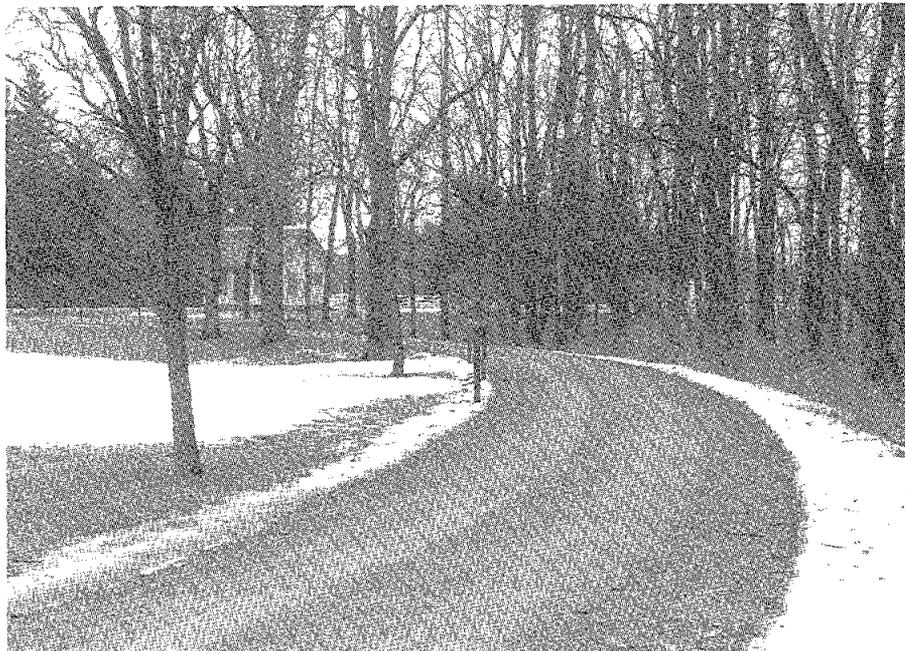
Figure 5.29: South drive, from main house toward south gate house, 1993 (Photo # CLR-1307. Uschold, SUNY CESF).

A number of changes and additions to the circulation systems occurred during this period. The entry drive, overgrown with vegetation at the start of the period, was re-established. Previously composed of compacted soil, crushed stone was added to the south portion of the drive, while the north remains compacted soil. The south drive is used regularly by the Park maintenance staff; the north is rarely traveled on (fig. 5.29 & 5.30). The farm road, accessing the Meyer farm complex behind the Park, was compacted soil at the start of the period. In 1989 the farm road was paved with asphalt (fig. 5.31). In the location of the garden, a temporary employee parking area has been constructed. It is composed of compacted soil and stone, accommodates approximately thirty cars, and is accessed by a road of the same materials extending from the farm road, at the intersection with the upper fish pond (fig. 5.32). A series of asphalt paths were constructed, connecting the parking, maintenance garage, mobile homes, and pole barn. Two paths were cut through the vegetation of the north wood lot. They provide the maintenance staff access to their storage areas, visitor access to the visitor rest rooms, and visitor nature walks.

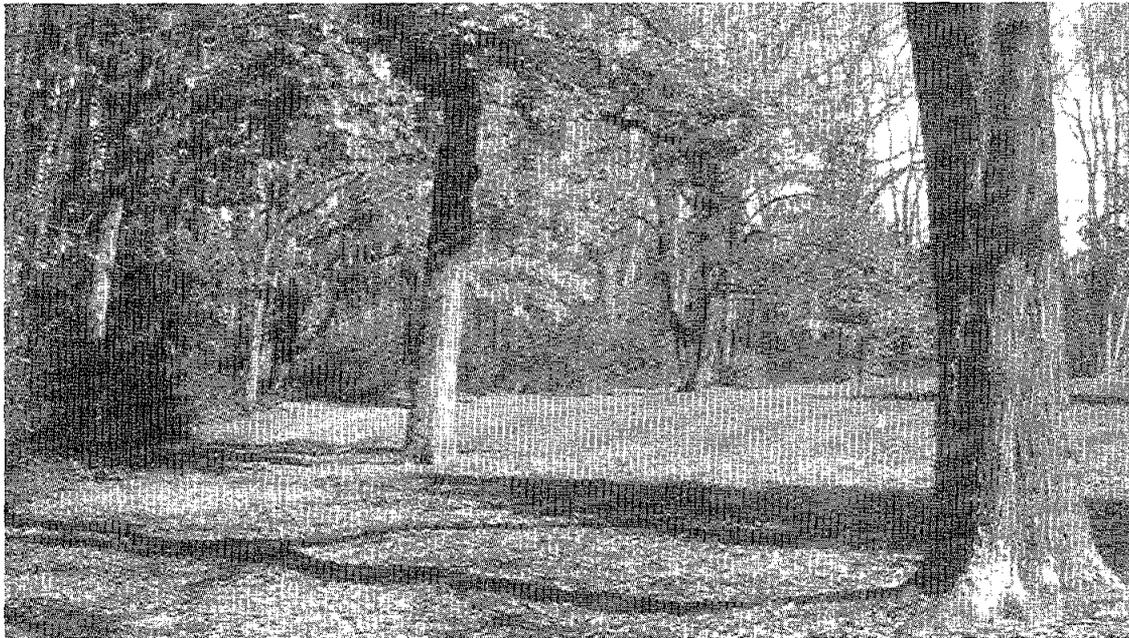
Figure 5.30: North drive, 1993 (Photo # CLR-1604. Uschold, SUNY CESF).

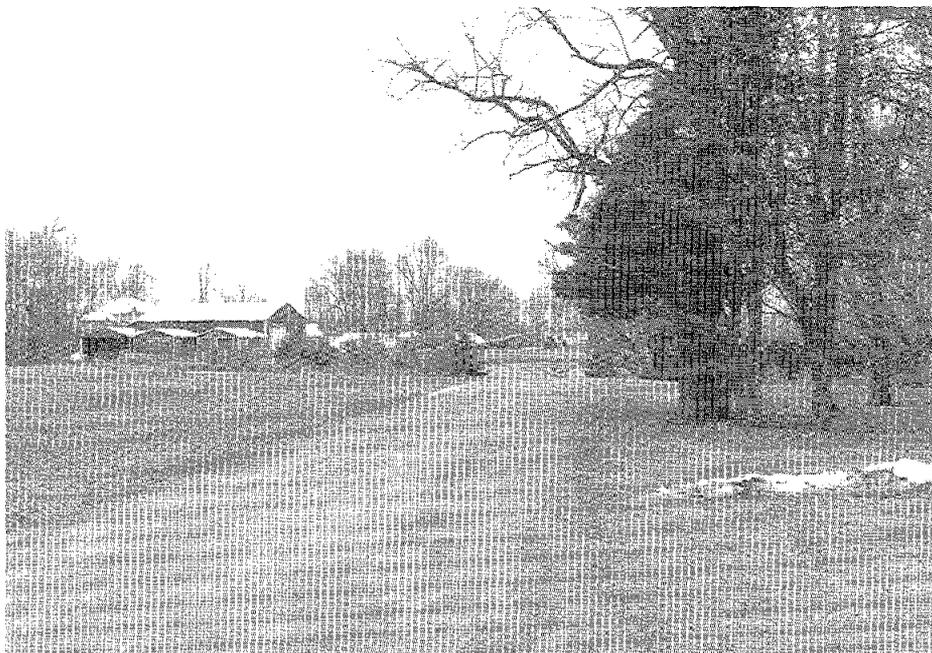
Figure 5.31: Farm road, from Rt. 9h, 1993 (Photo # CLR-1312. Uschold, SUNY CESF).

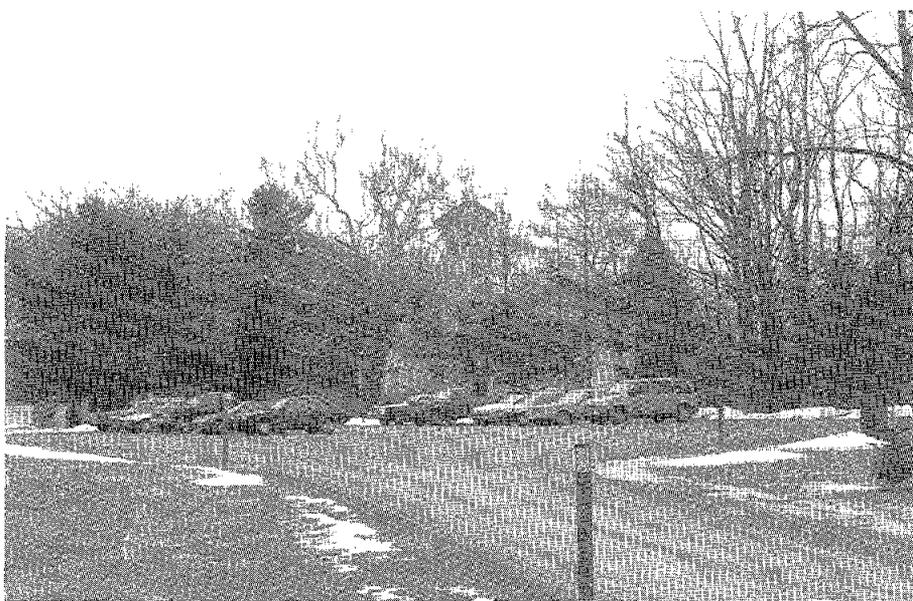
Figure 5.32: Employee parking area, from farm road, 1993 (Photo # CLR-1320. Uschold, SUNY CESF).

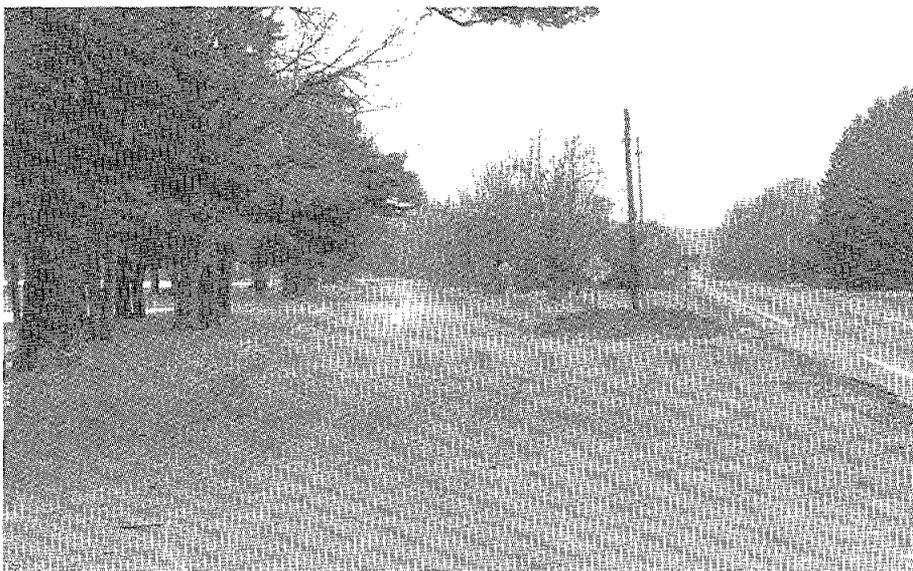
Figure 5.33: Visitor parking, along Post Road, 1993 (Photo # CLR-1311. Uschold, SUNY CESF).

Visitor parking for the Park is along Post Road, in front of the site. Visitors park along the road and walk across the front lawn or up either side of the entry drive. Handicap parking for two vehicles is available next to the maintenance garage behind the main house. It is accessed by the south entry drive. The north drive is blocked (fig. 5.33 & 5.34).

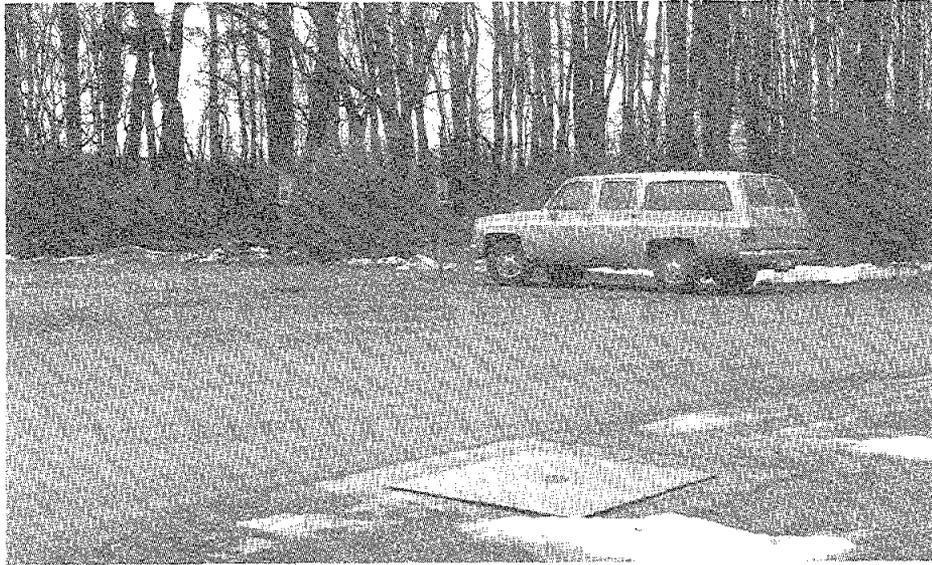
Figure 5.34: Handicap parking, rear of main house, 1993 (Photo # CLR-1121. Uschold, SUNY CESF).

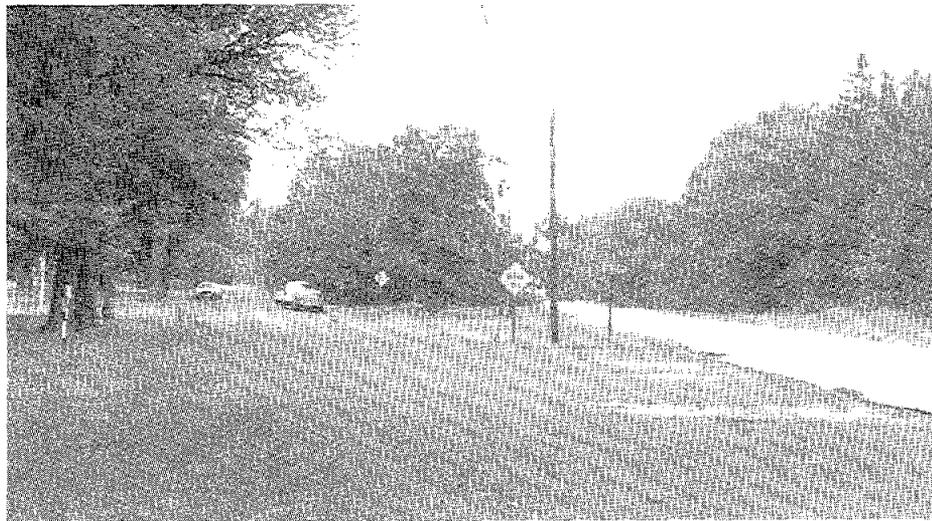
Figure 5.35: New York State Route 9h & Post Road, 1993 (Photo # CLR-1606. Uschold, SUNY CESF).

New York State Route 9h, which intersects Post Road in front of the Park, is a very busy, 55 mph highway. The intersection of this route and Post Road is directly in front of the south gate house. This is also the point where visitors access Post Road and enter the Park and Route 9h curves sharply to the south, intersecting Mill Road a few hundred yards to the south. This intersection creates a traffic hazard for any vehicle trying to access any of these roadways (fig. 5.35 & 5.36).

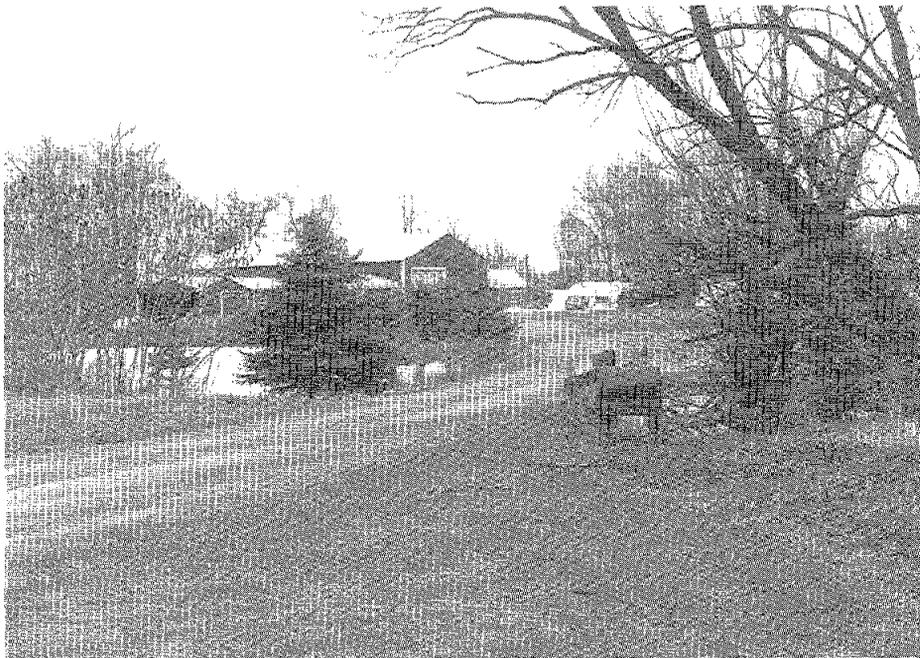
Figure 5.36: Upper fish pond and smaller pond flanking farm road, 1993 (Photo # CLR-1318. Uschold, SUNY CESF).

The only designed water feature within Park control is the upper fish pond. It abuts the farm road and is located on a conservation easement controlled by the Park. The pond, enlarged by Meyer during the deProsse Period, currently is used for irrigation purposes on his farm. On the opposite side of the farm road is a small pond created as a result of the farm road's construction. This small shallow pond has formed by the fill for this road. A culvert runs underneath the farm road, connecting this small pond with the upper fish pond. This pond fluctuates greatly depending on the season. It is almost non-existent during the dry summer months (fig. 5.36–5.38).

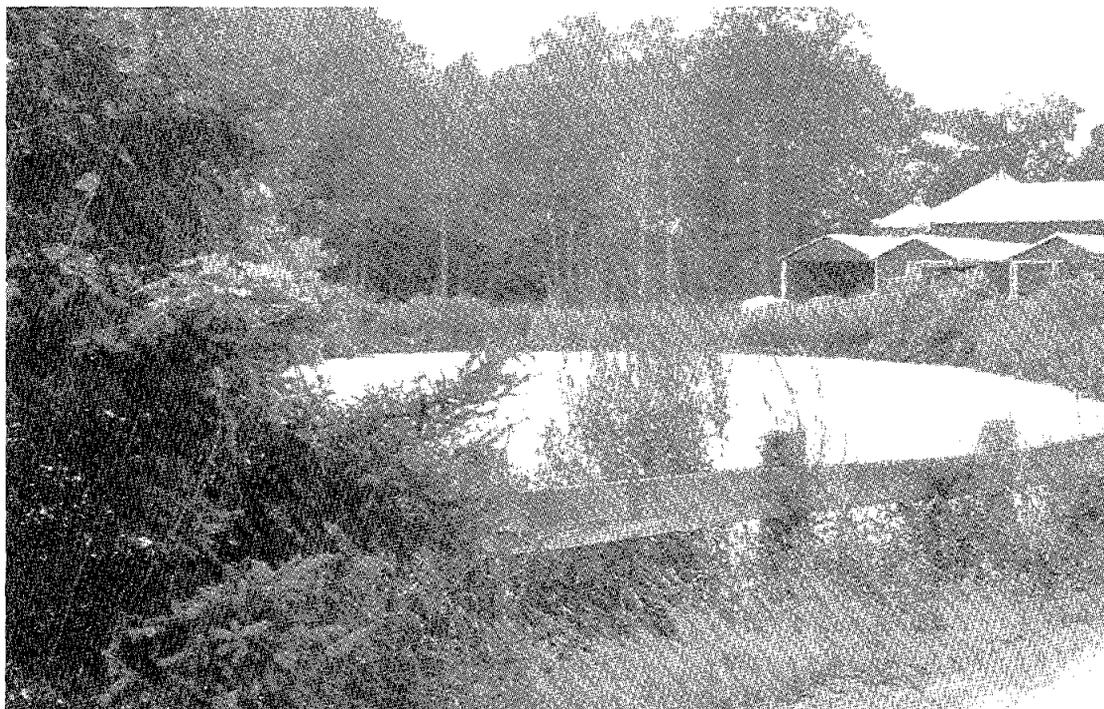
Figure 5.37: Upper fish pond, 1993 (Photo # CLR-3004. Uschold, SUNY CESF).

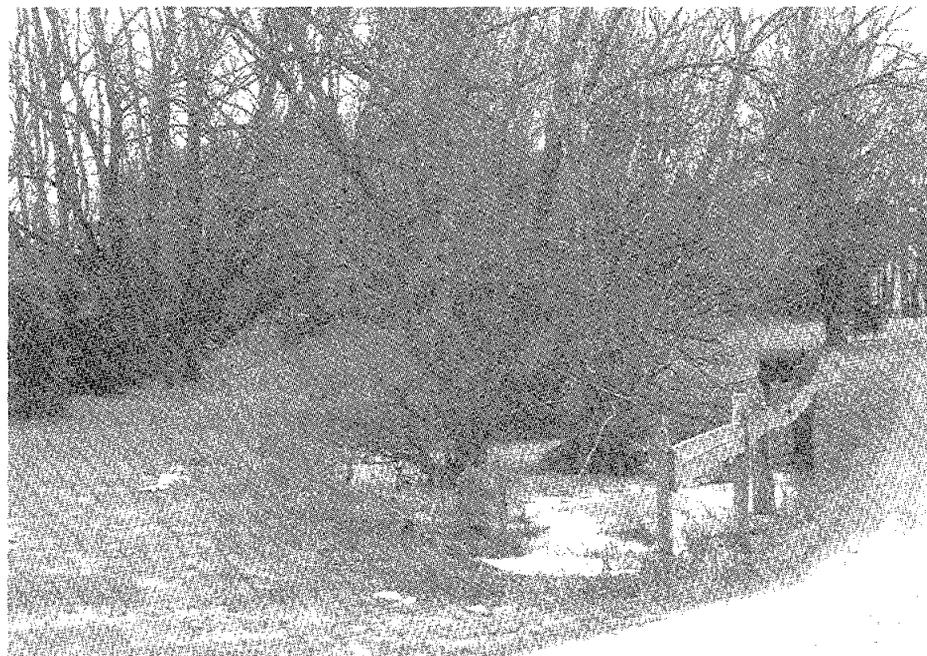
Figure 5.38: Small pond adjacent to farm road, 1993 (Photo # CLR-1319. Uschold, SUNY CESF).

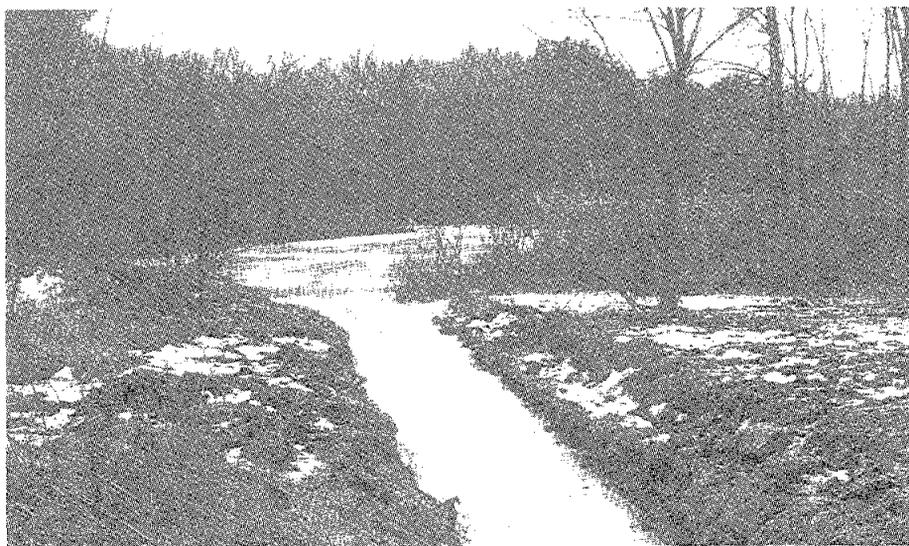
Figure 5.39: Existing pond at base of slope, 1993 (Photo # CLR-1107. Uschold, SUNY CESF).

Meyer also altered the existing pond on the second terrace at the bottom of the transition slope and constructed four additional ponds on the farm. The pond at the bottom of the slope was redefined and is now also used for irrigation on the farm. Meyer constructed two additional ponds at the southwest end of this existing pond. These three ponds directly abut the bottom of the slope (fig. 5.39–5.41). Two smaller ponds were constructed within the slope between the first and second terraces. A southern one located behind the farm complex and northern adjacent to the farm road leading to the second terrace (fig. 5.42 and 5.43).¹⁴³

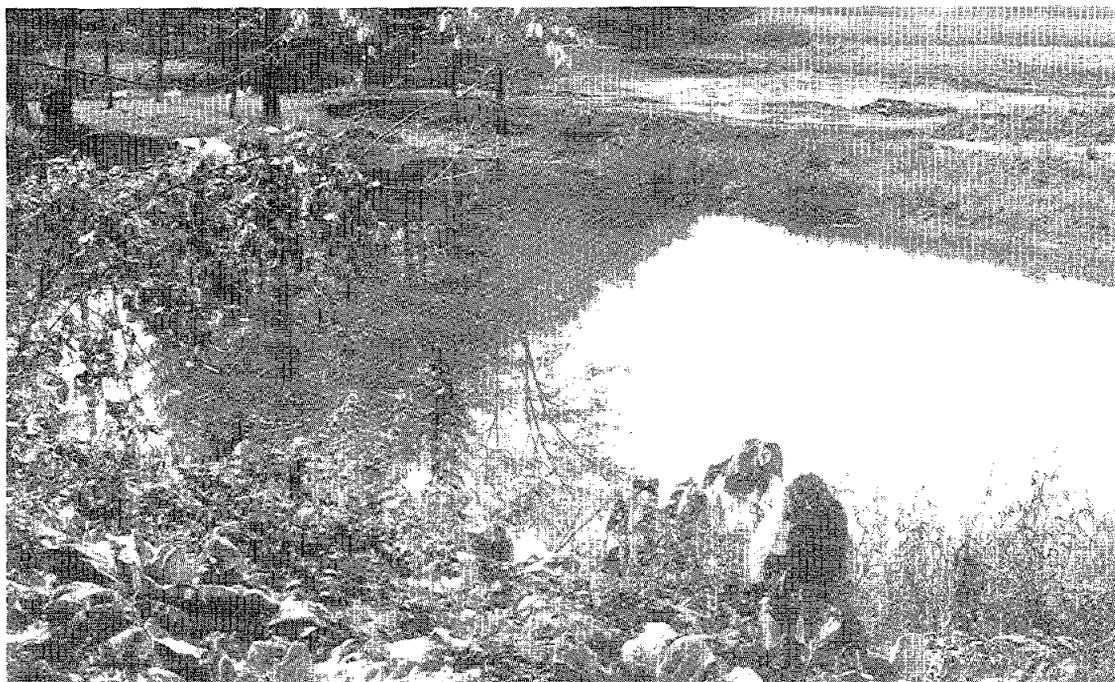
Figure 5.40: Northern Meyer pond at base of slope, 1993 (Photo # CLR-1672. J. Harris, NPS).

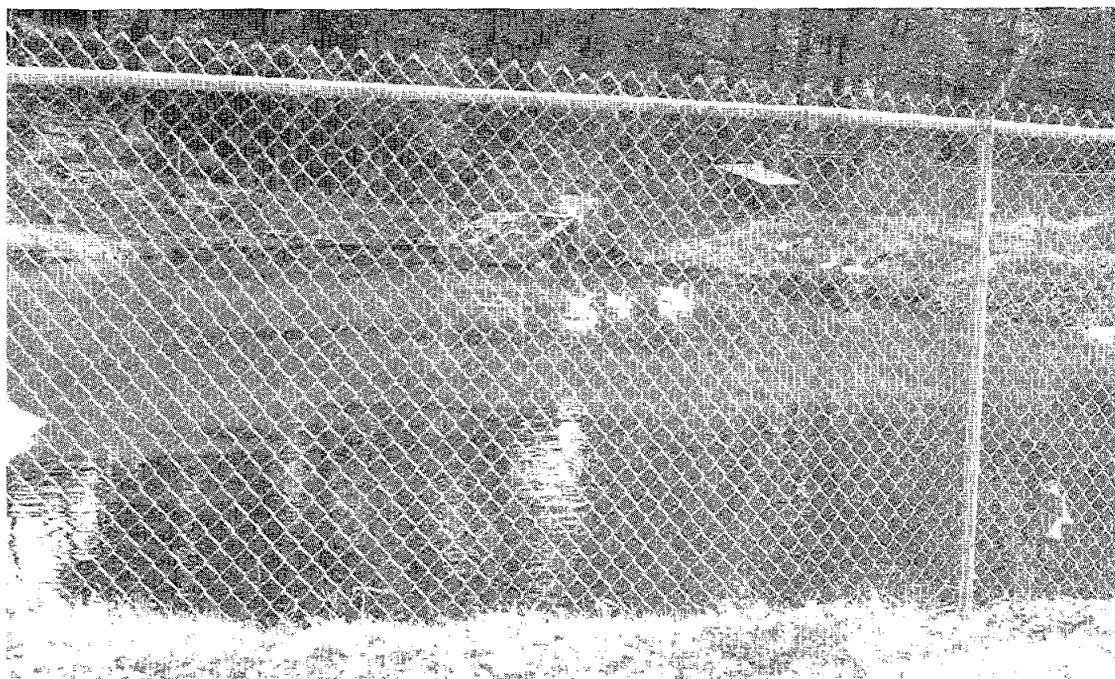
Figure 5.41: Southern Meyer pond at base of slope, 1993 (Photo # CLR-1671. J. Harris, NPS).

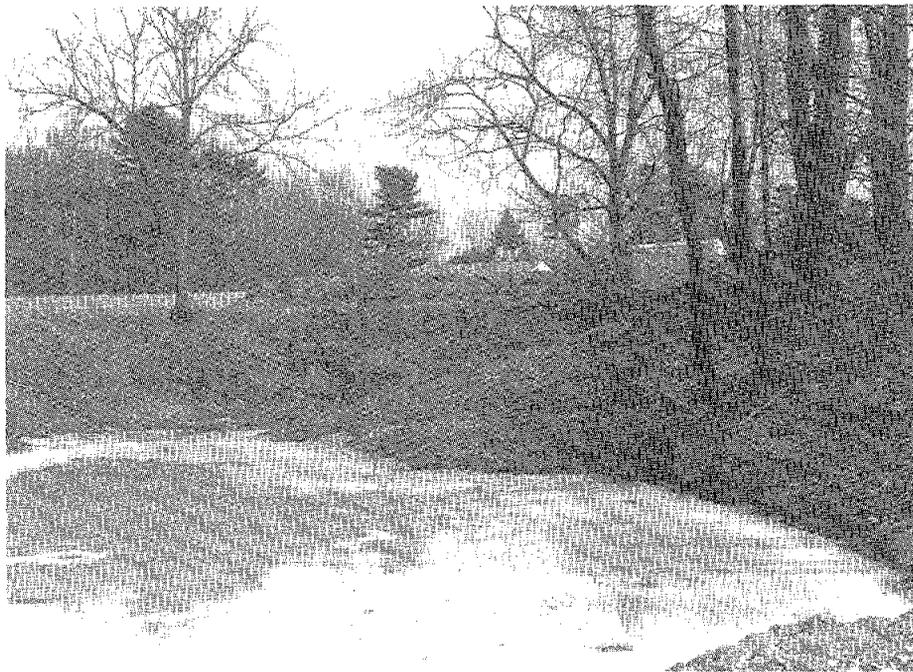
Figure 5.42: Northern Meyer pond within slope, 1993 (Photo # CLR-1110. Uschold, SUNY CESF).

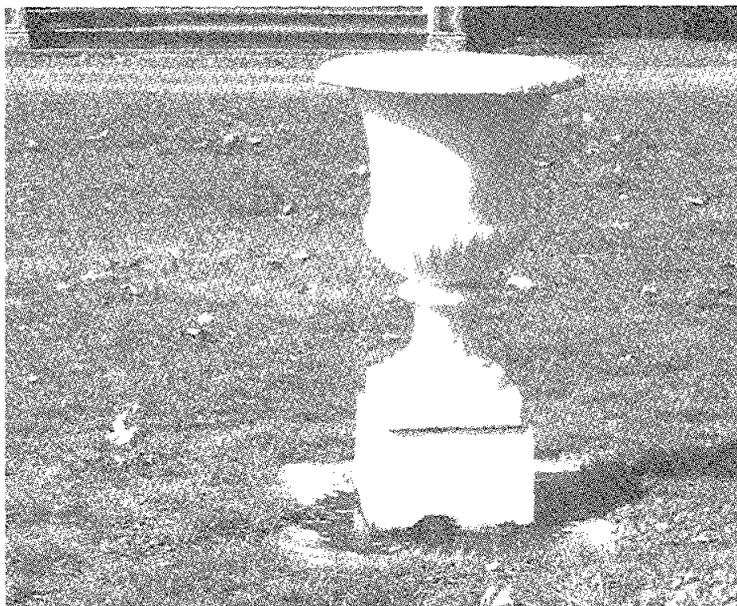
Figure 5.44: Urn in front of main house, 1993 (Photo # CLR-1662. Uschold, SUNY CESF).

While the staff was clearing the site of debris, all of the decorative items added by Campbell were removed, including all fences he constructed on the property. The only furnishing saved was the urn previously in front of the main house (fig 5.44). After the lawn was established, a replica of the urn was placed in the original location in front of the main house. A one-foot square concrete pad was constructed to support the urn. The original urn is kept in storage in the pole barn. A stone marker stands in front of the south gate house, placed there by Campbell as a result of his antique business. The origin of the marker was unknown at the time of the National Park Service grounds clean-up and it was, therefore, left in place (fig. 5.45).

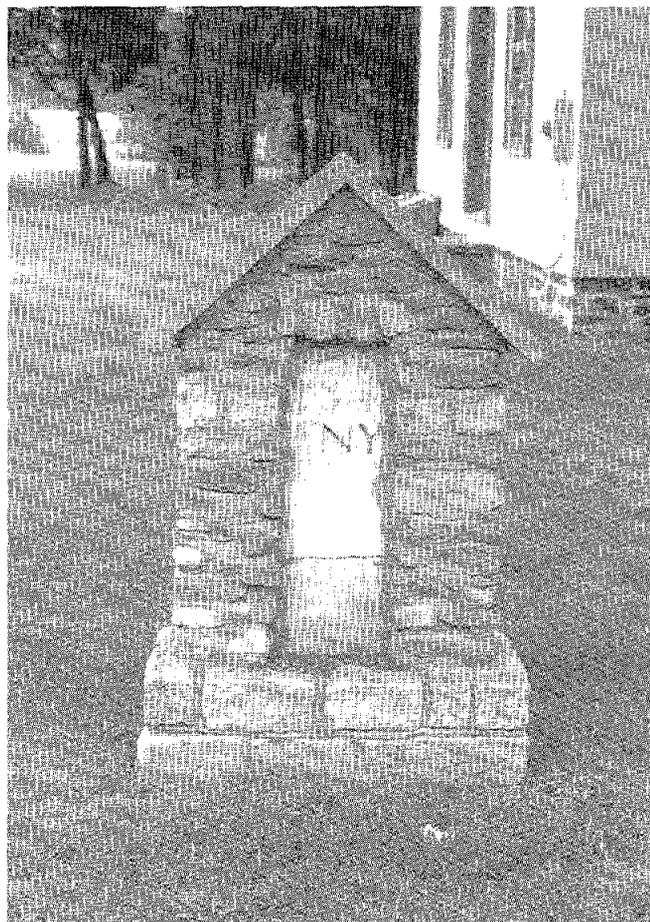
Figure 5.45: Stone marker in front of south gate house, 1993 (Photo # CLR-1601. Uschold, SUNY CESF).

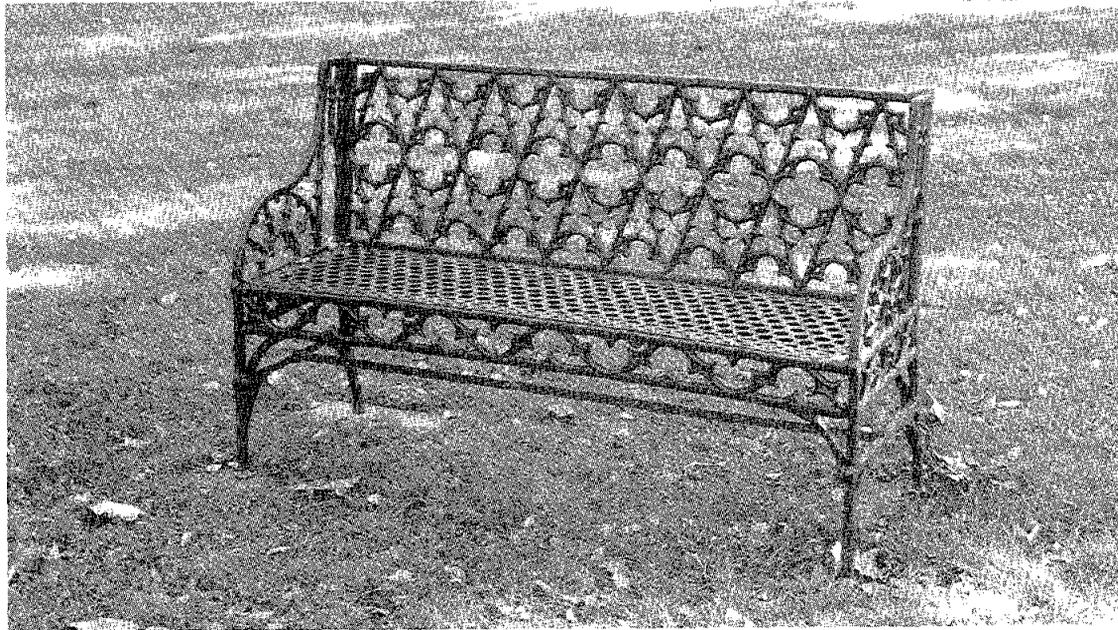
Figure 5.46: Benches on front lawn, 1993 (Photo # CLR-1659. J. Harris, NPS).

Many contemporary items have been added to the Park. Two reproductions of the original front lawn benches have been placed near the entrance to the main house (fig. 5.46). A flagpole and park sign also are on the front lawn, along the Post Road boundary. The flagpole is aluminum and approximately thirty feet tall. The sign is wood, approximately eight feet tall, and states the name of the Park (fig. 5.47). Three aluminum sheds have been placed behind the maintenance garage and mobile homes (fig. 5.48). Four portable toilets for visitor use are located in the north wood lot. They are positioned approximately twenty-five feet into the woods near the north entrance to the main house (fig. 5.49).

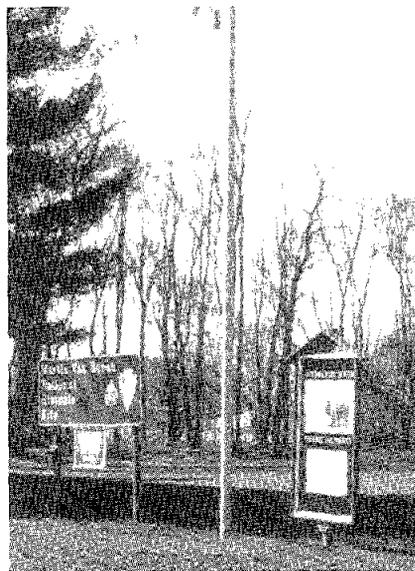
Figure 5.47: Park sign & flagpole in front of park, 1993 (Photo # CLR-3005. Uschold, SUNY CESF).

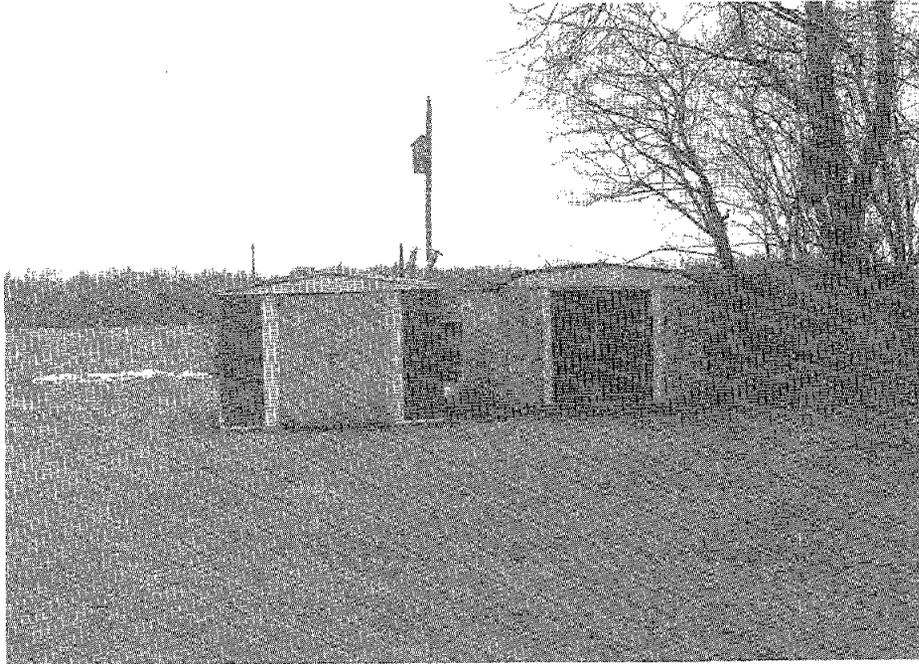
Figure 5.48: Aluminum sheds at rear of park, 1993 (Photo # CLR-1122. Uschold, SUNY CESF).

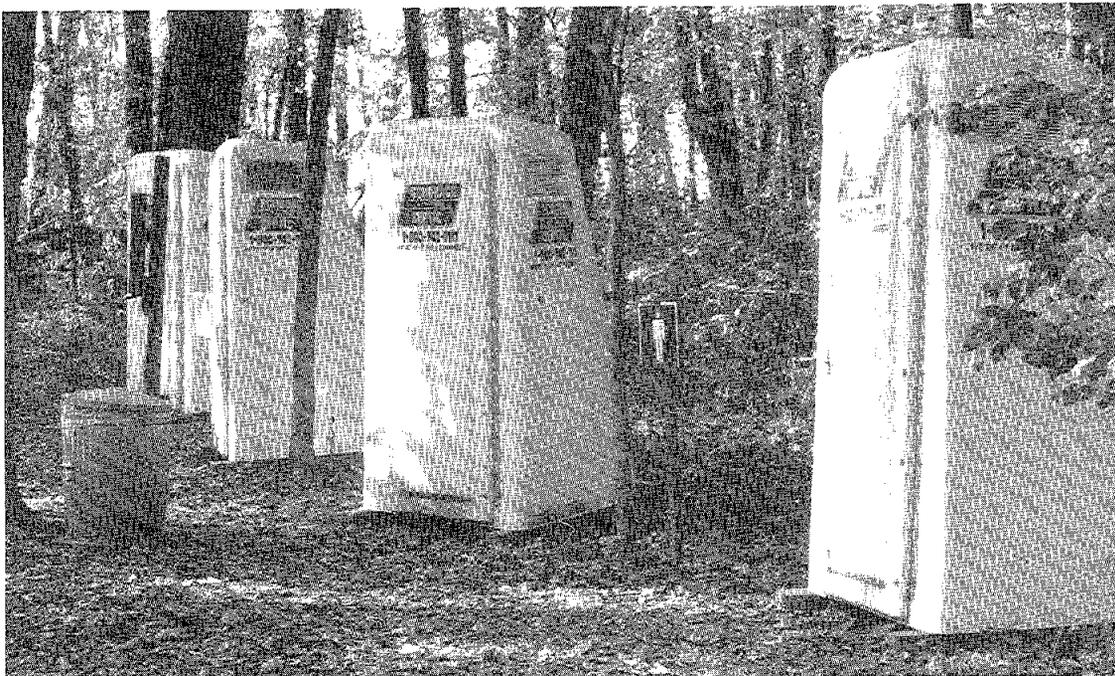
Figure 5.49: Portable toilets for visitor rest rooms, 1993 (Photo # CLR-3006. J. Harris, NPS).

The visitor restroom facilities are inadequate and do not meet the needs of the park. They also greatly contrast with the historic character of the property. However, they have been discreetly located to minimize their affect on the historic character. Combined, their inadequacy and contrasting character make them a priority for treatment.
