CULTURAL LANDSCAPE REPORT

MARTIN VAN BUREN

NATIONAL HISTORIC SITE

Site History, Existing Conditions, and Analysis

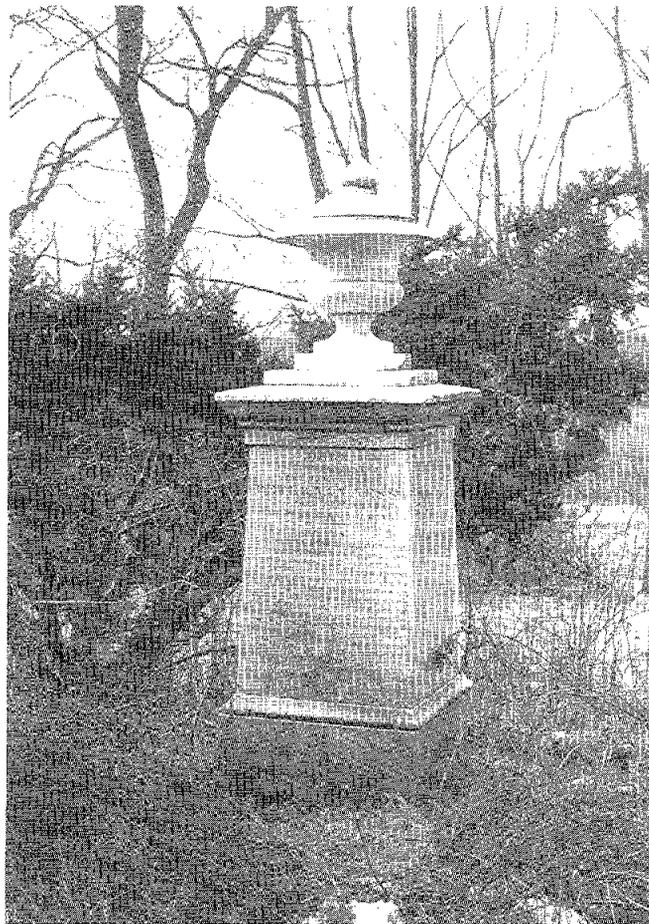
Figure 5.50: Headstone for Peter Van Ness grave behind main house, on Meyer property, 1993 (Photo # CLR-1102. Uschold, SUNY CESF).

Located on the Meyer property is the headstone and grave of Peter Van Ness and his wife. The grave is no longer surrounded by a fence and the surrounding agriculture fields are now encroaching within five feet of it (fig. 5.50).

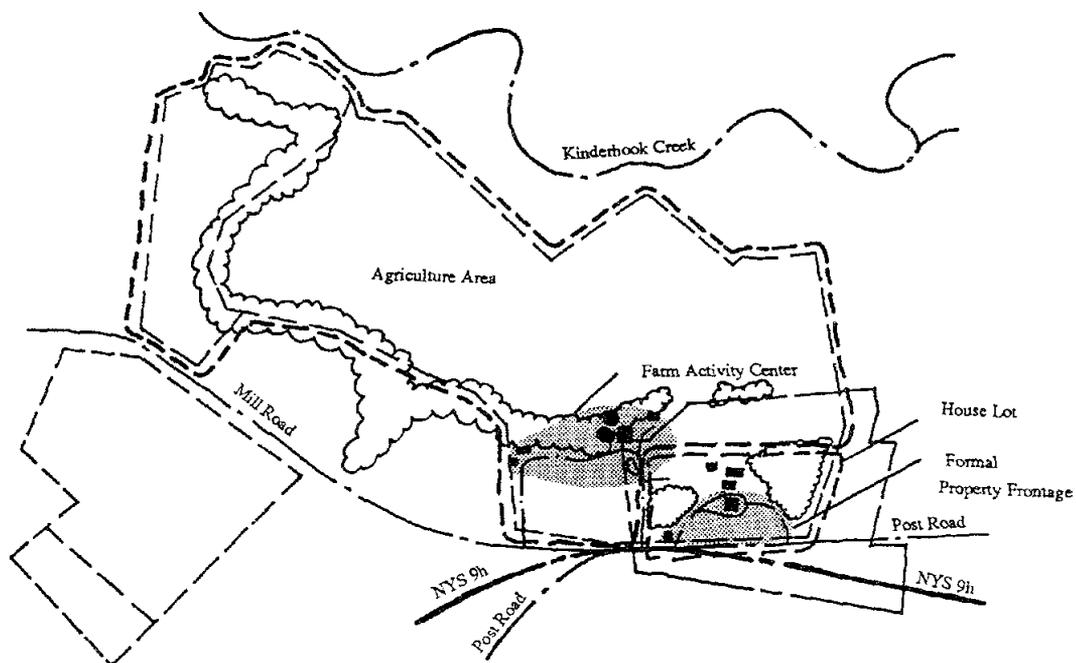
Figure 6.2: Spatial Organization of Lindenwald Farm, 1993 (Uschold, 1993. SUNY CESF).

While many of the elements that created the formal character of the front of the property have been lost, much of the character has been retained. The north and south wood lots have maintained the sense of enclosure, although more dense, once defined by the locust allee. The symmetry created by the combination of the gate houses, entry drive, locust allee, and front pine row is not as strong but is still evident. The lawn has a more manicured character today, but the form remains.

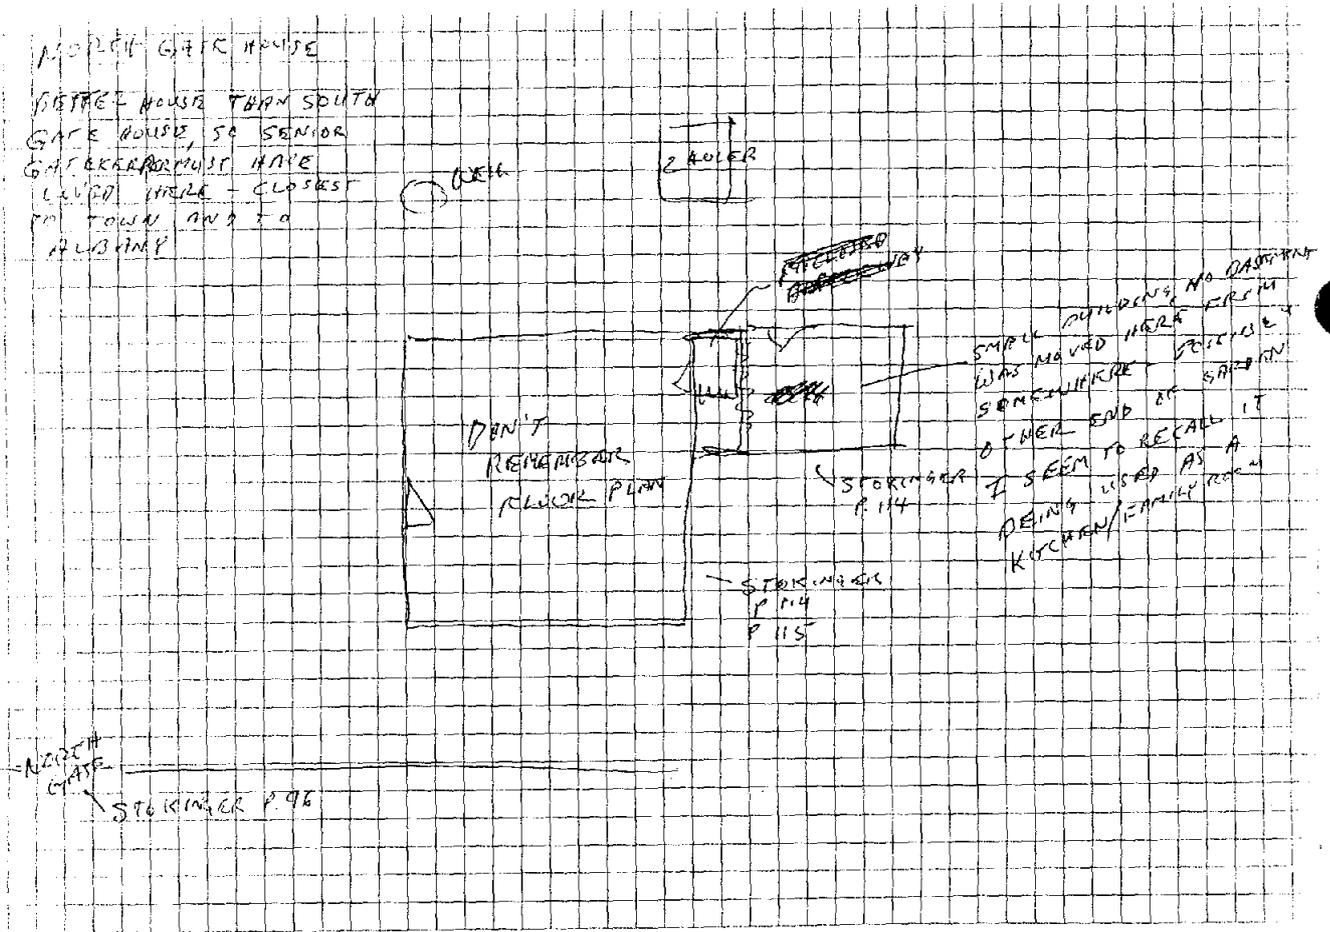
Figure F4: North gate house floor plan (William deProsse Jr., 1993).

Existing: The stone foundation to the north gate house exists. The basement portion has been back-filled while a one-foot section remains above grade. An extensive growth of volunteer Black Cherry trees is growing in and around the foundation.

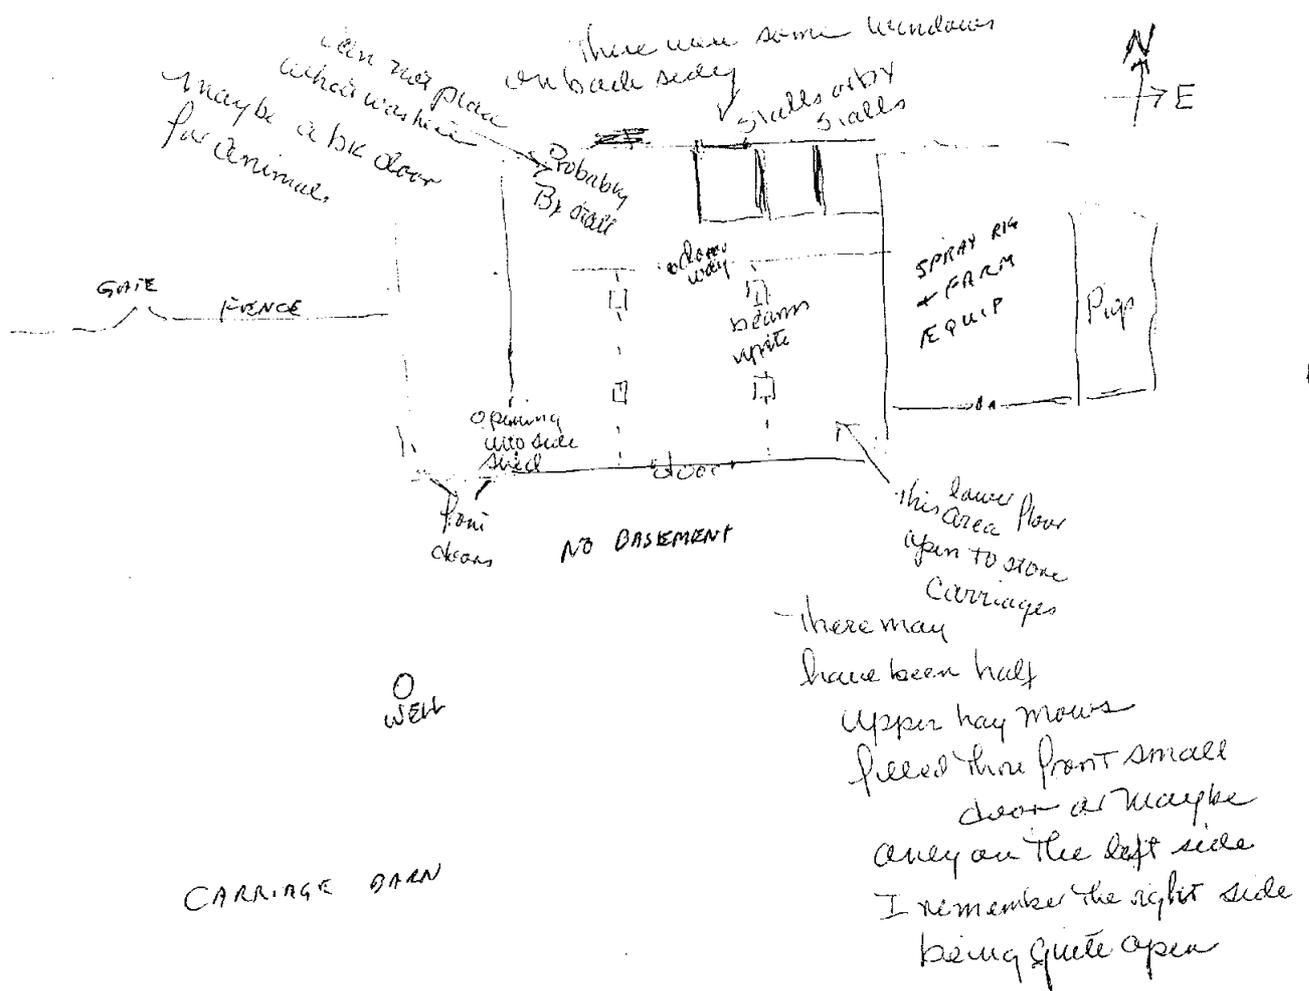
Figure F6: Carriage barn floor plan (William deProse Jr., 1993).

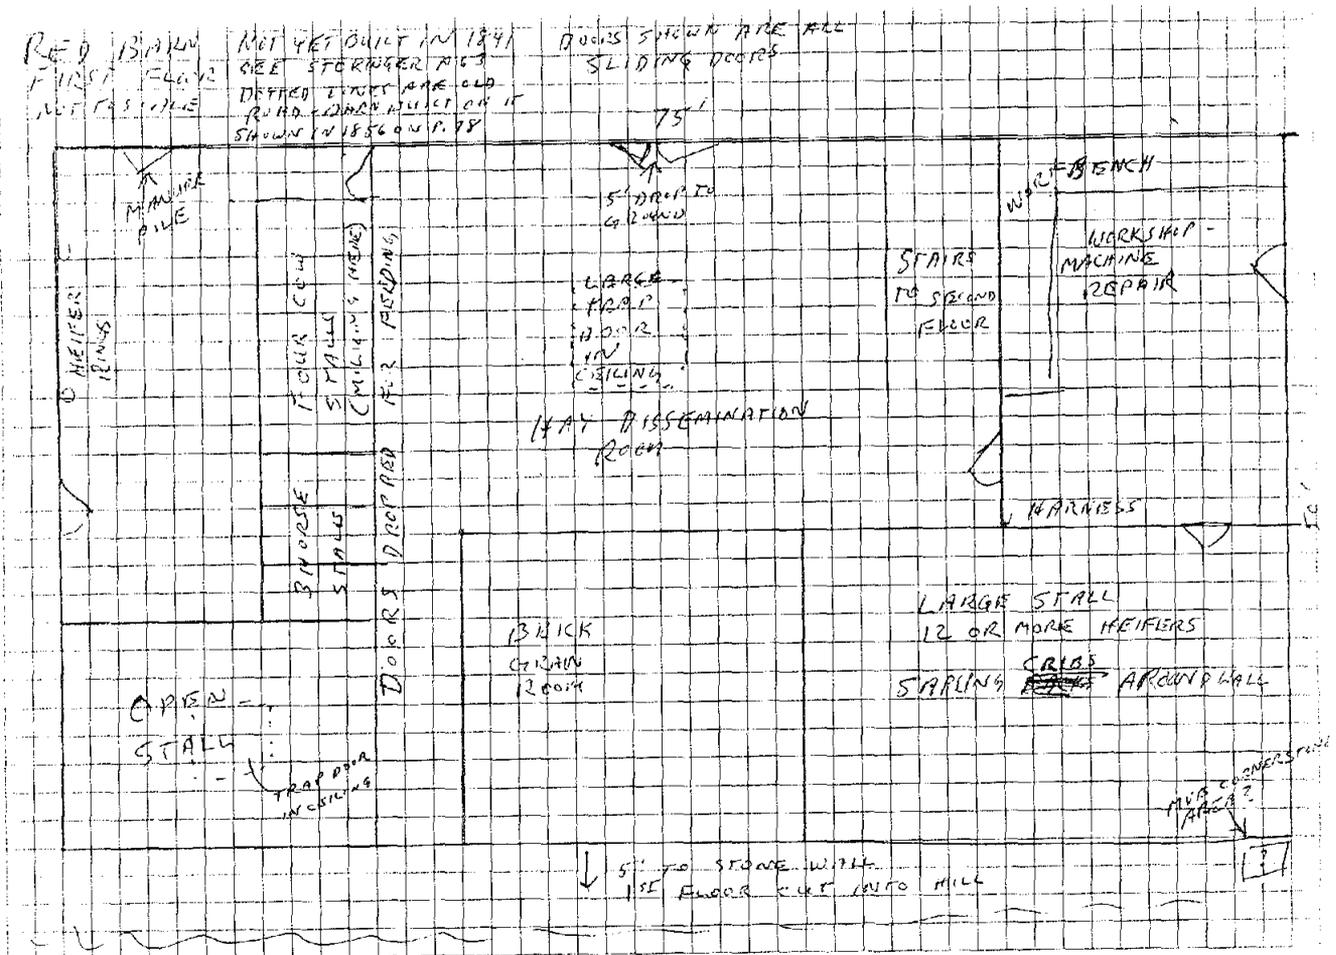
Figure F7: Red hillside barn floor plan, upper level (William deProse Jr., 1993).

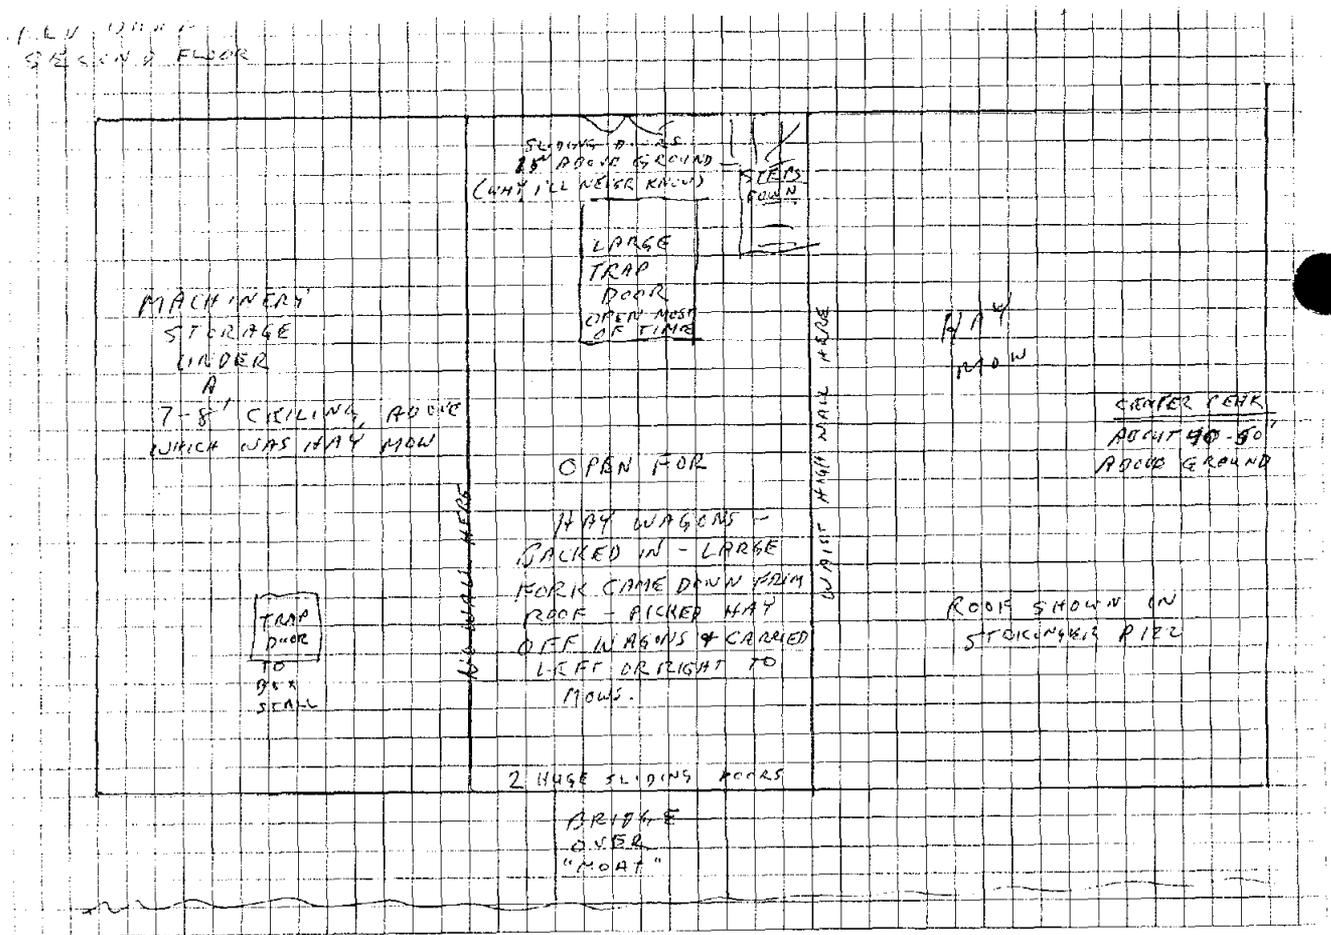
Figure F8: Red hillside barn floor plan, lower level (William deProse Jr., 1993).

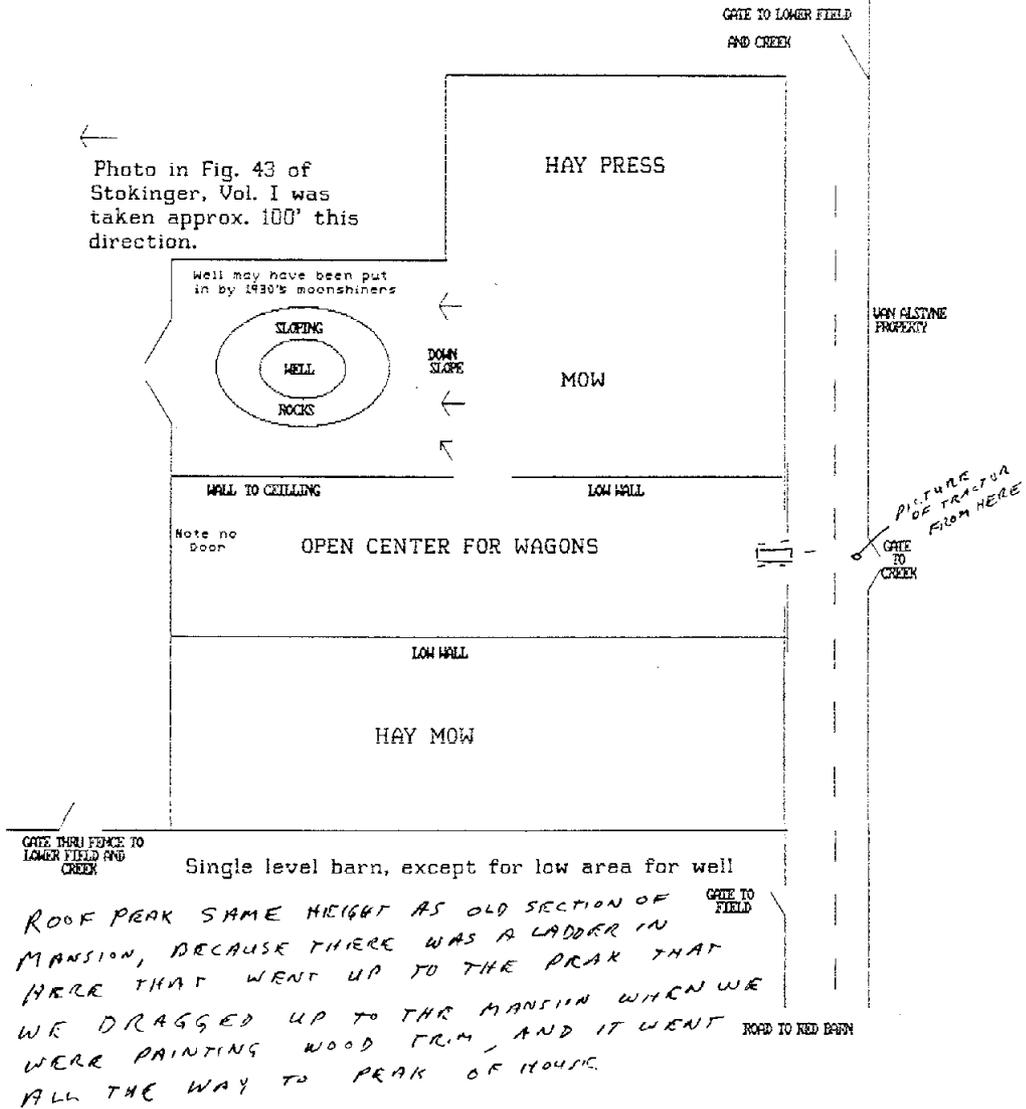
LOWER HAY BARN "BLACK BARN"

Figure F10: Black hay barn floor plan (William deProsse Jr., 1993).
