Beached Shipwreck Archeology: Case Studies from Channel Islands National Park

Submerged Resources Center
Professional Reports
Number 18

Submerged Resources Center
Intermountain Region
National Park Service

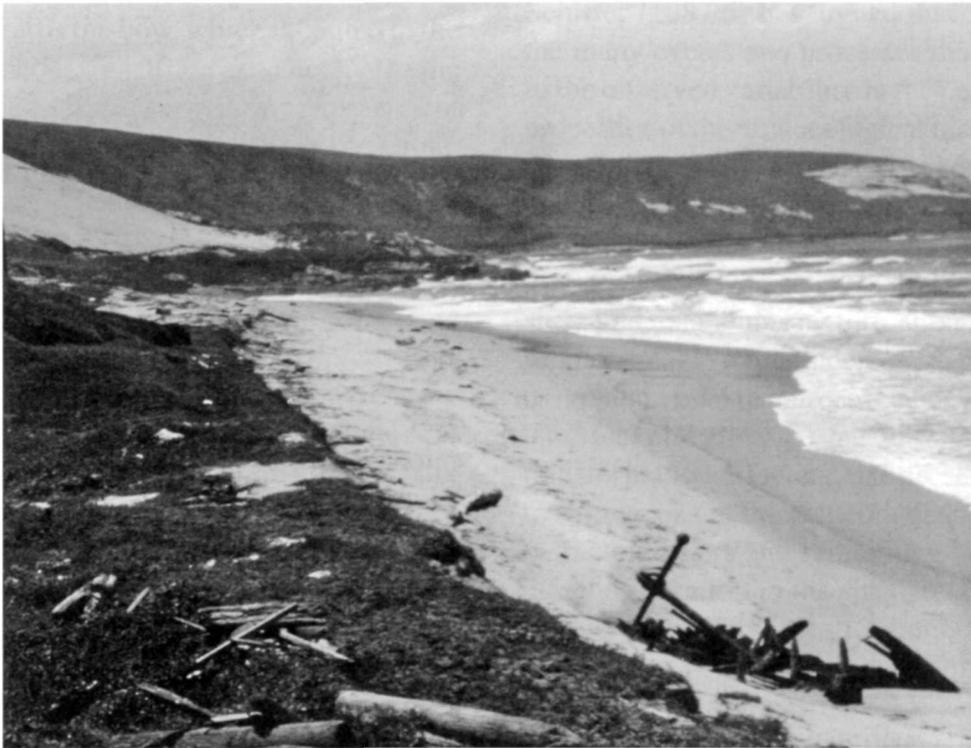
Figure 1.2. *Comet* site exposed in Simonton Cove in 1984. NPS photo by Reed McClusky.

National Park Service (NPS) personnel have known about the *Comet* site, located in Simonton Cove, San Miguel Island, since at least 1977 when the first documented site exposure occurred. The next recorded exposure was in 1984, when an NPS ranger took several photographs of *Comet's* exposed remains (Figures 1.2, 1.3 and 1.4). Although an anchor and capstan are clearly visible in the photographs, insufficient hull structure was exposed then to allow identification of specific features. Between 1984 and 1999, the site

Although investigators presumed the exposed remains were from *Comet's* bow (based on the anchor and capstan in the 1984 photographs), they were unprepared for just how intact and well preserved the site is. The hull remains observed include *Comet's* nearly

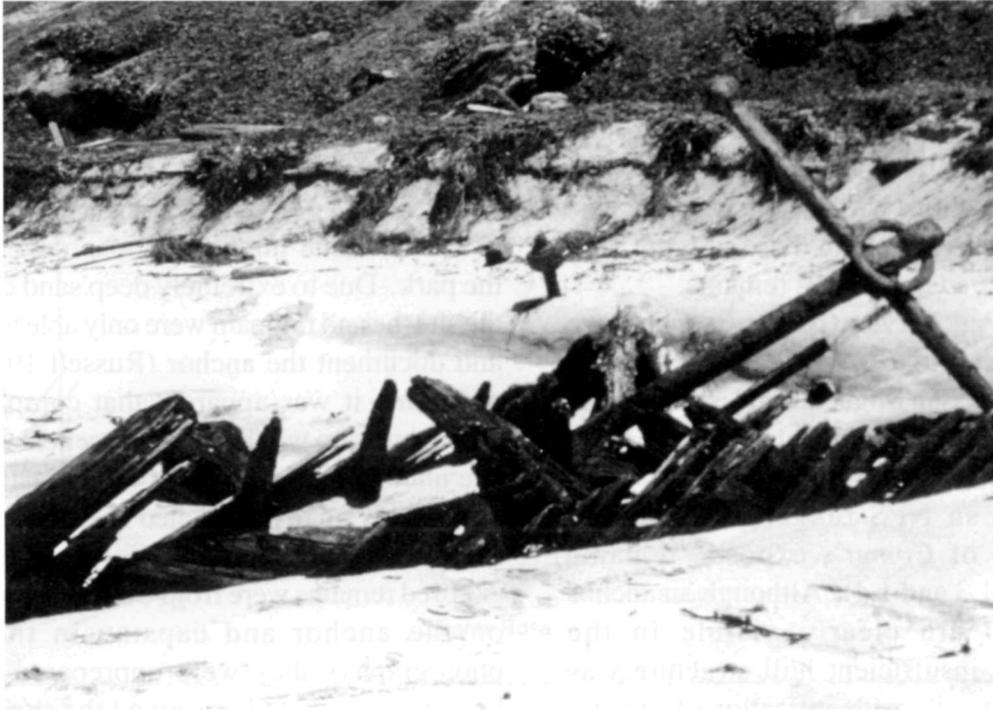
Figure 1.3. *Comet's* timbers and anchor exposed in 1984. NPS photo by Reed McClusky.

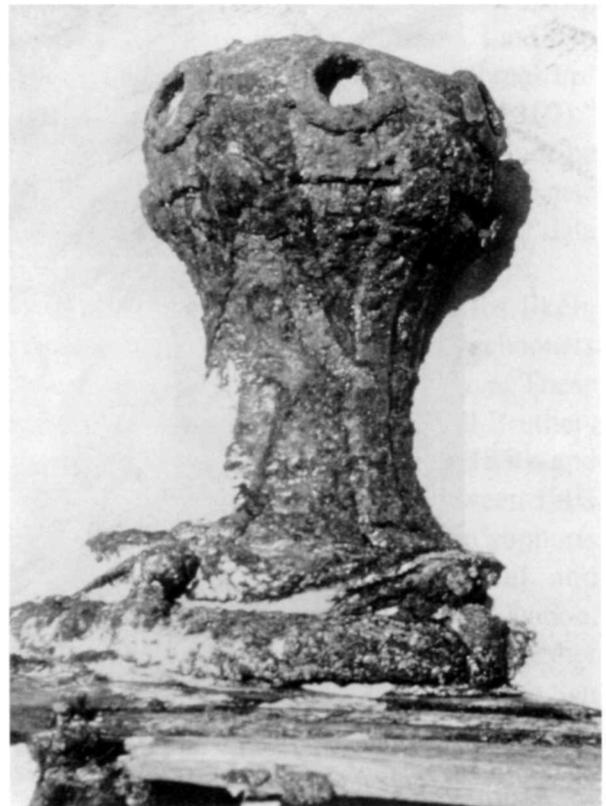
Figure 1.4. *Comet's* capstan in 1984. NPS photo by Reed McClusky.

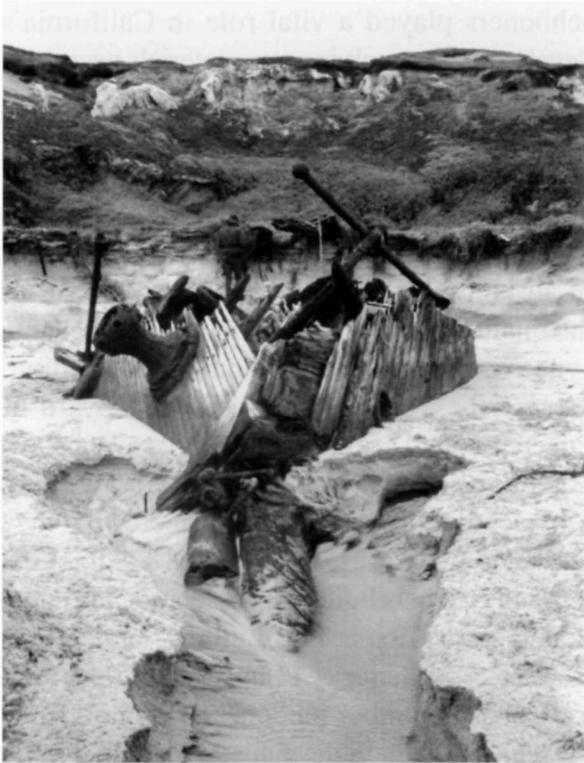
Figure 1.5. *Comet* site in April 1999, looking straight towards the bow, which is canted to the left in this photo. The forecastle deck is to the left, port side outer hull planking to the right and the bowsprit is in the bottom of the photo. NPS photo by Matt Russell.

intact bow from the break of the forecastle deck forward (Figure 1.5). The bow section is heeled to starboard; consequently, much of the port side has been exposed and is now deteriorated. But the starboard side, including the starboard half of the forecastle and main decks, is largely intact with machinery still mounted in its original location. Although only the bow section was observed during this project, this section of *Comet*'s hull is the most intact and well-preserved Pacific Coast lumber schooner documented in the archeological record. Only one other intact section of lumber schooner hull has been recorded on the West Coast, which was a small section of the side of

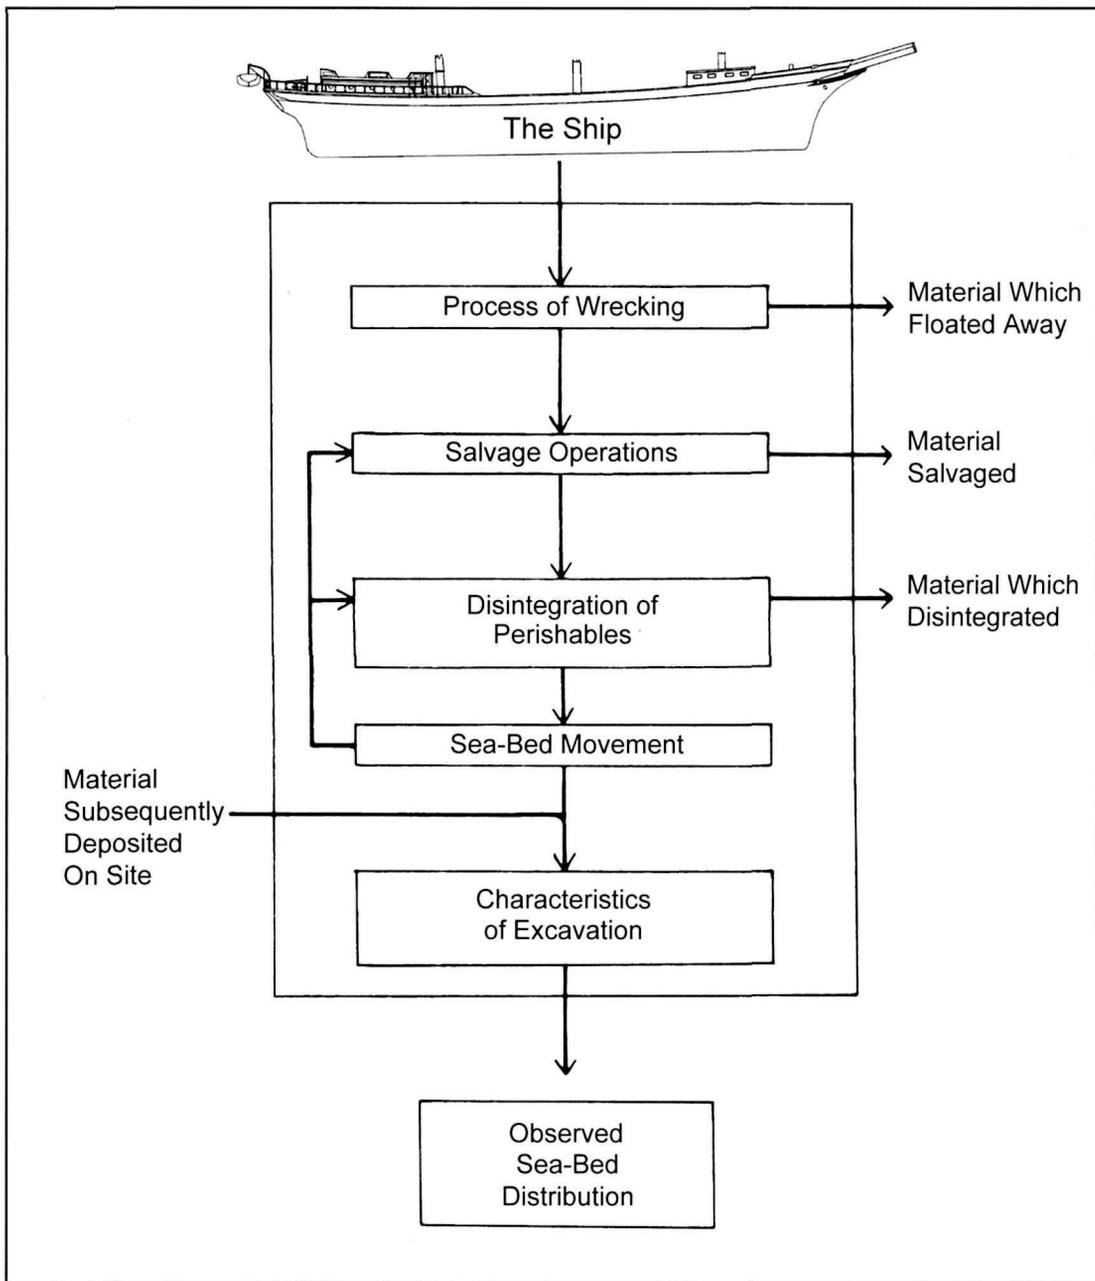
Figure 1.6. Shipwreck site formation processes based on Muckelroy (1978:158).

disintegration of perishables, sea-bed movement, and deposition of intrusive materials (Figure 1.6). A close examination of site formation processes at work on these three shipwrecks has contributed a more complete understanding of the archeological record.

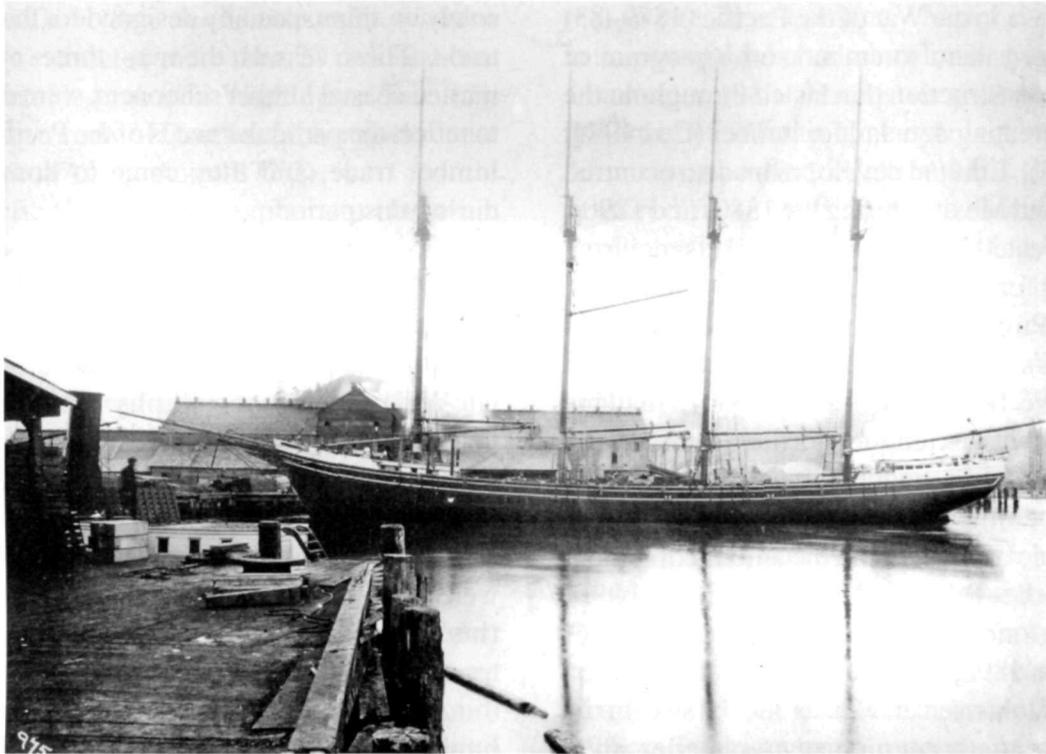
Figure 2.1. Schooner *Watson A. West* at an unknown port. *Watson A. West* was also built by the Hall Brothers. Photo courtesy of San Francisco Maritime NHP.

A distinctive vessel-type emerged for lumber transportation: the Pacific Coast lumber schooner, whose design was influenced by Pacific Coast environmental conditions and the requirement to carry an all-lumber cargo (Figure 2.1). The lumber schooner carried the raw material of California development. It delivered the basic construction material, which laid the foundation for nearly all California's metropolitan centers, making the vessel regionally significant as the primary cargo carrier.

Along with a distinct hull design, West Coast lumber schooners also had a unique schooner rig. Known as "baldheaded" schooners, they often carried only their gaff sails, preferring to run without topsails because "in the long beat to windward of the return trip there were no gafftopsails to shift when tacking" (Weinstein 1978:20). Many lumber schooners were "terns," or vessels with masts of equal height (Bauer 1988:271) (Figure 2.1). Some schooners were

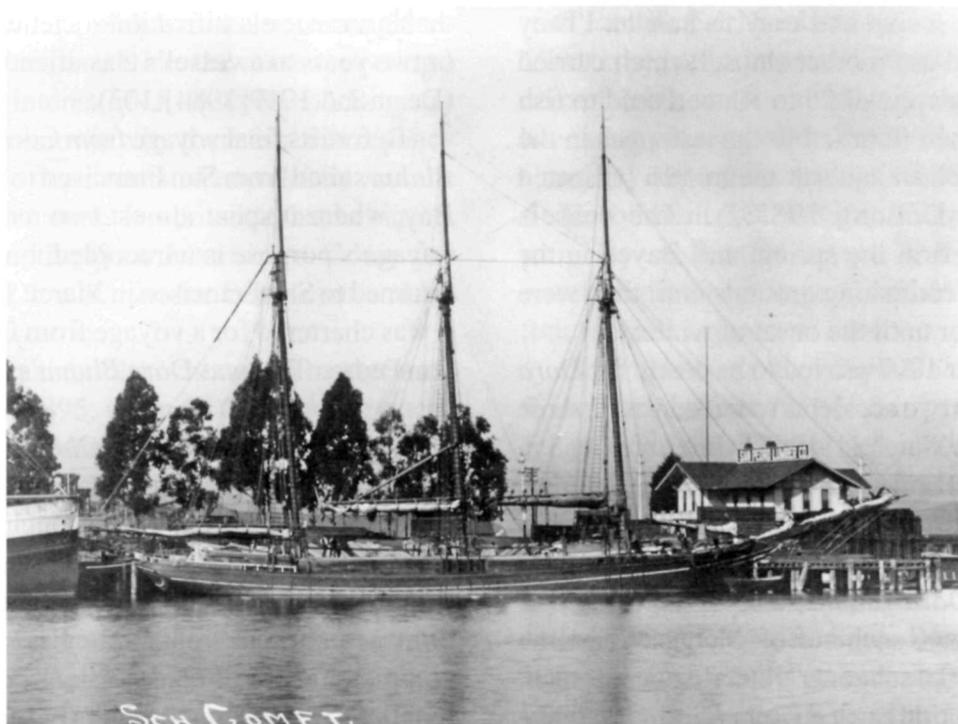
Figure 3.3. Schooner *Comet* docked at San Pedro, California. Photo by William Phelps, courtesy of San Francisco Maritime NHP.

The schooner *Comet* was launched from the Hall Brothers’ Port Blakely yard in October 1886 (Figures 3.3 and 3.4). Once again, the original contract for the vessel survives, giving a complete record of construction. *Comet* had a length of 136.0 ft. on the keel, 144.6 ft. overall, with a breadth of 35.2 ft., a depth of 11.4 ft., and registered 429.74 gross and 408.26 net tons (JPSL:Hall Brothers Shipyard Contract Number 49, 1886; NA 1886:RG 41:Registry 18). Like *Dora Bluhm*, it had one deck, three masts, a billet head and an elliptic stern (NA 1886:RG 41:Registry 18). It was constructed entirely of Douglas fir, again with the exception of the stempost and sternpost, which were “hardwood (JPSL 1886).” *Comet* was entirely iron fastened, with the addition of 1¼-in. locust treenails on the outer hull planking. The vessel was also equipped with a centerboard, and, like *Dora Bluhm*, had bow and stern ports for loading and unloading lumber. During construction, *Comet* was “salted from lower edge of wales to deck.” The rest of the fitting out and furniture was exactly the same as *Dora Bluhm*, down to the 24 in. windlass purchase and Number 3 capstan. For this vessel, the Hooper Brothers of San Francisco and C. F. S. Lass of Oakland agreed to pay \$30,000 in US Gold Coin, over four installments (JPSL 1886).

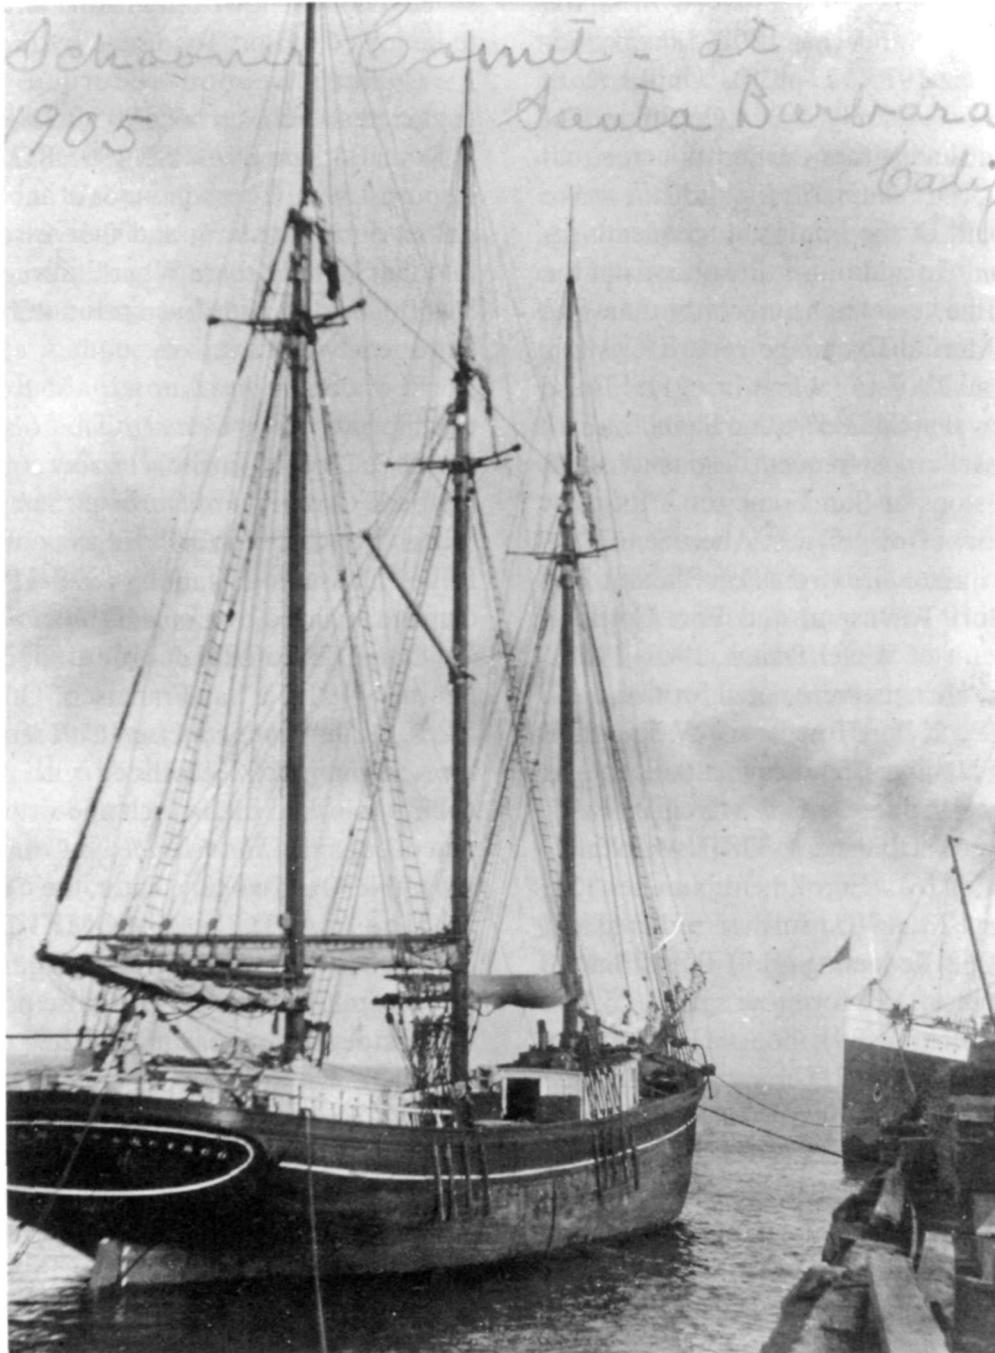
Figure 3.4. *Comet* at Santa Barbara, California, 1904. Photo courtesy of San Francisco Maritime NHP.

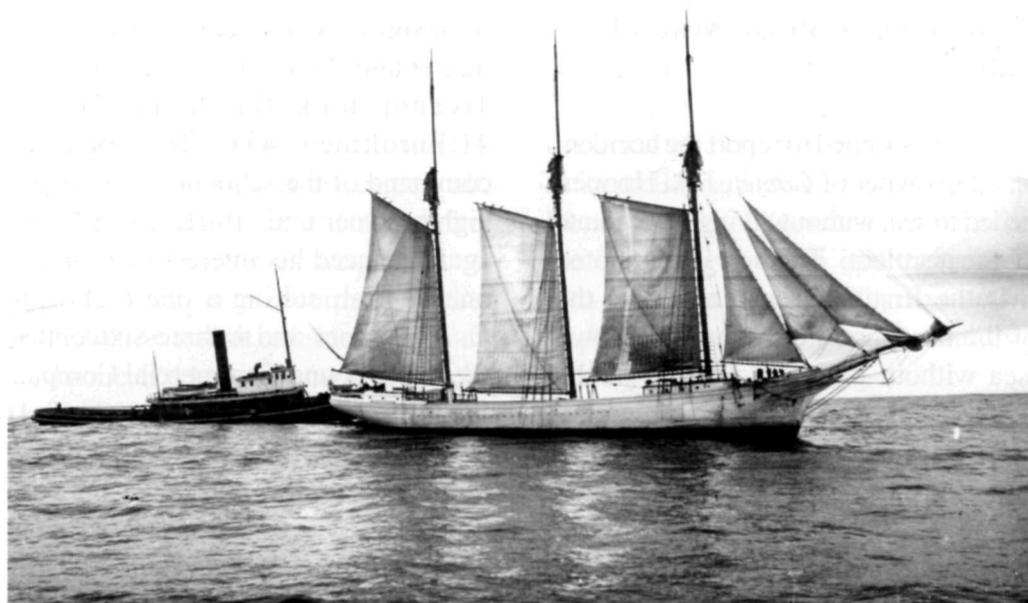
Figure 3.5. The schooner *J. M. Colman* about 1900, photographed off Cape Flattery or in the Straits of Juan de Fuca. *J. M. Colman* was built by the Hall Brothers Shipyard, who also built *Comet*. Photo by Hiram Hudson Morrison, courtesy of San Francisco Maritime NHP.

The Hall Brothers launched the schooner *J. M. Colman* in April 1888 (Figures 3.5 and 3.6). The vessel measured 157.0 ft. long, 37.0 ft. in breadth, 11.3 ft. deep, 471.95 gross tons, and 448.36 net tons. Like the other two schooners, it had one deck, three masts, a billet head and an elliptic stern (NA 1888:RG 41:Enrollment 43). It was built for J. J. McKinnon of San Francisco, who was the sole owner. Unfortunately, *J. M. Colman*'s original contract has not been located, but a hand-written ledger sheet indicates the vessel was originally known as Hull Number 56, and was built for \$33,286.84 (JPSL, Hall Brothers Shipyard Ledger Sheet Number 56, 1888). *J. M. Colman* was one of the largest three-masted schooners built on the coast, registering only 13 gross tons less than the largest, *W. F. Jewett* (Haller and Kelly 1990:22). The first master of *J. M. Colman* was C. H. Atwood (NA 1888:RG 41:Enrollment 43).

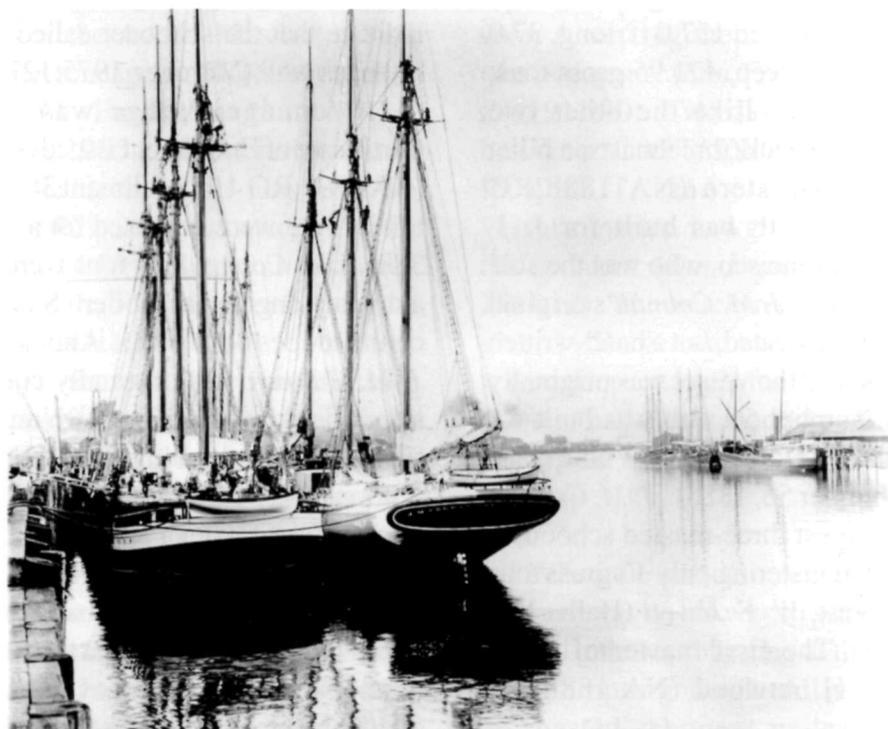
Figure 3.6. *J. M. Colman* in port at San Pedro, California. Photo courtesy of San Francisco Maritime NHP.

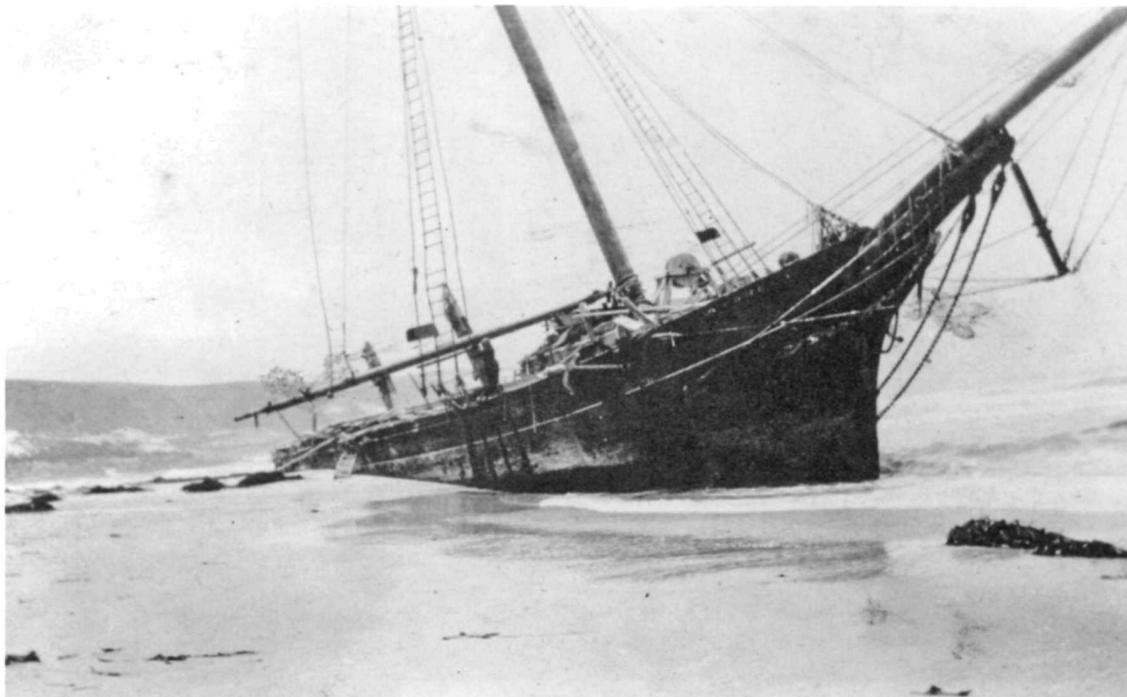
Figure 3.9. *Comet* aground in Simonton Cove, San Miguel Island. Photo courtesy of Santa Barbara Museum of Natural History.

As discussed above, a series of photographs were taken of *Comet* sometime after the wreck and before the vessel broke up. These undated photos, from the Santa Barbara Museum of Natural History's collection, show the schooner lying broadside to the surf with its port side to sea (Figures 3.9–3.11). The vessel is firmly embedded in the sand, probably between the

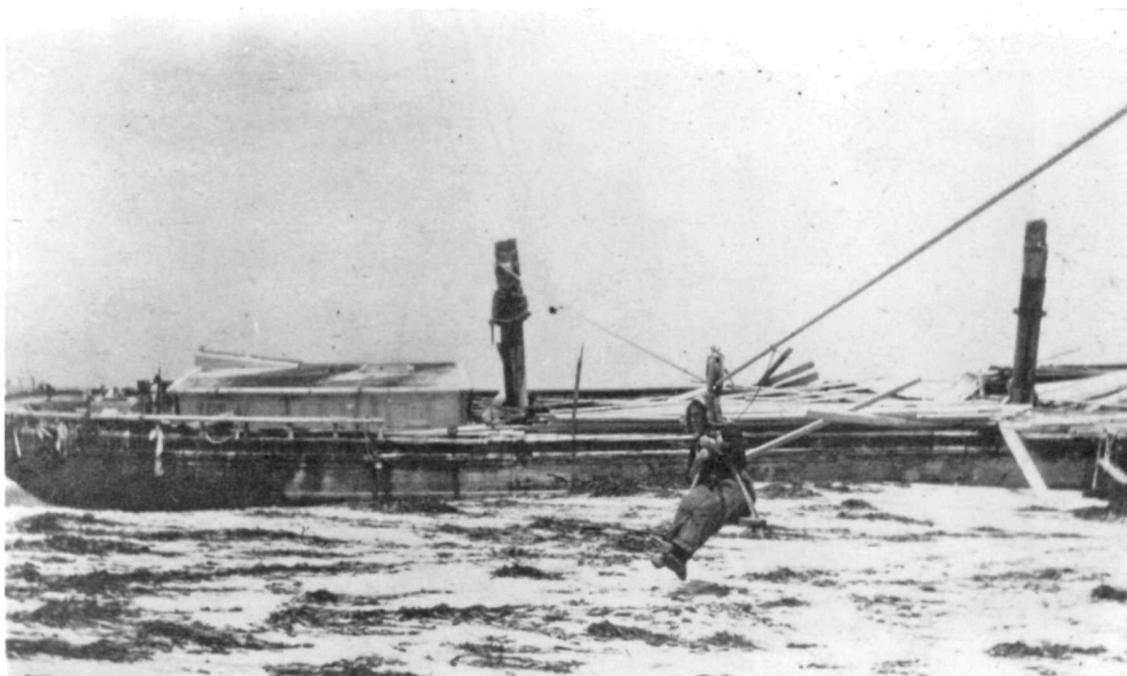
Figure 3.10. *Comet* aground in Simonton Cove, San Miguel Island, with unidentified woman. Photo courtesy of Santa Barbara Museum of Natural History.

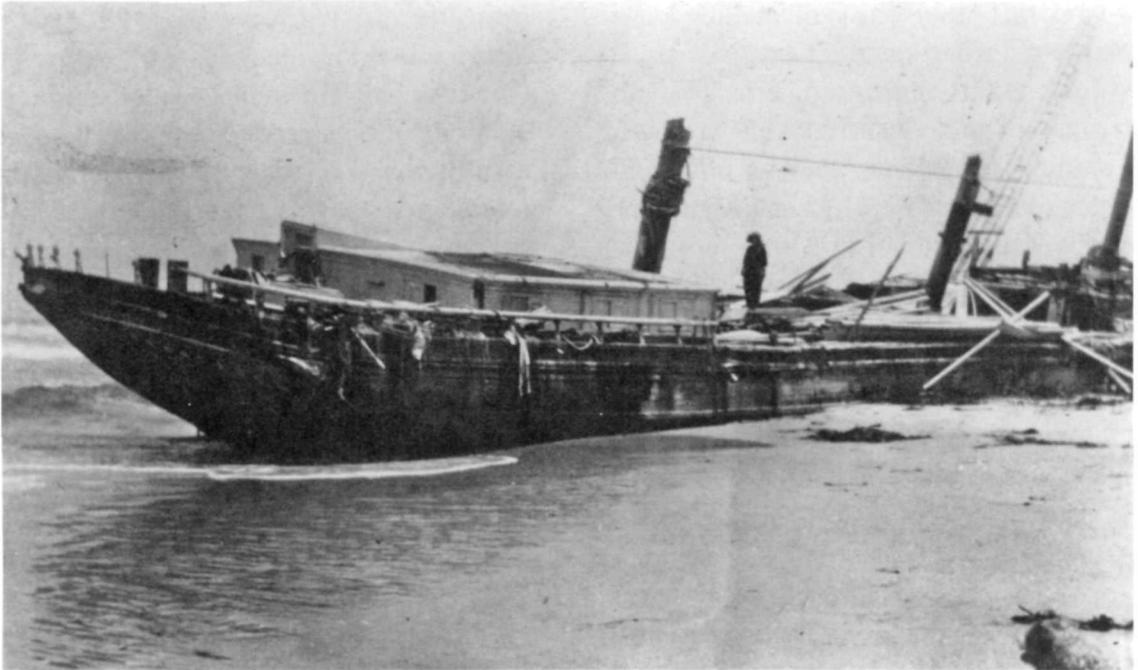
Figure 3.11. *Comet's* stern, aground in Simonton Cove, San Miguel Island. Photo courtesy of Santa Barbara Museum of Natural History.

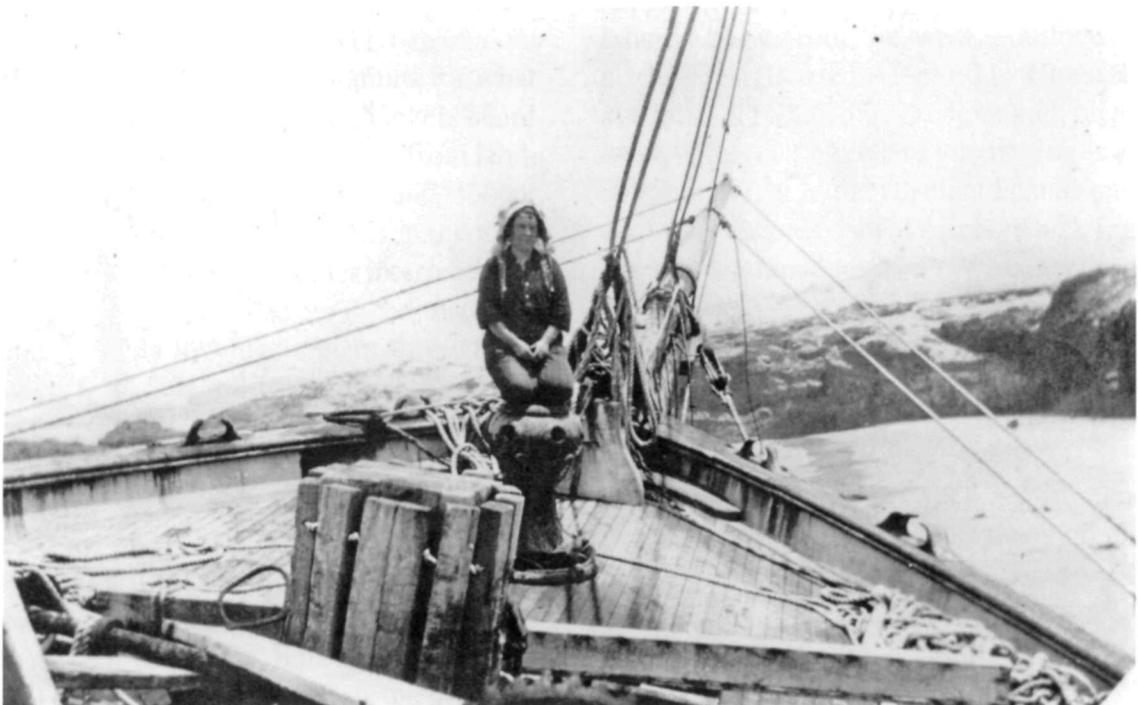
Figure 3.12. Unidentified woman on *Comet's* forecastle deck. Photo courtesy of Santa Barbara Museum of Natural History.

mean high- and low-tide lines. The foremast is still standing, but the main- and mizzenmasts are gone. Two photographs, taken from just forward of the foremast looking forward, show a man and woman standing on *Comet's* bow (Figures 3.12 and 3.13). These photographs are the key evidence in identifying wreckage in Simonton Cove as *Comet*. In the background of the photographs is an easily identifiable rock formation that is east of the wreckage in Simonton Cove today (Figure 3.14). Therefore, with the help of these historical photographs, a positive identification of the *Comet* wreck site can be made.

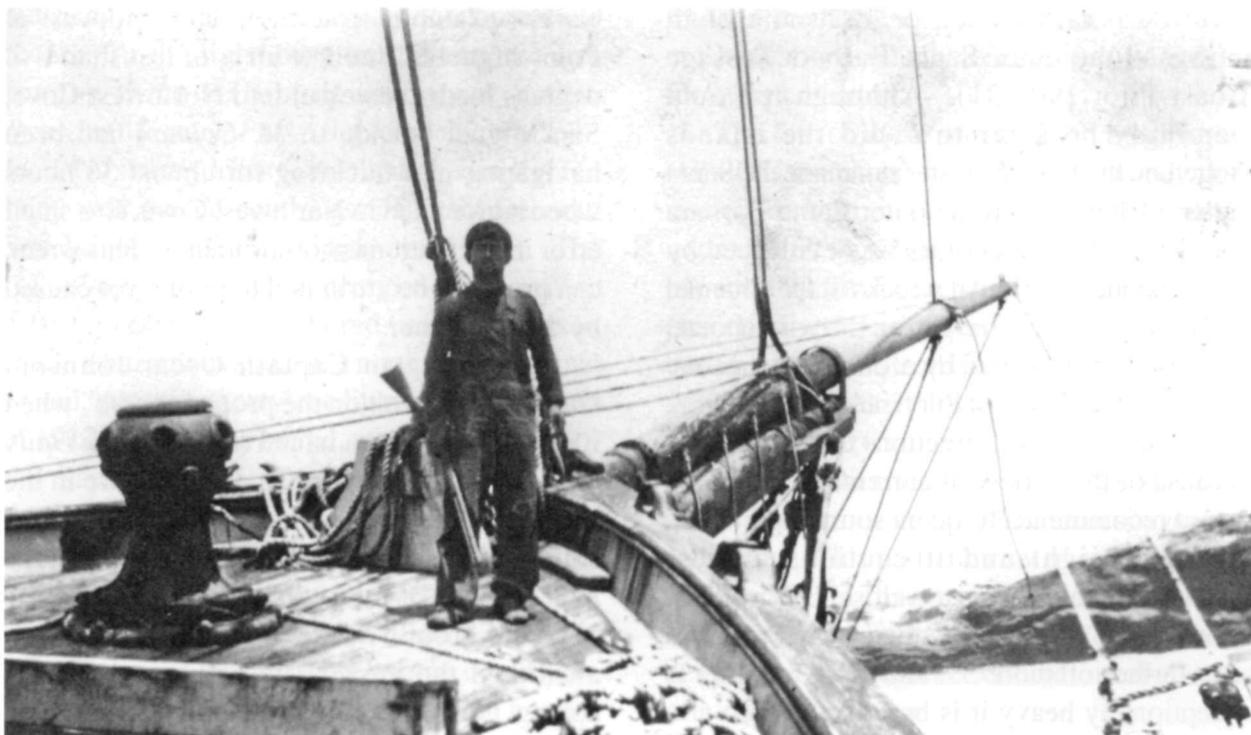
Figure 3.13. Unidentified man on *Comet's* forecandle deck. Note the capstan which is still mounted in the same location today. Also, note the rock ledge in the background which can be compared to Figure 3.14. Photo courtesy of Santa Barbara Museum of Natural History.

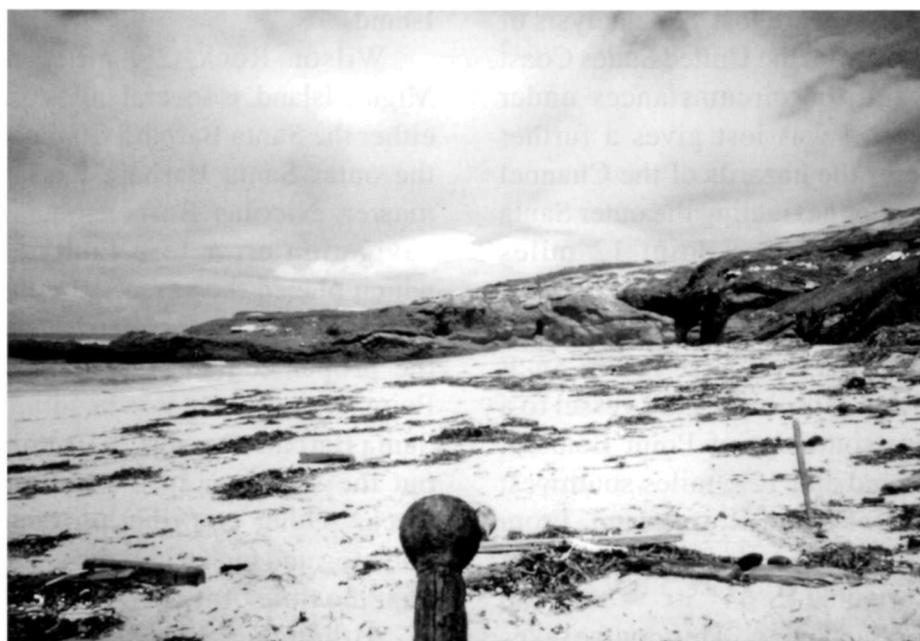
Figure 3.14. Anchor stock sticking out of the sand in Simonton Cove in the 1980s. Compare the rock ledge in the background to Figure 3.13. NPS photo by Don Morris.

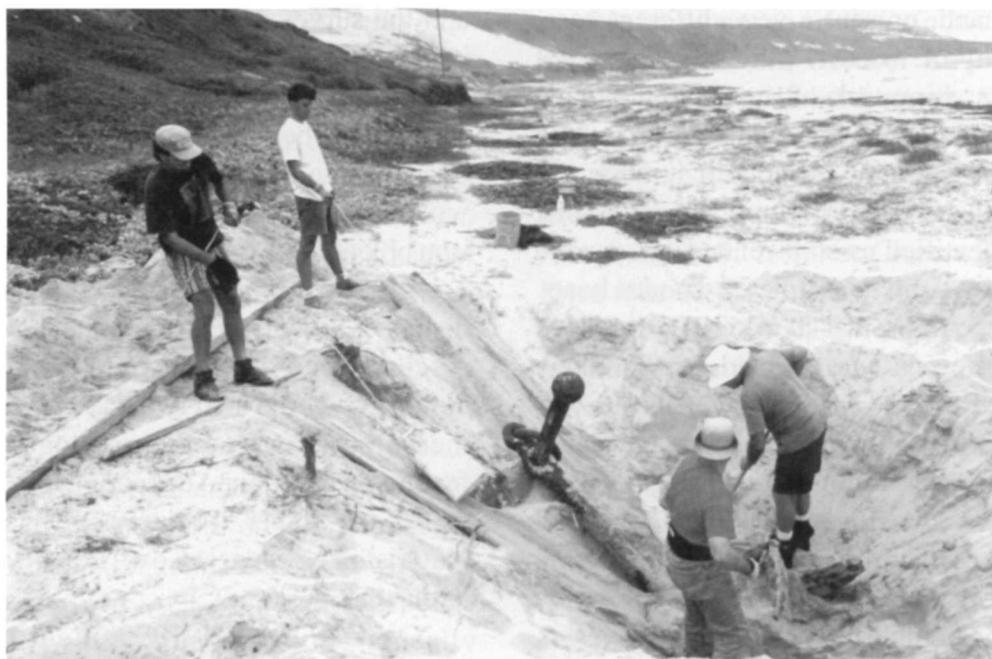
Figure 4.6. Volunteers working to expose *Comet* wreckage in October 1993. Just the tip of the anchor stock was exposed before digging began. NPS photo by Matt Russell.

Four volunteers arrived on October 19, 1993, and work began that afternoon. The tip of the anchor stock was used as a starting point for sand overburden removal. Project personnel and volunteers spent October 20–21, 1993, excavating (Figure 4.6). The anchor was

uncovered, along with a few timber ends, and nothing more. Although the timbers located are certainly from *Comet*, no details could be recorded because the unstable walls of the hole kept collapsing as the timbers were exposed. In total, about 21 cu. yds. of sand were removed from a hole 21 ft. in diameter at the top and 7 ft. deep. The few remains uncovered indicated this site could not be exposed without mechanical excavation and shoring. Barring landing a backhoe, *Comet* would have to wait for detailed recording until naturally uncovered.

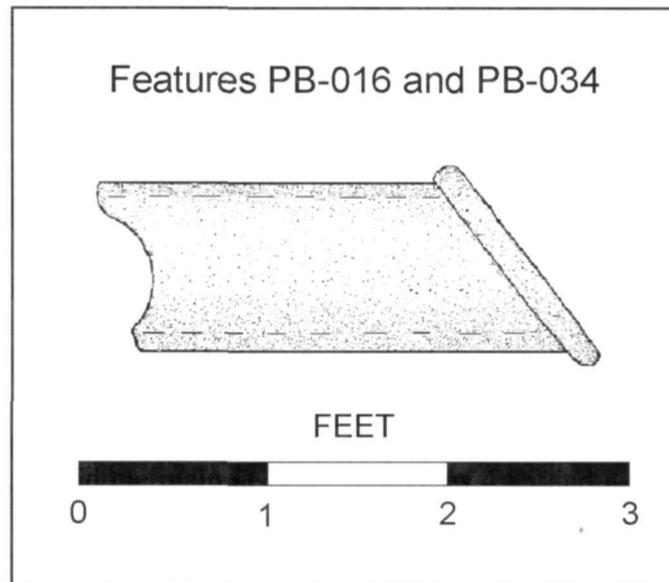
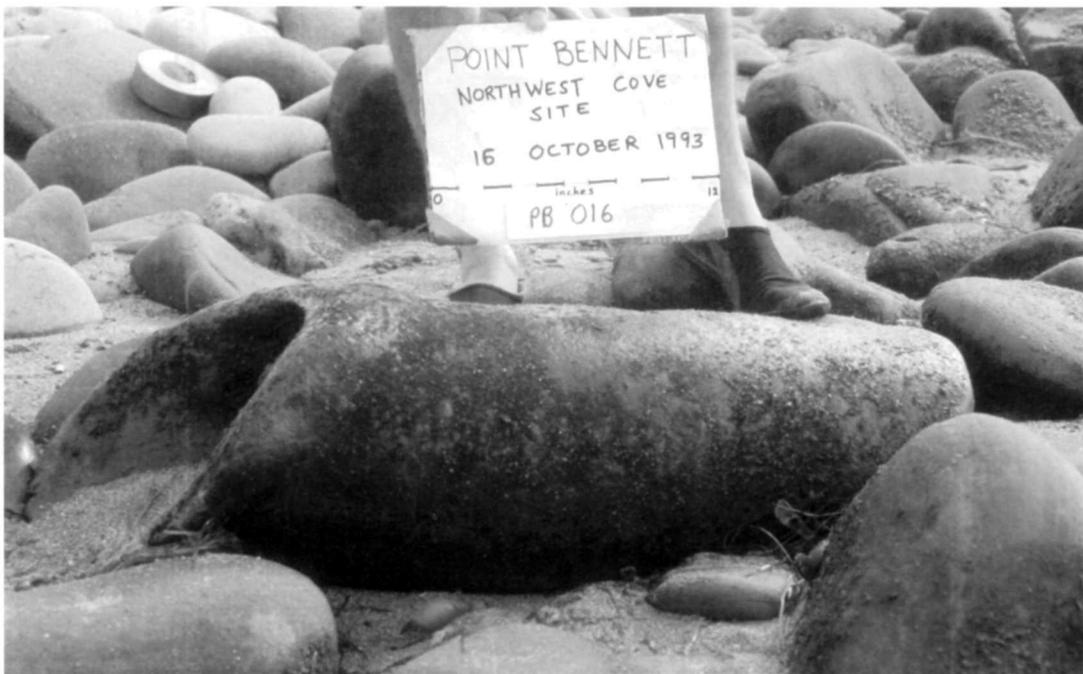
Figure 4.8. Features PB-016 and PB-034 are two identical hawse pipes. Drawing by Matt Russell.

Figure 4.9. Hawse pipe (feature PB-016). NPS photo by Adriane Neidinger.

The most diagnostic objects in the intertidal zone are two hawse pipes, features PB-016 and PB-034, of identical dimensions (Figures 4.8 and 4.9). Hawse pipes were located on each side of a vessel's bow and allowed the chain cable to pass through the hull. Hawse pipes are distinguishable from mooring pipes (which allowed mooring lines to pass through the main deck bulwarks on the main deck) and chain pipes (which allowed the chain cable to pass through the main deck into the chain locker) by their

length and their sloping outer faces, which must conform to a bow's compound curves. PB-034 is located 50 ft. 6 in. northwest of PB-016. The two hawse pipes have the same dimensions, which, combined with proximity, indicate they came from the same vessel. The pipes have an overall length of 2 ft. 11 in., an outside diameter of 11 in. and an inside diameter of 9 in.

tonnage, and showing hawse pipe size based on chain cable size. A wooden sailing vessel of 400 tons was required to carry a chain cable at least $1 \frac{5}{16}$ in. in diameter, which required a hawse pipe between $11\frac{1}{2}$ and $12\frac{1}{2}$ in. in diameter (Desmond 1919[1984]:157, 166). Although Desmond does not specify whether hawse pipe diameter is the inside or outside dimension, it is likely the inside dimension. The size of the hawse pipe does not entirely agree with the published historical data in this case. The reason for this is unknown, although the fact that this may not be *J. M. Colman* is a possibility. The preponderance of other evidence below makes this unlikely.

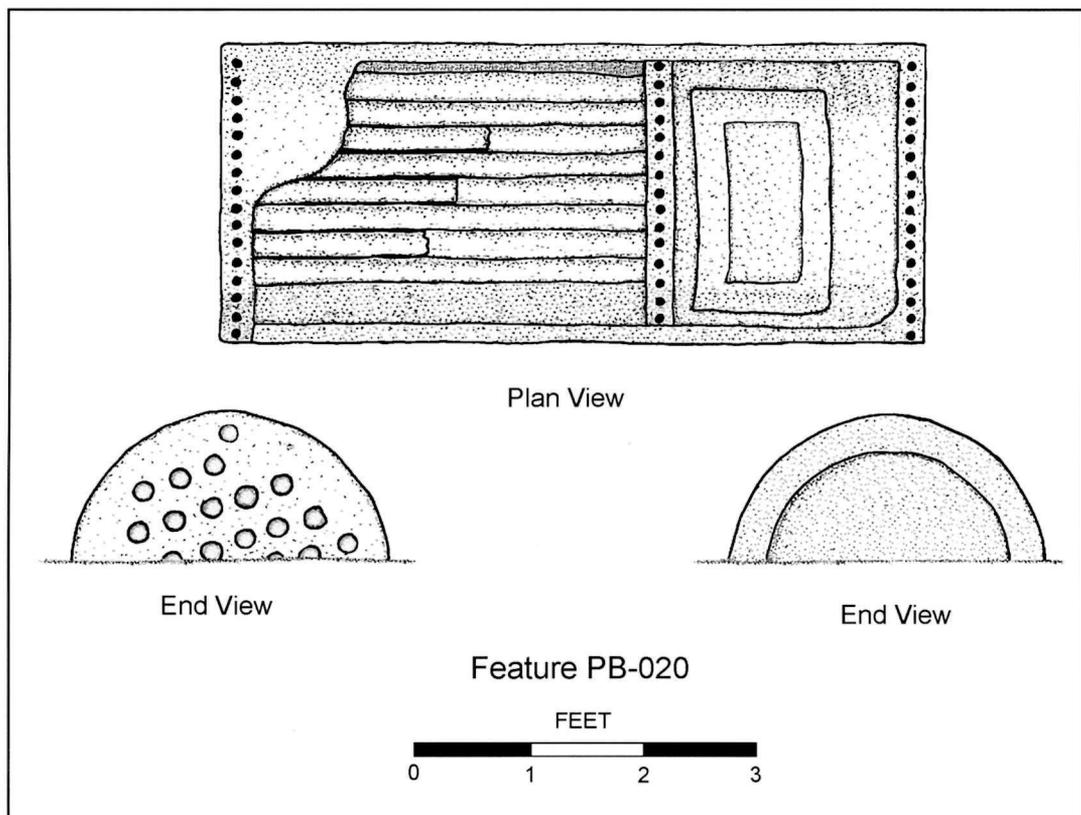
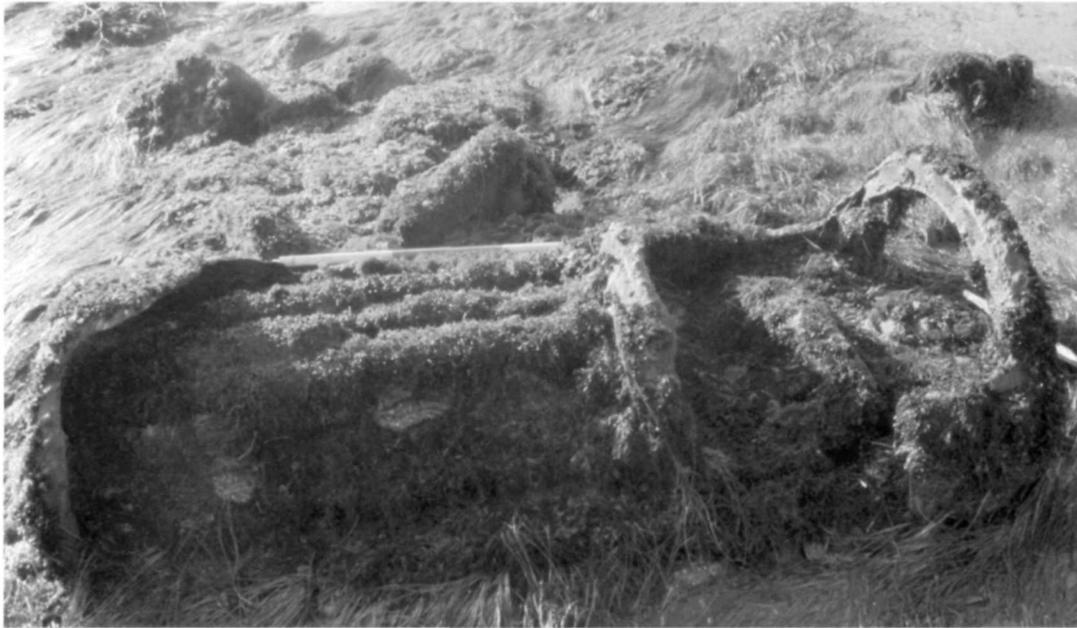
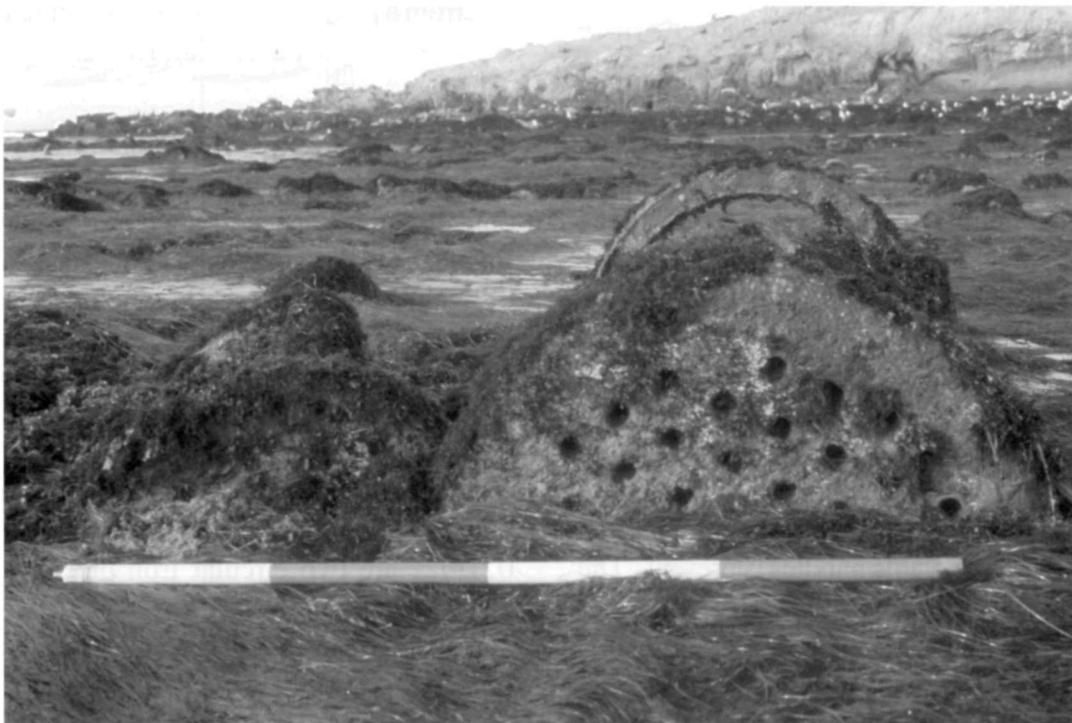
Figure 4.10. Donkey boiler (feature PB-020). Drawing by Matt Russell.

Figure 4.11. Donkey boiler (feature PB-020). NPS photo by Adriane Neidinger.

Figure 4.12. End view of the donkey boiler. NPS photo by Adriane Neidinger.

Feature PB-020 is another readily identifiable object, a steam donkey engine boiler (Figures 4.10–4.12). It is a cylinder

approximately 6 ft. 6 in. long and 3 ft. in diameter, its interior filled with 2¾-in. diameter tubes for about two-thirds of its length. Donkey engines, or “steam donkeys” as they were known, were found aboard coastal lumber schooners after the early 1880s (Cox 1974:231) and were used for a variety of purposes, including loading and unloading cargo, hoisting the sails and running the ship’s pumps. The donkey engine was usually located in the forward deckhouse, as in the coastal lumber schooner *C. A. Thayer*, built in 1895 by Hans D. Bendixsen and now on display at San Francisco Maritime National Historical Park. Like *J. M. Colman*, *Comet* and *Dora Bluhm*, *C. A. Thayer* is a three-masted lumber schooner and very similar in size and configuration to the Hall-built schooners.

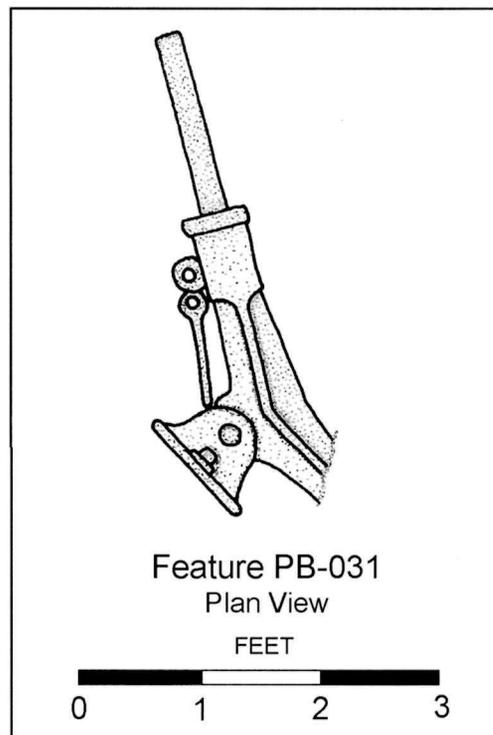
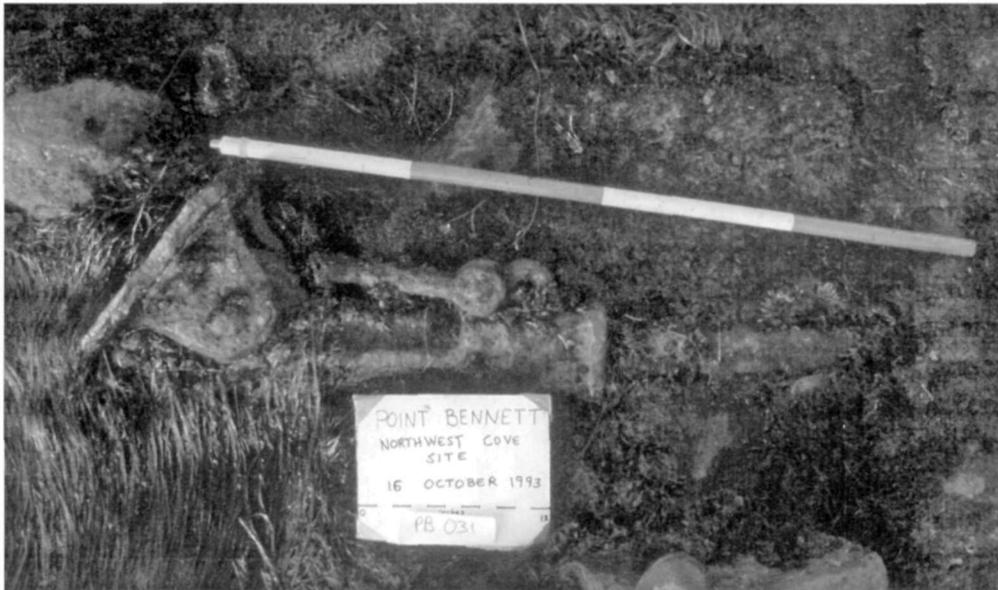
Figure 4.13. Crosshead mechanism from a pump-brake windlass (feature PB-031). Drawing by Matt Russell.

Figure 4.14. Crosshead mechanism from a pump-brake windlass. See Figure 4.96 for a similar mechanism. NPS photo by Adriane Neidinger.

Another intertidal-zone object identified is PB-031, which is the crosshead mechanism of a hand-operated, pump-brake windlass (Figures 4.13 and 4.14). An example of this mechanism can also be seen on board *C. A. Thayer*, where it is mounted on the forecastle deck, directly forward the sampson post above the windlass. The crosshead was attached to the windlass by connecting rods that passed through the forecastle deck and were connected to the windlass purchase rims (de Kerchove 1961:614). Removable handles were inserted into the crosshead and the up-and-down motion supplied by two seamen rotated the purchase rims, which turned the windlass. This is the same type of windlass and mechanism recorded on *Comet* (see below). Feature PB-031 is partially obscured by encrustation and marine growth, but a portion of one of the removable handles is present. The overall length of the piece is 4 ft. The base of the crosshead mechanism was secured to the forecastle deck with two 1-in. diameter iron fasteners. The base is about 10 in. square and 6½ in. tall, which is similar to the crosshead mechanism found on *C. A. Thayer*.

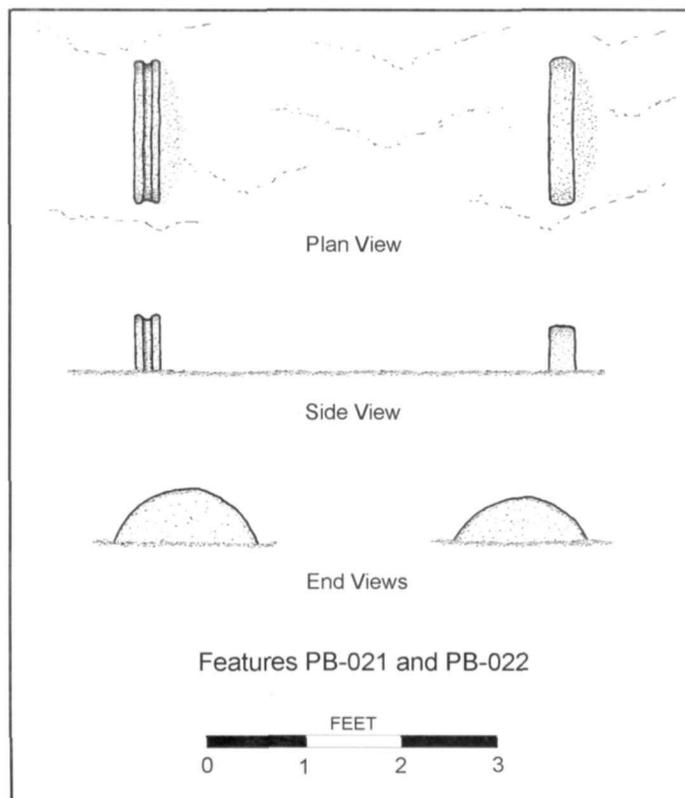
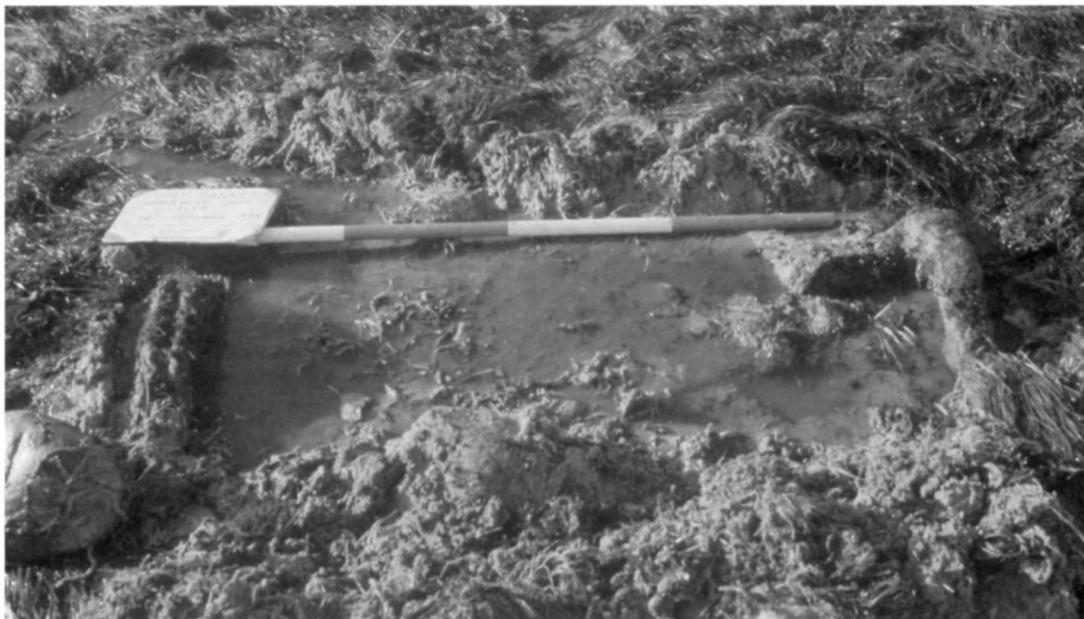
Figure 4.15. Part of the drive mechanism from a donkey engine (features PB-021 and PB-022). Drawing by Matt Russell.

Figure 4.16. The two upright circular features are connected by a buried drive shaft. NPS photo by Adriane Neidinger.

At least seven of the remaining intertidal zone features are either from a windlass, a donkey engine, or a messenger chain system that linked the two. A messenger chain used a series of chains, gears and shafts to connect a steam donkey engine to the windlass, pumps, auxiliary warping heads and other hoisting gear. *Comet* was equipped with a messenger chain system to drive its windlass (see below). Feature PB-021/022 (actually a single object) is likely part of a donkey engine (Figures 4.15 and 4.16). PB-021/022 are two circular iron pieces sticking upright out of the bottom, 4 ft. apart, and connected by a shaft that could not be exposed (which is why they were given separate feature numbers). The circular iron pieces are 1 ft. 6 in. in diameter. One of them (PB-021) is featureless, while the other (PB-022) is grooved

along the edge. Although positive identification is difficult, this feature is probably the drive spindle of a steam donkey engine (Figure 4.17).
