Beached Shipwreck Archeology: Case Studies from Channel Islands National Park

Submerged Resources Center
Professional Reports
Number 18

Submerged Resources Center
Intermountain Region
National Park Service

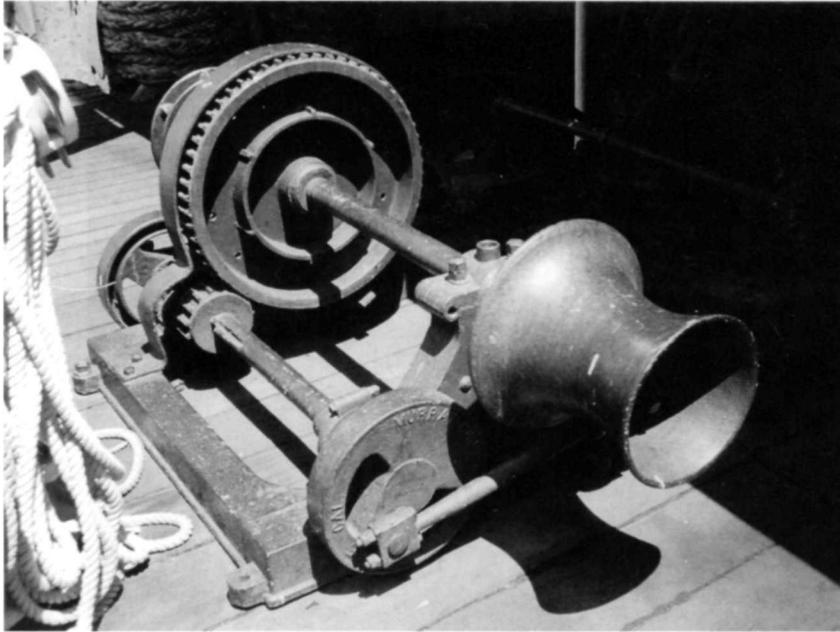
Figure 4.17. Windlass from *Falls of Clyde* in Honolulu, Hawaii. The smaller mechanism to the left is similar to features PB-021 and PB-022. NPS photo by Matt Russell.

along the edge. Although positive identification is difficult, this feature is probably the drive spindle of a steam donkey engine (Figure 4.17).

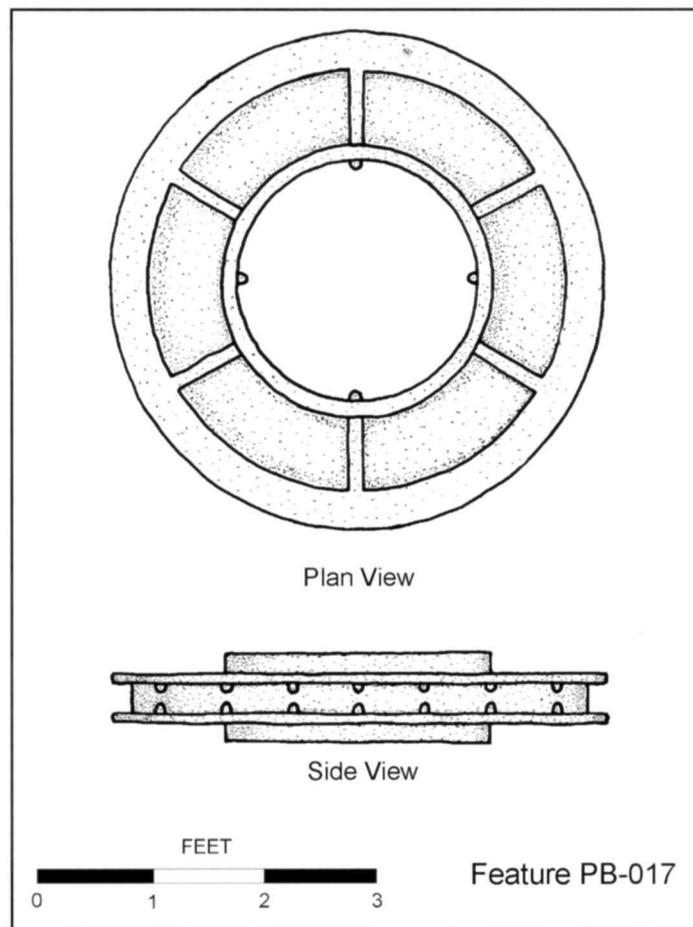
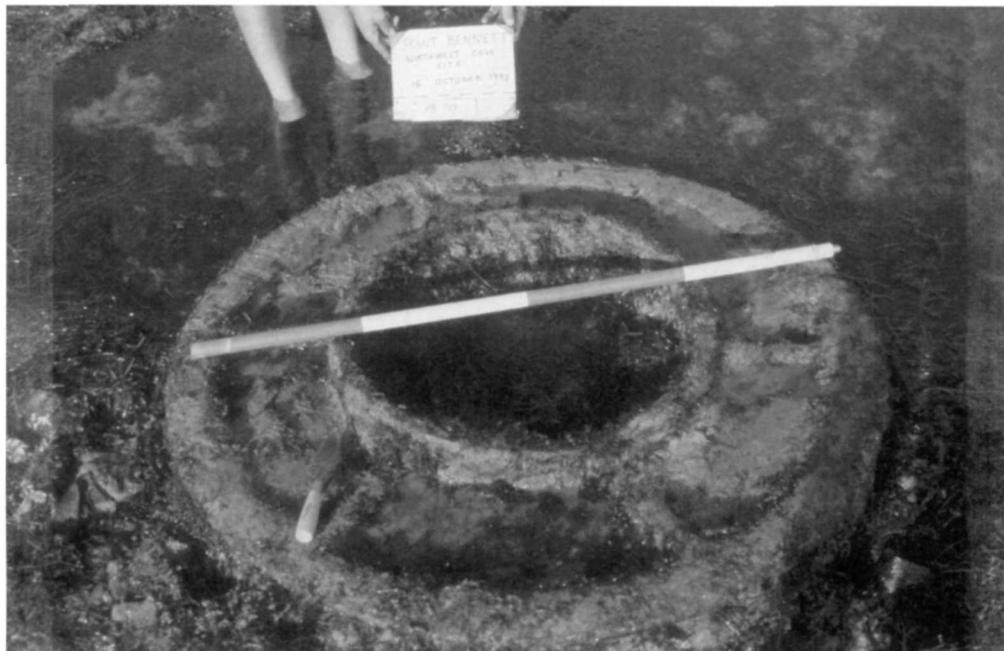
Figure 4.18. The widely-spaced teeth on this feature's outer edge indicate it is part of a messenger chain system that ran the windlass from a donkey engine. Drawing by Matt Russell.

Figure 4.19. Iron ring from a windlass messenger chain system (feature PB-017). NPS photo by Adriane Neidinger.

Features PB-017, 018 and 023 are all similar objects and part of a vessel's windlass or messenger chain system. PB-017 is an iron ring with an outside diameter of 4 ft. 4 in., an inside diameter of 2 ft. 1 in., with a thickness of the main part of the ring 5 in. An inner flange adds 2 in. in thickness to either side (Figures 4.18 and 4.19). PB-018, also an iron ring, has an outside diameter of 3 ft., an inside diameter of 2 ft. 2 in., and is 4 in. thick (Figures 4.20 and 4.21). PB-023 is a solid circular iron object 2 ft. 1½ in. in diameter and 4 in. thick (Figure 4.22). All three features have edges notched for gears. Edges of PB-018 and PB-023 have closely spaced gears, while the edge of PB-017 has teeth spaced about every 7 in. Feature PB-018 is likely the purchase rim of a windlass (Figure 4.23). The 7-in.-spaced teeth of PB-017 are from the messenger chain system that ran this machinery.

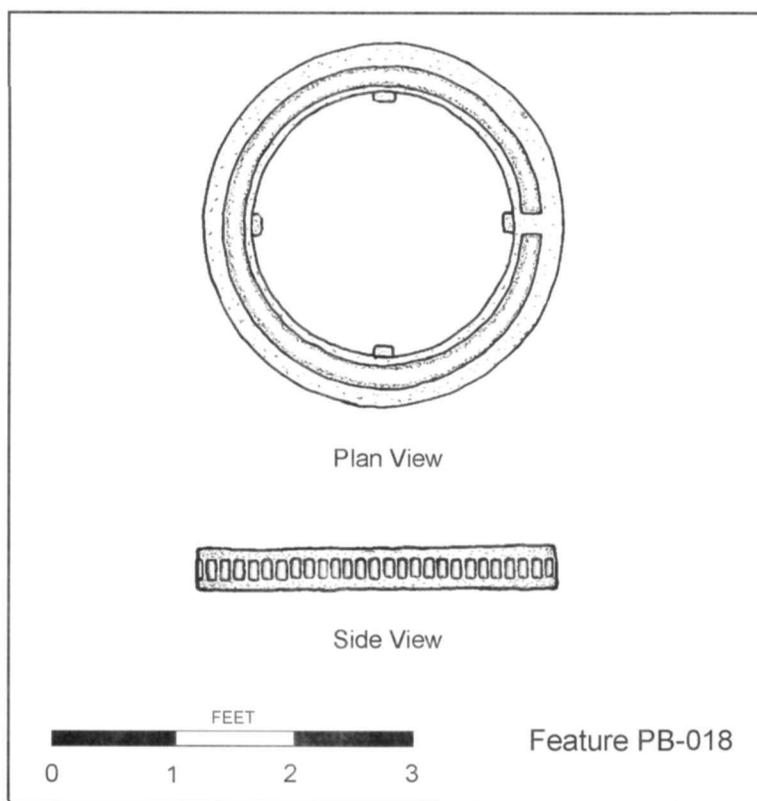
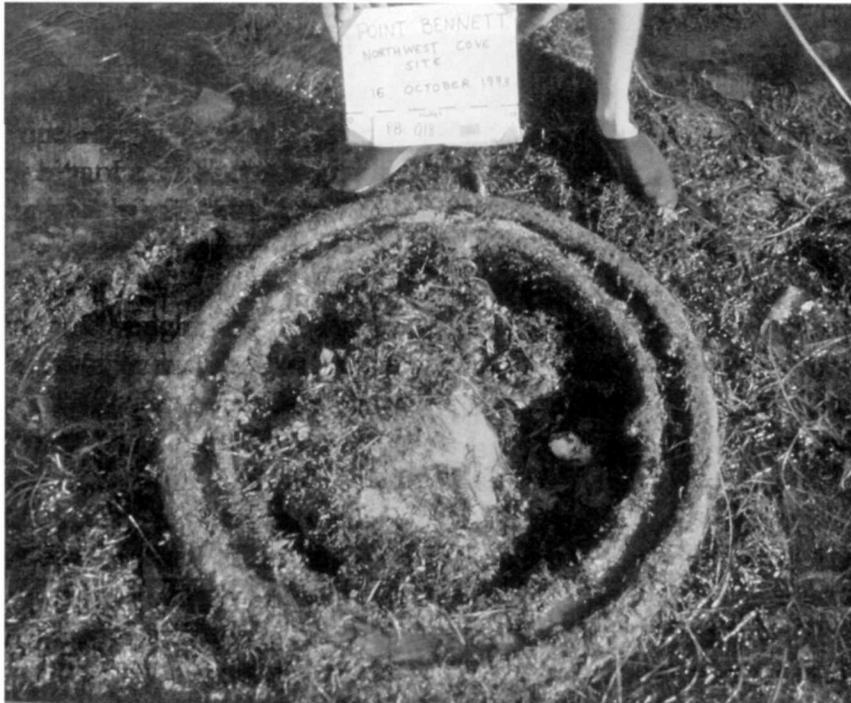
Figure 4.20. Purchase rim from a pump-brake windlass. Drawing by Matt Russell.

Figure 4.21. Purchase rim (feature PB-018). NPS photo by Adriane Neidinger.

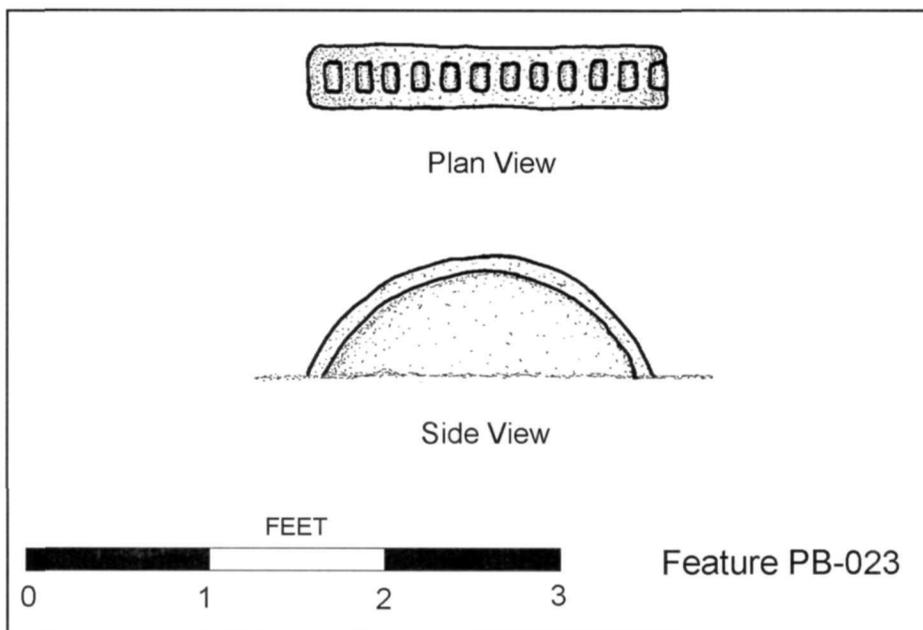
Figure 4.22. Unidentified windlass element (feature PB-023). Drawing by Matt Russell.

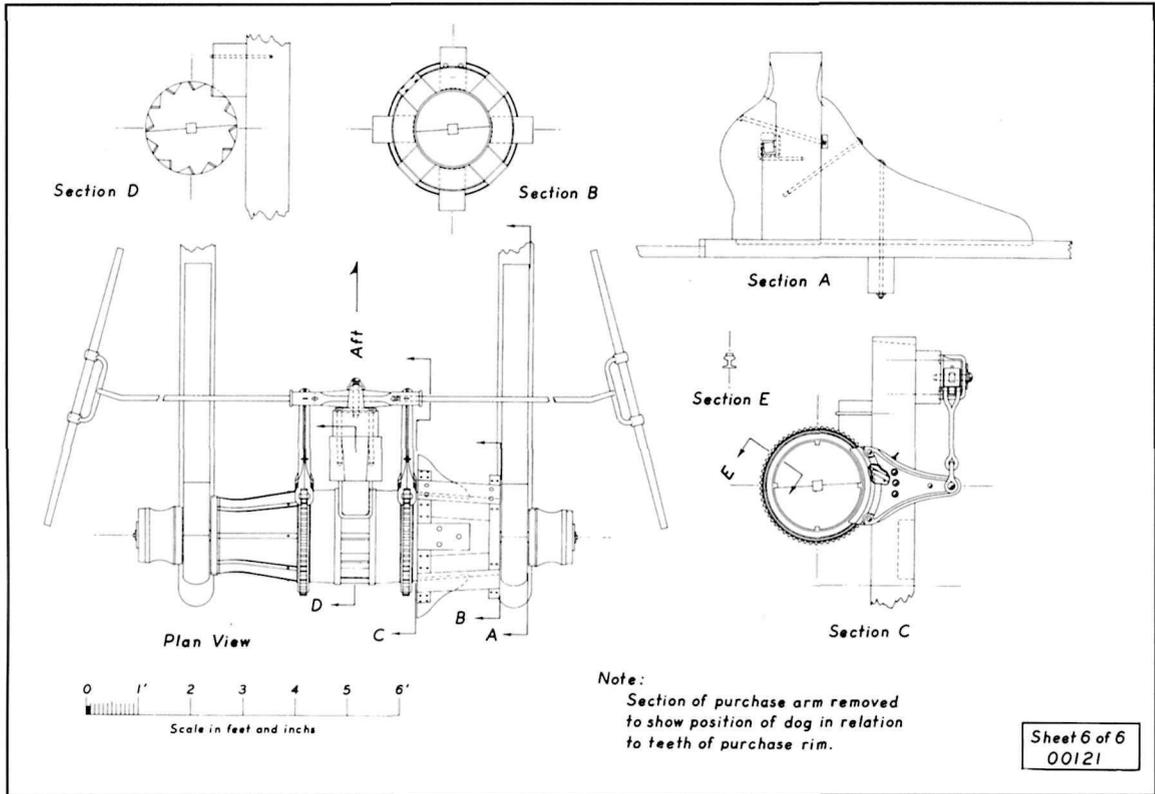
Figure 4.23. Feature PB-018 is a purchase rim, pictured here in Section C with the purchase arm attached. Note the four teeth on the inside of the rim that match those on feature PB-018. Drawing from the Smithsonian Institution.

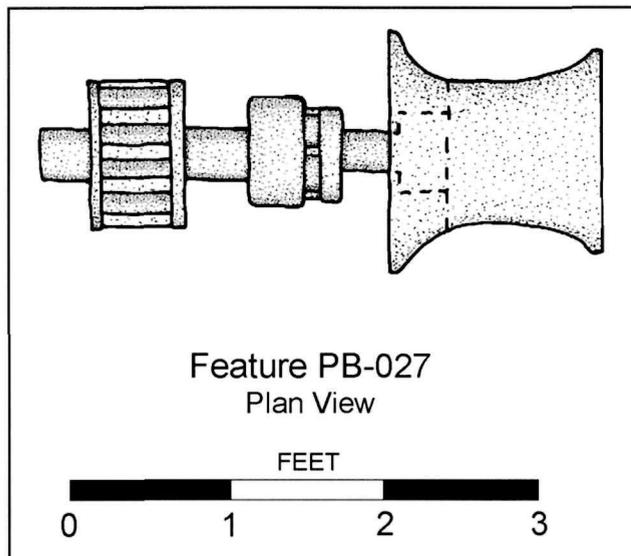
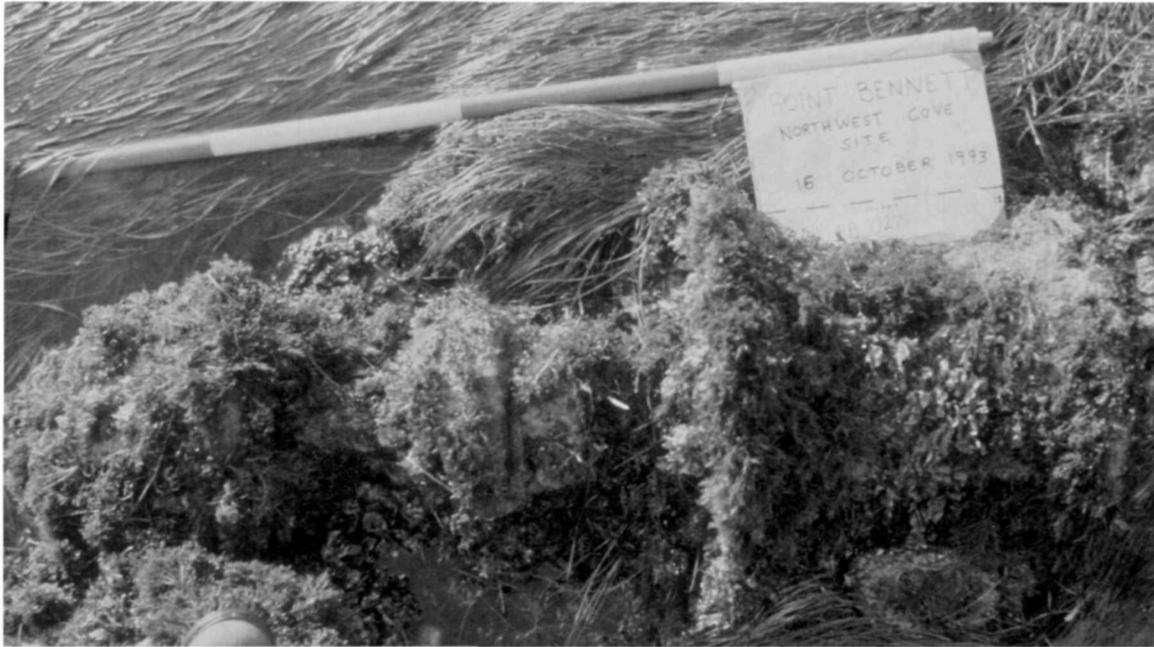
Figure 4.24. Unidentified windlass element with the warping hub (feature PB-027). Drawing by Matt Russell.

Figure 4.25. Feature PB-027. NPS photo by Adriane Neidinger.

Features PB-026, 027 and 029 are also likely parts to either a windlass or a donkey engine. Both PB-027 and PB-029 contain warping hubs and geared mechanisms on shafts, likely parts from the windlass, a deck winch or the donkey engine (Figures 4.24–4.27). PB-027 is 3 ft. 9 in. long, and PB-029 is 2 ft. long. The warping hubs on each are identical, 1 ft. 4 in. long and 1 ft. in diameter at their narrowest point. Feature PB-026 has a large, circular geared mechanism 1 ft. 10 in. in diameter, and a smaller circular object 1 ft. 5 in. in diameter (Figures 4.28 and 4.29). The teeth on the latter's edge are spaced on 7-in. centers, same as PB-017, which is also from the messenger chain system (Figure 4.30).

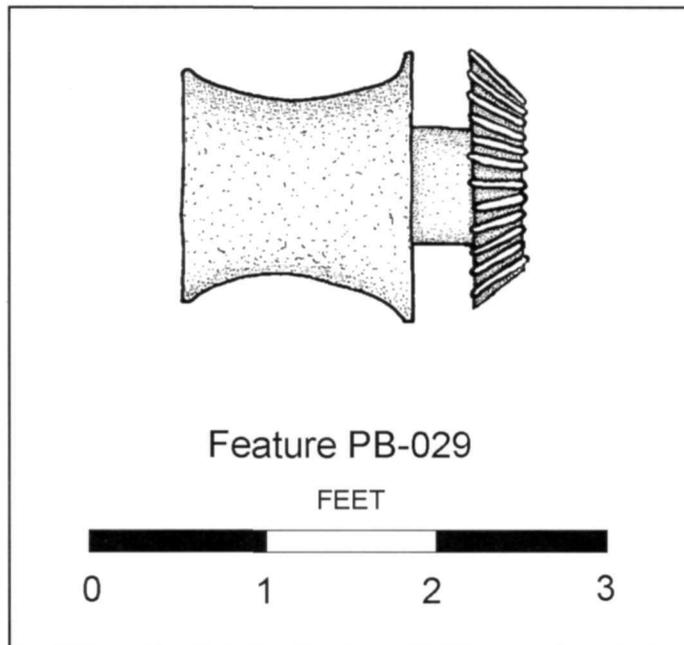
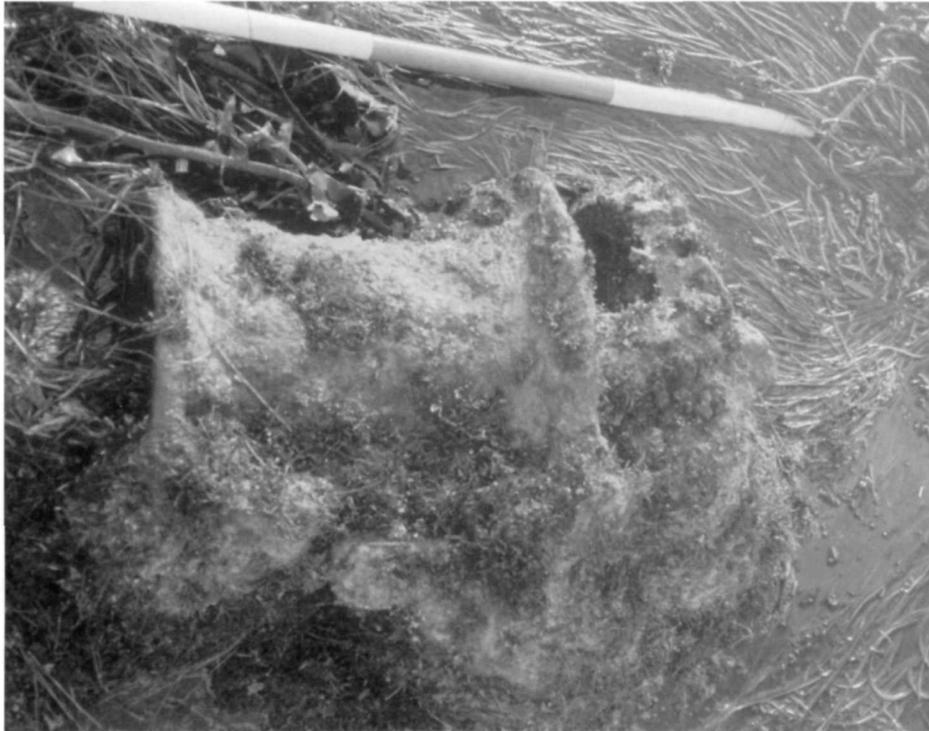
Figure 4.26. Another unidentified windlass element (feature PB-029). Drawing by Matt Russell.

Figure 4.27. Feature PB-029. NPS photo by Adriane Neidinger.

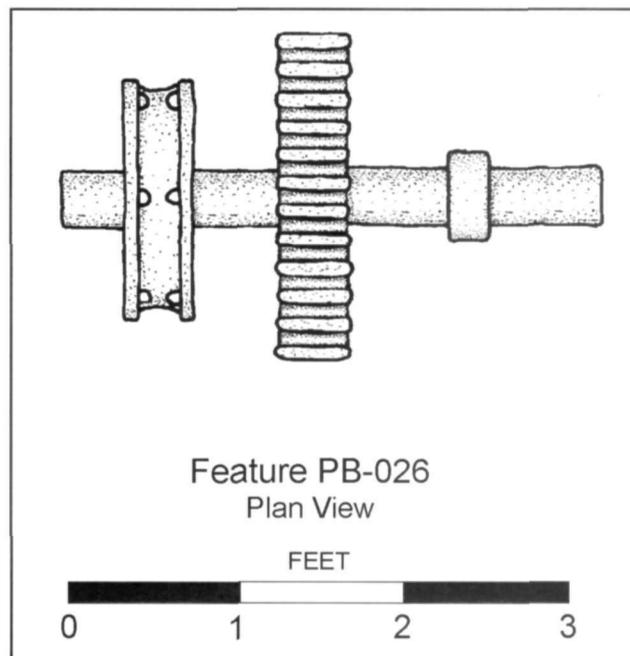
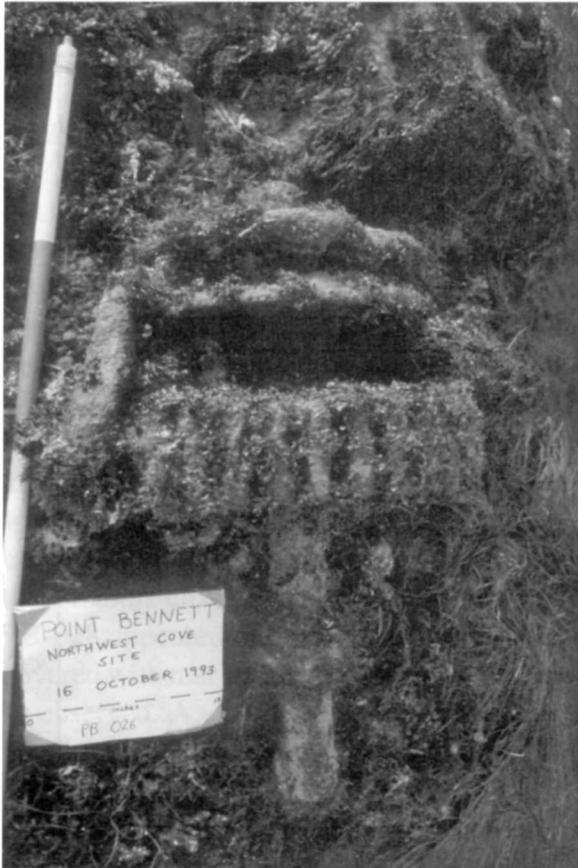
Figure 4.28. Unidentified windlass element with widely-spaced teeth for the messenger chain on the left. Drawing by Matt Russell.

Figure 4.29. Feature PB-026 with the messenger chain gear at top. NPS photo by Adriane Neidinger.

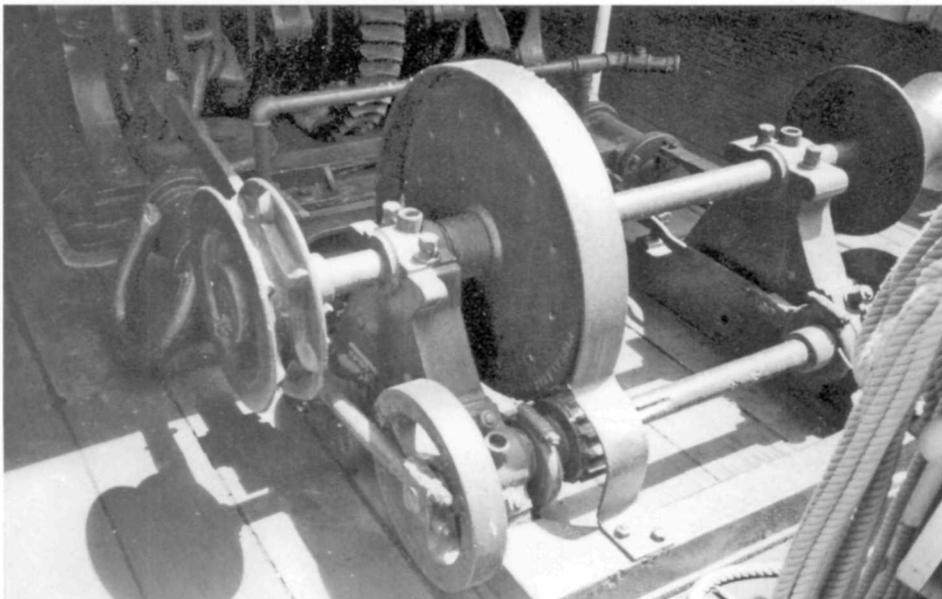
Figure 4.30. Windlass from *Falls of Clyde* in Honolulu, Hawaii. Note the gear to the left in the photograph that is from the messenger chain system. NPS photo by Matt Russell.

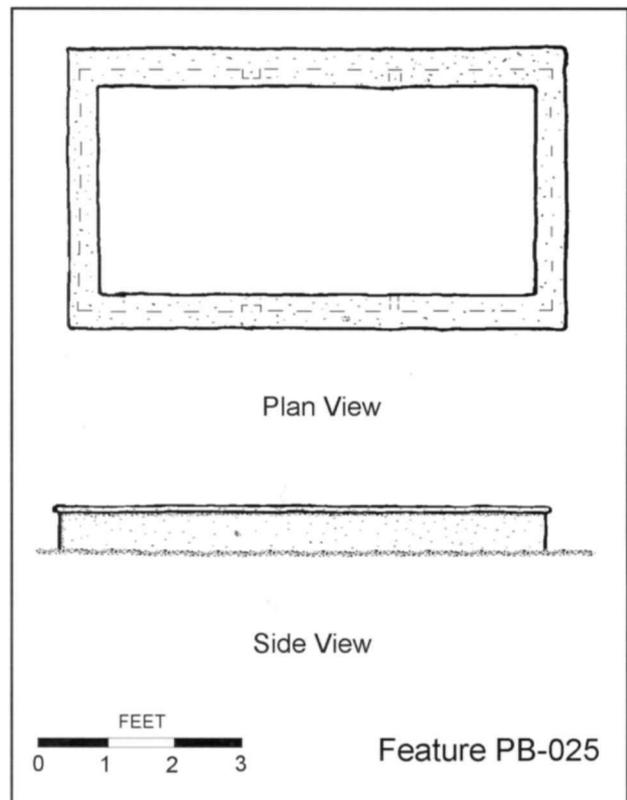
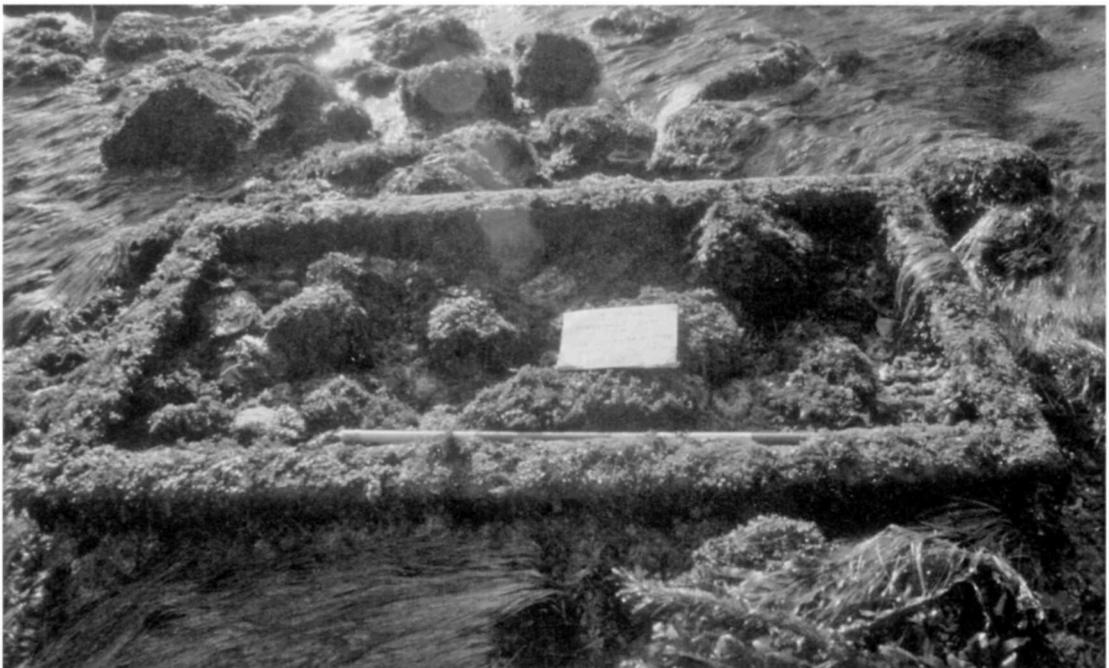
Figure 4.31. Machinery mount for the donkey engine (feature PB-025). Drawing by Matt Russell.

Figure 4.32. Feature PB-025. NPS photo by Adriane Neidinger.

PB-025 is a large, rectangular-shaped iron feature encrusted to the seabed. It has an outside length of 7 ft. 2 in. and an outside width of 4 ft. 1 in. The inside length is 6 ft. 4 in., while the inside width is 3 ft. 1 in. The object is 8 in. high (Figures 4.31 and 4.32). At first glance, the object appears to be some sort of hatch coaming, which is unlikely because cargo hatches on

ocean-going vessels would have been much larger and constructed of wood. Feature PB-025 is probably the machinery mount for the donkey engine.

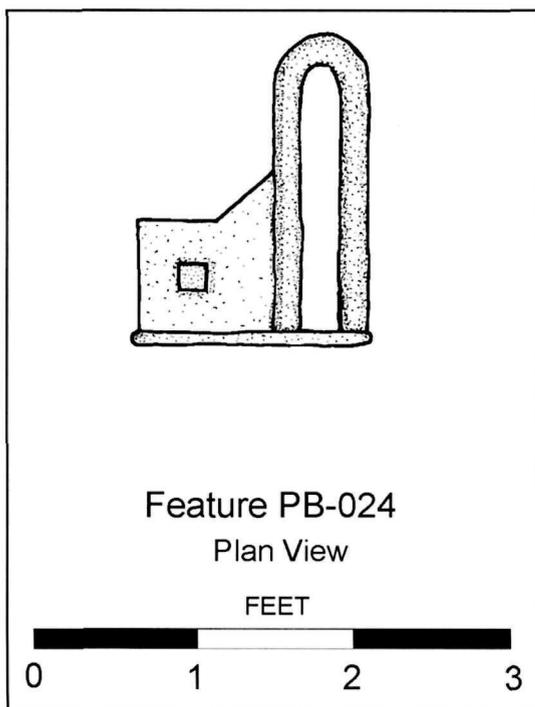
Figure 4.33. Unidentified object (feature PB-024). Drawing by Matt Russell.

The remaining six intertidal features could not be conclusively identified. Feature PB-019 is a deteriorated piece of wood firmly embedded in the bottom, probably attached through the encrustation of various iron fasteners or fittings. Feature PB-024 is an oddly shaped iron object with rough dimensions of 1 ft. 11 in. x 1 ft. 6 in. The main attribute is a U-shaped piece of iron attached to a base (Figure 4.33). The object was only drawn in two dimensions because it is encrusted into the bottom and surrounded by thick marine growth. Heavily encrusted, feature PB-028 appeared only as a small ferrous lump covered with marine growth and no details could be observed. A scale drawing was not produced. Feature PB-030 is an iron block 2 ft. 4½ in. long,

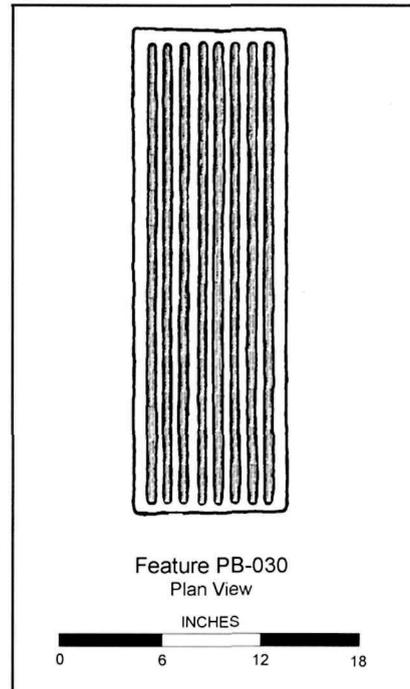
Figure 4.34. Unidentified object (PB-030). Drawing by Matt Russell.

9 in. wide and 4½ in. thick (Figure 4.34). The top (exposed) surface has shallow grooves ½ in. wide and ½ in. apart running lengthwise for the whole width of the piece. A group of three iron fasteners concreted onto the rocks make up feature PB-032. Their lengths are 9 in., 1 ft. and 1 ft. 3 in.; the two shorter ones are approximately 1-in. diameter; the longer is about 1½ in. in diameter. Feature PB-033 is a small, half-moon-shaped iron object 2 ft. 1 in. long across its base, just over 9 in. wide at the broadest point, and 1½ in. thick (Figure 4.35). The top surface has six shallow grooves running lengthwise that are ½ in. wide with ¾-in. spaces between them. The bottom surface of the object is smooth.

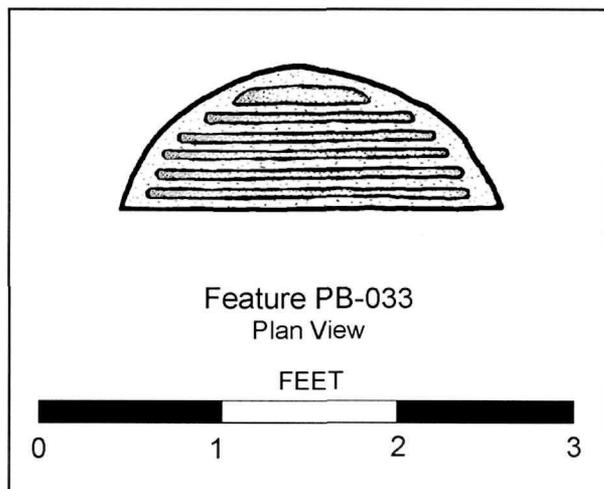
Figure 4.35. Unidentified object (feature PB-033). Drawing by Matt Russell.

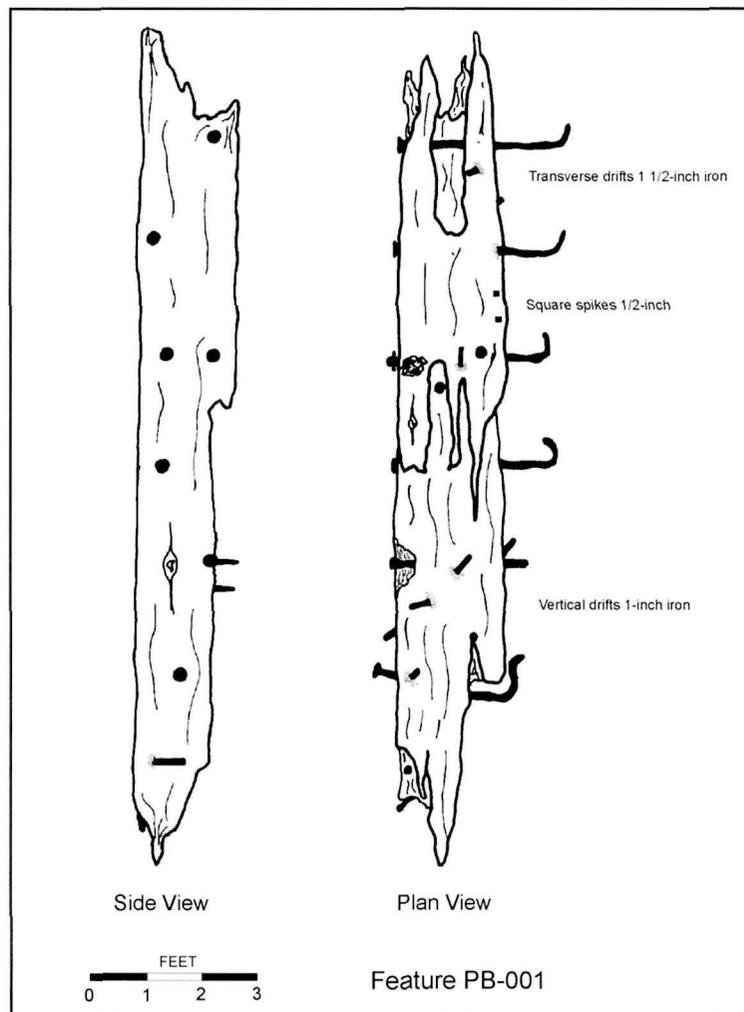
Figure 4.36. Keelson element with iron fasteners (feature PB-001). Drawing by Matt Russell.

in. (Figures 4.36 and 4.37). Both ends are broken off, so it is impossible to determine the element's original length. All extant surfaces are badly worn and deteriorated, so sided and moulded dimensions are approximate. The element's most conspicuous characteristics are size and number of iron fasteners. There are six large, iron drift pins driven through and protruding from the side. These drifts are approximately 1½ in. in diameter (though exfoliating badly) and range in length from 2 ft. 2 in. (broken) to 4 ft. 2 in. long spaced an average of 2 ft. apart. There are also nine 1-in. diameter

iron drifts and five spikes ½ in. square protruding from the timber's top surface. All are broken off close to the surface.

The element's size and fasteners make it likely this feature is part of a structural member from an ocean-going vessel. Furthermore, because of the element's large size and configuration of iron fasteners, it is most likely PB-001 is a portion of a vessel's centerline structure. The lack of rabbet, fasteners driven through both axis of the piece, and the observation that the large drifts were first driven through this piece and then, probably, into

another makes it impossible for this piece to be a portion of a keel. On the other hand, these same characteristics are consistent with a piece of a main, sister, rider or assistant keelson, which now rests on its moulded face. The element's western face, from which the large iron drifts were driven, is likely the top, or sided, surface. If PB-001 is a piece of the main keelson, then the six 1½-in. diameter drifts were probably driven through this piece, through the floors and into the vessel's keel. If it is from a sister keelson, then the large drifts were probably driven through this timber into the floors or first futtock of the vessel. If this timber is from a rider or assistant keelson, then the large iron fasteners were probably driven through the piece into the main or sister keelson. In all cases, the 1-in. diameter fasteners driven through the opposite axis of the timber edge-bolted this timber to its adjacent keelson component, indicating multiple keelson elements.

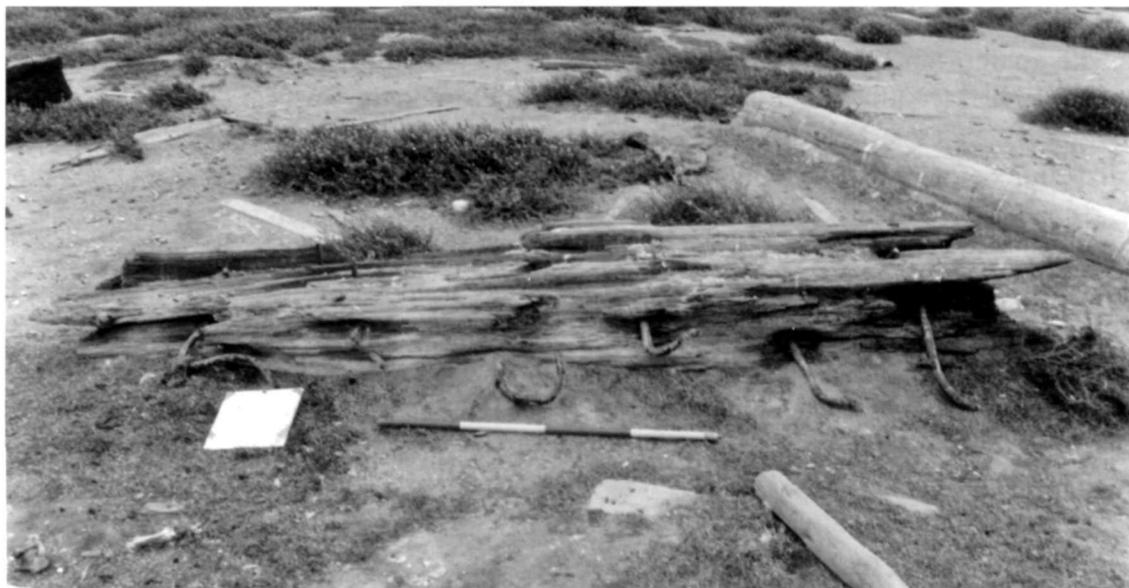
Figure 4.37. Feature PB-001. NPS photo by Matt Russell.

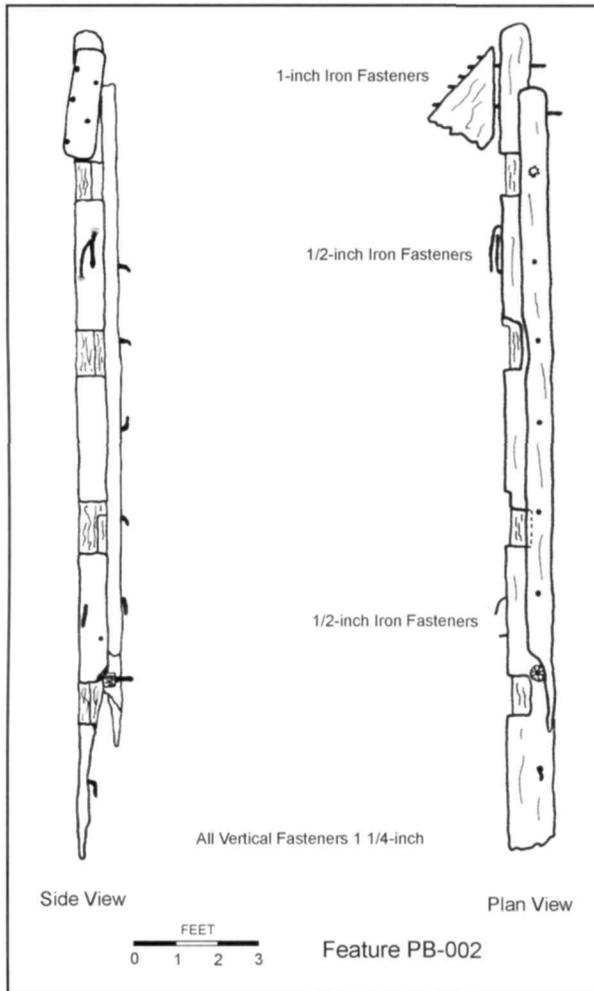
Figure 4.38. Feature PB-002. This fragment is possibly part of a deck clamp or shelf. Drawing by Matt Russell.

Another feature that is likely a scantling piece from a large, ocean-going vessel is PB-002 (Figures 4.38 and 4.39). This fragment consists of three wooden components: two long, rectangular pieces, one on top of the other, and a small trapezoidal piece fastened to the bottom timber. Also present are numerous iron fasteners. The bottom timber's total length is 19 ft. 8 in., it is 1 ft. 2 in. wide and 8 in. thick. This piece contains four mortises cut into its west side, which measure between 10 in. and 1 ft. 1 in. long, $3\frac{1}{2}$ in. high, and $5\frac{1}{2}$ in. deep. The mortises are indented about $1\frac{1}{2}$ in. from the side. The top timber, which was originally fastened to the bottom piece with eight $1\frac{1}{4}$ in. in diameter iron drift pins spaced 2 ft. on center, is 15 ft. 6 in. long, 8 in. wide, and 4 in. thick. On the feature's north end, a trapezoidal piece 2 ft. 2 in. long, 1 ft. $7\frac{3}{4}$ in. wide, and 8 in. thick is fastened to the lower timber with five iron, 1-in. diameter drift pins. In addition to these fasteners, the fragment also has two pairs of additional $\frac{1}{2}$ -in. diameter drifts in its west face.

Attributes of this feature suggest identification as a deck clamp or shelf. The mortises, spaced on 4-ft. centers, would have received the deck-beam ends. Deck beam spacing corresponded to frame spacing, so that the end of each deck beam rested against a frame (Desmond 1919[1984]:105). Generally, a vessel framed on 2-ft. centers would have a deck beam for every other frame, with deck beam spacing not exceeding 5 ft. (American Shipmasters'

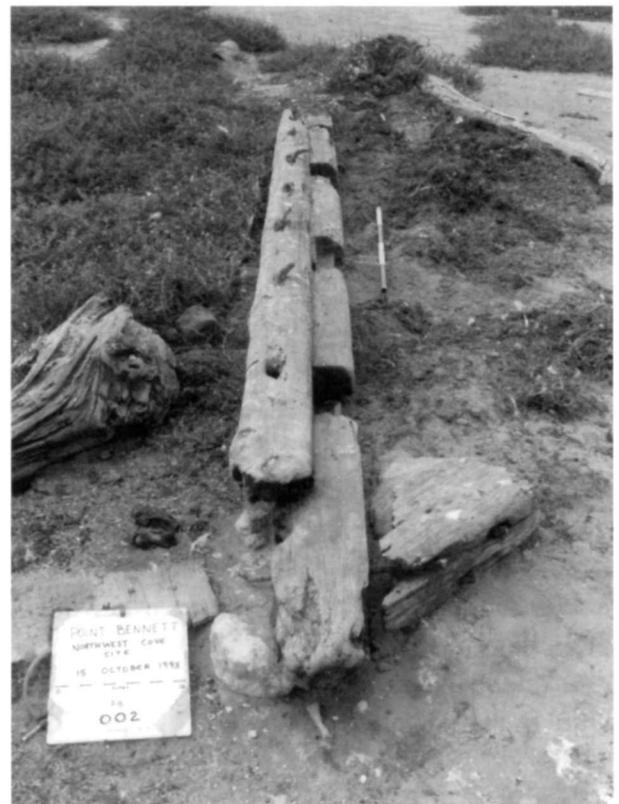
Figure 4.39. Feature PB-002. NPS photo by Matt Russell.

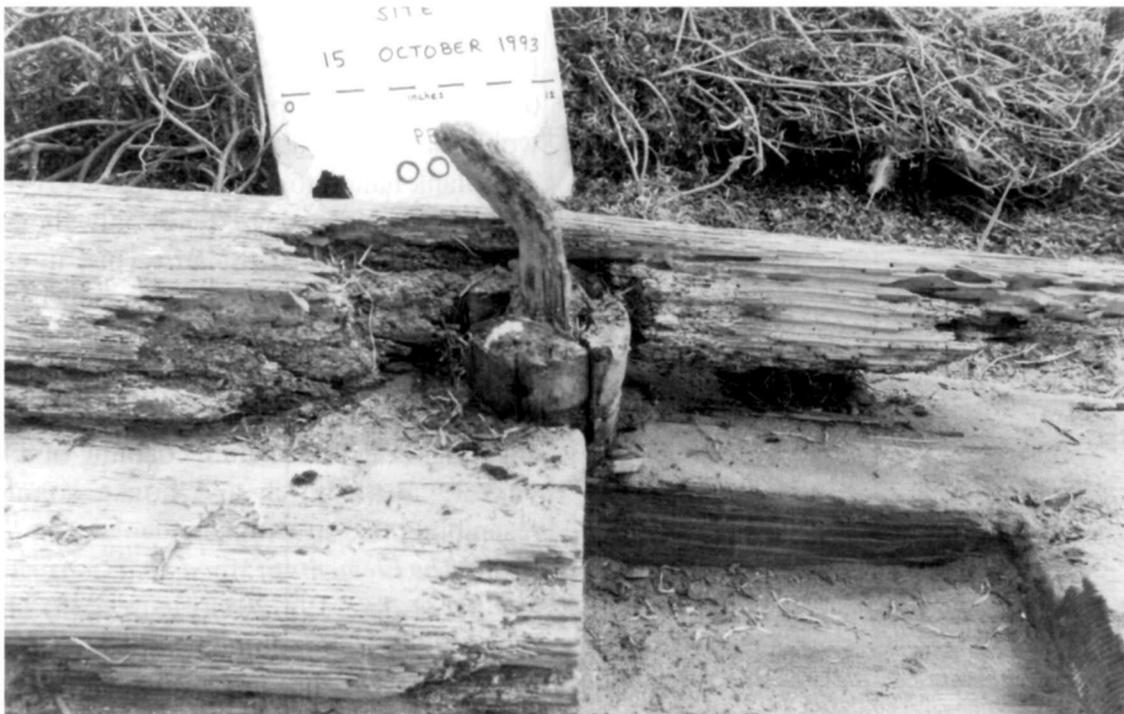
Figure 4.40. Iron fastener driven through an oak plug on feature PB-002. NPS photo by Matt Russell.

Finally, one of the most puzzling aspects of this fragment is that at least two of the vertical 1¼-in. fasteners joining the top timber to the bottom timber are driven through oak plugs (Figure 4.40). Only two could be examined, so it is possible that the remaining fasteners were also driven through plugs. Research into this practice has been inconclusive. It is unknown if this represents an effort to strengthen the bonding of these two timbers, or if this is evidence of a repair meant to replace a corroded fastener or possibly to augment wood that had deteriorated around the fastener. This may represent a peculiar and undocumented practice of the Hall Brothers. Identification as a portion of a deck clamp or shelf should be viewed as tenuous, especially when considering association with *J. M. Colman*.

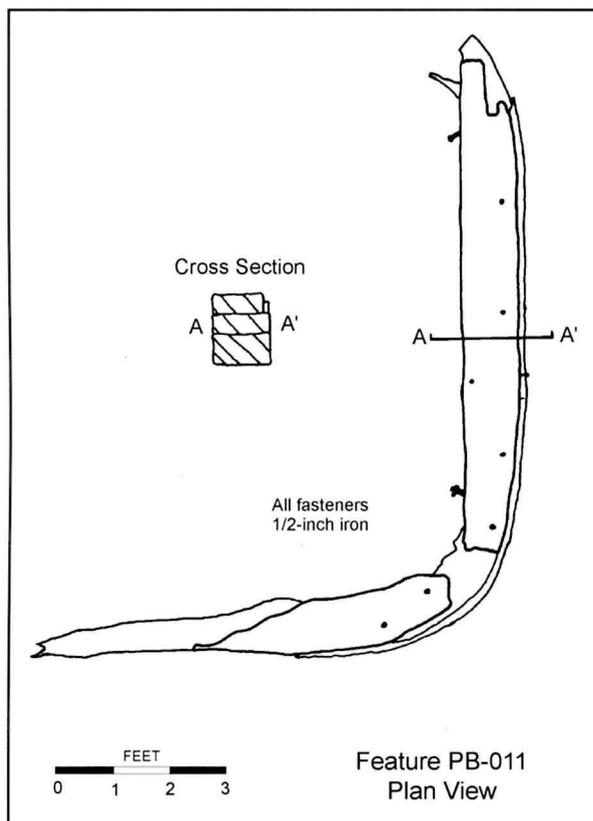
Figure 4.41. Plan view of feature PB-011, possibly part of a hatch coaming. Drawing by Matt Russell.

Features PB-011 and PB-014, constructed in the same manner, likely represent pieces of a wooden hatch coaming (Figures 4.41–4.44). The two fragments each have three layers of timbers, fastened together with ½-in. diameter, round iron fasteners. Originally, the structure was either U-shaped or, more likely, rectangular with rounded corners. PB-011 is sitting upright, with the three layers stacked, while PB-014 is laying face-down with the three layers side by side.

Feature PB-011's bottom timber is 6½ in. thick, the middle timber is 5 in. thick, and the top timber is 7 in. thick, giving PB-011 a total height of 18½ in. Each of the timbers is 1 ft. wide. Feature PB-011 is roughly L-shaped, with the longest side 11 ft. long, and the shorter 8 ft.

Each layer of wood on feature PB-011 is faced on the outside edge with thin, horizontal planks 1¼ in. thick. These are nailed to the main timbers with ¼-in. round nails. Wood species analysis identified these planks as *Quercus virginiana* or live oak. The main timbers were Douglas fir. It could not be determined if PB-014 included similar planks because the side they would have been attached to was face-down. The plank nailed to the top layer of PB-011 is only 4¼ in. wide, so it extends only about half the thickness of that timber. This, in effect, leaves a 2¾-in. deep, 1¼-in. wide rabbet around the outside of the structure's top face.

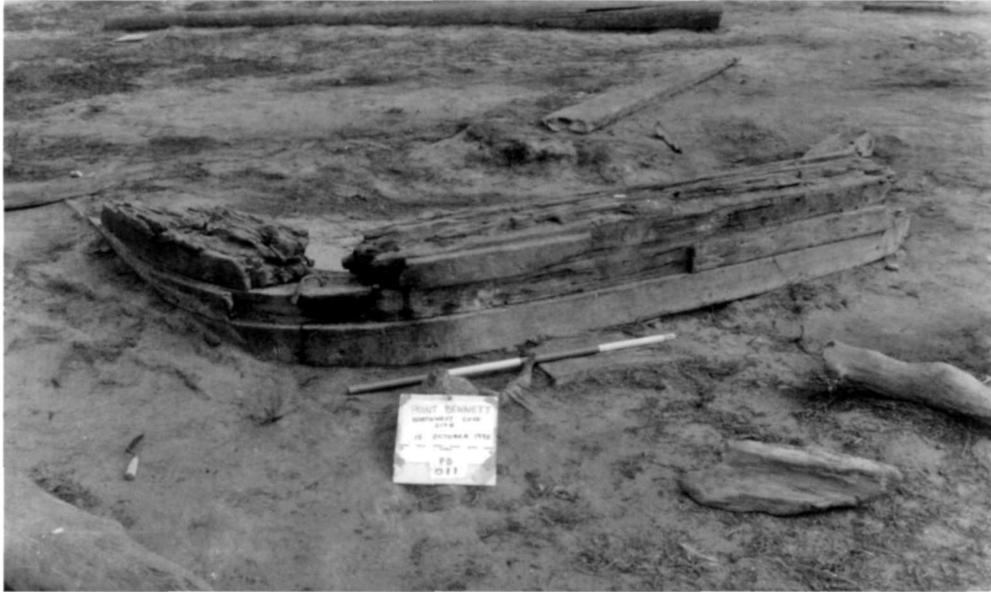
Figure 4.42. Oblique view of feature PB-011. NPS photo by Matt Russell.

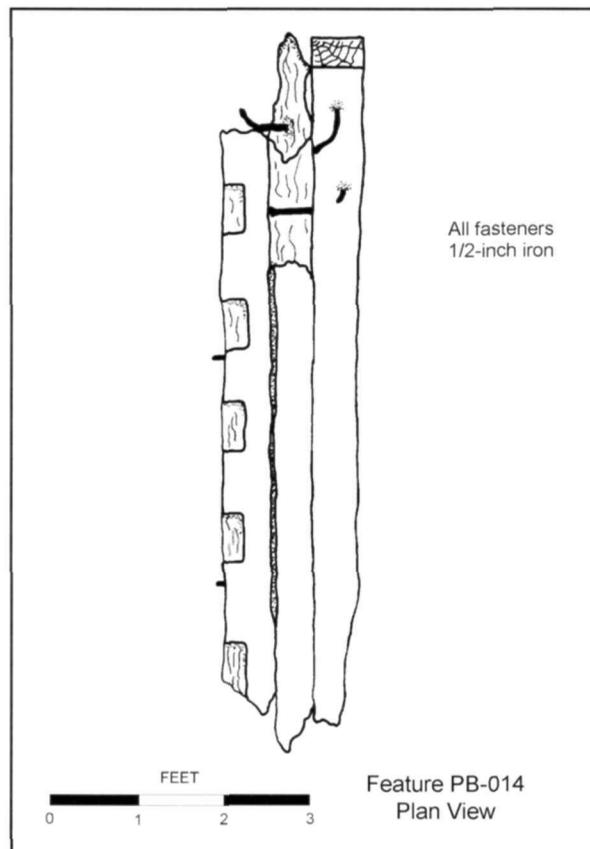
Figure 4.43. Plan view of feature PB-014, likely part of the same coaming as feature PB-011. Drawing by Matt Russell.

long; both ends are broken. The end of the longer side exhibits the beginning of a curve before the fracture. Feature PB-014 shows the beginning of a curve on one end before it is broken off, as well. In the one intact curve on PB-011, the two timbers forming the bottom layer meet in the middle of the curve. The timbers of the two top layers are joined in the curve by a chock. Feature PB-014 has shallow mortises along what would be the inside edge of the top timber, if it were standing upright. These mortises are 6 in. long, 3 in. wide with a maximum depth of 1½ in. The shorter length of PB-011 exhibits identical mortises on its inside face, suggesting that PB-014 was originally connected to PB-011 opposite their shorter length.

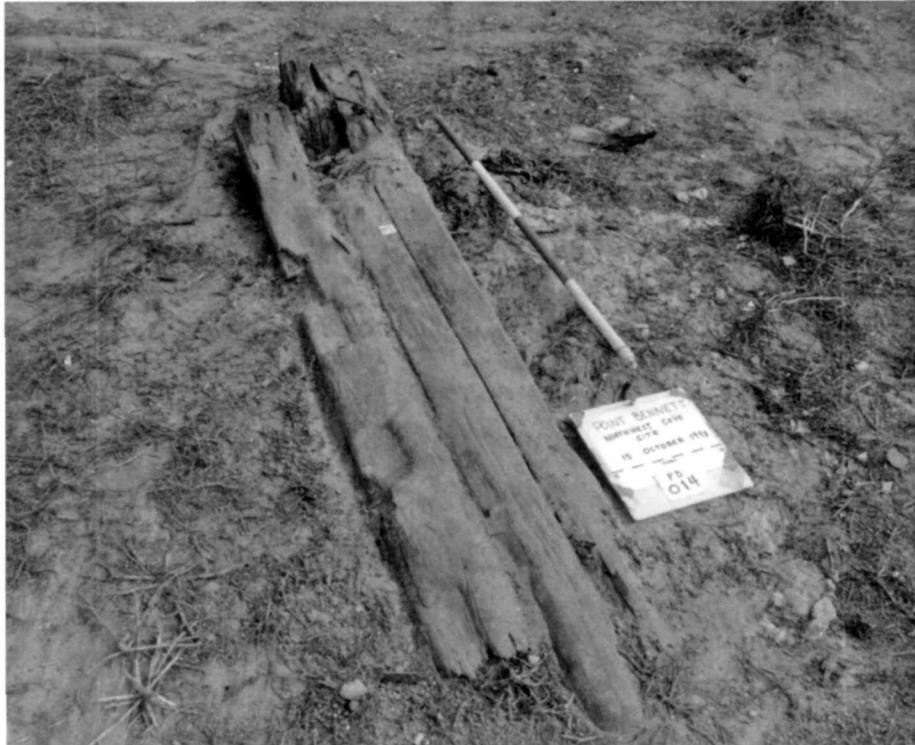
Figure 4.44. Feature PB-014. NPS photo by Matt Russell.

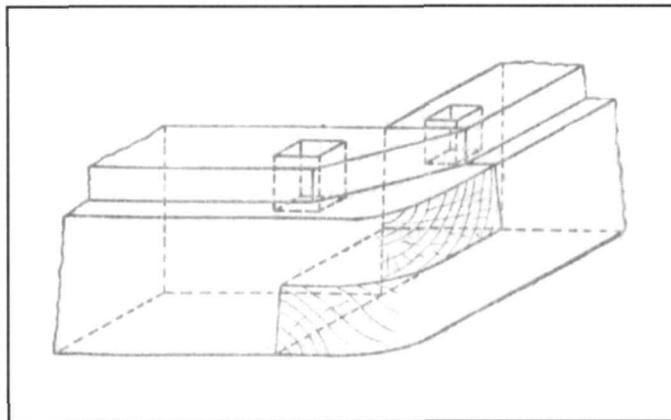
Figure 4.45. Hatch coaming depicted in Curtis 1919:200.

Positive identification of these fragments is difficult, but attributes are consistent with a hatch coaming, or deck structure coaming of a large vessel. Both hatch and house coamings resembling this structure are depicted in W. H. Curtis *The Elements of Wood Ship Construction* (1919:131, 152, 199, 201)(Figure 4.45). There is evidence to support this speculation and problems with this possibility, as well. In addition to the similarity to the structures depicted in Curtis, mortises cut into the top, inside edge of PB-014 and the shorter length of

PB-011 support the possibility of the structure being a hatch coaming. Hatch coamings contained a number of removable beams that criss-crossed the opening of the coaming. These beams, the transverse ones called strongbacks and the longitudinal ones called, simply, fore-and-aft beams, supported the hatch cover. These supports were necessary because the hatch cover had to support a great weight of deck cargo, particularly on lumber schooners where much of the cargo was carried on deck. These beams were supported on their ends by mortises cut into the coaming. One problem with this identification is that the hatch coaming would be securely fastened to the hatch framing with closely spaced, large, iron through-bolts (Curtis 1919:133). PB-011 has only five ½-in. diameter vertical fasteners along its entire 11-ft. length. It is possible, however, that either the lowest or the lower two layers were securely fastened to the hatch framing, and then the top layer fastened to them, thereby hiding the large through-bolts.

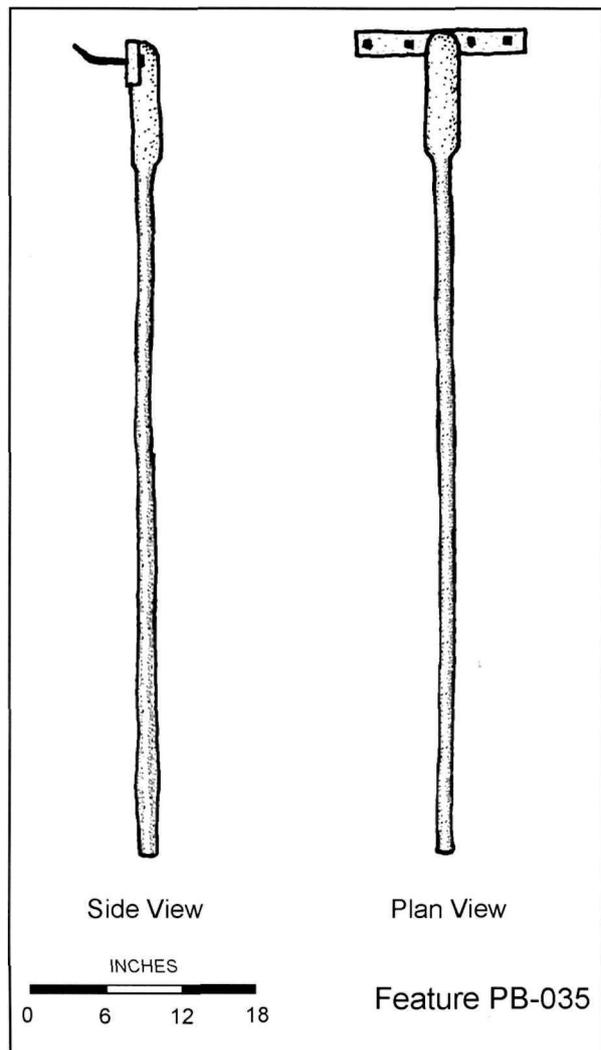
Figure 4.46. Unidentified object (feature PB-035). Drawing by Matt Russell.

As mentioned earlier, a single, unidentified iron piece, feature PB-035, was recorded above the high-tide line at Northwest Cove (Figure 4.46). This feature is a 4 ft. 8 in. long, 1¾-in. square iron bar, which ends in a 2-in. diameter, 10-in. long round portion. Connected to the bottom of the round end is a 1 ft. 3 in. x 3½-in.

rectangular piece, so that the whole object forms a “T.” This rectangular piece has four ½-in. square spikes through it. This object has not been identified.

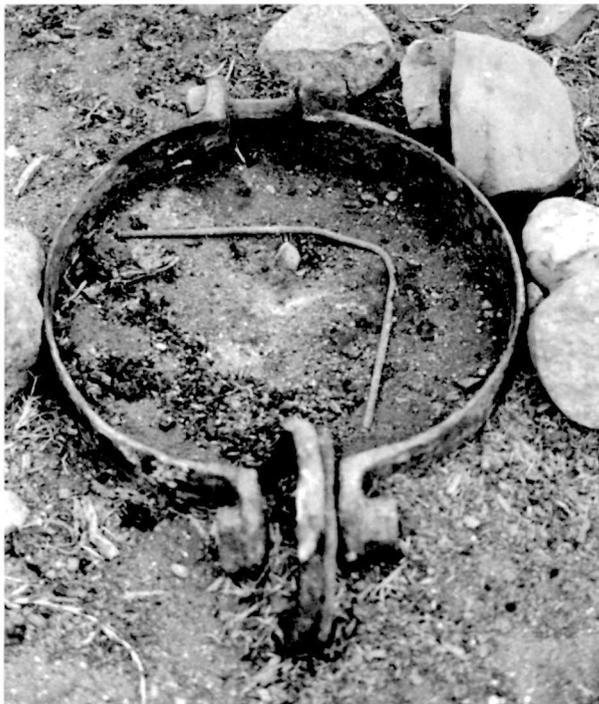
Figure 4.47. Iron mast-band used as a fire ring at Cluster Point. This object has since disappeared. NPS photo by Don Morris.

just south of Cluster Point. At that time it was being used as a fire ring, and it has since disappeared (Figure 4.47).

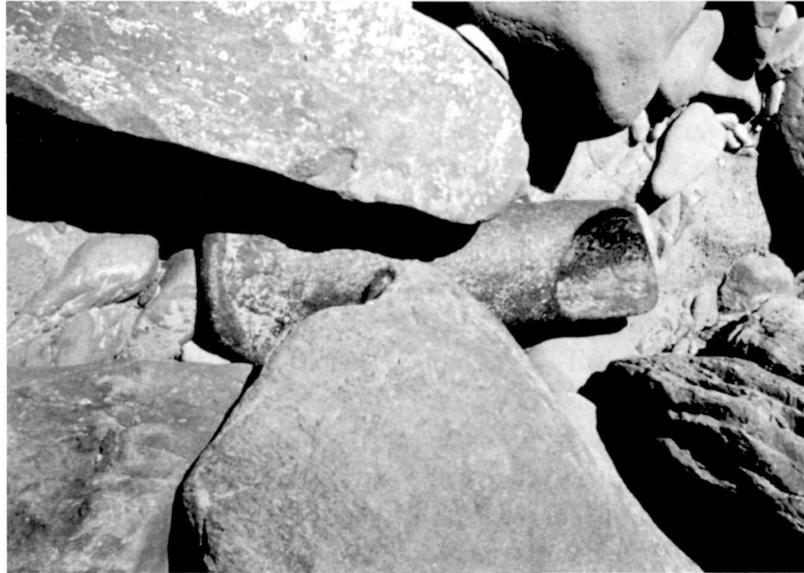
Figure 4.48. Hawse pipe located near Cluster Point. NPS photo by Don Morris.

The second feature reported by Morris is an iron hawse pipe measuring 3 ft. 5 in. long, with an external diameter of 9½ in. Originally located in the rocks to the south of Cluster Point, it could not be relocated during the present study (Figure 4.48). According to the tables found in Desmond (1919[1984]), a vessel of 300 tons (*Dora Bluhm* registered 330 gross and 315 net tons) required a hawse pipe measuring 11½ in. in diameter. This hawse pipe appears to be more appropriate for a vessel of approximately 150 tons (Desmond 1919[1984]:157), but this does not discount association with *Dora Bluhm*. It has already been demonstrated that dimensions were sometimes altered from published rules, as long as overall strength was not compromised.
