Beached Shipwreck Archeology: Case Studies from Channel Islands National Park

Submerged Resources Center
Professional Reports
Number 18

Submerged Resources Center
Intermountain Region
National Park Service

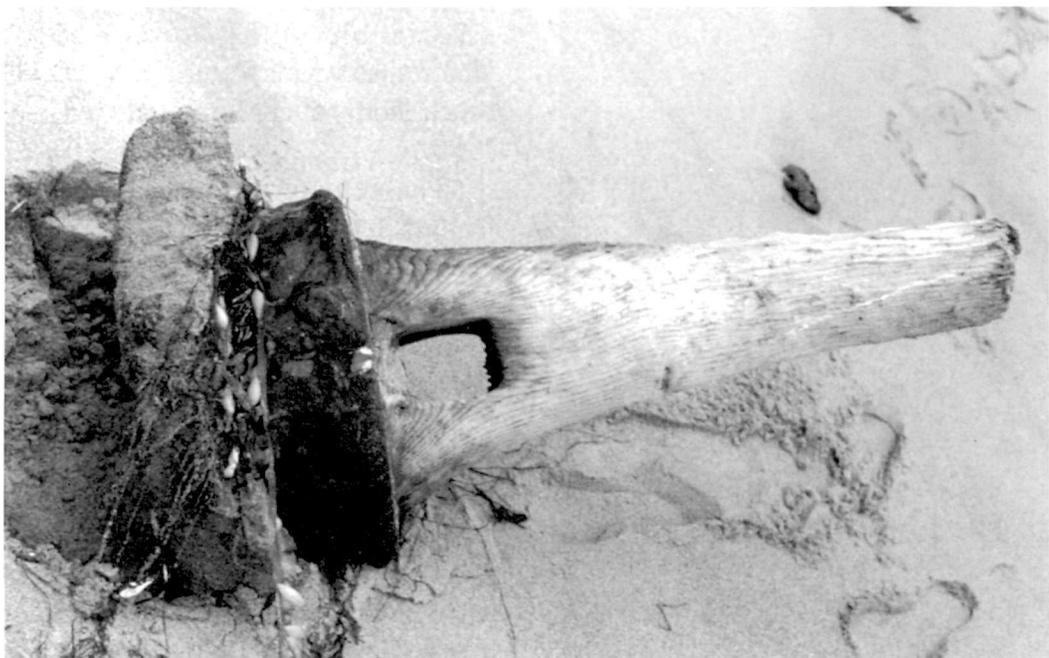
Figure 4.49. Portion of a rudder stock with the iron yoke that attached it to diamond-cut screw steering gear. NPS photo by Don Morris.

The third feature has been identified as the top of a rudder stock, which bears the yoke that attached it to a diamond-cut-screw steering gear (Don Morris, personal communication 1993; Figures 4.49–4.51). It consists of a worn wooden piece 12 in. in diameter clamped into an iron yoke, which is 10 in. wide. The iron yoke is composed of halves, connected by two iron fasteners on each side. Although there is no size comparison available, there are two pieces of evidence that support a *Dora Bluhm* association. First, the original contract for this schooner states that it was equipped with a diamond-cut-screw steering gear (JPSL 1883). Second, although not sampled for species identification, field observations by Morris indicate that the wooden portion of the feature, the top of the rudder stock, was hardwood, possibly oak. These two clues make this feature's association with *Dora Bluhm* likely. Unfortunately, this feature disappeared from the beach shortly after Morris recorded it in October 1988.

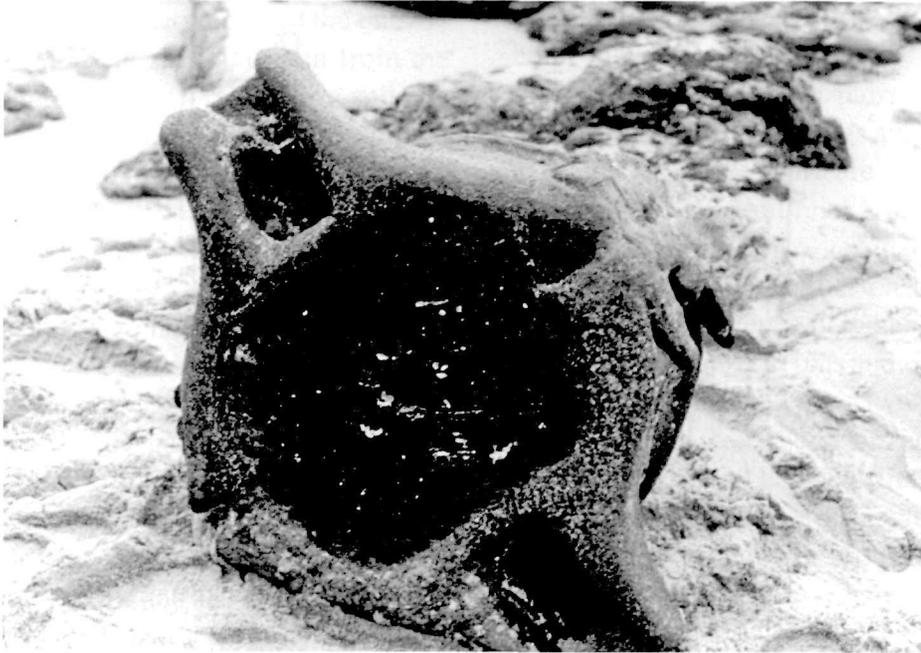
Figure 4.50. End view of the yoke attached to the end of a rudder stock.
NPS photo by Don Morris.

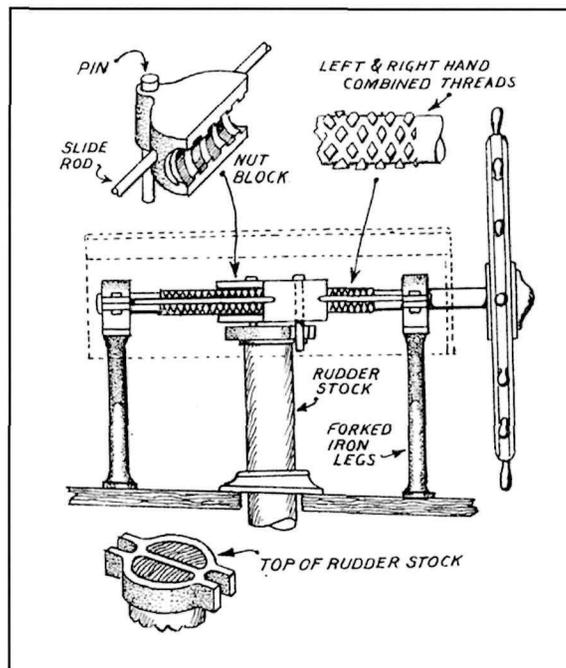
Figure 4.51. Top of rudder stock depicted with yoke that attached it to a steering gear (from Campbell 1974:127).

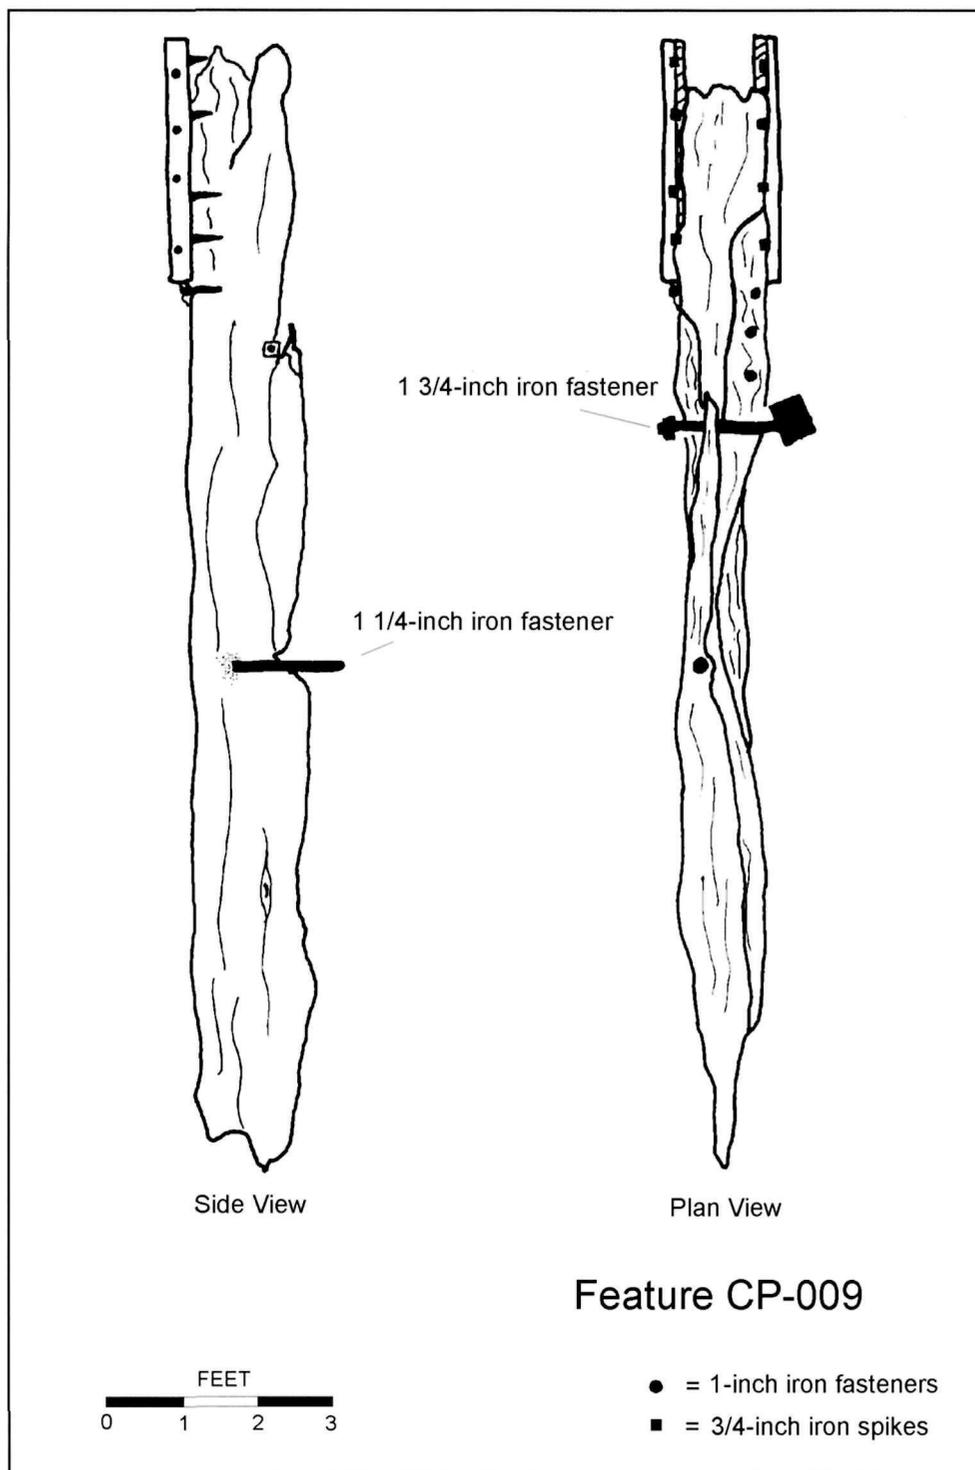
Figure 4.52. Feature CP-009, likely not part of *Dora Bluhm*. Drawing by Matt Russell.

The remaining discussion focuses on features recorded during 1993 fieldwork. All 22 elements and fragments analyzed and sampled were Douglas fir, so none could be discounted immediately, as with the Northwest Cove site (Puseman 1994:6–7). One timber, however, feature CP-009 (Figure 4.52), has a wooden component identified as a member of the Fabaceae family, probably ironwood (Puseman 1994:6–7). This is not a wood usually used in ship construction. The ironwood pieces are two narrow planks 3 ft. 2 in. long, 3½ in. wide and 3½ in. thick, which are fastened to either side of a large, extremely deteriorated Douglas fir timber measuring 14 ft. 8 in. x 17 in. x 16 in. As found, the ironwood planks are fastened along the timber's bottom edge, on the western end.

Four horizontal spikes, driven from the outside face and four vertical spikes, driven from the bottom, fasten each piece. Each iron spike is countersunk into the ironwood, and plugged with an ironwood plug. The main Douglas fir timber contains four vertical 1-in. diameter drift pins grouped near the ironwood planks; one 7/8-in. square spike; one 1¼-in. diameter vertical drift pin; and one horizontal 1¾-in. diameter bolt with a 1¾-in. square nut on one end, and a 6-in. square spacer on the other. The latter fastener's function is unknown, but it is not consistent with common late-nineteenth-century ship construction. This fastener arrangement, coupled with the relatively few fasteners in a timber this size and the unusual ironwood pieces, make this fragment's association with *Dora Bluhm* unlikely.

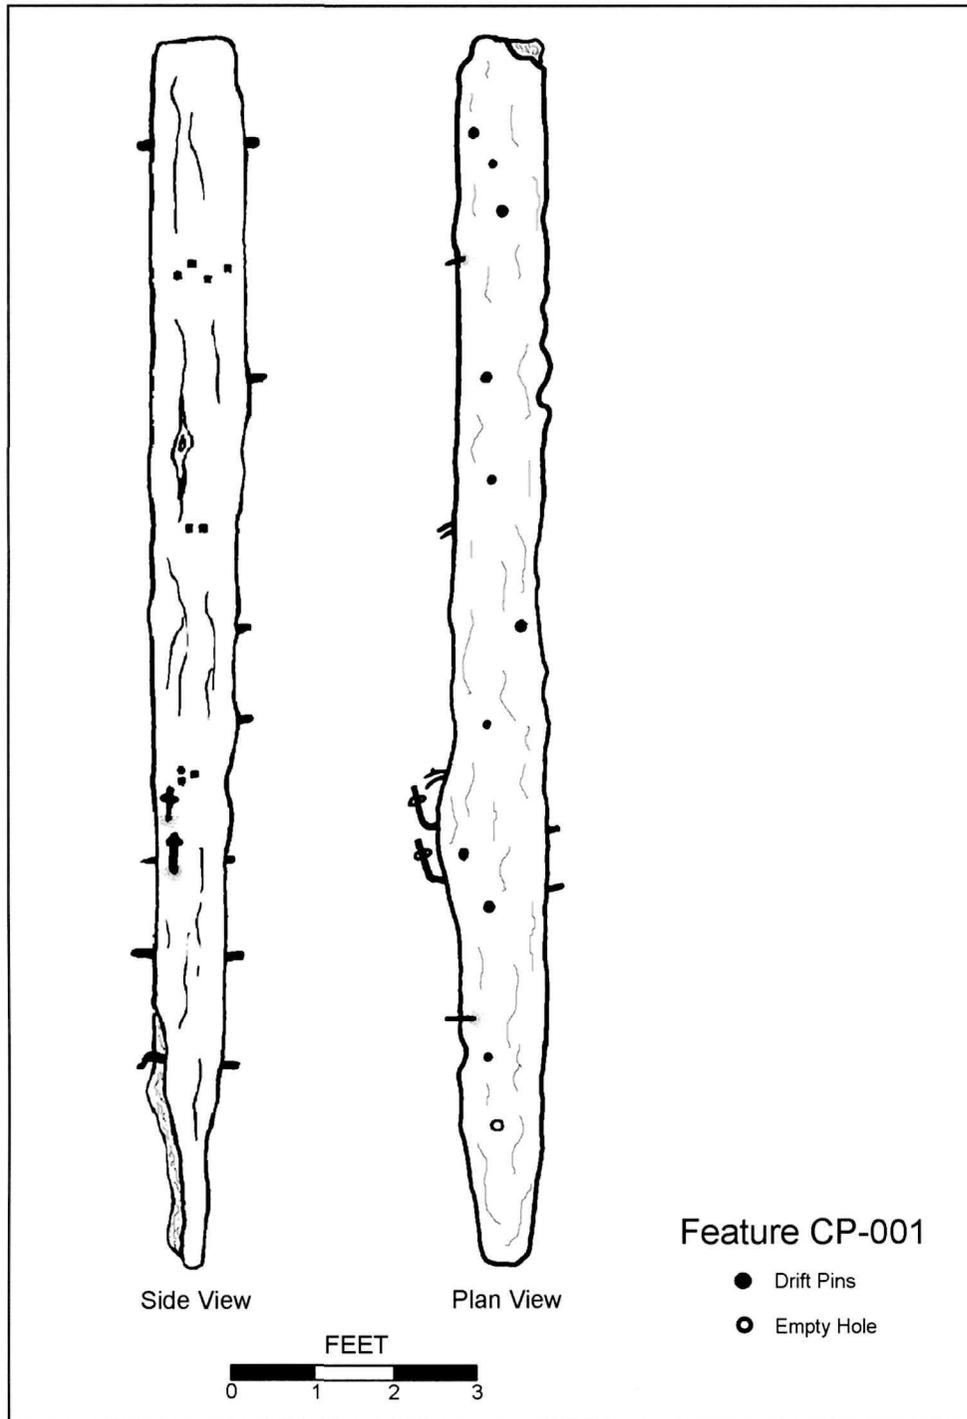
Figure 4.53. Keelson element with iron fasteners (feature CP-001). Drawing by Matt Russell.

Of the nine structural members, features CP-001, 010 and 012 are all similar Douglas fir elements with large, iron fasteners (Figures 4.53–4.55). The first (CP-001), heavily abraded and worn, is 14 ft. 10 in. long, with maximum dimensions of about 15 in. x 13 in. Both ends of the element are broken; original length is indeterminate. There are ten vertical, iron drift pins along its length, and there is an empty hole for an eleventh. Six drift pins are 1¼ in. in diameter (though slightly expanded by

corrosion), four measure 1 in. diameter, and the empty hole is 1 1/8 in. diameter. These fasteners are grouped roughly in pairs (including the empty hole): the paired pins are approximately 1 ft. apart, and the pairs are about 2 ft. apart. One pair has an additional 1-in. diameter drift between them. These vertical fasteners are broken close to the timber on both sides. In addition to the vertical fasteners, there are several transverse drift pins and spikes including four ½-in. square spikes and two ¾-in. diameter drift pins with 2-in. diameter (possible) clinch rings on one end. The two drifts are paired and 9 in. apart. The drifts protrude from the timber 7 in. on the ends with the clinch rings. There is no other evidence of fasteners on the timber's side faces.

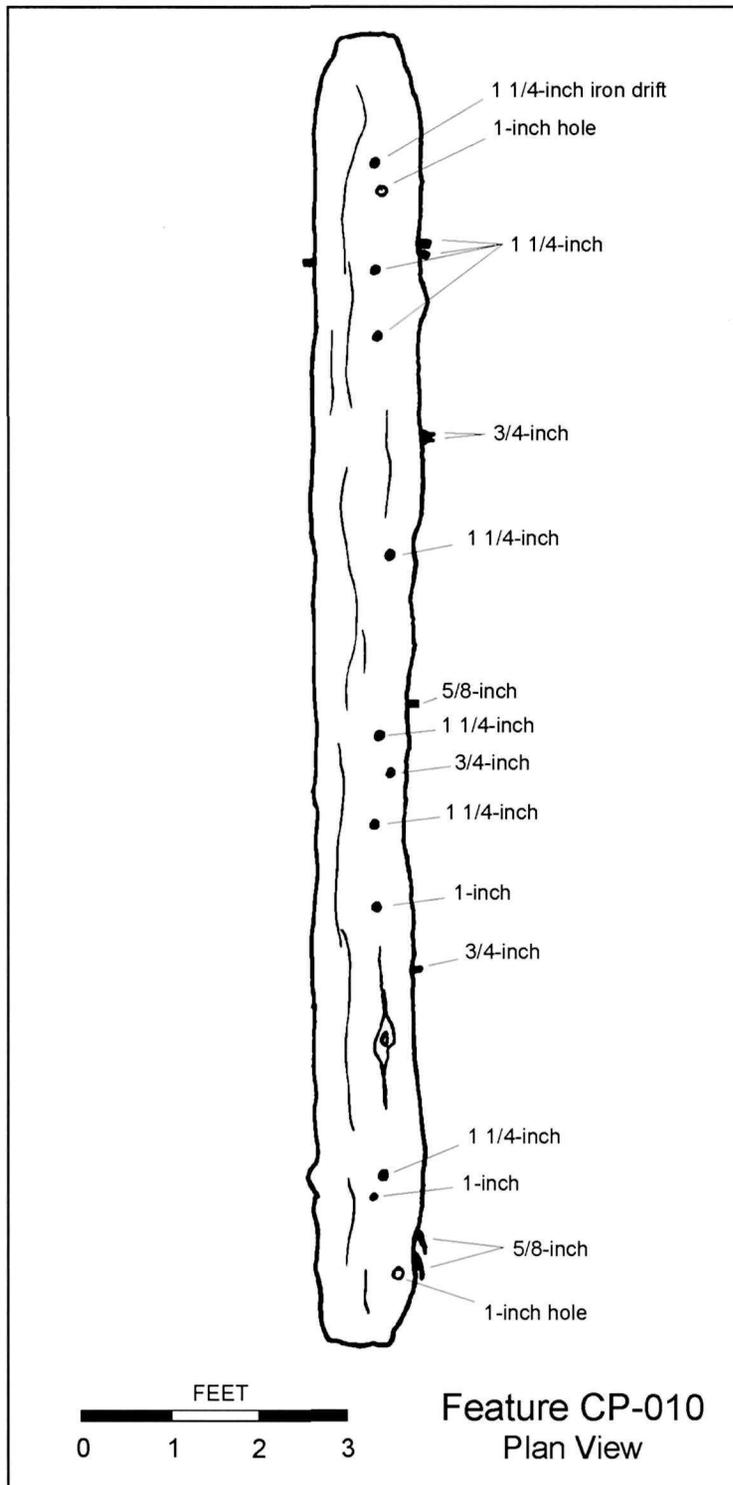
Figure 4.54. Keelson element with iron fasteners (feature CP-010). Drawing by Matt Russell

Feature CP-010 is 14 ft. 9 in. long (broken at both ends), with maximum dimensions of 15 in. x 11 in., though somewhat deteriorated, and contains ten vertical iron drift pins along its length, and holes for two more. These fasteners (and holes) include seven 1¼-in. diameter pins, four 1-in. diameter pins, and a single ¾-in. diameter pin. The element also contains transverse fasteners: a pair of 1¼-in. diameter drift pins; a pair of ¾-in. diameter drifts; a single 5/8-in. diameter drift; another, single ¾-in. diameter drift; and a pair of 5/8-in. diameter drifts. There is no discernible pattern to fastener spacing.

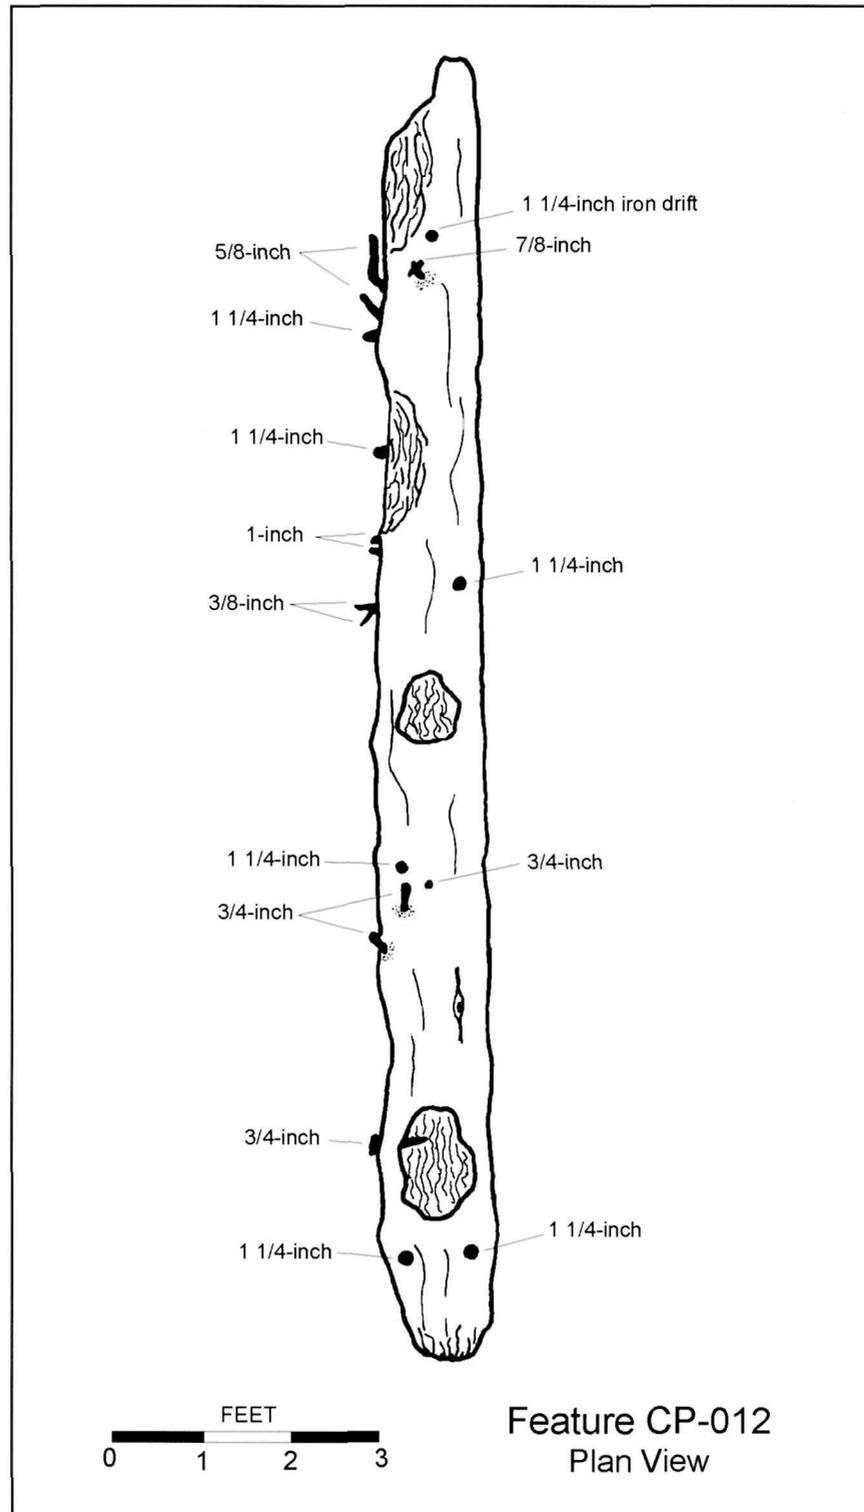
Figure 4.55. Keelson element with iron fasteners (feature CP-012). Drawing by Matt Russell.

Feature CP-012 is a similar element, measuring 14 ft. 3 in. long (broken at both ends), with maximum dimensions of 14 in. x 13 in., again with some deterioration. The most conspicuous features of this element, besides the fasteners, are two large holes penetrating all the way through the timber, apparently caused by some kind of differential deterioration. There are no large fasteners in or around these holes, so it is unknown if the deterioration was centered on iron drift pins, as seen in feature PB-001. Like the two previous features, CP-012 has

several vertical, as well as transverse, iron fasteners. The vertical fasteners include five 1¼-in. diameter drift pins, three ¾-in. diameter drifts, and a single 7/8-in. diameter bolt with a 1-in. square nut on the end. The transverse fasteners consist of two 5/8-in. diameter round drifts, two 1¼-in. diameter drifts, two 1-in. diameter drifts, two 3/8-in. diameter round spikes, and a single ¾-in. diameter round drift.

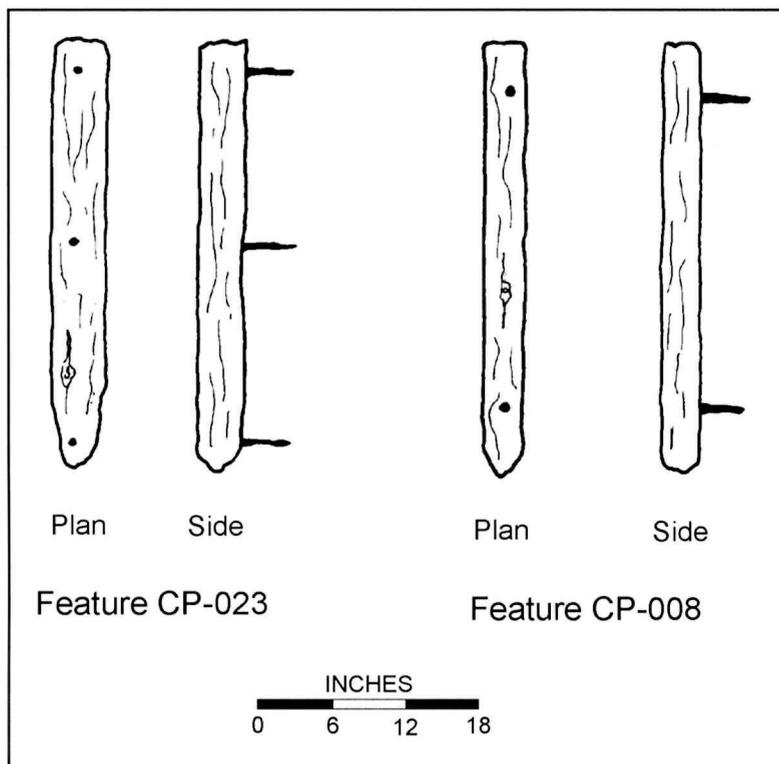
Figure 4.56. Deck planking elements with iron fasteners. Drawing by Matt Russell.

Two features that may represent small portions of structural members are features CP-008 and CP-023 (Figure 4.56). Both features are 3 ft. long and nearly square in cross-section. Feature CP-008 is 3½ in. wide and ¾ in. thick; all its faces are extremely worn. It contains two round spikes 2 ft. 2½ in. apart. One is ¾ in. diameter and the other is 7/8 in. diameter, though both are exfoliating badly. Feature CP-023 is slightly more than 4 in. wide and 3 7/8 in. thick; all its faces are also very worn. It contains three iron spikes, all ½ in. diameter. The first and second spikes are spaced 1 ft. 2 in. apart, and the second and third are 1 ft. 5 in. apart.

Dora Bluhm's contract calls for 4-in. x 4-in. main-deck planking (JPSL 1883). With deterioration taken into account, either element could be a piece of main-deck planking. Fastener spacing cannot be used as an indicator for identification of these features because it is possible that spikes were fastened into carlins or lodging knees and not only into deck beams. The fasteners may have been countersunk and plugged, which is typical practice for main-deck planks; the plugs have since disappeared and the face deteriorated enough to hide traces of countersinking. It is probable that features CP-008 and CP-023 represent portions of the main-deck planking of *Dora Bluhm*.

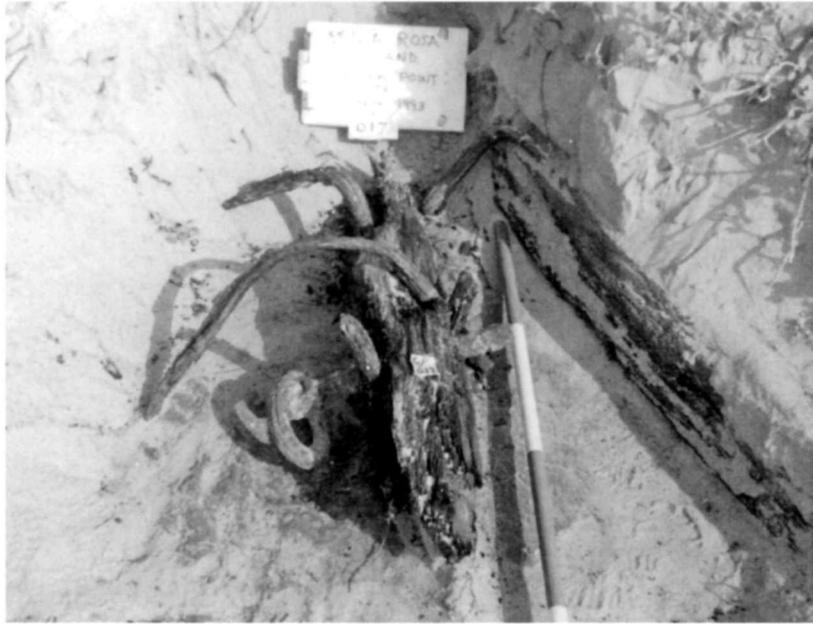
Figure 4.57. Unidentified element with large iron fasteners. NPS photo by Matt Russell.

Feature CP-017 is also a structural member from a large, wooden sailing vessel (Figure 4.57). The extremely deteriorated wood element is 3 ft. 4 in. long, 7 in. wide and 10 in. thick. It contains, however, five 1½-in. diameter iron drift pins (the longest 3 ft. long), and a 2-in. diameter iron eye-bolt with a 6½-in. outside diameter ring attached. The eye-bolt and ring represents a tie-down point, which could have been placed in many locations on the vessel. The five fastener's original measurements were considerably smaller, accounting for expansion caused by iron corrosion. The largest fasteners required in the *Dora Bluhm* contract were 1 1/8-in. drifts for the keel, keelson, stempost and sternpost. Feature CP-017 likely represents a small portion of any of these components.

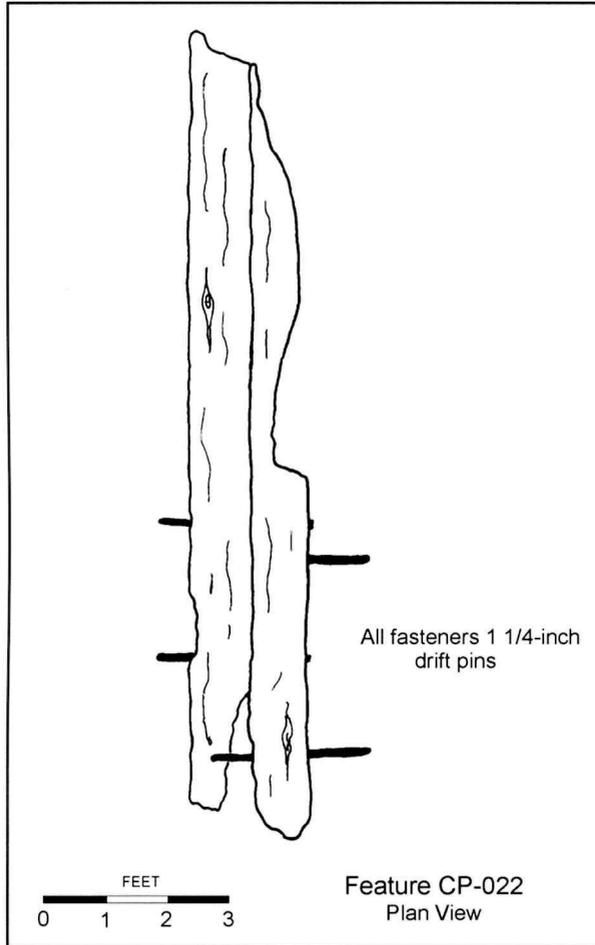
Figure 4.58. Fragment of the centerboard trunk (feature CP-022). Drawing by Matt Russell.

Another probable structural member of *Dora Bluhm* is CP-022 (Figure 4.58). This

fragment is composed of two timbers, each with an original width of 12 in. and surviving lengths of 12 ft. 10 in. The timbers are edge-bolted together with four 1¼-in. diameter drift bolts. The four fasteners originally edge-bolted at least two more timbers to the two surviving pieces, one on each side. The timbers have a present thickness of 5 in., but the undersides are extremely deteriorated, so they were originally thicker. The fasteners are slightly expanded, so they were probably originally 1 or 1 1/8 in. diameter.

to every frame. Another possibility, since *Dora Bluhm* was built with a centerboard, is that feature CP-022 is a portion of the centercase. The vessel's contract specifies the centercase was to be constructed of 8-in. thick timber and fastened with 1-in. iron (JPSL 1883). With the severe deterioration on the underside of this feature, these timbers may have originally been 8 in. thick. The fasteners also may have originally been 1 in. diameter. Furthermore, the centercase would have been entirely edge-fastened, which CP-022 clearly displays (Barkhausen 1990:11–12). This feature can be distinguished from the centerboard itself, which would have been more heavily fastened. Therefore, feature CP-022 is most likely a portion of the centercase, or centerboard trunk, of *Dora Bluhm*.

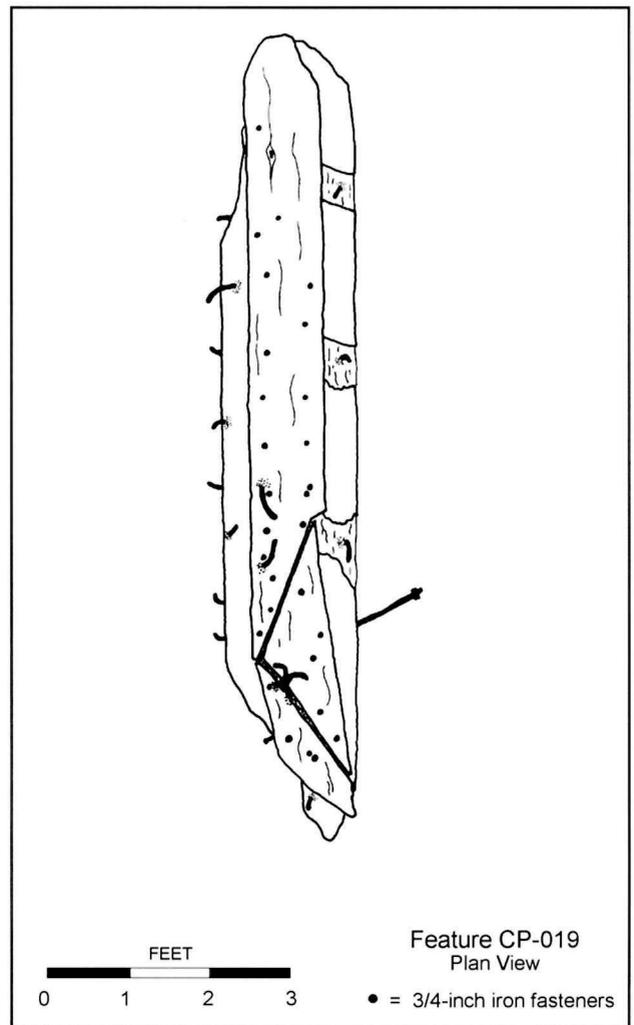
Figure 4.59. Feature CP-019. Drawing by Matt Russell.

Feature CP-019 is an oddly shaped fragment that exhibits characteristics that are clearly from a large, wooden vessel (Figure 4.59–4.60). The feature is sizable and contains 47 iron fasteners,

all of which are $\frac{3}{4}$ -in. diameter round drifts. The fragment is composed of two pieces: a large, lower timber with three mortises along one edge, and a top portion made up of three different sections. These segments include a long element joined to a smaller element by a triangular chock. These three sections are fastened to the lower timber by 33 fasteners. The bottom part of the feature is 9 ft. long, 18 in. wide and 12 in. thick. The top timbers are $10\frac{1}{2}$ in. wide and 3 in. thick. Like most of the other features, both ends are broken, so original length and configuration is unknown.

Dora Bluhm's contract does not go into sufficient detail to identify this feature based on the size of fasteners alone. This is clearly a unique piece, however, and could not have been incorporated into very many places on a sailing vessel. In addition, its size and number of fasteners denote a major structural function. The mortises suggest beams were fitted into the side of the timber, making that piece a deck shelf.

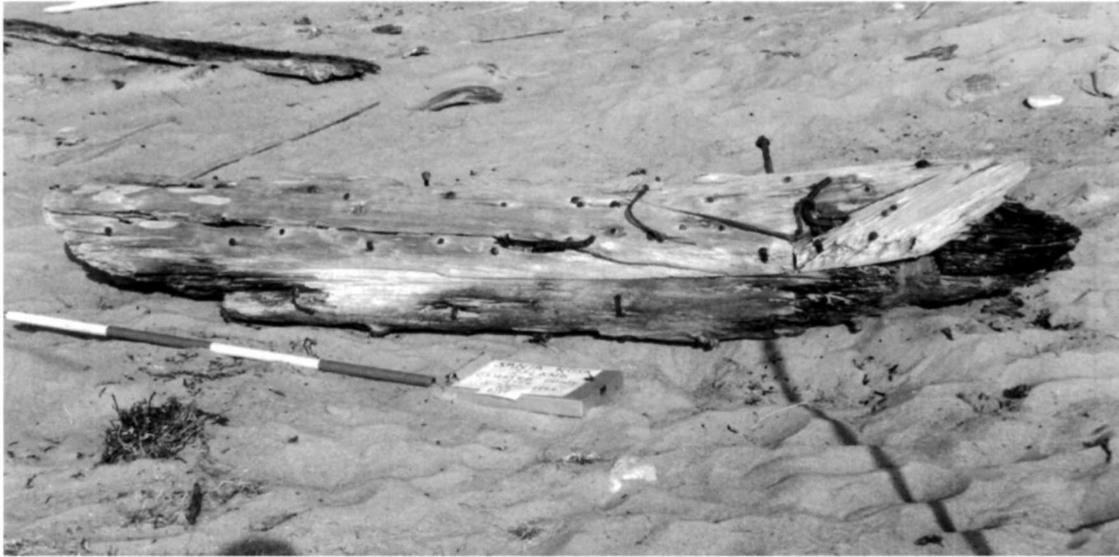
Figure 4.60. Feature CP-019. NPS photo by Matt Russell.

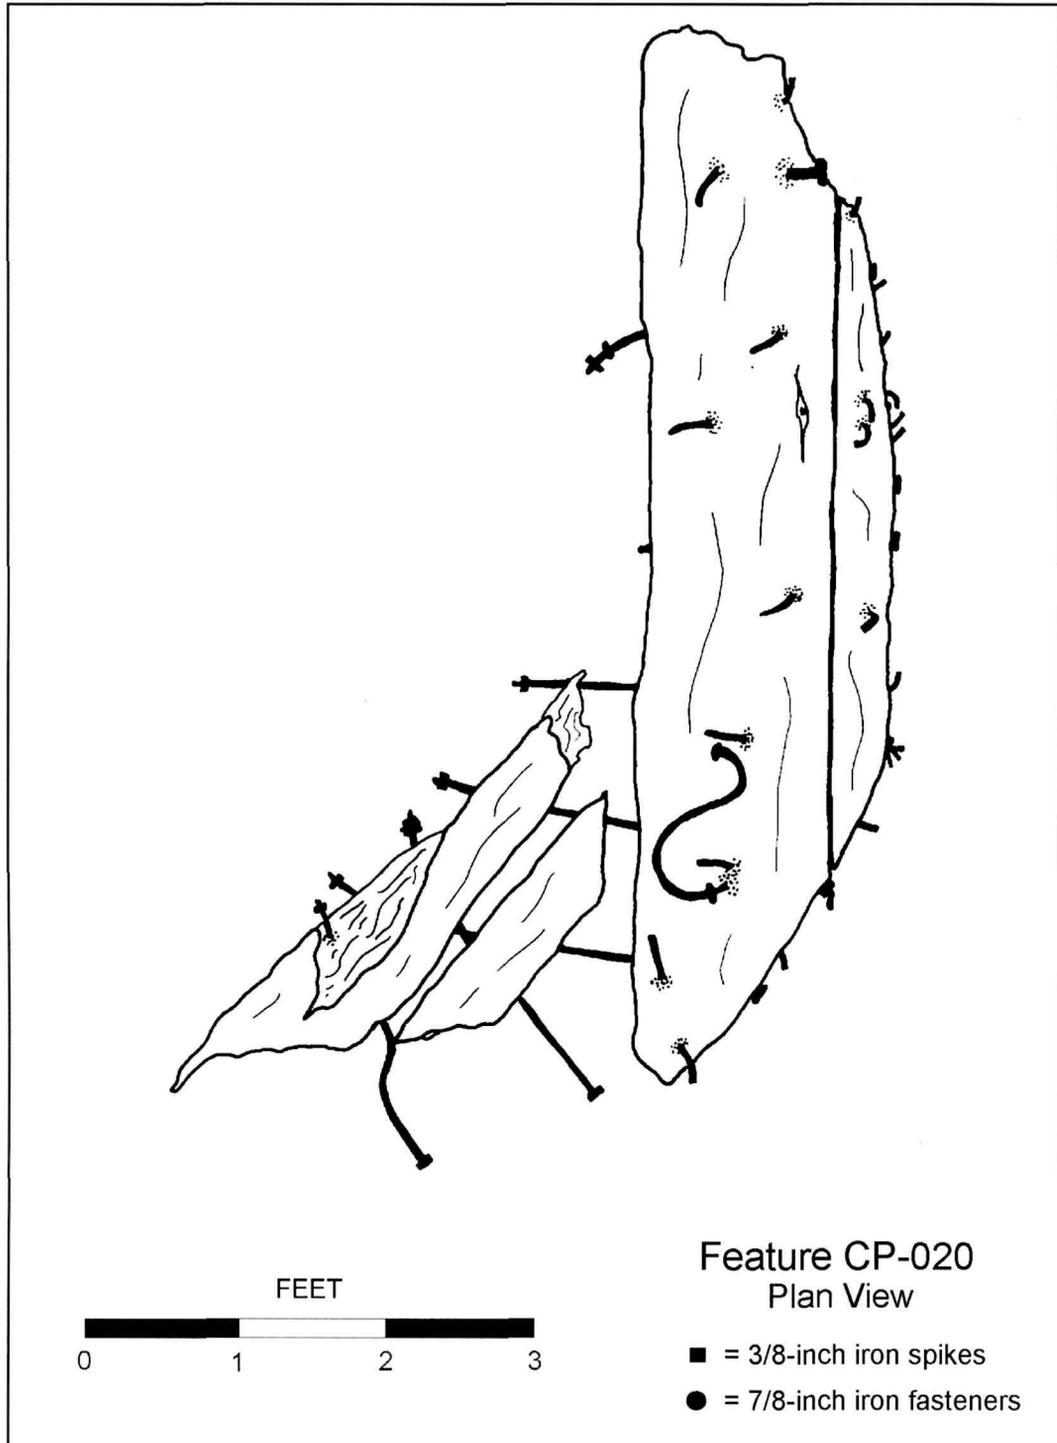
Figure 4.61. Feature CP-020. Drawing by Matt Russell.

The last structural member discussed is feature CP-020 (Figure 4.61–4.62). It is a relatively flat fragment with a uniform thickness of $8\frac{1}{2}$ in. The main timber is 7 ft. 3 in. long (though broken at the ends) and 1 ft. 9 in. wide; a smaller 4-ft. x 1-ft. 4-in. fragment is fastened to it at an angle. The feature contains nineteen $\frac{3}{8}$ -in. square spikes and seventeen $\frac{7}{8}$ -in. diameter drifts. Timber and fastener configuration suggest this piece represents a portion of the "rim" of a large, wooden vessel, while the smaller fragment attached to it is a component known as the anchor stock (Curtis 1919: 66). The rim circled the stern of the vessel

and formed the knuckle line, or main-deck line. The rim was generally composed of three sections joined by two chocks called anchor stocks. The upper ends of the stern frames ended at the bottom of the rim, and the solid work was directly above it. It was a major stern structural element.

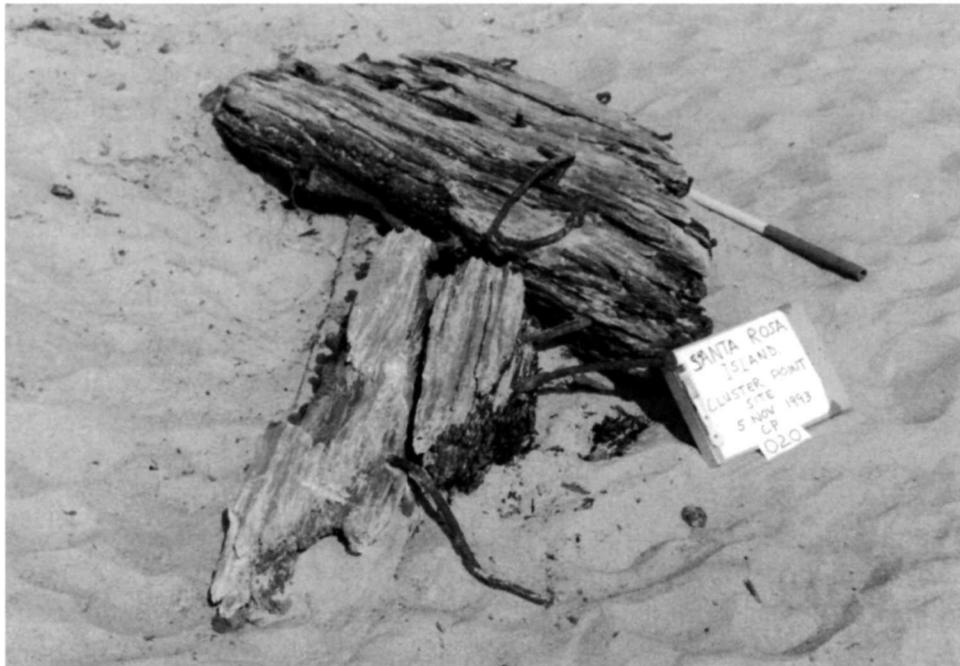
Figure 4.62. Feature CP-020. NPS photo by Matt Russell.

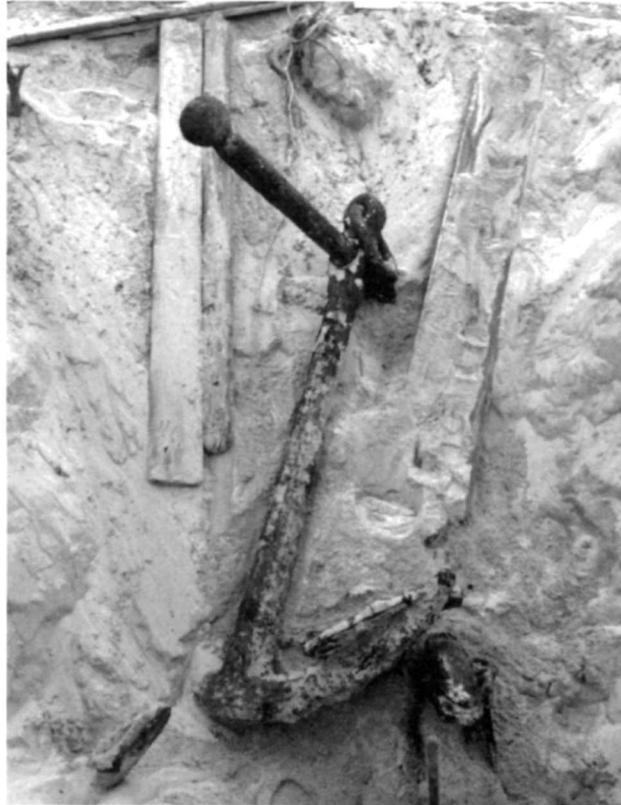
Figure 4.63. *Comet's* anchor after exposure in 1993. NPS photo by Matt Russell.

Although 1993 fieldwork exposed little of *Comet's* remains, it was possible to completely expose and record the anchor. *Comet's* anchor is iron with a collapsible iron stock (Figures 4.63–4.65). The anchor is fitted with a ring, but no cable is present. Overall length is 7 ft. 11 in.; stock length is 7 ft. 9½ in. Anchor arms are 3 ft. long, with 5 ft. 6 in. between palm tips. The palms measure 1 ft. 3¾ in. wide x 1 ft. 6 in. long, and 1¼ in. thick.

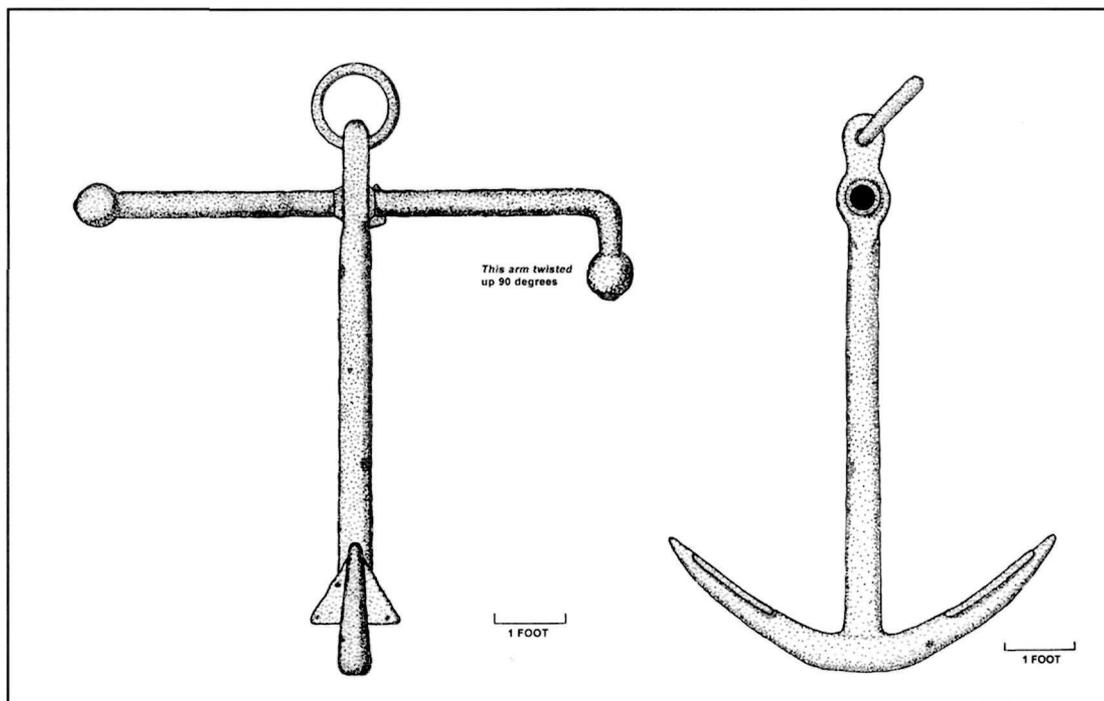
Figure 4.65. *Comet's* anchor. Drawing by Matt Russell.

tonnage (Paasch 1890:151). Calculating an anchor's weight can determine what role it played on a vessel. The *Cyclopaedia of Useful Arts* (1854) provides a formula for estimating anchor weight (in hundredweights [cwt] = 110 pounds): $cwt = \text{overall length}^3 \times .0114$ (Murphy 1993:288). Using this formula, *Comet's* anchor weighs approximately 5.6 cwt or 616 lbs. A table of minimum anchor weights for sailing vessels found in Desmond (1919[1984]) shows a 400-ton vessel (*Comet* registered 429 gross and 368 net tons) was required to carry two 1,850-lb. bower anchors, a 600-lb. stream anchor and a 300-lb. kedge anchor. The anchor found on *Comet* most likely represents its stream anchor.

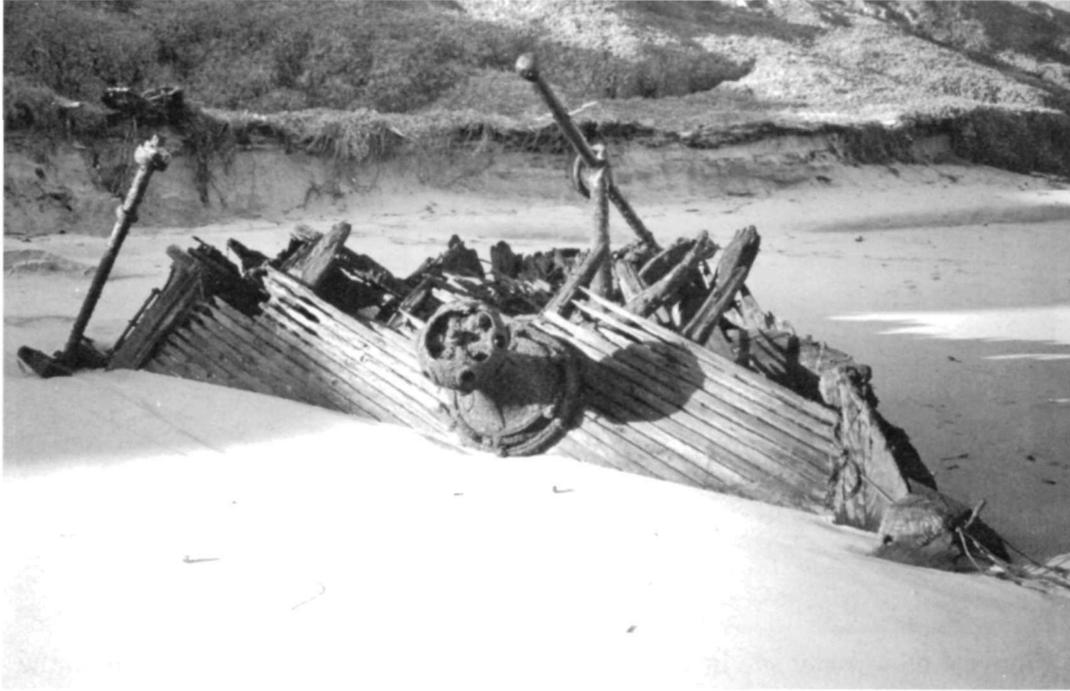
Figure 4.66. *Comet's* bow section looking down at forecastle deck. NPS photo by Matt Russell.

approximately 10 m x 8 m. The nearly intact bow section points out to sea on a heading of 317° magnetic, and the bow is heeled 55° to starboard and tilted down 20°. Much of the bow's port side has been worn away by natural deterioration (Figures 4.66–4.69).

The starboard side of the forecastle deck is intact from the bow to the deck's aft end above the windlass (Figure 4.80; also Figures 4.66 and 4.69). Forecastle deck remains are supported by five deck beams; the three forward-most beams are 5½ in. sided, and the two aft beams,

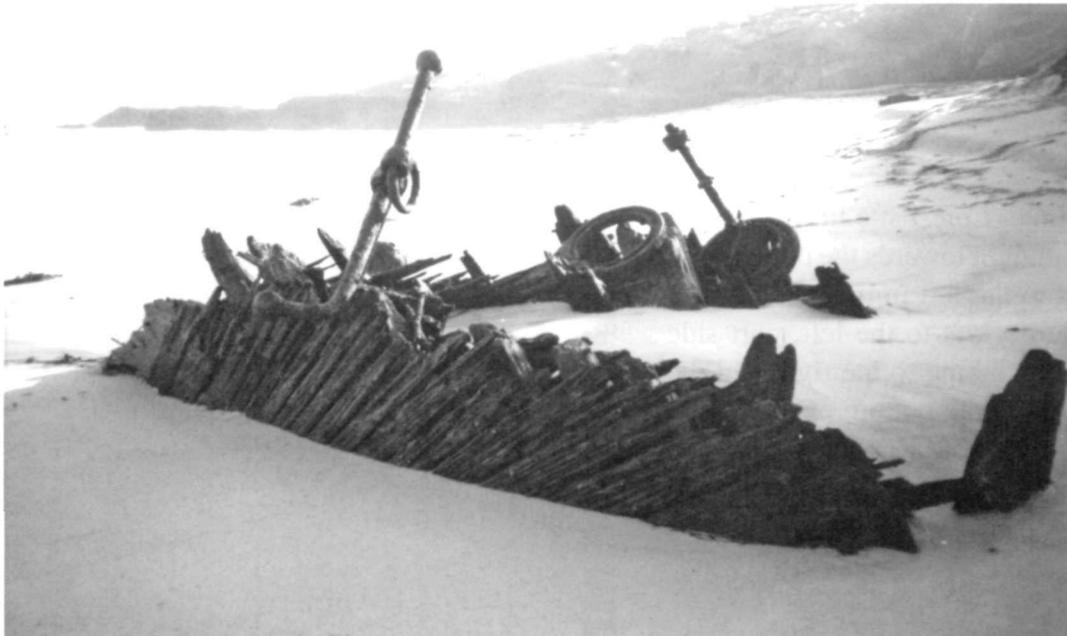
Figure 4.67. *Comet* site in April 1999, looking at the port side outer hull timbers. NPS photo by Matt Russell.

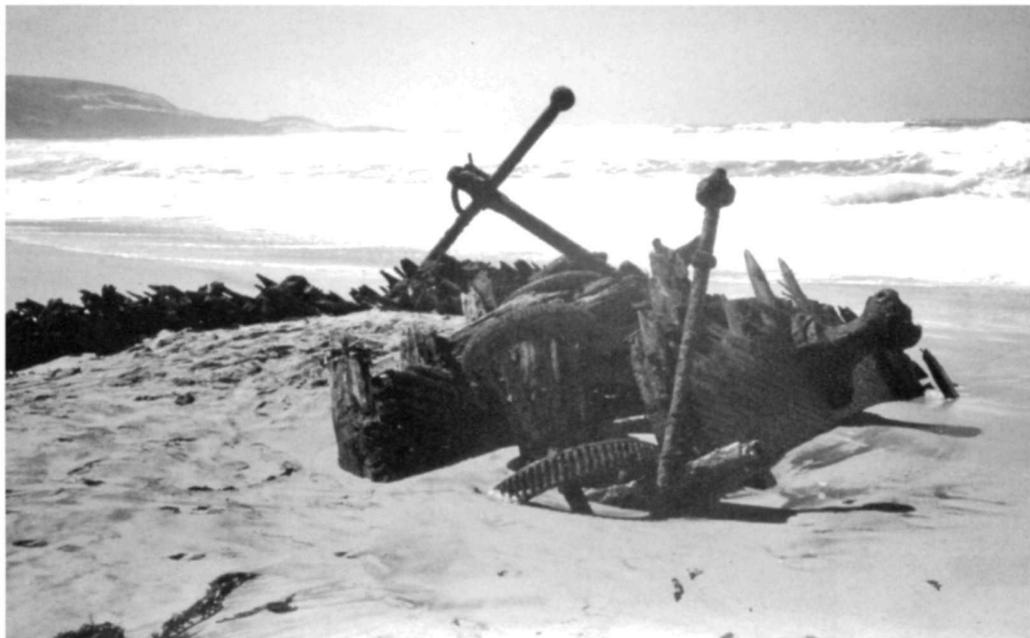
Figure 4.68. *Comet* site in 1999, looking towards the windlass (mounted on the main deck) in the center of the photo, with the capstan (mounted on the forecastle deck) to the right. NPS photo by Don Morris.

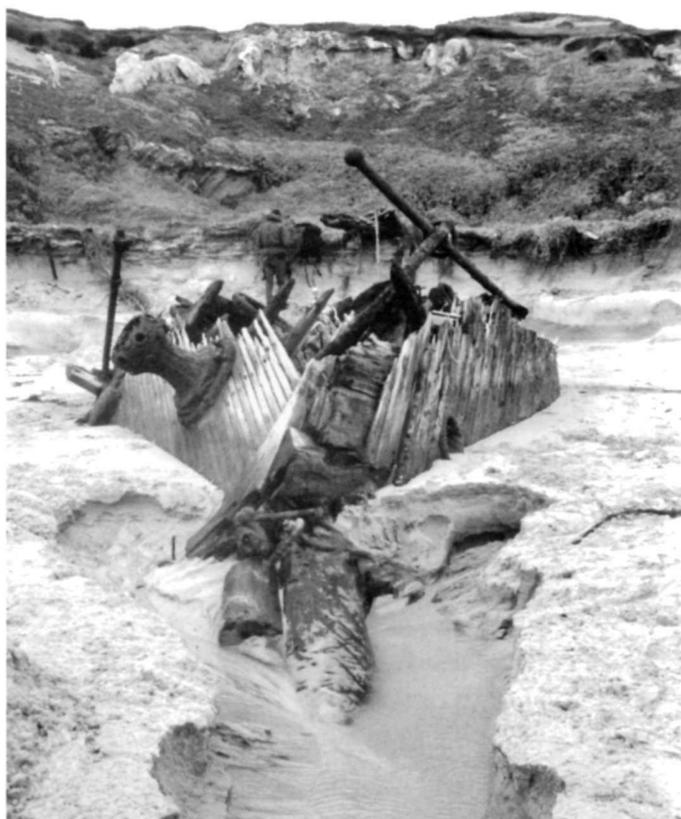
Figure 4.69. *Comet* site in April 1999, looking straight towards the bow, which is canted to the left in this photo. The forecastle deck is to the left, port side outer hull planking to the right and the bowsprit is in the bottom of the photo. NPS photo by Matt Russell.

Comet's bowsprit is present and appears to be completely intact, though its outboard end, called the head, could not be uncovered. The bowsprit heel is stepped into a 6-in. wide x 10-in. high x 7-in. deep notch in the pawl post's forward face. At the heel, the bowsprit is 10 in. high x 1 ft. 7 in. wide (the width of the pawl post). A filler piece is fitted below the bowsprit heel between the bowsprit and the main deck. This filling timber is 9 in. thick, with an exposed length of 6 ft. 9 in. (its forward end was buried beneath the sand). The forward-most section of the bow, between decks, is buried in the sand, so the point where the bowsprit exits the hull could not be examined, however, the bowsprit presumably passes on top of the stempost and between the knightheads. Forward of the bow, the bowsprit transitions from a square cross-section to a rounded cross-section, and most likely begins to taper (Figures 4.69 and 4.75–

As noted above, *Comet*’s bowsprit is intact and in its original position (Figures 4.69, 4.70 and 4.75–4.77). On a wooden sailing vessel, the bowsprit, a spar that projects forward from
