Beached Shipwreck Archeology: Case Studies from Channel Islands National Park

Submerged Resources Center
Professional Reports
Number 18

Submerged Resources Center
Intermountain Region
National Park Service

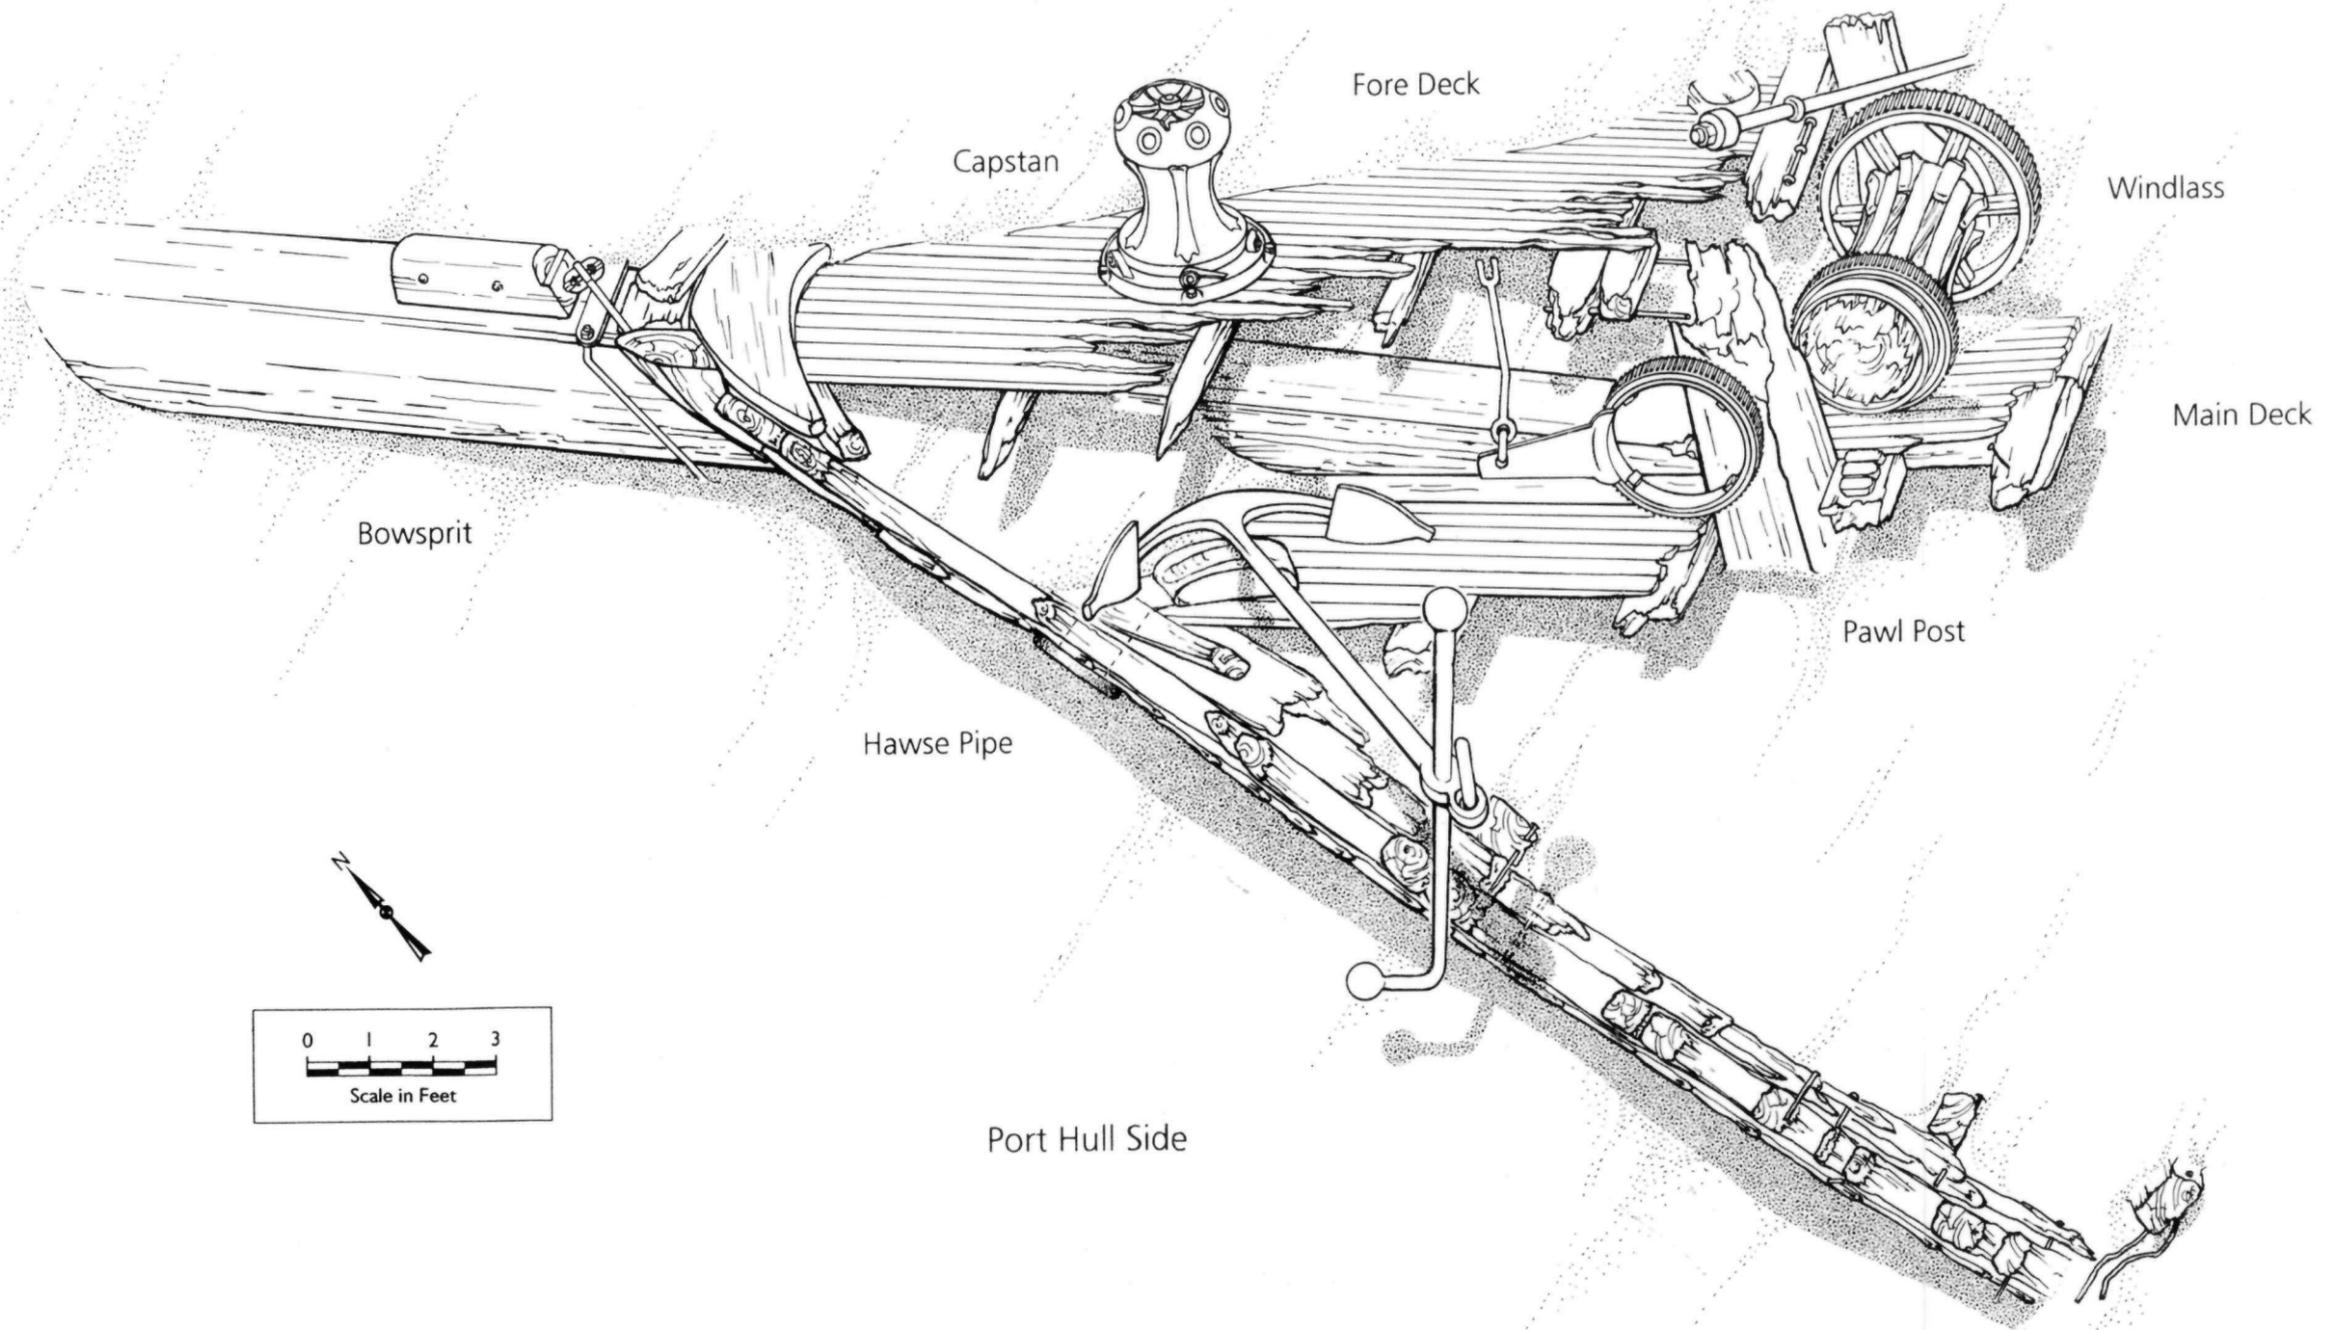
Figure 4.70. *Comet* site plan. Field drawing by Matt Russell; final drawing by Robert Turner.

Nearly all *Comet's* original bow structure and related features are represented on the site (Figure 4.70). Exposed structural elements include port-bow framing and outer-hull planking; the partially intact forecastle deck and forecastle-deck beams; the partially intact main deck and main-deck beams below the forecastle deck; the pawl post (sometimes called a pawl bitt or Samson post) extending through the main deck and broken off at the forecastle-deck level; the bowsprit, extending from where it is stepped into the pawl post's forward face to about 19 ft. forward of the bow; the forecastle- and main-deck deck-hooks and waterway hooks; and several bow pointers. Other features present

The final structural members discussed are two timbers in the site's southwest corner, rising vertically out of the sand inside the ceiling planks (Figure 4.70). At the deepest exposure, about 2 ft. of these timbers were visible. The aft-most timber measures 1 ft. 2 in. x 9 in., and has two 7/8-in. diameter iron fasteners in it. The forward-most of these two timbers measures 11 in. x 7 in. These structural timbers are likely pointers, placed in the bow and stern angled down diagonally in their normal upright position (Figures 4.85 and 4.86). According to Curtis (1919:101), pointers are used to “. . .furnish additional stiffening to the hull at the locality where the pointer is placed, to aid in resisting panting movements and stresses, and . . . to add additional strength against torsional strains such as are experienced at the ends of a ship when rolling heavily at sea.” Pointers are fastened at a 45° angle atop the ceiling planks and into the cant frames, and they extend from the lower part of the hull upwards to the first, or in *Comet's* case, main deck (*Great Lakes Register*

As noted above, *Comet*’s bowsprit is intact and in its original position (Figures 4.69, 4.70 and 4.75–4.77). On a wooden sailing vessel, the bowsprit, a spar that projects forward from

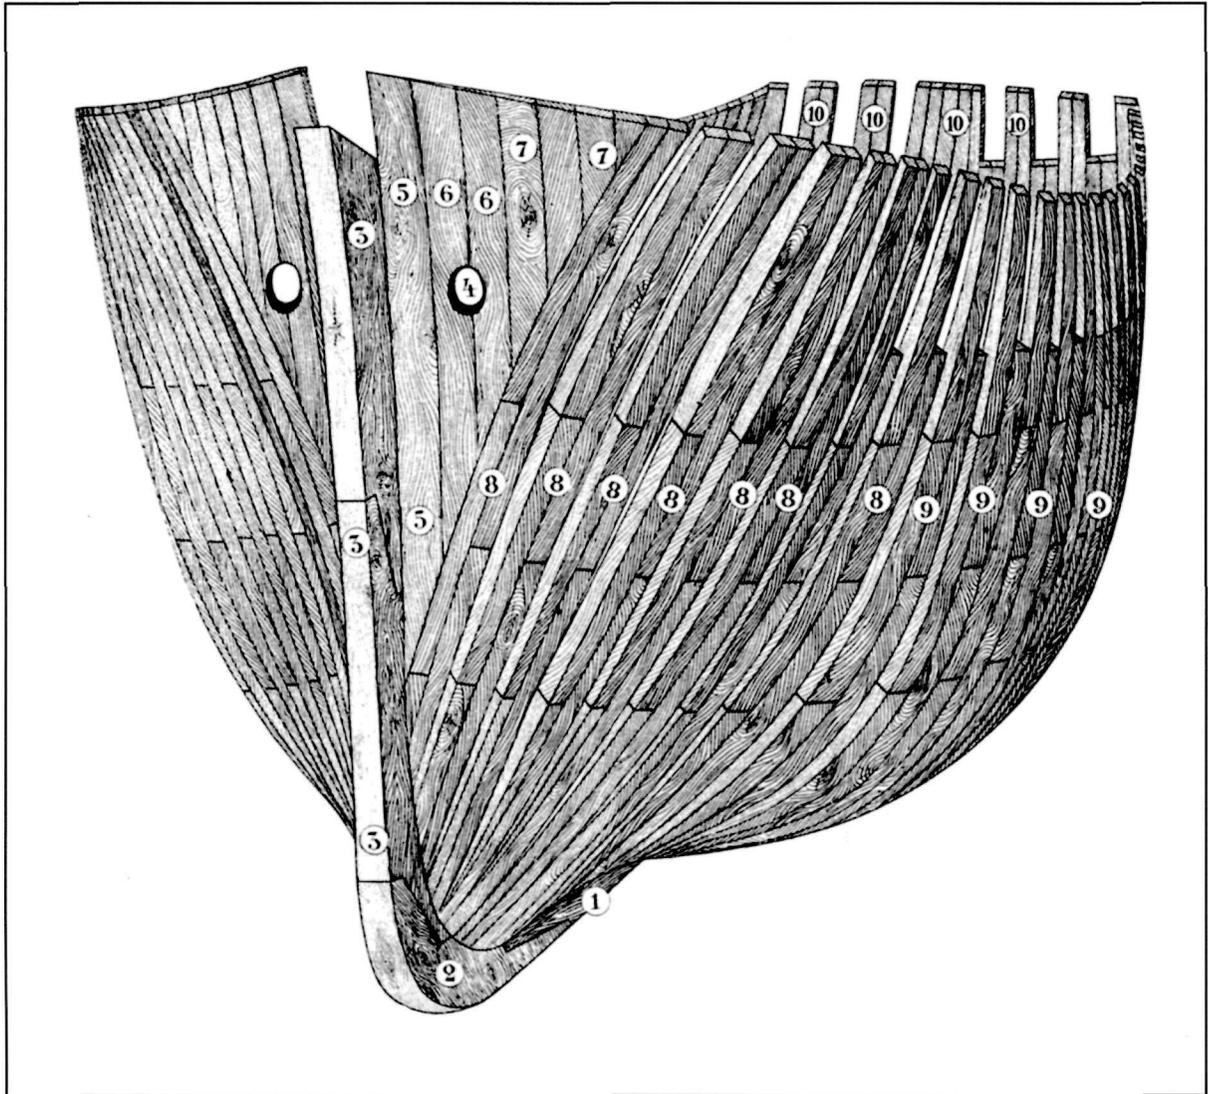
Figure 4.71. Bow framing, including stempost (3), knighthead (5), hawse timbers (6) and cant frames (8) (from Paasch 1977:plate 5).

Bow framing in a wooden vessel of this period includes cant frames, hawse timbers, knightheads, and the stempost (Figures 4.71–4.73). Cant frames are frame pairs, made up of futtocks and top timbers (futtock heels are notched into the bow deadwood, so there are no floors) that are rotated forward of perpendicular to the keel to create the vessel's bow form. Forward of the cant frames are hawse timbers, which solidly fill the space between the cant frames and knightheads. A vessel's hawse pipes pass through the hawse timbers, which provide a solid foundation for fastening the hawse pipe flanges. The knightheads are timbers located on both sides of the stempost and extend above it to support the bowsprit, which rests atop the stempost and between the knighthead timbers (Desmond 1919[1984]:50, 55).

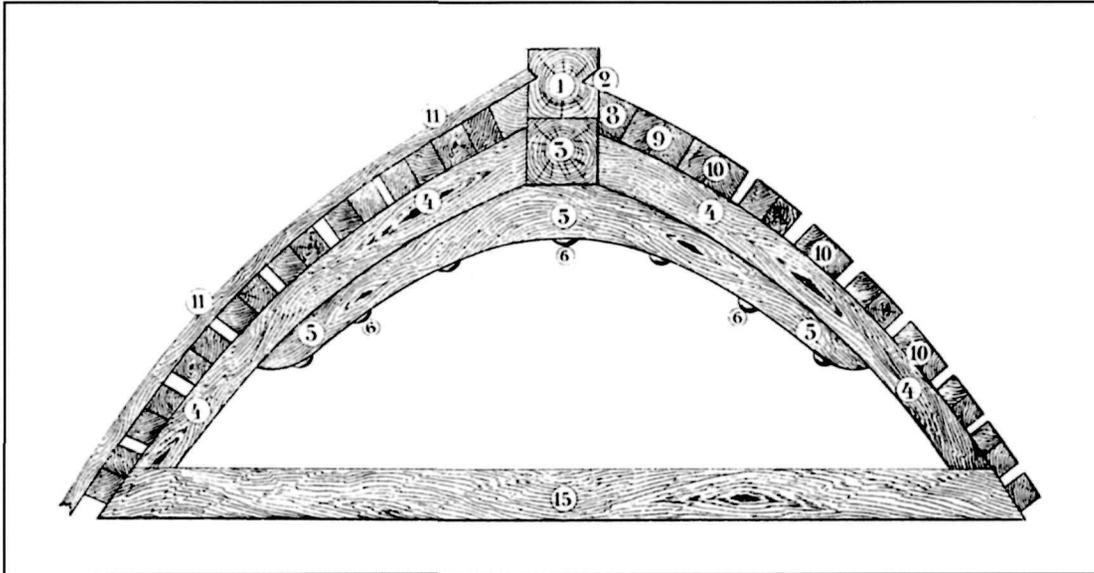
Figure 4.72. Bow framing, including stempost (1), knighthead (8), hawse timbers (9) and cant frames (10). Additional features observed on *Comet* include the deck hook (5), deck beams (15) and outer hull planking (11) (from Paasch 1997:plate 15).

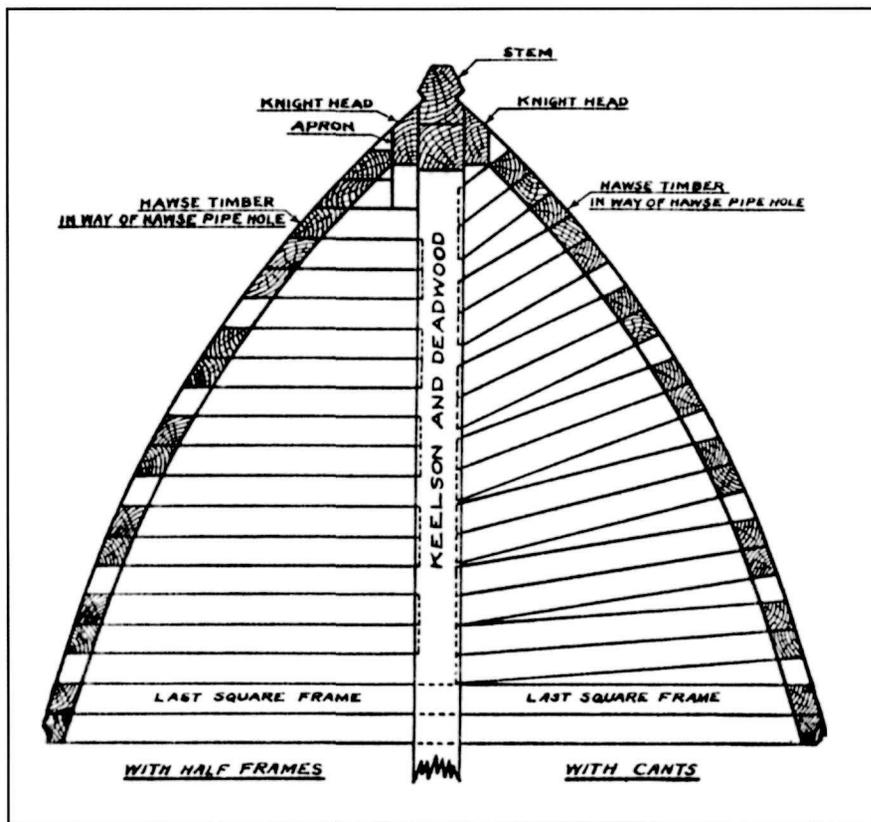
Figure 4.73. Bow framing, showing difference between cant frames and half frames (Curtis 1919:58).

Although it was difficult to verify because of limited access and complex angles involved, the five frame pairs are most likely all cant frames as opposed to half frames (Figure 4.74 and see Figure 4.73). At their greatest exposed dimension, each frame measured 9½ in. sided and 10 in. molded. Each frame's molded dimension at the top, approximate main-deck level, was 8 in. *Comet's* contract specifies frames as sided 10 in. and molded 13 in. at the keel and 6½ in. at the deck (JPSL 1886). *Rules for the Construction of Wooden Vessels* stipulates a 400-ton vessel built of "yellow fir" should have top timbers (frames at deck-level)

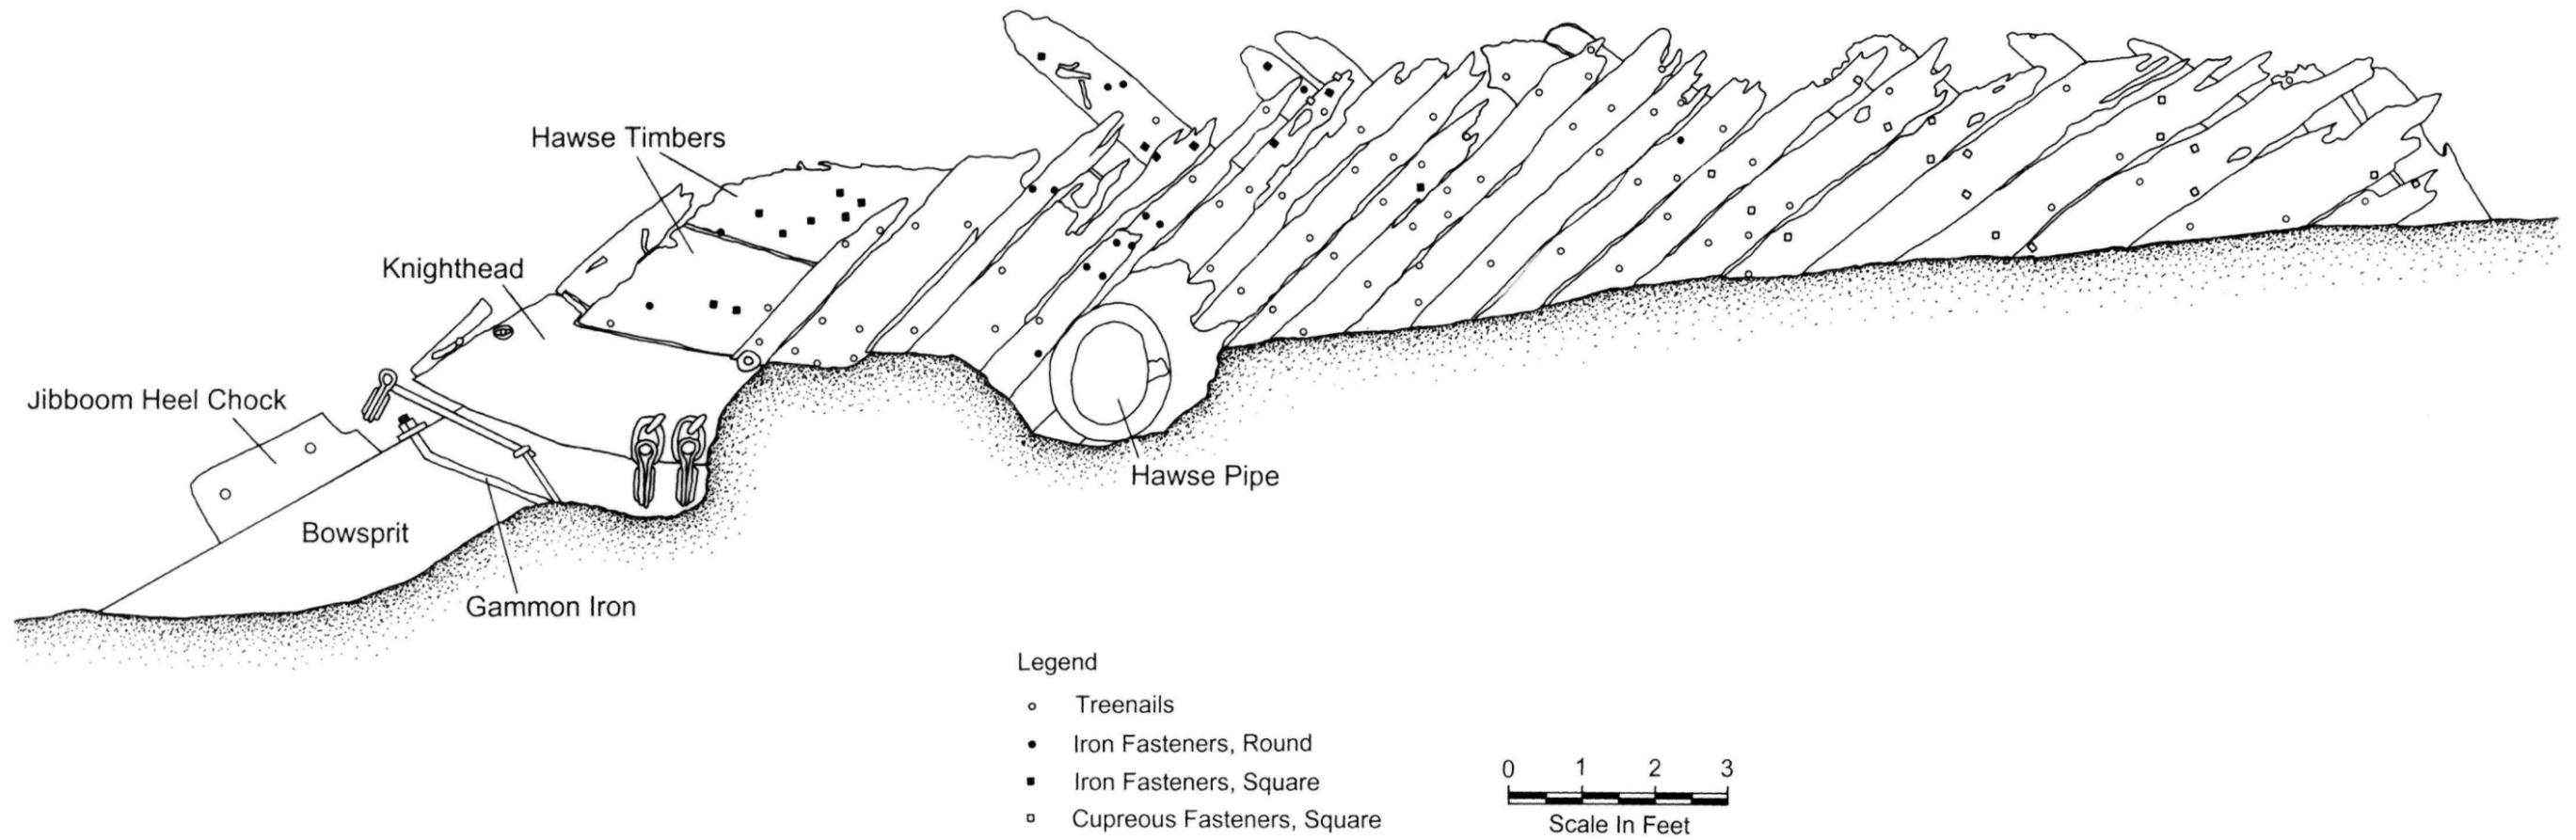
Figure 4.74. *Comet* port elevation drawing. Drawing by Jim Bradford; inked by Nancy Lamm.

Forward of the frame pairs are two hawse timbers, or hawse pieces (Figure 4.75; see Figure 4.74). These timbers “. . . close the openings between forward cant frames from the knightheads aft as far as necessary to give good solid fastening for hawse-pipe flanges. The lower ends of hawse timbers are bolted to the apron and the several hawse timbers are edge-bolted together . . .” (Desmond 1919[1984]:55). The hawse pieces are 6 in. molded and 2 ft. sided, though their sided dimension appears to narrow over their length, and the aft hawse piece is eroded on its aft side, making an accurate original sided dimension difficult to measure. The top edge of the hawse pipe is located 5 ft. 5 in. below the upper surface of the hawse timbers.

Forward of the hawse timbers is the port-side knighthead (Figures 4.76 and 4.77; see Figure 4.74). The knightheads strengthen the bowsprit and support the hooding ends, which are the forward ends of the outer hull planks (Desmond 1919[1984]:50). The knighthead is rhomboid in shape, with each side varying slightly between 1 ft. 2 in. and 1 ft. 3 in., and its shape narrows and curves over its length. Neither hawse timbers nor knightheads are mentioned in *Comet's* contract, but the *Rules for the Construction of Wooden Vessels* states that knightheads and hawse timbers should have double the sided dimension of the frames (American Shipmasters' Association 1879:xxi). *Comet's* hawse timbers are sided more than double the frames' sided dimensions, and the port knighthead, if measured on the diagonal, also follows this specification. The starboard knighthead and stempost were buried in the sand beneath the bowsprit and neither was observed.

A total of 21 outer hull planks were recorded, varying in width from 5 in. to 1 ft. 2 in. and from 1 to 2 in. thick (Figure 4.74). *Comet's* contract states planking should be 4 in. thick, while *Rules for the Construction of Wooden Vessels* specifies it should be 3½ in. thick (JPSL 1886; American Shipmasters' Association 1879:xxviii). Erosion likely accounts for the difference between *Comet's* outer hull planking thickness and the thickness recorded in historical documents. Outer hull planks were fastened to the frames with a combination of treenails, round iron fasteners, and square iron and cupreous spikes, which conforms to outboard fastenings specified in the contract (JPSL 1886). Two strakes overlay the outer hull planking directly above the hawse pipe, creating a double layer of planking. This feature is undocumented in contemporary historical records, and how common a construction practice this was in Pacific Coast lumber schooner shipbuilding is unknown. The ends of eight ceiling planks were

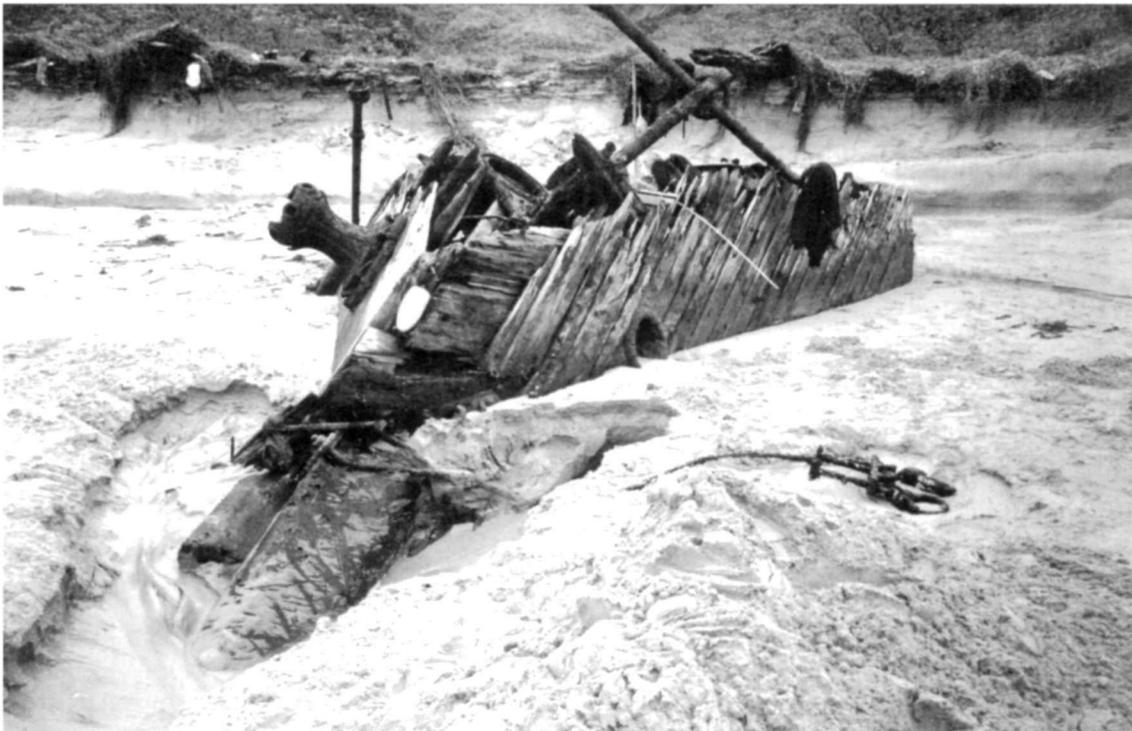
Figure 4.75. *Comet's* bow. The hawse timbers are in the center with the white float on them. The hawse pipe is visible at the sand-line, to the right of the hawse timbers. In the right foreground is an unattached rigging element. NPS photo by Matt Russell.

Comet's bowsprit is present and appears to be completely intact, though its outboard end, called the head, could not be uncovered. The bowsprit heel is stepped into a 6-in. wide x 10-in. high x 7-in. deep notch in the pawl post's forward face. At the heel, the bowsprit is 10 in. high x 1 ft. 7 in. wide (the width of the pawl post). A filler piece is fitted below the bowsprit heel between the bowsprit and the main deck. This filling timber is 9 in. thick, with an exposed length of 6 ft. 9 in. (its forward end was buried beneath the sand). The forward-most section of the bow, between decks, is buried in the sand, so the point where the bowsprit exits the hull could not be examined, however, the bowsprit presumably passes on top of the stempost and between the knightheads. Forward of the bow, the bowsprit transitions from a square cross-section to a rounded cross-section, and most likely begins to taper (Figures 4.69 and 4.75–

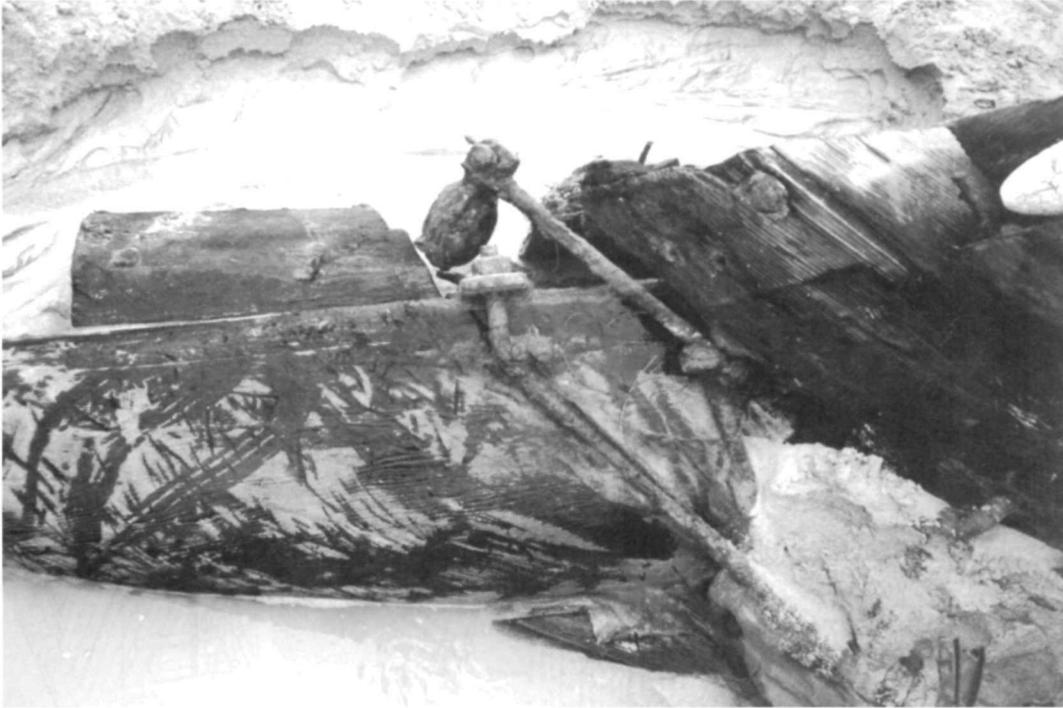
Figure 4.76. The port knighthead is the large timber on the right side of the photograph. The bowsprit extends horizontally to the left in the photo with the jibboom heel chock on top; also visible are the gammon iron and a single bull's-eye that held the foremast stay.

Just forward of the knighthead, set up around the bowsprit, is the gammoning or gammon iron (Figures 4.76 and 4.77). The gammoning secures the bowsprit to the stempost and counters the upward lift of the foremast stays. Before the late-nineteenth century, gammoning consisted of rope or chain lashed over the bowsprit; later it was replaced by an iron band, which could be tightened with nuts and bolts (de Kerchove 1961:323). Chapelle (1973:479) depicts gammon iron consisting of iron straps for both the horizontal (across the bowsprit’s upper surface) and vertical (down the bowsprit’s sides and bolted to the stempost) components (Figure 4.87; see Figure 4.84). *Comet* has 5-in. wide x 1-in. thick iron strap across the bowsprit’s upper face secured by 1½-in. diameter, round iron bar stock on either side of the bowsprit to the stempost. The top of the bar stock is threaded and tightened to the strap with 2¾-in. hex nuts. The point where the bar stock attaches to the stempost was buried and could not be documented.

Located on the bowsprit’s upper surface, just forward of the gammon iron, is the jibboom heel chock or block, also called the jibboom saddle (Figures 4.76 and 4.77) (Chapelle 1973:359, 368, 503; de Kerchove 1961:408; Underhill 1958:33). This is a small wood block that supported the jibboom heel. The jibboom is a spar located on top of and attached to the bowsprit that extends forward of it (Figures 4.84 and 4.87)(de Kerchove 1961:408).

Another single bull's eye attached to a 1½-in. diameter iron rod is bent over on top of the bowsprit (Figures 4.76 and 4.77). The bottom of the iron rod is buried in the sand below the bowsprit, so its attachment point could not be recorded. The bull's eye itself has the same dimensions as the bull's eyes described above.

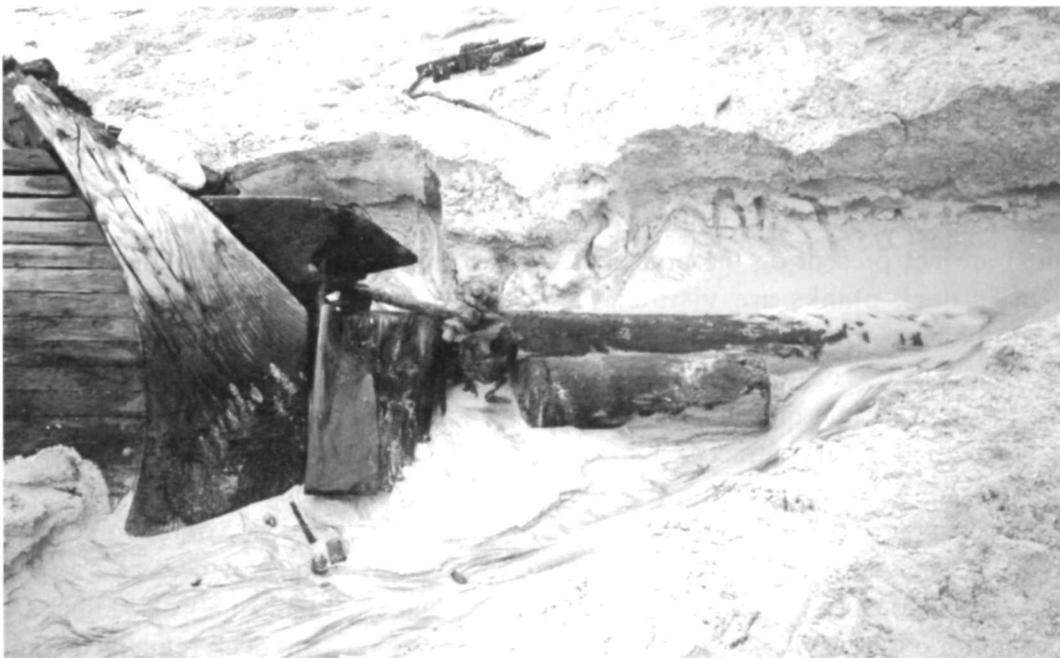
Figure 4.77. Top view of *Comet's* knighthead (to the lower right of the white float), bowsprit and jibboom heel chock. NPS photo by Matt Russell.

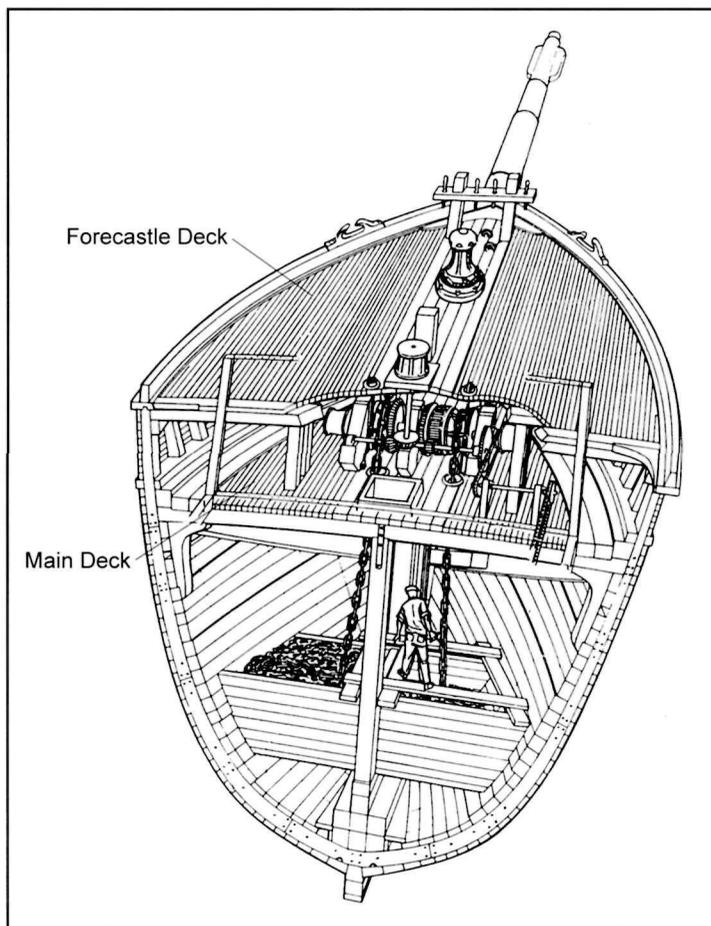
Figure 4.78. Bow section of a wooden-hulled schooner showing main deck, forecastle deck and location of windlass (from Greenhill and Manning 1995:90).

Both the main deck and forecastle deck are intact and in place from the centerline starboard, though almost the entire port half of each deck has deteriorated due to natural erosion (Figure 4.78). Four main-deck beams are visible supporting remnants of the main deck. Exposed ends of each deck beam are eroded, but dimensions vary from 10 to 13 in. wide and 7 to 9 in. thick, indicating the deck beams were originally at least 1 ft. 1 in. wide x 9 in. thick. Deck beams are specified in *Comet's* contract as being sided 14 in. and molded 11 in. (JPSL 1886), which matches reasonably, taking into account timber erosion. This again exceeds the 10½ in.-sided dimension specified in *Rules for the Construction of Wooden Vessels* (American Shipmasters' Association 1879:xxviii). Although not noted in the literature, possibly larger deck beams were used because of the large deckloads lumber schooners were required to carry. Thickening deck beams would have increased ship construction costs minimally, but returns on this small investment would have accrued throughout the vessel's operational life. Two deck beams are located directly fore and aft of the pawl post, a third is located 1 ft. 4½ in. aft of the beam butting the pawl post's aft face, and the fourth is located 2 ft. 10¾ in. forward of the

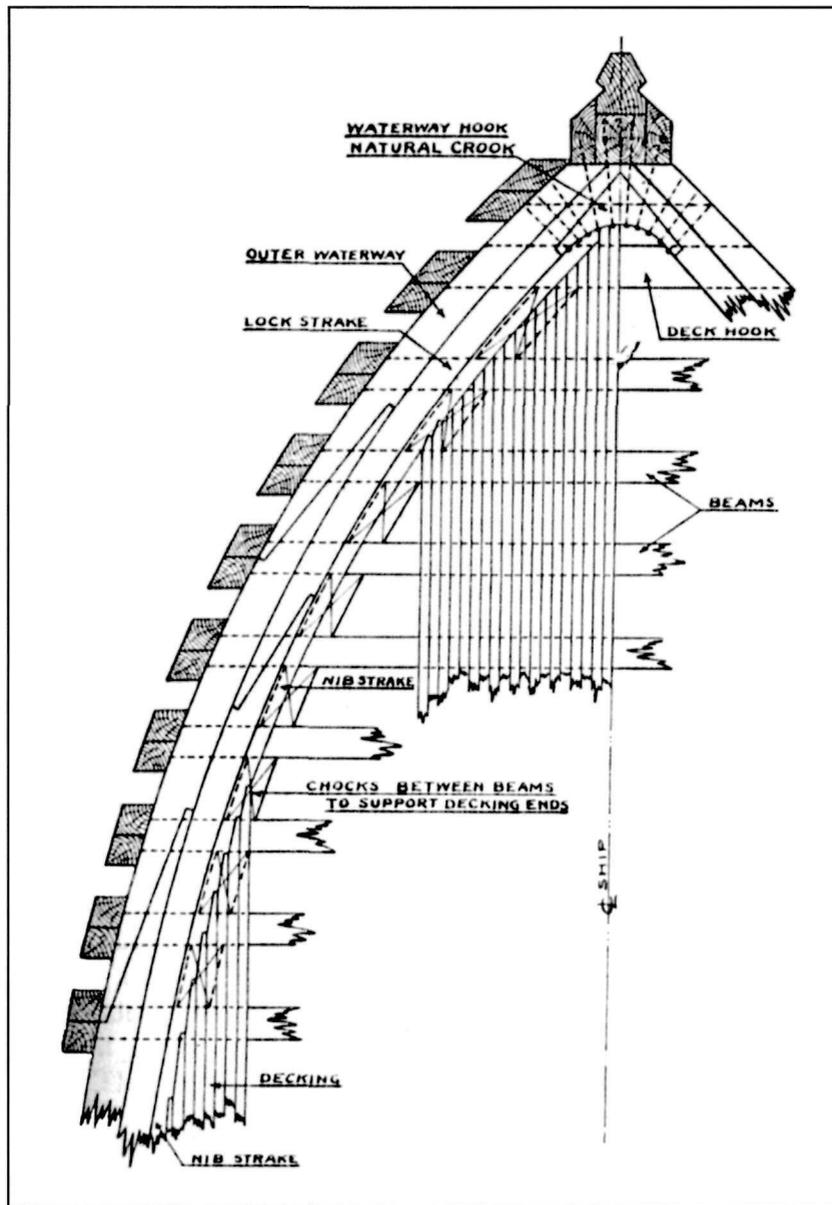
Figure 4.79. Planking details, showing deck and waterway hooks (from Curtis 1919:146).

in. long with 7/16-in. square shanks and 13/16-in., four-faceted heads, and are countersunk and plugged with 1-in. diameter wooden plugs. A main-deck hook and main-deck waterway hook are present in the bow, and the forward ends of the main-deck planks rest on and are fastened to the main-deck hook and butt against the main-deck waterway hook, which follows the typical practice (Figure 4.79)(Curtis 1919:134–135, 144–145). As with the deck clamps, waterway strakes are no longer present.

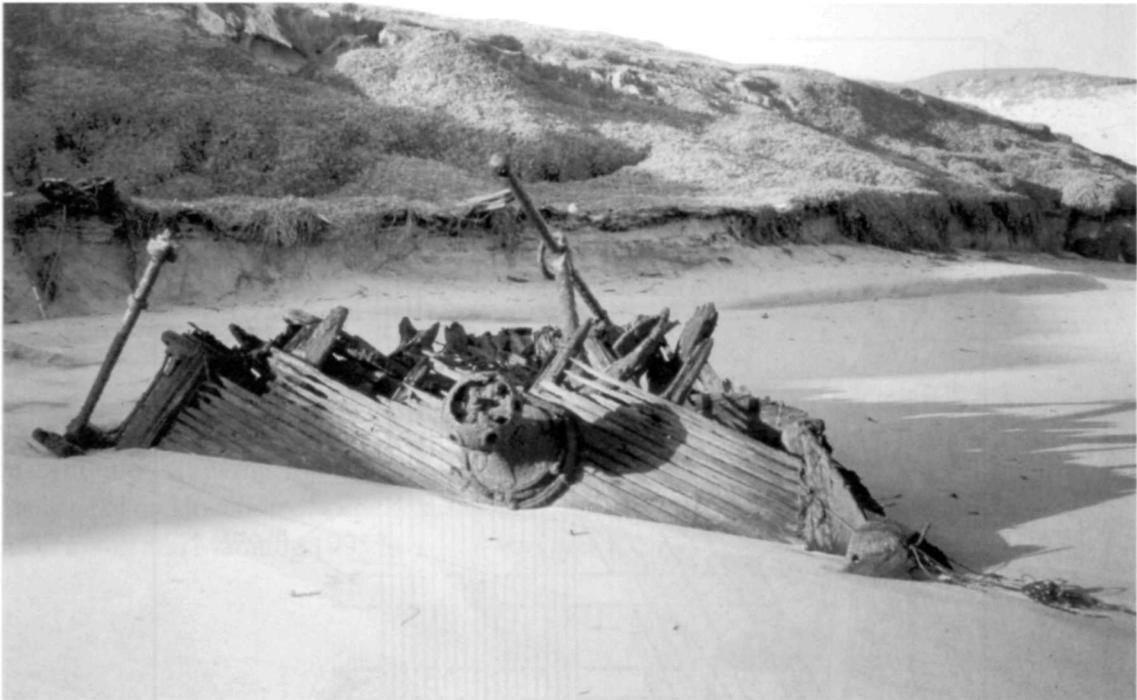
Figure 4.80. *Comet* site in April 1999, looking down on the fore-castle deck with the capstan mounted to it. The bow is to the right. NPS photo by Matt Russell.

The starboard side of the forecastle deck is intact from the bow to the deck's aft end above the windlass (Figure 4.80; also Figures 4.66 and 4.69). Forecastle deck remains are supported by five deck beams; the three forward-most beams are 5½ in. sided, and the two aft beams,

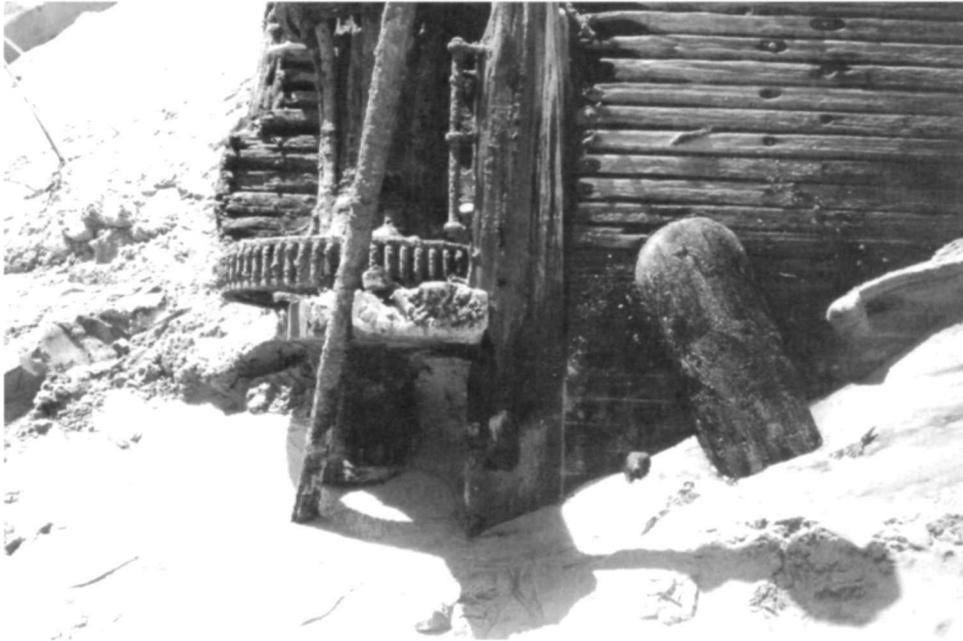
Figure 4.81. Top view of the aft end of the forecastle deck. The aft-most forecastle deck beam is the vertical timber in the center of the photo. The windlass is to the left, mounted on the main deck below; the starboard cathead is the angled timber to the right. NPS photo by Matt Russell.

fore- and aft- the pawl post, are sided between $9\frac{1}{2}$ and $10\frac{1}{2}$ in. Like on the main deck, port clamps are absent. Thirty fore-castle-deck planks are exposed; all 3 in. sided x $2\frac{1}{2}$ in. molded. Each plank is fastened with a single boat spike at its forward end, a single boat spike at its aft end (for complete planks), and a single boat spike in each deck beam. Fore-castle-deck spikes are $5\frac{1}{4}$ in. long with $\frac{5}{16}$ -in. square shanks and $\frac{11}{16}$ in., four-faceted heads and are countersunk and plugged with 1-in. diameter wooden plugs. Deck plank forward ends are resting on and fastened to the fore-castle-deck hook and are butted against the fore-castle-deck waterway hook (Figure 4.77). Again, like the main deck, waterway strakes are gone. Complete deck plank aft ends are resting on and fastened to a recessed shelf notched into the forward edge of the aft-most fore-castle-deck beam (Figure 4.81). Fore-castle deck beam and

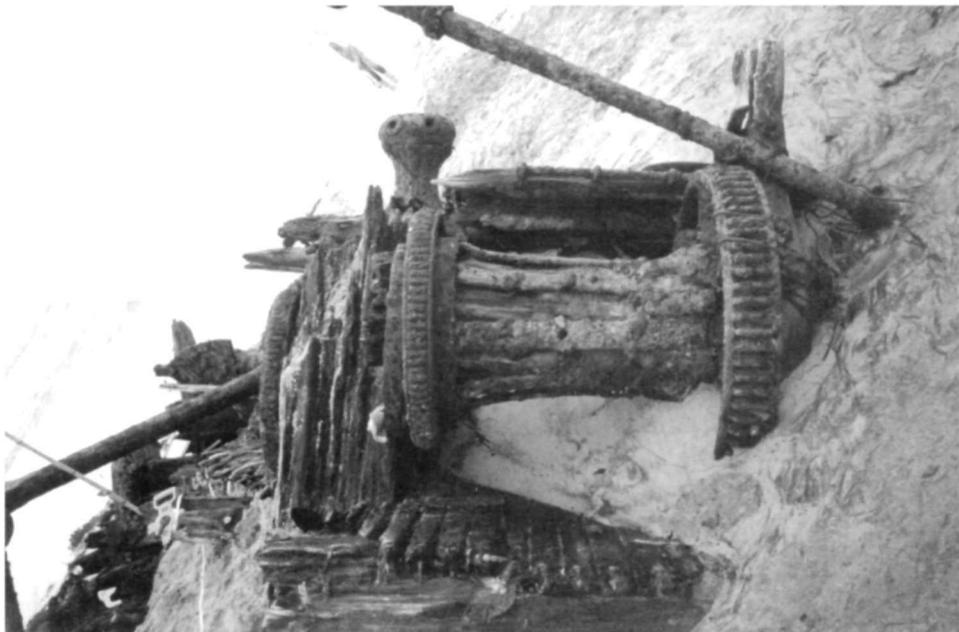
Figure 4.82. Photograph taken from the perspective as if the viewer were standing on the main deck looking forward. The pawl post is to the left of the windlass. NPS photo by Matt Russell.

The pawl post, sometimes called the pawl bitt, Samson post or heel bitt when the bowsprit is stepped into it, is present from fore-castle-deck level to the main-deck level, where it is buried in the sand (Figures 4.82–4.84). The pawl post is a solid timber, usually stepped into the keelson or bow deadwood, which extends upward and ends above fore-castle-deck level (Chapelle 1973:368–370; de Kerchove 1961:91; Underhill 1958:88). In *Comet*, the pawl post served two purposes: 1) the bowsprit's inboard end, called the heel, is stepped into the pawl post's forward face; so the pawl post serves as a major reinforcing member for the bow rigging; and 2) the windlass pawl was mounted on the pawl post's aft face, though neither the windlass pawl nor pawl rim are present on site. The pawl post

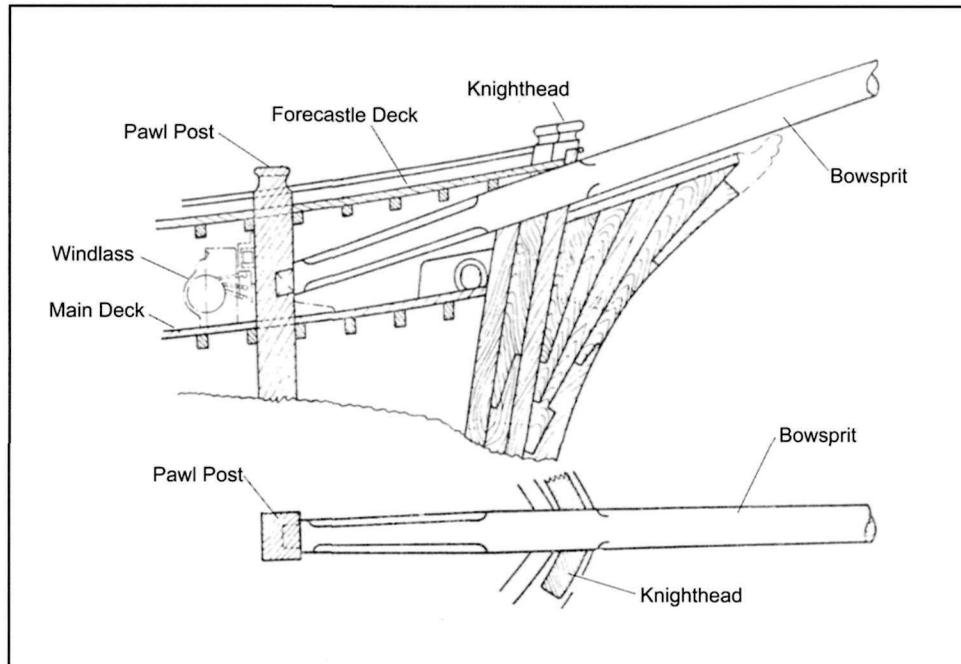
Figure 4.83. Schooner bow section showing the bowsprit stepped into the forward face of the pawl post (after Underhill 1958:88).

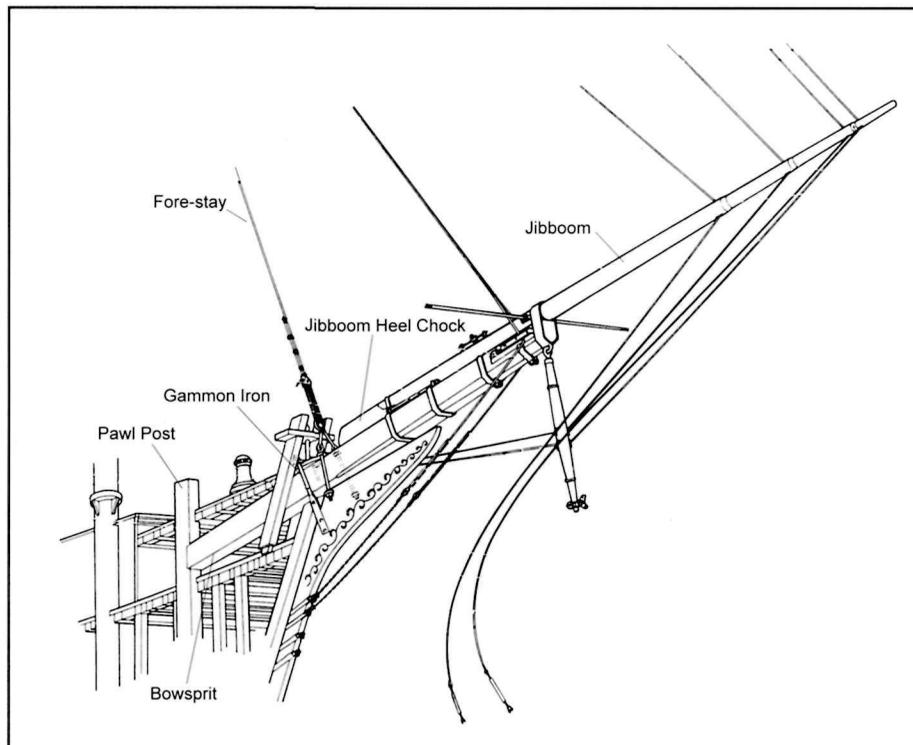
Figure 4.84. Schematic of a schooner bow-section, showing the bowsprit stepped into the pawl post, the jibboom, jibboom heel chock, gammon iron and fore-stay (after Greenhill and Manning 995:113).

the bow, serves two main purposes: 1) to extend the head sails forward, balancing the sail plan by counteracting the effect of the after sails; and 2) to support the foremast, which is fastened to it with stays (Figure 4.84) (de Kerchove 1961:90). *Comet*’s bowsprit is formed from a single, large timber, most likely Douglas fir.

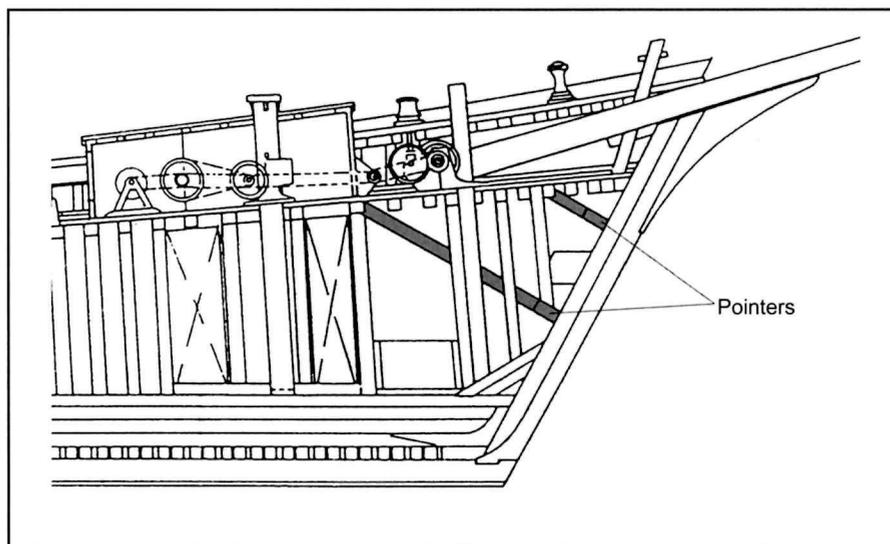
Figure 4.85. Bow pointers in a wooden-hulled schooner (after Greenhill and Manning 1995:63).

uses. Salvage alone cannot explain, however, why only the bow is present today. Observation of site layout suggests a series of events that led to the wreck's present condition. The last known historical photographs of *Comet* (see Figures 3.9–3.11) show the vessel laying broadside to the shoreline, somewhere between high and low tide. Subsequently, *Comet*'s bow broke away from the rest of the hull at a point just aft of the forecastle deck and forward of the forward deckhouse (Figure 4.105). It is possible the stempost/keel joint broke, but the pointers kept the bow structure to aft of the forecastle deck together. The pointers crossed and were fastened into multiple frame pairs, including all the cant frames, and would have provided reinforcement to help bind them together (Figures 4.85 and 4.86).

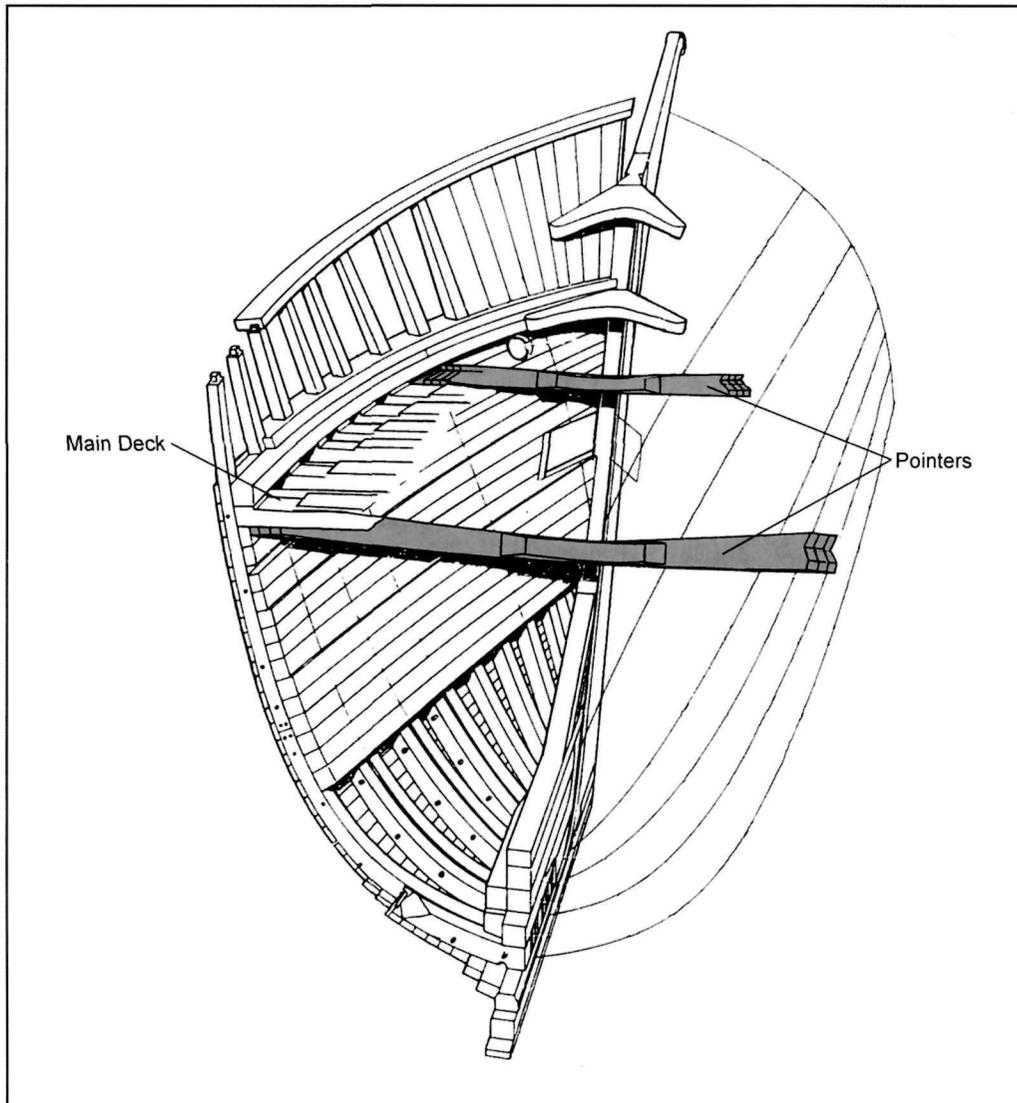
Figure 4.86. Schematic showing location of bow pointers in a wooden-hulled schooner (after Greenhill and Manning 1995:70).

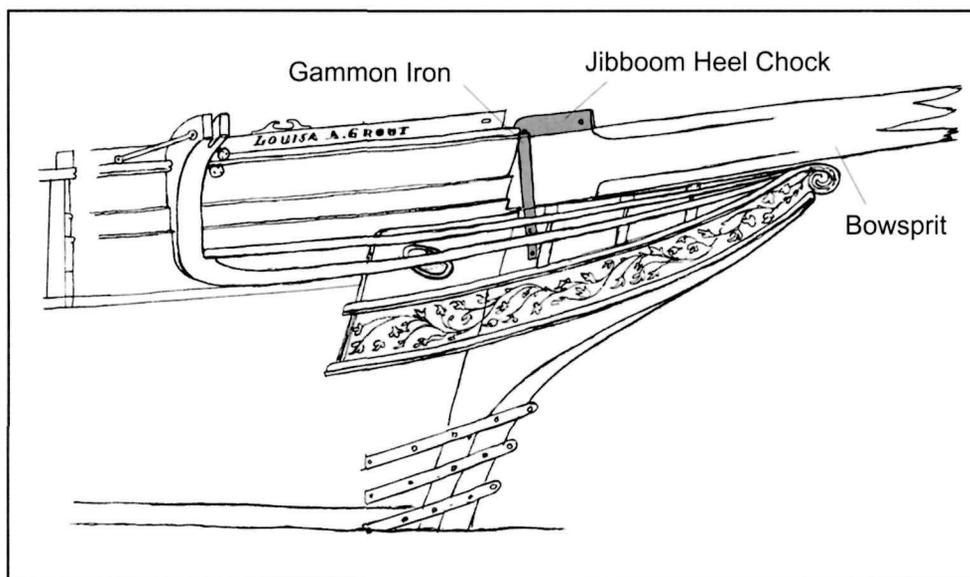
Figure 4.87. Vessel bow section showing location of the gammon iron and jibboom heel chock (after Chapelle 1973:359).

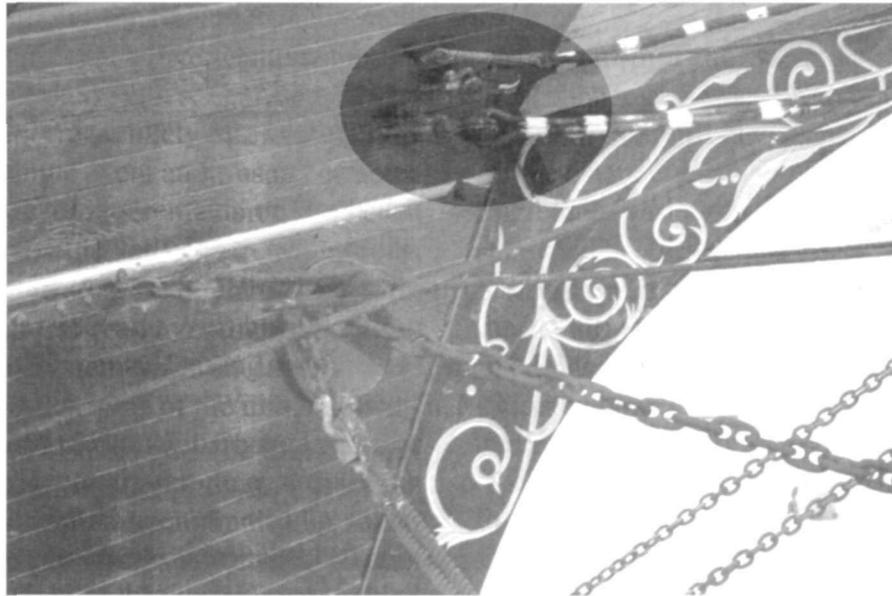
Figure 4.88. Bull's eye above and forward of the hawse pipe (at the top-center of photo) support the bowsprit guys on *C. A. Thayer* in San Francisco Maritime National Historical Park. NPS photo by Matt Russell.
