Beached Shipwreck Archeology: Case Studies from Channel Islands National Park

Submerged Resources Center
Professional Reports
Number 18

Submerged Resources Center
Intermountain Region
National Park Service

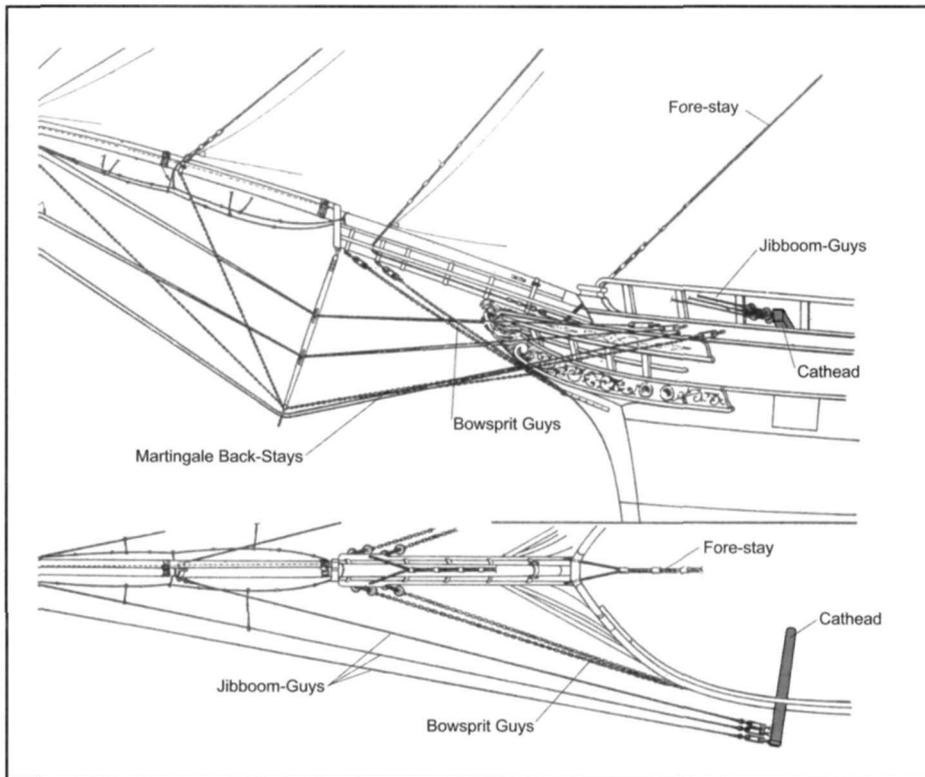
Figure 4.89. Bow rigging elements found on *Comet* site (after Underhill 1958:64).

This is most likely one of the attachment points for the fore-stay, which supported *Comet's* foremast. *C. A. Thayer* has identical bull's eyes supporting its foremast in the same location. Underhill (1958:64) also depicts a similar forestay configuration (Figure 4.89).

the attachment point for the inner- and outer-jibboom guys, or shrouds (Figure 4.89) (Underhill 1958:64). Chapelle (1973:398) notes that “as long as the schooners carried jibbooms the jibboom shrouds were set up with hearts, or small deadeyes, and lanyards on the foresides of the catheads.” *C. A. Thayer* has similar, though not identical, rigging elements on the foresides of its catheads, which support the jibboom guys (Figure 4.92). In addition, historical photos of *Comet* wrecked in Simonton Cove give indirect evidence for this identification. Although the photos do not show the cathead or this particular element, they depict the jibboom guys coming to a point that can only be on the foresides of the catheads (see Figures 3.12 and 3.13). The iron hooks are called jib stay hooks (Greenhill and Manning 1995:103), and the iron rod was a brace between the cathead and the rail (Chapelle 1973:398). The rod’s angle identifies this object coming from the port, rather than the starboard, cathead.

The aft end of the starboard cathead was visible attached to the forecastle deck (Figures 4.80 and 4.81). A cathead is a wood beam that projects out over port and starboard bow to support the anchor before releasing or while retrieving or stowing (Figure 4.89) (de Kerchove 1961:132)—when the anchor ring has been hoisted up to the cathead, it has been “catted.” *Comet's* cathead is a solid timber, 11¹/₄ in. wide x 5 in. thick with an exposed length of 2 ft. 7 in. A 3³/₄-in.diameter, 1-in. thick iron ring is fastened to its upper surface at the lowest exposure, 2 ft. 7 in. from the aft end. No other details about the cathead were observed because most of its length was buried.

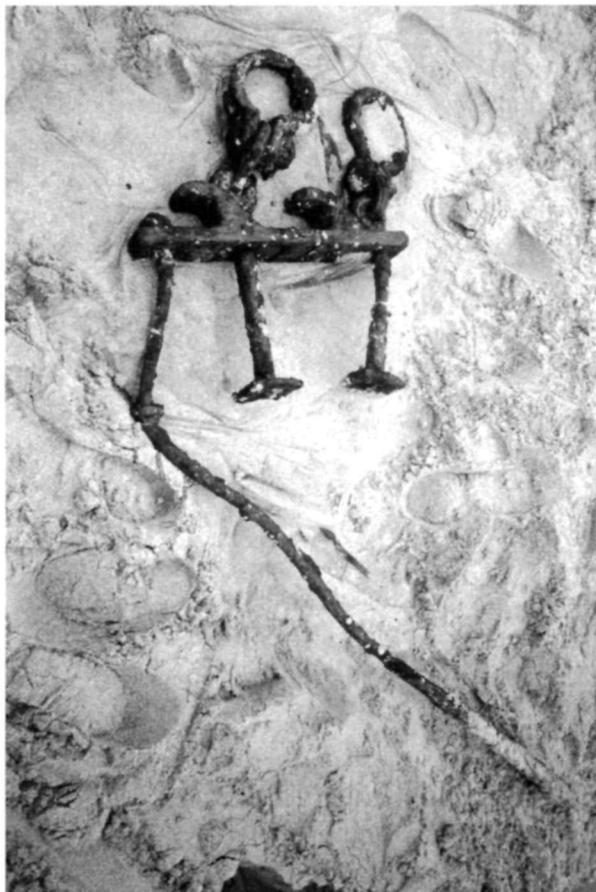
Figure 4.90. Rigging element off *Comet's* port bow. NPS photo by Matt Russell.

Located off *Comet's* port bow is an unattached iron rigging element (Figure 4.90 and 4.91; also Figure 4.75). It consists of a 4 ft. 3 in.-long iron rod with a 5 in. long x 2½ in. wide x ½ in. thick plate on one end, attached to an 11½-in. long x ¾ in. diameter iron fastener that is attached to a 1 ft. 6½-in. long x 1-in. thick iron plate. The plate is pierced by two 1 ft. 3-in. long x 1-in. diameter eyebolts, each of which has an iron ring attached to an iron strop from a bull's eye or deadeye (the wooden block is no longer present), similar to those described above. In addition, the iron plate has two iron hooks cast as part of its upper surface. Although documentary research could not identify the element's proper name, its function was identified. This object was originally fastened to the foreside of the port cathead and provided

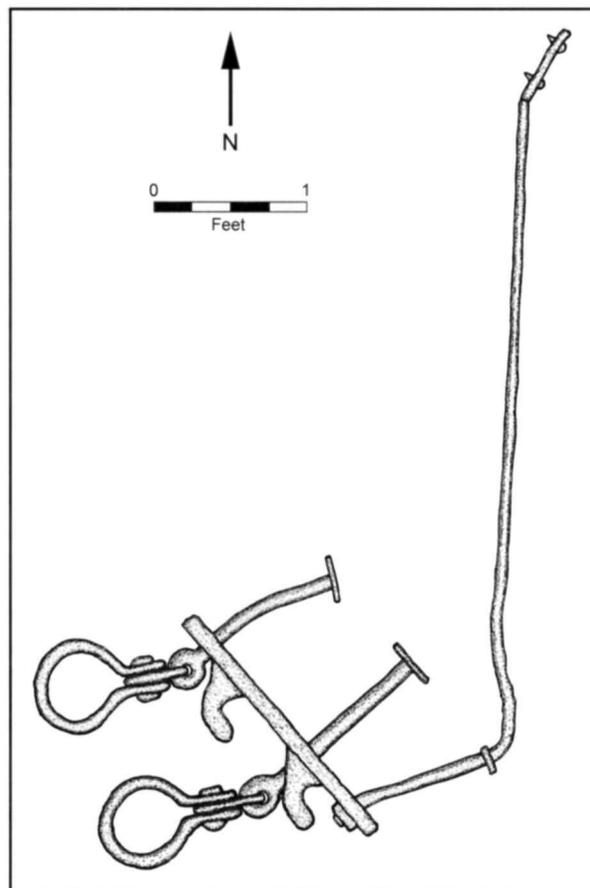
Figure 4.91. Rigging element from port cathead that secured the jibboom guys. Drawing by Matt Russell and Don Morris.

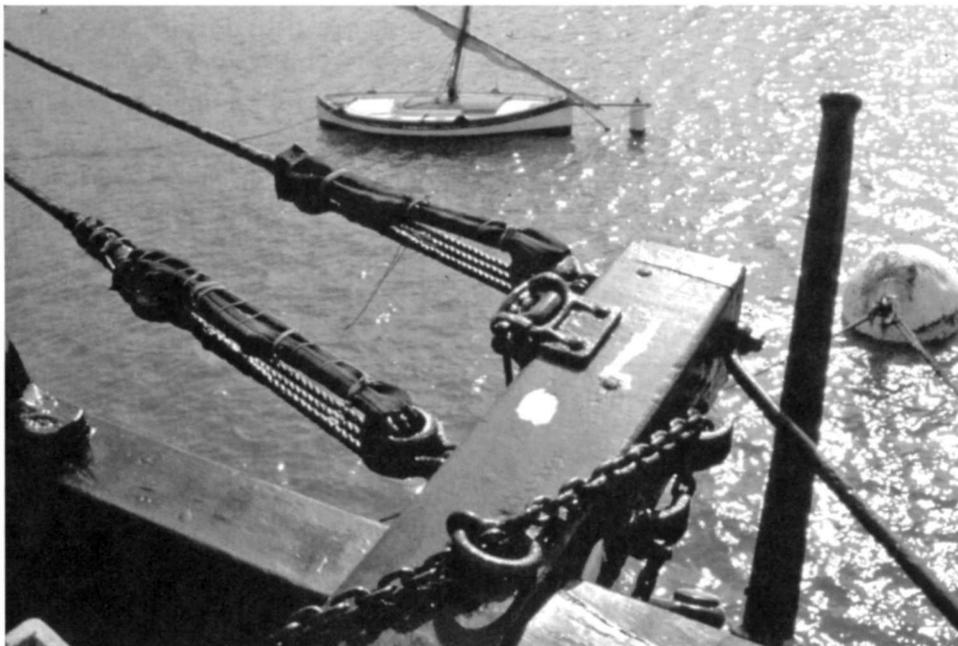
Figure 4.92. Rigging element supporting jibboom guys on forward side of *C. A. Thayer*’s cathead. NPS photo by Matt Russell.

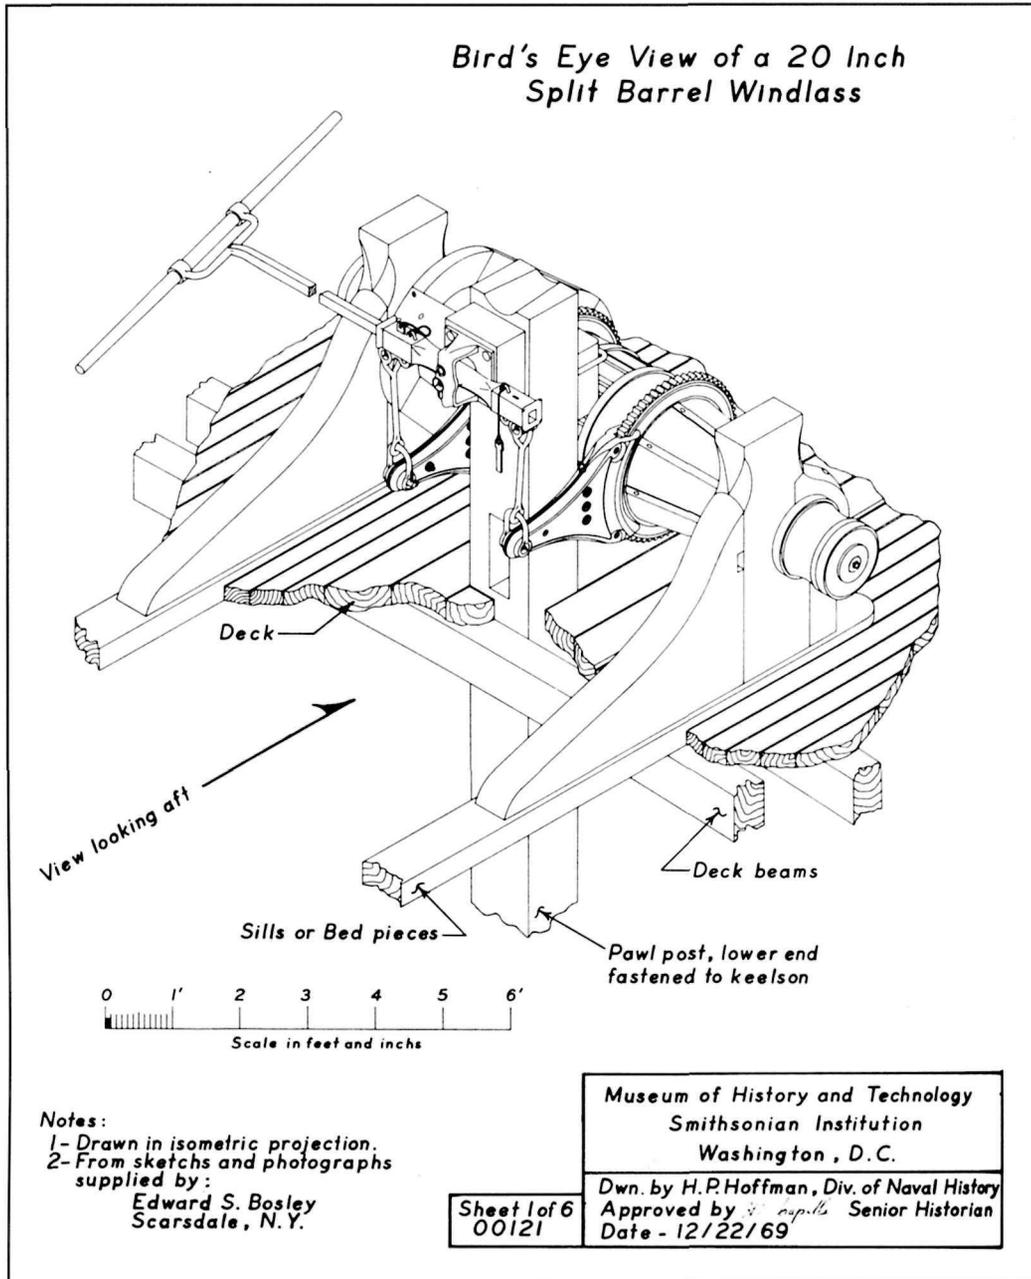
Figure 4.93. Pump-brake windlass. Drawing from the Smithsonian Institution.

Comet’s windlass is a type generically known as an “Armstrong Patent”, or pump-brake, windlass, which was introduced during the 1840s, quickly replacing older models employing handspikes. Pump-brake windlasses, which used purchase levers and pump handles, remained in use into the twentieth century (MacGregor 1984:88). Chapelle (1973:677) refers to this type of windlass as a “wooden, or log, windlass, with pump-brake ironwork” (Figures 4.93).

On this windlass type, a pawl mounted on the aft face of the pawl post engaged either teeth cut into the center of the windlass barrel or an iron pawl rim mounted on the windlass barrel, which prevented the barrel from reversing direction (Figure 4.93) (Chapelle 1973:677; Paasch 1890:Plate 70). Neither the pawl nor a pawl rim is present on the *Comet* site, possibly indicating the pawl engaged teeth cut directly into the windlass barrel rather than a pawl rim. An auxiliary warping drum, or gypsy head, was present outside each carrick bitt (Figure 4.95). Only the starboard half of the windlass barrel remains intact, including the starboard purchase rim and arm, the starboard carrick bitt supporting the windlass, and the starboard warping drum outside it. Much of the windlass's port-side ironwork is present, however, laying loose on the main deck against the bowsprit's port side, including the port purchase rim (Figure 4.97), arm and rod; four iron whelps from the port-side windlass barrel; a single large iron fastener with a diamond-shaped rove that held

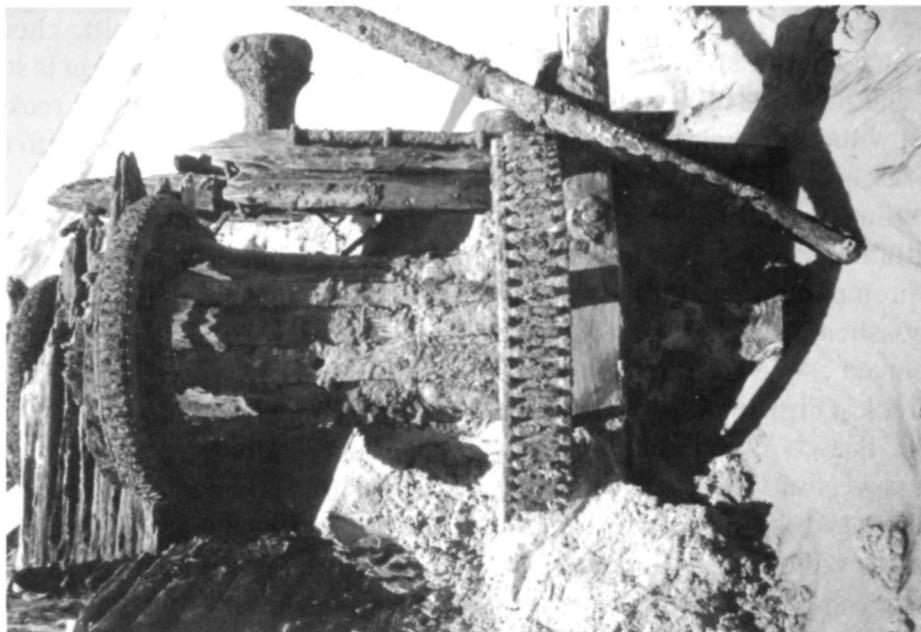
Figure 4.94. *Comet's* windlass mounted on the main deck. NPS photo by Matt Russell.

Comet's windlass is mounted on the schooner's main deck, just aft of the pawl post (Figure 4.94 and 4.95). The windlass has a wooden barrel with iron whelps supported by hardwood carrick bitts. It was worked with two iron purchase rims (with 1 ft. 11½ in., or 23½ in., inside diameter) and purchase arms connected by iron purchase rods to a pivoting rocker, or crosshead, mechanism that was originally mounted above the windlass on the forecastle deck (Figure 4.96)(Chapelle 1973:669–680; Paasch 1890:Plate 70). Just forward of the pawl post at forecastle-deck level are two fasteners and the remains of a block that supported the crosshead on the forecastle deck. On either side of the pawl post are openings in the forecastle deck where the purchase rods connected the windlass purchase arms to the rocker on the forecastle above (Figure 4.80).

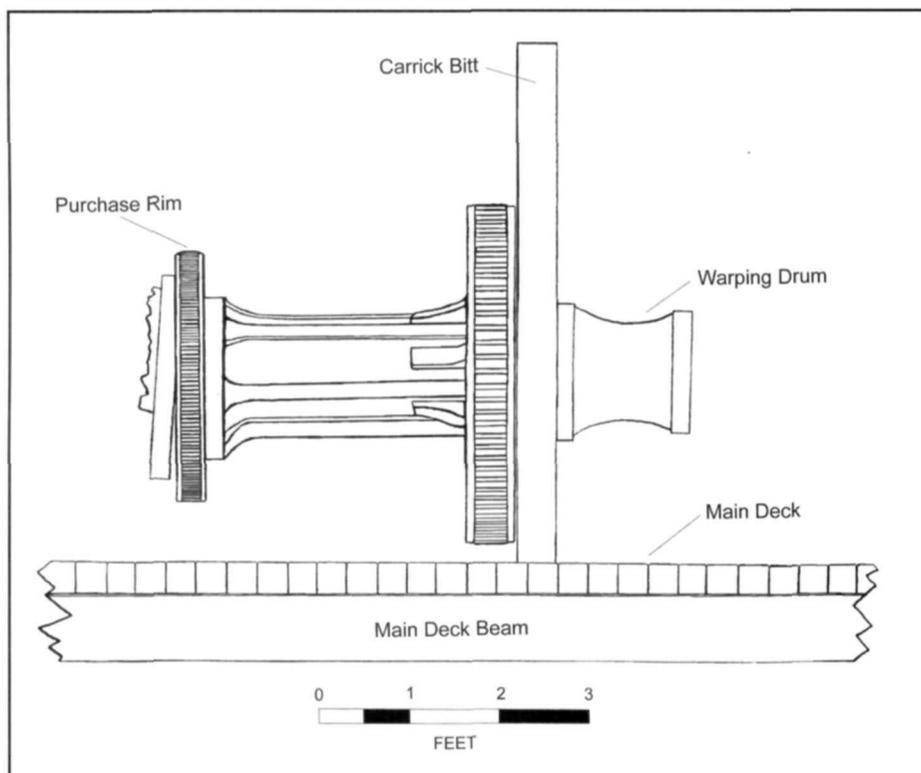
Figure 4.95. *Comet's* windlass, elevation view looking forward on main deck. Drawing by Jim Bradford and Matt Russell.

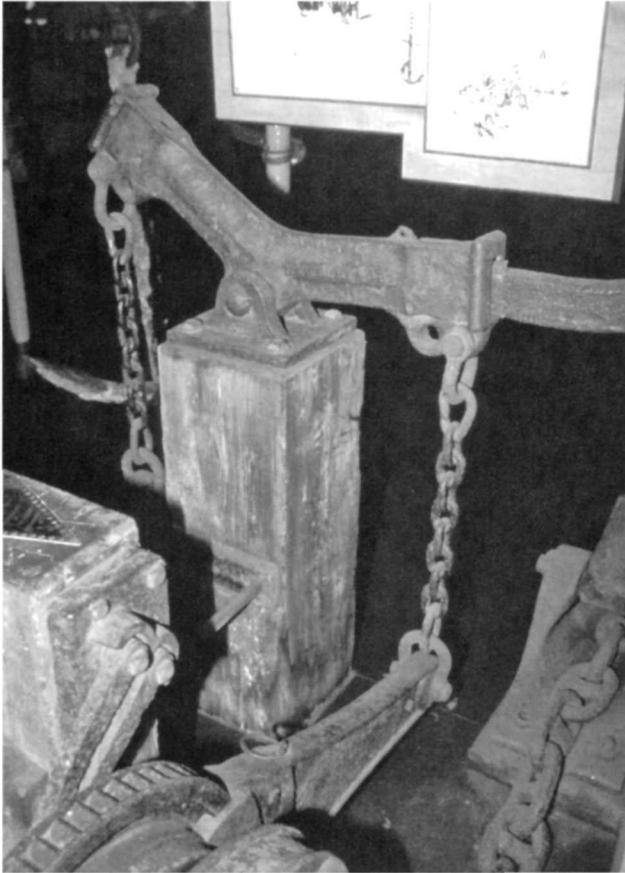
Figure 4.96. Pivoting rocker, or crosshead, mechanism connected to a windlass purchase arm with chain. *Comet* was equipped with a similar windlass type. NPS photo by Matt Russell.

Included in the iron material located on the main deck are an eyebolt fastened into the bowsprit's port face with another eyebolt attached to it, some small link chain with 2-in. long x ½-in. diameter links, 10 loose iron fasteners and an iron bar measuring 3½ to 4 in. square x 3 ft. 9½ in. long. The fasteners are probably from the windlass's port side, the link chain is possibly from the messenger chain or connected the purchase arm with the rocker (Figure 4.96) and the iron bar is possibly part of one of the pump-brake hand levers.

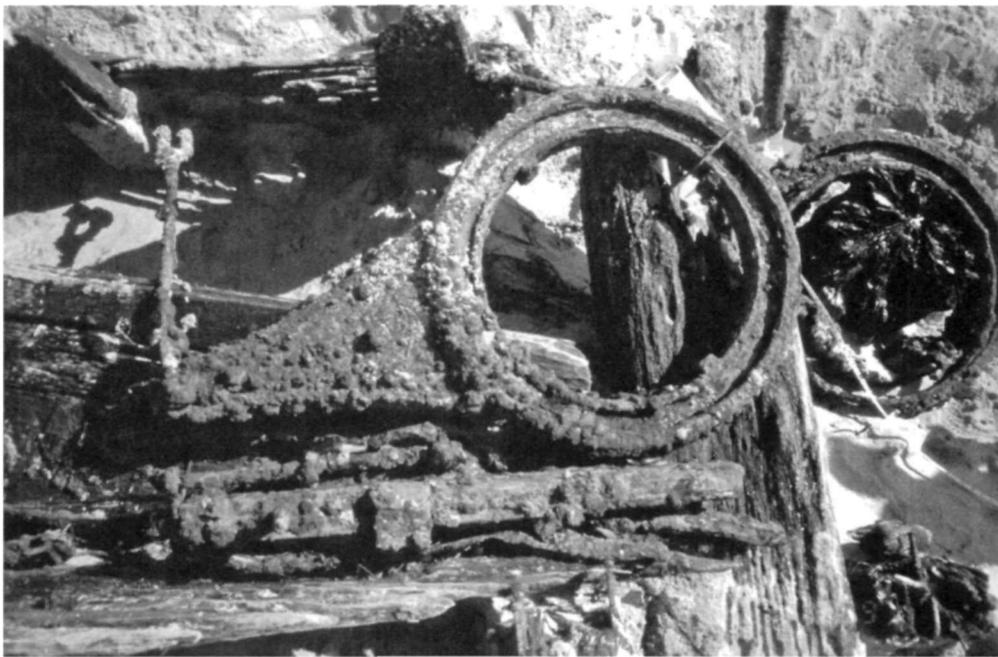
Figure 4.97. *Comet*'s port windlass purchase arm and windlass hardware on the main deck laying against the port side of the pawl post and bowsprit. NPS photo by Don Morris.

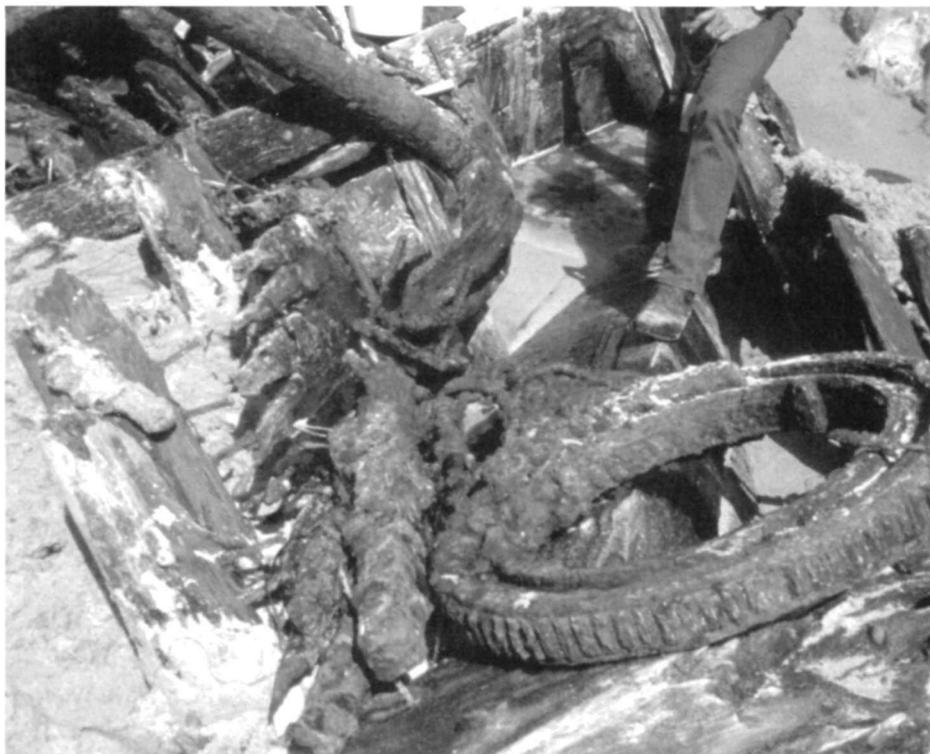
Figure 4.98. *Comet's* port windlass hardware laying on the main deck. NPS photo by Don Morris.

the port-side carrick bitt, cheek and knee together (an identical fastener is still in place on the starboard side); and the rocker base plate with two fasteners that held it to the forecastle deck (Figure 4.98).

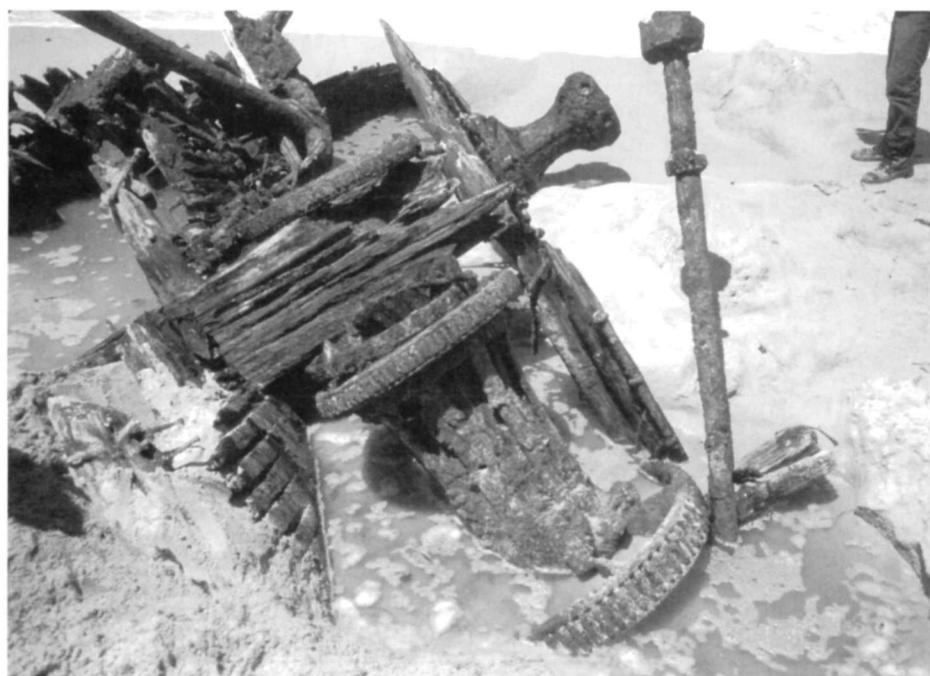
Figure 4.99. *Comet's* windlass and the iron shaft sticking out of the sand on the right side of the photograph. NPS photo by Matt Russell.

On the windlass's starboard end, just inside the carrick bitt, is a 3 ft. 6½-in. diameter gear that is not integral to the primary workings of the windlass. In addition, an upright iron shaft with some heavily encrusted bands that may have been gearing is sticking out of the sand near the windlass's starboard end (Figure 4.99; see Figure 4.95). This is part of a messenger chain system for driving the windlass by an endless chain from a donkey engine. Figure 4.100 depicts a similar arrangement, with a geared shaft mounted above the windlass articulated to a large gear on the windlass's outside end. A similar system is depicted in drawings of *Bertha L. Downs*, another late-nineteenth century schooner (Figure 4.101) (Greenhill and Manning 1995:79–81, 90). Essentially, a messenger chain system was used to run several pieces of machinery off a single donkey engine. Using a system of shafts, gears and chains, a donkey engine could power the windlass, pumps, auxiliary warping heads and other hoisting equipment. As discussed in Chapter 3, *Comet* was probably not originally equipped with a donkey engine, but one was added in the 1890s.

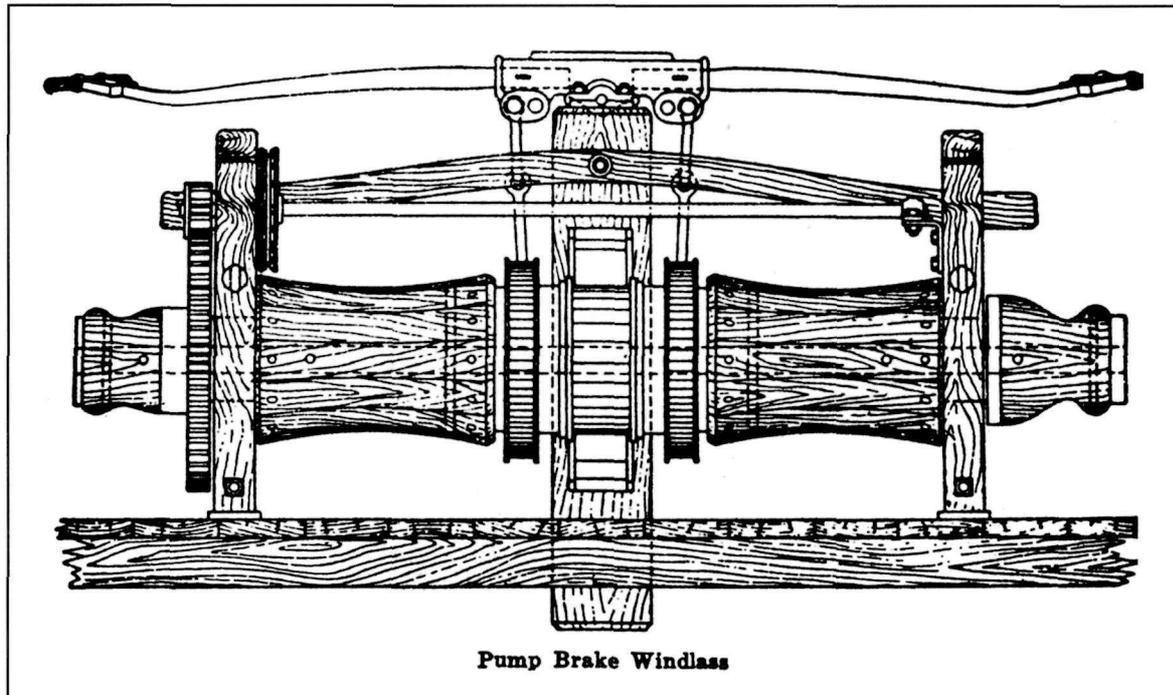
Figure 4.100. Windlass nearly identical to *Comet's* windlass, including the gearing (in this case on the port side) for the messenger chain system.

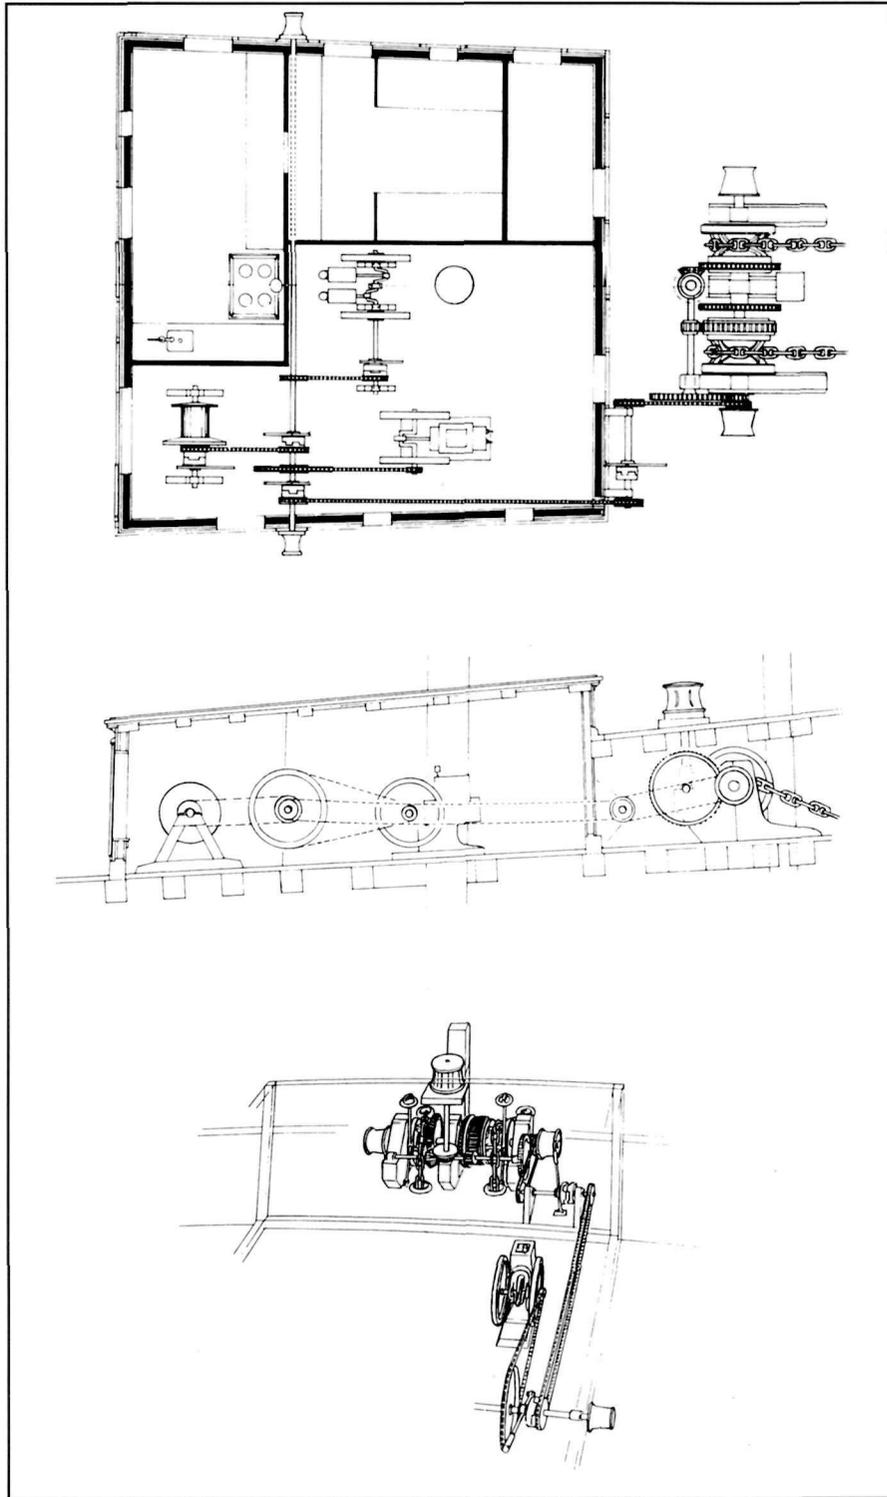
Figure 4.101. Messenger chain-driven windlass system (from Greenhill and Manning 1995:79 and 90).

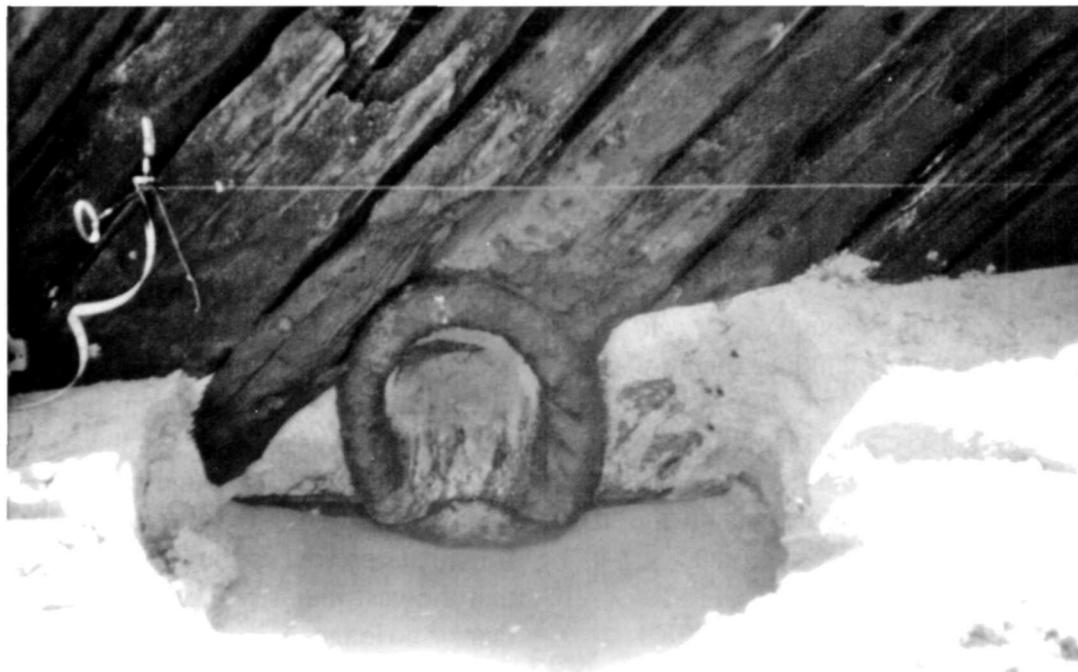
Figure 4.102. *Comet's* port-side hawse pipe. NPS photo by Don Morris.

The port hawse pipe is in place, piercing the port hull at main-deck level (Figure 4.102). The hawse pipe provided an opening for the anchor chain cable to pass through the bow to the windlass, and from the windlass into the chain locker. The hawse pipe is a flanged iron pipe with an outer face angled to fit the shape of the outer hull. The flanged opening is 1 ft. 5 in.

long x 1 ft. 6 in. wide, and the hawse pipe has an 11-in. interior diameter. Doing the same kind of analysis as above for the hawse pipes in Northwest Cove gives a different result. Using the same tables in Desmond (1919[1984]), a 400-ton vessel should carry a 1 1/8 in. diameter chain cable, which requires a 10³/₄ in. hawse pipe. This matches very well with *Comet's* 11-in. inside diameter hawse pipe. This complicates the identification of the shipwreck in Northwest Cove.

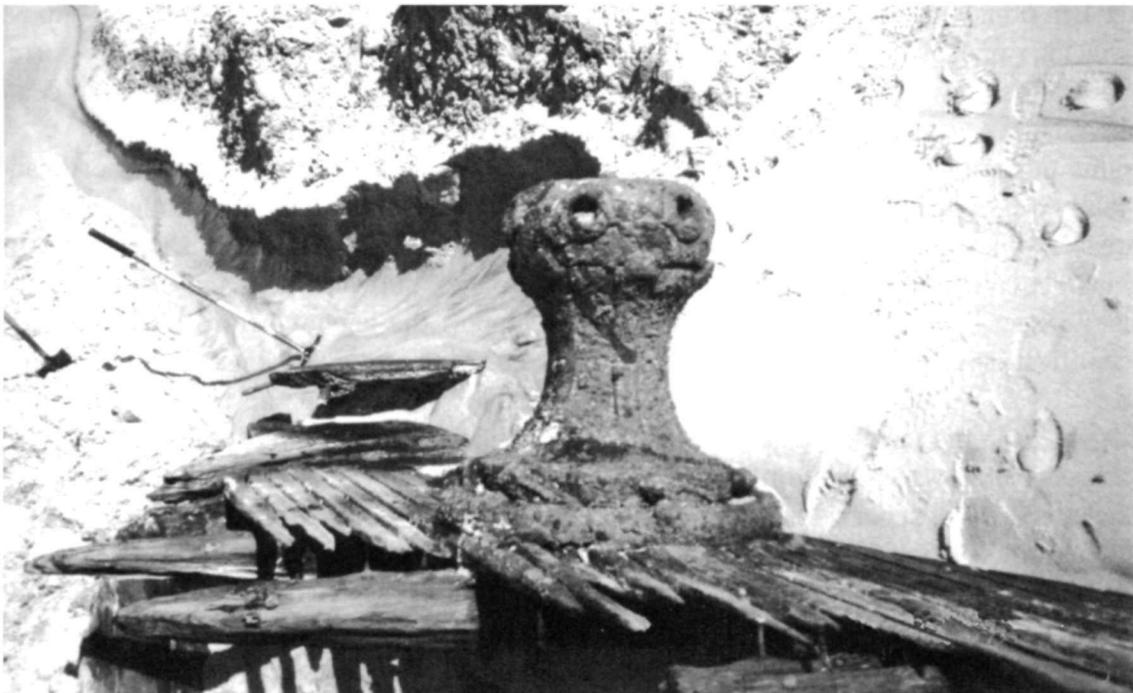
Figure 4.103. *Comet's* capstan, mounted in the center of the forecastle deck. NPS photo by Don Morris.

A hand-powered capstan is mounted in the center of the forecastle deck (Figures 4.103 and 4.104). It is not linked to the windlass, so is not technically part of the ground tackle. It was used for warping only, including such tasks as handling lines and assisting with raising sail (Campbell 1974:135). The capstan is 2 ft. 10 in. tall, with a 2-ft. 8-in. diameter base and 1 ft. 8-in. diameter head. This is presumably the "#3 capstan" specified in *Comet's* contract.

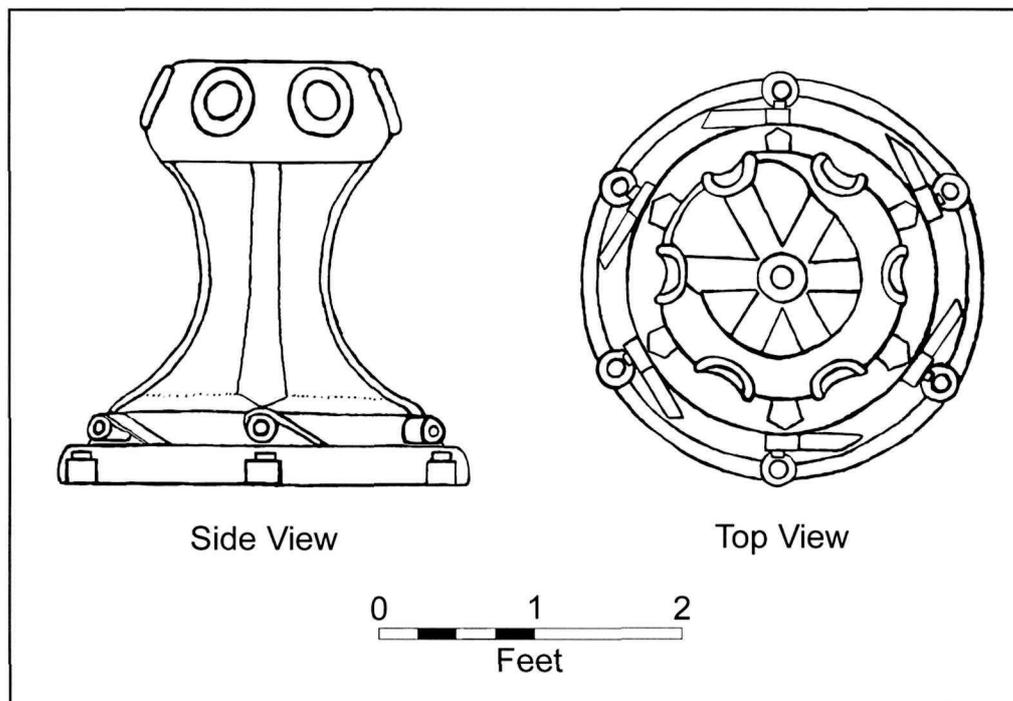
Figure 4.104. *Comet's* capstan. Drawing by Jim Bradford.

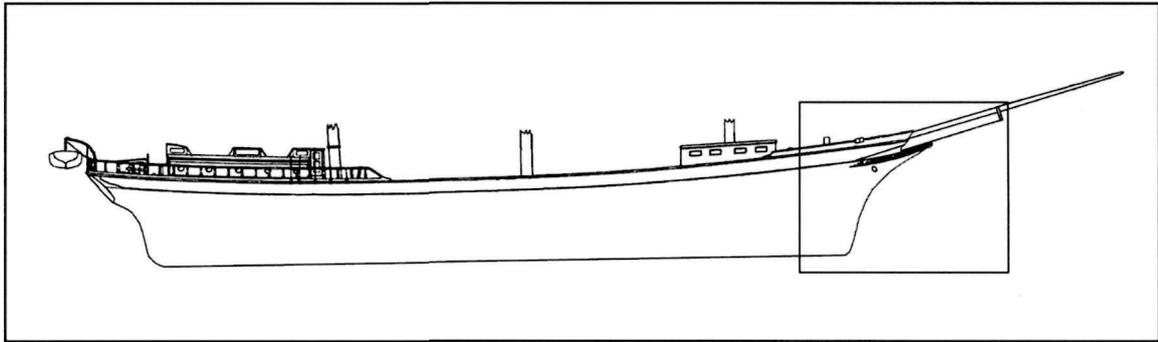
Figure 4.105. Area of *Comet's* preserved hull.
