SOUTHWESTERN MONUMENTS

MONTHLY REPORT MARCH 1937

EXCAVATIONS AT TUMACACORI-1934

By Paul Beaubien

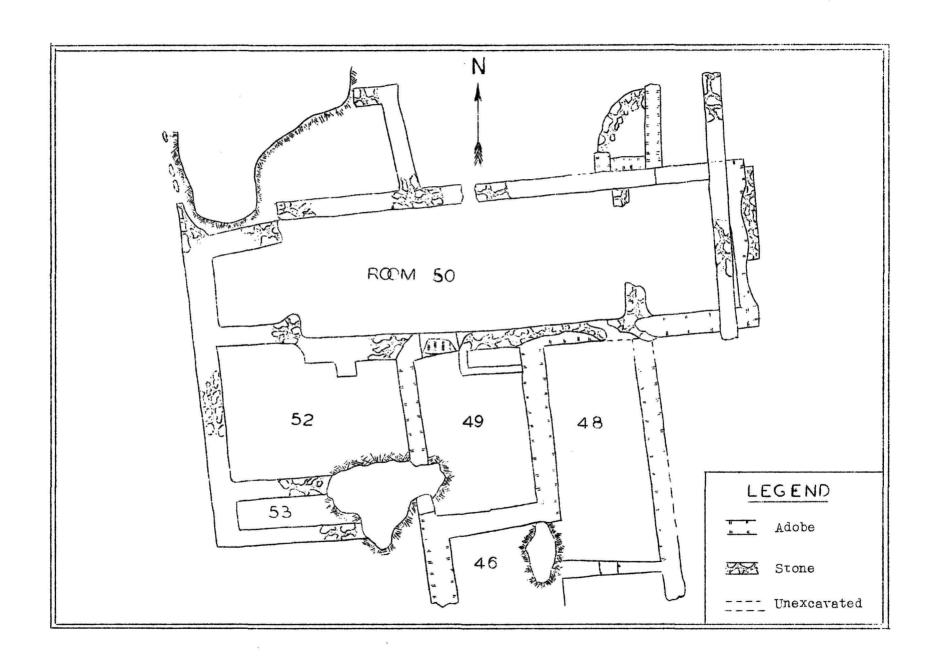
ROOMS 52 AND 53

Except for a few adobe bricks, laid side by side, on the east wall foundation, only stone foundations remained. The side walls of Room 53 ended at the edge of a treasure hunter hole which extended into Room 49. The north wall of Room 53 did not end in as ragged a fashion as did the south wall, so the rim of the treasure hunter hole may have coincided with the side of a doorway or the end of the wall.
