**Cultural Landscape Report  
and Environmental Assessment  
Raspberry Island Light Station  
Apostle Islands National Lakeshore  
Bayfield County, Wisconsin**

Prepared by the  
National Park Service,  
HRA Gray & Pape LLC,  
and  
Woolpert LLP

November 2004

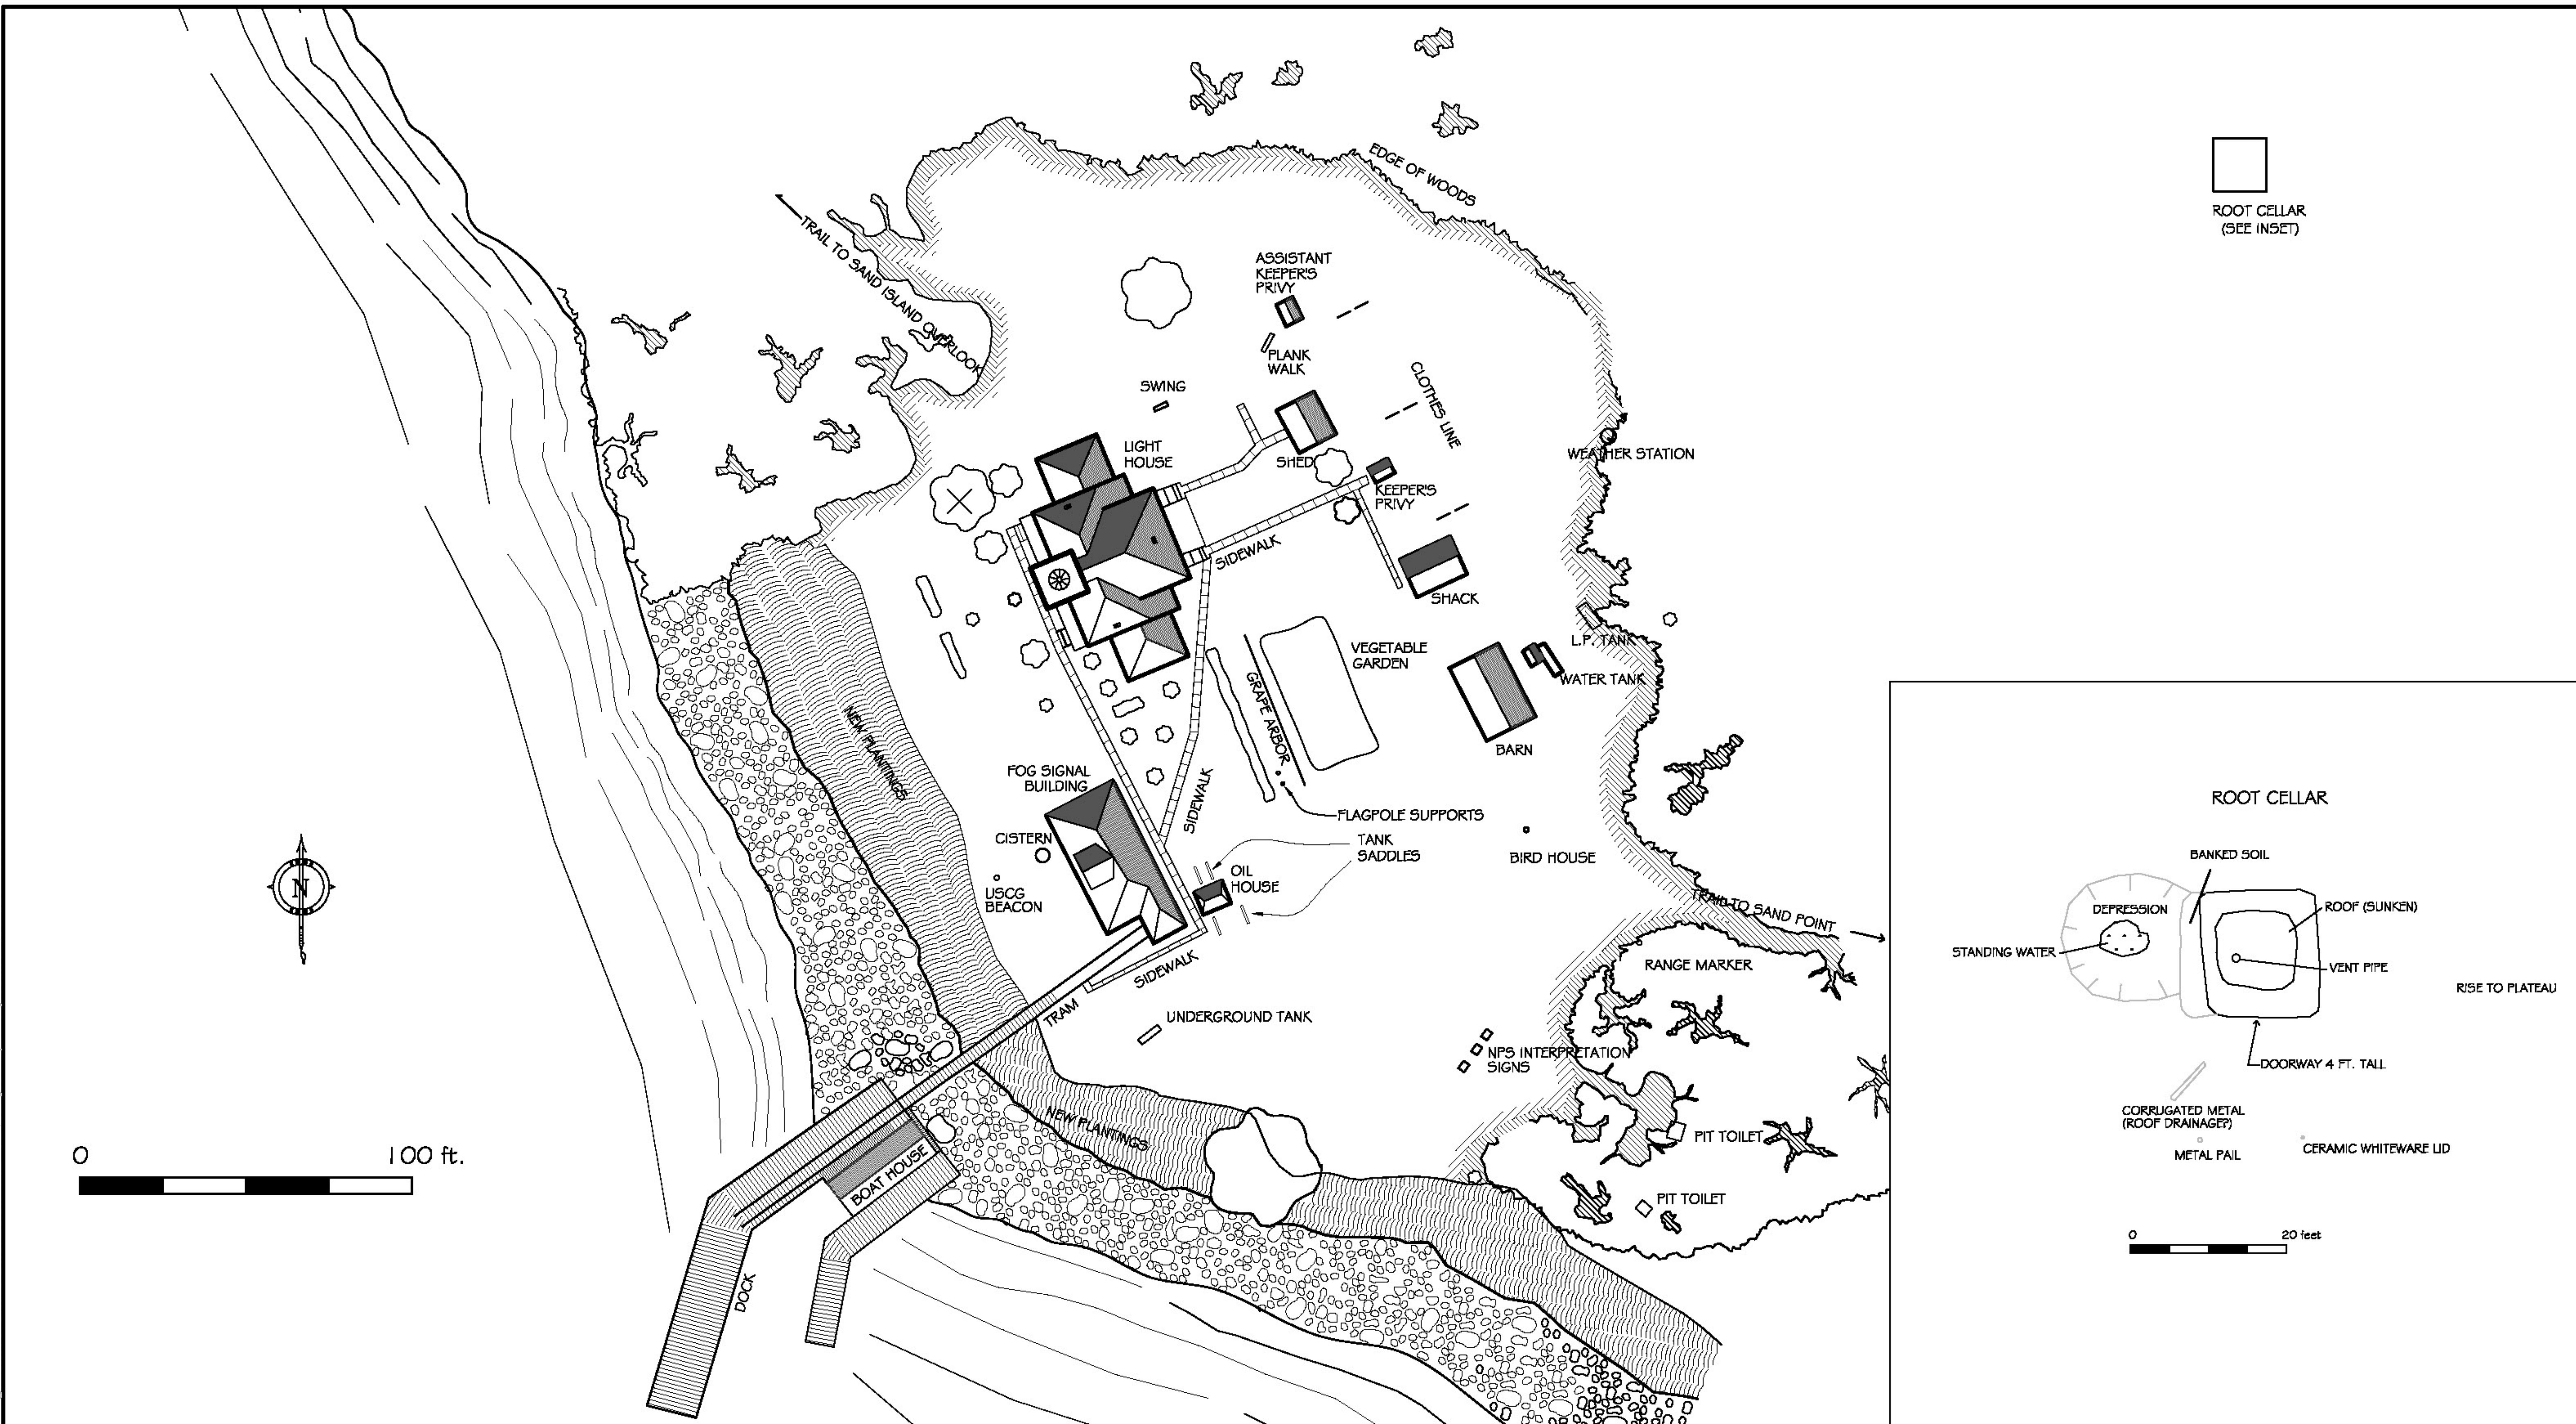
Figure 3. Site map.

-Figure Created in AutoCAD 2000 for HRA/Gray & Pope Project 02-32012 - Draft of 5-13-2004

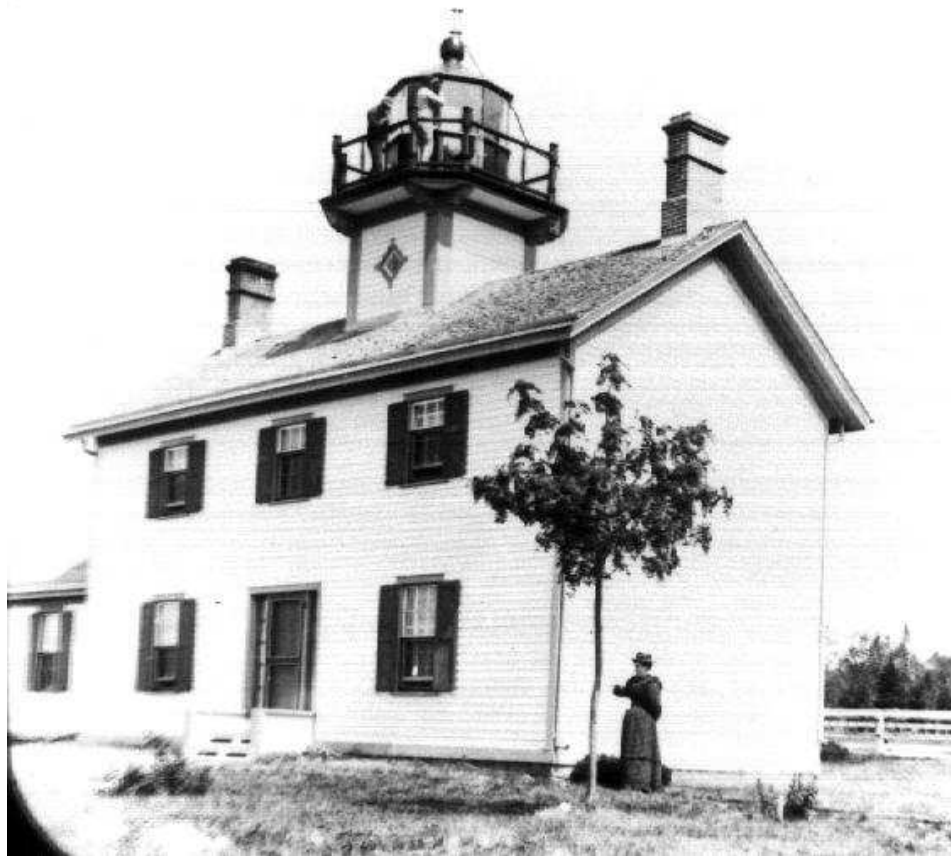
Figure 5. View to northeast of lighthouse, ca. 1890. Note board fence to right, rear. The woman appears to be standing on a plank walkway (Lakeshore archives).

Initial construction at Raspberry Island included a wood-frame single-family residence/lighthouse tower erected on a high bluff at the southwest end of the island, where the light would be visible to those plying both the West Channel and the lake proper (Figure 5). The location was ideal for a lighthouse, not only because it faced the West Channel, but also because the lighthouse could be built atop a high clay bluff that rises 40 feet above the surface of the lake. Workers cleared the native timber from an area of roughly six acres. The site selected for the lighthouse lay slightly south of center within the clearing, far enough from the edge of the bluff that erosion would not endanger the building. Construction of the 37-foot tall lighthouse tower created a 77-foot-high focal plane above the lake level. The clearing defined the arc of the light – between roughly 145 and 340 degrees – towards the West Channel and northward into the lake. Topography and vegetation blocked the projection of the light to the east. Within the tower, the Lighthouse Service installed a "catadioptric lens of the fifth order, system of Fresnel" that showed a fixed white light, varied by bright flashes at intervals of 90 seconds, visible "in ordinary states of the atmosphere, from the deck of a vessel, [for] a distance of fourteen (14) nautical miles."<sup>31</sup>

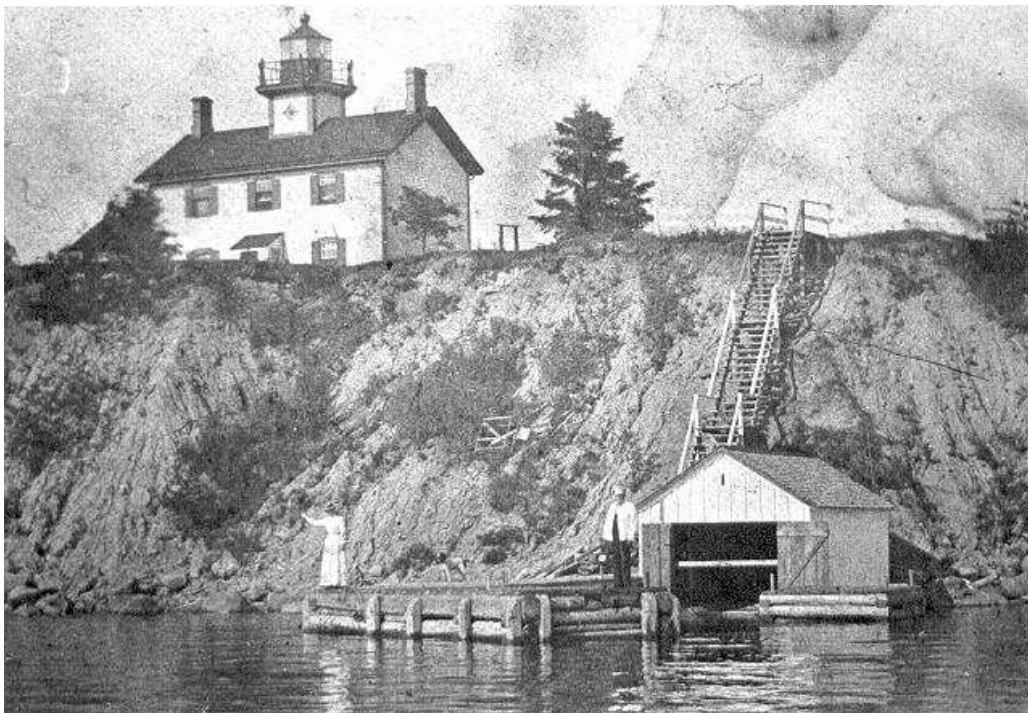
Figure 7. Lighthouse, dock, and boathouse, ca. 1901. Note storm shed on lighthouse entry; small size of dock and boathouse; stairs to bluff, swing to right of lighthouse; and board fence at far right (Lakeshore archives).

In 1867 the Lighthouse Board noted in its *Annual Report* that the station needed a boat landing and steps leading from the landing to the top of the bluff where the buildings stood. This improvement would spare the station keepers the arduous chore of hauling all goods and supplies from the sand point. Completed in 1868, the landing consisted of a cribbed dock. The stairs, however, were not completed until 1873. In 1877 the U.S. Lighthouse Engineers constructed new stairs and dock cribs at the station, and in 1878 they erected a boathouse, presumably at the sand point since a ca. 1891 photograph of the station (Figure 9) does not include a boathouse.<sup>36</sup> In any event, the station dock and boathouse were subject to serious damage almost every winter as a result of ice floes and storms, and repairs to the dock and boathouse were a priority nearly every spring, when the keeper and his assistants returned to the island. The *Annual Report of the Lighthouse Board* of 1894 notes that "The landing was extended by the addition of a crib. The boathouse was taken down and rebuilt adjoining the landing, on a foundation crib. New stairs were erected at the bank approaching the landing." The deck/crib structure was rebuilt again in 1900<sup>37</sup> (Figure 7).

Figure 41. View to east from lake, ca. 1970s. Note encroachment of vegetation into station clearing and erosion of bluff. Compare to Figure 7 (Lakeshore archives).

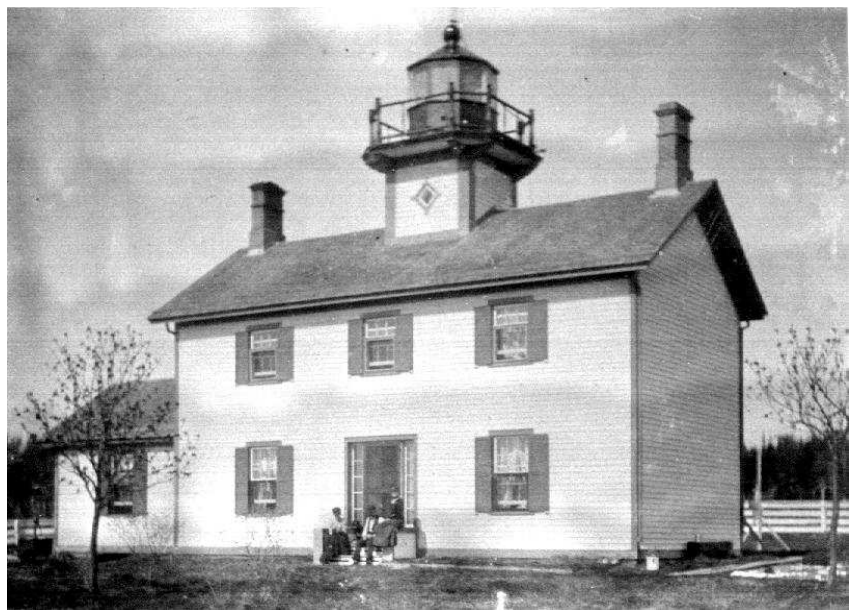
Figure 8. View to northeast of lighthouse, ca. 1890. Note board fence visible to left and right of building; plank walkway at front and side of building; and apparent absence of outbuildings behind lighthouse (Lakeshore archives).

Early on, two distinct zones developed within the light station clearing. By 1877 a fence had been erected around the lighthouse and its associated buildings, enclosing an area of about one and a half acres<sup>47</sup> (Figure 8). From 1877 until automation of the light in 1947, some sort of fence enclosed the main building cluster, although the type of fence and its exact configuration appears to have varied. In July 1896 Keeper John Eddy reported construction of a whitewashed fence enclosing the lawn –

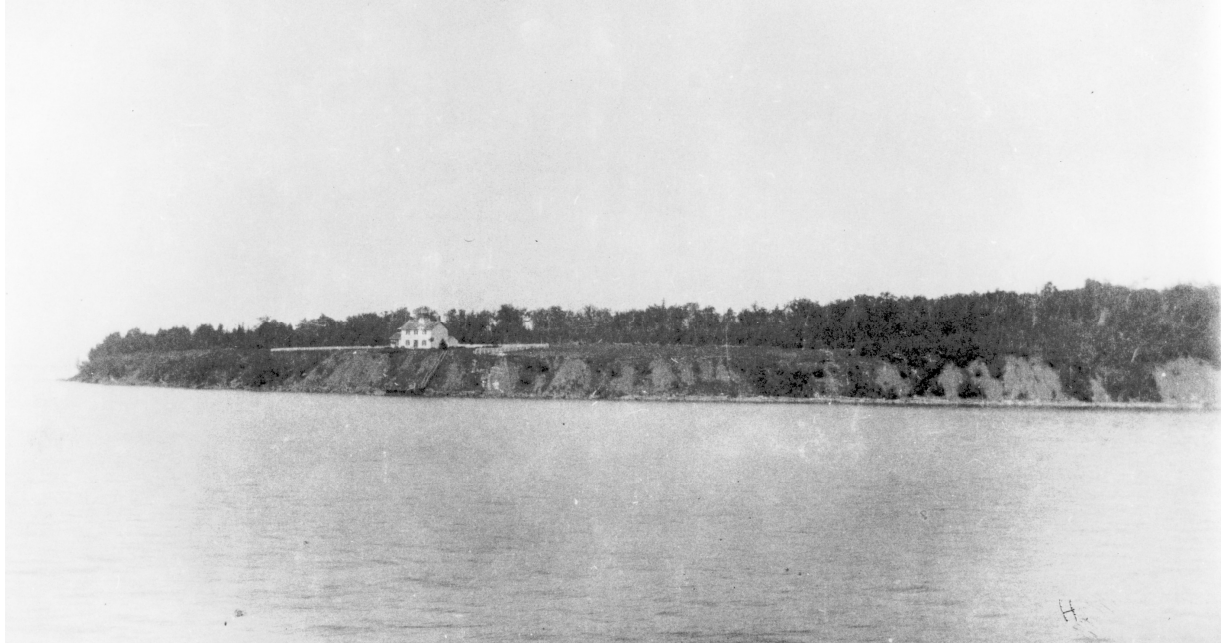
Figure 9. View of lighthouse and station clearing from lake, ca. 1891. Note fence surrounding lighthouse yard and extent of station clearing (Lakeshore archives).

appear to have paralleled the edge of the bluff west of the lighthouse strongly suggests that it was not intended as a safety device, despite the fact that several keepers had small children living with them on the island (Figures 9 and 10).

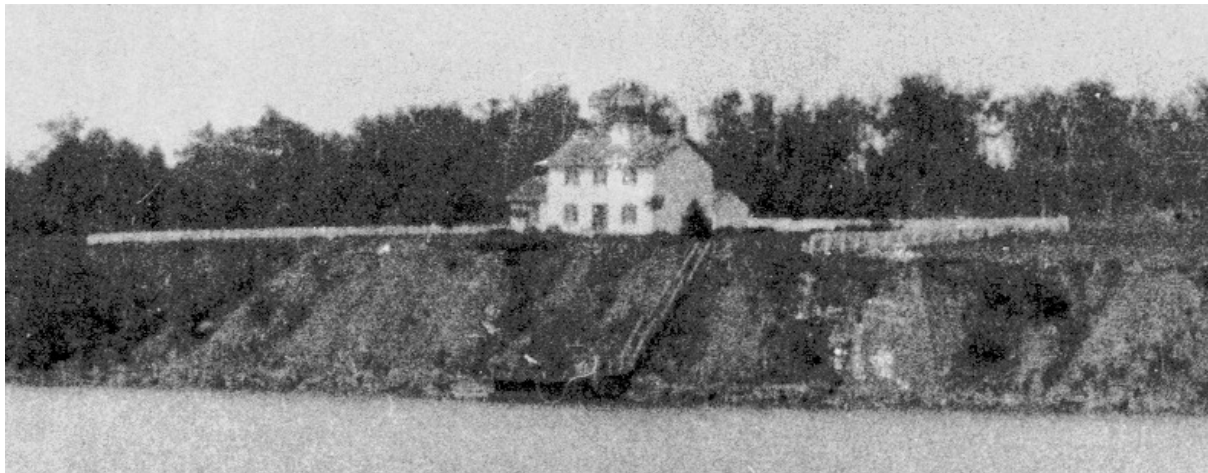
Figure 10. Detail of Figure 9. Note stairs from dock to bluff; fence around yard; absence of a boathouse; and the outbuilding visible at right of lighthouse (Lakeshore archives).

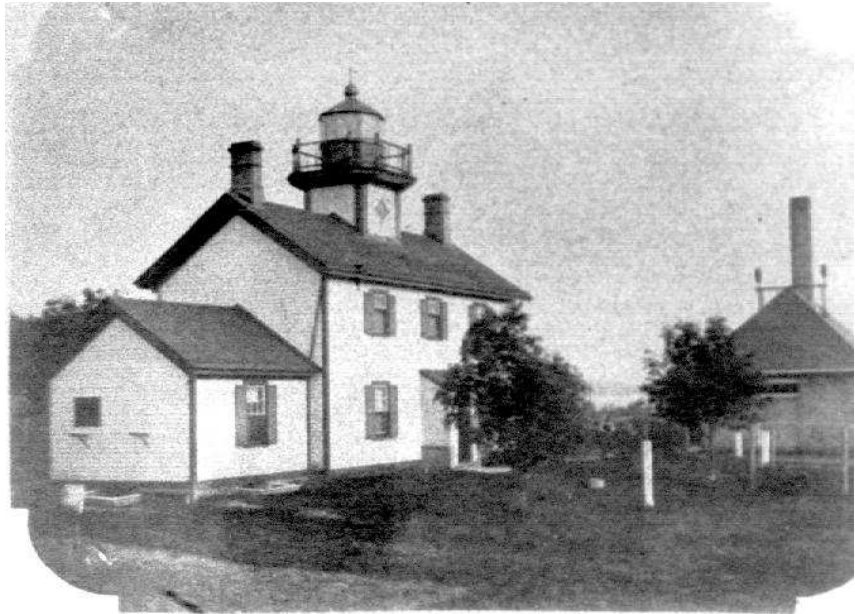
Figure 14. View to south of lighthouse and fog signal building, ca. 1903. Note access to cellar beneath kitchen wing at left (Lakeshore archives).

engine occupied a small (roughly 9 feet square) attached structure, accessible only from the exterior, at the south end of the building.<sup>92</sup> On August 8, 1903, Raspberry Island Keeper Hendrickson wrote "the 10-inch steam whistle at this Station has today, for the first time, been sending its sound over Lake Superior."<sup>93</sup> The Lighthouse Service Office of the Inspector ordered that the signal be sounded in blasts of 3 seconds' duration, separated by silent intervals of 17 seconds, during times of "thick weather"<sup>94</sup> (Figure 14).

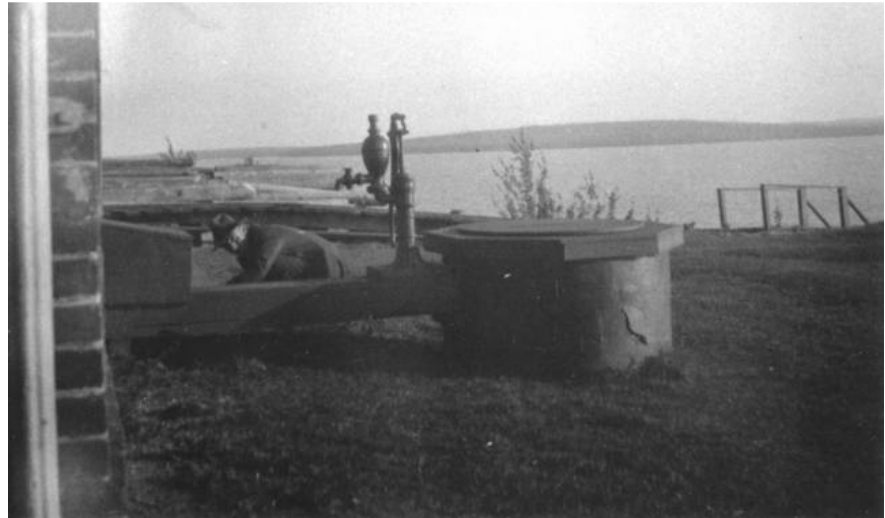
Figure 15. View to southwest of fog signal cistern, date unknown. Note hand pump; boxed-in waterline between cistern and fog signal building; and wood tramway at rear (Lakeshore archives).

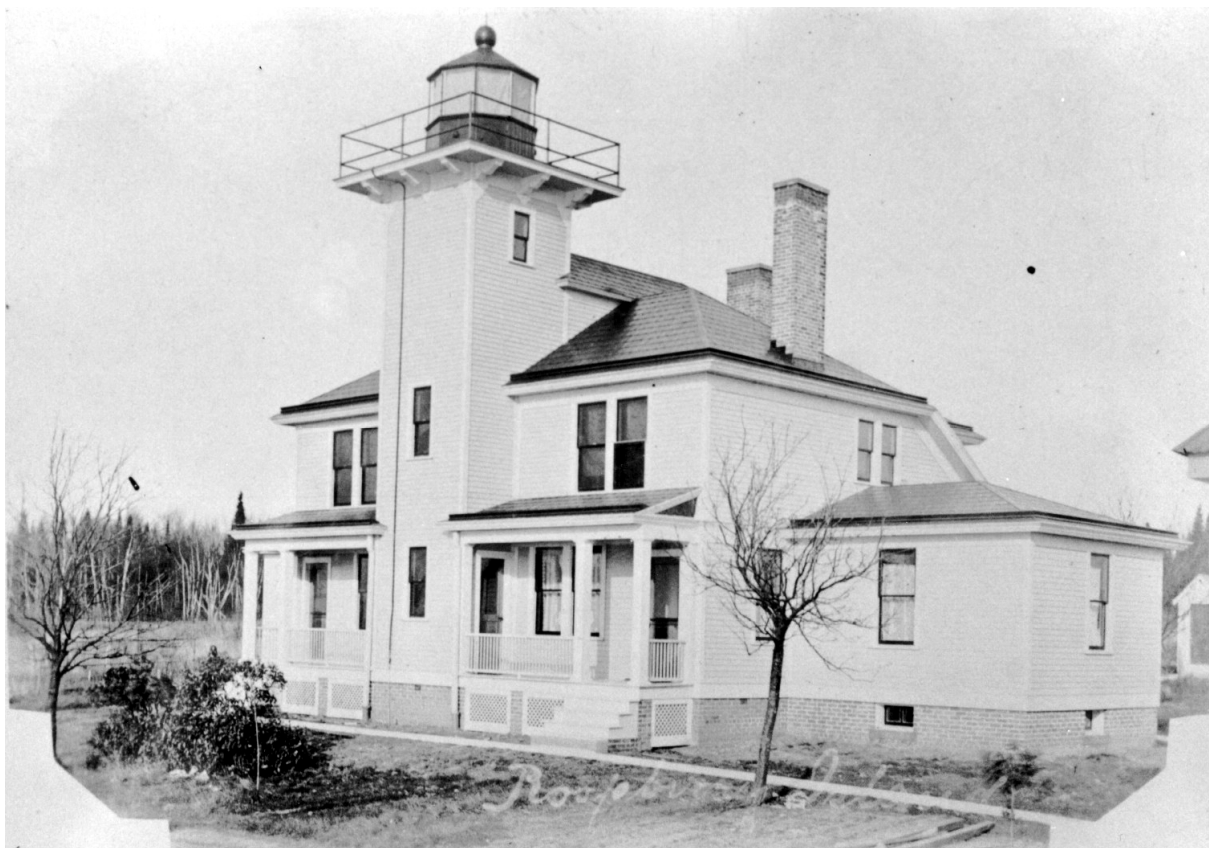
Figure 16. View to northeast of lighthouse, ca. 1906. Photo taken shortly after completion of remodeling. Note concrete walks; keeper's privy just visible at right rear (Lakeshore archives).

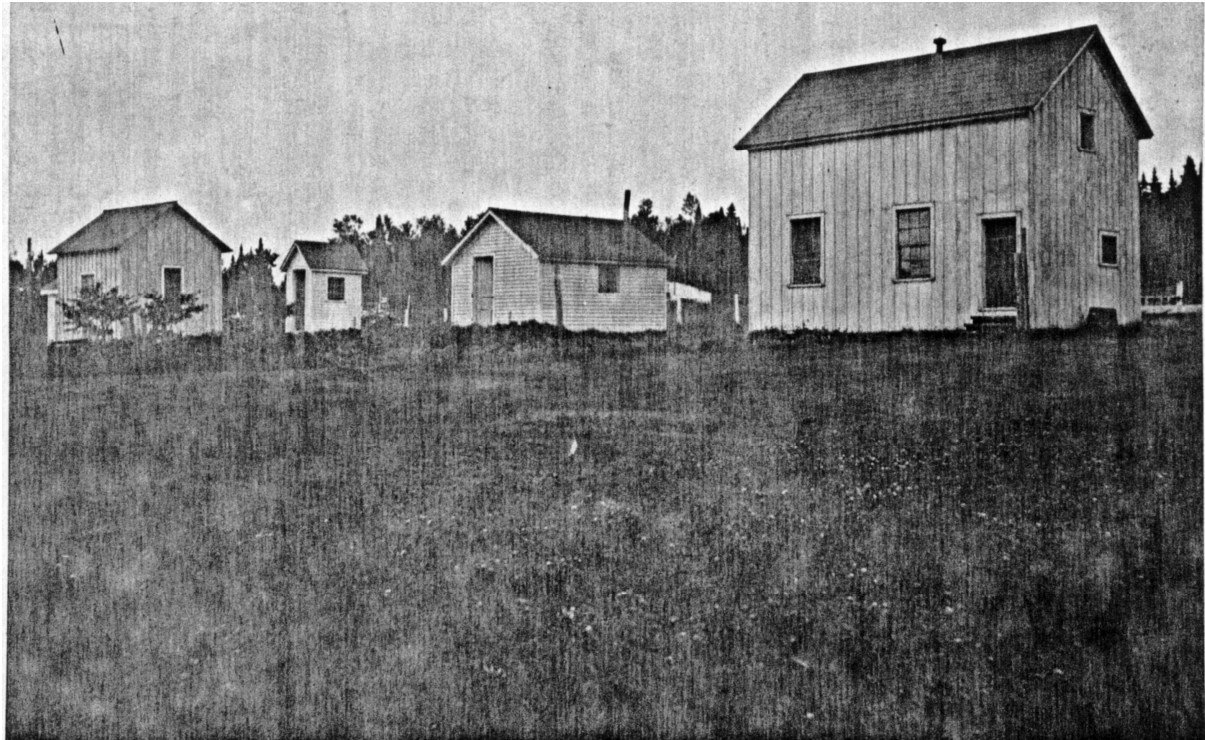
Figure 17. View of station outbuildings, date unknown. From left to right: assistant keeper's privy (just visible); shed #2; keeper's privy, shed #1, and barn. Note stove pipe projecting from roof of shed #1; clothesline to rear of outbuildings; apparent wire yard fence; and absence of obvious paths and walks (Lakeshore archives).

In May 1906 the keepers moved to a "temporary house," probably the existing barn. In October they moved back into the dwelling.<sup>108</sup> The reconfiguration of the lighthouse necessitated by the assignment of a second assistant keeper to the station to help with the increased workload that resulted from construction of the fog signal, also led to changes and additions to some of the ancillary buildings at the site. The existing barn was likely built during this period and may have served as temporary quarters for the keepers. A log entry from October 1906 records moving "the kitchen outfit from the old shed to the new barn."<sup>109</sup> A May 1907 entry refers to painting the wood shed, watercloset, and carpenter shop, the first reference in the logs to this later building.<sup>110</sup> The location of the carpenter shop is unknown, though it may be the building presently referred to as shed #1. It is certain that this building has served a variety of uses over the years (Figure 17).

Possibly constructed ca. 1862 as part of the initial period of development, the keeper's privy may be the oldest building at the station. Placed on a concrete foundation by the NPS ca. 1978, this building retains high integrity and is considered a contributing element of the cultural landscape (see Figures 17 and 60).

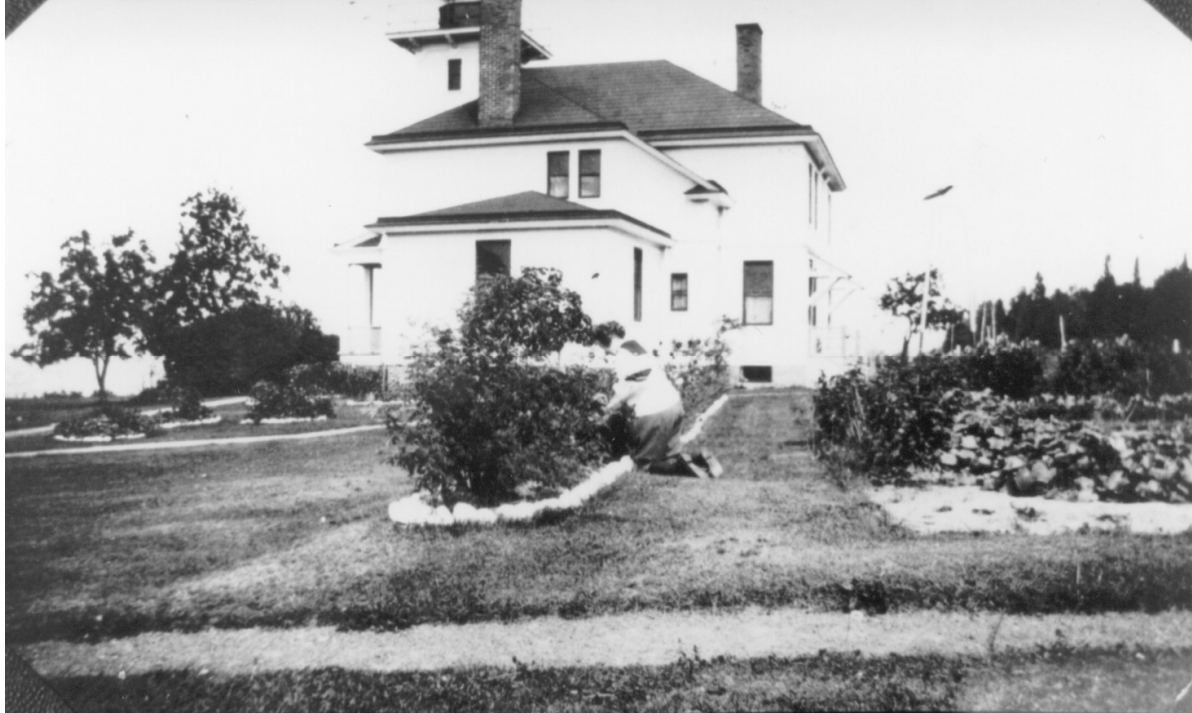
Figure 19. View to north of gardens, August 1922. Note vegetable garden to right; cinder path leading to barn in foreground; and flower beds bordered with painted stones (Lakeshore archives).

harvest seasons (Figure 19). In one of these exceptions, a 1905 keeper describes clearing and planting a domestic strawberry patch, auxiliary to the abundant native strawberries on the island.<sup>119</sup>

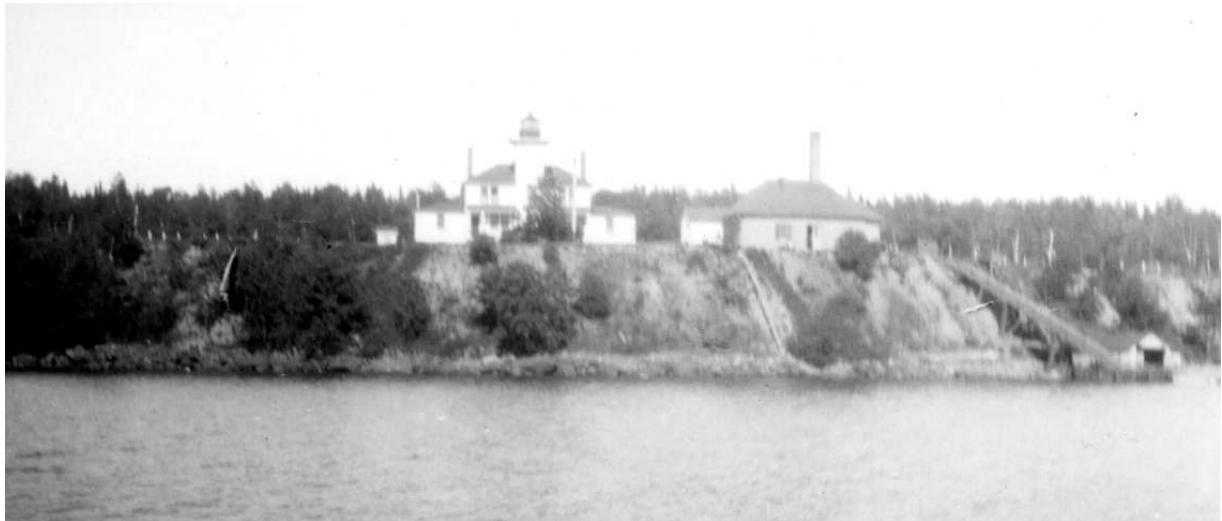
Figure 20. View from lake, ca. 1906. Note wood tramway at right; apparent wire fence (white-painted fence posts); and sewer/drainage lines on bluff face to left of lighthouse and below fog signal building. Outbuildings are visible to the rear of the lighthouse and fog signal building (Lakeshore archives).

more intensive use of the station dock, since it greatly reduced the amount of labor required to haul supplies and equipment up the bluff to the station (Figure 20).

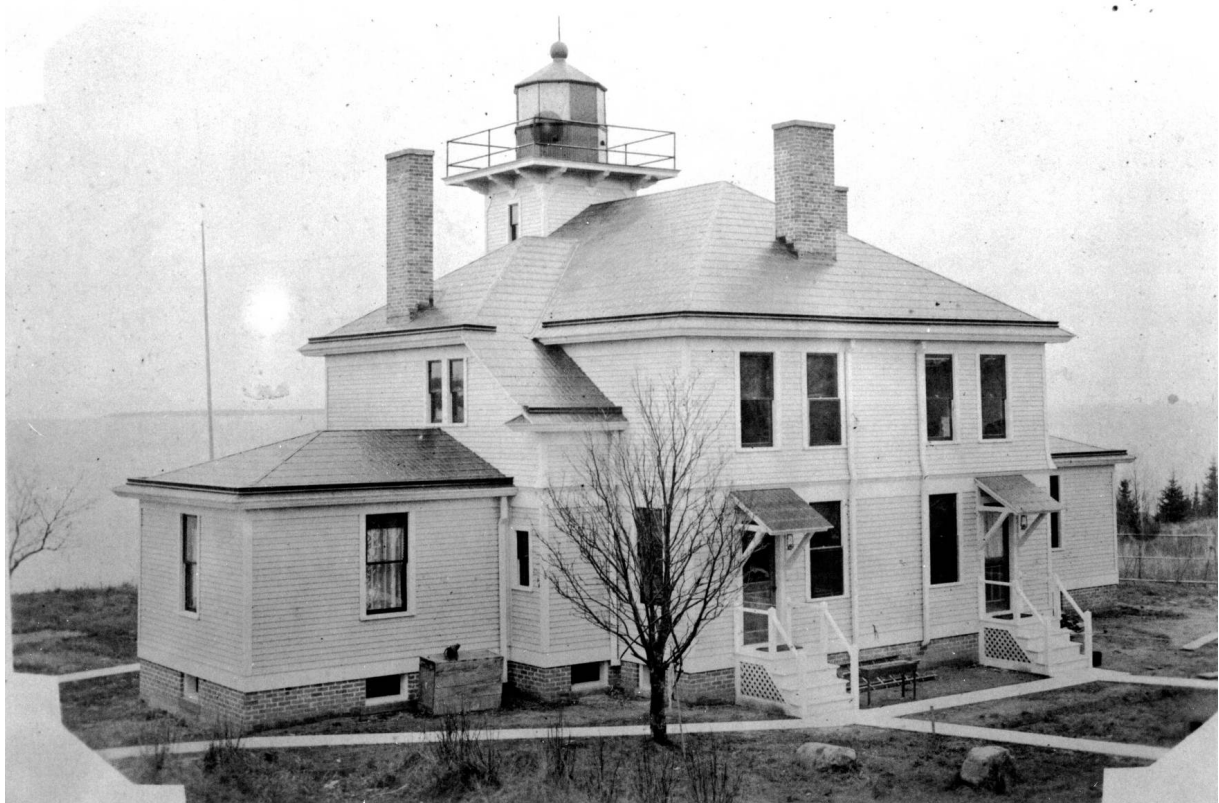
Figure 21. Rear (east) façade of lighthouse, ca. 1906. View taken after completion of remodeling. Note simple flagstaff in front (west) of lighthouse; concrete walkways; and wire yard fence gate. The tree behind the lighthouse and the two large rocks beside the walkway are no longer extant (Lakeshore archives).

signal building to the front (west) and rear (east) sides of the lighthouse, and from the rear of the lighthouse to towards the wood shed and the keepers' privy (Figure 21). The first log reference to cement or concrete sidewalks is found in 1909 and, as with so many previous entries, refers to cutting the sod away from the walk<sup>121</sup> (Figure 22). References to concrete walk repair and reconstruction include mention of hauling gravel from the sand point, possibly for use as a component in the concrete mix.<sup>122</sup>

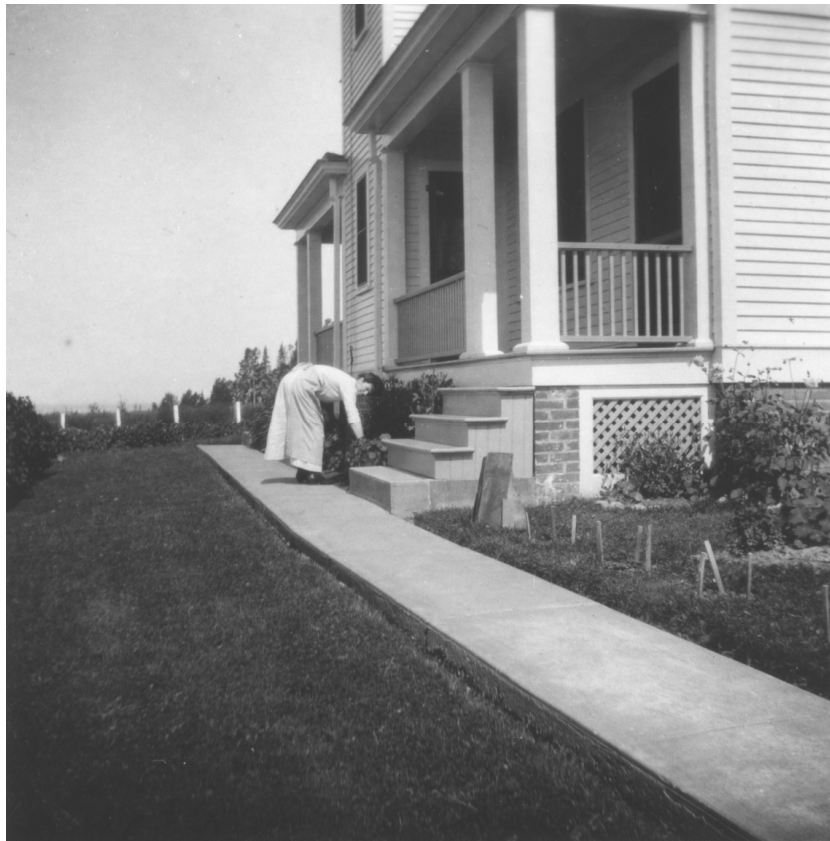
Figure 22. View to north of front (west) lawn of lighthouse, ca. 1920s. Note height of concrete walkway above grass; wire yard fence (painted cedar posts); and flower beds. This view shows the beds before they were bordered with painted stones (Lakeshore archives).

In 1909-1910 the four-rail yard fence was replaced by a wire fence with white-washed cedar posts (see Figures 22 and 23). The keepers cut and hauled the posts from the woods on the island.<sup>135</sup> The area enclosed by the fence was changed in 1930, when the Keeper's log notes that the old fence posts were pulled from the ground and the fence moved – whether to enclose a larger or smaller area is not known.<sup>136</sup>

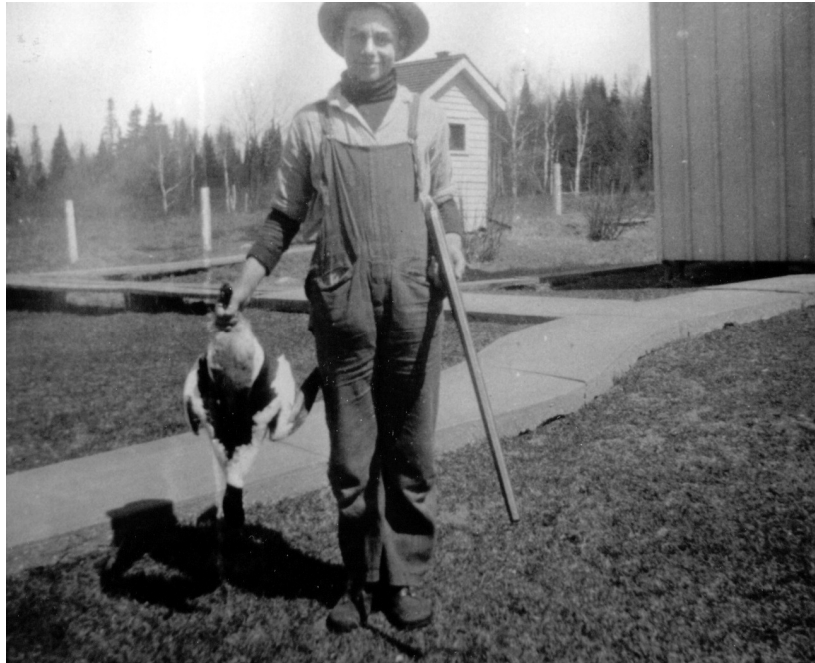
Figure 23. Harold Benton (son of Keeper Lee Benton) in front (west) of shed #2, ca. 1920. Note cement walk high above surrounding grass; plank walkway leading to assistant keeper's privy and alongside shed #2 to clothesline area; wire yard fence; and extent of station clearing beyond the fence (Lakeshore archives).

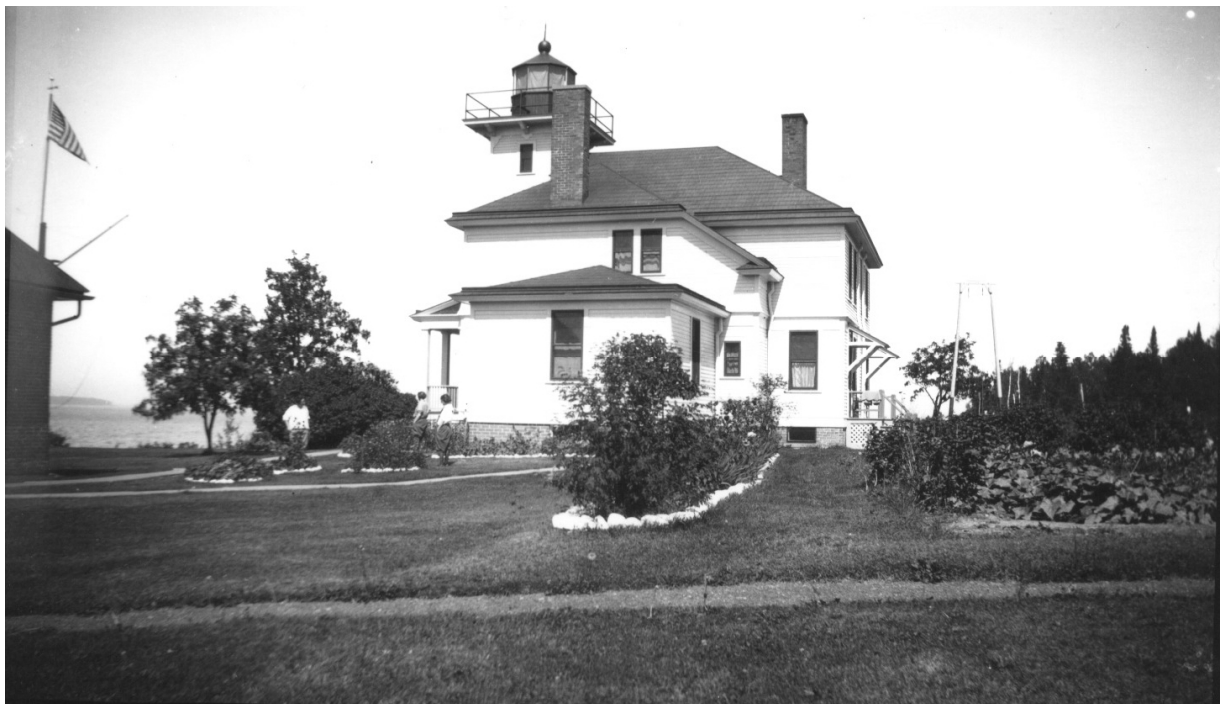
Figure 24. View to north of gardens, August 1922. Note flagstaff with topmast and gaff; flower beds outlined with painted stones; cinder path to barn in foreground; vegetable garden to right; and swing behind vegetable garden (Lakeshore archives).

shed #2 and, possibly, connected shed #1 to the barn. A photograph from the 1920s clearly shows a wood walkway extending from the end of the cement walk in front of shed #2 towards the assistant keepers' privy and a second wood walkway alongside the north side of shed #2, leading towards the area occupied by the station's clothesline (Figure 23).<sup>124</sup> A cinder walk, first noted in 1917, but probably dating from ca. 1906, appears to have extended from the vicinity of the oil building to the barn.<sup>125</sup> This walk is clearly visible in a photograph from 1922 (Figure 24).

Historic paths or walks that are no longer extant include a concrete walkway that connected the shed #1 and the barn, which appears to have been removed after the 1940s, and a cinder path that extended from the fog signal building to the barn along the south side of the lawn (Figure 93; see also Figure 24).

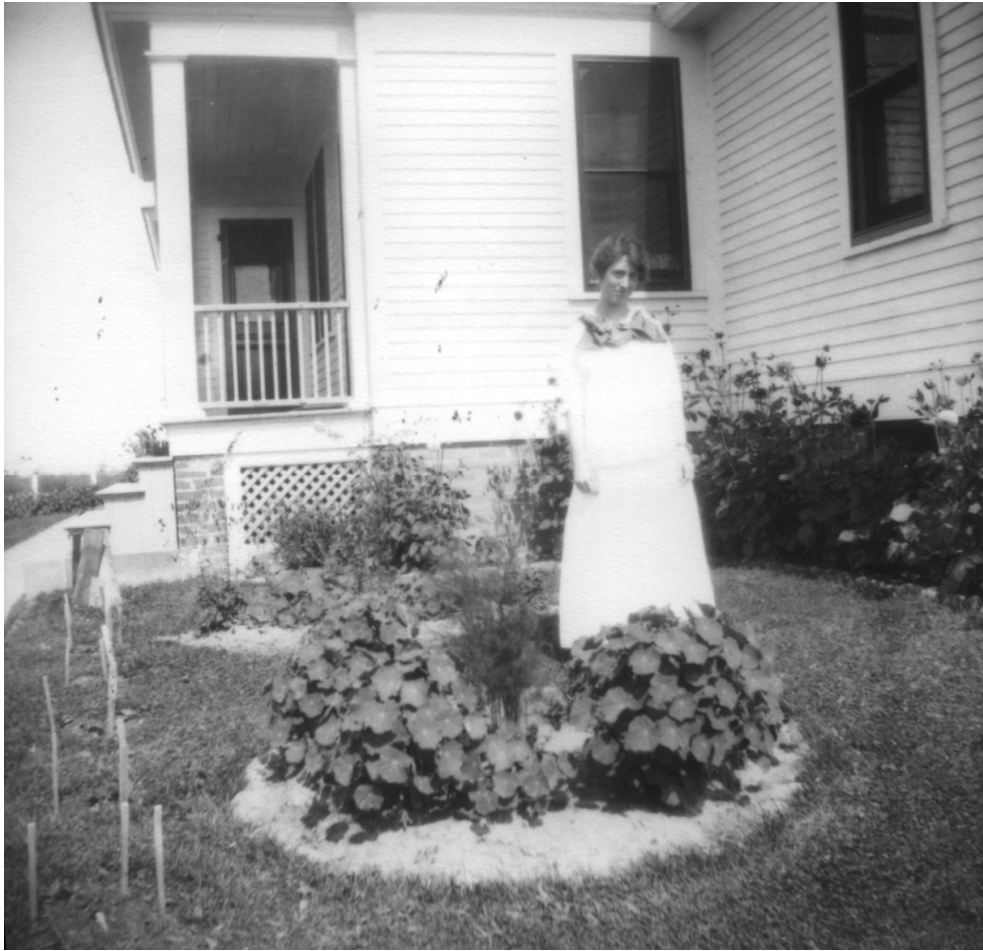
Figure 28. View to north of flower gardens at southwest corner of lighthouse, ca. 1920. Compare with Figure 22. Foundation bed border appears to be brick placed on end. Plantings appear to include astilbe, nasturtium, and dahlias (Lakeshore archives).

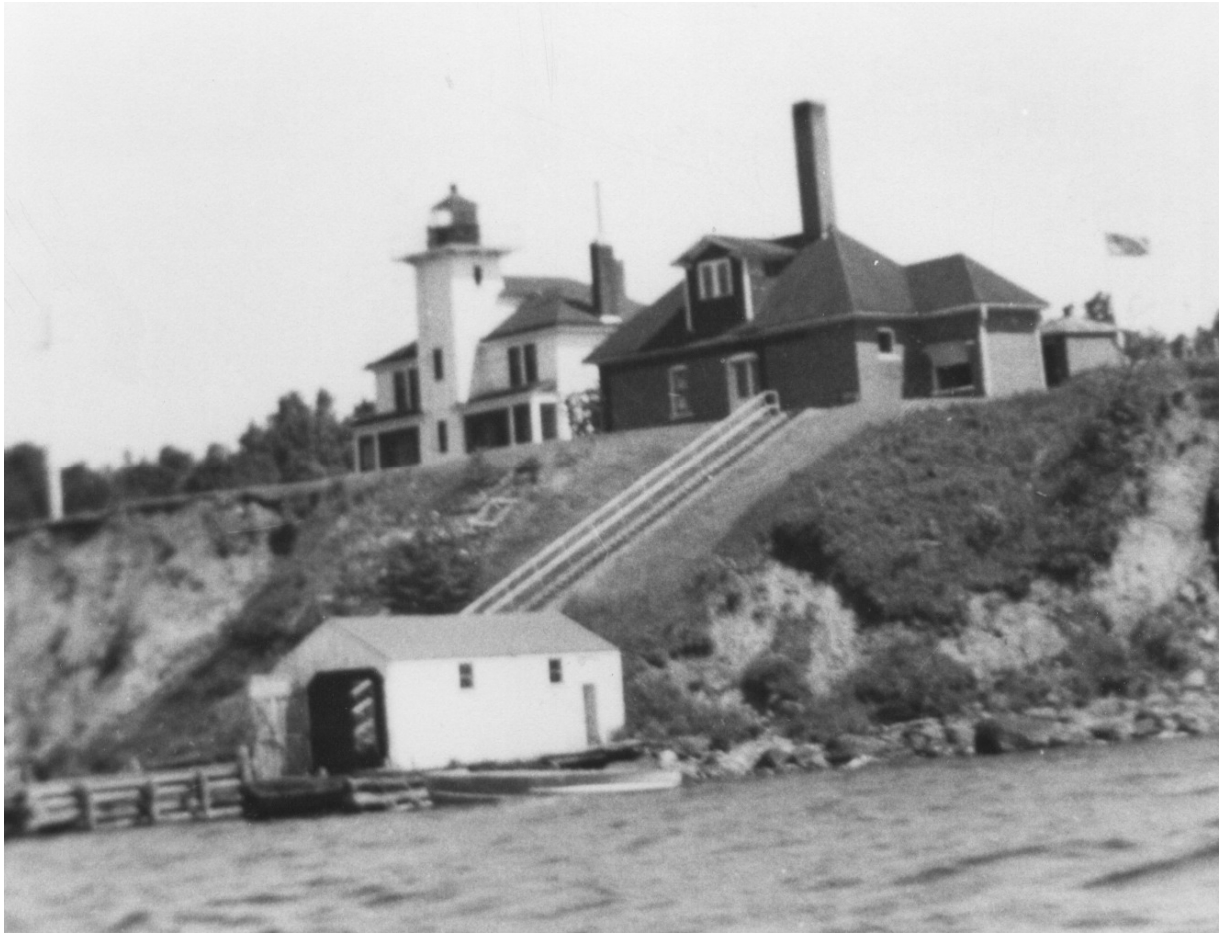
Figure 29. View from lake, ca. 1936. Note flagstaff to rear (east) of fog signal building (Lakeshore archives).

A variety of other minor site improvements and/or modifications took place during this period. The first mention of a flagstaff at the station is found in a log entry from 1903, which records the loss of the flagstaff in a gale.<sup>133</sup> It is likely that a flagstaff had existed at the station for many years, though photographs taken before the construction of the fog signal building do not appear to show a flagstaff. A 1906 photograph (see Figure 21) shows a simple wood flagstaff located west of the lighthouse near the edge of the bluff. This pole appears to have blown down in 1913, and the keepers replaced it with a much more elaborate flagstaff that included a topmast and a gaff (see Figure 24). The pole was replaced on several subsequent occasions.<sup>134</sup> A 1930s photograph clearly shows a flag flying from a second pole located east of the fog signal building. This flagstaff appears to be in the location of the supports located near the existing vegetable garden (Figure 29).

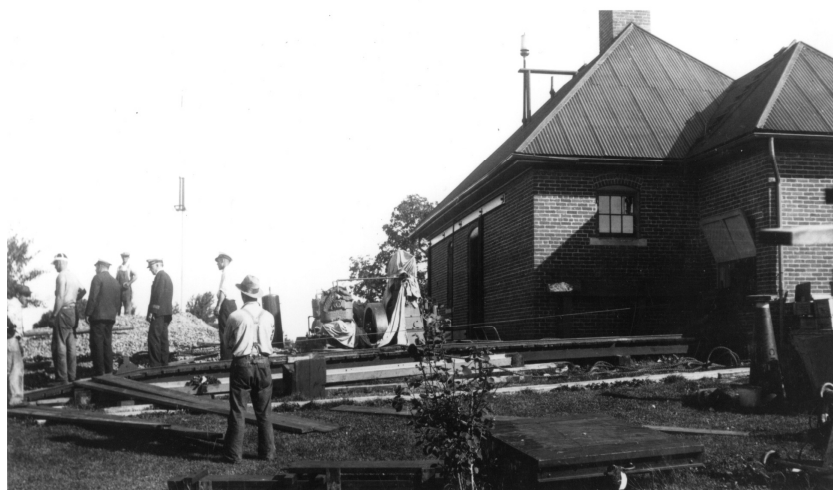
Figure 30. Hauling equipment for refitting of fog signal, ca. 1932. Note I-beam on front (west) façade of building, added in 1925 (Lakeshore archives).

The fog signal building was significantly altered on two occasions after its construction. In 1925 it was determined that the drain beneath the building, used to dispose of water used to wash the floors, had broken and was allowing water to seep under and weaken the building's foundation. Repairs entailed removing the floor, replacing the drain line, and applying a steel I-beam to the west façade of the building to provide increased structural stability<sup>140</sup> (Figure 30).

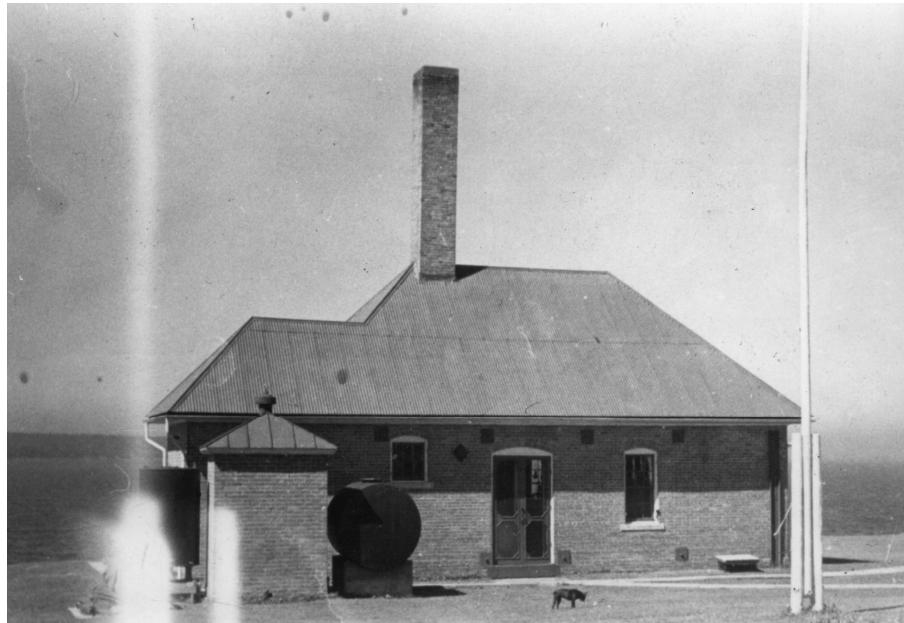
Figure 31. View to west of fog signal building, ca. 1945. Note fuel oil tanks flanking oil building; and flagstaff/aerial mast (Lakeshore archives).

In 1932 the steam-powered fog signal whistle was replaced with an air diaphone system. Run by "semi-diesel engines" and air compressors, the new air diaphones represent an innovation introduced throughout the federal lighthouse system. Keepers and assistant keepers were thereafter spared the time-consuming chores of shoveling coal and maintaining steam boilers and faced instead the more complicated task of diesel engine maintenance. Related infrastructure changes included removal of the fog signal building's interior wall, which had divided the coal- and wood-storage area from the machine room and conversion of the area to work space. A large gable-roofed dormer that provided the height required by the air diaphone apparatus was added to the west facade (see Figure 29). The horns extended through the windows in the dormer. Two diesel fuel storage tanks, consisting of metal tanks resting on concrete "saddles," were constructed adjacent to the southeast corner of the building, flanking the oil building to the north and south<sup>142</sup> (Figure 31).

Constructed in 1901 as a storage building for the kerosene used in the lighthouse light, this building is based upon Lighthouse Service standardized plans of the period.<sup>178</sup> The building retains a high level of integrity and is a contributing element of the cultural landscape (see Figures 31 and 57).

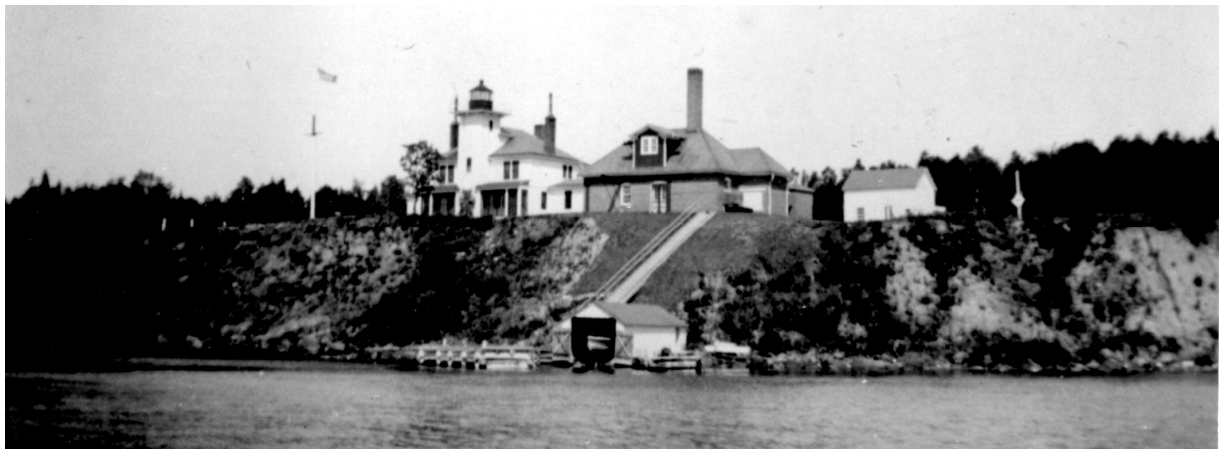
Figure 33. View from lake, ca. 1936. Note flagstaff with topmast, and range marker at right (Lakeshore archives).
