**Cultural Landscape Report  
and Environmental Assessment  
Raspberry Island Light Station  
Apostle Islands National Lakeshore  
Bayfield County, Wisconsin**

Prepared by the  
National Park Service,  
HRA Gray & Pape LLC,  
and  
Woolpert LLP

November 2004

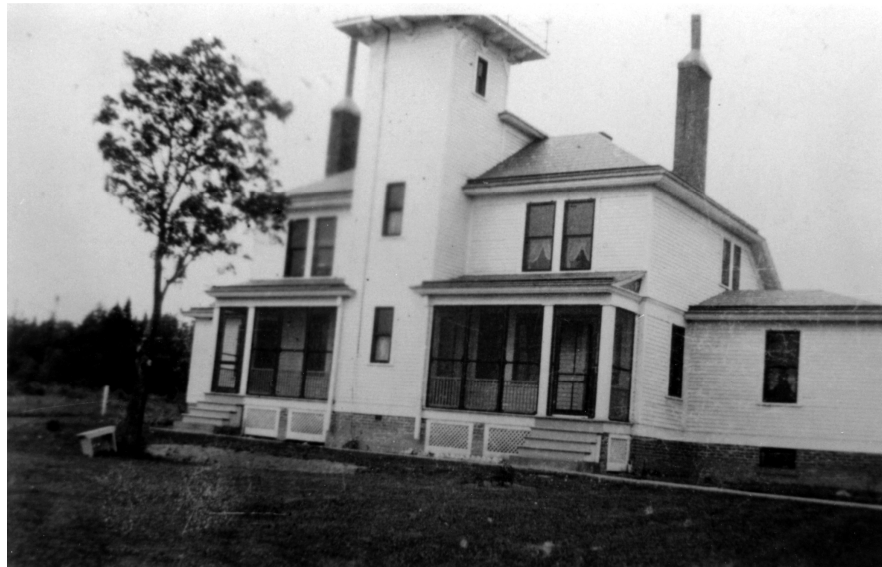
Figure 34. View to northeast of lighthouse, ca. 1936. Note screened porches and mountain ash directly west of light tower (Lakeshore archives).

Alterations related to the life of the keepers and their families included the enclosure of the front (west) porches of the lighthouse with screening in 1931<sup>146</sup> (Figure 34). In 1935, keepers built a bridge across one of the ravines on the trail to the sand point<sup>147</sup>, and also added a "root house," in the "woods back of dwelling."<sup>148</sup>

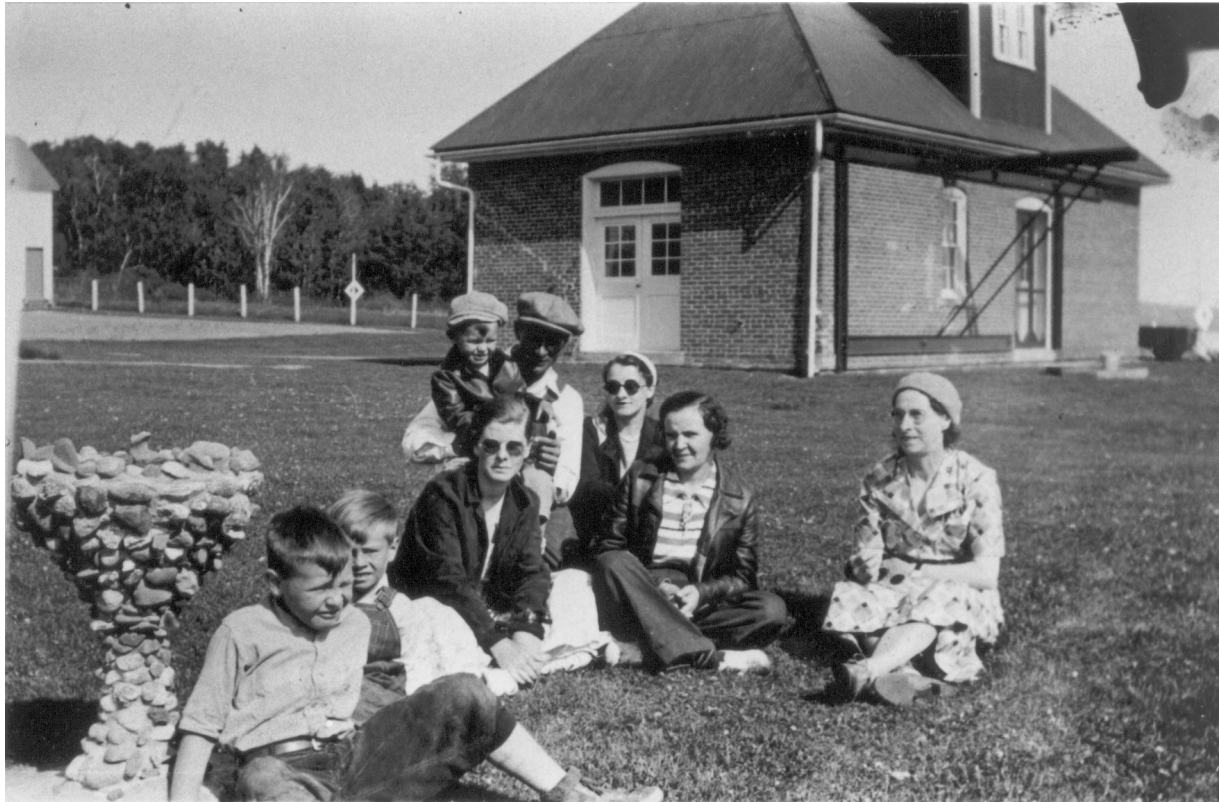
Figure 35. View to southeast of family group, ca. 1936. Note birdbath; wire yard fence at rear; range markers behind yard fence between barn and fog signal building and at extreme right. The open area between the buildings may be the vegetable garden (Lakeshore archives).

Birdhouses were erected in 1931, and are visible, outside the yard fence, in photographs from the early 1940s.<sup>149</sup> A cobble stone birdbath was constructed just south of the flagstaff in front of the lighthouse in the mid-1930s (Figure 35).

A cobblestone birdbath, located west of the lighthouse and south of the primary flagstaff, is visible in a ca 1936 photograph and a 1940s aerial photograph (see Figures 35 and 36). The date of construction of this non-extant feature is unknown.

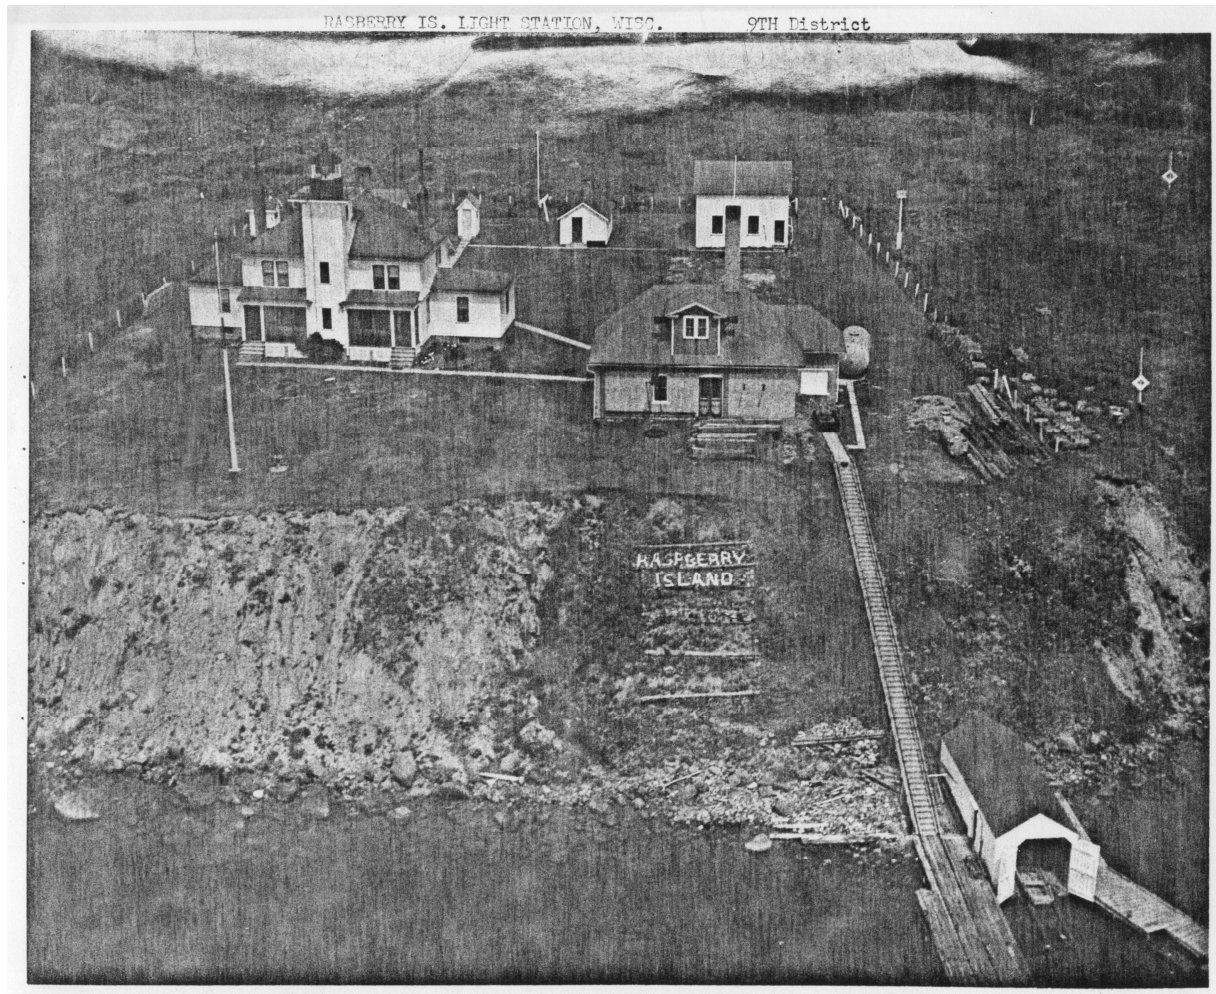
Figure 36. Aerial view to east of the station, ca. 1940. Note the extent of the clearing; wire yard fence; flagstaff with topmast; birdbath to south of flagstaff; clothesline behind outbuildings; birdhouse to south of barn; range markers at far right; flower garden and station name on bluff below fog signal building; fuel oil tank at southeast corner of fog signal building; and equipment and material at southwest corner of yard (Lakeshore archives).

largely absent by the 1940s, replaced by the previously described hillside garden that included an identifying sign constructed of white painted stones, below the fog signal building (see Figures 36 and 37). At least some of the keepers continued the tradition of growing a vegetable garden (Figure 39).

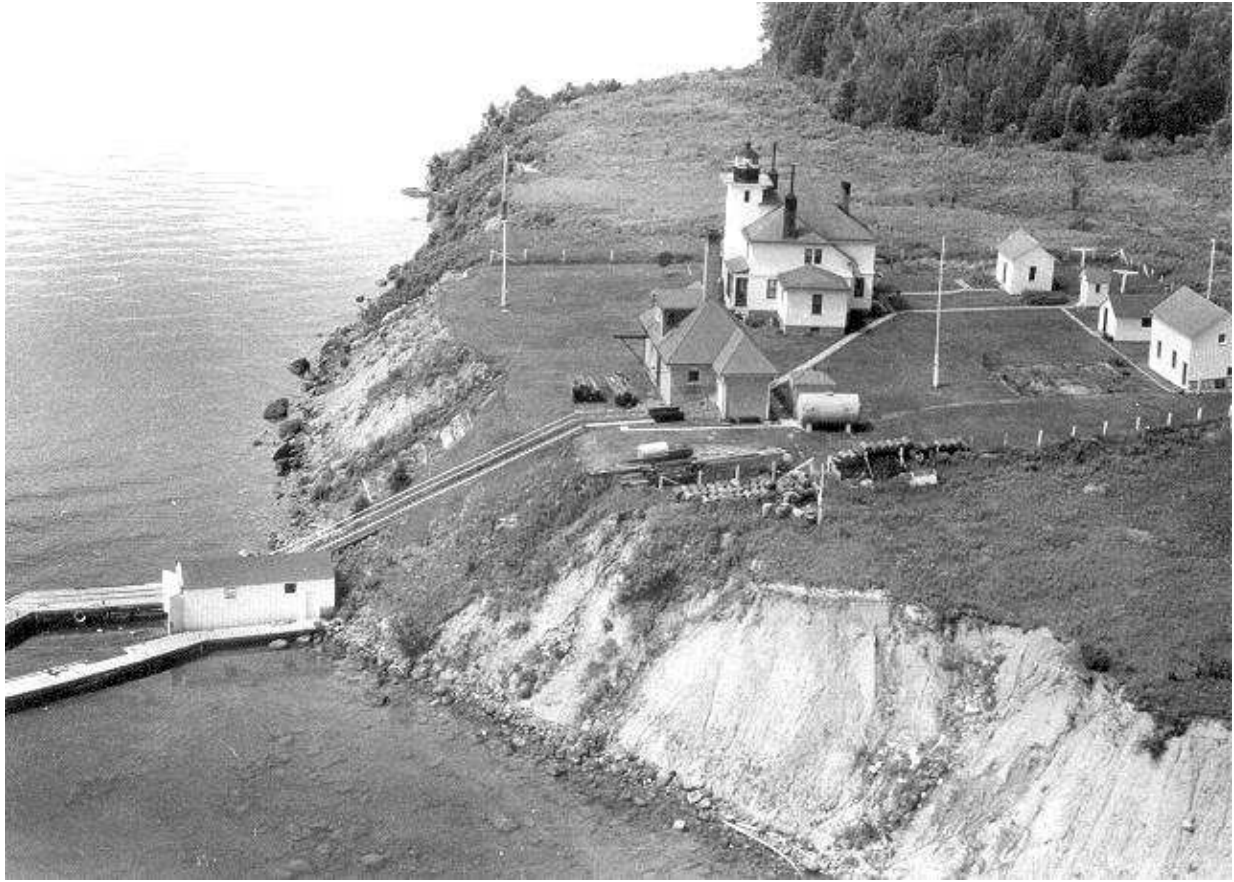
Figure 37. Aerial view to north of the station, ca. 1940. Compare with Figure 36. Note garden patch in front (west) of barn; and flagstaff or aerial mast, with supports, west of garden plot (Lakeshore archives).

Other aspects of the cultural landscape have not fared so well. The light station clearing, established in 1862, has not been maintained since at least 1957 (see Figure 37). As a result, the secondary forest canopy now encroaches on the station clearing. Pioneer species such as red osier dogwood are establishing themselves at the margin of the lighthouse yard, formerly defined by a fence, and, if not controlled, will overcome some of the ornamental plantings at the yard's perimeter. The regeneration of the forest within the clearing adversely affects the integrity of the historic site, by making it more difficult to understand the importance of the historic lighthouse placement and function. In addition, the accumulation of forest fuels in proximity to the wooden lighthouse buildings poses a fire threat that should be mitigated. Besides the natural processes that threaten the Raspberry Island cultural landscape, proposed alterations to the site associated with the rehabilitation of the lighthouse have the potential to introduce new, noncontributing elements to the historical scene. New maintenance and preservation efforts will be required in order to stabilize Raspberry Island's contributing cultural landscape features.

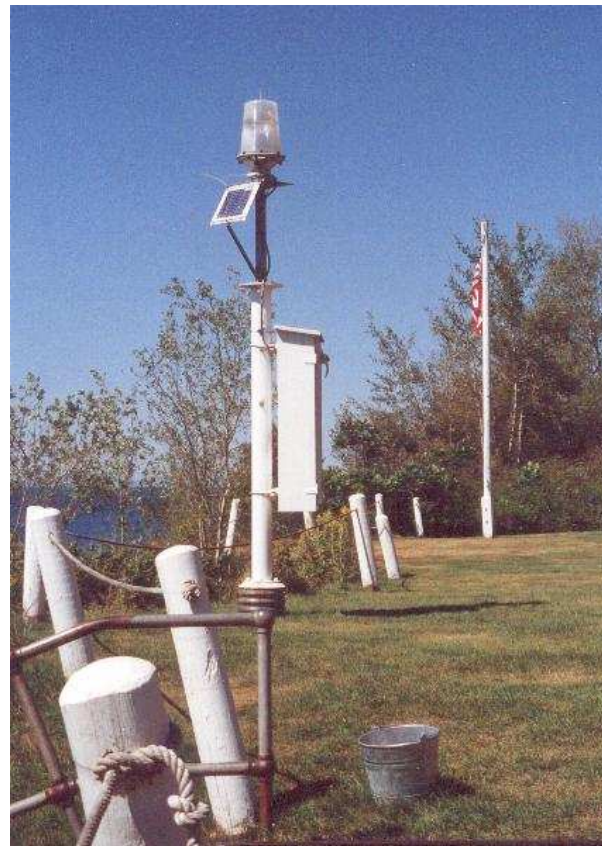
Figure 40. U.S. Coast Guard Navigation beacon, view to north, ca. 2000.

Between 1948 and 1958 the buildings at Raspberry Island stood largely uninhabited. The new battery operated light projected from the lighthouse tower without the need for maintenance and attention from resident keepers. In 1957, the Coast Guard removed the Fresnel lens from the lighthouse and donated it to the Madeline Island Historical Museum. The light was replaced with a 160-candlepower light mounted atop a pole located at the bluff's edge in front of the fog signal building. This light was visible to passing ships for a distance of seven miles<sup>155</sup> (Figure 40).

The Coast Guard light beacon located west of the fog signal building was installed in 1948 (see Figure 40). It consists of a metal pole with a solar panel, and equipment box, and the light beacon. It is maintained in good working condition and is useful in interpreting the decline of historic lighthouse lifestyles and operations, and the resulting change in the view shed.

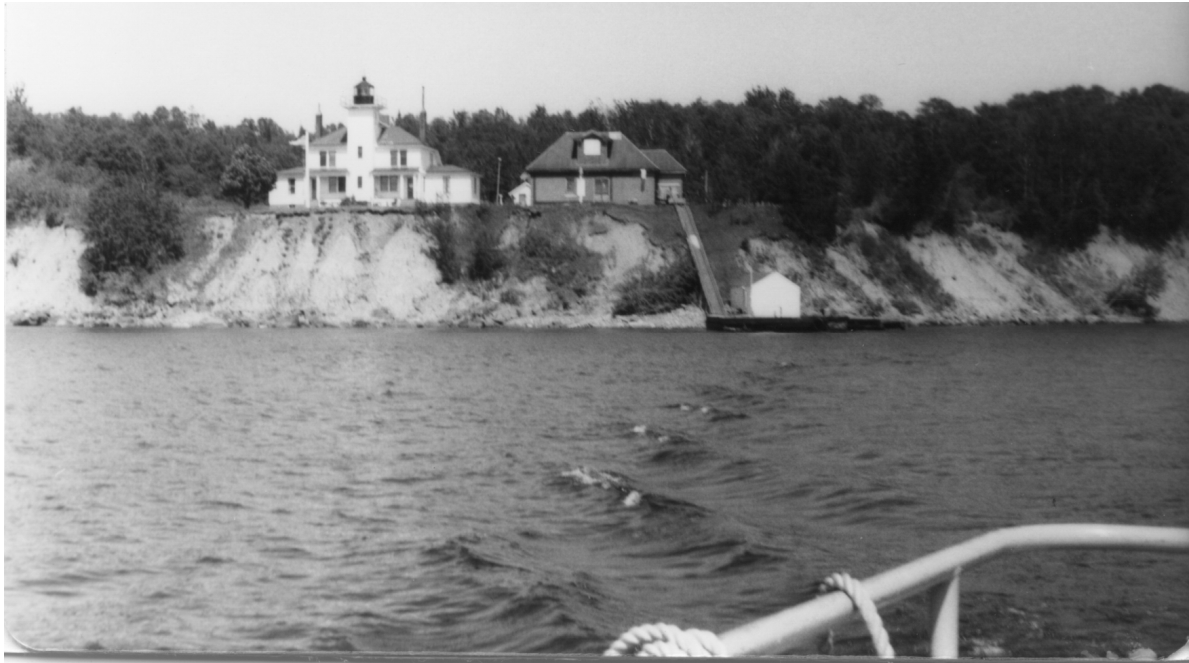
Figure 41. View to east from lake, ca. 1970s. Note encroachment of vegetation into station clearing and erosion of bluff. Compare to Figure 7 (Lakeshore archives).

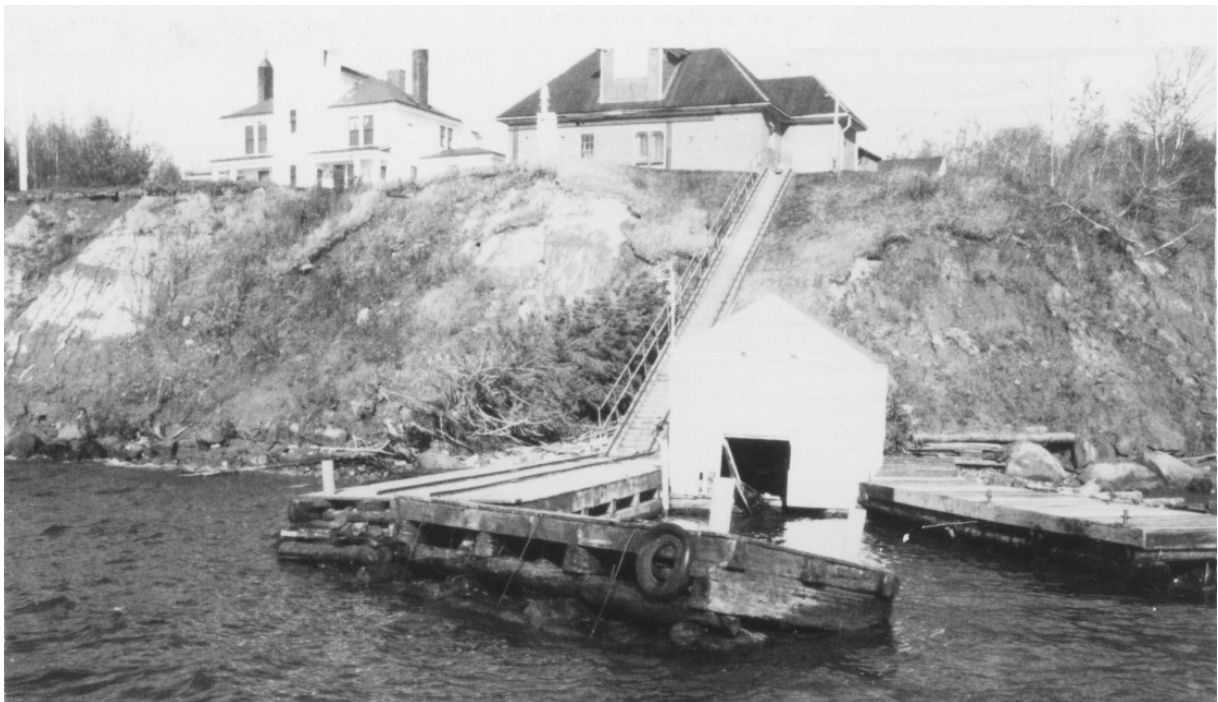
Figure 43. Boathouse and dock. View to east, 1977 (Lakeshore archives).

Lakeshore staff and professional historical architects from the Midwest Regional Office began to stabilize the Raspberry Island buildings in 1977 (Figure 43). Efforts were devoted principally to the lighthouse, and included construction of a concrete block retaining wall along the entire east foundation wall of the lighthouse, application of masonry waterproofing, installation of site drainage lines, painting to historic specifications, and improvements associated with health and safety requirements. Site work also appears to have included construction of a drainage ditch along the east side of the lighthouse yard – apparently an attempt to divert water draining from the slope east of the buildings. In 1982 the park service undertook significant window repairs. This work appears to have entailed stripping, refinishing, and reglazing of historic sash and selected replacement of damaged sash. In 1987 the steps and porches of the two east (rear) entries were rebuilt and are "virtually identical to their historic counterparts."<sup>161</sup>

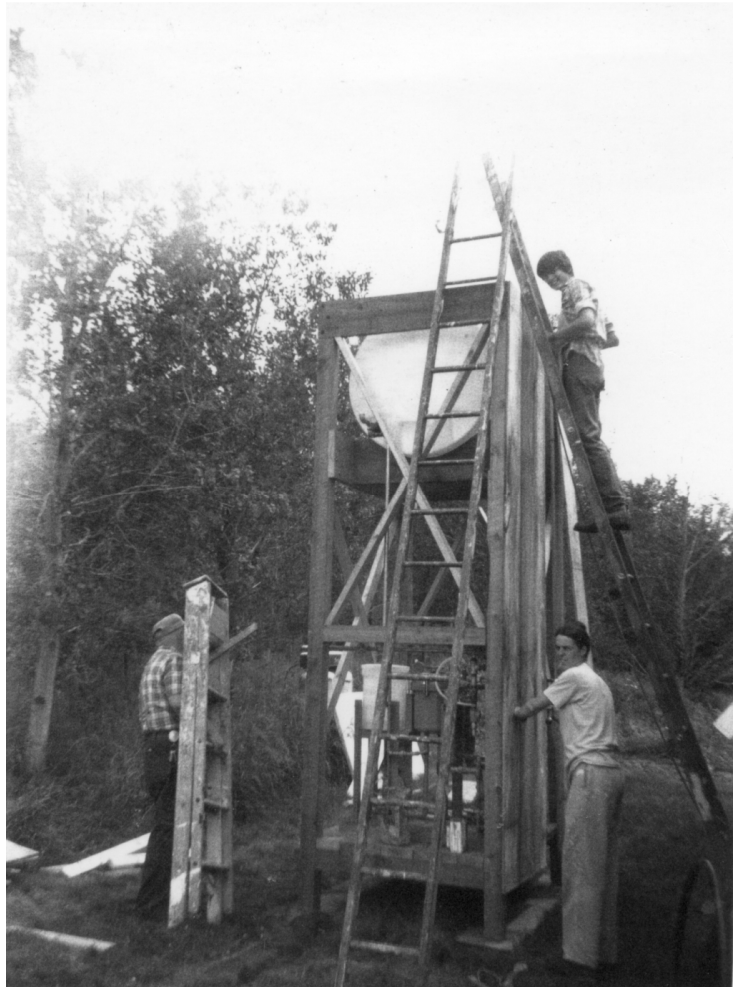
Figure 47. Construction of water tank, ca. 1982 (Lakeshore archives).

Also in 1982, the lakeshore upgraded the island's water system. From a new intake pipe a pump in the boathouse raised water to a 200-gallon fiberglass storage tank located behind the barn (Figure 47). The main, copper distribution line was replaced with PVC pipe, and a new distribution line brought water to the barn. The old distribution line to the lighthouse was tied to the new main line.<sup>164</sup>

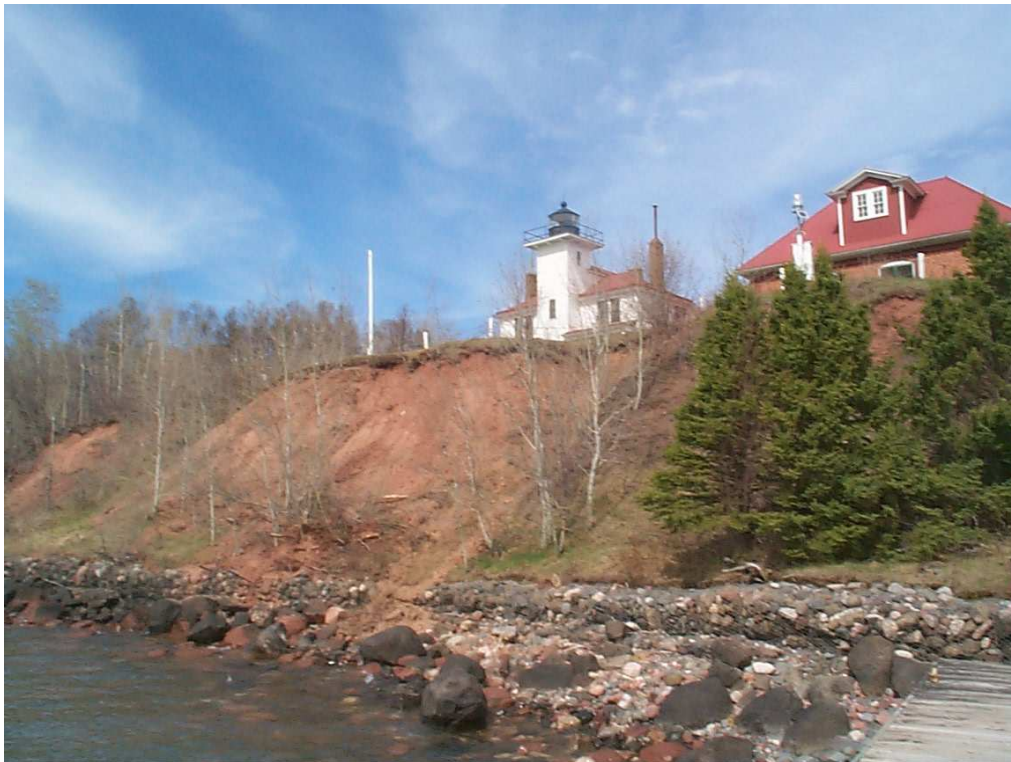
Figure 48. View to northeast of bank erosion, May 2001(Lakeshore archives).

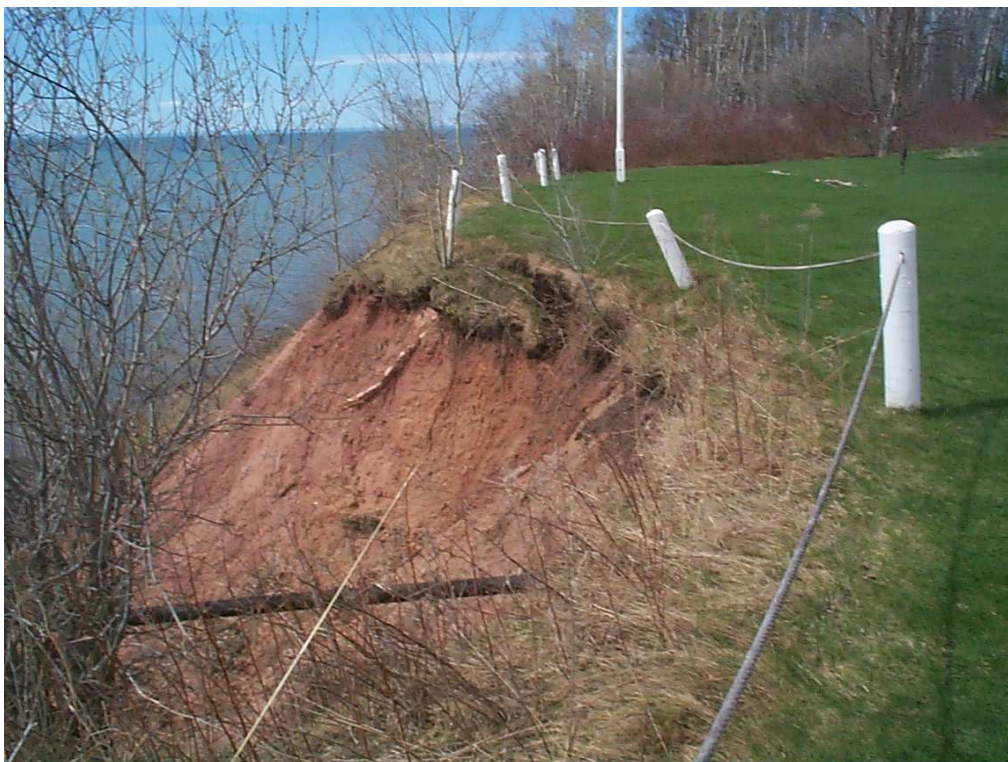
Figure 49. Bank erosion detail. View to north, May 2001(Lakeshore archives).

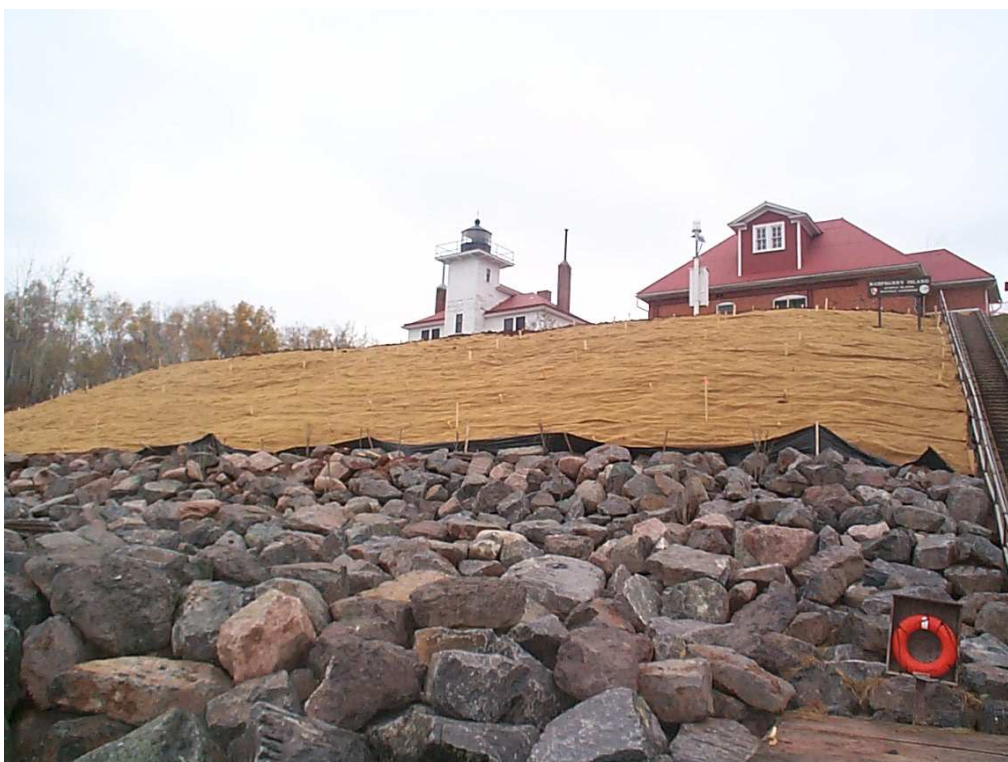
Figure 50. Revetment construction. End of first construction season, 2002.

Most recently, the lakeshore has undertaken a major bank stabilization project below the light station buildings. Erosion of the clay bank in front of the building had been an ongoing problem for years – the "loose stone shore protection" located at the base of the bank during the majority of the historical period proved insufficient to prevent erosion and slumping at the edge of the cut bank in front of the lighthouse complex (Figures 48 and 49). The edge of the bluff is presently as much as twenty to forty feet closer to the fog signal building and lighthouse than during the first quarter of the twentieth century. The solution selected by the lakeshore entailed placement of a rubble mound revetment along roughly 200 feet of bank below the buildings. The revetment consists of a band of "armor" stone (boulder-sized rock) that extends roughly 25 feet into the water, with smaller filter stone extending from the armor stone to the top of the bank. The filter stone is covered with soil and will eventually support native vegetation (Figures 50 and 51).

A 1910 map (see Figure 84) of the site indicates that measures were taken at an early stage to address the erosion of the bluff. The map highlights 'loose stone shore protection' placed to the north and south of the dock. Since the island has been under NPS management, the Lakeshore has consistently taken measures to curb bluff erosion, especially immediately west of the historic building cluster. In the 1980s the Lakeshore built a low riprap wall that proved unsuccessful. Most recent changes, completed in 2003, include the addition of nearly forty feet of material to the base of the bluff and construction of a stable slope planted with native vegetation (Figure 88; also see Figure 50).

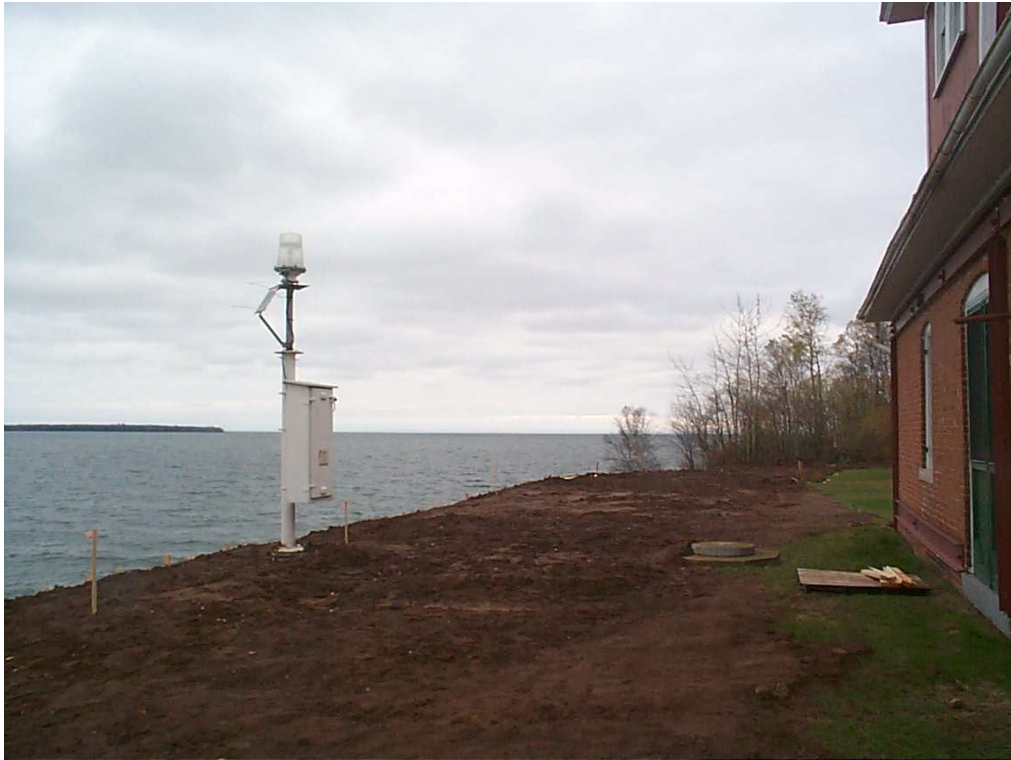
Figure 51. Top of slope at end of first construction season. View to northwest, 2002.  
Note U.S. Coast Guard beacon and fog signal cistern.

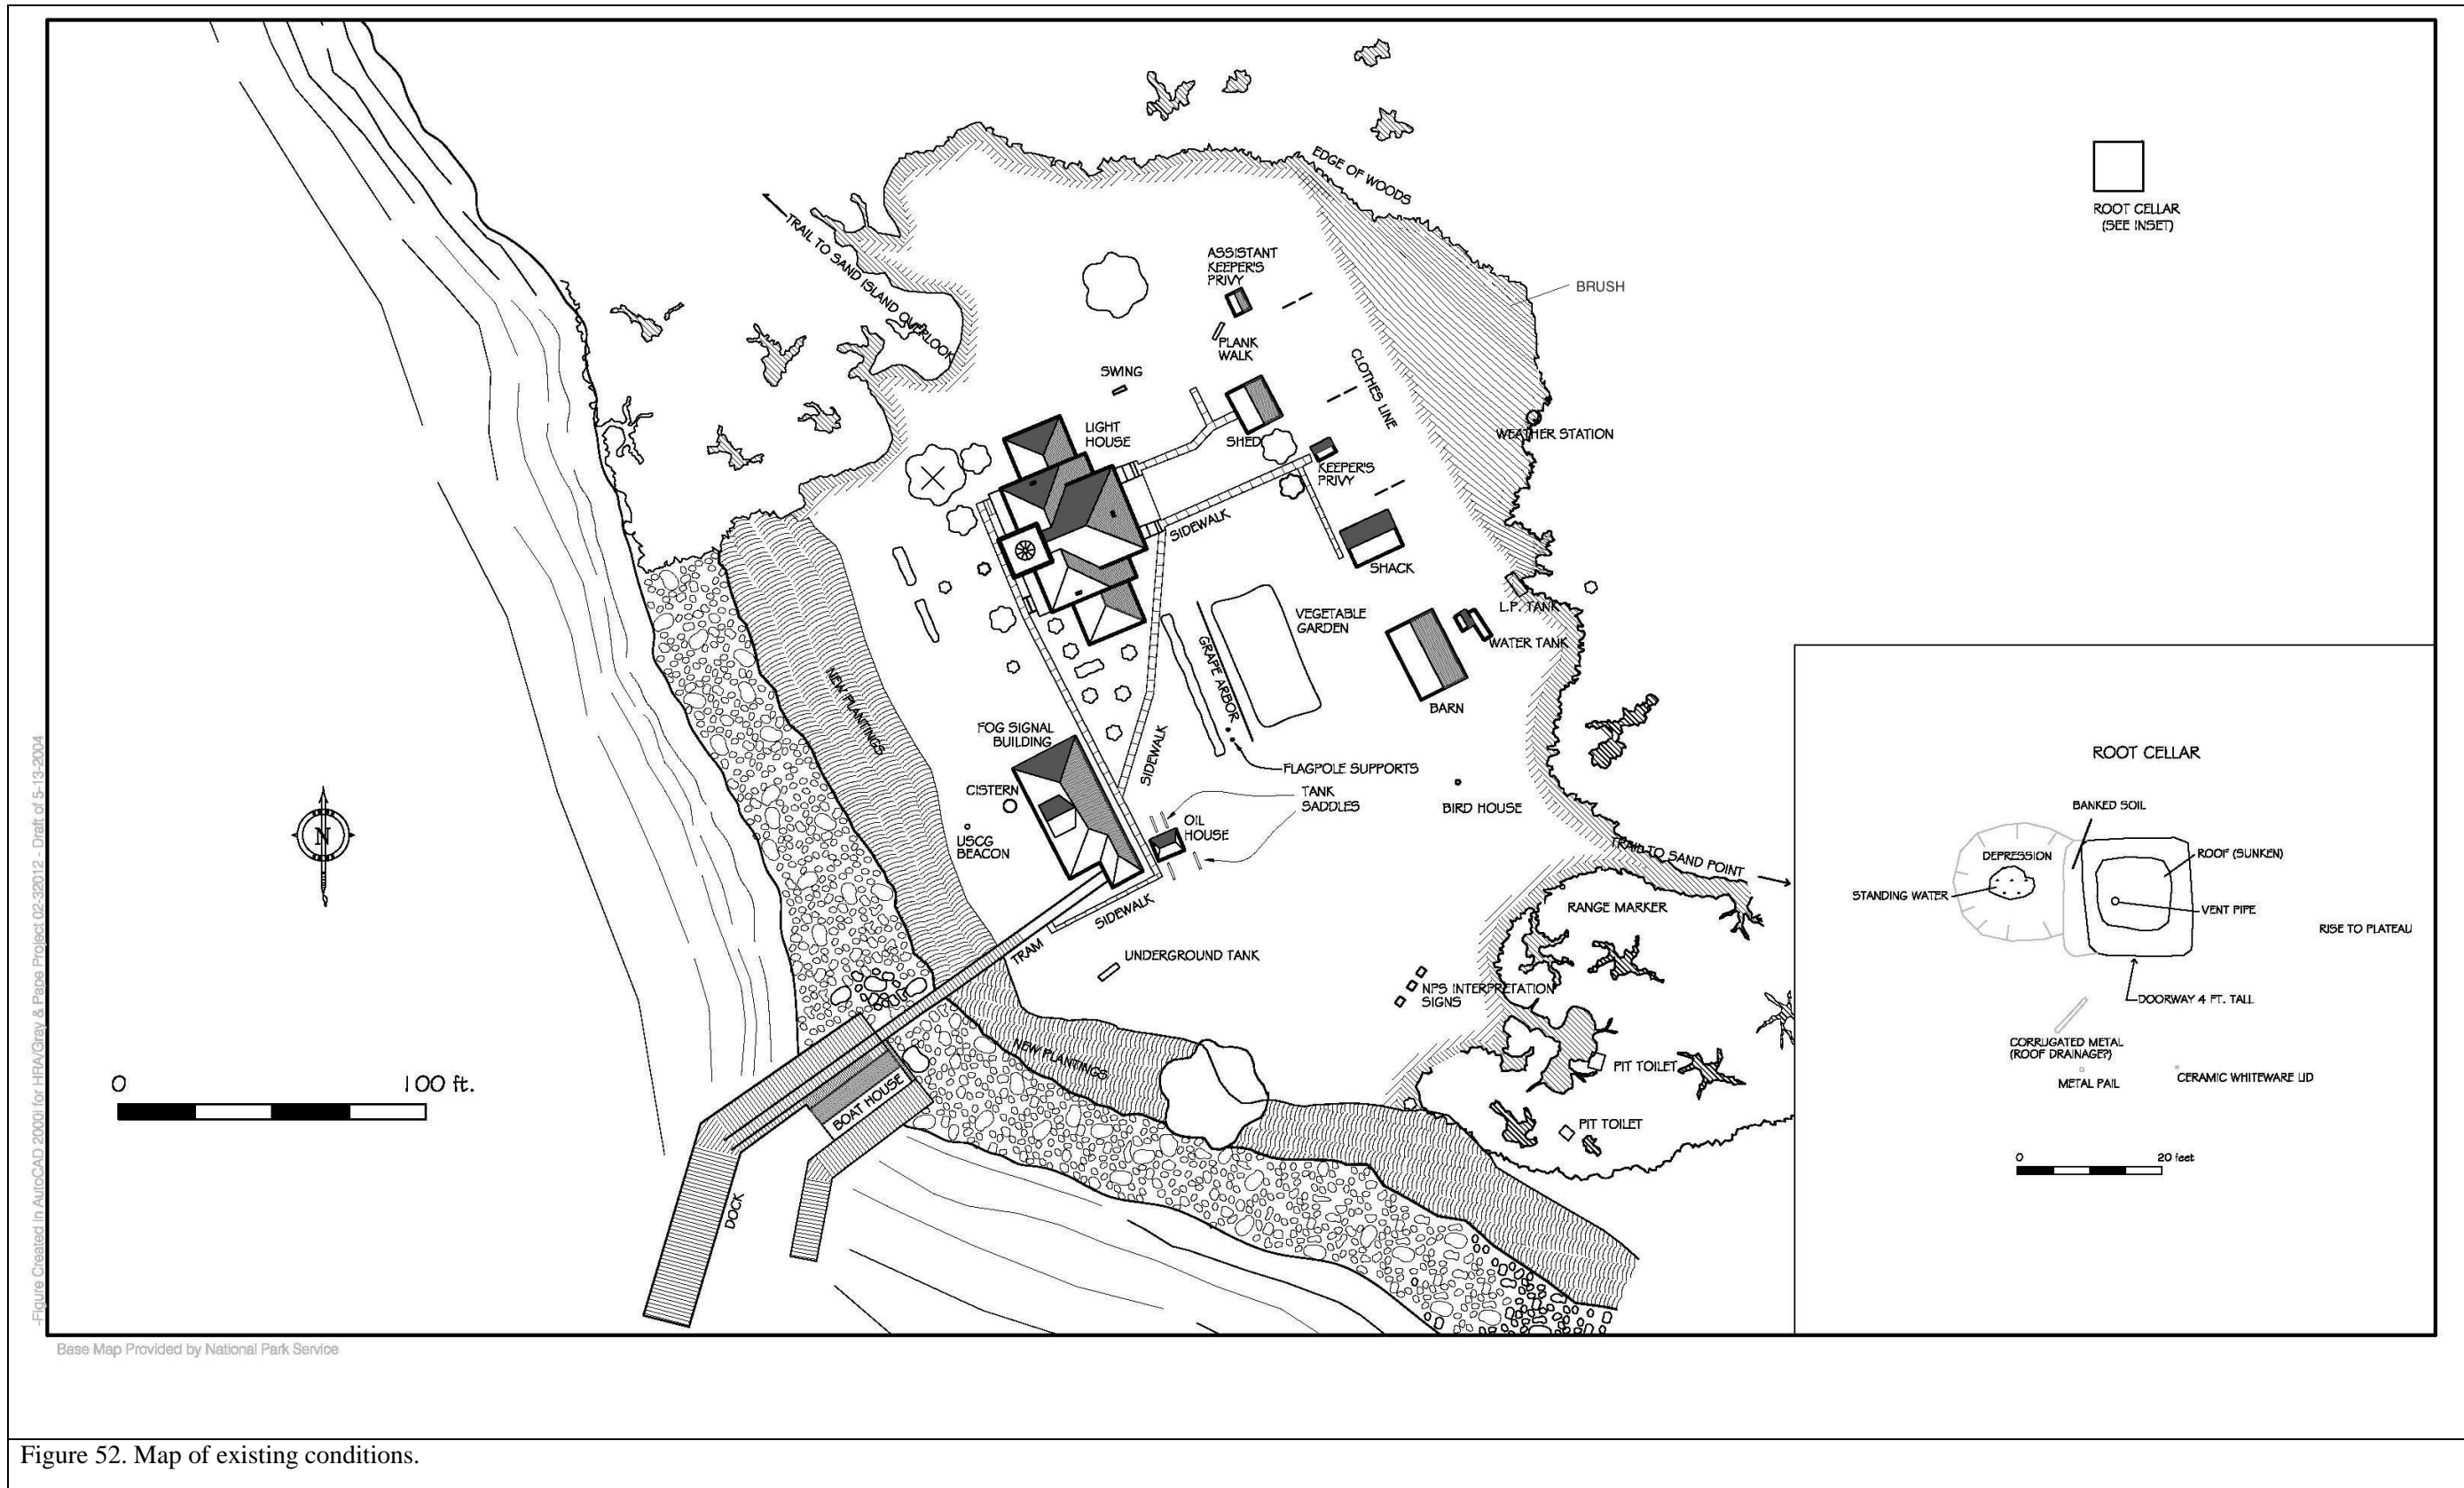
Figure 52. Map of existing conditions.

This chapter describes the contemporary Raspberry Island Station landscape. Based upon archival research and field survey, it documents various landscape characteristics such as circulation systems, vegetation, structures, and land use that together comprise the island's cultural landscape (Figure 52).

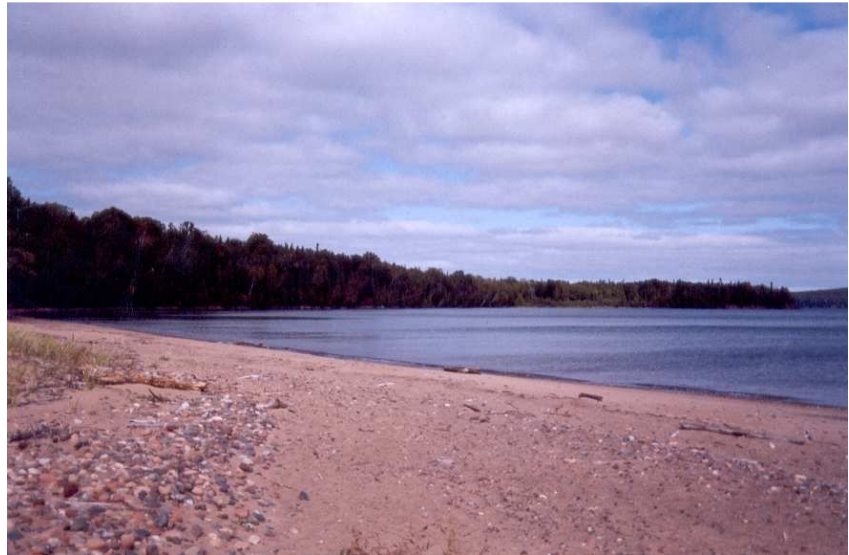
Figure 53. Sand spit. View to north, 2003.

An alternative landing is available at the "sand spit" on the southeast end of the island, roughly three-quarters of a mile from the light station clearing (Figure 53). This landing is used by small privately owned watercraft during most weather conditions and by larger NPS vessels when conditions preclude landing at the main dock. Visitors landing on the island at the sand point walk to the light station clearing on a trail that passes through the woods

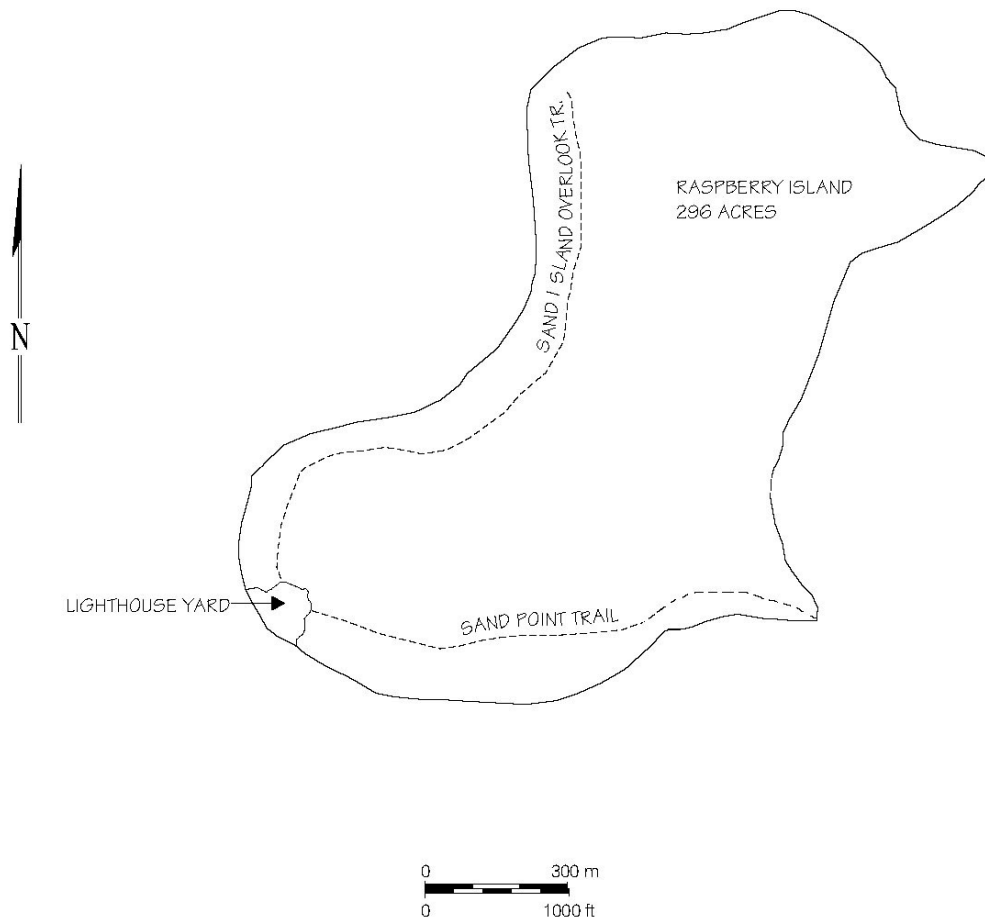
Figure 54. Approximate locations of existing trails.

A second trail extends north from the light station clearing for roughly one mile to the Sand Island overlook. This is a primitive, cleared path through the woods constructed by the NPS. The trail dead-ends at the point where NPS staff believes the Raspberry Island keepers made daily trips, beginning in the 1920s, to check on the operation of the automated Sand Island light (Figure 54).

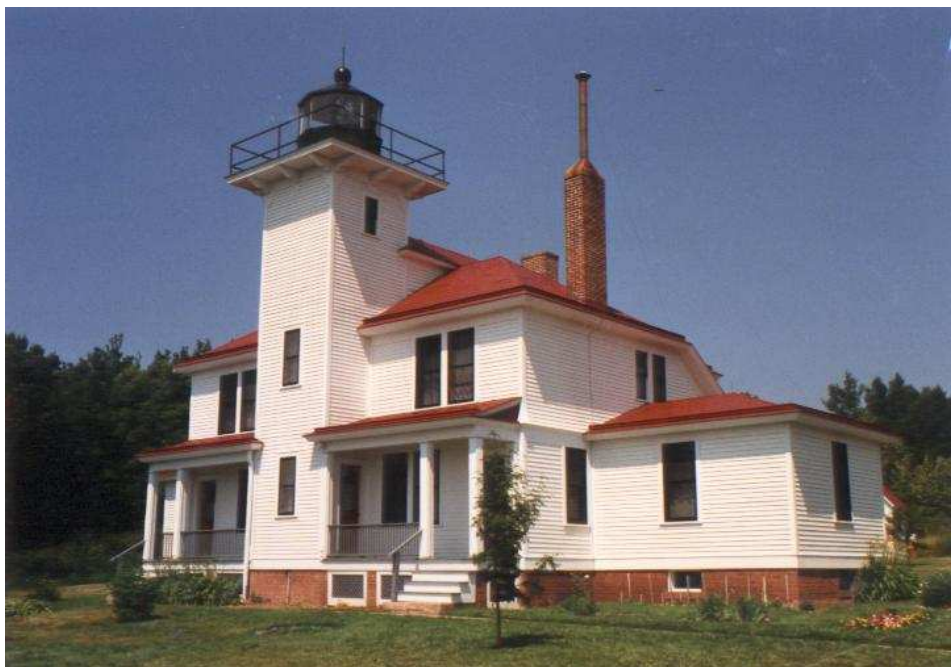
Originally constructed in 1862, this building was completely reconstructed in 1906 to provide living quarters for a third assistant. The current appearance of the building reflects the period 1906-1947. The building is two stories in height, with a square light tower centered on the front (west) façade (Figure 55). It has a brick foundation, clapboard wood siding, and hipped roofs covered with embossed metal shingles. Due to historic circulation patterns within the lighthouse yard, and the erosion of the bluff west of the building, the lighthouse is best viewed from the water.

Figure 55. West façade of lighthouse, 1988 (Lakeshore archives).

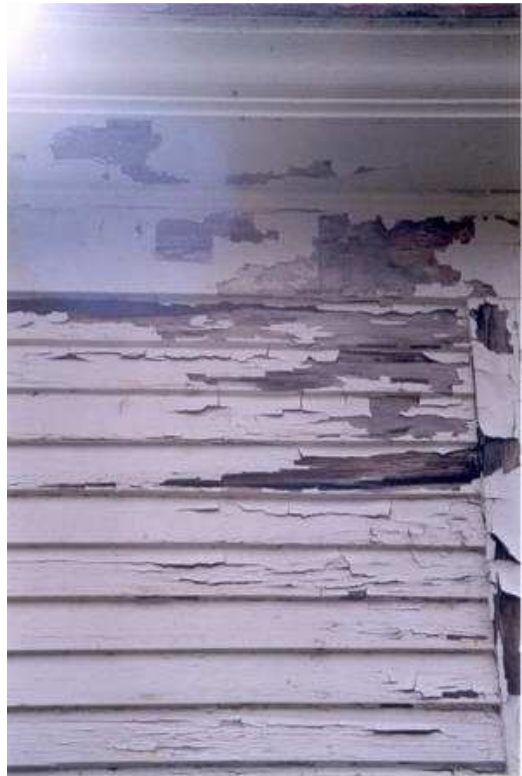
The building is in fair condition. Current exterior needs include limited repair of damaged wood siding, paint, gutters, and window and door weatherization (Figure 56). Interior spaces display damaged plaster.

Figure 56. Damaged siding. North façade of lighthouse, 2003.

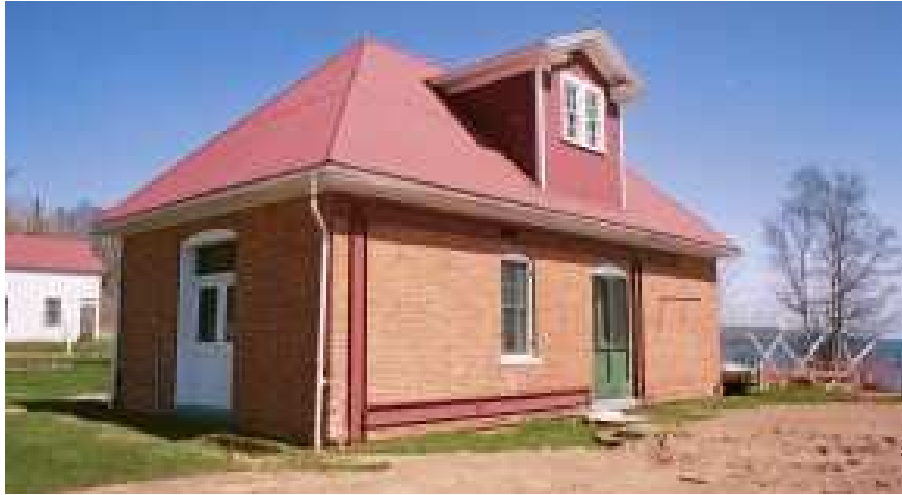
The building is in good condition and has received major stabilization over the years. A covered cistern associated with the original 1903 steam fog signal is located on the west side of the building (Figure 57).

Figure 57. West (front) and north facades of fog signal building, 2003

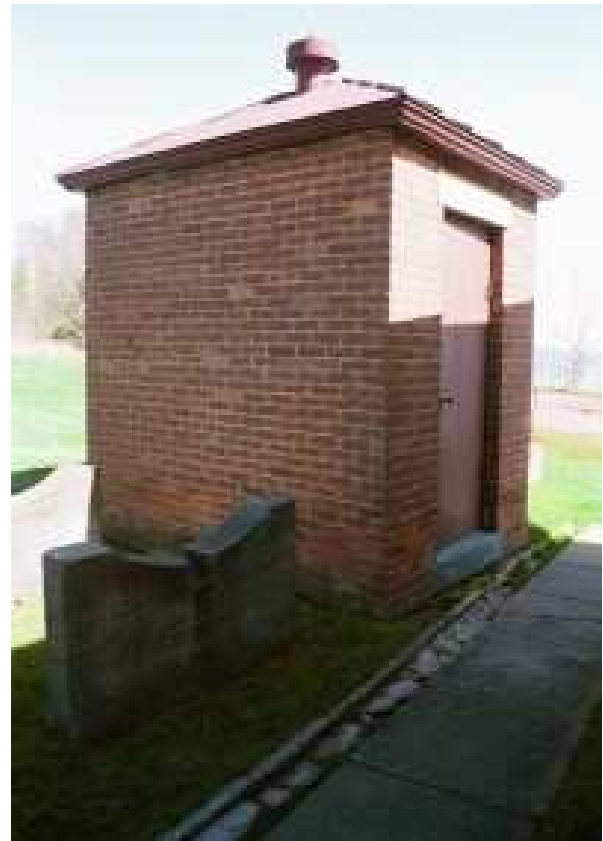
The single story brick oil building was built in 1901 and is located immediately east of the southeast corner of the fog signal building. The building is not open to the public; however, its historic function is an integral part of island interpretation. The building is in good condition and is flanked by two pairs of concrete tank cradles that once supported fuel tanks (Figure 58).

Figure 58. Side and front (west) facades of oil building, 2003. Note concrete tank cradles north of building.

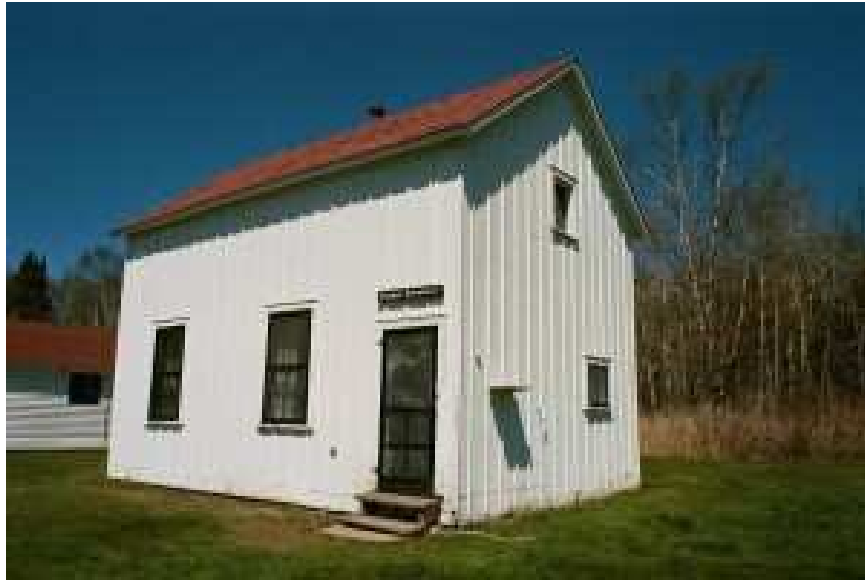
The one and one-half story wood frame barn dates from ca. 1906. The building has a side-gabled roof and is clad with board and batten siding. Remnants of a wood plank walkway lie immediately in front (west) of the building entry. This building has been identified by a number of historic names, including "barn," "warehouse," and "shop." It is unclear whether or not the building ever served as a barn, providing shelter for livestock, but it has clearly served as a warehouse and shop building. In the 1960s Ellerbee Architects converted the building into living quarters for the island caretakers. The building presently provides housing for seasonal Lakeshore staff. The exterior of the building is currently used in interpretation to the extent that it conveys the rural, self-sufficient nature of life on the island. The barn is in good condition (Figure 59).

Figure 59. Front (west) and south facades of barn, 2003.

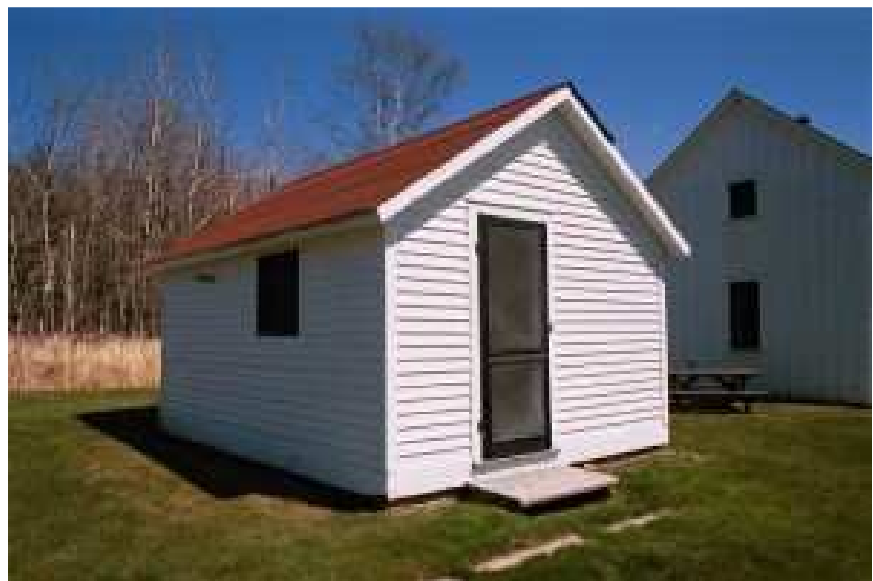
This single story, front gabled, wood frame and clapboard sided building is located between the barn and the keeper's privy (Figure 60). The building is referred to by a number of names in historical documents and served a variety of functions. It appears to date from the first period of development on the island and may have served as a shed during this period. It later served as a carpenter shop, washhouse/laundry, and as a second

Figure 60. Side and front (west) facades of Shed #1, 2003.

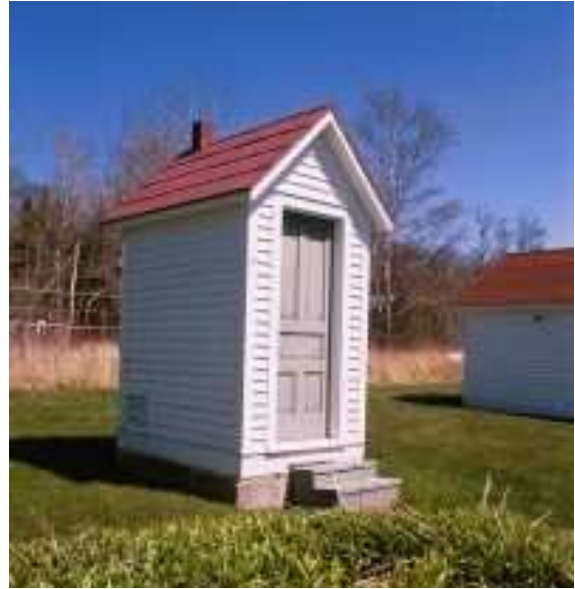
The keeper's privy is located directly east of the lighthouse; in line with the rear entry to the keeper's quarters in the south half of the building. The privy is a single story, wood frame, front gabled building with clapboard siding and embossed metal roof shingles. This building is associated with the initial period of site development. Although its date of construction is unknown, it may be the oldest extant building at the site. The privy was placed upon a new poured concrete foundation by the NPS. This building is used in interpretation of the site as it illustrates, along with the assistant keepers' privy, the hierarchical nature of life on the island and the separation of space along familial lines. The building is in good condition (Figure 61).

Figure 61. Side and front (west) facades of keeper's privy, 2003.

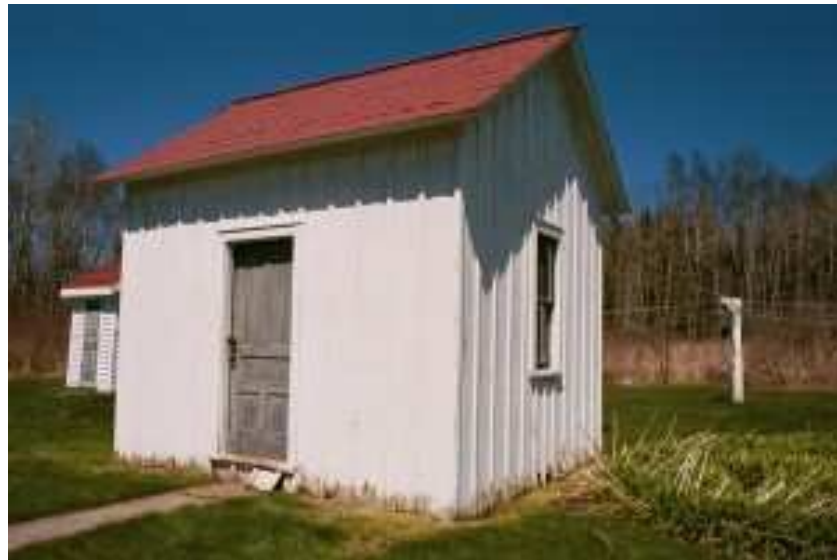
Shed #2 is a single story, wood frame, side-gabled building located between the two privies. The siding consists of board and battens. The roof is clad with embossed metal shingles. The building appears to date from 1904. It sits low to the ground and shows signs of considerable deterioration along its foundation. It is in need of significant repair and maintenance and is in poor condition. It is currently interpreted as part of the lighthouse cluster of buildings (Figure 62).

Figure 62. Front (west) and south facades of Shed #2, 2003. Note deterioration of board and batten siding at the base of the building due to poor drainage.
