**Cultural Landscape Report  
and Environmental Assessment  
Raspberry Island Light Station  
Apostle Islands National Lakeshore  
Bayfield County, Wisconsin**

Prepared by the  
National Park Service,  
HRA Gray & Pape LLC,  
and  
Woolpert LLP

November 2004

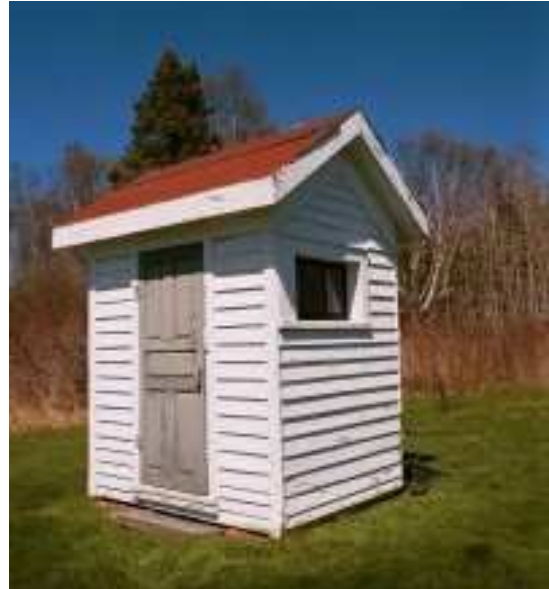
The assistant keepers' privy is located in the northeast corner of the formerly fenced lighthouse yard. This privy, apparently built ca. 1906 when a second assistant keeper was assigned to the station, is single story, wood frame, side gabled building with clapboard siding. The roof is covered with non-historic rolled roofing. Remnants of a wood plank walkway lie within the path leading to this building. This building is in good condition, and like the keeper's privy, illustrates the hierarchy of station life and separation of private spaces (Figure 63).

Figure 63. Front (west) and south facades of assistant keepers' privy, 2003.

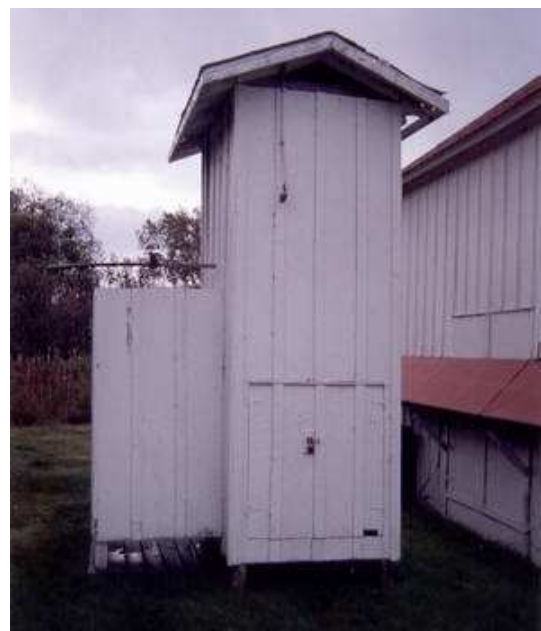
Immediately east of the barn is the water tank and solar-heated outdoor shower constructed by the NPS in 1982. The building has board and batten siding and a gabled roof, and is designed to blend in with the historic buildings. The building is in good condition (Figure 64).

Figure 64. North facade of water tank and solar shower, 2003.

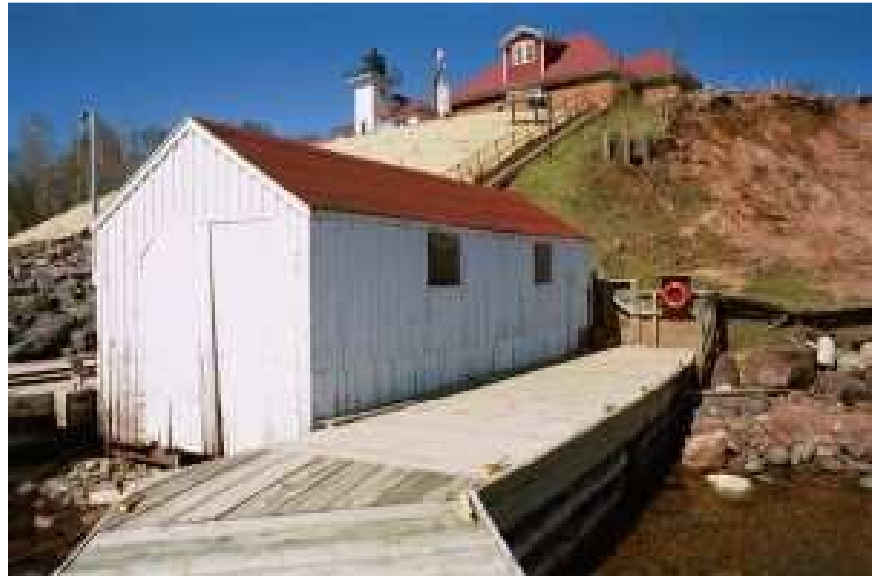
The present boathouse is in fair condition and continues to require constant upkeep due to its extreme exposure to the elements. Its appearance and function are representative of the boathouses that existed at the site throughout the historic period. It is not actively interpreted (Figure 65).

Figure 65. Front (west) and south facades of boathouse, 2003.

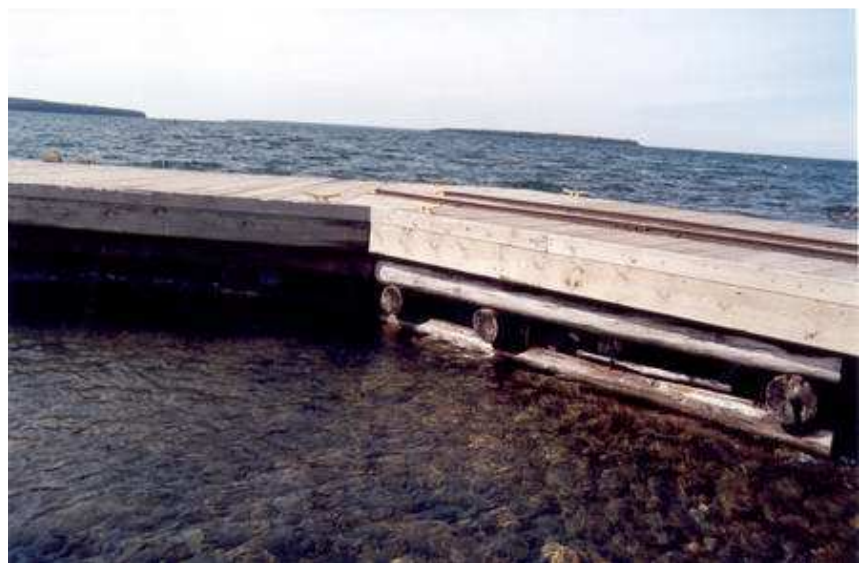
The first station dock was built in 1868. Similar to the associated boathouse, the structure has been rebuilt, repaired, and modified on numerous occasions. The present dock, consisting of rubble filled stone crib substructure and wood superstructure, was constructed by the National Park Service. Its location and configuration approximate that of the historic structure. The dock is regularly maintained and is in good condition. It is not actively interpreted. As the landing site for most island visitors, it is easily included in the interpretation of the island experience as the historical approach to the lighthouse complex atop the bluff (Figure 66).

Figure 66. View to northwest of dock cribs, 2003.

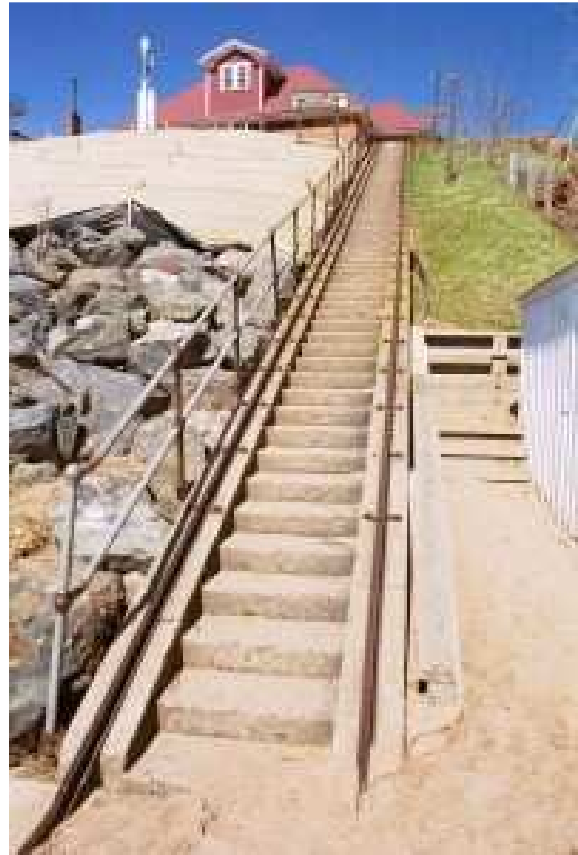
The existing concrete stairs and tramway date from 1932. A wood tramway was originally constructed in 1902 prior to construction of the fog signal building. The present tramway consists of 76 concrete steps extending from the edge of the bluff to the boat dock. The concrete steps serve as the foundation for the tram and are flanked by metal tracks that carry the tramcar. The north side of the stair has a metal handrail that extends the length of the stair. Visitors use the stairs to access the lighthouse yard from the dock. The tram is an important feature in interpretation of the site as it illustrates the evolution of access to the lighthouse station. This structure is in fair condition due to its age and exposure to the elements (Figure 67).

Figure 67. Steps and tramway. View to east, 2003.

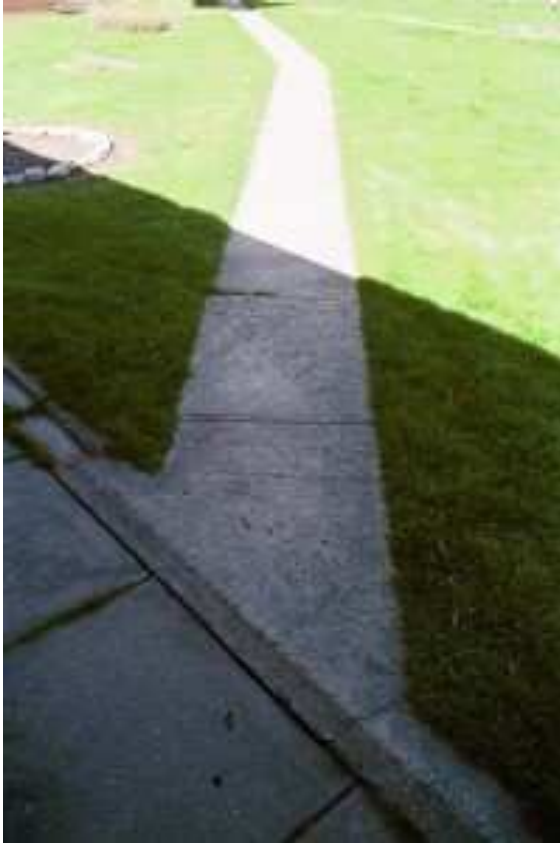
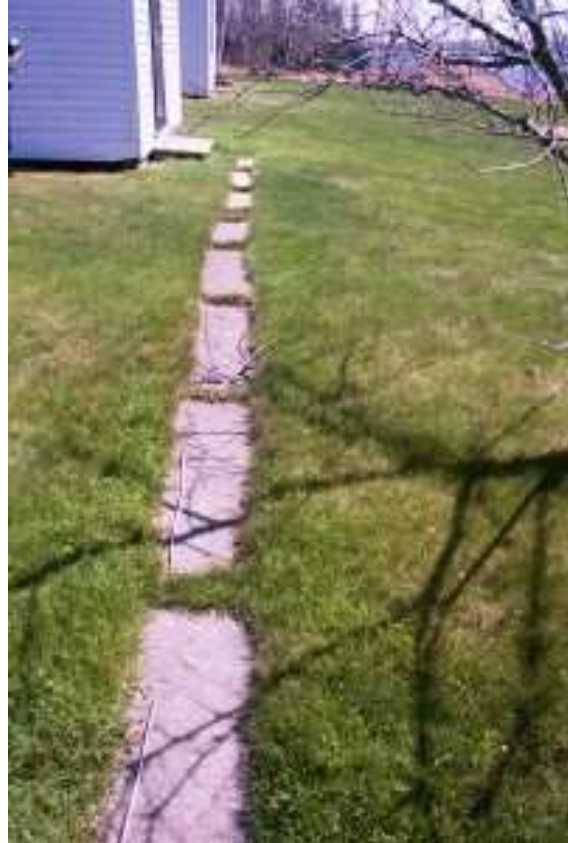
The site originally included a network of cement, wood plank, and cinder walkways. Only the cement walkways, installed ca.1906 and repaired on numerous occasions, are extant. Some of the cement walks form a continual path while others are arranged like stepping-stones. The walks are in fair condition, though grass has been allowed to cover the edges of the walks, visually reducing their apparent width. The walkways help illustrate the daily patterns of circulation on the site (Figures 72 and 73).

Figure 72. Concrete path leading to rear of lighthouse. View to northeast, 2003.

Figure 73. Concrete path from keeper's privy to shed #1. View to south, 2003.

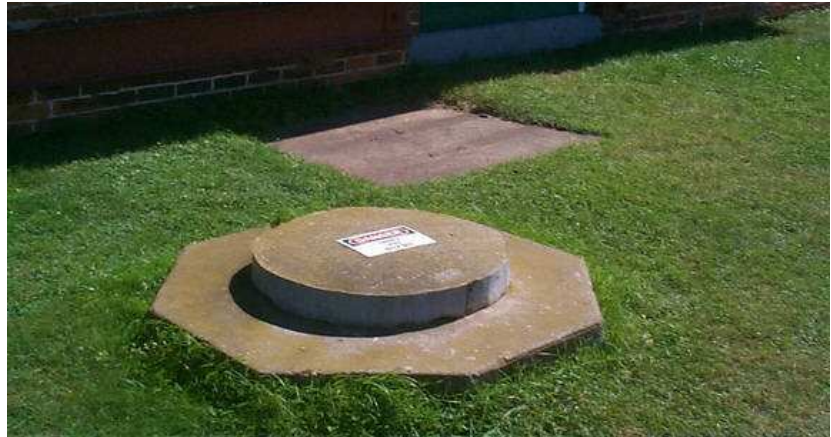
The cistern located in front (west) of the fog signal building dates to the original 1903 construction of the building. It provided water, siphoned from the lake, for the boilers that powered the steam whistle. The cistern consists of a poured concrete hexagonal base with a raised circular element. During the historic period it was capped by a hand pump. The cistern does not appear to be actively included in interpretive programs. It is in fair condition (Figure 74).

Figure 74. Cistern. View to southeast, 2003.

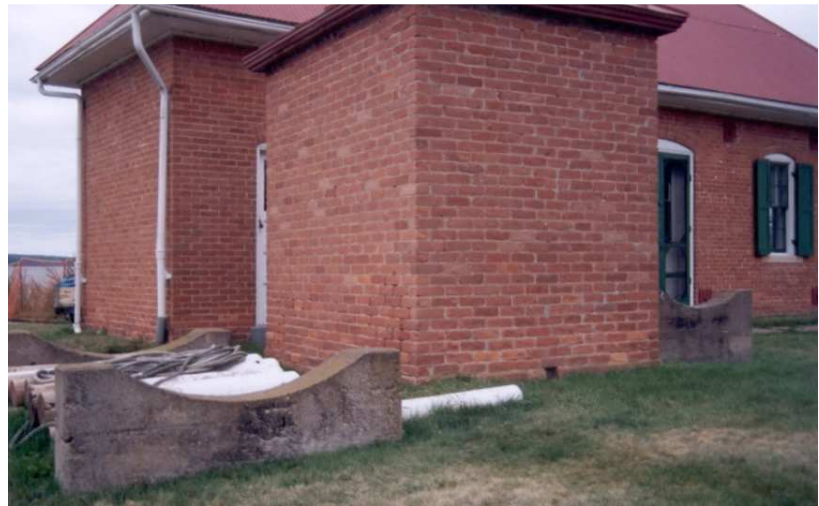
Two sets of concrete oil cradles flank the oil building to the north and south. These originally supported fuel oil tanks. The cradles are useful in understanding the spatial relationship and function of the oil building. They are in good condition (Figure 75).

Figure 75. Concrete oil cradles. View to northwest, 2003.

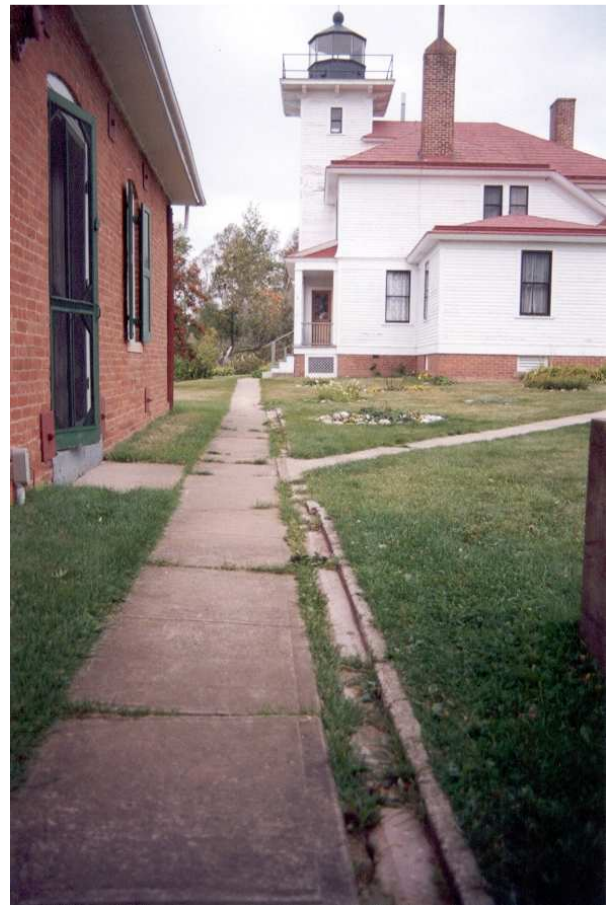
does not contribute to interpretation. It is in poor condition (Figure 76).

Figure 76. Drainage trough and cement walkways. View to north, 2003.

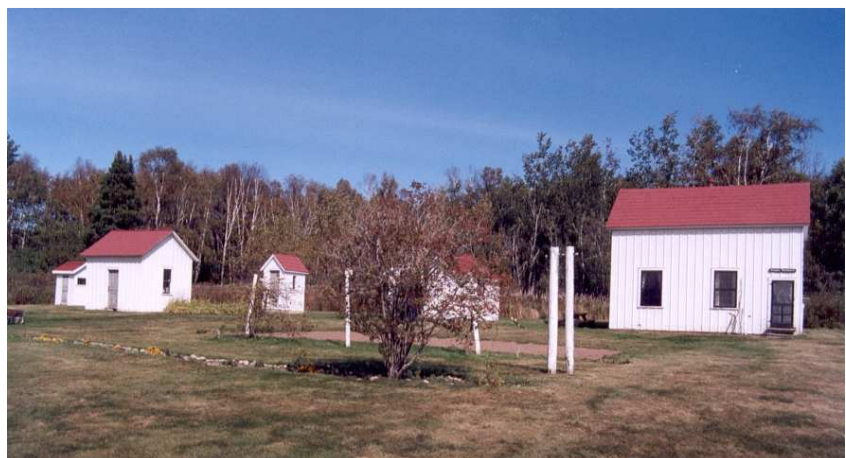
A pair of wooden poles, approximately six feet in height, are located between the fog signal building and the reconstructed vegetable garden. The poles appear to have flanked and supported a taller pole, presumably used as a secondary flagstaff in the 1930s, and possibly used as a radiophone antenna in the late 1940s. This feature is not actively interpreted. It is in fair condition (see Figure 77).

Figure 77. Grape arbor and pole supports. View to east, 2003.

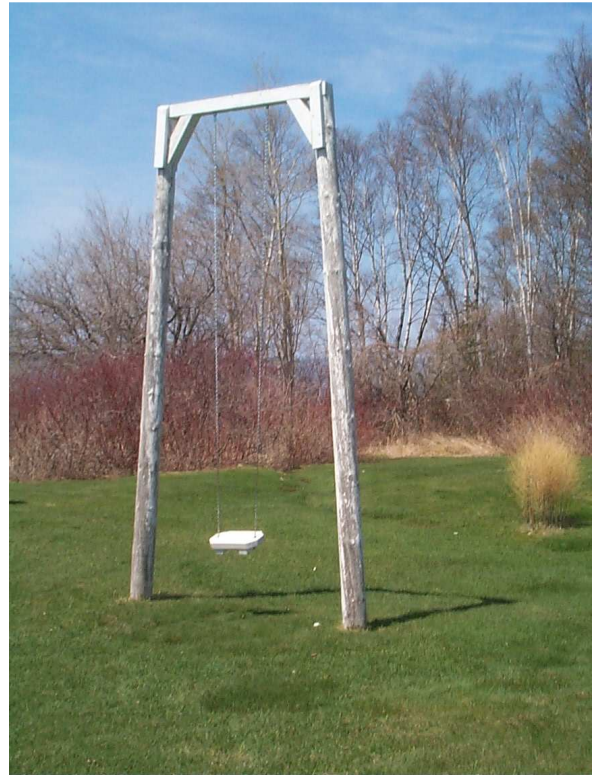
A swing existed in the lighthouse yard from as early as 1900. The existing swing is an NPS reconstruction dating from the 1970s. It is located near the northeast corner of the lighthouse and is, according to photographic evidence, in approximately the location of the historic swing. It consists of two tall poles with a crossbar from which the swing is suspended. The present swing is very tall by modern standards; yet historic photos reveal that the historic swing stood much higher. It is in fair condition and contributes to the interpretation of family life and entertainment at the lighthouse (Figure 78).

Figure 78. Swing. View to northwest, 2003.

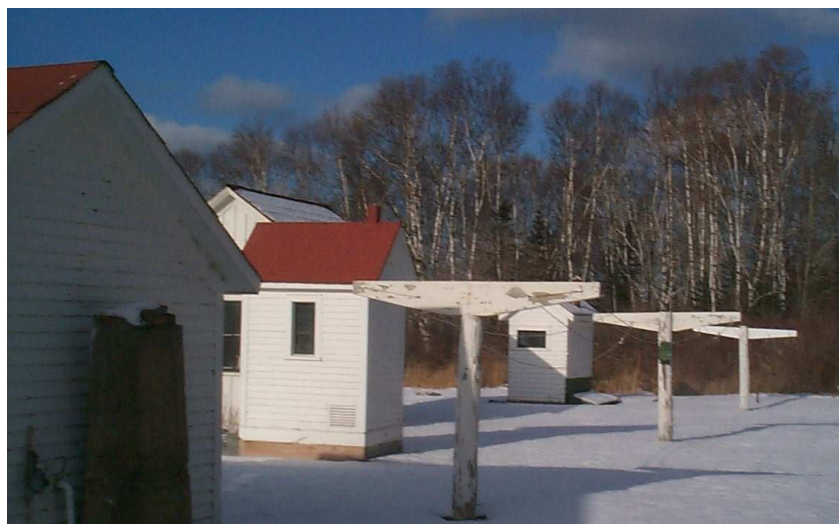
The clothesline is located at the east edge of the yard. It consists of three cedar poles with crossbars, and appears to date from ca. 1939. Clotheslines existed in this approximate location for many years, and during at least the 1930s a wood walkway paralleled the clothesline. The clothesline was replaced on several occasions according to the Keepers' logs. Though there is no record of the exact placement of earlier clotheslines, this location is well documented in period photographs. The presence of the clothesline adds to the interpretation of daily routines of island life. The clothesline is in fair condition (Figure 79).

Figure 79. Clothesline. View to north, 2003.

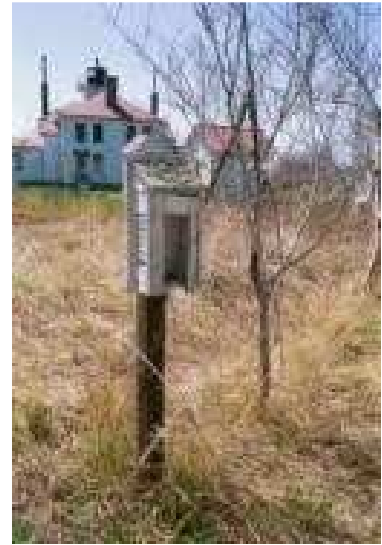
The weather station is located in the historic clearing, east of the keeper's privy. It consists of a wood post topped by a wood box that at one time contained the station instruments. The US Coast Guard erected the weather station in the 1940s. The station is in an area of overgrowth and is inaccessible to the public. It is not currently operational and is not included in interpretation of the site. This feature is in poor condition (Figure 80).

Figure 80. Weather Station.  
View to west, 2003.

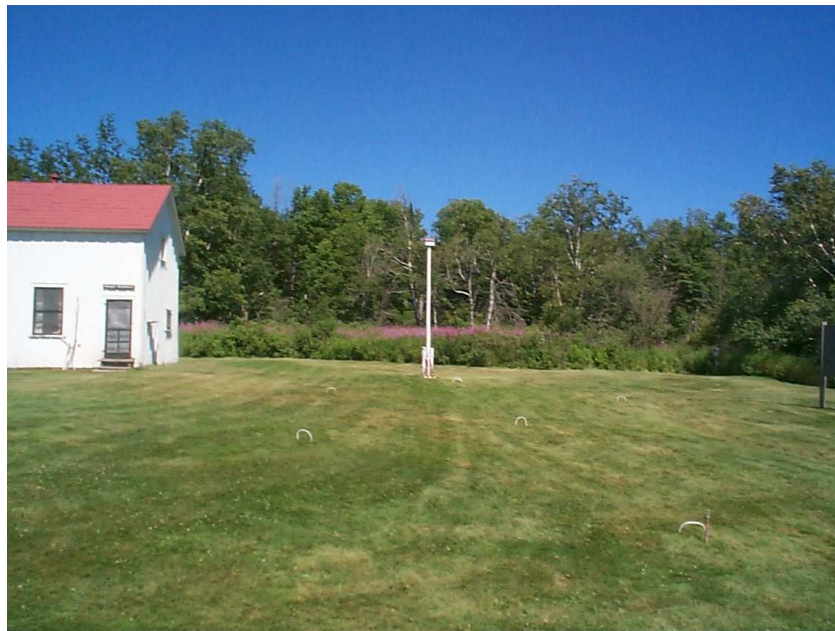
A birdhouse is mounted on a pole southeast of the barn. Birdhouses are mentioned in 1931 logbook entries, but may have existed on the site much earlier. The current birdhouse is sited in accordance with historic photographs and was constructed by NPS staff some time in the 1970s. It is not actively incorporated into the interpretive program. The birdhouse and pole are in fair condition (Figure 81).

Figure 81. Bird House. View to east, 2003.

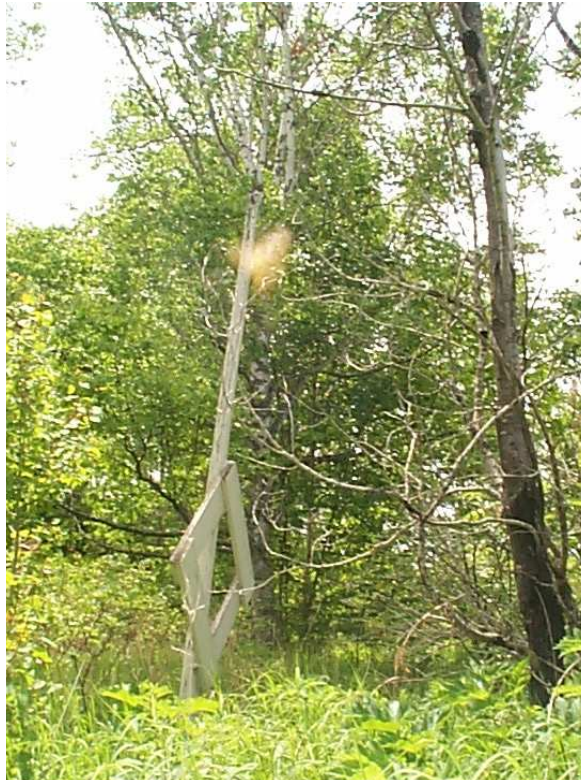
Located within the historic clearing, inside the edge of the encroaching woods near the start of the trail to the sand point, the range marker is one of two historic range markers erected on the island in the 1930s. The range markers provided a visual, daylight reference for passing ships that allowed navigators to determine whether they were within the main navigation channel. The remaining marker consists of a cedar pole with a diamond-shaped device made of rough lumber.

The second marker, no longer extant, was located to the west and was of similar design and construction. The marker is an important feature for interpreting the history of navigation, but is not currently included in any programs. It is in poor condition, and because it is partially hidden by vegetation, it is not visible from either the lighthouse yard or the lake. (Figure 82).

Figure 82. Range marker. View to west, 2003.

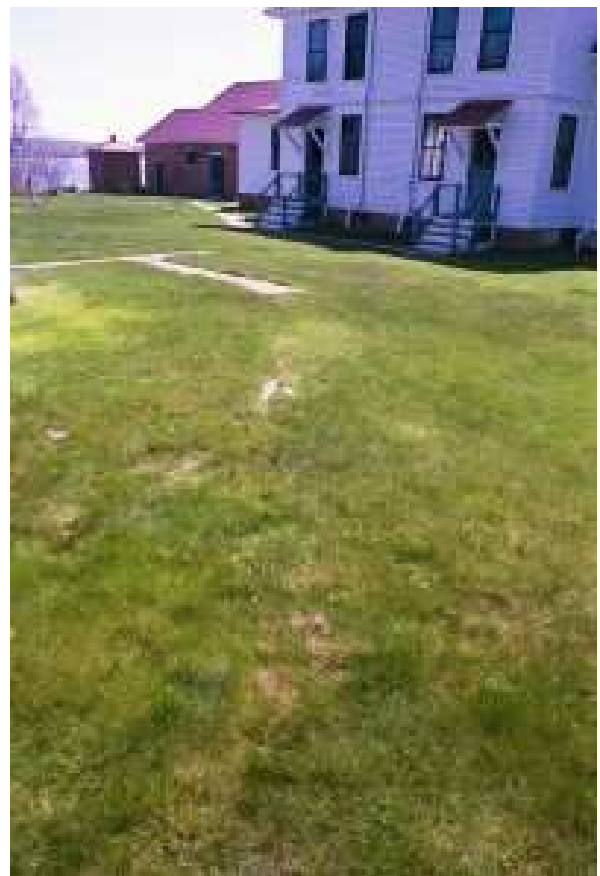
Figure 83. Remnant of plank walkway. View to southwest, 2003.

Wood plank walkways are first mentioned in the Jacker diary in 1886 and were maintained throughout the historic period. In the 1930s a wood plank walk paralleled the clothesline. One badly deteriorated section of plank walkway survives, partially buried in the lawn, near the entry to the assistant keepers' privy. Another remnant appears to exist immediately in front of the entry to the barn. These partially exposed resources could be negatively affected by lawnmowers. This resource is not interpreted and is in poor condition (Figure 83).

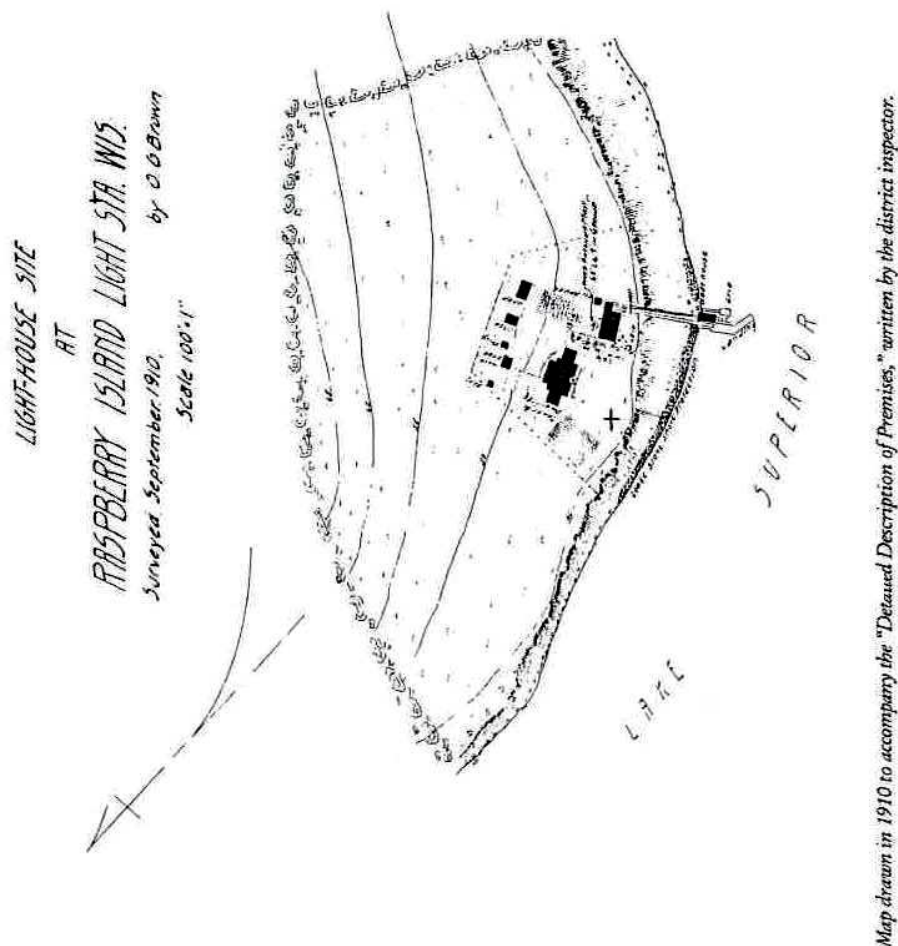
Figure 84. 1910 site map showing topography. Note location of yard fence and extent of

Historic maps from 1877 (see Figure 6) and 1910 (Figure 84) indicate that the topography of the island has experienced little change since establishment of the station, with the exception of the erosion of the bluff immediately west of the lighthouse. Within the station clearing the land slopes from east to west (from the historic edge of the clearing towards the bluff) at an approximate rate of 1:10 (Figure 85).

A 1910 map (see Figure 84) of the site indicates that measures were taken at an early stage to address the erosion of the bluff. The map highlights 'loose stone shore protection' placed to the north and south of the dock. Since the island has been under NPS management, the Lakeshore has consistently taken measures to curb bluff erosion, especially immediately west of the historic building cluster. In the 1980s the Lakeshore built a low riprap wall that proved unsuccessful. Most recent changes, completed in 2003, include the addition of nearly forty feet of material to the base of the bluff and construction of a stable slope planted with native vegetation (Figure 88; also see Figure 50).

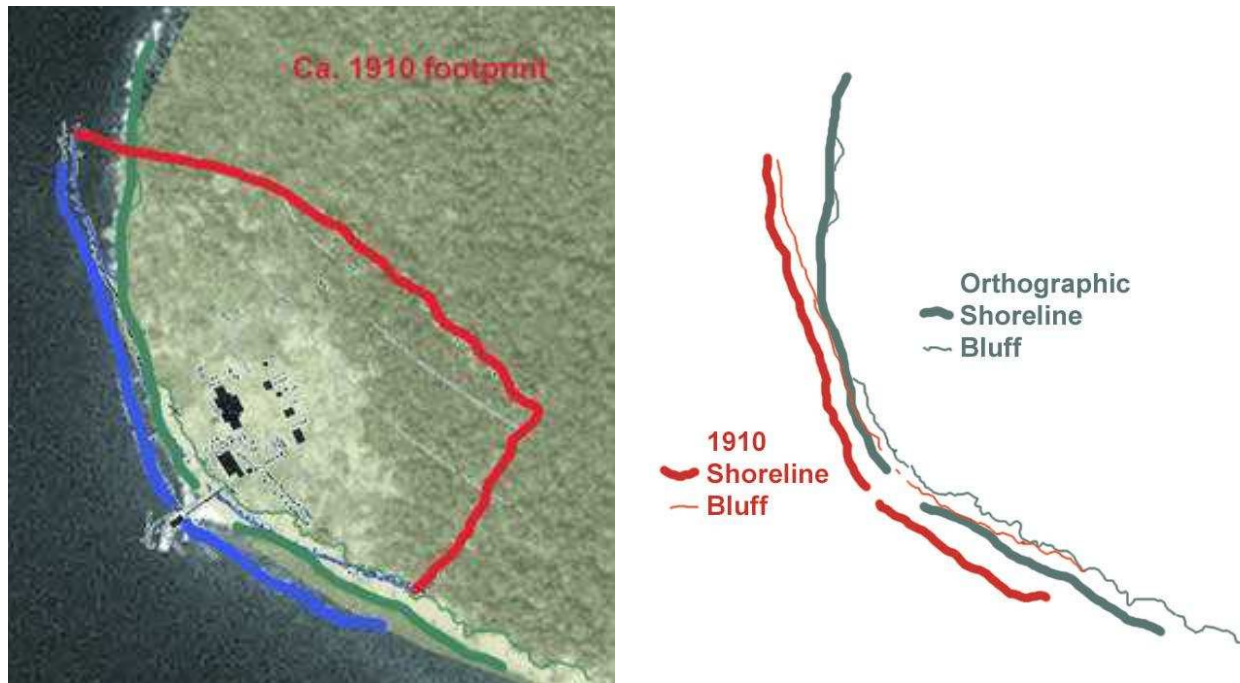
Figure 86. Change in shoreline and bluff. Comparison of 1910 map with ca. 1990s aerial photograph.

Erosion of the bluff, as a result of both natural and human forces and human efforts to stem this erosion, has significantly altered the bluff face. Erosion has significantly altered spatial relationships in the lighthouse yard by eliminating a strip of level ground twenty to forty feet in width from the area immediately west of the lighthouse and fog signal building (Figure 86)

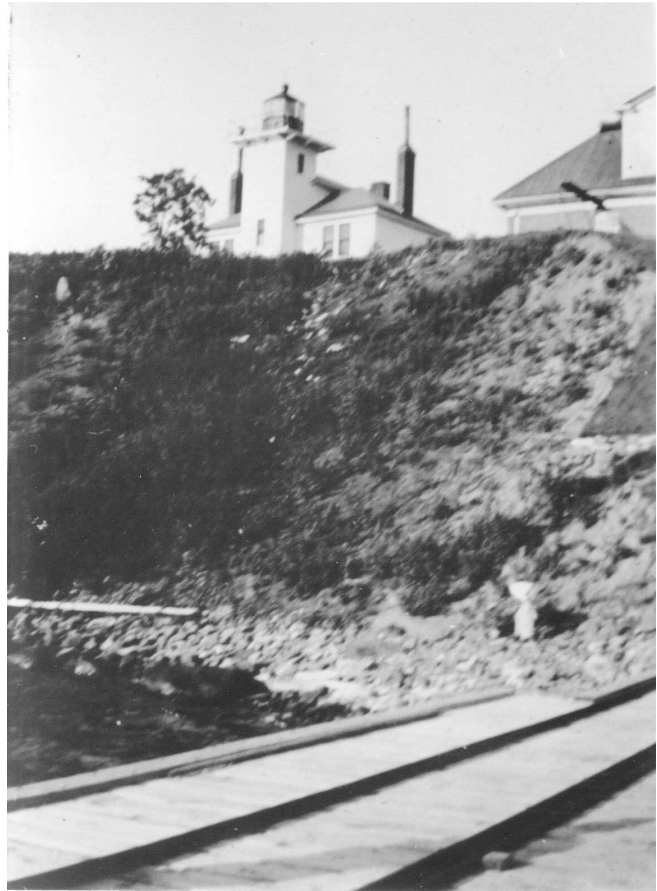
Figure 87. Bluff conditions. View to northeast, post-1932 (Lakeshore archives).

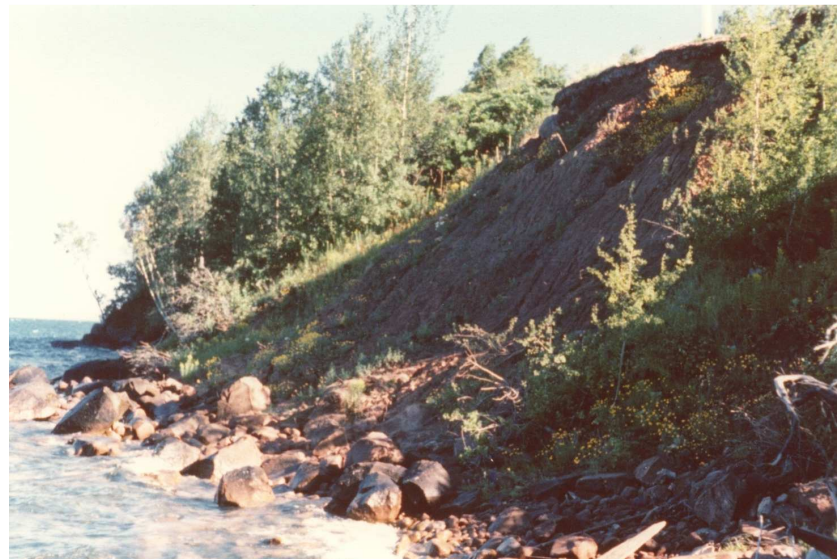
Figure 88. Bluff conditions, 1977 (Lakeshore archives).

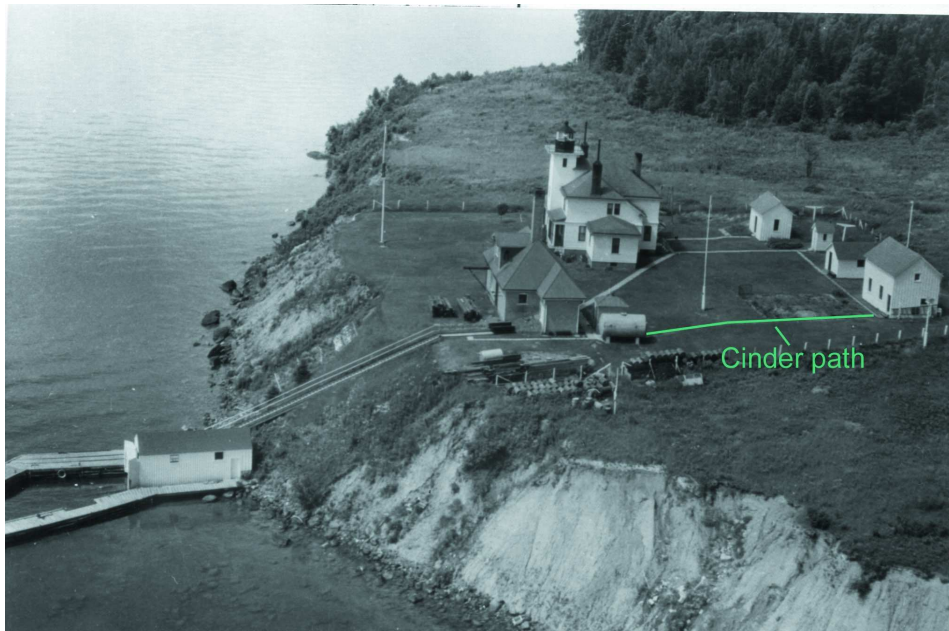
Figure 93. Cinder path location, ca. 1940. Also note walkway between shed #1 and barn (Lakeshore archives).

Historic paths or walks that are no longer extant include a concrete walkway that connected the shed #1 and the barn, which appears to have been removed after the 1940s, and a cinder path that extended from the fog signal building to the barn along the south side of the lawn (Figure 93; see also Figure 24).

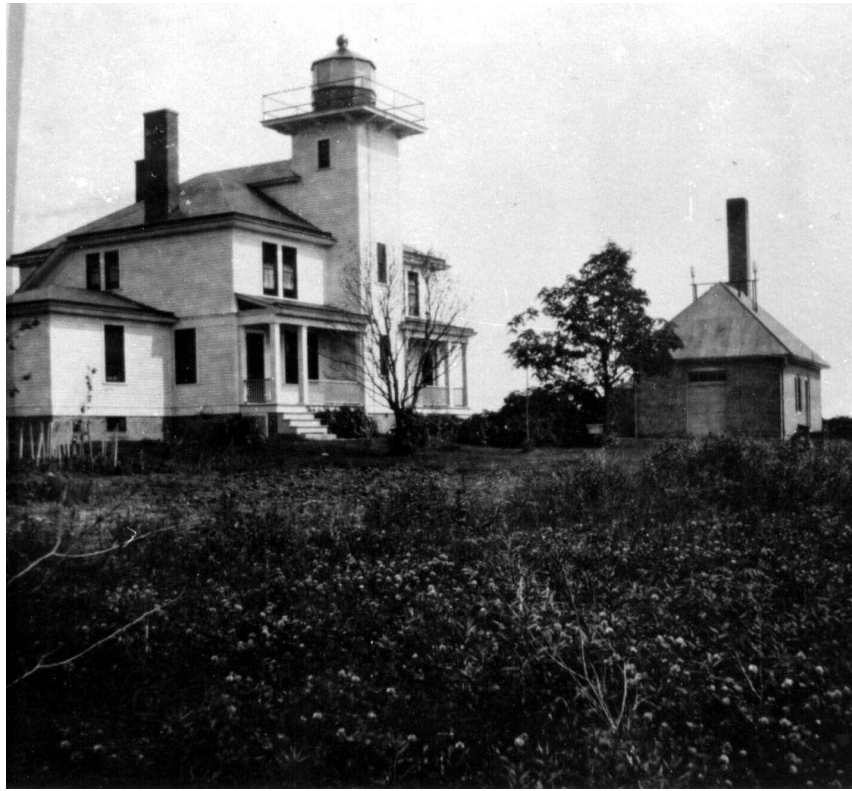
Figure 94. Lighthouse and fog signal building ca. 1920. View to southeast. Note height and character of lawn (Lakeshore archives).

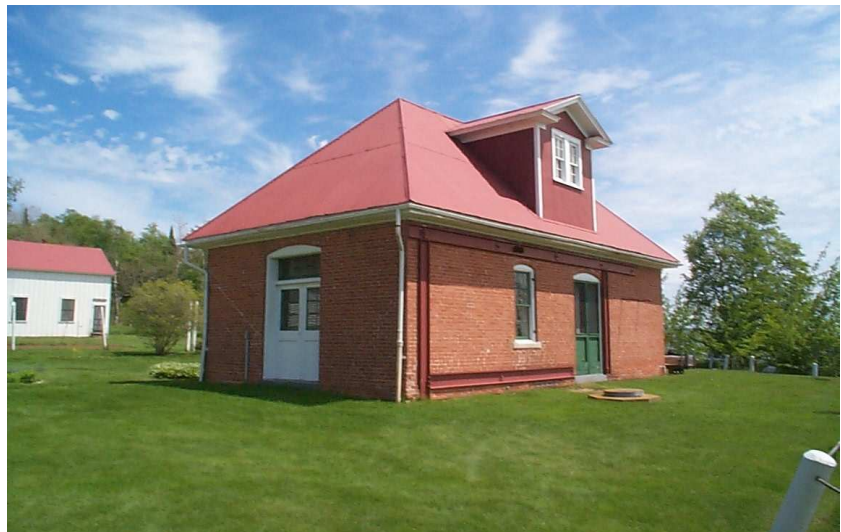
Figure 95. View to southeast of fog signal building, 2003.

Constructed in 1903 from standardized Lighthouse Service plans, the fog signal building is a single story brick building with a hipped metal roof. A gable roofed dormer on the west façade dates from the 1932 conversion of the fog signal from a steam whistle to an air-powered diaphone. The I-beam reinforcements visible on the west façade date from 1925. The historic chimney was removed after 1944. The alterations

experienced by this building all occurred during the period of significance and do not detract from the building's integrity (Figure 95). The fog signal building retains high degree of integrity and is considered a contributing element of the cultural landscape.

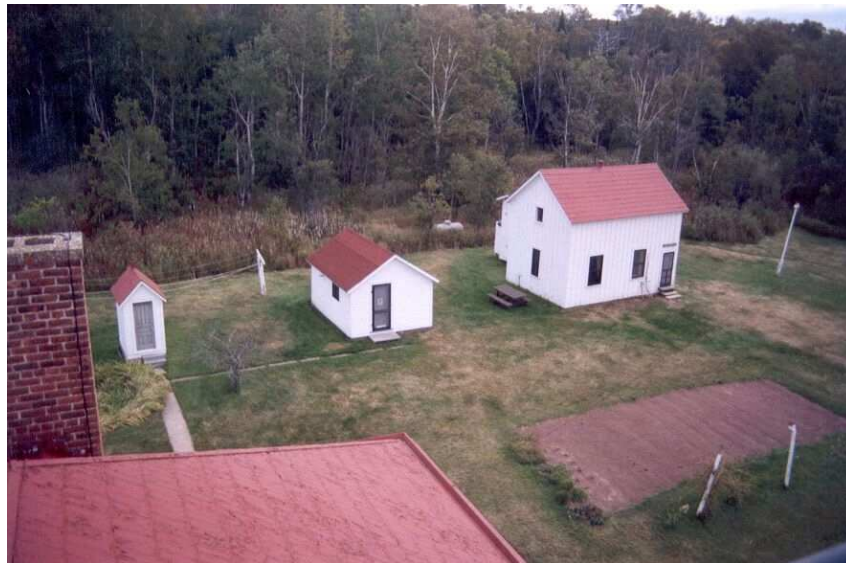
Figure 96. Contemporary view to southeast of building cluster (left to right: keeper's privy, shed #1, barn), from lighthouse tower, 2003. Compare to Figure 17. Note clothesline behind (east) of buildings, propane tank in clearing east of barn, reconstructed birdhouse south of barn, vegetable garden plot, and non-historic grape arbor west of vegetable garden.

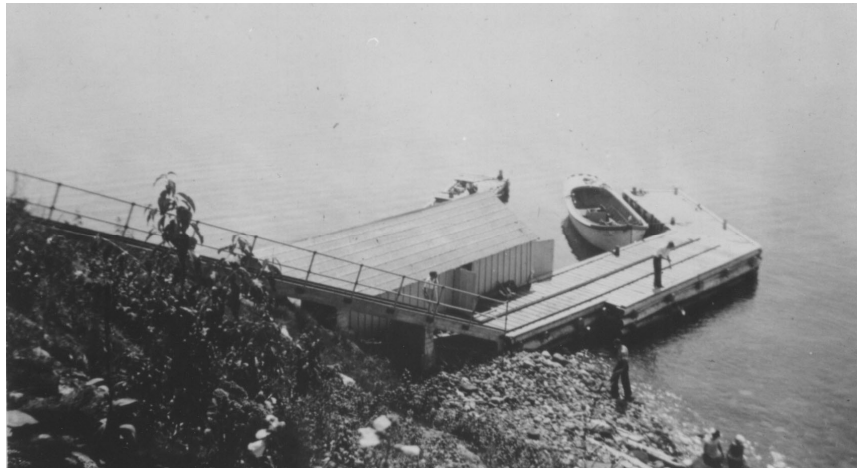
Figure 97. Dock and boathouse. View to southwest, 1936 (Lakeshore archives).

the structure.<sup>180</sup> It retains a high degree of integrity and is considered a contributing element of the cultural landscape (Figure 97; also see Figure 64).

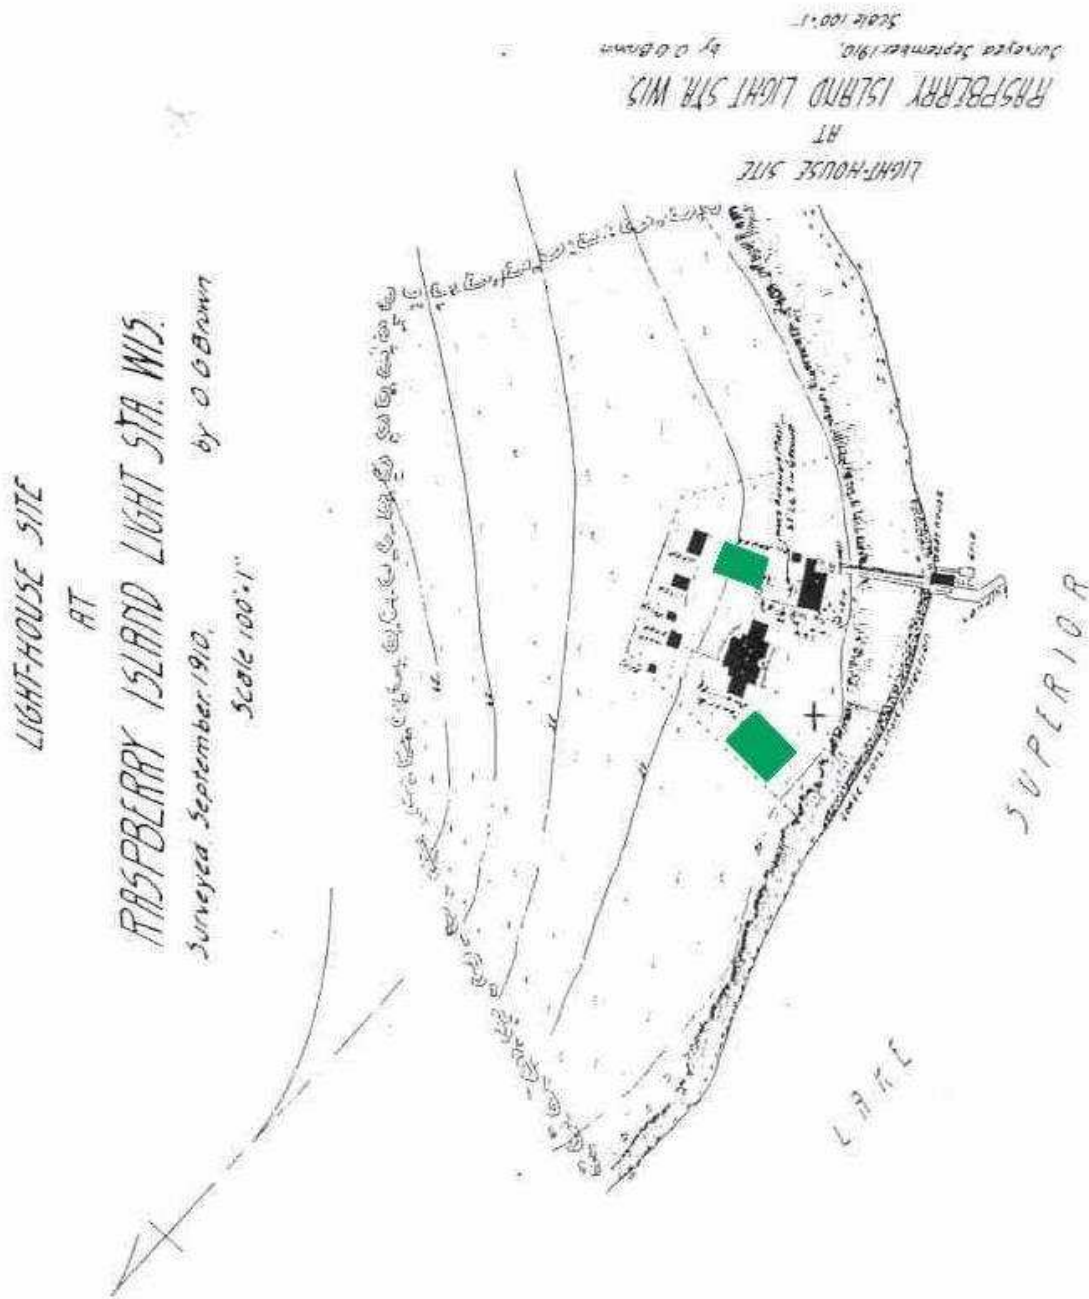
Map drawn in 1910 to accompany the "Detailed Description of Premises," written by the district inspector.

Figure 98. Historic garden locations as indicated on 1910 site map.

The following evaluation of the station gardens is limited to available documentation and clarification of design intent; it does not include archeological investigation. The most useful documentation for the historic period vegetable gardens is the 1910 Light Station map (see Figure 98), which identifies the locations of two garden plots. One is located directly in front (west) of the barn, while the second, larger plot is located immediately northwest corner of the lighthouse and is oriented at an angle so that the north edge of the plot parallels the yard fence.

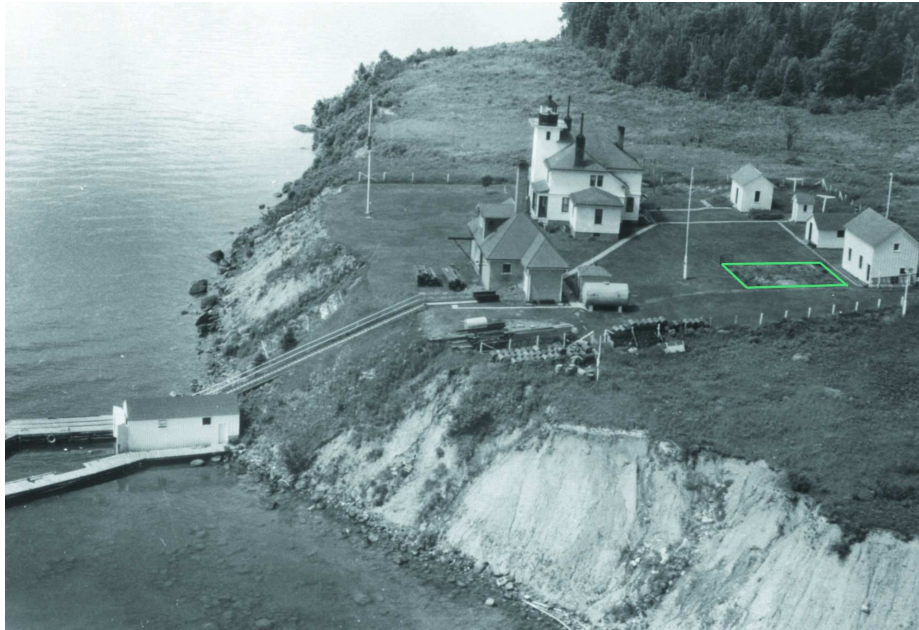
Figure 100. Historic location of vegetable garden, ca.1940 (Lakeshore archives).

An aerial photograph from ca. 1940 definitively locates one historic garden, and indicates that one of the garden locations shown on the 1910 map continued to be used, at least on an intermittent basis, for several decades (Figure 100). Additional cultivated plots may have been located outside the yard fence, but there is no firm evidence to indicate their exact location without archeological investigation.

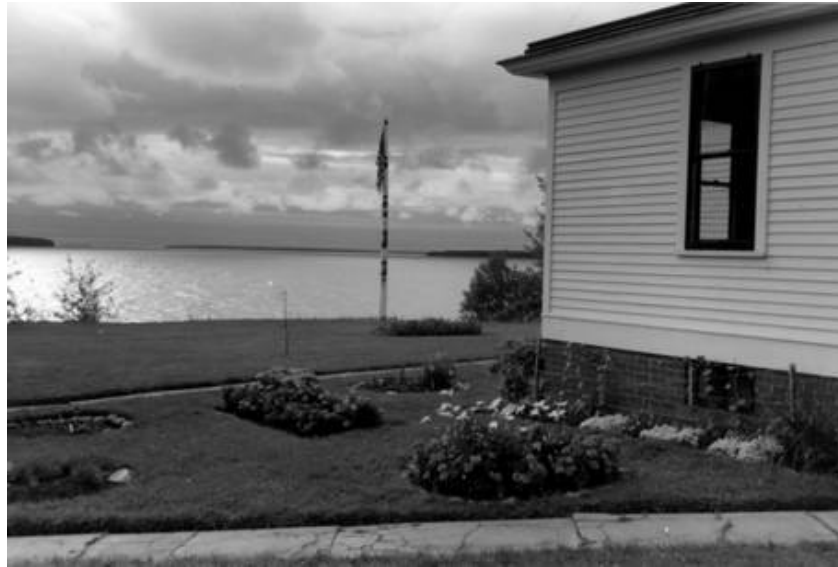
Figure 102. Cobbled beds, ca 1982 reconstruction (Lakeshore archives).

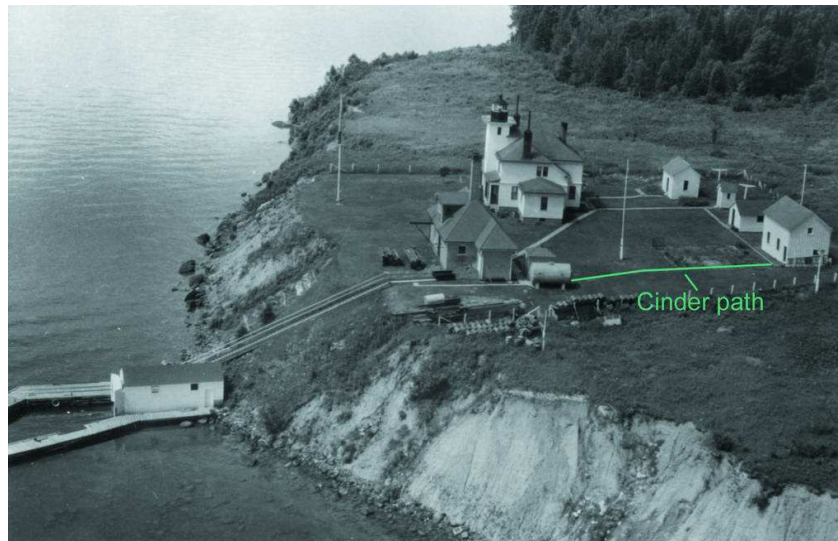
The cinder path will be reconstructed in its historic location between the barn and the oil building. The path runs between the oil building and the south concrete oil cradle, curving slightly north toward the west edge of the garden, and then parallels the garden's south edge to the barn entry. The path is no wider than the barn entry, approximately three feet wide. (Figure 136; see also Figure 24). At present, it can be difficult to procure cinder, and potash is a common substitute. In this setting, however, potash would likely be blown away and thus would be neither economical nor ecological to use. An acceptable substitute would be the use of small (5 centimeters or less), dark-colored pumice stone. This is visually comparable to cinder and is readily available.

Figure 136. Cinder path and garden placement (Lakeshore archives).
