Geraldine Lucas Homestead,  
~~G~~eraldine Lucas Cabin  
On west bank of Cottonwood Creek approximately  
2 1/2 miles downstream of Jenny Lake  
Moose Vicinity  
Teton County  
Wyoming

HABS No. WY-113-A

HISTORIC AMERICAN BUILDING SURVEY  
GERALDINE LUCAS HOMESTEAD, GERALDINE LUCAS CABIN

Geraldine Lucas Cabin (WY-113-A):

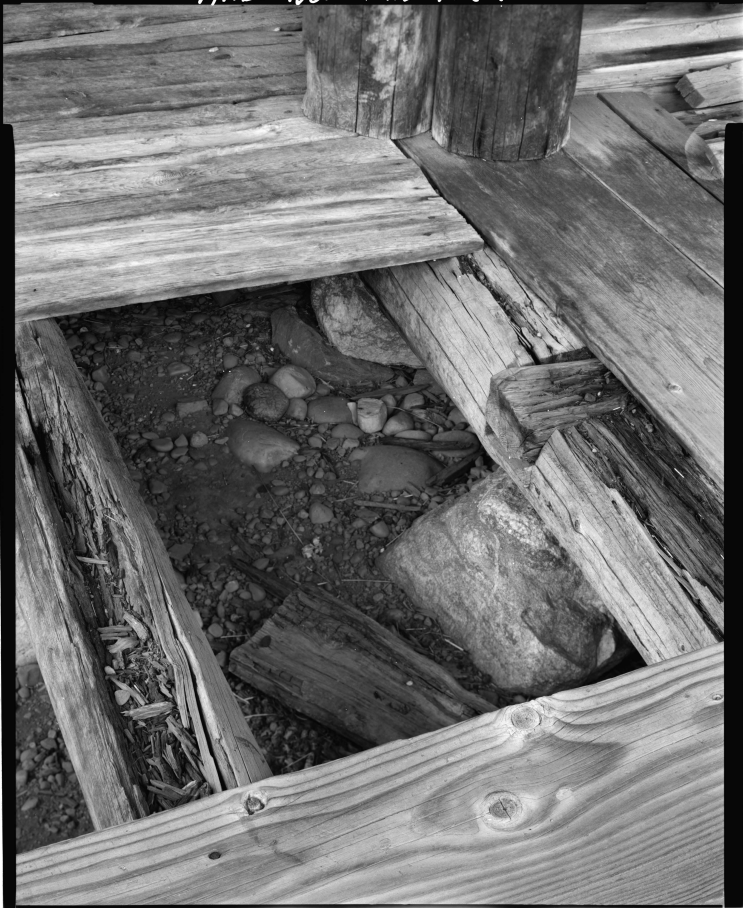
HABS NO. WY-113-A-4

| WY-113-A-4 | GERALDINE LUCAS CABIN, PORCH DETAIL SHOWING<br>FOUNDATION CONSTRUCTION. |

1. Overall dimensions: 60'-9" by 32'-5"
2. Foundation: The main cabin does not have a foundation. However, the shed addition to the northeast, which is the bathroom, has an uncoarsed rubble foundation.

4. Structural system: The structure of the main cabin is log, while the bathroom addition has a wood frame structural system.
5. Porches and bulkheads: The U-shaped porch, which surrounds the living/dining room, is covered but does not have a foundation. This porch is constructed of log floor beams, which rest on large rocks to elevate them off of the earth. Unfinished wood planks comprise the porch's floor. There is also a small covered porch on the cabin's eastern wall, by the bathroom addition. This small porch has a dry laid rubble foundation, log floor beams and unfinished wood plank flooring. There is a wooden bulkhead on the northern and southern walls of the cabin leading to a crawl space.

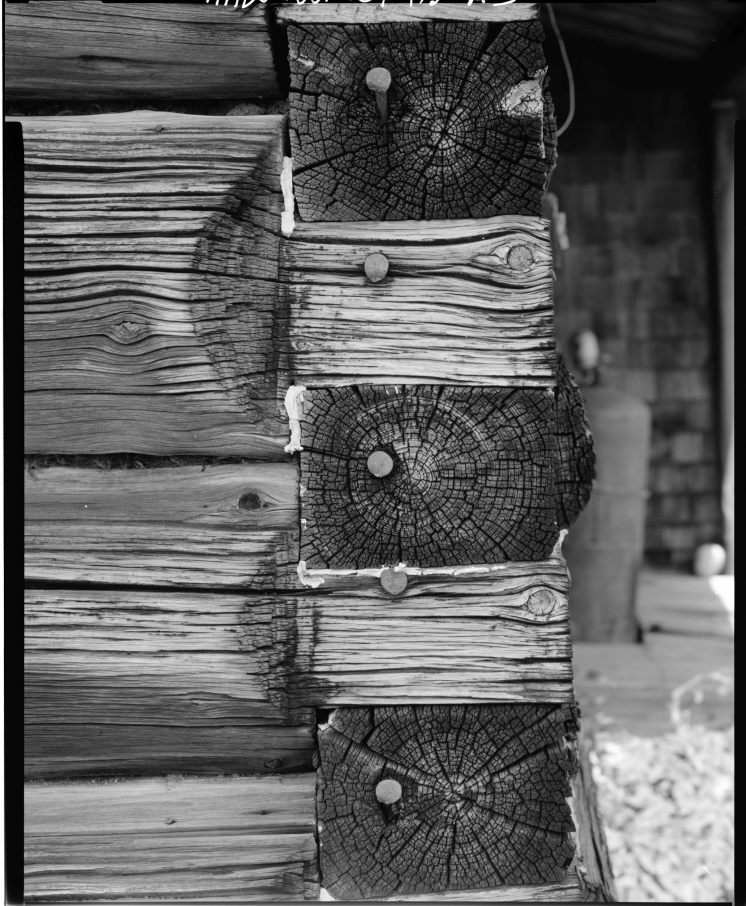
HABS No. WY-113-A-5

| WY-113-A-5 | GERALDINE LUCAS CABIN, REAR CORNER DETAIL, LOOKING<br>NORTH. |

3. Walls: The main cabin has log walls with square lap rebated cornering. The bathroom addition to the east has plain shingle siding. Traces of brown stain are still seen on some of the logs.
