# Coastal Hazards & Sea-Level Rise Asset Vulnerability Assessment for Gulf Islands National Seashore

## *Updated Summary of Results*

NPS 635/194634, September 2024

Program for the Study of Developed Shorelines  
Western Carolina University  
Cullowhee, North Carolina 28723

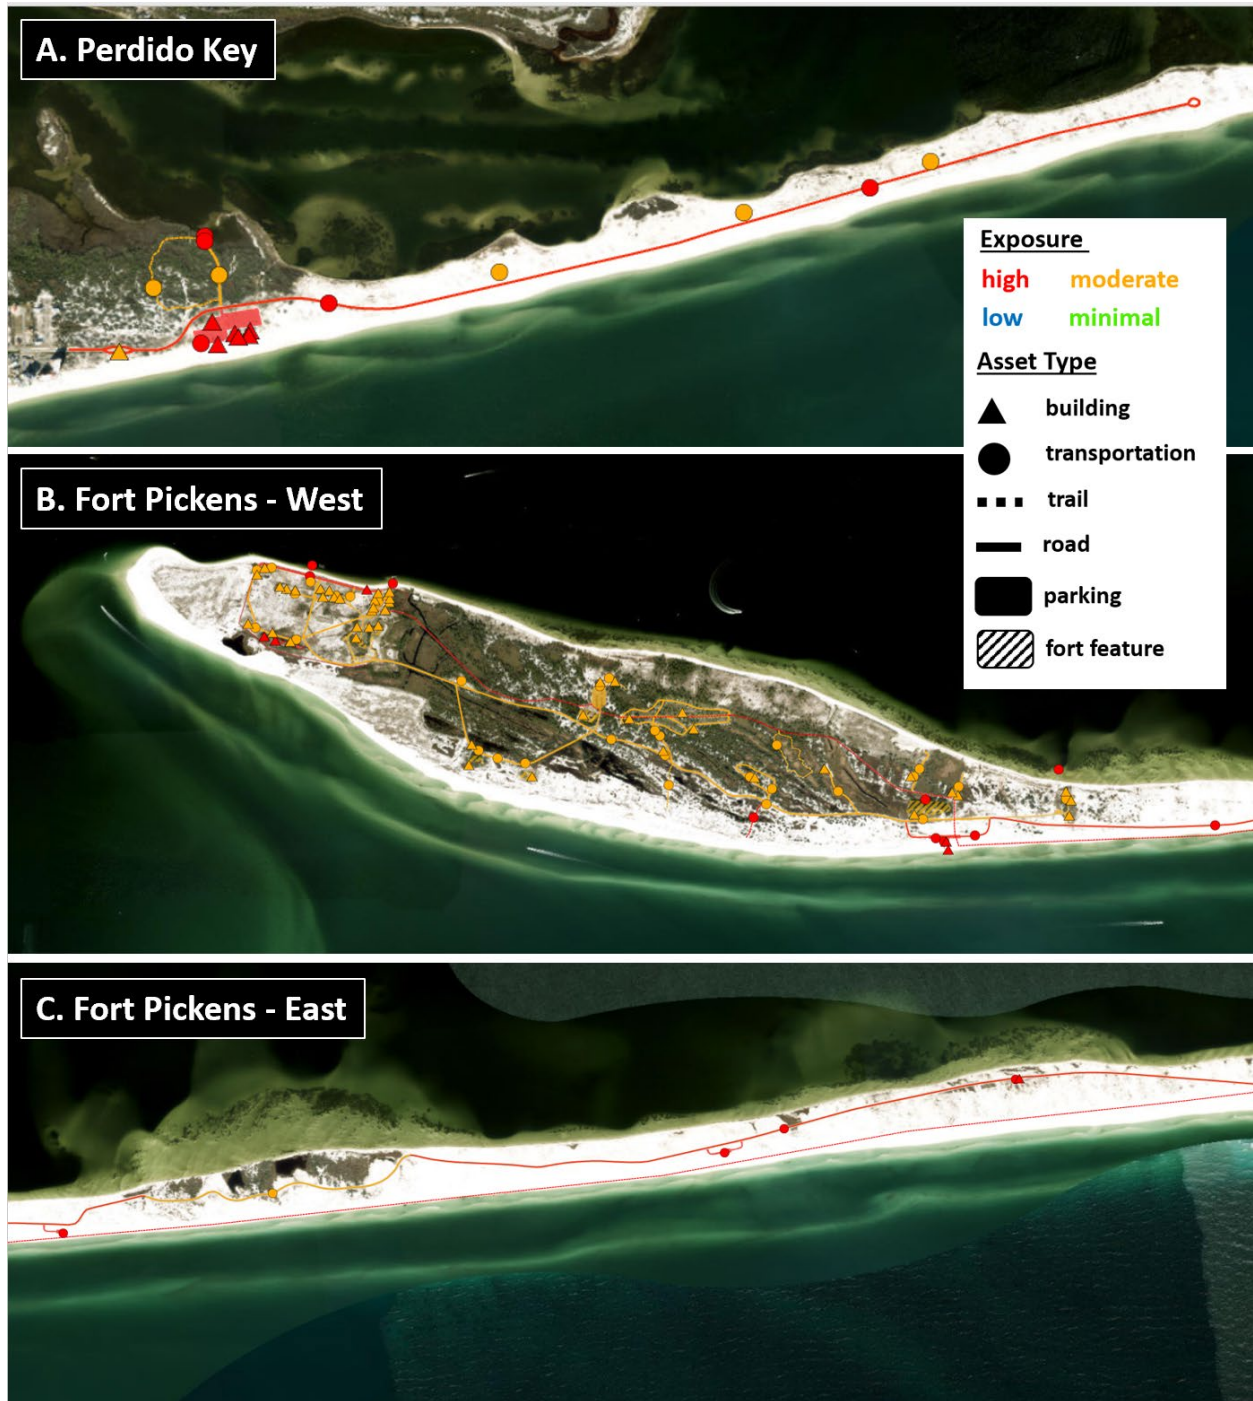
**Figure 2.** GIS exposure results summary for the A) Perdido Key (Fort McRee area not shown), B) Fort Pickens - West, and C) Fort Pickens - East areas of the FL district. Background is 2021 ESRI world imagery.

Over one-quarter (27%) of assets located in the FL district of GUIS have high exposure to the coastal hazards evaluated, while one-half have moderate exposure (Table 3, Figures 1-4). Only 5% of these assets have low exposure, and 18% have minimal exposure. All low and minimal exposure assets in FL are in the Fort Barrancas, Pensacola Lighthouse, and Naval Live Oaks areas (Figures 1 and 4). Seven assets in this district are within all evaluated exposure hazard zones: Fort Pickens Ferry Pier Marina, Fort Pickens Marina/Waterfront (Fishing Pier), Fort Pickens Ranger Station Marina, the east segment of Fort Pickens Road, Perdido Key Waterfront (Canoe Launch), Perdido Key Natural Trail Parking, and Okaloosa Marina and Waterfront.

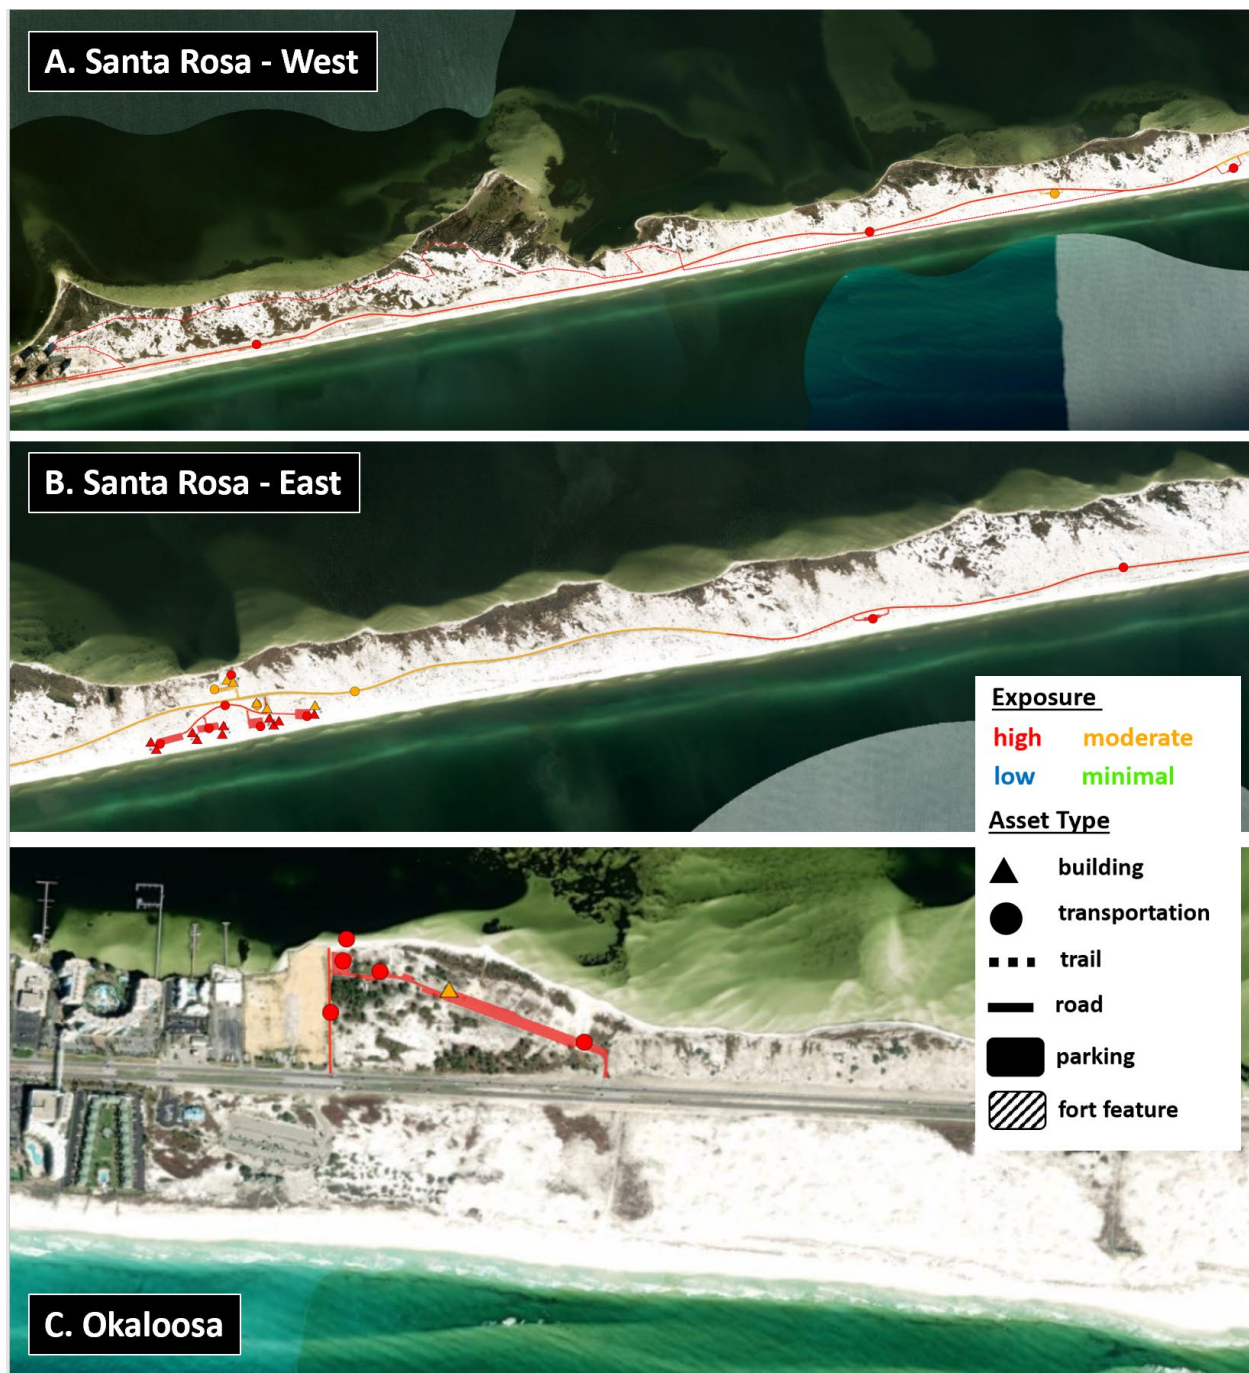
**Figure 3.** GUI exposure results summary for the A) Santa Rosa - West, B) Santa Rosa - East, and C) Okaloosa areas of the FL district. Background is 2021 ESRI world imagery.

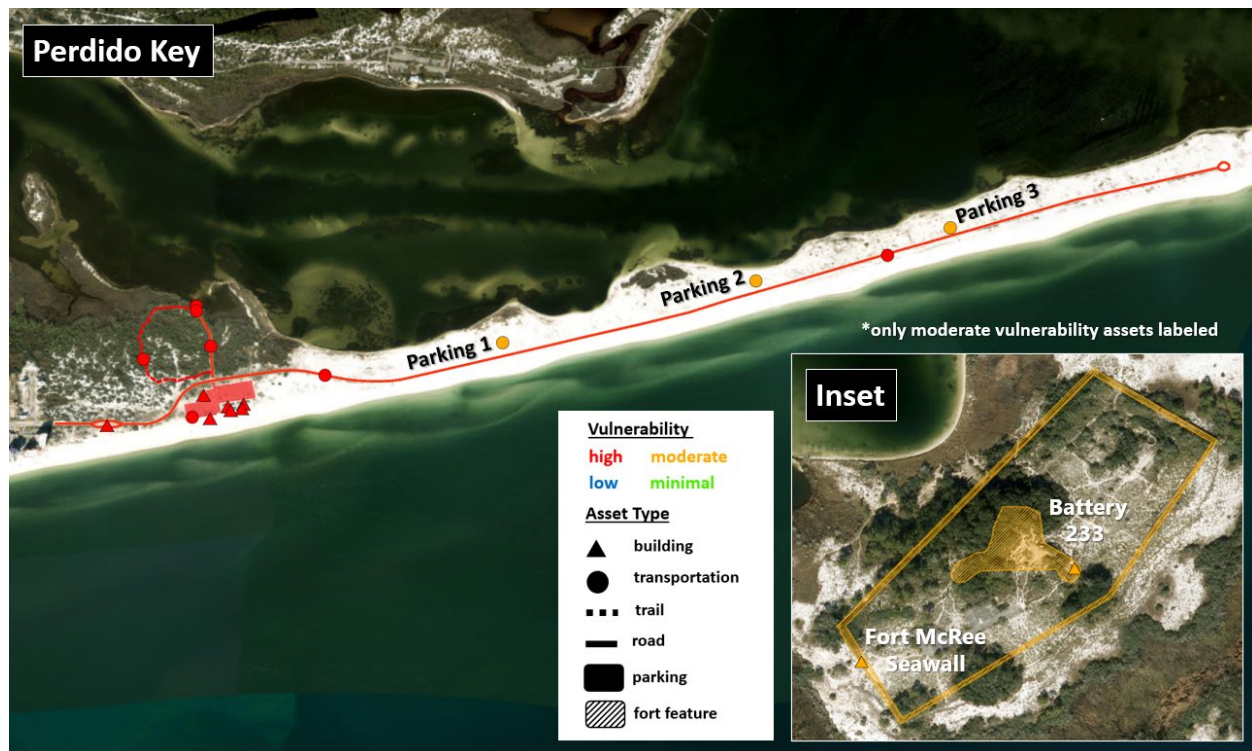
**Figure 6.** GUIS vulnerability results for the Perdido Key area of the FL district (inset shows Fort McRee area). Background is 2021 ESRI world imagery. Only moderate vulnerability assets are labeled.

Over half (57%) of the assets located in the FL district of GUIS have high vulnerability to the coastal hazards evaluated, while one-quarter have moderate exposure (Table 9, and Figures 6-12). No FL assets have low exposure, and 18% have minimal exposure. Transportation assets make up the majority of the high vulnerability assets in this district. Forty-eight assets have both high exposure and high sensitivity, including multiple restrooms, picnic shelters, and parking lots in the Santa Rosa area, as well as several segments of Fort Pickens, Johnson Beach, and Earle Bowden roads (Figures 6, 10-12).

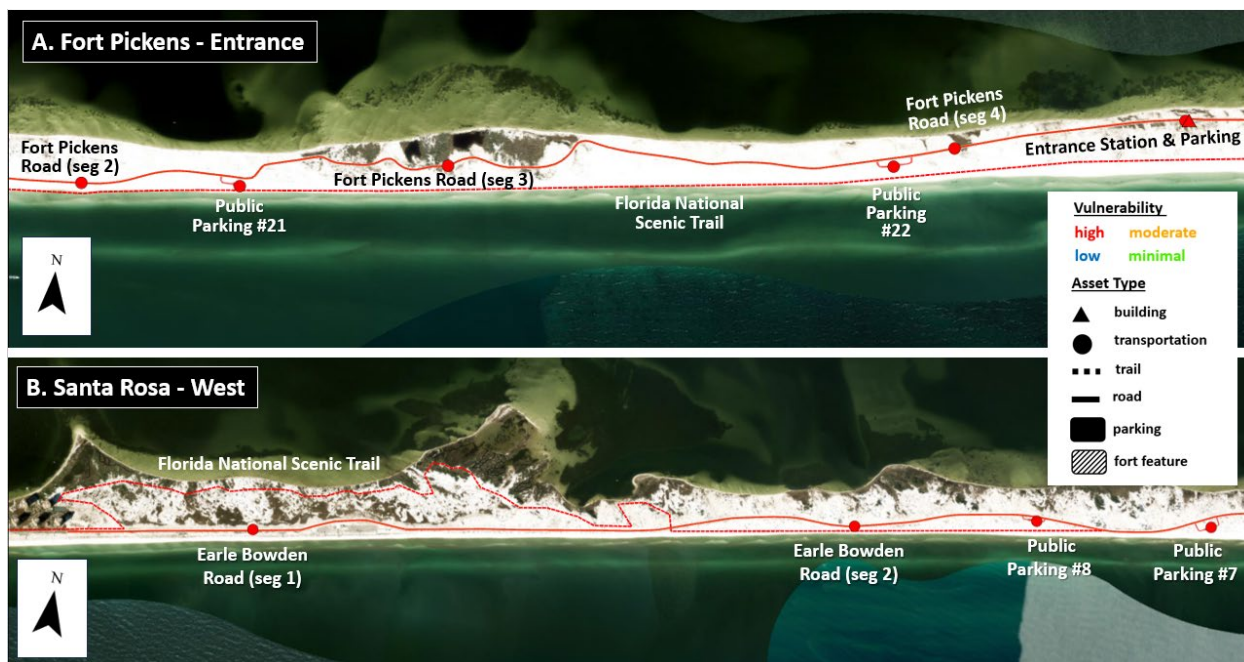
**Figure 11.** GUI vulnerability results for the A) Fort Pickens - Entrance and B) Santa Rosa - West areas of the FL district. Background is 2021 ESRI world imagery. Note the direction of north.

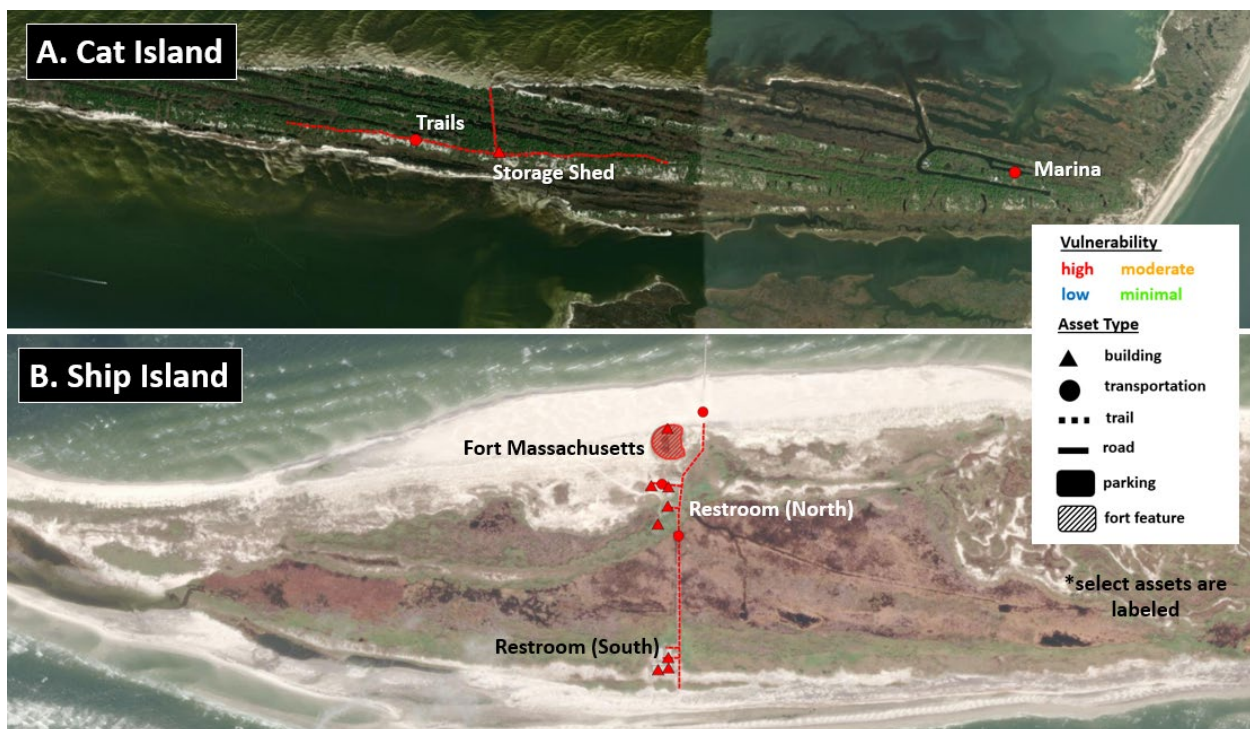
**Figure 15.** GUIS vulnerability results for the A) Cat Island and B) Ship Island areas of the MS district. Background is 2021 ESRI world imagery. Select assets are labeled for Ship Island (B).
