PHOTOGRAPHS
WRITTEN HISTORICAL AND DESCRIPTIVE DATA

ARLINGTON MEMORIAL BRIDGE

HAER No. DC-7

Date of Construction: Designed 1929, Completed 1932

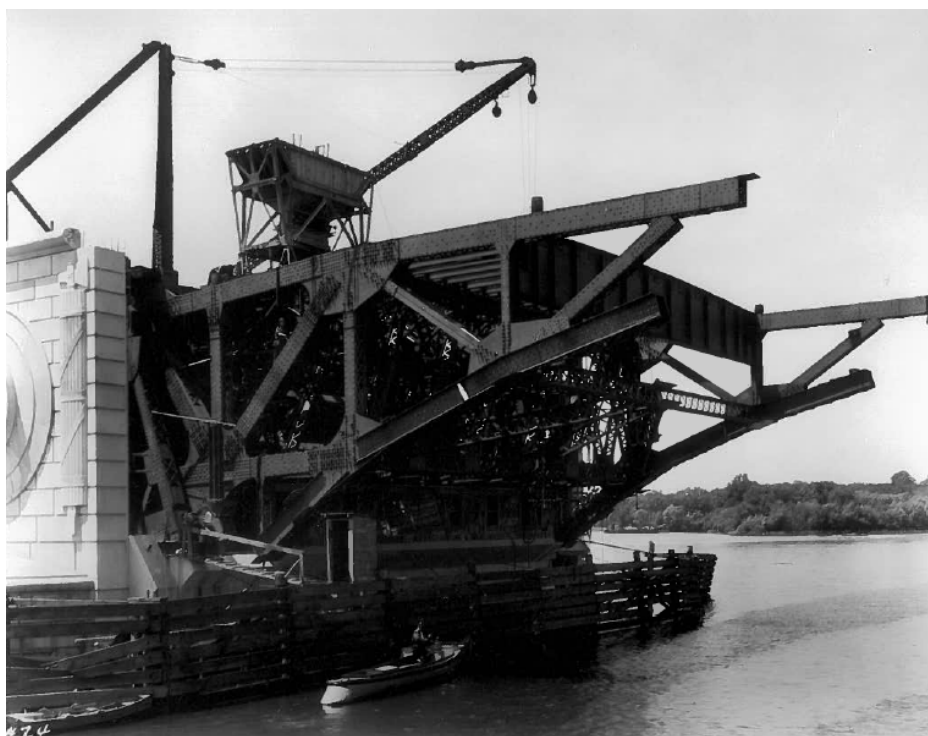
Figure 4. Each leaf of the bascule span was assembled with rivets from components fabricated at Phoenix Bridge's shop. The east leaf was erected first, and then raised to provide clearance for ships while the west leaf was being built. (NARA RG 42-AMB-1-30)
