National Park Service  
Cultural Landscapes Inventory

2012

Utility Area  
Mesa Verde National Park

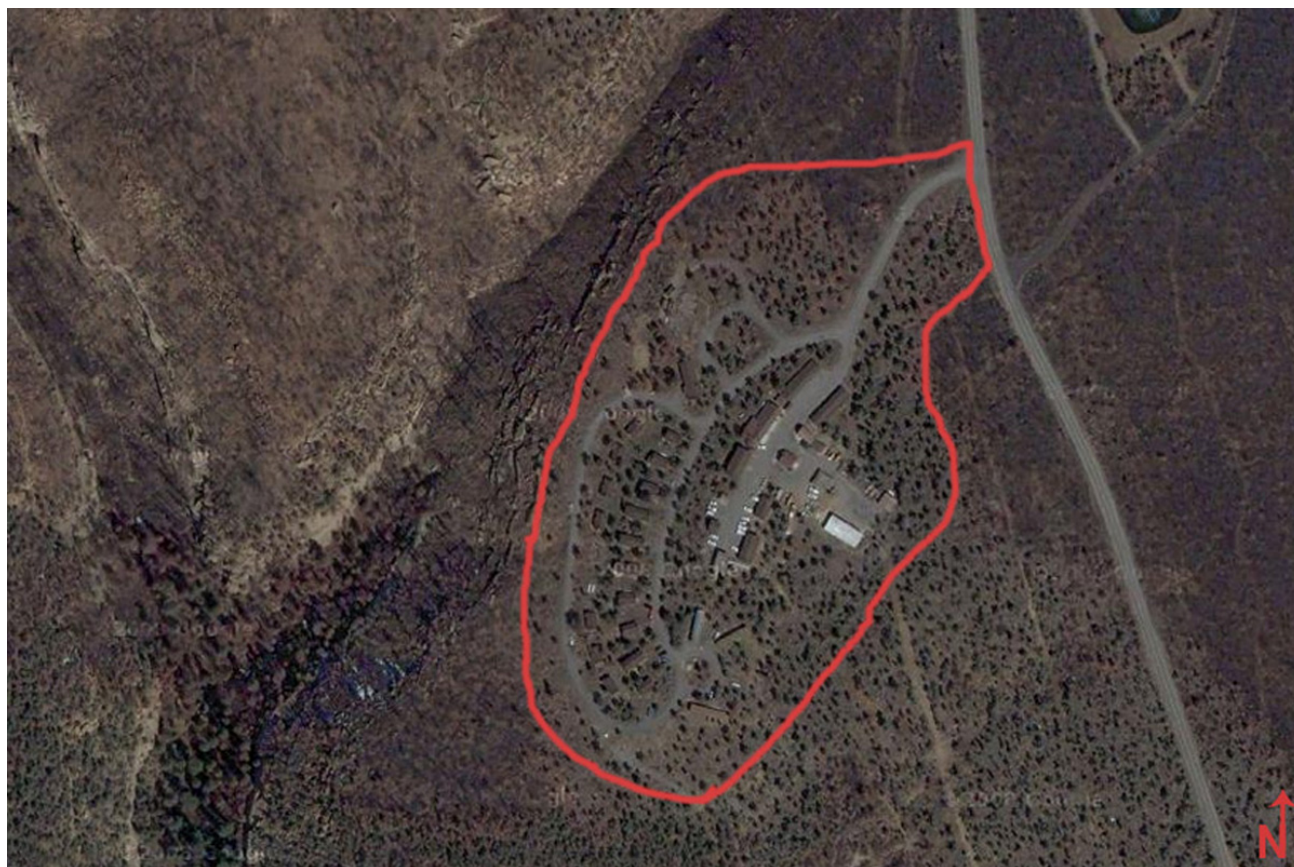
*Aerial view of the Utility Area showing the landscape boundary addressed in this CLI. (Source: Google Maps; augmented by K. Miller)*

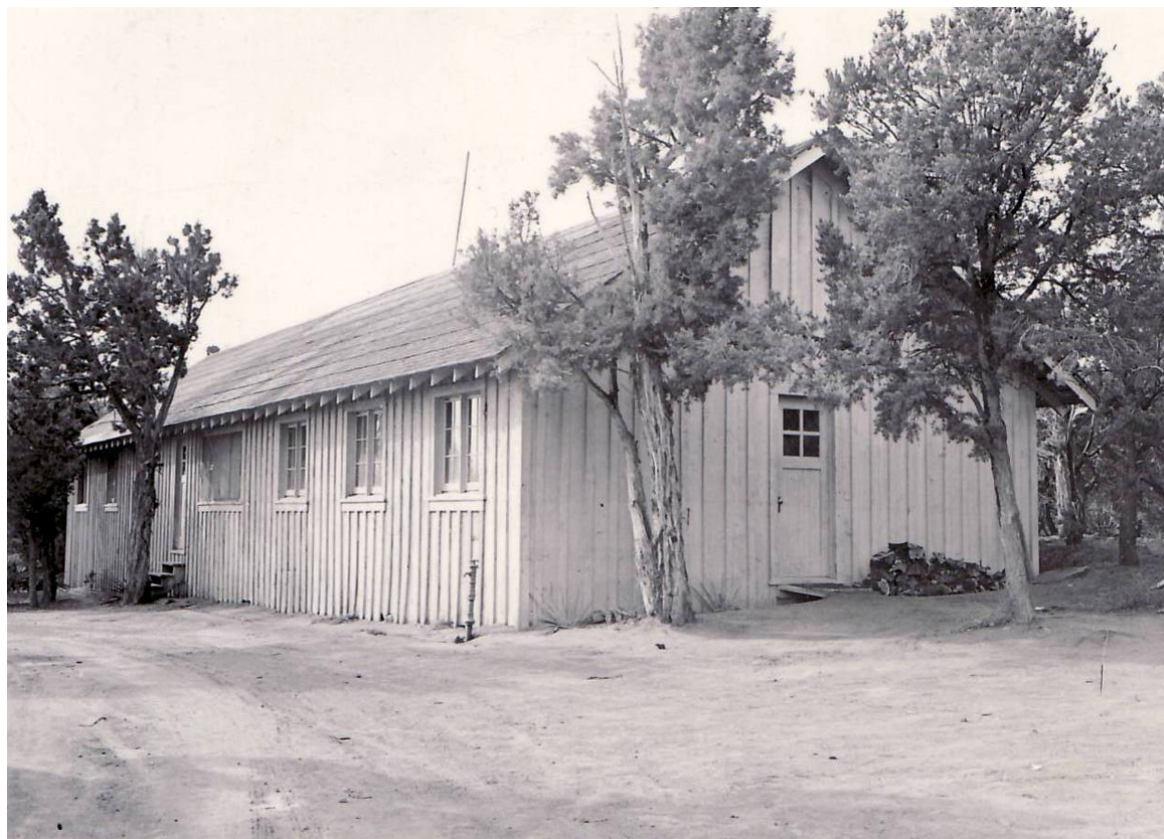
*Bunkhouse/duplex (no. 16), October 1932. Source: Markley, Mesa Verde Archives, 9031.*

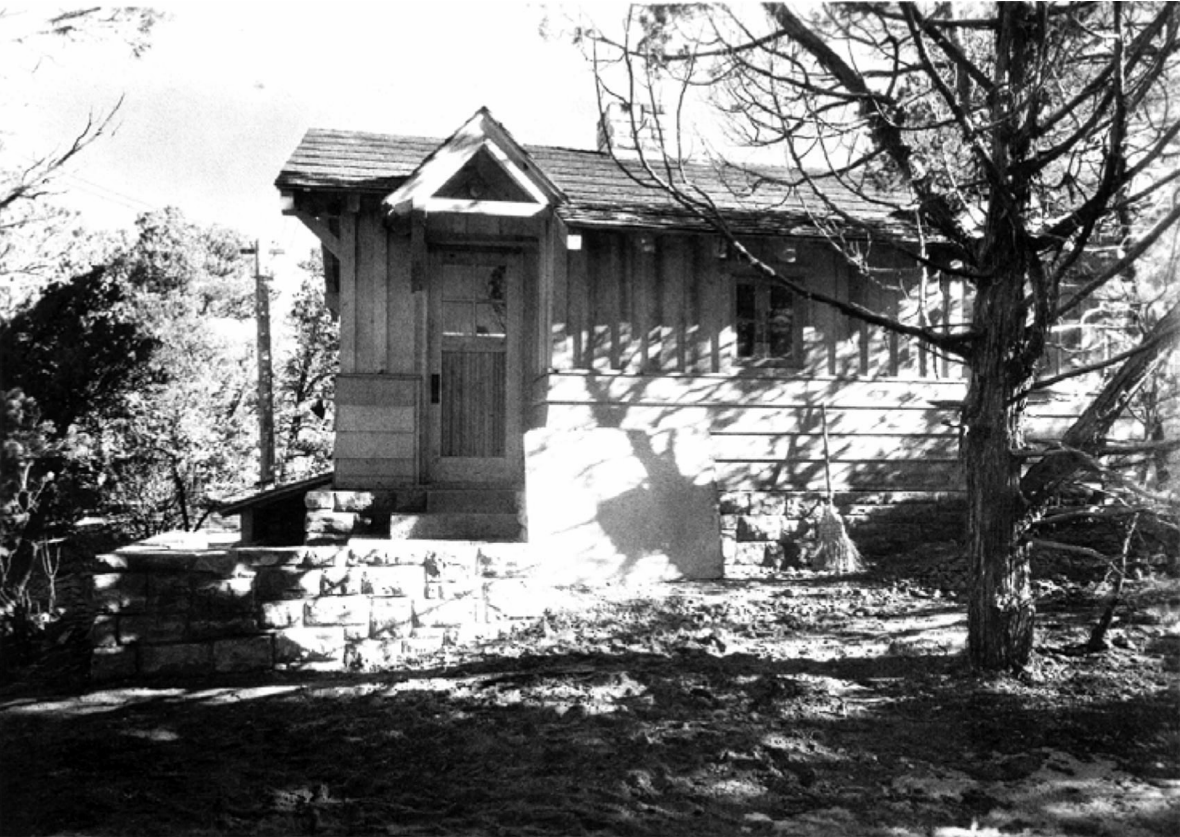
*Southern view of one of the Utility Area Residences. "NPS Rustic" style features include sandstone foundations, wood siding, and retention of native landscape material, February, 1935. Source: Markley, No. 809, Mesa Verde Archives.*

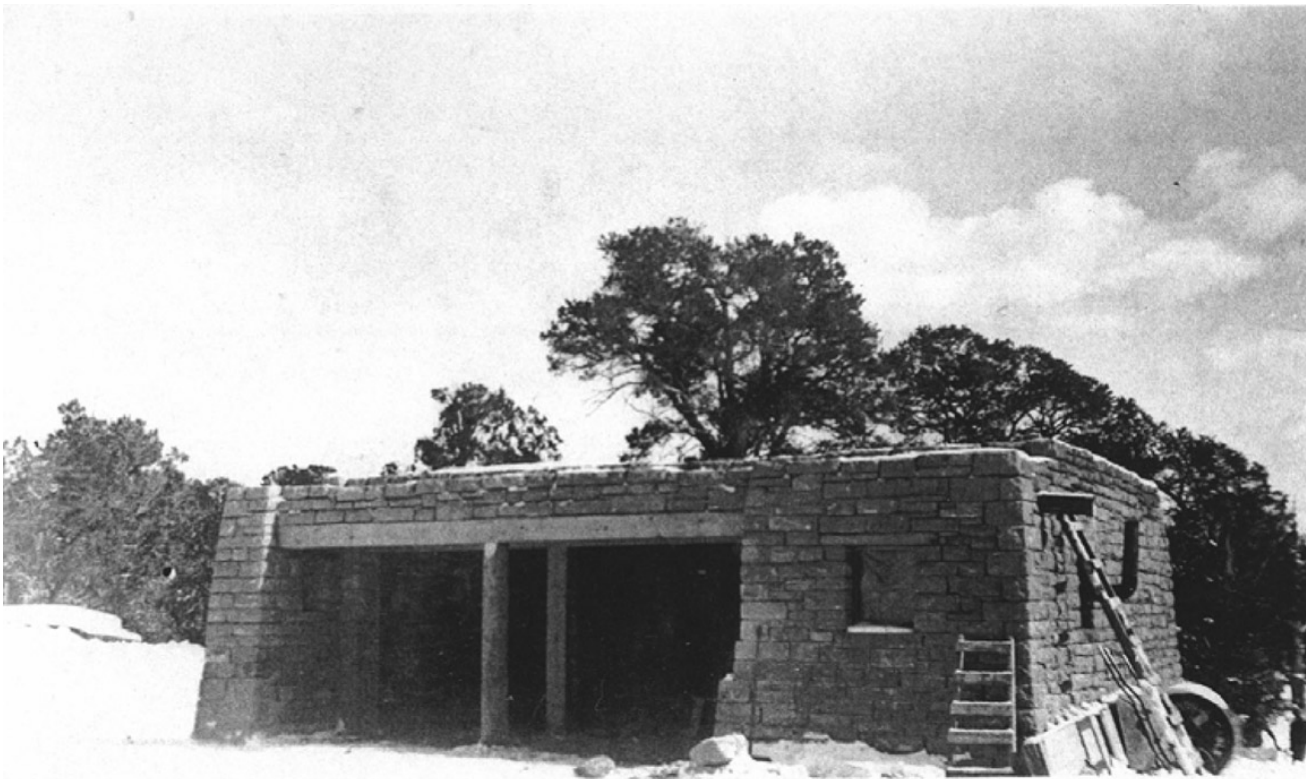
*The fire equipment storage shed or fire cache (no. 51) is the only example of the Modified Pueblo Revival style in the Utility Area, January 26, 1937. Source: Photographer Unknown, No. D-156, Mesa Verde Archives.*

In addition to Rustic forms of architecture, the fire cache building (no. 51) in the Maintenance Yard is an example of the Modified Pueblo Revival property type through its low-profile scale, native sandstone exterior walls, protruding vigas, and a flat roof.

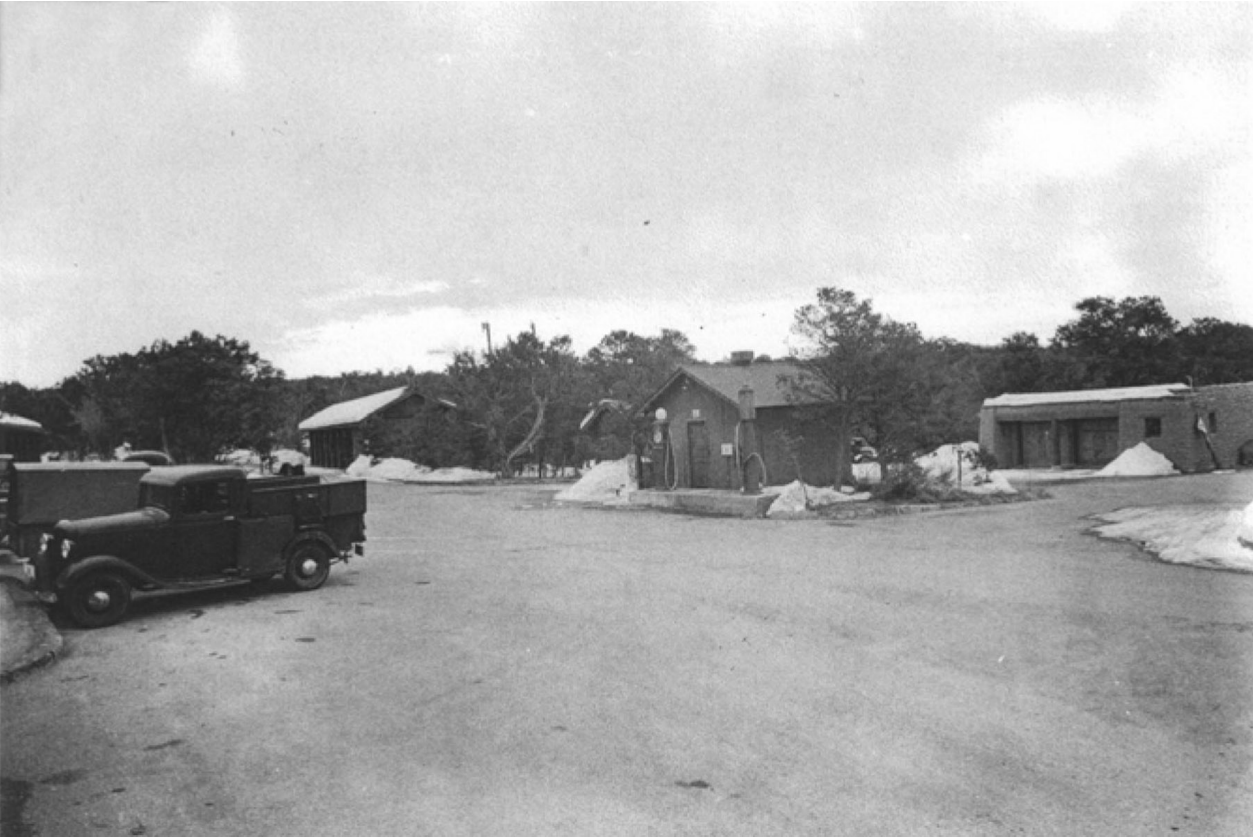
*The Utility Area as seen from the porch of the Warehouse (no. 53). The southern equipment shed (no. 50), gas & oil house (no. 52), and fire cache (no. 51) are shown, January 20, 1941. Source: Fluckey, No. 1558, Mesa Verde Archives.*

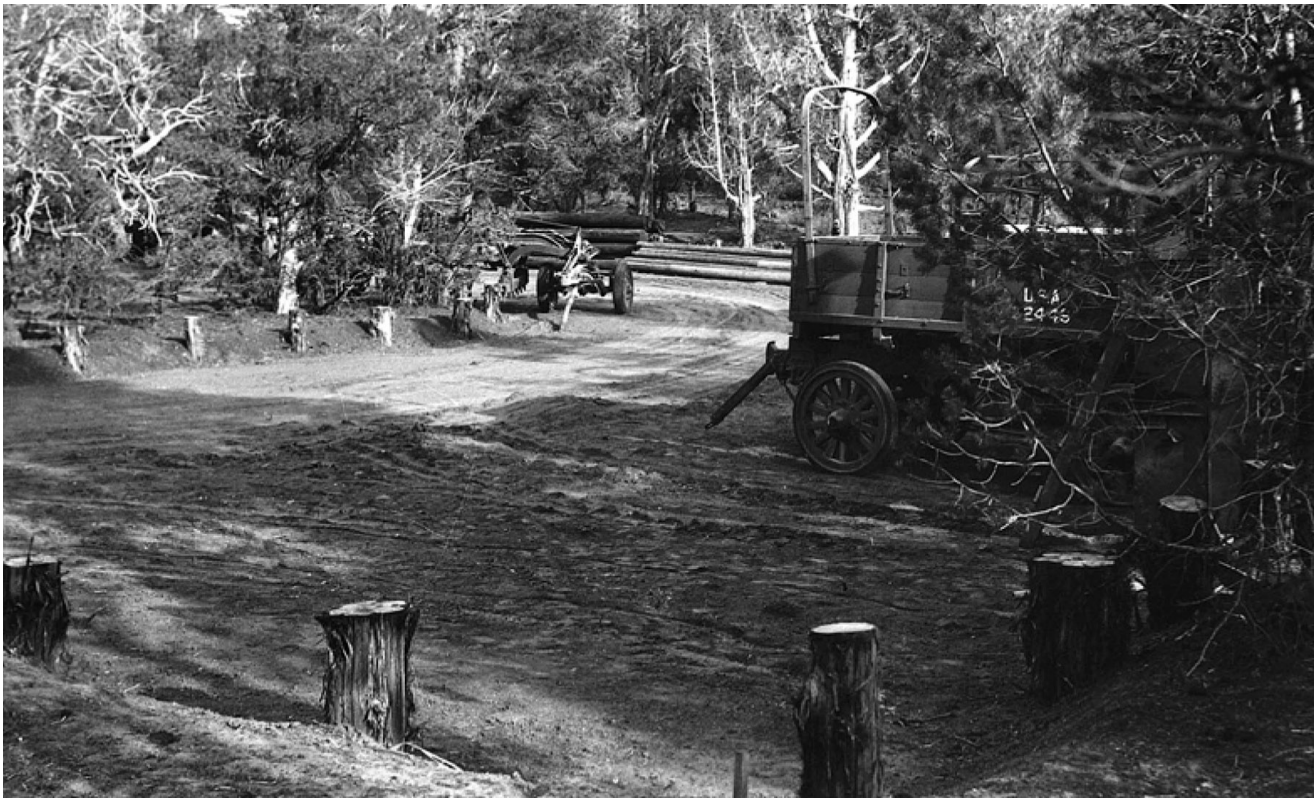
*Parking area in the Maintenance Yard. Notice the log bollards used for parking delineation, nd. Source: Photographer Unknown, Mesa Verde Archives.*

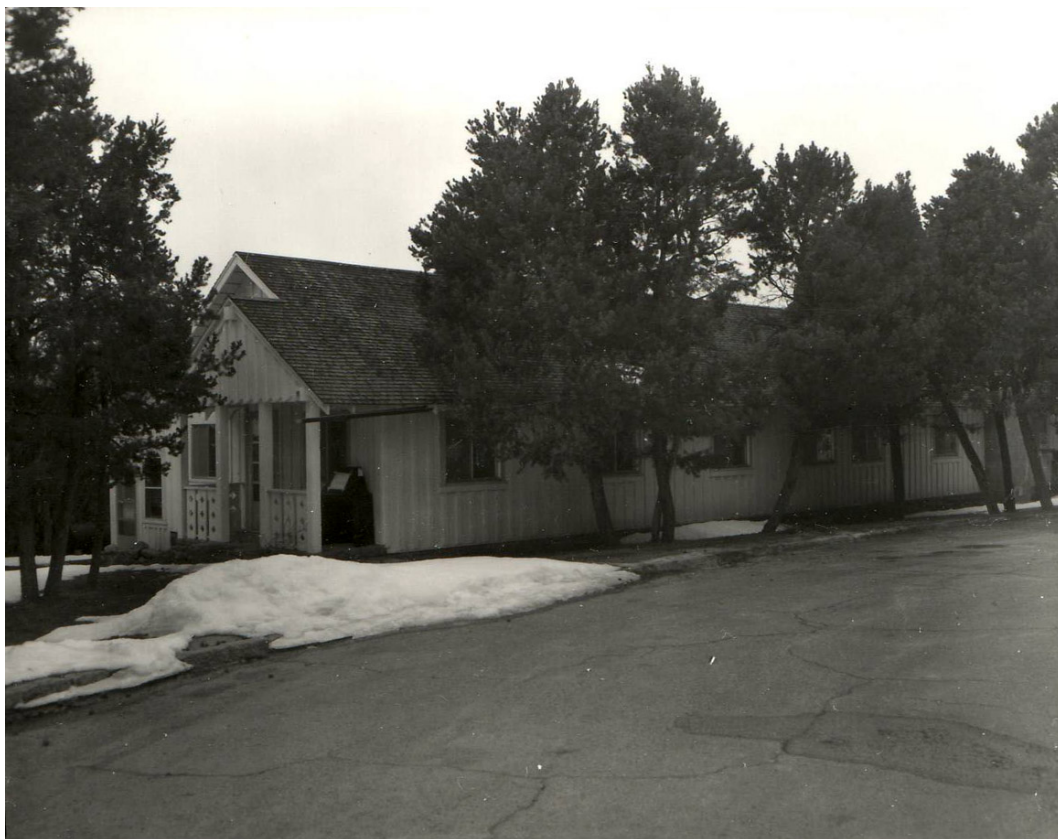
*Bunk house (no. 16) and grounds, 1975. Source: Photographer Unknown, Mesa Verde Archives, 8539.*

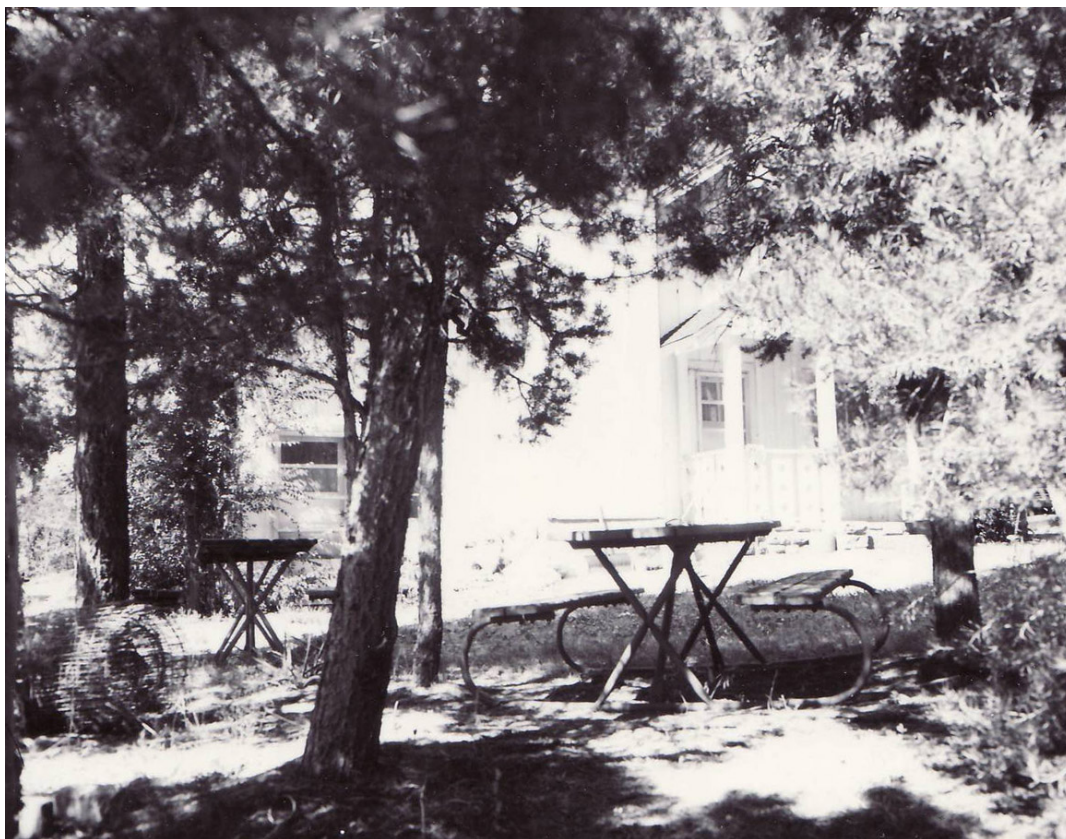
*Bunkhouse (no. 16) and grounds, October 1979. Source: Wenger, Mesa Verde Archives, 9031.*

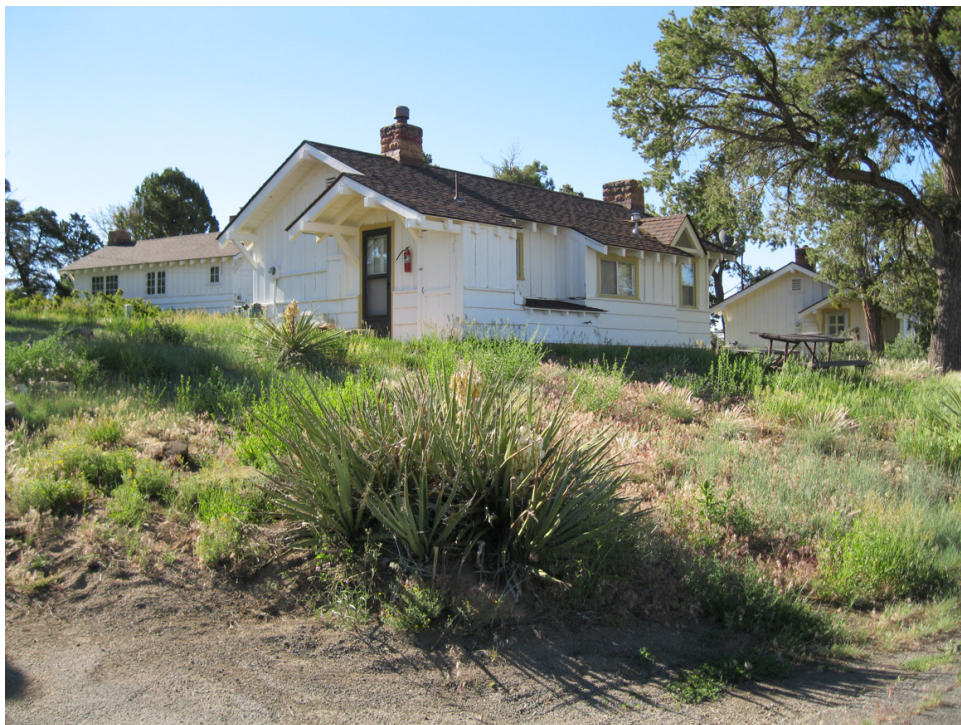
*Residence No. 29 of the Utility Area Housing, constructed in the NPS Rustic Style of architecture, June 2010. Source: K. Miller, National Park Service.*

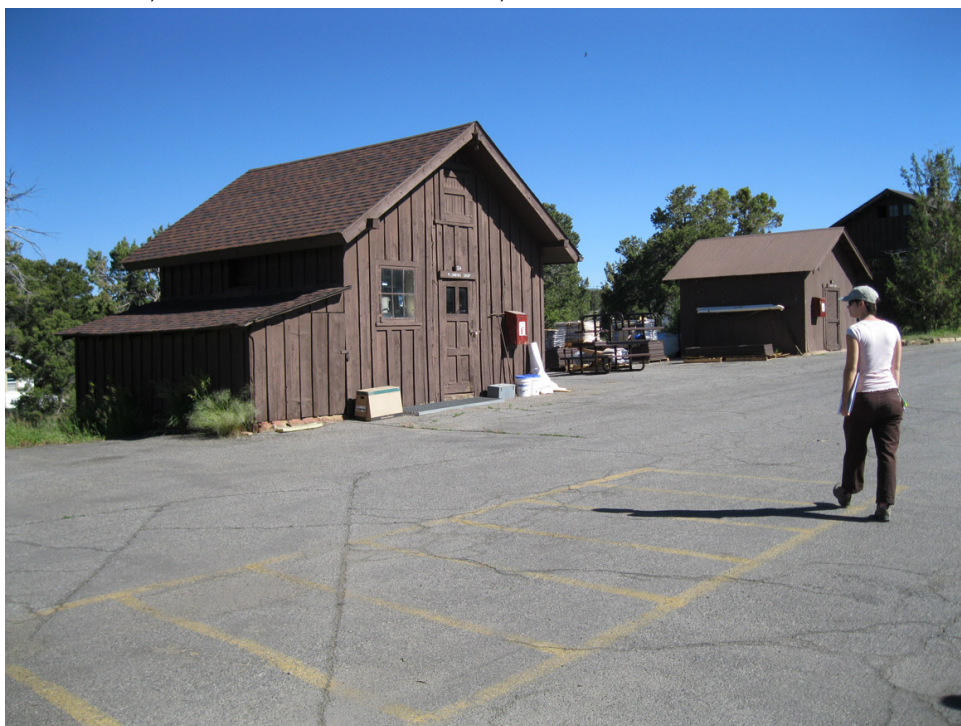
*Plumbing Shop within the Maintenance Yard, constructed in 1929 in the NPS Rustic Style, June 2010. Source: K. Miller, National Park Service.*

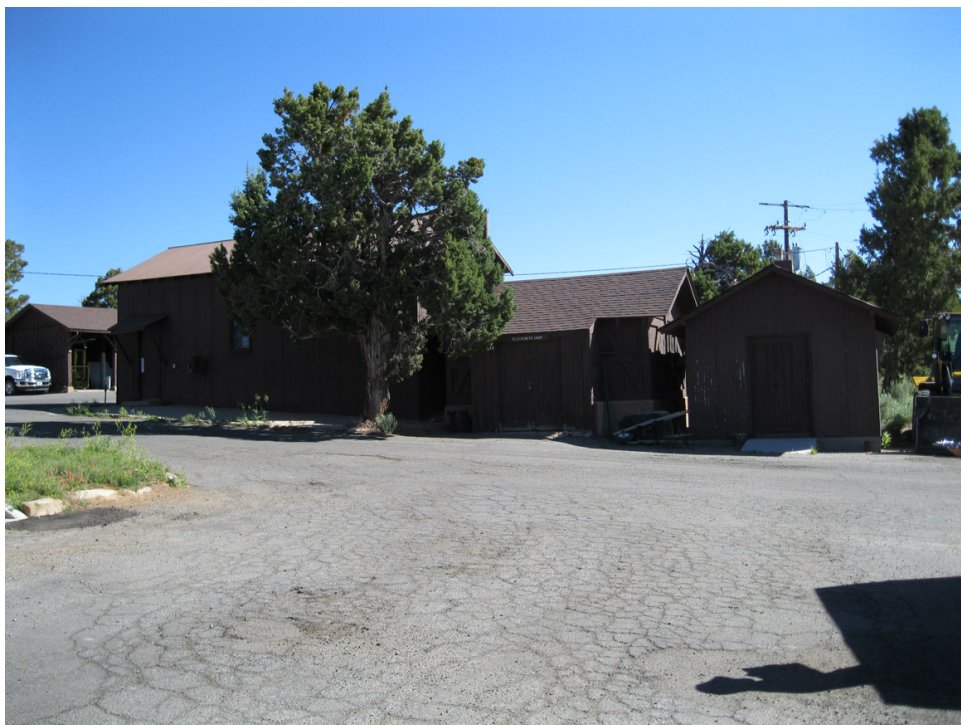
*From L to R: The Snow Blast Shed, Blacksmith Shop, and Oil House, June 2010. Source: K. Miller, National Park Service.*

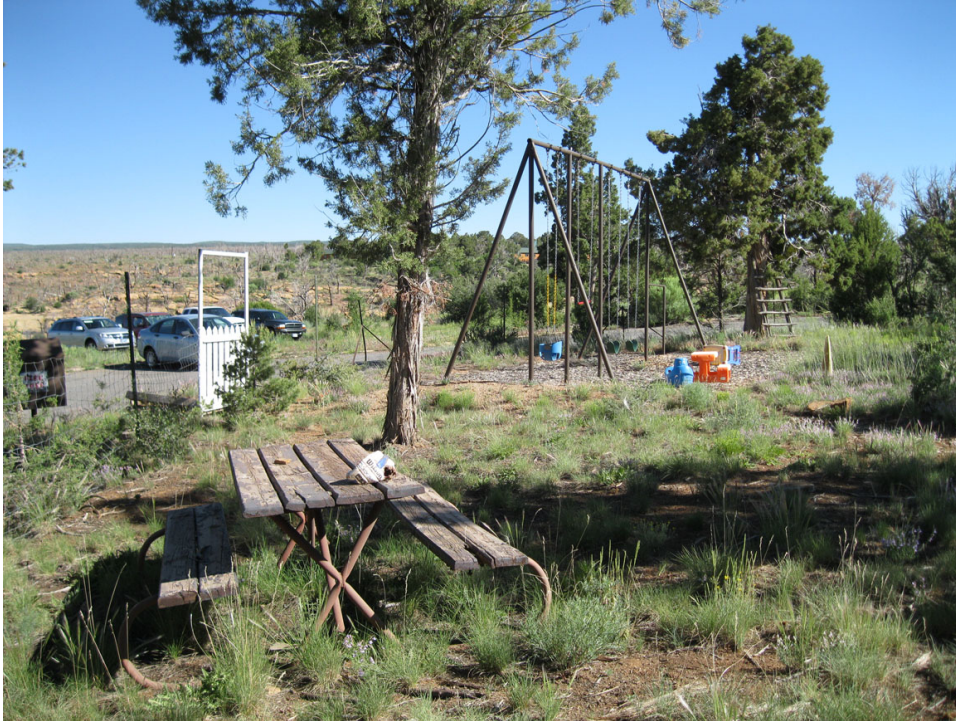
*Playground space north of the cottages, surrounded by a wire fence with wooden gates, June 2010. Source: K. Miller, National Park Service.*

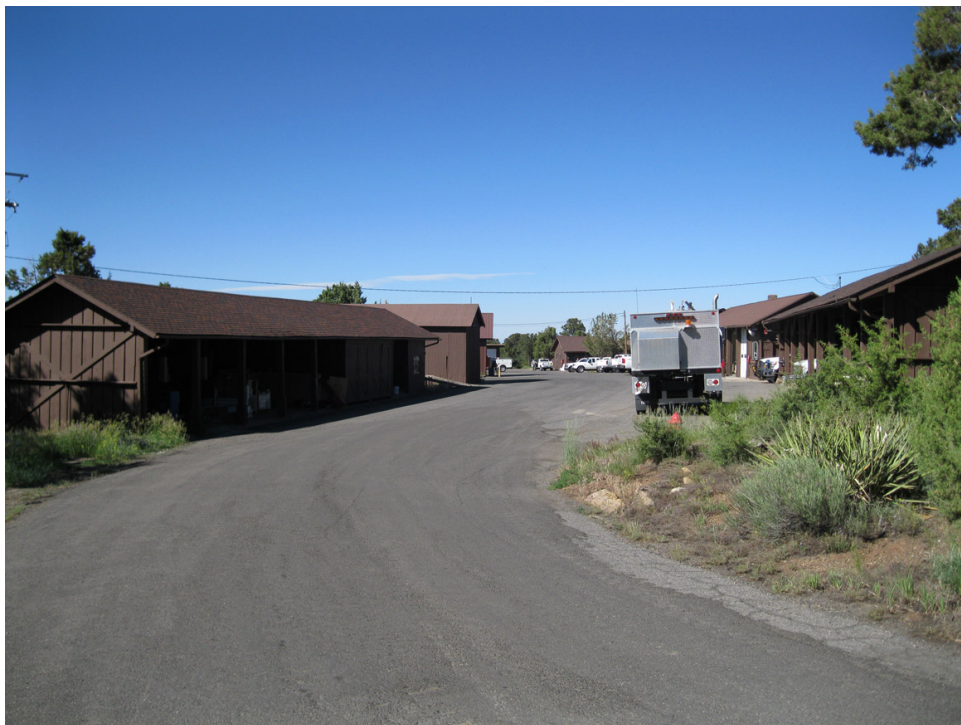
*The entrance road to the Maintenance Yard, looking southeast, June 2010. Source: K. Miller, National Park Service.*

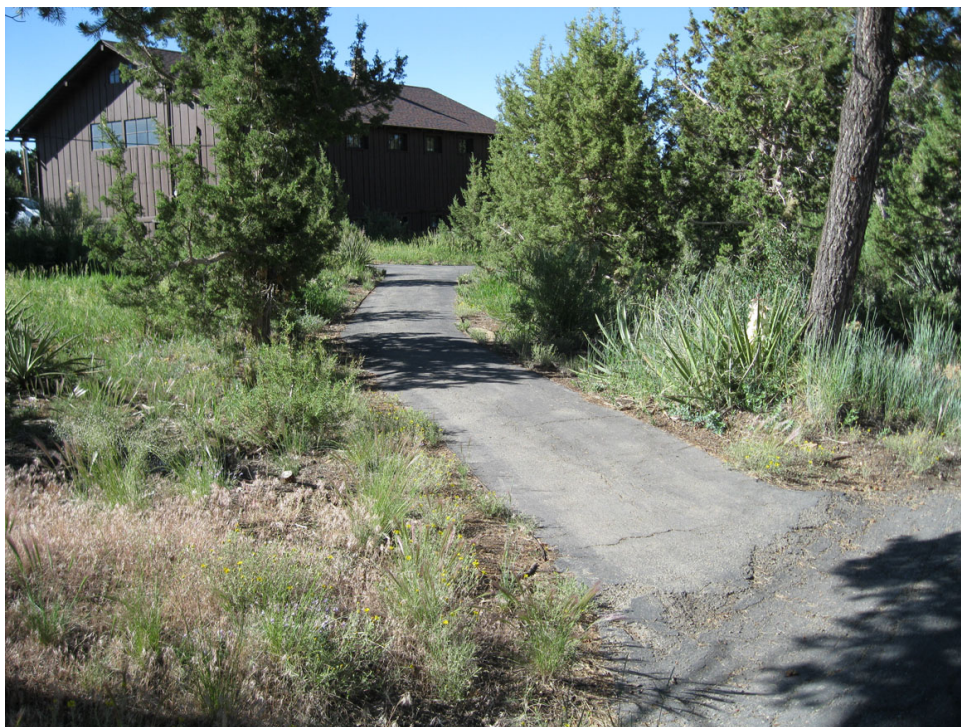
*Pedestrian path leading from the Utility Area Housing to the Maintenance Yard, June 2010. Source: K. Miller, National Park Service.*

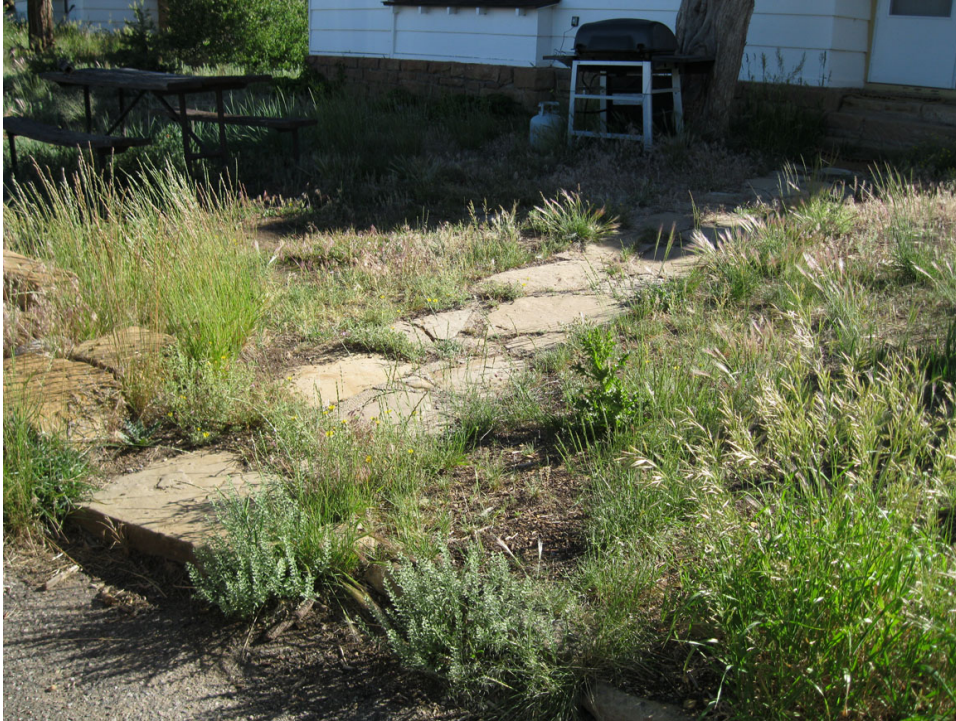
*Flagstone walk at Residence no. 27, June 2010. Source: K. Miller, National Park Service.*

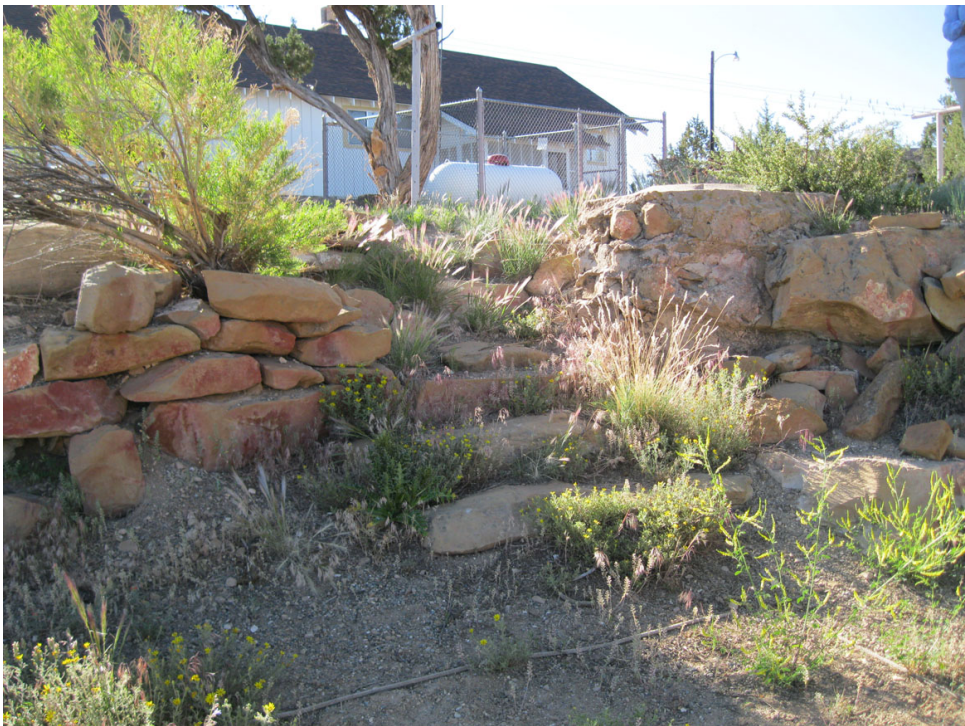
*Stone steps, retaining walls, chainlink fences, and propane tanks are common small-scale features throughout the housing area, June 2010. Source: K. Miller, National Park Service.*

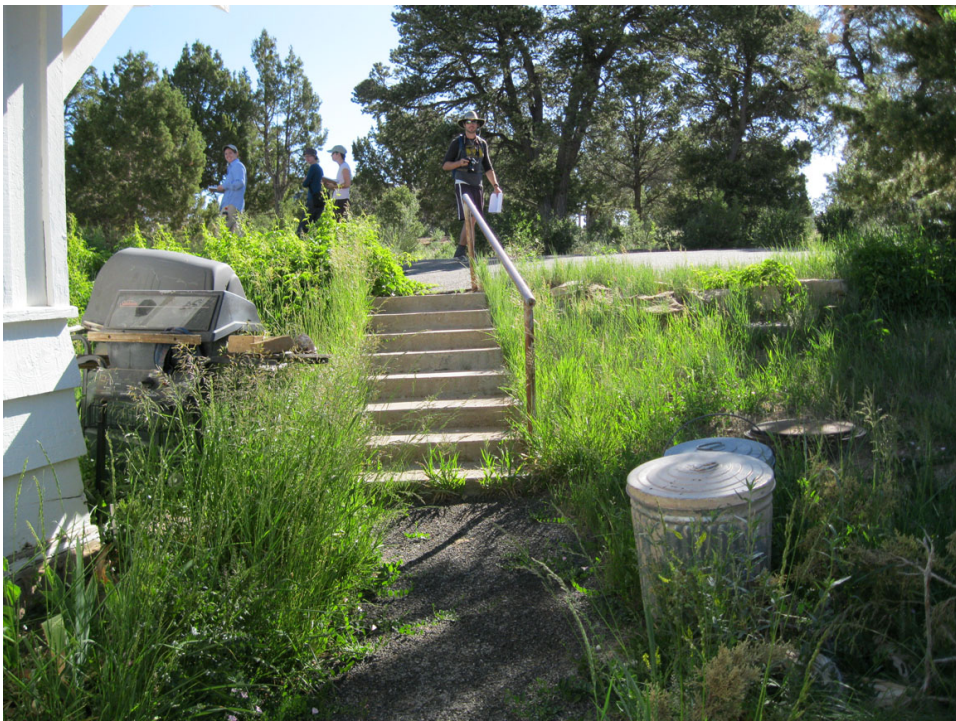
*Other small-scale features around the residential area include steps, railings, trash cans, and grills, June 2010. Source: K. Miller, National Park Service.*

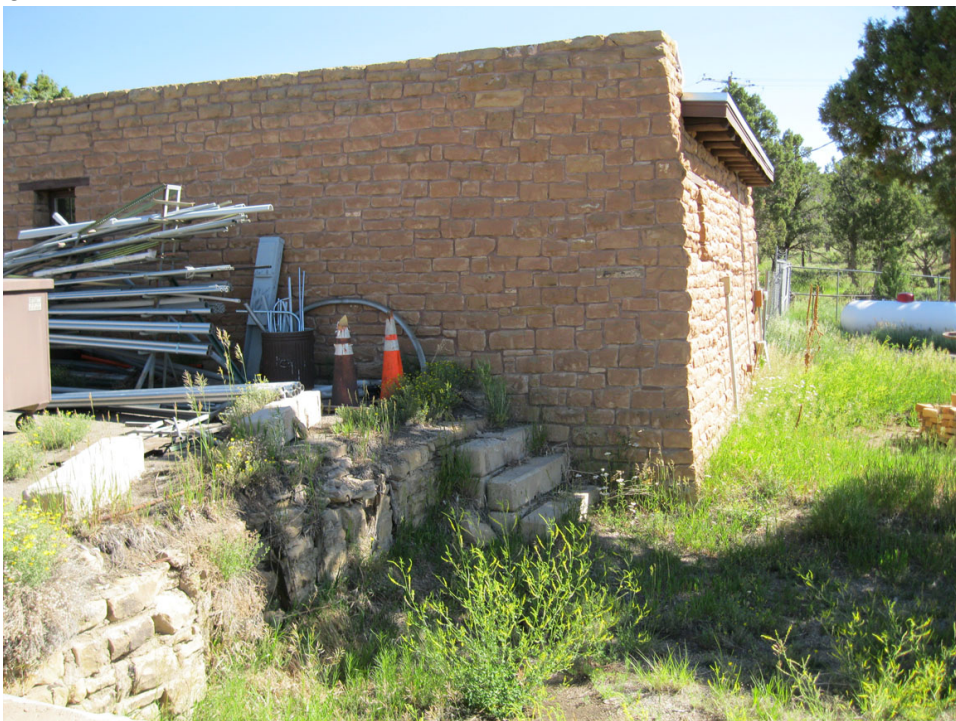
*A 4-foot tall stone retaining wall and stockpile area at the southeast corner (rear) of the fire cache, June 2010. Source: K. Miller, National Park Service.*

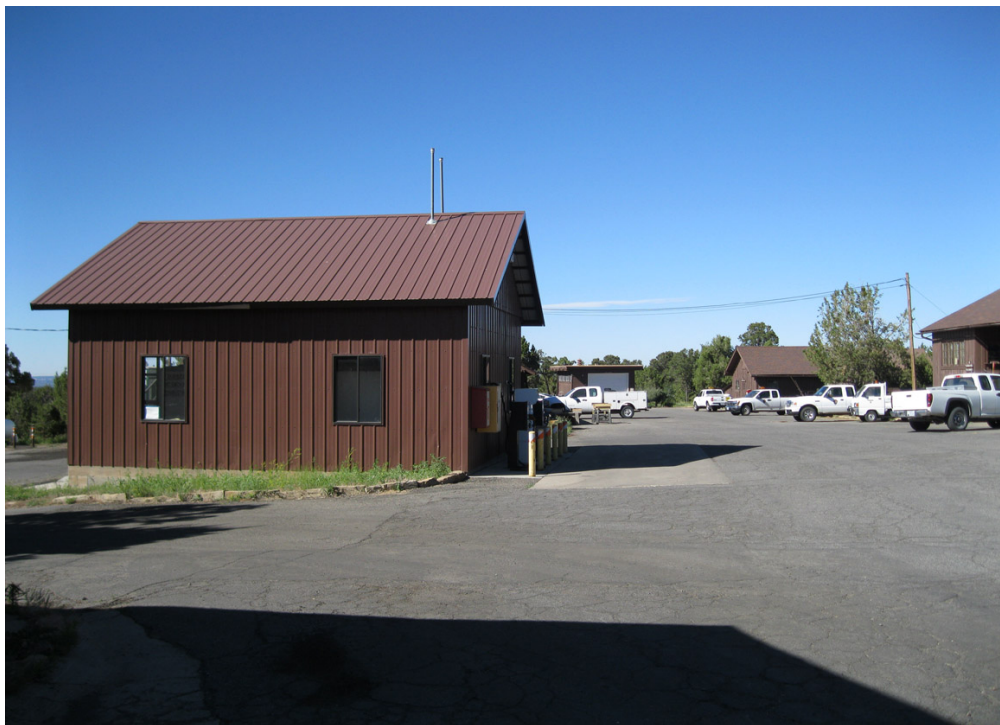
*The center of the “T” configuration within the Maintenance Yard with the fuel house in the foreground, looking southeast, June 2010. Source: K. Miller, National Park Service.*

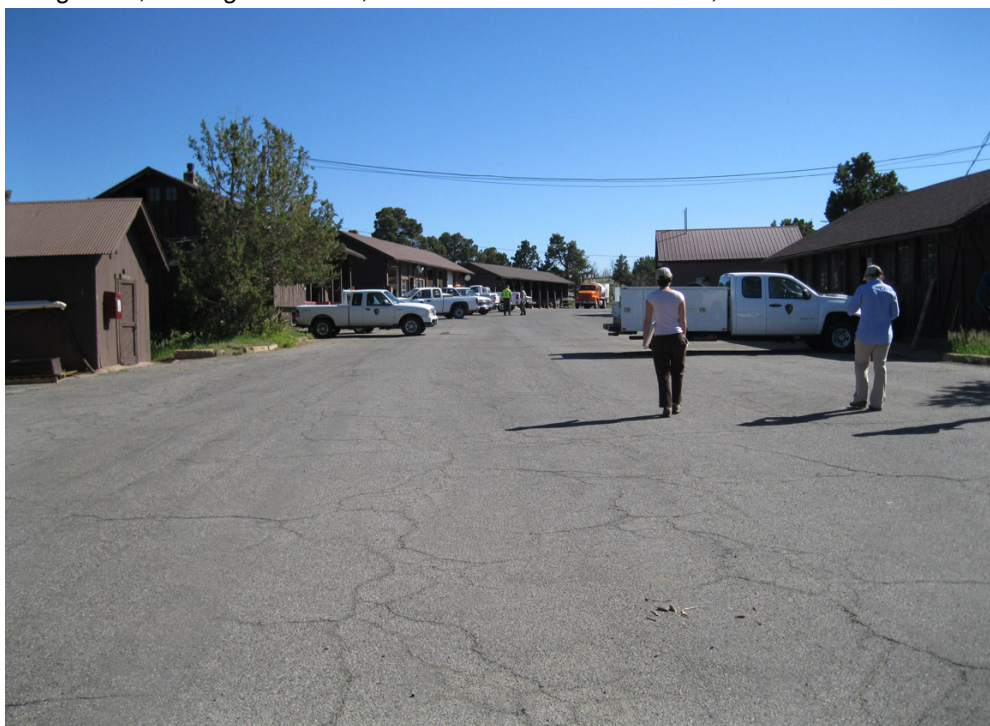
*Cluster of buildings along the cross of the “T” formation within the Maintenance Yard, June 2010. Source: K. Miller, National Park Service.*

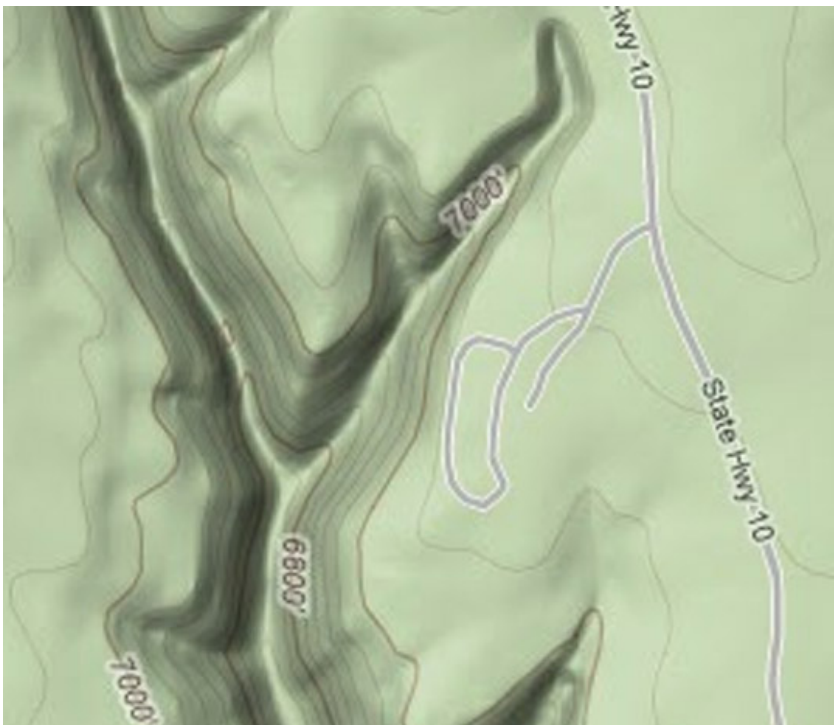
*The Utility Area is bounded to the north, west and south by steep slopes that terminate in Spruce Canyon, July 2010. Source: Google Maps.*

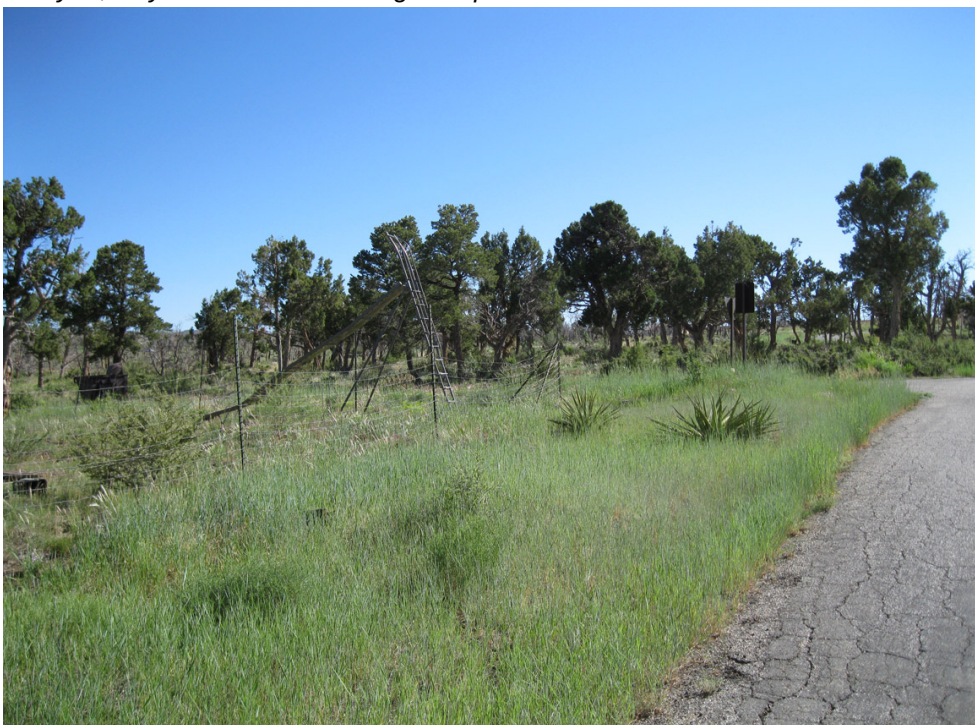
*Generally flat terrain up to the canyon edge was an ideal location on which to construct the Utility Area, looking southwest, June 2010. Source: K. Miller, National Park Service.*
