**THE BARN  
AT THE FARWELL JONES HOUSE  
STRUCTURAL ASSESSMENT REPORT**

**Minute Man National Historical Park  
Concord, Massachusetts**

*Prepared for*  
**National Park Service  
400 Foot of John Street  
Lowell, Massachusetts**

**September 2004**

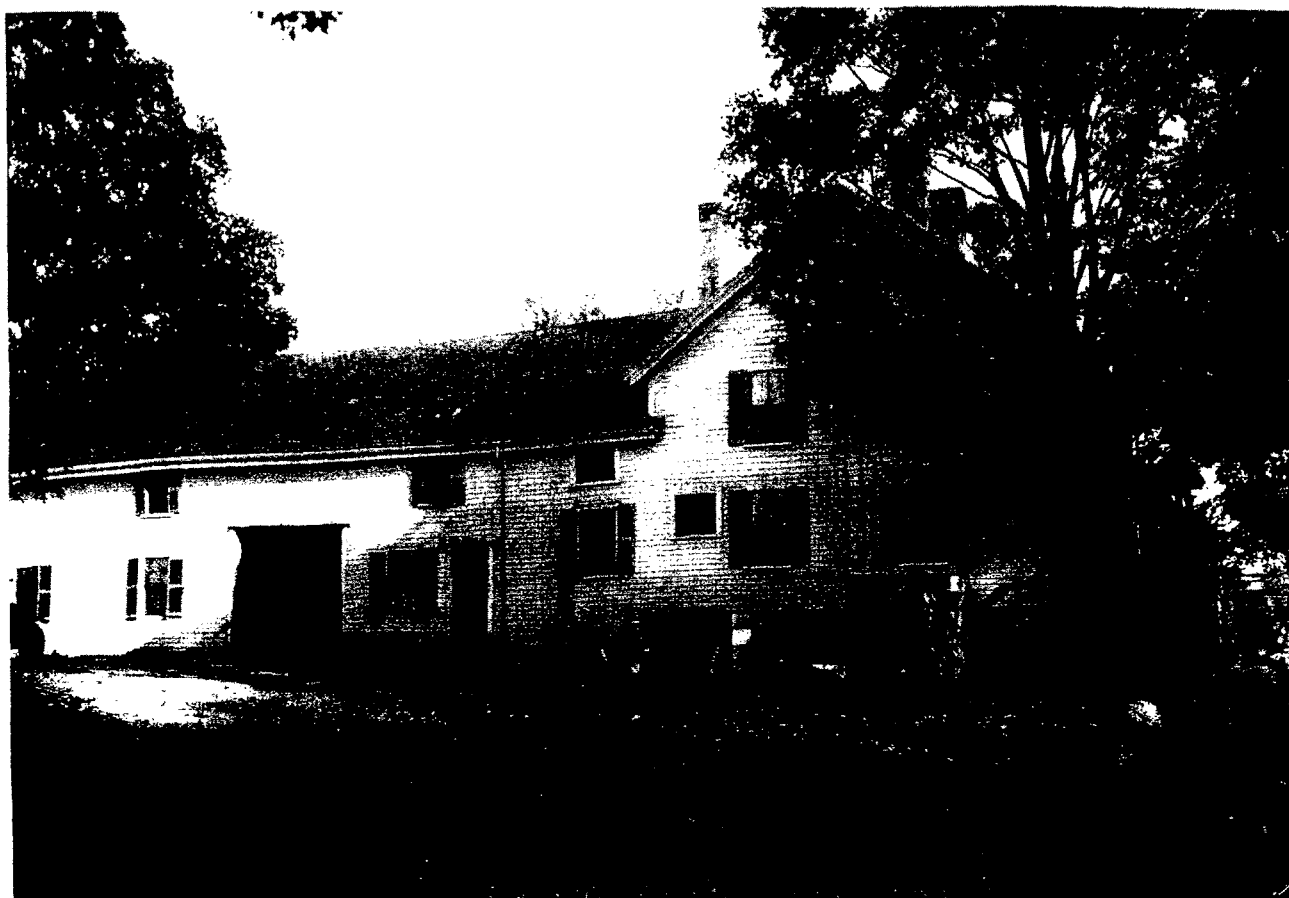
Figure 2. West elevation of the Farwell Jones House and rear barn connector, circa 1937.

No documentation has been found, such as written descriptions or photographs, of the original exterior paint color(s) of the barn. The earliest known photograph, a black-and-white view dated circa 1937, shows the barn connector that joined the house and barn, but not the barn itself (fig. 2, page 13). Both the house and connector were then painted a light shade, with the door, window sashes, and shutters a dark shade. The barn may have been finished in a similar manner. The connector had been removed by 1963 when a number of exterior photographs were taken of the barn for two separate appraisals of the property. One noted that the barn was then "in excellent condition being recently painted and repaired." The black-and-white photographs show a paint scheme similar to that of circa 1937, with light siding and dark doors and window sashes (figs. 4-10, pages 18-21). This same paint scheme is also shown in another set of black-and-white photographs taken in 1972 for a third appraisal of the property (figs 12 & 13, page 23).

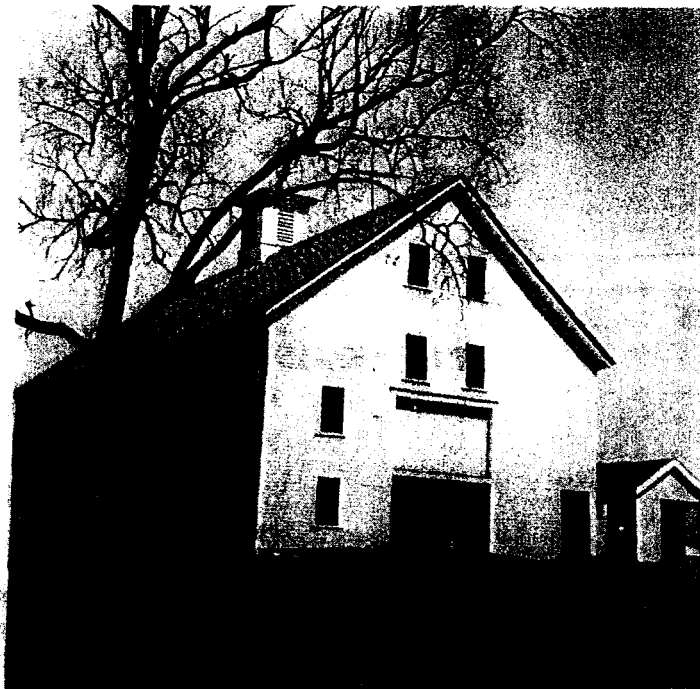
Figure 5 Front and west elevations of the barn, April 1963.

Physical evidence of an earlier, smaller, connector is preserved within the existing connector at the barn wall. This missing connector was narrower than the existing connector and had a lower gable roof. The evidence includes a clear outline of the former roof and extant metal flashing. The earlier connector was associated with the circa-1958 metal silo, based on a photograph dated April 1963 (fig. 8).

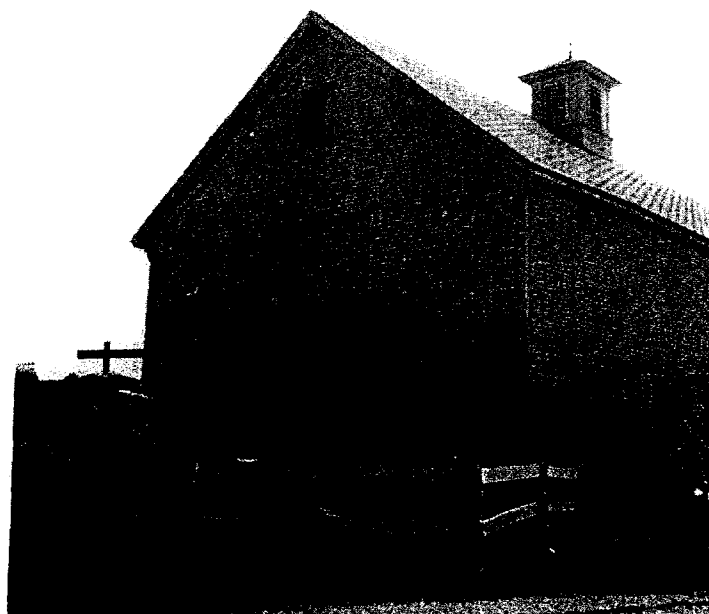
Figure 10. Rear and west elevations of the barn, April 1963.

Most of the doorways retain their original doors of simple board-and-batten construction, some glazed with single-light panels in aluminum frames. These aluminum frames replaced the original wood-framed, 6-light panels sometime after 1972. The two doorways in the rear elevation are missing their original doors. In the main story, a particleboard panel replaced an original plank door at the livestock entrance (D-105) sometime after 1972. The original door is stored in the loft today. In the loft story, a large corrugated metal door on a later exterior overhead track replaced a pair of glazed wooden doors at the high-drive entrance (D-202) sometime between 1963 and 1972. The missing original doors are documented by photographs dated 1963 (figs. 9 & 10).

High Drive. The rear loft entrance (D-202) is accessed by an original (1903) earthen ramp with stone retaining walls that leads to a steel-rail-supported, wood-plank bridge. This entrance enabled loads of hay to be directly driven into the loft, saving the labor of hoisting from below. The bridge also provided a lower pass-through, or could serve as an open shelter for farm vehicles and/or animals. A protective barrier of wooden fencing is missing today from either side of the ramp and bridge, as is a wooden gate at the end of the ramp. Both the fencing and gate are documented in photographs dated 1963 and 1972 (figs. 9, 10, & 13).

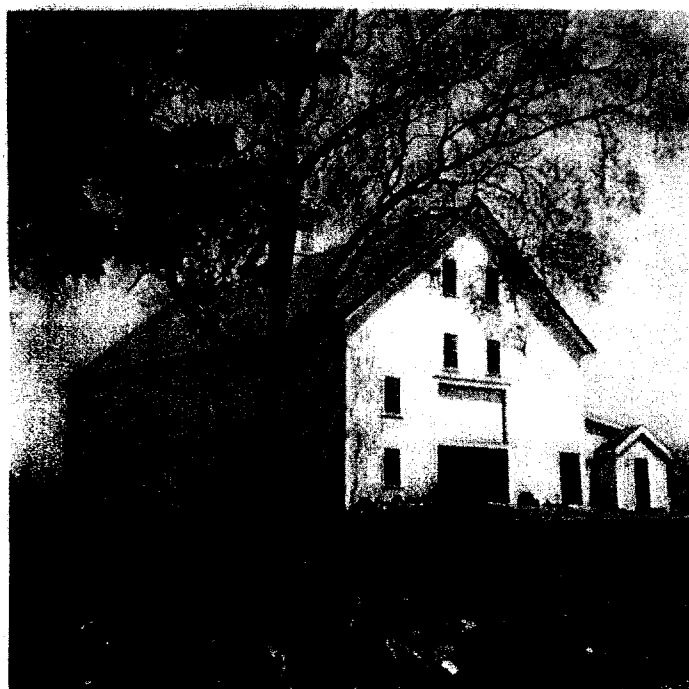
Figure 12. Front and west elevations of the Nowalk barn, May 1972.

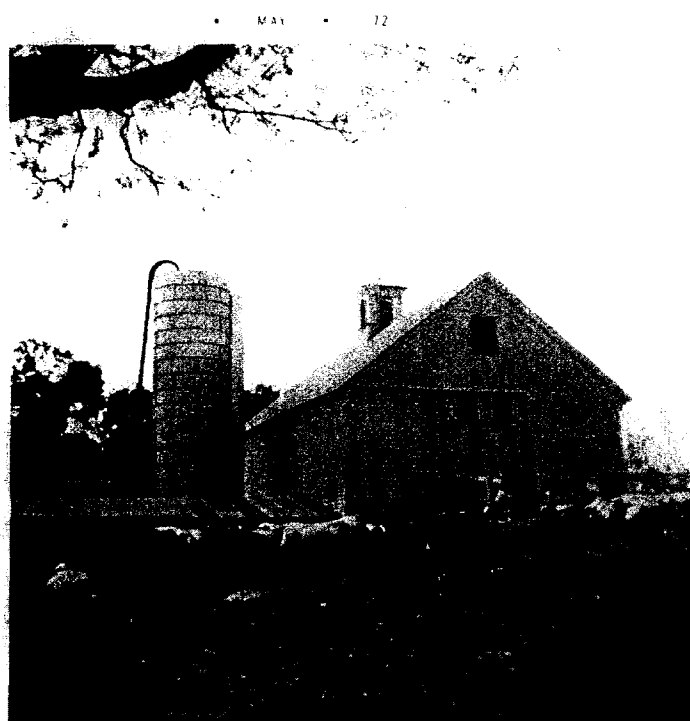
Figure 13. Rear and east elevations of the Nowalk barn and silo, May 1972.
