# Coastal Hazards & Sea-Level Rise Asset Vulnerability Assessment for Point Reyes National Seashore

## *Summary of Results*

NPS 612/199461, April 2026

## Executive Summary

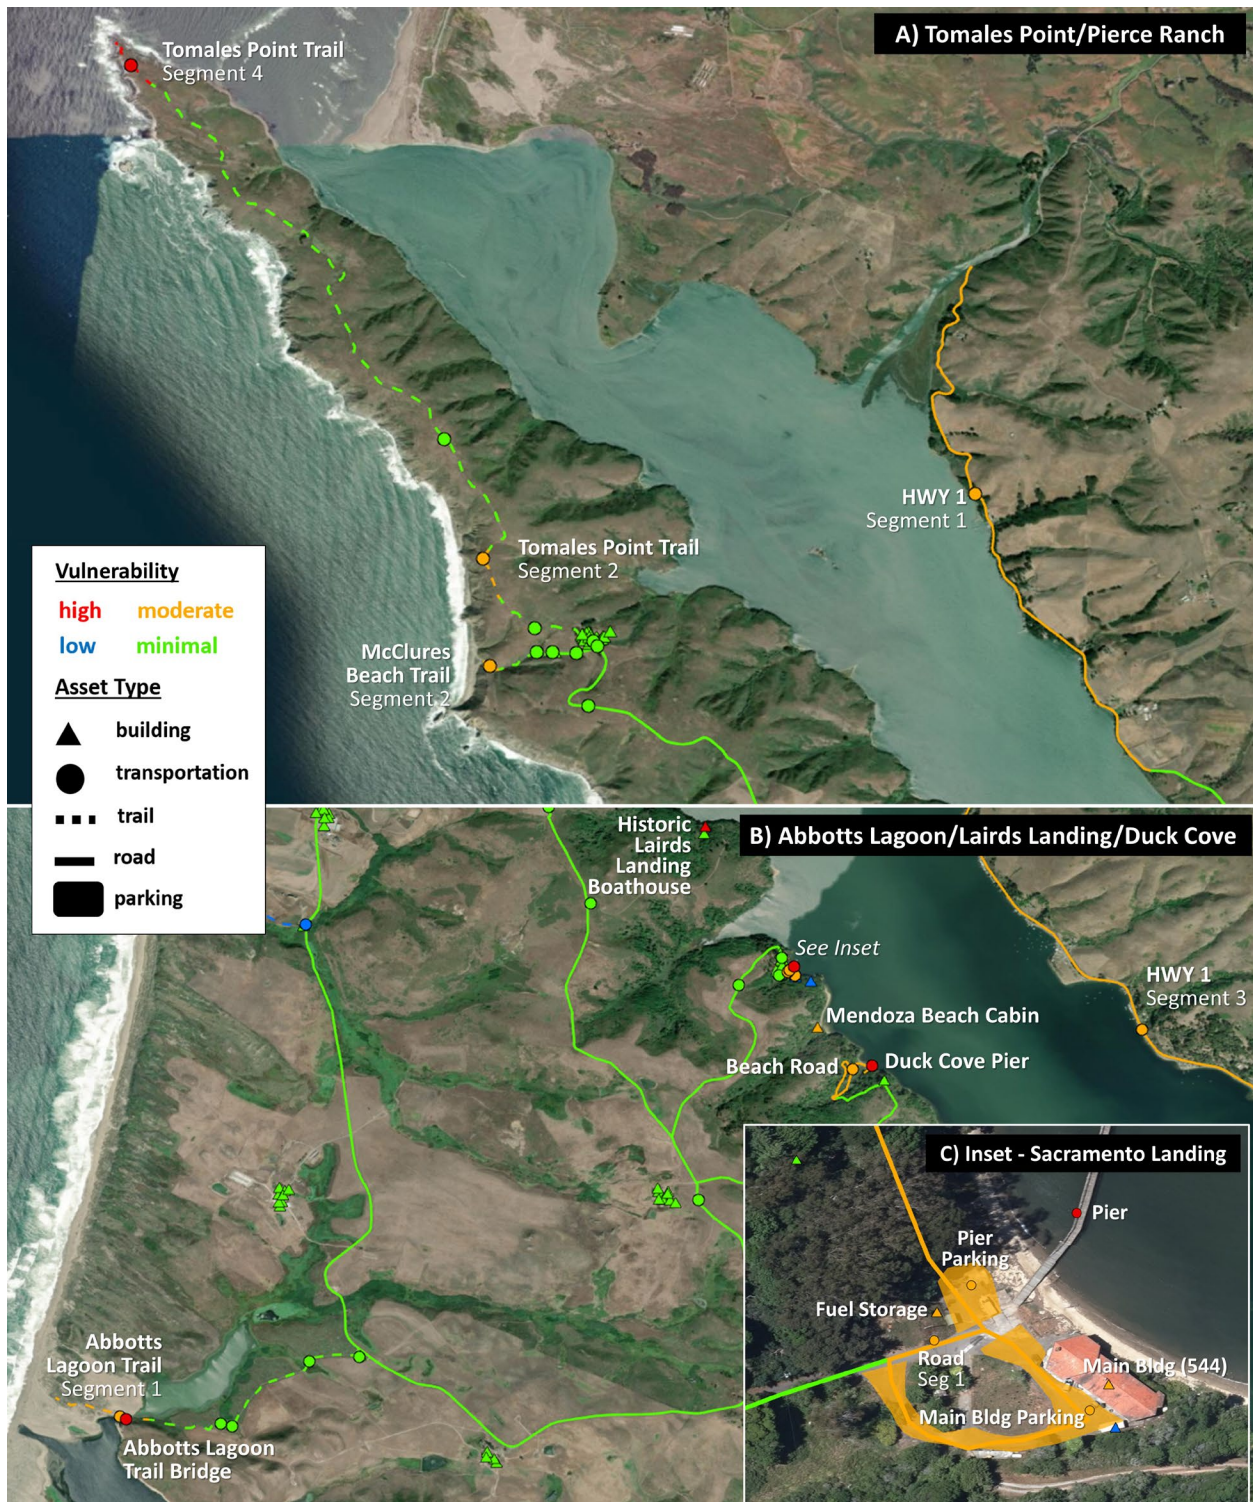
**Figure 7.** PORE vulnerability results summary for the A) Tamales Point/Pierce Ranch, B) Abbotts Lagoon/Lairds Landing/Duck Cove, and C) Inset – Sacramento Landing areas. Only high and moderate vulnerability assets are labeled. Background is 2023 ESRI world imagery.

Twenty-four assets (4%) analyzed at PORE have high vulnerability to the evaluated coastal hazards (Table 4, and Figures 7-11). Nine assets have both high exposure and high sensitivity: Mendoza Fish Dock, Mendoza Fish Dock Shed, Schooner Bay Kayak Launch Vault Toilet, Schooner Bay Parking Lot, Estero Trail Bridge (near Home Bay), Sculptured Beach Trail – Segment 1 (west near stairs), Peter Behr Overlook – Segment 1 (near parking), Duck Cove Pier, and Sacramento Landing Pier. Fifty-three (8%) assets have moderate vulnerability, 35 (5%) have low vulnerability, and 573 (84%) assets have minimal vulnerability. The significant number of minimal vulnerability assets is a factor of the high elevations in many areas of the park.
