Mission San Jose Y San Miguel De Aguayo, Church  
6539 San Jose Road  
San Antonio  
Bexar County  
Texas

HABS No. TX-333-A

MISSION SAN JOSE Y SAN MIGUEL  
DE AGUAYO, CHURCH

Location: 6539 San Jose Road, San Antonio, Bexar County, Texas.  
Present Owner: Roman Catholic Archdiocese of San Antonio.  
Present Use: Public museum.  
Significance: The church is a typical component of a Spanish mission complex built during the period of Texas frontier.

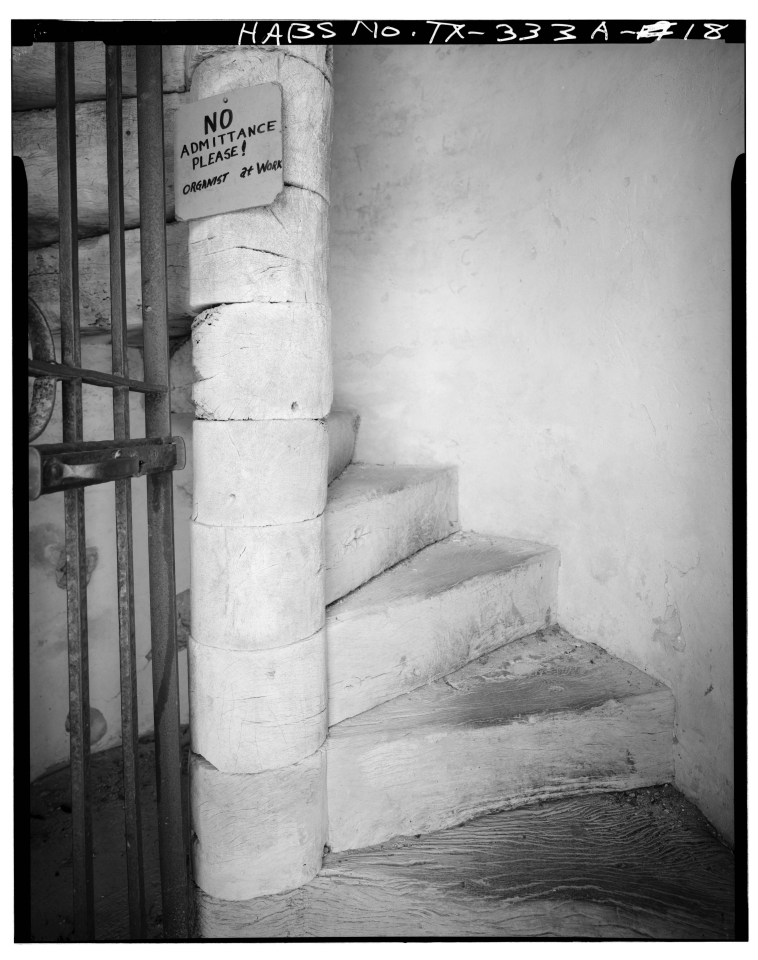
A black and white photograph showing a narrow staircase. On the left, a metal gate with vertical bars is partially open, revealing a wooden door handle. A sign is attached to the gate. The staircase is made of wide, light-colored wooden steps. The wall on the right is light-colored and textured. The floor at the bottom of the stairs is made of dark wood.
