# GENERAL PHILIP SCHUYLER HOUSE

Saratoga National Historical Park  
Schuylerville, New York

Historic Structure Report  
Volume I

**GENERAL PHILIP SCHUYLER HOUSE**  
**HISTORIC STRUCTURE REPORT**

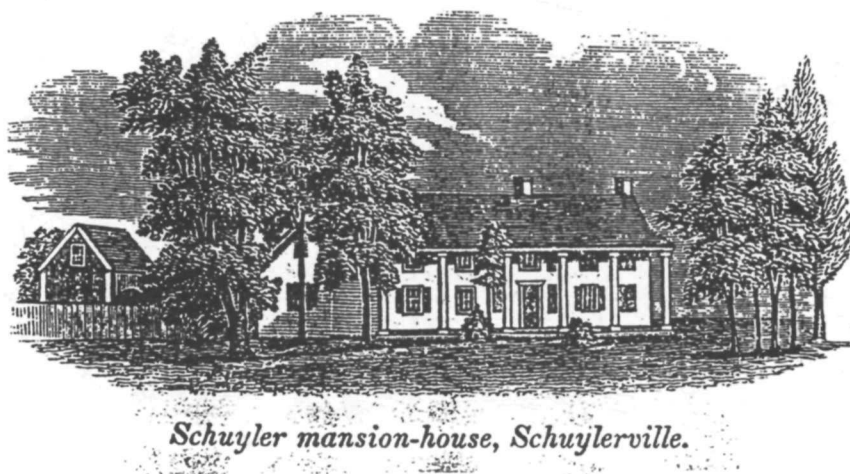
**Figure 4.** Schuyler House: Wood-block engraving of west facade (1841).  
(Note the two-story piazza, center chimney, and kitchen wing with window.)

The vent pipe from the stove in the second-story hall traveled up through the roof to a brick chimney (see fig. 4).

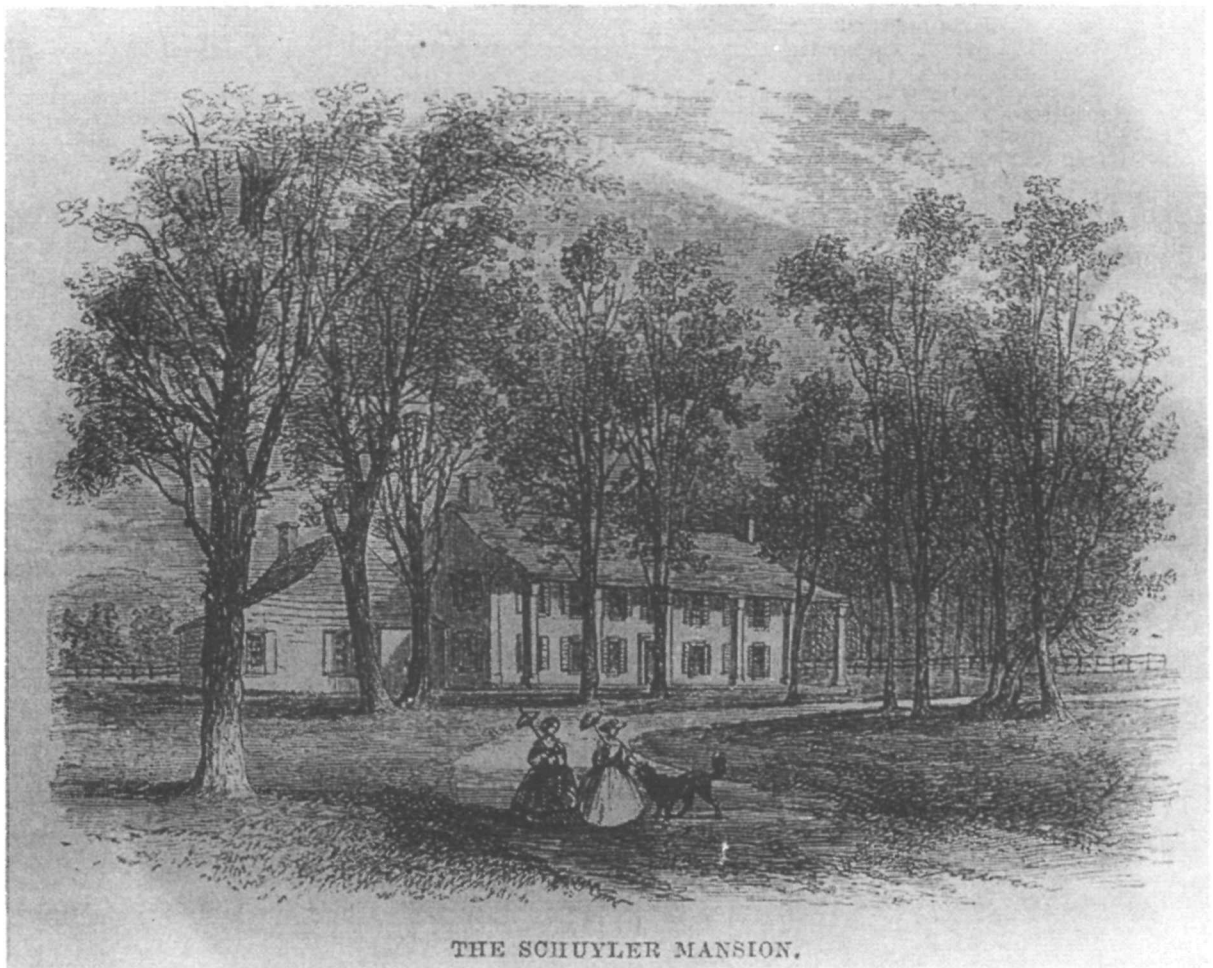
**Figure 5.** Schuyler House: Sketch of west facade (1850).  
(Note the pantry addition and enclosed north kitchen porch.)

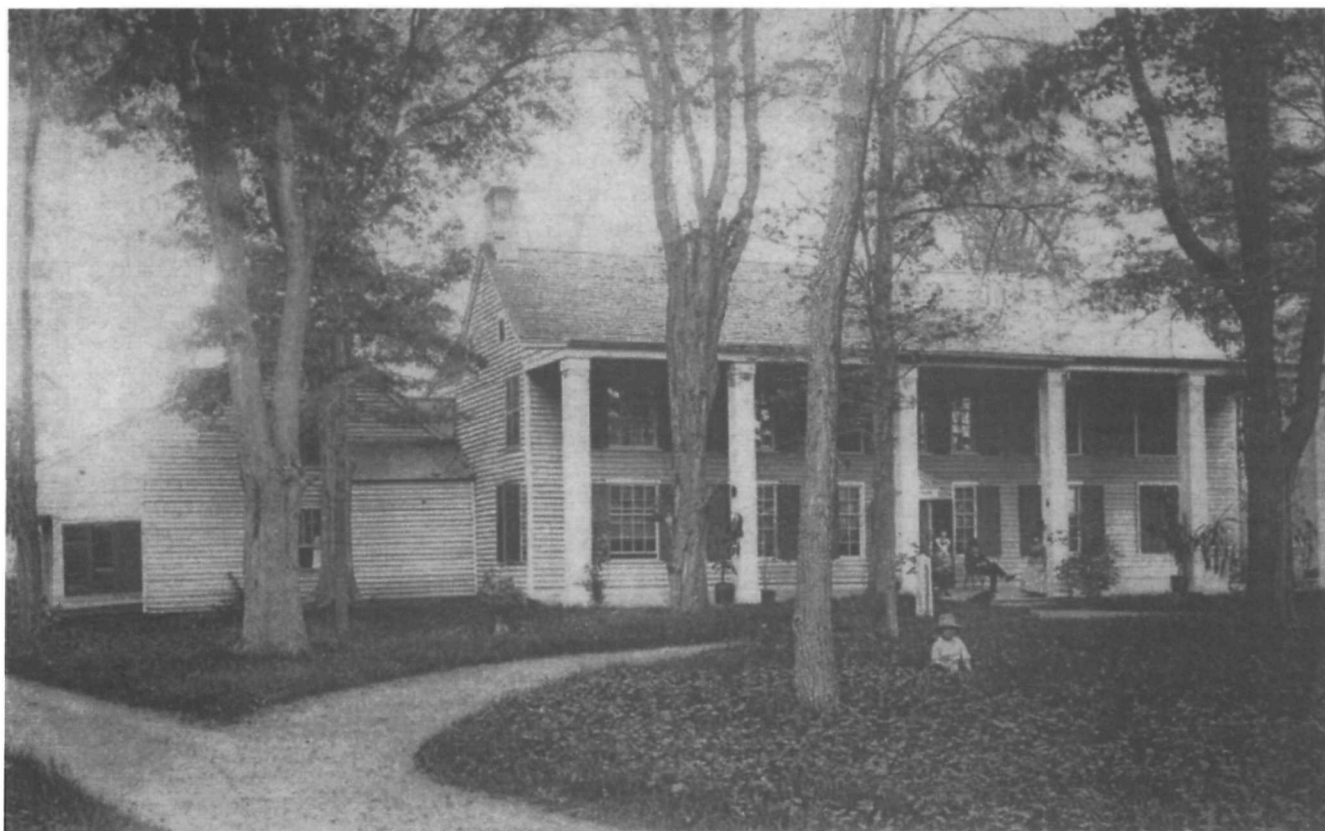
**Figure 6.** Schuyler House: Photograph of west facade (1897). The pantry addition is easily visible.  
Note also the louvered blinds on end wall of north kitchen porch.

In the kitchen wing, the fireplace was altered again and a “boiling station” was installed after 1815 (fig. 31).<sup>72</sup> The original wide-board flooring was covered with late 19<sup>th</sup>-century narrow-board flooring, and a closet was installed in the southeast corner of the room (fig 32).<sup>73</sup> The kitchen's north porch was opened on its north side, and louvers were installed at its east and west ends (figs. 6, 11, and 24).

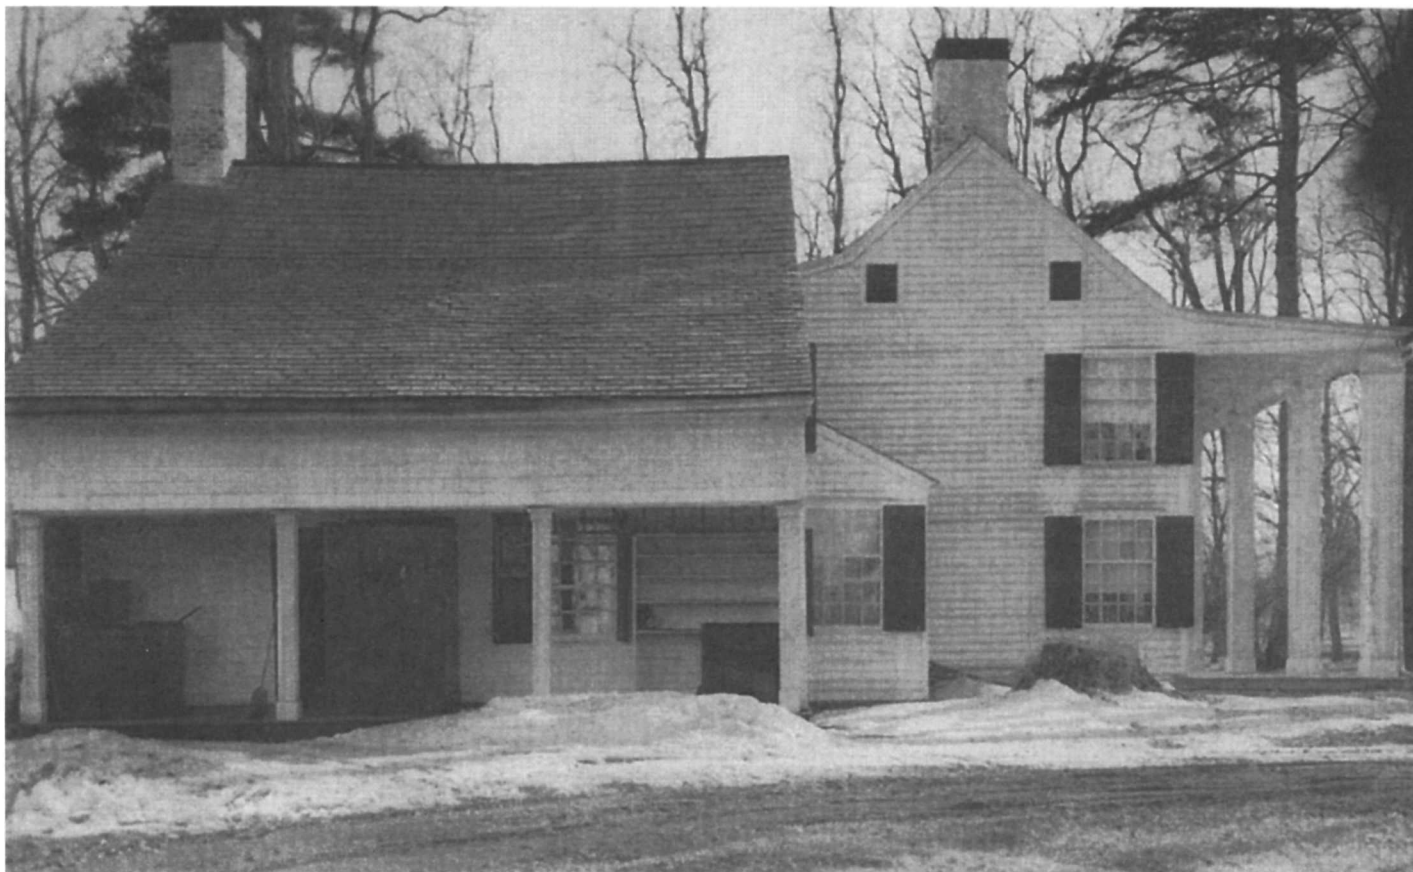
**Figure 11.** Schuyler House: North elevation (1947).

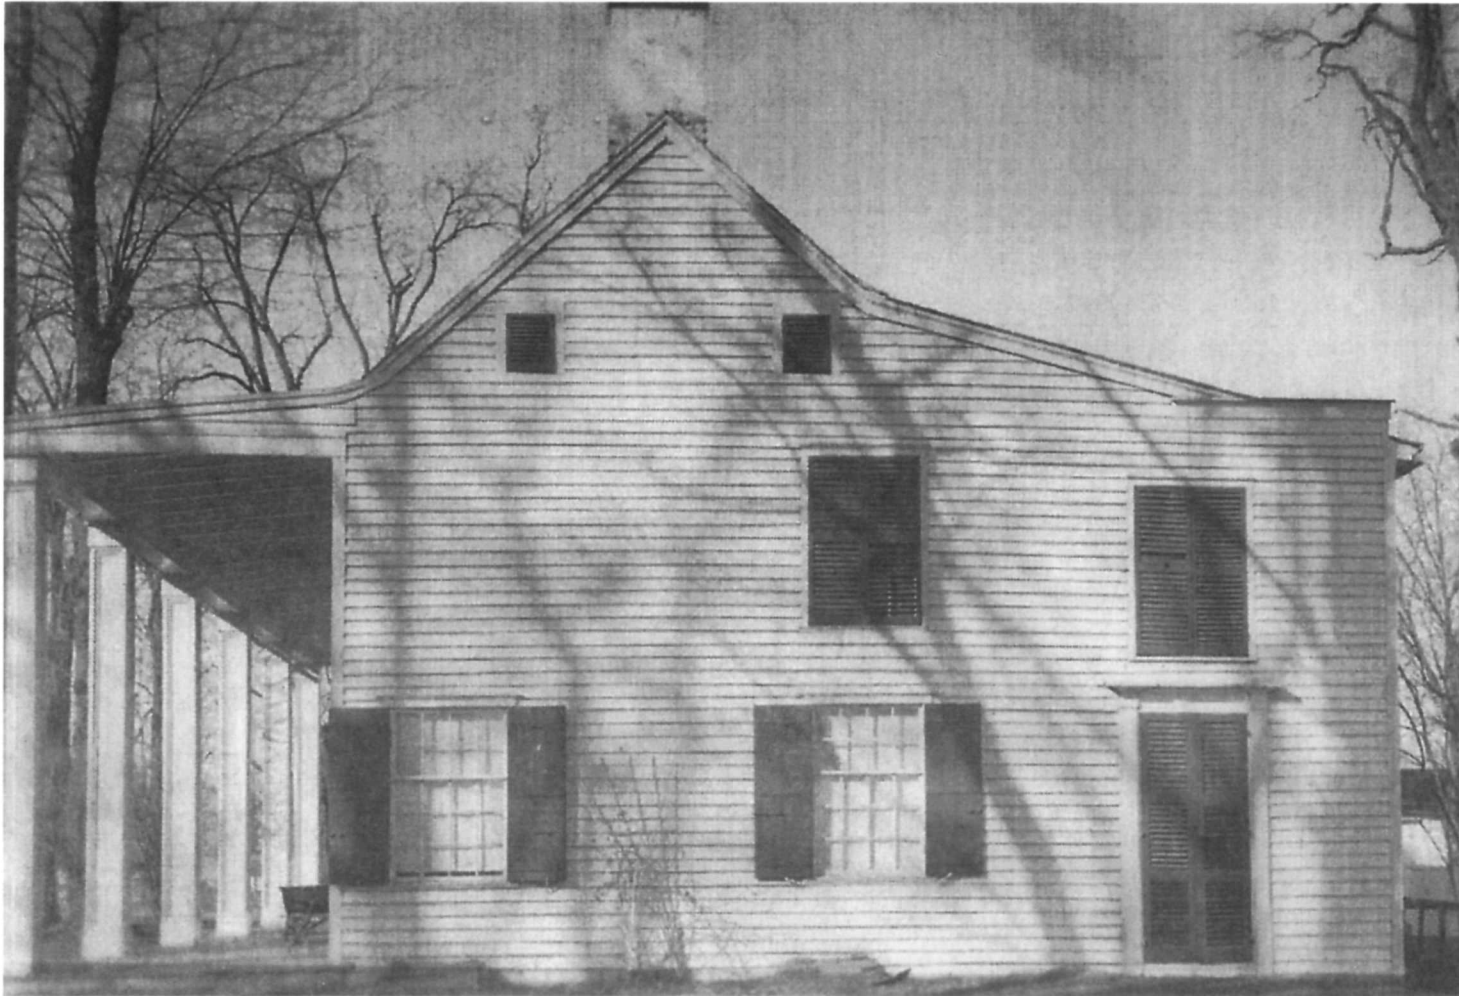
**Figure 12.** Schuyler House: South elevation (1947).

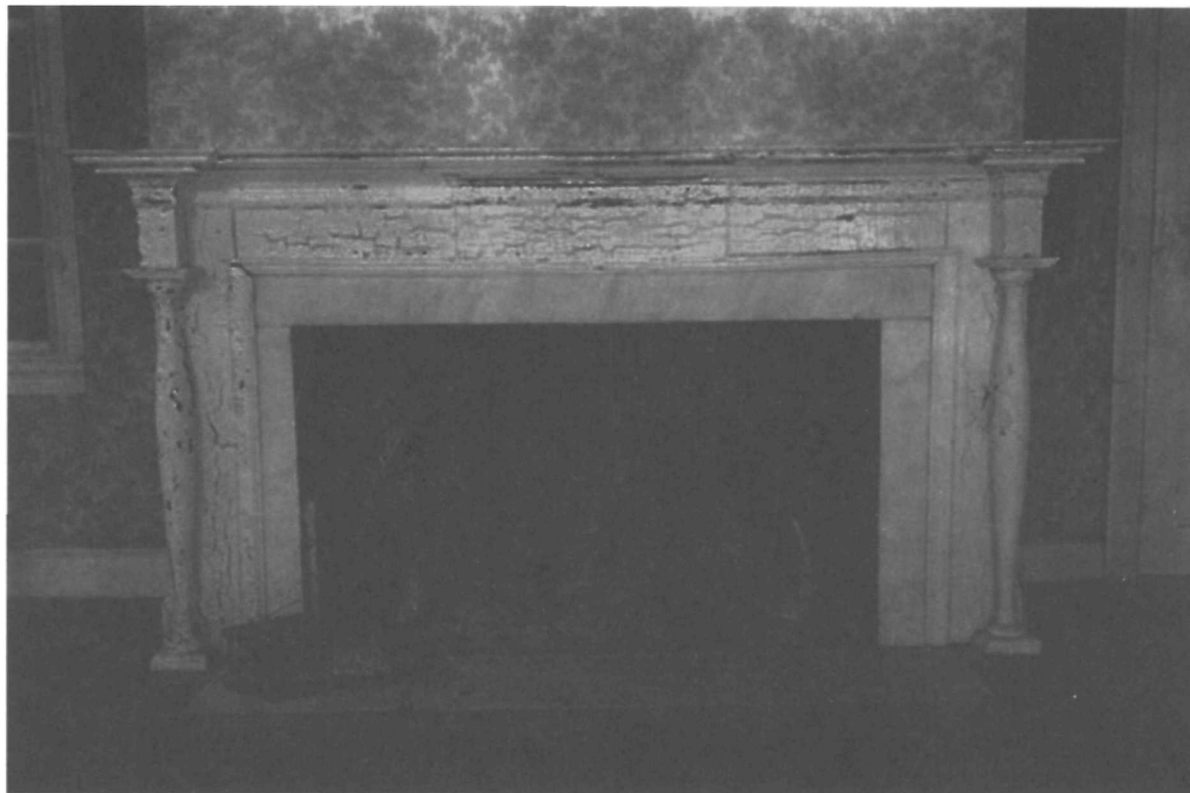
**Figure 26.** Schuyler House: Dining room (Room 103), north wall and mantelpiece (ca.1955).

The extant dining-room mantelpiece was probably installed during the ca.-1815 remodeling (fig. 26). The restoration team noted that “the saw marks in the lumber, the type of nails and the method of assembly suggest that this mantel was first fabricated between 1795 and 1815.”<sup>66</sup> According to the accepted research of the 1950s, the type of nail that dated to 1795-1815 would have been a hand-headed cut nail. The current accepted chronology of the manufacture of cut nails concurs.

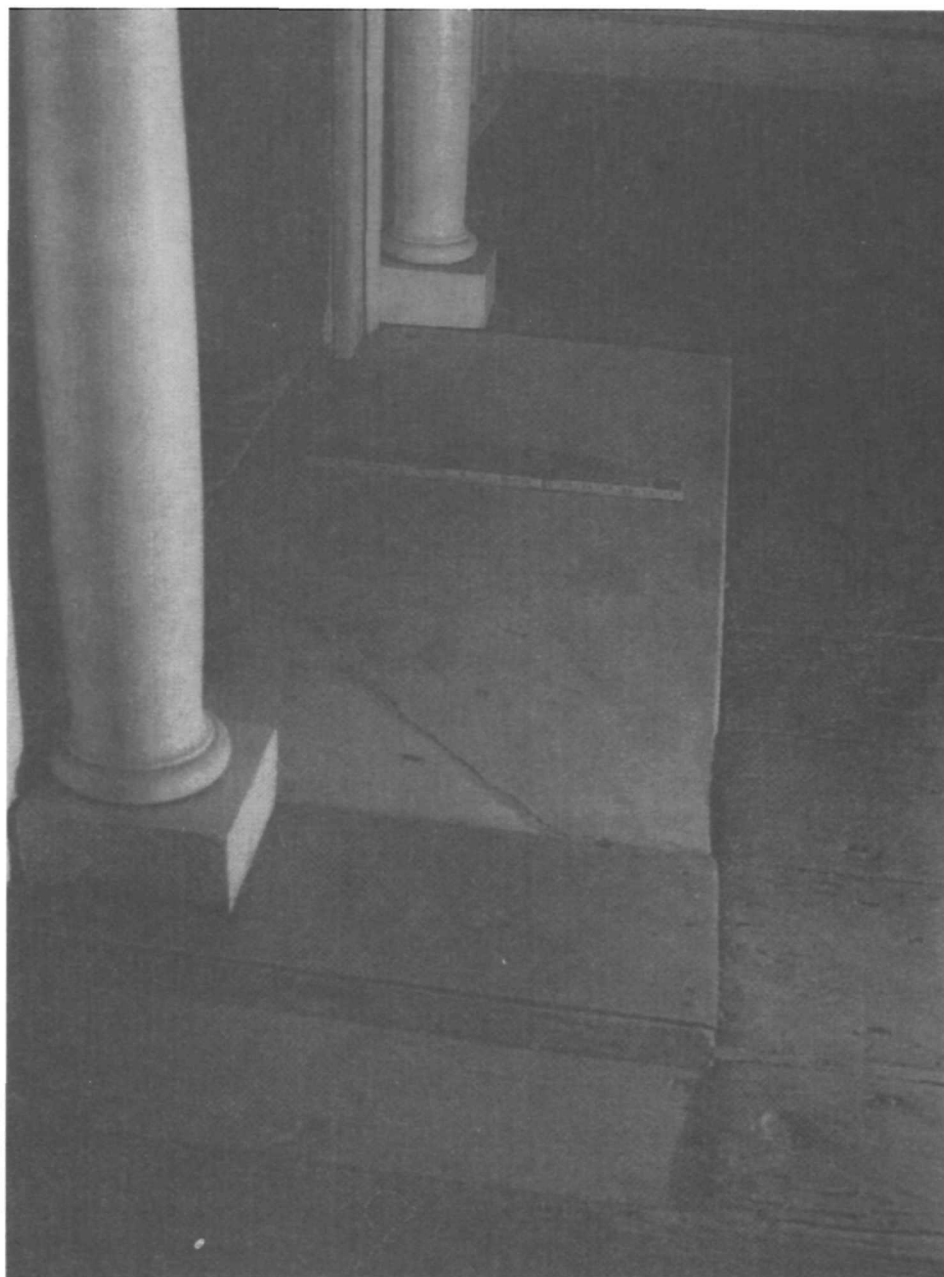
**Figure 27.** Schuyler House: Dining room (Room 103), fireplace hearth (ca. 1955).

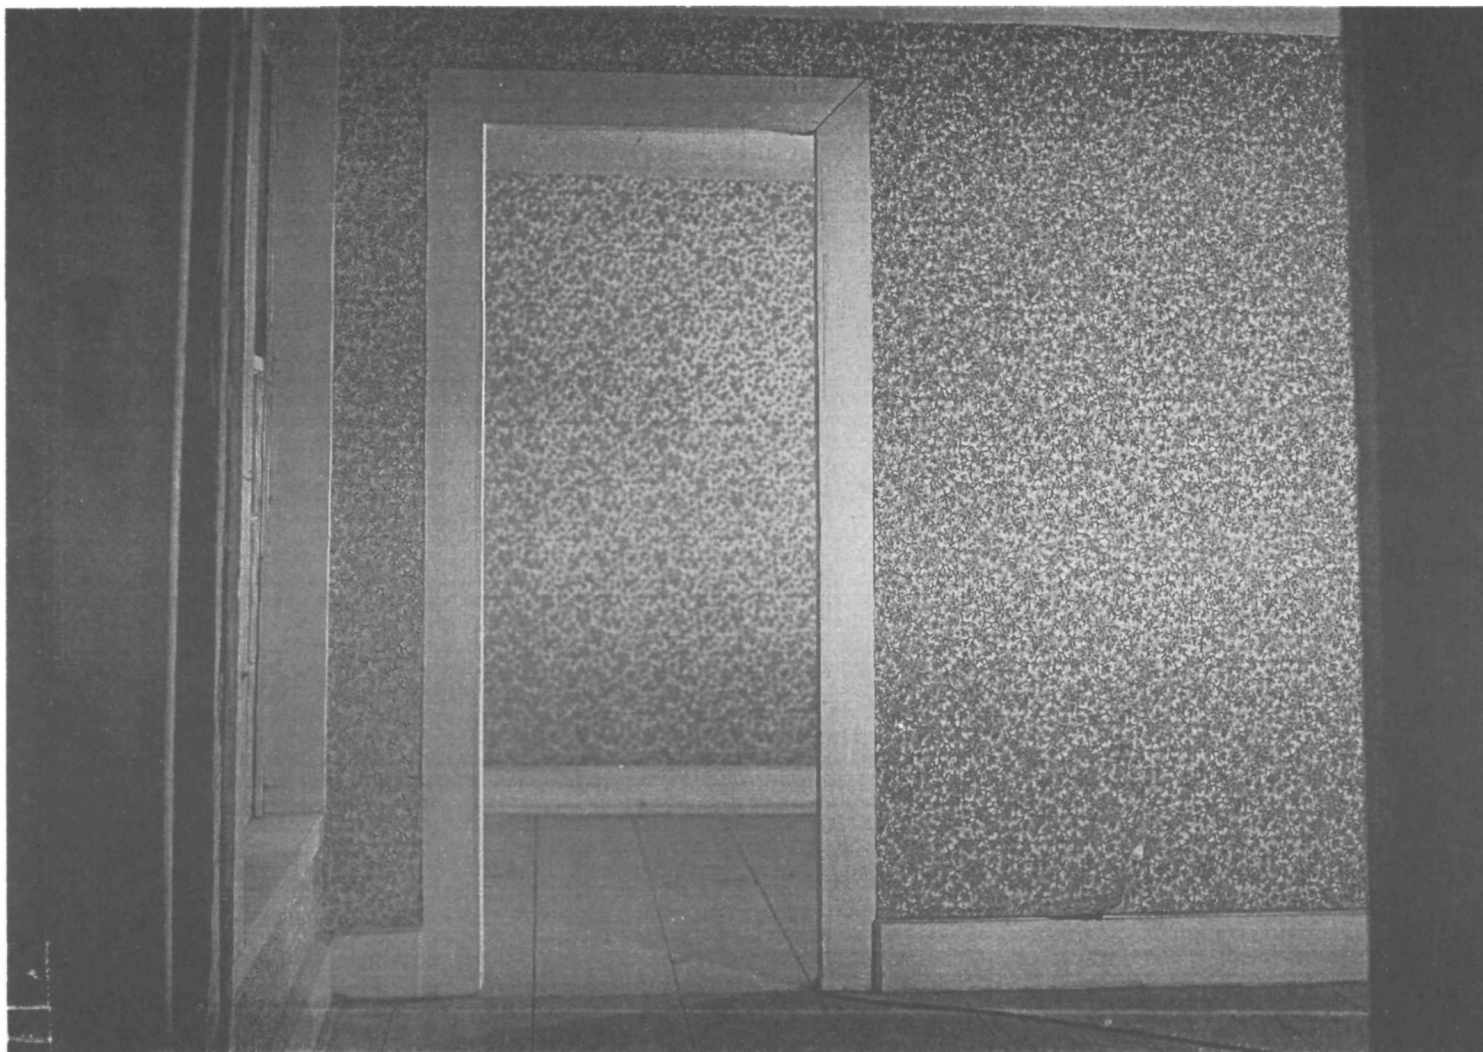
**Figure 29.** Schuyler House: View from south chamber (Room 202) through former doorway to hall chamber (Room 203) and storeroom (Room 204) beyond, ca. 1955.

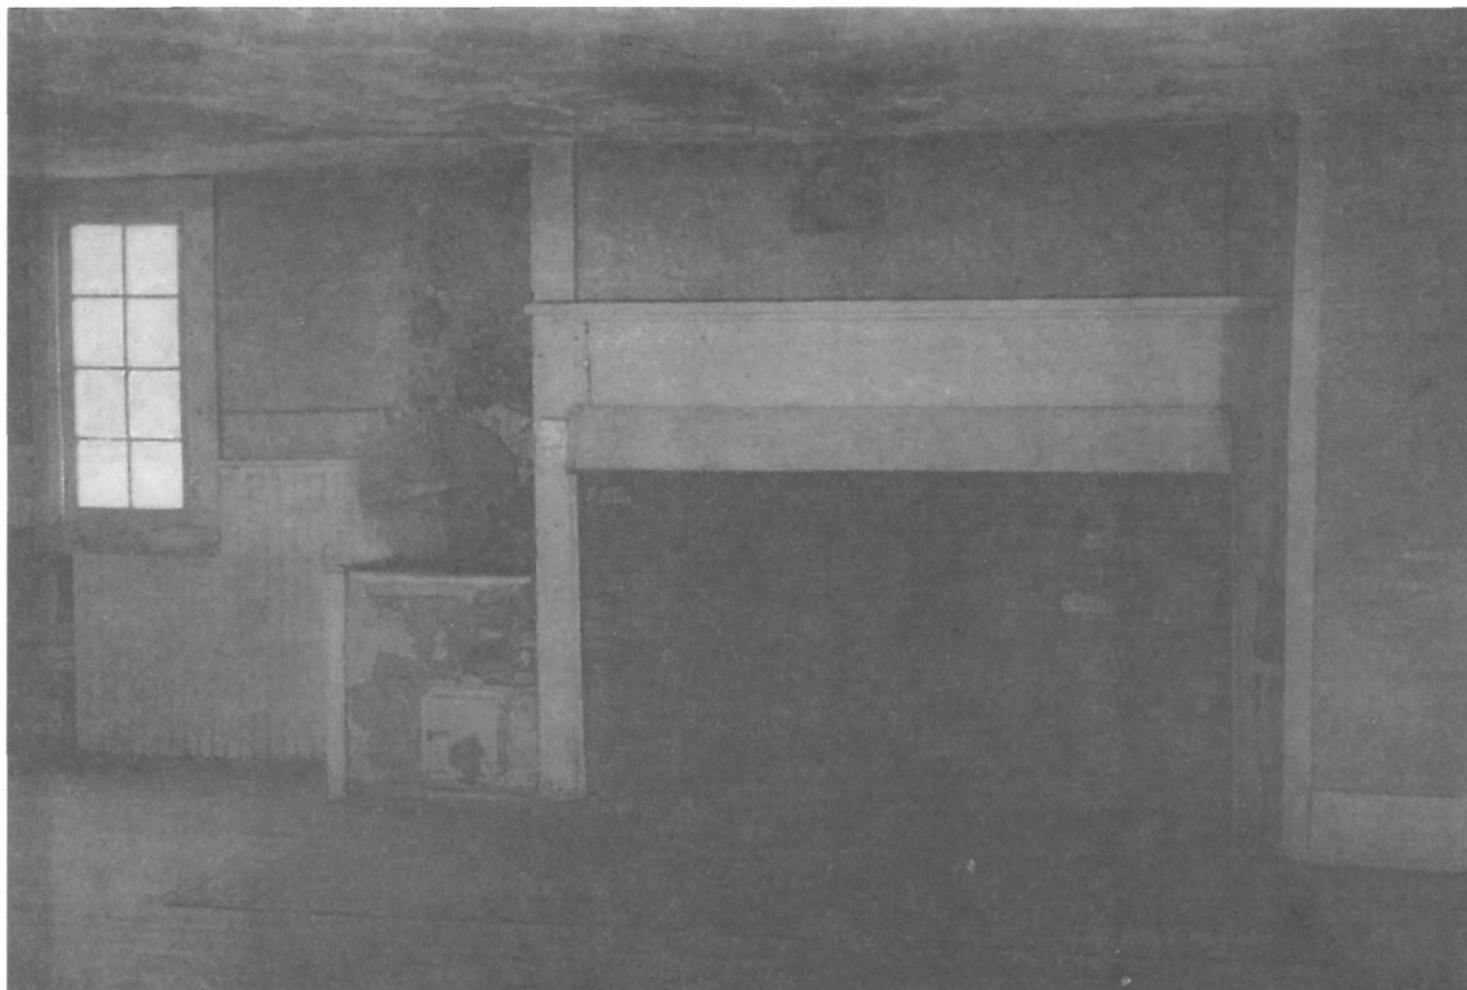
**Figure 31.** Schuyler House: Kitchen wing, east wall of kitchen (Room 105) before restoration (ca. 1955).

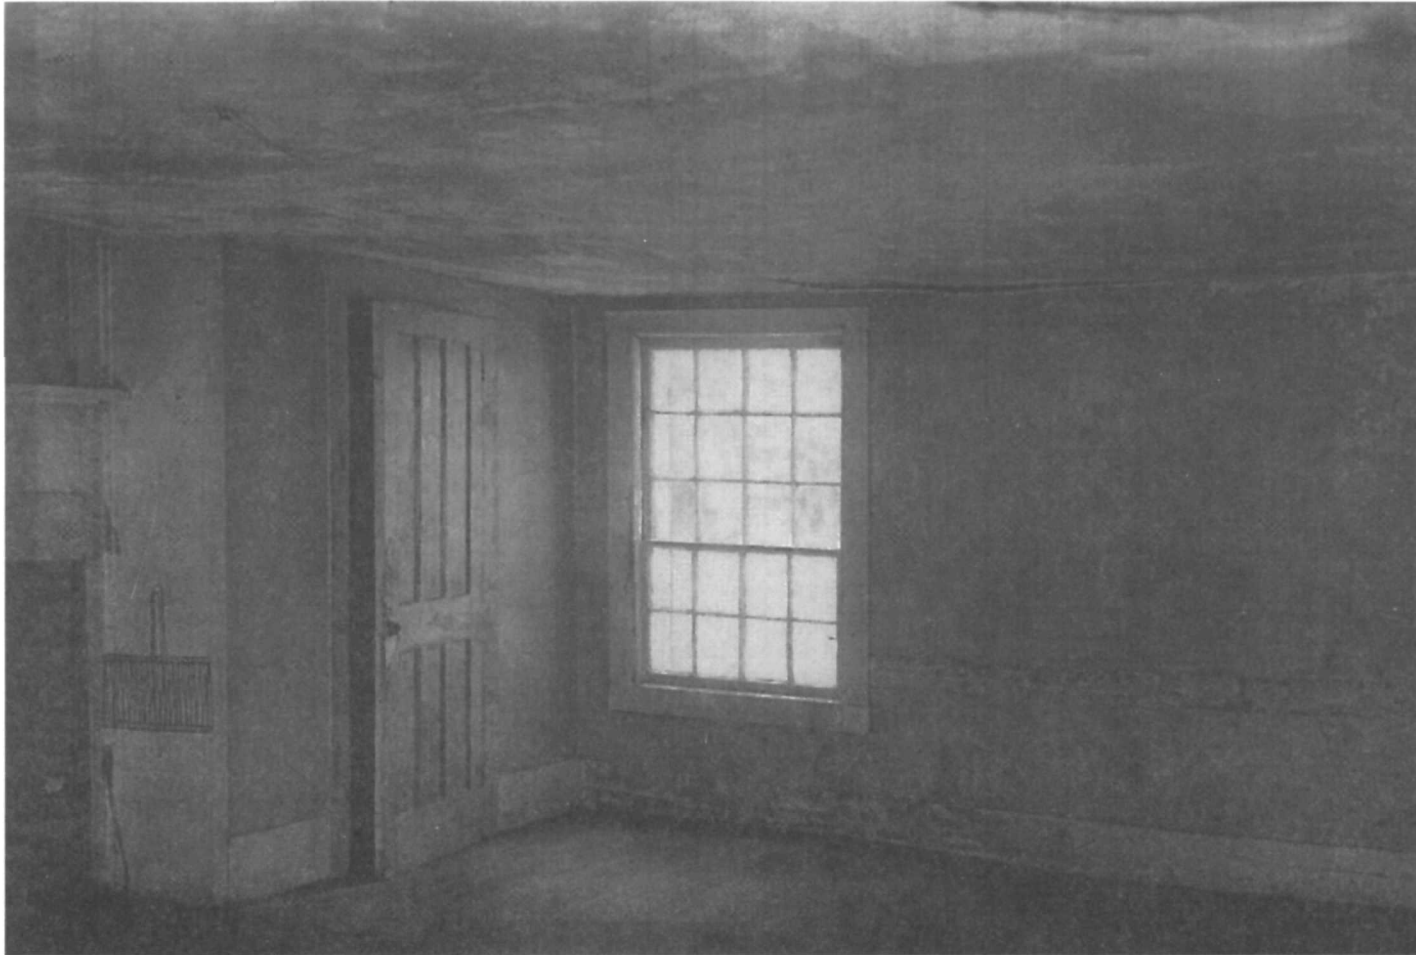
**Figure 32.** Schuyler House: Kitchen wing, southeast corner of kitchen (Room 105) before restoration (ca. 1955).

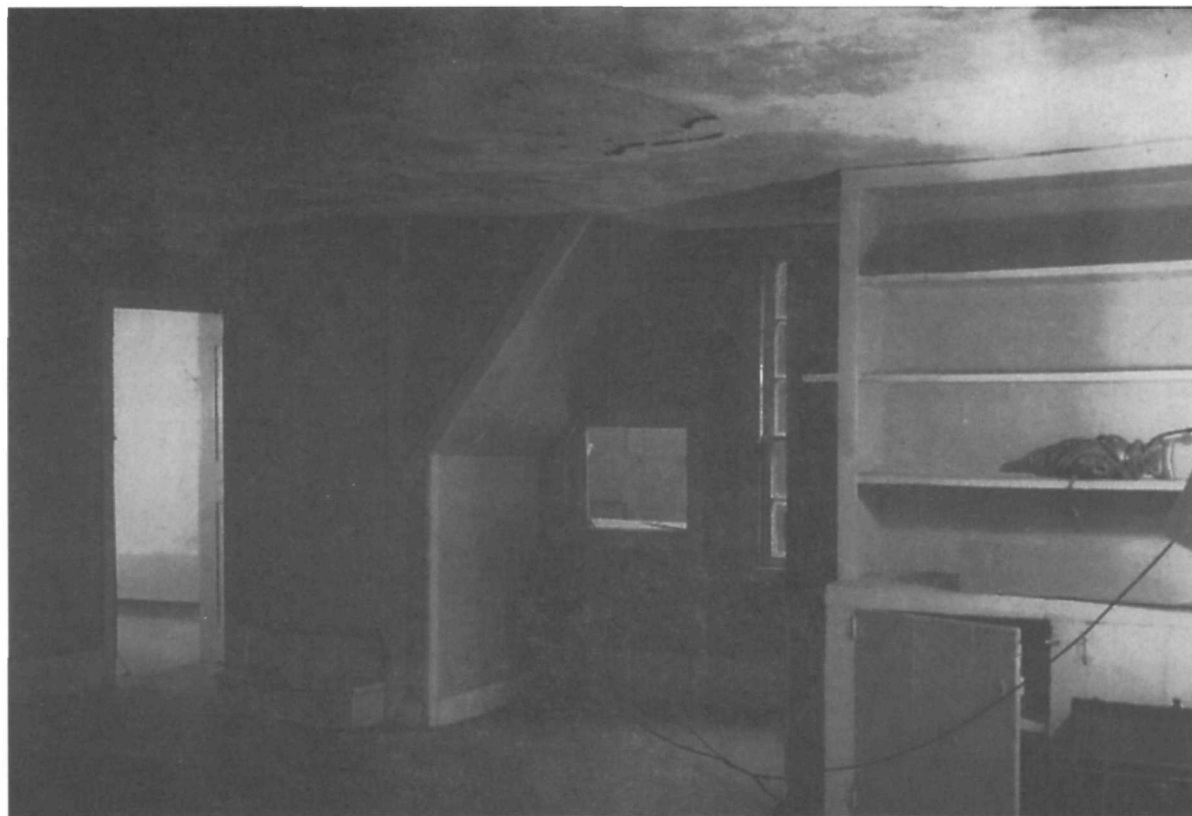
**Figure 33.** Schuyler House: Kitchen wing, southwest corner of kitchen (Room 105) before restoration (ca. 1955).

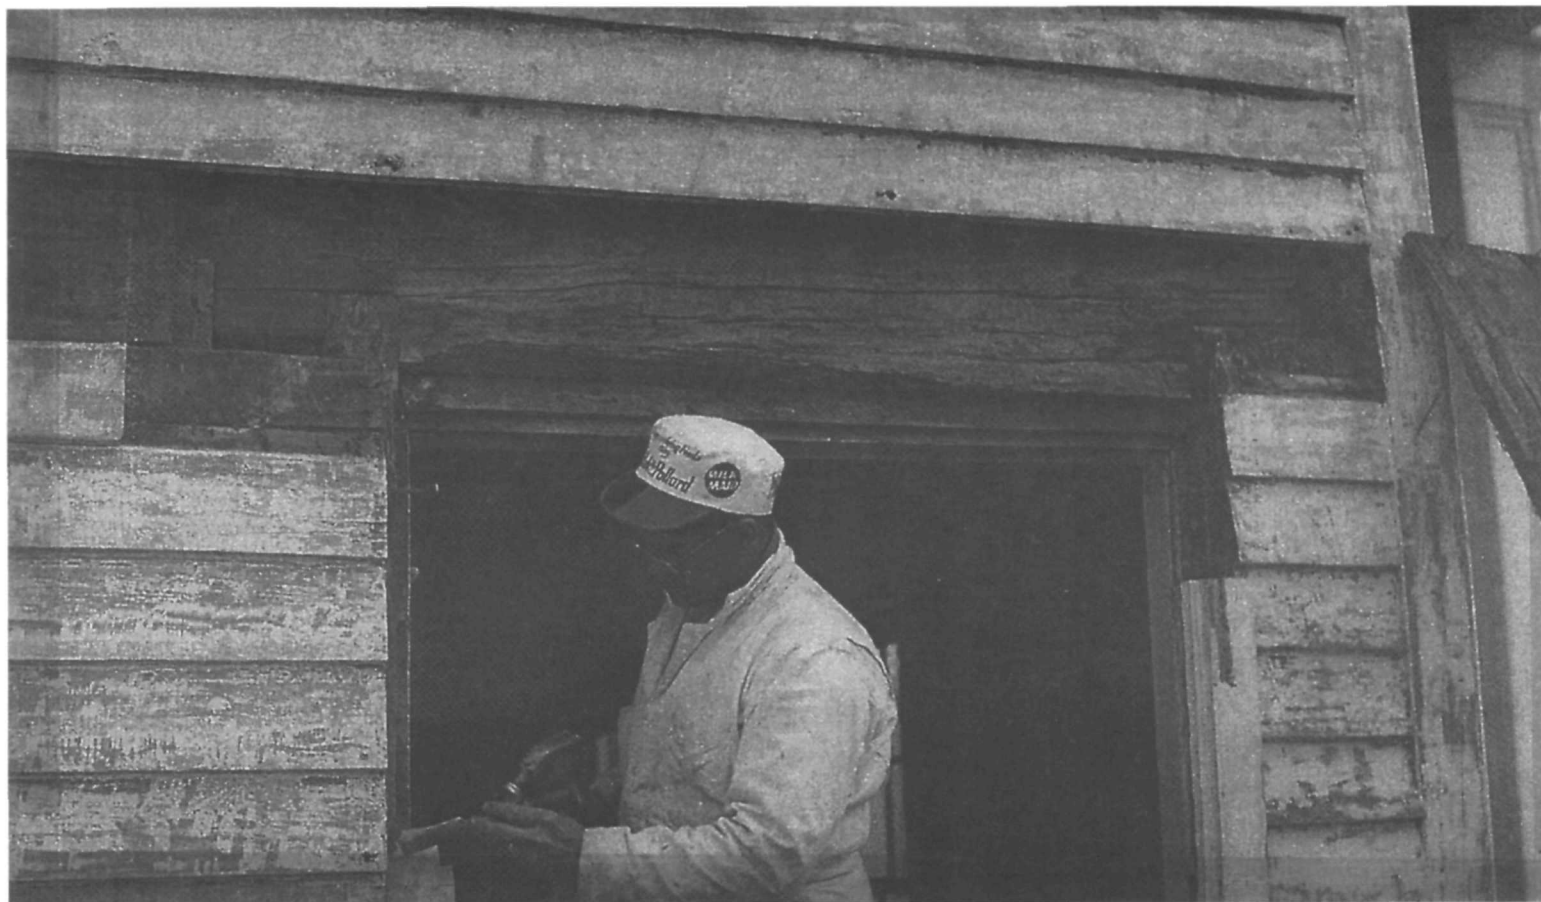
**Figure 38.** Schuyler House: Northwest corner, window W112 repairs (ca. 1955).

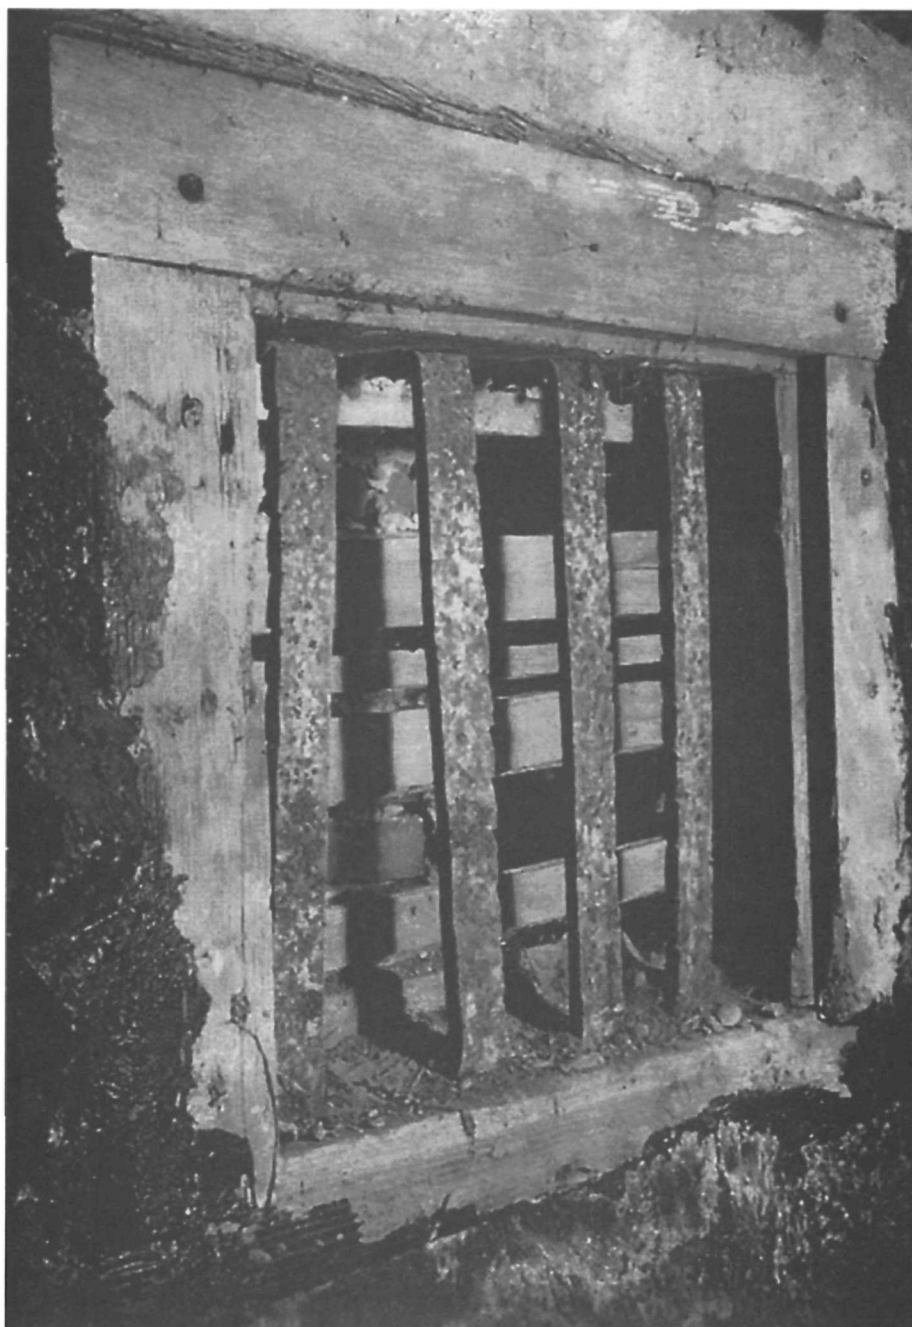
**Figure 40.** Schuyler House: West façade, opening O001 with original whitewashed areaway (1958).

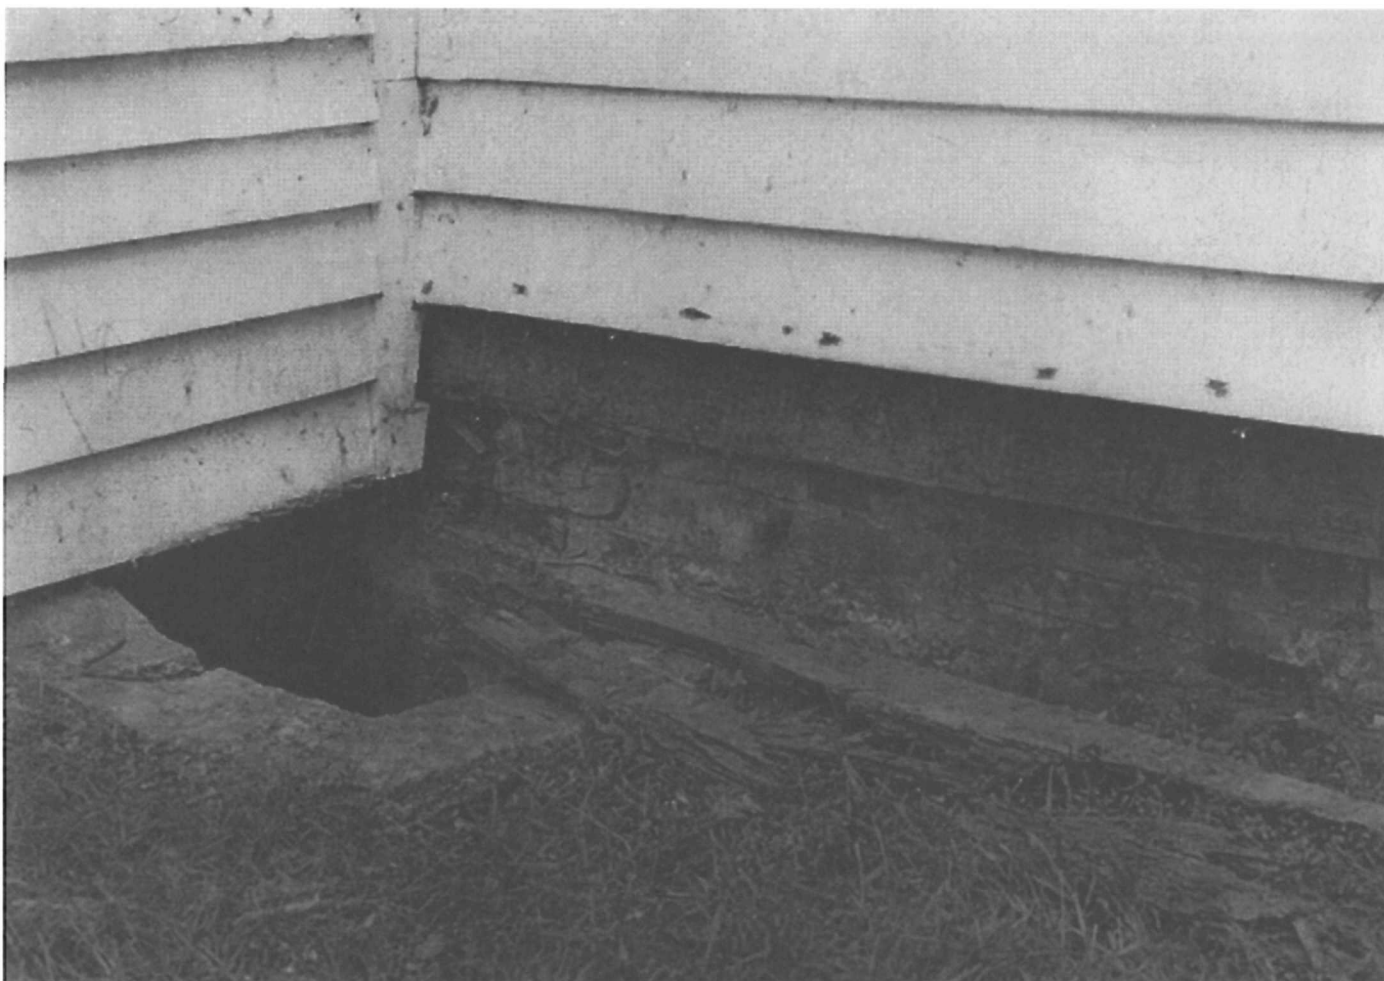
**Figure 41.** Schuyler House: West façade, cellar window W001 (1958).

There were three windows in the cellar, all located along the west foundation wall, that dated to 1777 or earlier. (See the preceding section “Structural Features, Foundation.”) One window (W001) opened into the storage room at the north end of the cellar, and a second window (W002) opened into the kitchen at the south end. A third opening was located in the west wall of the center cellar room (the food storage room), but it is not known if it was used after 1777, since it was just to the north of the front entrance located above it. Both the north and south windows had been filled with bricks on the interior, but when the piazza floor on the exterior was removed, the restoration team found the following: an original frame and four vertical iron bars in place of the original sash in the north window (fig. 41), and the original fieldstone areaway, frame, and part of the sash in the south window. The center opening had been filled circa 1815 with stone masonry, which was not removed by the restoration team.

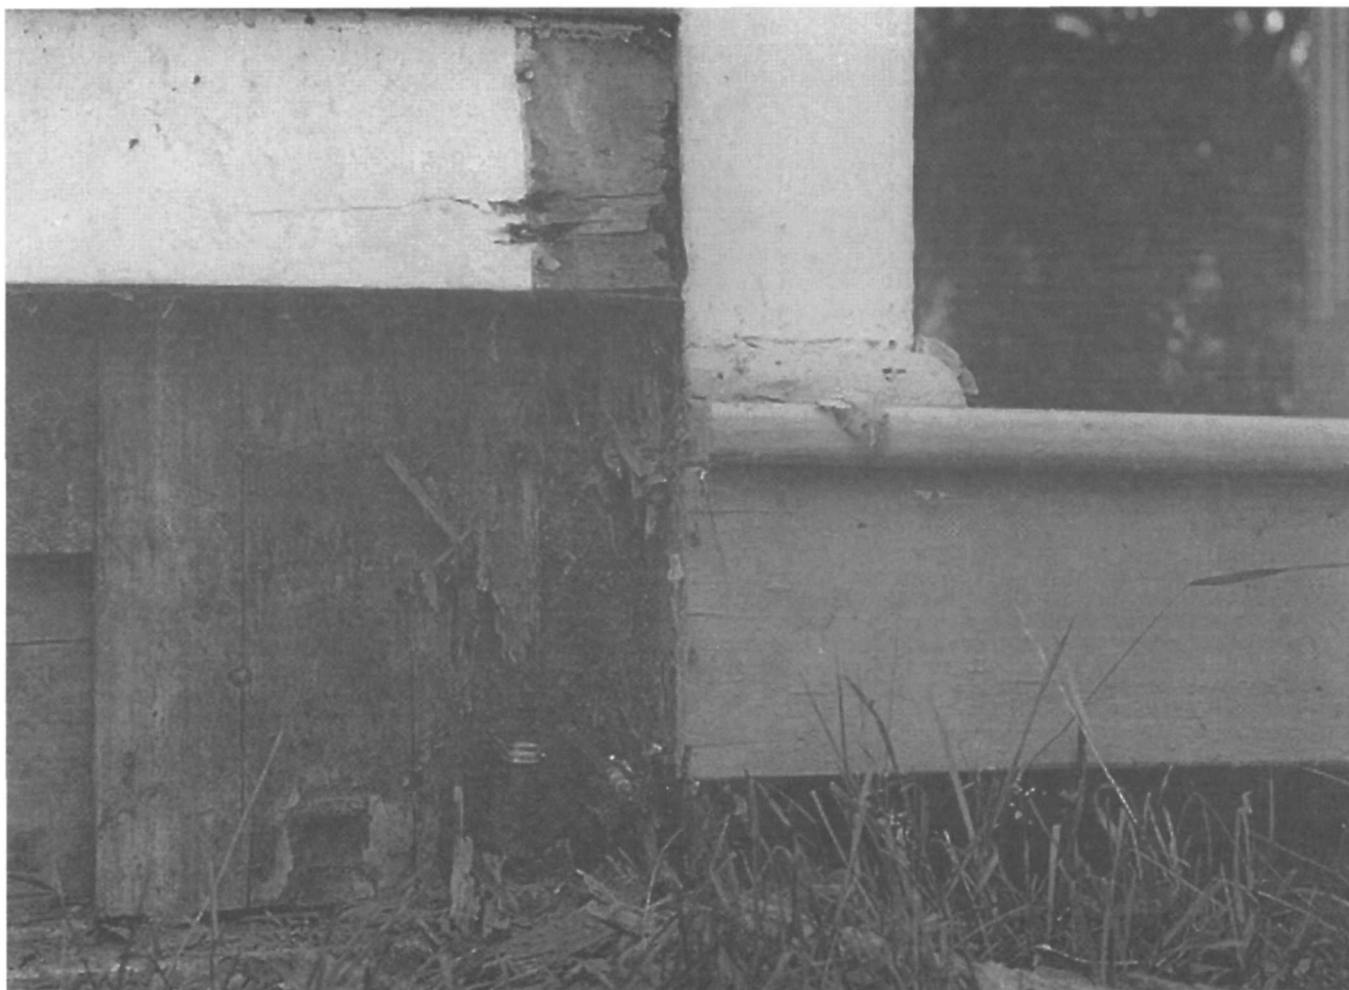
**Figure 42.** Schuyler House: North elevation, 1777 chimney base, pre-1815 areaway, and bottom of ca.-1815 pantry addition (1958).

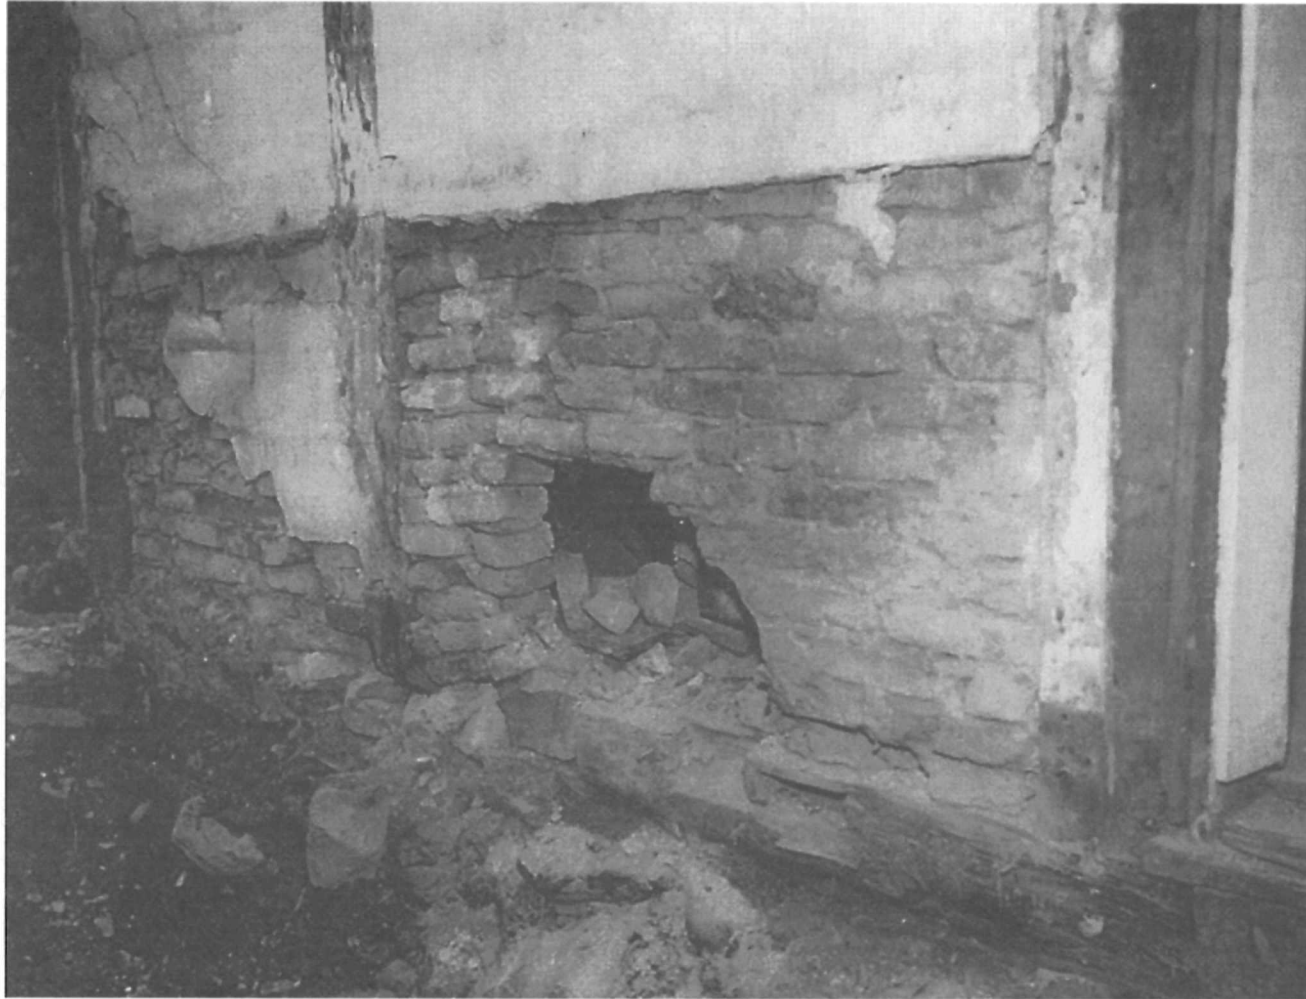
**Figure 46.** Schuyler House: Kitchen wing, southeast corner, exposed ends of original weatherboards at left (ca. 1958).

The restoration team found that the exterior walls of the kitchen wing were filled with nogging and then covered on the exterior with thick weatherboarding attached directly to the frame. A few of the original weatherboards had survived on the north and east walls of the structure that were uncovered when later features were removed. The boards were 1 inch thick and 12 inches wide; they lacked the bead on the boards on the main house, but had their edges beveled to overlap the board below (fig. 46; see also Appendix E, sheet 4). Analysis of paint samples removed from surviving original weatherboards suggests that they were not originally painted (see Appendix L).

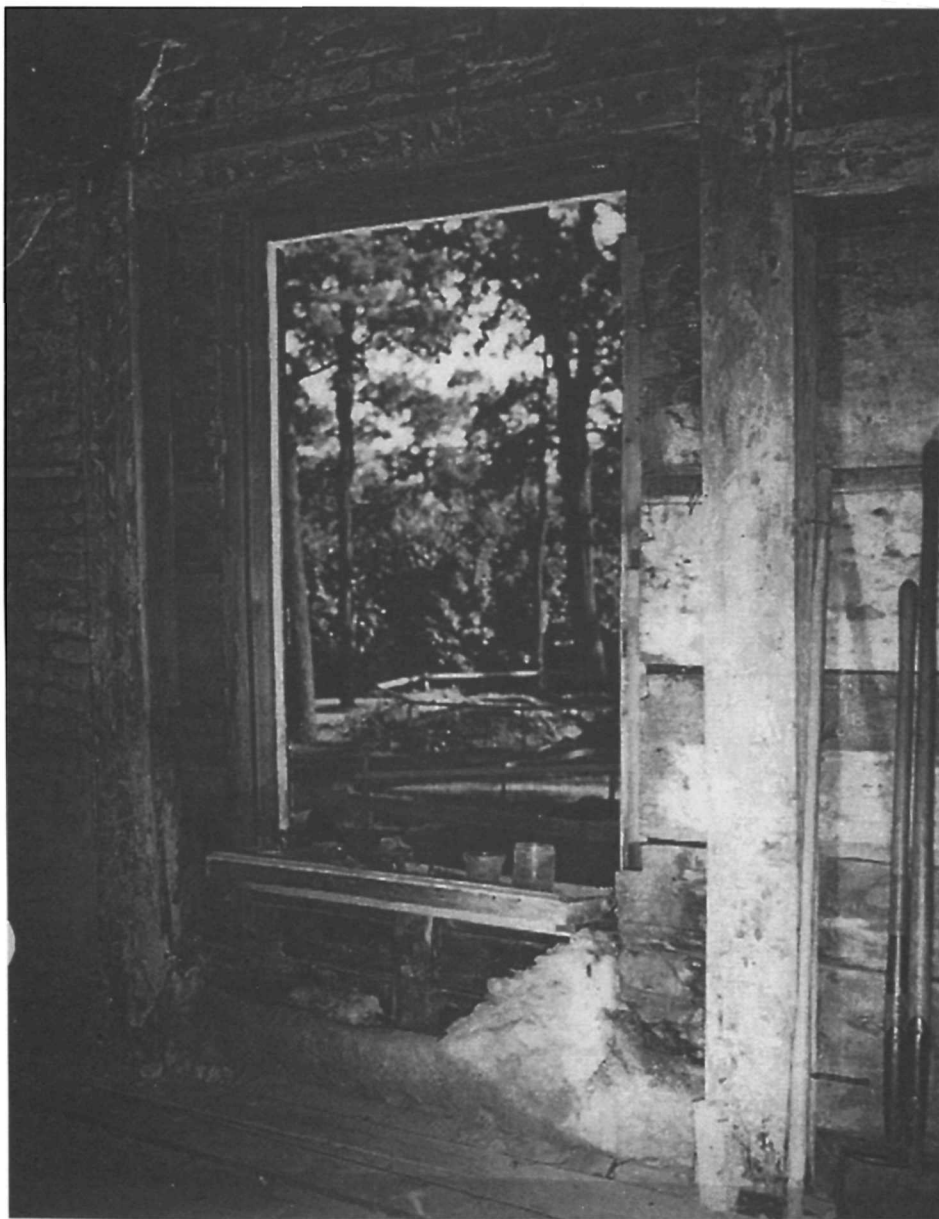
**Figure 52.** Schuyler House: First story of kitchen wing after ca.-1815 lath and plaster removed; framing for ca.-1780 doorway in south wall of kitchen (Room 105) blocked by later east-tier staircase (1958).
