# GENERAL PHILIP SCHUYLER HOUSE

Saratoga National Historical Park  
Schuylerville, New York

Historic Structure Report  
Volume I

**GENERAL PHILIP SCHUYLER HOUSE**  
**HISTORIC STRUCTURE REPORT**

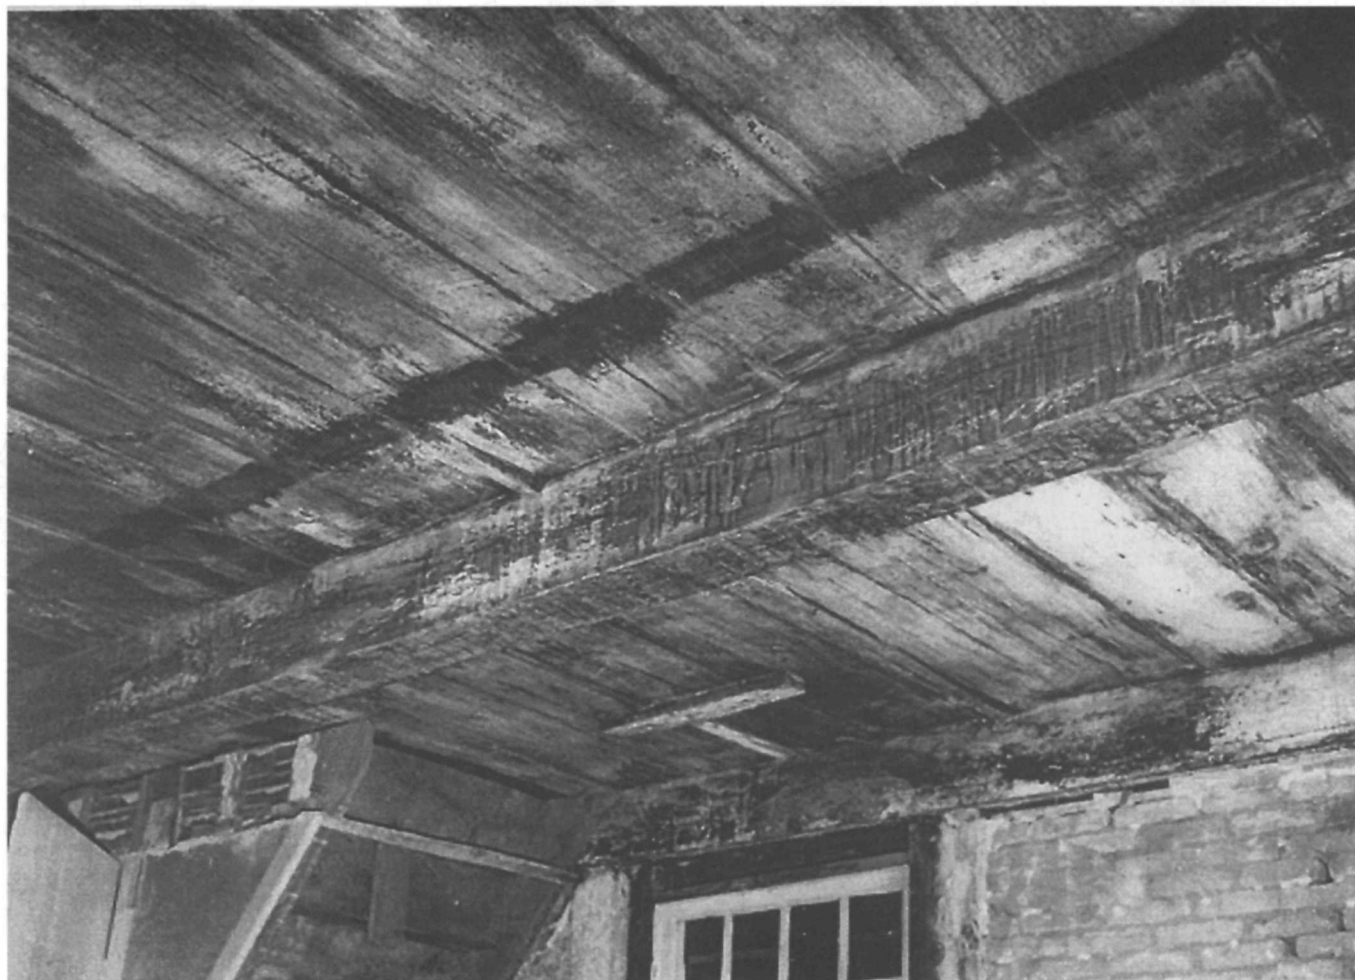
**Figure 53.** Schuyler House: First story of kitchen wing after ca.-1815 lath and plaster removed; evidence of original window in south wall of kitchen (Room 105) in ca.-1780 framing surrounding later window frame (1958).

There were two windows in the kitchen wing. A window with double casement sashes was located in the south wall of the kitchen in the same position as a later double-hung window (W110). The restoration team found part of the original framing, and ghosts of the other members of the framing and of the hinges (fig. 53). A second window, this one with a narrow casement sash, was located on the west gable end (W210—also in the same position as a later double-hung window) that illuminated the second-story kitchen hall.

There was one window in the first story of the kitchen wing, located at the east end of the kitchen's south wall. The opening held double casement sashes. Part of the original framing, and ghosts of the other members of the framing and of the hinges, were revealed during the 1950s restoration (fig. 53).

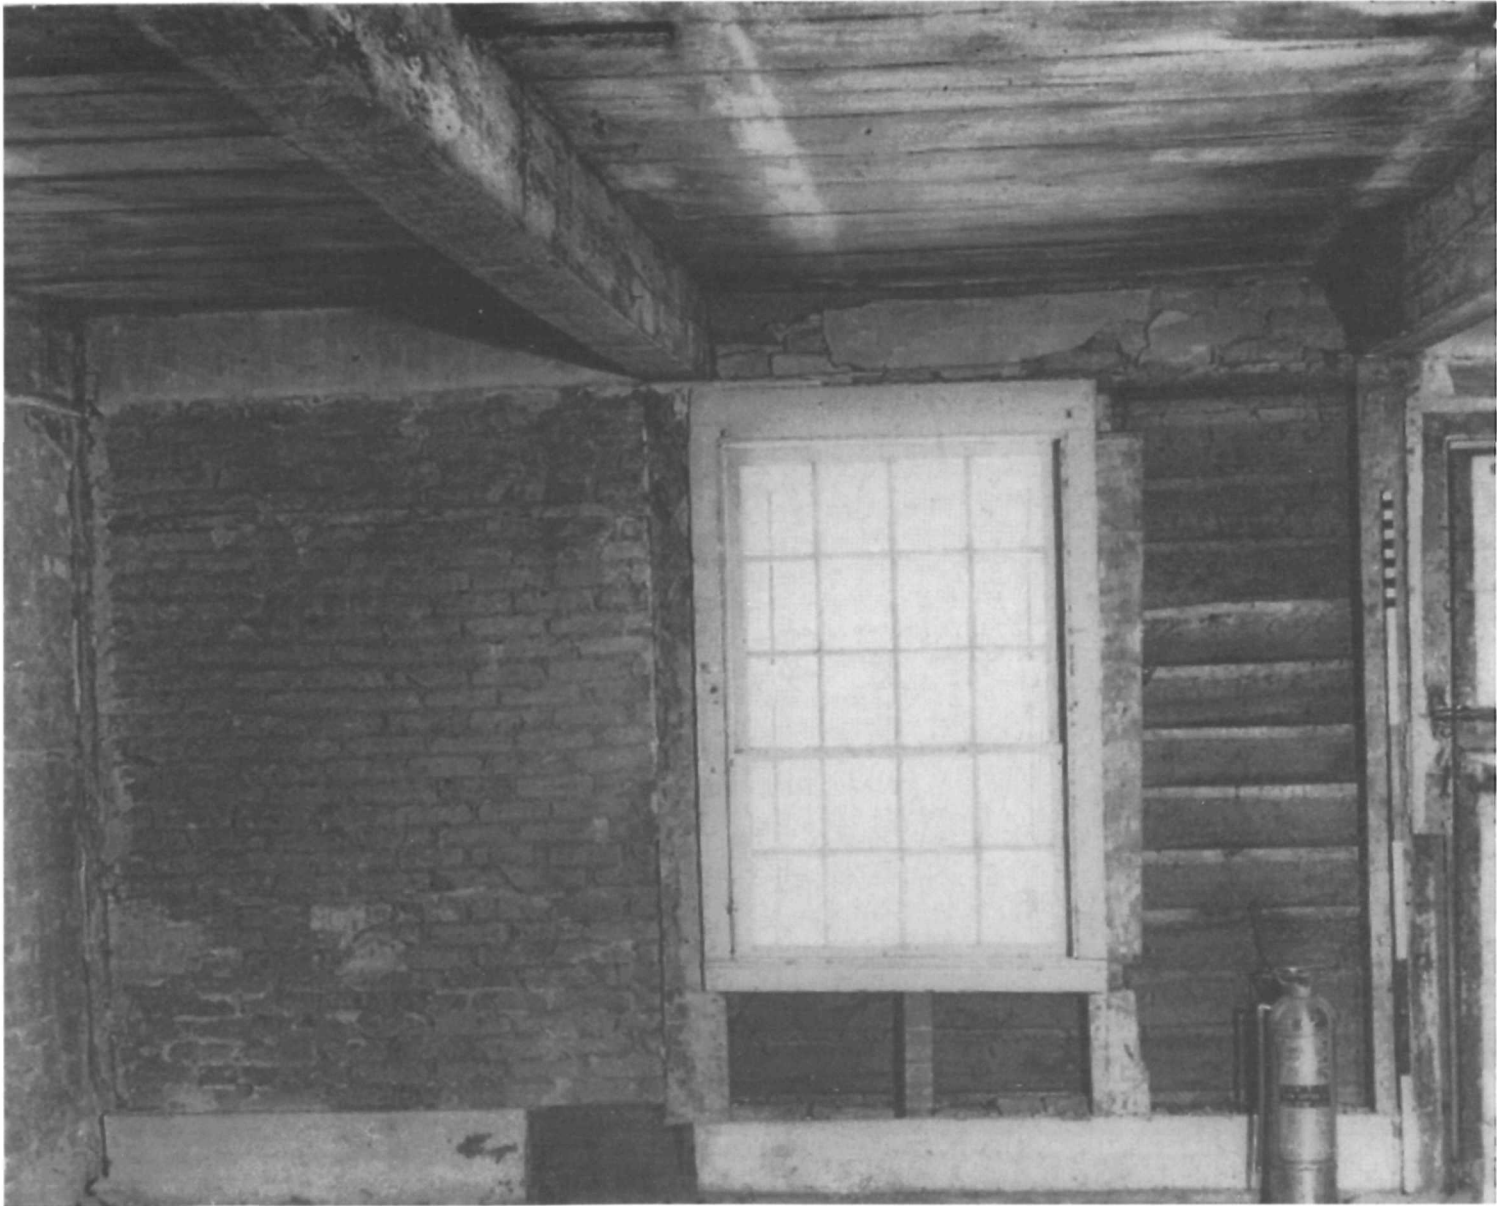
**Figure 54.** Schuyler House: First story of kitchen wing after ca.-1815 lath and plaster removed; shadow line on ceiling marks location of ca.-1780 partition that separated kitchen from storage room and hall (1958).

The exterior walls of the kitchen wing were filled with brick nogging, and the interior walls were constructed of thick vertical planks. The restoration team was able to determine the location of the interior partitions on the first story from marks on the ceiling boards that were exposed when a later lath-and-plaster ceiling was removed (fig. 54).

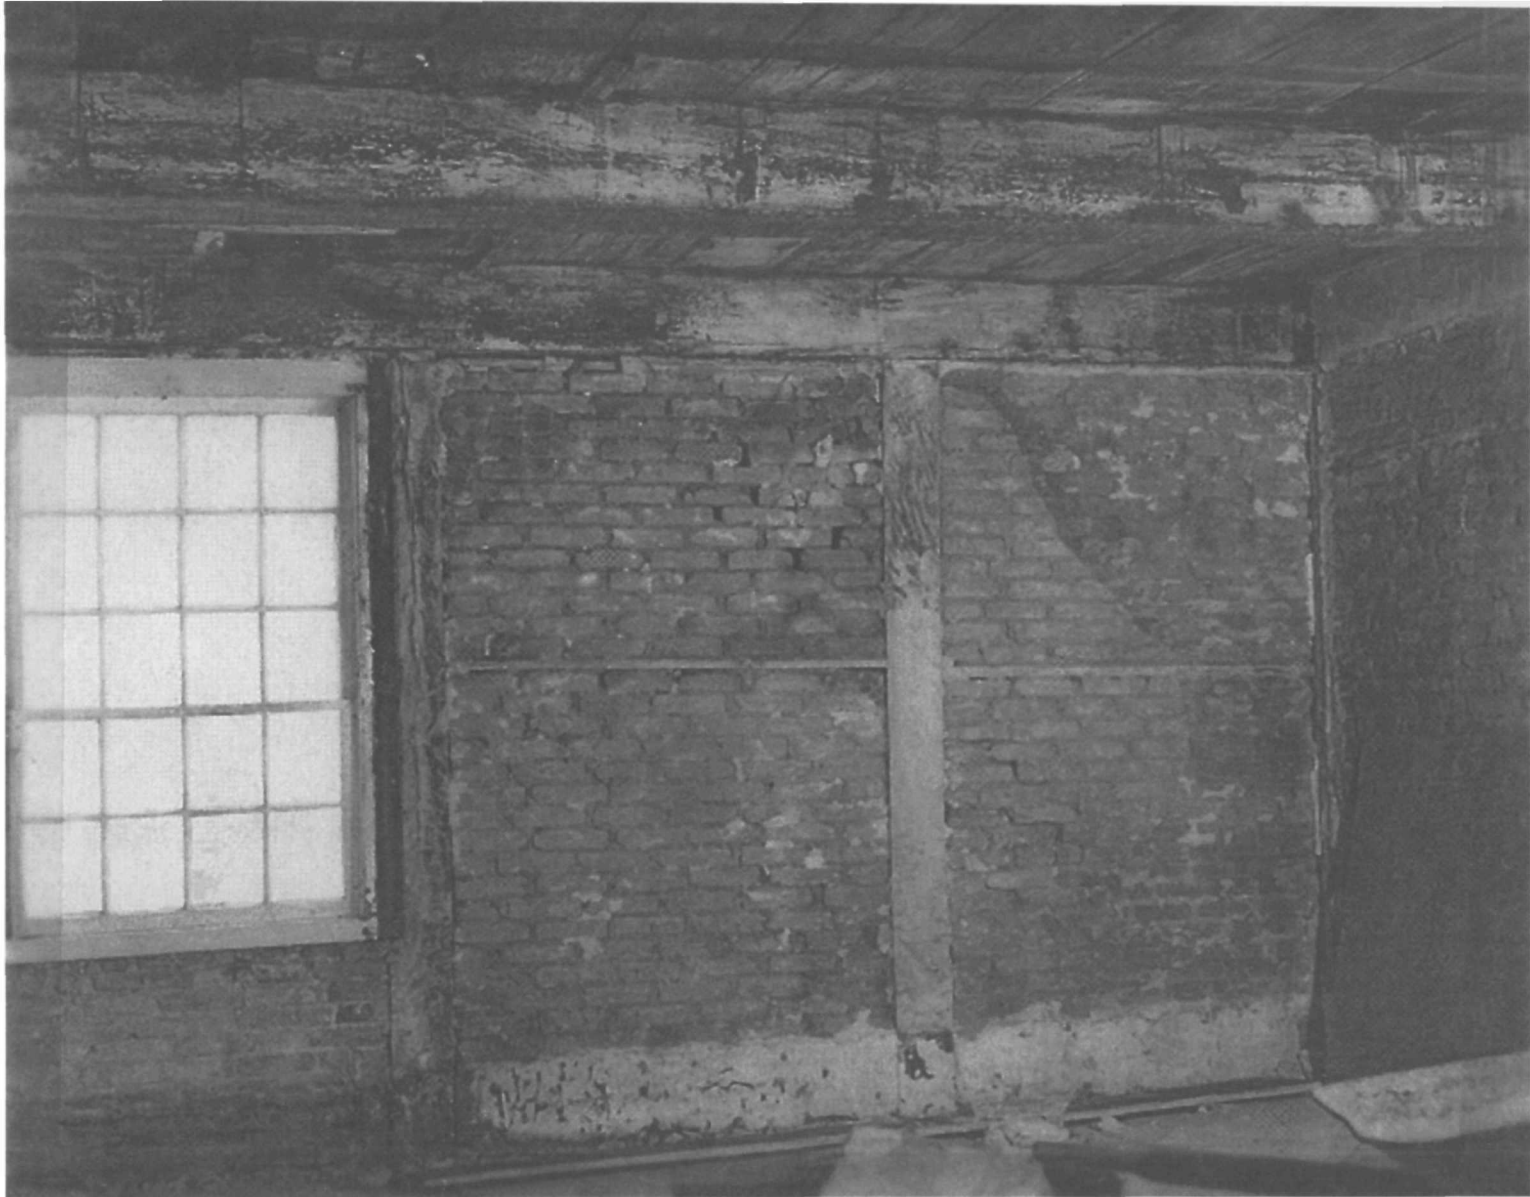
**Figure 55.** Schuyler House: First story of kitchen wing after ca.-1815 lath and plaster removed; view toward west end of north wall, showing mark of ca.-1780 partition in line with later window (1958). Original nogging for storage room at left.

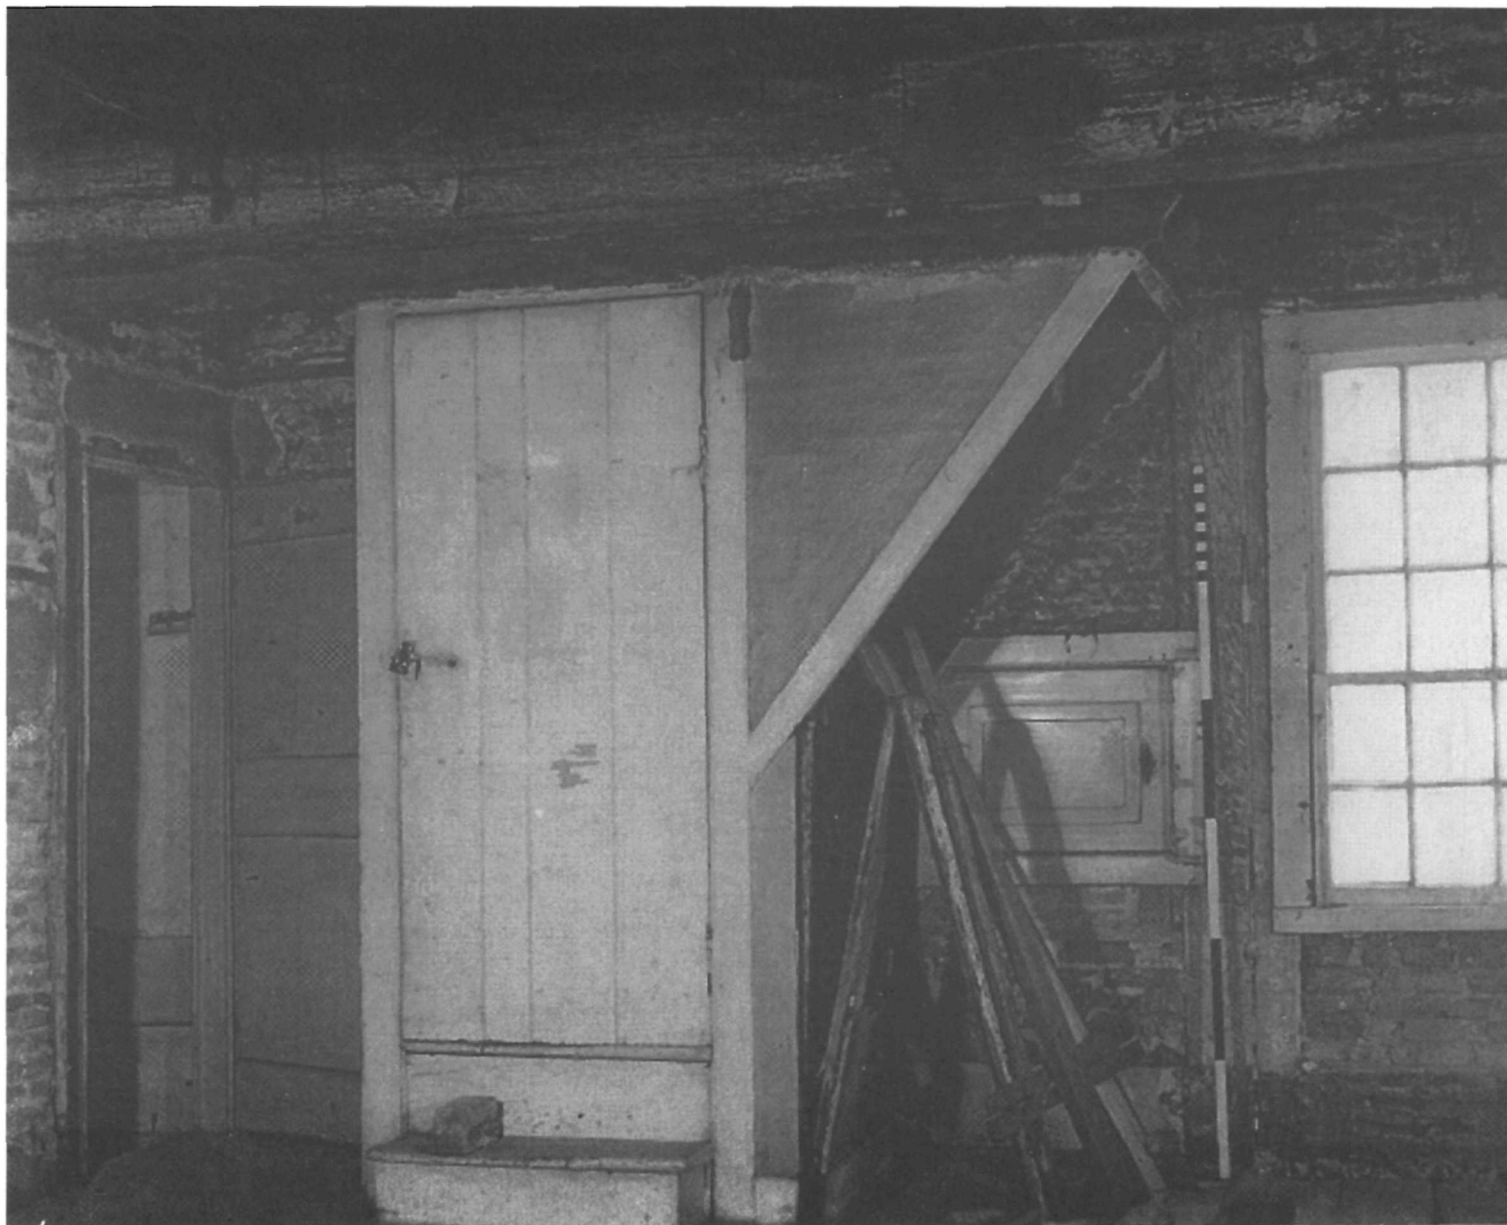
**Figure 56.** Schuyler House: First story of kitchen wing after ca.-1815 lath and plaster removed; north end of west wall in location of ca.-1780 storage room (1958). Window at left was originally a ca.-1780 exterior doorway.

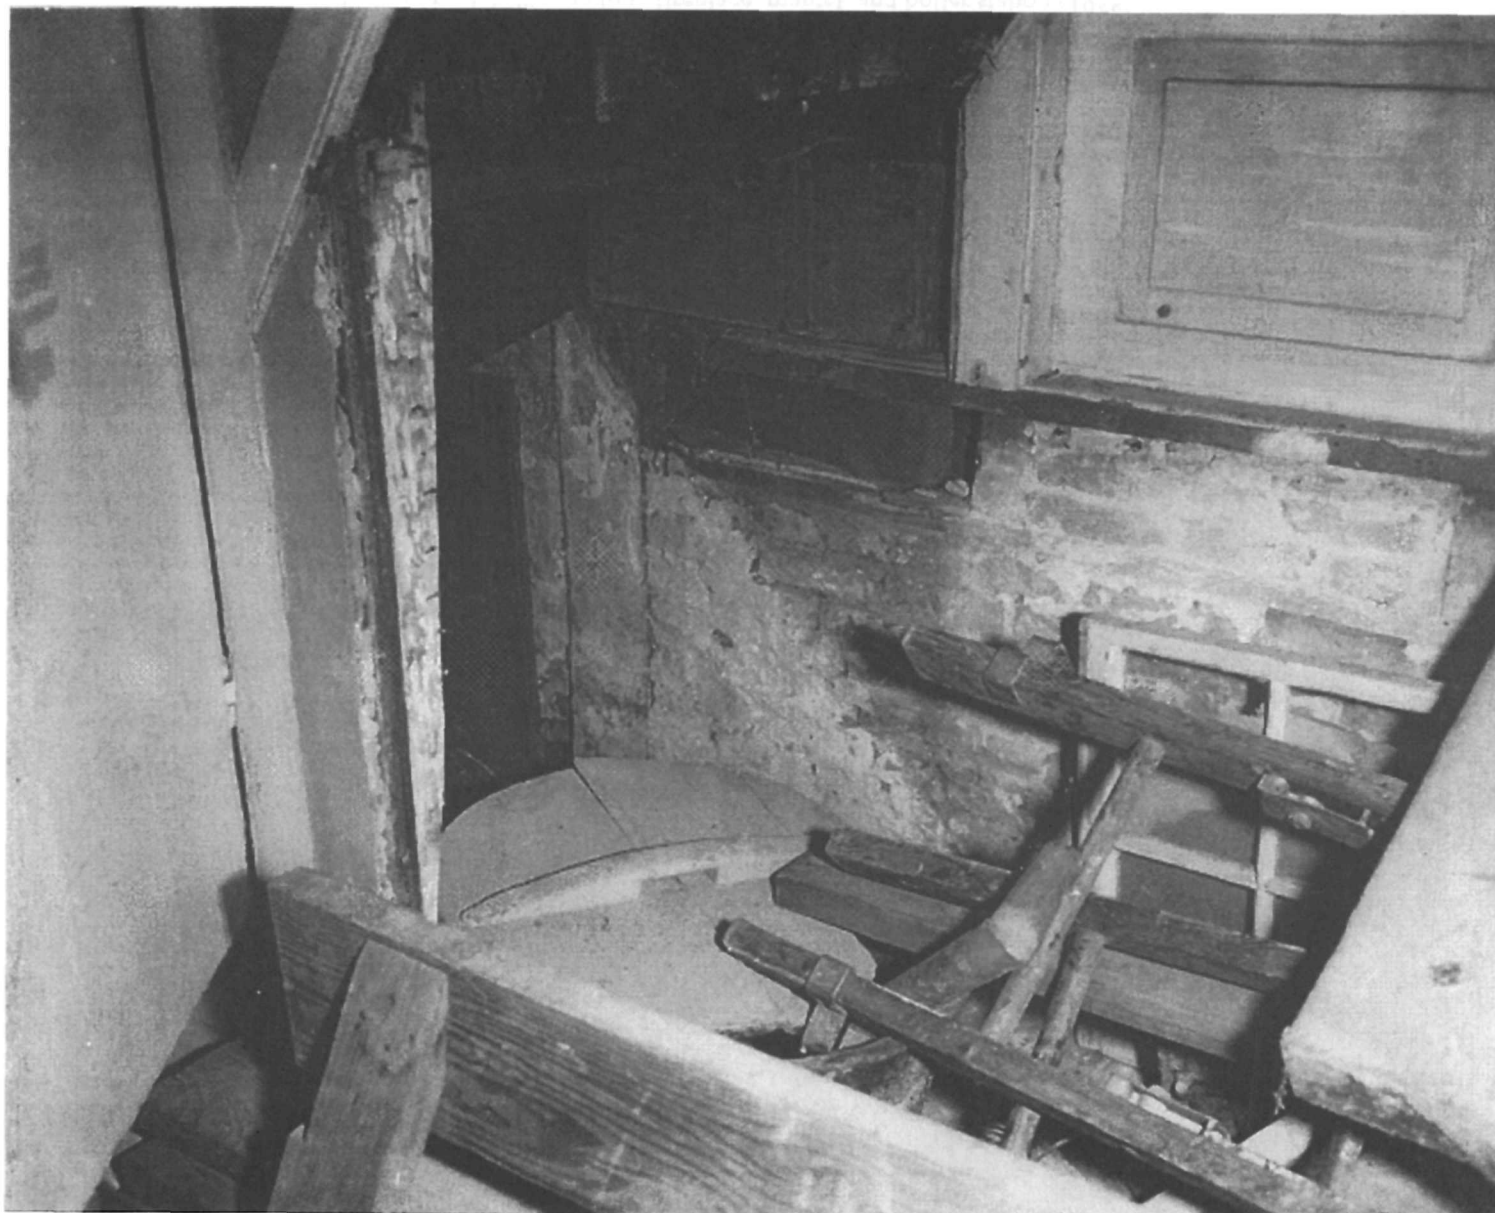
**Figure 57.** Schuyler House: First story of kitchen wing after ca.-1815 lath and plaster removed; ca.-1815 features at south end of west wall (1958). From left: doorway to east tier, doorway and staircase to second story, pass-through to dining-room pantry, and window in former ca.-1780 exterior doorway.

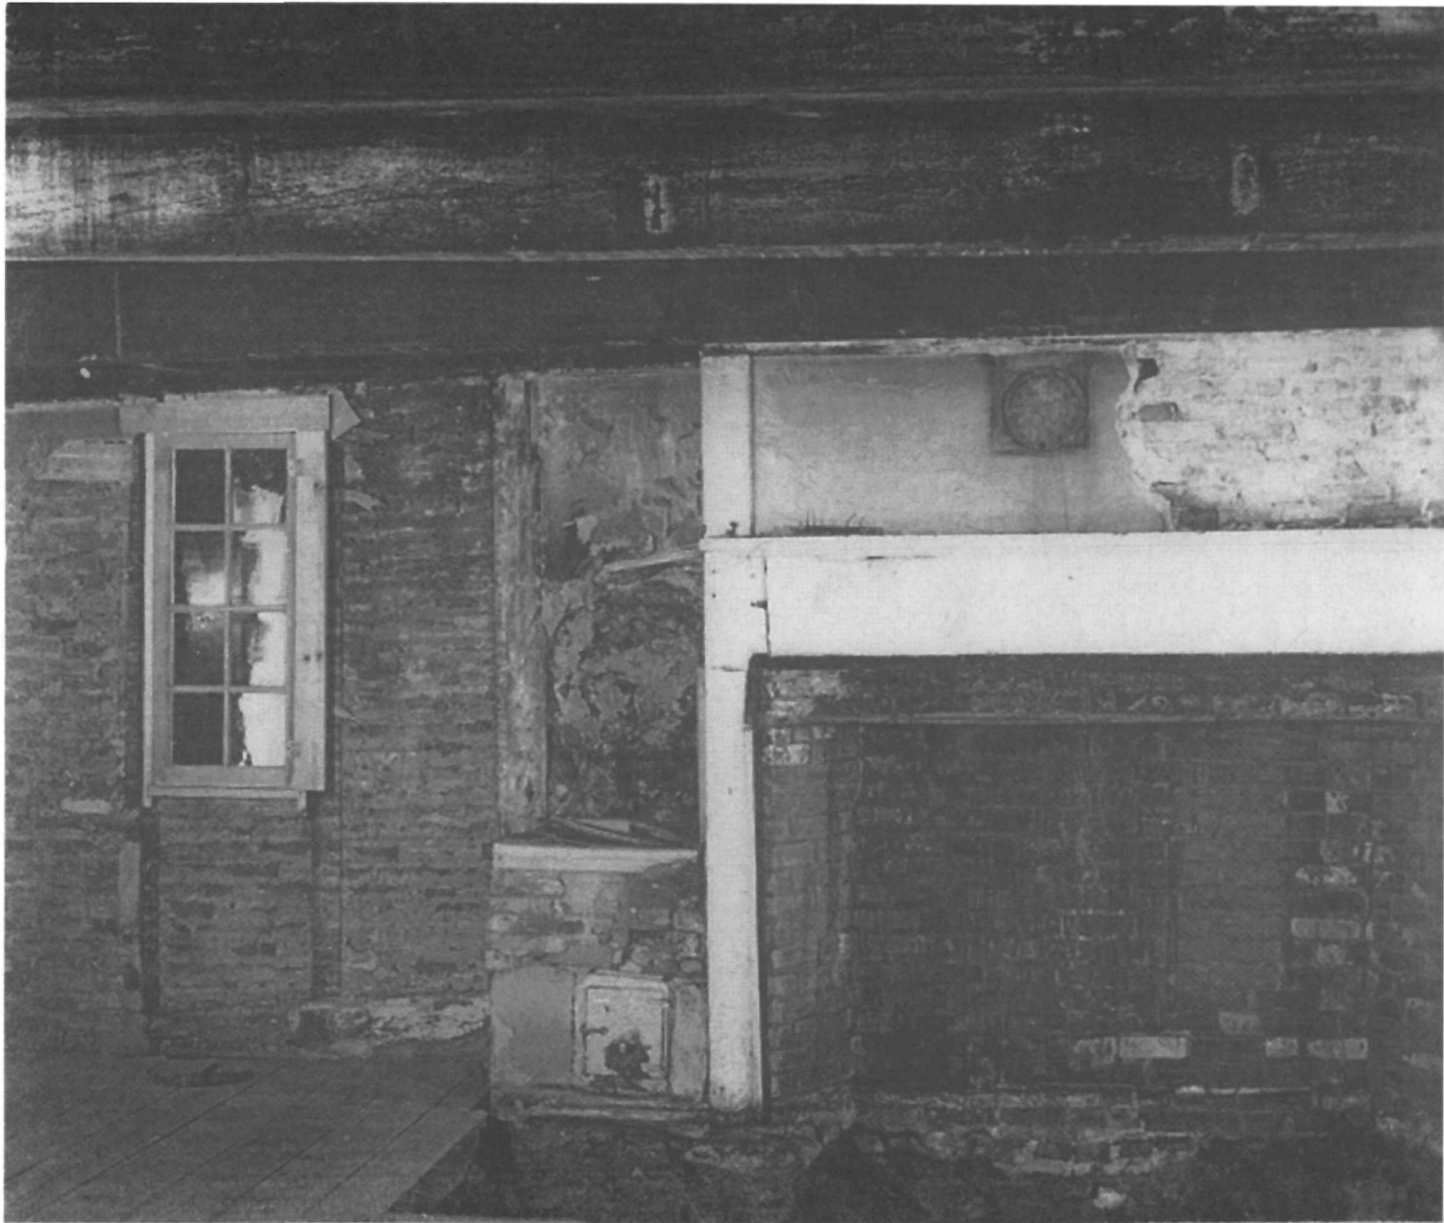
**Figure 58.** Schuyler House: First story of kitchen wing after ca.-1815 lath and plaster removed; west wall, area under ca.-1815 pass-through to dining-room pantry and paint line of original staircase to second story (1958).

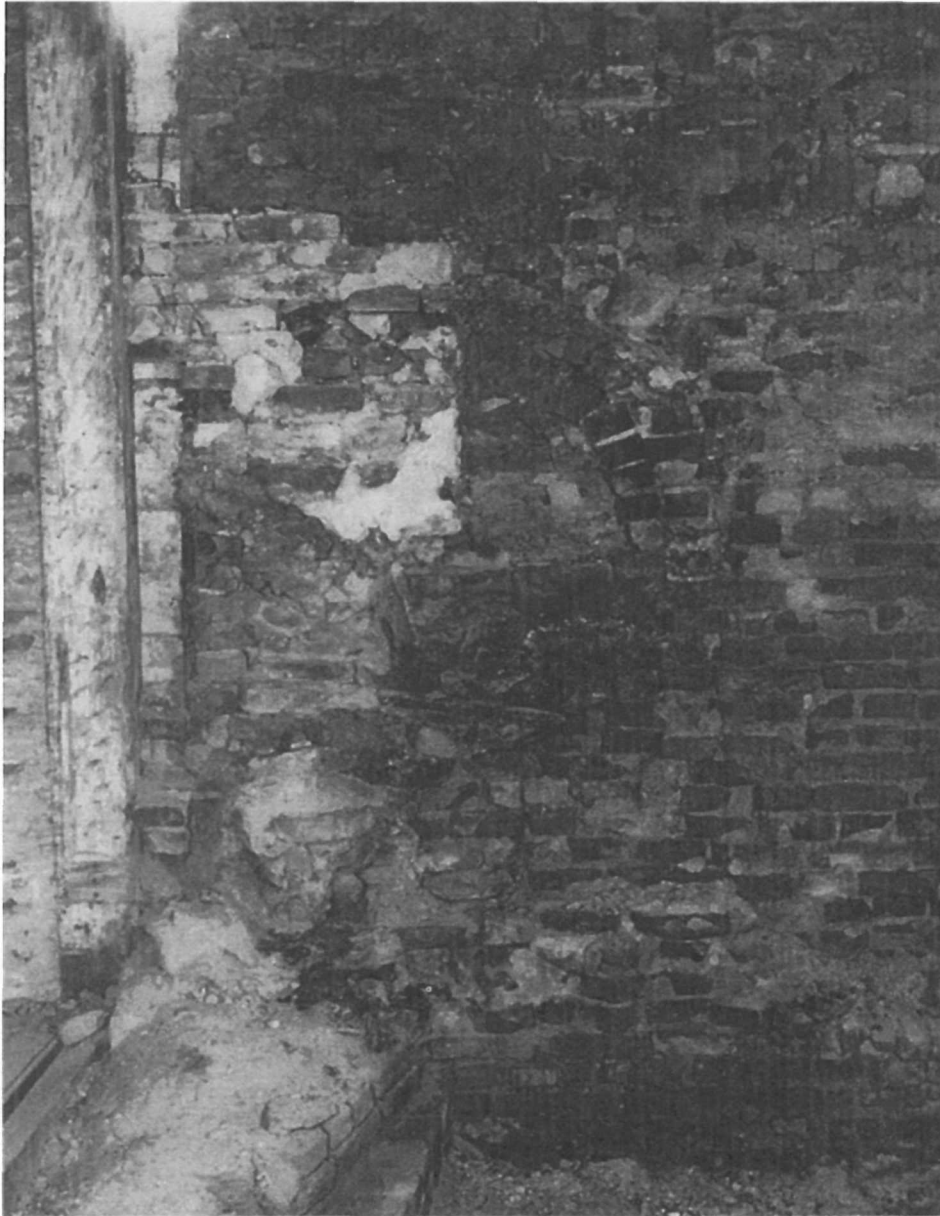
**Figure 59.** Schuyler House: First story of kitchen wing after ca.-1815 lath and plaster removed; view of east wall showing post-1780 window, fireplace, mantel, and boiler station (1958).

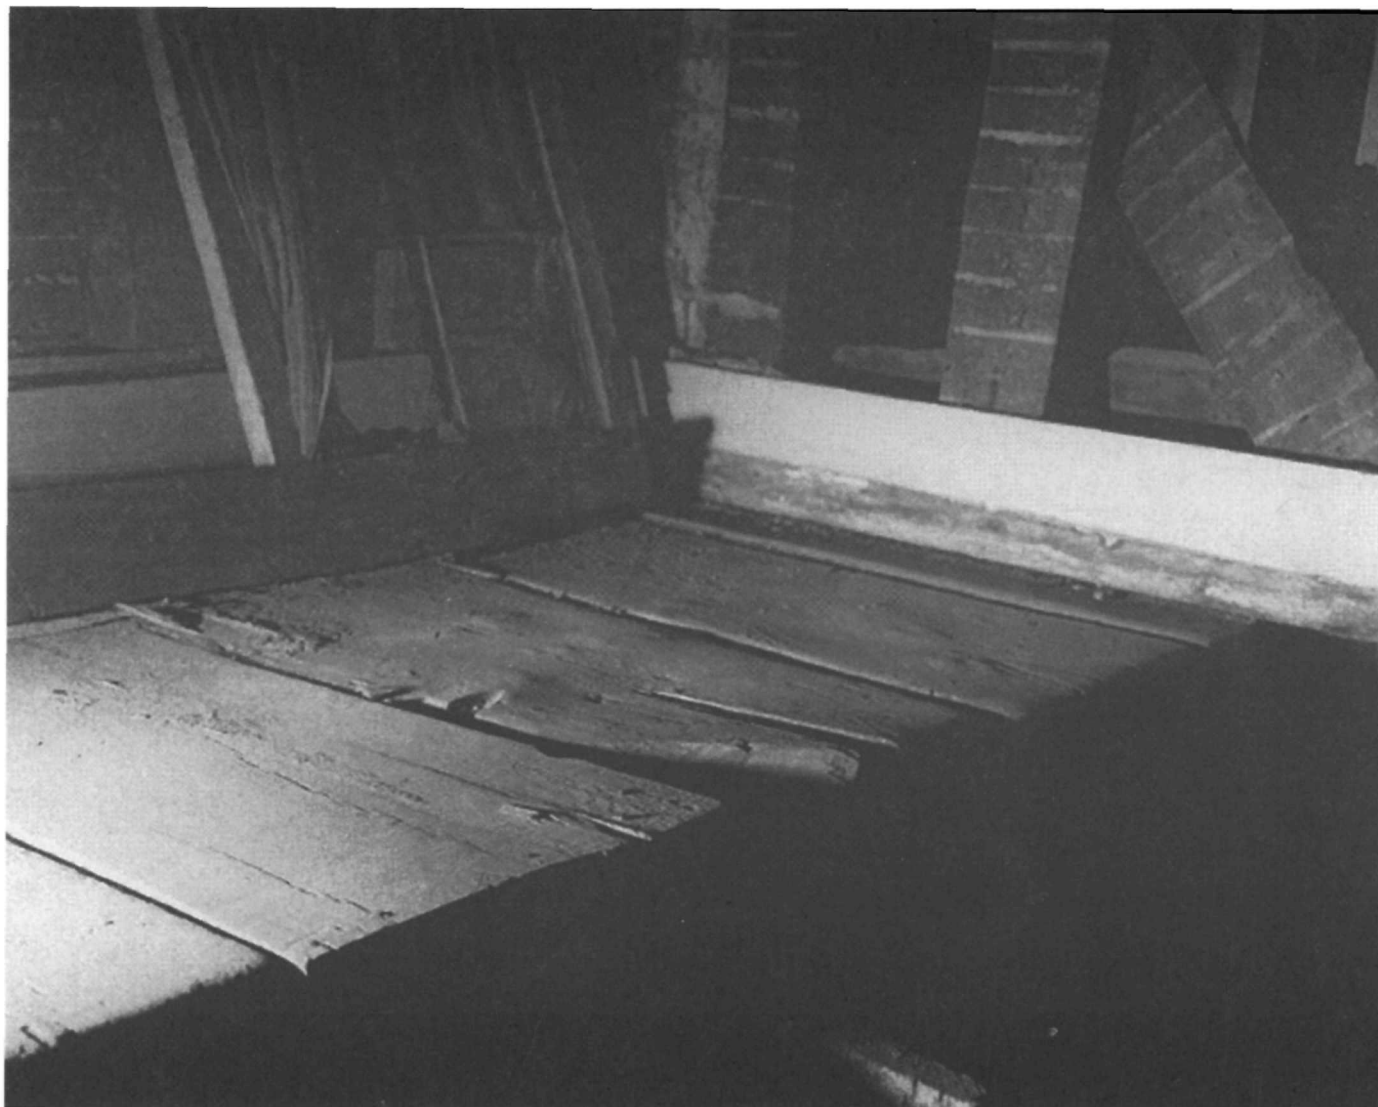
**Figure 60.** Schuyler House: First story of kitchen wing, east wall after post-1780 fireplace removed (1958); detail shows evidence of bake oven.

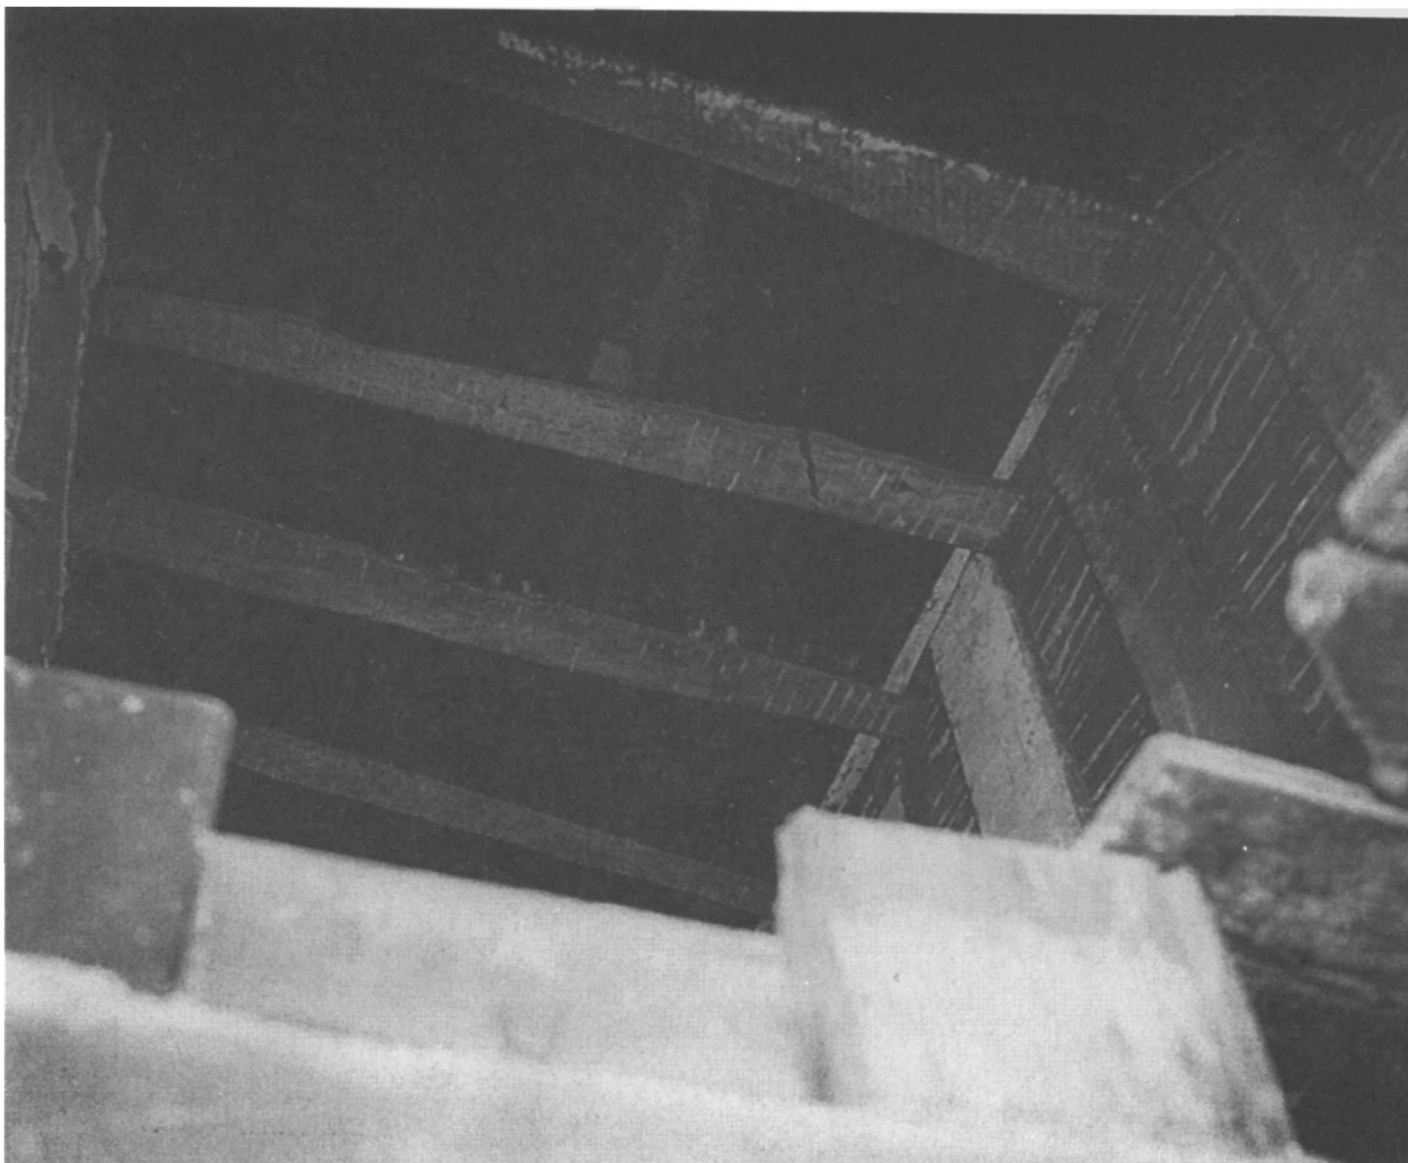
**Figure 61.** Schuyler House: Second story of kitchen wing after ca.-1815 lath and plaster removed; worn flooring in hall (Room 206) at location of ca.-1780 staircase landing (1958).

The original staircase from the first story to the garret was located along the west wall and was accessed from the stair hall. This staircase was reconfigured during the ca.-1815 remodeling so that its direction was reversed. The pattern, angle, and direction of the steps could be seen in a whitewash outline on the wall (fig. 58), and the bottom of the newel post, which had been cut off when the later staircase was installed, was found when a later ceiling was removed (figs. 61-62).

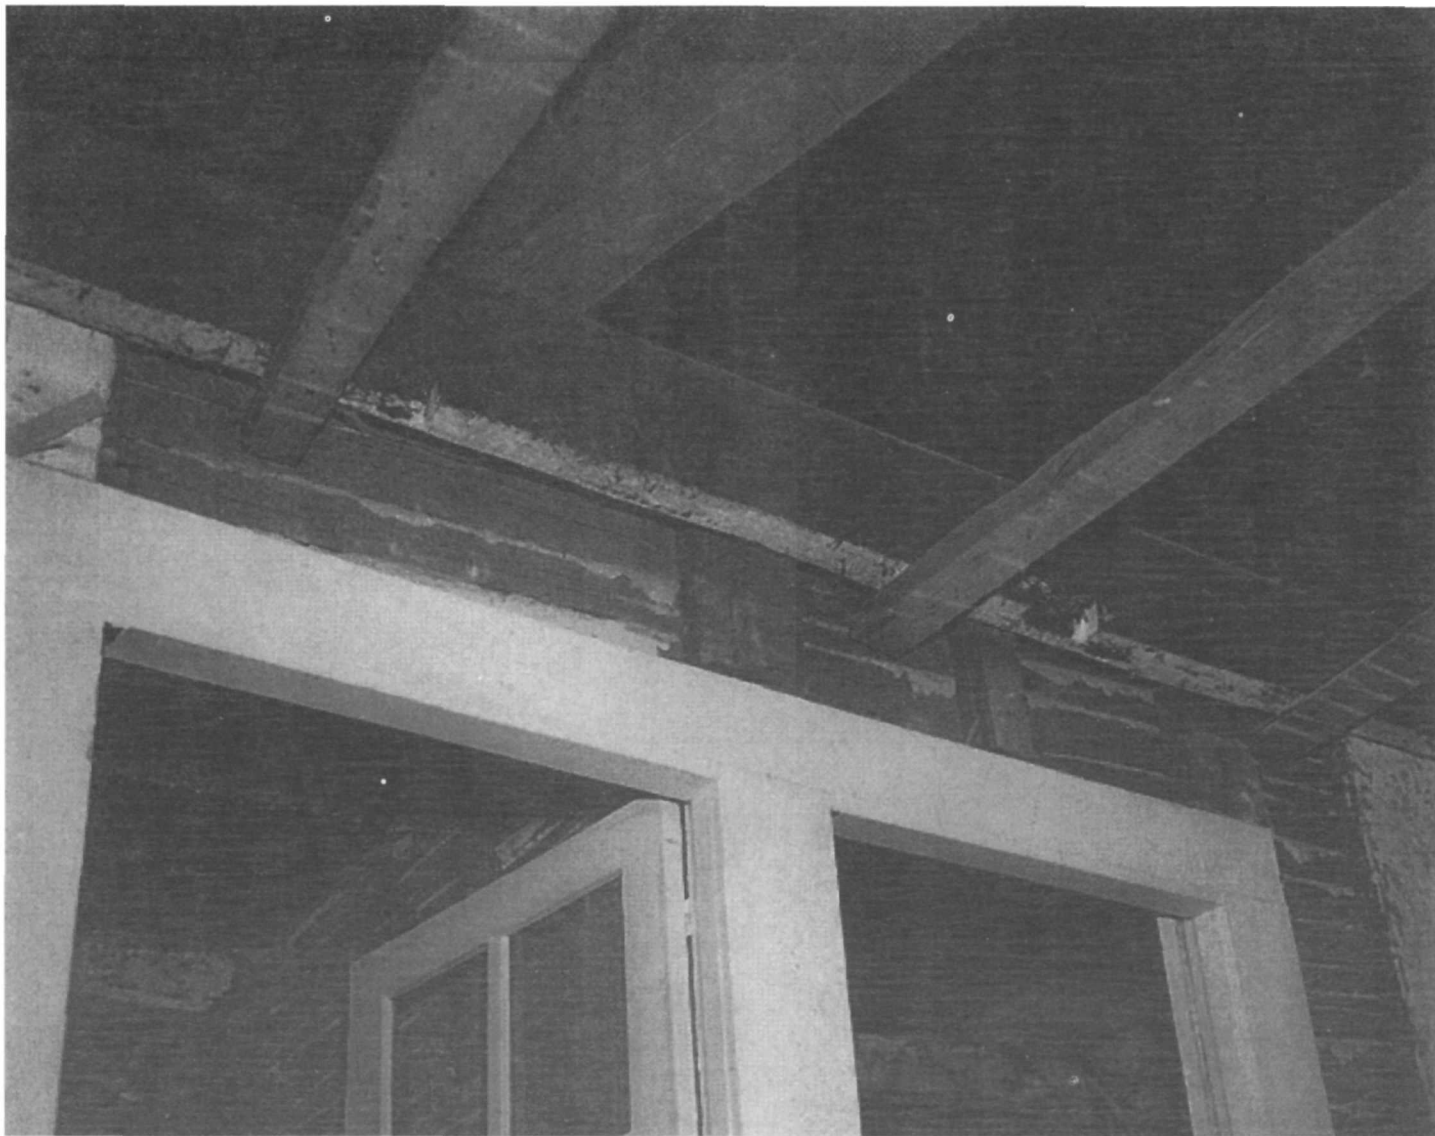
**Figure 62.** Schuyler House: Second story of kitchen wing after ca.-1815 lath and plaster removed; remnants of original newel post in hall (Room 206) at location of ca.-1780 staircase (1958).

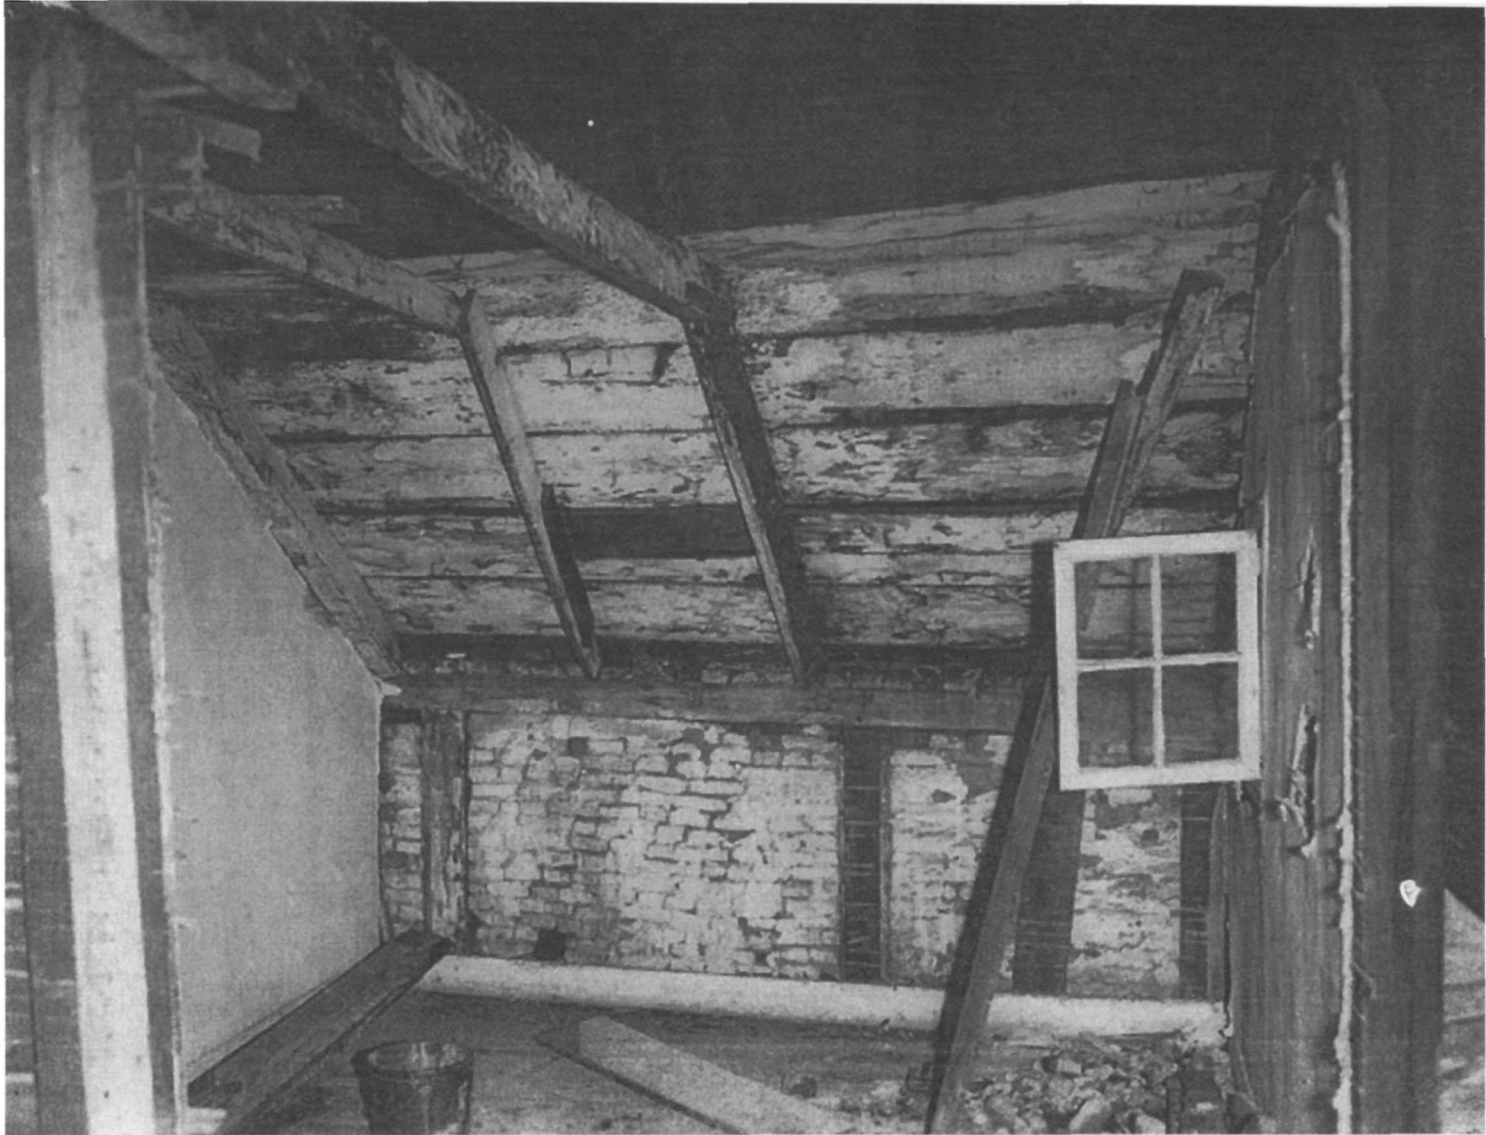
**Figure 63.** Schuyler House: Second story of kitchen wing after ca.-1815 lath and plaster removed; east wall of hall (Room 206), where mortises in collar beam over ca.-1815 doorways mark location of ca.-1780 doorway (1958).

On the garret level, one doorway opened from the hall into the center room, and one doorway led from the center room to the east room. Stud pockets for these doorways can be seen today in the collar joists (figs. 63, 228, and 246).

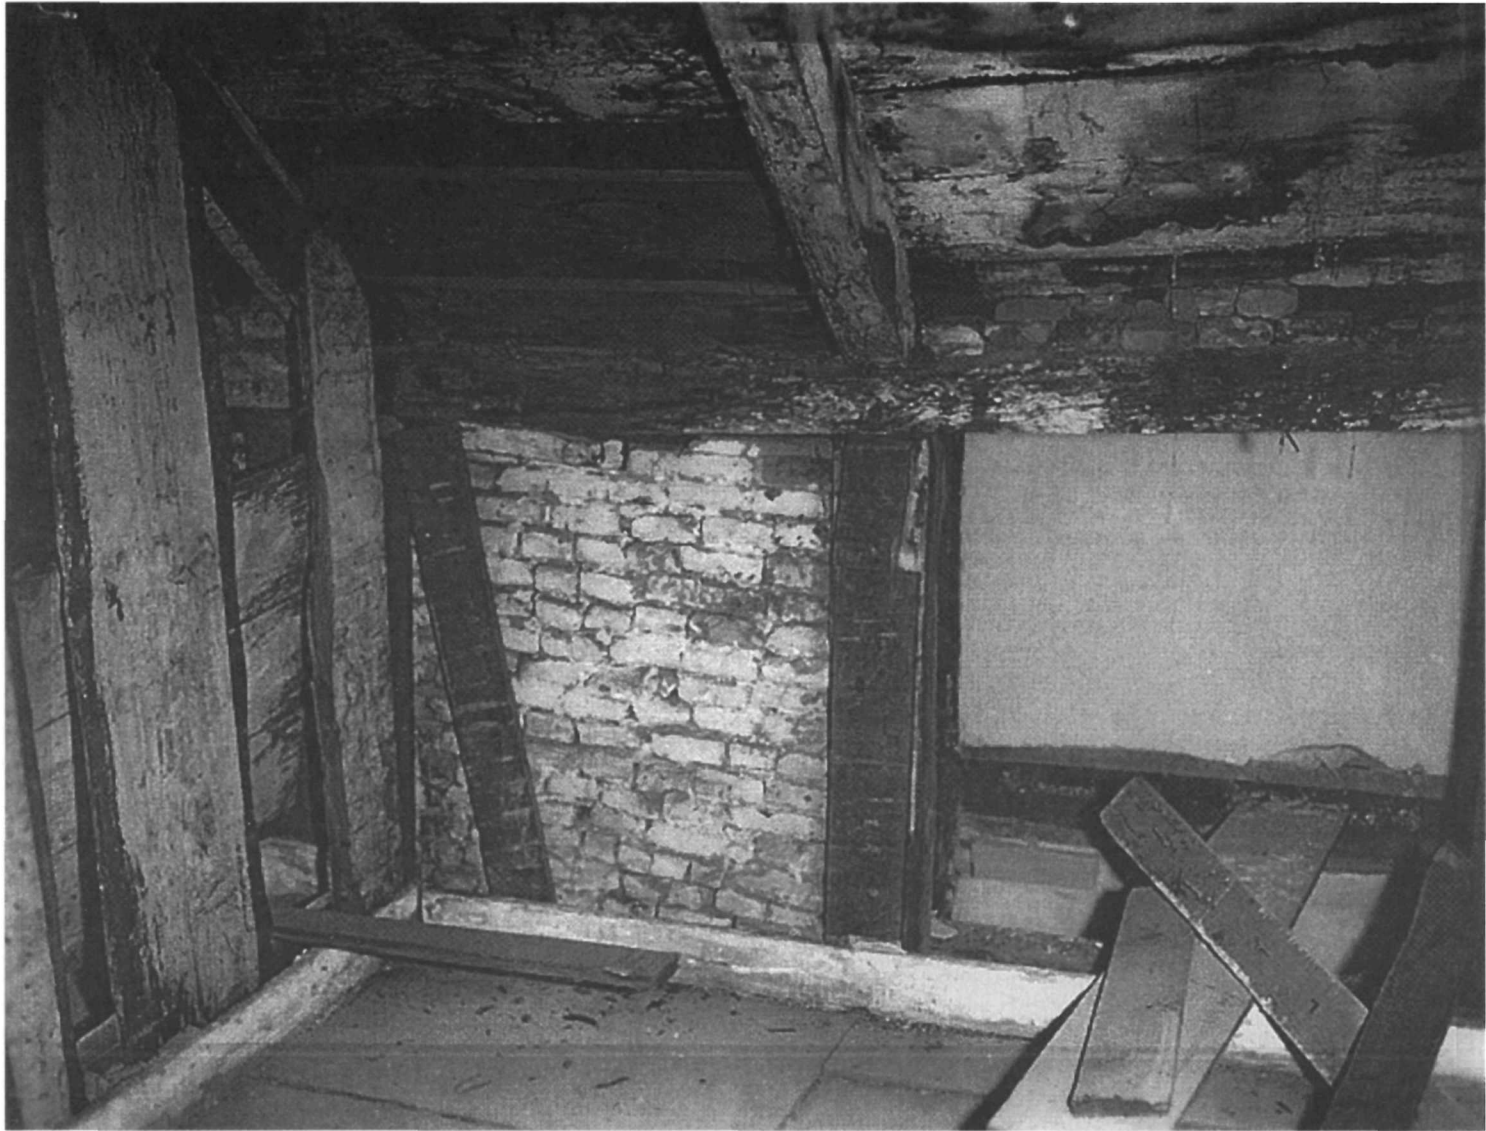
**Figure 64.** Schuyler House: Second story of kitchen wing after chimney removed; view looking north in east servants' room (Room 209), showing pre-1815 whitewash on nogging and ceiling boards, ca.-1815 plaster walls, and mid-19<sup>th</sup> century window sash to right (1958).

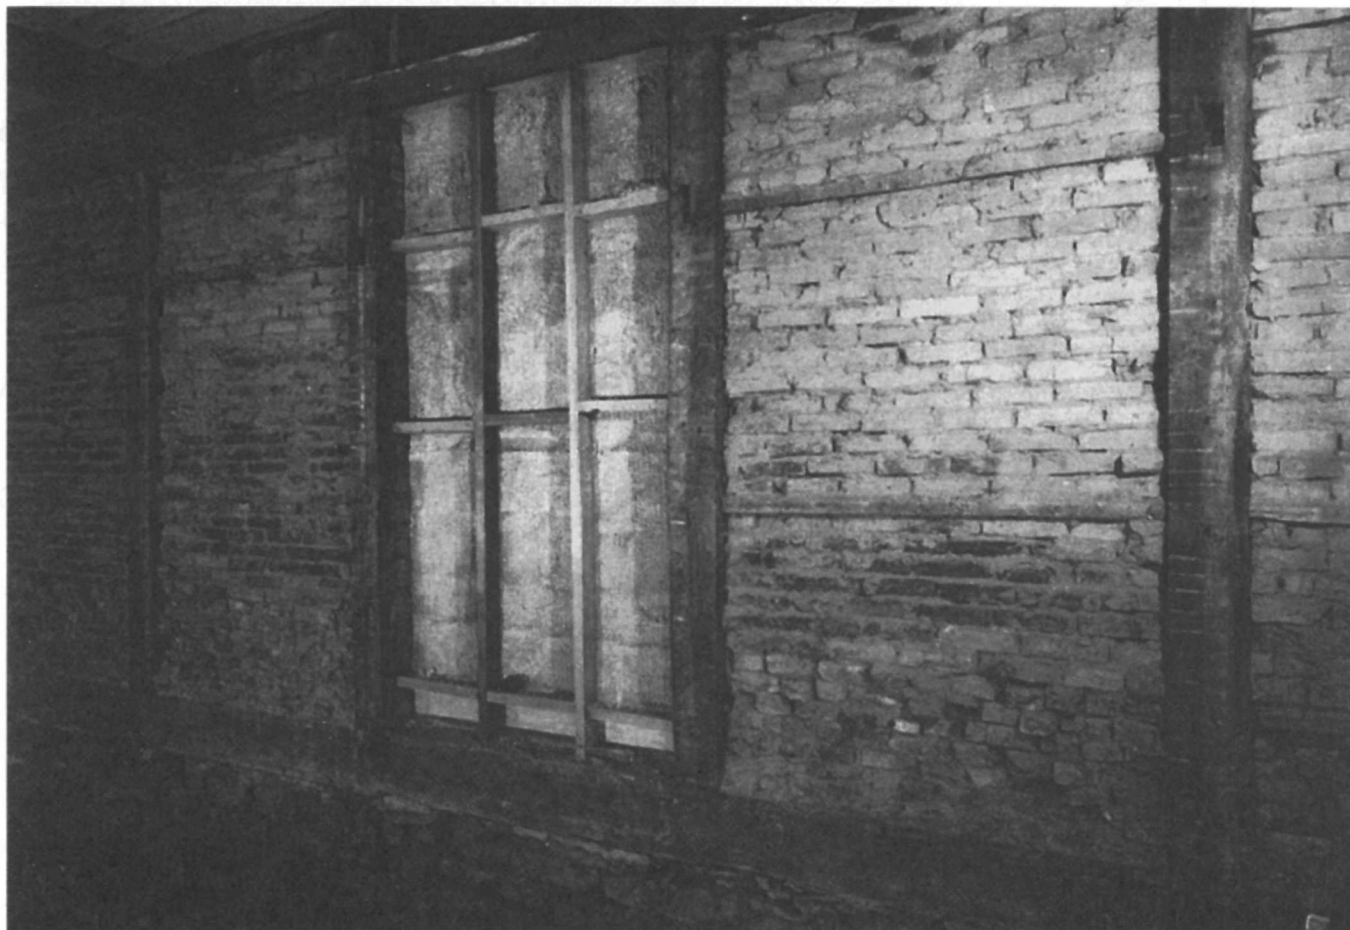
**Figure 65.** Schuyler House: Second story of kitchen wing after ca.-1815 lath and plaster removed; southeast corner of south servant's room (Room 207), showing whitewash lines on edges of planks where other planks had originally overlapped (1958).

The extant interior partitions on the garret level date to the ca.-1815 remodeling, but evidence of whitewash and stud pockets on the collar joists identify the location of the original partitions. The partitions were composed of thick wide planks that were overlapped several inches, creating a board-and-batten effect. These planks, which have retained the whitewash markings, were later used as studs for the ca.-1815 partitions (fig. 65).
