# GENERAL PHILIP SCHUYLER HOUSE

Saratoga National Historical Park  
Schuylerville, New York

Historic Structure Report  
Volume I

**GENERAL PHILIP SCHUYLER HOUSE**  
**HISTORIC STRUCTURE REPORT**

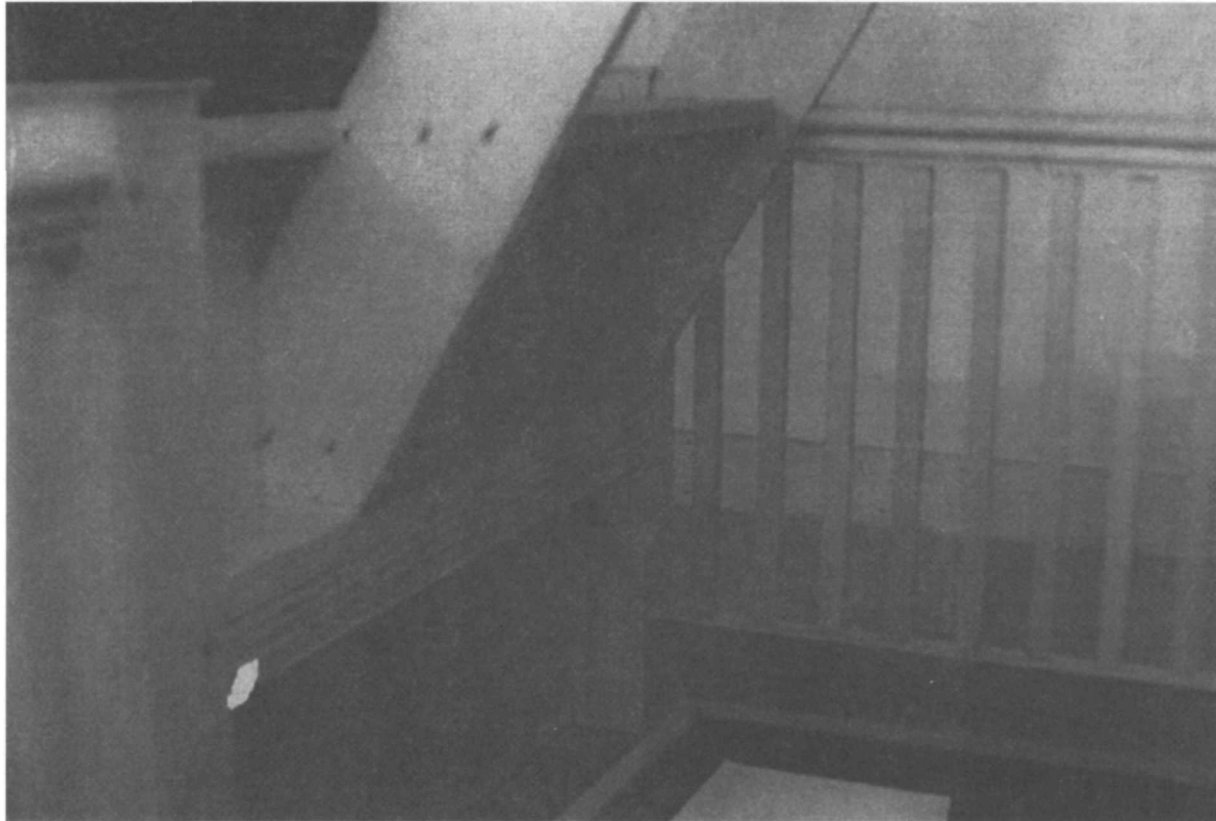
**Figure 78.** Schuyler House: Second-story hall (Room 201), reconstruction of staircase, balustrade, and attic ladder stairway (ca. 1960).

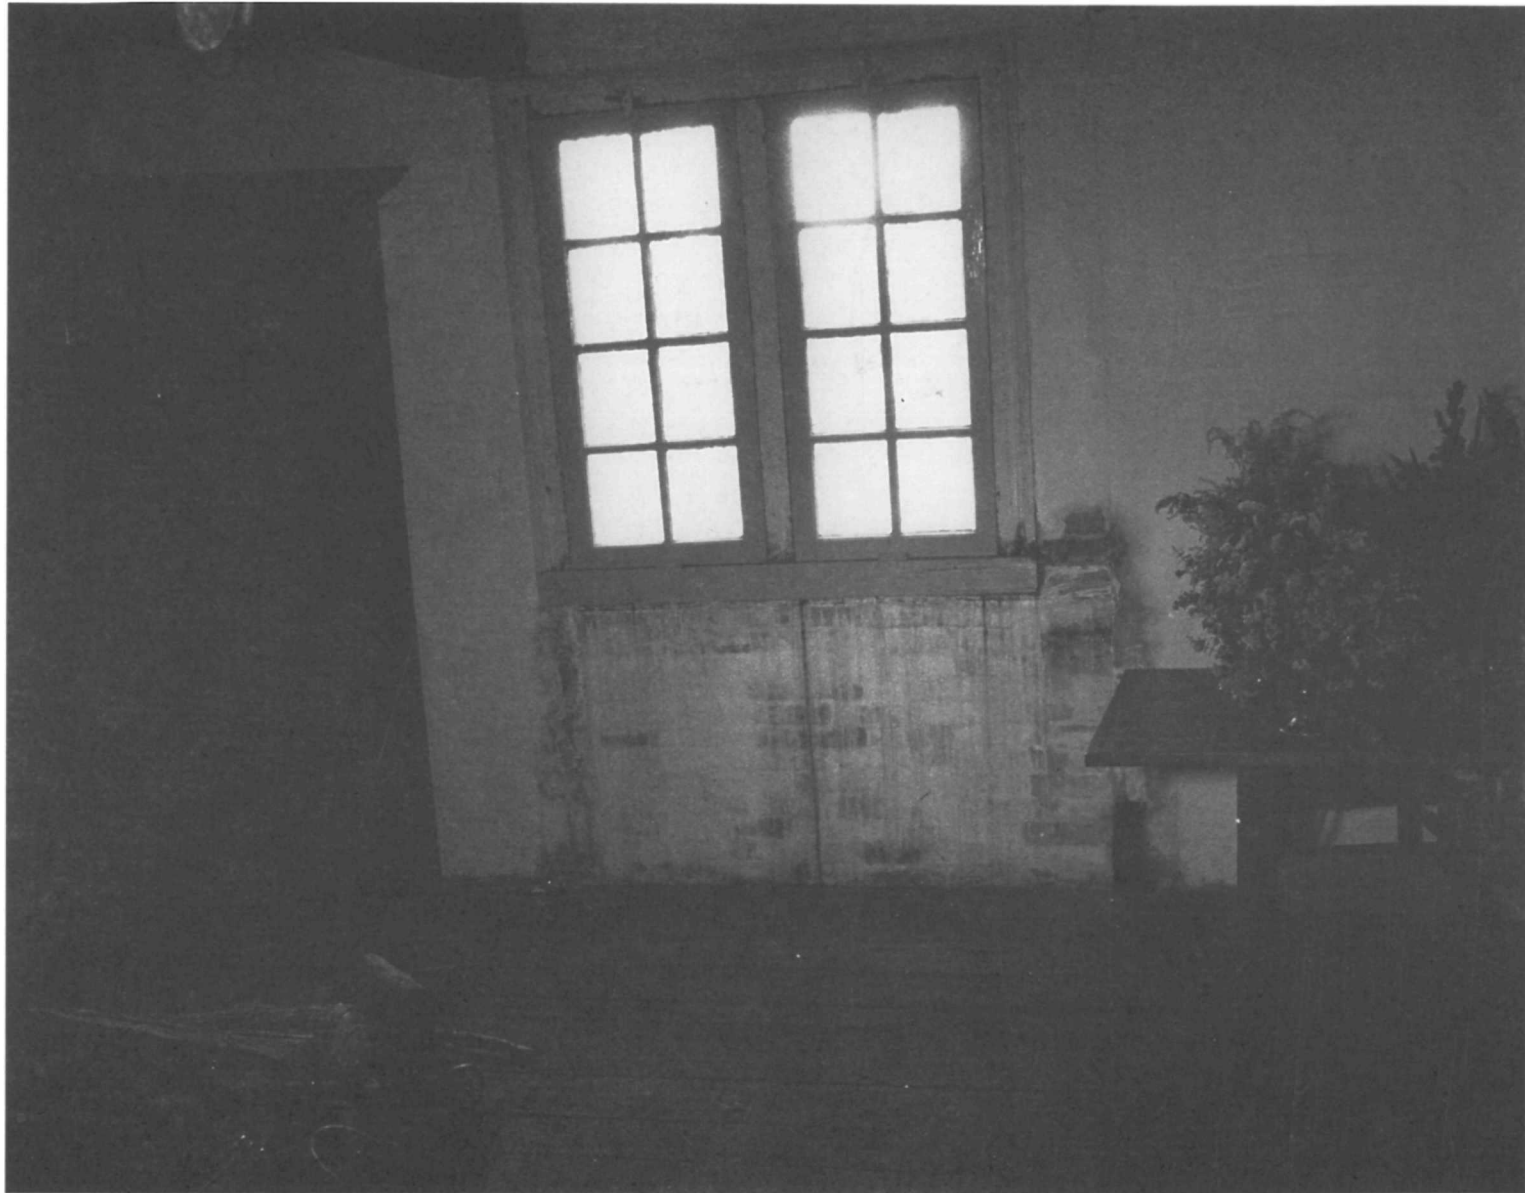
**Figure 93.** Schuyler House: Cellar kitchen (Room 004), view to south along west foundation wall (ca. 1990).

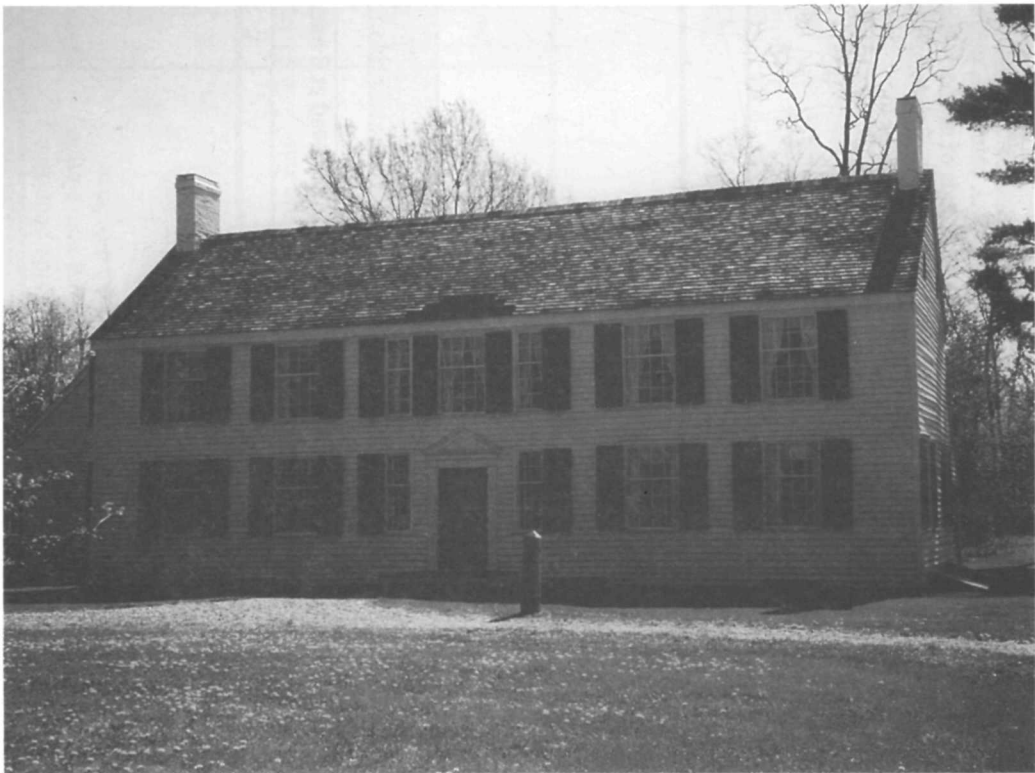
**Figure 95.** West façade.

The Schuyler House (fig. 95) consists of a two-story main house with a one-story addition on its rear (east) wall (fig. 100), and a story-and-a-half kitchen wing attached to its northeast corner (figs. 96-99). The main house is a rectangular structure that measures approximately 60 feet 4 inches wide by 21 feet deep; it sits on a fieldstone foundation with full cellar. The rear addition measures 15 feet wide by 12 feet deep, and the kitchen wing measures approximately 25 feet by 26 feet 4 inches; both sit on low fieldstone foundations. Brick bake ovens are built against the kitchen wing's east exterior wall (fig. 139). The main house faces west, and has a gable roof whose ridge runs north/south. The kitchen wing also has a gable roof, with its ridge oriented east/west, at right angles to that of the main house. The rear addition and its flanking porches are covered by a shed roof that extends across the entire east (rear) wall of the main house; on the kitchen wing, deep shed-roofed porches protect the north wall and the bake ovens on the east wall (figs. 99-101 and 137-140).

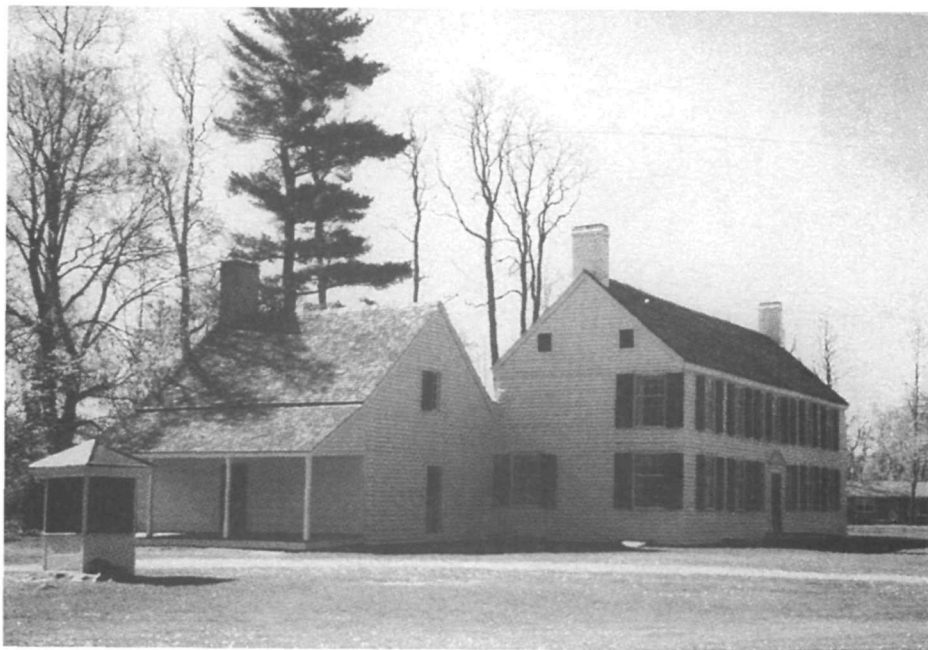
**Figure 96.** View from the northwest.

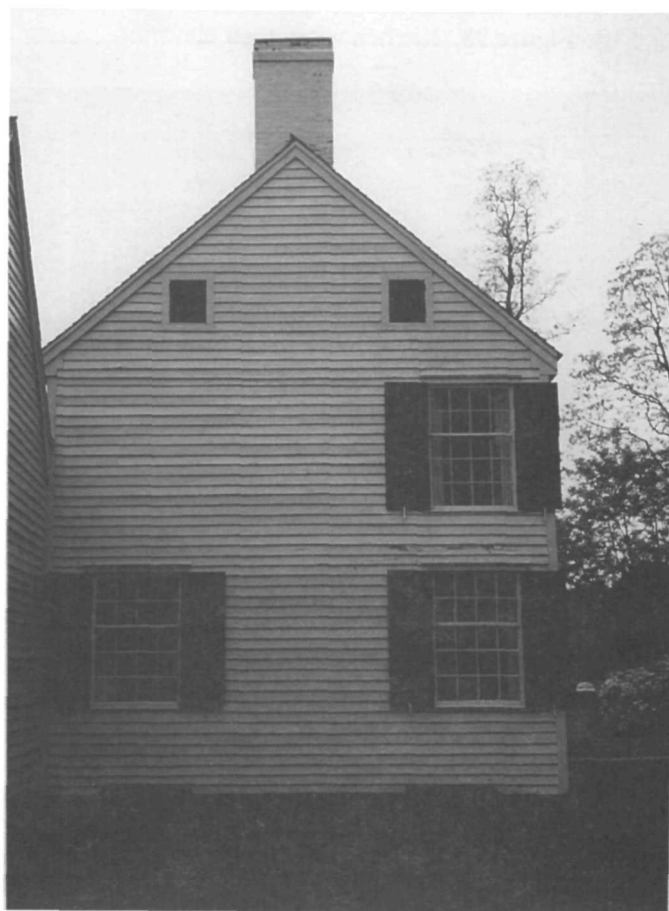
**Figure 97.** Main house, north elevation.

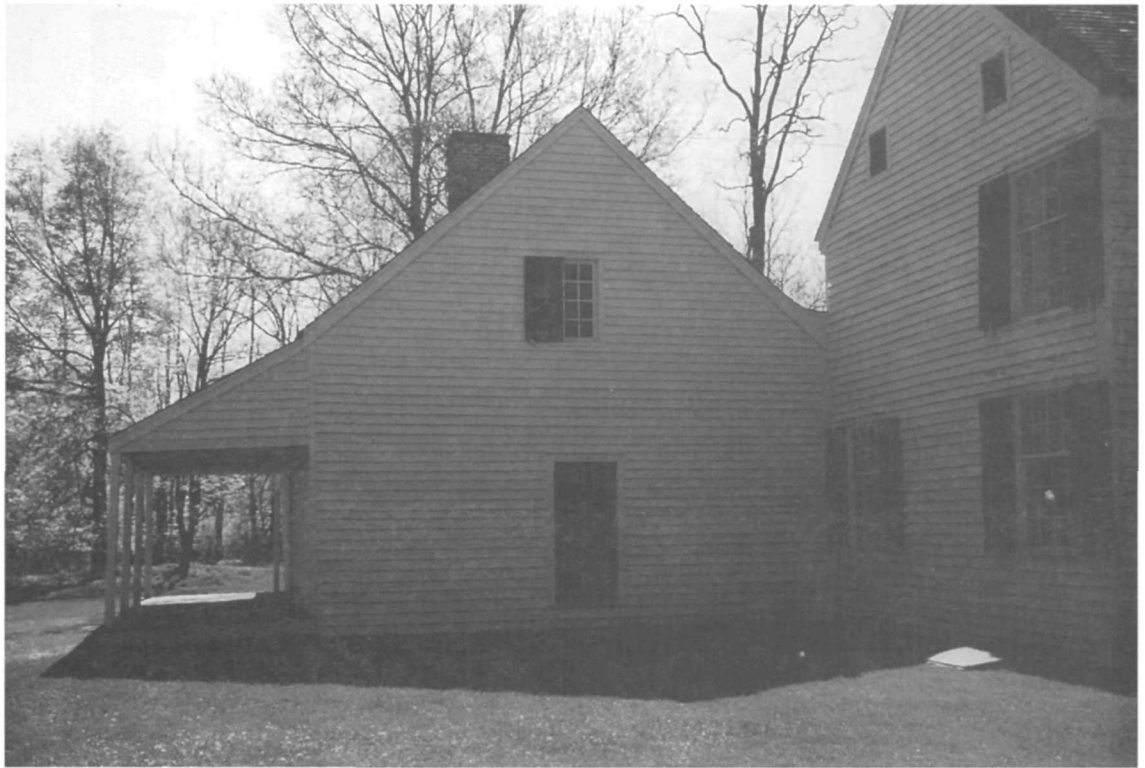
**Figure 98.** Kitchen wing, west elevation.

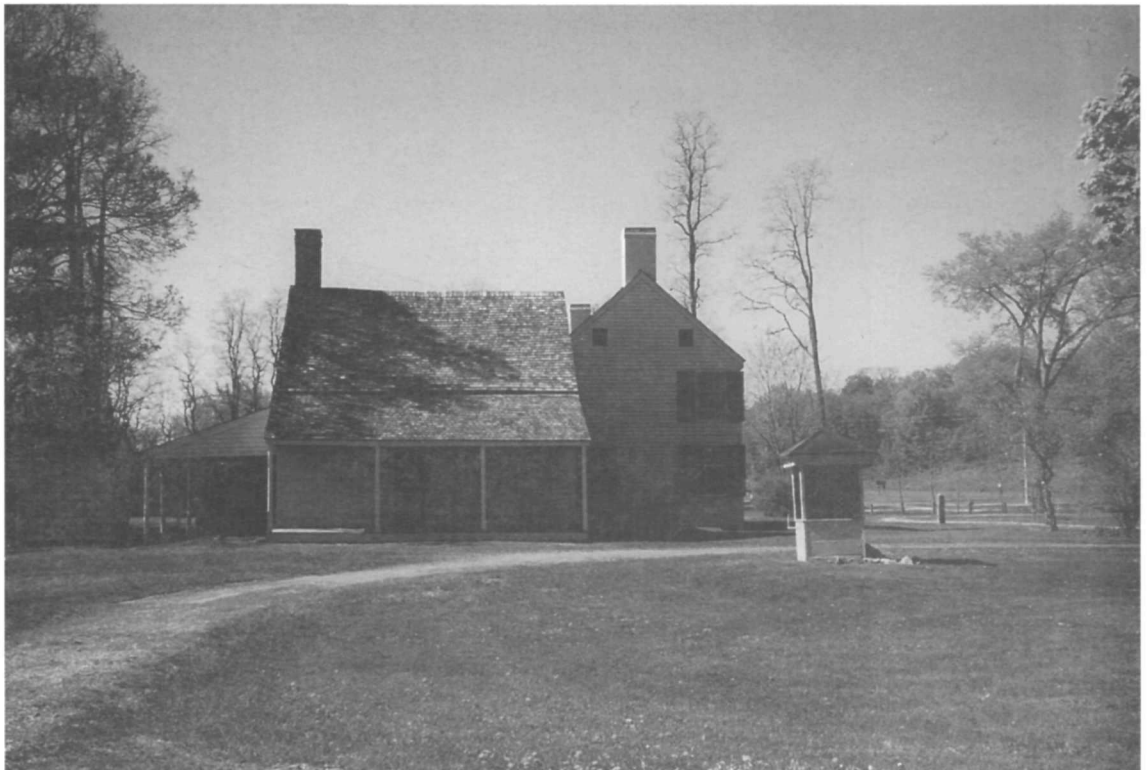
**Figure 99.** North elevation.

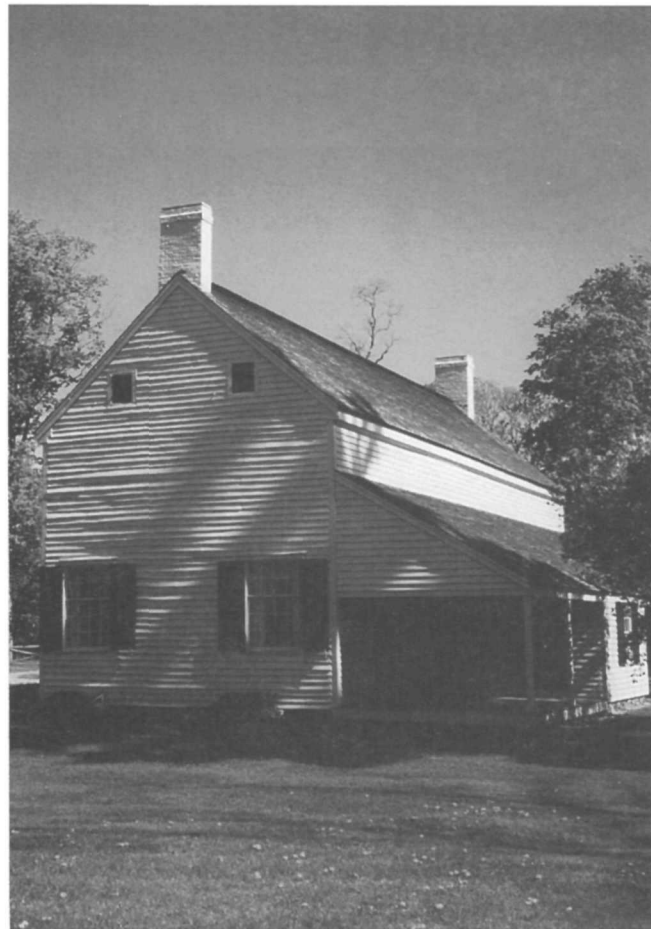
**Figure 103.** Main house, south elevation.

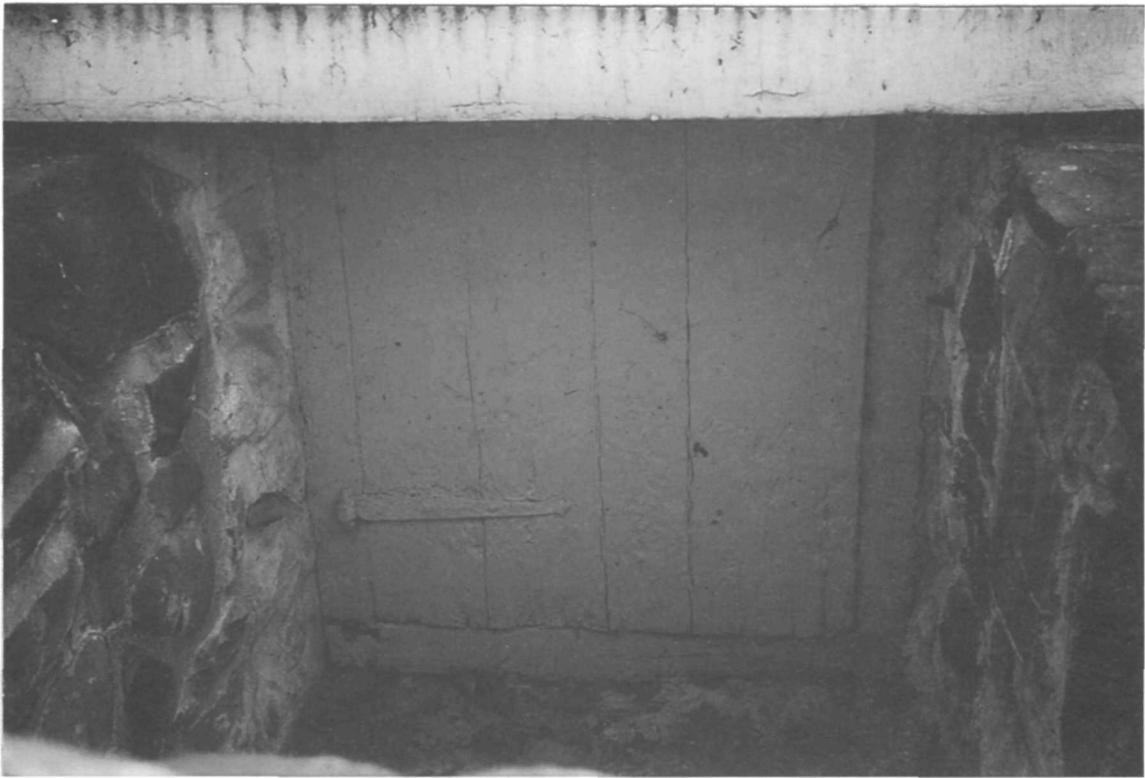
**Figure 104.** Main house, west façade, opening O001.

The primary entrance to the Schuyler House is a pedimented doorway centered on the west façade (fig. 106). Other doorways are located in the south wall of the rear addition (fig. 108); in the east wall of the main house (figs. 109-110); and in the south, north, and west walls of the kitchen wing (figs. 110-115). A bulkhead opening to the cellar is located on the east elevation of the main house (fig. 105), and a small opening to the cellar kitchen is located in the west foundation wall (fig. 104).

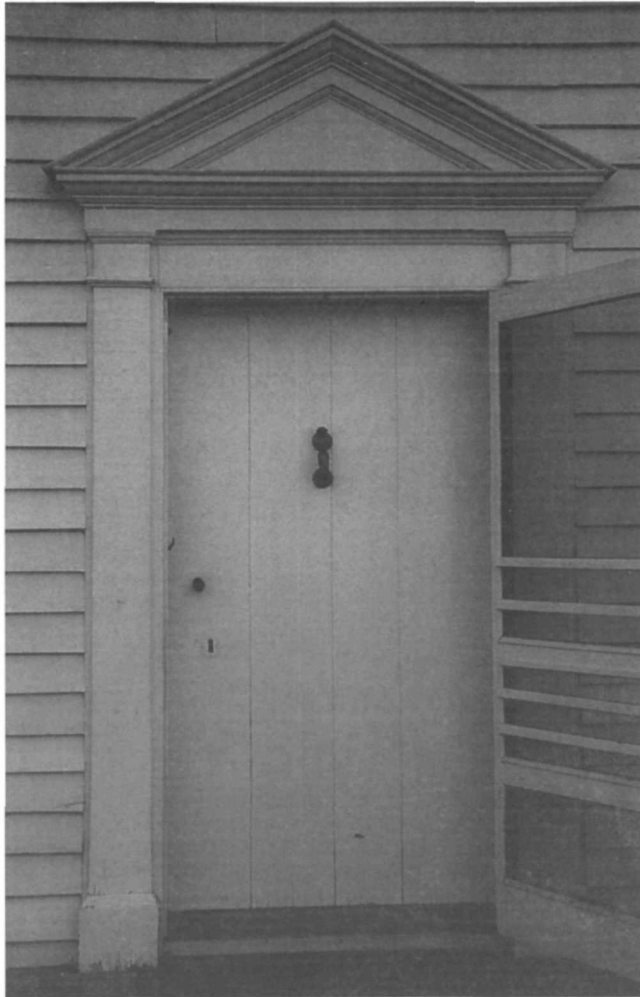
**Figure 106.** Main house, west façade, doorway D101.

| Num<br>ber | Location | Opening<br>Size | Door | Casing | Hardware | Other |
|---|---|---|---|---|---|---|
| D101 | West Façade, Center Main House<br>1777 | 3' 8" wide<br>6' 8" high | 1 ⅞" thick; <b>solid batten</b> ; four ext vertical boards 9"-12½" wide; hand-planed<br>1787 [1960 repair] | Carved wood plinth; plain 7 ½" wide pilasters support carved wood pediment<br>1787 [1960 & 1980 repairs] | 1787 key lock & oval brass knob; 19 <sup>th</sup> -c. brass door knocker | Front/main entrance |

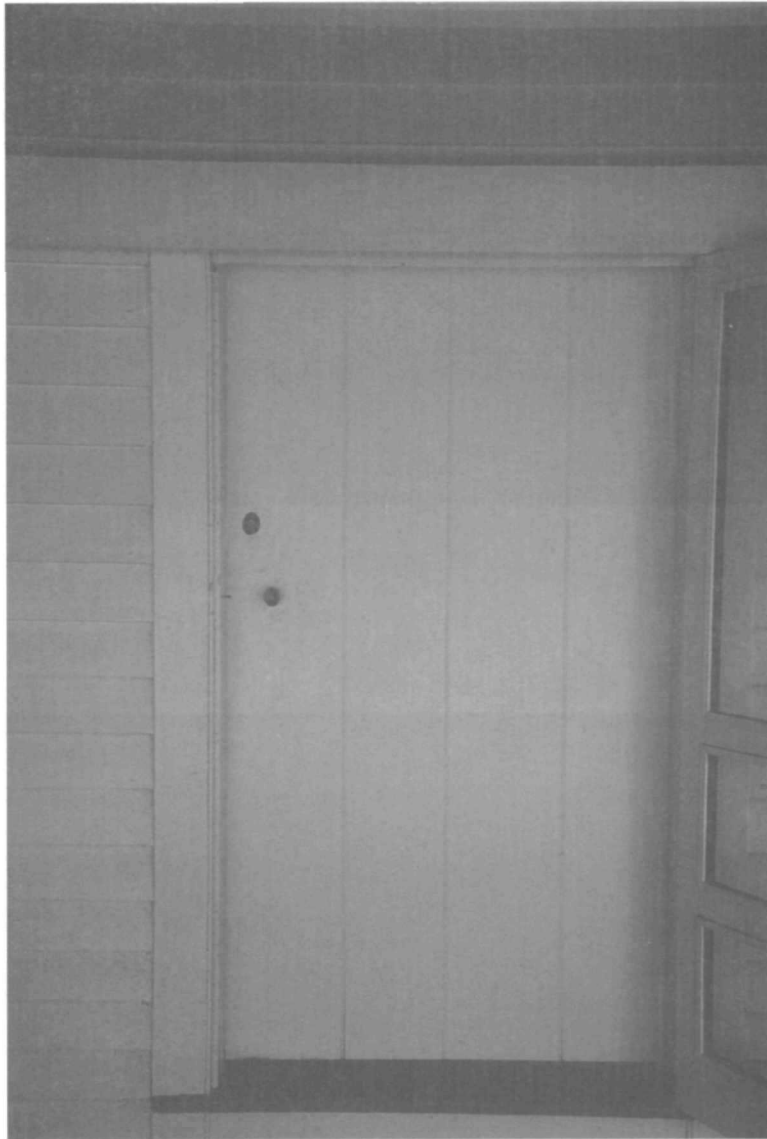
**Figure 108.** Rear addition, south wall, doorway D102.

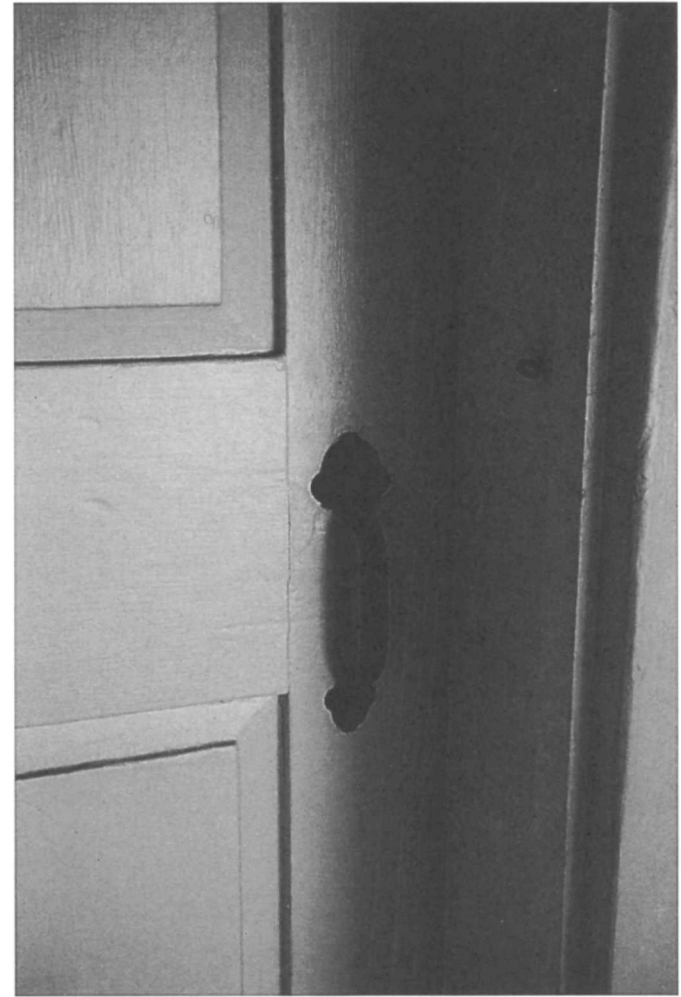
**Figure 110.** Main house, east elevation, hardware detail of doorway D103.

| Num<br>ber | Location | Opening<br>Size | Door | Casing | Hardware | Other |
|---|---|---|---|---|---|---|
| D103 | East Wall, North Main House<br>ca. 1780 | 2' 11" wide<br>6' 6" high | 1¼" thick; six raised panels; Federal style<br>ca. 1815 (?) | Butt w/ mitered, 4 ½" wide, ogee molding<br>1960 | Cast-iron Suffolk latch | Doorway to dining room; door/hardware antique replacement |

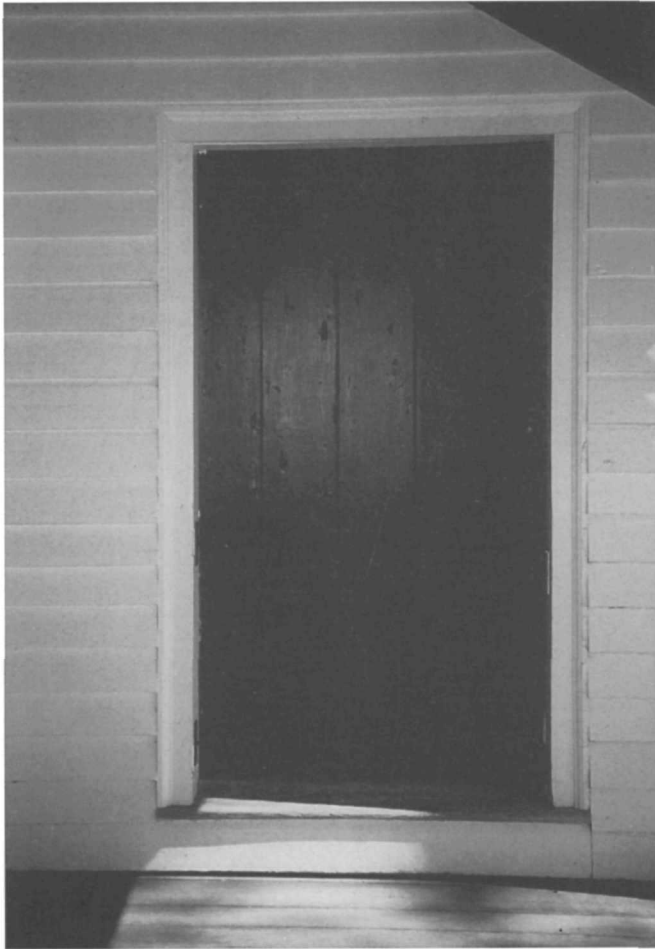
**Figure 111.** Kitchen wing, south elevation, doorway D104.

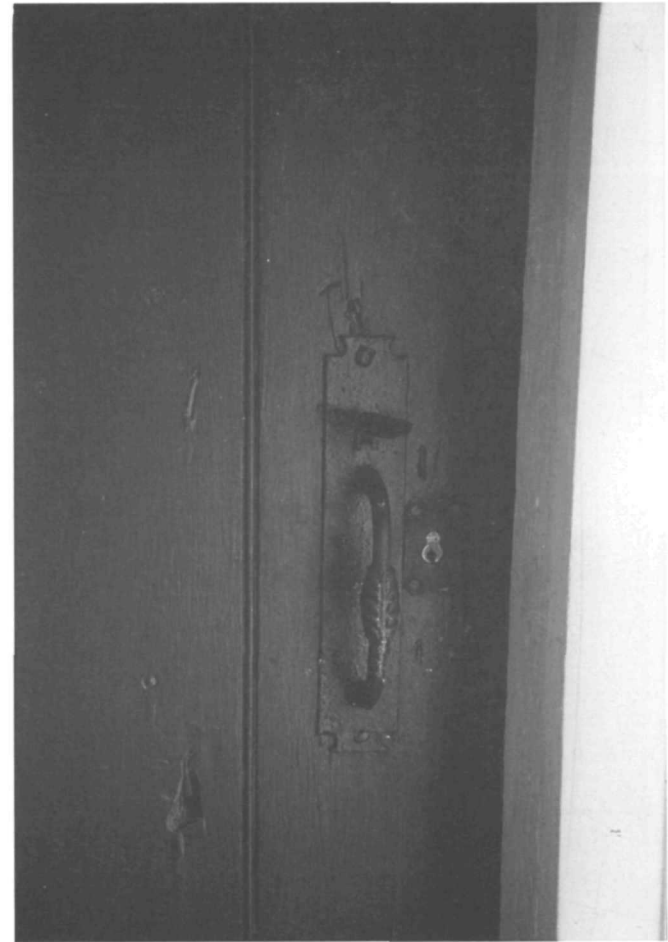
**Figure 112.** Kitchen wing, south elevation, hardware detail of doorway D104.

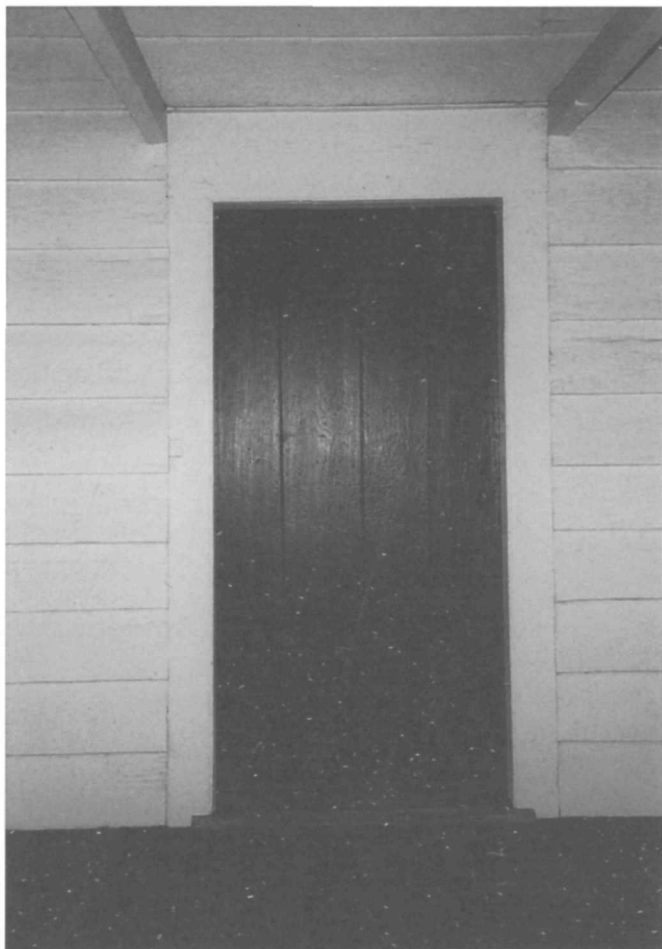
**Figure 113.** Kitchen wing, north elevation, doorway D105.

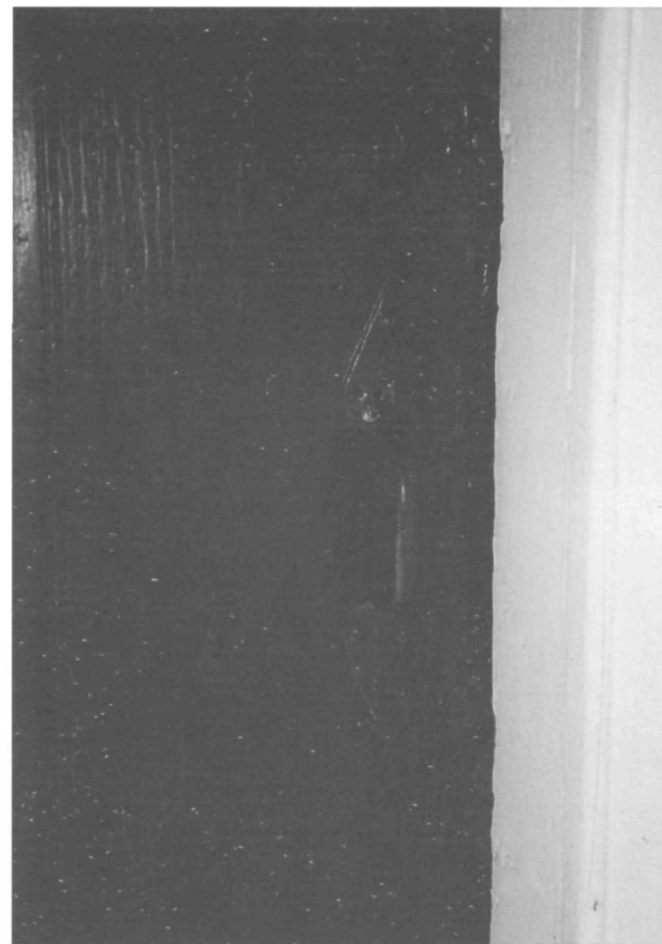
**Figure 114.** Kitchen wing, north elevation, hardware detail of doorway D105.

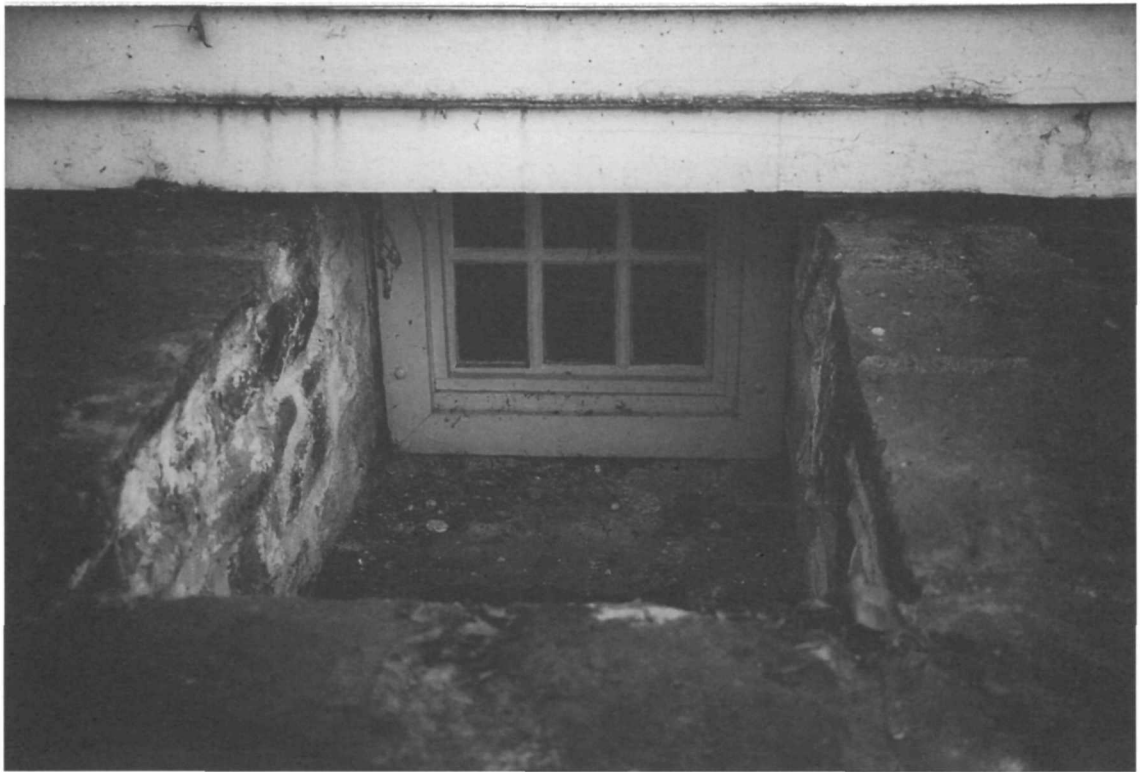
**Figure 116.** Main house, north elevation, window W106.

On the west façade of the main house, narrow windows flank the main entrance. Large windows with double-hung sashes are positioned on either side of the doorway, and across the second story (figs. 95, 120, and 127-128). Large windows with double-hung sashes are also located as follows: two on the first story of the main house's south wall (figs. 118-119); two on the first story, and one on the second story, of the main house's north wall (figs. 97, 125-126); and one on the rear addition's east wall (fig. 121). On the kitchen wing, casement windows are located on the south wall (fig. 122), on the second story of the east wall (fig. 102), and on the second story of the west wall (fig. 98). All windows are fitted with solid exterior blinds. Two small casement windows protected by wooden louvered blinds are at the north and south gables of the main house. Cellar windows with stone-lined areaways and wooden hatch covers are located on the west façade, and on the north and south walls, of the main house (figs. 116-118).

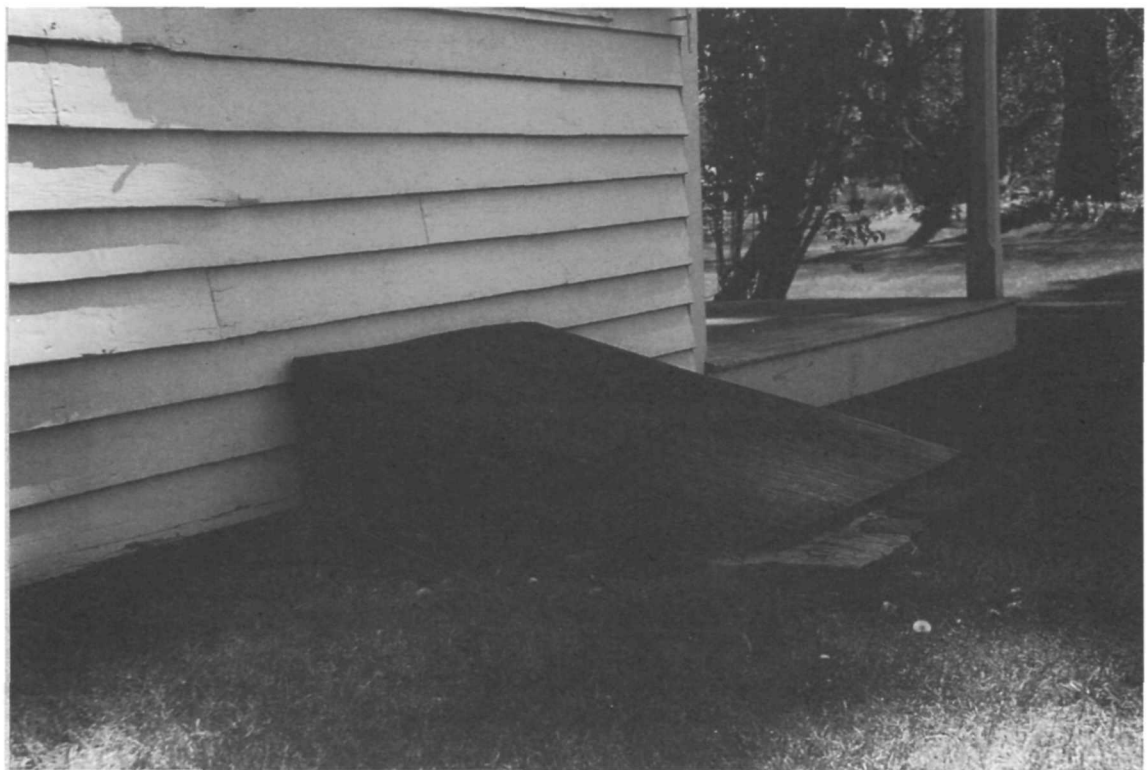
**Figure 117.** Main house, south elevation, window W004 areaway cover.

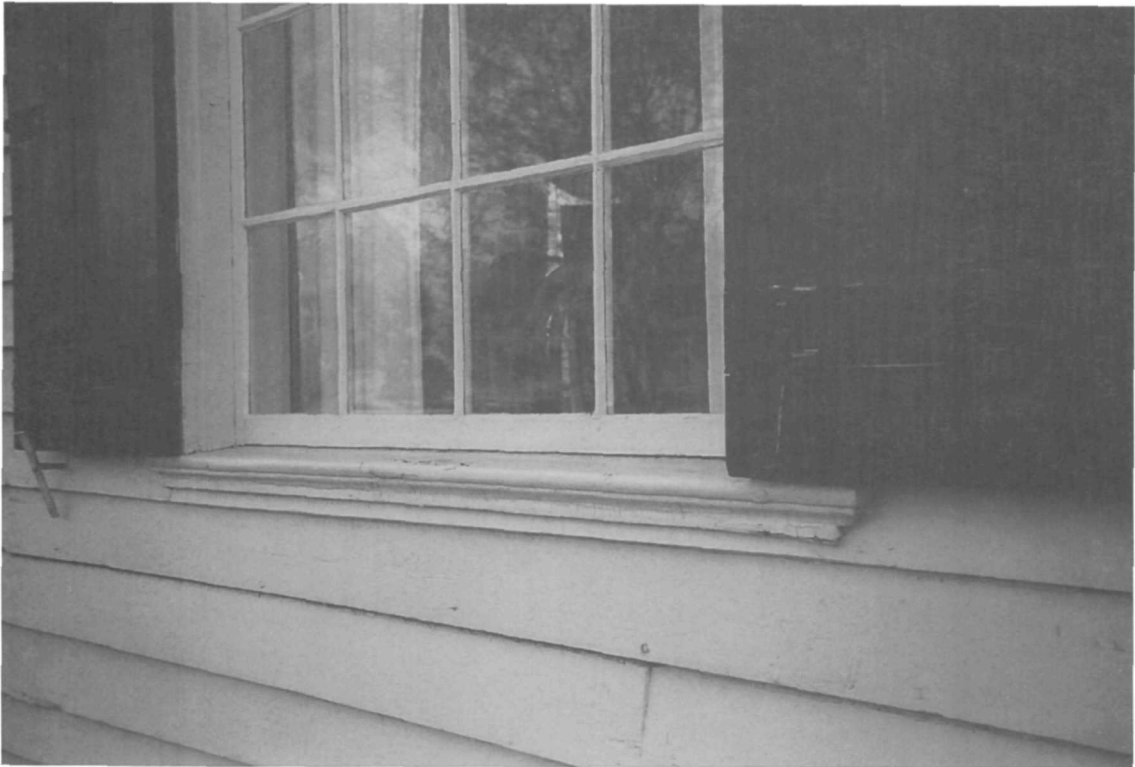
**Figure 119.** Main house, south elevation, sill detail of window W108.

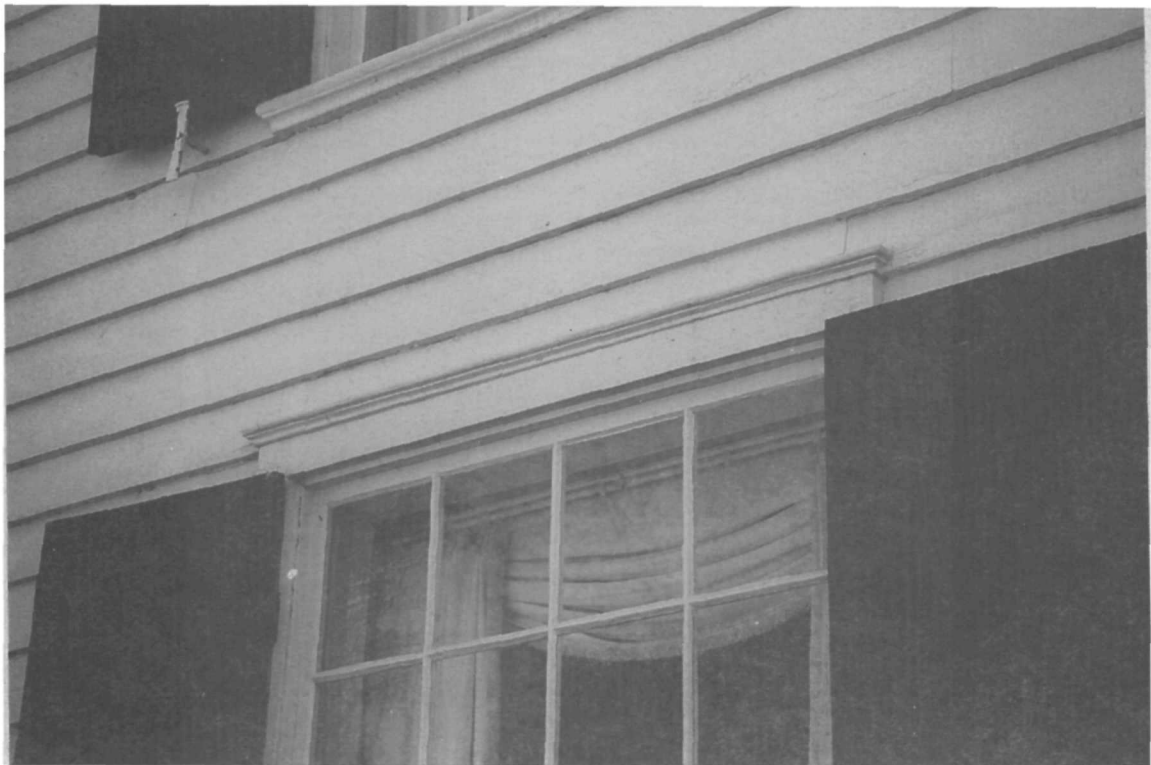
**Figure 120.** Main house, west façade, cornice detail of window W106.

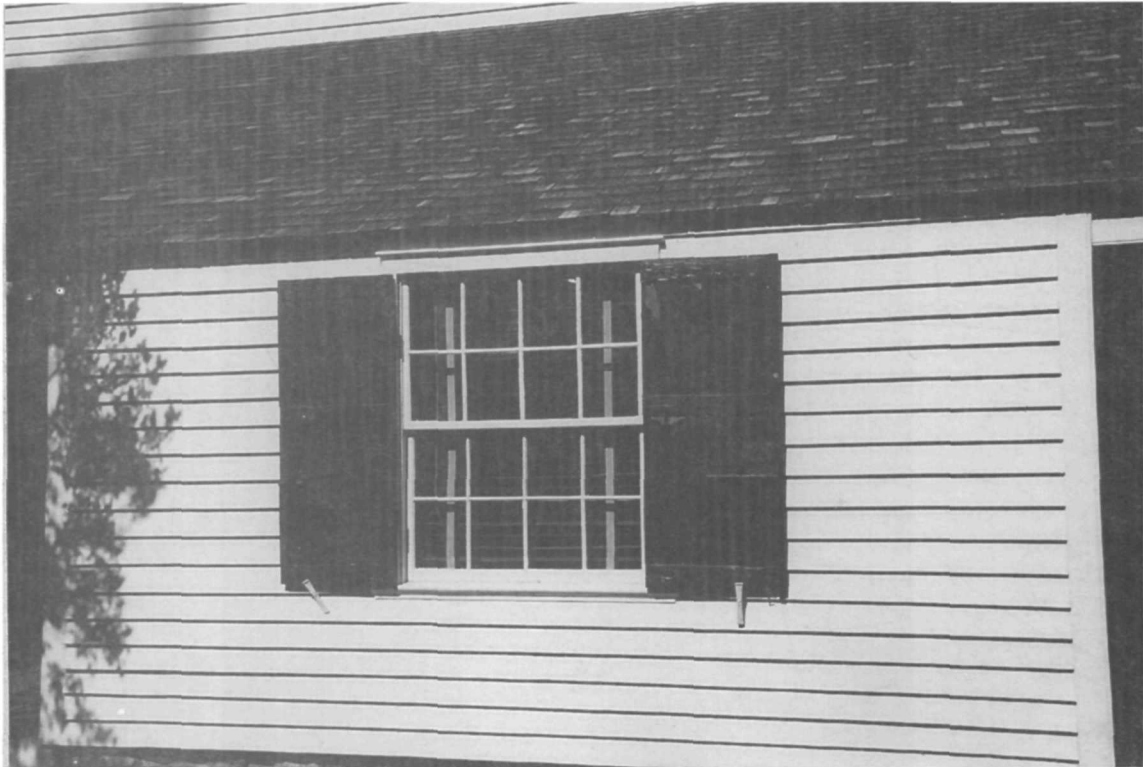
**Figure 121.** Rear addition, east elevation, window W109.

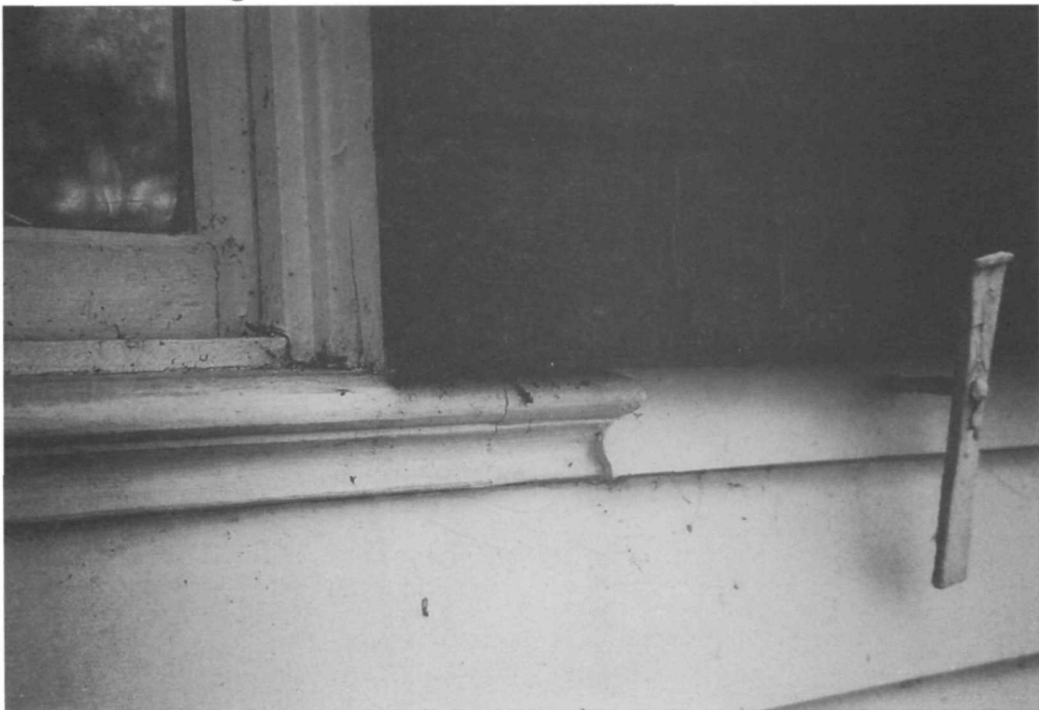
**Figure 124.** Main house, north elevation, sill detail of window W111.

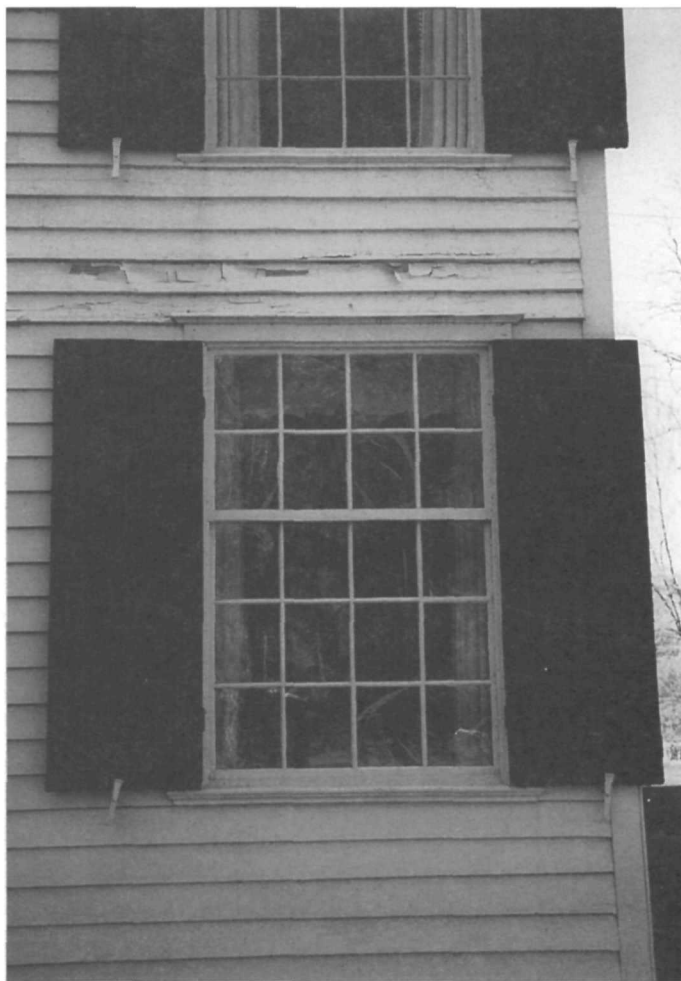
**Figure 125.** Main house, north elevation, window W112.

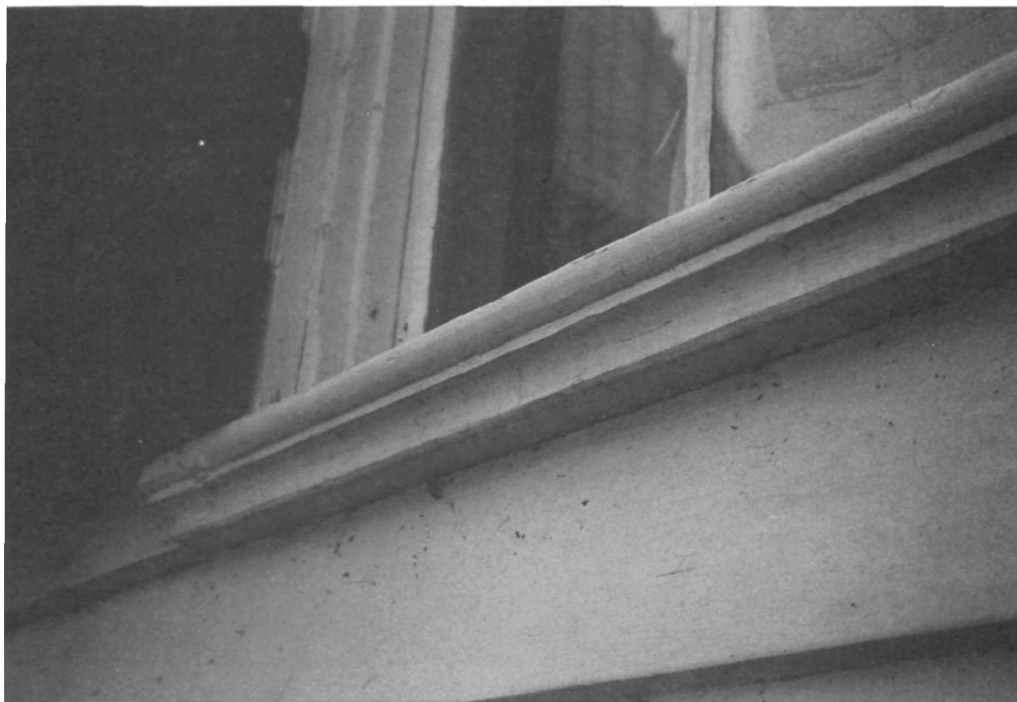
**Figure 126.** Main house, north elevation, sill detail of window W112.

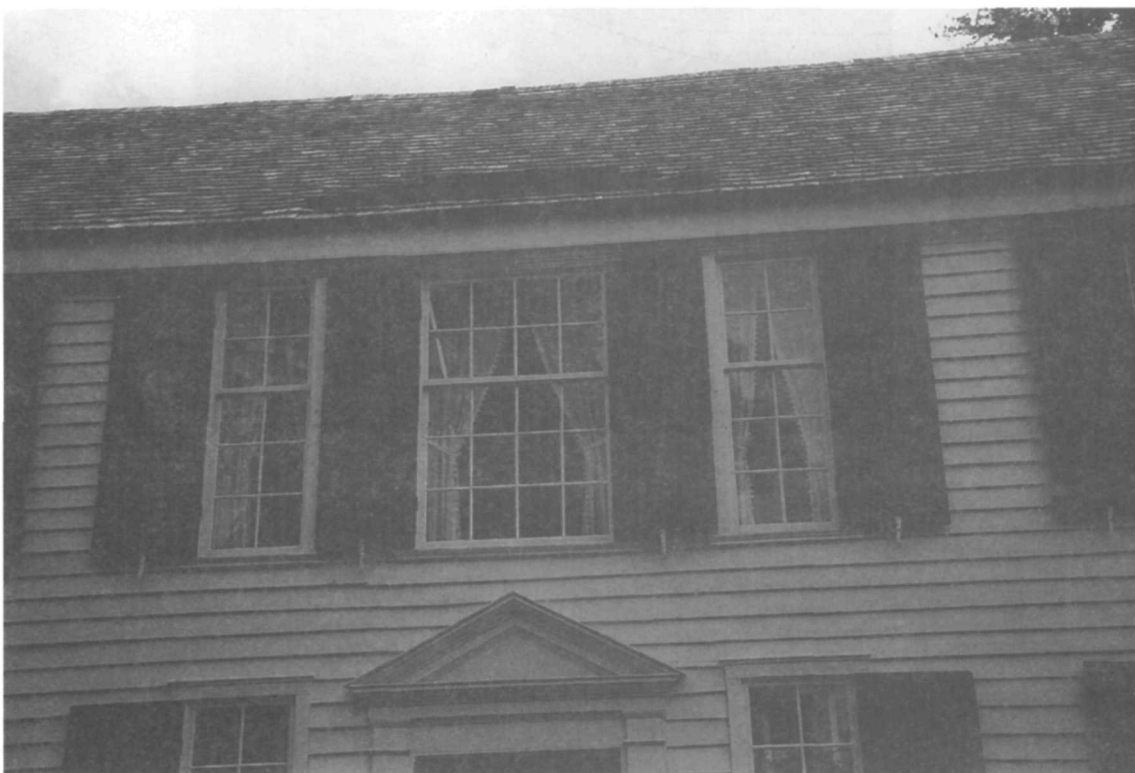
**Figure 127.** Main house, west façade, windows W203-W205.

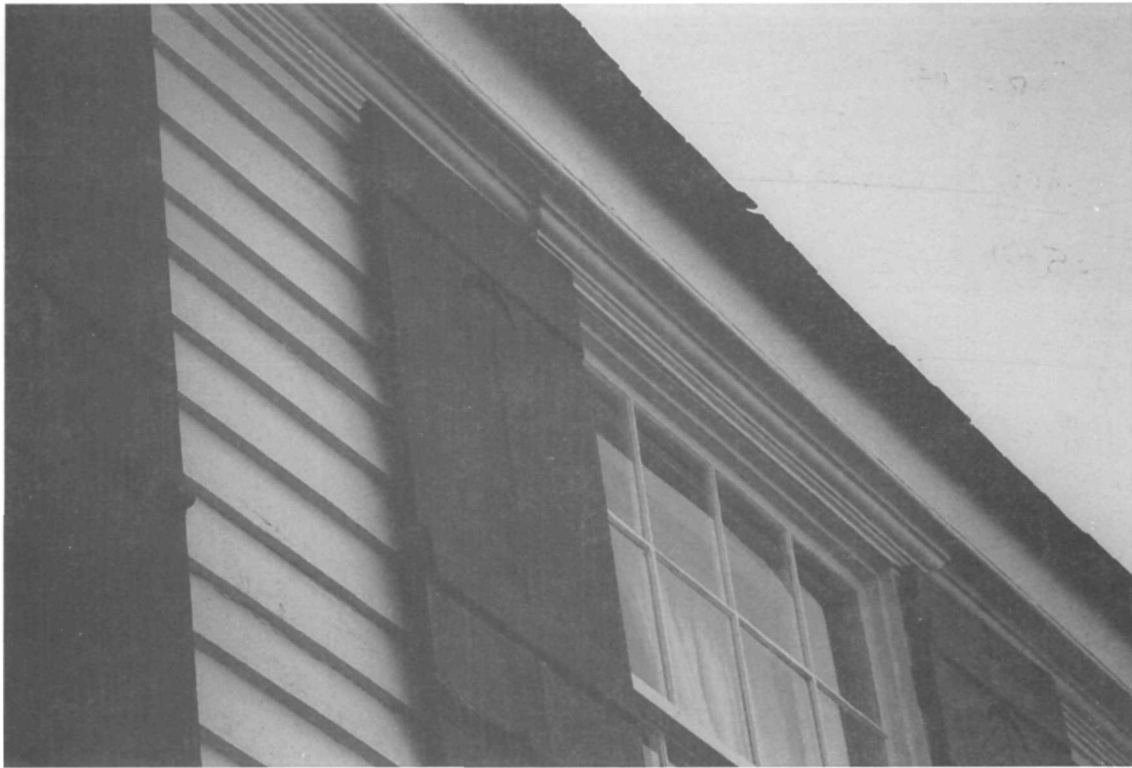
**Figure 128.** Main house, west façade, shutter detail of window W206.
