# GENERAL PHILIP SCHUYLER HOUSE

Saratoga National Historical Park  
Schuylerville, New York

Historic Structure Report  
Volume I

**GENERAL PHILIP SCHUYLER HOUSE**  
**HISTORIC STRUCTURE REPORT**

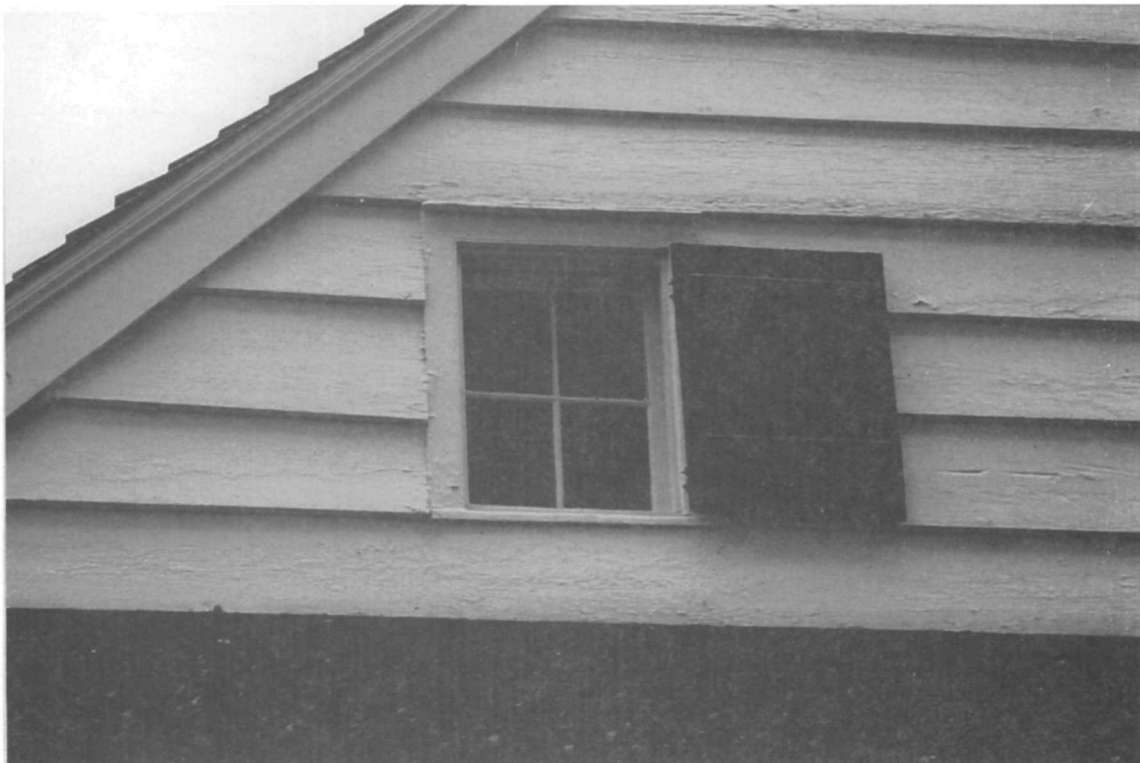
**Figure 129.** Kitchen wing, east elevation, window W208.

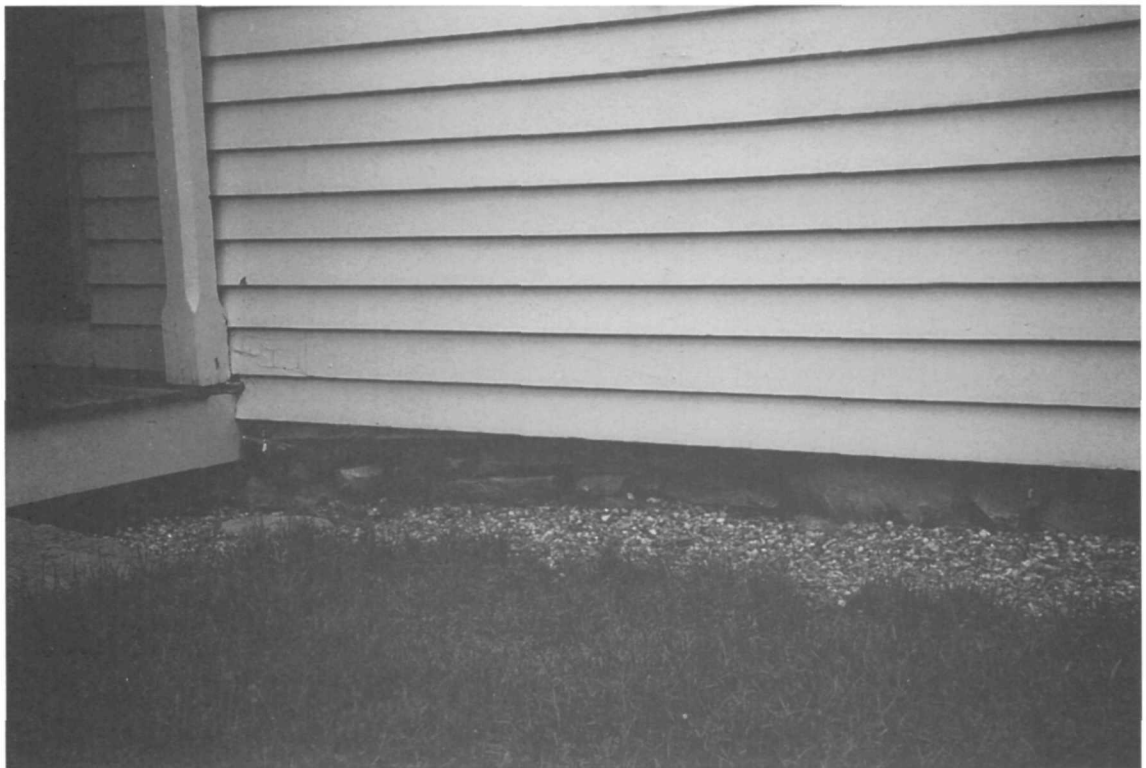
**Figure 131.** Kitchen wing, south elevation, fieldstone foundation.

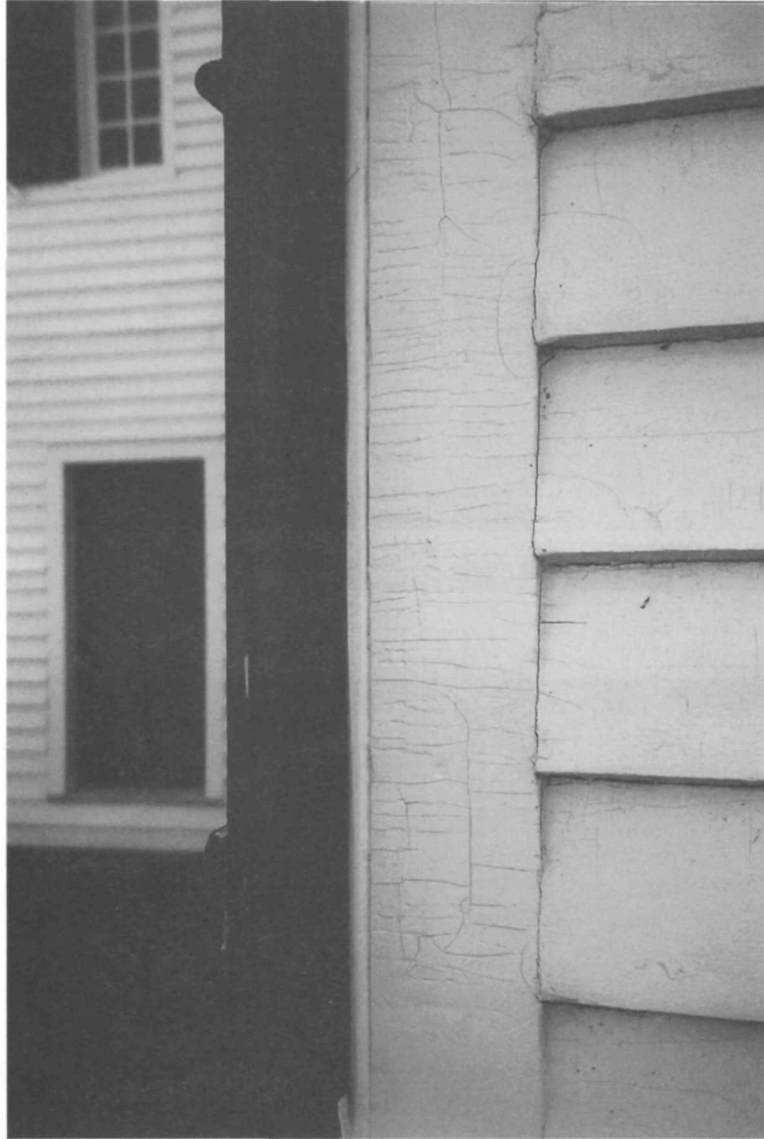
**Figure 132.** Main house, west façade, north corner board.

All of the walls of the Schuyler House are covered with clapboards except for the north and east walls of the kitchen wing, which are covered with wide weatherboards. The walls of the main house are trimmed with beaded corner boards 5 inches wide (fig. 132); the walls of the kitchen wing have corner boards 4 inches wide. Molded wood cornices with 5-inch overhangs trim the eaves of the east and west walls of the main house (fig. 128). A verge board 6 ½ inches wide with an ogee molding 2 ½ inches wide trims the gables of the main house and the kitchen wing, the top of the south wall of the kitchen wing, and the rakes and eaves of all of the porch walls. All roofs are covered with wood shingles; the west slope of the main-house roof, and the north slope of the kitchen-wing roof, end in roof combs (fig. 136). Brick chimneys are located at the north and south ends of the main-house roof, and at the east end of the kitchen-wing roof (fig. 101). A restored 19<sup>th</sup>-century privy (not a subject of this report) sits to the east of the kitchen wing.

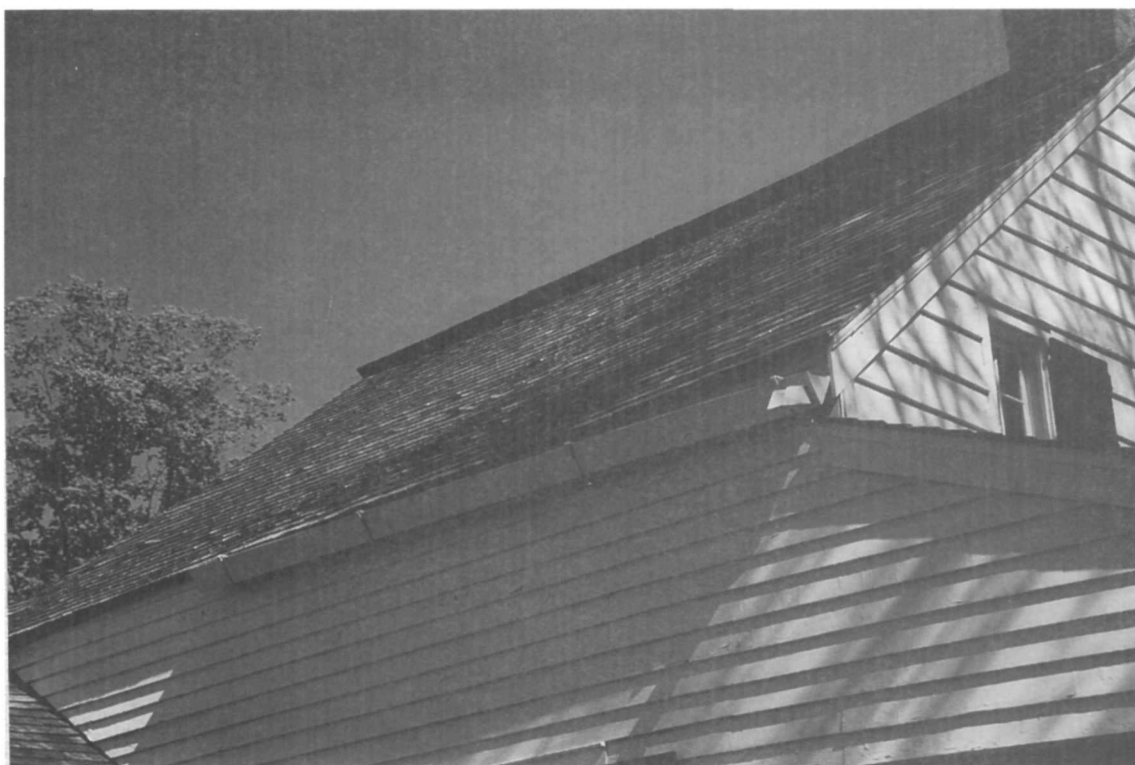
**Figure 133.** Kitchen wing, south elevation, south roof and north-roof comb.

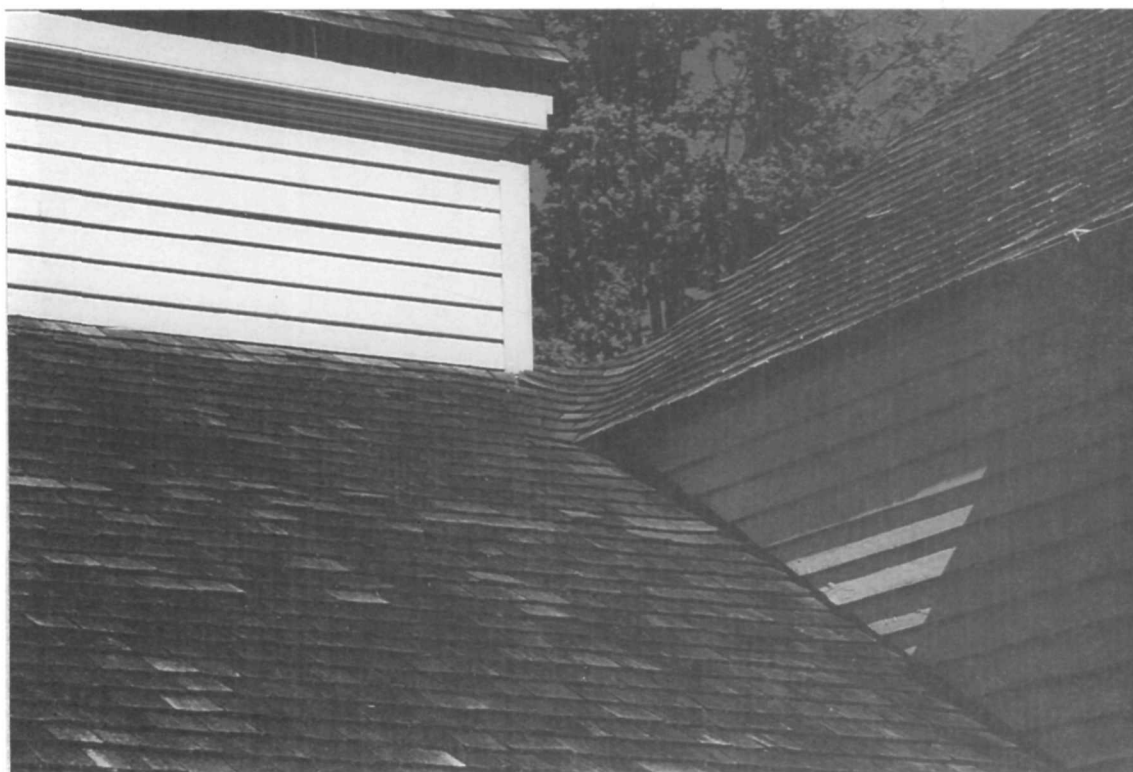
**Figure 134.** East elevation, cricket at junction of north-porch roof and kitchen-wing roof.

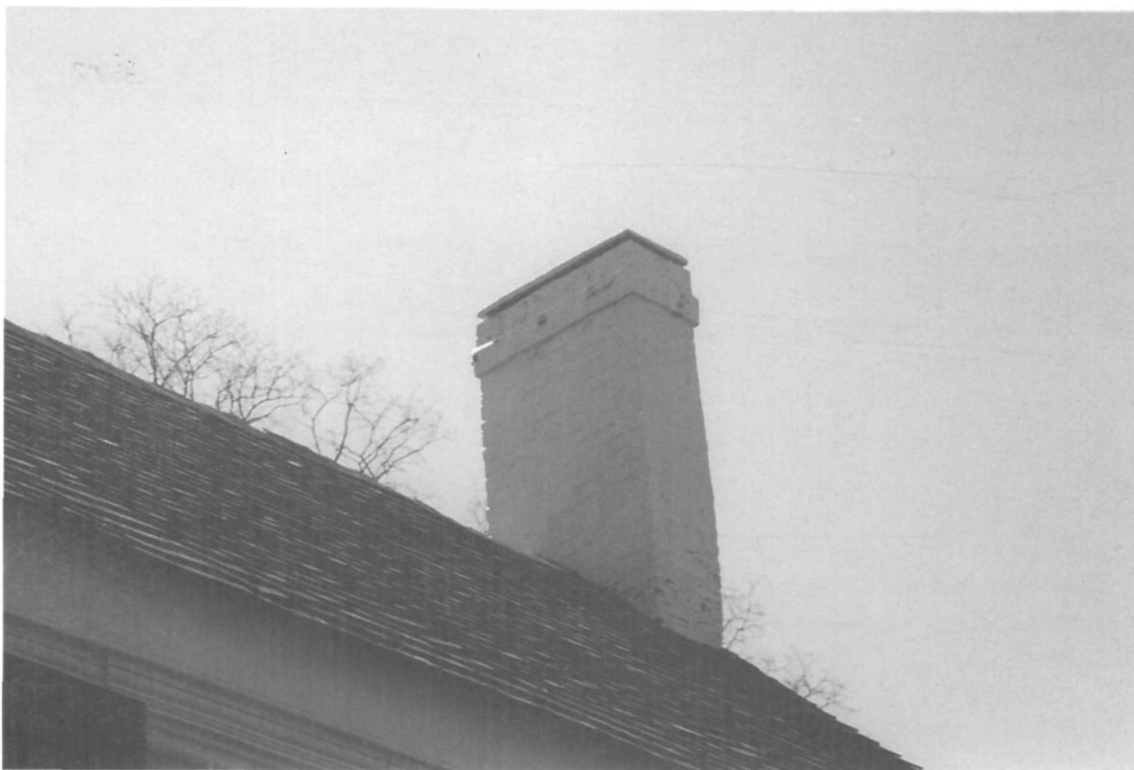
**Figure 135.** Main house, south chimney.

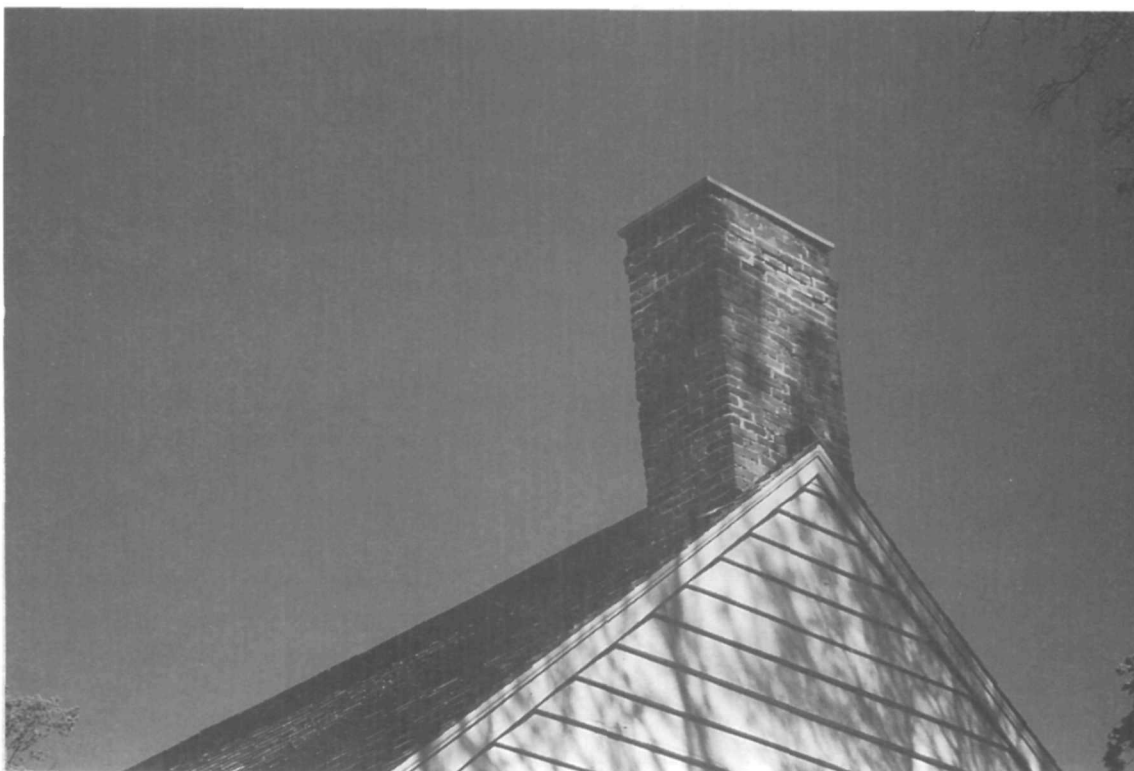
**Figure 136.** Kitchen-wing chimney.

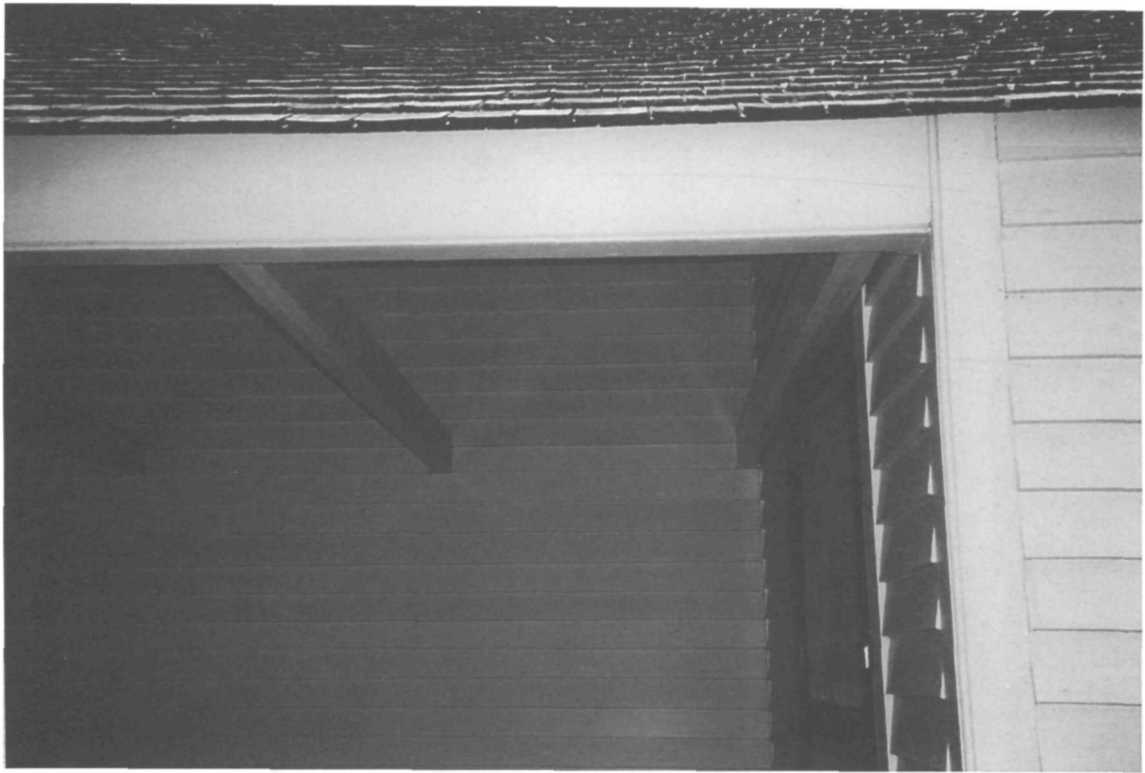
**Figure 137.** Main house, east elevation, south porch at rear addition.

The Schuyler House (fig. 95) consists of a two-story main house with a one-story addition on its rear (east) wall (fig. 100), and a story-and-a-half kitchen wing attached to its northeast corner (figs. 96-99). The main house is a rectangular structure that measures approximately 60 feet 4 inches wide by 21 feet deep; it sits on a fieldstone foundation with full cellar. The rear addition measures 15 feet wide by 12 feet deep, and the kitchen wing measures approximately 25 feet by 26 feet 4 inches; both sit on low fieldstone foundations. Brick bake ovens are built against the kitchen wing's east exterior wall (fig. 139). The main house faces west, and has a gable roof whose ridge runs north/south. The kitchen wing also has a gable roof, with its ridge oriented east/west, at right angles to that of the main house. The rear addition and its flanking porches are covered by a shed roof that extends across the entire east (rear) wall of the main house; on the kitchen wing, deep shed-roofed porches protect the north wall and the bake ovens on the east wall (figs. 99-101 and 137-140).

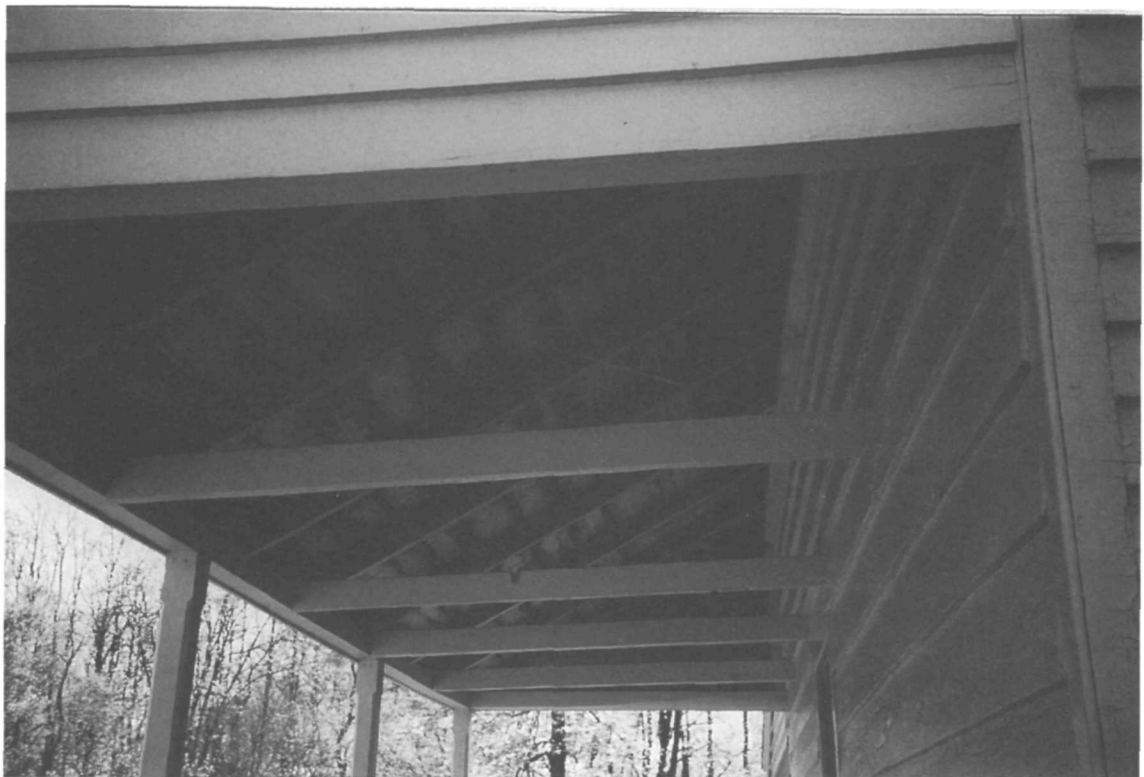
**Figure 138.** Kitchen wing, porch on north elevation.

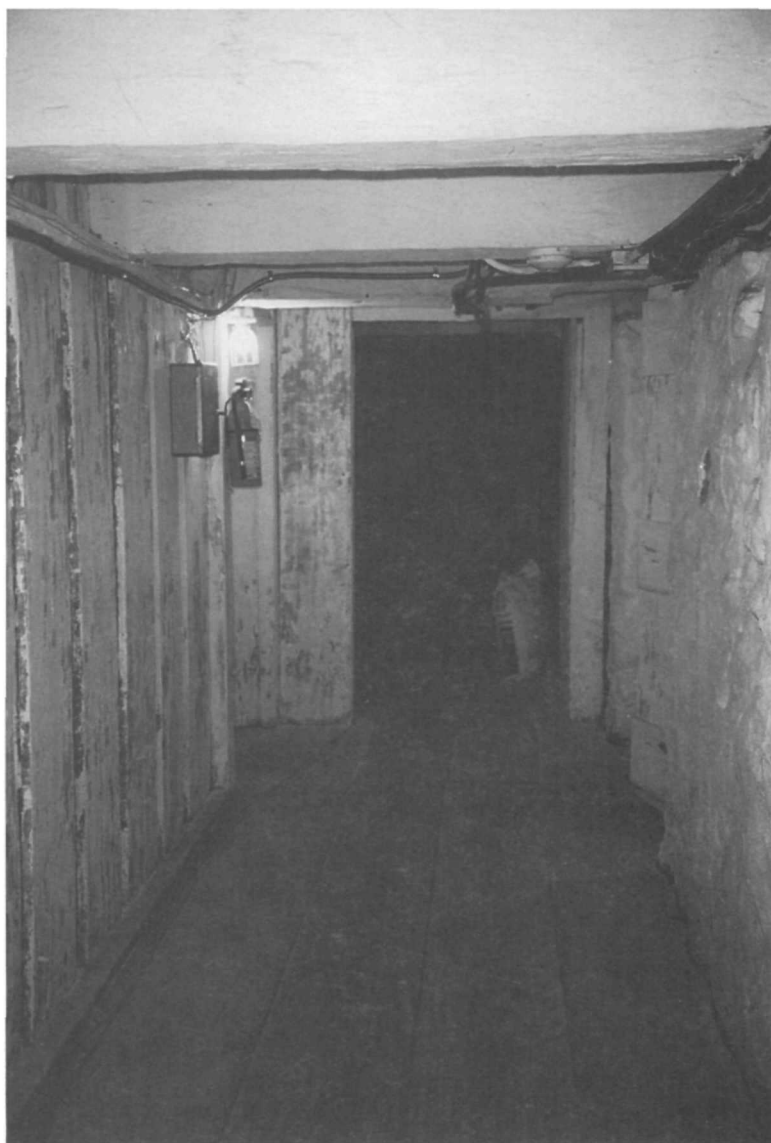
**Figure 141.** Cellar hall (Room 001), looking north to doorway D003.

The cellar hall (fig. 141) is centered along the east side of the cellar level of the Schuyler House. The room measures approximately 6 feet wide by 16 feet long. The east wall of the room is the fieldstone foundation wall; the north and south walls are occupied by doorways; and the west wall is a vertical-plank partition. There are a total of four doorways in the hall. A double doorway (D002) near the north end of the east wall opens to the exterior, bulkhead entrance to the cellar. The single doorway (D003: fig. 142) in the north wall opens to a storage room (Room 002), while the single doorway (D005: fig. 143) in the south wall leads to the cellar kitchen (Room 004). A single doorway (D004: figs. 144-145) at the north end of the west wall opens to a food storage room (Room 003). There are no windows in the room.

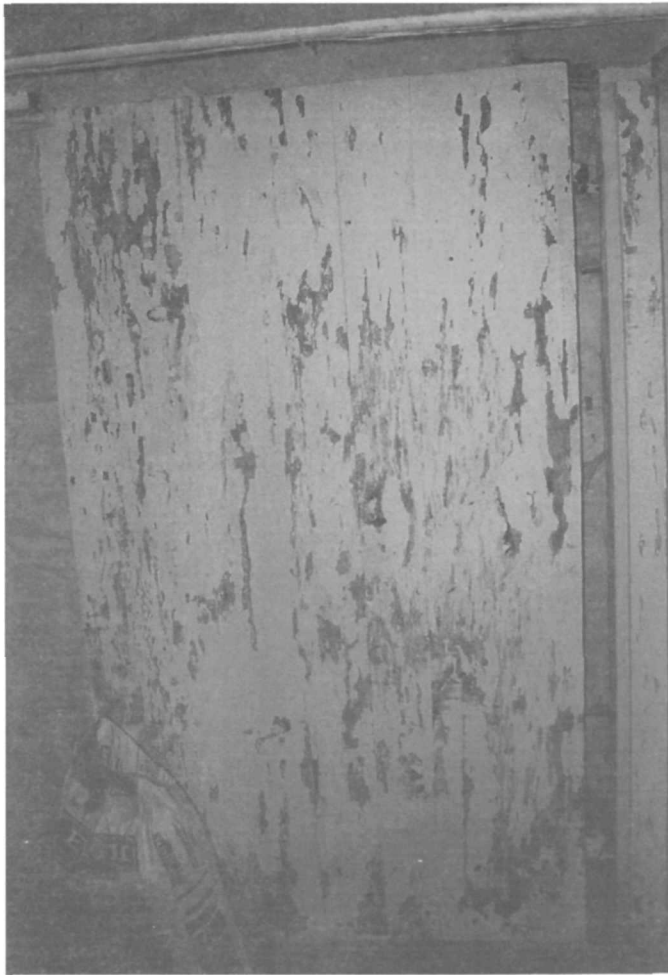
**Figure 142.** Storage-room side of door in doorway D003.

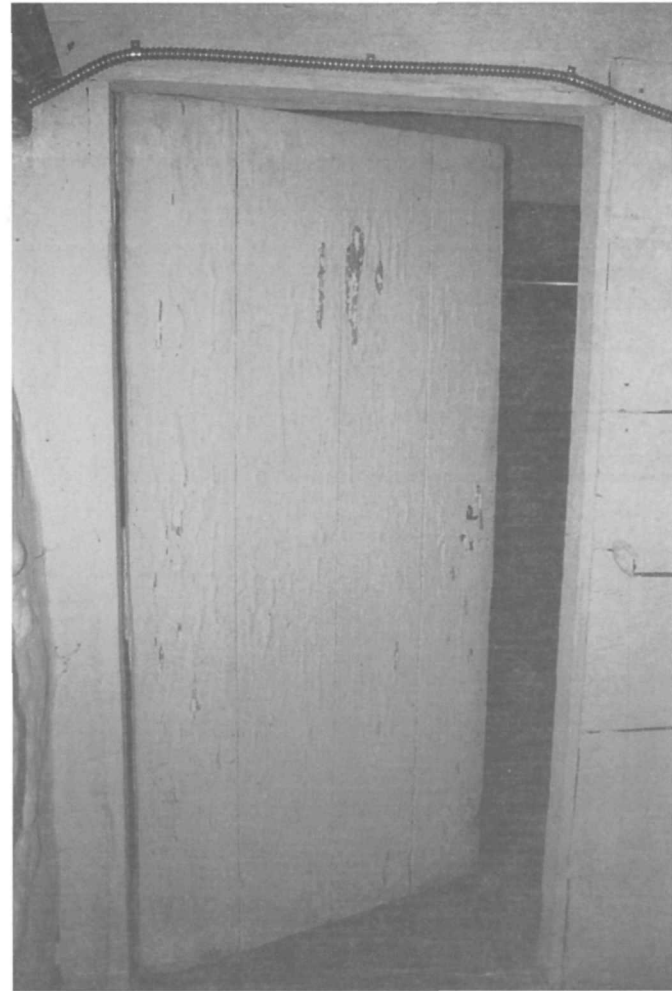
**Figure 143.** Cellar hall (Room 001), south wall, doorway D005.

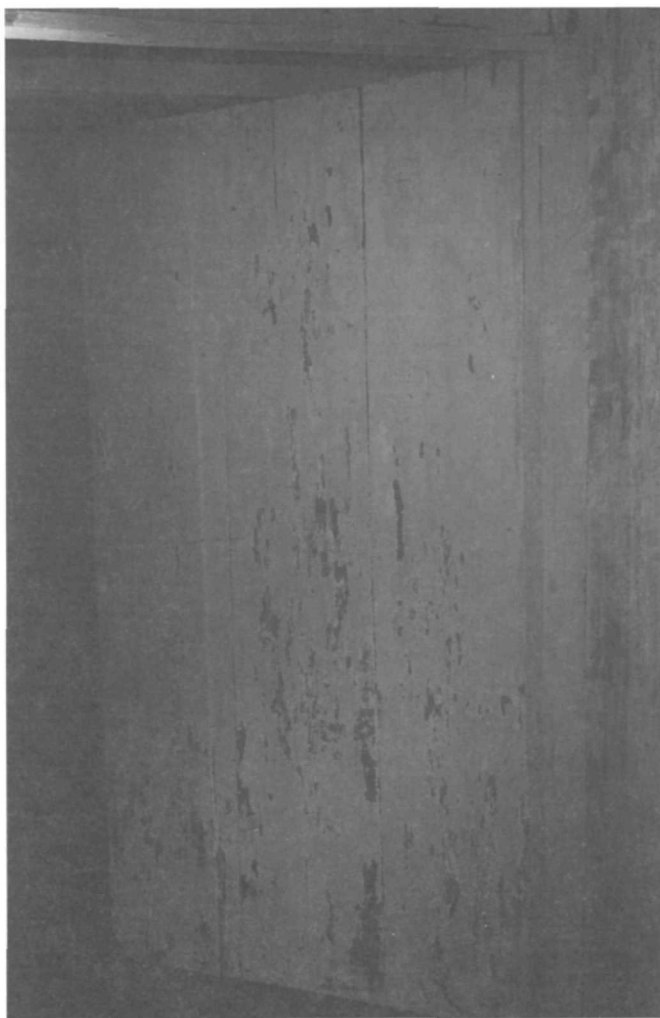
**Figure 144.** Cellar hall (Room 001), west wall, doorway D004.

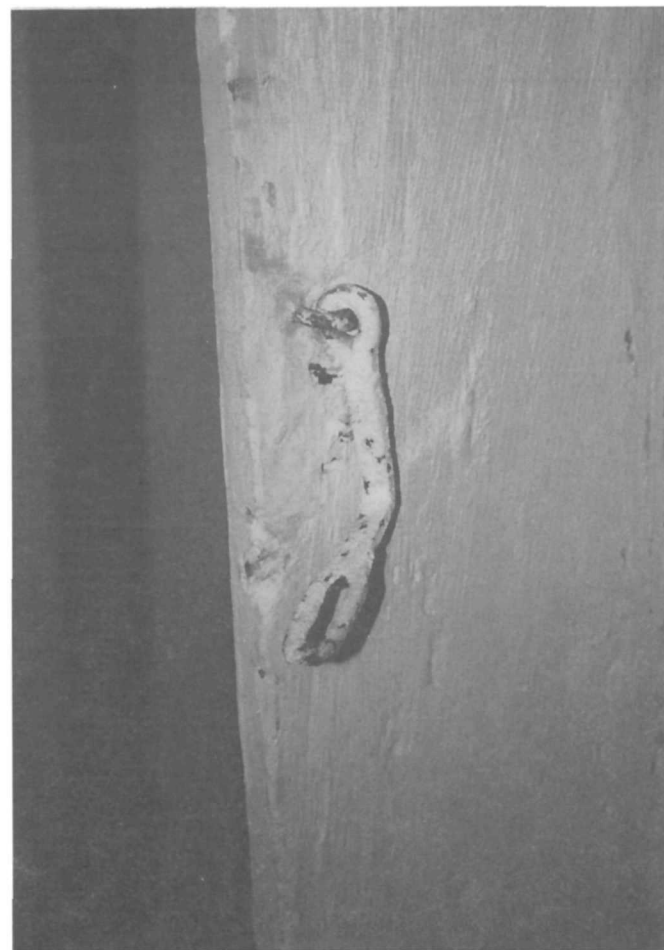
**Figure 145.** Cellar hall (Room 001), west wall, detail of doorway D004 hardware.

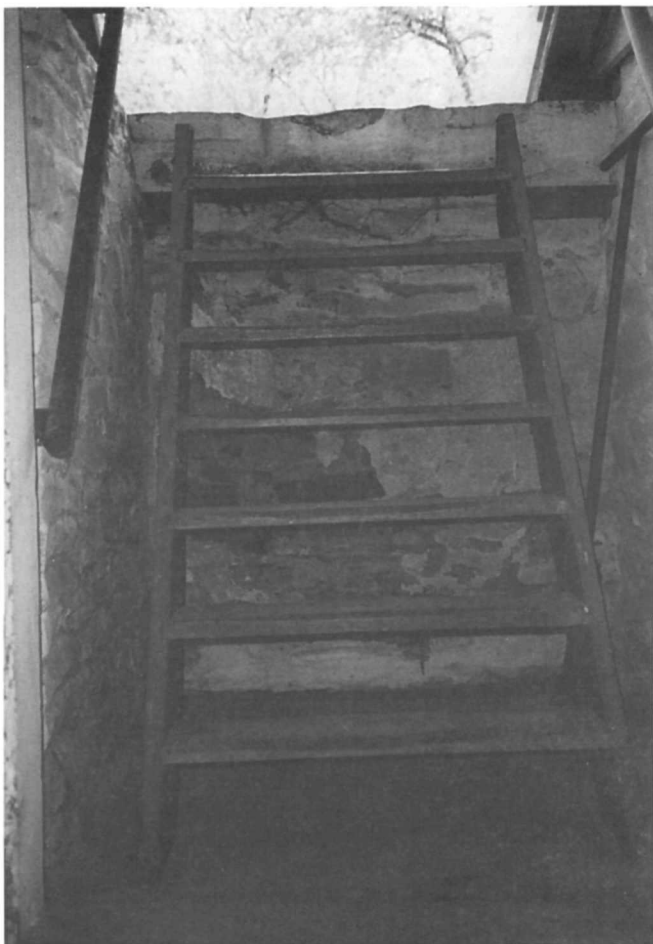
**Figure 146.** Cellar hall (Room 001), looking east through doorway D002 at bulkhead stairway.

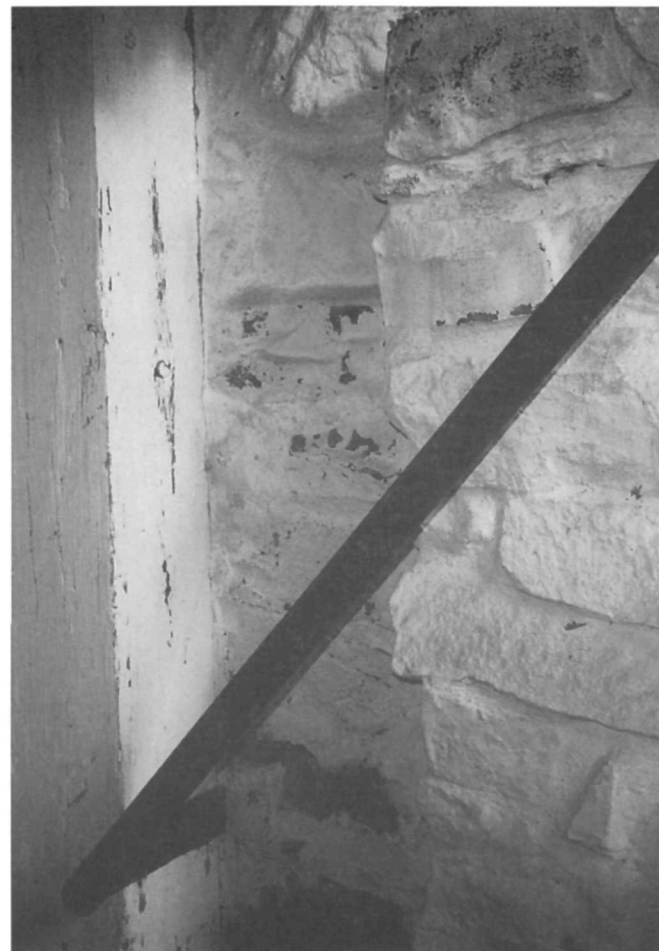
**Figure 147.** Cellar hall (Room 001), north wall of bulkhead, showing former location of doorway jamb.

Most of the features in the cellar hall appear to date to the 1777 construction of the house except for the bulkhead, which was altered during the 1950s restoration work. The doorway to the bulkhead (D002) holds what appears to be the original door leaves, but the door jamb was moved 1 foot to the west (fig. 147). In addition, the bulkhead stairway was rebuilt (fig. 146), and the stone wall was repaired. It also appears that the batten door (D004) in the doorway to the storage room was moved here from the doorway (D006) between the storage room and the food storage room.

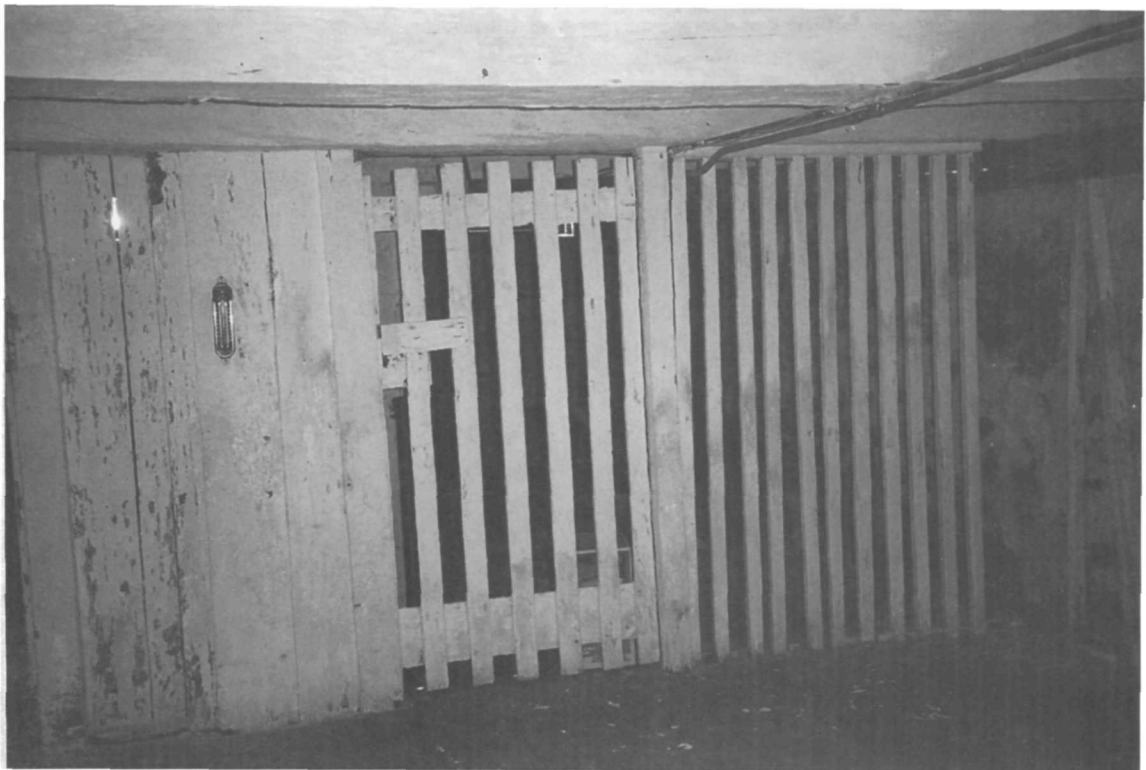
**Figure 149.** Cellar storage room (Room 002), south wall.

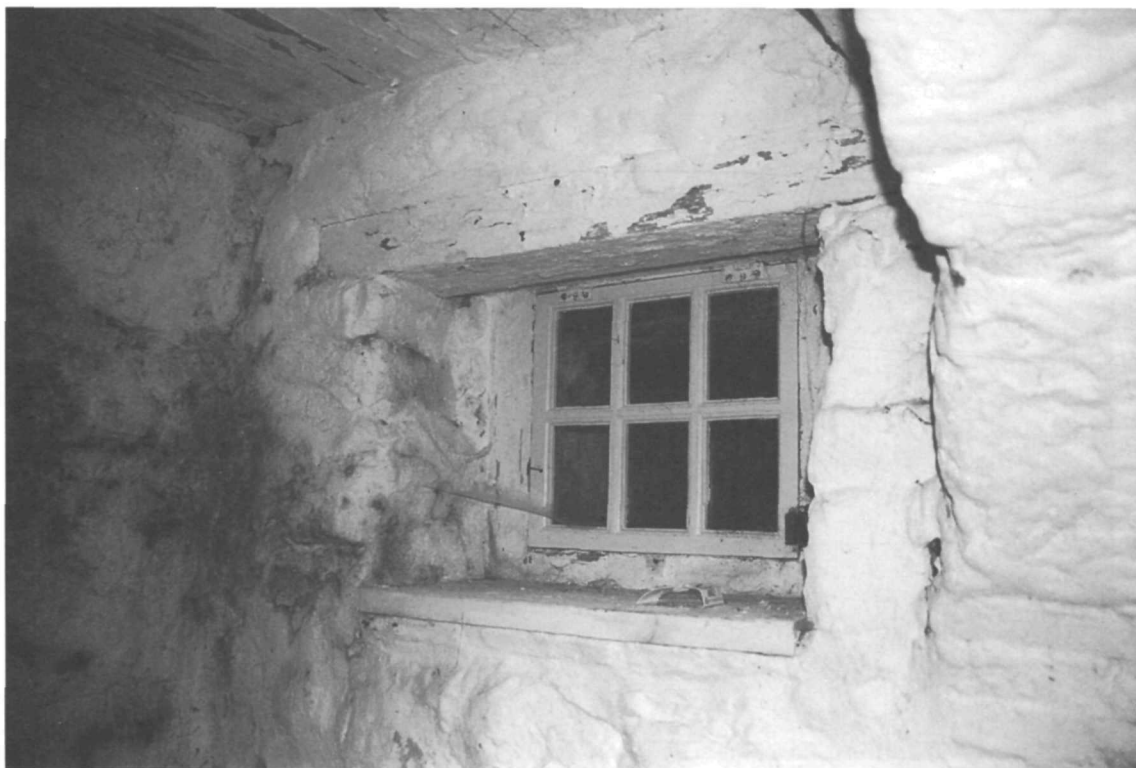
**Figure 150.** Cellar storage room (Room 002), north wall, window W006.

The cellar storage room (fig. 148) is located at the north end of the cellar level of the Schuyler House. The room measures approximately 16 feet 6 inches square. The east, north, and west walls of the room are the fieldstone foundation walls, and the south wall is constructed of spaced wooden slats (an "open-slat partition"). A doorway (D003) at the east end of the south wall opens from the cellar hall (Room 001), and an open-slat doorway (D006) at the center of the south partition (fig. 149) leads to the food storage room (Room 003). A brick chimney arch sits at the center of the north wall (fig. 148). Cellar windows (W005, W006) are located east and west of the chimney arch (figs. 148, 150), and in the west foundation wall (W001: fig. 151).

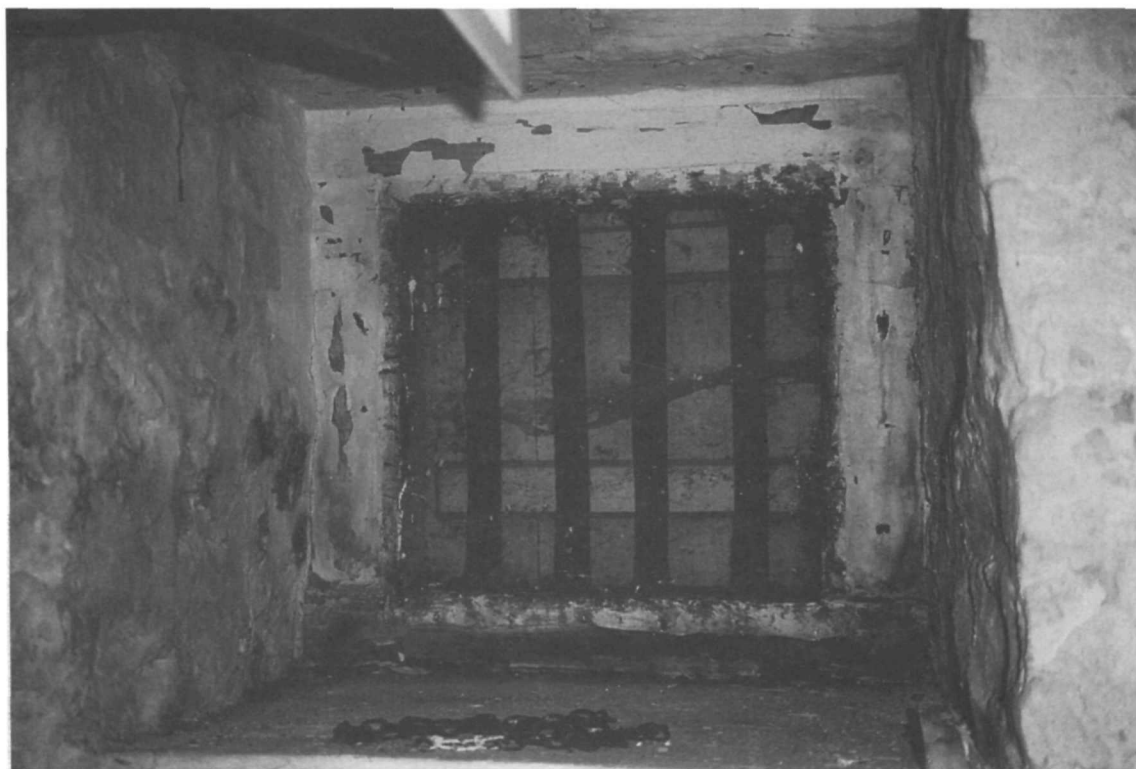
**Figure 151.** Cellar storage room (Room 002), west wall, window W001.

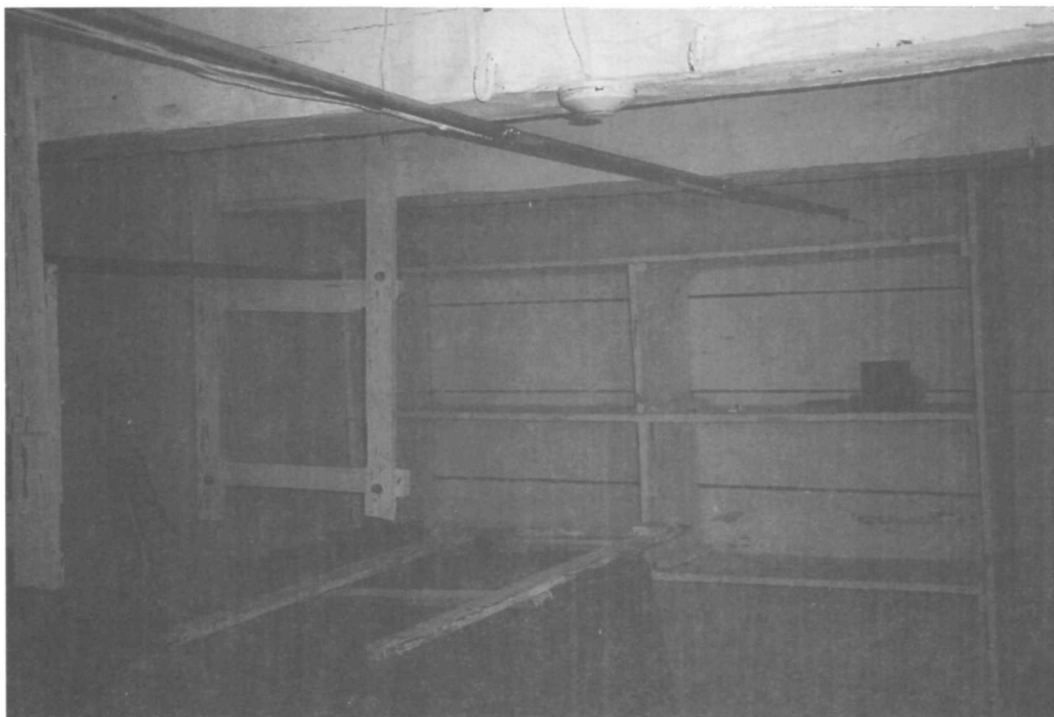
**Figure 153.** Food storage room (Room 003), looking southeast.

The food storage room (figs. 152-153) is centered on the west side of the cellar level of the Schuyler House. The room measures approximately 16 feet wide by 10 feet deep. The west wall of the room is the fieldstone foundation wall. The north wall is the open-slat partition described in connection with the storage room (Room 002). The south wall is a horizontal-board partition (over brick nogging on the kitchen-cellar side). The east wall is brick nogging backed by the vertical-plank partition described in association with the cellar hall. A doorway (D004) at the north end of the east wall leads to the cellar hall (Room 001), and an open-slat doorway (D006) at the center of the north partition opens to the storage room (Room 002). A hatchway with a trap door to the dining-room pantry above is located in the ceiling just west of the doorway from the cellar hall. Deep shelves are located at the east end of the south wall, and suspended frames for addition shelving are located on the east wall. There are no windows in the room.

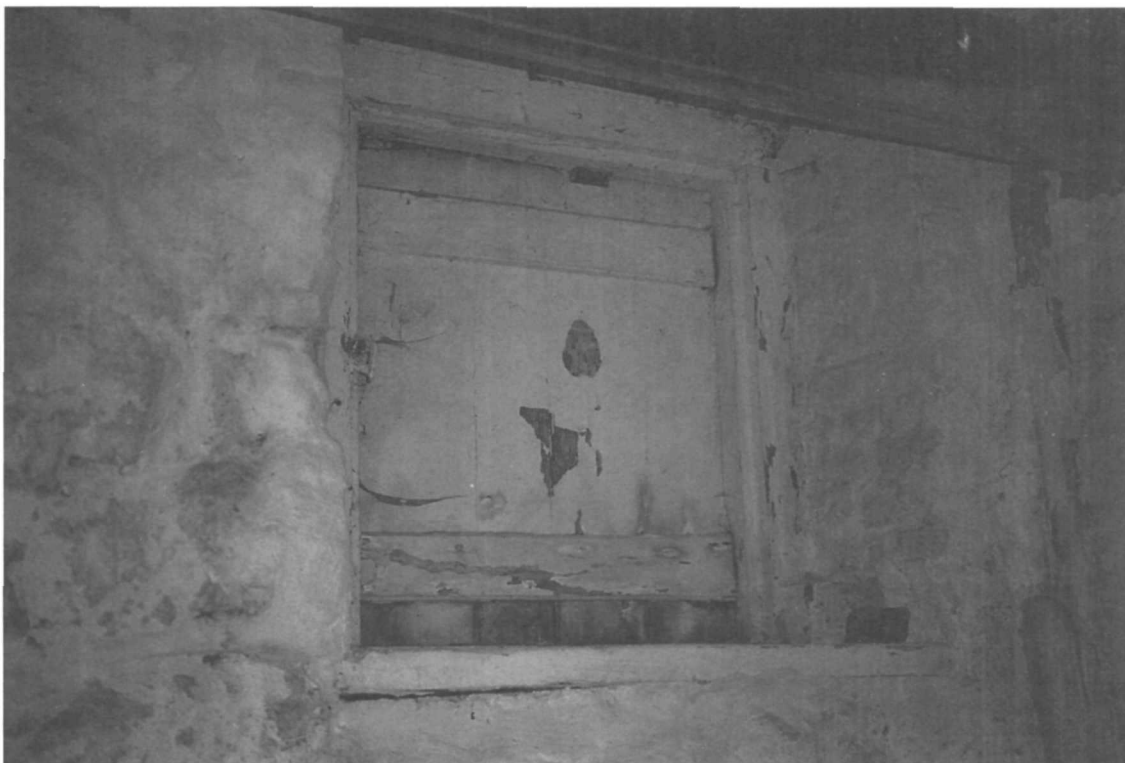
**Figure 157.** Cellar kitchen (Room 004), west wall, opening O001.

The cellar kitchen (figs. 154-160) is located at the south end of the cellar level of the Schuyler House. The room measures approximately 16 feet 6 inches wide by 22 feet deep. The east, south, and west walls of the room are the fieldstone foundation walls; the north wall is brick nogging backed by the horizontal-plank partition described in connection with the food storage room. A doorway (D005) at the east end of the north wall opens from the cellar hall (Room 001), and a small exterior opening (O001) with a batten door is located at the north end of the west wall (fig. 157). A brick fireplace is built against the south wall (fig. 154). Cellar windows are located east and west of the fireplace (W004, W003: figs. 154, 160), and near the south end of the west foundation wall (W002: fig. 158).

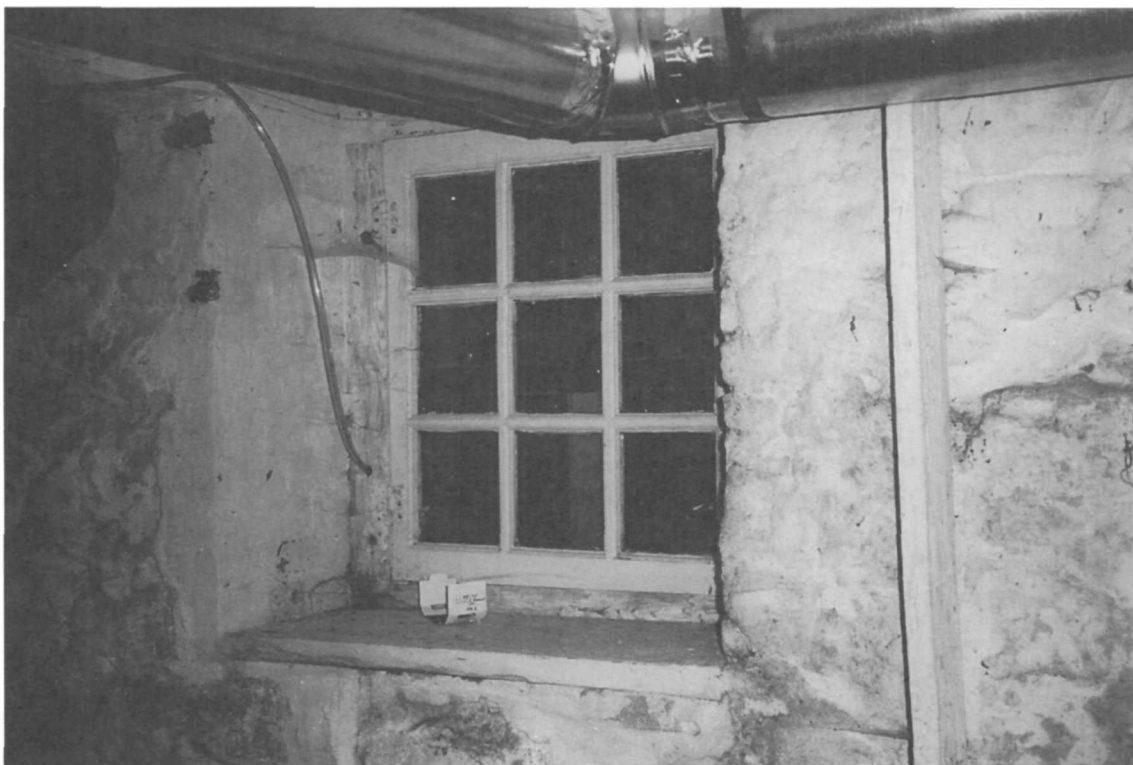
**Figure 158.** Cellar kitchen (Room 004), west wall, window W002.

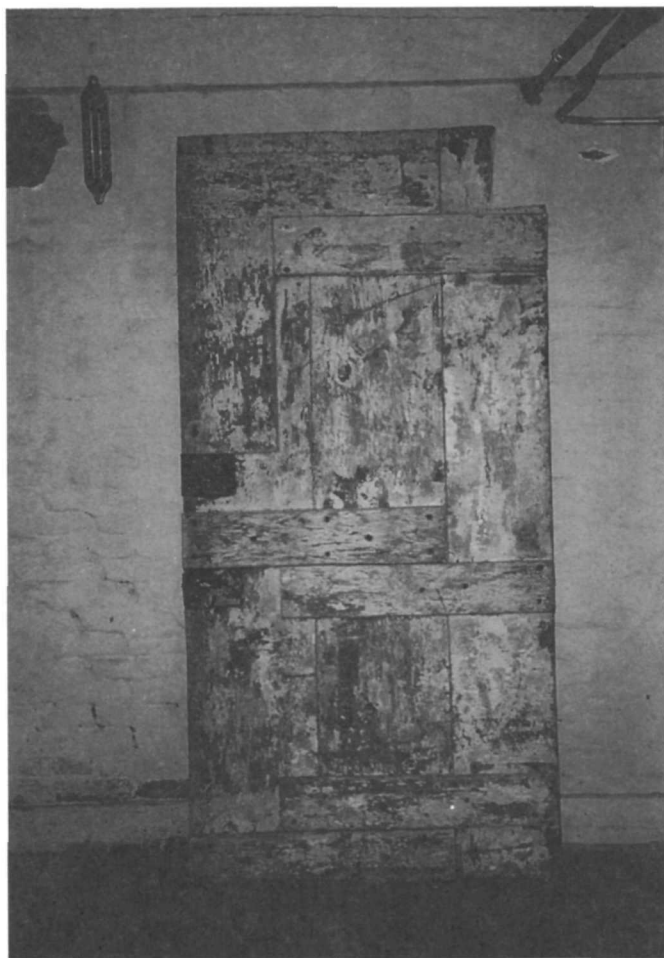
**Figure 159.** Cellar kitchen (Room 004), stored door.

The configuration of rooms in the extant main house reflects for the most part the 1777 plan, except for the cellar kitchen and the two west rooms in the second story. The kitchen is missing a partition that apparently enclosed its northwest corner. Henry Judd noted that physical evidence indicated there had been a “room” here, but he did not elaborate. The partitioned area is thought to have been original because it seems to have been linked functionally with the small hatch-like opening (see above), an original feature that would have allowed items to be brought into the partitioned area from the outside. There are studs attached to the west and north walls, and a “baseboard” along the west wall (see figs. 155-156), that have no apparent purpose; these may remain from the partition. A loose door currently stored in the kitchen (fig. 159) may have come from a doorway in the partition.

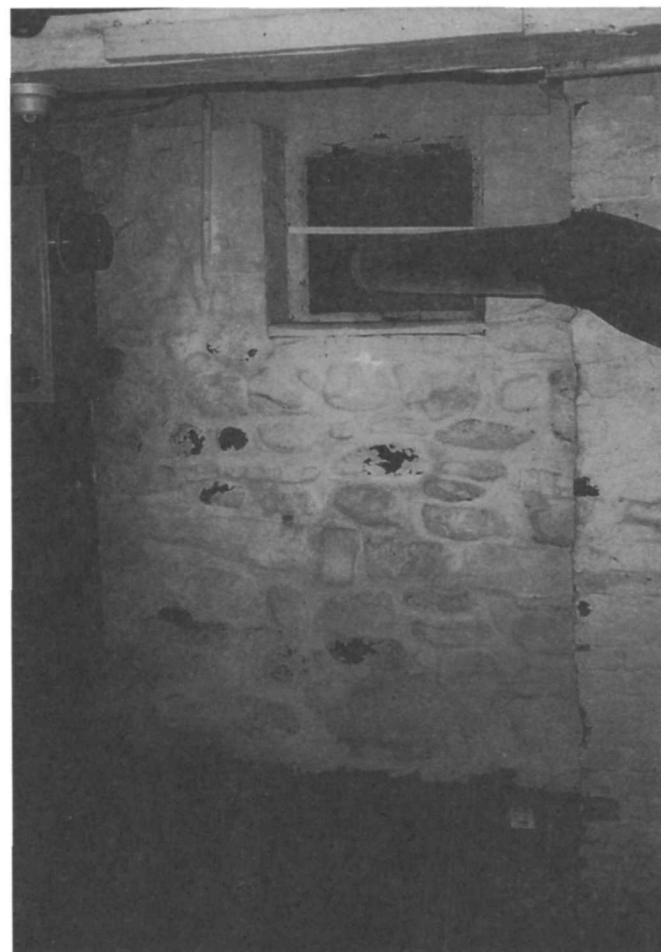
**Figure 160.** Cellar kitchen (Room 004), south wall, window W004.

Most of the features in the cellar kitchen, except for some window elements, appear to date to the 1777 construction of the house. The south-wall windows were installed in the 19<sup>th</sup> century. During the 1950s restoration, reproduction sashes were installed in all three windows in the room, and a post-1850 brick hearth was replaced with antique bricks. Currently the south-wall sashes have been removed to accommodate vent ducts (fig. 160). The presumably original partition enclosing the northwest corner of the cellar kitchen is also missing.

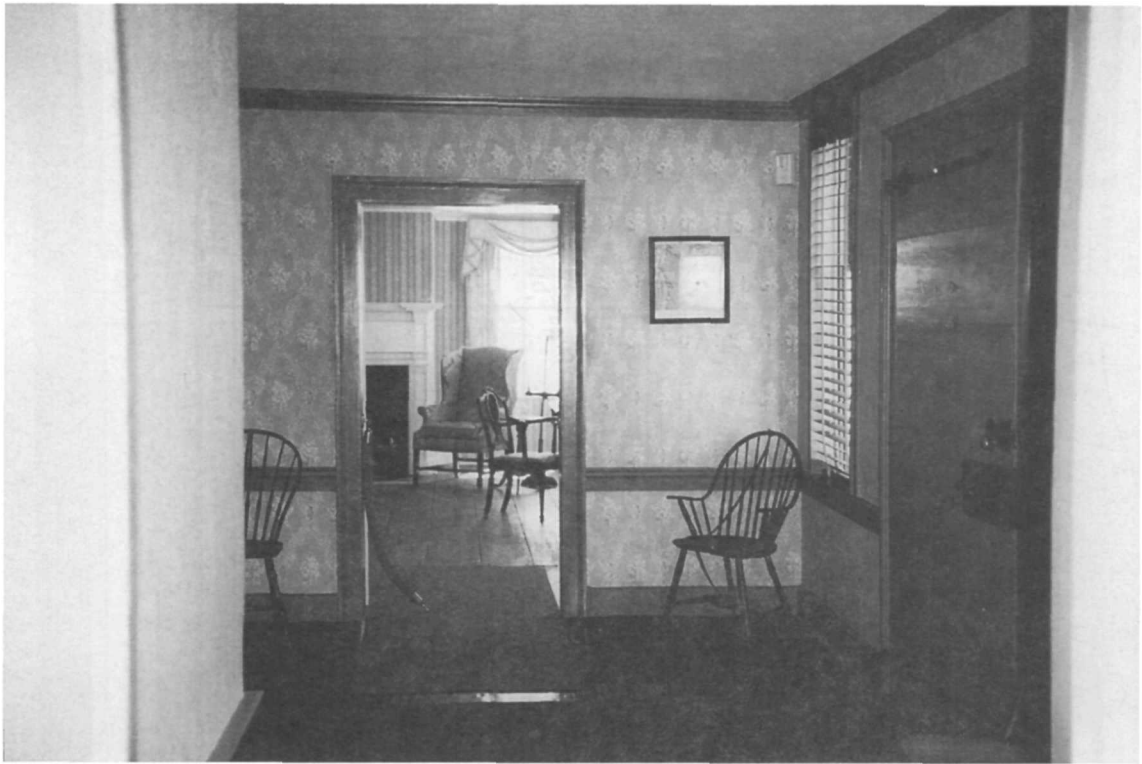
**Figure 161.** Reception hall (Room 101), looking south to doorway D107.

The reception hall of the Schuyler House (figs. 161-168) is located at the center of the first story of the main house. The room measures approximately 17 feet 1½ inches wide by 20 feet deep. A staircase to the second story is located on the north wall of the room (figs. 165-166). The primary exterior entrance to the house is located on the west wall (D101: figs. 167-168). A doorway at the west end of the south wall (D107: fig. 161) opens into the parlor (Room 102); one at the west end of the north wall (D109: fig. 162) leads to the dining room (Room 103). A doorway on the east wall (D108: fig. 163) opens to Father's Office (Room 104), and one under the staircase (D101a) opens to a closet. Narrow windows with double-hung sashes (W103, W104) are located in the west wall on either side of the main entrance. They feature carved wooden valances and wooden venetian blinds dating to the 1950s restoration. The flooring is the original wide-board flooring, and the walls are trimmed with baseboards, chair rails, and cornices (fig. 164).
