# GENERAL PHILIP SCHUYLER HOUSE

Saratoga National Historical Park  
Schuylerville, New York

Historic Structure Report  
Volume I

**GENERAL PHILIP SCHUYLER HOUSE**  
**HISTORIC STRUCTURE REPORT**

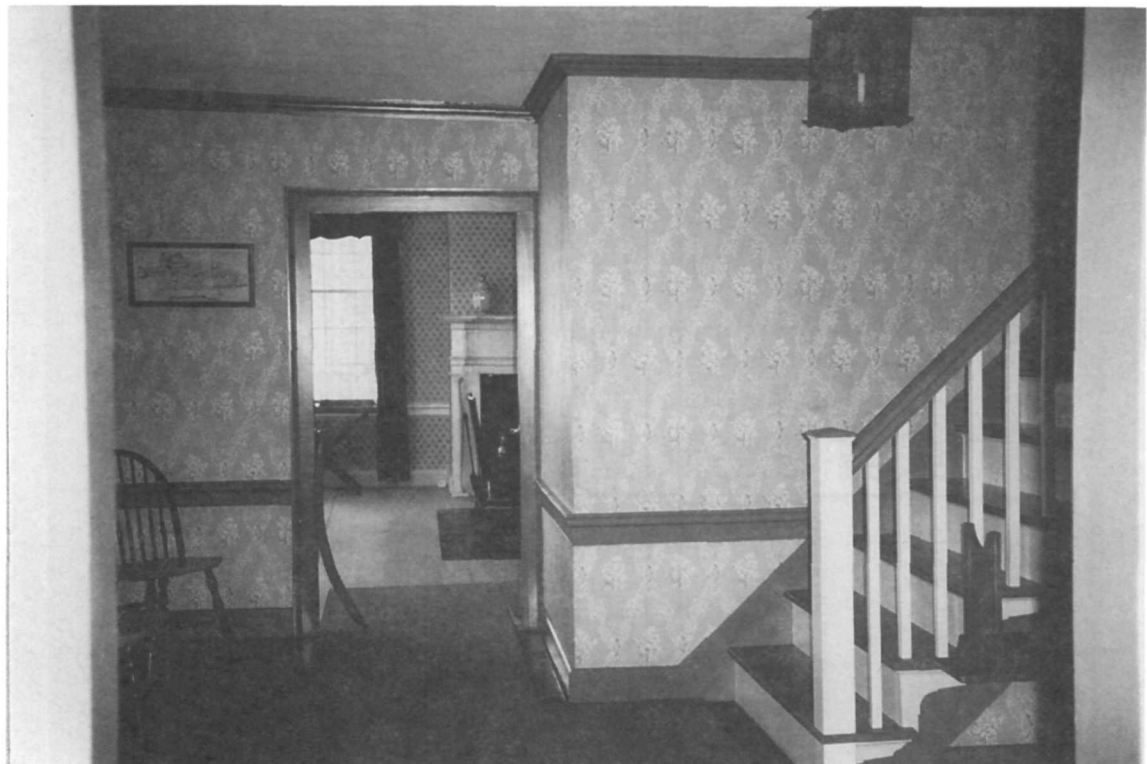
**Figure 162.** Reception hall (Room 101), looking north to doorway D109.

The reception hall of the Schuyler House (figs. 161-168) is located at the center of the first story of the main house. The room measures approximately 17 feet 1½ inches wide by 20 feet deep. A staircase to the second story is located on the north wall of the room (figs. 165-166). The primary exterior entrance to the house is located on the west wall (D101: figs. 167-168). A doorway at the west end of the south wall (D107: fig. 161) opens into the parlor (Room 102); one at the west end of the north wall (D109: fig. 162) leads to the dining room (Room 103). A doorway on the east wall (D108: fig. 163) opens to Father's Office (Room 104), and one under the staircase (D101a) opens to a closet. Narrow windows with double-hung sashes (W103, W104) are located in the west wall on either side of the main entrance. They feature carved wooden valances and wooden venetian blinds dating to the 1950s restoration. The flooring is the original wide-board flooring, and the walls are trimmed with baseboards, chair rails, and cornices (fig. 164).

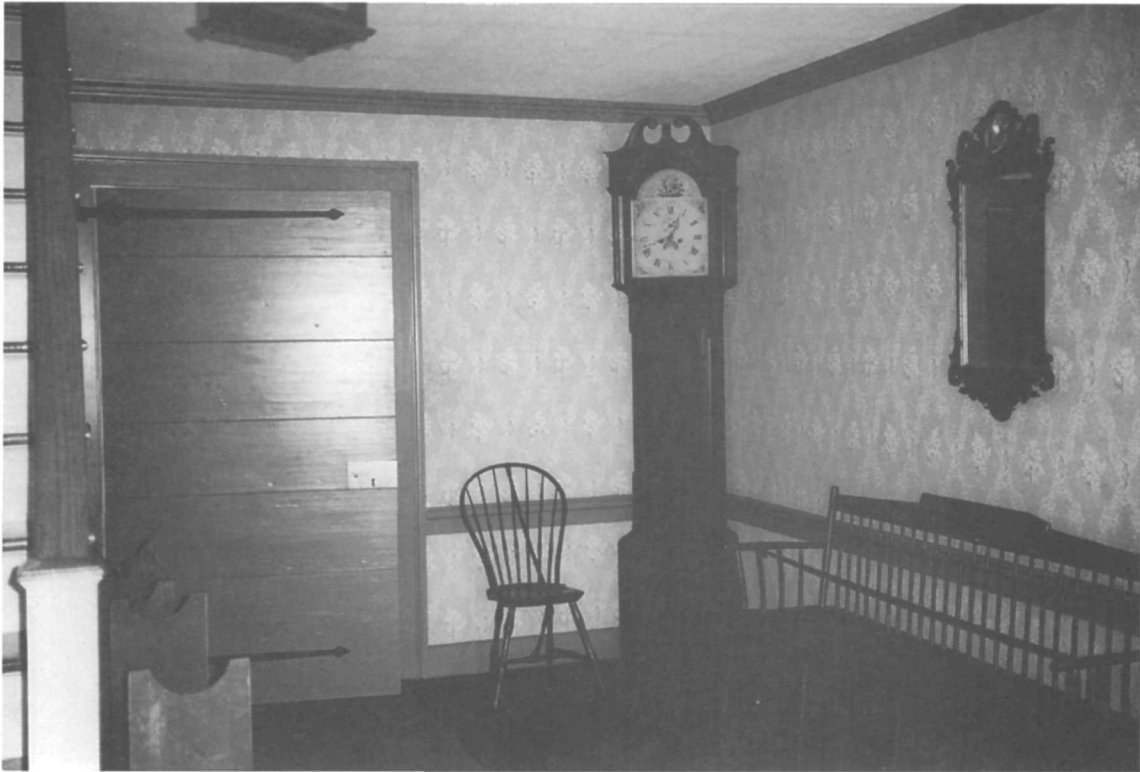
**Figure 163.** Reception hall (Room 101), looking east to doorway D108.

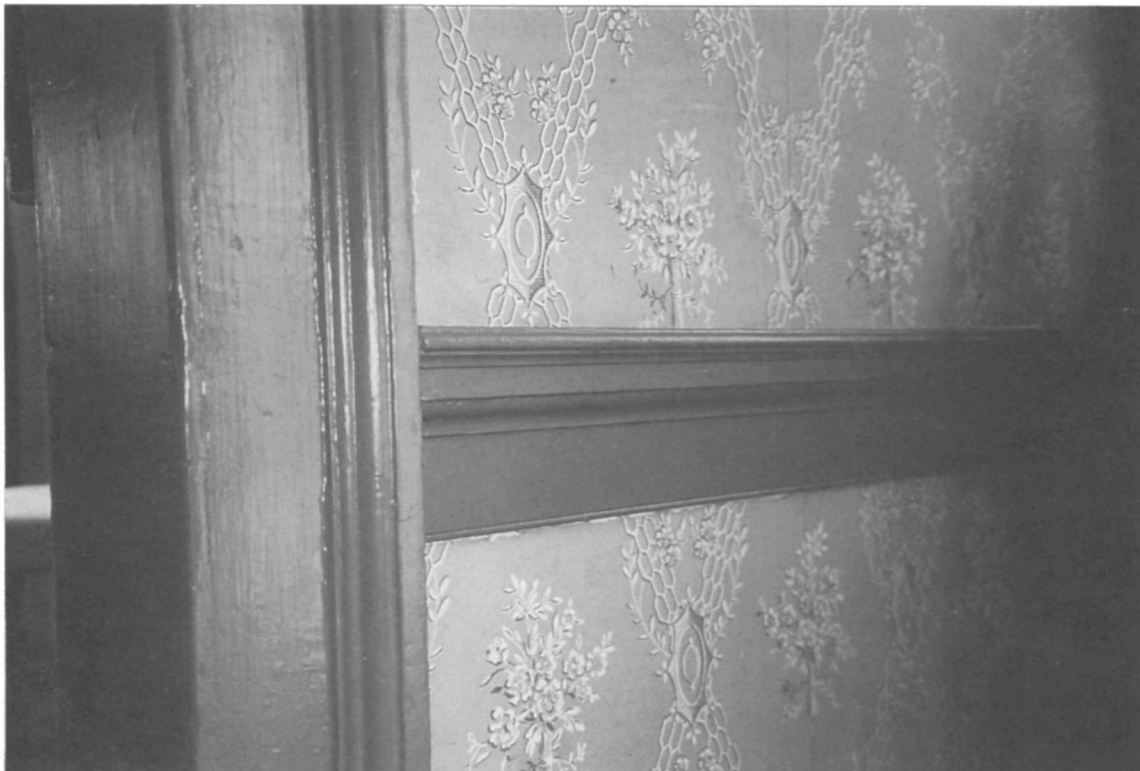
**Figure 164.** Reception hall (Room 101), west end of south wall, chair-rail detail.

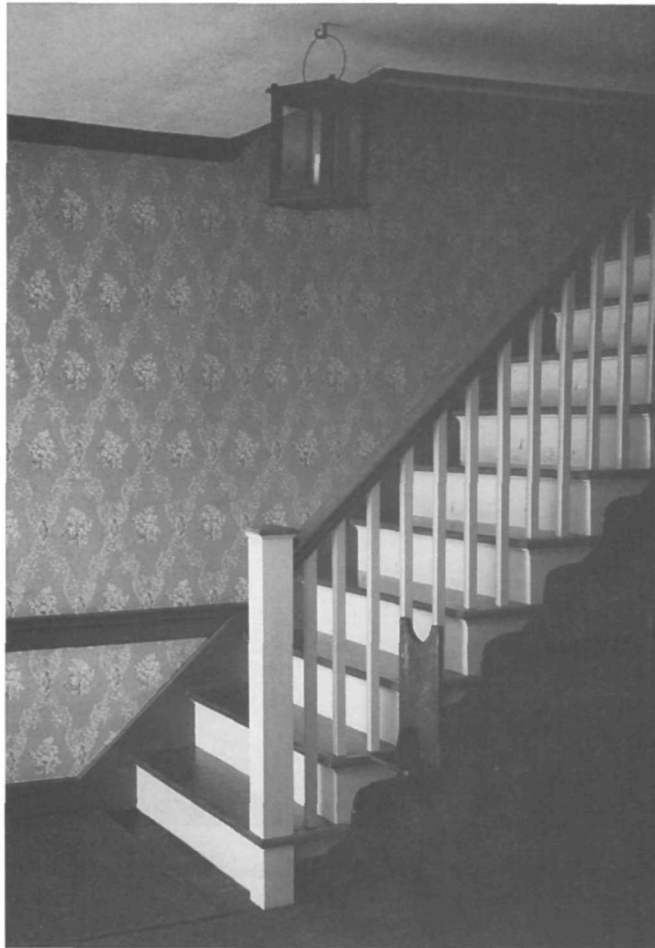
**Figure 165.** Reception hall (Room 101), north-wall staircase.

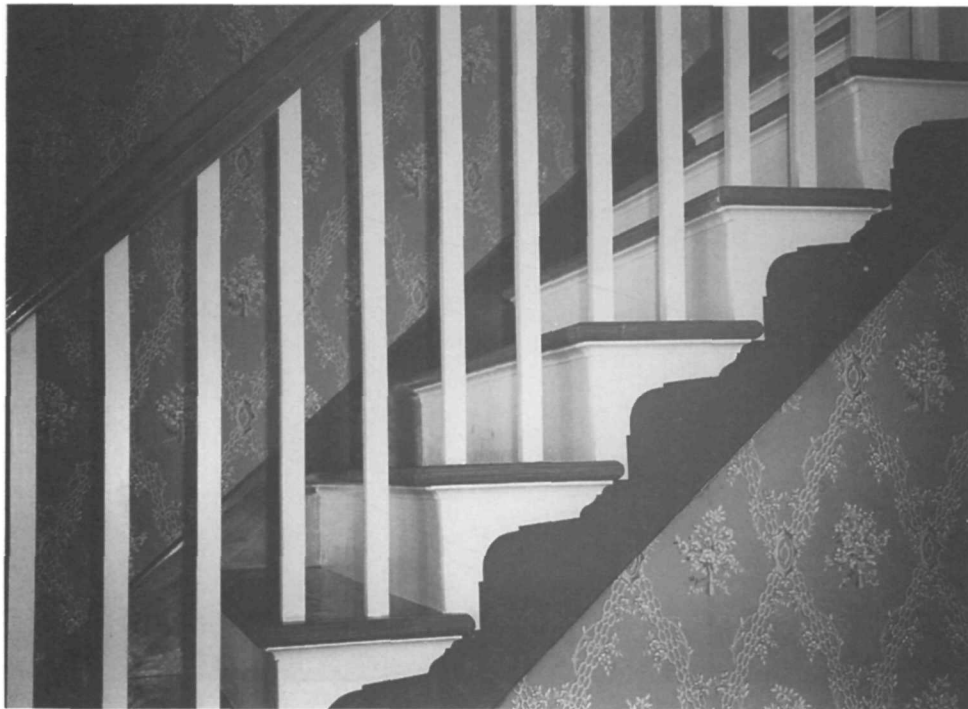
**Figure 166.** Reception hall (Room 101), north-wall staircase detail.

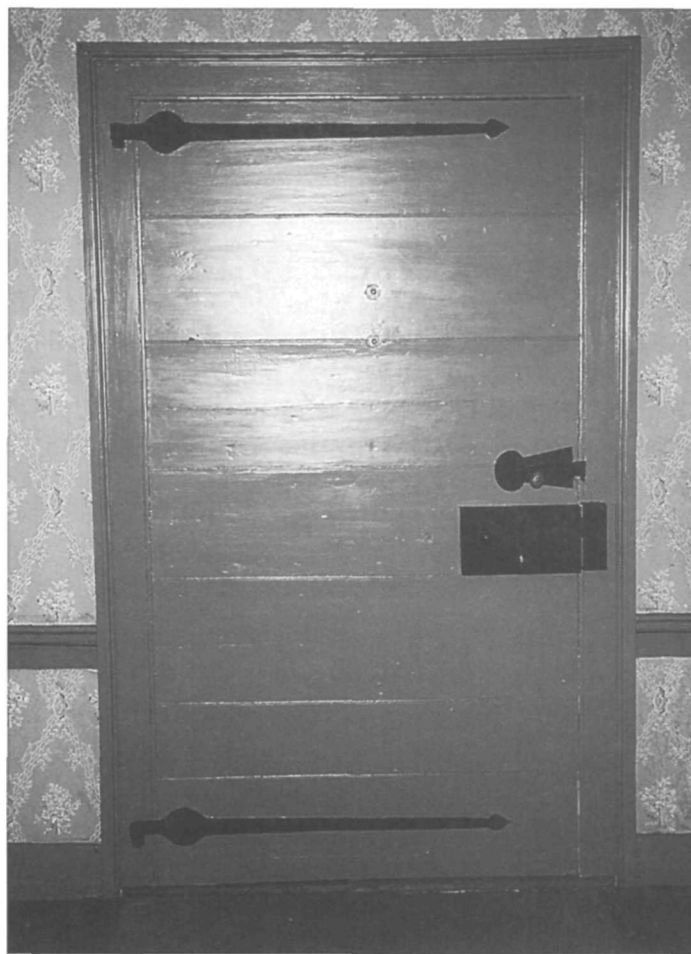
**Figure 167.** Reception hall (Room 101), west wall, doorway D101.

| FEATURE | DESCRIPTION | COMMENT |
|---|---|---|
| D101 - West Wall | <b>Opening</b> - 3' 8" wide x 6' 8" high; <b>solid batten door</b> - [bottom repaired 1960], 1¾" thick, hand-planed, horizontal boards ea. 12 ½" wide, <b>casing</b> - 6" wide butt w/ side casings outside top casing, <i>door casing Profile A</i> ; <b>hardware</b> - two strap hinges on pintles 3' 3" long, rim lock w/ key 7" x 12"; keeper on casing 7" x 2½", key-shaped wrought-iron latch w/ brass oval knob | Main exterior entrance<br>1777 doorway<br>1787 door, hardware, casing |

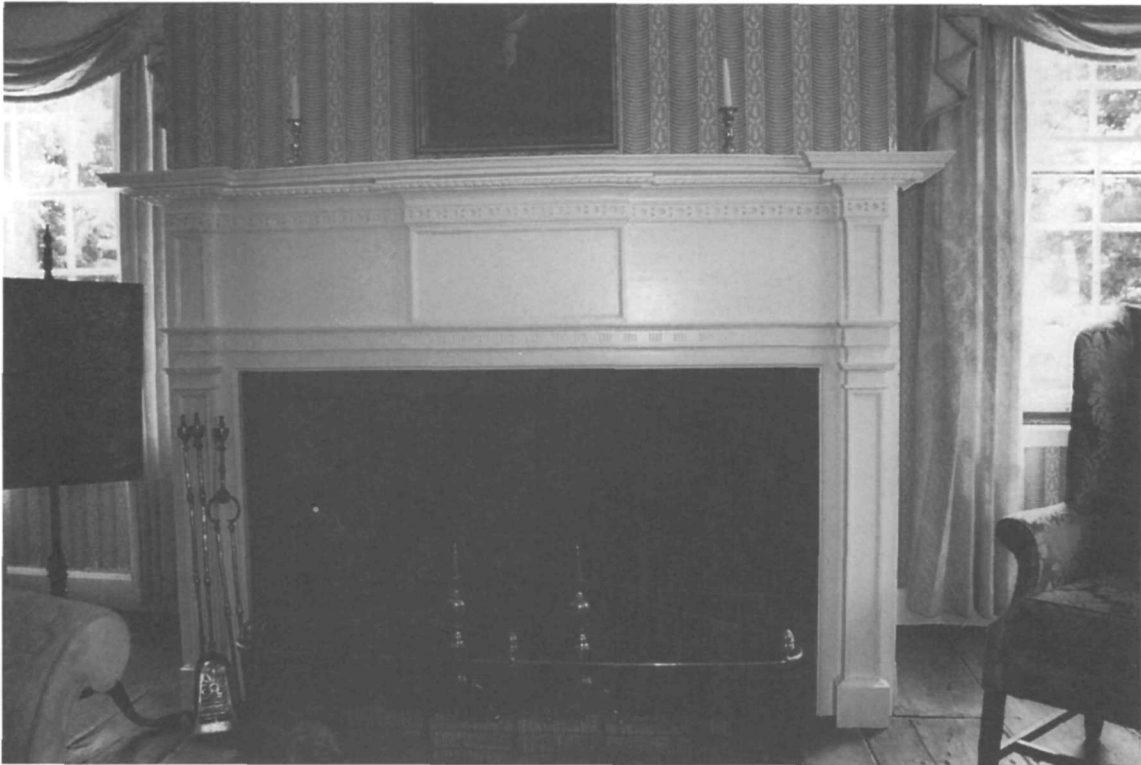
**Figure 171.** Parlor (Room 102), south-wall mantelpiece.

The parlor (figs. 169-175) is located at the south end of the first story of the Schuyler House. The room measures approximately 22 feet 7 inches wide by 20 feet deep. A fireplace is located on the south wall (figs. 171-172). A doorway at the west end of the north wall (D107: fig. 173) opens from the reception hall (Room 101). Two windows with multi-pane double-hung sashes are located in the west wall (W105, W106: fig. 169); two more in the south wall (W107, W108) flank the fireplace. The flooring is the original wide-board flooring (fig. 174), and the walls are trimmed with baseboards and cornices (fig. 175).

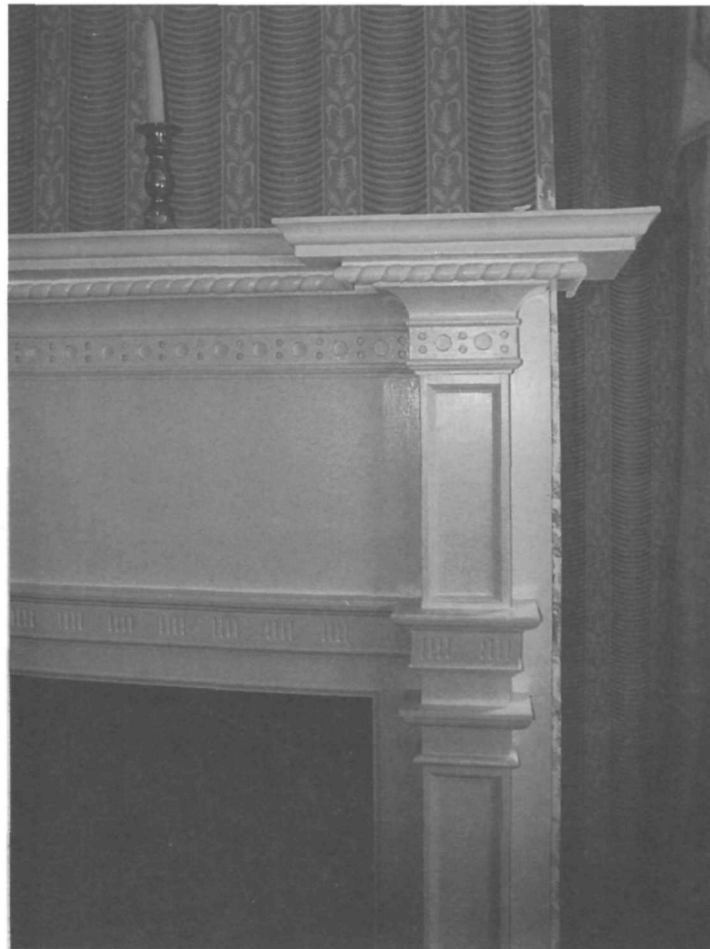
**Figure 172.** Parlor (Room 102), south-wall mantelpiece detail.

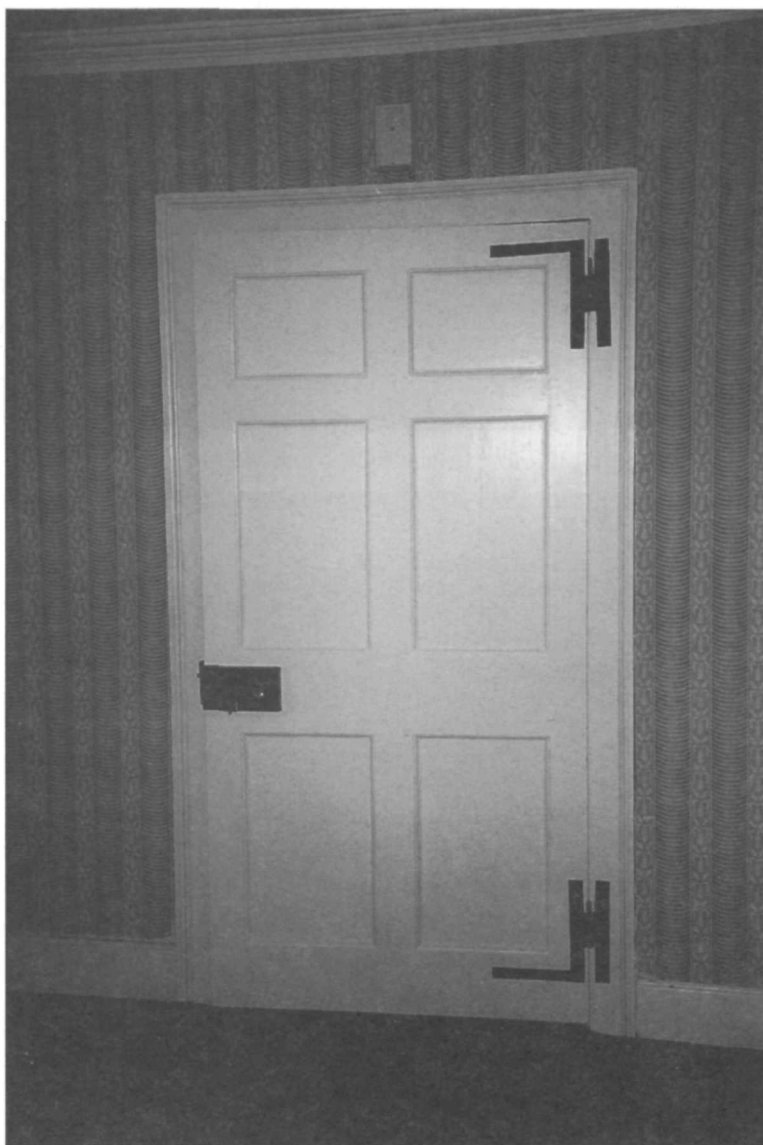
**Figure 173.** Parlor (Room 102), north wall, doorway D107.

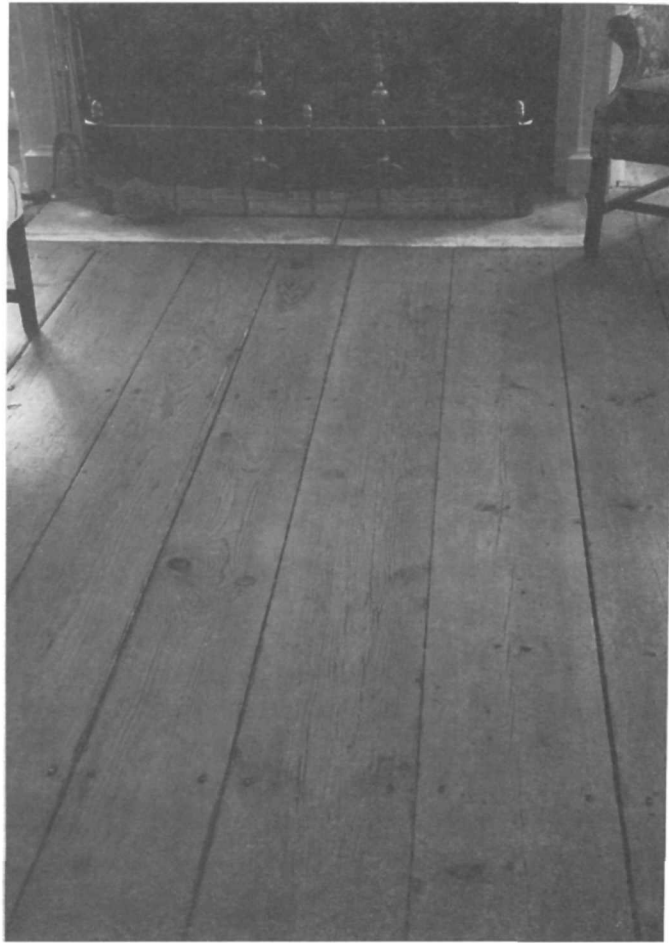
**Figure 174.** Parlor (Room 102), 1777 flooring.

| FEATURE | DESCRIPTION | COMMENT |
|---|---|---|
| | Wood - tongue & groove w/ two tongues on one board, two grooves on next; 9"-12" wide, most 12' 10" long; laid N/S, continuous from R101 [small patch at edge near D107]; replaced boards on W side of hearth [hand-headed nails] | 1777<br>1952 repairs |

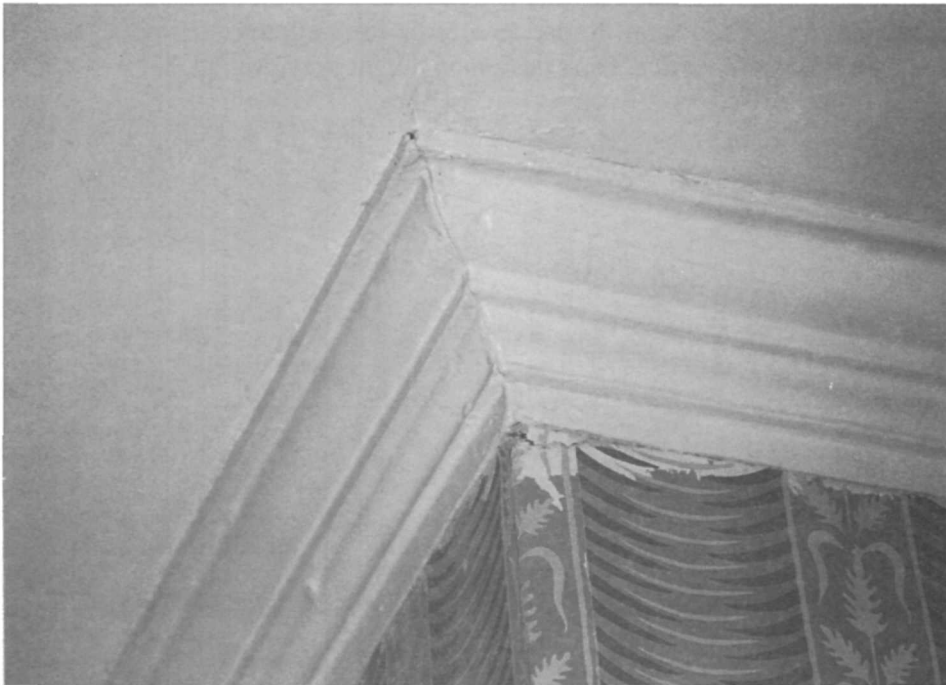
**Figure 175.** Parlor (Room 102), south-wall cornice detail.

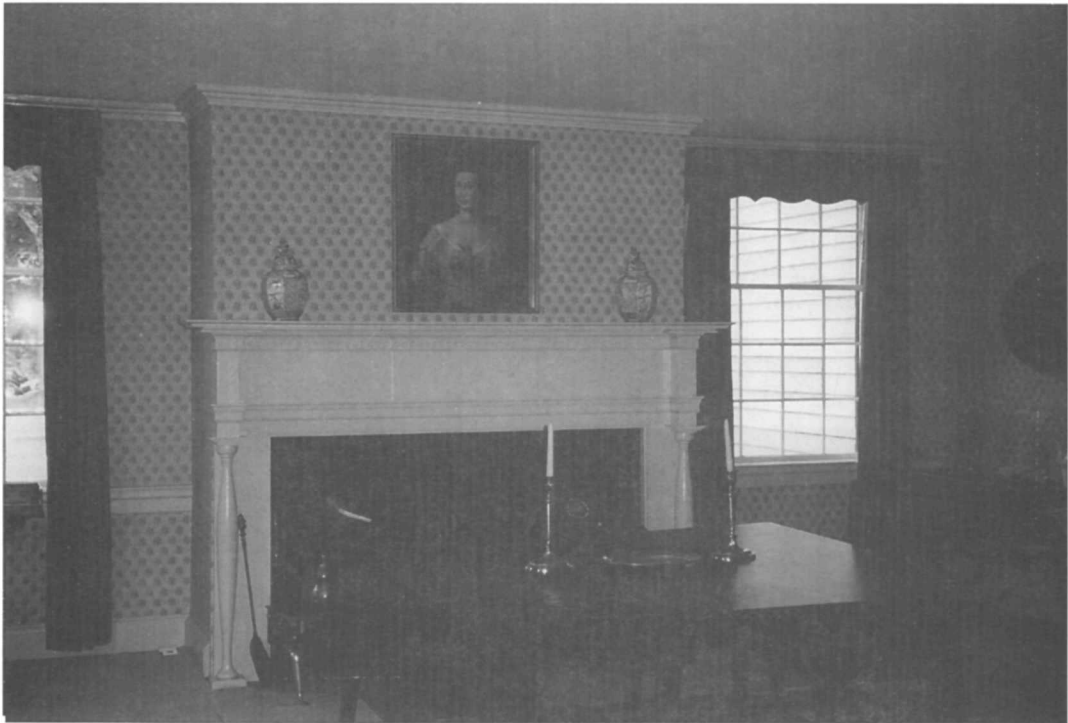
**Figure 177.** Dining room (Room 103), north wall.

The dining room (figs. 176-181) occupies the north end of the first story of the Schuyler House's main block. The room measures approximately 18 feet 7 inches wide by 20 feet deep. A fireplace is located on the north wall (figs. 177-178). The south wall has two doorways; one at the west end (D109: fig. 179) opens to the reception hall (Room 101), and one just east of the center of the wall leads to a pantry (D103a: fig. 180). A third doorway, in the east wall (D103: fig. 181), opens to the north porch on the east elevation. Two windows with multi-pane double-hung sashes are located in the west wall (W101, W102), and two more in the north wall (W111, W112: fig. 177) flank the fireplace. The walls are trimmed with baseboard, chair rail, and cornice.

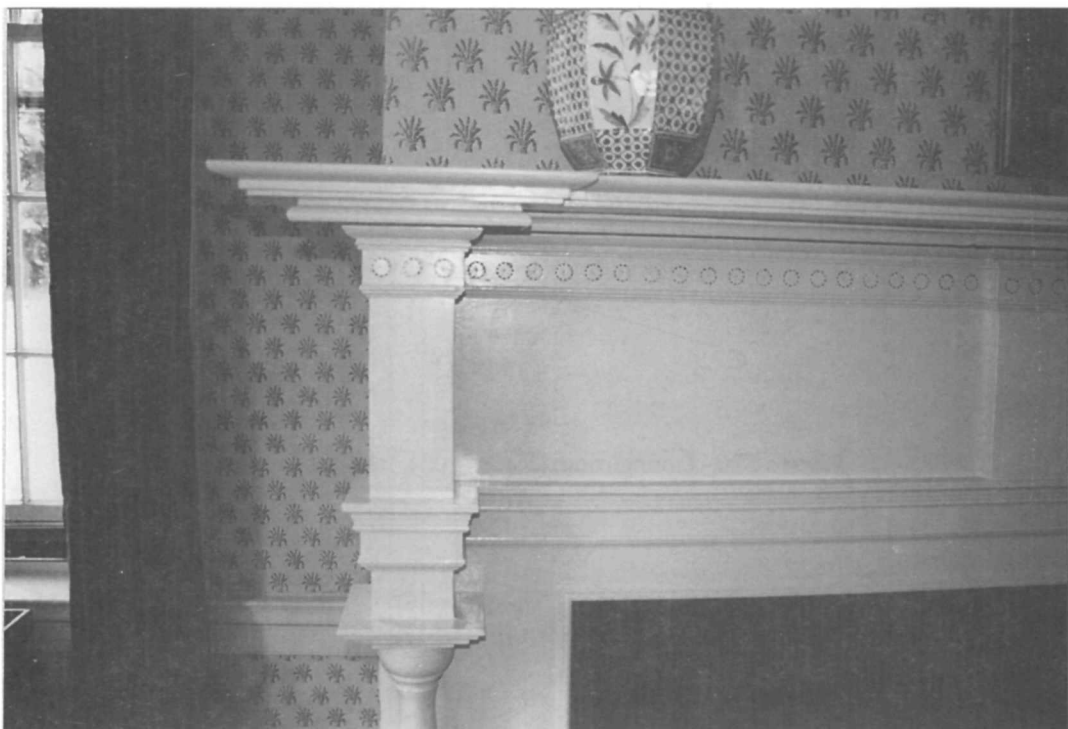
**Figure 178.** Dining room (Room 103), north-wall mantelpiece detail.

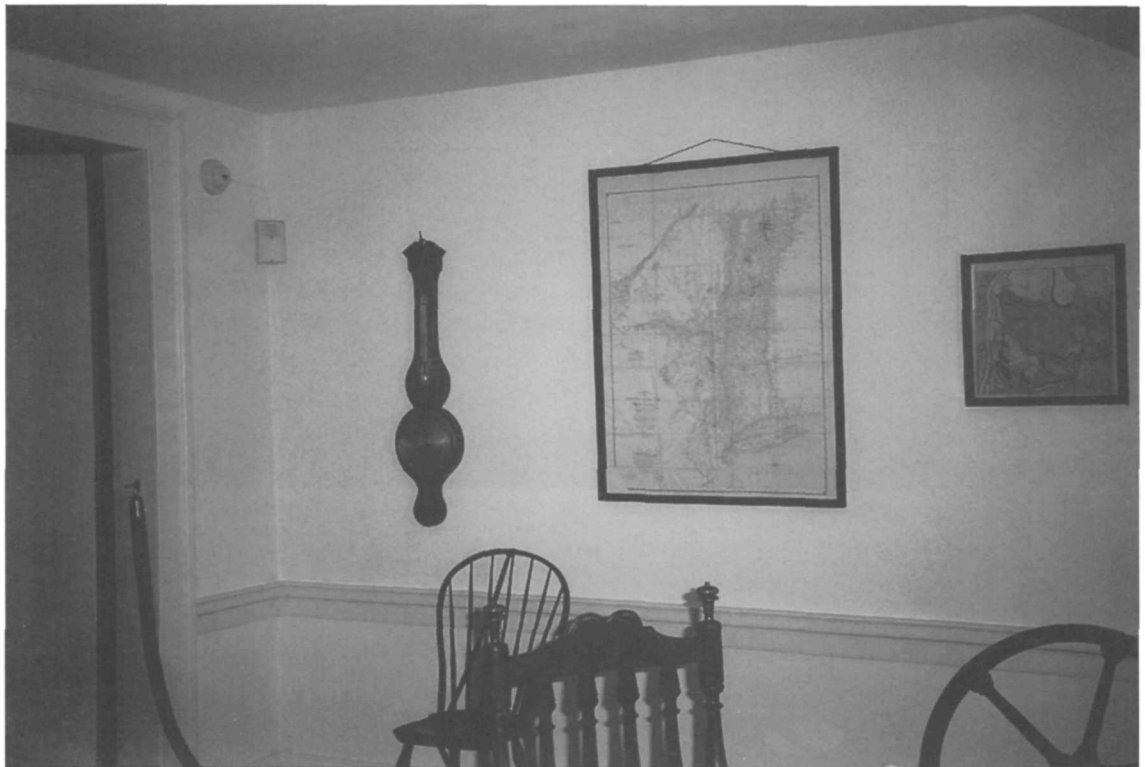
**Figure 183.** Father's Office (Room 104), looking north/northwest.

Father's Office (figs. 182-184) occupies the rear addition of the Schuyler House. The room measures approximately 12 wide by 9 feet deep. A doorway at the north end of the west wall (D108: fig. 183) opens from the reception hall (Room 101). A second doorway, at the east end of the south wall (D102: fig. 184) leads to the south porch on the east elevation. One window with multi-pane double-hung sashes (W109: fig. 182) is located in the east wall. It features a carved wooden valance and wooden venetian blinds dating to the 1950's restoration. The walls in the room are trimmed with baseboard and chair rails.

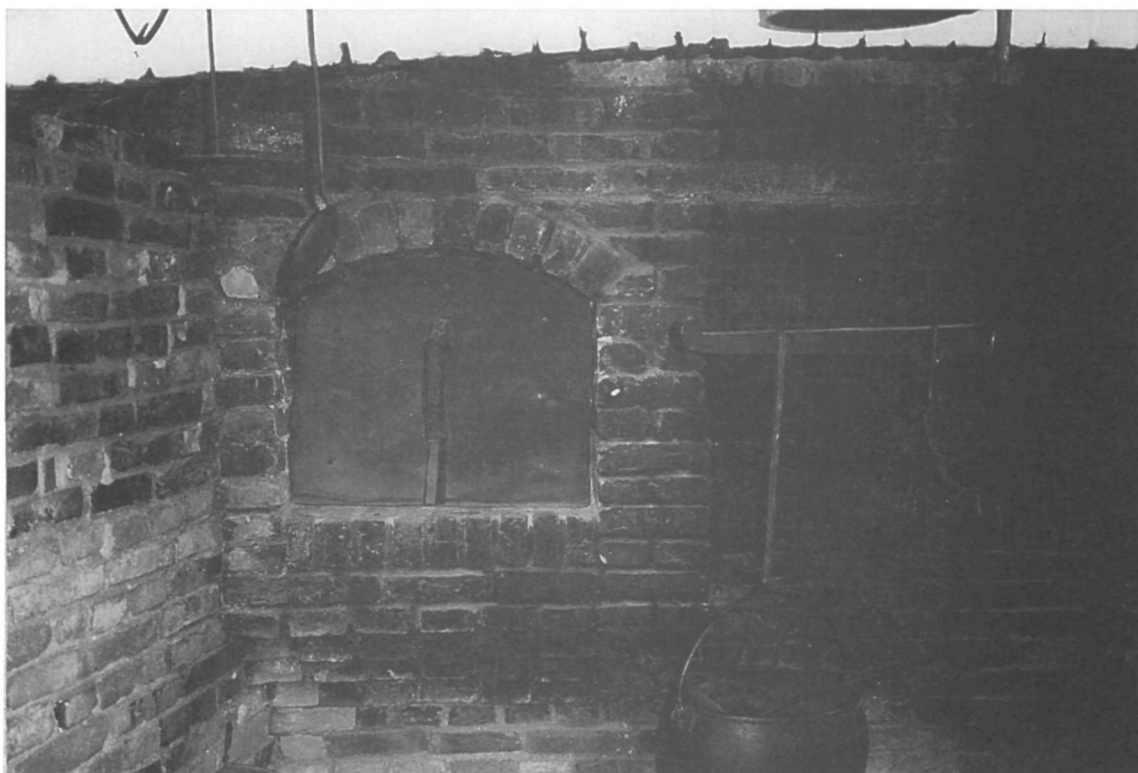
**Figure 189.** Kitchen (Room 105), east wall, bake oven in fireplace.

The kitchen (figs. 185-193) occupies most of the first story of the Schuyler House kitchen wing. The room measures approximately 25 feet 4 inches wide by 22 feet 9 inches deep. A fireplace with a bake oven and a tile hearth is located on the east wall (figs. 185, 189). A doorway at the west end of the south wall (D104: fig. 188) leads to the north porch on the east elevation of the main house. A second exterior doorway, centered on the north wall, opens to the porch on the north elevation of the kitchen wing (D105: figs. 190-191). There are also two interior doorways; one (D110) leads to the kitchen stair hall (Room 107) to the west, and one (D111: fig. 186) leads to a storage room (Room 106) off the northwest corner of the kitchen. One window with a pair of two-by-four casement sashes is located in the south wall (W110: fig. 187). The north, east, and south walls are composed of exposed framing and nogging that is whitewashed, while the west wall is a vertical-board partition. The ceiling is the exposed framing and flooring of the garret above.

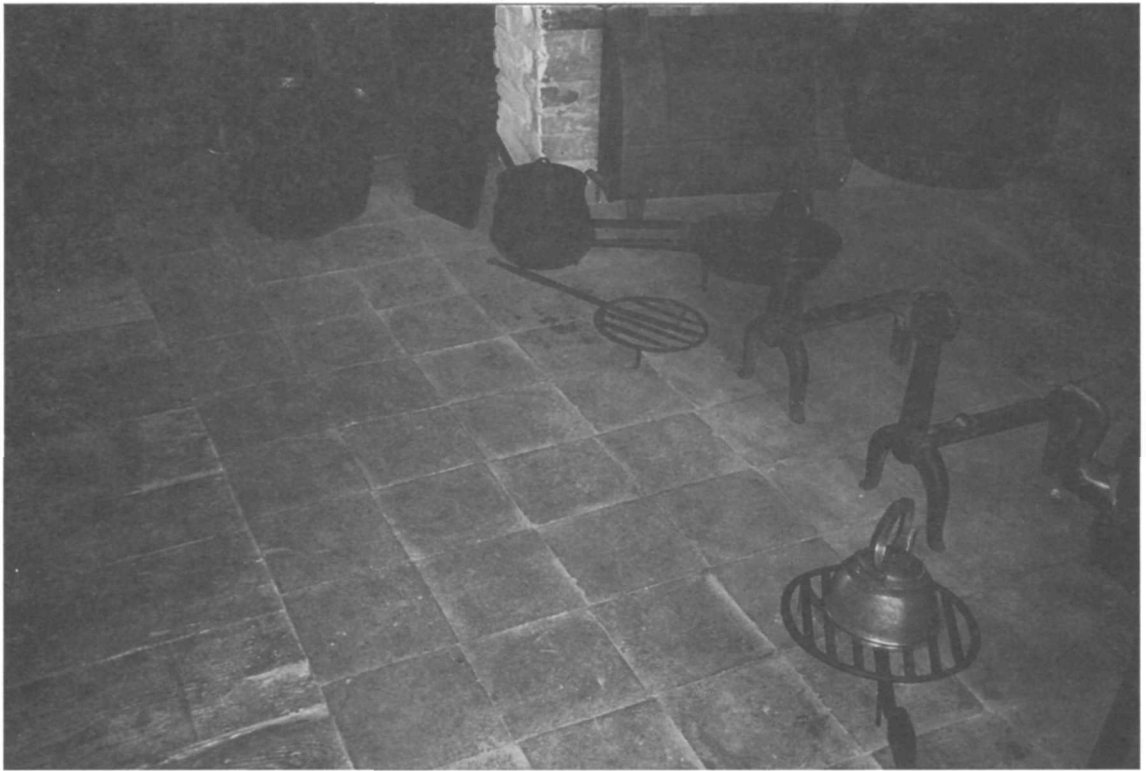
**Figure 192.** Kitchen (Room 105), fireplace hearth.

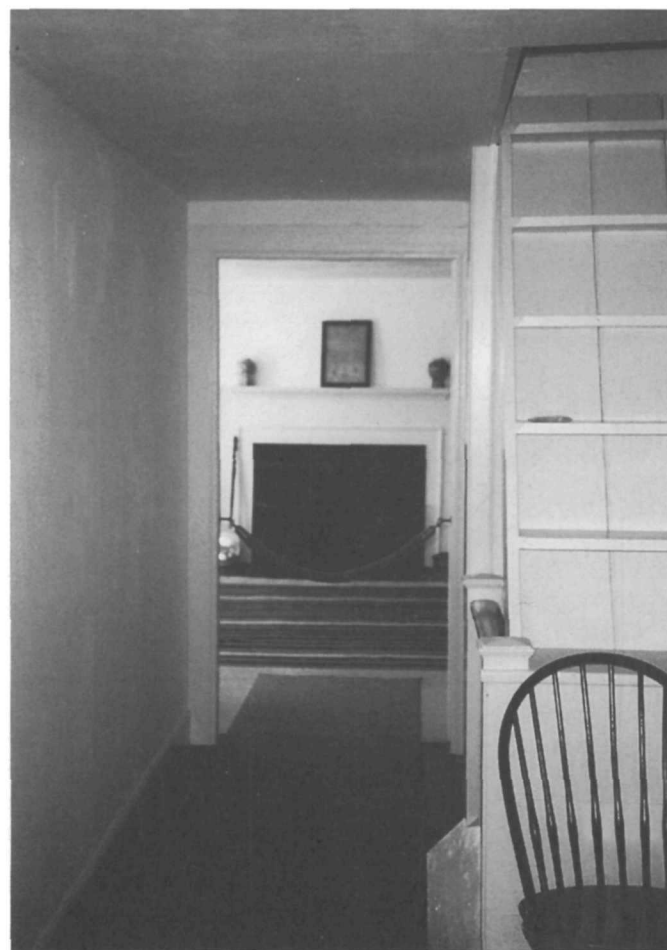
**Figure 199.** Second-story hall (Room 201), looking north to doorway D203.

The second-story hall of the Schuyler House (figs. 196-201) is centered on the east side of the second story of the main house. The main part of the room measures approximately 14 feet 6 inches deep by 21 feet 6 inches; in addition, a short hallway extends northward from the west end of the north wall (fig. 199). The remainder of the north wall features the staircase from the first story and a ladder-type stairway to the attic hatchway (figs. 196, 200-201). A doorway at the west end of the south wall (D201) leads to the south chamber (Room 202); figure 197 shows this doorway, and also a doorway in the west wall (D202: fig. 198) that leads to the hall chamber (Room 203). A third doorway (D203), at the north end of the short hallway, opens to the north chamber (Room 205). A fourth doorway (D201a), in the east wall of the short hallway, leads to a closet. The closet is an original feature of the house; it measures approximately 3 feet 8 inches wide by 7 feet 7 inches deep. There are no windows in the room.

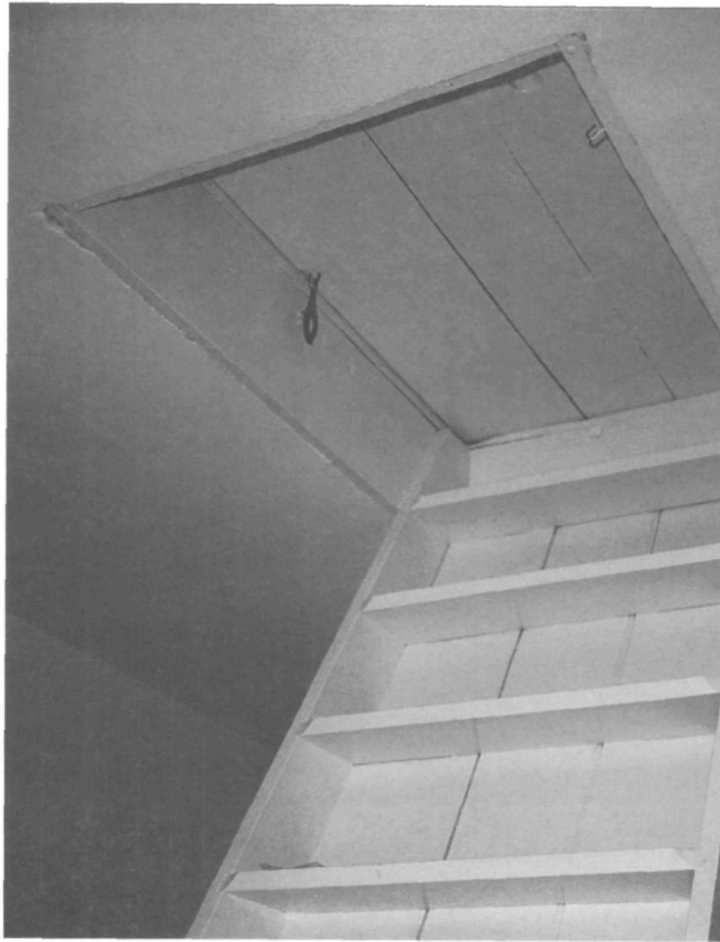
**Figure 200.** Second-story hall (Room 201), attic ladder-stairway and hatchway D301.

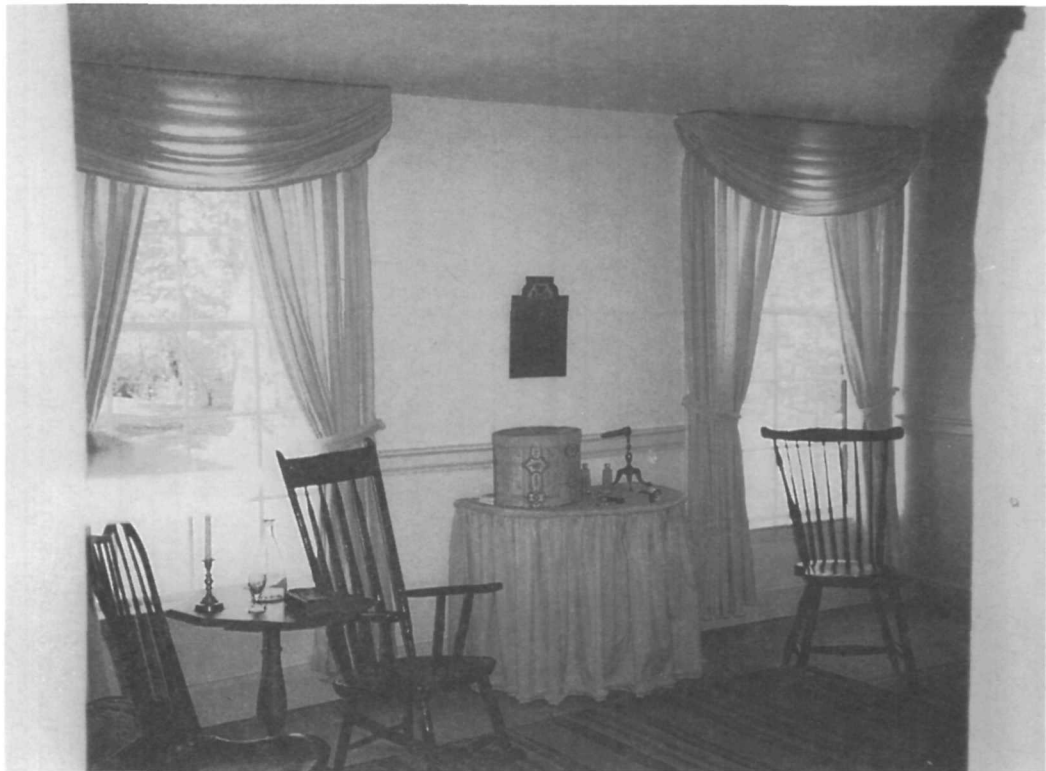
**Figure 202.** South chamber (Room 202), west wall, windows W206 and W207.

The south chamber (figs. 202-211) is located at the south end of the second story of the Schuyler House. The room measures approximately 20 wide by 16 feet deep. A fireplace is located on the south wall (figs. 210-211). A doorway in the north wall (D201: figs. 205-206) opens to the second-story hall (Room 201). Two windows with multi-pane double-hung sashes are located on the west wall of the room (W206, W207: fig. 202). A small closet at the west end of the south wall (figs. 203, 207-209) is accessed by doorway D202a. The flooring is the original wide-board flooring, and the walls are trimmed with baseboards and chair rails.

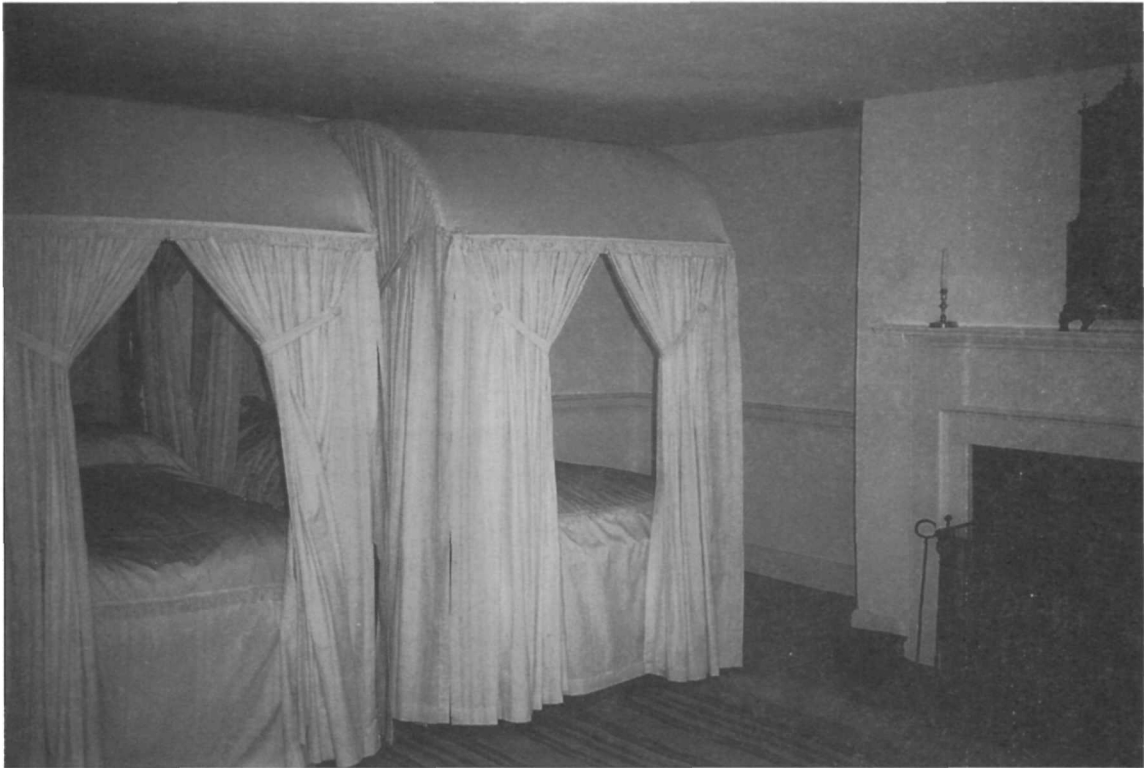
**Figure 204.** South chamber (Room 202), looking southeast.

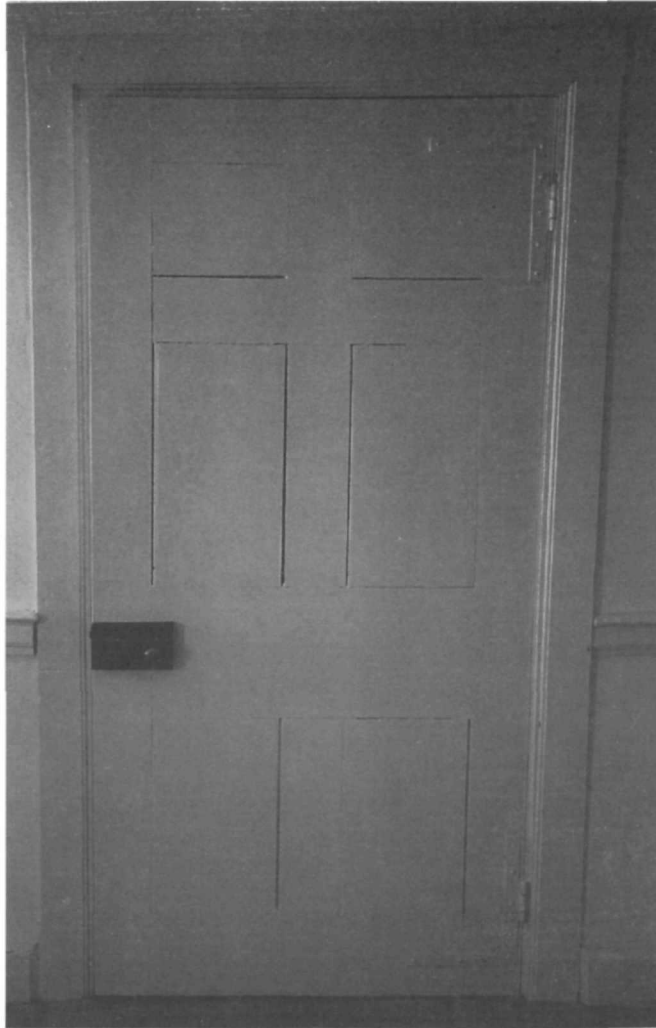
**Figure 205.** South chamber (Room 202), north wall, doorway D201.

| FEATURE | DESCRIPTION | COMMENT |
|---|---|---|
| D201 - North Wall | <b>Opening</b> - 3' 2½" wide x 6' 6½" high; <b>door</b> - 1 ⅜" thick, through-tenon, six-panel early Federal style, 11 ¾" wide flush panels: top 9¼" high, center 1' 9" high, bottom 1' 5½" high, small bead along vertical edges of lower panels and horizontal edges of top panels; <b>casing</b> - 5" wide butt, <i>door casing Profile E</i> ; <b>hardware</b> - HL hinges w/ "H" attached behind casing; antique or repro rim lock w/ keyhole (brass knob missing) | Doorway from R201<br>1777 doorway<br>1787 door & casing |

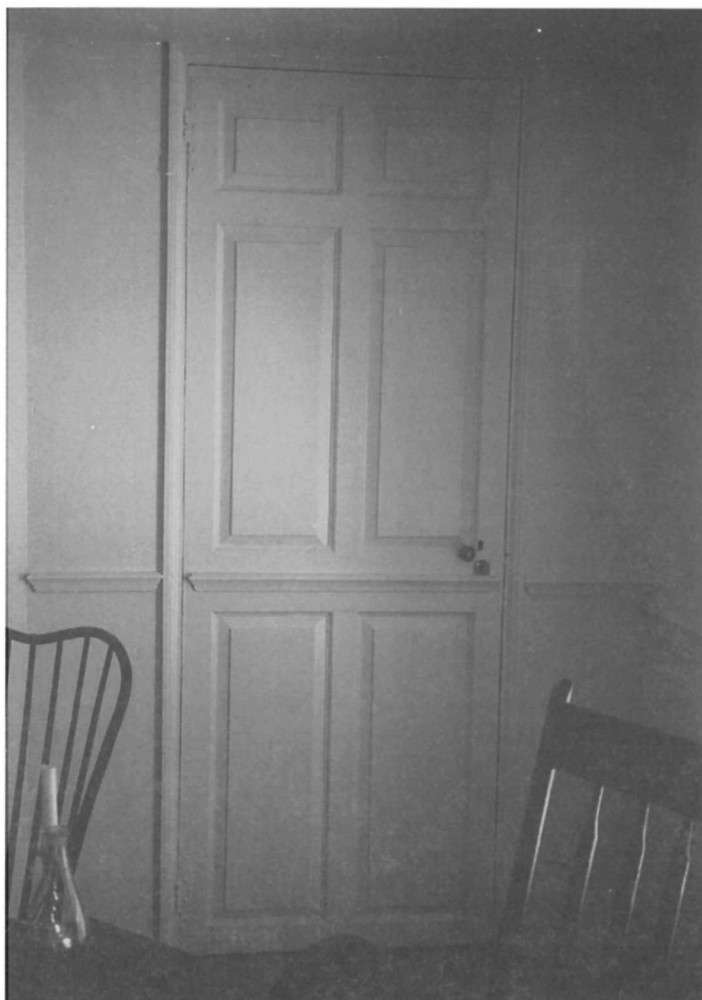
**Figure 207.** South chamber (Room 202), south wall, closet doorway D202a.

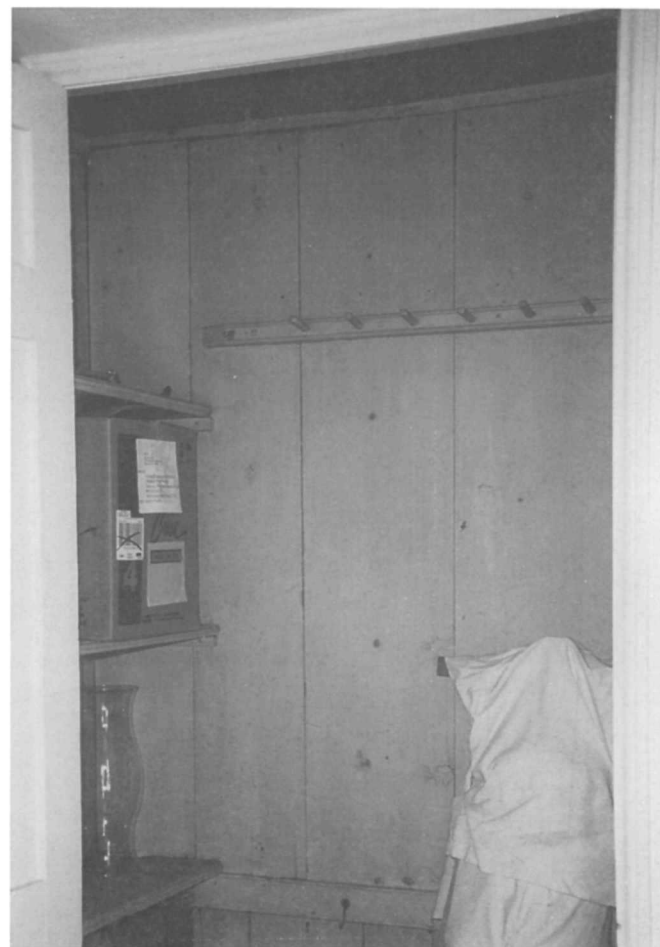
**Figure 208.** South chamber (Room 202), south wall, closet interior.

| FEATURE | DESCRIPTION | COMMENT |
|---|---|---|
| R202A | <b>Location</b> - SW corner; <b>size</b> - 5' wide x 2' 2" deep; <b>shelves</b> - <i>W wall</i> : loose boards, 11 ¼" deep, bottom shelf two tongue & groove boards; <i>E wall</i> : fixed boards w/ beaded edge, 11" deep; <b>peg board</b> - S wall, 1 ¾" wide, beaded top & bottom edges, beveled ends, dowel-like pegs, wrought nails | 1777 w/ 19 <sup>th</sup> -c. alterations; S-wall vert. boards possibly removed & reattached 1957 |

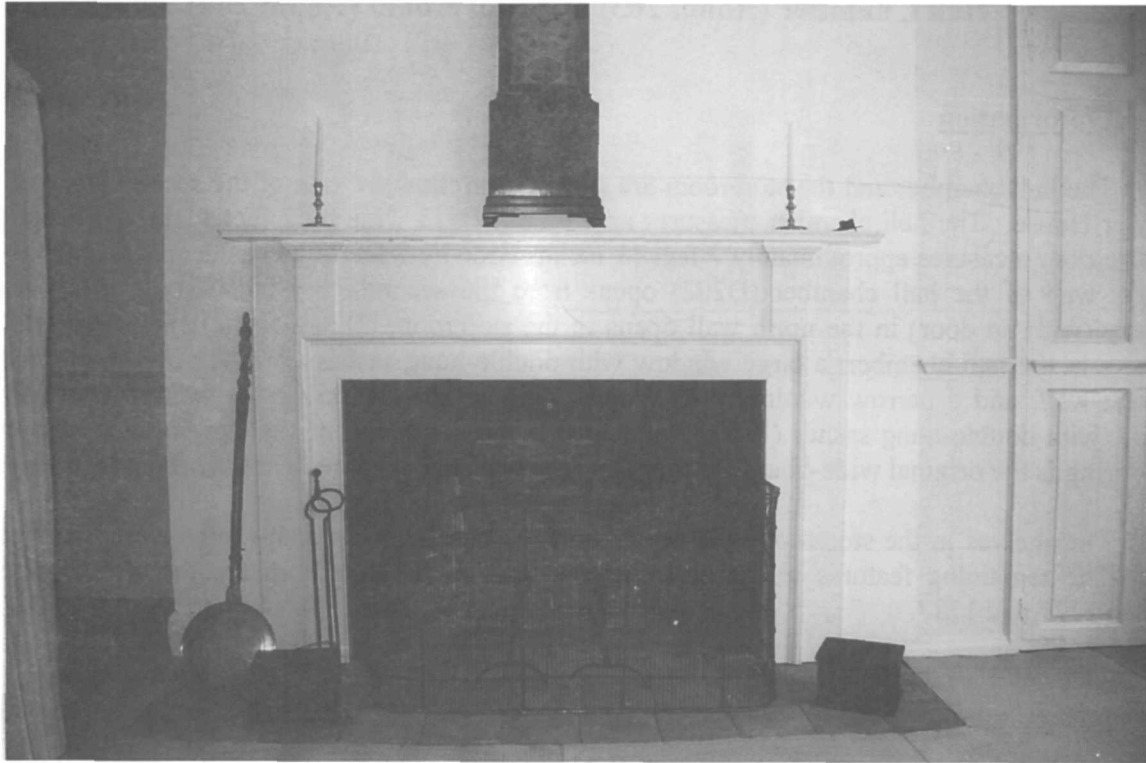
**Figure 210.** South chamber (Room 202), south-wall fireplace and mantelpiece.

| FEATURE | DESCRIPTION | COMMENT |
|---|---|---|
| South Wall | <b>Opening</b> - 3' 11" wide x 2' 9" high x 1' 7" deep; burned brick firebox; <b>hearth</b> - 6' 6" wide x 1' 10" deep; repro 8"-square fired clay tiles [also firebox floor] replaced ca.-1815 marble hearth; <b>mantel</b> 4' 4 ½" high x 6' wide (see "Conditions Before 1956 Restoration," sheet 13, in <b>Appendix B</b> and "Mill Detail for South Bedroom Mantel" in <b>Appendix C</b> ) | 1777 opening; 1960 mantel replaced 1787 mantel, modified ca. 1815 |

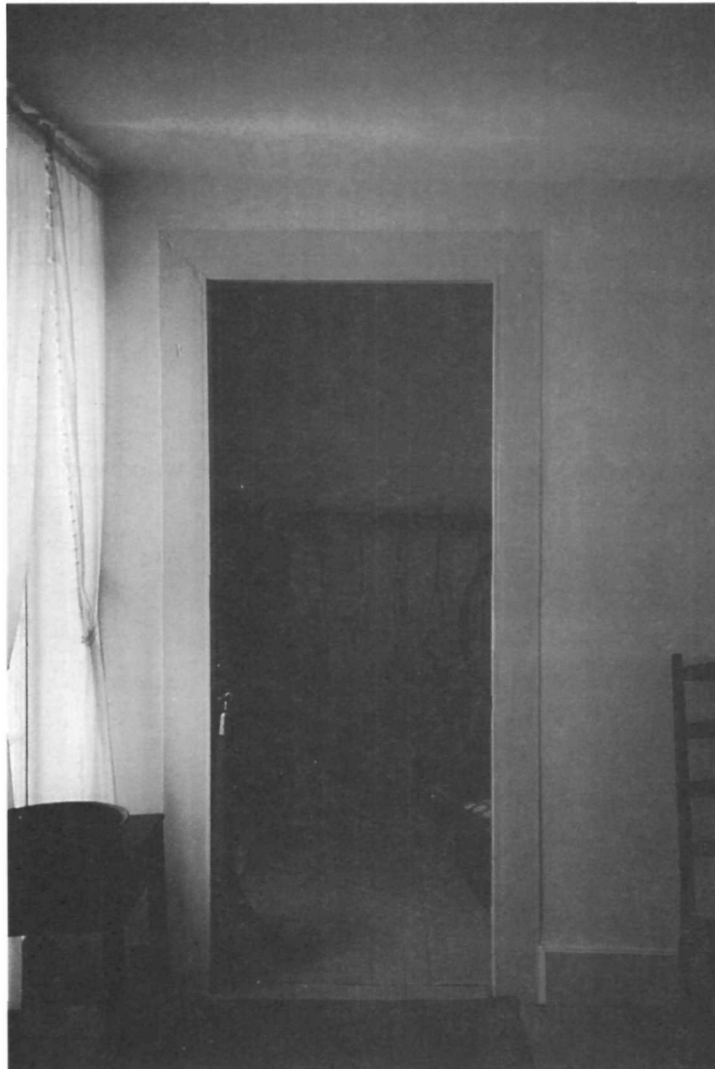
**Figure 212.** Hall chamber (Room 203), looking north through doorway D204 to storeroom (Room 204).

The hall chamber and the storeroom are centered on the west side of the second story of the Schuyler House. The hall chamber measures approximately 13 wide by 7 feet 11 inches deep, and the storeroom measures approximately 7 feet 11 inches wide by 7 feet 8 inches deep. A doorway in the east wall of the hall chamber (D202) opens from the second-story hall (Room 201), and a doorway (with no door) in the north wall opens to the storeroom (D204: fig. 212). There are two windows in the hall chamber: a large window with double-hung sashes (W204) at the north end of the west wall, and a narrow window with double-hung sashes (W205) to its south. One narrow window with double-hung sashes (W203) is located at the south end of the storeroom's west wall. All flooring is the original wide-board flooring, and the walls are trimmed with baseboards.
