# GENERAL PHILIP SCHUYLER HOUSE

Saratoga National Historical Park  
Schuylerville, New York

Historic Structure Report  
Volume I

**GENERAL PHILIP SCHUYLER HOUSE**  
**HISTORIC STRUCTURE REPORT**

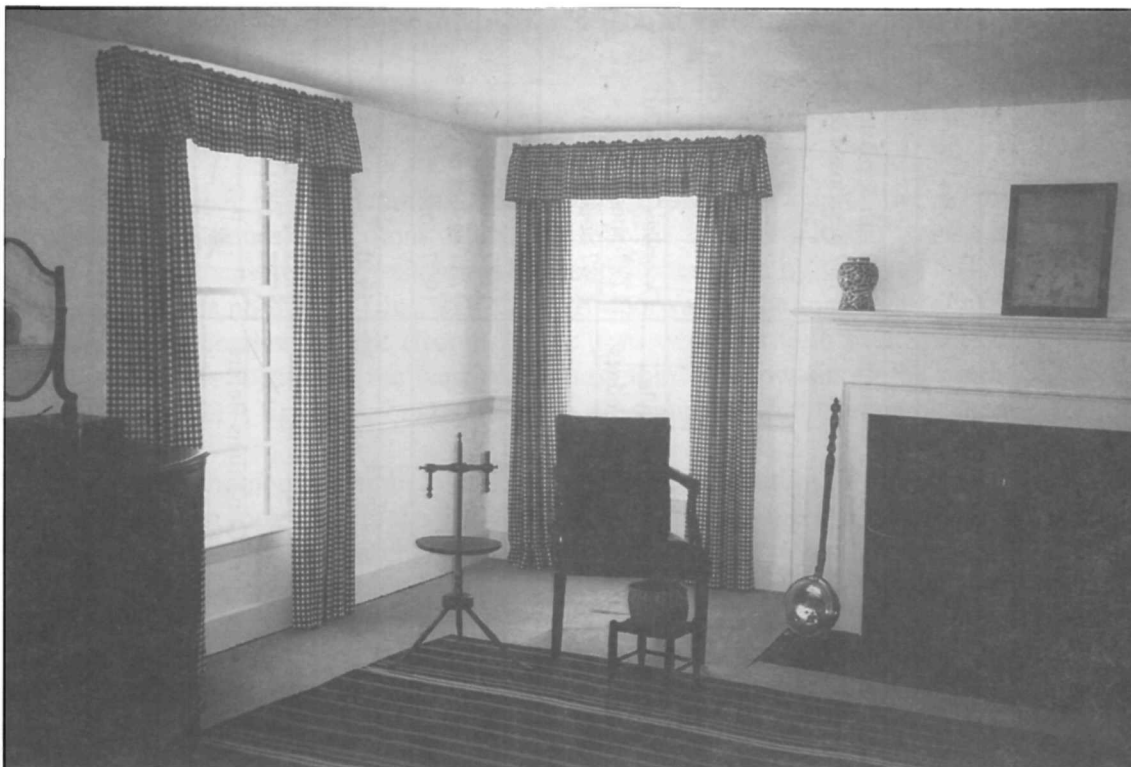
**Figure 213.** North chamber (Room 205), looking northwest.

The north chamber of the Schuyler House (figs. 213-222) occupies the north end of the second story of the main house. The room, which was labeled “Mother’s Room” on the early plan of the house (see fig. 14), measures approximately 18 feet 6 inches wide by 19 feet 11 inches deep. A fireplace is located on the north wall (figs. 218-220). A doorway in the south wall (D203: figs. 215-216) opens from the second-story hall (Room 201). Two windows with multi-pane double-hung sashes (W201, W202) are located in the west wall, and a third window sits in the north wall to the west of the fireplace (W211: figs. 213, 217). The walls are trimmed with baseboards and chair rails.

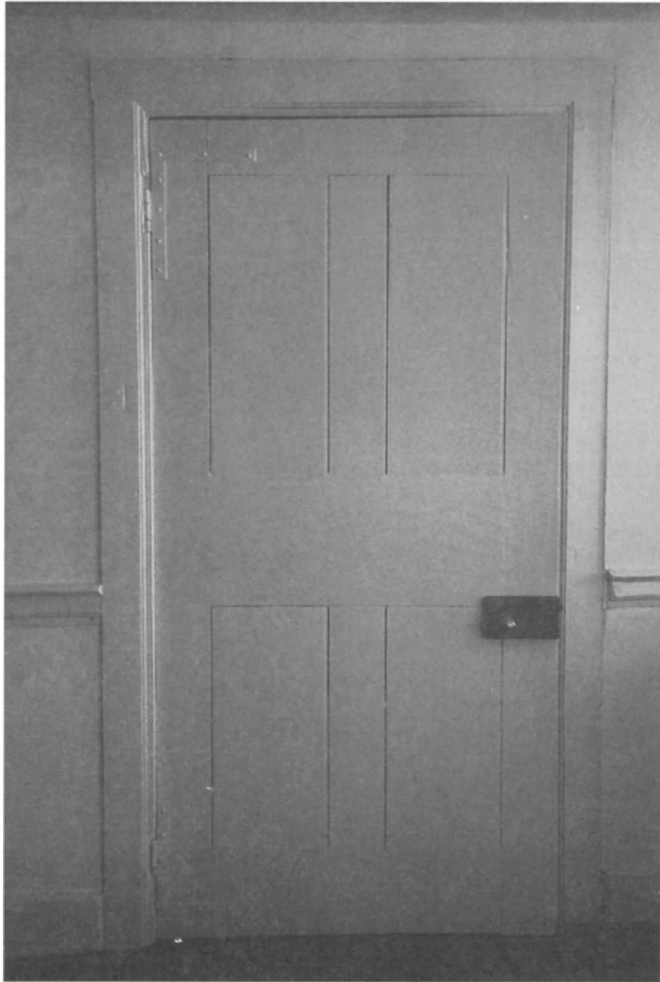
**Figure 215.** North chamber (Room 205), south wall, doorway D203.

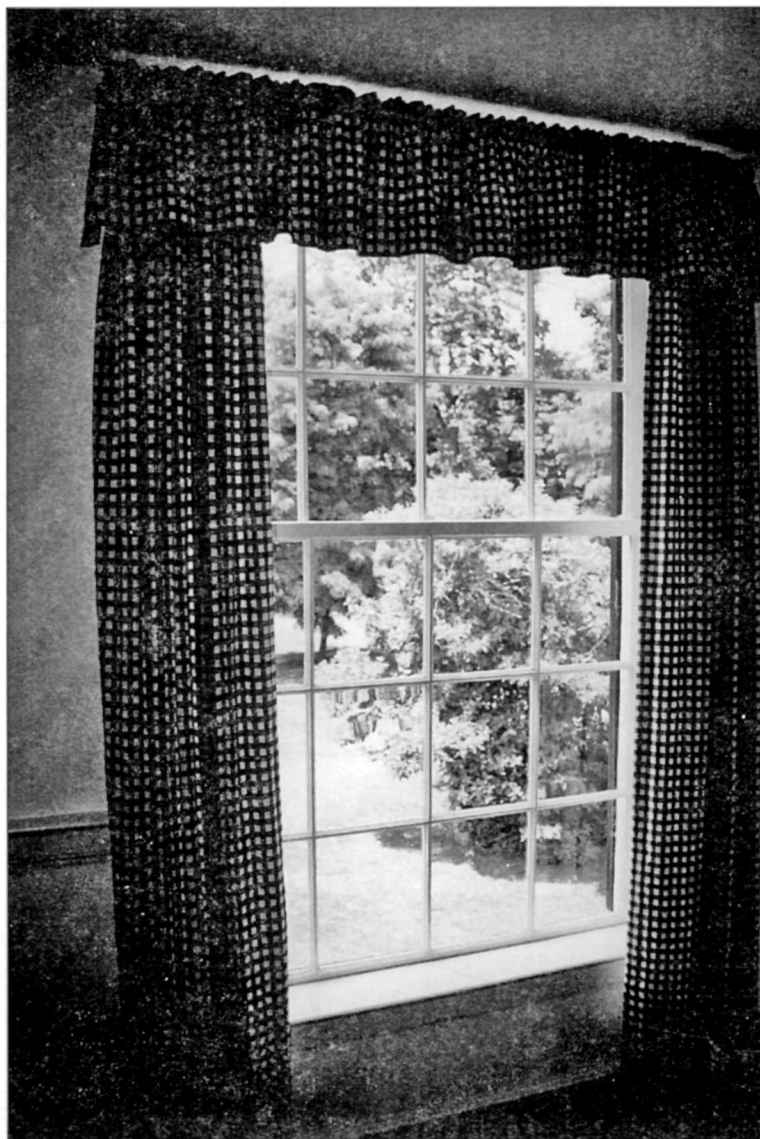
**Figure 217.** North chamber (Room 205), west wall, window W201.

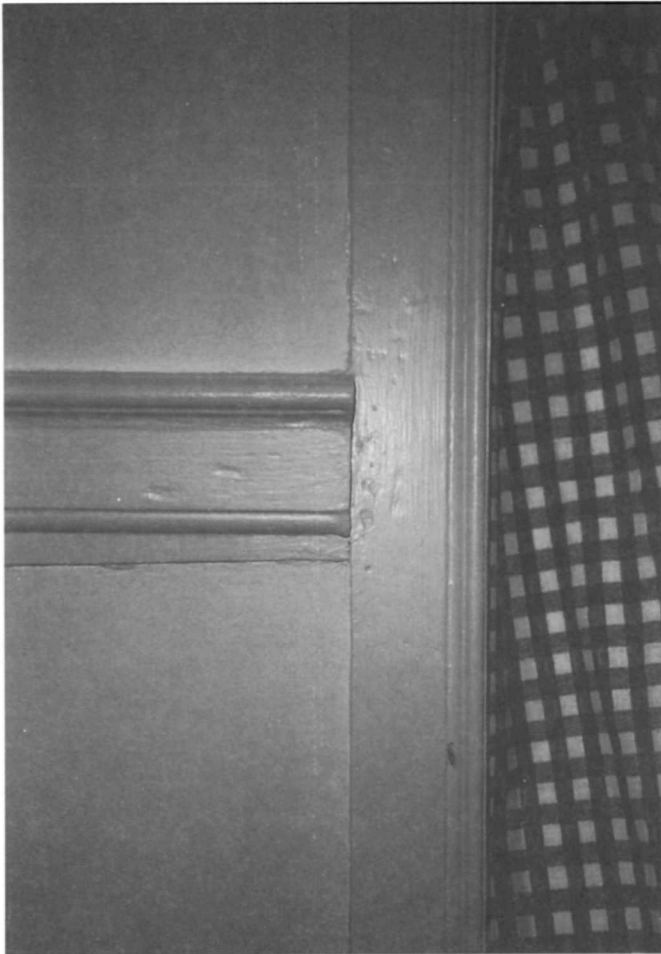
**Figure 221.** North chamber (Room 205), detail of window casing and chair rail.

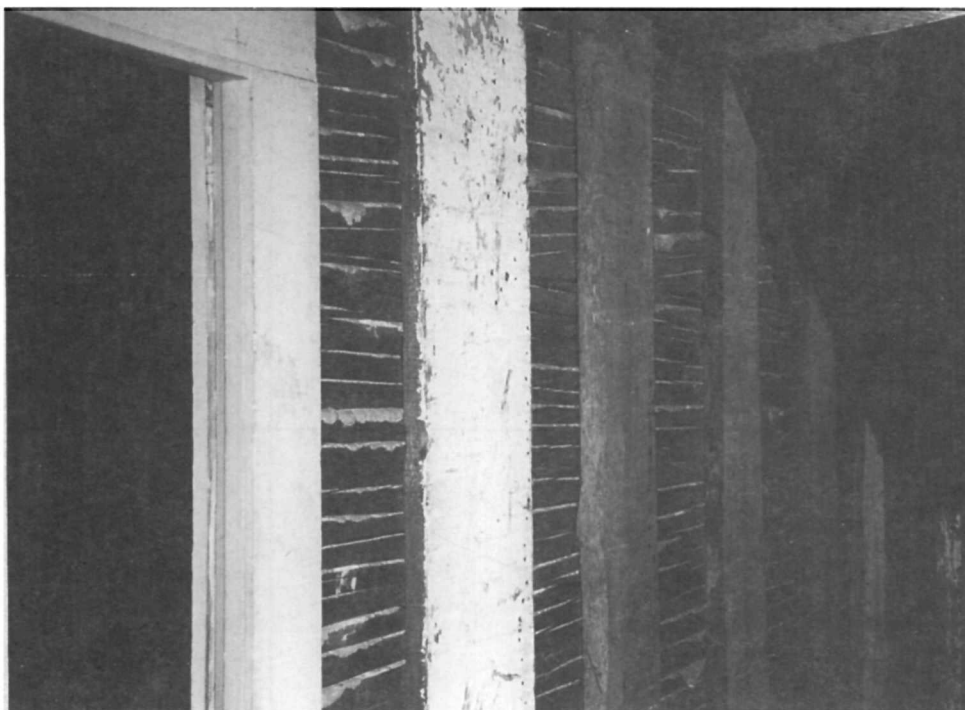
**Figure 224.** Second-story kitchen hall (Room 206), south end of east wall.

The second-story kitchen hall (figs. 223-229) extends along the west side of the kitchen wing's second story. The room measures approximately 6 feet 3 inches wide by 22 feet 8 inches deep. The south, west, and north exterior walls are exposed framing and exterior sheathing, and the east wall is composed of wide-plank studs that remained after the ca.-1815 lath and plaster was removed by the 1950s restoration team (figs. 223-224). Two doorways in the east wall open to servants' quarters (D205, D206: figs. 225-226), and a window with a casement sash sits in the west wall (W210: fig. 227). A stairway along the west wall ascends from the kitchen hall, terminating at a landing at the south end of the room.

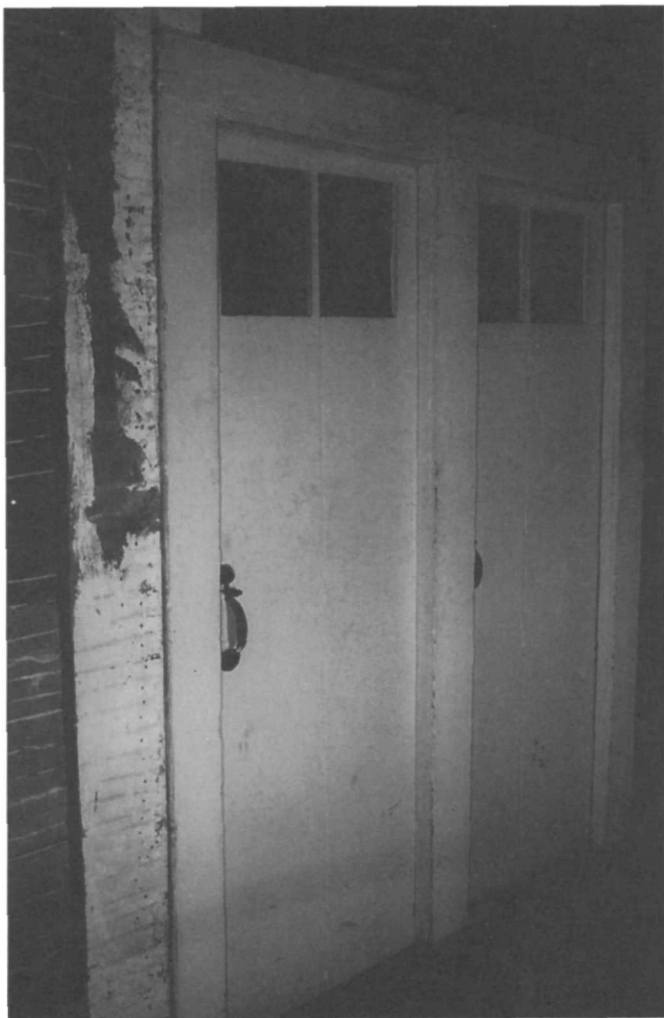
**Figure 225.** Second-story kitchen hall (Room 206), east wall, doorways D205 and D206.

The thick-plank flooring and the exposed framing in the second-story kitchen hall date to the ca.-1780 construction of the kitchen wing. The doorways in the east wall date to the 1815 remodeling, but the doors are older, and may have been reused from 1780 openings in the kitchen wing. The remainder of the room has been stripped of its ca.-1815 features to reveal evidence of the original ca.-1780 configuration of the room, such as the location of the original doorway in the east wall (fig. 228).

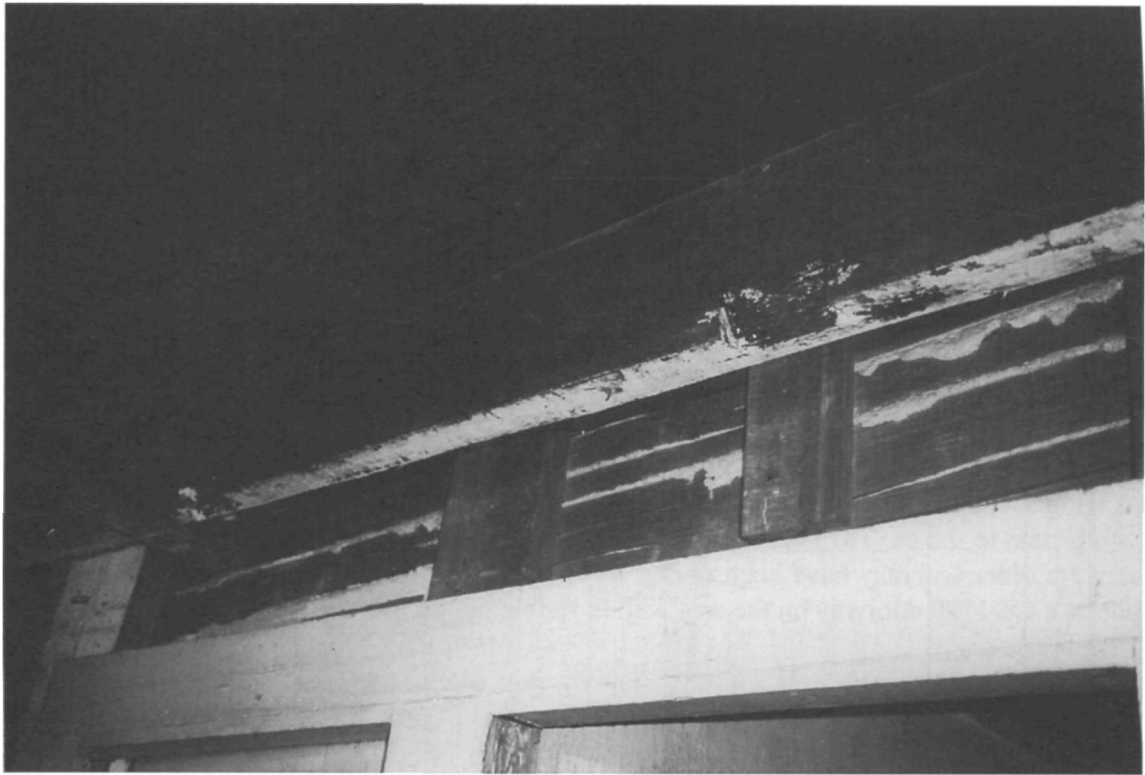
**Figure 228.** Second-story kitchen hall (Room 206), east wall, stud-pocket evidence of former doorway.

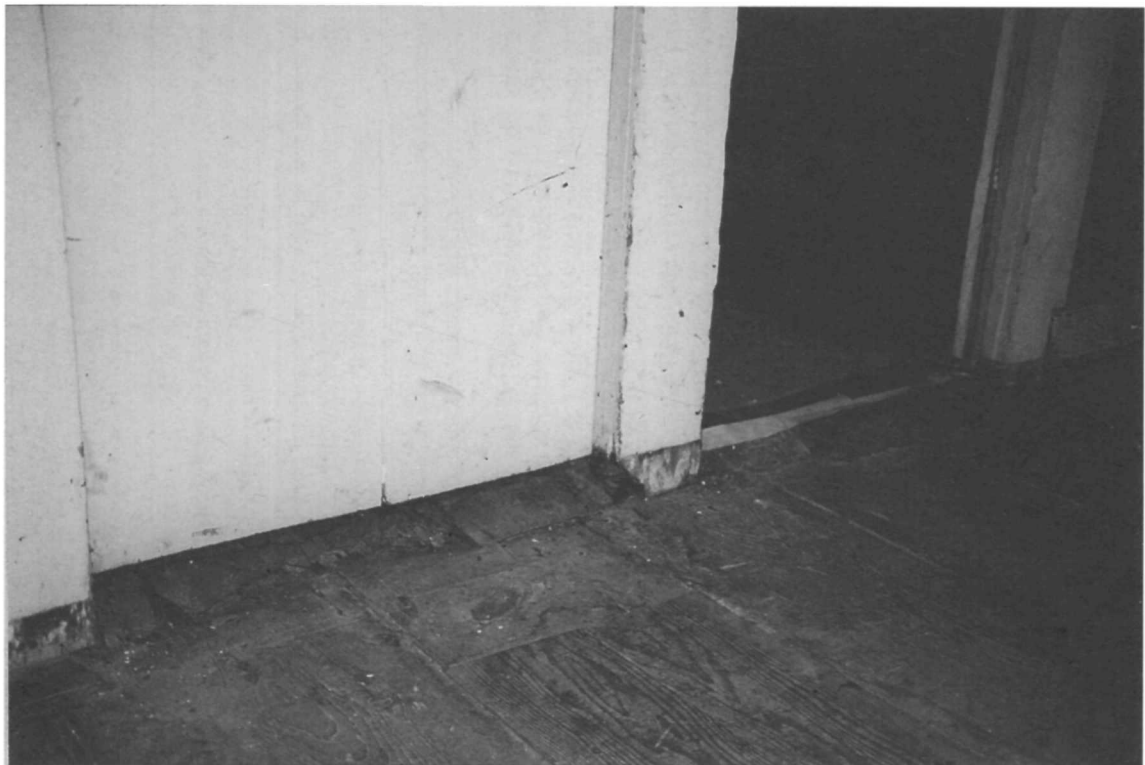
**Figure 229.** Second-story kitchen hall (Room 206), east wall, later flooring in adjacent rooms beveled to meet original flooring in room.

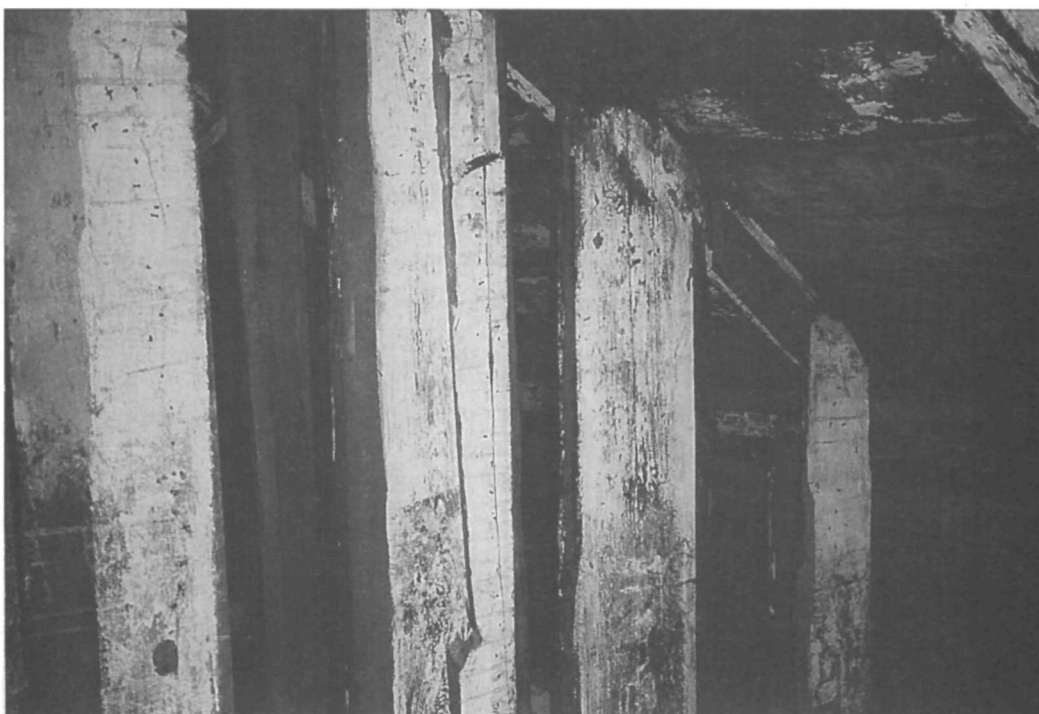
**Figure 230.** South servant's room (Room 207), south end of east wall.

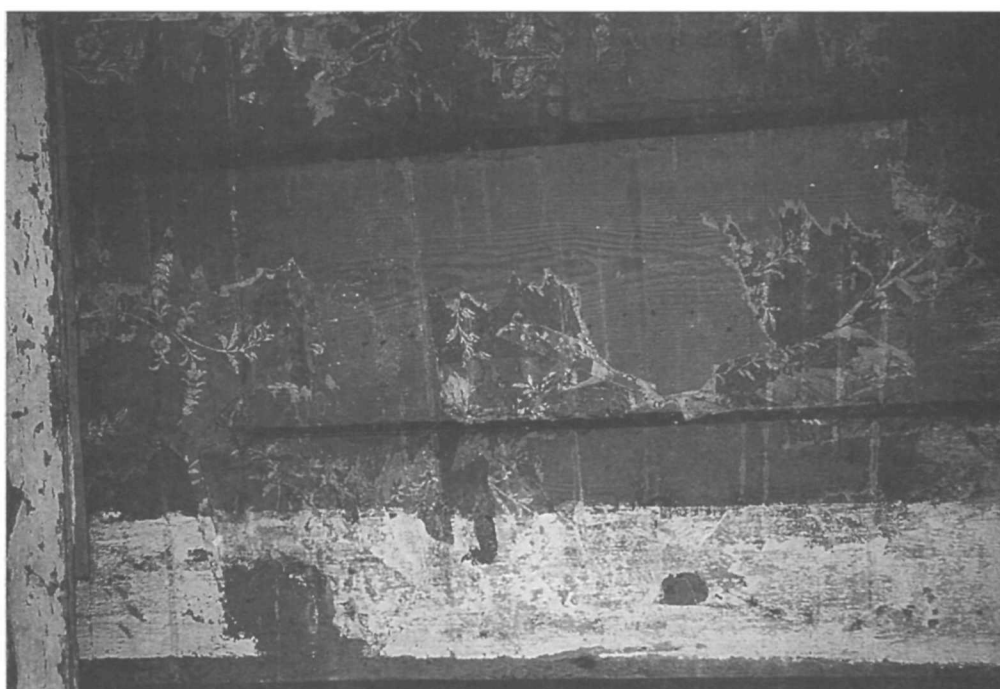
**Figure 231.** South servant's room (Room 207), east wall, pre-1815 wallpaper and whitewash.

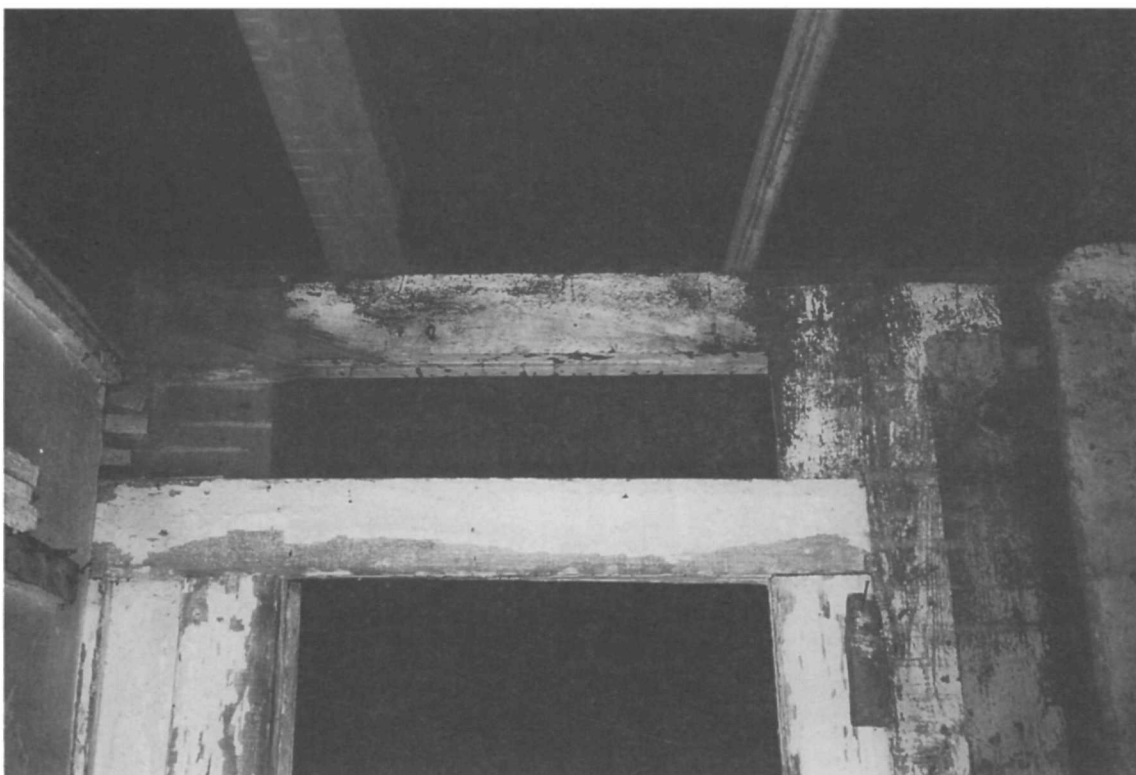
**Figure 234.** South servant's room (Room 207), north end of east wall, whitewash evidence of former doorway.

The exposed framing in the south servant's room dates to the ca.-1780 construction of the kitchen wing. The thick-plank flooring, the lath and plaster walls, and the location of the exposed plank studs date to the ca.-1815 remodeling of the room. The doorways also date to circa 1815, but the doors are older and may have been reused from 1780 openings in the kitchen wing. Whitewash evidence of a ca.-1780 doorway on the east wall is visible on the framing (fig. 234).

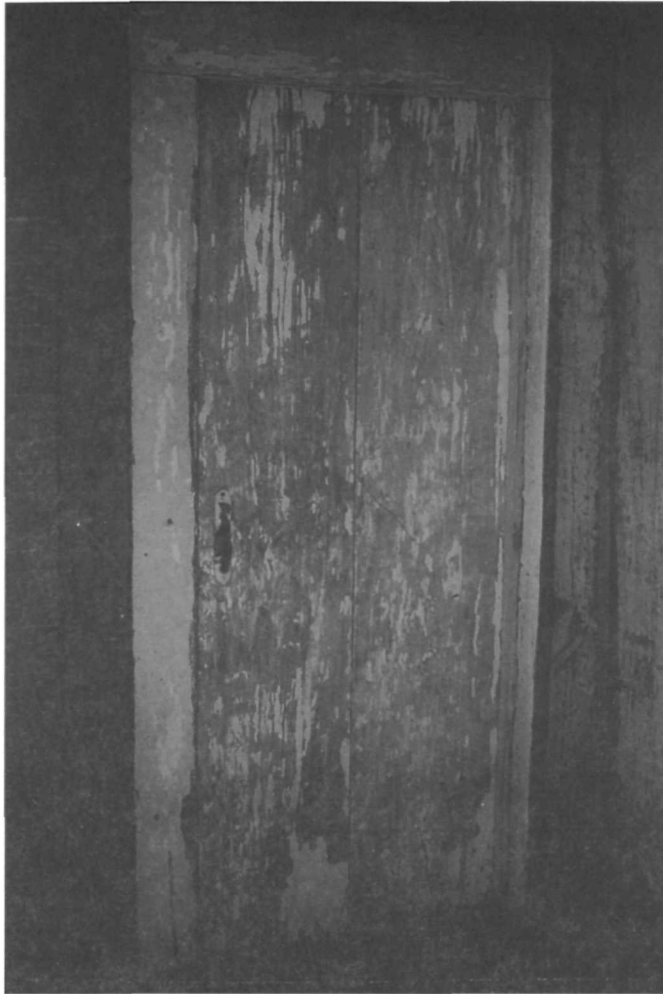
**Figure 238.** North servant's room (Room 208), south end of east wall, doorway D208.

The north servant's room (figs. 235-239) is centered on the north side of the kitchen wing's second story. The room measures approximately 11 feet 5 inches wide by 8 feet 5 inches deep. The north exterior wall is exposed framing and exterior sheathing; the west wall is plastered; and the east and south walls are composed of wide-plank studs that remained after the ca.-1815 lath and plaster was removed by the 1950s restoration team (figs. 235-237). A doorway in the west wall (D206: fig. 237) opens from the second-story hall (Room 206), and a doorway in the east wall leads to the east servants' room (D208: figs. 238-239). There are no windows in the room.

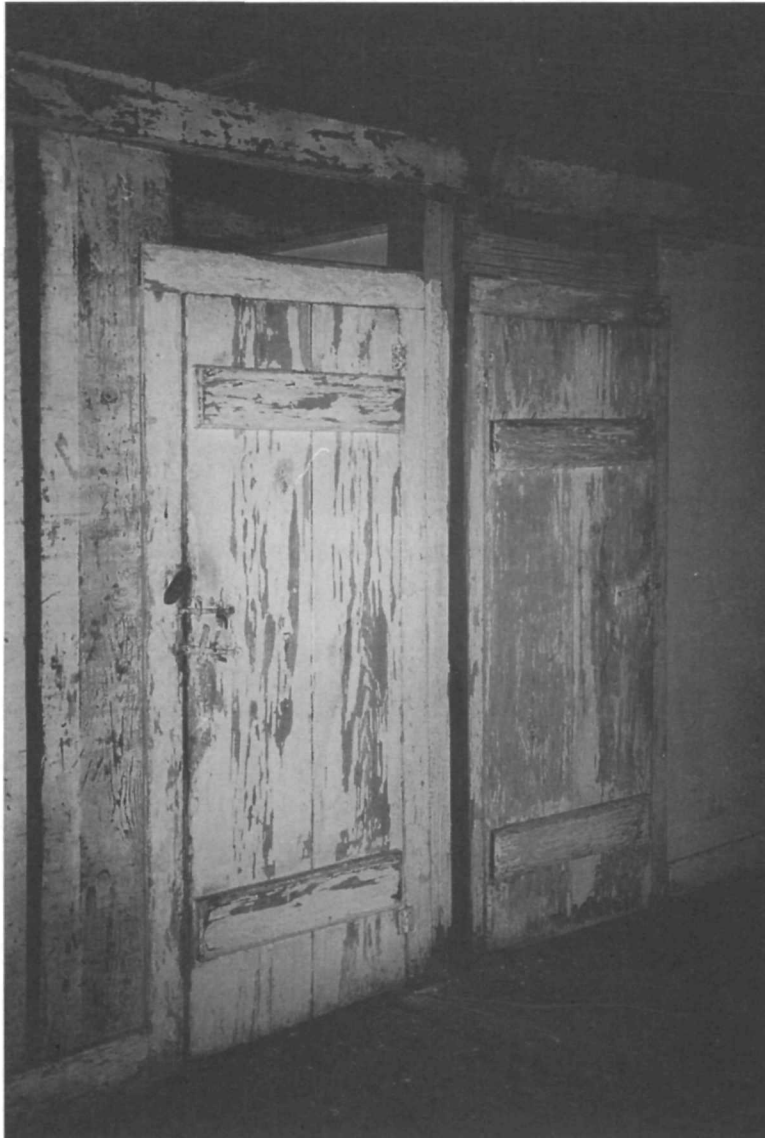
**Figure 242.** East servants' room (Room 209), west wall, doorways D207 and D208.

The east servants' room (figs. 240-246) extends along the east side of the kitchen wing's second story. The room measures approximately 22 feet 8 inches wide by 10 feet deep. The space was divided into two rooms until 1963 when the center partition was torn down to rebuild the chimney on the east wall. The south, east, and north exterior walls are exposed framing and exterior sheathing (figs. 240-241). The north end of the west wall is plastered, and the south end is composed of wide-plank studs that remained after the ca.-1815 lath and plaster was removed by the 1950s restoration team. Doorways in the west wall (D207, D208: figs. 242-244) open to the south and north servants' rooms (Room 207 and Room 208), respectively. Small windows with casement sashes (W208, W209: fig. 245) are located in the east wall on either side of the chimney.

| FEATURE | DESCRIPTION | COMMENT |
|---|---|---|
| D207 - West Wall<br>[south of center board] | <b>Opening</b> - 2' 2½" wide x 6' ¾" high; <b>batten door</b> - two horizontal ledge boards, 6" wide, attached to R207-side vertical boards w/ wrought nails; <b>casing</b> - 4" wide butt, sash-sawn plain-board, <b>hardware</b> - two loose-pin butt hinges, three-knuckle; two latch bars & staples: wrought-iron bar mounted under cast-iron bar | Doorway from R207<br>ca.-1815 opening<br>ca.-1780 door (?)<br>Mid-19 <sup>th</sup> -c. hinges & keeper |

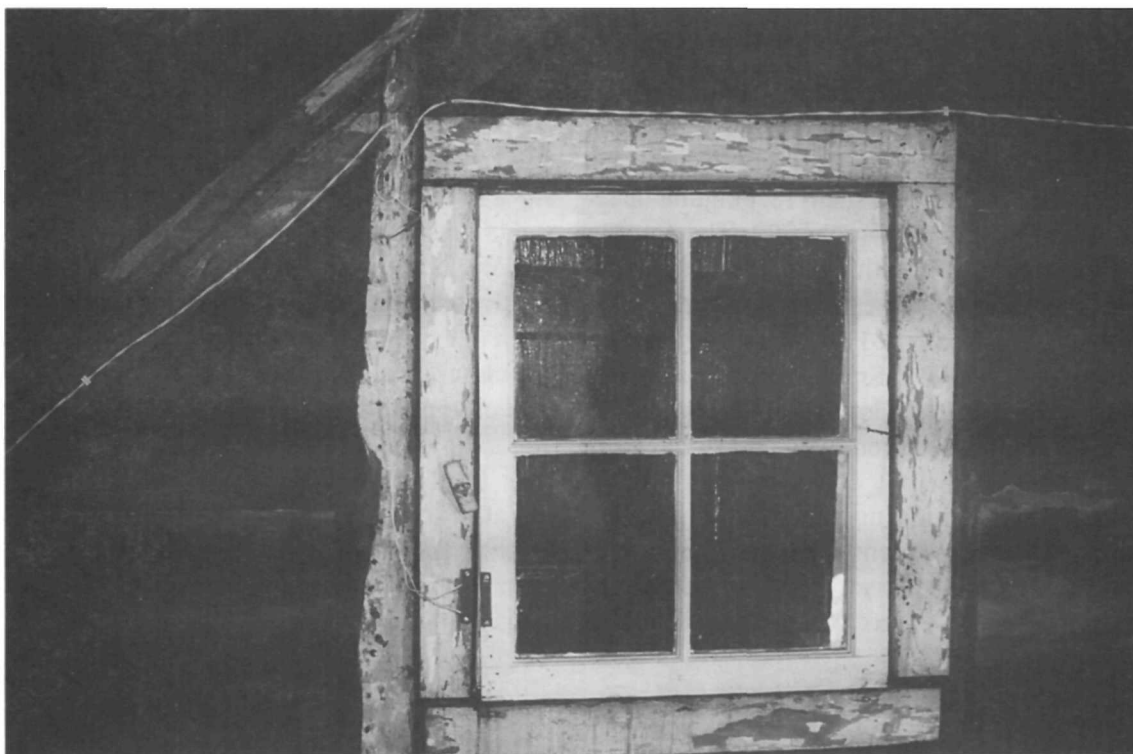
**Figure 245.** East servants' room (Room 209), east wall, window W209.

| FEATURE | DESCRIPTION | COMMENT |
|---|---|---|
| W208 - East Wall, South<br>W209 - East Wall, North | <b>Openings</b> - 1' 7 ½" wide x 1' ½" high; <b>sashes</b> - casement, 4 lights [2 x 2], <i>muntin Profile C</i> ; <b>casings</b> - 3" wide butt, plain-board; <b>hardware</b> - wood turn latch secures loose sashes; cut nails hold remnant of leather hinge on S casing of W208 & nail holes in S casing of W209 evidence of similar hinge; circular wear mark on N casing of each opening indicate former wood turn latch | ca.-1815-1835 openings &<br>casings<br>Post-1890 sashes |

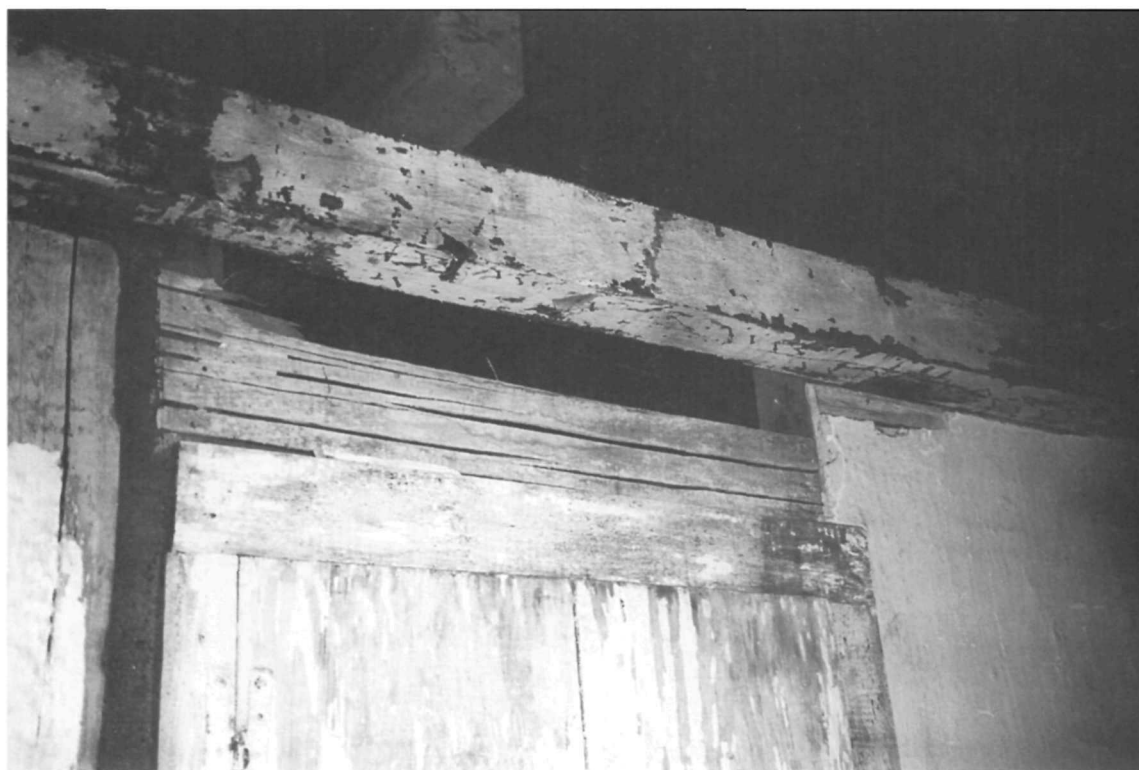
**Figure 246.** East servants' room (Room 209), west wall, stud-pocket evidence of former doorway.

The exposed framing in the second-story kitchen hall dates to the ca.-1780 construction of the kitchen wing. The thick-plank flooring, the lath and plaster walls, and the exposed plank studs date to the ca.-1815 remodeling of the room. The doorways also date to circa 1815, but the doors are older and may have been reused from 1780 openings in the kitchen wing. Whitewash evidence of a ca.-1780 doorway is visible on the framing of the west wall (fig. 246).

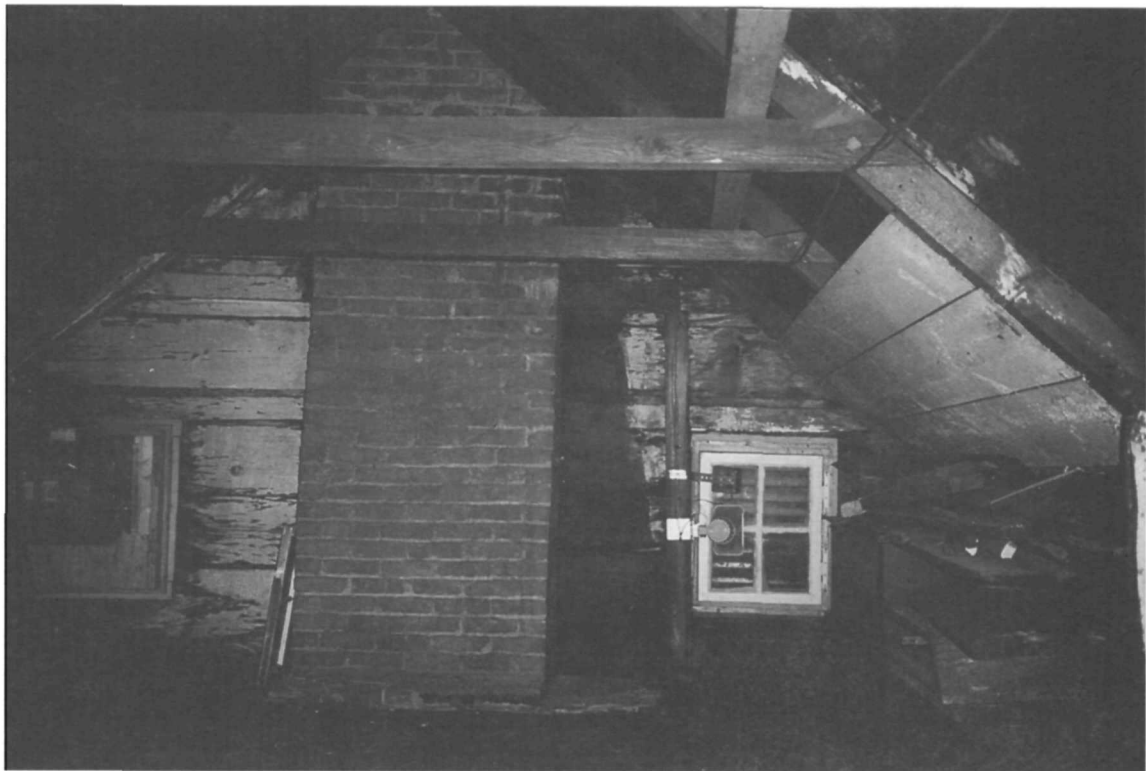
**Figure 248.** South attic room (Room 301), south wall.

The south attic room (figs. 247-251) occupies the southern two-thirds of the attic space in the main house. It consists of a main rectangular space, and also the two eaves spaces along the east and west walls of the adjacent Room 302. The south, east, and west exterior walls of Room 301 are the exposed framing and sheathing of the main roof. The north wall (fig. 247) is the vertical-plank partition separating the space from the north attic room (Room 302). A hatchway (D301) from the second-story hall (Room 201) is located in the floor, and a doorway to the north attic room is located on the north wall (D302). Small windows are located on either side of the chimney on the south wall (fig. 248). The west window (W301) retains its single casement sash, while the sash of the east window (W302) has been removed and stored (fig. 251).

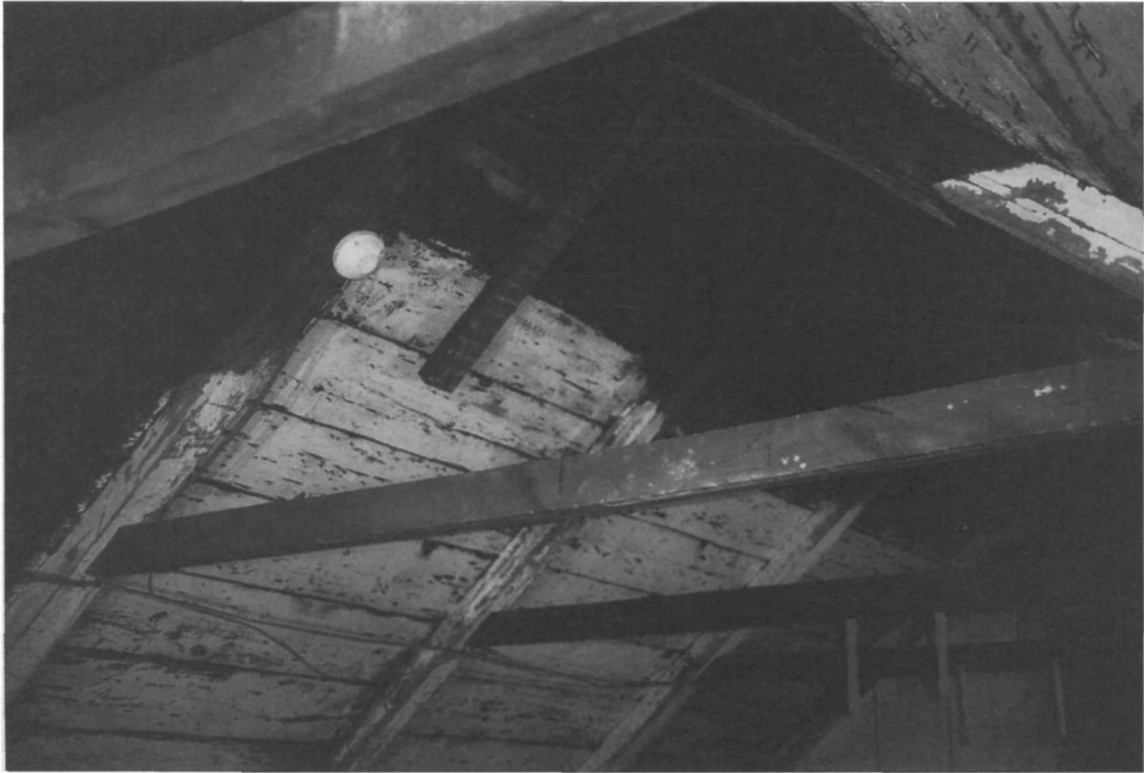
**Figure 249.** South attic room (Room 301), ceiling apex.

The exposed framing and sheathing in the south attic room date to the 1777 construction of the house and to subsequent repairs. The casement sashes appear to predate 1800. The vertical-plank north wall and doorway date to the ca.-1815 remodeling. Whitewash evidence of former partitions is visible on the roof framing and sheathing (figs. 249-250).

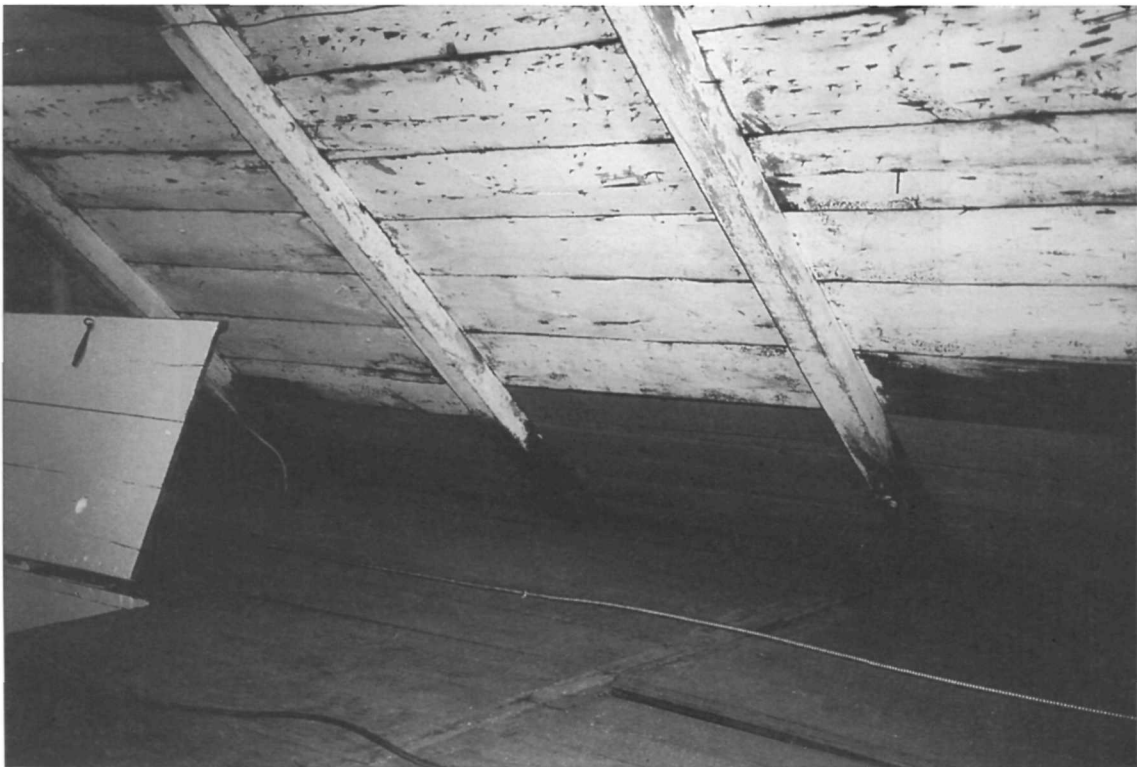
**Figure 250.** South attic room (Room 301), east ceiling slope and edge of hatchway D301.

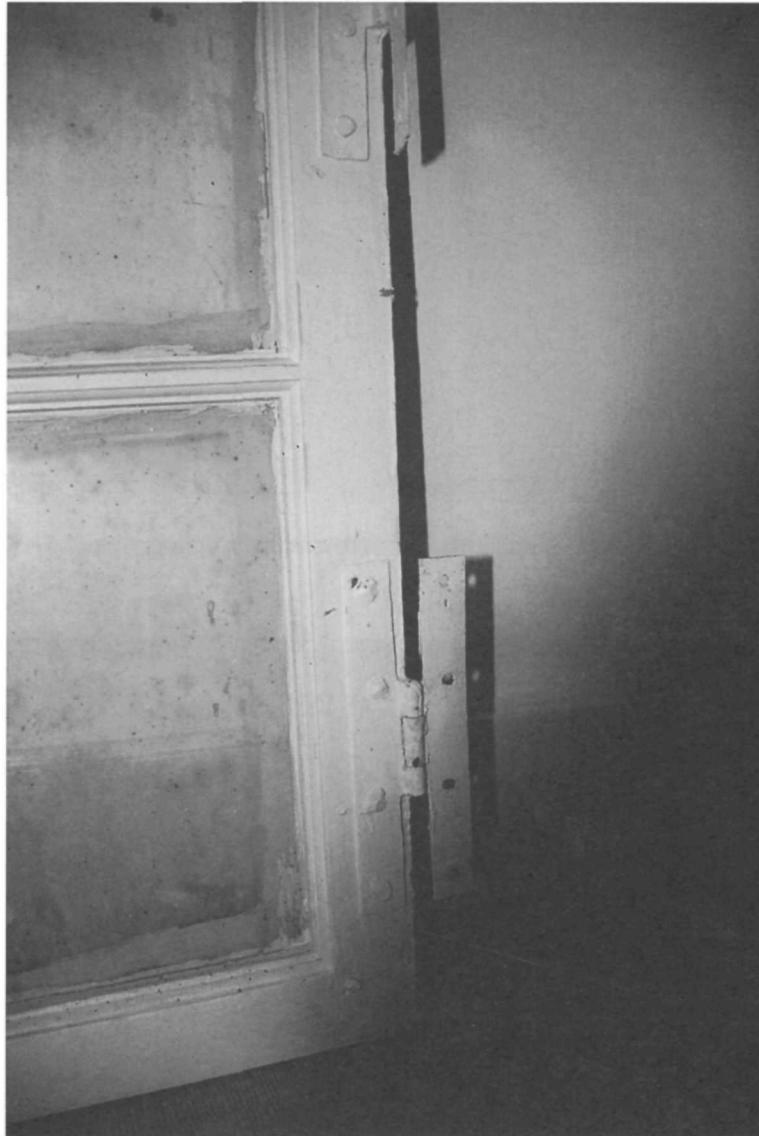
**Figure 251.** South attic room (Room 301), sash from window W302, detail showing wrought H hinges attached with wrought nails.

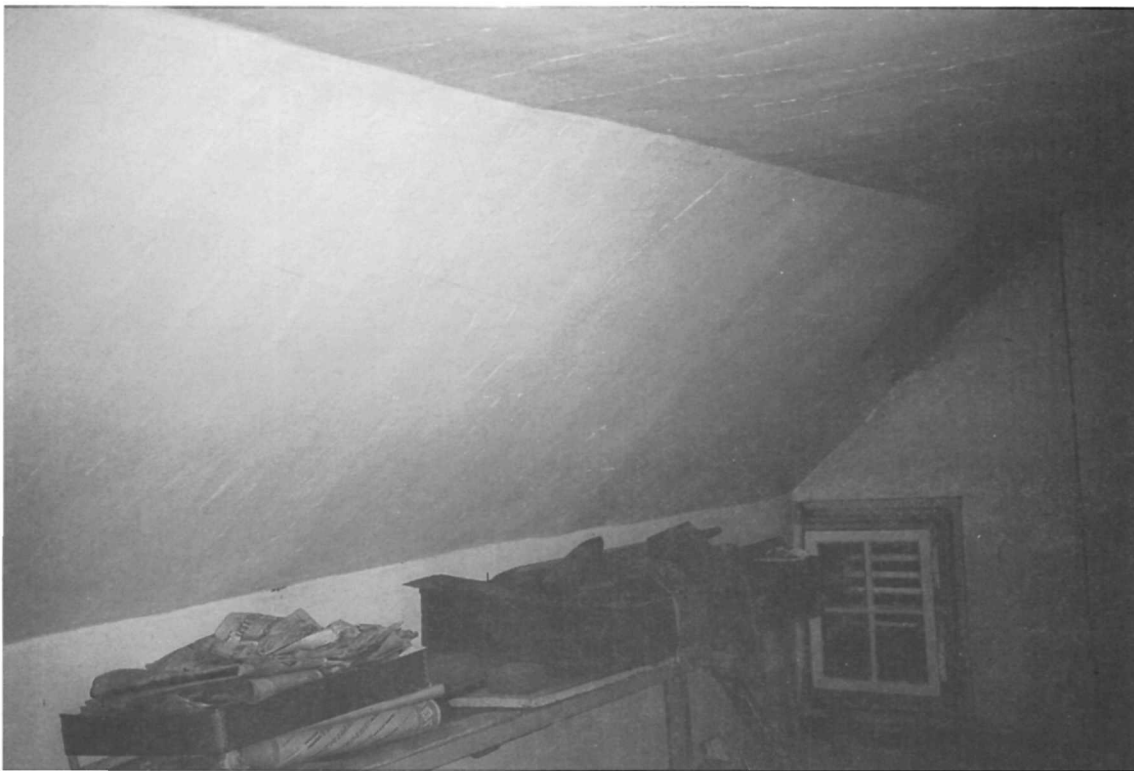
**Figure 253.** North attic room (Room 302), looking northwest.
