# NDCRS ARCHITECTURAL FORM

Field Code NPS-THRO-PCVCSITS# 32 BIMap Quad Fryburg NWSite Name Painted Canyon Visitor Center

Determination of Eligibility - Theodore Roosevelt National Park, Painted Canyon Visitor Center  
 Leah Edwards, NPS MWRO Historical Landscape Architect  
 John Rosemurgy, NPS MWRO Historical Architect

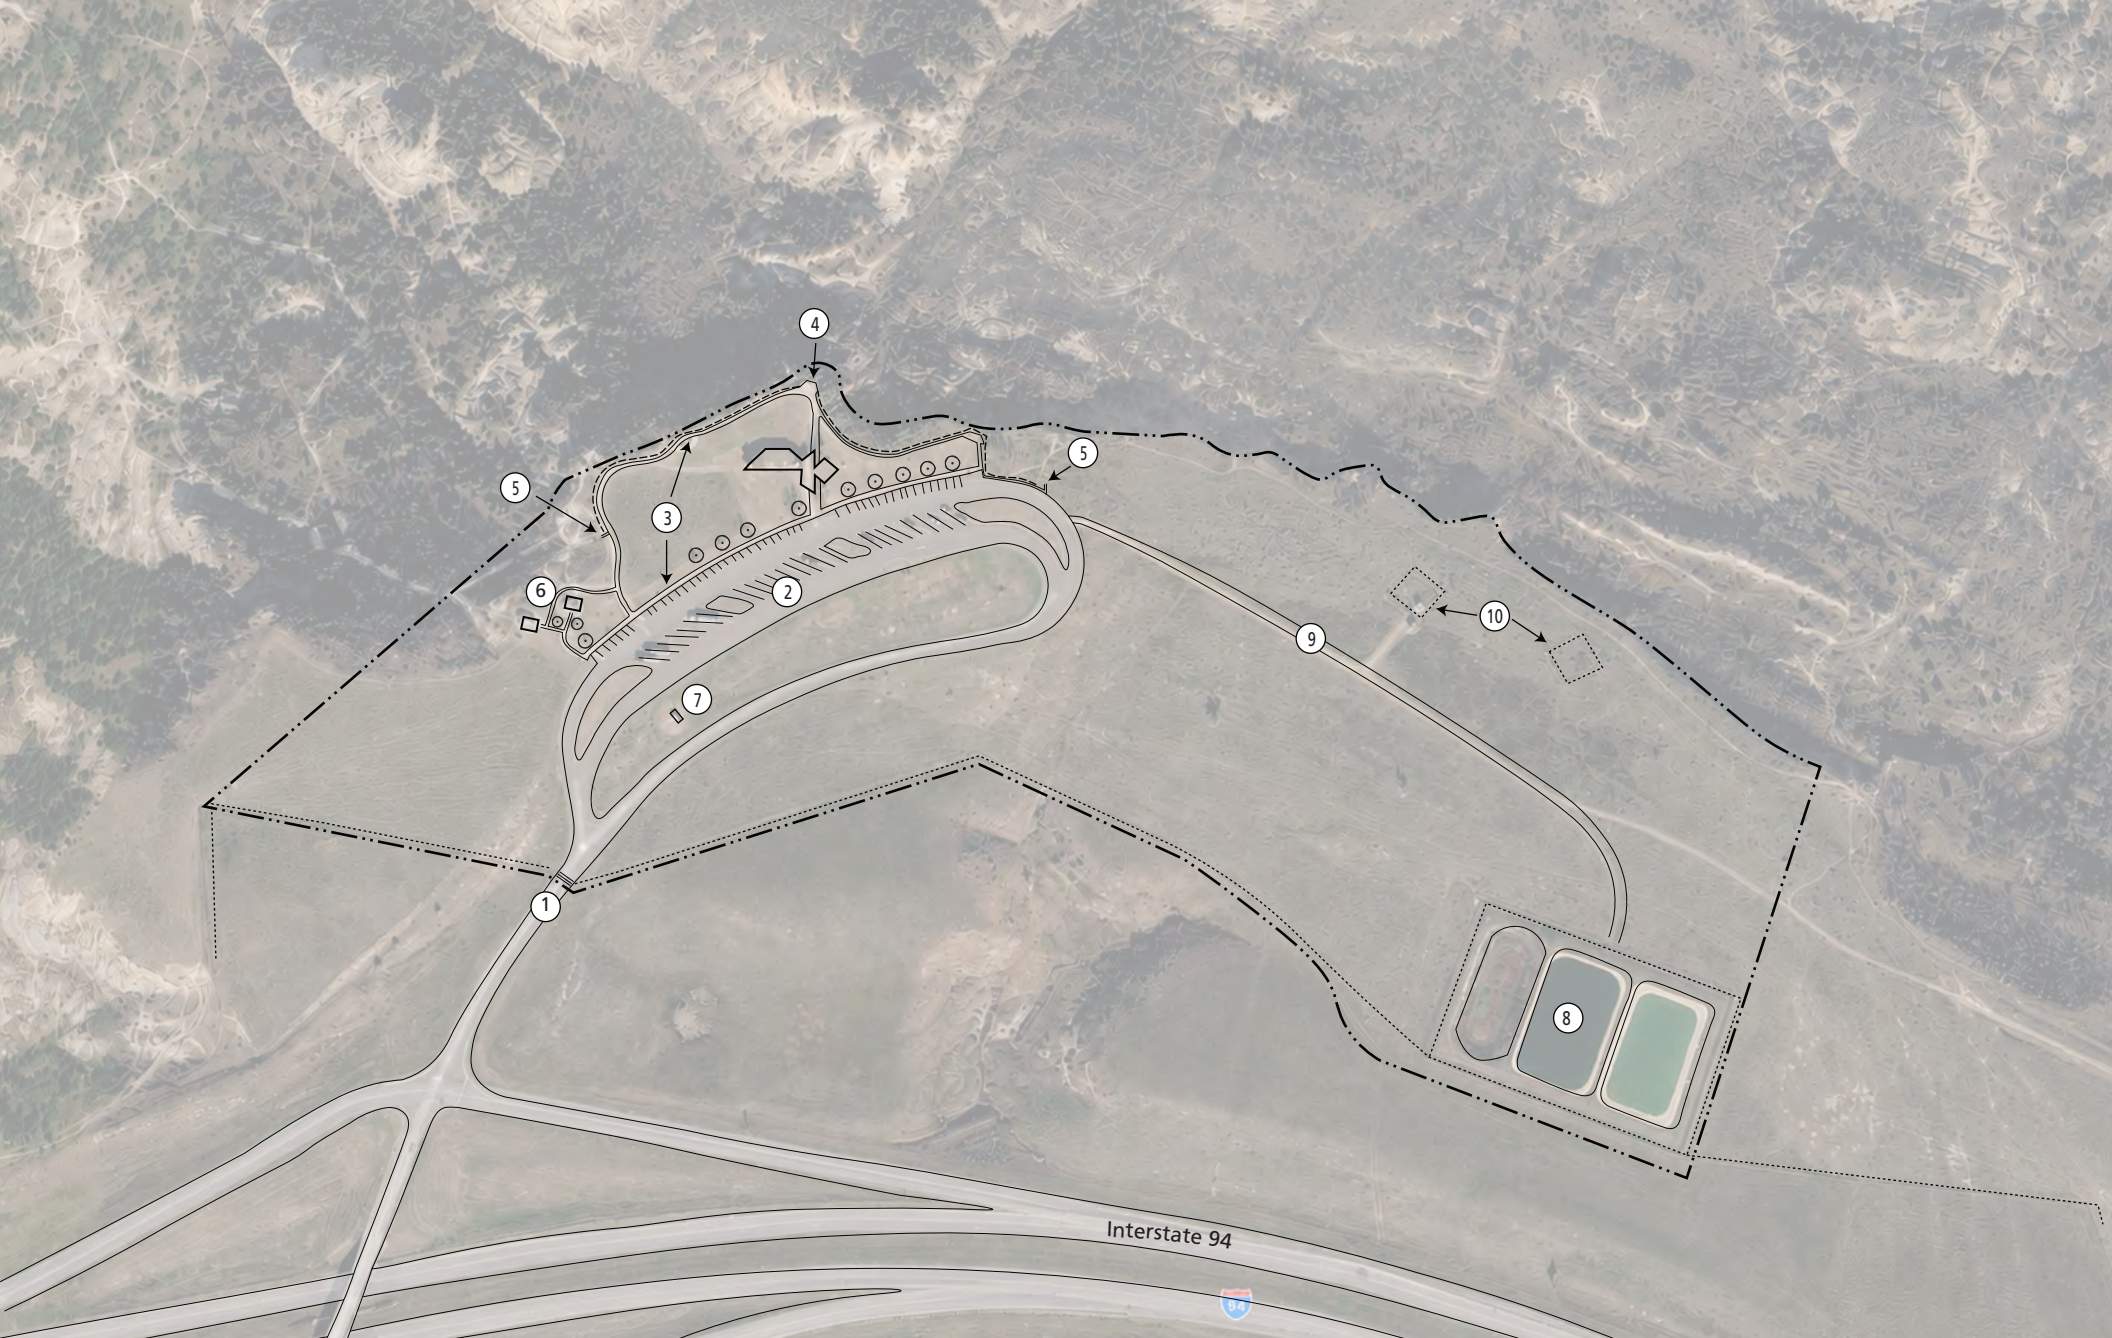
Painted Canyon Visitor Center Site  
Site Plan

Painted Canyon Visitor Center Site—Site Plan. Adapted from Google Earth imagery by Edwards, 2026.

- Boundary
- Metal/Wire Fence
- Wood Fence

- ① Entrance Drive
- ② Parking Area
- ③ Walkways
- ④ Stone Overlook
- ⑤ Painted Canyon Trailhead  
Painted Canyon Nature Trailhead
- ⑥ Picnic Shelters
- ⑦ CCC Entrance Pylon Sign
- ⑧ Wastewater Lagoons
- ⑨ Gravel Service Drive
- ⑩ Air Quality and Weather  
Monitoring Station

Several alterations have occurred since the site's completion. Changes include the removal of a segment of walkway leading to the former eastern overlook, removal of a masonry sign, removal of the service road extending to Interstate 94, reconfiguration of the wastewater lagoons, installation of the air quality and weather monitoring station, addition of a minor overlook along the northern walkway, and the development of informal pedestrian paths. In addition, ornamental and foundation plantings identified in the original plans are largely absent.

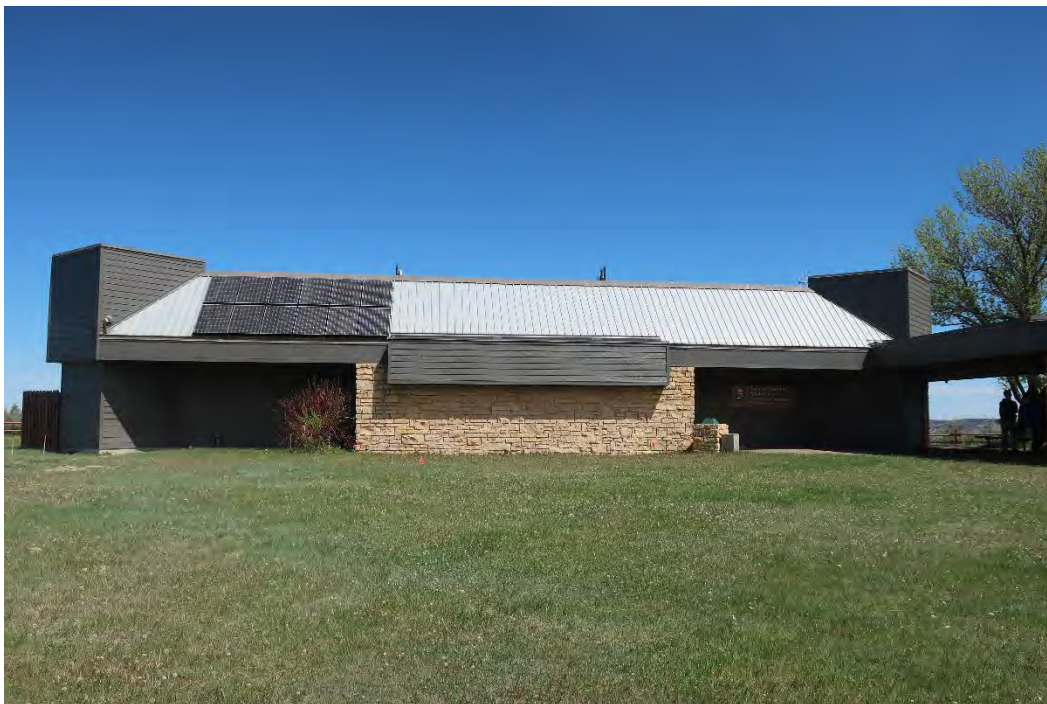
South elevation, Painted Canyon Visitor Center, Theodore Roosevelt National Park. NPS photograph, May 2026.

Intact original exterior materials include stone masonry walls and columns, wood shiplap soffits and canopy ceilings, exterior entrance doors, and some windows. Conversely, the original south facing photovoltaic panel roof has been replaced with standing seam metal roofing. Original diagonal wood siding that conveyed a textured and rustic appearance, has been replaced with cement fiberboard siding that has a low sheen with a simulated woodgrain surface texture. Materials that were originally specified for their natural qualities have been replaced with incompatible synthetic substitutions. The overall integrity of materials is diminished.

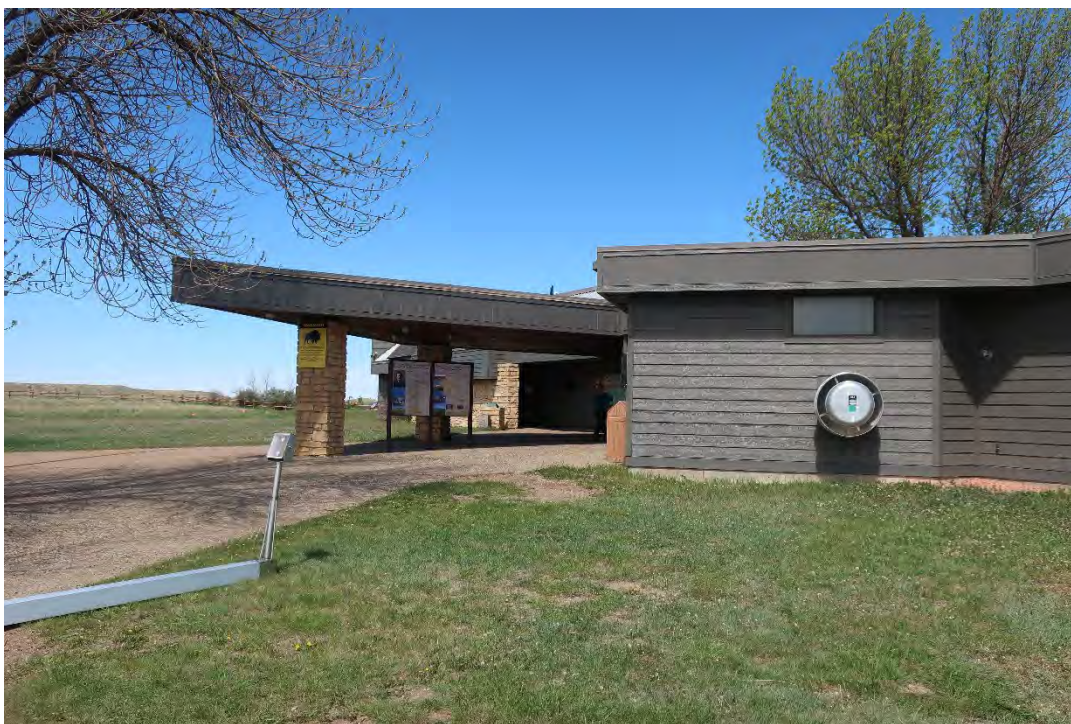
East elevation, Painted Canyon Comfort Station and Canopy, Theodore Roosevelt National Park. NPS photograph, May 2026.

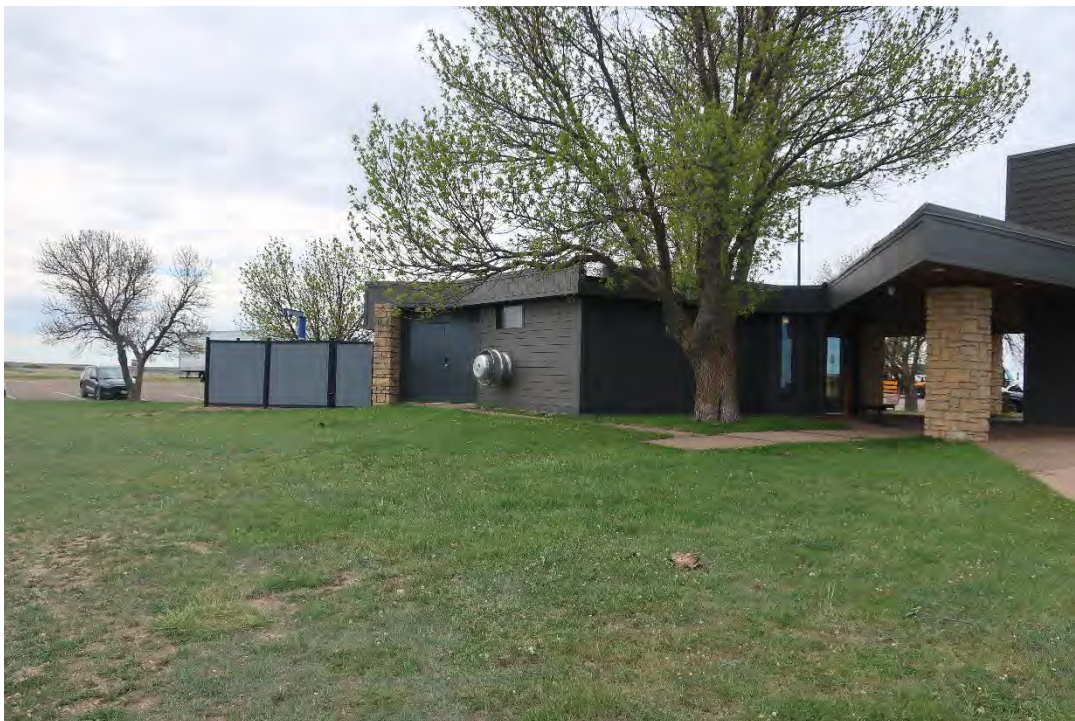
North elevation, Painted Canyon Comfort Station and Canopy, Theodore Roosevelt National Park. NPS photograph, May 2026.

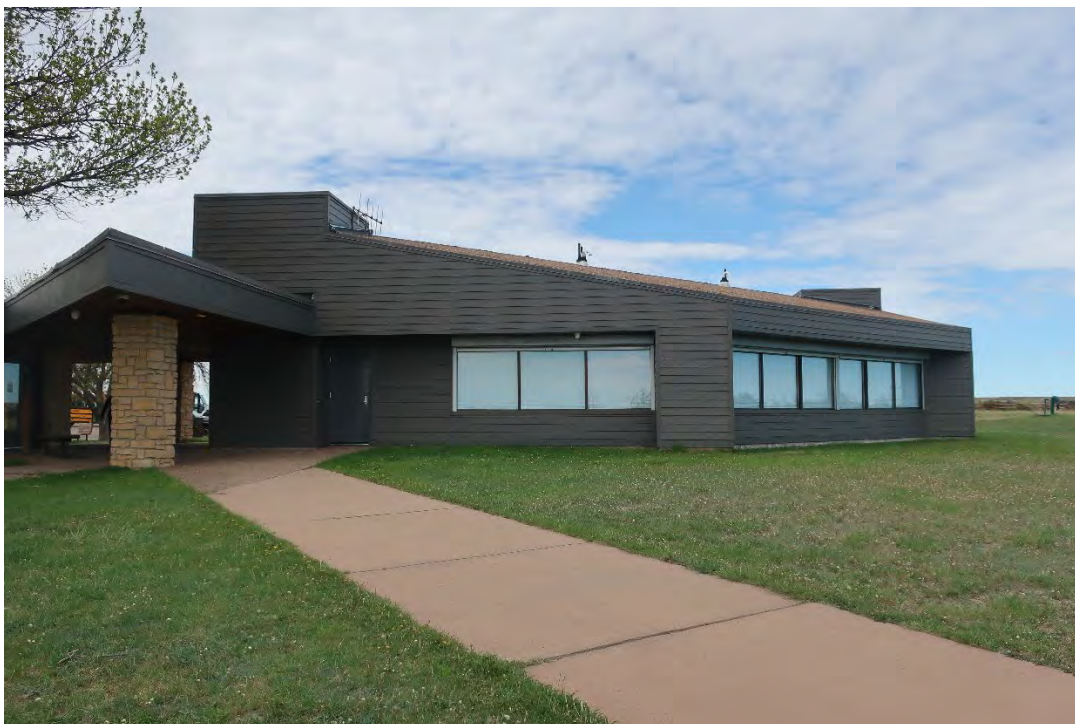
North elevation, Painted Canyon Visitor Center, Theodore Roosevelt National Park. NPS photograph, May 2026.

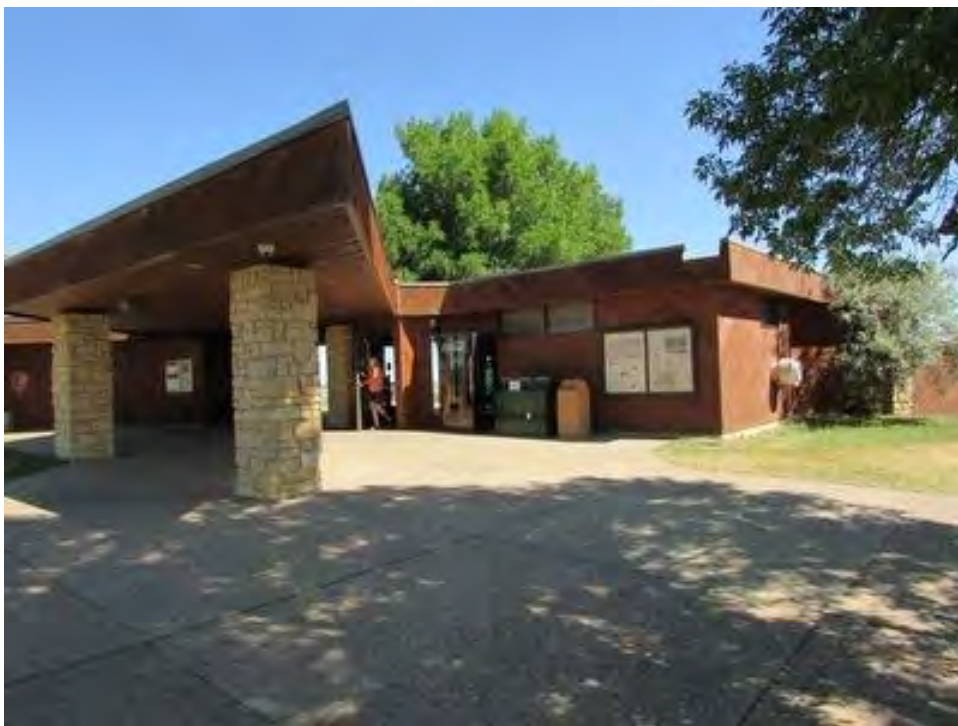
South elevation, Painted Canyon Comfort Station and Canopy, Theodore Roosevelt National Park. NPS photograph, ca. 2010.

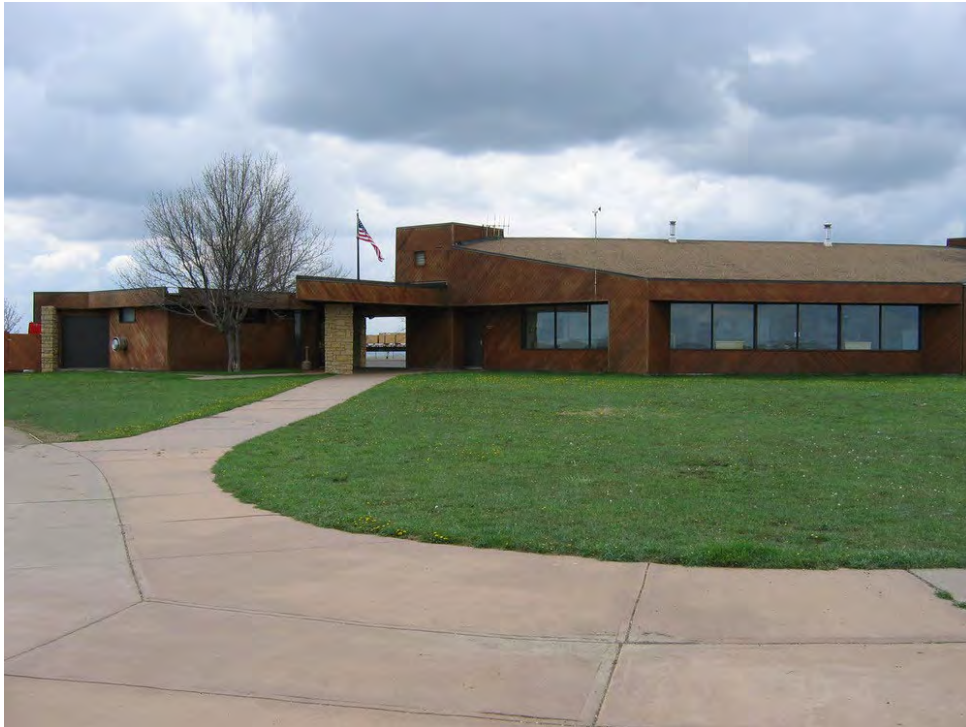
North elevation, Painted Canyon Visitor Center, Canopy, and Comfort Station, Theodore Roosevelt National Park. NPS photograph, ca. 2010.

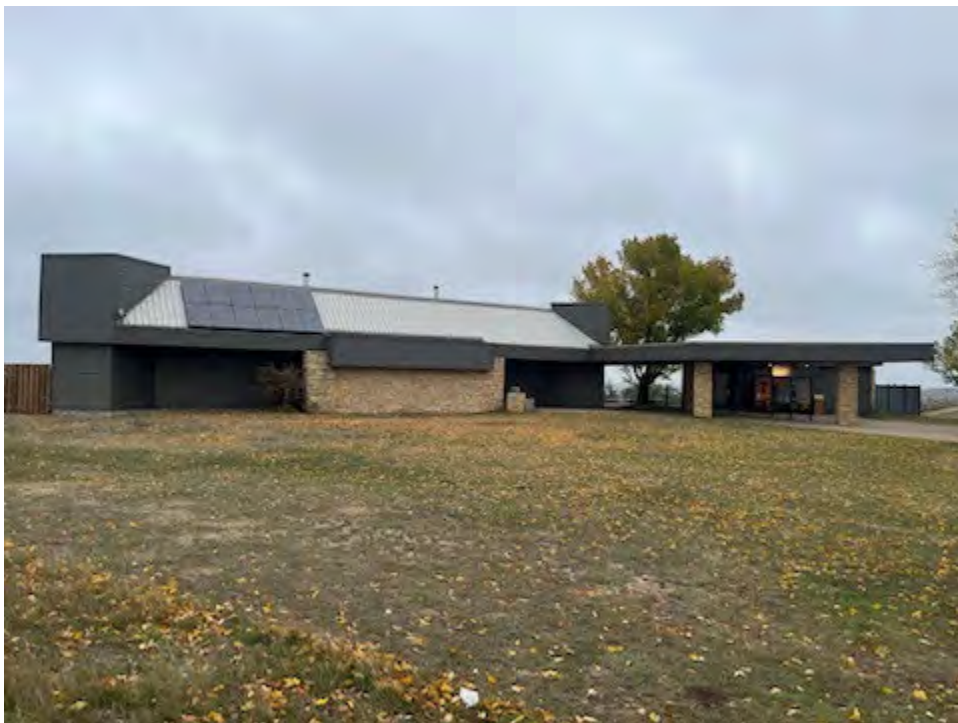
South elevation, Painted Canyon Visitor Center, Canopy, and Comfort Station, Theodore Roosevelt National Park. NPS photograph, 2023.

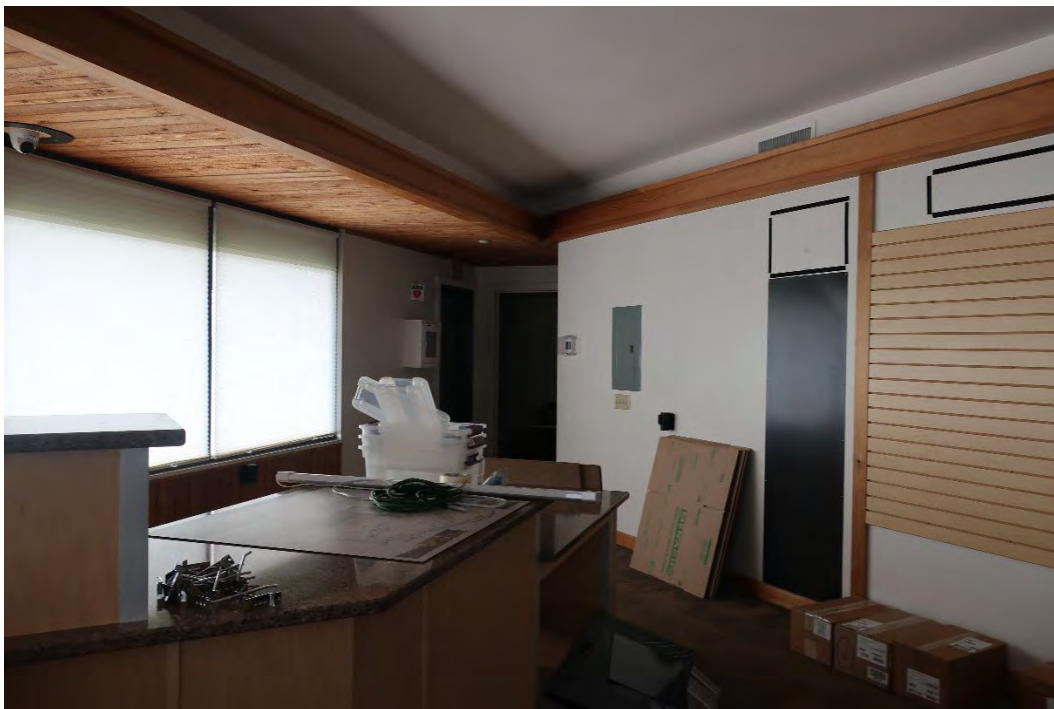
East facing, Interior of Painted Canyon Visitor Center, Theodore Roosevelt National Park. NPS photograph, May 2026.

Interior alterations to the visitor contact station include concealment of the original wood parquet flooring with carpeting and removal of the original customer service desk, replaced with a reconfigured design. The overall integrity of design is diminished.

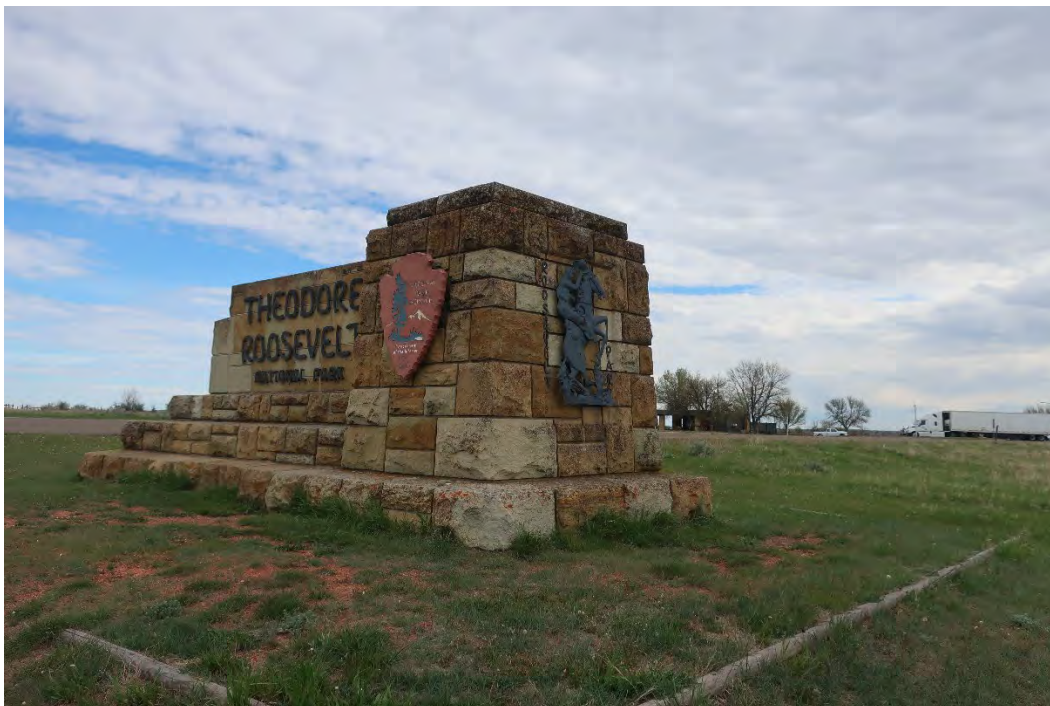
Facing northwest, CCC Entrance Pylon Sign, Theodore Roosevelt National Park. NPS photograph, May 2026.

The evaluation and recommendation presented herein apply only to the Painted Canyon Visitor Center Site. The historic entrance pylon sign located within the site is a contributing feature to the previously determined eligible CCC-era resources of the South Unit at Theodore Roosevelt National Park and is not included in this recommendation of ineligibility.

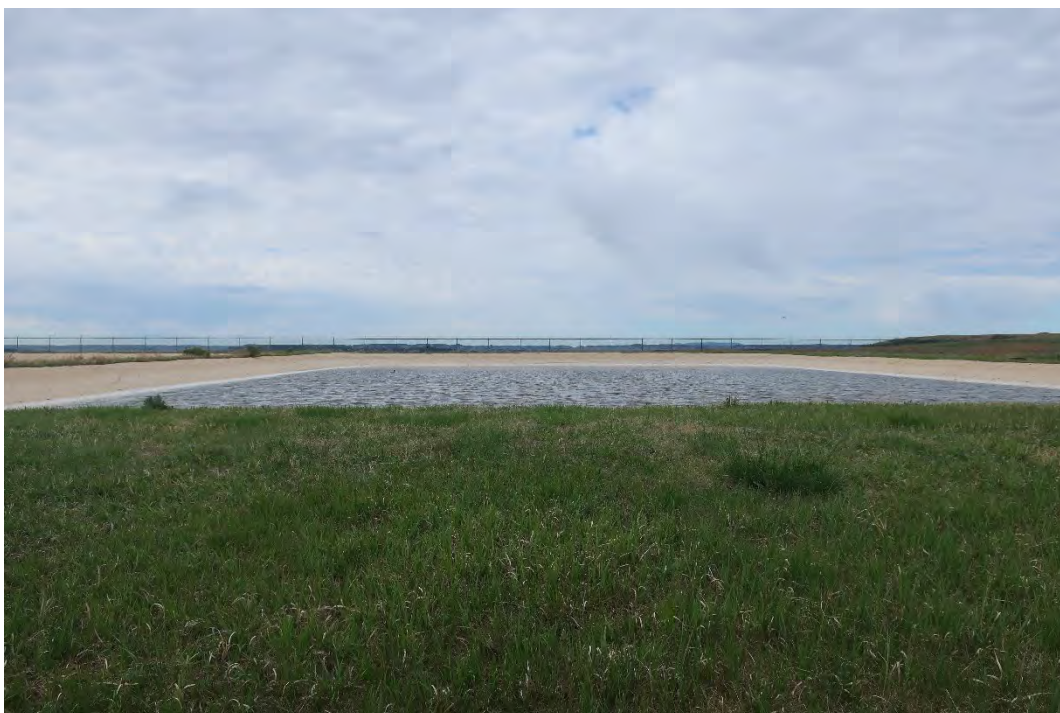
Facing south, Center Wastewater Lagoon, Theodore Roosevelt National Park, NPS photograph, May 2026.
