# Preservation/Restoration of Moton Field

Tuskegee Airmen  
National Historic Site  
Tuskegee, Alabama

*Historic Structure Report*  
Hangar Number Two

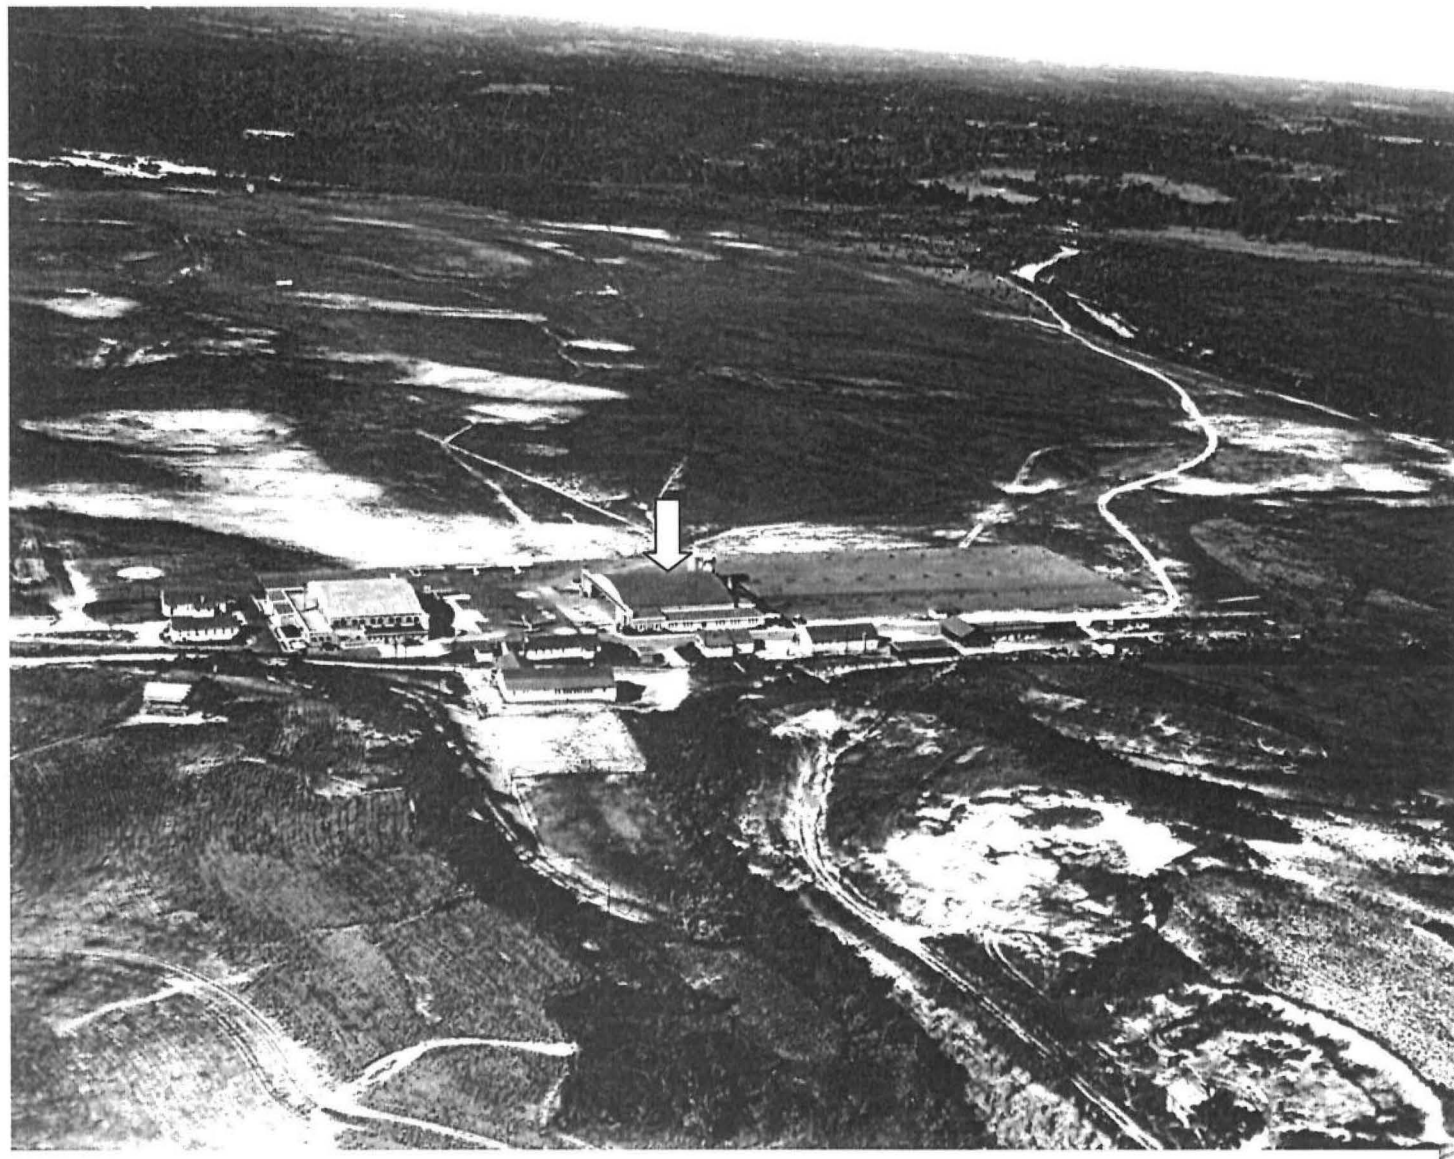
**Figure 4:** Circa 1945 aerial photograph of Moton Field showing Hangar Number Two. Historic Photograph Collection, National Park Service Curatorial Storage Facility, Tuskegee Institute NHS.

Numerous historic photographs of Moton Field document Hangar Number Two as it was constructed.<sup>32</sup> Two aerial photographs from c.1944 and post-March 1945 provide good views of the hangar.<sup>33</sup> (See *Figure 4*.) According to these photos and the original architectural drawings, the large hangar area was constructed of brick masonry. The dope room on the building's southwest corner, the boiler room on the rear east facade, and the control tower were also of brick construction for fire safety purposes. The remainder of the perimeter rooms around Hangar Number Two were of frame construction finished with novelty wood siding. (See *Figures 5, 6*.) The hangar's segmentally arched roof was covered with roll roofing rather than the corrugated metal used on the first hangar. (See *Figure 7*.) A number of historic interior photos of Hangar Number Two also exist, documenting some interior finishes and furnishings. (See *Figure 8* and *Appendix A*.)

The c.1945 aerial photograph provides a view of the south and west sides of the hangar. (See *Figure 4*.) The entire south side of the hangar space and the perimeter rooms is visible. Also, the west side of the large hangar space with sliding hangar doors can be seen. This photograph confirms that the window and door openings, frame and masonry walls, shed roofs, and other details that can be seen of the south perimeter room facade match those of the 1942 architectural drawings.

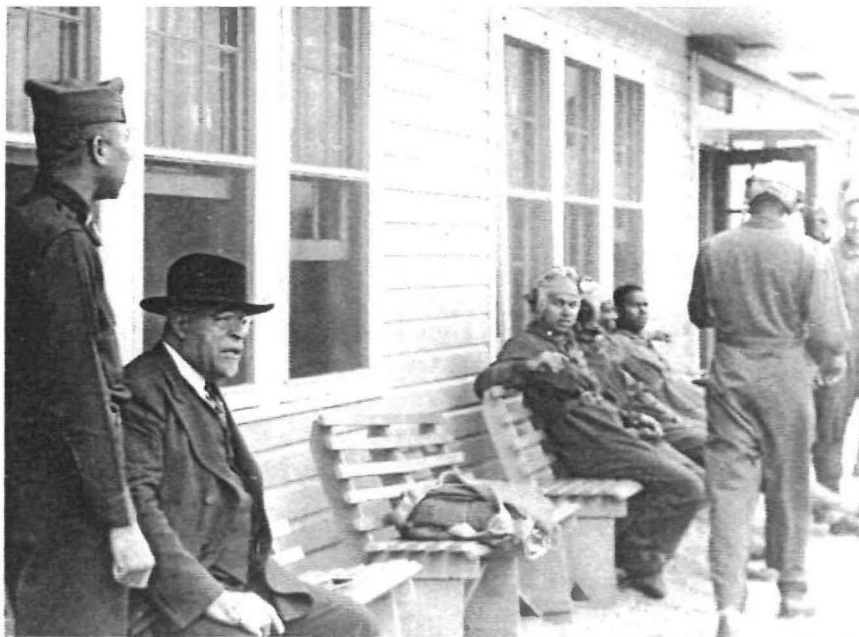
**Figure 6:** Historic photograph of cadets and visitors outside the north facade of Hangar Number Two. Historic Photograph Collection, AFHRA, Maxwell AFB.

A photograph of the south side perimeter rooms under construction clearly shows the masonry wall of the dope room, the frame wall of the link trainer room and class room, the shed roof structure, and window and door openings. (See *Figure 5*.) Another historic photograph from April 1945 shows cadets and visitors sitting on benches outside the north wall of the north side perimeter rooms. (See *Figure 6*.) This photo shows details of the six-over-six double-hung windows, window screens, window moldings, novelty wood siding, a door with a frame canopy above it, and boxed eave overhangs with vents there were part of the frame portion of the north side perimeter rooms. The window and door arrangement and other details shown in the photo match the window and door arrangement and details for the north side perimeter rooms indicated on the original 1942 architectural drawings. A third photograph also shows the north side perimeter rooms with cadets sitting in front of it. (See *Appendix A*.) As in the previous photo, the window and door arrangement and details match those of the original architectural drawings. A fourth photograph shows a portion of the north side perimeter rooms from an angle looking toward the Control Tower. (See *Appendix A*.) This photo documents the evidence of frame canopies above the door openings along the north side of the perimeter rooms. Also, two light fixtures on the hangar's northwest corner are visible. A fifth historic photograph documents the roof of Hangar Number Two. (See *Figure 7*.) The roll roofing on both the hangar space and the perimeter rooms, the horizontal siding, window openings, and vent of the east roof end, and the brick chimney on the north side of the boiler room are all visible. A sixth photograph

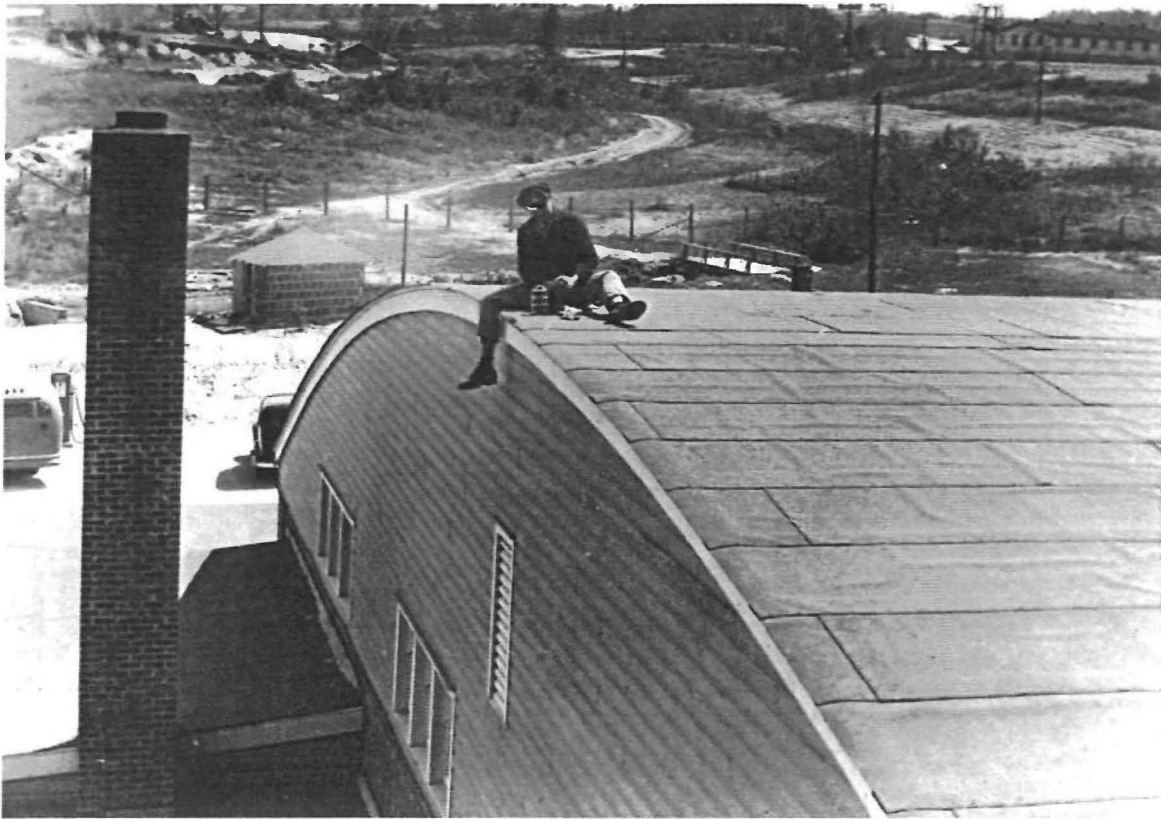
**Figure 7:** Historic photograph documenting the roof of Hangar Number Two. Historic Photograph Collection, Howard University.

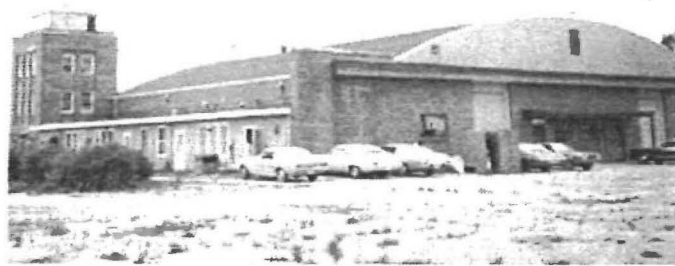
**Figure 9:** 1977 photograph of Hangar Number Two showing alterations made by the Tuskegee University Veterinary School. Booker Conley's Files, Physical Plant, Tuskegee University.

drawings were prepared by the architectural and engineering firm Lockwood Greene for more alterations to the hangar for the Veterinary School.<sup>35</sup> The hangar was used for environmental labs for the school's large animal practice, which included cattle and swine. A very large door was reportedly put into the hangar to accommodate giraffes, but it is not known if any giraffes were actually brought there.<sup>36</sup> A large number of animal corrals and pens used by the school were located at the rear of Hangar Number Two. Photographs from the 1970s illustrate these alterations.<sup>37</sup> (See *Figure 9*.)
