CRM BULLETIN

A National Park Service
Technical Bulletin

Rome Center Experts Direct Tumacacori Project

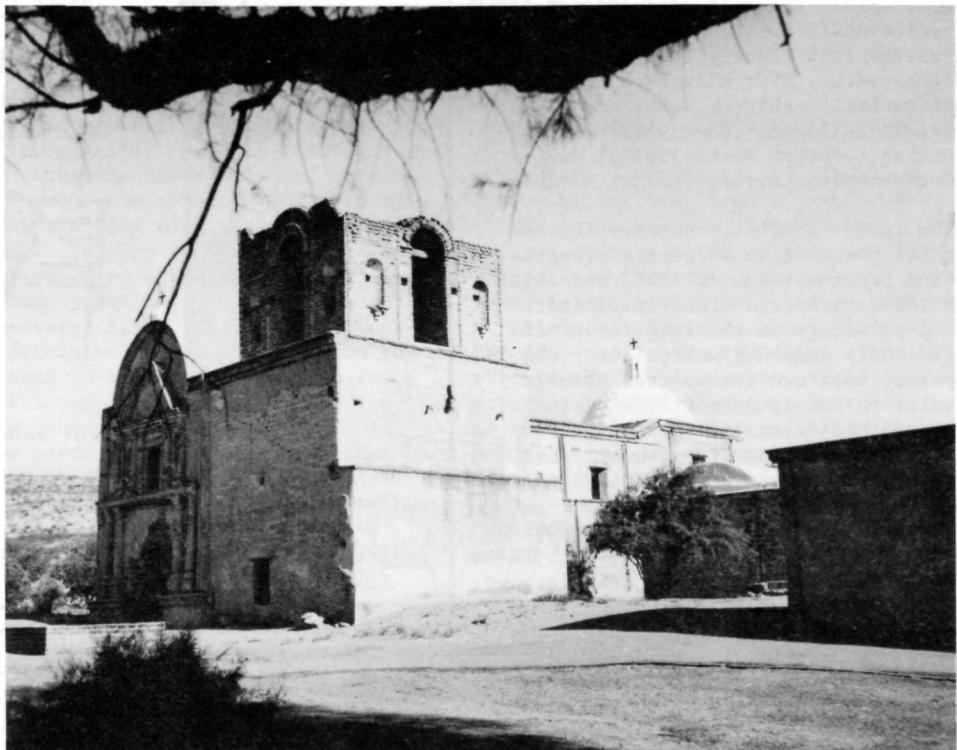
The mission church of San Jose de Tumacacori. The massive bell tower was never completed by the Franciscans. Much of the recent conservation work centered in the dome area.

The recent project, representing the final phase of an extensive preservation program begun in 1975, was organized to preserve historic plaster and paintings on the interior of the sanctuary dome and walls. Over the years, moisture transported soluble salts to the surface of the plaster, where they crystallized and forced the decorative paintings away from the walls. These recrystallized salts also damaged much of the plaster as well. In addition, the salts drew, through hygroscopic action, more moisture to these already deteriorated areas of plaster and paint. The source of the problem, moisture penetrating from the exterior of the dome and not by capillary action from the foundation up through the walls, was eliminated (see the schematic drawing); but the results, flaking paint and gypsum wash, and stained, friable, missing and poorly attached plaster, remained to be corrected.

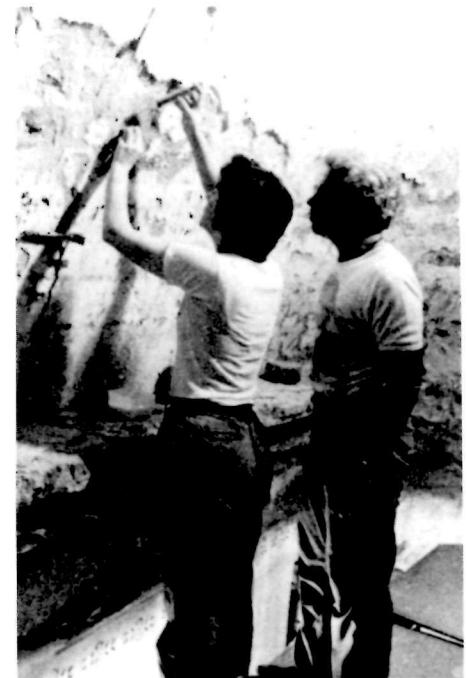
Carole Perrault (left), architectural conservator, North Atlantic Historic Preservation Center, and Paul Schwartzbaum (right), conservator from the International Center for the Preservation and Restoration of Cultural Properties, are shown reattaching gypsum wash to the interior surface of the mission church's dome.

A long fiber Japanese tissue and water were used to reattach the wash. The tissue was used primarily to protect the gypsum during subsequent conservation work. It also served as a vehicle for transporting moisture, applied with a soft, natural bristled brush to the wash. Water had to be applied only at a rate that the wash could easily absorb. If it were applied too quickly, the water would displace the fragile wash. As the wash absorbed the water, it became pliable, and a light brushing on the protective tissue pressed the wash back in place on the plaster. Additional pressure was then consistently and carefully applied to secure the wash back onto the wall. An hour after application, the tissue was
