Aleutian World War II National Historic Area
Unalaska, Alaska

*Fort Schwatka
Self-Guided Tour*

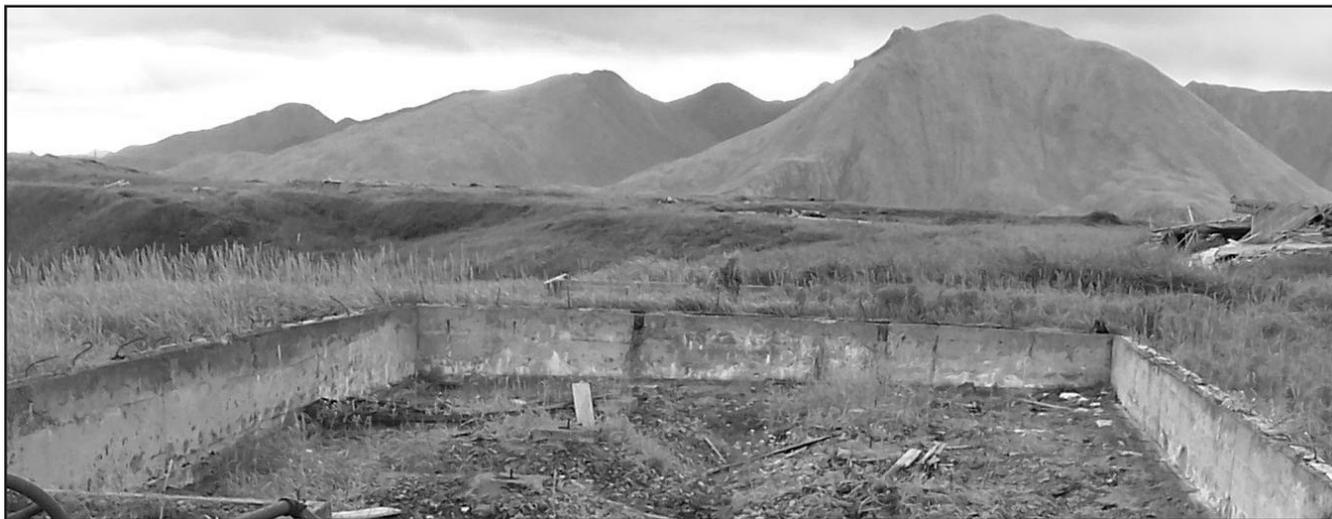
Stop 1

This is the remnants of one of four large barracks of Fort Schwatka (above). Of the four barracks, three housed sixty-three men each and one forty-five men. The opposite page shows one of Fort Schwatka’s wood framed barracks. The building design, typical for this era, is the Army’s standard 700-series architecture.

In the immediate vicinity of this stop, you will notice all that is left of many wooden buildings are piles of lumber and weather flattened walls and roofs. Before collapsing, these buildings withstood many years of harsh Aleutian storms with heavy rain, strong winds, and deep snow. The intensity of the climate is why much of what remains of Fort Schwatka is rusting metal, rotting wood, and weathering concrete structures.

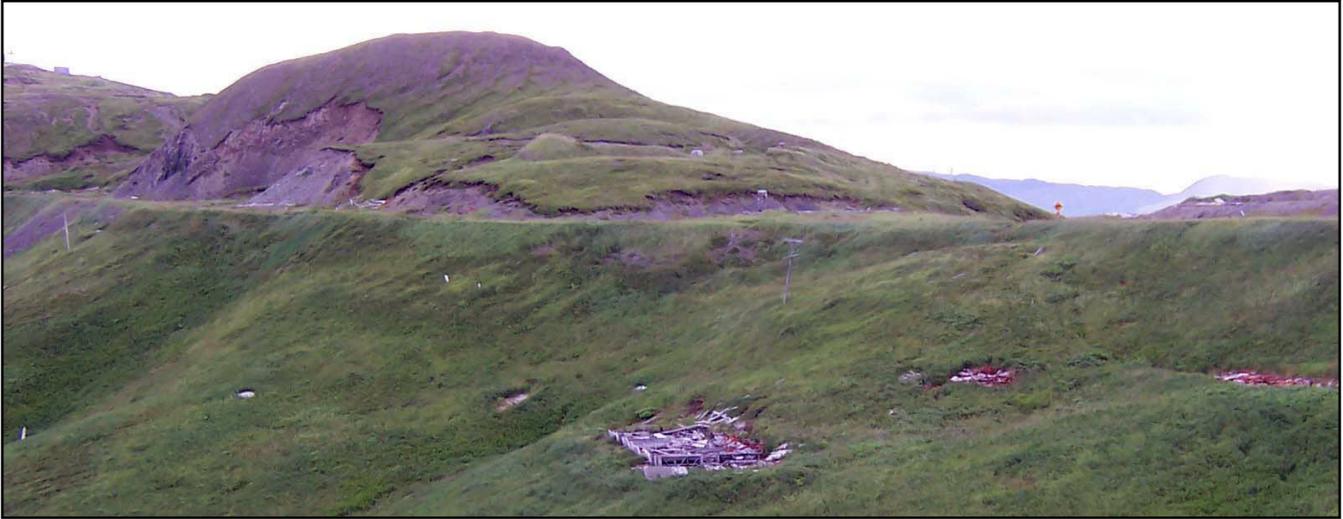
Stop 2

The quonset hut ruins of the enlisted mens recreation center (above) is across the valley and on the slope below the road junction and orientation sign.

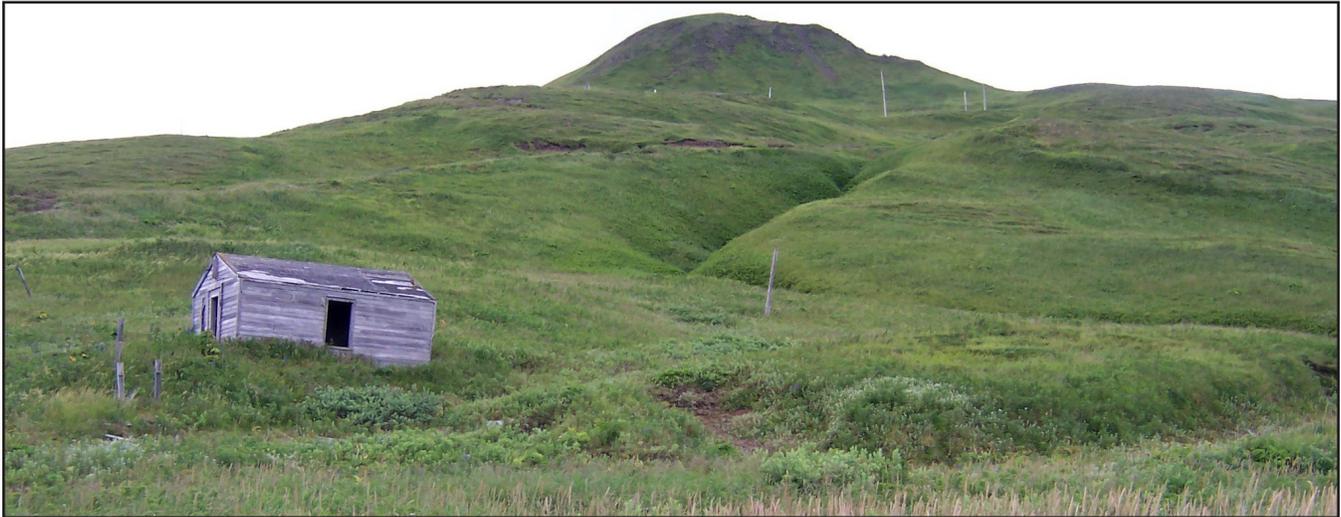
Stop 3

This is the only remaining wooden building standing at Fort Schwatka (above). This “cabana” commonly housed four officers. It was the smallest barracks for the soldiers of Fort Schwatka. Unlike the officers, the larger barracks in this immediate vicinity (including the one you stood by at Stop 1) housed enlisted men that were packed in like sardines (opposite). Many men found the conditions appalling. One wrote years later that “It was absolutely the worst duty that I ever served and I spent 27 years in the army.” Others, however, found the exotic location, the entrancing scenery, and the camaraderie helped make this the best time in their lives, writing, “I would not trade my experience in Dutch Harbor for anything. It gave me a much broader outlook on human nature and behavior.” At left is a soldier posing in front of barracks.

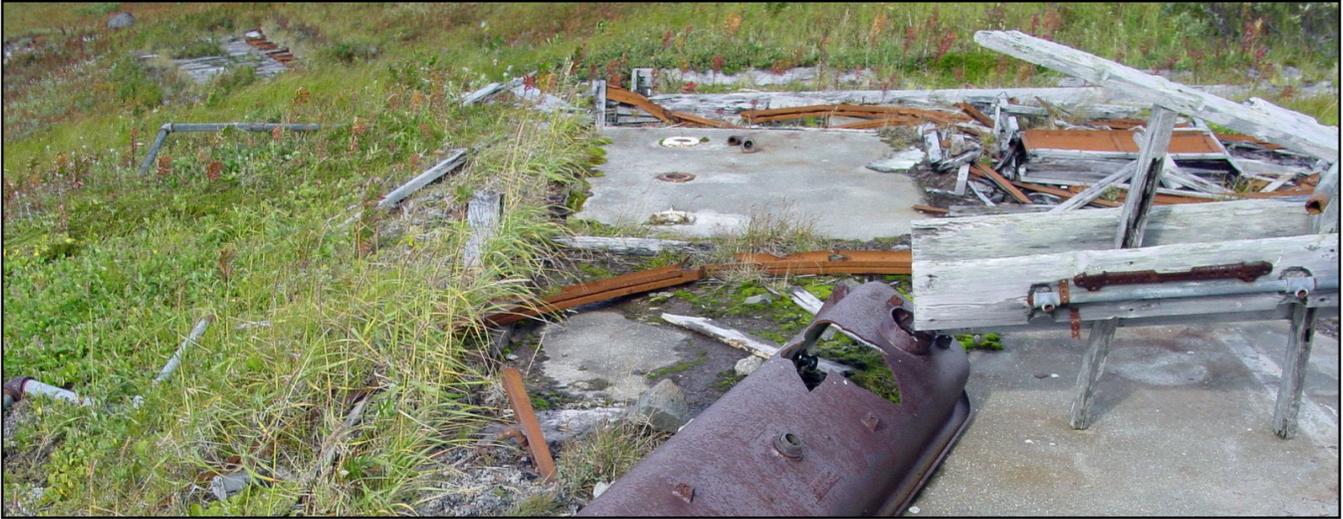
Stop 4

The dispensary for the men at Fort Schwatka (located at the road junction directly behind you when you face the orientation sign) was a well-constructed building; being different from the barracks it has a concrete floor. Anyone in need of minor medical treatment came here – the building even had a pharmacy on site and a few beds for patients needing bed rest. Besides Battery 402 and its base end stations and command posts the only other facility with a cement floor is the latrine. The latrine ruins (above) are located down slope from the turnout by the intersection of Stop 5b. Note the sink and plumbing drains.

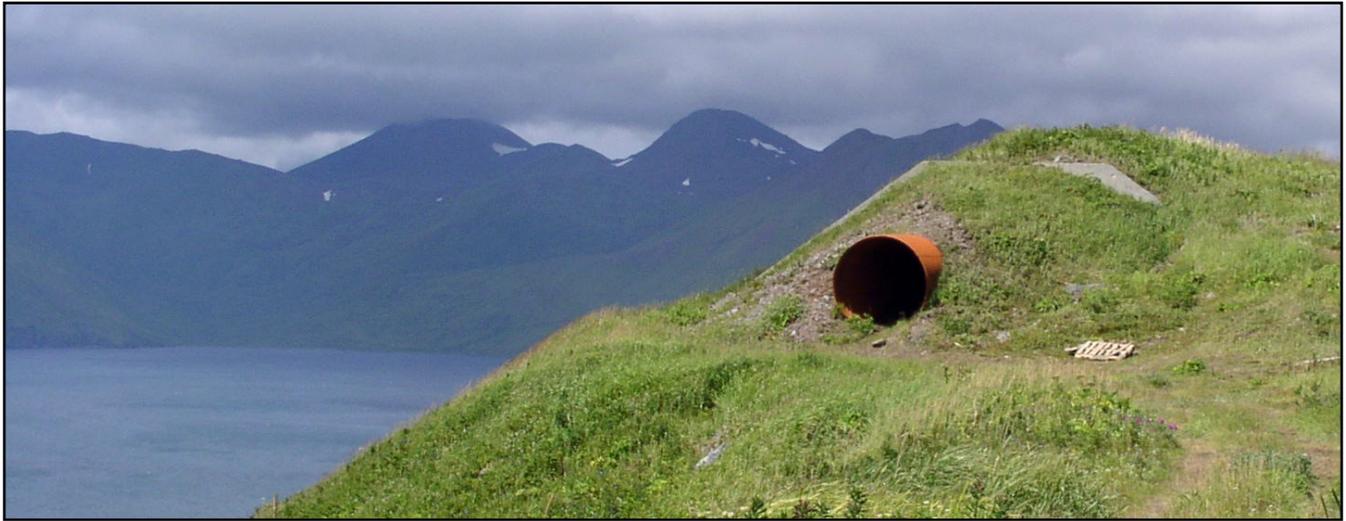
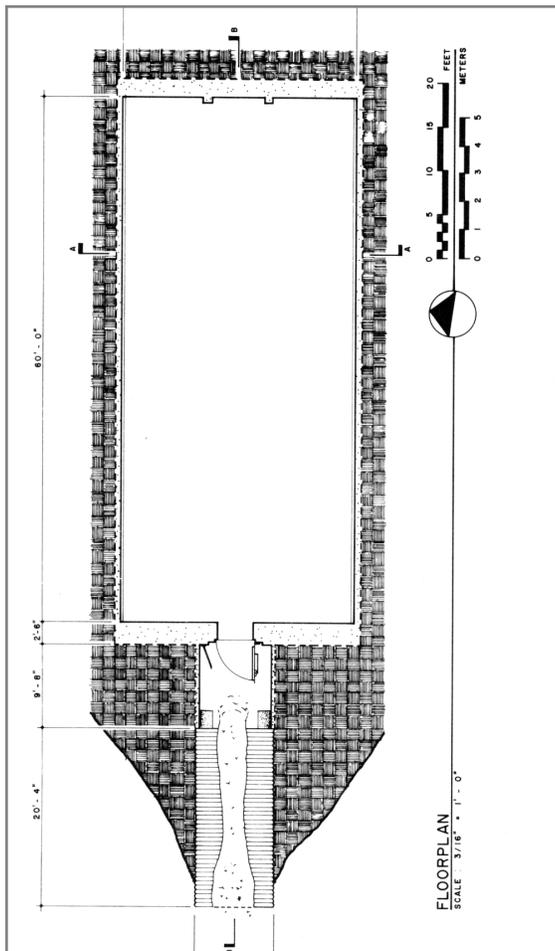
Stop 6

This munitions magazine is known as an “elephant steel” shelter or Armco hut. The shelter design is shown in the left diagram. These structures were built on a cement foundation with panels of heavy-gage corrugated steel bolted together and covered with soil. A turf covered bunker embedded in the hillside made it nearly invisible from the air. If a Japanese plane flew over, the pilot would see another contour on the mountainside. Other magazines are located at Stop 6a and 6b.

The magazine across the road from this stop is shown in the above photo. The historic photograph on the opposite page shows the same shelter prior to being covered with turf. In this photo it is easy to see the concrete walls and heavy metal doors designed to protect it from a nearby bomb blast.

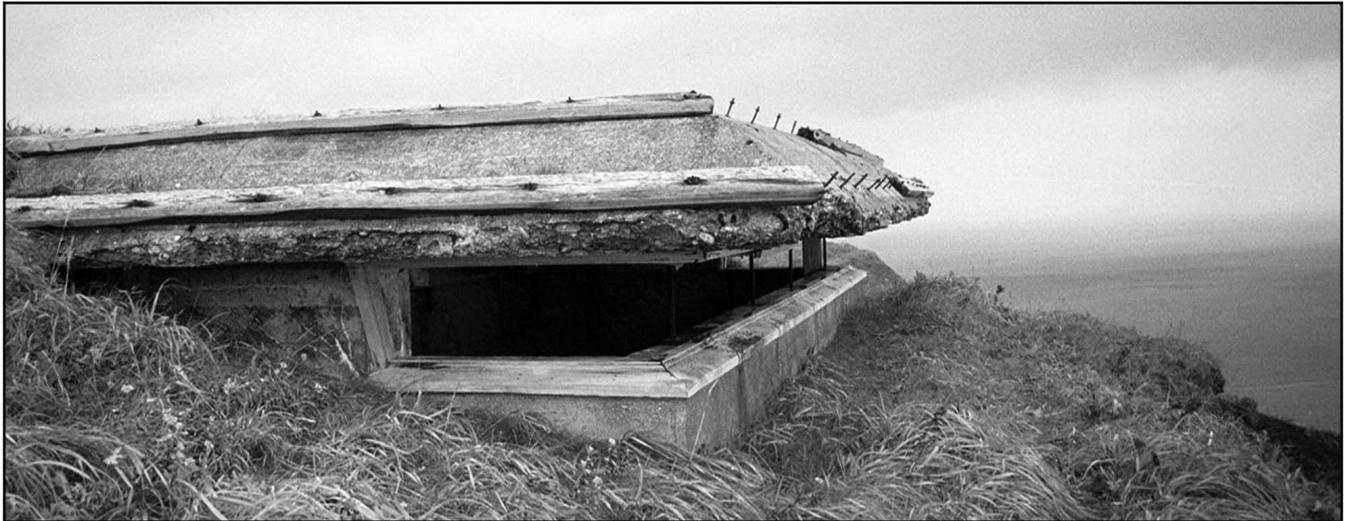
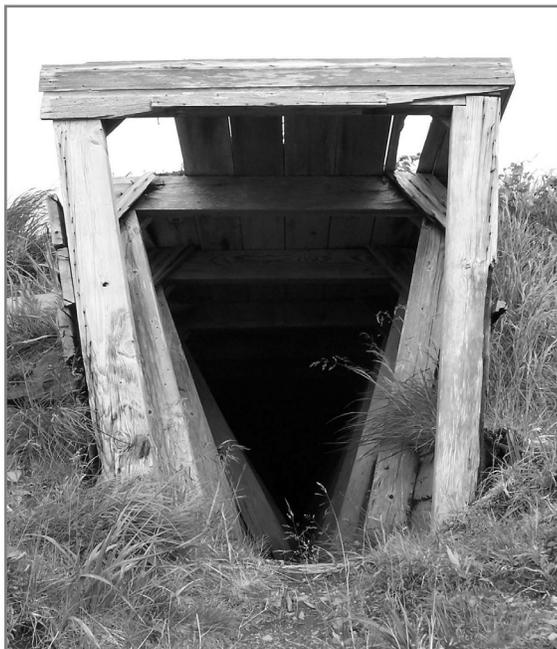
Stop 7

This is the Harbor Entrance Command Post that was constructed in 1943. Soldiers used the tunnel (below) to access the underground operational center and the embedded observation post (above). *Please use the trail to the left of the tunnel to travel to the observation post.* Traveling through the tunnel and into the underground facility is unsafe.

The underground command post was entirely self sufficient with its own power, ventilation, and plumbing. Protecting it were heavy wooden blast doors (opposite). Contained within were a radar, plotting and intelligence rooms, and chemical warfare service equipment. A steep stairway connects the below ground center to the observation post. An airlock manhole door separated the two areas and would have provided some measure of protection from chemical agents.

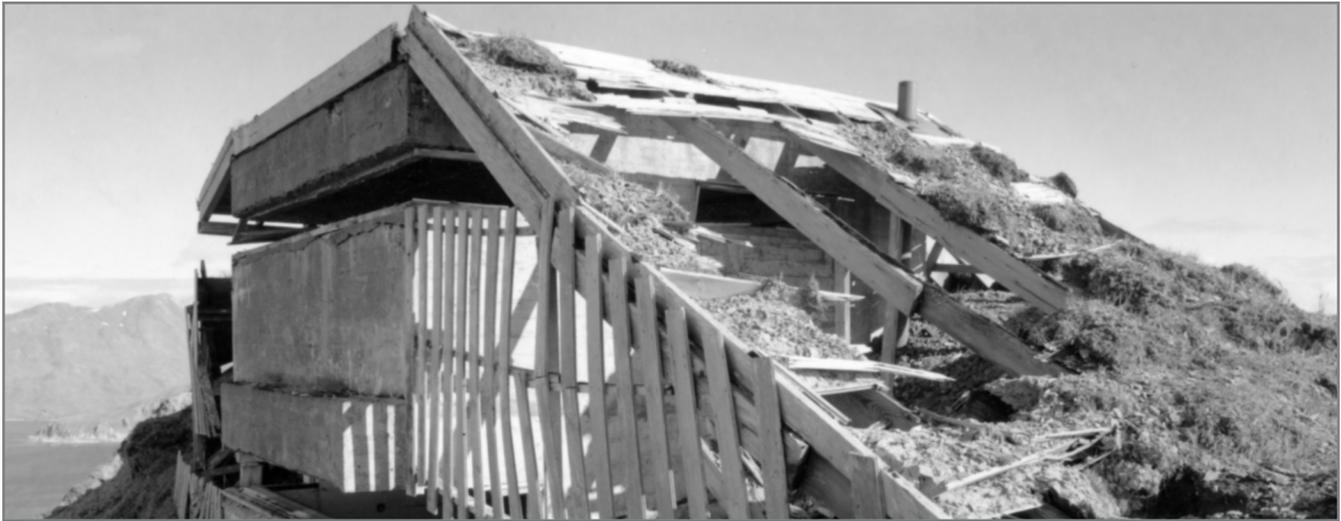
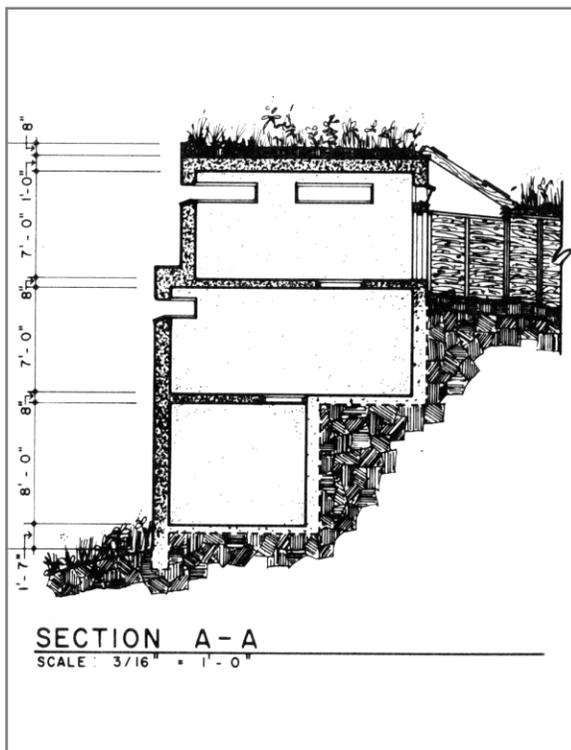
Stop 8

Battery 402 complex was completed in January 1944 and was assigned its sequential construction number which was “402.” This is the Battery Command Station and one of the base end stations of the battery (above, left, and opposite). On the upper level the Battery Commander would coordinate all operations of the battery including target acquisition, targeting priority, ammunition type, and firing orders. Directly behind the base end station is what remains of the state-of-art SRC 592 radar room and the once earth covered tunnel that leads to the concealed below ground plotting room.

On the lower levels of this base end station spotters using an M1910 Azimuth instrument would scope and train on the target and feed information to the engineers in the plotting room located down the hill and across the road (Stop 8a). The engineers in the plotting room would use this data to triangulate on the target, obtain its range and then telephone these coordinates to the 8-inch gun battery station.

Radar provided the battery with target tracking information when visibility was poor due to weather or darkness. This was one of two radar stations at Fort Schwatka; the other one was at Stop 7.

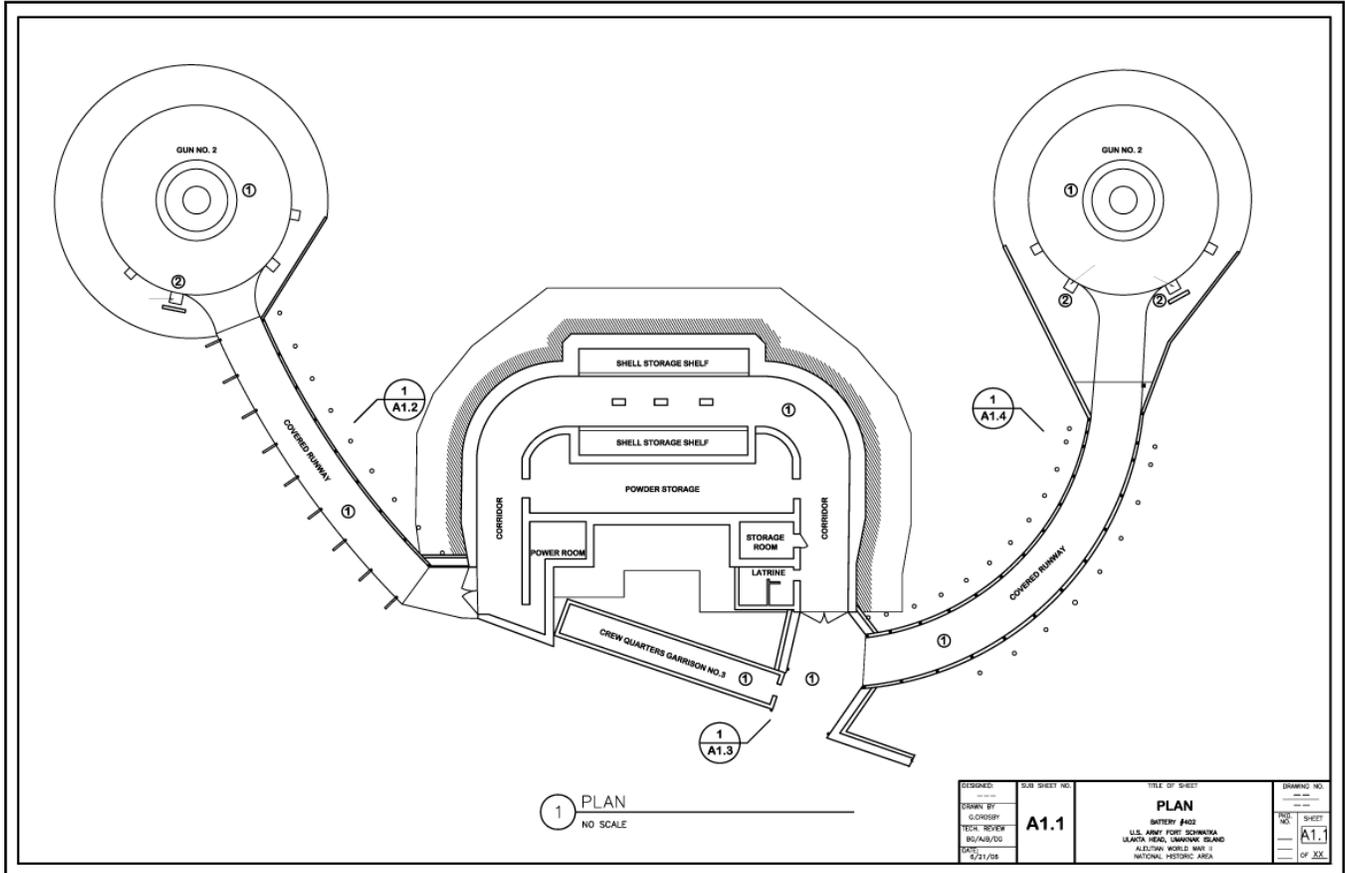
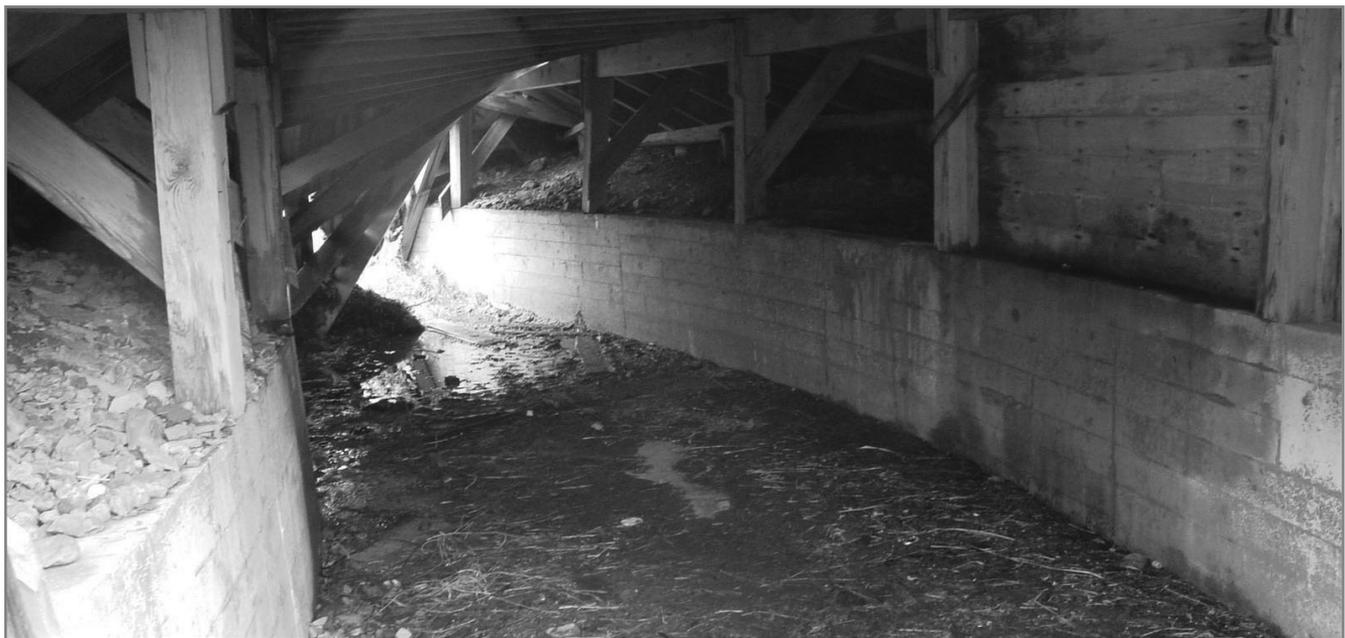
Stop 9

This is the magazine complex of Battery 402 with its two 8-inch gun platforms. The horseshoe design with the connected sod-covered roadways (opposite lower) supplied both guns. The ammunition needed for immediate response was stored on the cement shelf of the ready ammunition room, located in the middle of the corridor (opposite upper). Using carts, shells were wheeled through the thick wooden blast doors to the gun positions at the end of each roadway. Powder sacks were stored in the central room and fuses in another.

The semi-circular quonset room (left of the right side entrance to the battery) was the quarters for the ready crew who manned the guns. Entirely self sufficient, an interior latrine was provided for the ready crew. Two diesel generators housed in a separate room supplied backup electricity to the entire battery including the guns and searchlights (left).

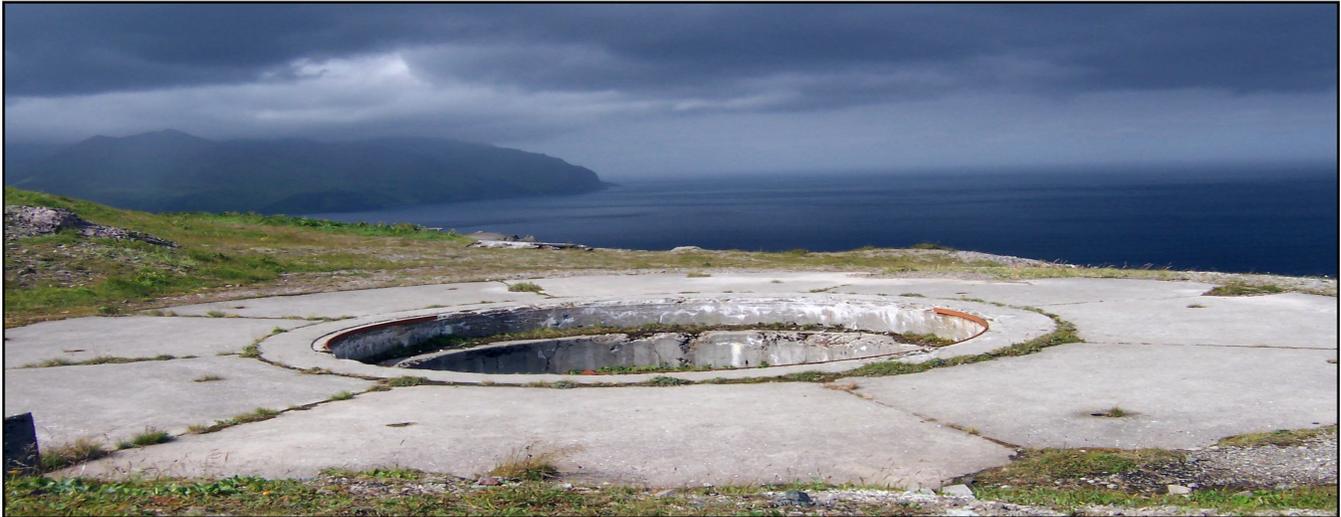
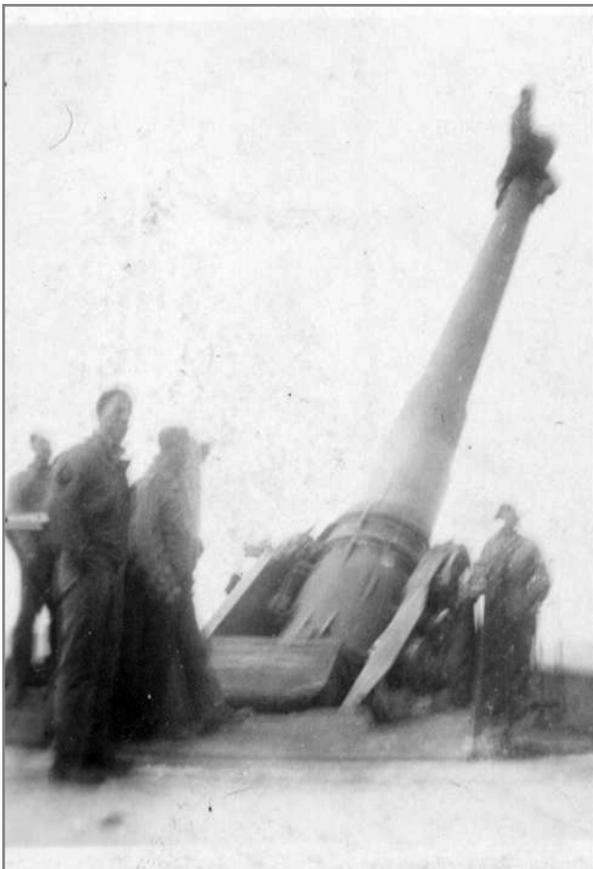
Stop 10

The circular concrete platform directly in front of you is a barbette carriage. This mount is for one of the two 8-inch guns of Battery 402; the other shown in the above photo is on the opposite side of the battery. These 8-inch guns were the largest caliber weapon in the “iron ring” defense. The huge MkVI, Mod 3A2 gun was 30-foot long and weighed 51.5 tons. These guns could fire a 240-pound shell up to 22 miles, dwarfing the range and power of the older 155mm guns that it replaced.

The gun was mounted in the center of the platform (opposite). The nearly 10-foot deep bowl provided space for ballast necessary to balance the cannons heavy barrel. The circular shape gave it a full 360 degree rotation. Notice the narrow table directly behind the gun barrel; this is the ammunition loader (these loaders are now in the semi-circular quonset hut of Battery 402). The shells were carried from inside the battery on wheeled carts, then placed on the trough and rammed into the gun barrel. Manned by the Battery “A” of the 264th Coastal Artillery each gun had a 25 man crew (left).

The guns had a short life. They were placed in service in late 1943 and destroyed by explosives in August 1946. Only small pieces of these huge guns remain.

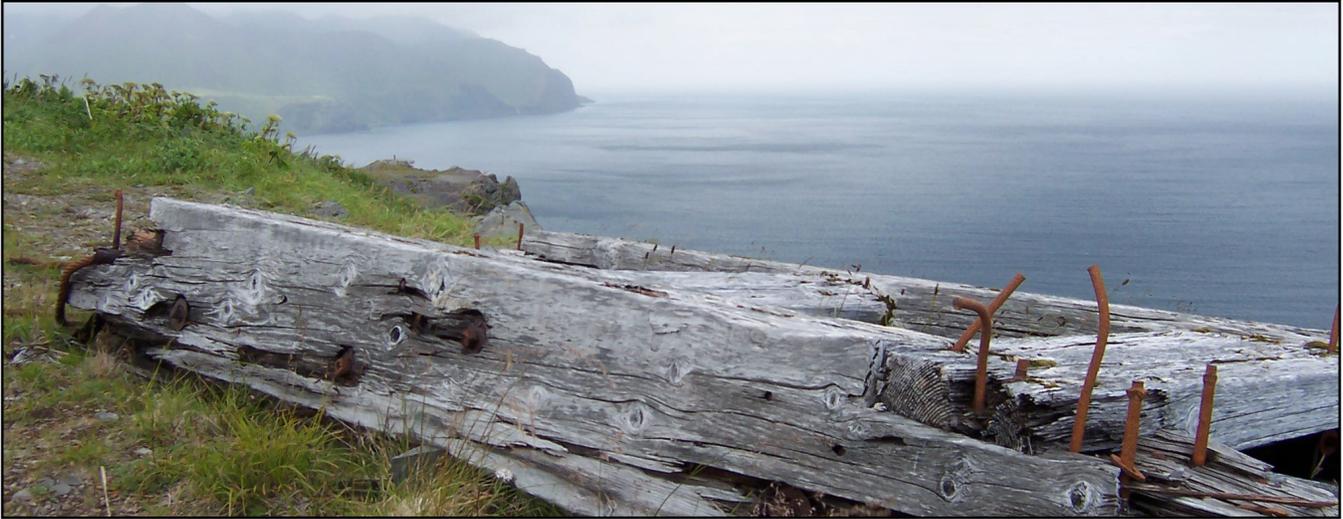
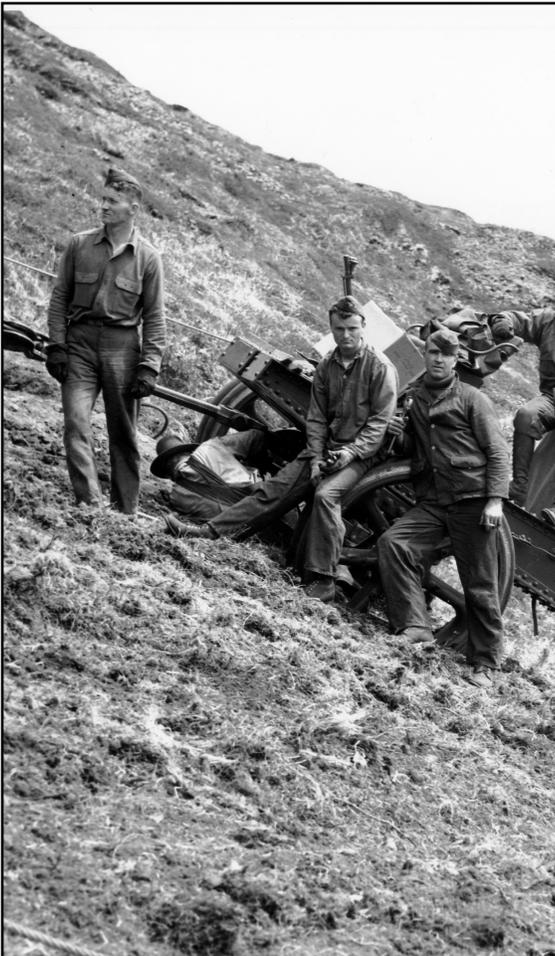
Stop 11

In summer 1941, for the initial defense of Dutch Harbor, this sled (above) was used to haul materials up the slope of Ulakta Head. The photos (opposite and left) show a heavy 13-ton 155mm gun moved up the steep slope. On the beach of Dutch Harbor, by the park entrance, a large engine mounted to a frame would winch the guns and sleds up the slope by using cable running from top to bottom. At the top of the slope a firmly anchored sled called a “donkey” held the cable (below). When the winch rolled the cable in, the sled moved up the steep slope. Later that summer, as Fort Schwatka developed, construction of the road eased the burden of transporting materials to Ulakta Head.

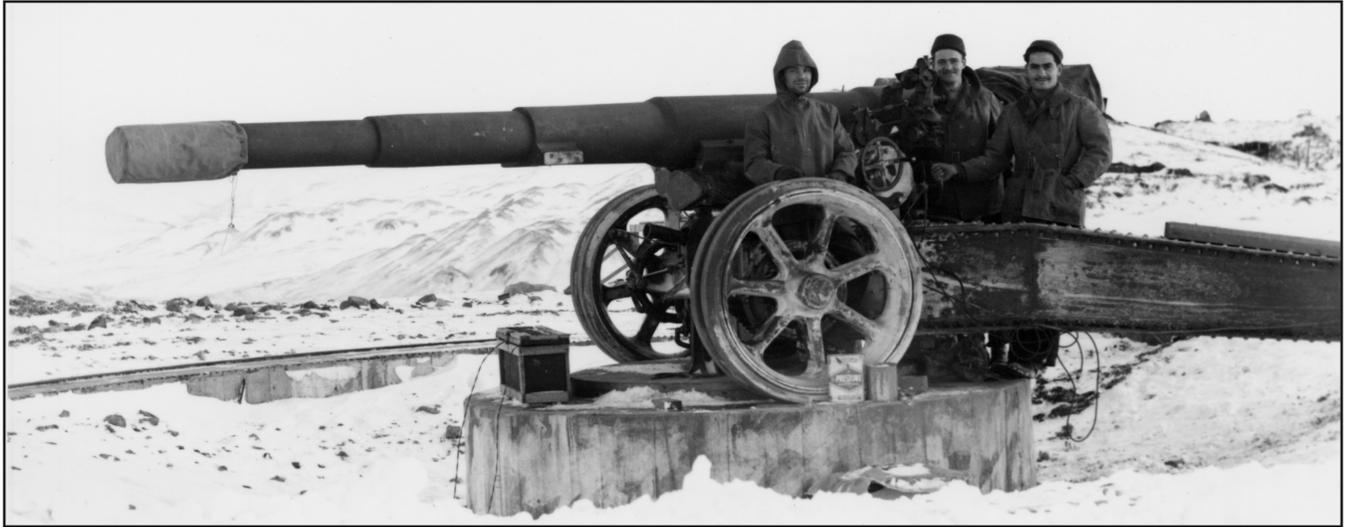
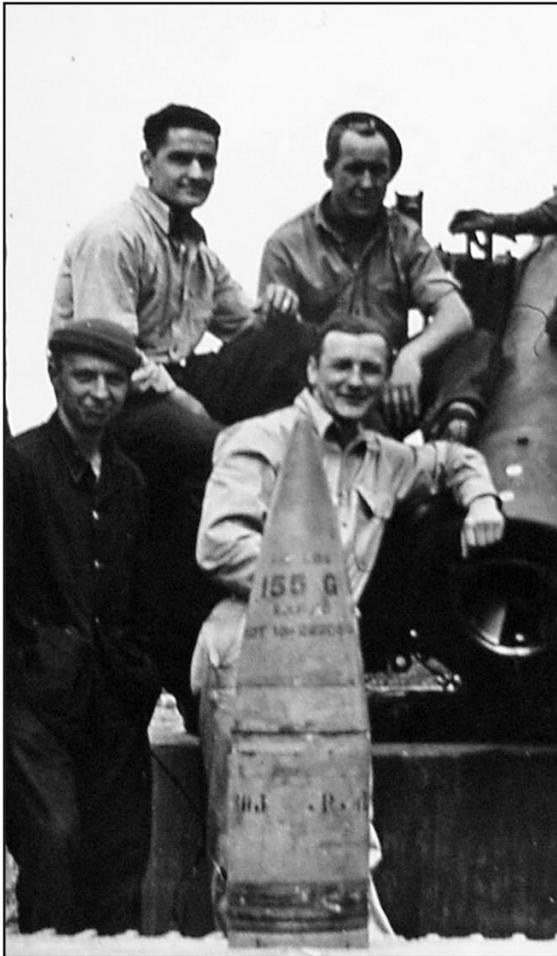
Stop 12

This circular concrete structure is the one of the four Panama mounts on Ulakta Head. Constructed in the summer of 1941, these were the original gun emplacements. It is named a Panama mount because the initial design was first used for defense of the Panama Canal. The 155mm guns placed on these mounts had solid rubber tires that would rest on the “pintle” or concrete cylinder in the center of the mount. The guns’ split-trail carriage rode on the outer rail giving them a full 360 degree rotation. The 155mm gun, a hold over from World War I, is known as American M1917A1 cannon. The barrel of the cannon was 18 feet long and the gun weighted nearly 13-tons. From Ulakta Head the cannons could fire a 95-pound projectile 12.5 miles. Each gun had an 18 man crew.

The photo (opposite page) shows men of “B” Battery of the National Guard Unit 250th Coastal Artillery preparing to fire a gun. The crew is posing with a shell (left) and gun (above). The 250th served here until May 1943.

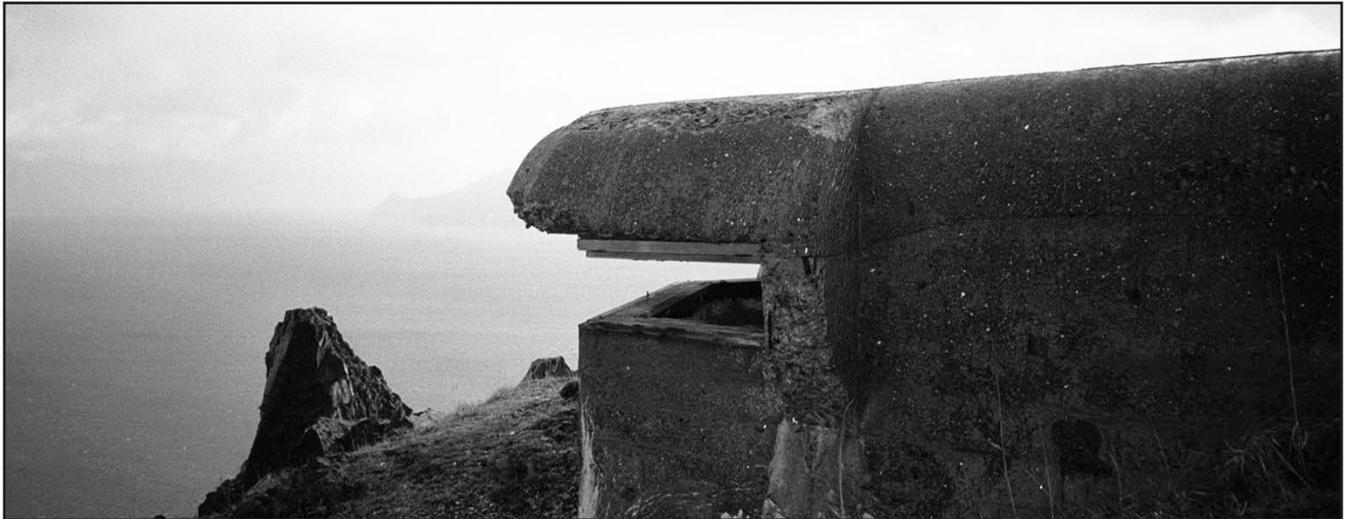
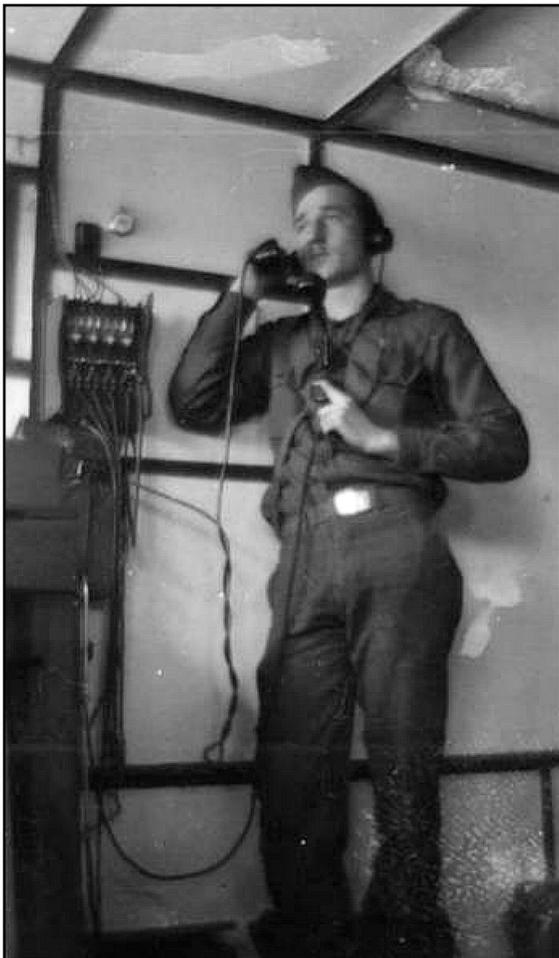
Stop 13

Once inside the base end station (above and opposite), you will notice an iron mount bolted to the floor. The mount held a M1910 Azimuth scope that was used to find the location and distance of the target. Telephoned to engineers (left), this data would allow them to triangulate on the target and obtain its range. Data from at least two base end stations were needed in order to triangulate and calculate the speed of a target.
