CASTILLO DE SAN MARCOS

HISTORIC RESOURCE STUDY

**CASTILLO DE SAN MARCOS
NATIONAL MONUMENT
HISTORIC RESOURCE STUDY**

March 1997

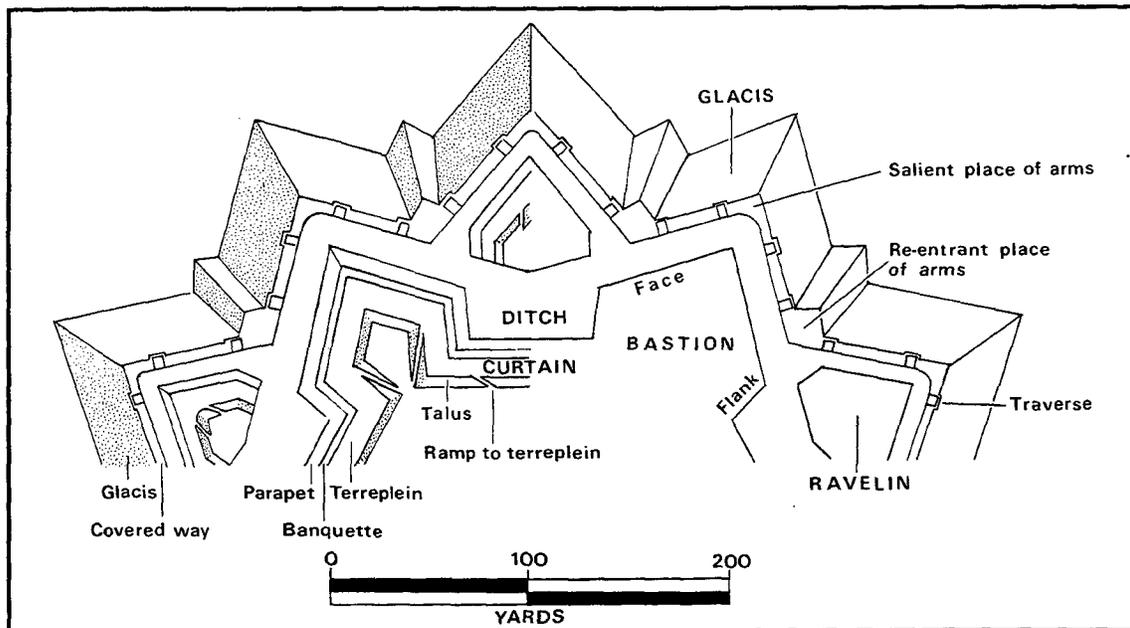
Figure 4. Plan of a simple bastioned fort

fortress and allowed the defenders to move farther into the landscape against the enemy. As a complete defensive fortification, the bastioned fort and its outer defenses provided a great deal of security to its occupants during a siege, although a persistent enemy might breach the walls given sufficient time and manpower.¹³

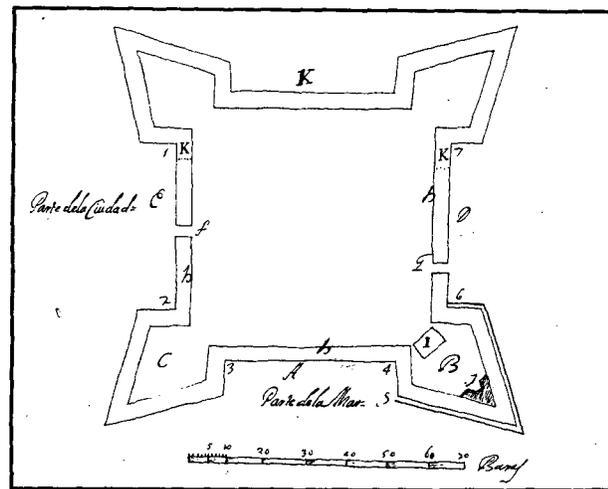
Figure 5. Plan of Castillo, 1675

Local Indians, convicts, African-American slaves, and occasionally Spanish soldiers labored alongside the skilled workers imported from Cuba. Work progressed at a steady rate on the fortress, although funding shortages and disease epidemics occasionally slowed construction. By 1686, the main block of the Castillo was complete. At that time, the outer curtain walls and bastions of the fort were coquina, while the interior walls and roof were wood; the terreplein was made of tabby, a cement made of lime and seashells, laid on top of wood planks. The fort housed troop quarters, a chapel, and a number of storerooms for the garrison. Ten years later, the moat and seawall were finished, thus enhancing the Castillo's defenses.¹⁷

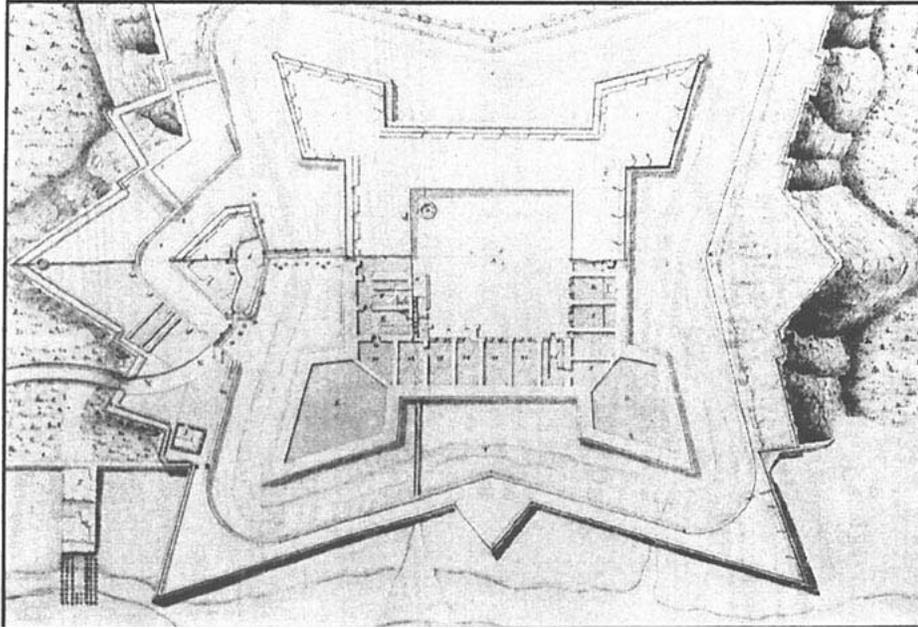
Figure 6. Plan of Castillo, 1763

the fortress walls and improved outer defense works. By 1739, the eight vaults along the east curtain wall were completed, increasing the total height of the wall five feet. The outbreak of war between England and Spain the same year slowed construction, however, and completion of the project was postponed until the end of the war.²²

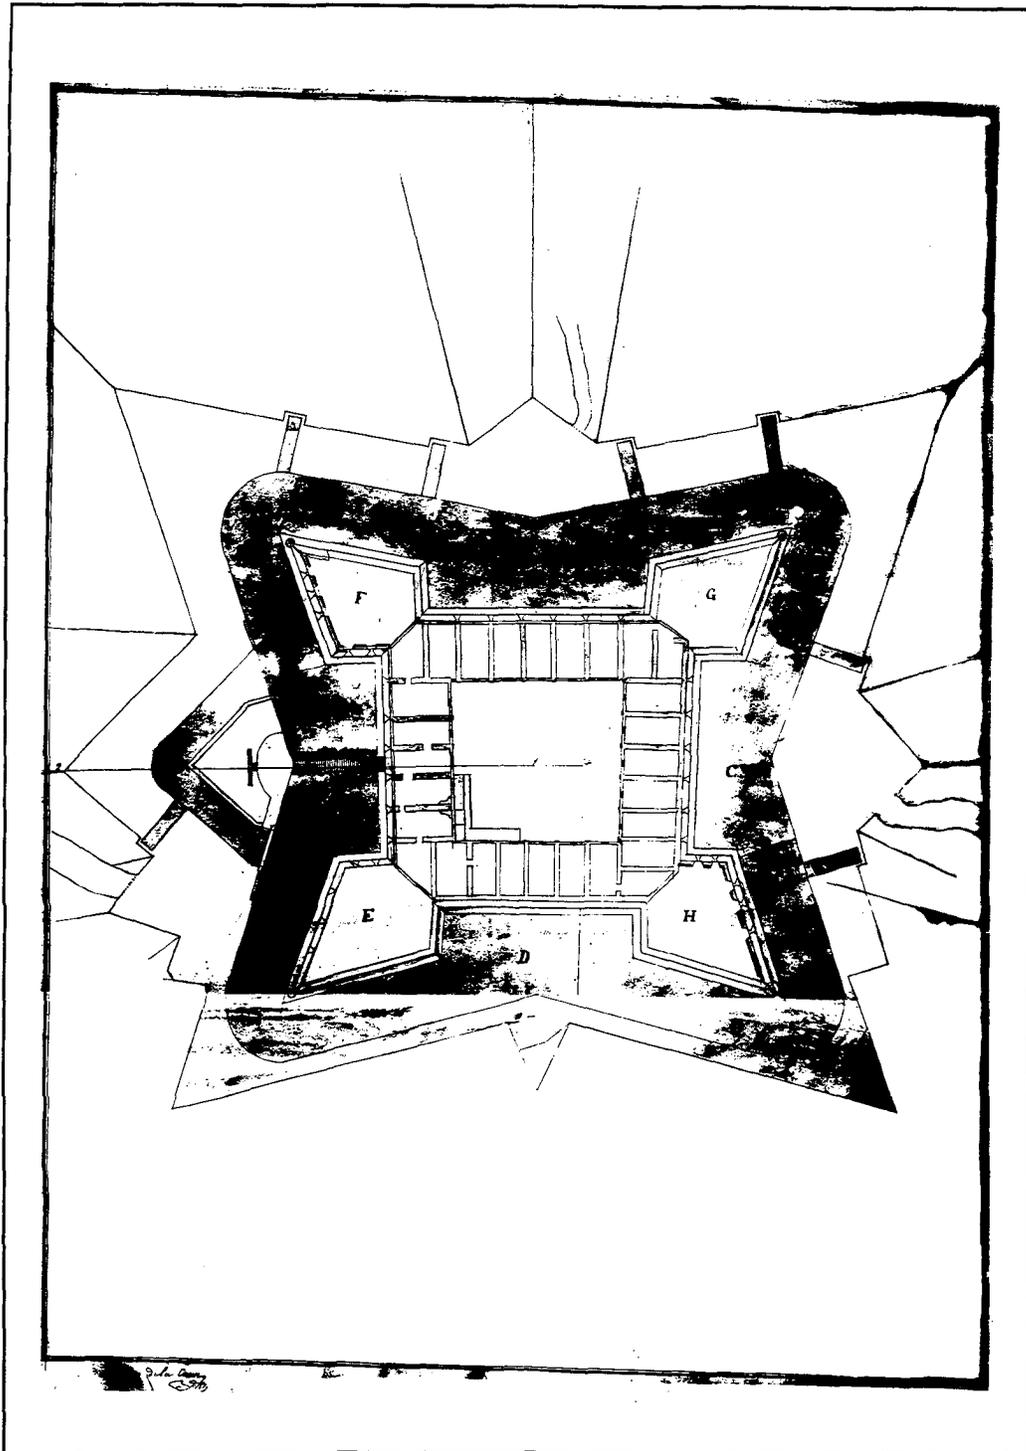
Figure 10. Plan of Castillo, 1821

masonry walls, a crumbling water battery, and leaks in the terreplein were among the structural problems identified by American engineers. These problems made the fort uninhabitable; therefore, the St. Francis barracks, built during the British period to house soldiers, were repaired to house the garrison, and Fort Marion was used to store supplies and provisions. The War Department also permitted local authorities to use several casemates as a prison.⁴⁰

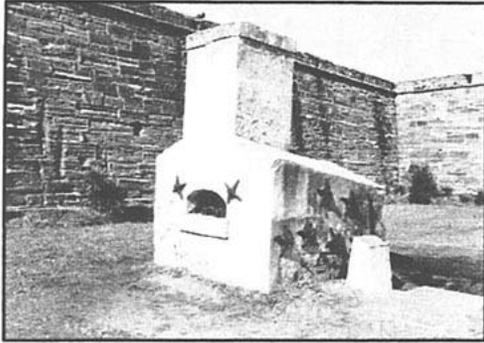
Figure 12. View of hot shot furnace from south, 1995

Hot shot furnace, 1842: Stuccoed coquina furnace measuring nine feet long by eight feet wide has a chimney eleven feet high on the south end. Small arched openings with lintels provide access to the interior of the furnace on the south and north ends. The exterior of the structure is marked with iron cross-ties on all sides. The hot shot furnace sits on top of the water battery on the east side of the fort. (structure; IDLCS 91419)

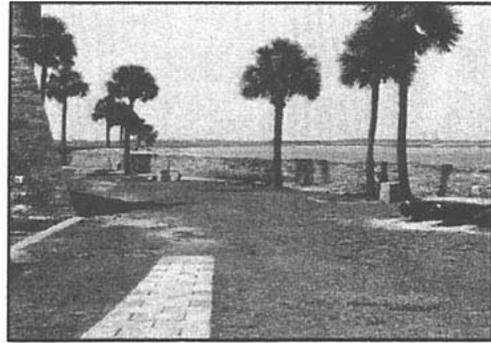
Figure 13. View of water battery from south, 1991

Water battery, 1842: The earth and coquina structure comprises the east side of the Castillo de San Marcos, between the curtain wall and the seawall. The water battery was built on top of the east side of the moat by the Army Corps of Engineers between 1842 and 1844 to permit placement of guns facing the harbor. (structure; IDLCS 07174)

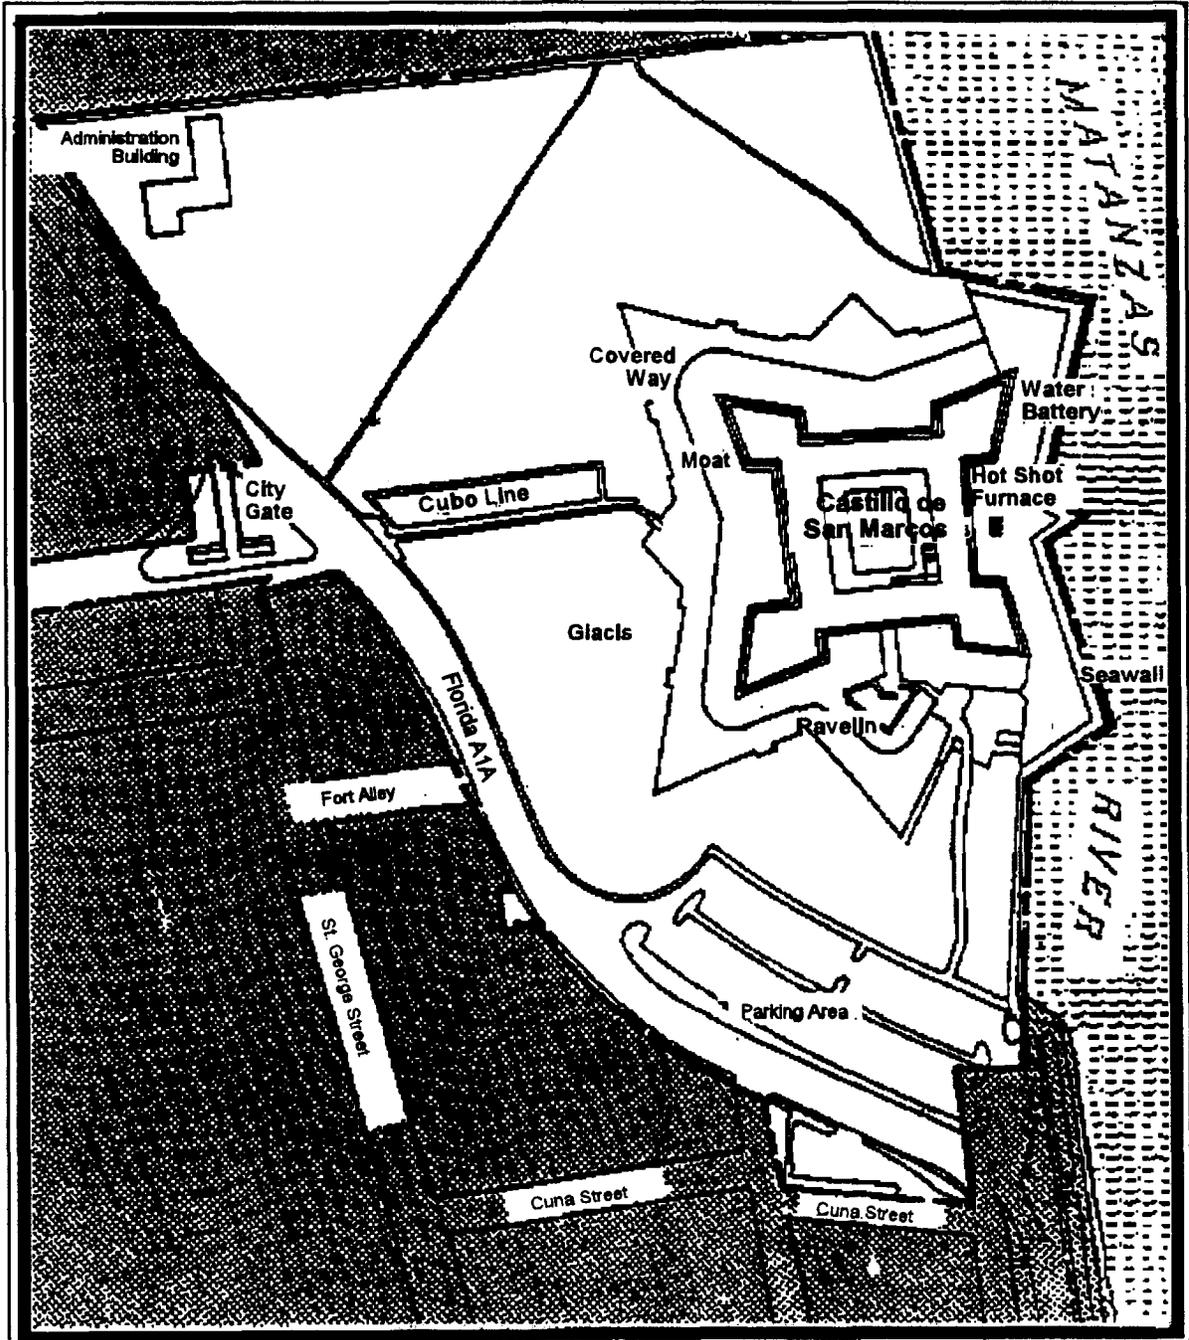
Castillo de San Marcos National Monument
Historical Base Map

The historical base map (Appendix B) depicts the existing historic resources within the park that are documented in this study. The map shows the Park boundaries, nearby bodies of water, and major area highways. National Park Service maps prepared by the Denver Service Center for the Park’s General Management Plan served as the basis for the maps included in this study. The historical base map does not attempt to depict a historic scene or identify nonextant historic structures.
