SUNRISE LODGE
Mount Rainier National Park
~~Longmire vicinity~~ Sunrise
Pierce County
Washington

HABS No. WA-237

WRITTEN HISTORICAL AND DESCRIPTIVE DATA

HISTORIC AMERICAN BUILDINGS SURVEY
COLUMBIA CASCADES SUPPORT OFFICE
National Park Service
U.S. Department of the Interior
909 First Avenue
Seattle, WA 98104-1060

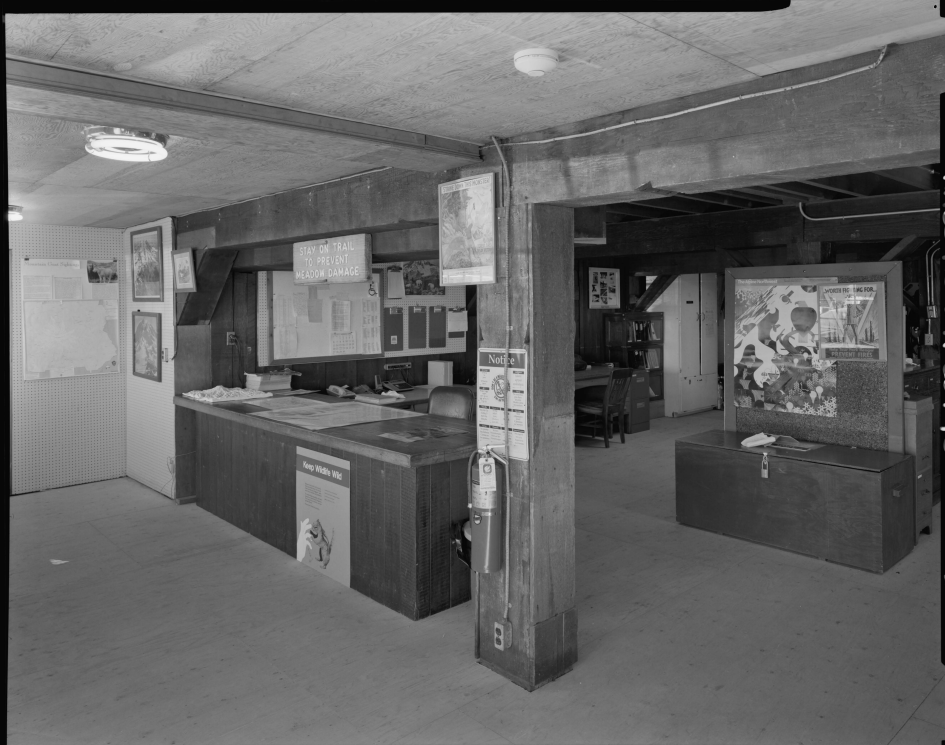
- WA-237-10 INTERIOR VIEW OF RANGER STATION, LOOKING NORTHWEST.
- WA-237-11 INTERIOR VIEW OF DINING ROOM, LOOKING SOUTH.
- WA-237-12 INTERIOR VIEW OF DINING ROOM, LOOKING NORTH.

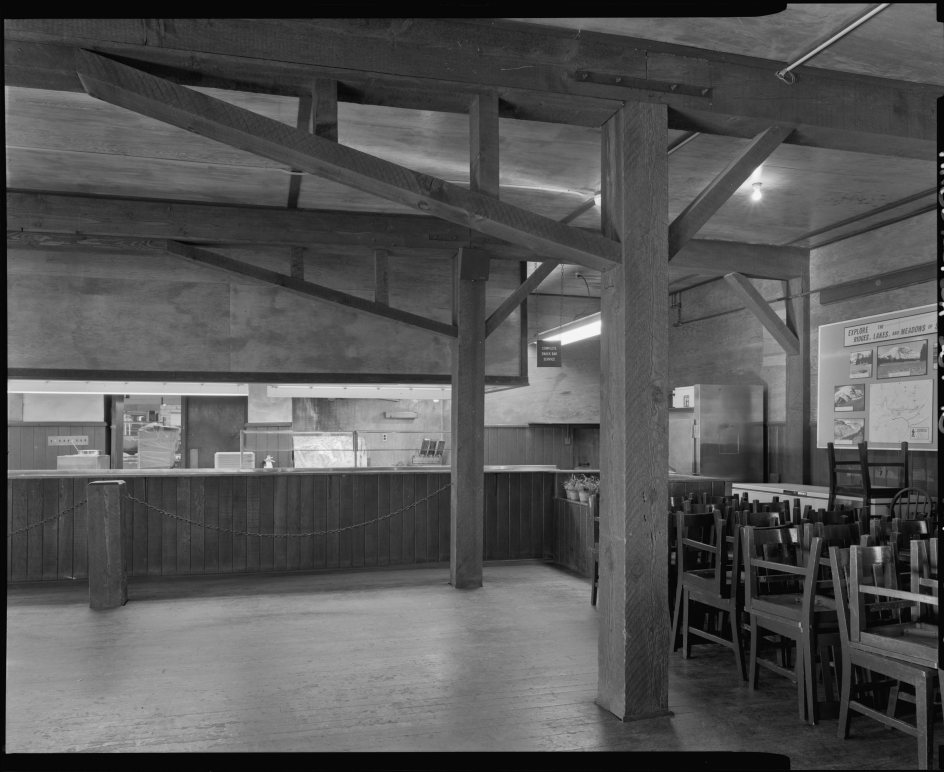
HASS No. LA-237-13

- WA-237-13 INTERIOR VIEW OF NORTHEAST CORNER OF DINING ROOM.
- WA-237-14 INTERIOR VIEW OF KITCHEN, LOOKING WEST.
- WA-237-15 INTERIOR VIEW OF UPSTAIRS DORMITORY, LOOKING SOUTH.
