Subject: Alterations Without Historical Basis

Technical Preservation Services, National Park Service

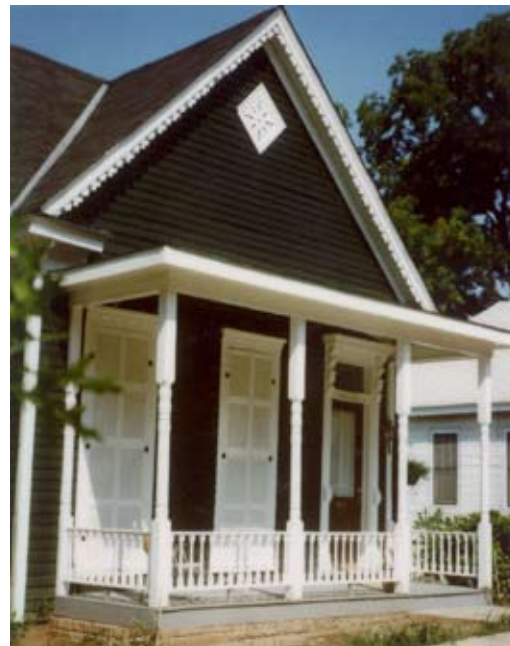
Left: In the course of rehabilitation, the owner installed new windows in a historic design, which extended to the first floor. Full-length blinds were also added.

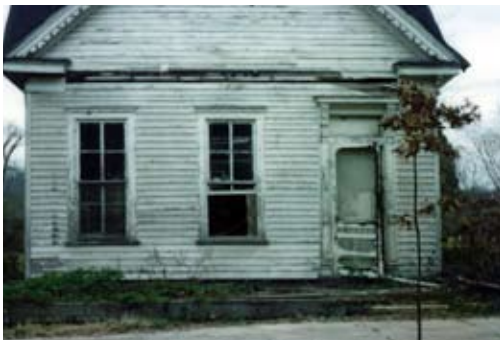
This 1880s cottage was in deteriorated condition prior to rehabilitation. Ghost marks of the missing porch are evident.

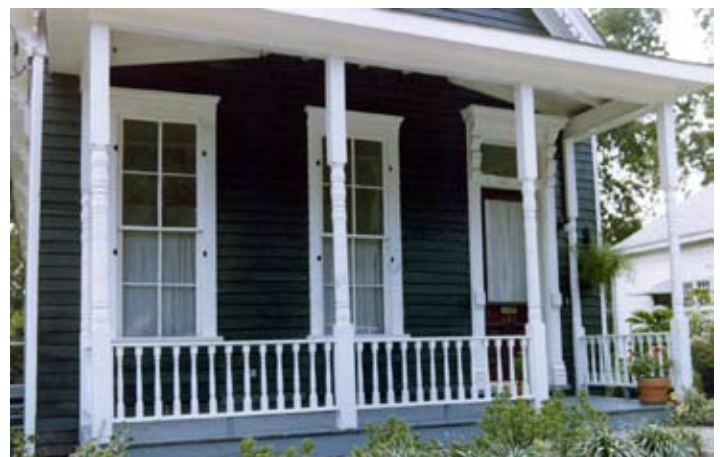
Below: To bring the project into conformance with the Standards, the original windows were reinstalled.

Application 1 (*Incompatible treatment corrected to meet the Standards*): Plans for the rehabilitation of a small late-nineteenth century cottage included replacing a missing porch, removal of two original first floor windows and replacing them with floor-to-ceiling windows—a type of window generally found on buildings of an earlier period in that area. The introduction of the new sash and exterior shutters that extended to the porch floor created a design feature that, although commonly found in the historic district, never existed on this particular structure and gave the building an inappropriate historic appearance. In order to bring the project into conformance with the Standards the owner reinstalled the original sash.

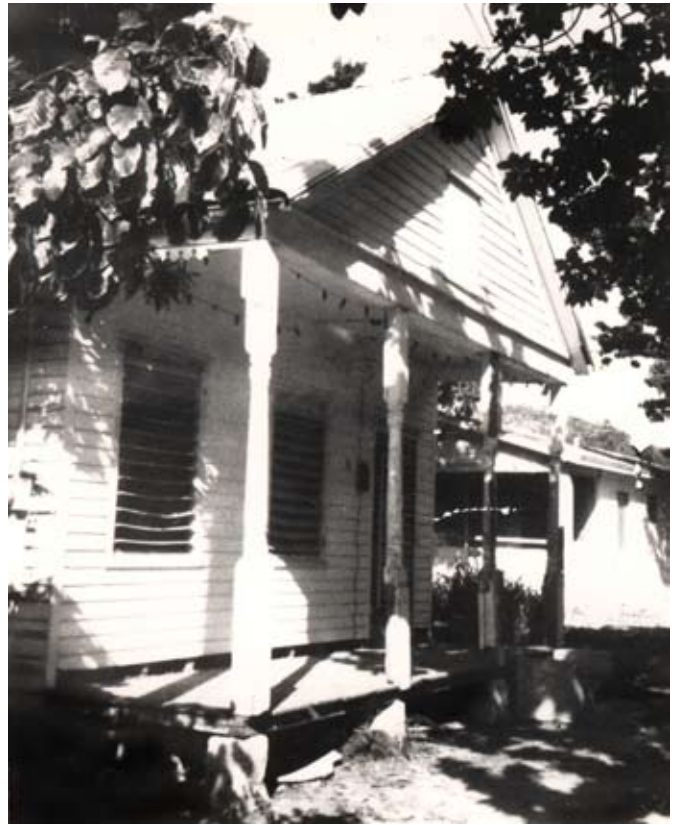
Right top: Simple turned posts and plain windows were the only expressive details of the vernacular frame building.

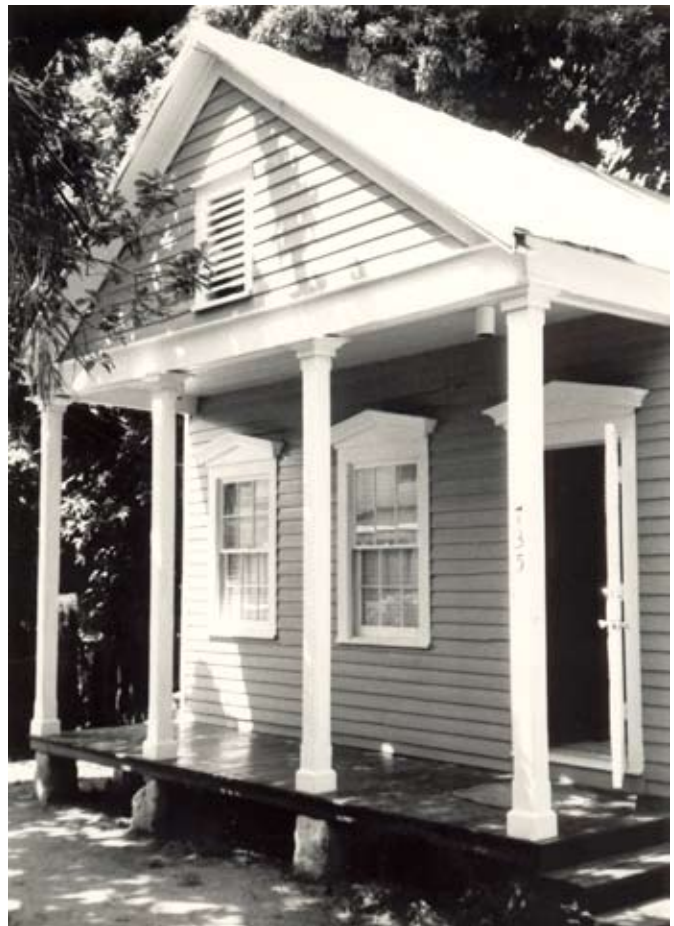
Right: The dramatic shift in appearance from a vernacular structure to a higher style building is achieved with Greek Revival posts and triangular window pediments. The building was not originally fitted with these details.

This project failed to meet the Standards because of the removal of historic materials and the fact that the rehabilitation misrepresented the historic appearance of the building. If the added features were removed and the original posts re-installed, the historic appearance of the porch and windows would have been reestablished and the project would have met the Standards.
