Holzwarth Trout Lodge,
Joe Fleshut's Cabin
Trail Ridge Road
Rocky Mountain National Park
Grand Lake Vicinity
Grand County
Colorado

HABS No. CO-79-M

PHOTOGRAPHS
WRITTEN HISTORICAL AND DESCRIPTIVE DATA

HOLZWARTH TROUT LODGE,
JOE FLESHUT'S CABIN

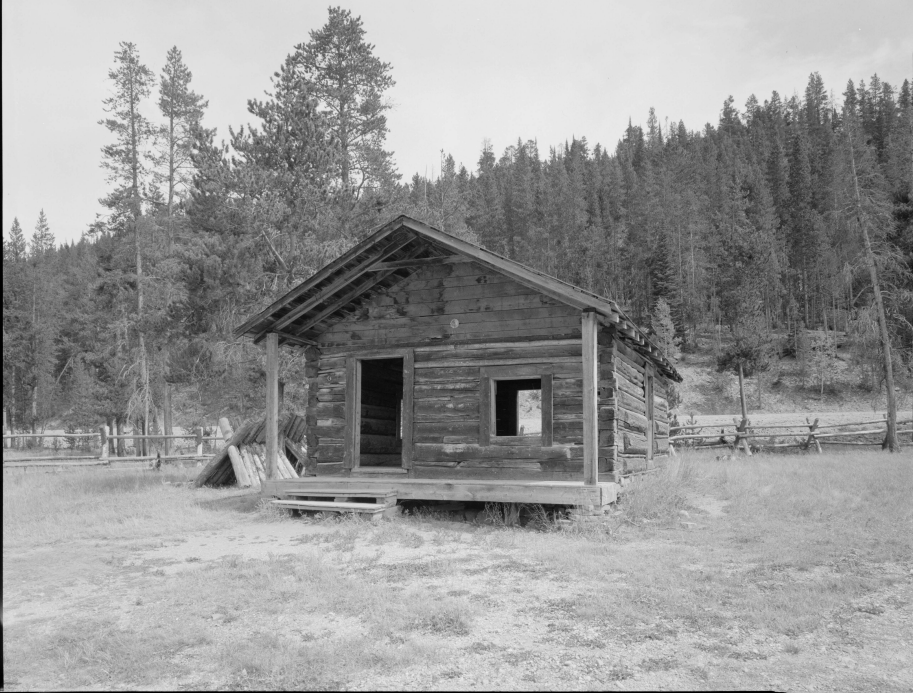
HABS NO CO-29 M-1

CO-79-M-1 JOE FLESHUT'S CABIN, VIEWING NORTHEAST.
