# YOSEMITE NATURE NOTES

NOVEMBER 1957

## SAVING THE WAWONA COVERED BRIDGE

**By Jack Fry, Ranger Naturalist**

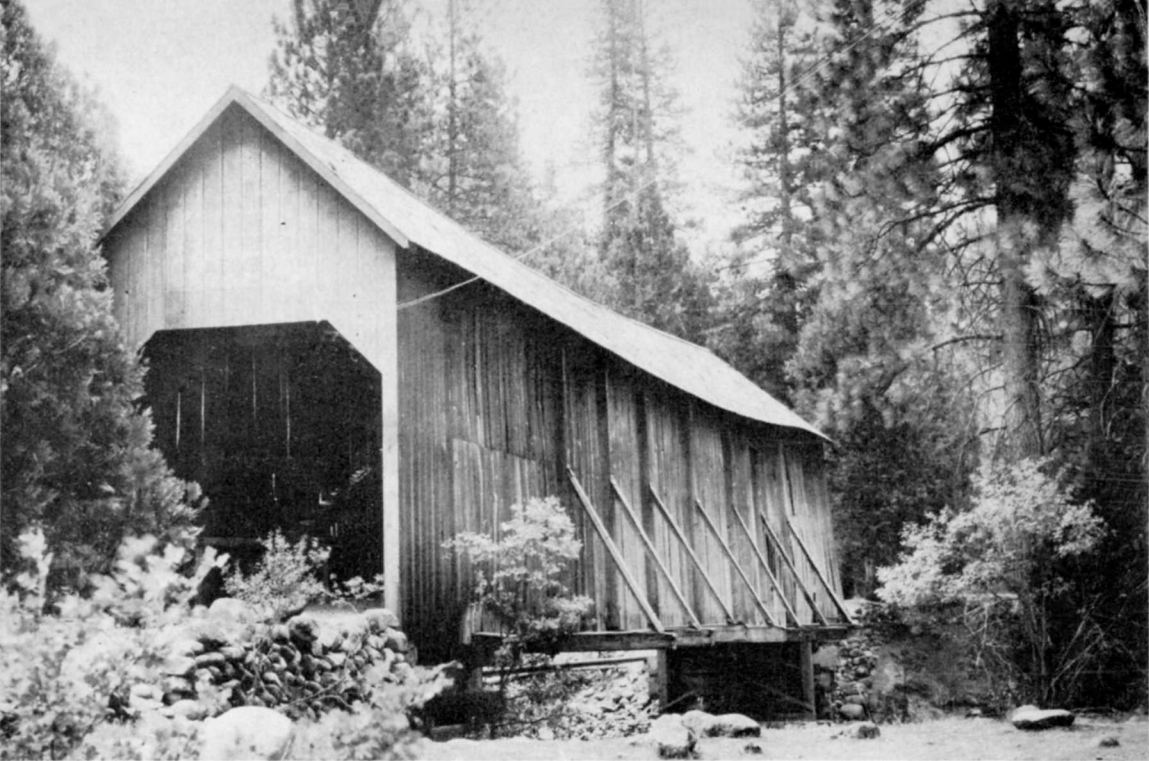
In 1955 the bridge was beginning to sag.

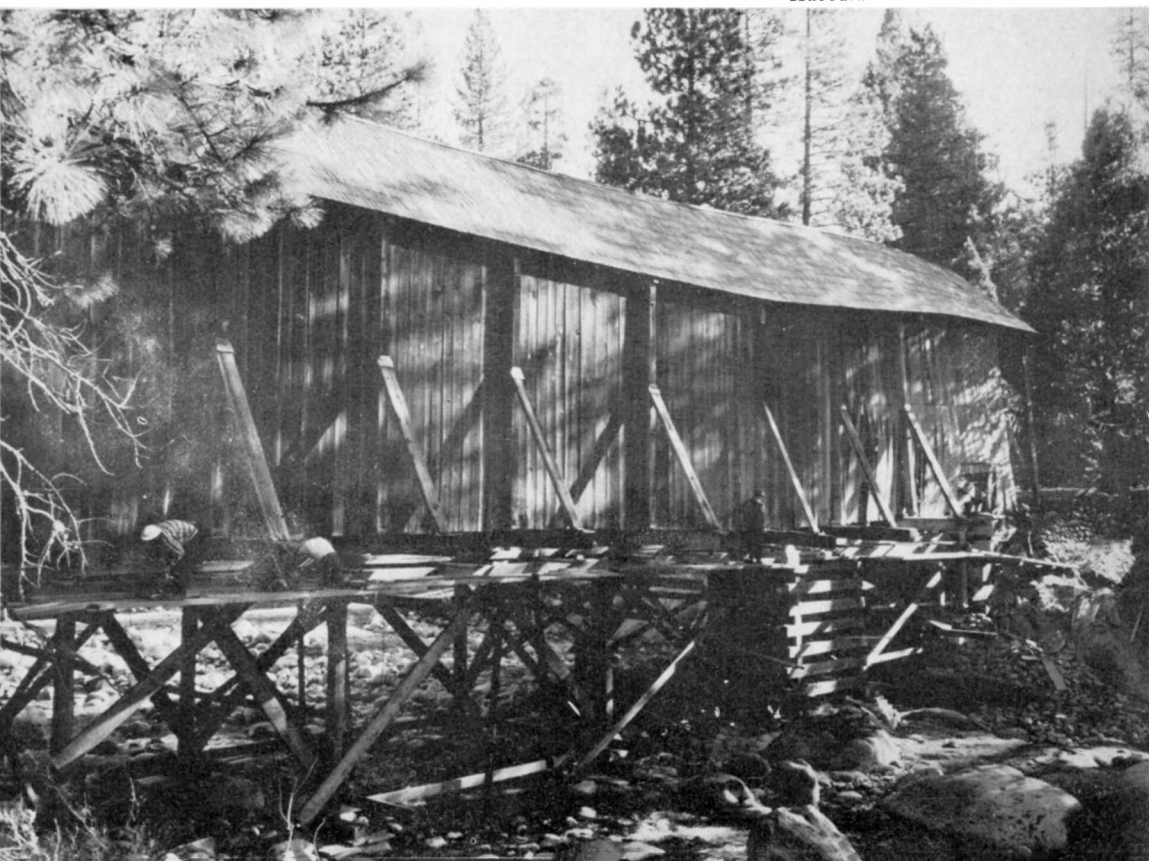
After the flood of 1955 cribbing saved the bridge.

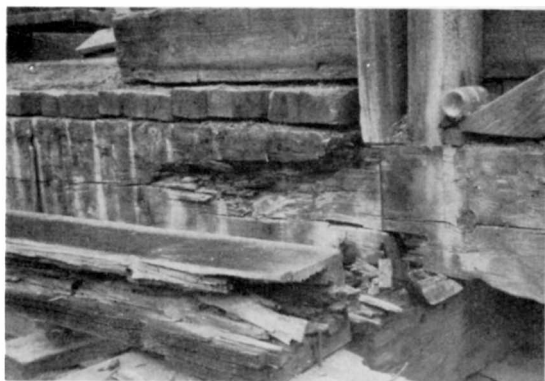
Rot was at work.

The rotted timbers were no longer able to stand up against the swirling waters of the river at flood stage. A temporary wooden pier was placed under one end of the bridge to prevent its total collapse—which seemed apt to occur at any time. One thing was very evident—the bridge could not survive another winter. Something had to be done.

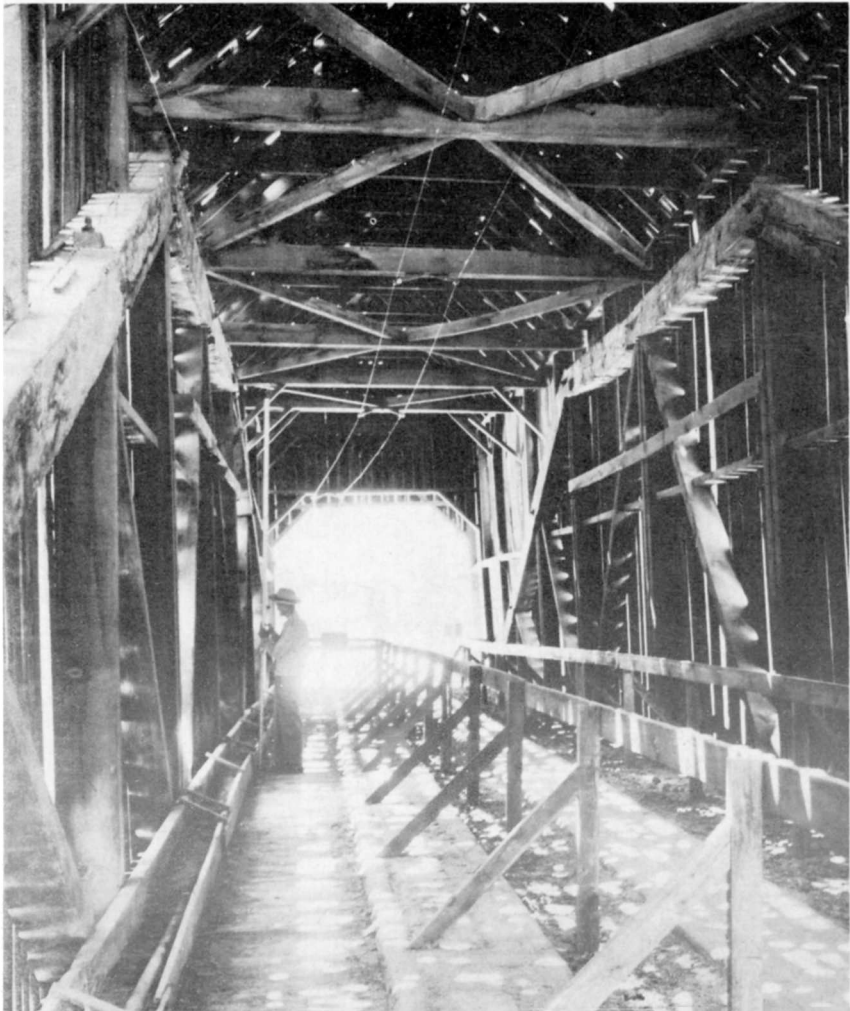
Careful measurements were made.

After careful measurements had been taken, the bridge was dismantled. All rotted timbers and materials were discarded and all salvageable wood was carefully saved. To facilitate the removal of the shingles, about 14 bundles of 20% dynamite were strung beneath the roof, then detonated. The blast removed the shingles neatly and loosened the nails so that they could be pulled out easily.

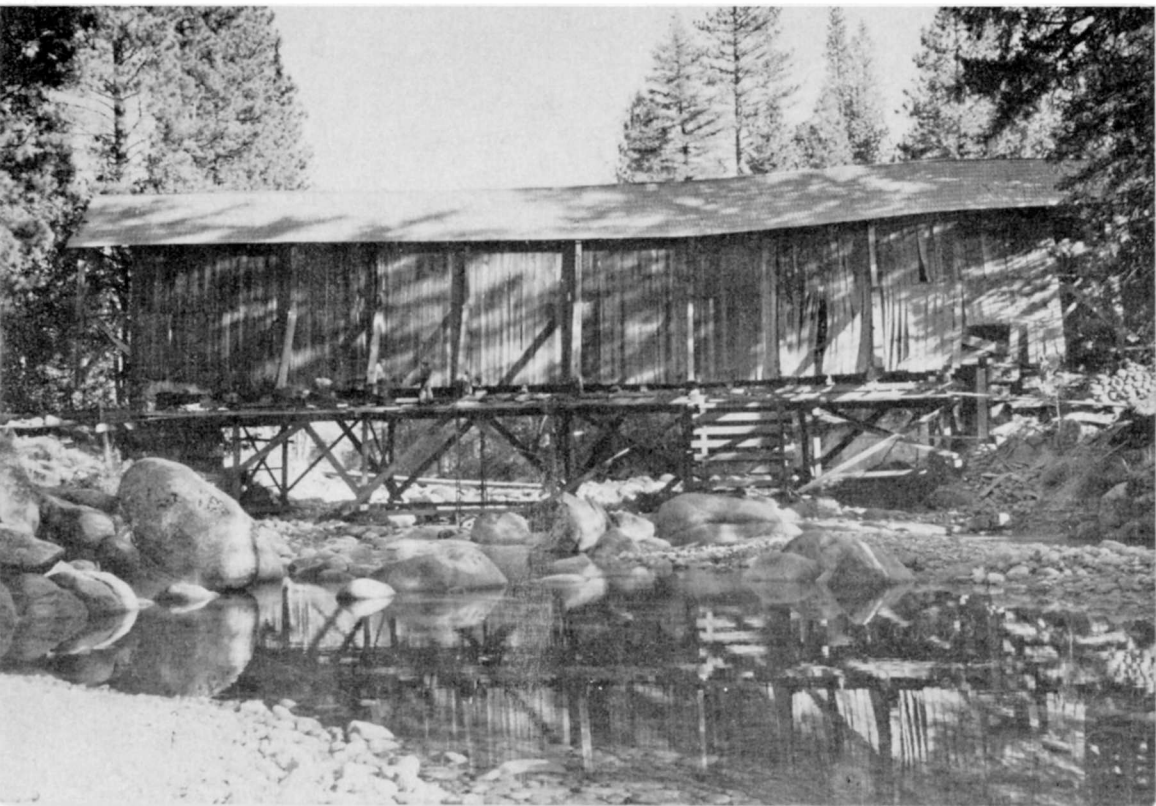
Preparing to move the bridge.

The first and most urgent step was to pull the bridge over to the north bank before the flood season began. To do this, it was jacked up and a cribbing built of wooden beams placed beneath it. Pieces of 3-inch pipe were placed between wooden tracks and the lower chords to serve as rollers. Blocks and cables were rigged and the winch on a caterpillar tractor pulled the old bridge to safety on November 29, 1956.

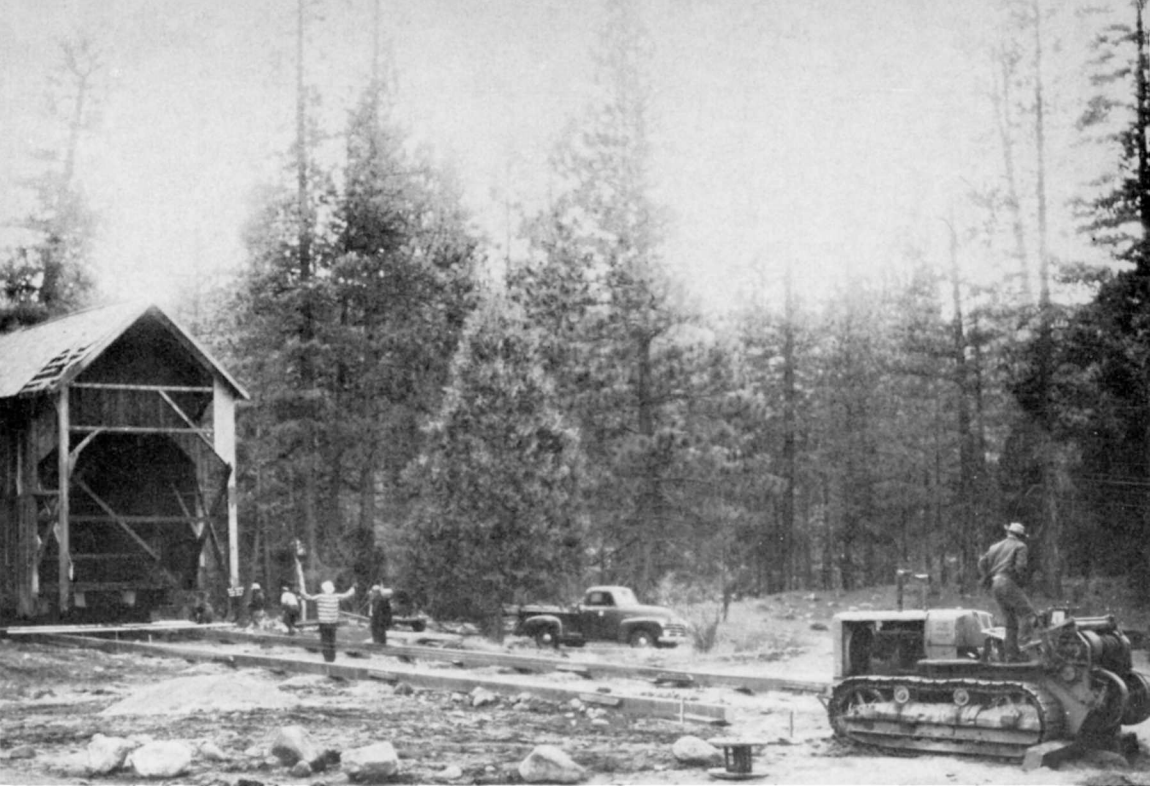
The bridge moved smoothly ashore.

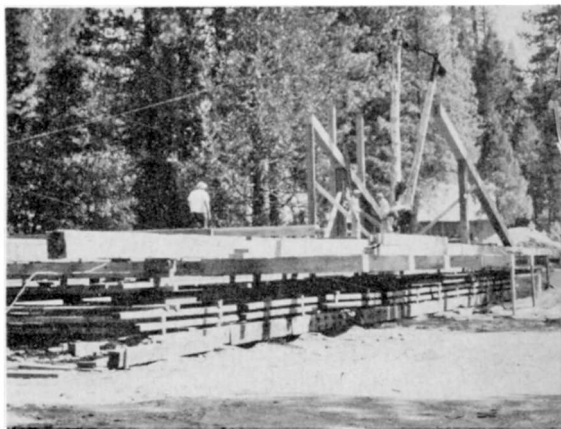
Replacing the timbers called for special skills.

The reconstruction of the bridge took place on the north bank of the river. New timbers were hand hewn from ponderosa pine and the trusses were assembled on steel "I" beams

(steel beams whose cross-section resembles the letter "I"), which were to serve as "tracks" when the bridge was pulled back into place. To guard against water, all joints were made watertight so that moisture could not invade them and provide a suitable habitat for fungi which would cause

rotting, one of the major factors contributing to the weakening of the old bridge. Paper and sealing material were placed between all timbers. This plus the weight of the timbers produced a watertight seal.

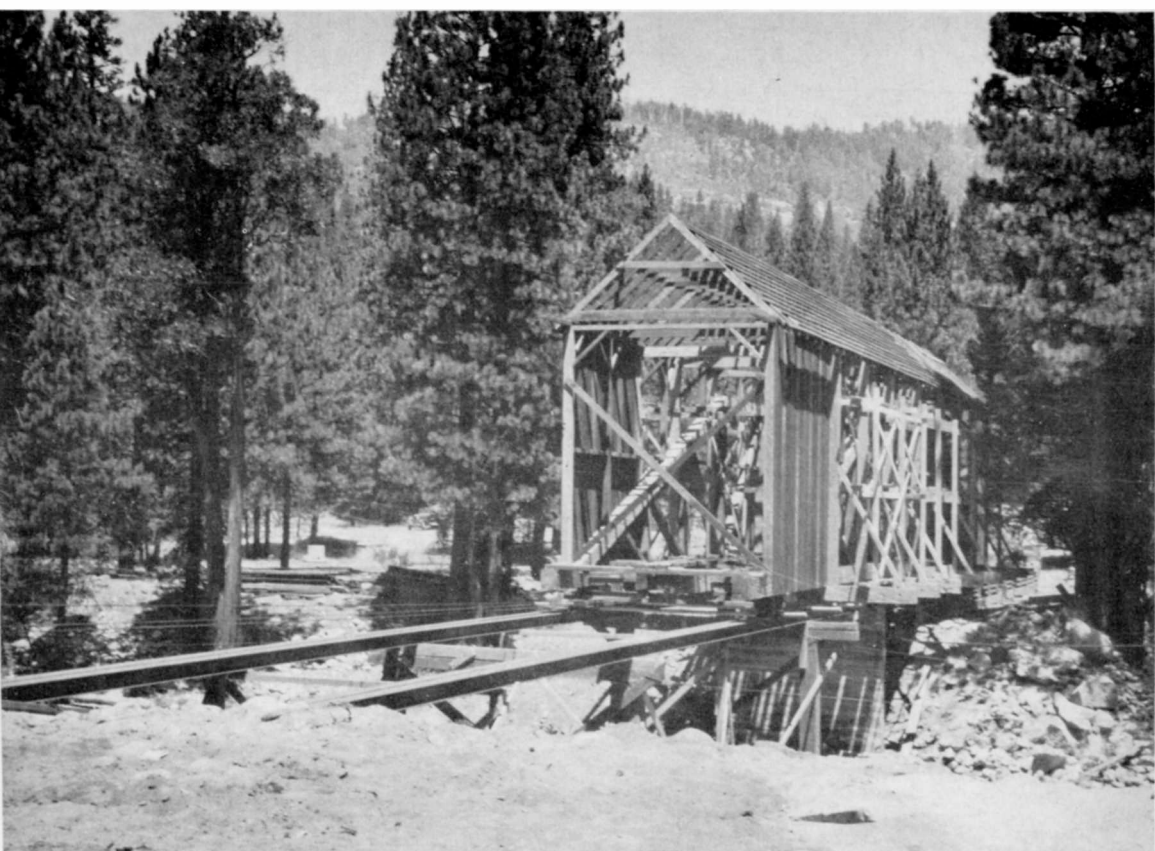
With gentle easing the bridge came back.

resting. These were then welded together forming one continuous "track". The bridge was then raised and three inch pipe was placed between the lower chords and the track so that the restored bridge could be pulled back into place just as the old bridge had been pulled to safety. After the bridge had been pulled back into position, an operation which lasted about 5 hours, it was once more jacked up, the pipe and "I" beams were removed, and it was lowered onto its abutments, never, it is hoped, to be moved again.

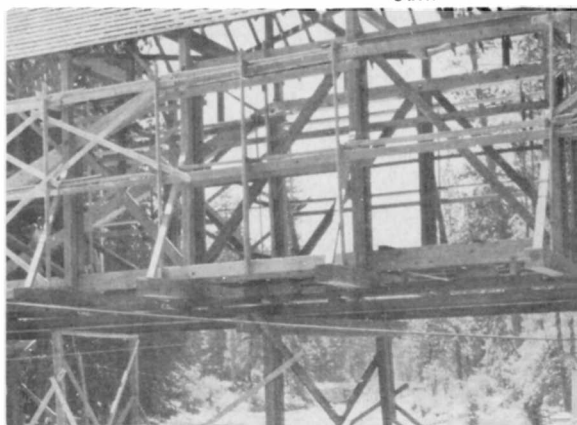
Once in place the shell was replaced.

Now with the siding, flooring, and shingles in place, the Wawona Covered Bridge stands again. It stands solidly, with no temporary piers to help support it. It stands true with no sag or lean. Now today's children and after them their children, can see

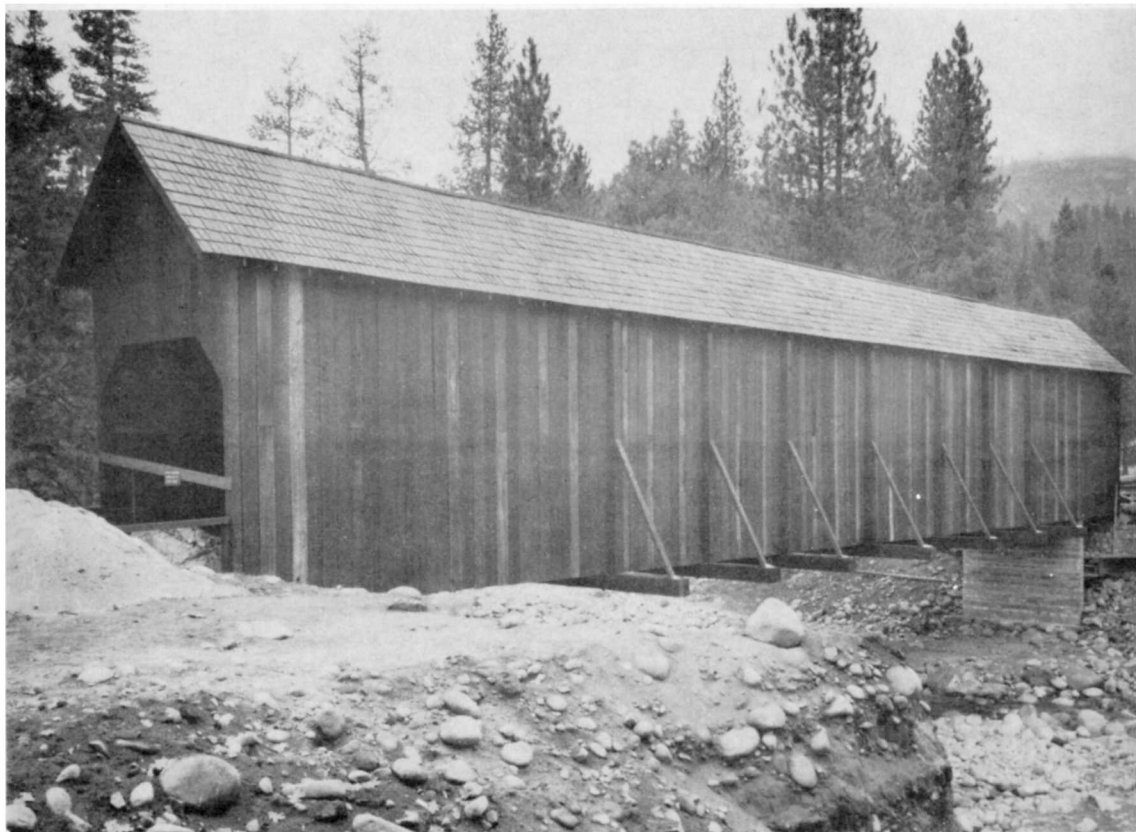
The bridge as it appears today. Only rock work and fill remain to complete the job.
