UNITED STATES DEPARTMENT OF THE INTERIOR  
NATIONAL PARK SERVICE  
**NATIONAL REGISTER OF HISTORIC PLACES  
INVENTORY -- NOMINATION FORM**  
FOR FEDERAL PROPERTIES

The Carriage Paths, Bridges and Gatehouses, Acadia National Park

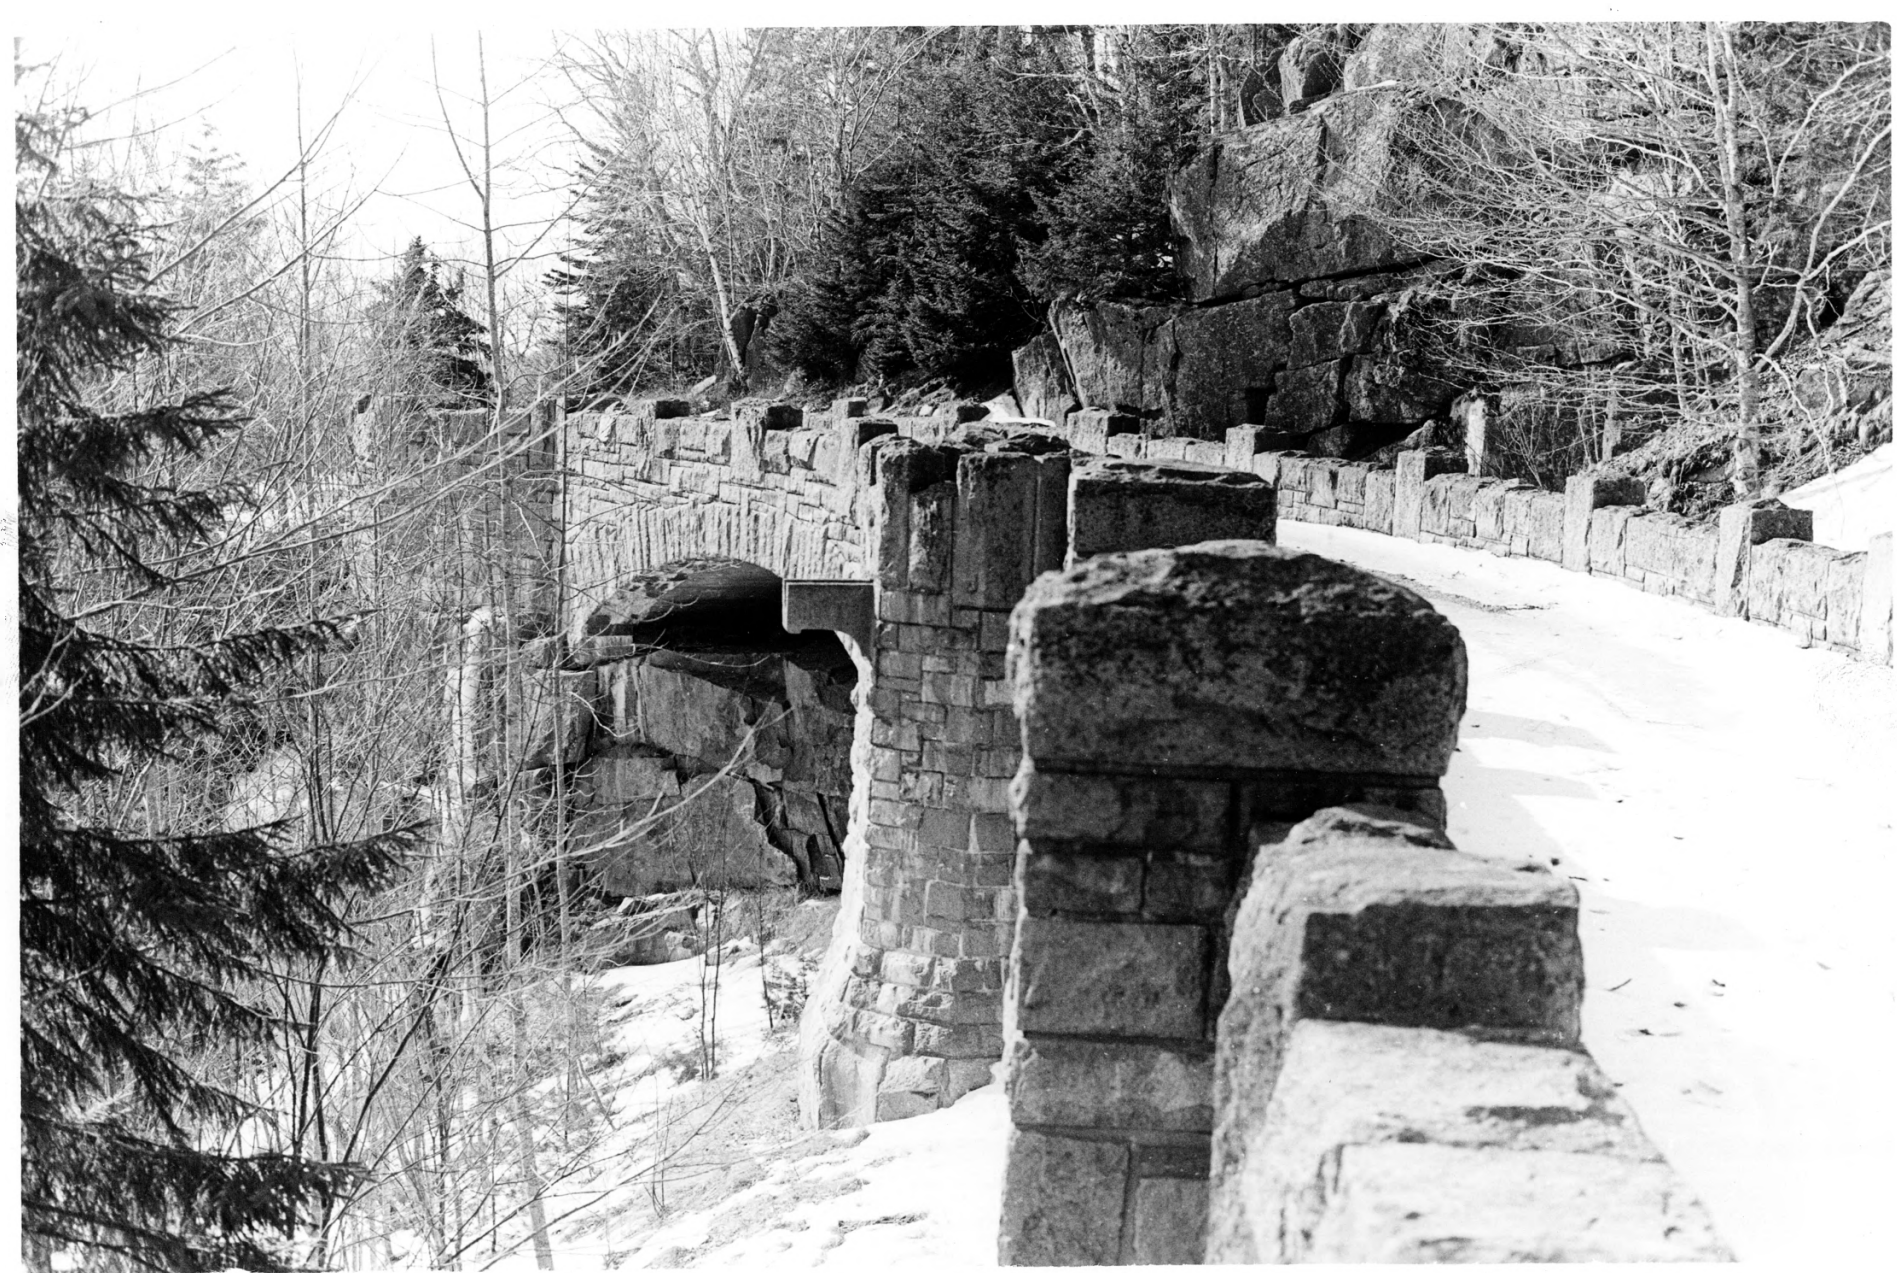
Hancock County, Maine # 20130

The Cliff Side Bridge, completed in 1932, is a 232-foot-long structure that most closely resembles a medieval battlement. The two-lane gravel-surfaced Carriage Path curves out over a vast ravine. The stone and mortar substructure is clad in quarry-faced random laid ashlar. The 50-foot span segmental arch has a row of slender and tall radiating voussoirs. On either side of the arch are massive bayed abutments, battered at the base, which at the bridge deck become viewers' platforms. The railing of the bridge is crenelated by the upright placement of massive handhewn boulders at regular intervals. The viewers' platforms have the same ponderous crenelation, as well as finely dressed stone chutes set in the masonry to drain water from the structure.

Jordan Ridge - Cliffside Bridge 1932

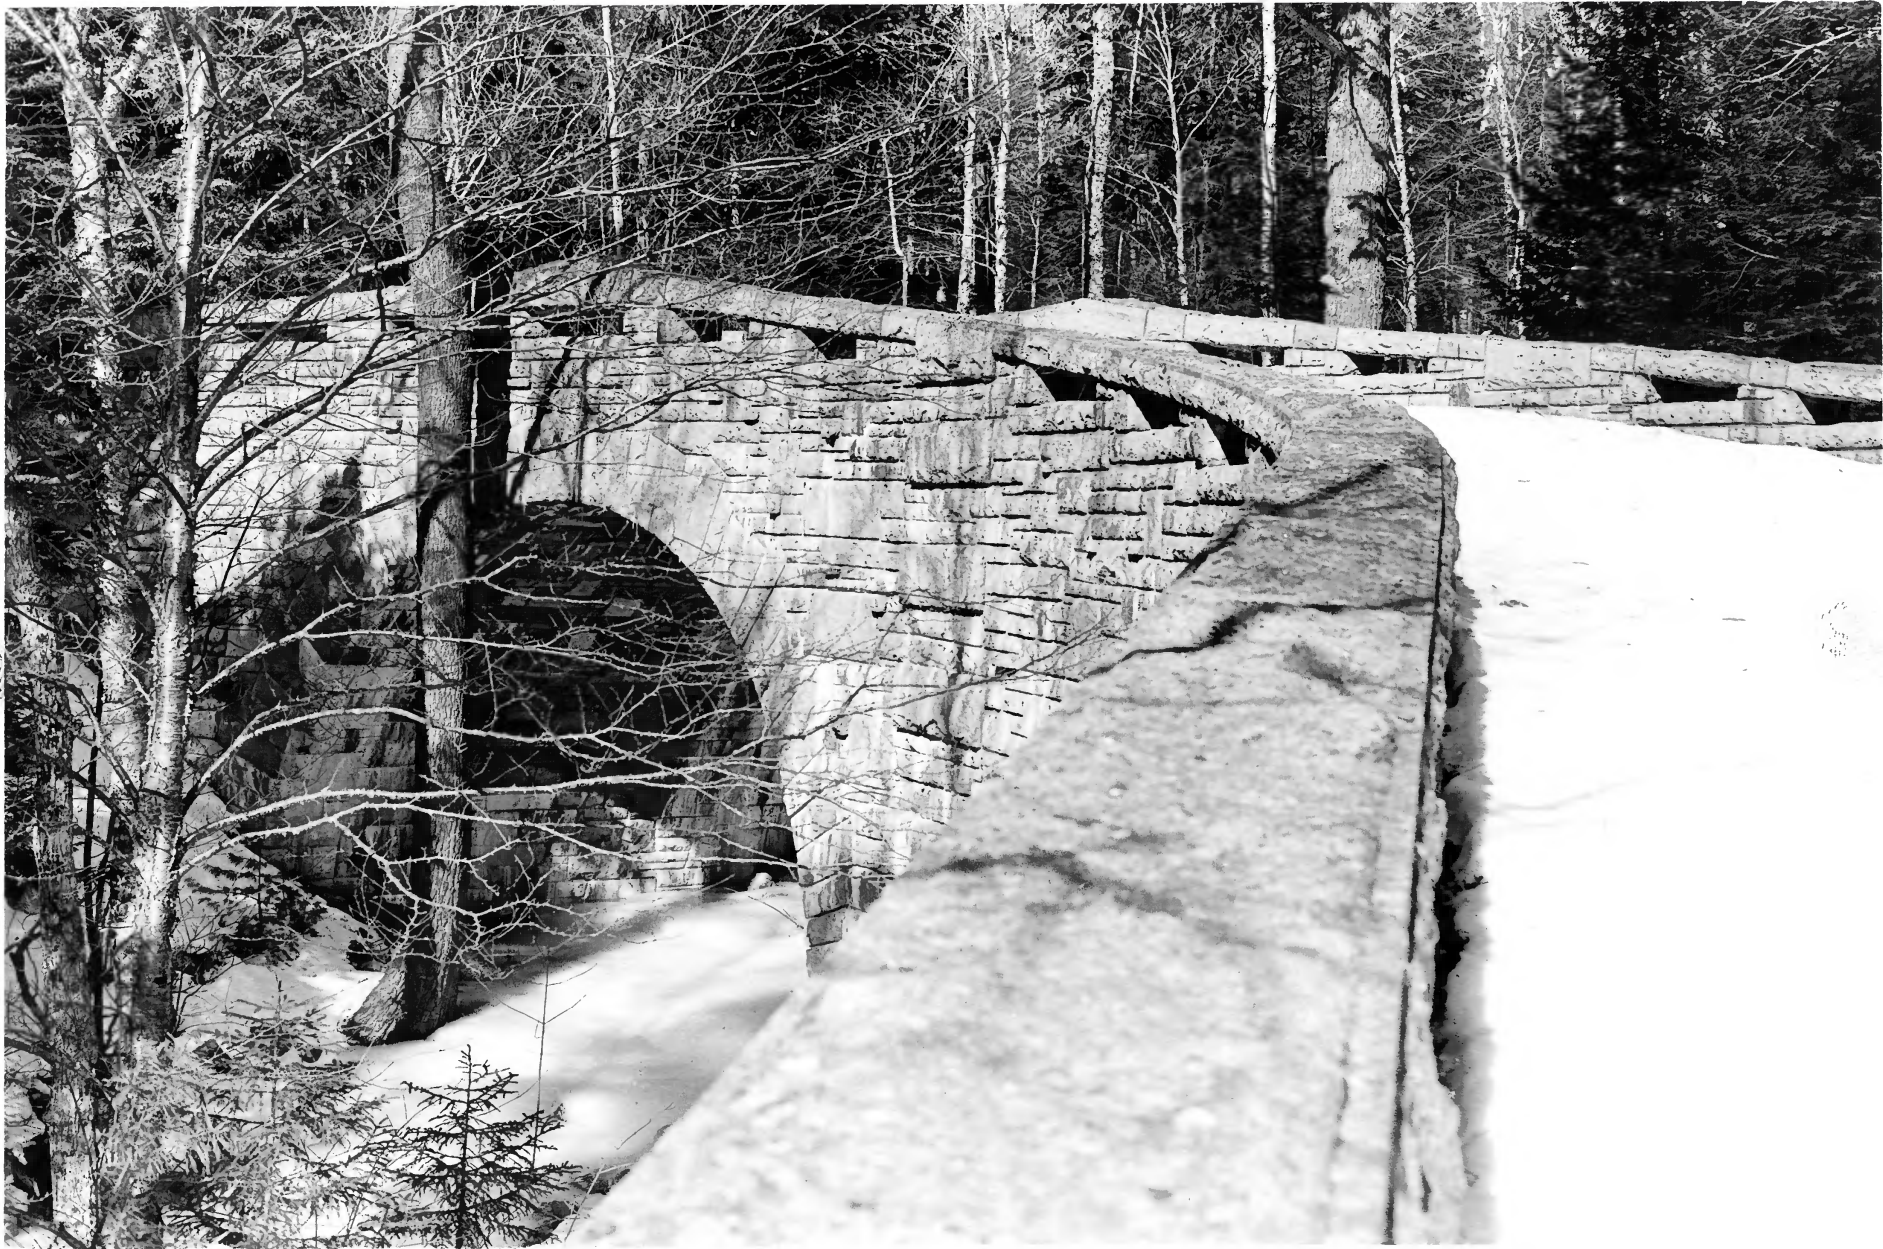
The Amphitheatre Bridge, built in 1928, is a long, 236-foot structure that traverses the deep Amphitheatre ravine and carries a two-lane Carriage Path. The gravel-surfaced deck flares broadly at either end. The 50-foot rounded arch span is constructed of rough-dressed, uneven radiating voussoirs and has a prominent keystone. The stone and mortar substructure is clad in quarry-faced random laid ashlar and incorporates large projecting blocks set in several discontinuous vertical rows. The railing copings are of heavy, rectangular blocks of rough-dressed granite with beveled edges and with a gently peaked stone in the center. The rows of ashlar are not completed to their outer edges and this stepped motif, together with the continuous railing coping their edges support, creates a series of triangular openings piercing the wall.

Amphitheater Bridge 1931

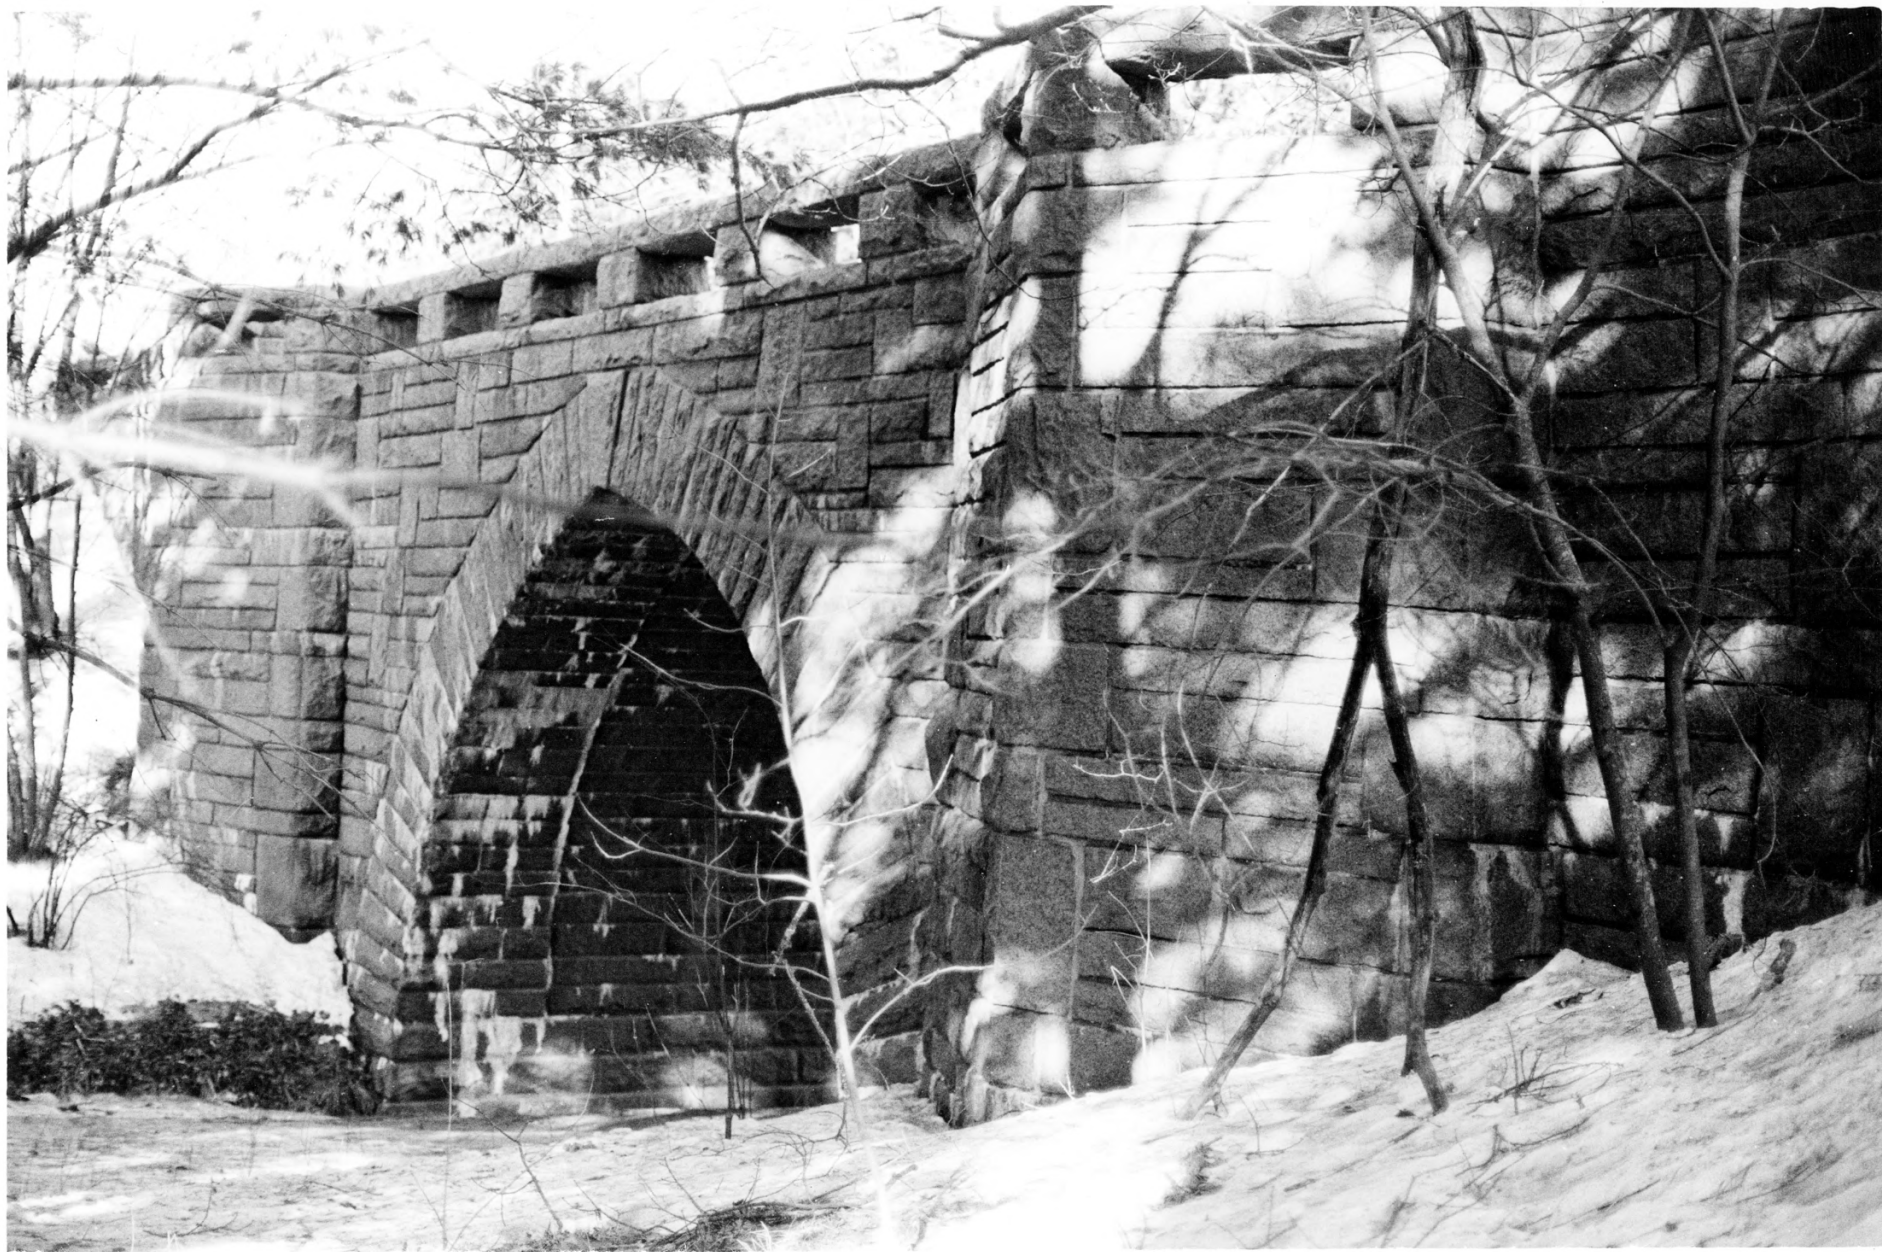
The Carriage Path passes underneath the Gothic-arched Eagle Lake Bridge which carries Route 233 above. It was built in 1927 and is 118 feet in length. The refined Gothic arch spans 30 feet. The stone and mortar substructures are clad in quarry-faced random laid ashlar and the arch is outlined in radiating voussoirs of the same material. There is a two-lane deck of bituminous concrete with an asphalt surface that traverses the two-lane, gravel-surfaced Carriage Path. This bridge was the object of a 1974 widening project that expanded the upper deck to accommodate Route 233 traffic and which received engineering awards for the division, the separation move made on a system of ball bearings, and the excellent reseaming with the newly added masonry.

Eagle Lake Bridge on Route #233 1928

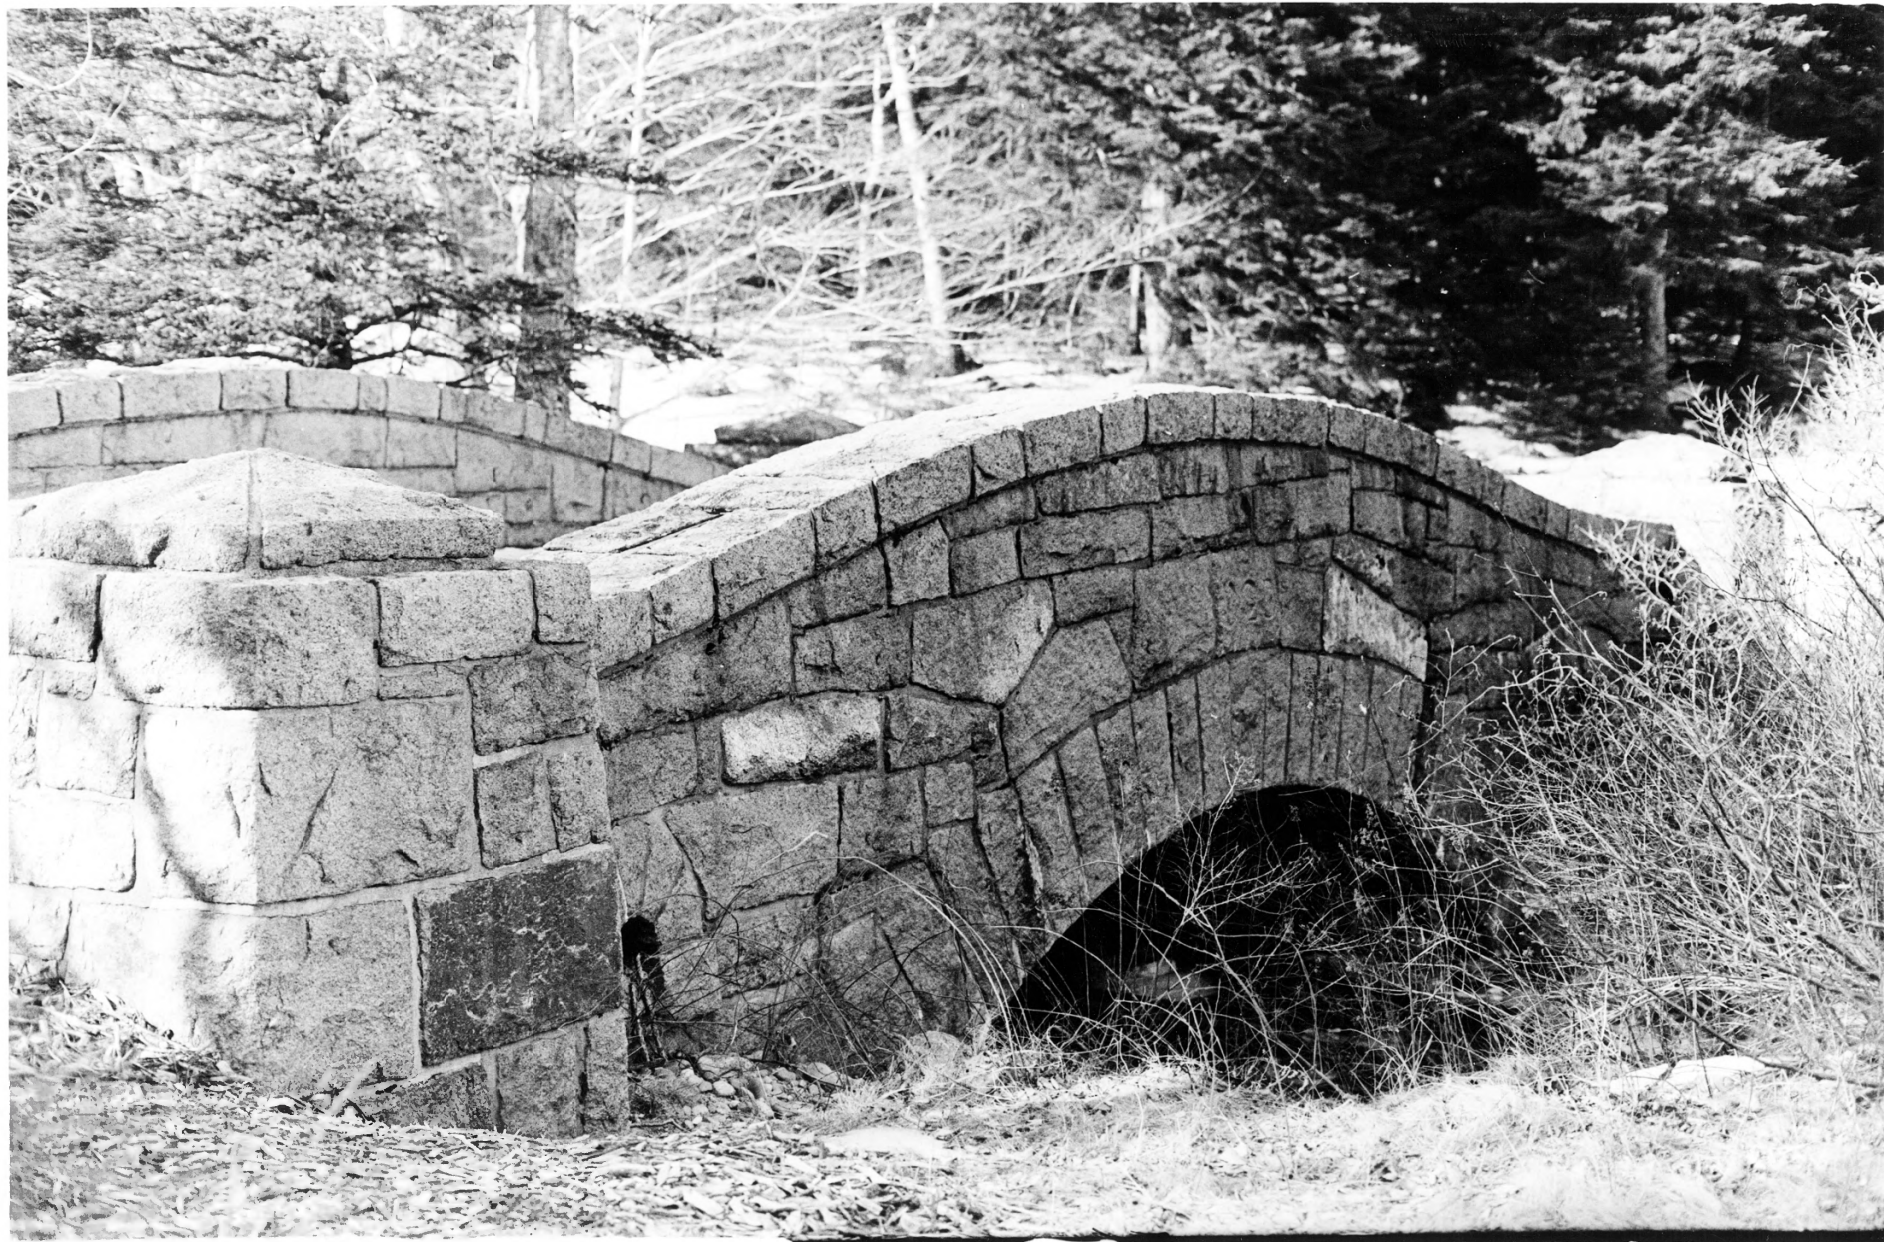
The Small Stone Bridge was completed in 1920 and is a compact and powerful 40-foot length with a 20-foot single segmental-arched span. Its two-lane, arched, gravel deck is flared at either end. The stone masonry substructure is surfaced in quarry-faced granite blocks which are laid both random and polygonally between the radiating voussoirs of the arch and orderly coping stones of the gently arched rail. The abutments are square, solid masses surfaced in random ashlar and with a flattened pyramidal capstone.

Small Stone Bridge - Jordan Stream 1920

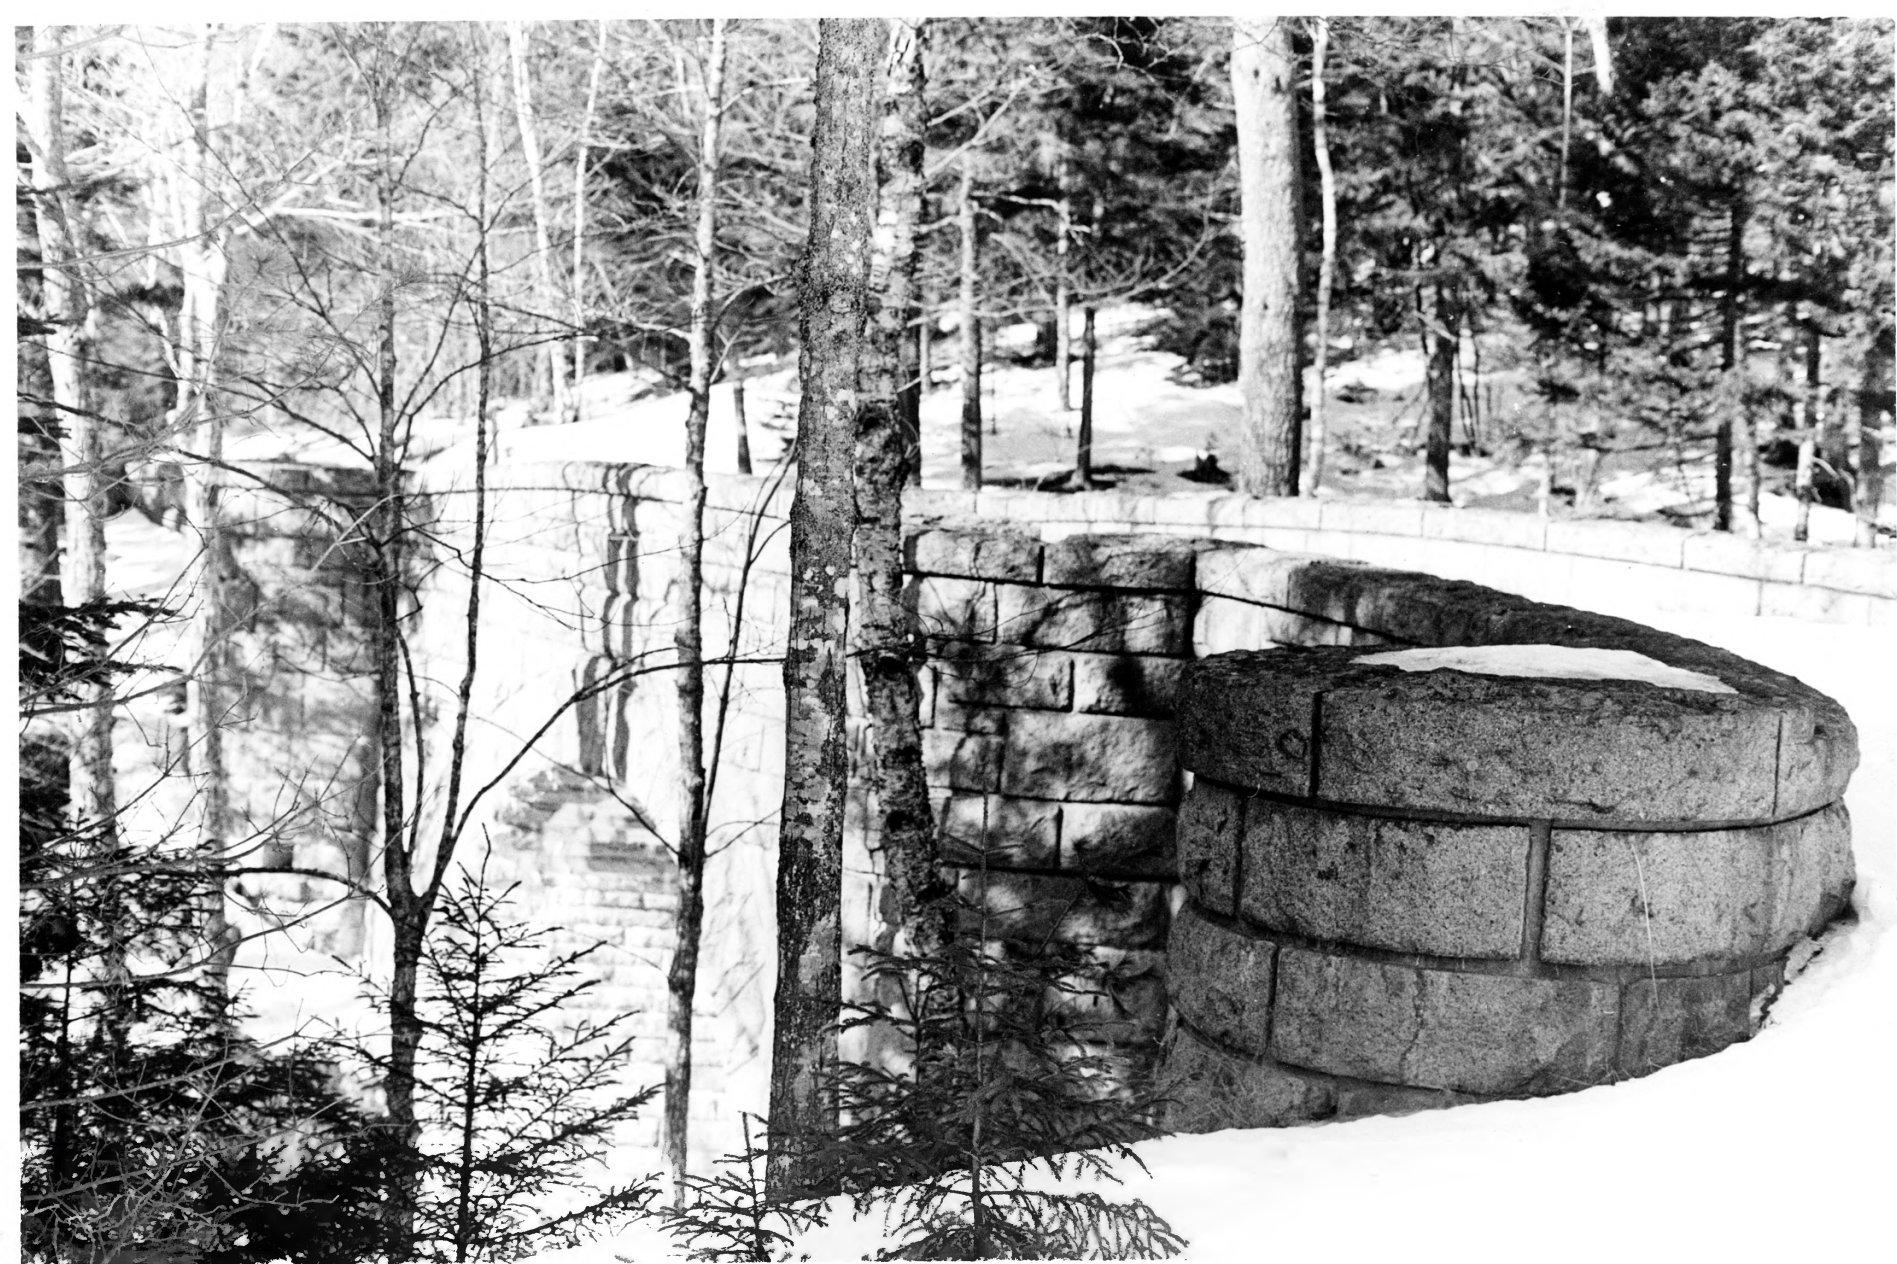
The Waterfall Bridge, completed in 1925, carries the two-lane gravel-surfaced deck over Hadlock Brook. The structure is 125 feet in length and flares gently at the ends. The 20-foot span of its rounded arch is outlined by a firm row of quarry-faced radiating voussoirs. The stone and mortar substructure is clad in quarry-faced random laid ashlar and bold blocks of the same material form the railing copings. A pair of semi-circular viewing platforms bow out on either side to take advantage of the tread and deep ravine.

Waterfall Bridge 1925

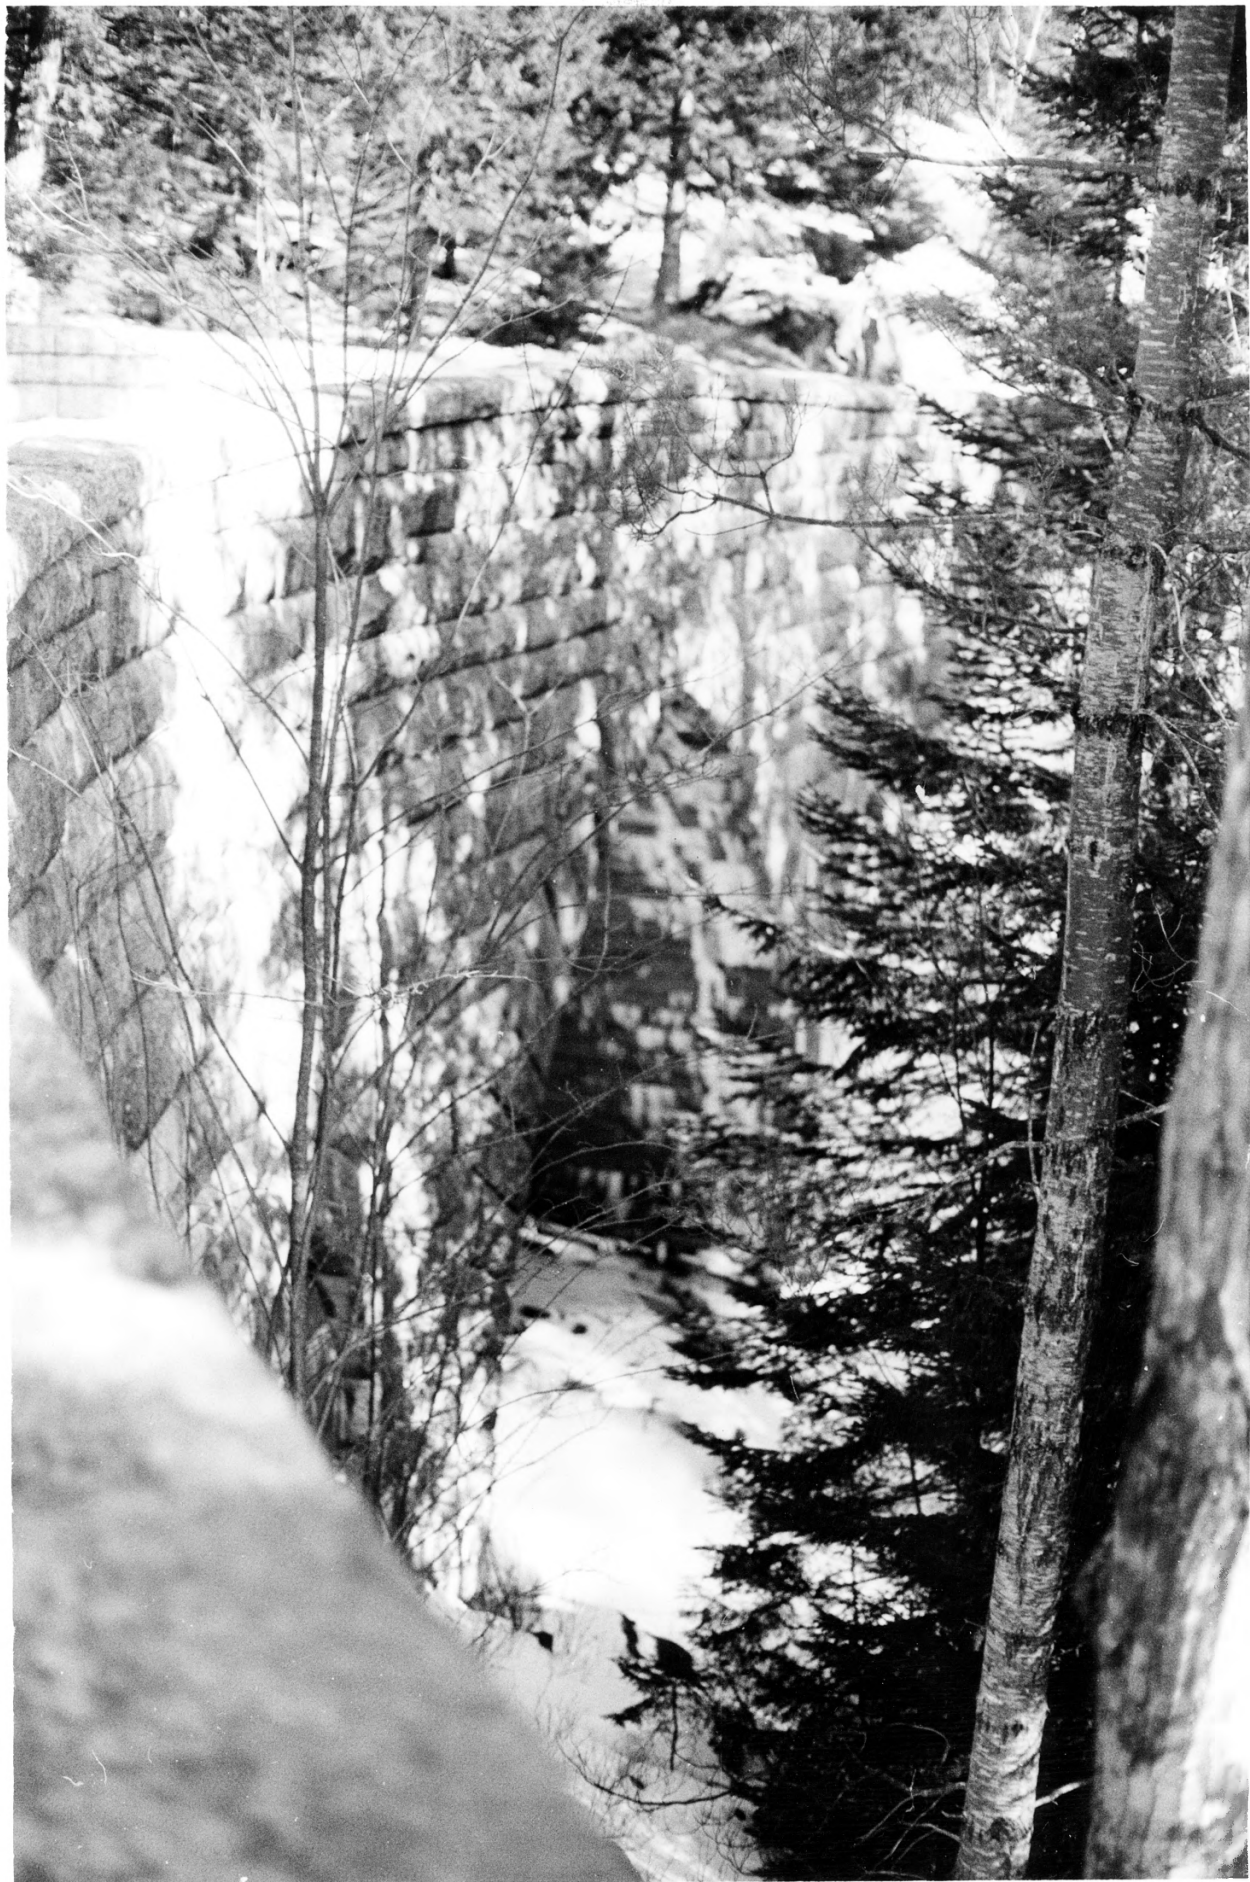
The Hemlock Bridge, built in 1925, is a massive Gothic-arched structure crossing Maple Spring Brook. It is a very long 185 feet that curves back sharply in a flare at either end. The Gothic arch span is 30 feet across and is sharply outlined in radiating voussoirs. The stone and mortar substructure is entirely clad in quarry-faced random laid ashlar and the rail coping of large solid square of granite are similarly dressed.

Maple Spring or Hemlock Brook 1924

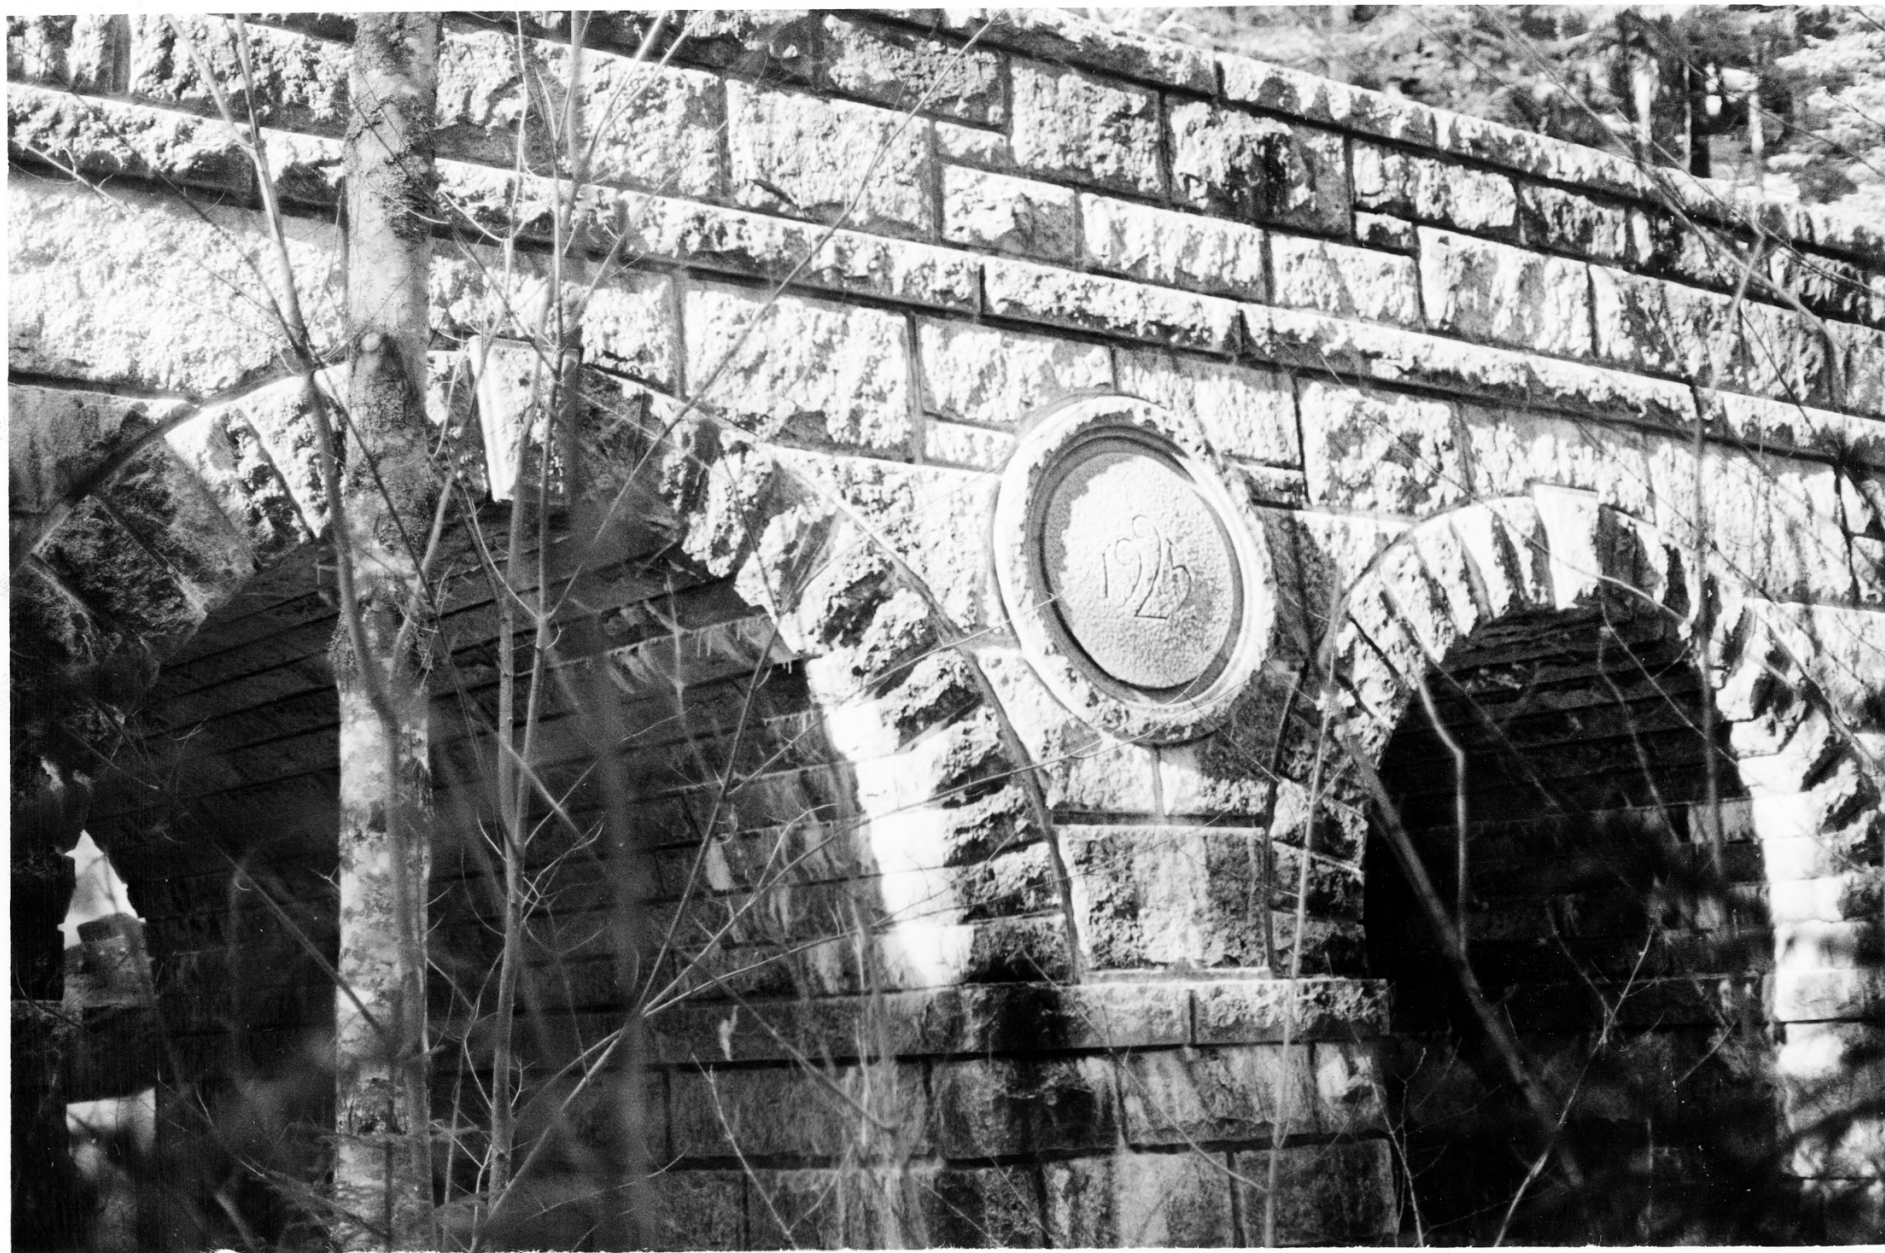
The Deer Brook Bridge, completed in 1925, is a two-lane structure that soars high above its namesake near the Jordan Cliffs. It is 140 foot long, two-lane bridge that has a gravel-surfaced deck and is flared at either end. The two-rounded arches are tall and narrow 8-foot spans, separated by a delicate pier and outlined by slender radiating voussoirs. The entire stone and mortar substructure is clad in quarry-faced random laid ashlar. Set into the spandrel of the arches is a plain, circular medallion into which has been carved the year 1925.

Deer Brook Bridge 1925

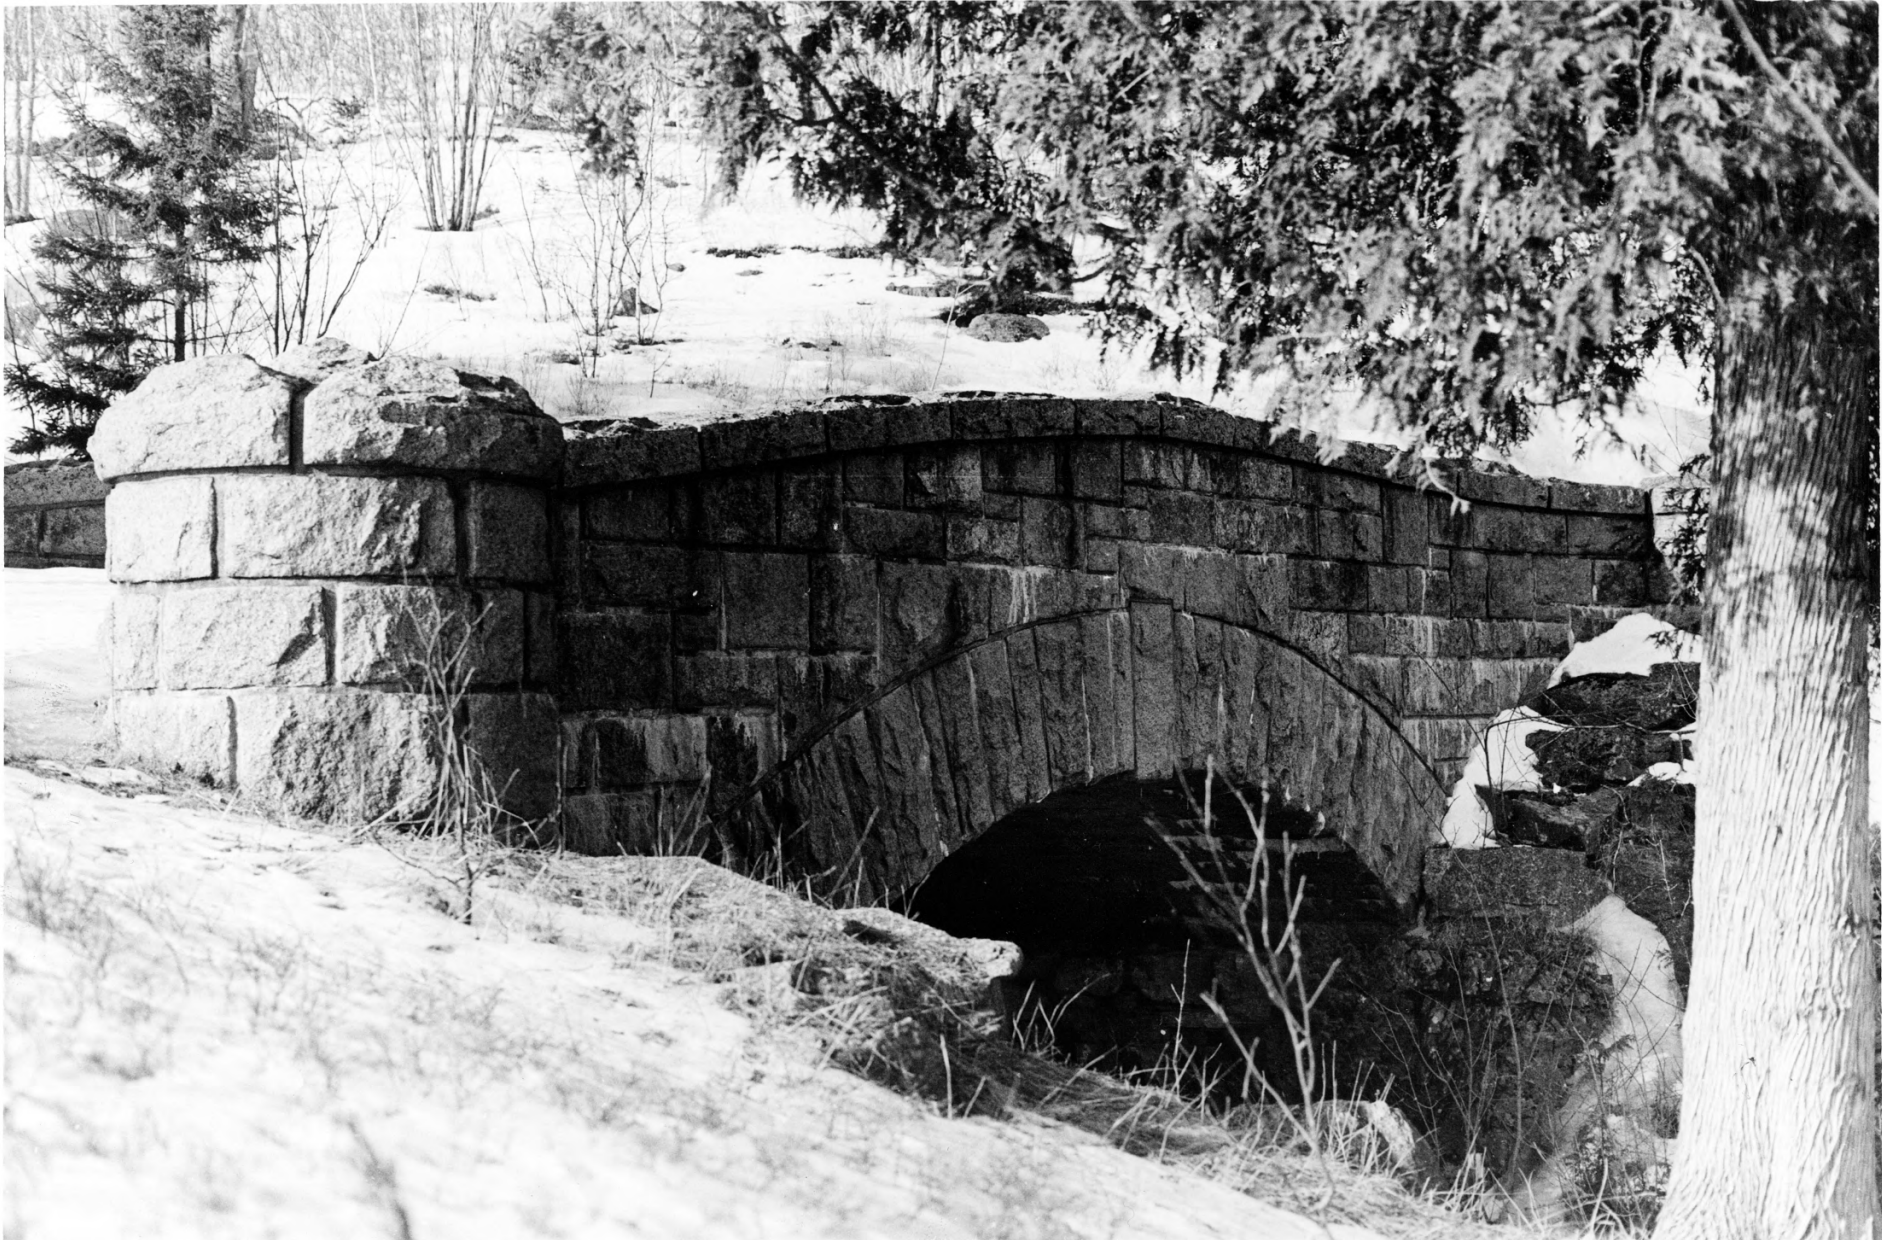
The Chasm Brook Bridge, completed in 1927, is a rustic and small-scaled 20-foot span that is 40 feet in length. It is built over Chasm Brook and has a stone and mortar substructure clad in quarry-faced random laid ashlar. The long, slender, radiating voussoirs and keystone of the segmental arch and the railing copings are also dressed in the same manner. The two-lane, gravel-surfaced deck is handsomely flared and terminates at pairs of rounded abutments which form pedestals for their gently peaked caps.

Chasm Brook Bridge 1927-28

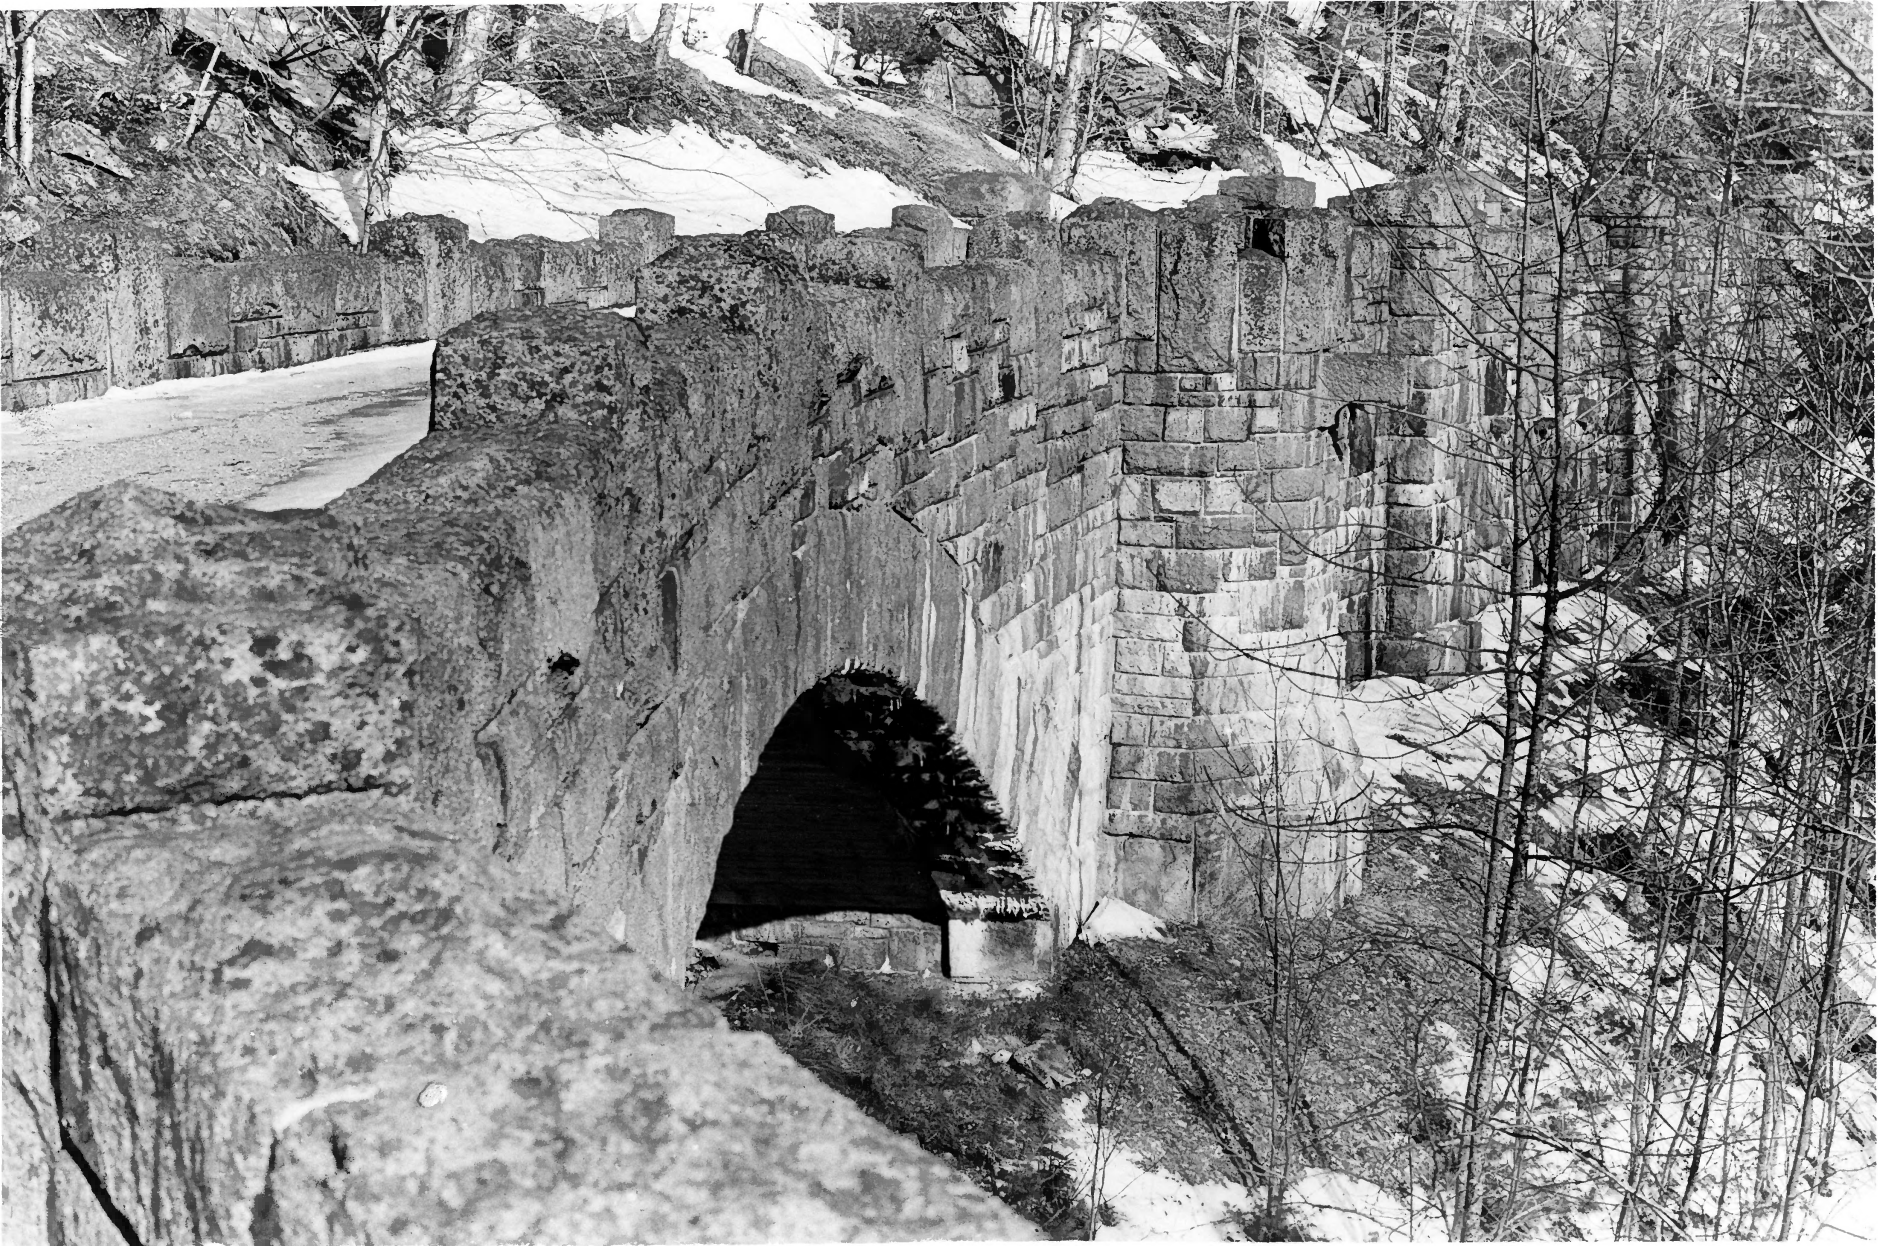
Jordan Ridge - Cliffside Bridge 1932
